Use Of A Rock Ramp For Grade Control – Dueñas Bridge Case

Julio M. Kuroiwa, Alfredo J. Mansen and Edgar Rodriguez
Mansen, Kuroiwa Ings Asoc. SAC

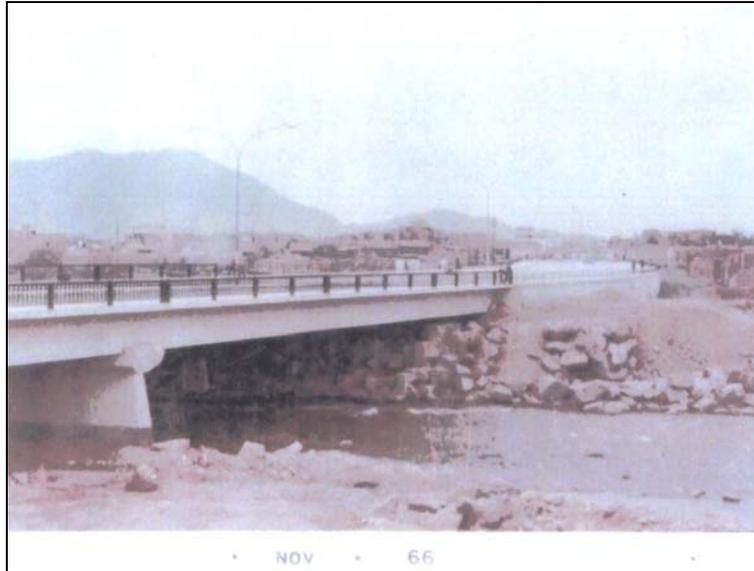
Figure 1. View of the Dueñas Bridge in 1966. This photograph was taken from the left bank. Notice that river flows underneath the two openings of the bridge.

The Dueñas Bridge is a two-span crossing structure supported by abutments in the right and left banks and a central pier. At first, the river flowed underneath the two openings of the bridge as seen in Figure 1. Since its construction, finished in 1966, the river morphology has undergone major changes due to the construction of other bridges, accumulation of sediment of foreign origin (mainly garbage) and the construction of remedial works. The so called remedial works not only did not solve the problem at hand, but accelerated the rate of incision of the river.

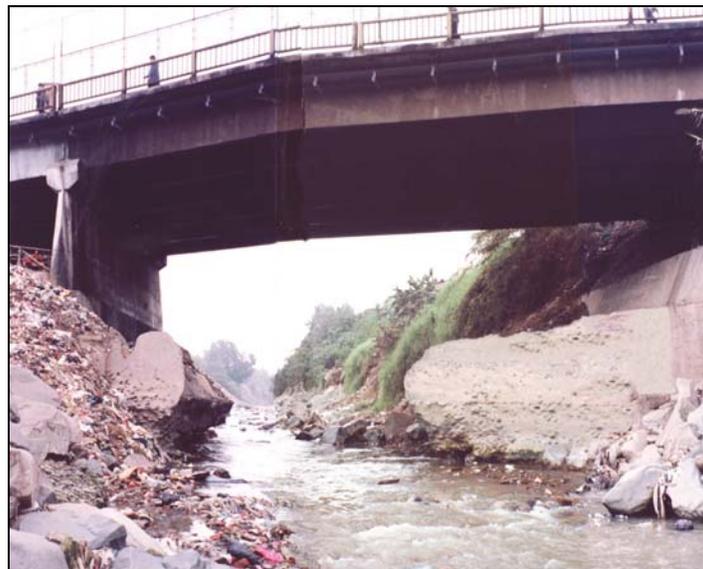
Figure 2. View showing the bed level in 2001. Notice that the river flows underneath one opening. Also notice scour in the right bank (left) and leftovers of a remedial work.

At the Dueñas Bridge the river level had descended 8 m (26.7 feet) approximately. At the time the Dueñas Bridge had been designed, the designers considered that the width of the river was 60 m (196.9 feet), but the occupants of both banks have been pouring garbage and waste to narrow the stream and add land to their properties.

The narrowing of the stream has caused deepening of the river. Officers of the Ministry of Transportation and Communication (MTC) were hired by INVERMET to rebuild the foundation and reinforce the river bed in 1978. The original right abutment of the bridge is not compromised because due to the incision of the left opening of the bridge it does not flow water underneath the right opening. Even a two-lane road has been built underneath the right opening.

Scour of the river bed has continued even after the remedial works where conducted. The foundation has been undermined below the bottom of the reconstructed foundation.

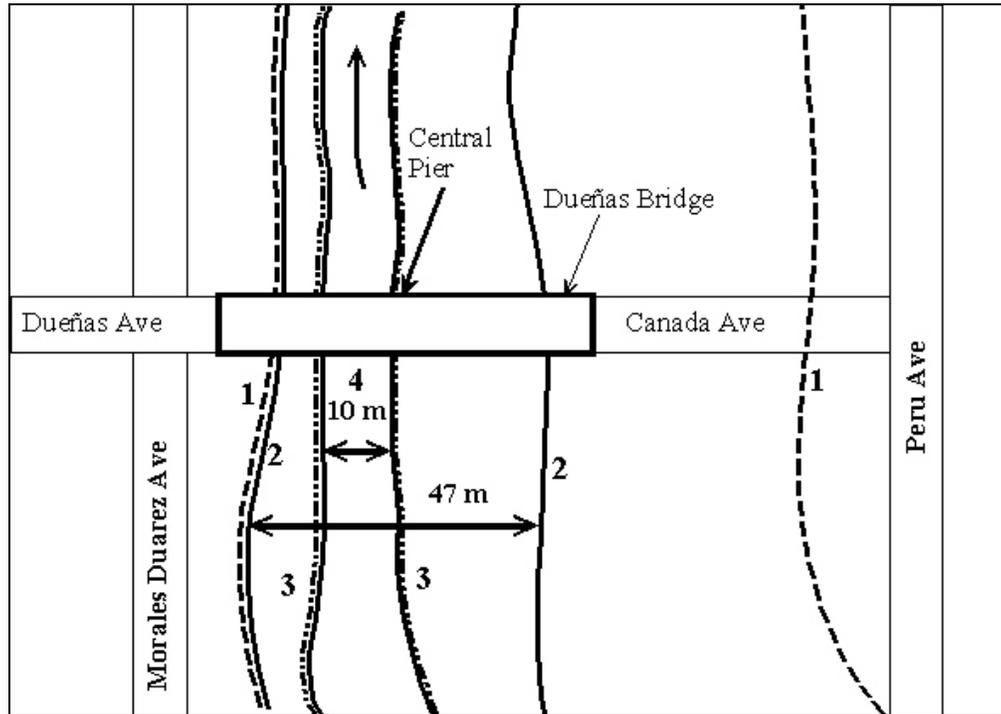
Riprap protection had been built to train the river upstream of the bridge. At the time of the construction of the bridge, the stream was 50 m (164 ft) wide. Narrowing of the stream, together with the training of the river and the construction of civil works has caused significant changes in the stream morphology.

The incision of the stream was more pronounced in the left opening of the river, exposing the foundation of the central pier and left abutment, so that additional footing was placed underneath the existing foundations of the central pier and the left abutment.

A grade control structure was built in 1977. It consisted mainly of a concrete drop with a stone embedded in concrete apron built downstream of the drop for scour protection. This structure merely protected the bed upstream of the bed temporarily, but regressive erosion occurred downstream of the apron, leading to cracking of the structure because no major reinforcement was included.

Figure 3. This sketch shows the evolution of the Rimac River with time. (1) Broken lines show the limits of the Paleo Rimac River. (2) Limits of the river in 1966. (3) River bottom when remedial works had been built. (4) Width of the river in 2001.

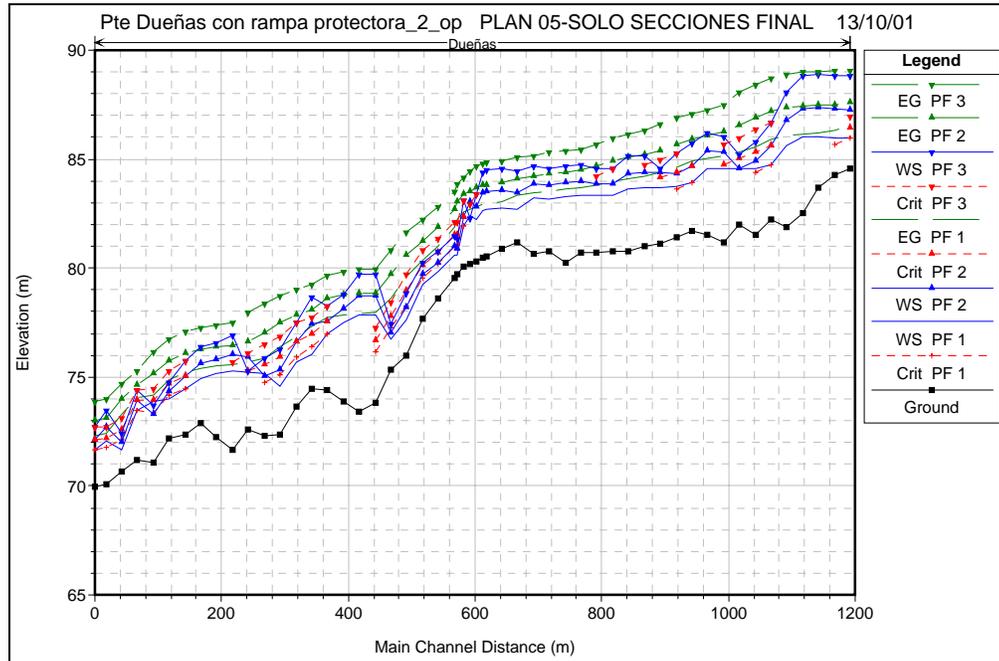
The rock ramp is divided in two reaches. From section 0 + 550 to 0 + 620 it has a 1.33 % slope. From the latter section to 0 + 725 it has a 3.65 % slope until it intercepts the natural terrain. (See Figure 6 at the end of paper). The profiles of the backwater curves corresponding to the two-year flow discharge ($129 \text{ m}^3\text{s}^{-1}$) and five-year flow discharge ($198 \text{ m}^3\text{s}^{-1}$) are shown in Figure 4. This output was obtained using USACOE’s HEC-RAS 2.2b.

The hydraulic simulations showed that the shear stress distribution was very uneven. Just downstream of the slope change the maximum shear stresses are produced. A summary of the results is presented below in Table 1.

Figure 4. Graphical output of the hydraulic simulation using USACOE’s HEC-RAS 2.2b.

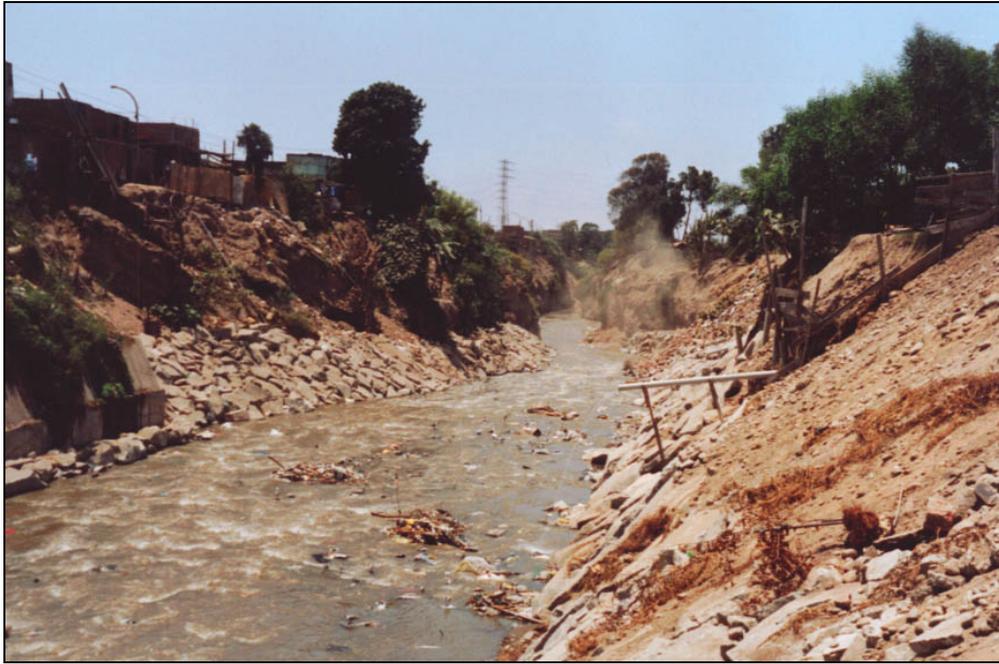
discharge was $94 \text{ m}^3\text{s}^{-1}$ (3319.6 cfs) at station R2 and during the 2002 – 2003 the peak discharge was $124 \text{ m}^3\text{s}^{-1}$ (4379 cfs). The behavior of the rock ramp was videotaped and it will be presented at the session. Upstream of the structure the flow is mild, but at the slope break the flow becomes very turbulent. Water impacts the rocks, angular in nature, and energy tends to dissipate. Figure 5 shows the Rimac River downstream of the Dueñas Bridge in January 2001. The authors have visited the area several times and no movement of rocks has been detected. The rock ramp is still in service and has not been replaced so far.

Figure 5. This photograph shows the rock ramp downstream of the Dueñas bridge. This picture was taken from the right bank of the river.

- a) The rock ramp has effectively protected the river bed against scour for almost two years. The river bed is stable and no major changes have occurred.
