THESIS

EVALUATING THE LONG-TERM DURABILITY OF FIBER REINFORCED
POLYMERS VIA FIELD ASSESSMENTS OF REINFORCED CONCRETE
STRUCTURES

Colorado State University

Fall 2011

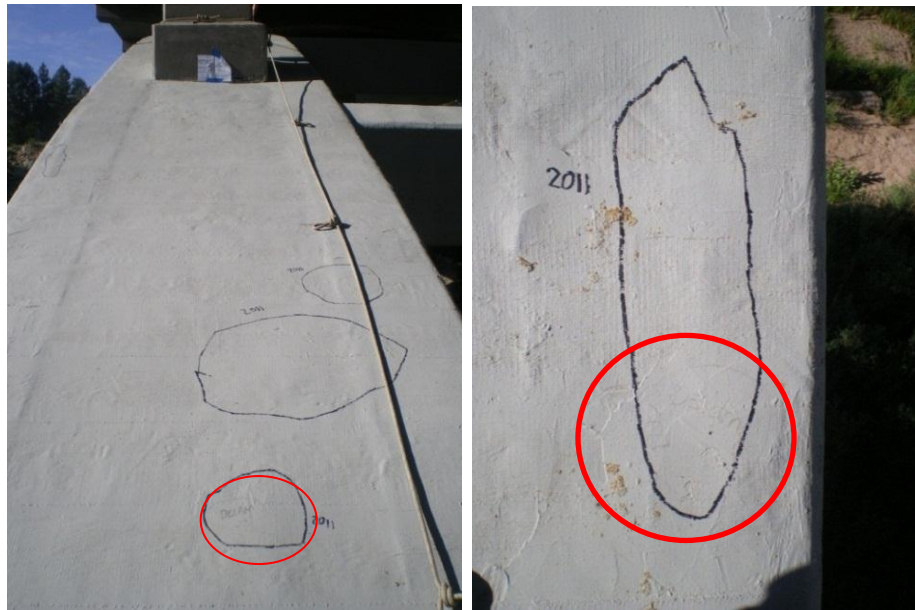
Markings made with a “permanent” marker on the bridge from the 2007 bridge inspection were barely visible at the time of the 2011 field assessment. Depending on the exposure from moisture and sun, markings on the bridge can exist for only a relatively short time with respect to the life span of the bridge. Below are three photographs of the areas identified from June 2007, two of which were barely visible at the time of the July 2011 visit. There were no markings found on the east arch from the inspections in 2005 and 2009. In addition to the three voids, three cracks in the CFRP were also identified in 2007, one of which can be seen below.

Figures 3.17 and 3.18. Outlined in permanent marker are identified areas of debonding between the FRP and the substrate developed in the structure between inspections in 2007 and 2011. Faintly denoted in the bottom of the photographs (enclosed in red circles) are previously found voids identified with “DELAM 07” and lines distinguishing the boundaries of the voids.

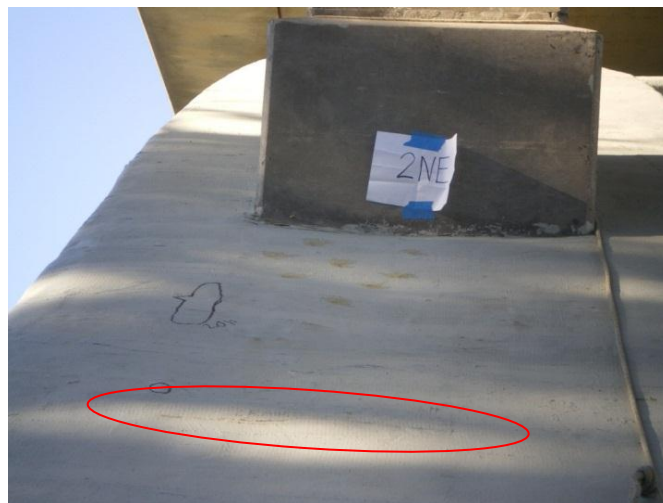
Figure 3.20. Crack identified in 2007

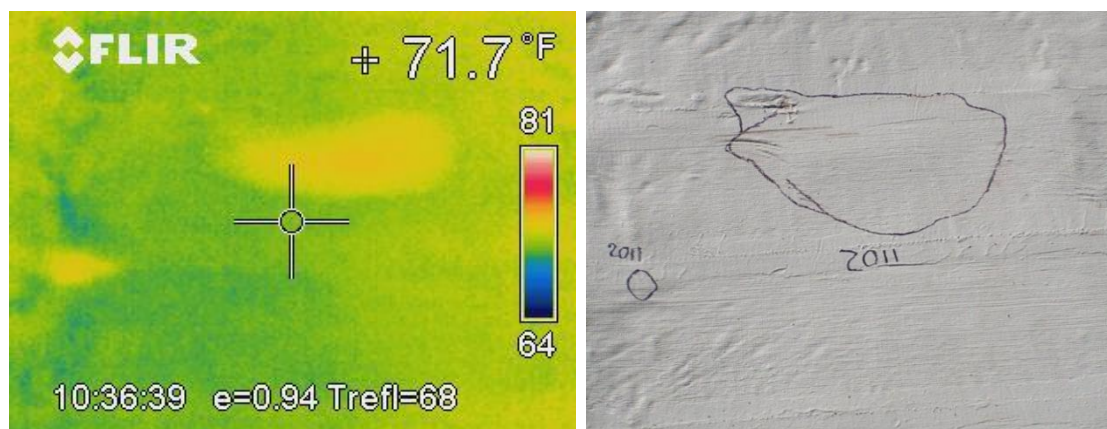
Figures 3.21 and 3.22. Photograph and thermal image from an infrared camera of two voids, (appearing yellow), found in 2011 on the 1st bay on the north side of the east arch

The images above are of two voids found in the 1st bay on the north end of the east arch. The area of the larger void was one of two areas eventually removed from the arch and is referred to as the “smaller” patch removed from the arch. Note the horizontal or transverse cracks enclosed in the red oval near the top of the void in Figure 3.23.

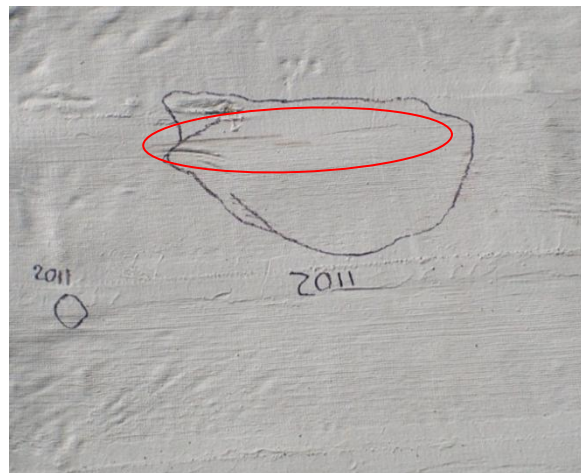
Figure 3.23. Two identified voids during the 2011 inspection, visible cracks in CFRP

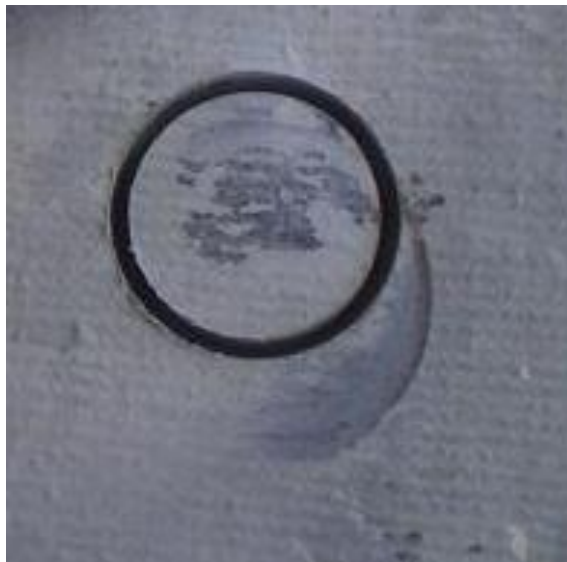
Figure 3.25. Damage caused by core bit without the use of the jig

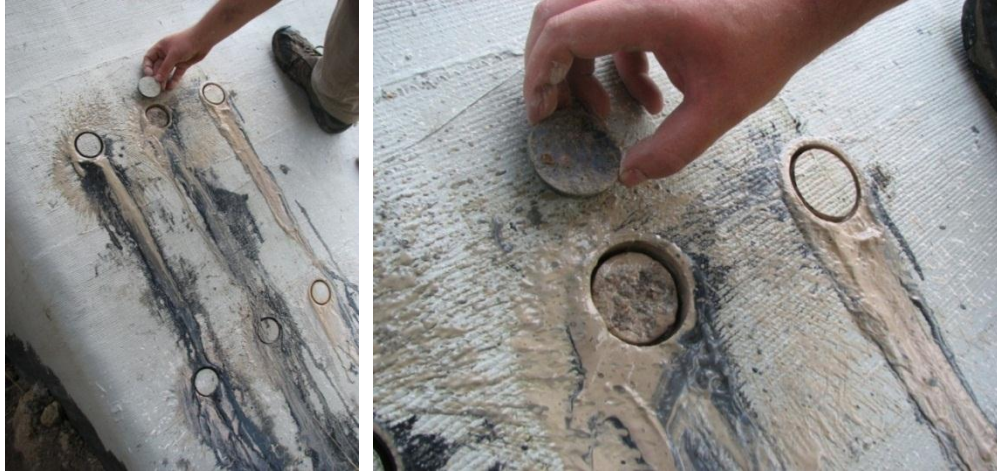
Adding torsional stresses to the circular area of CFRP and substrate inside the cored circle was inevitable due to the drilling process. These stresses were minimized by using a less aggressive drill bit with diamonds instead of a coring bit which has more aggressive carbide teeth for instance. Wet drilling by use of the ice also reduced stresses by adding water which created a slurry that removed displaced debris while using the finer particles to aid the diamonds in the cutting process. In one instance out of the 27 cored locations, the stresses induced by the drilling were enough to fail the cored section at the interface between the CFRP and the substrate. Figures 3.27 and 3.28 illustrate this occurrence.

Figures 3.27 and 3.28. The core drilling location that failed due to torsional stresses during the core drilling process, bay 1NW

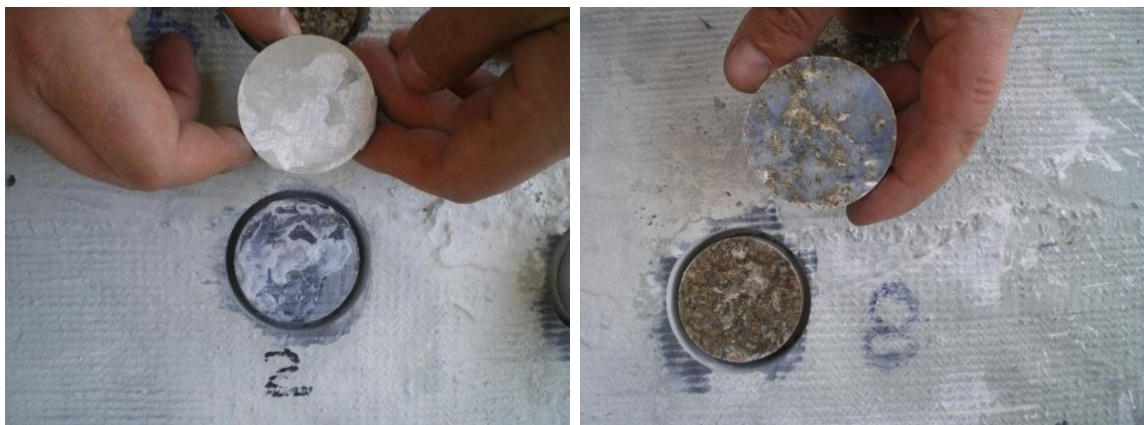
Figure 3.40 and 3.41. Failure Mode A: bonding adhesive failure at loading fixture (on left), Failure Mode E: Adhesive failure at CFRP/substrate adhesive interface (on right)

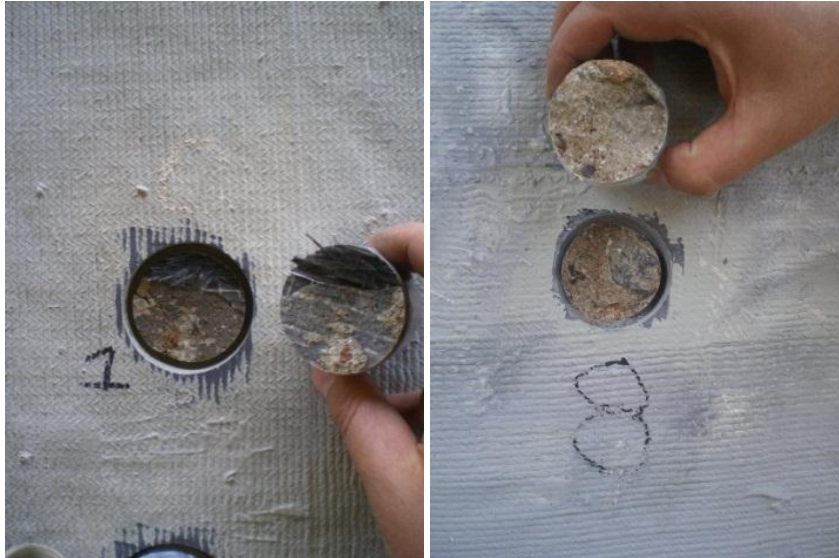
Figures 3.42 and 3.43. Failure Modes B and F: cohesive failure in FRP laminate, and mixed cohesive failure in substrate and adhesive failure at the adhesive/substrate interface, respectively (on left), Failure Mode G: cohesive failure in concrete substrate (on right)

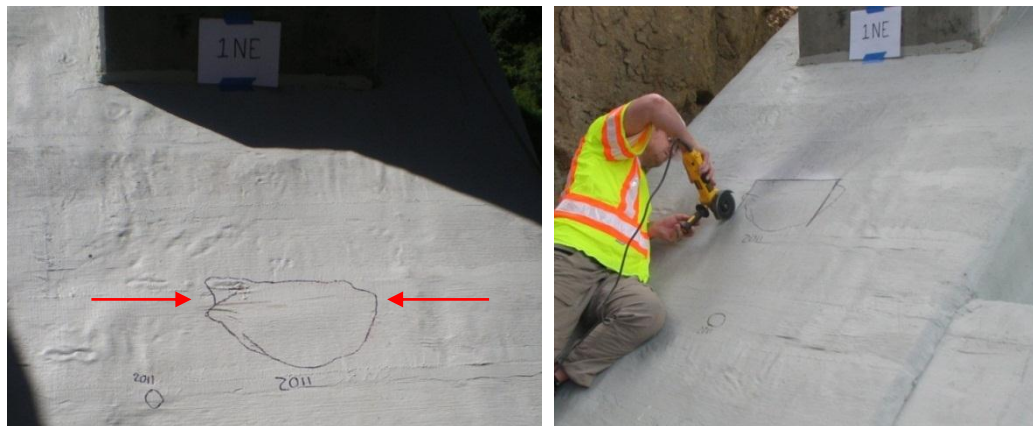
Upon cutting the lower edge of the CFRP rectangle, water exited the cut at the bottom of the void revealing standing water at the interface between the CFRP and substrate. Photographs of the void and the removal of the CFRP layer are shown in Figures 3.48 – 3.52 below.

Figures 3.48 and 3.49. Void in CFRP with transverse crack identified with red arrows and Cutting the perimeter of the void in the CFRP

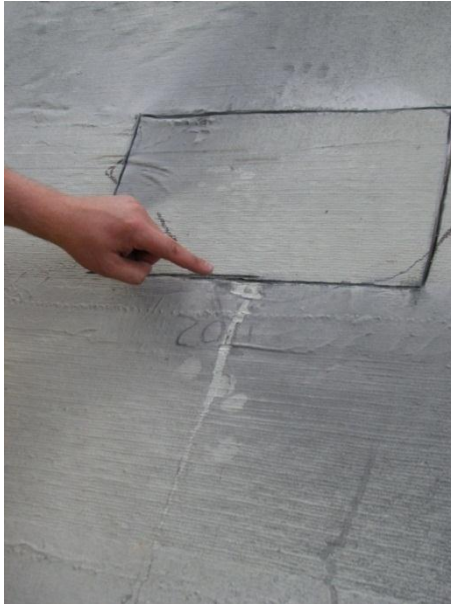
Figure 3.50. Water exiting the void area directly after the lower cut through the CFRP was completed

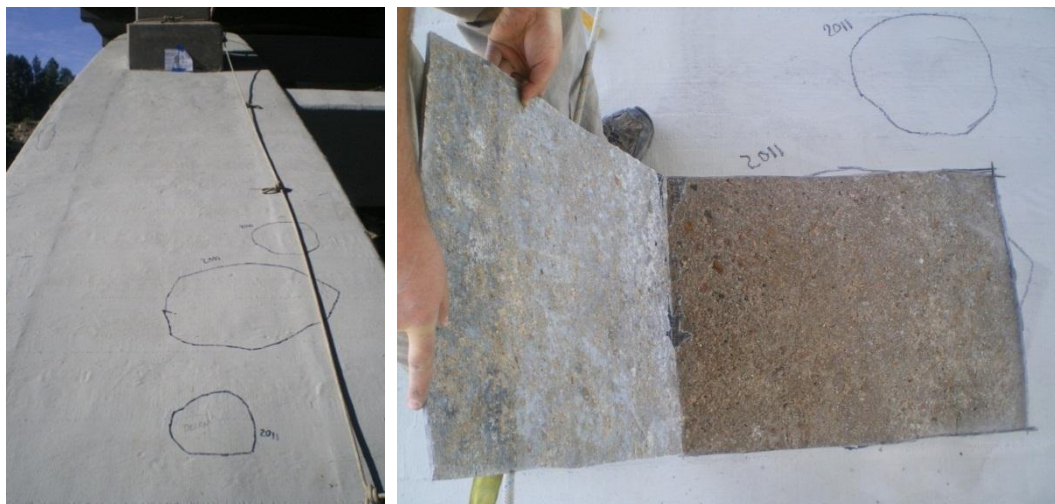
The second void was removed from the 3rd bay on the north end of the east arch. A rectangular section of the CFRP was removed with the same procedure previously described. Photographs of the area of the void and the removal of the CFRP rectangle are in Figures 3.53 and 3.54 below. There was no standing water or evident moisture in this larger void area, but there was significant pieces of the substrate adhered to the underside of the CFRP patch removed.

Figures 3.53 and 3.54. Voids found in the 3rd bay on the north end of the east arch and removal of the CFRP of the largest void

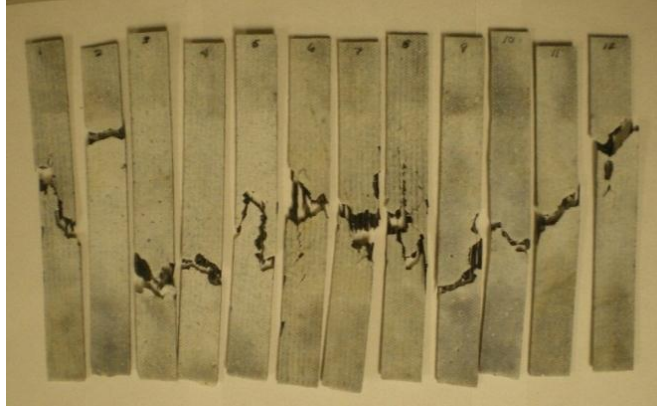
Figure 3.63. Failed tensile test specimens from the small void removed from bay 1NE, note the milky appearance

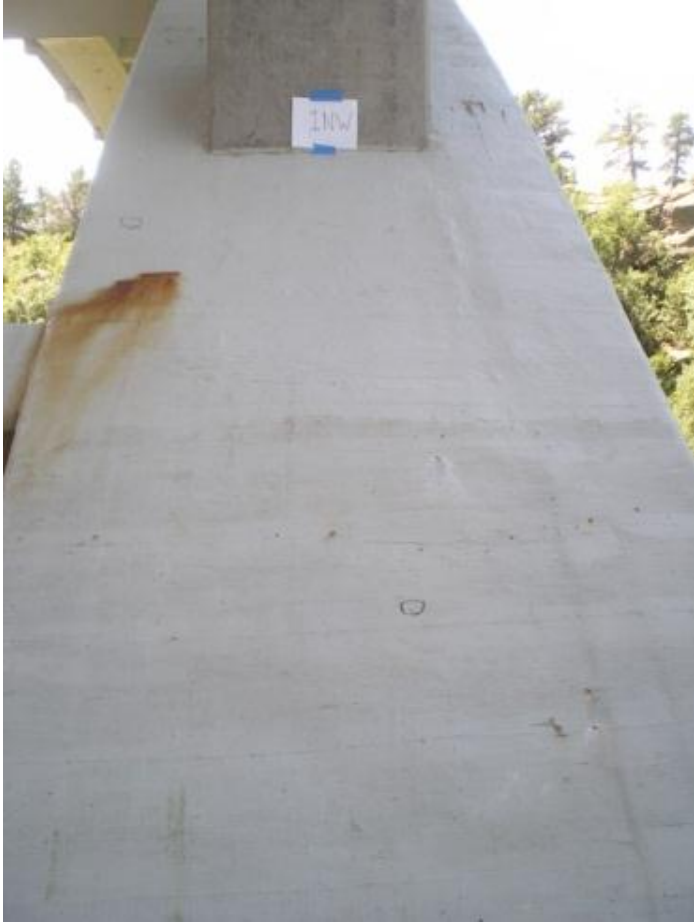
Bay 1NW: 3 Voids, 1 Rust Spot

Figure A1. Bay 1NW, 2 of the 3 small voids and rust spot

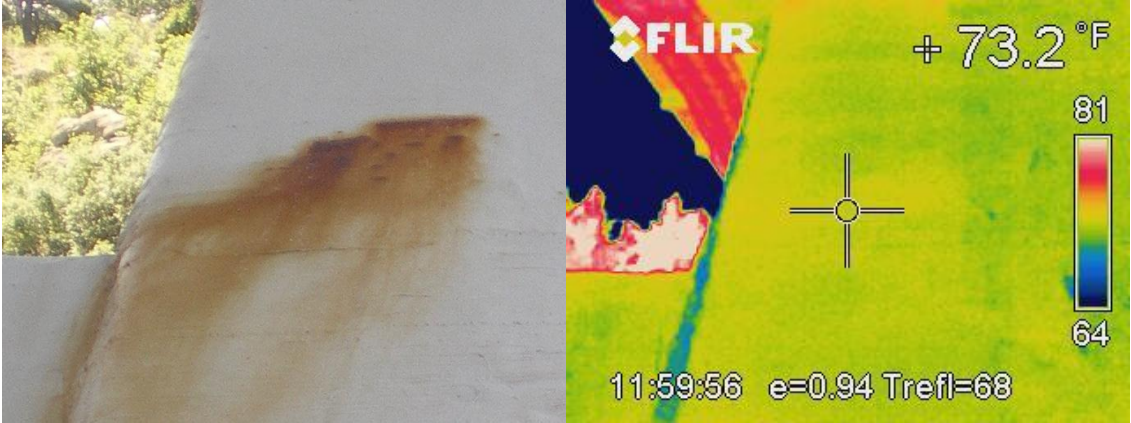
Figure A2. Photograph and thermal image of rust spot

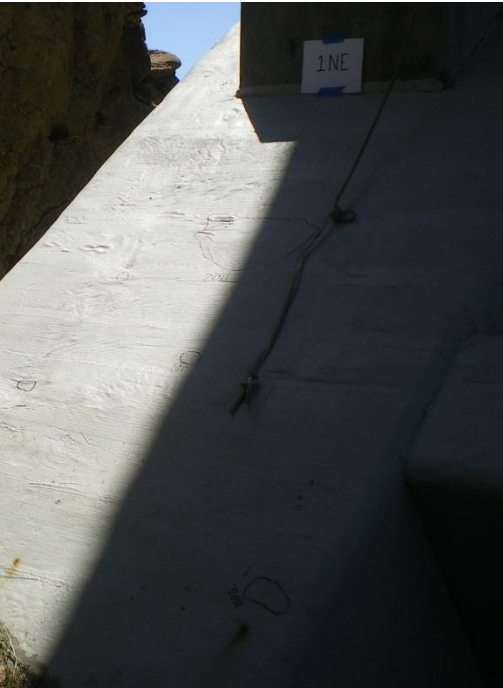
Figure A3. Bay 1NE, 5 voids

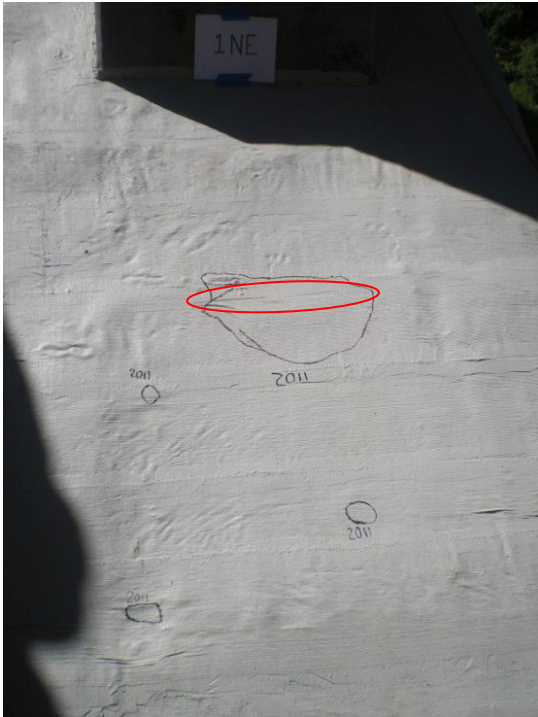
Figure A4. Bay 1NE, 4 of the 5 voids; Crack exists, enclosed in red oval, in the top of the largest void

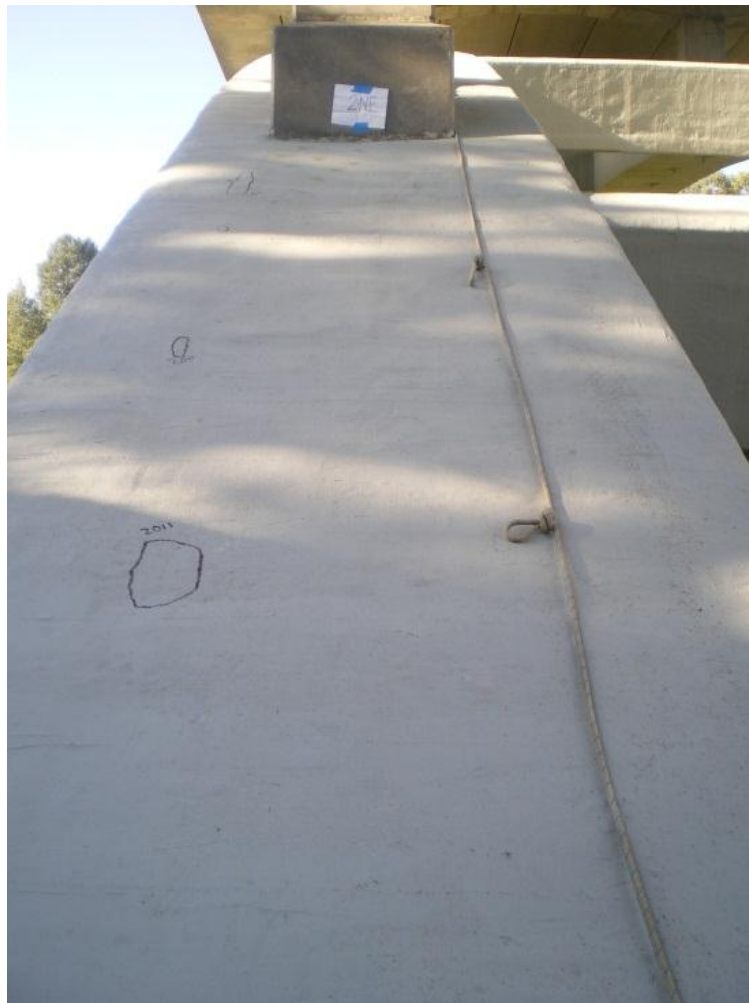
Figure A6. Bay 2NE, 3 Voids

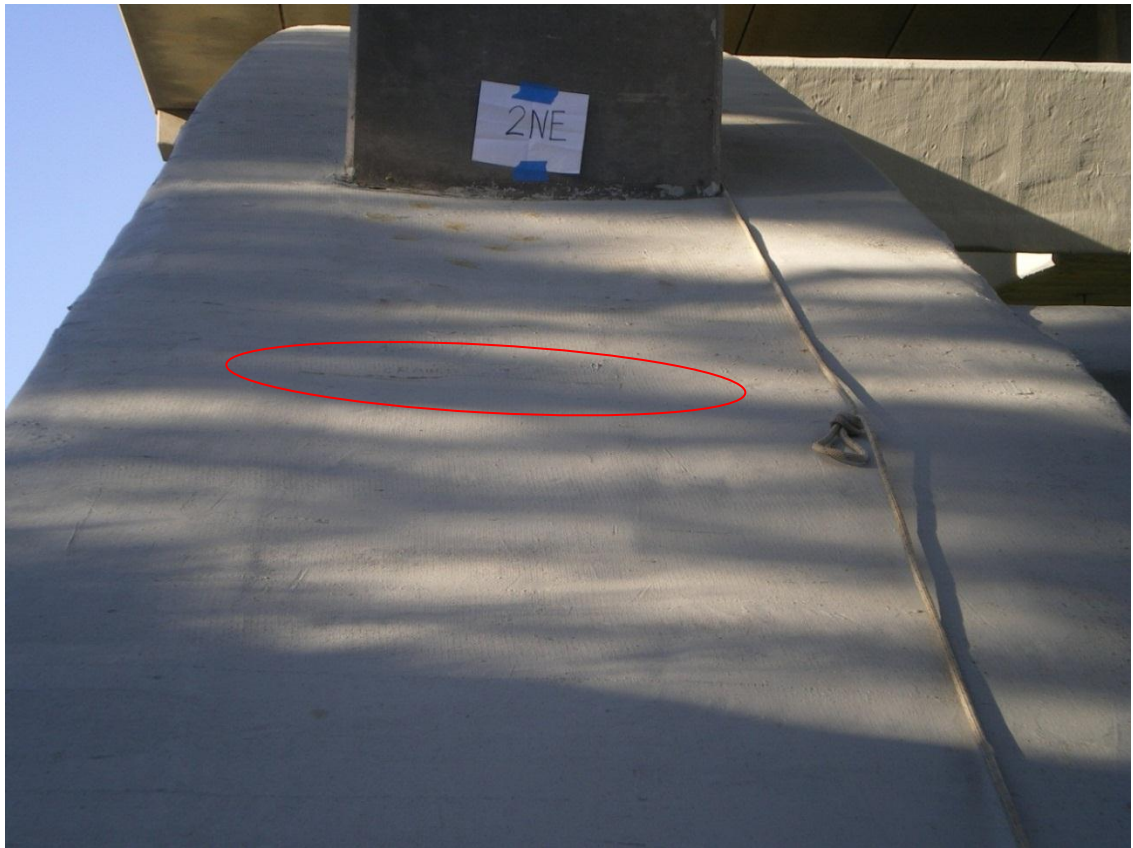
Figure A7. Bay 2NE, Crack enclosed in red oval was identified in 2007

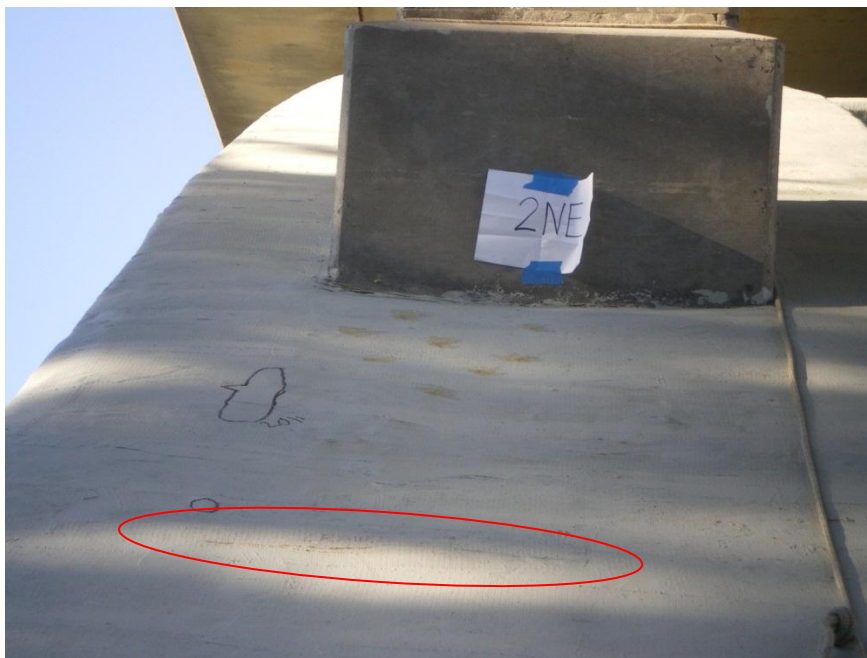
Figure A8. Previously identified in 2007, a crack enclosed in the red oval, no debonding at the location of the crack

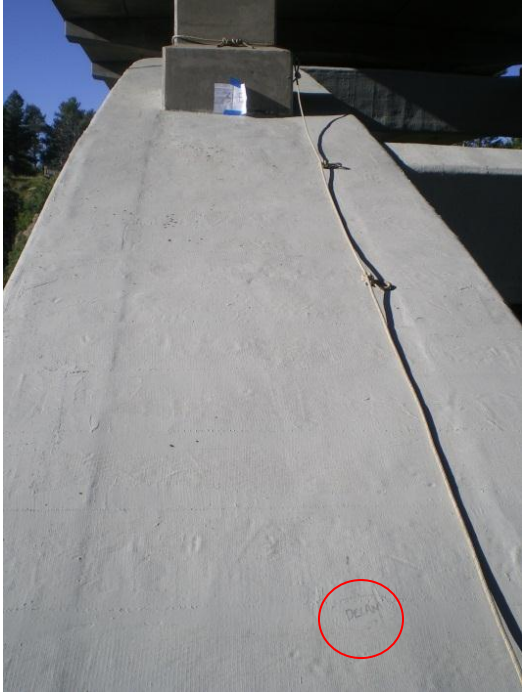
Figure A9. Bay 3NE with 1 of the 2 defects found in 2007 shown

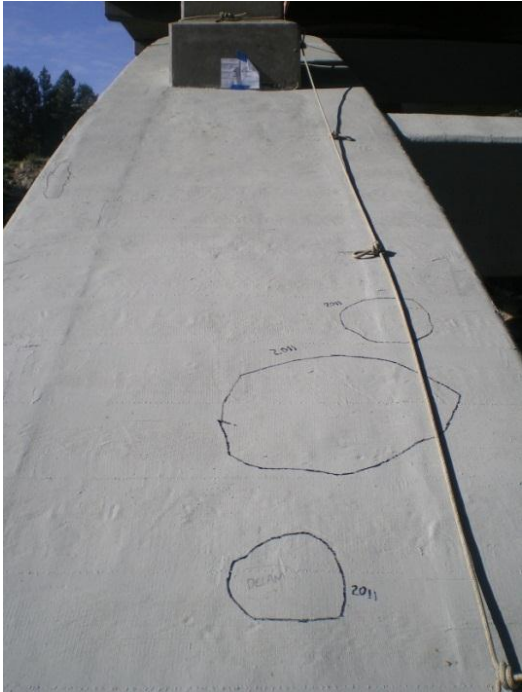
Figure A10. 4 of the 5 voids found in 2011

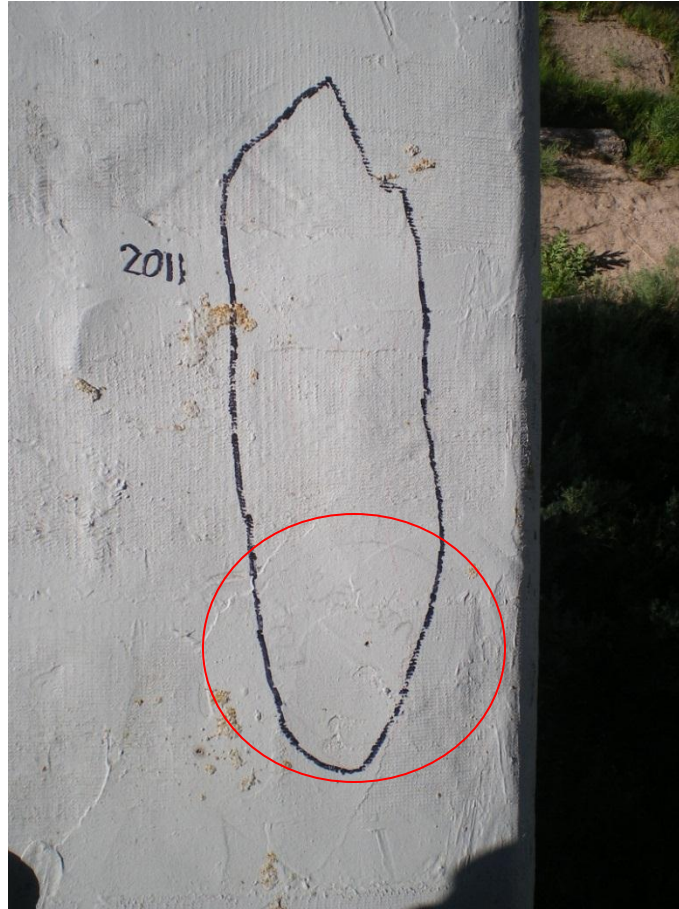
Figure A11. Enclosed in the red circle is 1 of the 2 voids found in 2007

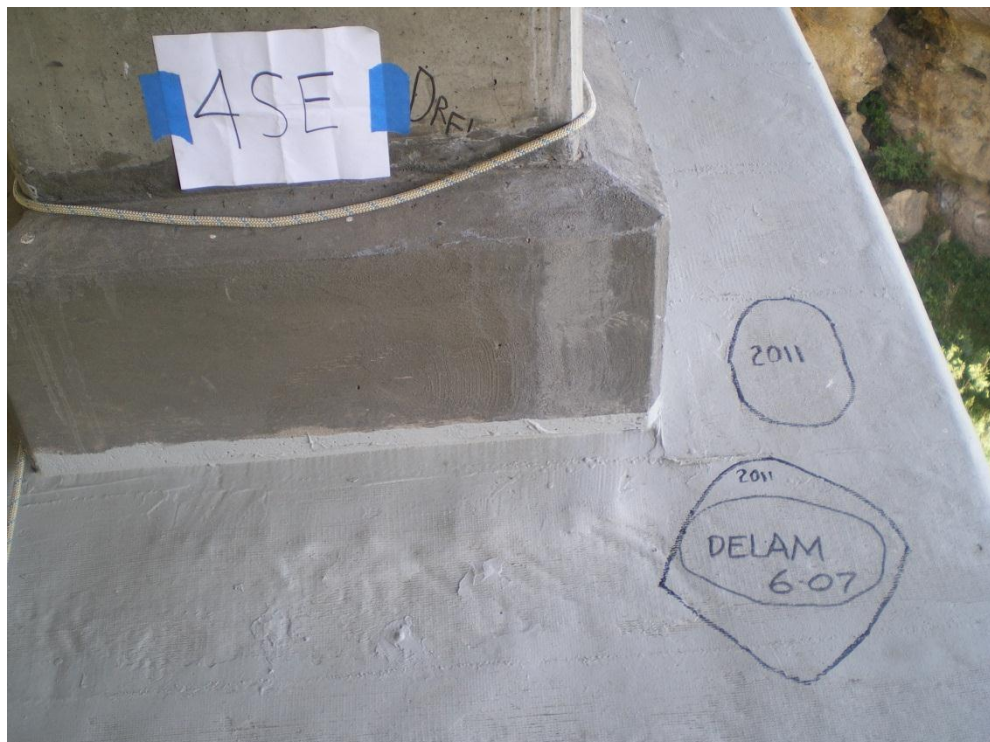
Figure A17. Void from 2007 has grown and a new void developed

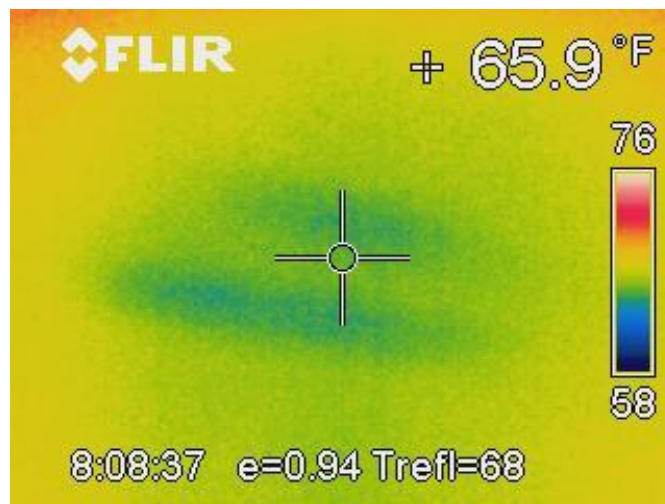
Figure A19. Thermal image of cracks previously identified in 2007

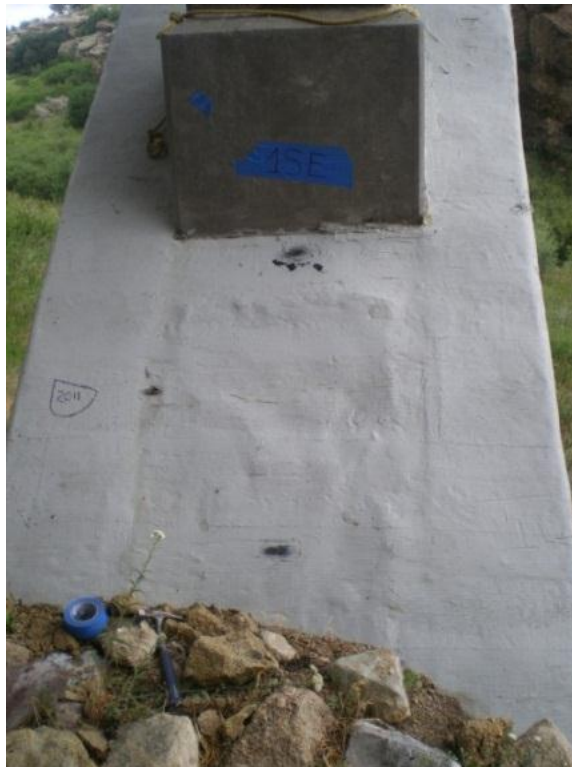
Figure A23. Bay 1SE, 1 void

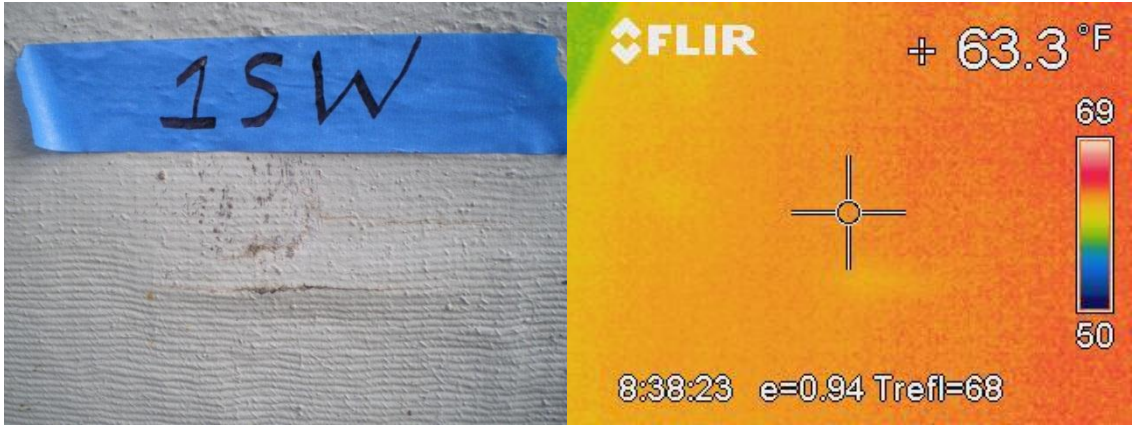
Figure A24. Photograph and thermal image of a defect found in Bay 1SW

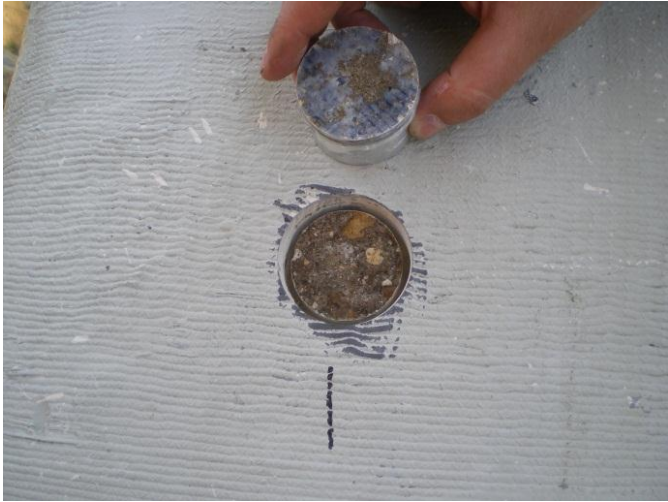
Figure B9. Test No.10, weak bond strength, and Test No.11 not available, cored area failed during drilling

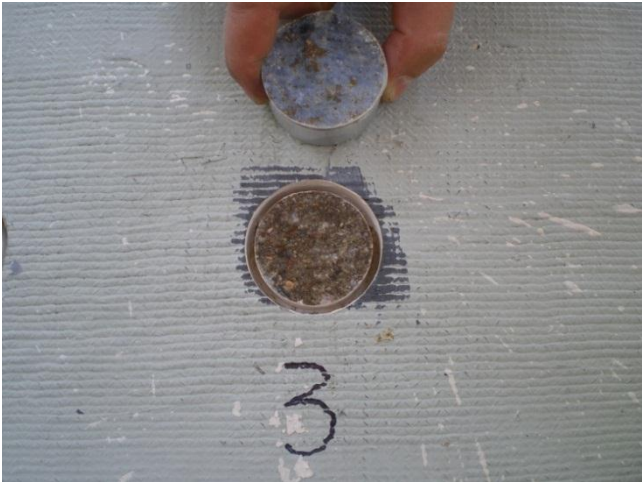
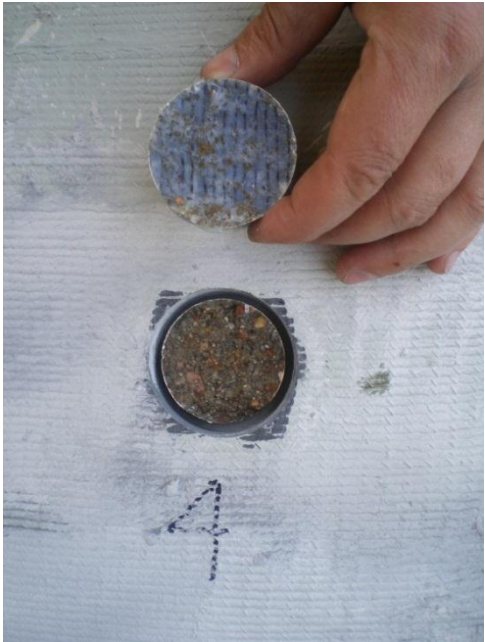
Figures B10 and B11. Test No.12, weak bond strength, and Test No.13, weak bond strength
