MANAGING A LARGE IRRIGATION SYSTEM UNDER EMERGENCY CONDITIONS: HIRAKUD PROJECT CASE STUDY, INDIA

STRUCTURAL DISTRESS/PARTIAL COLLAPSE OF THE DANTA AQUEDUCT

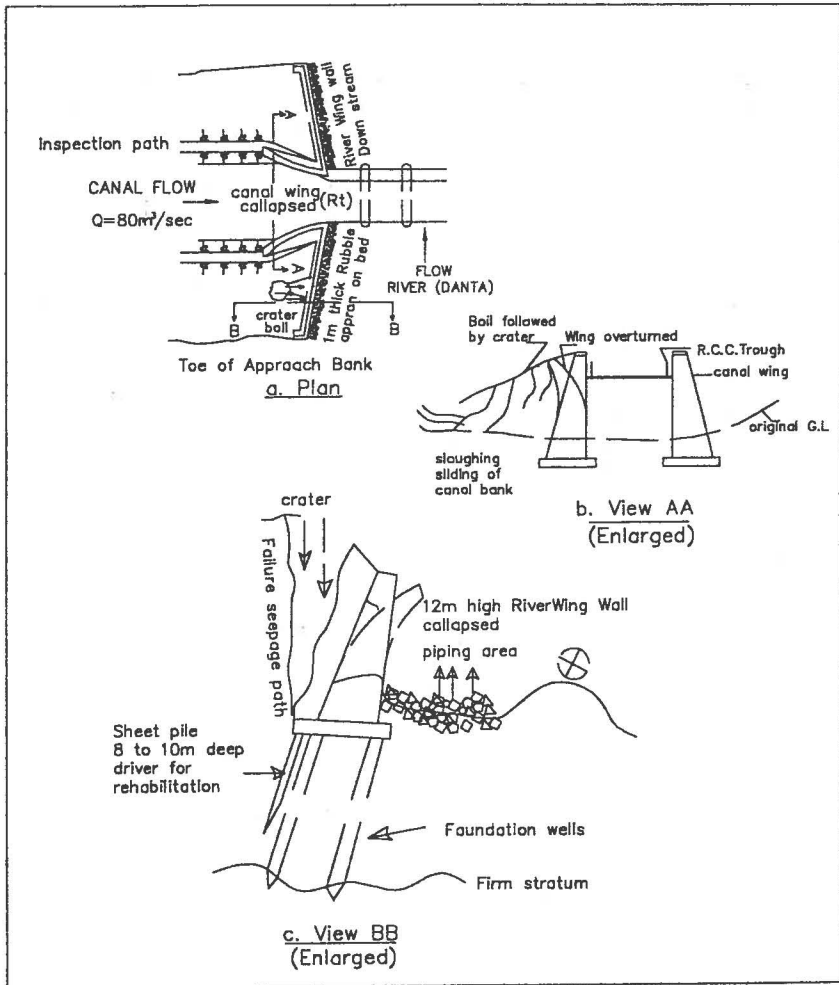
Figure 2. Partial Collapse of Danta Aquaduct

Transition to the reinforced concrete trough was through canal wings of 20 m length on shallow foundation in firm ground that was rising slowly from the river edge. Essentially, the canal wings, river wings with well compacted earthen banks, which were lined with concrete on the canal section formed a seepage barrier against 15 m of hydraulic head (canal full supply level to river bed level). A creep length of 60 m was provided with the assumption that the river bed at the toe of abutment/wing wall will not erode dangerously (by provision of launching apron) to facilitate a piping path to develop. The river and canal wings were provided with 0.5 m thick filter backing with deep holes on the river wings for keeping the backfill unsaturated. A base width of only 0.3 to 0.4 height of the wall was considered adequate and was provided with the above assumption. Figure 2 details the aqueduct structure.

Following 150 mm of rainfall between October 1, 1984 and October 5, 1984, a medium flood of 5 m depth occurred at the aqueduct, which led to 1 m subsidence of the apron over a 5-m diameter patch, protecting the left upstream wingwall. Some boiling was noticed. The distress that occurred from the evening of October 5, 1984, is detailed below:

- sudden collapse of the earth slope between the right upstream canal wing and left upstream wing occurred over a 5 m diameter patch leading to a crater, through which water from the canal was flowing.

- a 10 m stretch of canal wingwall collapsed against the crater and 50 m³/sec out of the canal discharge of 80 m³/sec flowed out under and over the collapsed canal wing and exited under the river wing causing the protective rubble apron to move out over almost a 10 m stretch, with violent noise; the residual head at the boil location was almost 5 m.

- a large mass of saturated earth flowed from the crater adjacent to the canal wing and literally pushed a 20 m stretch of 10 m high river wing wall to overturn into the river, about 2 m above the well cap; all of this resulted in a substantial collapse of the right protective transition upstream of the trough, which remained firmly seated on the abutment. Figure 2 details the damages that occurred.

A critical analysis of the failure revealed that uncontrolled piping led to the failure, but the failure of both canal and river wings were due to inadequate section to retain the over-saturated soil mass as a gravity structure. The base width of 0.3 to 0.4 of height of surcharge was certainly inadequate. The basic assumption of dry backfill, assuming satisfactory functioning of this filter backfill provided was deficient. Further, in order to ensure a safe seepage path for the large head difference between the canal full supply level and the river bed level. It was decided to extend the reinforced concrete trough section by 70 m upstream, where the canal bank is only 5 m in height. The extension of the reinforced concrete trough supported on piles was carried by underwater technique, deploying barges on the running canal. The canal supplied irrigation, industrial and drinking water throughout the year. The short-term remedial works (October 1984) cost Rs 4 M, and the long-term (1985-1986) cost Rs 15 M, against the original structure cost of Rs 1 M (1955-1957).

As the canal wingwalls and the river training walls with rubble apron at the river bed were the main barriers against uncontrolled seepage, their restoration above the firm broken surface was considered emergent. But a trial barrier just upstream of the river wing by steel sheet piles driven to clay with a capping beam was considered an essential appurtenance. The sequence of activities were:

- re-building the collapsed stretches of canal wingwall (20 m long) and upstream river training wall (15 m long) with reinforced concrete wall by buttressed support; prosper keys were introduced into the old edges—October 9 through 20.

- driving 8 to 10 m deep steel sheet pile over 20 m length just upstream of the well cap to cover the broken zone of river wingwall; large pieces of rubble masonry from the broken canal wingwall moved 30 m and were blocking the pile path; the pile line was, however, taken to rest on hard clay/weathered rock to prevent any possibility of soil movement in between the foundation wells; the sheet piles were capped by a reinforced concrete beam which was tied to the well cap—October 10 through 15.

- clayey soil was compacted below optimum moisture content in 0.15 m thick layers between the reconstructed canal and river wingwalls, pneumatically tamped in 0.05-m thick layers (foundation of canal and river wing junction of sheet pile)—October 10 through 23.

- a well-designed 1 m thick filter layer was laid at the back of the river wing along with weep hole to safely drain any seepage water—October 20 through 24.

- the displaced rubble apron on the river bed was thoroughly cleared and a 5 m wide, 1 m thick graded rubble apron was added to ensure safe exit gradient to seepage and also safety against scour during high floods—October 20 to 24.
