Performance of RCC Used for Overtopping Protection and Spillways

Kenneth D. Hansen, P.E.¹, and Thomas J. Fitzgerald, P.E.²

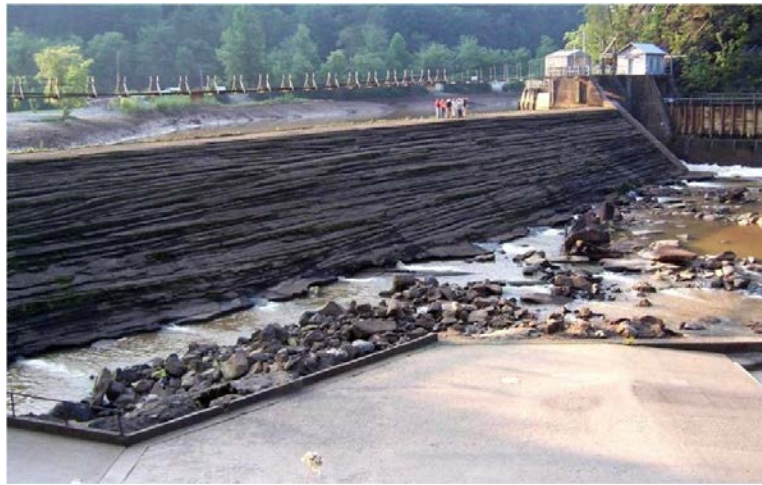
Figure 2. Ocoee No. 2 Dam, TN – After More Than 3,000 Intentional Overtoppings

Therefore Ocoee No. 2 Dam has now been intentionally overtopped more than 3000 times with no apparent distress to the RCC. Most of the time, the depth of overflow has been about 1-foot, or less. However, during a flood in 1990,

it was overtopped by a maximum of 12 feet. See Figure 2 for the condition of the downstream slope after 25 years of service as well as drains at the toe of the dam flowing.

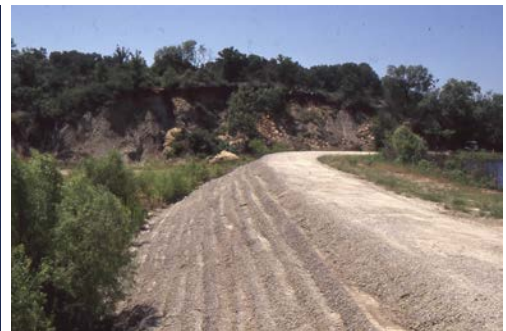
Figure 4. Brownwood Country Club Dam, TX
– After Seven Years in Service

The RCC protected embankment was overtopped six times during its first year of operation to a maximum depth of about one foot. It has been reported that the dam has been overtopped from 1 to 2 times a year since then with a maximum depth of overflow at 2 feet. See Figure 4 for the condition of the exposed RCC which had received no special downstream edge treatment after seven years.

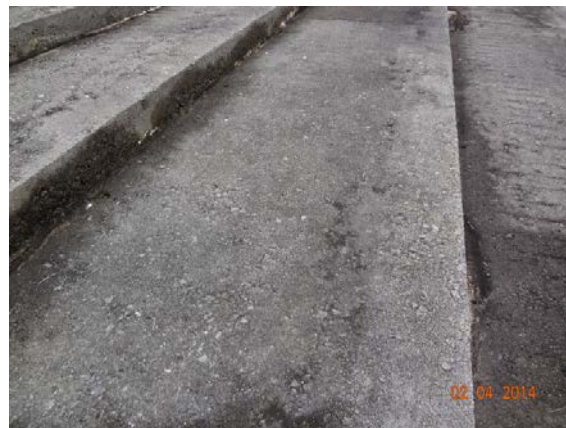
Figure 6. Lake Tholocco Dam, AL
– Condition of Steps 2014

The RCC overtopping protection was first tested in September of 2004 when it experienced an estimated flow depth of 3 feet due to Hurricane Ivan and again in March 2005 when it overtopped by 1.5 feet. (See Figure 5). The condition of the RCC steps in 2014 after about ten overtoppings is shown in Figure 6. It has been observed to be in excellent condition with only a slight polishing of the RCC surface.

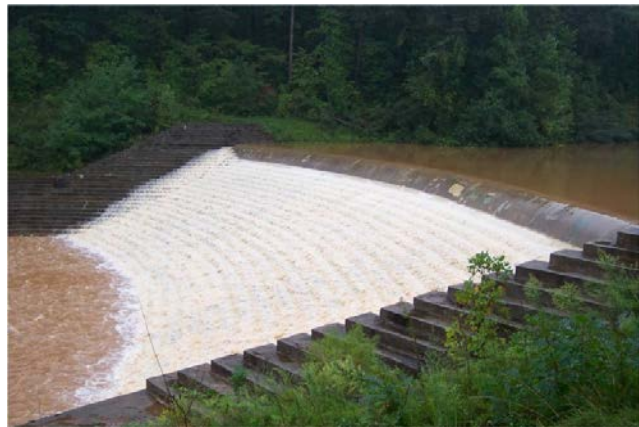
Figure 8. Y14 Dam, GA – During Overtopping

Y14 was overtopped for up to 30 hours with a maximum depth of overflow of 1.9 feet as shown in Figure 8. Following the overtopping, the RCC stepped surfaces were described as having a slight polish, but no significant damage to the RCC was reported.

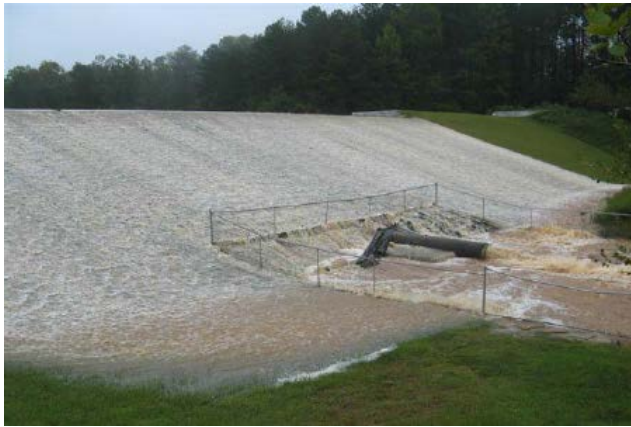
Figure 9. Y17 Dam, GA – During Overtopping

The Y-17 structure was also overtopped for nearly 30 hours with a maximum depth of flow of 1.2 feet over the highest crest elevation surveyed by the high water mark. This corresponded to a peak discharge of about 800 cfs and unit discharge of 4 cfs/foot. The structure performed as designed with no apparent distress noted. See Figure 9 for the Y-17 spillway operating.

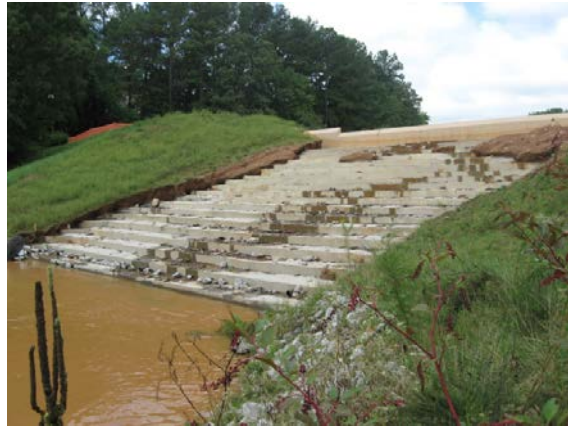
Figure 10. Y16 Dam, GA – After Overtopping

Y15 was overtopped for 30 hours by maximum depth of overflow of about 2.75 feet while Y16 only overtopped for 14 hours. The erosion of the soil/grass cover was quite different for each dam. For Y16, the flow eroded the entire cover over the RCC, as shown in Figure 10, while only a portion of the cover was washed away as shown in Figure 11 for Y15. In each case, the soil and grass that was washed down the steps did not produce any clogging of the stream channel downstream.

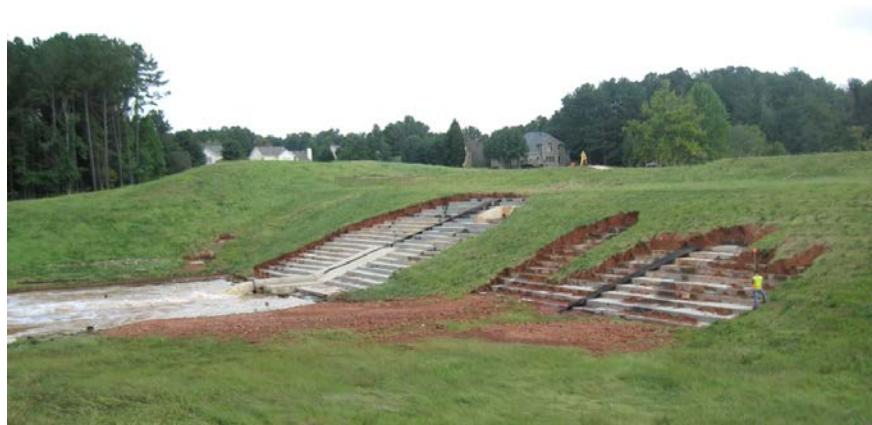
Figure 11. Y15 Dam, GA – After Overtopping

Following the overtoppings, the grass covers for three of the dams were restored at a minimal cost compared to that needed to repair flood damaged roads and bridges in the county. In April 2010, the stilling basins for each dam were dewatered and inspected for damage. No damage to the stilling basins was noted nor any scour holes downstream of the stilling basins' end sills. However, riprap downstream of Y15 had been displaced.

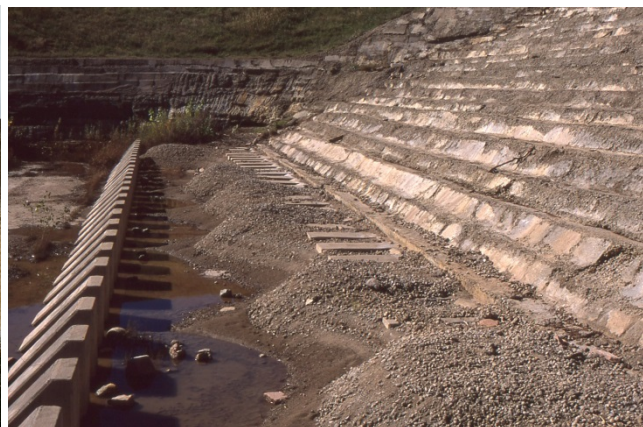
Figure 13. Left Hand Valley Dam, CO
– After Overtopping

At the time of the overflow, the stepped RCC surface had been subjected to some freeze-thaw (F/T) deterioration for 15 winters. These cycles of expansion and contraction produced some loose aggregate on the RCC surface of the dam's auxiliary spillway.

The water that overtopped the structure to a maximum estimated depth of 8-inches contained silt, portion of trees, and F/T loosened aggregate. The aggregate laden water caused some erosion of RCC steps with more erosion noticed in the lower portion of spillway. The latter was due to greater amounts of loose aggregate picked up as the overflow bounced down the RCC steps. See Figure 13 for the piles of aggregate deposited at the toe of the spillway. The amount of aggregate was estimated as 10 cubic yards out of the 4920 cubic yards of RCC placed initially.

The RCC was designed to achieve a maximum compressive strength of 2000 psi in 28 days and contained 325 lbs. of cement per cubic yard. The maximum horizontal erosion of the RCC steps which occurred in only a few places appeared to be about 6-inches. Still, there remains about 7 feet – 6 in. of RCC in the horizontal direction.

Following the overflow, the RCC steps are not very pretty. But then, they were not very pretty before the flooding either. In summary the RCC overlay of the auxiliary spillway performed as designed including the drains operating when subjected to overtopping for a week due to a 500 year flood or greater.

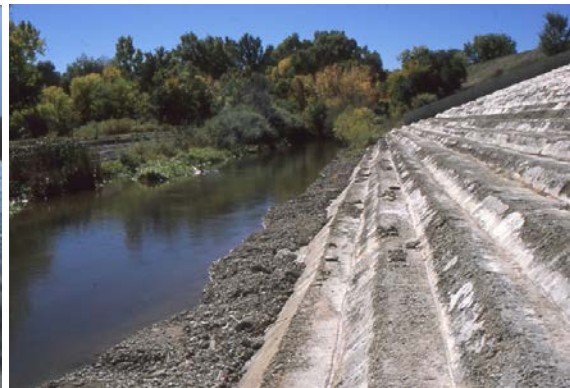
Figure 15. Leyden Dam, CO
– After Overtopping

Similar to Left Hand Valley Dam, F/T loosened aggregate was washed down the steps to the toe of the dam as shown in Figure 15. Once again, the RCC protected auxiliary spillway performed as designed when subjected to a 1 in 100 year overflow. Its appearance is better than that of Left Hand Valley Dam before and after the overtopping.

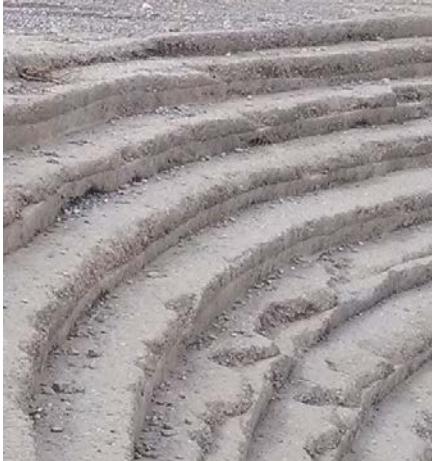
Figure 18. Steps on Kyle Canyon Inlet No. 3 After Overtopping

The runoff overtopping Inlet Structure No. 3 was well in excess of the design flow of 2.43 inches and overtopped the left training wall causing erosion of the soil behind it as shown in Figure 19. An inspection of the stepped RCC on the inlet structure showed some surface erosion due to the flow as shown in Figure 18. Thus, the RCC performed well when subjected to a flow well in excess of its design hydraulic capacity that contained large amounts of abrasive flow including rocks.
