# SYNTHETIC CANAL LINING EVALUATION PROJECT

Eric Leigh<sup>1</sup>  
Askar Karimov<sup>2</sup>  
Guy Fipps, Ph.D., P.E.<sup>3</sup>

## ABSTRACT

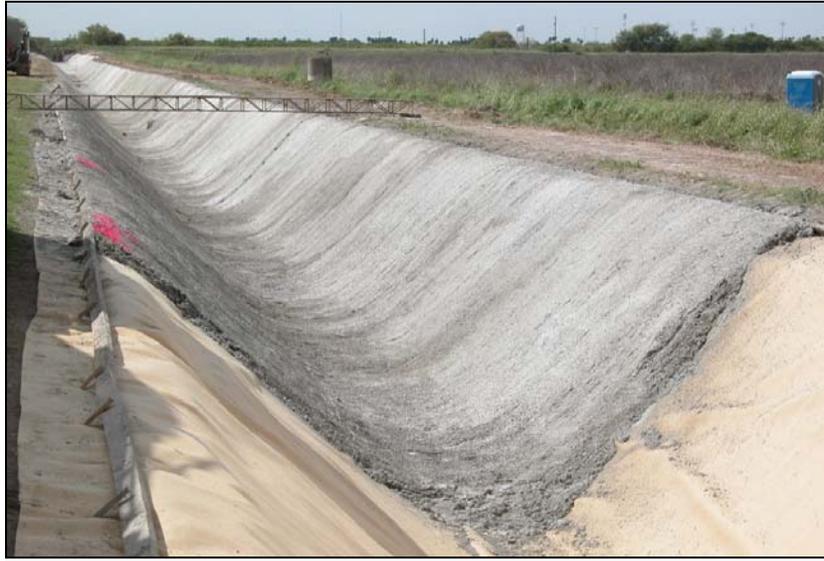
The best performers were the synthetic liners with a layer of shotcrete. This system is effective as the liner reduces seepage losses dramatically, while the layer of shotcrete prevents damage to the liner. Five projects extending over about 17 miles were implemented using this system with two different liners: polyester and PVC. The protective barrier consisted of 2 - 3 inches of shotcrete as shown in Figure 2.

To-date, these projects show no evidence of problems and have required no maintenance. No difference in performance was observed between the two types of liners. Hairline cracks developed in the shotcrete on a small stretch of Project #5, but no related problems have been observed.

Figure 2. Polyester canal liner with a 3-inch protective barrier

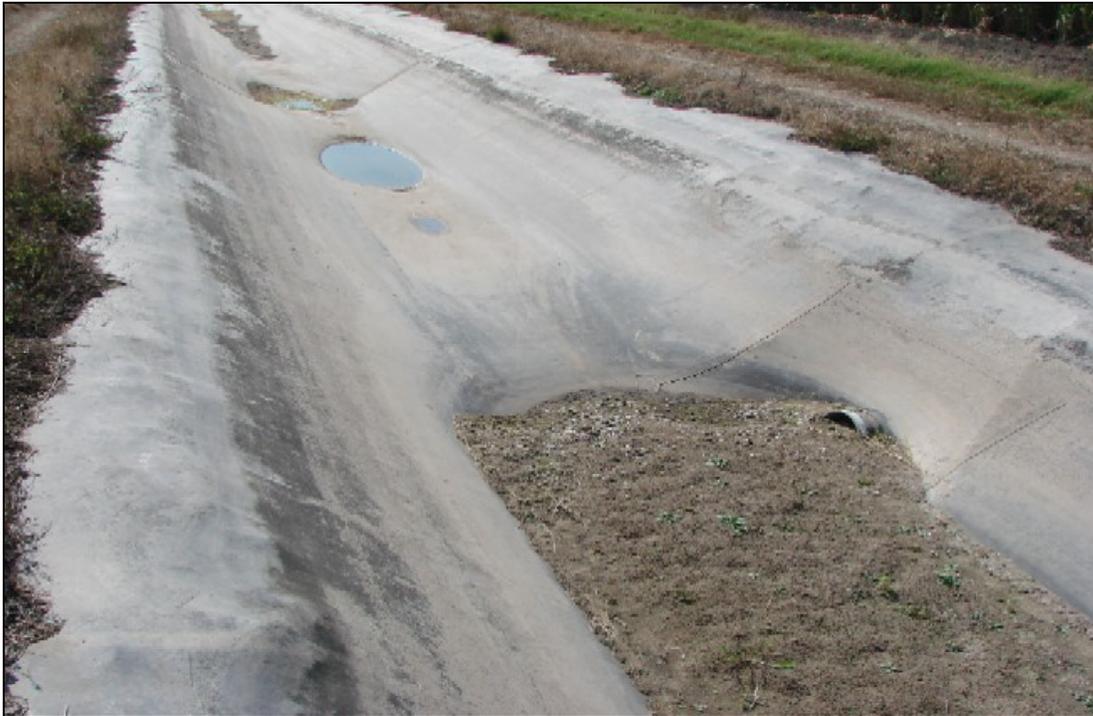
Installation and maintenance of the liners also appears to explain some of the variation in performance of these projects as discussed below. Another consideration with exposed liners is the potential damage that machinery can cause during normal district mowing operations and while cleaning out aquatic vegetation and sedimentation (Figure 3).

Figure 3. Aquatic vegetation and sedimentation clogging a farm outlet pipe

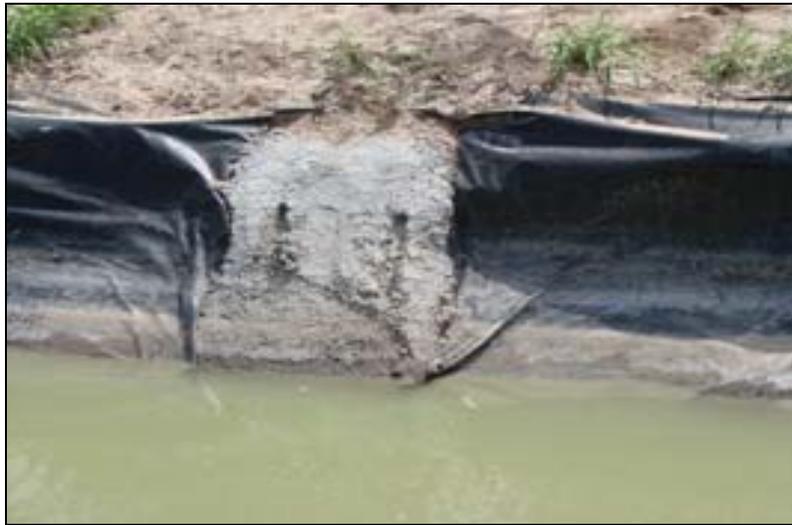
For the project shown in Figure 4, concrete sections approximately 1-foot wide were poured on top of the liner at a spacing of 500 feet. The rationale is that the concrete sections will help keep the liner in place and provide access points for sediment removal. Our conclusion is that long-term evaluation is needed to determine if such sections are useful for these purposes.

Figure 4. Concrete sections poured on top of a polypropylene liner

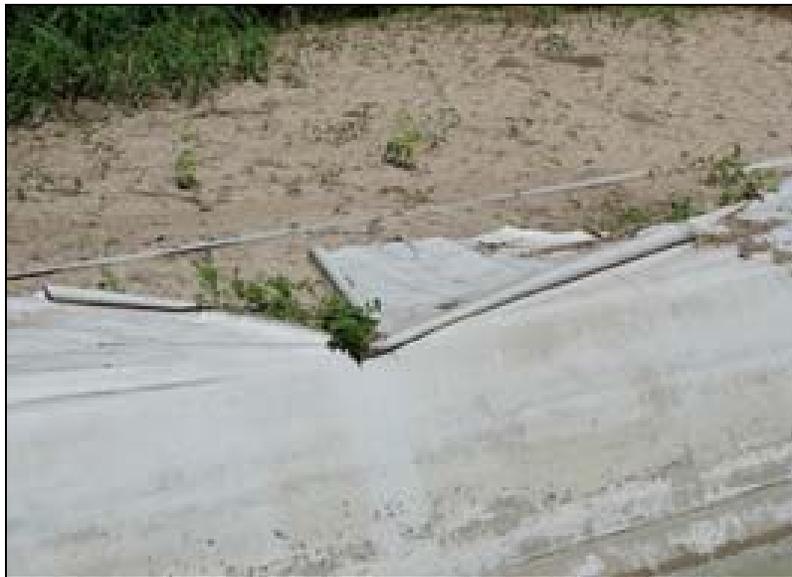
PVC Alloy Three short sections of PVC alloy were installed in 1999, ranging in length from 38 to 148 ft. This material has performed well, requiring little maintenance, with no major damage observed. However, cuts and tears have occurred in the exposed area of the liner (Figure 5) which could develop into larger problems if not taken care of in a timely manner. The overall performances for these small test segments are excellent to good.

Figure 5. PVC Alloy liner damaged on the exposed area

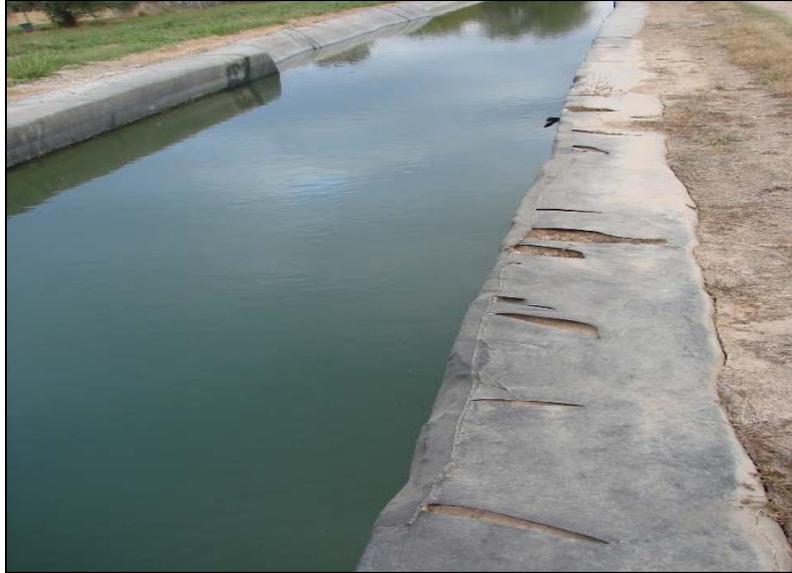
many cuts and tears initially occurred on the exposed areas where there is the most human and animal traffic (Figure 6). Unless repaired in a timely manner, these tears may lead to increasing amounts of damage (Figure 7).

Figure 6. Cuts/tears in a rubber liner

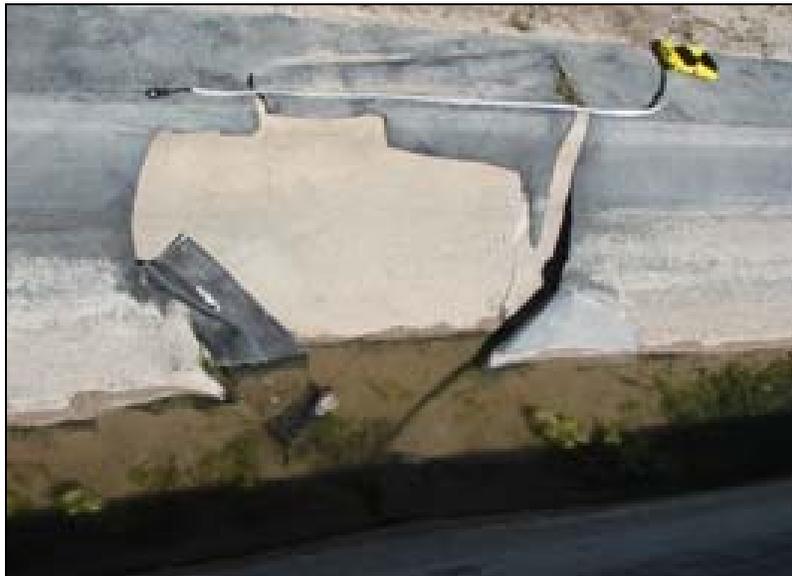
Figure 7. A rubber liner damaged possibly due to vandalism

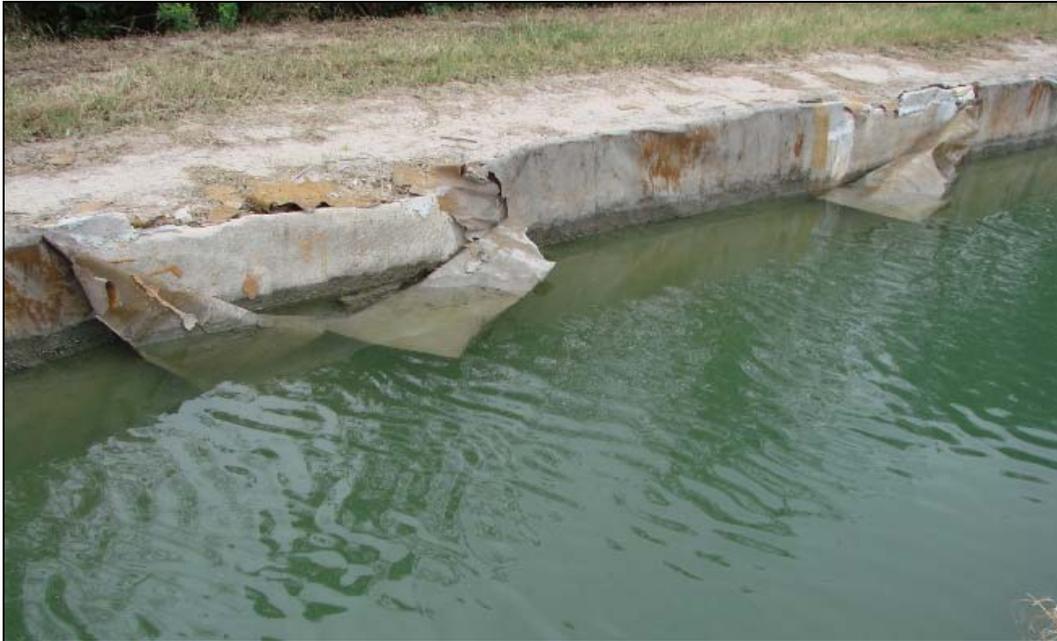
Polyurethane During 1999 - 2000, nine short sections were lined with polyurethane, totaling 1.42 miles. The current condition of these projects varies from excellent to serious problems, with one section a total failure. Observed problems include the liner falling off the canal walls which was likely caused by a combination of severe UV damage (Figure 8), material defects, and vandalism. In some segments, the top layer of the material has peeled off, while in others, the entire liner has worn off (Figure 9).

Unlike the other liners, the polyurethane was manufactured on-site by specialized machinery, and requires that the chemicals used to be properly handled. Several problems occurred during its manufacture and installation, including inconsistency in product thickness, which may account for the large variation in performance. In addition, little to no maintenance has occurred since installation.

Figure 8. Polyurethane liner is shown hanging off the canal wall.

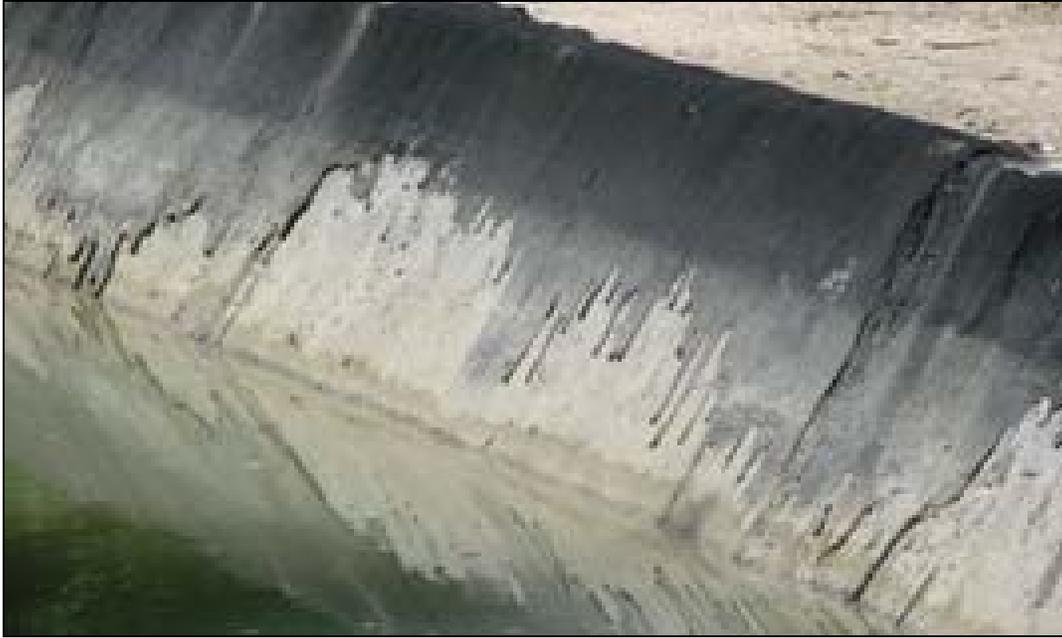
Figure 9. Residue left from a deteriorated polyurethane liner

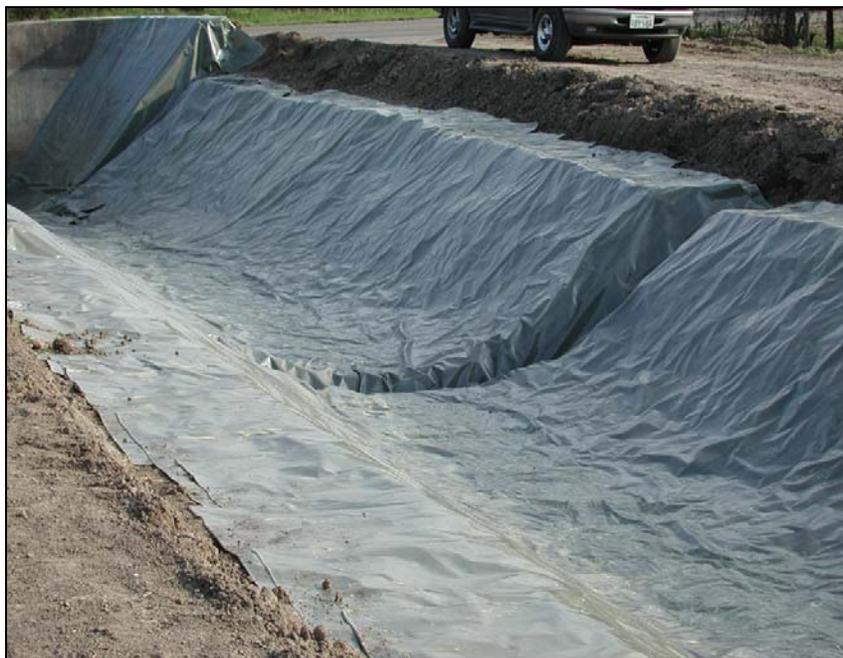
In one of early lining projects, the liner size was not planned properly to overlap and extend onto the top of the levee (Figure 11). As seen in Figure 12, the operating depth of the canal was higher than the top of the liner. The water eventually got underneath this liner and caused it to float.

Figure 11. Canal liner installed too low on the levee

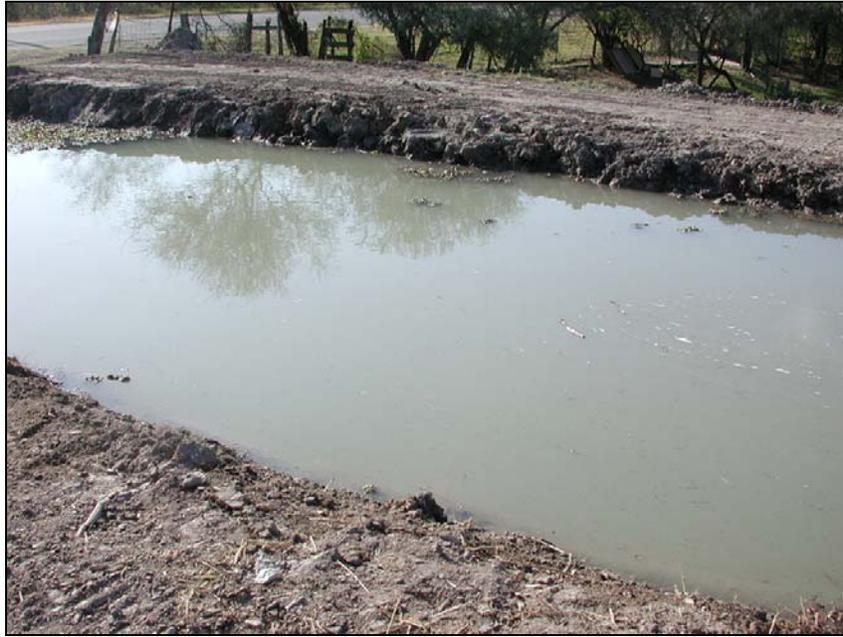
Figure 12. Water level higher than the canal liner installed

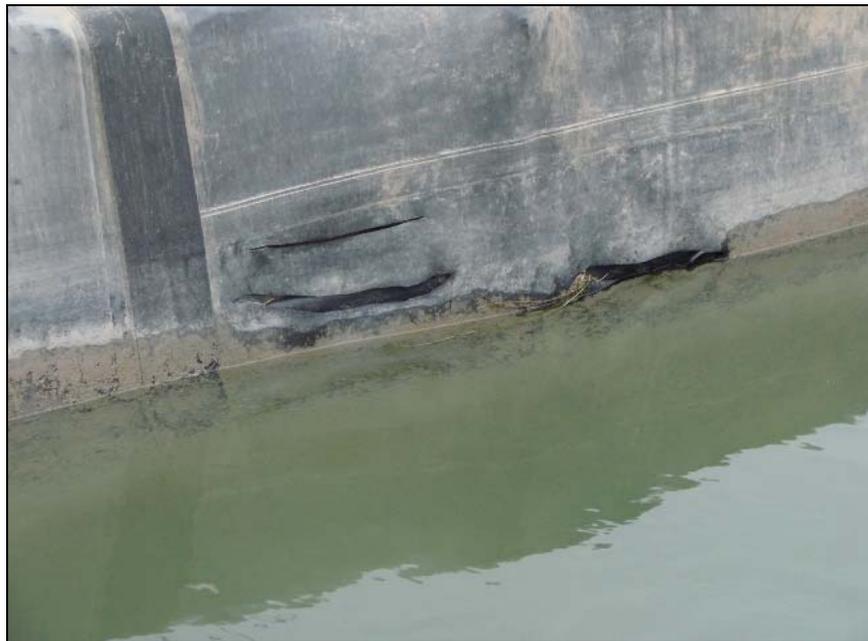
Most damage has occurred on the exposed areas of the liner and top side walls of the canal. Figure 13 shows a cut made with a sharp object (probably intentional vandalism) versus Figure 14 could have been a case of unintentional vandalism. In areas where kids are playing, swimming in the canals, or being mischievous, intentional and unintentional vandalism will occur. Vultures have been reported to pick at the seams on the EPDM Rubber; animal hoofs can cut some liners.

Figure 13. Horizontal cuts likely due to vandalism on the canal sidewall

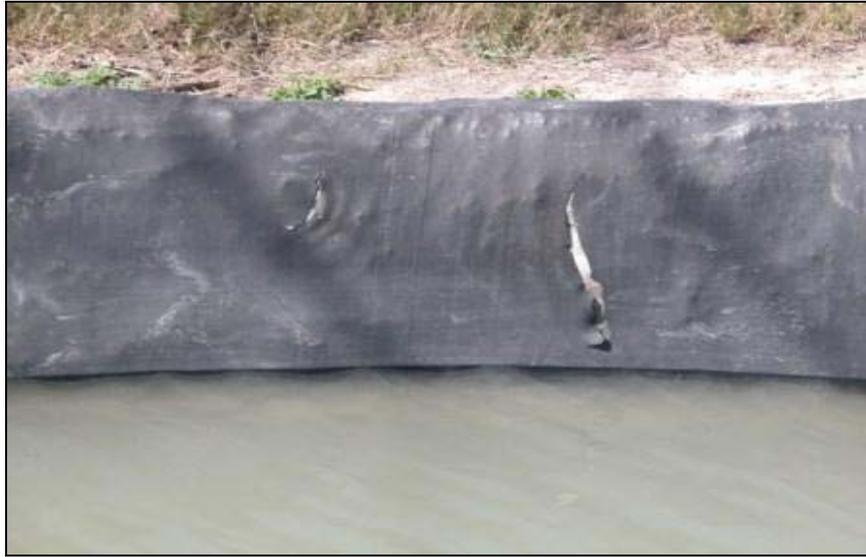
Figure 14. Vertical cut or tear on canal side wall caused unintentionally

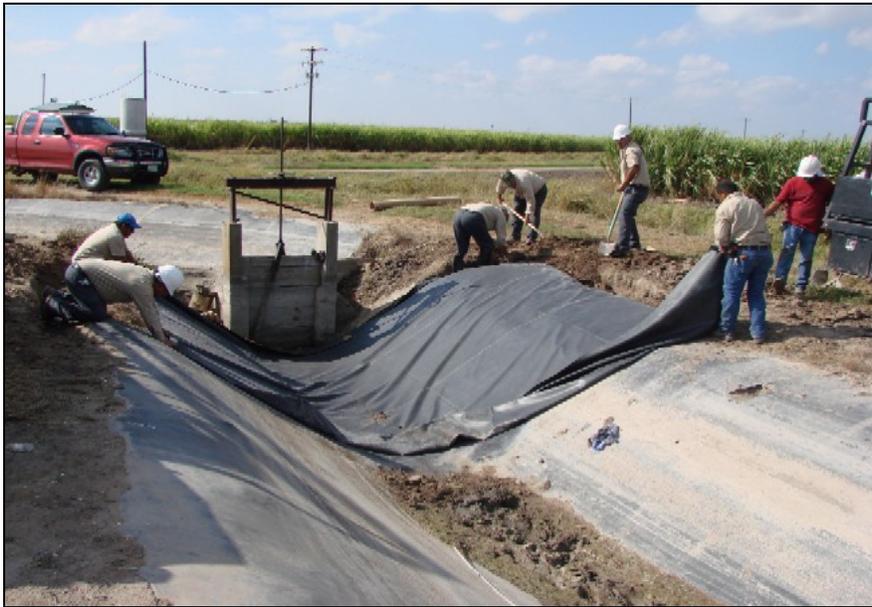
Figure 16. A district maintenance crew repairing a damage section of lining

A regular inspection and maintenance program is important so that repairs can be completed on a time basis. Once a tear or cut starts, it will tend to expand or be susceptible to further damage until it is repaired. Districts should consider having their personnel trained to performed the repair and maintenance which sometimes requires specialized equipment, and similar glues and adhesives used during the installation process (Figures 16 and 17). Removing sediment from lined canals may be more difficult due to the limitations of using heavy machinery, and may require increased manual labor (Figure 18).

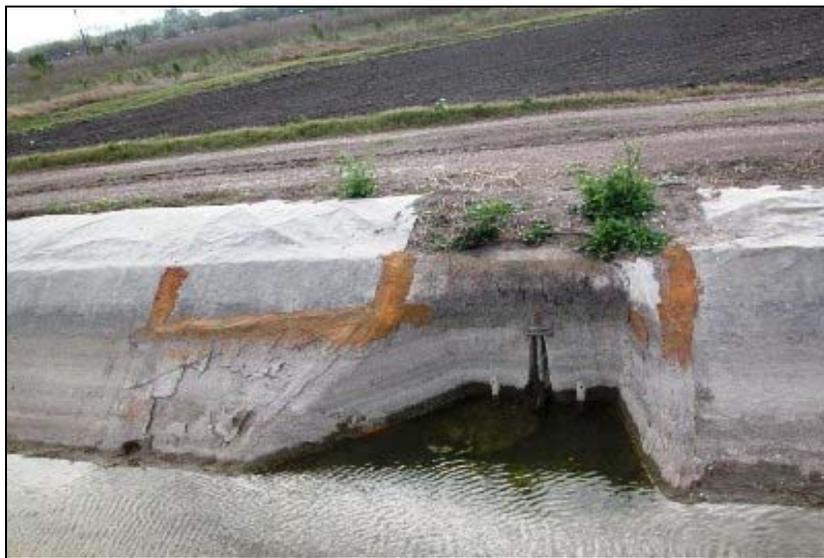
Figure 17. Repair of the liner joints around a structure with glue

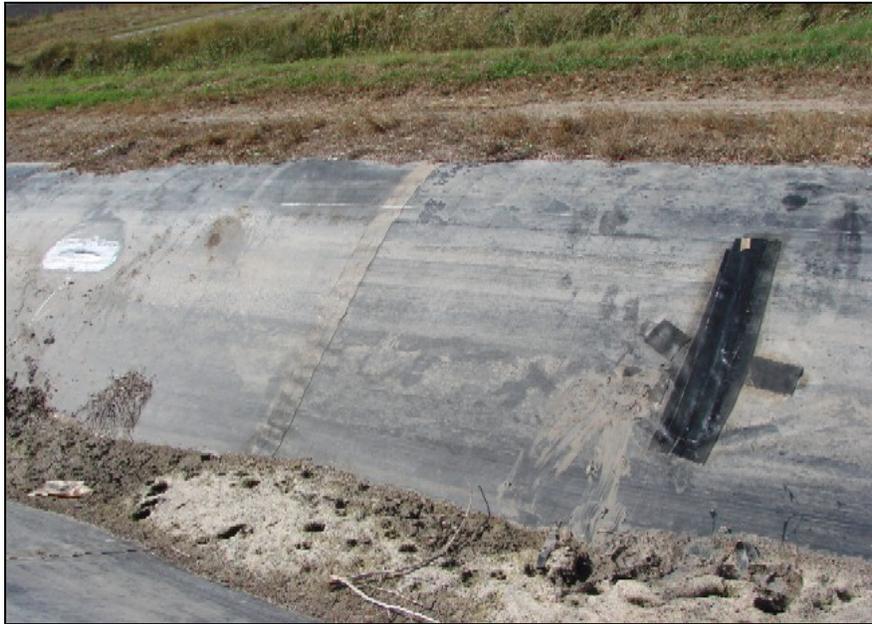
Figure 18. Sedimentation at the bottom of a lined canal
