MOST ASKED QUESTIONS ABOUT GEOSYNTHETIC CANAL LININGS
DO THEY WORK? AND HOW MUCH DO THEY COST?

ABSTRACT

The Bureau of Reclamation (Reclamation) is collaborating with several irrigation districts in central Oregon to demonstrate and evaluate various canal linings under actual field conditions. This paper shows the results of more than 7 years of field testing and includes a series of photographs showing the subgrades, construction, and required maintenance. This paper also examines the effectiveness of the various geosynthetics and other materials to control seepage and compares construction costs.

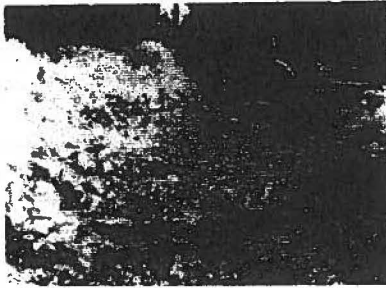
Oregon's volcanic geology contributes to high seepage rates (Gilbert, 1991), and canals in the area typically lose 35 to 50 percent of their water to seepage because they have fractured basalt bottoms (Fig. 1) and/or sides of highly porous soil, or soil and rock (Fig. 2). The fractured basalt subgrade also hinders excavation in the canal prism. Therefore, specialized lining technologies are needed to reduce seepage in these areas. Subgrade conditions for the one test section in Oklahoma were mostly fine sands with some gravel.

Fig. 1. Basalt Subgrade

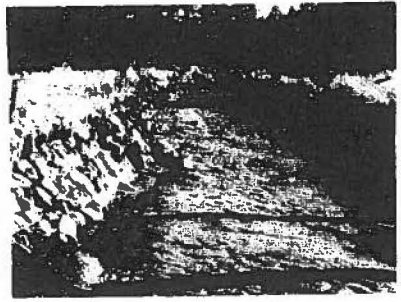
Fig. 2. Invert Sediment

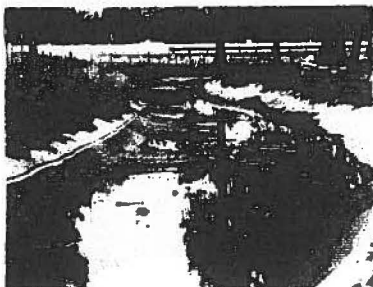
Condition: Excellent - After almost 6 years service, the shotcrete lining is in excellent condition, completely protecting the underlying Petromat geosynthetic liner from weathering and mechanical damage (Fig. 3). The only significant damage is that the shotcrete cover is showing extensive cracking over the anchor trench where the shotcrete was tapered-down to a thickness of less than 1 in (Fig. 4). Tapering of the shotcrete over the anchor trench is not recommended for future installations; instead the shotcrete should maintain a minimum thickness of 2 inches over the anchor trench.

Fig. 3 - Overview of
both A-1 and A-2

Condition: Excellent - After 5½ years, the shotcrete lining is in excellent condition, completely protecting the underlying VLDPE geosynthetic liner (Fig. 3). Dozens of transverse contraction cracks have developed on each bank. Some new cracks appear every year, and many of the old cracks grow in length, but do not widen significantly. Cracking in the thin, tapered shotcrete over the anchor trench is moderate to severe (Fig. 4). Again, tapering of the shotcrete over the anchor trench

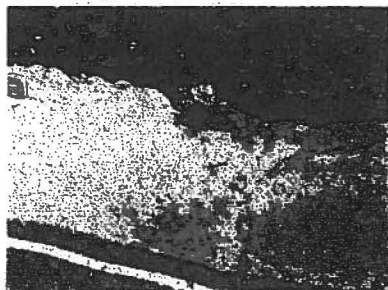
Fig. 4 - Cracking over
anchor trench at top

is not recommended for future installations, instead the shotcrete should maintain a minimum thickness of 2 inches over the anchor trench.

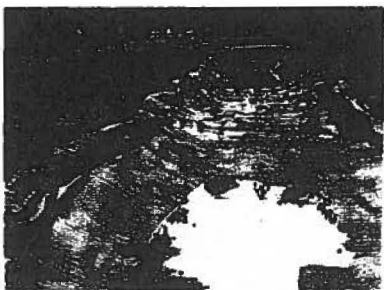
Condition: Very Good - After 5½ years of service (Fig. 5), the exposed HDPE liner is performing well, with only a few small tears over sharp subgrade rocks (Fig. 6).

Fig. 5 - Overview of A-3

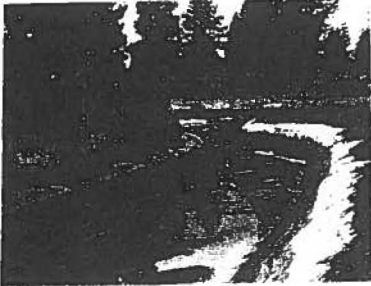
Condition: Very Good - After 6 years (Fig. 7), the PVC is holding up well with no visible deterioration or stiffening, even where exposed. The geotextile cover is slowly weathering away (especially where unbonded at seams). Sediment (up to 1 foot deep) has collected in the invert providing additional UV protection. Some aquatic growth is impeding flow.

Fig. 7 - Overview of A-4

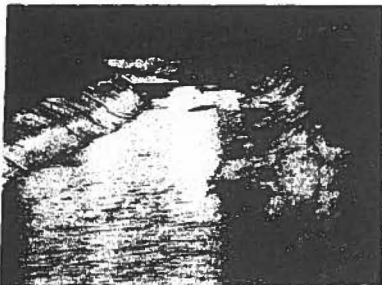
Condition: Very Good - After 6 years, the exposed CSPE geomembrane (Fig. 9) is holding up well. Standing water and a layer of sediment covers almost the entire invert, typically 0.5 to 1.0 foot deep. Some vegetation is growing but has little effect on flow to date. A couple of small tears have developed at the anchor trench (Fig. 10) and a sharp subgrade rock has punctured the liner at the waterline.

Fig. 9 - Overview of A-5 and A-6

Condition: Very Good - After 6 years, the exposed CSPE geomembrane (Fig. 9) is holding up well. The upstream transition between Test Sections 5 and 6 has a transverse adhesive-bonded seam which is working well. Backhoe operators have caused more damage to the exposed linings to date than any other element. A few small tears near the anchor trench need to be repaired.

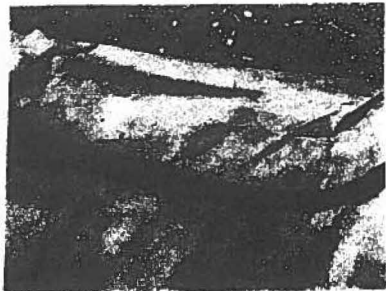
Fig. 10 - Tears at anchor trench

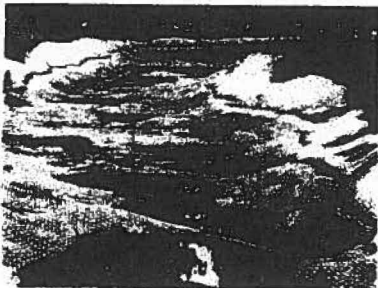
Condition: Excellent - After 6½ years, the grout-filled mattress is in excellent condition, completely protecting the underlying PVC geomembrane. The mattress is fairly uniformly grouted in spite of the uneven rocky subgrade (Fig. 11). The outer fabric is beginning to deteriorate (Fig. 12), especially where subjected to abrasion. When the water is turned off, this test section holds water all winter, while the adjacent Test Section A-8 holds water for only a couple of weeks. This side-by-side comparison demonstrates the difference in seepage rates due to the geomembrane underliner.

Fig. 11 - Overview of A-7 and A-8

Condition: Excellent - After 6 years, the grout-filled mattress is in excellent condition with no freeze/thaw damage (Fig. 11). The first 200 feet with zippered seams has a much neater appearance than the second 500 feet with sewn seams. The grout-filled mattress is well tied-in to the bridge, with no gaps that would allow seepage. The outer fabric of the grout mattress is in good condition, with little deterioration, except for one location on the left bank where the geotextile has worn away, and several concrete "bricks" are missing.

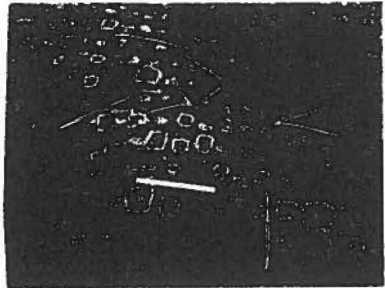
Fig. 12 - Mattress fabric is wearing away

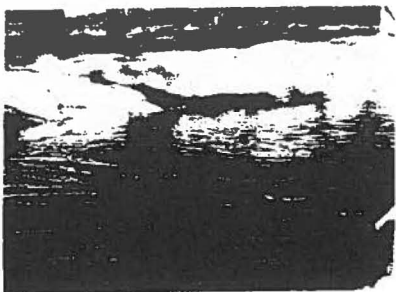
Condition: Removed from study after 2 ½ years - Liner "whales" were restricting flow (Fig. 13). Attempts to deflate the "whales" with knife-cuts, and attempts to ballast with concrete blocks were largely unsuccessful as the "whales" tended re-appear elsewhere. Figure 14 shows contractor patching numerous holes, tears, and rips from sharp subgrade rocks. Eventually, the invert liner was removed with the grout-filled mattress left in place on the sideslopes. The cause of the "whales" in Test Sections A-9 and A-10 was never resolved. Volcanic gases are suspected to be the cause.

Fig. 13 - Liner "whale" impeding flow

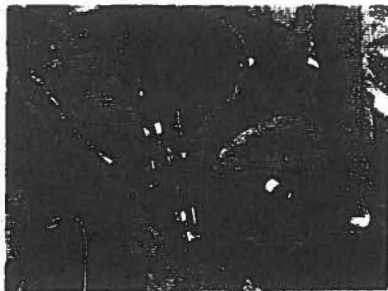
Fig. 14- Patching of tears in geomembrane

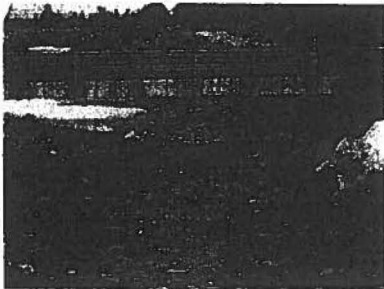
Condition: Partially failed - After 5 years, most of the invert foam has washed out of these test sections (Fig. 15). The washout initiated in the first few weeks of service just below the drop at the start of Test Section N-1 where loose sand and gravel deposits offered little uplift resistance to the buoyant foam (Fig. 16). The high velocities then undercut large, loose subgrade rocks, allowing more foam to break free. The failure then propagated downstream washing out the invert foam in Test Section N-2.

Fig. 15 - View after fifth year

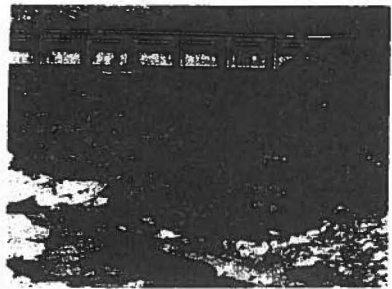
Fig. 16 - View after first year

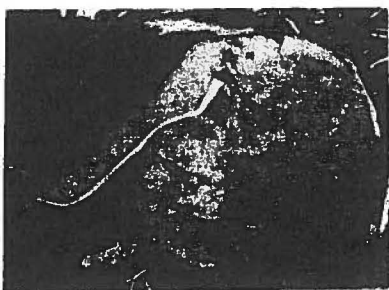
Condition: Complete failure - On the first day of service, large sections of the geotextile liners washed out resulting in complete failure (Fig. 17 and 18).

Fig. 17 - View of foam anchoring system

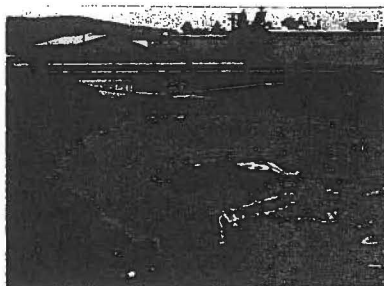
Fig. 18 - Lining floating downstream

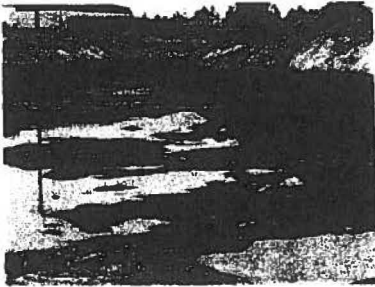
Condition: Excellent - After 6 years all the shotcrete is in excellent condition. No visible differences exist in the performance of the four shotcrete test sections. No freeze/thaw damage is evident. Small pools (Fig. 19) are present on all four test sections, even several weeks after water turn off, indicating low seepage rates. Contraction cracks on the side walls (Fig. 20) have developed every 100 to 200 feet. Crack width varies from hairline to 1/8-inch. The thickness of the shotcrete is highly variable (ranging from 1 to 6 inches thick) because of the uneven subgrade conditions, and normal problems with field installation quality control. Many large rocks (up to 1 foot in diameter) are collecting in the canal invert (perhaps rolled in by local youths). Vegetation is growing out of cracks in the shotcrete near the top of side slopes.

Fig. 19 - Small pools holding water in winter

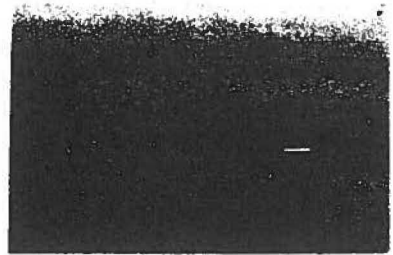
Fig. 20 - Contraction cracks in side walls

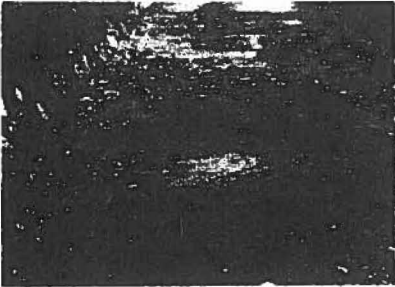
Condition: Poor - After 4 years, the membrane is completely disbonded (due to high velocities) in the invert and has rolled up into the corners against the side walls (Fig. 21). Material on the vertical side walls has lots of small tears and pinholes (Fig. 22).

Fig. 21 - Material rolled up into corners

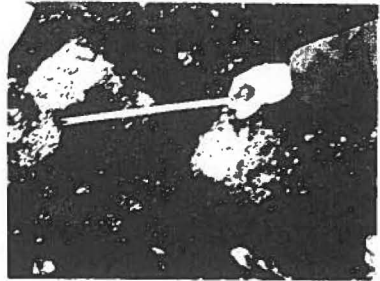
Fig. 22 - Small holes on side walls

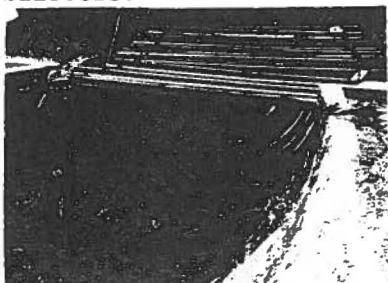
Condition: Very Good - After 3 to 4 years the membrane is well bonded to 99 percent of the steel flume (Fig. 23). No leakage is evident. Numerous blisters (Fig. 24) have developed where the membrane is poorly bonded to underlying old tar material.

Fig. 23 - View of coated steel flume

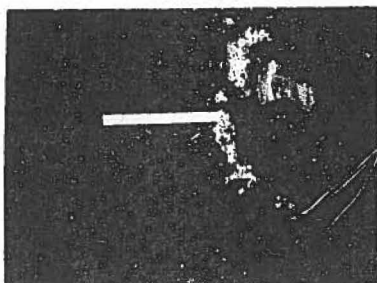
Fig. 24 - Blisters formed on old tar

Maintenance: Minor maintenance required to repair blisters.

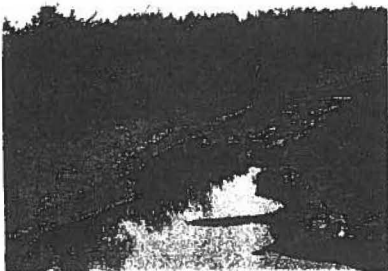
Condition: Very Good - After 4 years of service (Fig. 25), the geomembrane is in very good condition. Figure 26 shows a piece of new material on top of the 4-year-old material. The alligator cracking began to appear after about one year, but the material remains quite flexible.

Fig. 25 - View of canal after 4 years

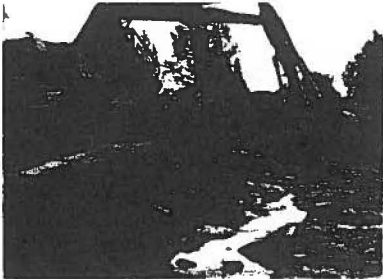
Condition: This new installation (only 6 months old) over fractured basalt (Fig. 27) has not yet gone through a full irrigation season (Fig. 28).

Fig. 27 - Trackhoe trying to excavate basalt

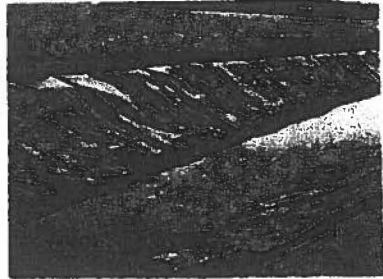
Fig. 28 - View of completed canal
