TECHNICAL REPORT N-70-10

SURVEY OF GULF COAST  
STRUCTURAL DAMAGE RESULTING FROM  
HURRICANE CAMILLE, AUGUST 1969

M. E. Criswell, R. S. Cummins

April 1970

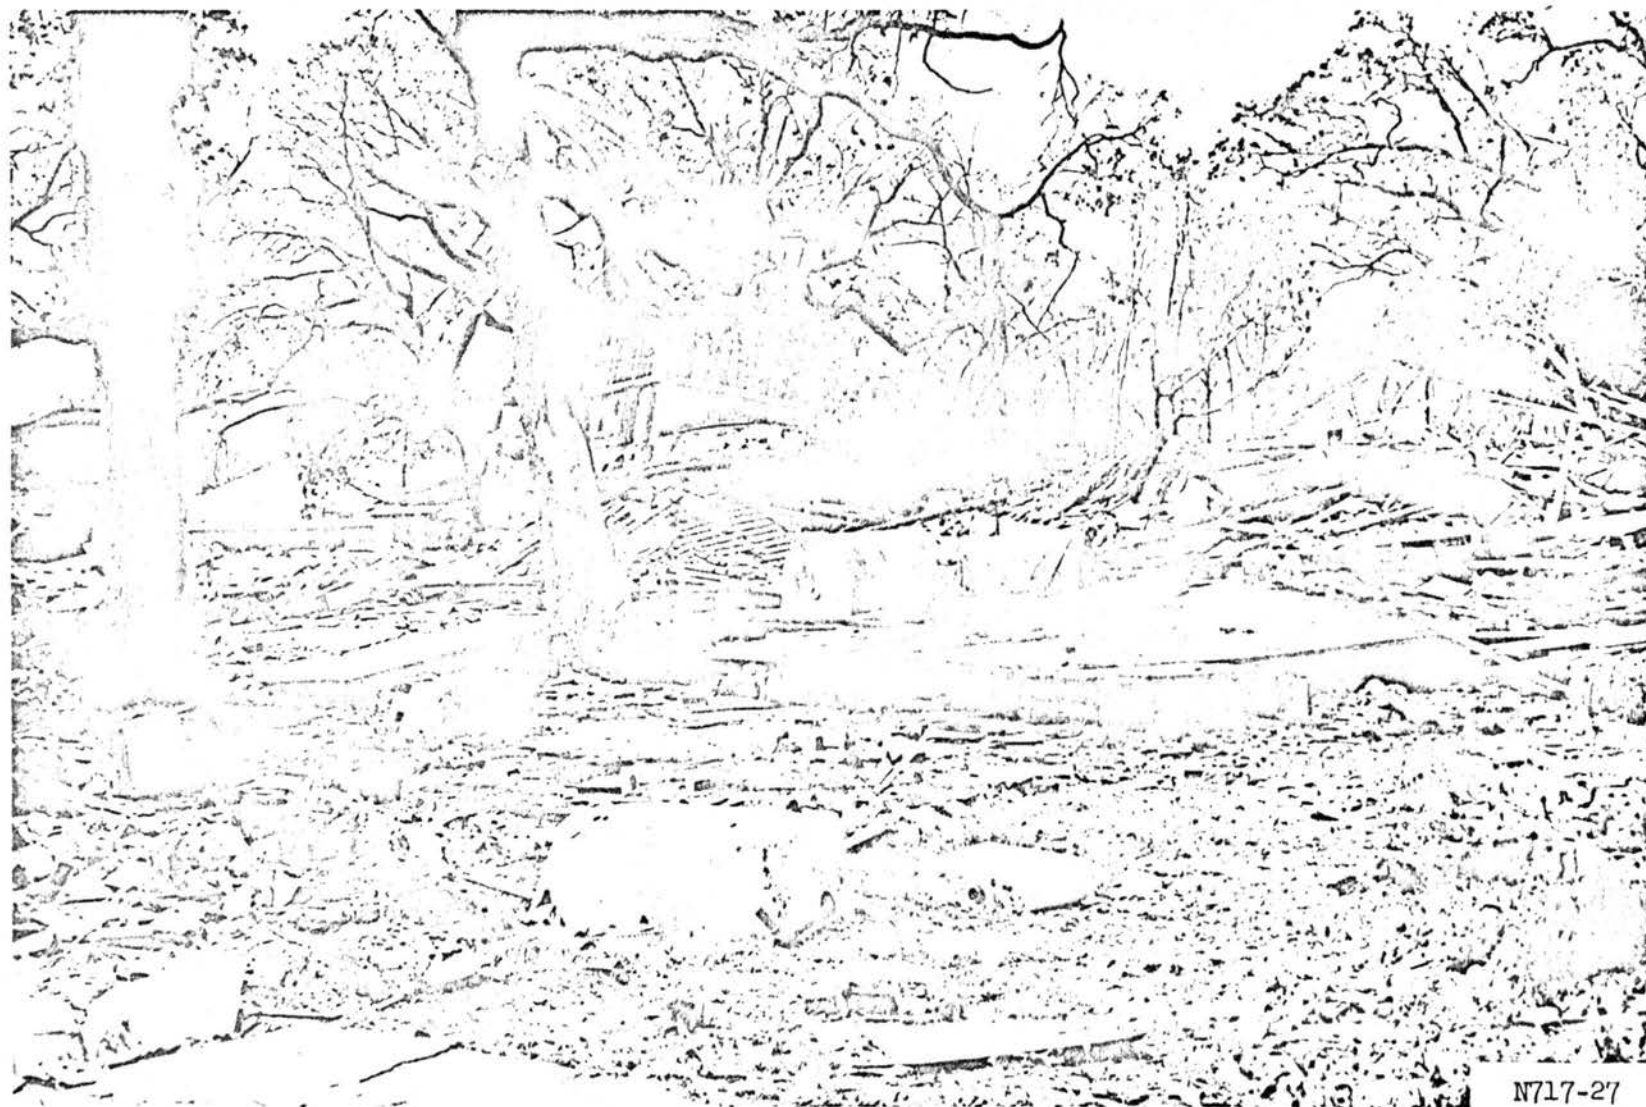
N717-27

Figure 2.28 Tug and paper rolls in debris, west Gulfport, Mississippi.

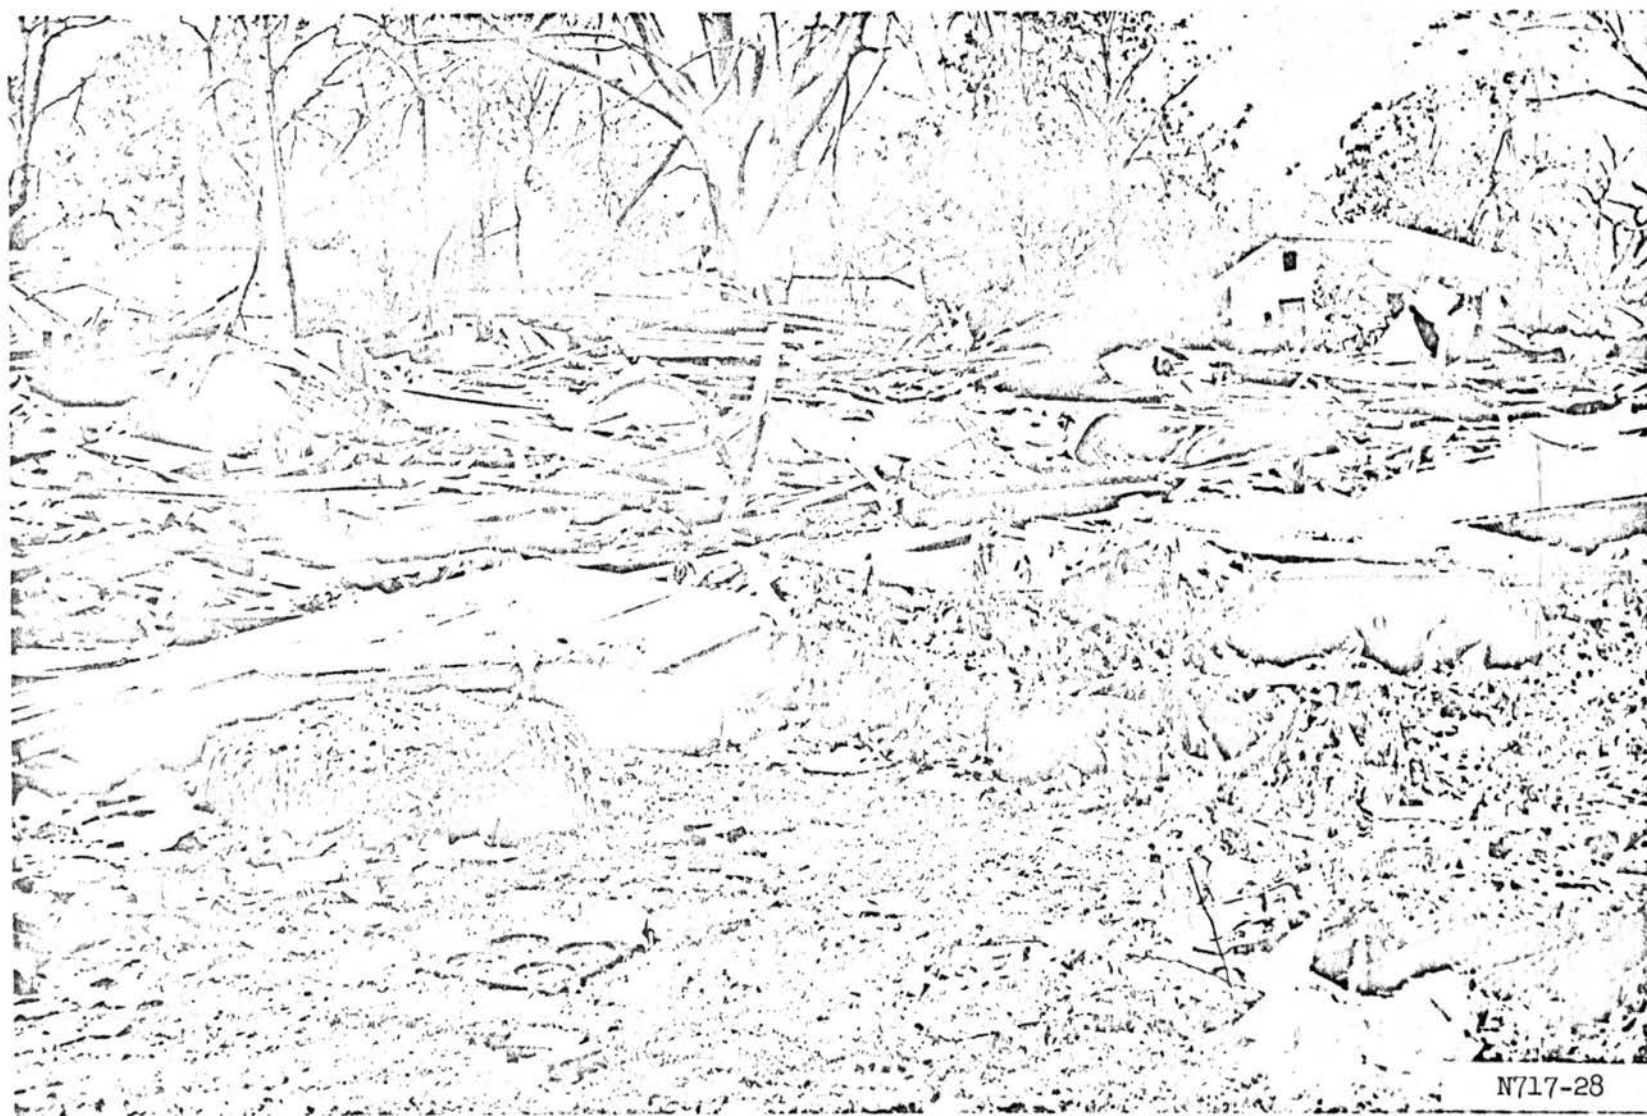
N717-28

Figure 2.29 Debris from residences and Port facilities, west Gulfport, Mississippi.

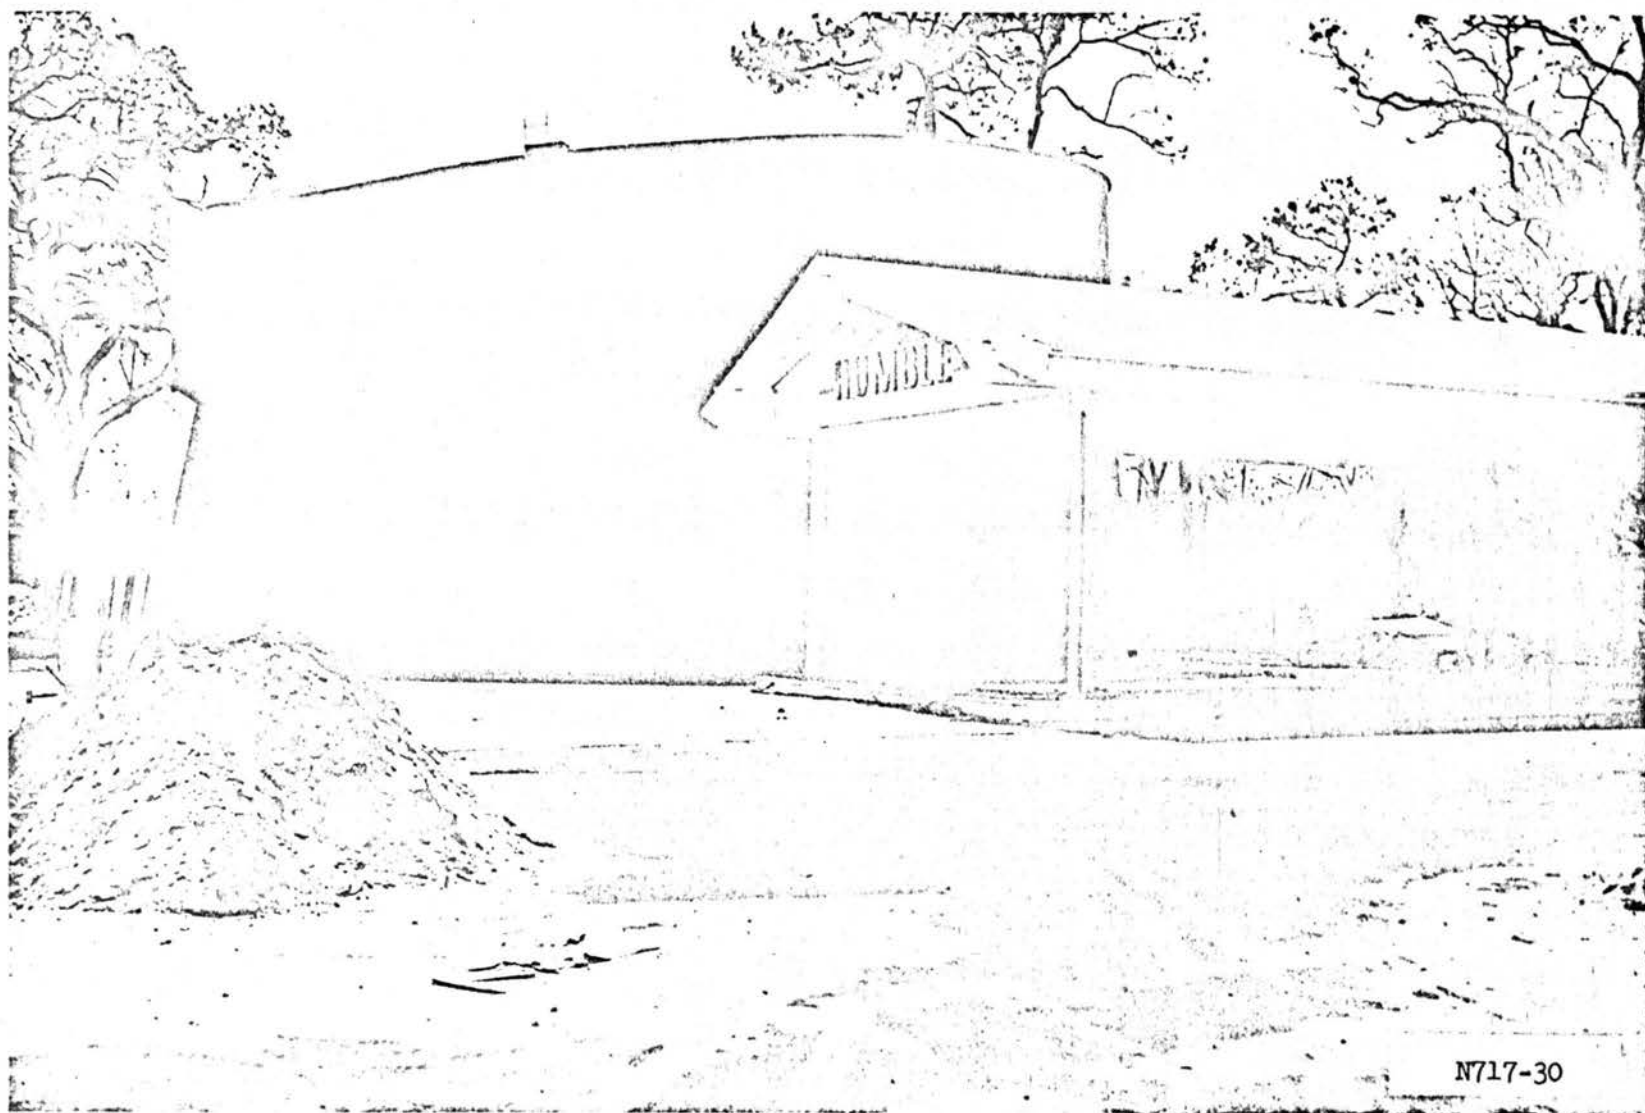
Figure 2.30 Tank floated in from harbor, west Gulfport, Mississippi.

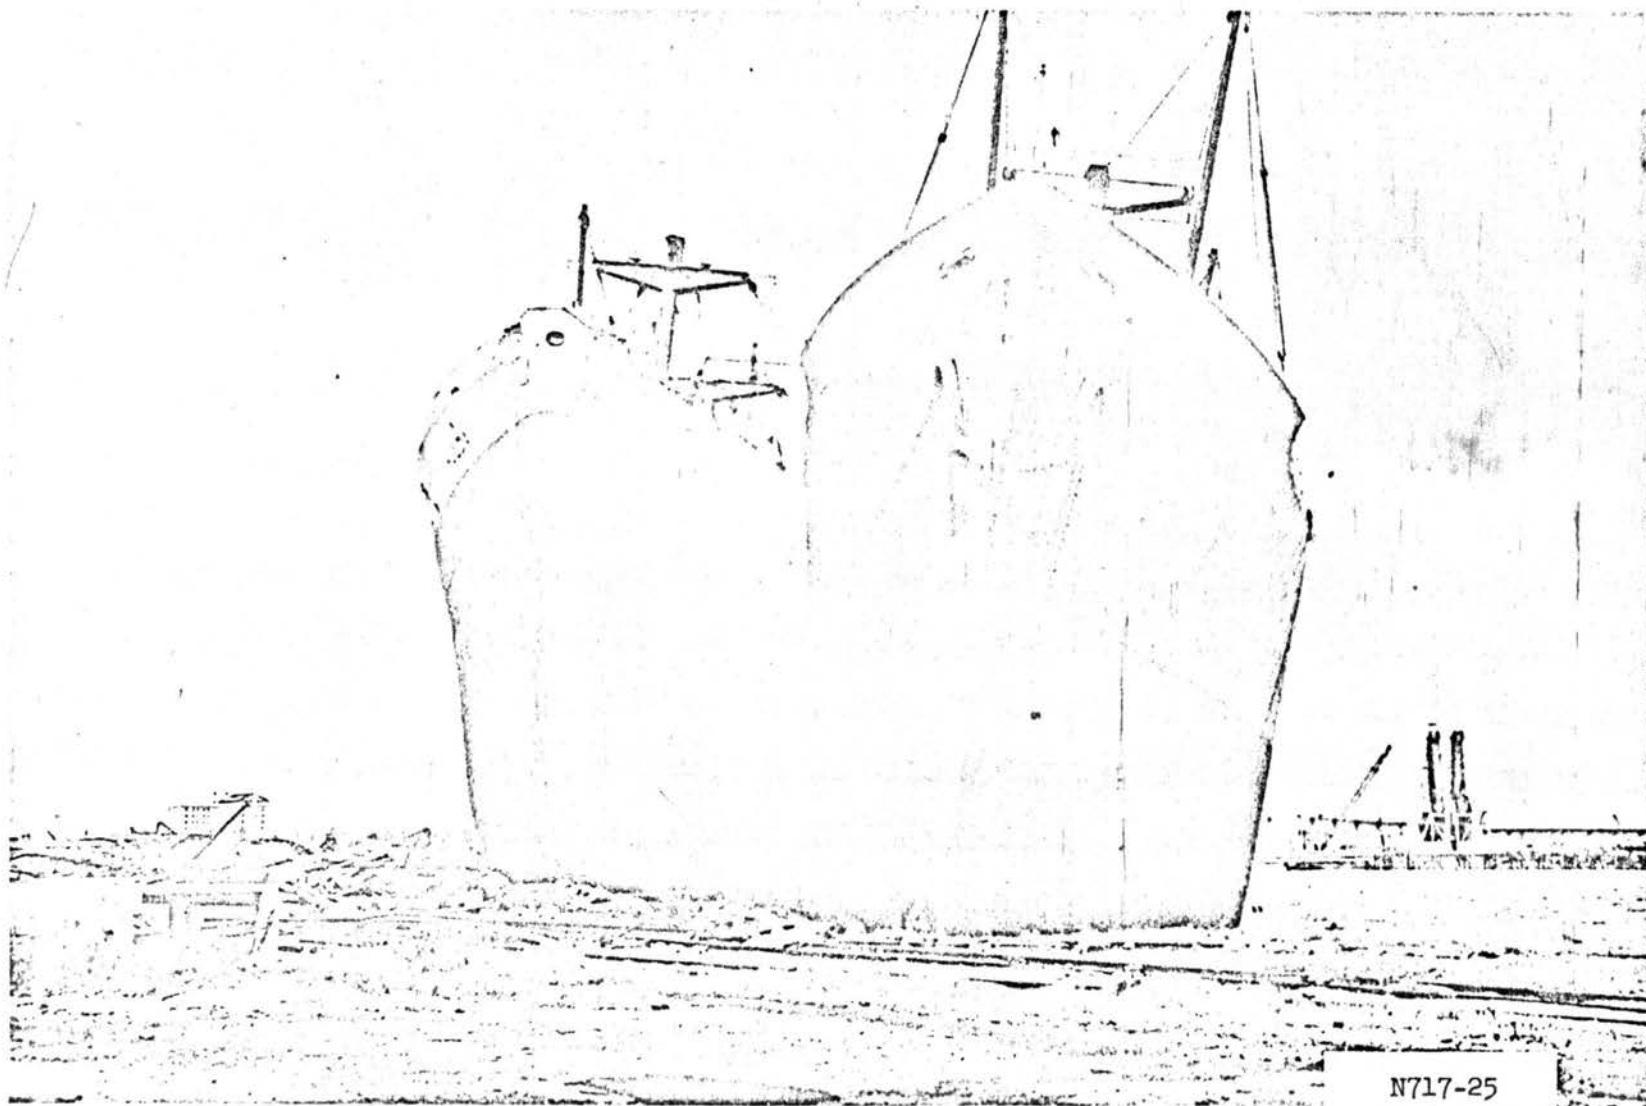
N717-25

Figure 2.31 Ships aground, Port of Gulfport.

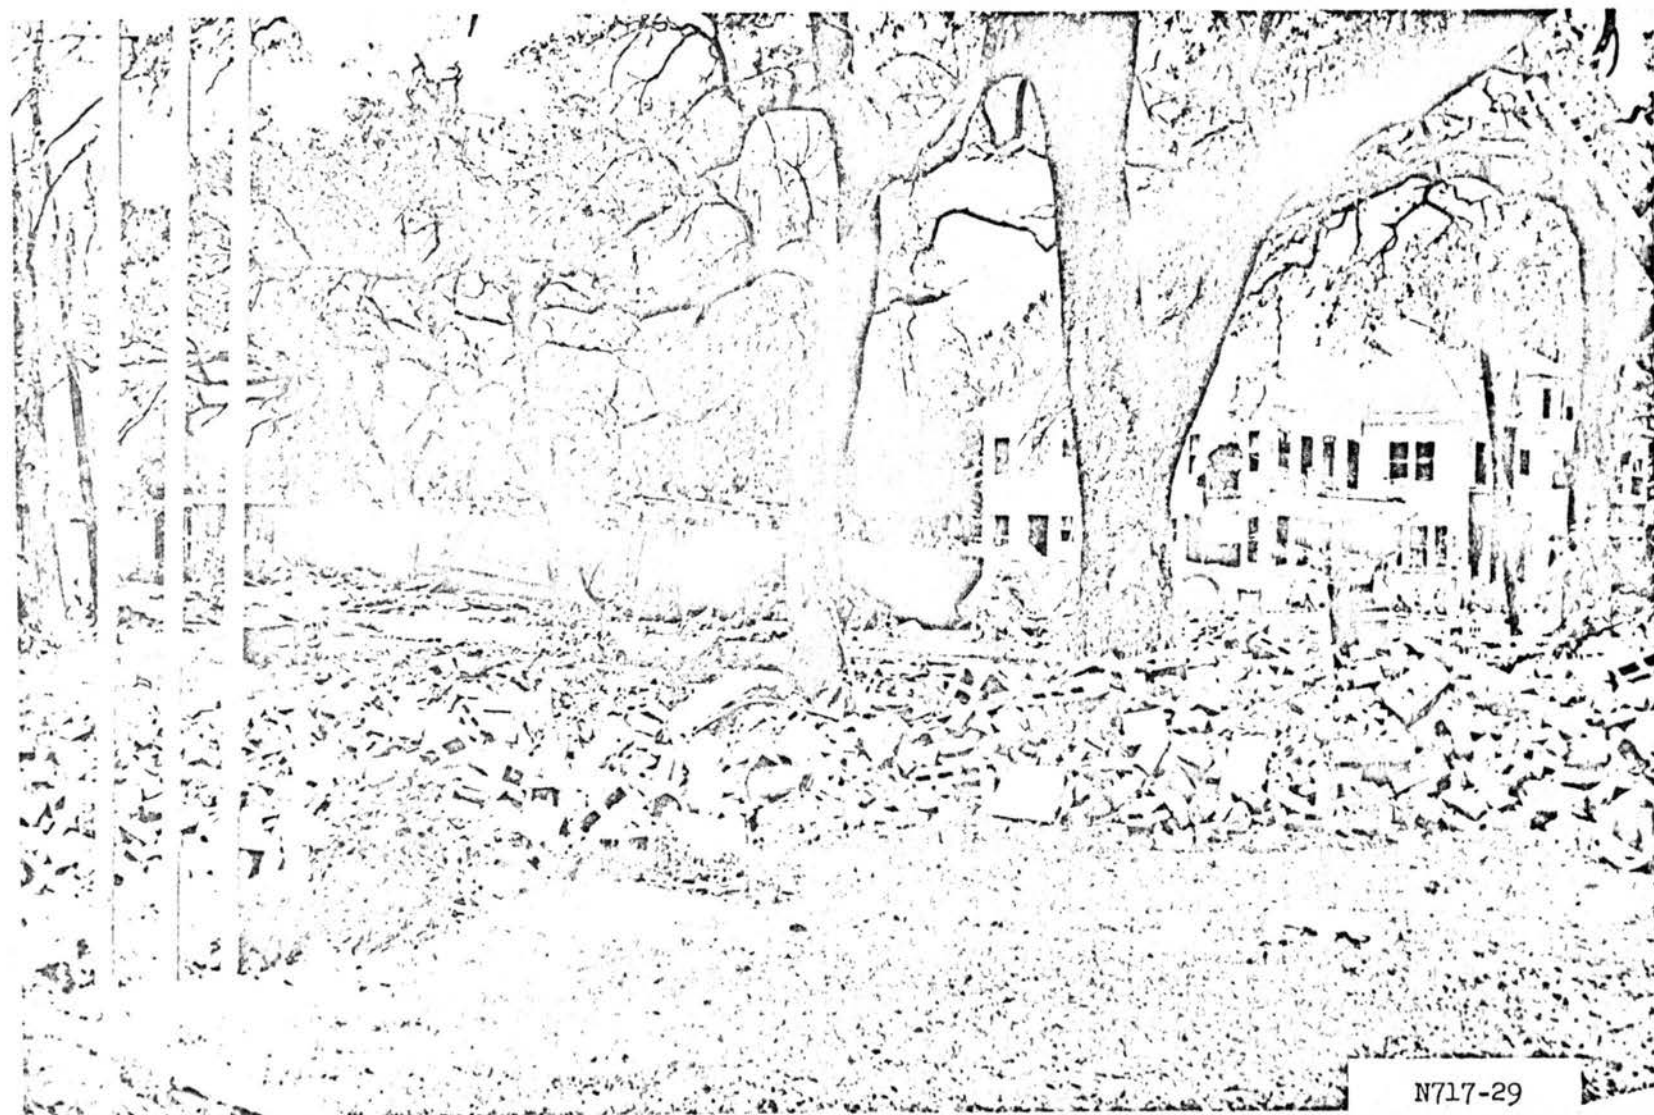
N717-29

Figure 2.32 Barge, debris, and damaged residence, west Gulfport, Mississippi.

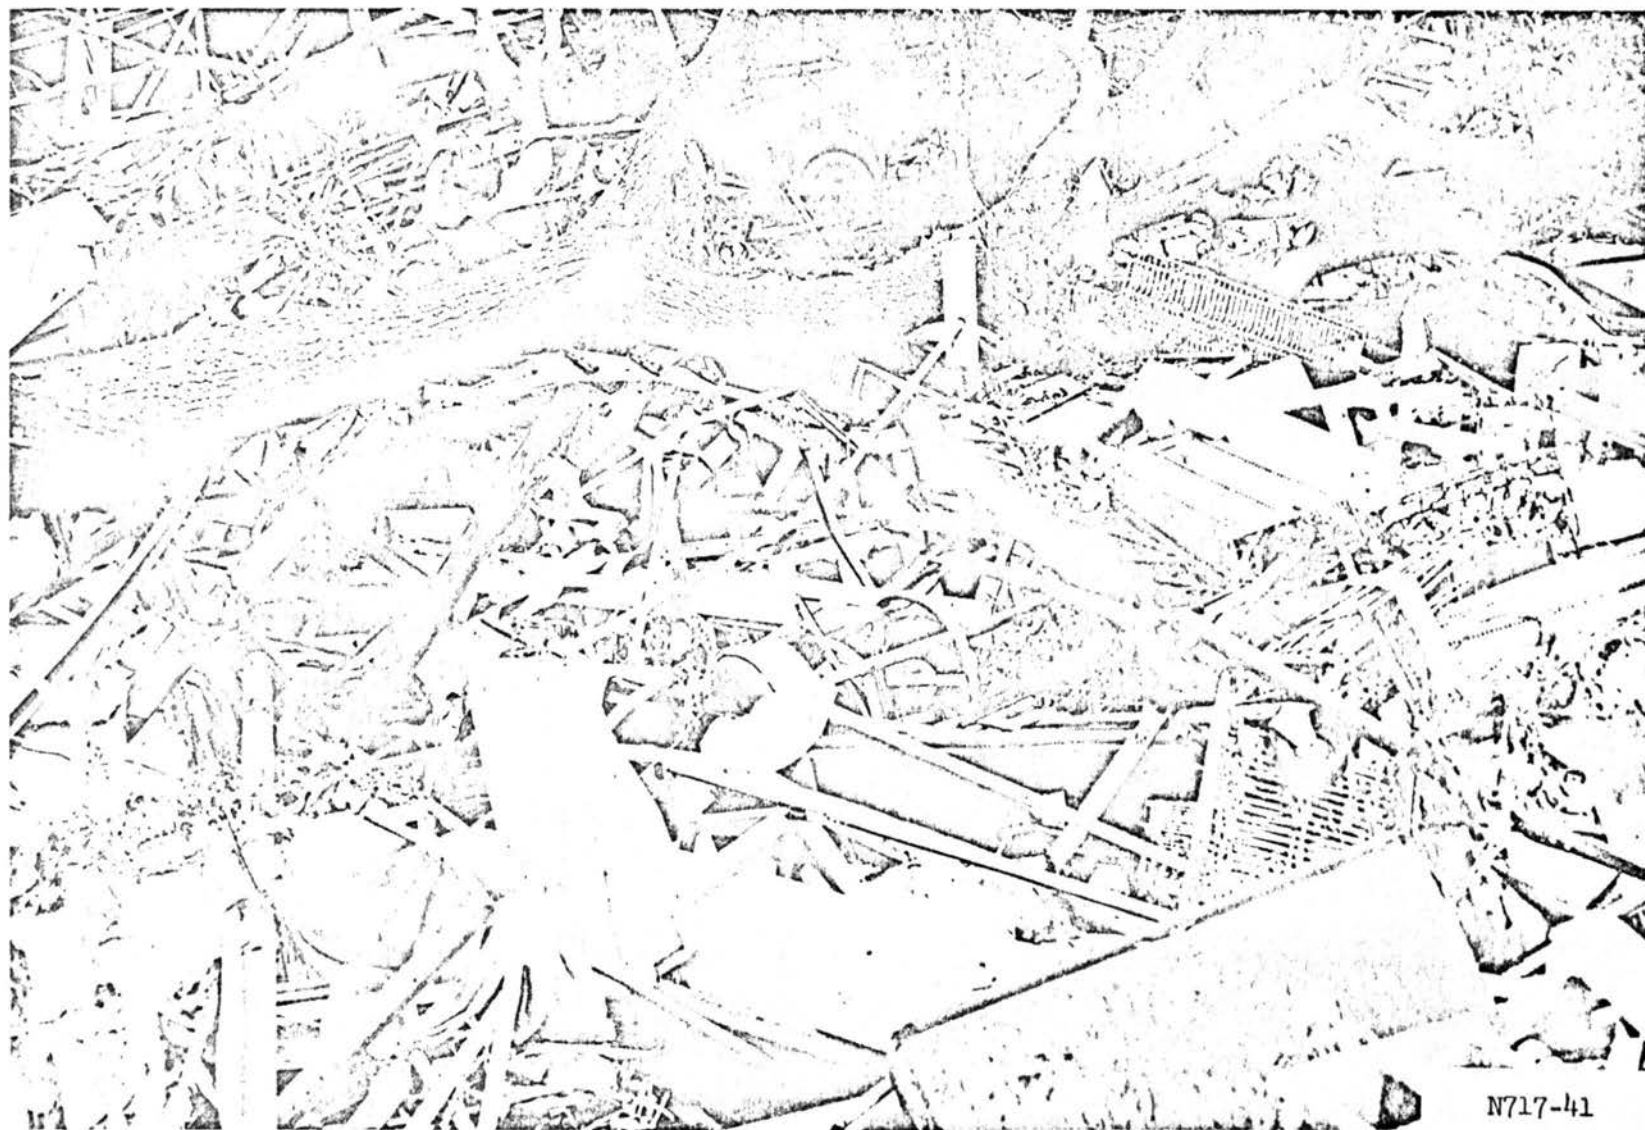
Figure 2.33 Debris of a shopping center, Long Beach, Mississippi.

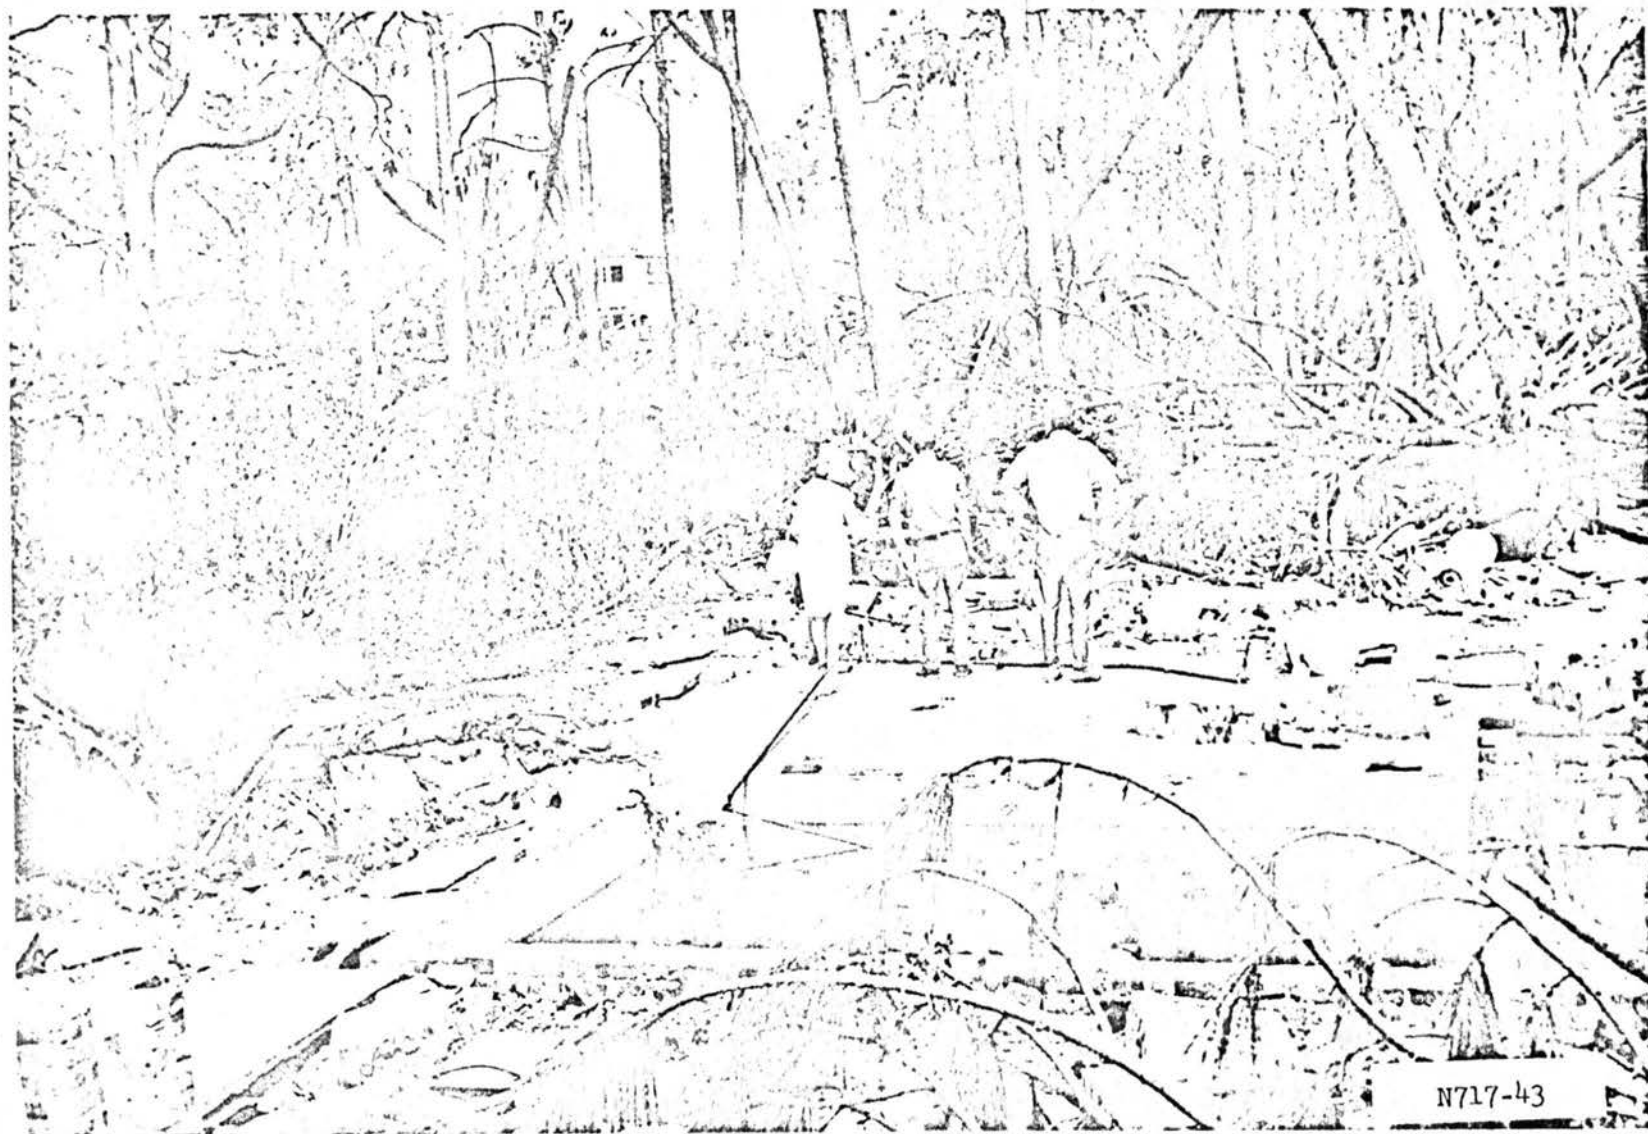
N717-43

Figure 2.34 Destroyed residence from front doorsteps, Long Beach, Mississippi.

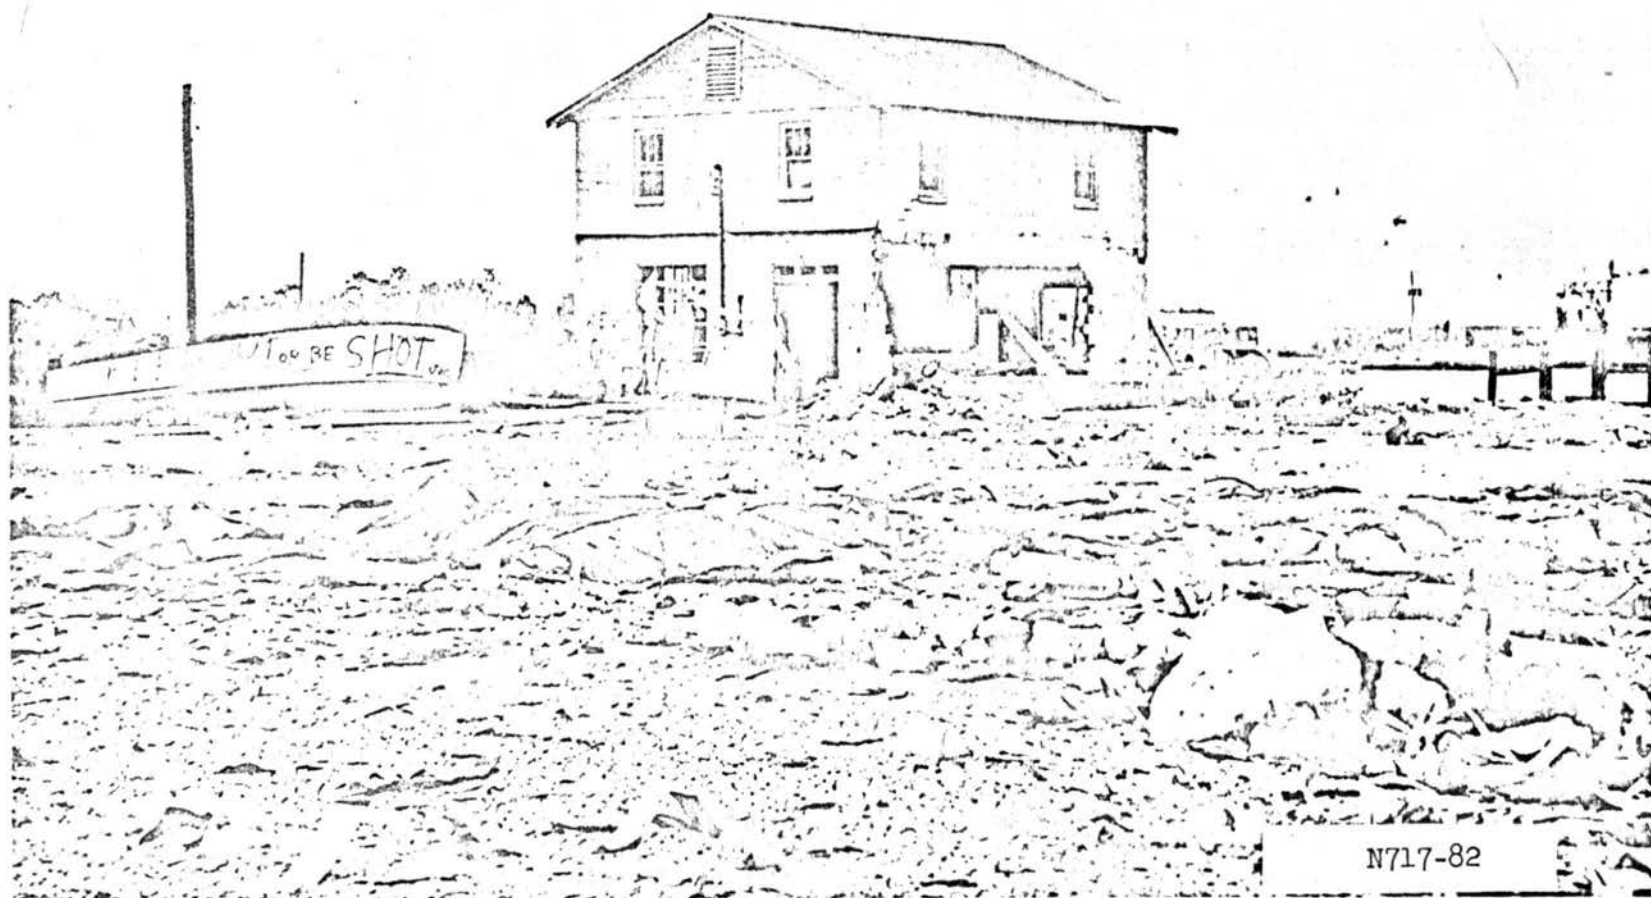
Figure 2.38 Water-damaged building, Back Bay of Biloxi.

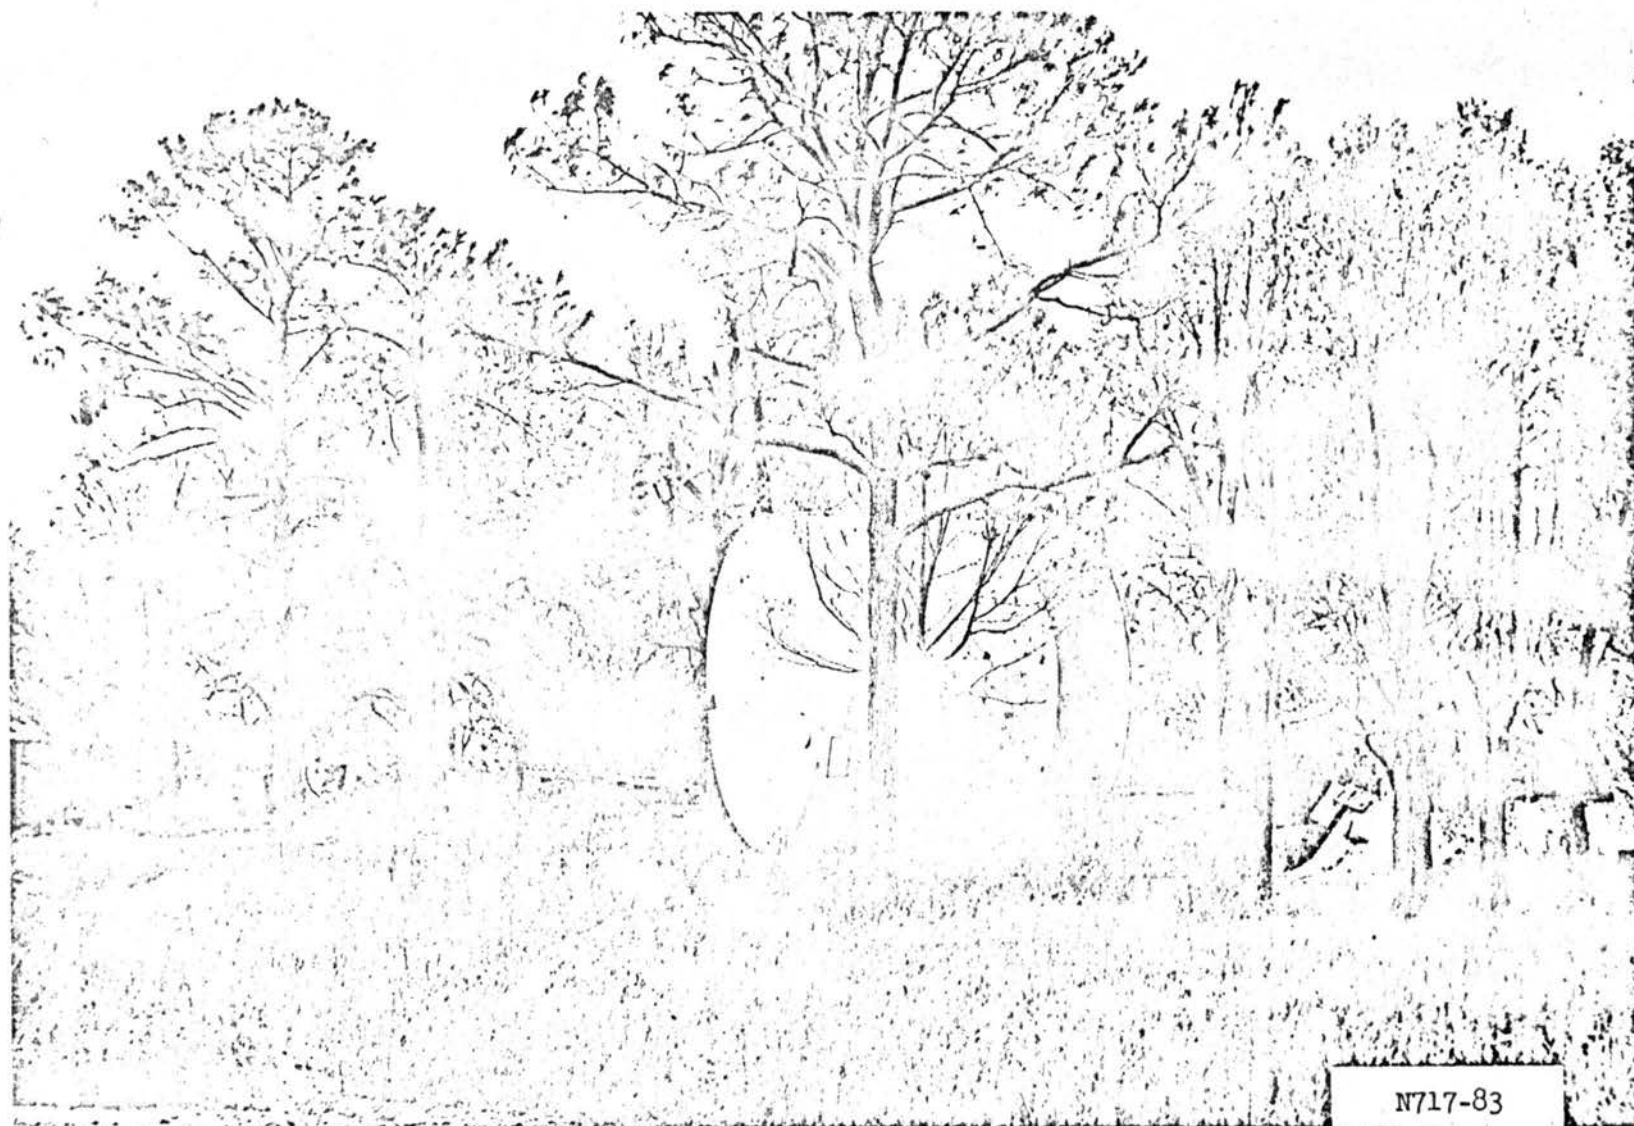
Figure 2.39 Oil storage tank floated inland, Back Bay of Biloxi.

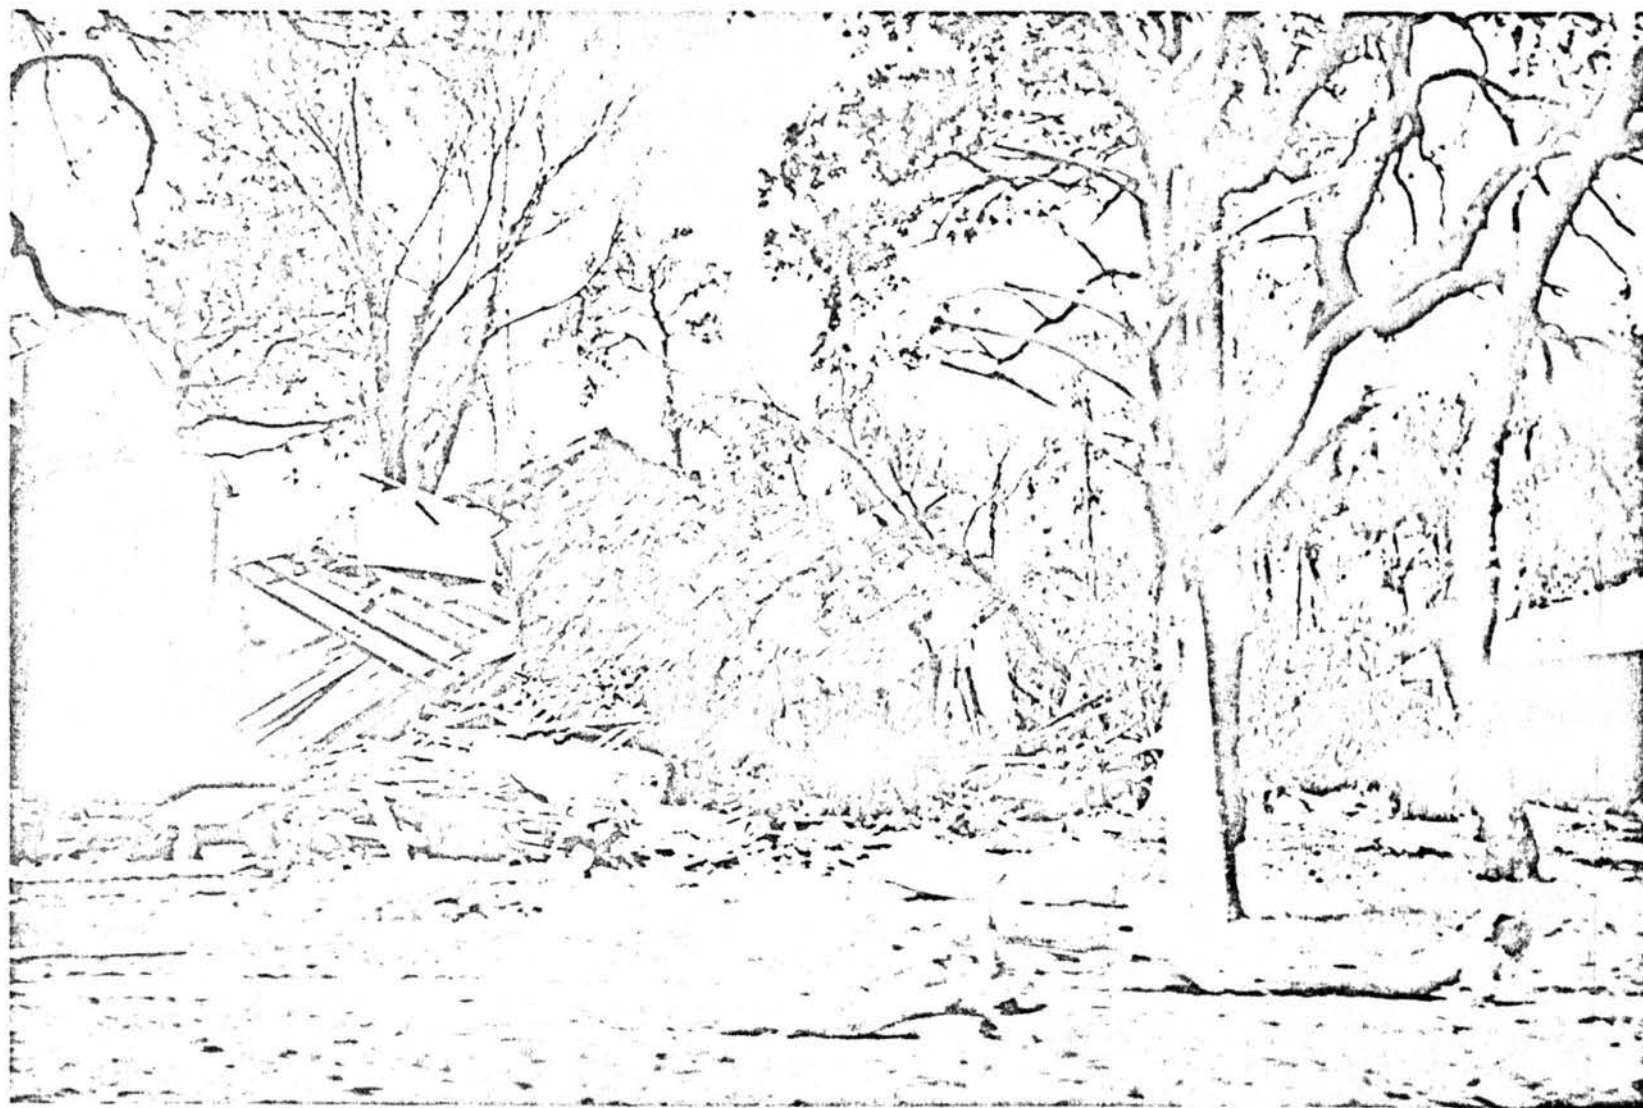
Figure 2.47 Collapsed frame house, between Biloxi and Gulfport, Mississippi.

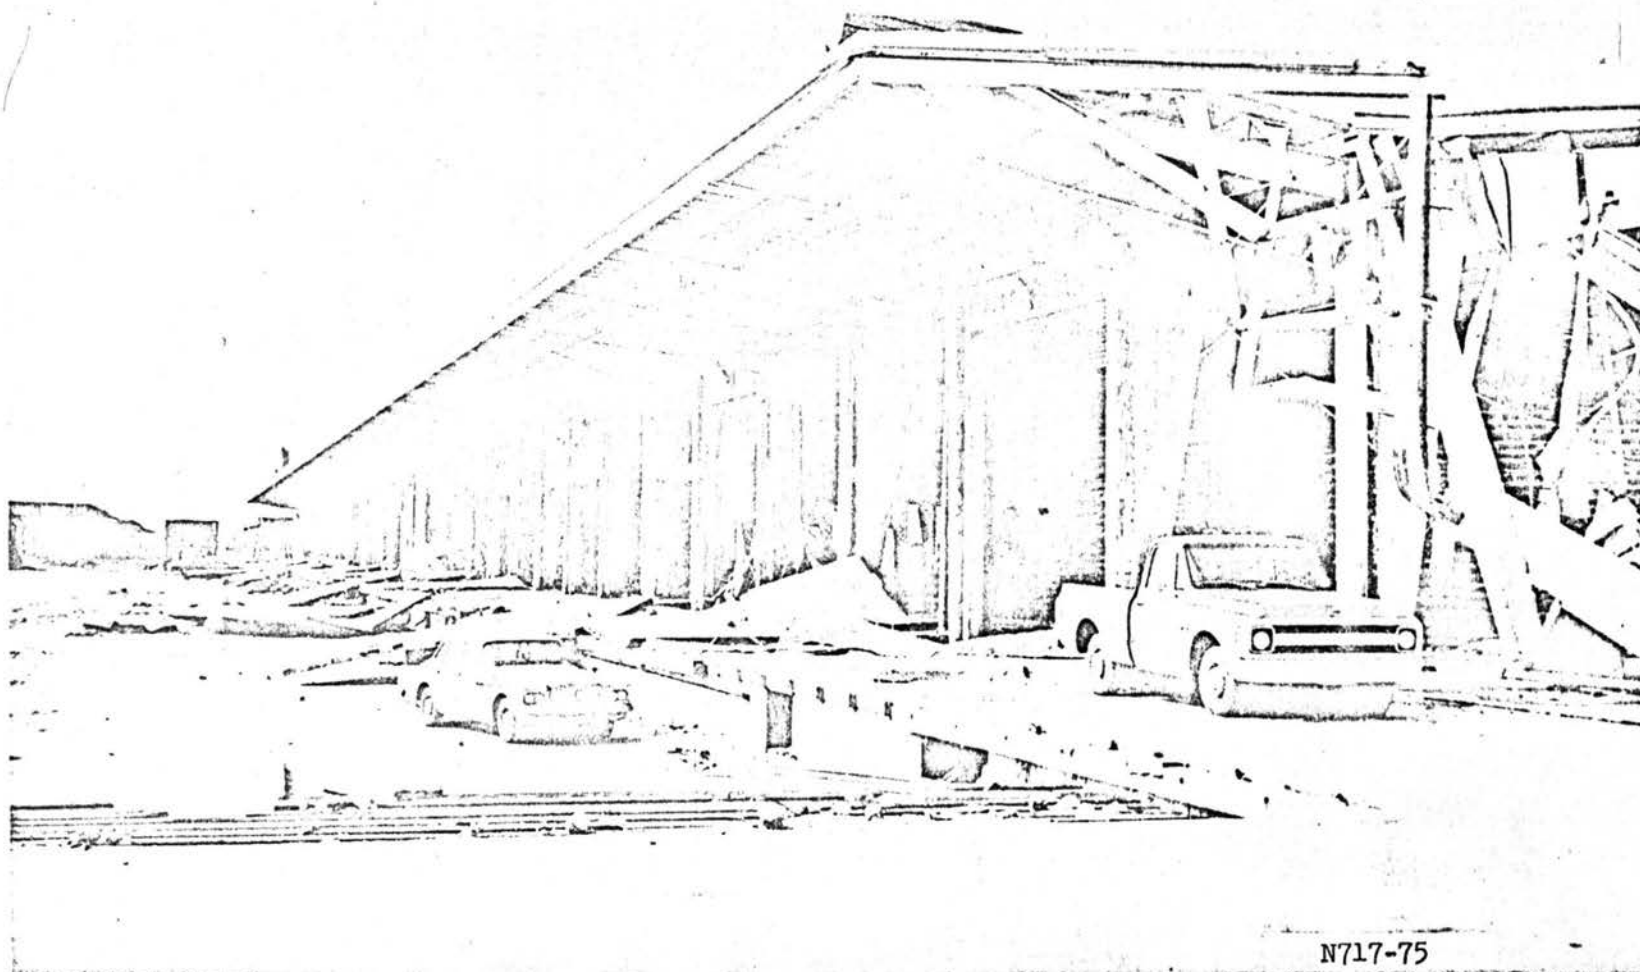
Figure 3.5 Failure of tilt-up walls along west side of State Dock.

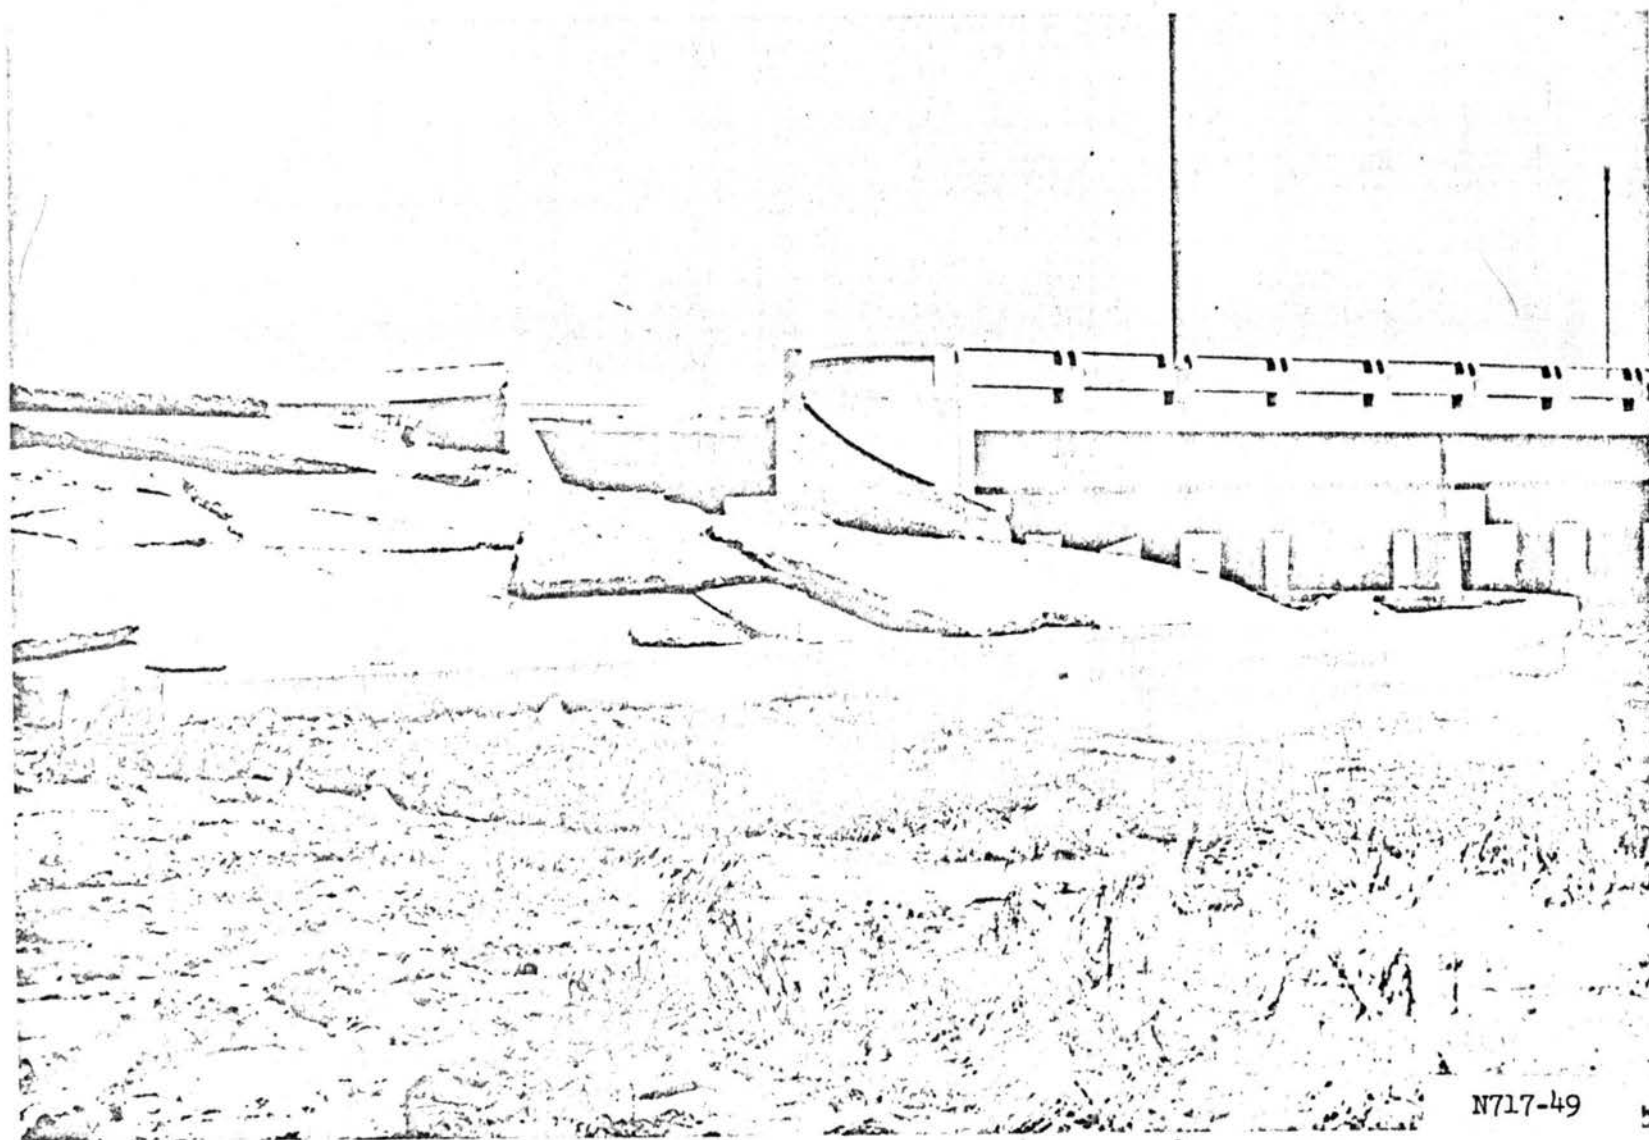
N717-49

The water appeared to have lifted the seaward deck slabs up enough for the rocker bearings on the east end of each span to fall out, resulting in a sawtooth appearance along the south side of the bridge (Figures 3.52 and 3.53). Some of the railing sections were tilted inland, and all but one lamp was torn from its pole. One span was moved about 4 feet laterally (Figure 3.54). Considerable concrete was spalled along the bridge centerline where the two deck slabs joined. The west abutment was heavily damaged by wave action (Figure 3.55).

Figure 3.55 West abutment of Bay Saint Louis Bridge.
