Flood of 31 July 1976 in Big Thompson Canyon, Colorado

D. B. Simons, J. D. Nelson, E. R. Reiter, and R. L. Barkau

Committee on Natural Disasters
Commission on Sociotechnical Systems
NATIONAL RESEARCH COUNCIL

National Academy of Sciences Washington, D.C. 1978

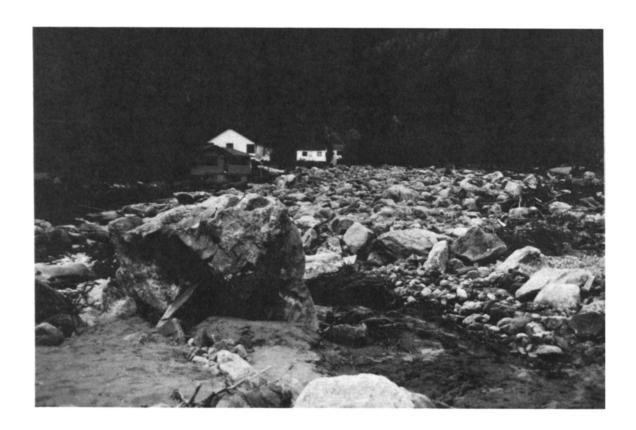
FIGURE 14 Boulder Deposit Upstream of Drake

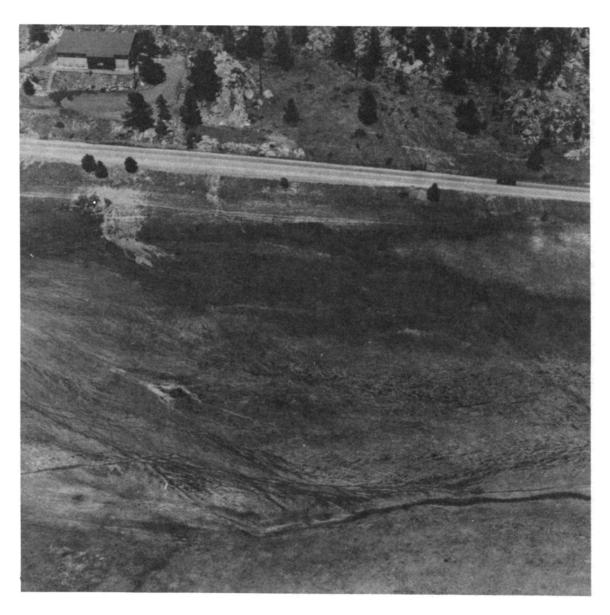
Sheet erosion results from the suspension of fine surface materials by overland flow. Sheet erosion most commonly occurs on the gentle to moderate (5 to 15%) slopes where rainfall is so intense that the infiltration capability of the soil is exceeded. Poorly developed soils of granitic origin (gruss) with little vegetative cover are subject to severe erosion. During the 1976 flood, sheet erosion removed almost 6 inches of gruss from intense rainfall areas (Doehring 1976). Soils that had developed from the weathering of metamorphic rocks were less susceptible to severe erosion. On steeper slopes sheet erosion was replaced by rill wash and Gullying. Figure 15 shows an area of sheet erosion along Dry Gulch near Estes Park.

FIGURE 15 Sheet Erosion along Dry Gulch near Estes Park

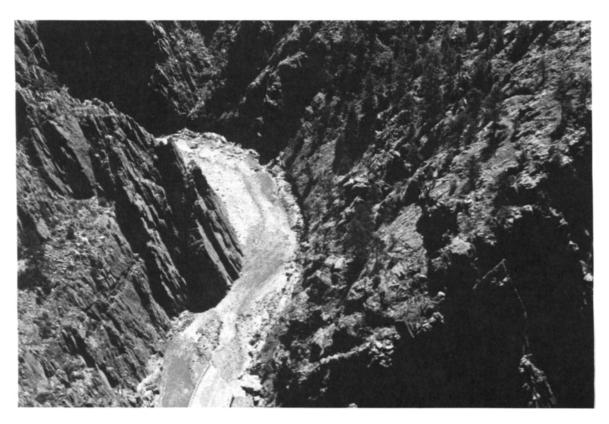
FIGURE 16 Erosion along Outside and Deposition along Inside of Stream Bed

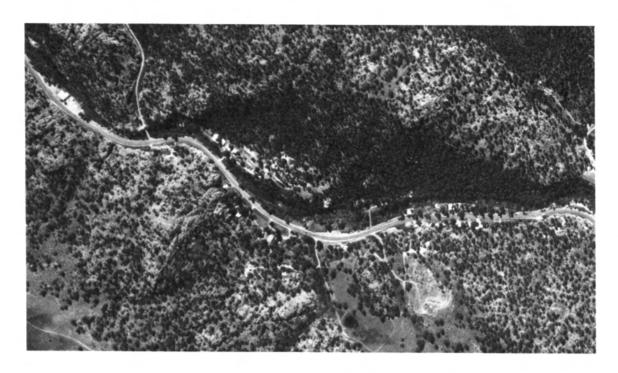
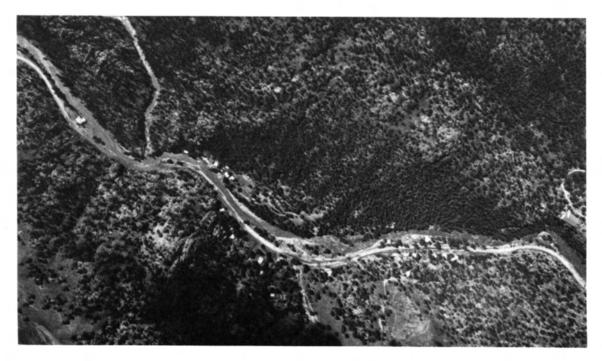
FIGURE 22 Small Tributaries Entering the Big Thompson River near Glen Comfort, before and after the Flood

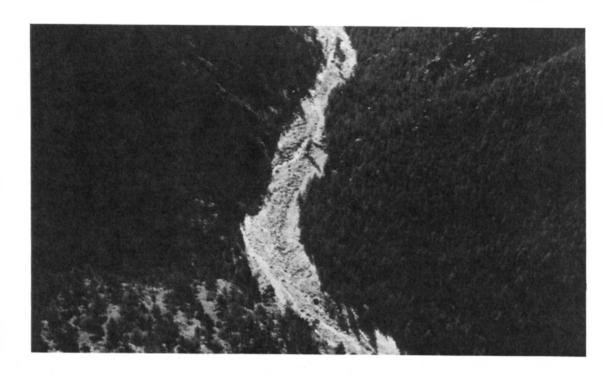
FIGURE 25 Scour on the Upstream Reach from Drake

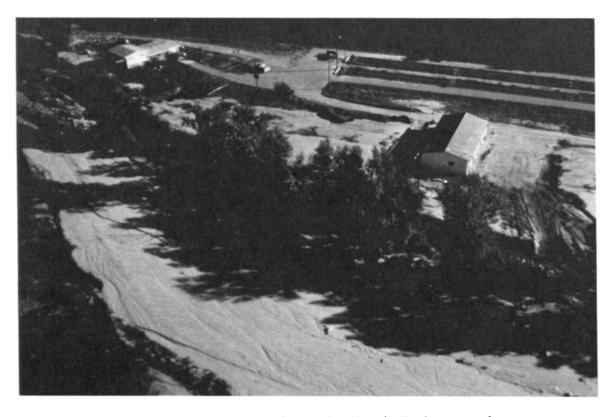
FIGURE 28 Deposits along the North Fork near the Fish Hatchery just Upstream from Drake

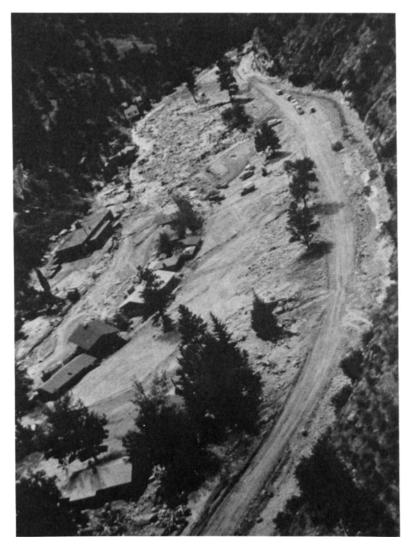
FIGURE 29 Grading of Materials Deposited by the Big Thompson River at Drake

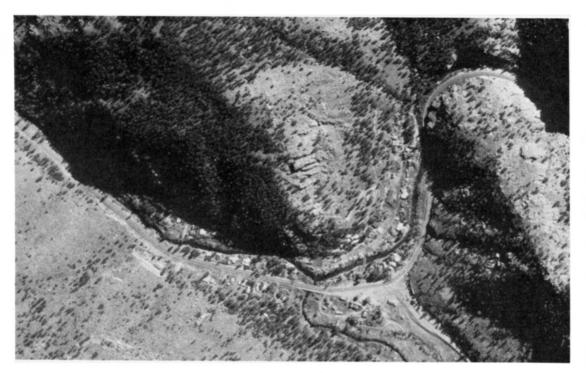
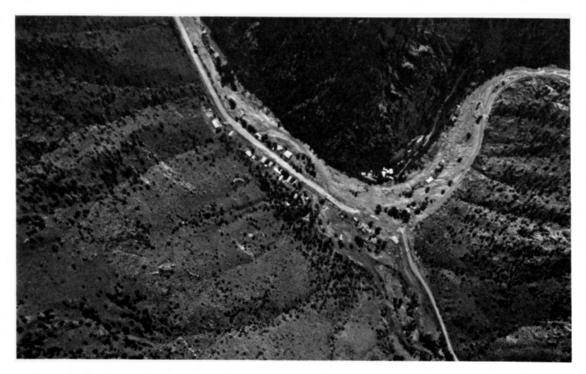
After the Flood FIGURE 30 Drake

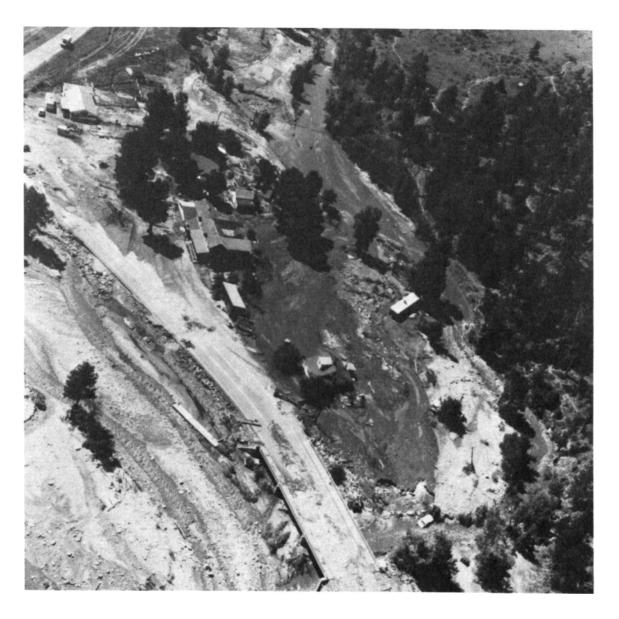
FIGURE 31 Deposits from the North Fork at Drake

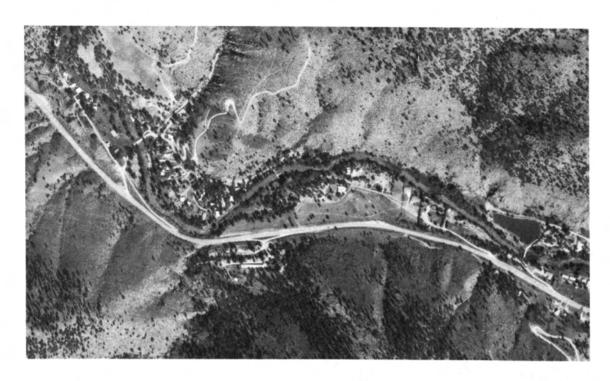
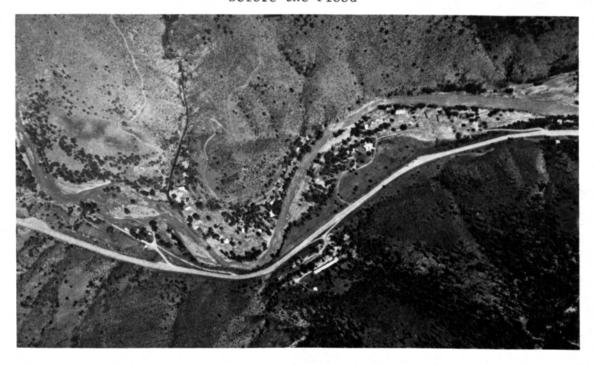
FIGURE 32 Deposits near Cedar Grove

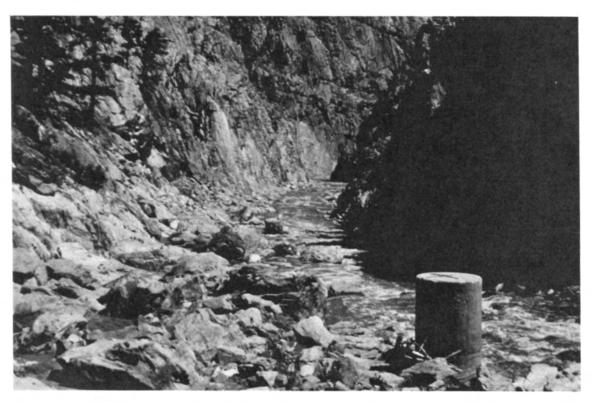
FIGURE 33 Scour in the Narrows Area near the Bureau of Reclamation Diversion Structure

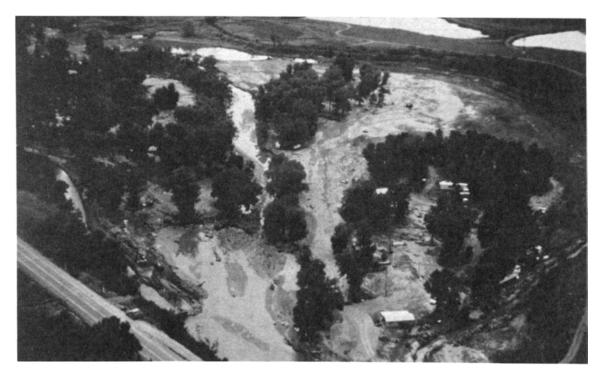
FIGURE 35 Overbank Deposits in the Plains Area

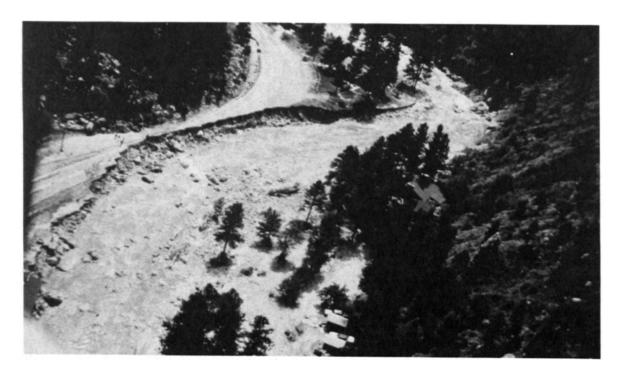
FIGURE 36 Erosion of Outside Bend on U.S. Highway 34

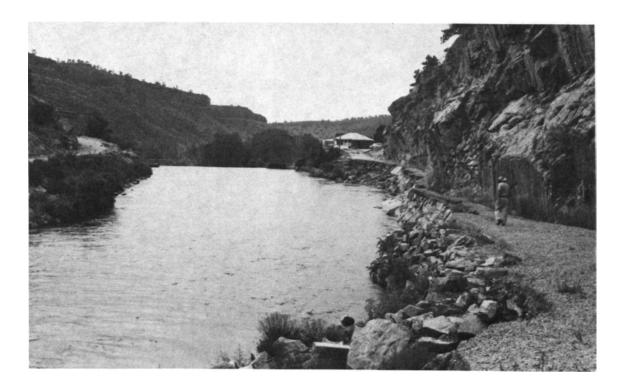
FIGURE 37 Erosion of Road between Bridge and Dam at Loveland Filtration Plant

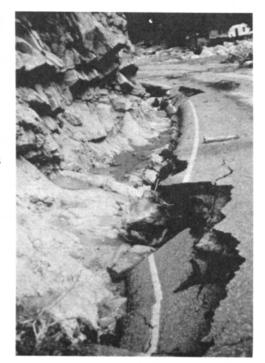
FIGURE 38 Scour in Drainage Ditch on inside of U.S. Highway 34

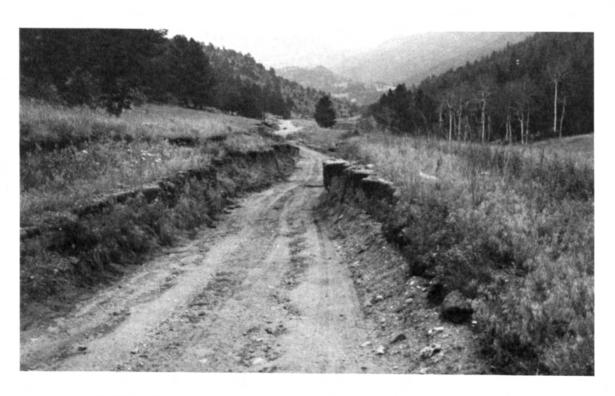
Extensive gullying along roadways was also evidenced in the Dun-raven Glade area north of the North Fork. Such gullying can be seen in Figure 39. Extensive erosion was fairly common along roadways or around man-made structures.

FIGURE 39 Extensive Gullying in Dunraven Glade Area

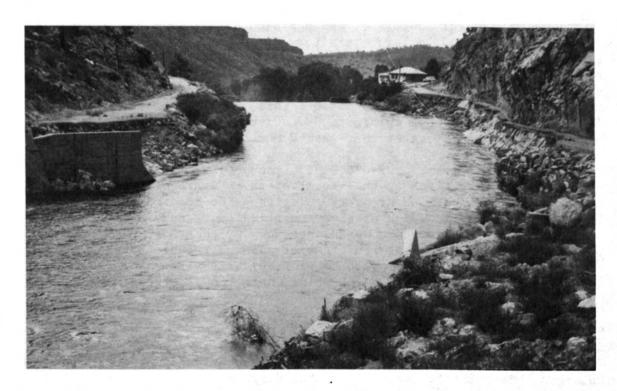
FIGURE 41 Abutments of Destroyed Bridge near Loveland Filtration Plant

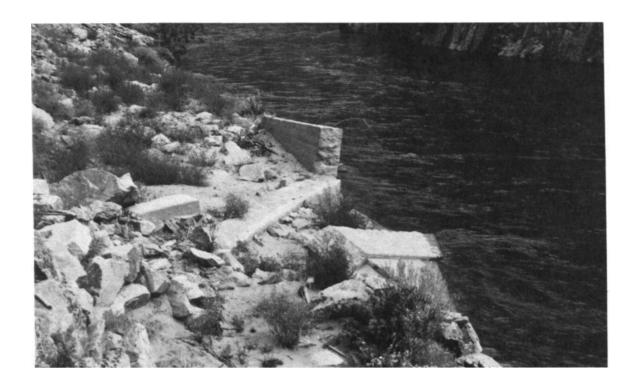
FIGURE 42 Close-up View of Right Abutment Shown in FIGURE 41

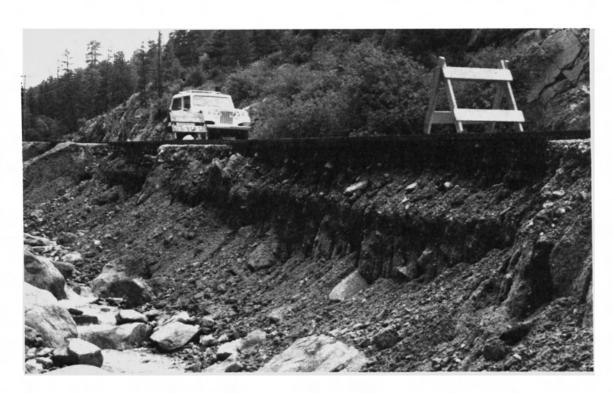
FIGURE 43 Repaired Highway Embankment Washed out by Subsequent Storm

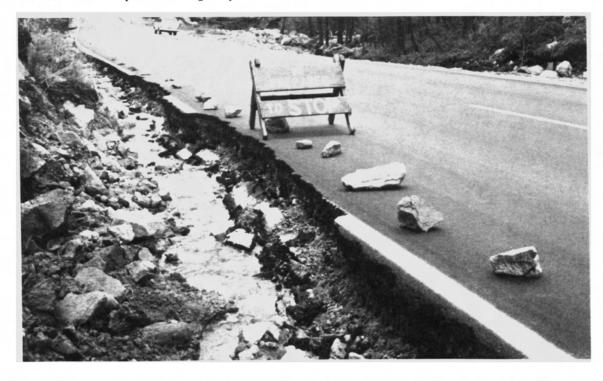
FIGURE 44 Repaired Pavement Eroded by Scour in Drainage Ditch

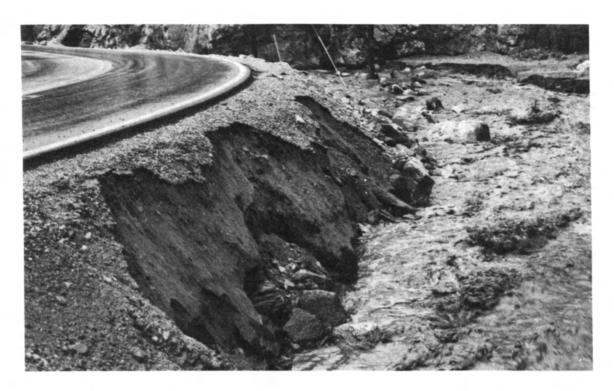
FIGURE 45 Repaired Highway Embankment Eroded by Water from Tributary

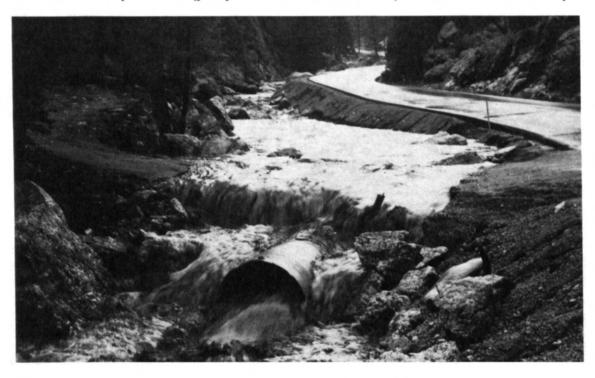
FIGURE 46 Storm Waters Washing over Culvert

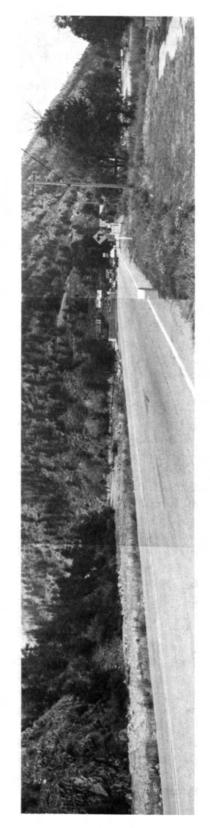
FIGURE 47 Town of Drake after the Flood

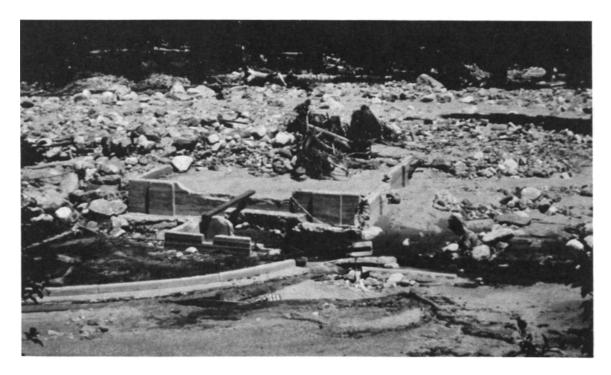
Figure 48 shows the remains of the Loveland City Power Plant. The foundation structure survived well but the entire masonry superstructure and large generators were washed away. Wooden structures were often floated off the foundations and deposited at a different point.

FIGURE 48 Loveland Power Plant

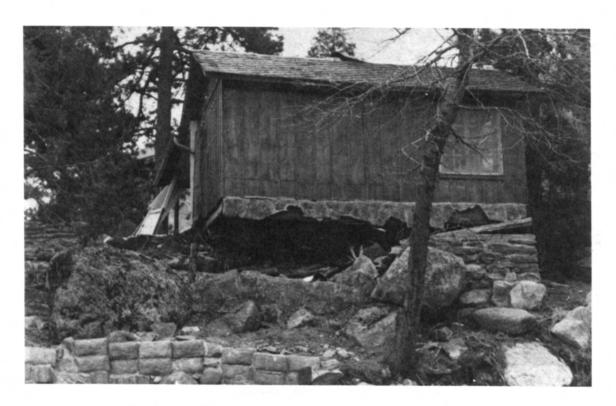
FIGURE 49 Failure of Timber Foundation with Stone Masonry Facing

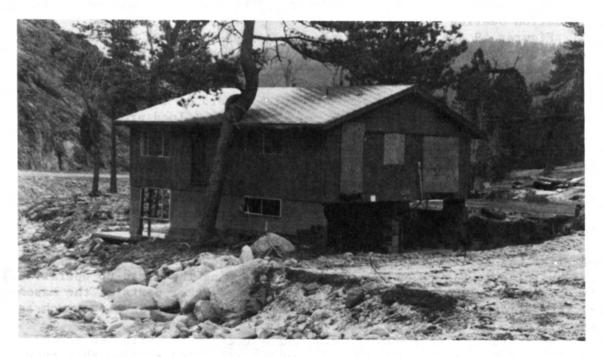
FIGURE 50 Failure of Concrete Block Foundation

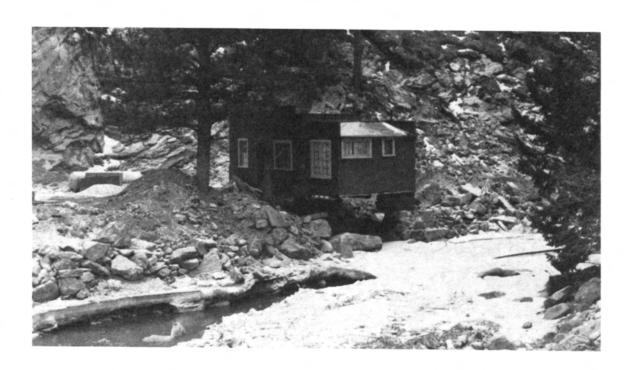
FIGURE 51 Erosion of Foundation Bearing Material

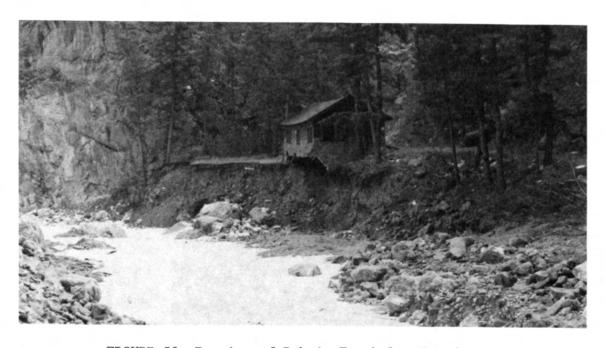
The structure in Figure 52 was constructed on a debris fan formed below a gulch that is normally dry. In the following section this type of failure will be discussed in more detail with regard to slope stability. The point to be made, however, is that, although the floodwaters

FIGURE 52 Erosion of Debris Fan below Foundation

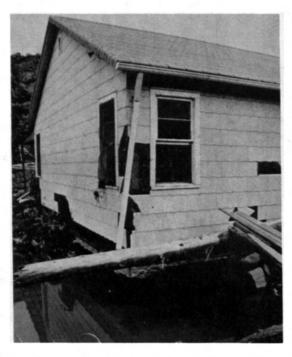
FIGURE 54 Erosion below Slab on Grade Foundation

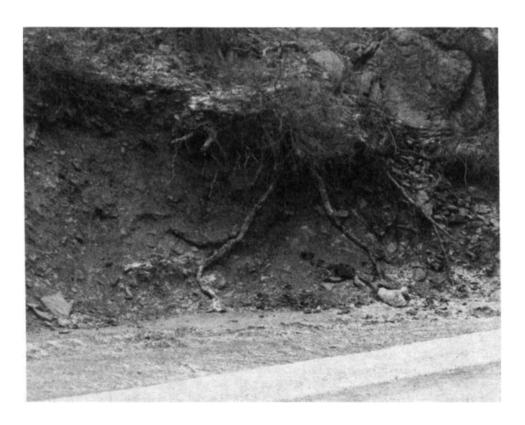
FIGURE 55 Root Zone of Soil Cover

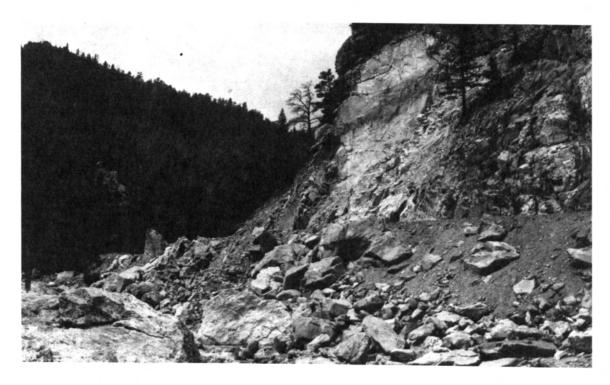
FIGURE 56 Rock Fall along Highway

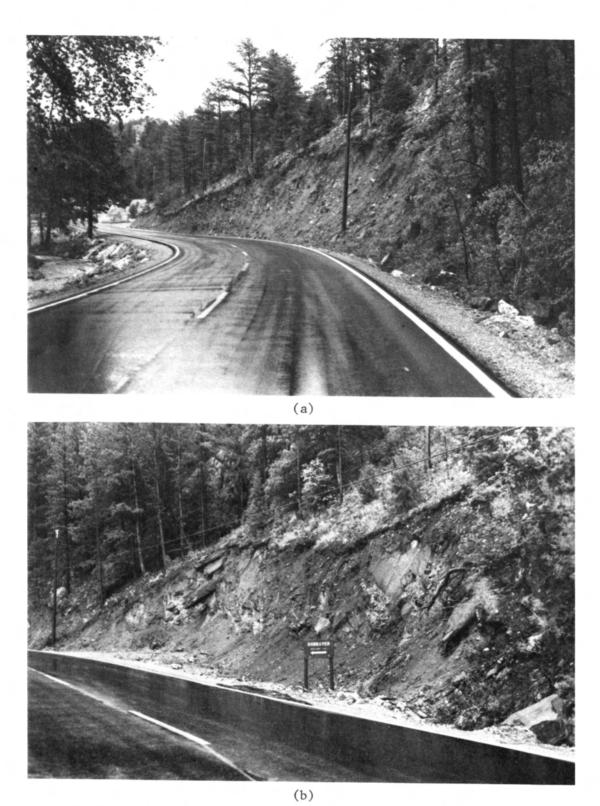
Figure 58, taken about one year after the flood, shows two slopes along the road approximately 6 miles upstream from Drake along the North

FIGURE 58 Slope in Colluvium along North Fork

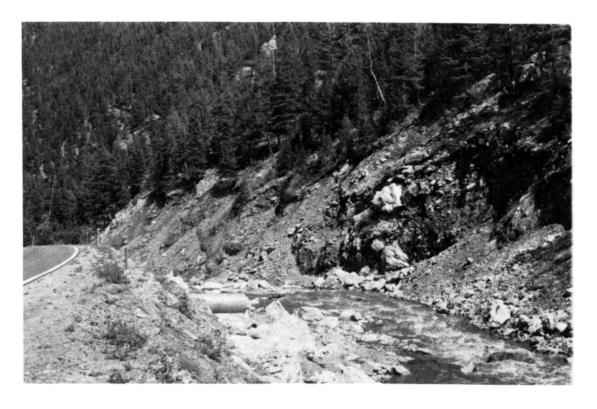
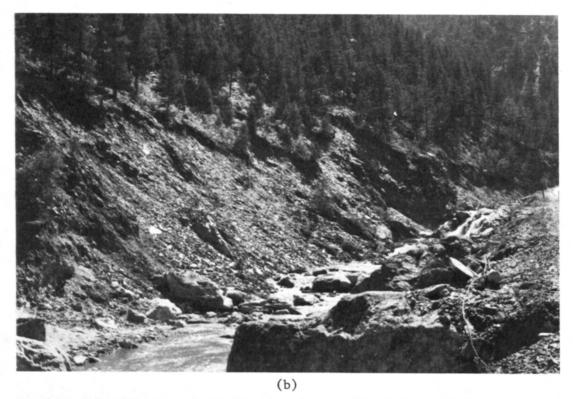
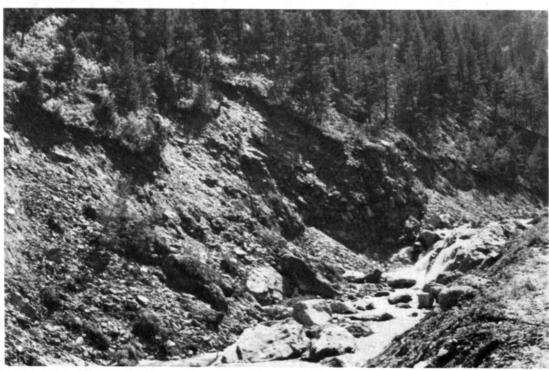
FIGURE 59a

The soil and rock debris at the bottom of the slides was deposited sometime after the flood. River flows in the year after the flood have been abnormally low and the material at the toes of the slopes continues to accumulate. In subsequent periods of high flow this material may be

(c)
FIGURE 59 Slope Failure in Colluvium along Big Thompson River
Approximately 3 to 4 Miles west of Drake

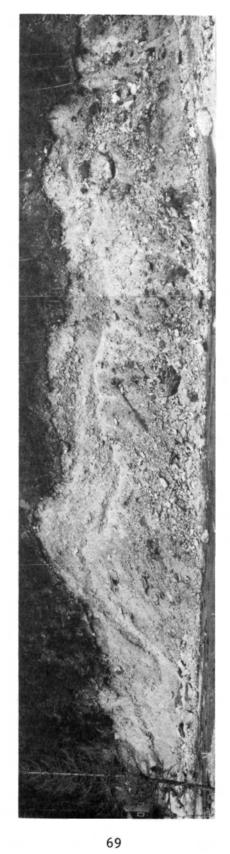
FIGURE 60 Slope Failure at Drake

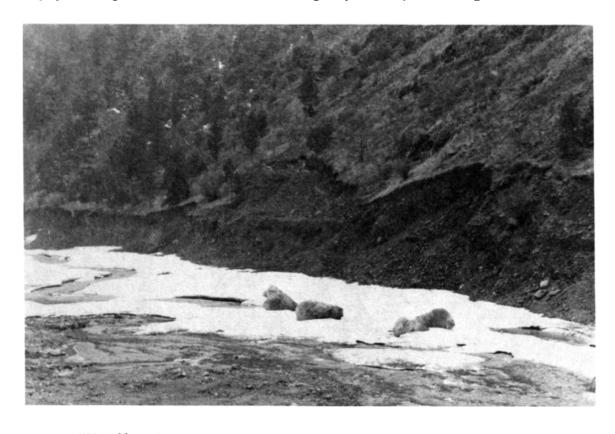
FIGURE 61 Slope Failure Formed about One Week after the Flood

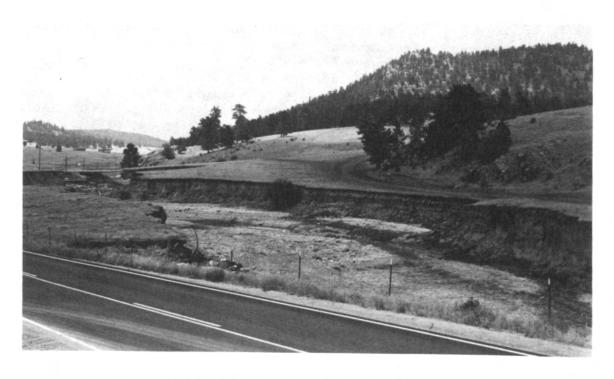
Another class of slope failure includes the erosion of debris fans where they existed in the floodplain. Figure 62 shows an area in Olympus Heights near Estes Park along Dry Gulch; the large amount of

FIGURE 62 Erosion along Dry Gulch

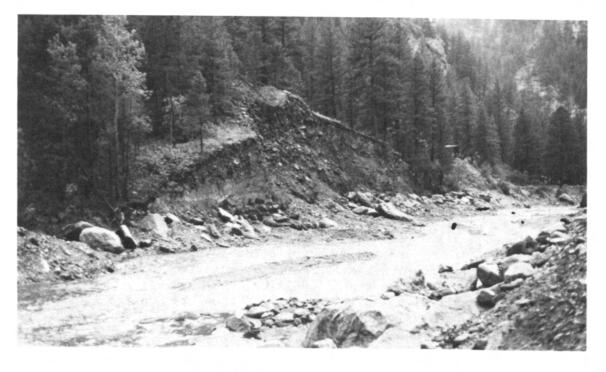
FIGURE 63 Erosion of Debris Fan

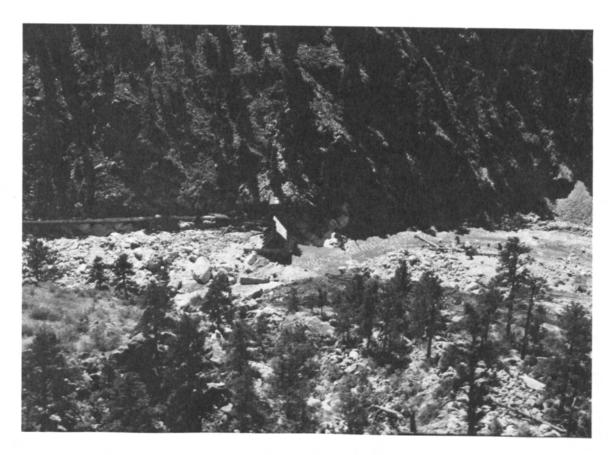
FIGURE 64 Remains of Loveland Hydroelectric Dam

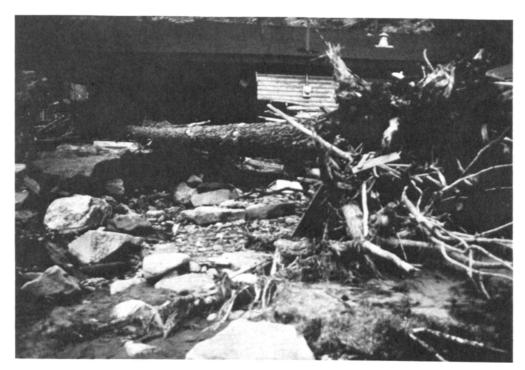
During the night of the Big Thompson flood almost 500 structures were damaged to some extent: 242 structures were damaged less than 50%, and 252 were damaged more than 50% (U.S. Corps of Engineers, 1976). Damage was mainly concentrated along the valley floor, although some damage to structures along higher ground were reported due to landslides, rockfalls, and other mass wasting processes. Destruction came mostly from battering by debris and materials moved by the stream. Figure 66 shows a house where the stream hurled a tree through the upstream wall.

FIGURE 66 House Damaged by Tree Hurled through Upstream Wall

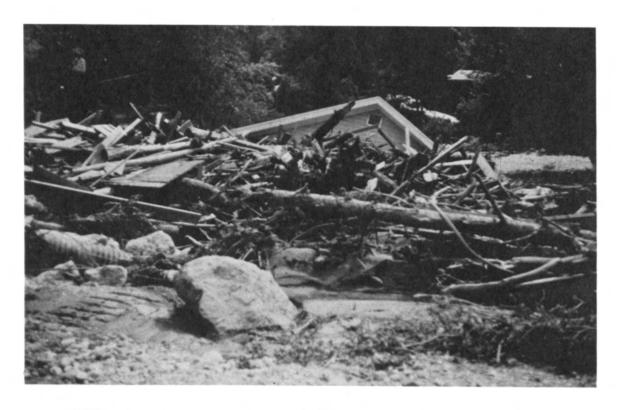
FIGURE 67 House near Drake Flattened by Boulders and Debris

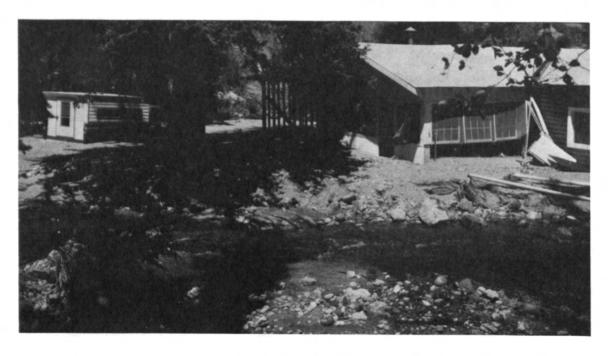
FIGURE 68 Sediment Deposited around House along West Creek

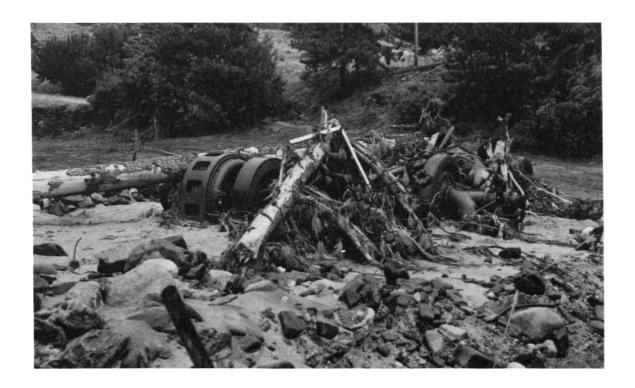
FIGURE 69 Remains of Loveland Power Plant at Loveland Mountain Park

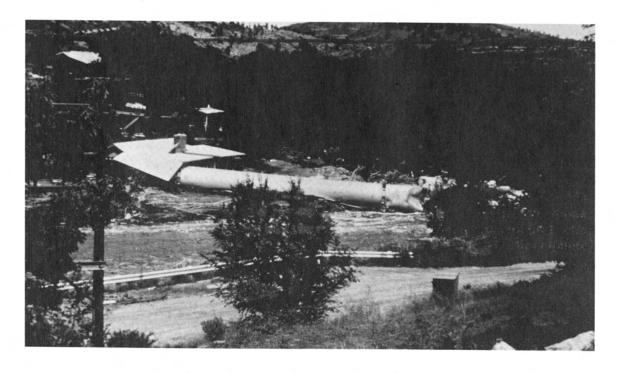
FIGURE 71 Remains of the U.S. Bureau of Reclamation Siphon
