INVESTIGATION OF THE CANDLESTICK PARK WIND PROBLEM

Volume III

Conclusions, Recommendations
and Summary of Investigation

Prepared for Department of Public Works
City of San Francisco

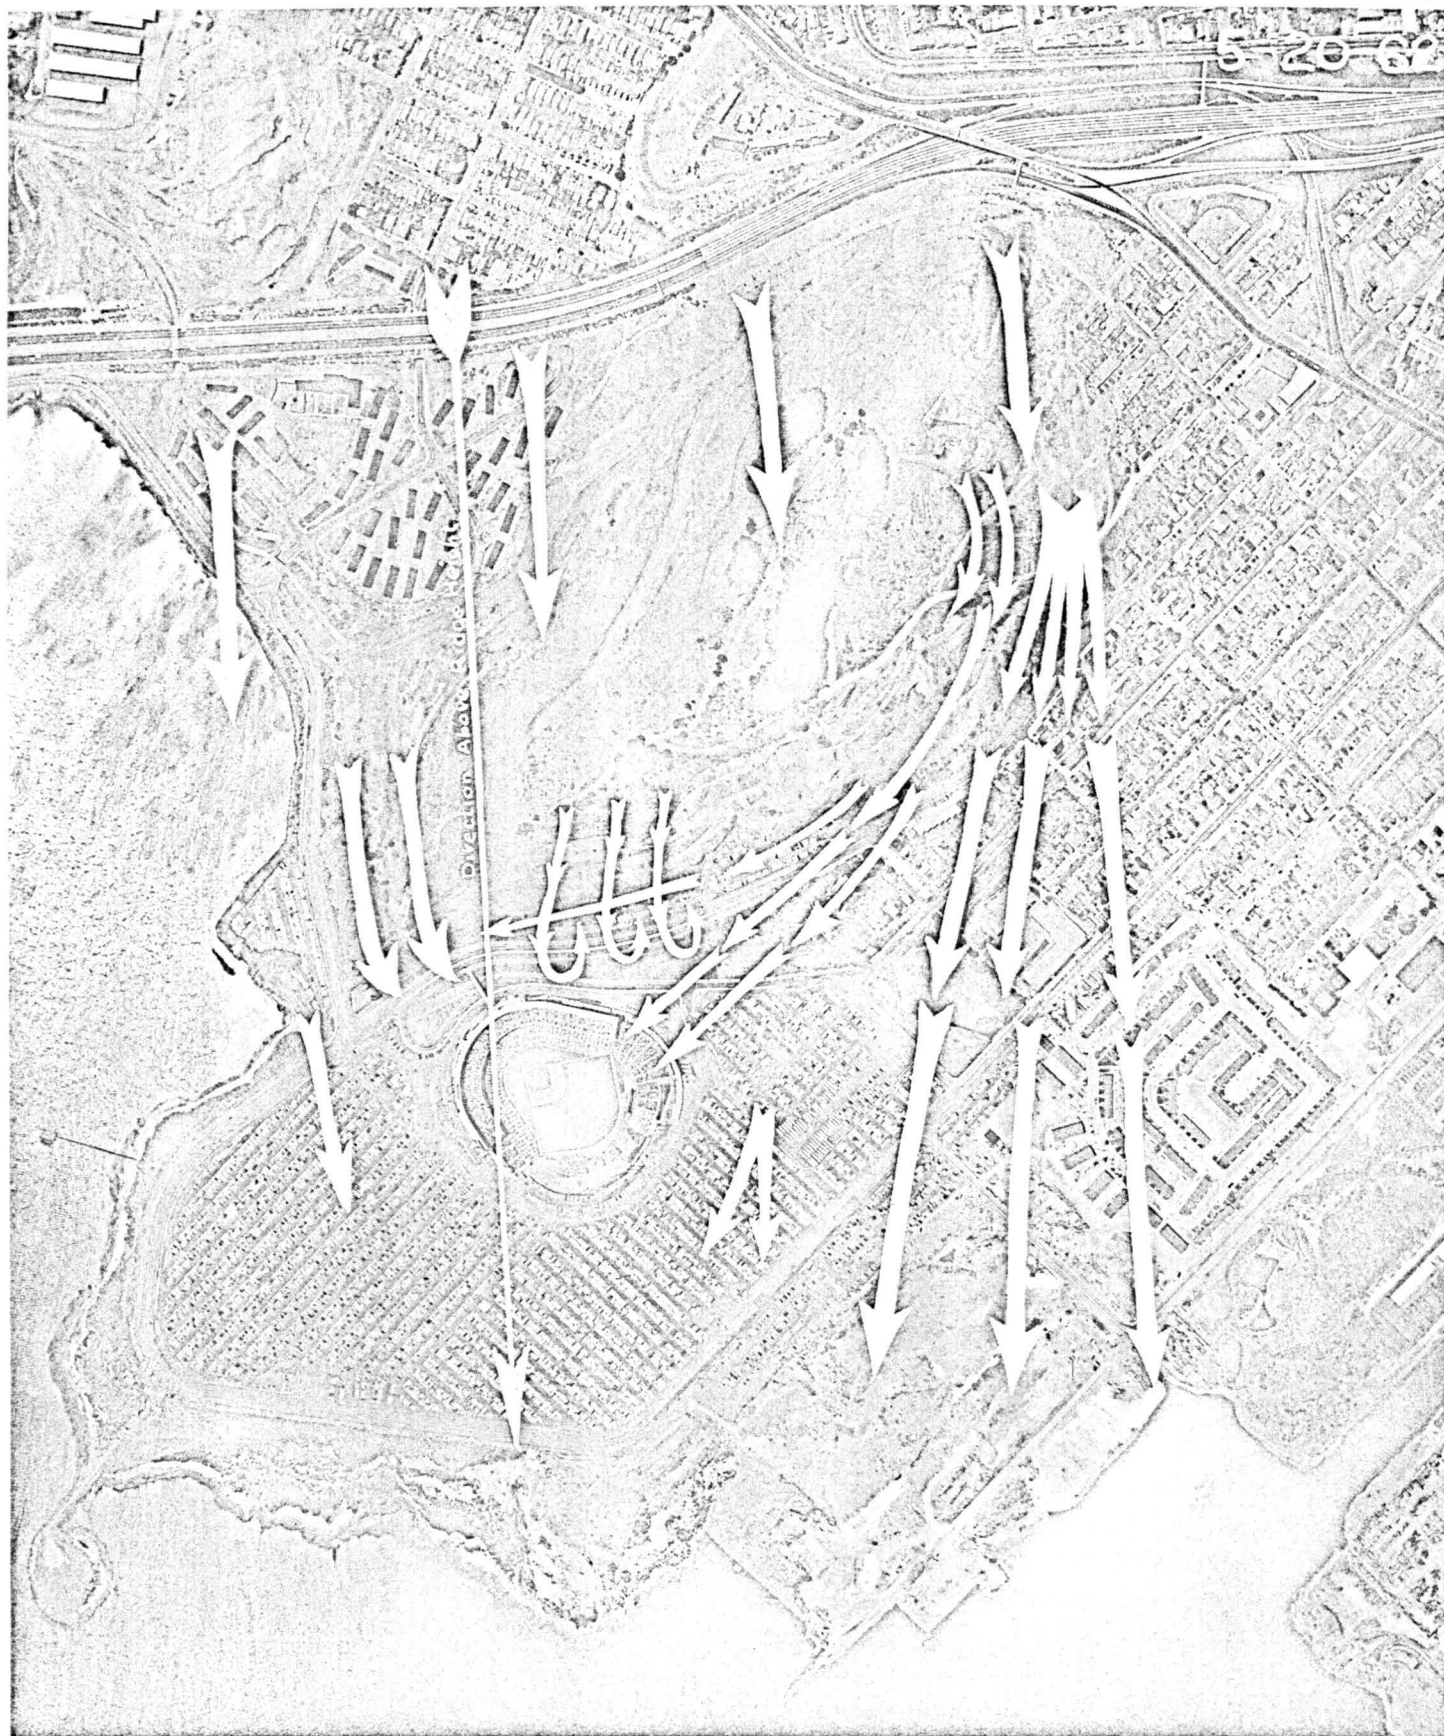
Insofar as the conditions within the stadium are concerned, the significant effect of Bay View Hill is to produce two potentially controlling wind directions across the stadium. One is from the diverted flow originating at the northerly end of the hill. The other is from the flow carried around the southerly end of the hill and approaches the stadium from approximately 30° south of west. Although the position of the stadium is in line with the approximate wind shadow of the hill, it is far enough removed to be in one or the other of the two flows around the hill.

Fig. 3--Characteristic wind flow pattern around Bay View Hill based on field observations during the baseball season. Diversion of air below the ridge line at the northerly end of Bay View Hill produces a flow into left field and a characteristic circulation pattern within the stadium. A second characteristic pattern results from air reaching the stadium around the southerly end of the hill.

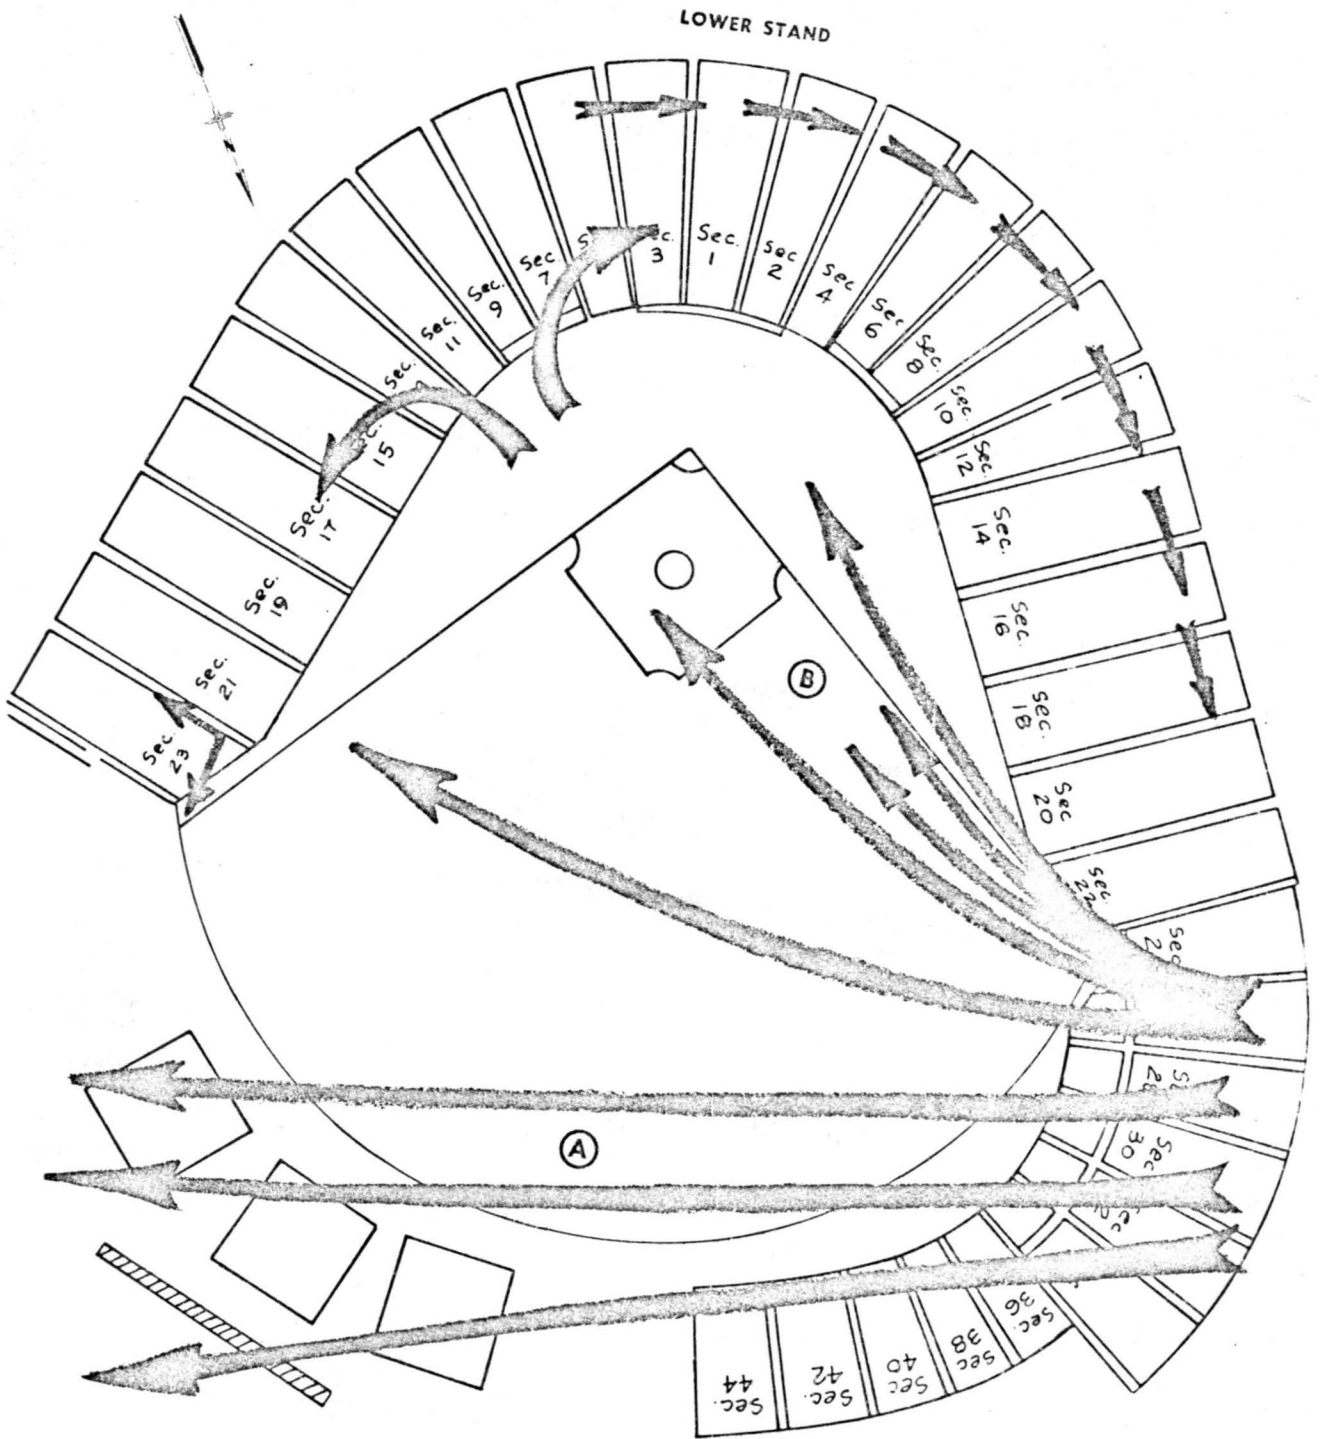
iv) The schematic diagrams (Figs 4-7) indicate the average pattern for the two flow conditions. Flow conditions are not necessarily constant throughout a given afternoon and may vary about the average as drawn.

Fig. 4--Wind circulation pattern in the lower stands under Left-Field Control conditions.

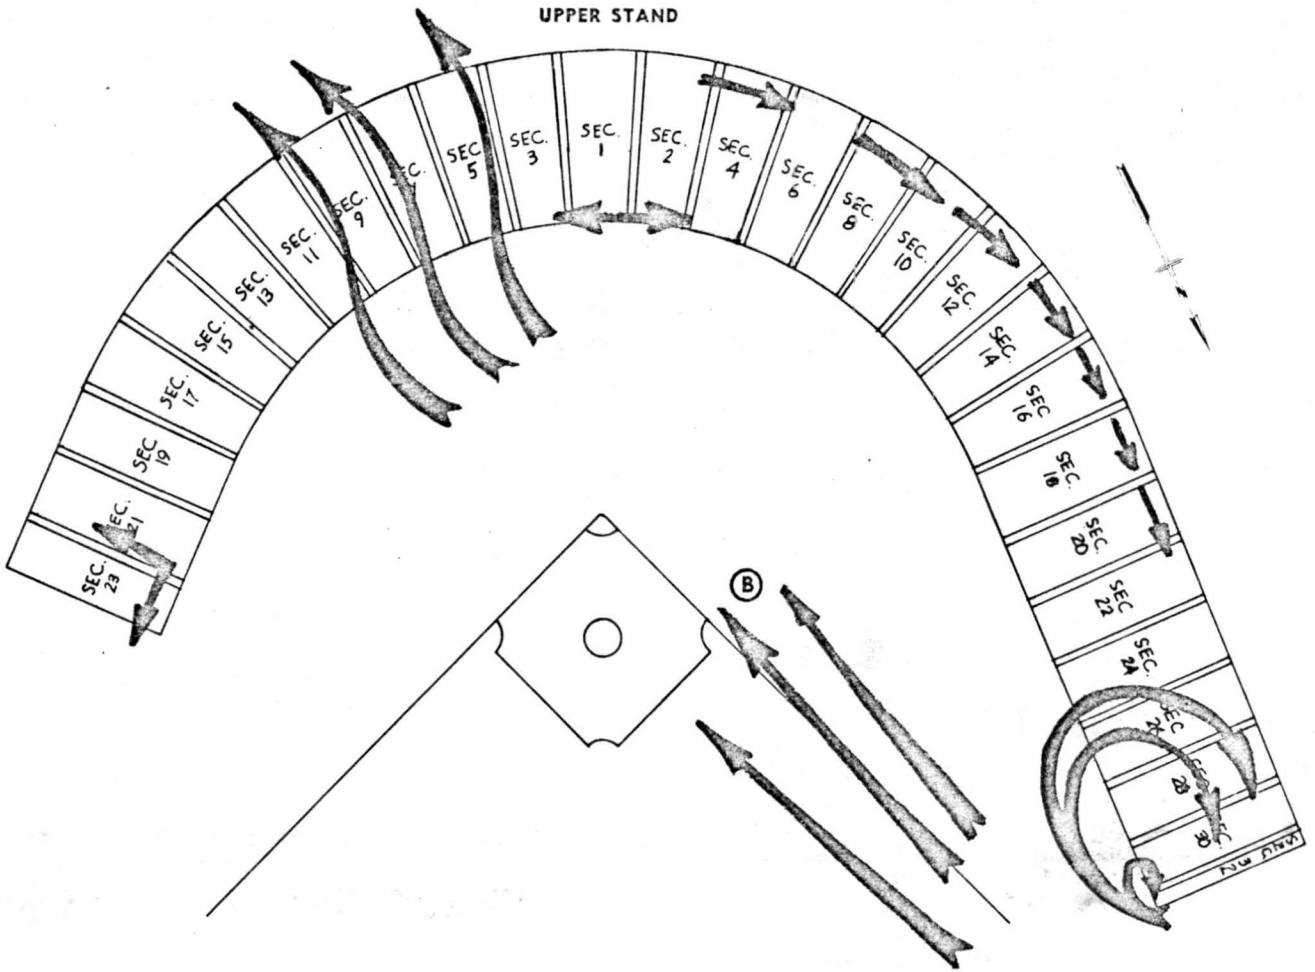
Fig. 5--Wind circulation pattern in the upper stands under Left-Field Control conditions.

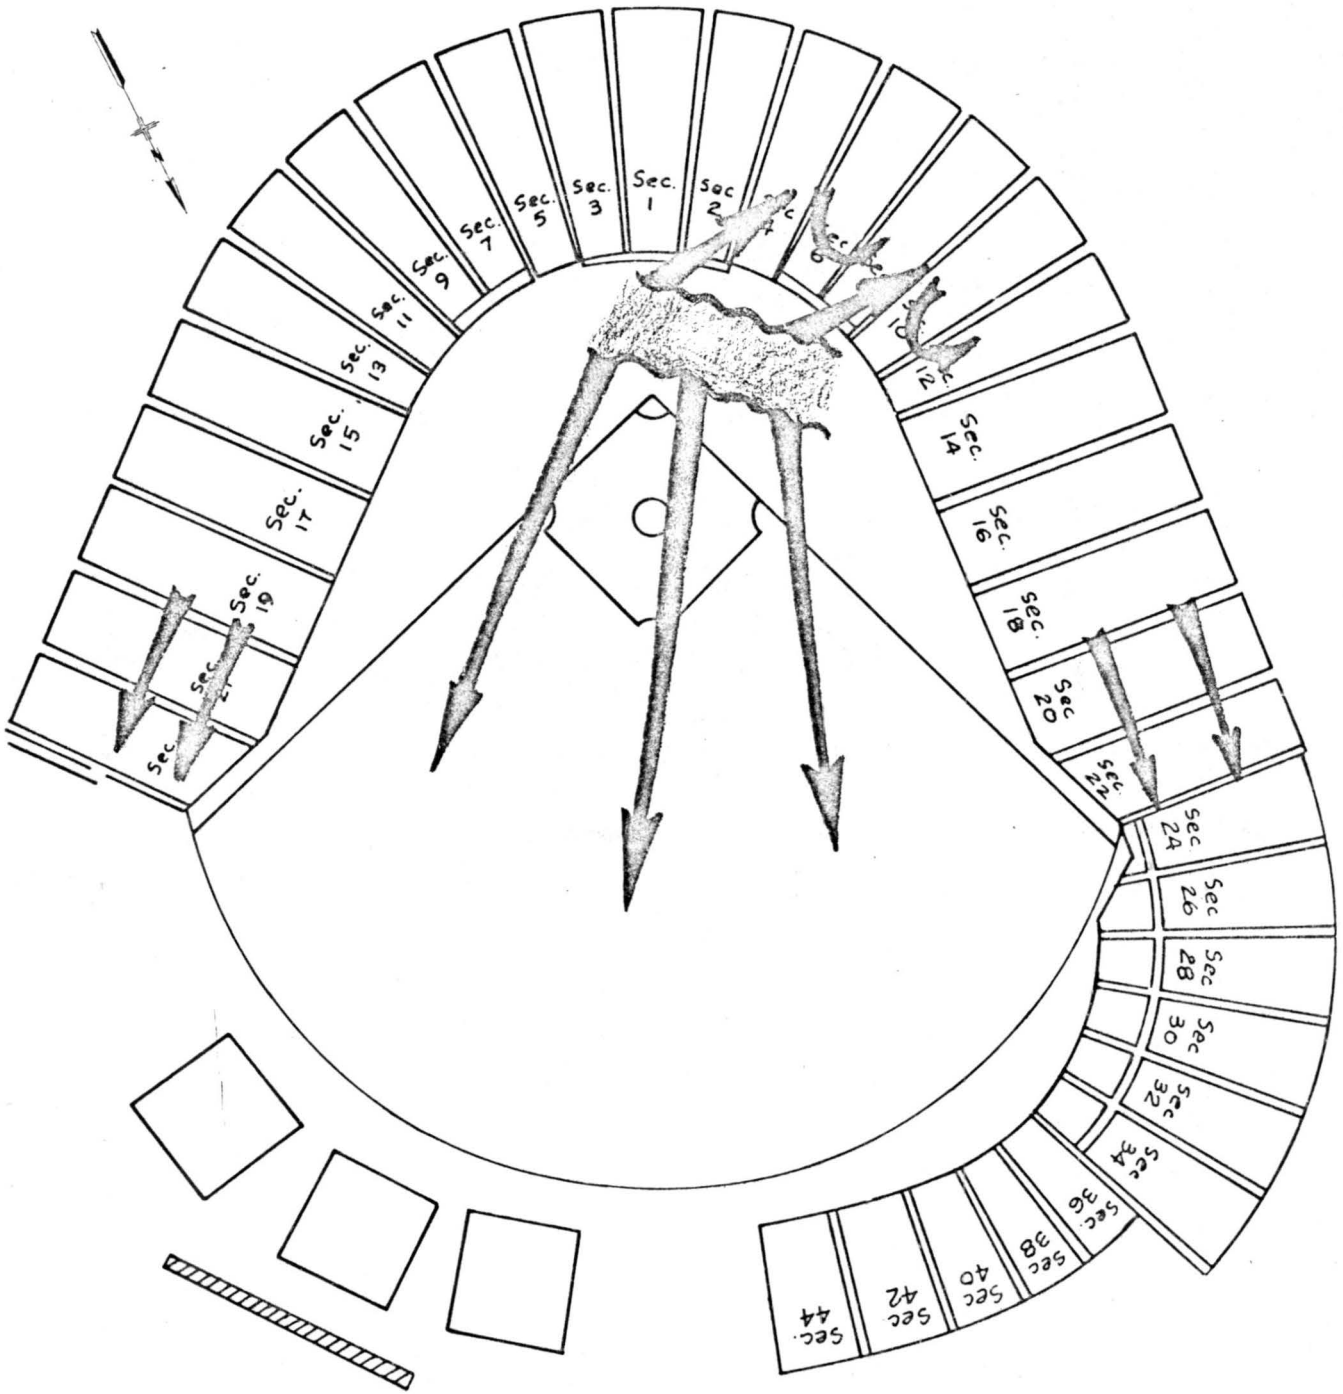
Fig. 6--Wind circulation pattern in the lower stands under Southerly Control conditions.

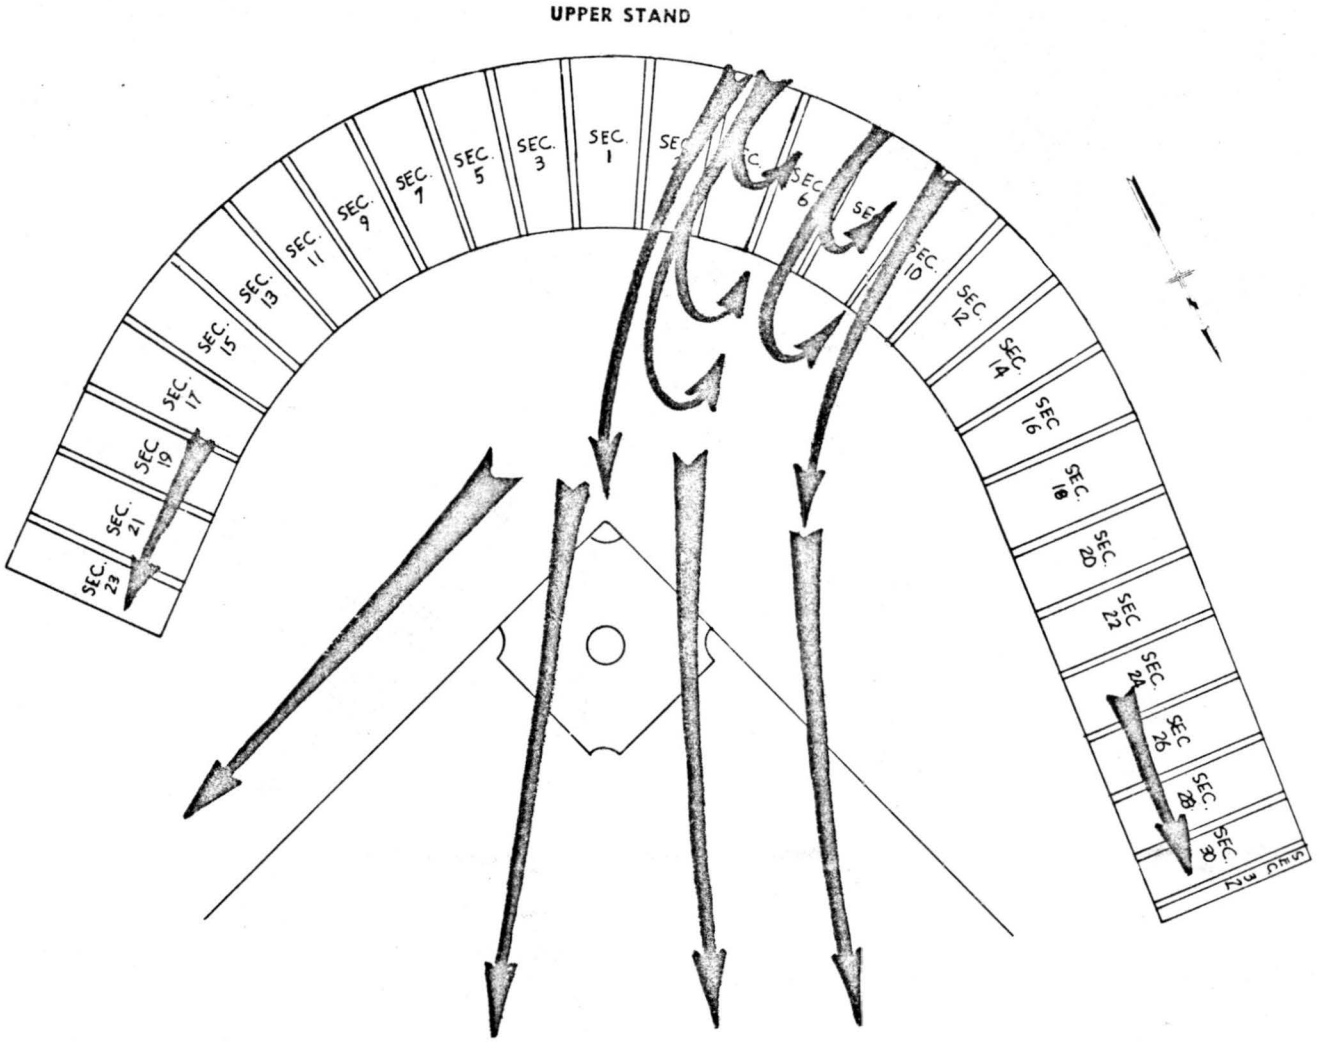
Fig. 7--Wind circulation pattern in the upper stands under Southerly Control conditions.

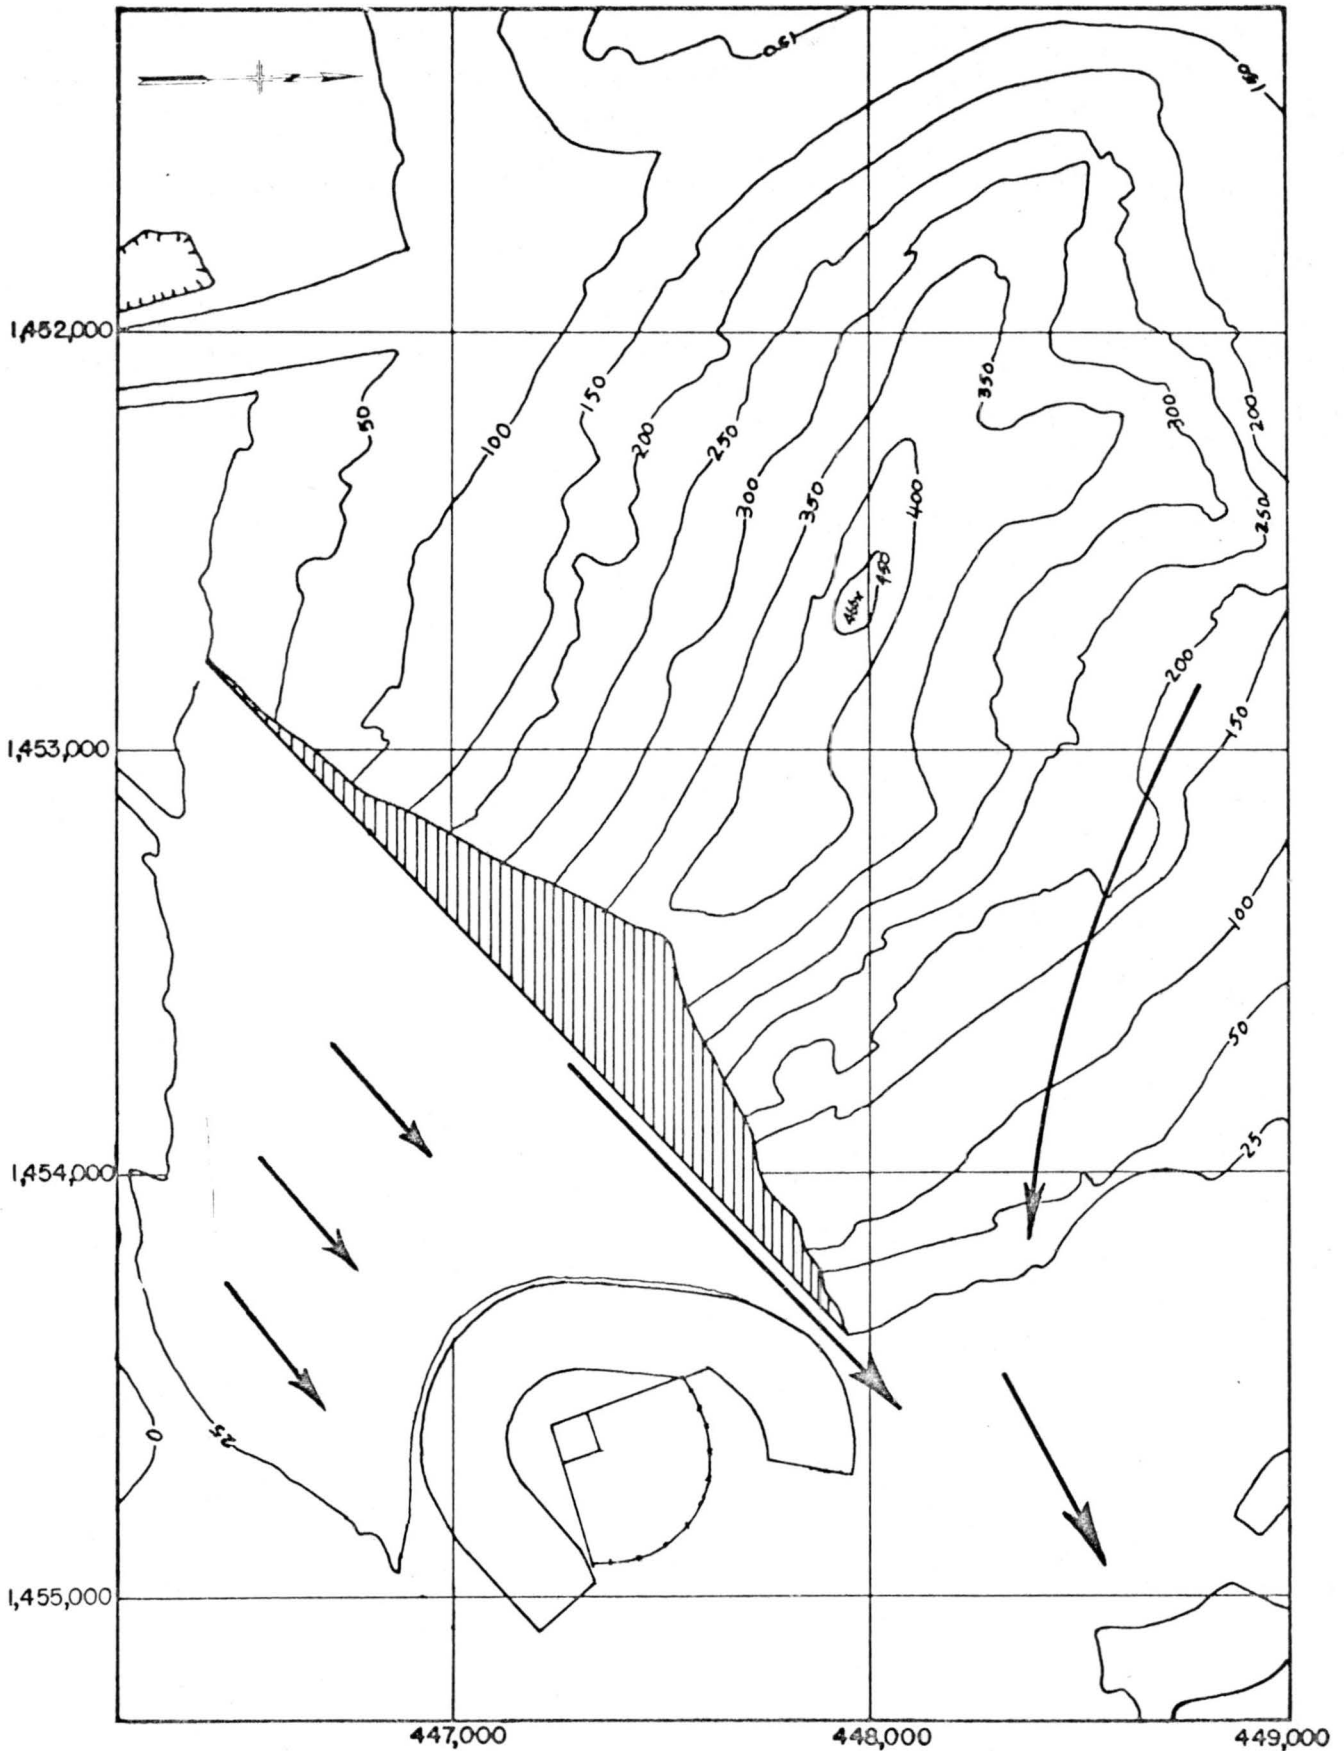
Of all the modifications studied, only excavation of the south end of the hill or making a cut through the south end of the hill as shown in Figs. 11 and 12 effectively eliminated Left-Field flow characteristics without introducing equally unsatisfactory conditions not subject to control. Both of these hill modifications allow a current of air to pass around the south end of the hill, intercept the current of air flowing toward the stadium along the northeast side of the hill and divert it away from the stadium. The interaction of the air streams shown in Figs. 11 and 12 prevents strong flow onto the playing field from the left-field side. In effect, these hill modifications eliminate Left-Field Control and introduce a persistent Southerly Control which can be reduced or eliminated by other means.

Fig. 11-Bay View Hill modified by removing southerly end. With the end removed the general wind pattern is altered to give a southwesterly flow across the stadium. As a consequence the flow normally entering left field is diverted away from the stadium. Contours and 1000-ft grid lines are from topographic map provided by Director of Public Works.

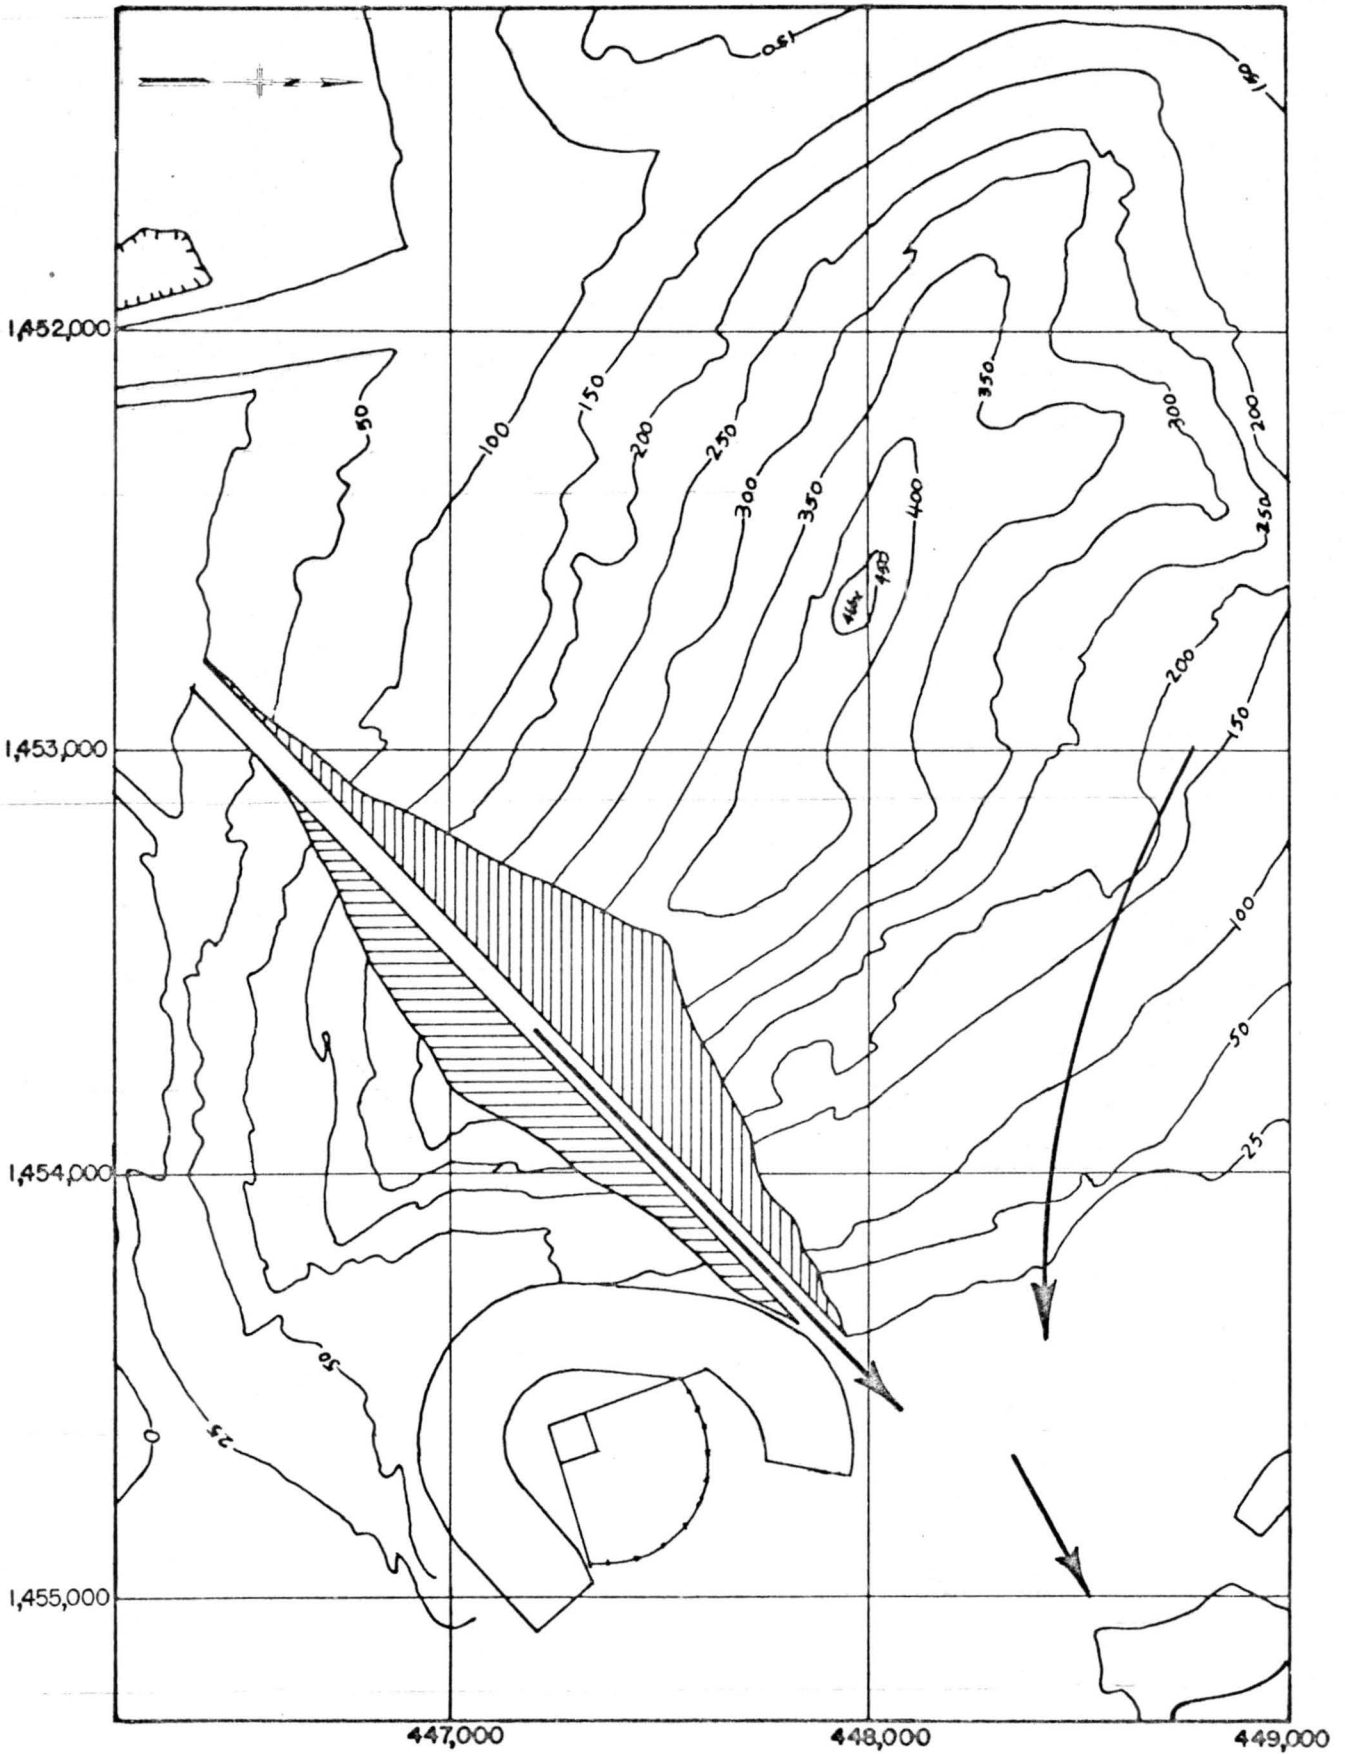
Fig. 12--Bay View Hill modified by cutting through south end. Air flow through cut diverts left field flow away from the stadium. Cut is approximately 100 feet wide at the bottom; slopes are 45°. Contours and 1000-ft grid lines are from map provided by Director of Public Works.

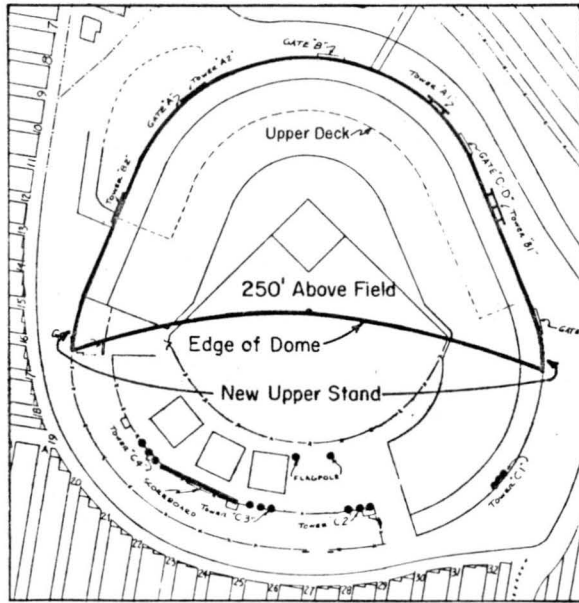
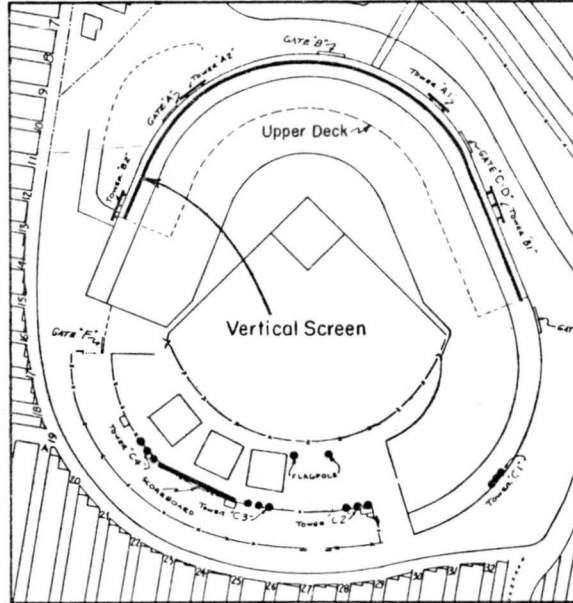
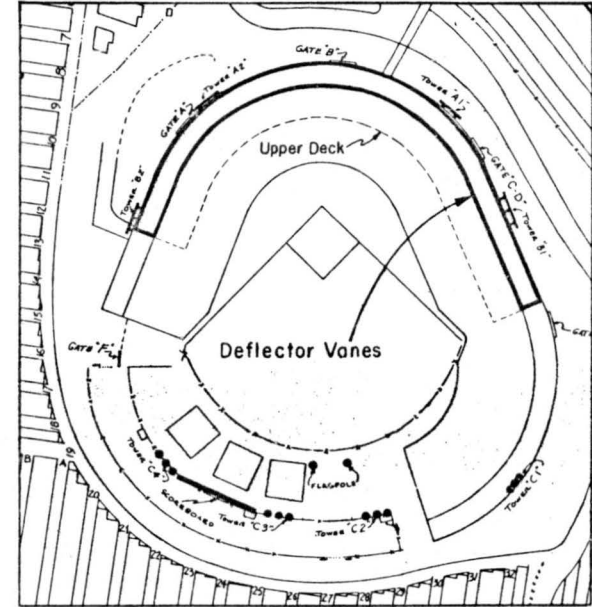
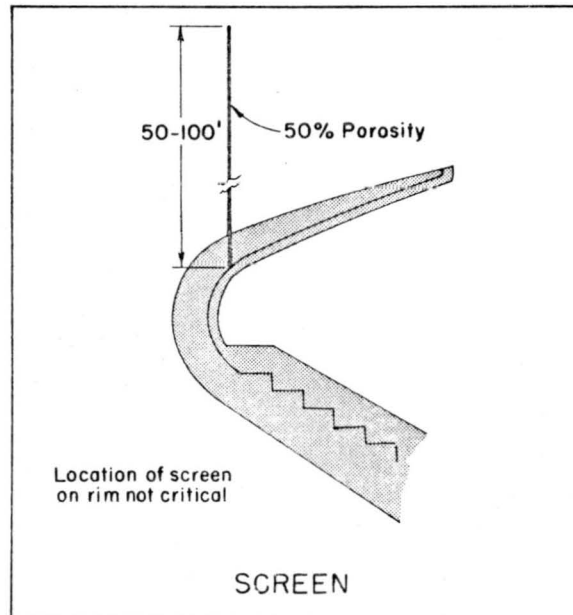
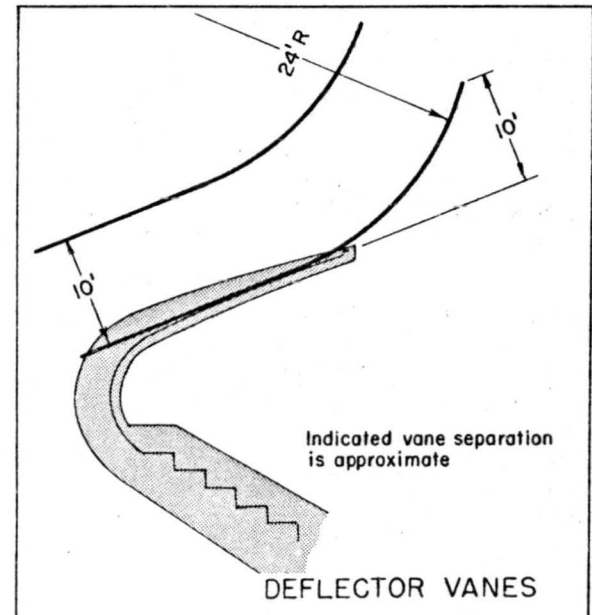
Fig. 13--Stadium modifications for the elimination of Southerly Control conditions. a) Partial dome across stadium. b) Vertical porous screen around existing rim. c) Vanes on rim to provide vertical deflection of the air across the stadium.

1. Addition of a partial dome and modification of the southerly end of the hill should be given first consideration as a remedy for the wind problem. This solution gives the best reduction of wind speed and gustiness.

2. In the event that the construction of a partial dome is not economically feasible, consideration should be given equally to the addition of vanes or a vertical screen on the stadium rim in conjunction with the modification of the south end of the hill.
