**Survey of Selected Wetlands within the
Bureau of Land Management
Kremmling Field Office Management Area
(Grand County, CO)
2006**

Prepared for:
Kremmling Field Office
P. O. Box 68
2103 East Park Avenue
Kremmling, CO 80459

Prepared by:
Jennifer Jones, Wetland Ecologist and Denise Culver, Ecologist
May 2006

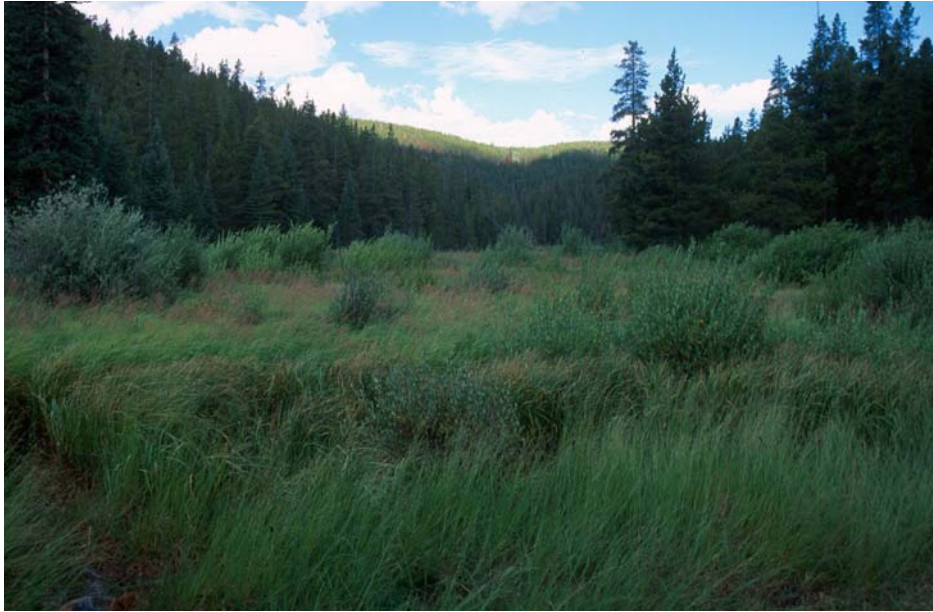
Potential Wetland is functioning below its potential natural community due to road encroachment.

Photo 1. Mountain willow with bluejoint reedgrass riparian shrubland at Behler Creek.

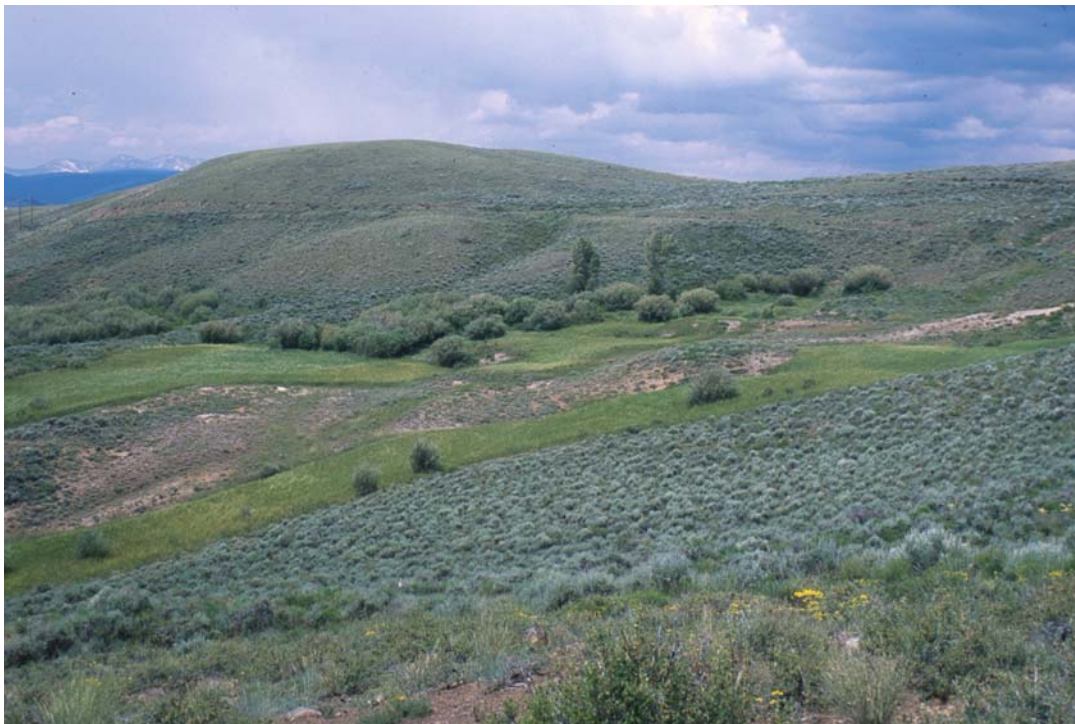
Potential The potential natural community for the site is difficult to estimate due to origin of wetland which has been altered due to dirt work in the area. This area is resultant from filling of past landfill and may have originally been a small, Salix dominated drainage.

Photo 3. Beaked sedge herbaceous vegetation at Landfill Seep Site.

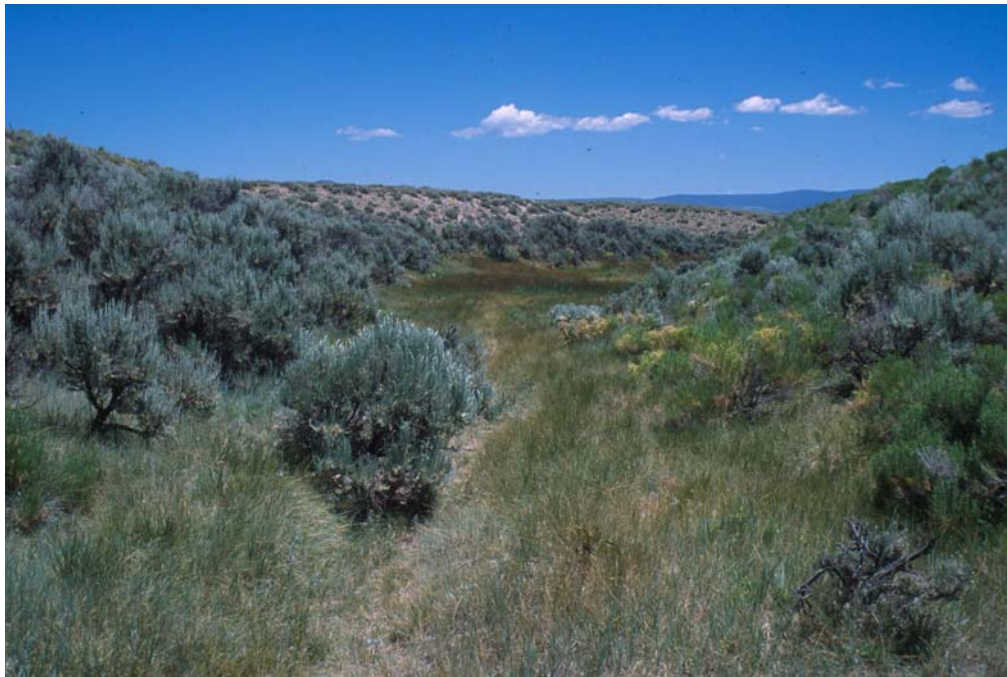
Potential Area is not functioning at its potential natural community due to multiple limiting factors that are not likely to be amended in the future. Adjacent road and quarry are contributing to weedy species invasion, altering microclimate conditions, and may be adding sediment to the drainage. Large trough for livestock watering is situated below the spring and before its junction with Sulphur Gulch, but it is no longer in use.

Photo 5. Beaked sedge herbaceous vegetation at Scholl Spring Site.

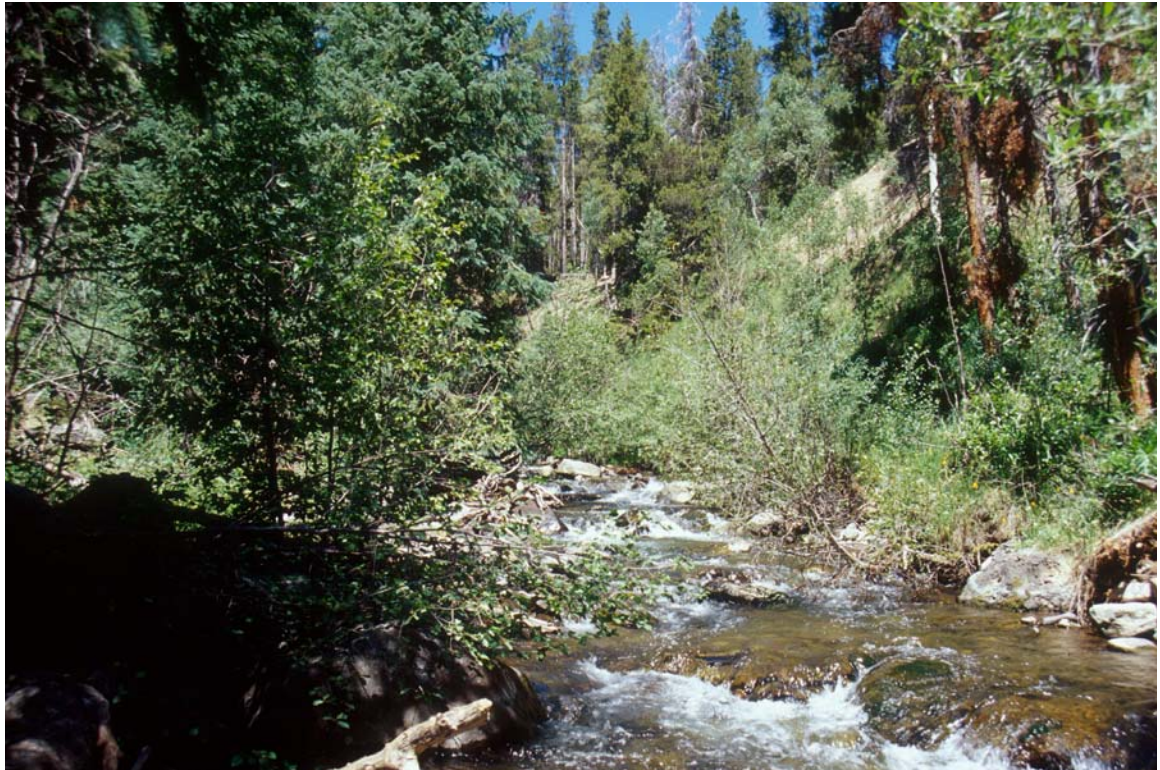
Potential Site is functioning below its capability due to altered hydrology and low flows created by upstream dam. Flows would need to be restored to achieve the potential natural community.

Photo 7. Thinleaf alder with Drummond willow riparian shrubland at Upper Troublesome Creek.

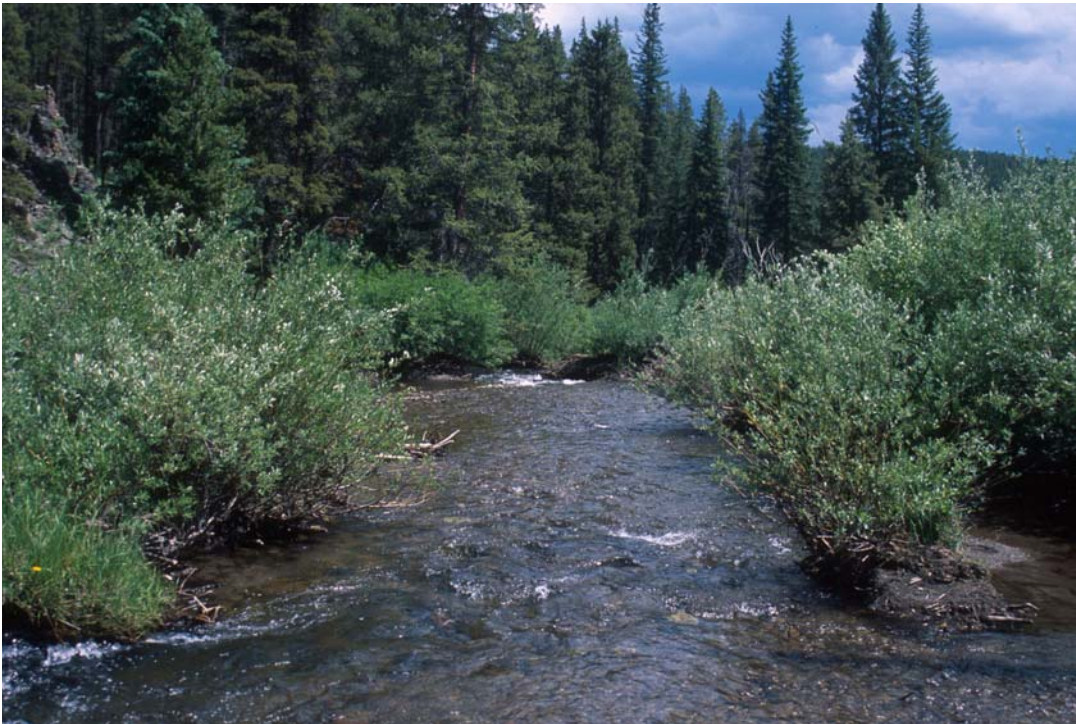
Potential Wetland area is functioning near its potential natural community. Although there are anthropogenic disturbances present including a ditch and road, both remain as historic disturbances and do not seem to be currently in use. There are no hydrologic alterations other than natural alterations from beaver activity and logging in the area is patchy.

Photo 8. Drummond willow with bluejoint reedgrass riparian shrubland at Rabbit Ears Creek.

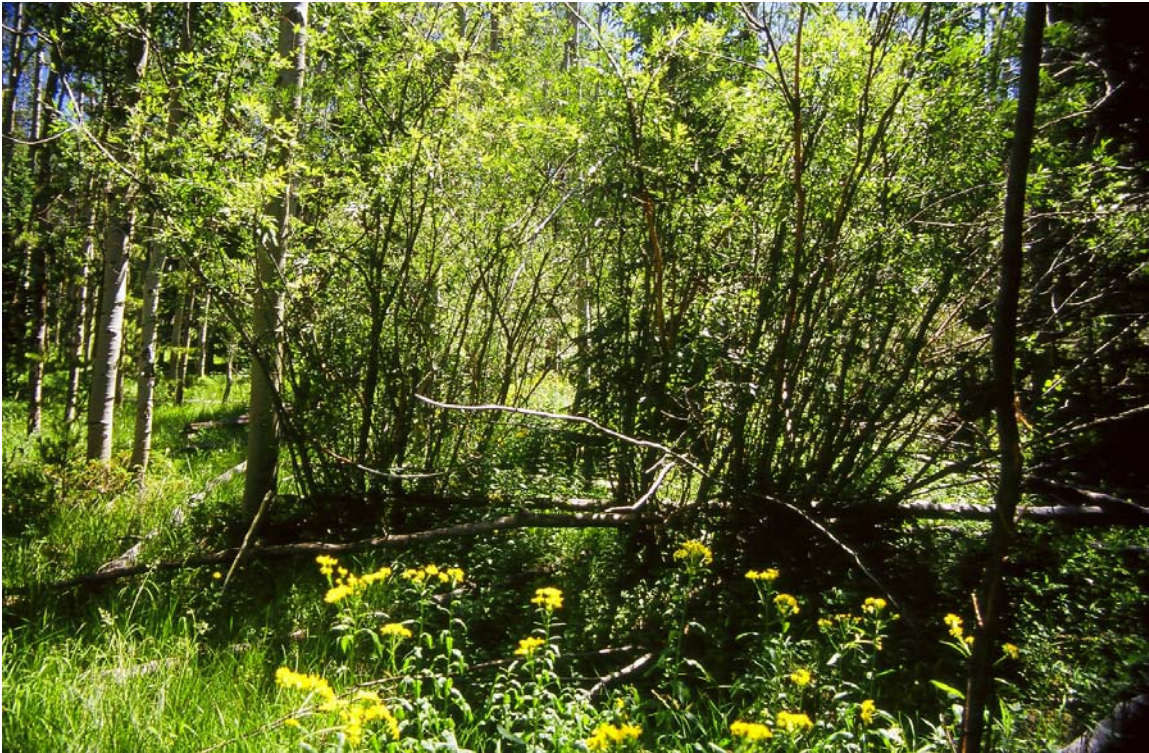
Photo 10. Charlie Creek Seep.

Potential Site is functioning at its potential natural community with very few alterations or disturbances.

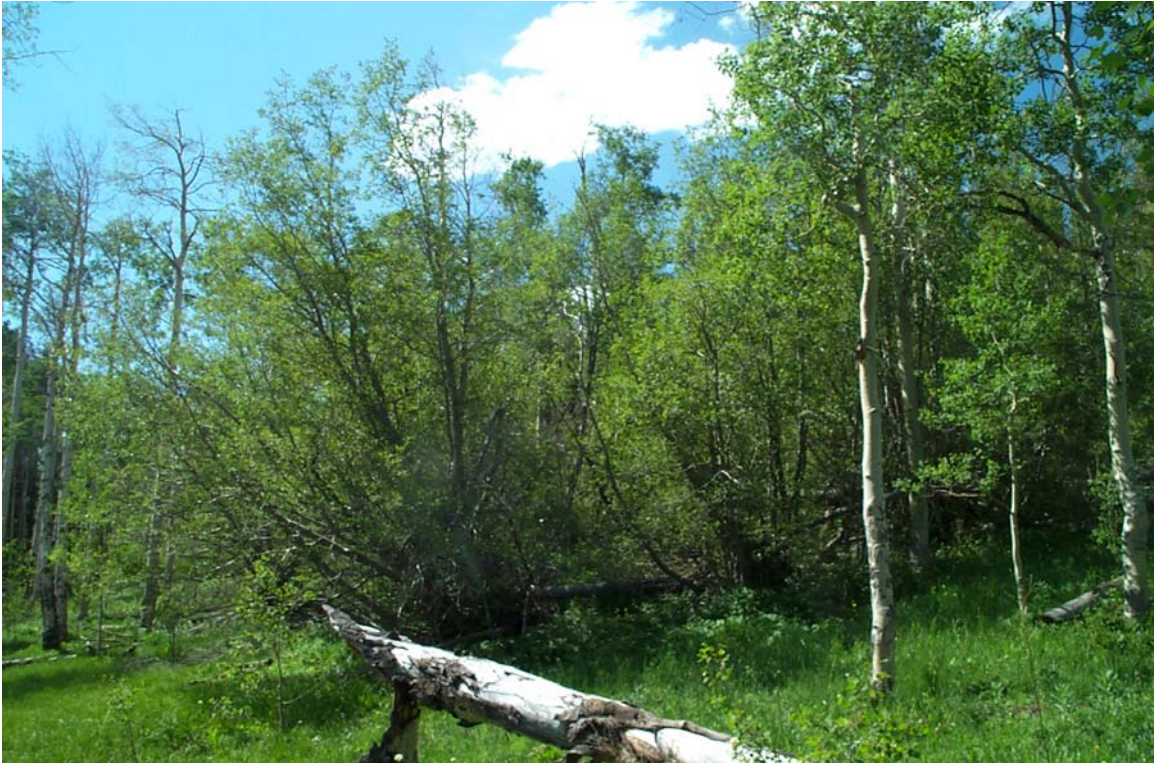
Potential Wetland area is functioning at its potential with all wetland functions acting to create the potential natural community

Photo 13. Alder with mesic forb shrubland at Cabin Creek Seep.

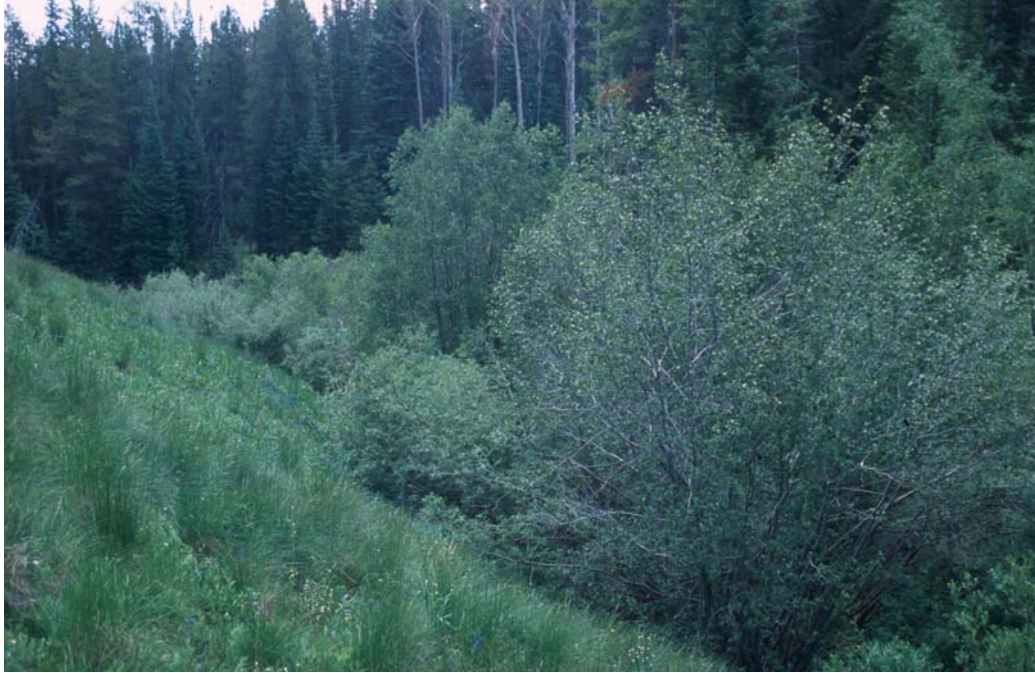
Potential Area is functioning at its potential. Hydrology is restricted only at the drainages upper reaches at a small culvert and road crossing. Otherwise, the only evident current disturbances are natural from seasonal flooding and wildlife use.

Photo 14. Thinlead alder with Drummond willow riparian shrubland at Black Mountain Reservoir.

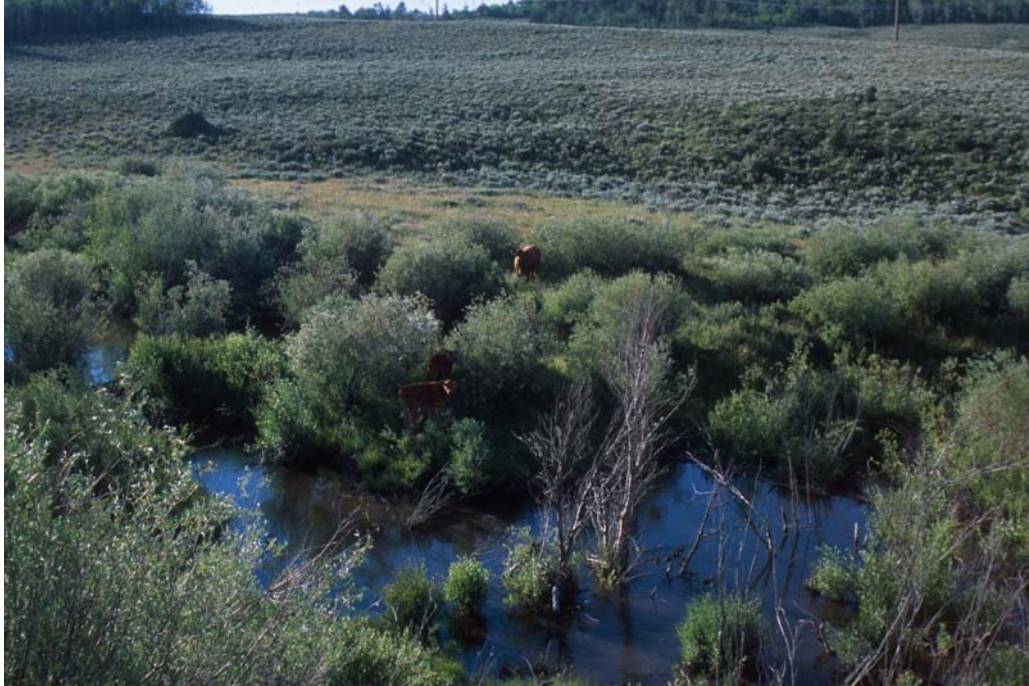
Potential Riparian area along Kinney Creek is not functioning at its potential due to limiting factors including hydrologic alterations from beaver activity, property ownership downstream where there is concentrated grazing and the stream has been channeled, intense grazing on BLM owned property, and road encroachment. All of these factors are contributing to the degradation of the system including non-native species invasion, bank erosion, upland species encroachment, and loss of many riparian functions that are necessary to achieve ultimate wetland values.

Photo 15. Mountain willow with mesic forb riparian shrubland at Kinney Creek.

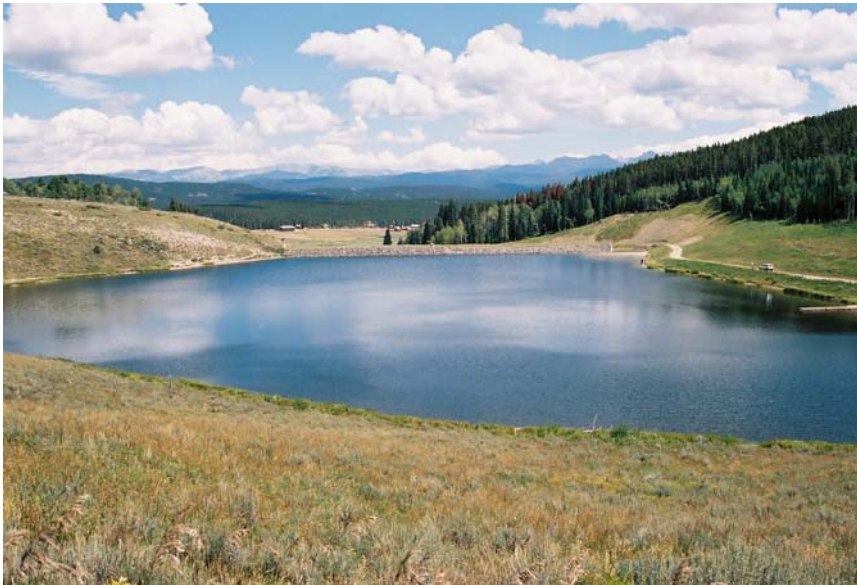
Photo 19. Gaylord Reservoir.

Potential There is likely no way for this site to achieve potential. Historically, this area was part of the riparian corridor of a tributary of Pole Creek. In order to achieve a potential natural community for this area flows would need to be unobstructed and past streamside vegetation reestablished.
