**Survey of Critical Wetlands
Bureau of Land Management Lands
South Park, Park County, Colorado
2003-2004**

**Prepared for the
Royal Gorge Field Office
3170 East Main Street
Cañon City, CO 81212**

September 2004

Prepared by:
**Denise R. Culver
September 2004**

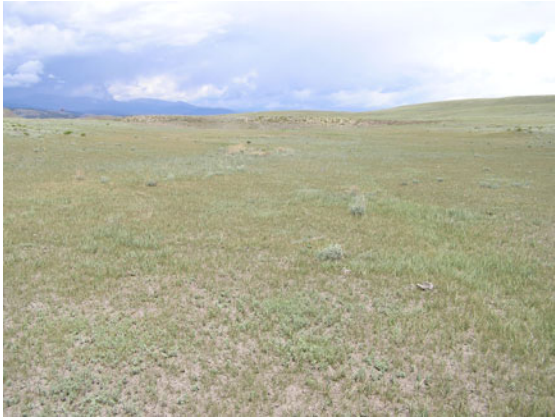
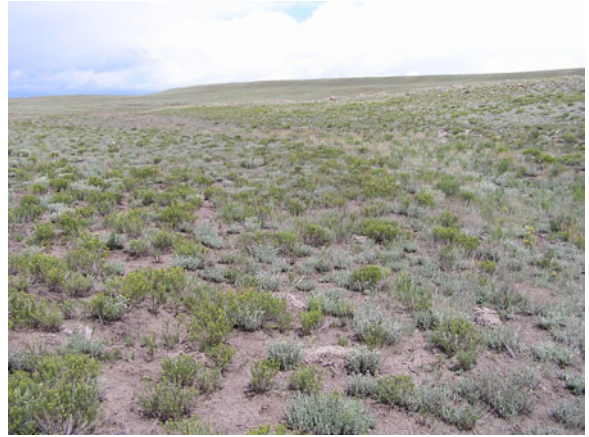
Dry playas at Three Mile Creek

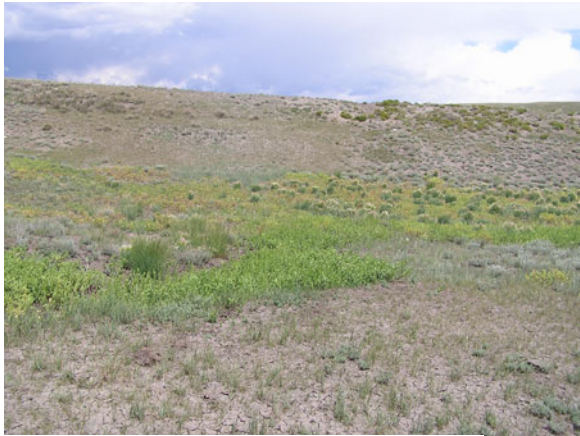
Dry Playa at Three Mile Creek

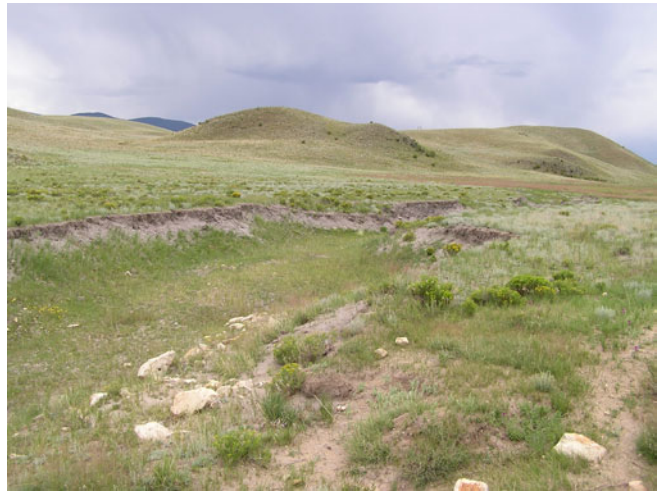
Dry gully at Cross Creek

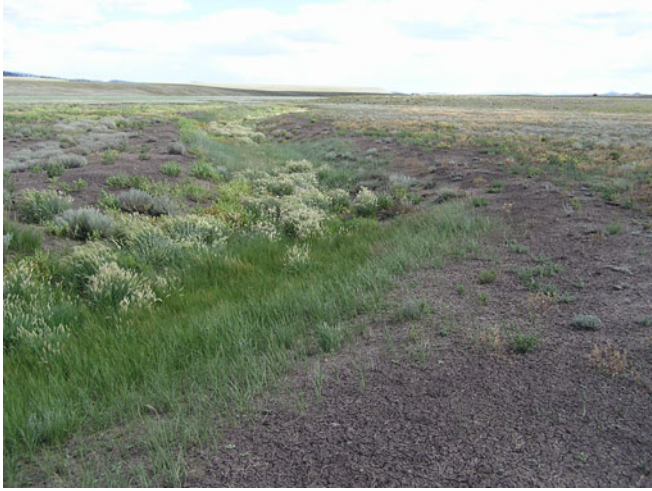
General description: At time of survey, gully was dry. Gully is 6 feet wide and 4 feet deep in places. Currently there are wetland plants that provide some bank stabilization, but the hydrology is completely altered due to improper grazing and water retention ponds.

Improper grazing, agriculture activities, hydrological alteration

Agate Creek dry gully

The goal for this parcel is to restore the hydrology, remove the noxious weeds and allow native wetland plants to recolonize.

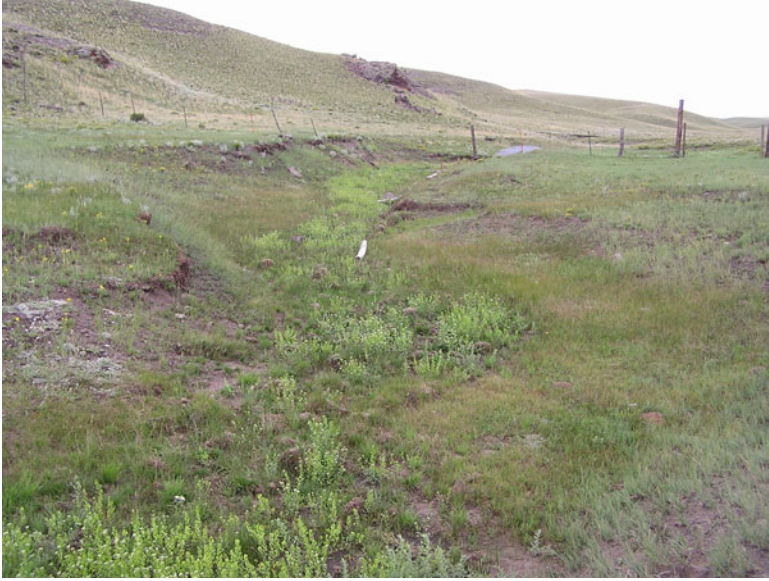
Buffalo Gulch

Improper grazing, agriculture activities, hydrological alteration

The riparian area has been degraded via hydrologic alterations and grazing. With current management, this parcel will continue to decline.

The goal for this parcel is to restore the hydrology, remove the noxious weeds and allow native wetland plants to recolonize.

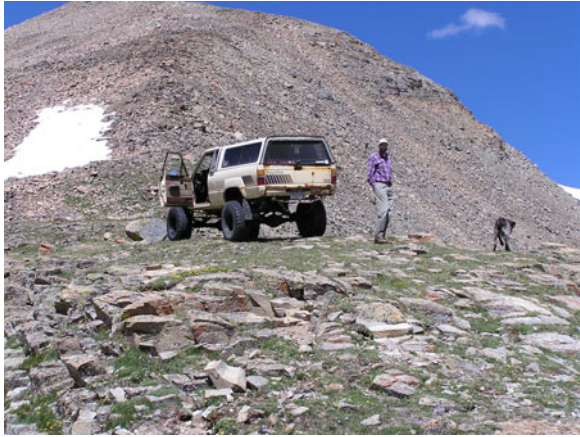
Main Threat—4 WDs off designated road.

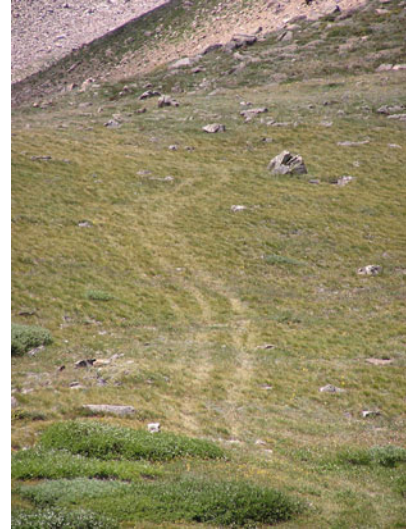
Result from off road travel in alpine area

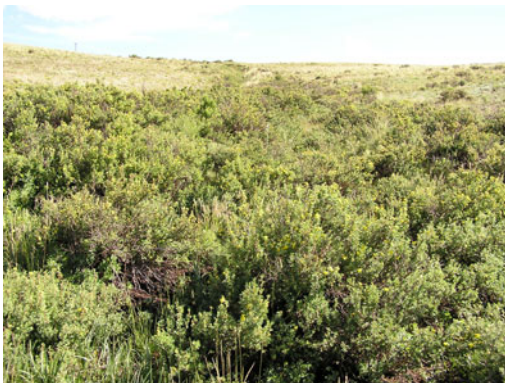
95	7/22/04	X	O'Neil Ditch	Riparian/ Montane Grassland	8S	76W	33	21.89	NF	ditch is vegetated with shrubby cinquefoil, soils are moist not hydric. No water and no obligate wetland plants.
106	7/21/04	x	Red Mountain Pass	Riparian/Mt.Plover/ Montane Grassland/T&E Plants	9S	75W	7	13.69	NF	no wetlands, subalpine fir with aspen
116	7/21/04	x	Trout Creek/CR 7	Riparian/Mt.Plover/ Montane Grassland	9S	76W	18	0.11	NF	no wetland, short grass prairie
120	9/17/03	x	Indian Hills Spring	Riparian/Montane Grassland	9S	75W	22	9.56	NF	no wetland
148	7/28/04	x	Steel Gulch	Riparian/Mt.Plover/ Montane Grassland	11S	74W	4, 32	3.08	NF	no water, wetland plants, or soils
150, 156	7/28/04	x	Sevenmile Gulch	Riparian/Mt.Plover/ Montane Grassland	11S	75W	6, 18	25.62	NF	no water, wetland plants, or soils

O'Neil Ditch with *Dasiphora floribunda*

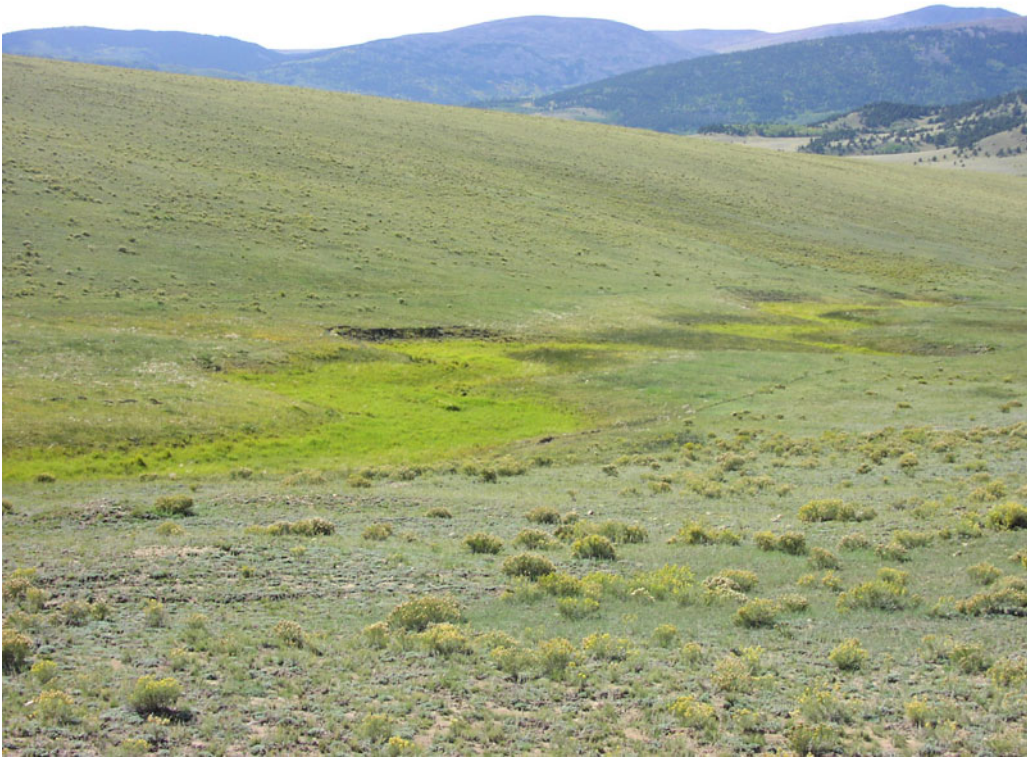
Overview of Park Gulch #2

Presently the wetland is functioning at risk with a downward trend with the current grazing regime. The wetland vegetation present would facilitate the restoration of riparian health if grazing issue is addressed.

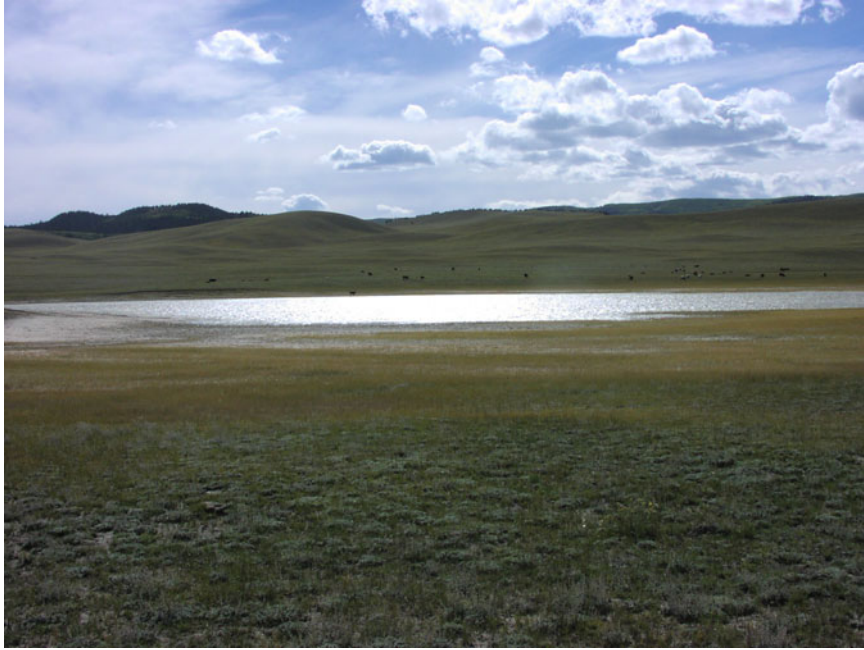
Playa Lakes at Park Gulch Overview

Currently the wetland is functioning at risk due to grazing impacts to hydrology.

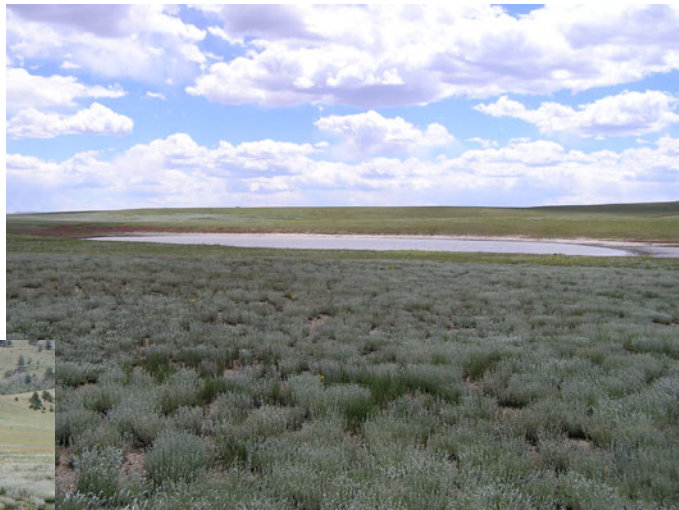
North Playa and North Playa with headcut on eastern side

Monitoring of grazing is essential to prevent degradation of shores and hydrology. Elk, deer and pronghorn use area, likely a main water source for wildlife.

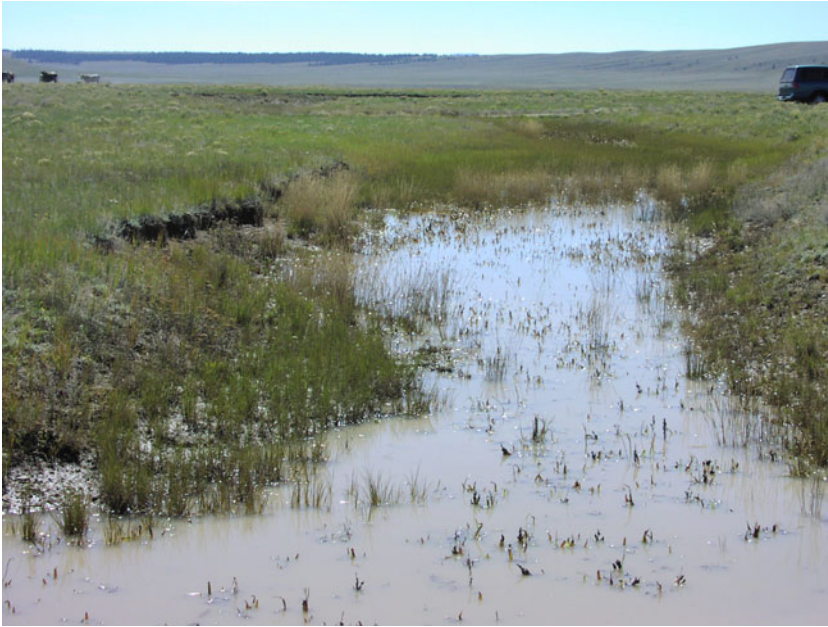
Currently the wetland is functioning at risk due to grazing impacts to hydrology.

James M. Jones SWA
Intermittent stream with *Juncus*
balticus wetland

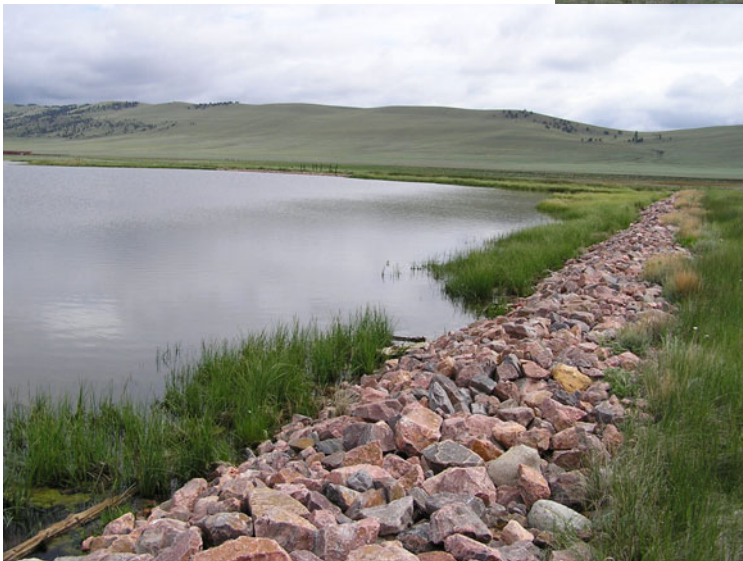
Berm on south side of Trout Creek Pond

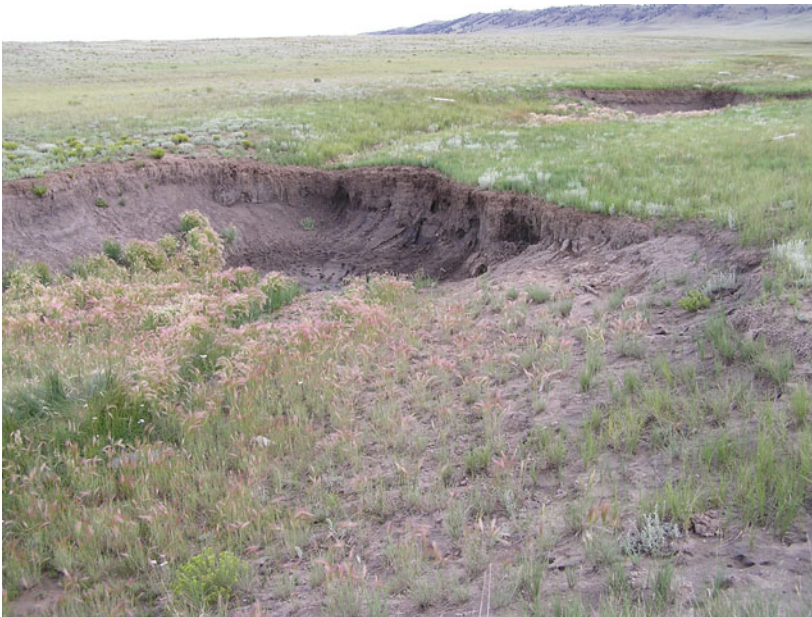
Excavations along Sevenmile Gulch

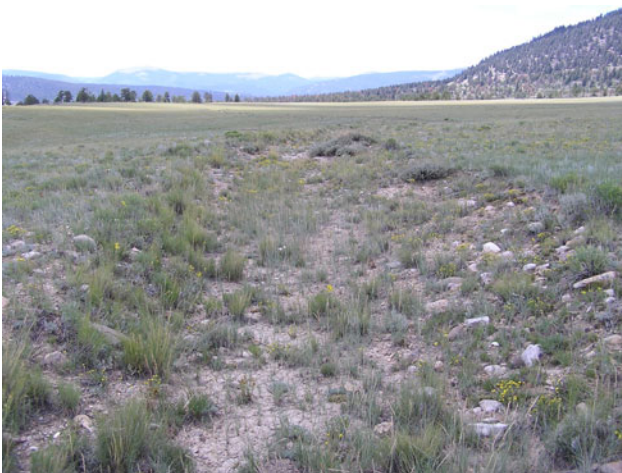
Gully at Black Mountain Parcel
