FOREST STEWARDSHIP PLAN

**Horsetooth Tract
Colorado State University Research Foundation
PO Box 483
Fort Collins, CO 80522
970-482-2916**

**Prepared by:
Jamie M. Dahl
Fort Collins District
Colorado State Forest Service
Foothills Campus, Building 1052, CSU
Fort Collins, Colorado 80523-5075
(970) 491-8660**

September 2010

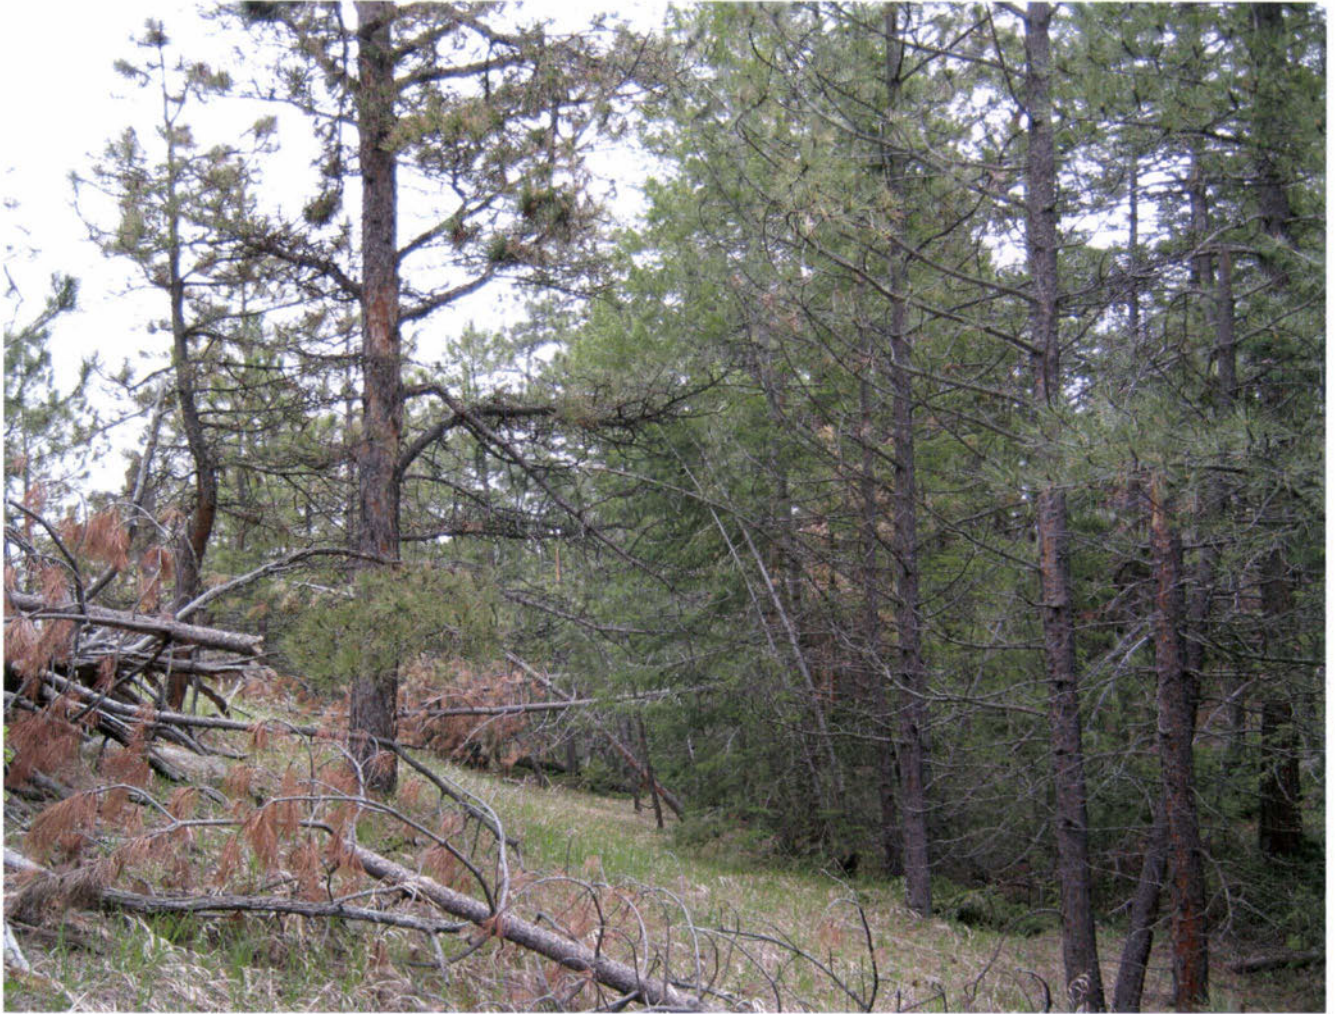
Management Unit 1

Description: Unit 1 is 22 acres of ponderosa pine and Douglas-fir. The slopes in this unit range between 10 and 35 percent and have aspects of southwest, south, southeast, east, north, and northeast. Mountain pine beetle infested trees were present in some areas; those noted were designated on Map 3. Dwarf mistletoe was also a serious and fairly widespread problem in this unit. There is also evidence of storm damage, most likely from a late snowfall in the spring of 2009. This area is a proposed treatment area and will be thinned by Larimer County in 2010-2011, through ARRA funding.

The trees have an average DBH of 9.6 inches and an average height of 35 feet. Unit 1 contains areas with open growing trees and also areas with more dense pockets. The average basal area across the unit is 63 square feet per acre, which is a healthy stocking level for this mixed conifer stand. Regenerating trees include 86 ponderosa pine and 79 Douglas-fir saplings, and 57 ponderosa pine and 136 Douglas-fir seedlings per acre.

Unit 1 is mapped as having a very high wildfire hazard.

Recommendations: The priority for this unit is the management for health and diversity and to mitigate wildfire danger to existing transmission towers. This unit should be maintained at a growing stock level (GSL) between 60 and 80. Though the basal area in this unit is within this

range, some thinning is necessary in order to remove trees hit by the mountain pine beetle and dwarf mistletoe and to protect the communication towers from wildfire. Mitigation of both of these issues will involve removing infested trees, in-order to minimize the spread of the mistletoe and mountain pine beetles. See the Insect and Disease section and Appendix G for more information. Treatment is scheduled for this unit in 2010-2011. Treatment will also involve some fuels mitigation to help decrease the potential fire hazard; removal of infested trees will also help to meet this objective.

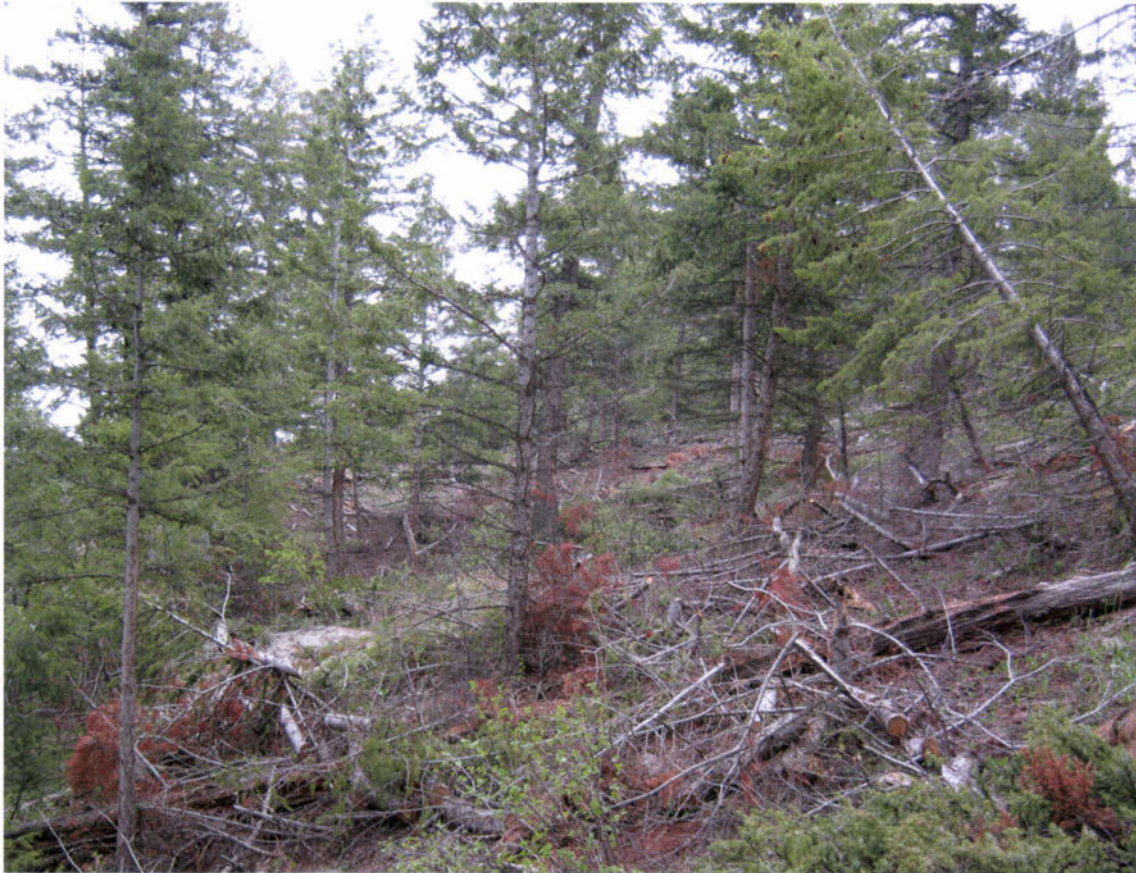
Management Unit 2

Description: Unit 2 consists of 12 acres mixed ponderosa pine and Douglas-fir that was treated in 2009. There is a considerable amount of slash scattered throughout this unit. This unit contains slopes between 5 and 35 percent on northeast, south, and west aspects. Despite past treatment, mountain pine beetle infested trees were still present in several areas. Dwarf mistletoe was not observed in this unit, but it may have been mitigated as part of the treatment.

Unit 2 is mapped as having a very high wildfire hazard.

Recommendations: The priority for Unit 2 is management for health and diversity. This unit should be maintained at a growing stock level (GSL) of 80. Though this unit has already been treated some additional thinning is necessary in order to remove trees hit by the mountain pine beetle. Mitigation will involve removing infested trees, in-order to minimize the spread of the mountain pine beetles. See the Insect and Disease section and Appendix G for more

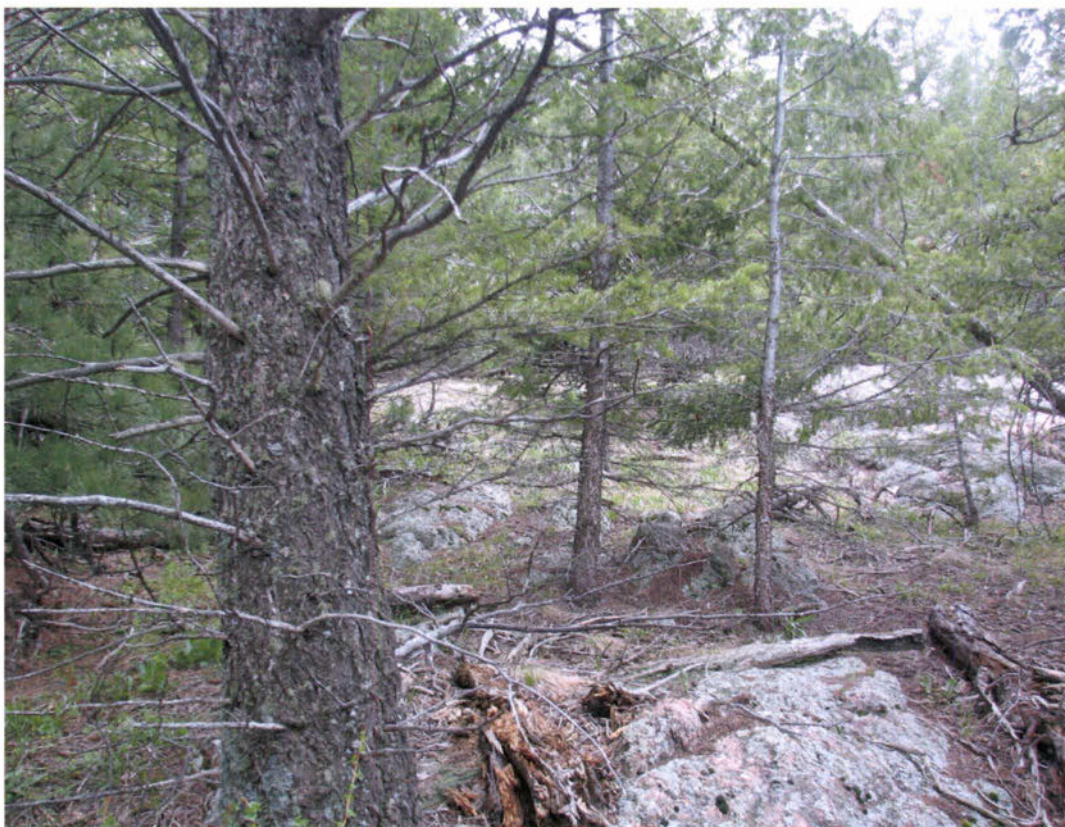
Management Unit 3

Description: Unit 3 is 8 acres of Douglas fir with some ponderosa pine mixed in. The slopes in this unit range between 25 and 50 percent and include west and southwest aspects. Dwarf mistletoe was present on some ponderosa pines in this unit.

Only Douglas-fir trees were captured in the basal area estimates, these trees have an average DBH of 9.9 inches and an average height of 39 feet. The average basal area in this unit is 60 square feet per acre, which is a healthy overall growing stock level for this stand of trees. However, it appeared that patches in this unit were well above the recommended stocking level and could use some thinning. Regeneration is moderate with 100 ponderosa pine seedlings per acre, and 50 Douglas-fir seedlings per acre.

Recommendations: The priority for Unit 3 is management for health and diversity. This unit should be maintained at a growing stock level between 60 and 80 square feet/acre. However, mitigation of dwarf mistletoe trees may require an even lower basal area in some portions of this unit. Dwarf-mistletoe might be managed and contained in this unit if the infected trees are removed. Creating a 50 foot buffer may be appropriate, to prevent spread. Forest management activities will be feasible in the portion of Unit 3 located in the far northwest corner of the property. The remaining piece of this unit, located along the southern boundary, is steep and has very low access, making forest management there a low priority. In general the same slash disposal guidelines should be followed as in Unit 1.

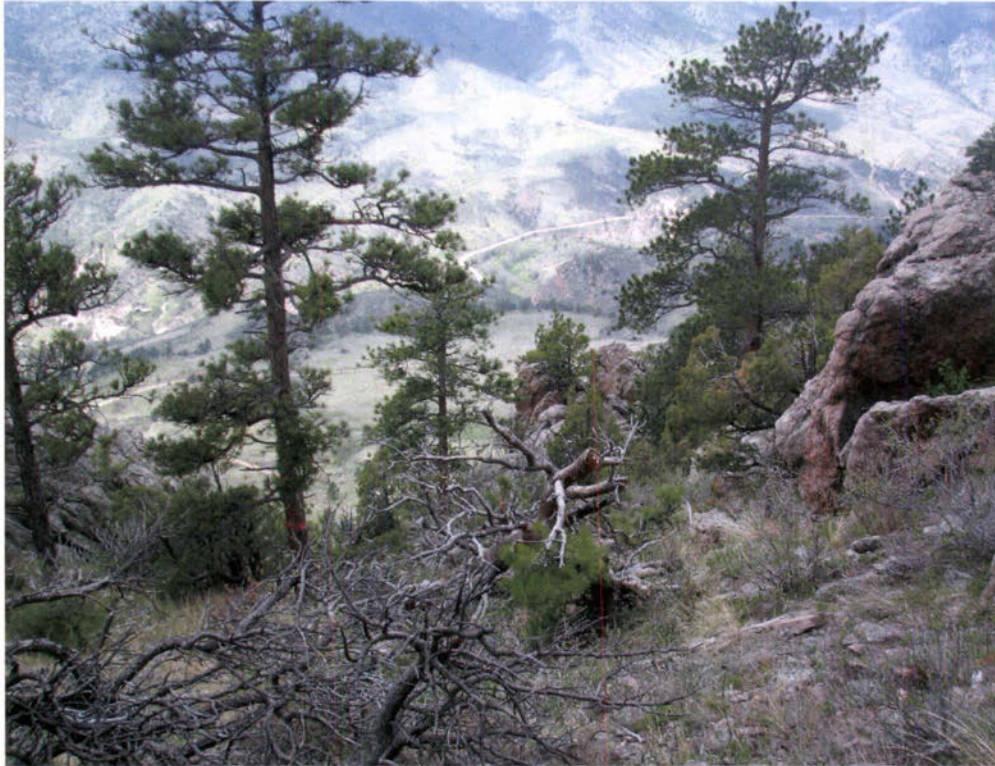
Management Unit 4

Description: Unit 4 is 32 acres of extremely rocky and steep terrain. Large portions of this unit are inaccessible. The slopes in this unit range between 20 and 60 percent and have a west aspect. Mountain pine beetle infested trees were present in some areas. Dwarf mistletoe is a problem in portions of this unit.

The trees have an average DBH of 11.3 inches and an average height of 37 feet. With 80 square feet of basal area, the unit is adequately stocked for the recommended growing stock level (GSL) of 80. Regeneration is moderate with 57 Douglas-fir seedlings and 86 ponderosa pine saplings.

This unit is mapped as a very high fire hazard, though a small portion of the south west corner is only a moderate fire hazard.

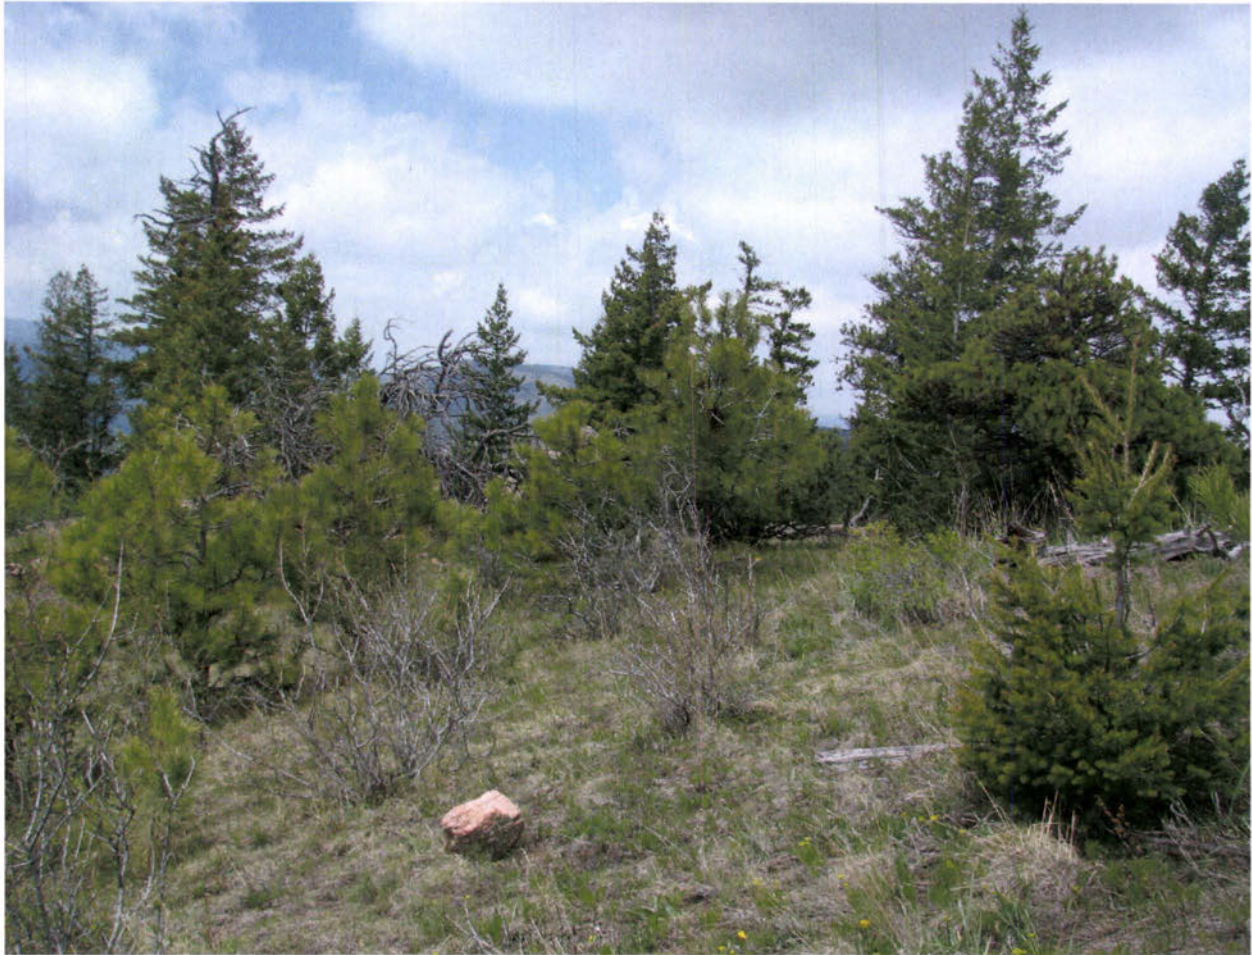
Management Unit 5

Description: Unit 5 consists of 6 acres of meadow and open ponderosa pine with patches of regeneration. Blow-down created several openings that are regenerating well. This unit has a 20 percent slope and a west and southwest aspect. Again, mountain pine beetle infested trees were present in some areas. Dwarf mistletoe was extremely aggressive, especially in sapling stage ponderosa pines. These stressors appear to be the cause of a great deal of blow down and woody debris in this unit. There were signs of past management in this unit, though not within recent years.

No basal area of trees greater than 3 inches was recorded on these plots, though there were sparse patches of mature trees in this unit. Basal area was estimated to range from 5-15 square feet per acre.

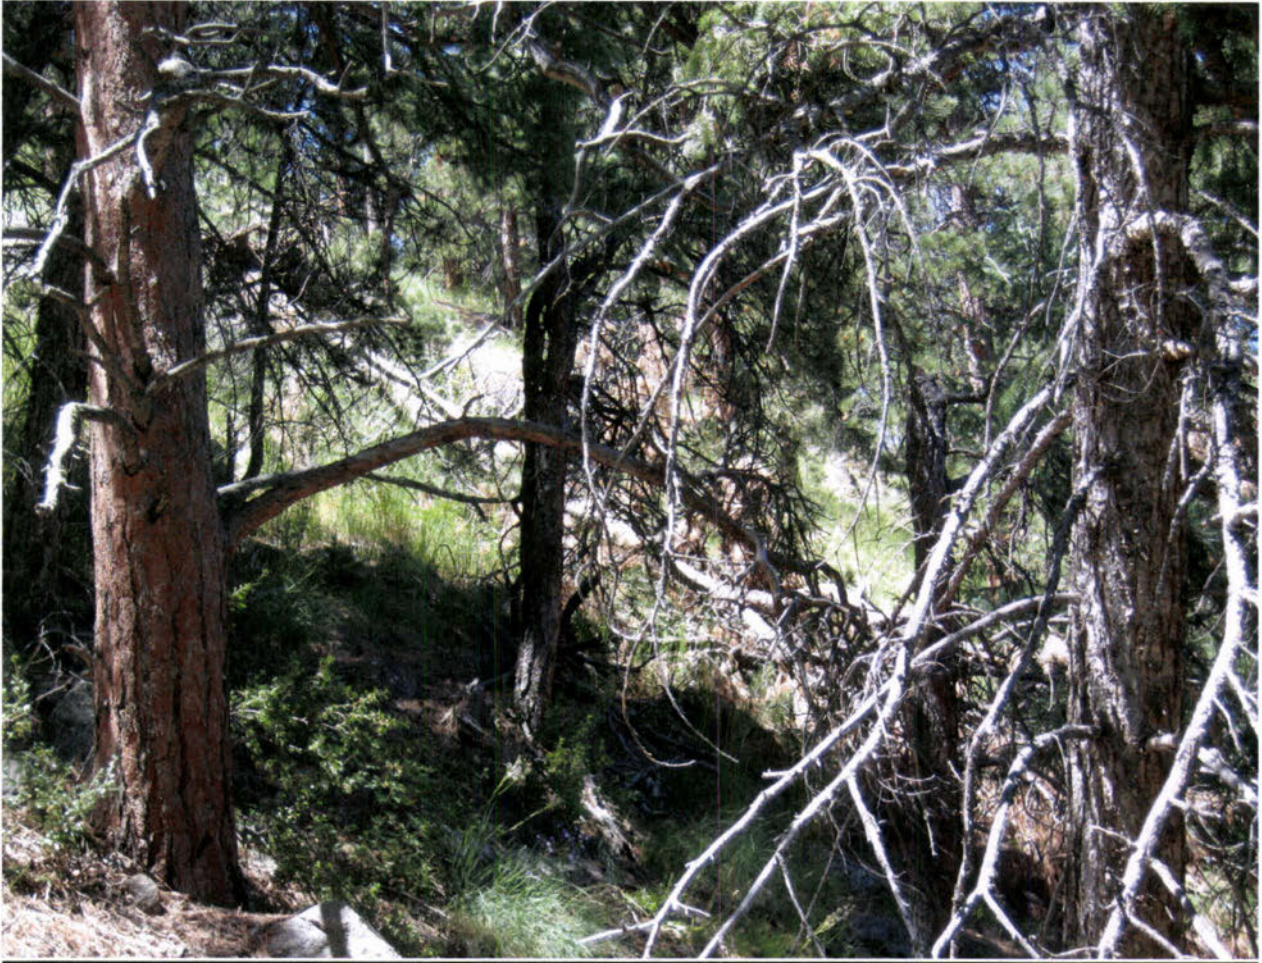
Management Unit 6

Description: Unit 6 is 21 acres within the Mill Creek portion of Horsetooth Tract. This unit consists of open ponderosa pine mixed with Douglas-fir. It is less dense overall than the remainder of the Mill Creek property, described in Unit 7. The slopes in this unit range between 30 and 60 percent and aspects include east, northeast, and west (most slopes are east and northeast). Some portions of this unit were heavily impacted by dwarf mistletoe.

The trees have an average DBH of 11.6 inches and an average height of 39 feet. Tree stocking is at a healthy level with an average of 63 square feet of basal area per acre. Regeneration is good with 143 ponderosa pine and 43 Douglas-fir seedlings, and 29 ponderosa pine saplings.

This unit is mapped as a very high fire hazard.

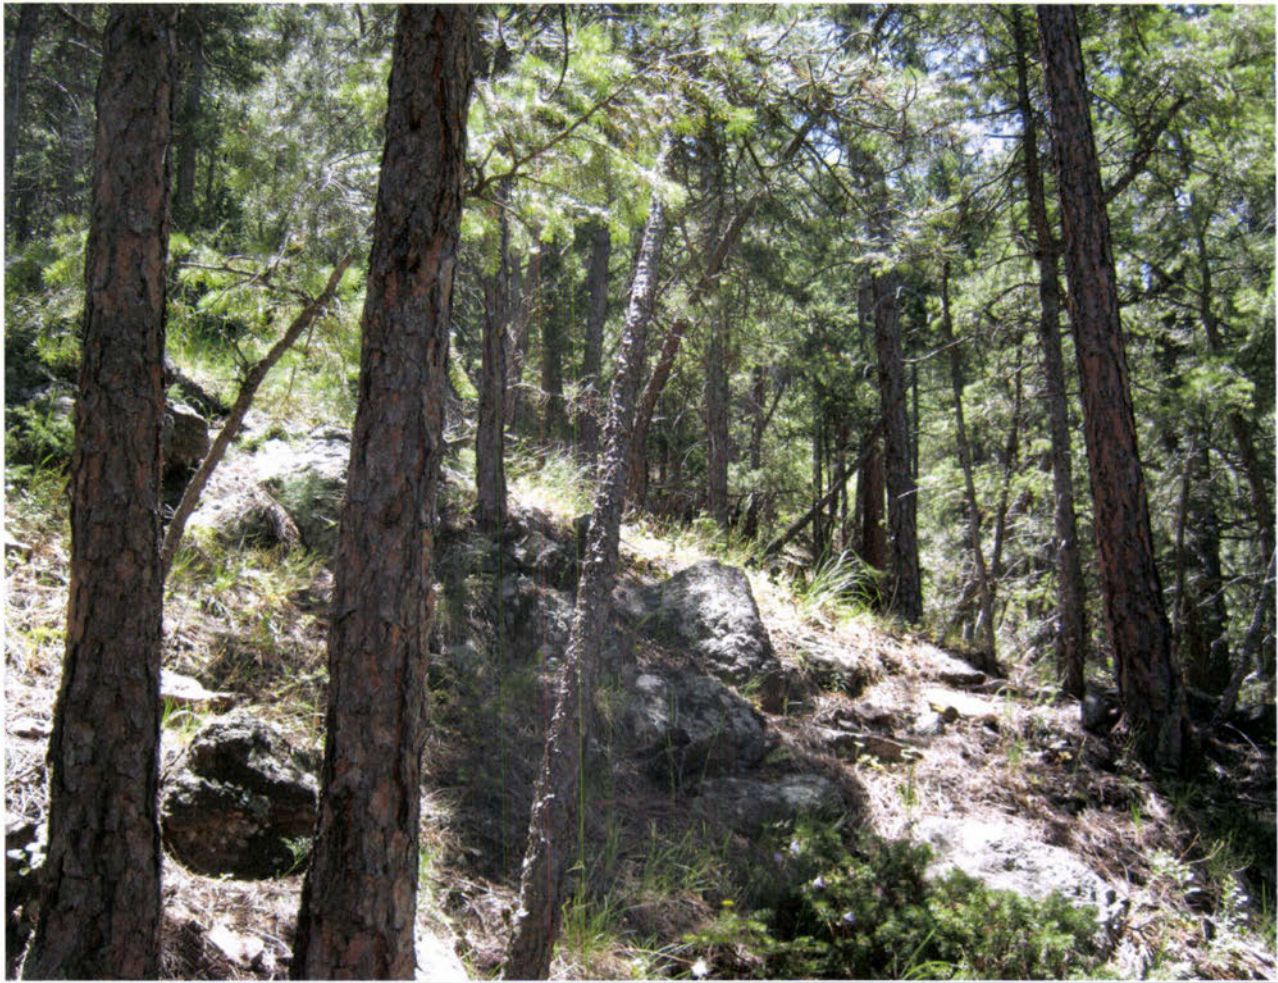
Management Unit 7

Description: Unit 7 is 19 acres of Douglas-fir and ponderosa pine within and around the 2 main drainages of this property. Large portions of this unit are very steep, rocky, and inaccessible. The slopes in this unit range between 30 and 60 percent and have a north, northeast, or east aspect. Both dwarf mistletoe and mountain pine beetle were present in portions of this unit.

The trees have an average DBH of 9.6 inches and an average height of 34 feet. With 82 square feet of basal area, the unit is adequately stocked for the recommended growing stock level (GSL) of 80. Regeneration is high with 500 Douglas-fir and 22 ponderosa pine seedlings, as well as 211 Douglas-fir and 100 ponderosa pine saplings.

This unit is mapped as a very high fire hazard.

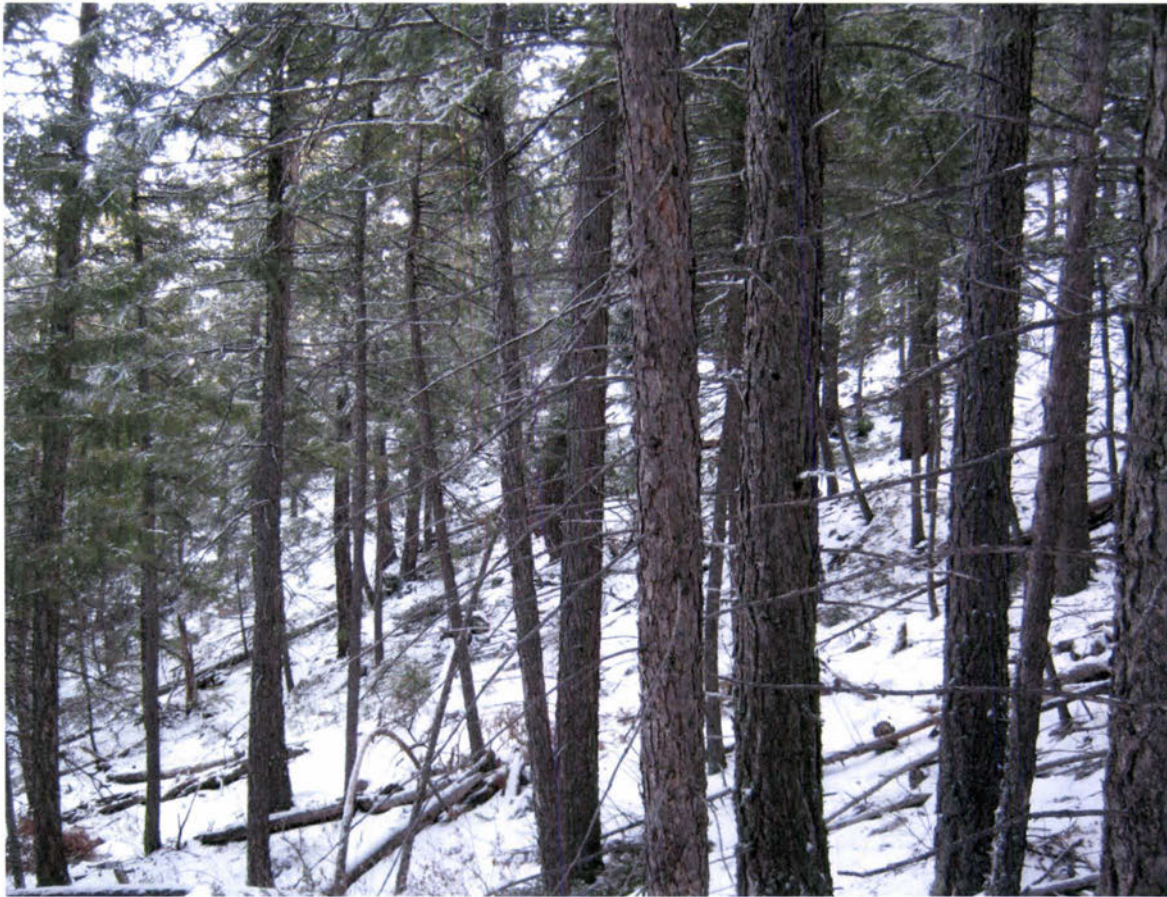
Management Unit 1

Description: Unit 1 consists of 146 acres of dense Douglas-fir and a small component of ponderosa pine. The generally north-facing slopes in this unit are steep and range from 20 to 70%. Some areas have moderate to heavy accumulations of down woody material and the tree density is high.

The trees have an average DBH of 9.7 inches and an average height of 41 feet. Average basal area is 107 square feet per acre, which is typical of a Douglas-fir stand growing on a cool, moist, north-facing slope. Unit 1 contains abundant regeneration with 673 Douglas-fir and 45 ponderosa pine seedlings, and 36 Douglas-fir and 27 ponderosa pine saplings per acre.

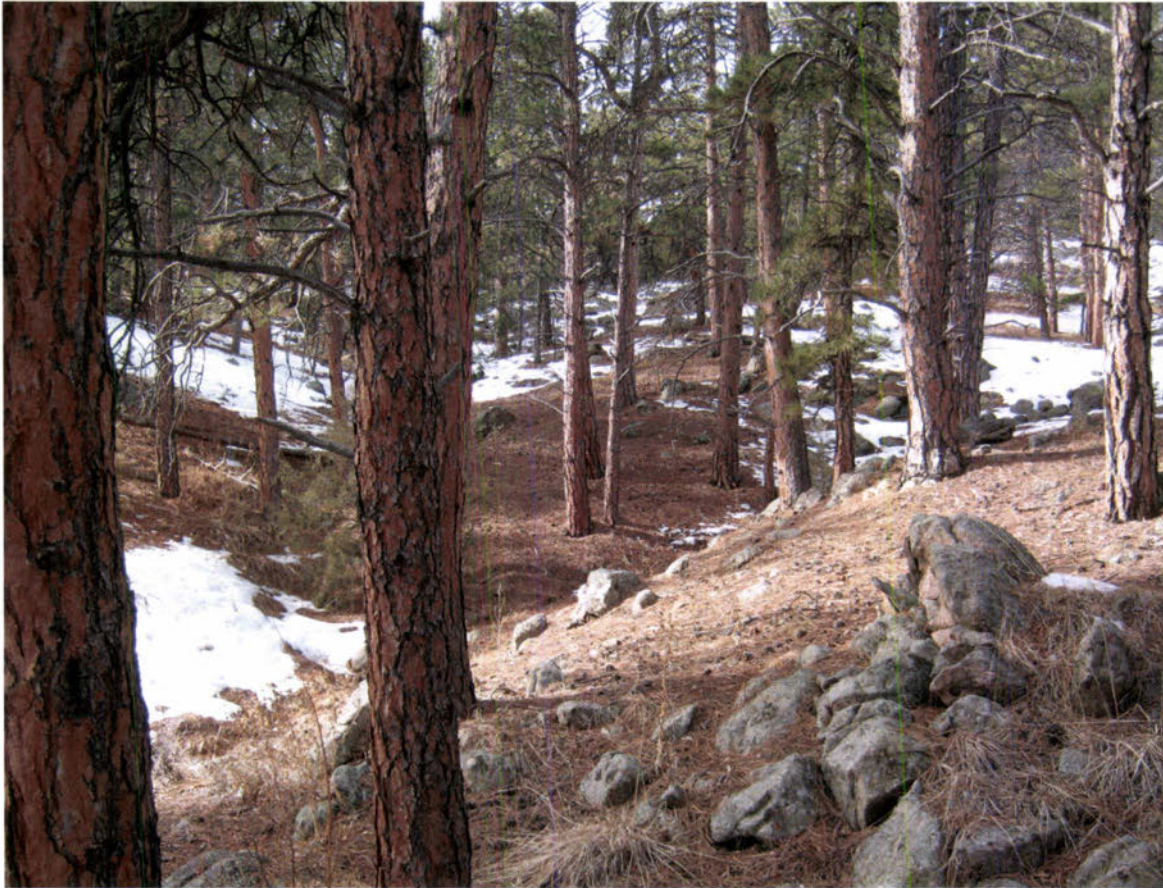
Management Unit 2

Description: Unit 2 consists of 305 acres of ponderosa pine forest with some Douglas-fir in the drainages and interspersed with small meadows. This unit has an eastern aspect with slopes between 10 and 60 percent. The primary forest health concern across Unit 2 is dwarf mistletoe. Refer to Map 3 to identify centers of infestation.

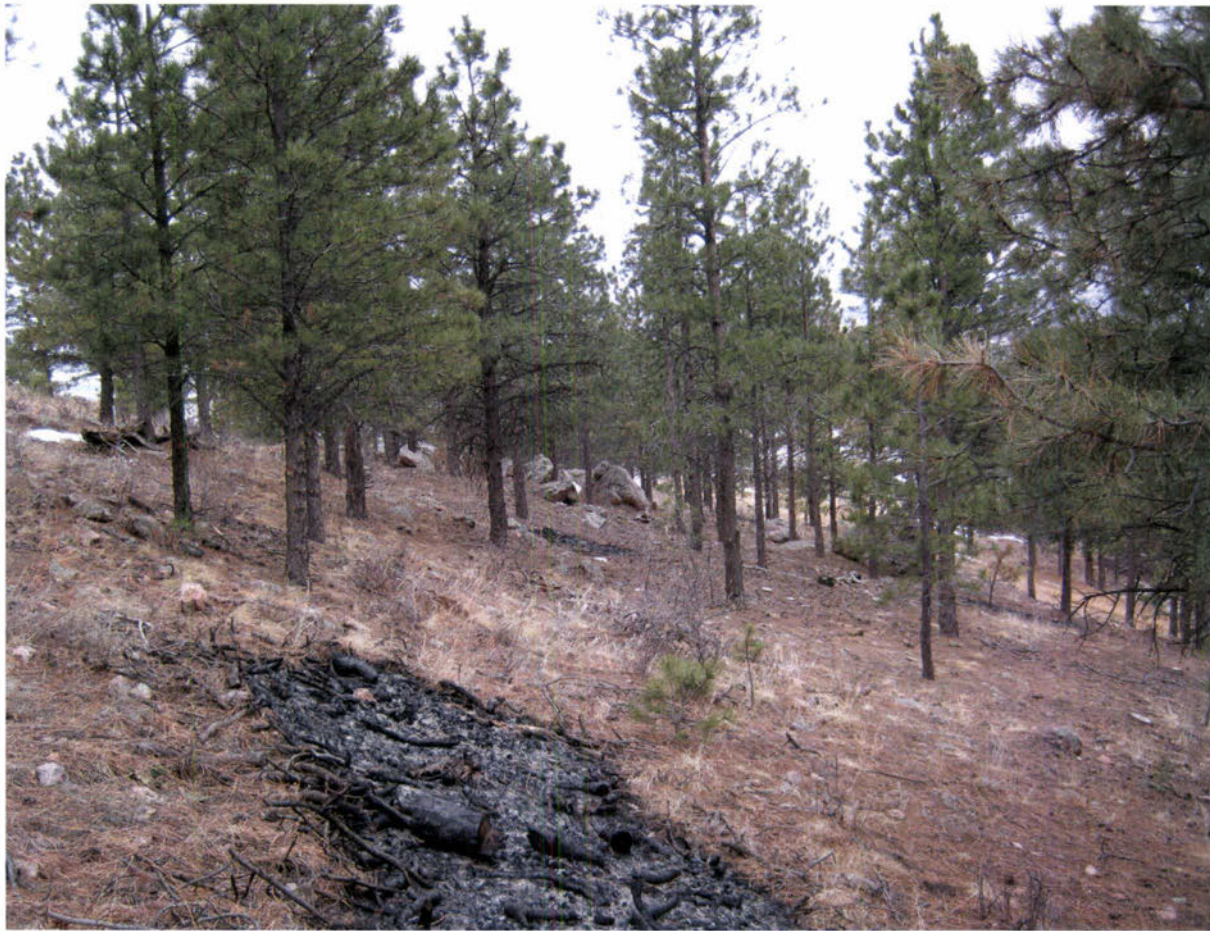
Management Unit 3

Description: Unit 3 is 125 acres of open ponderosa pine and some Douglas-fir. The stand conditions result from recent fuels and dwarf mistletoe mitigation thinning treatments that occurred in 2008. Some dwarf mistletoe still exists, but it has been largely eliminated. Some storm breakage and windthrow has occurred on residual trees, but overall, this unit contains healthy trees and favorable tree densities. Many slash piles remain to be burned and some logs and log sections remain on site. The slopes in this unit range between 10 and 50 percent with aspects of south, east, and northeast.

Residual trees have an average DBH of 9.2 inches and an average height of 34 feet. Current stand basal area averages 53 square feet per acre, although some areas across Unit 3 are much more open. Regeneration consists of 159 ponderosa pine and 95 Douglas-fir seedlings, and 36 ponderosa pine and 5 Douglas-fir saplings per acre.

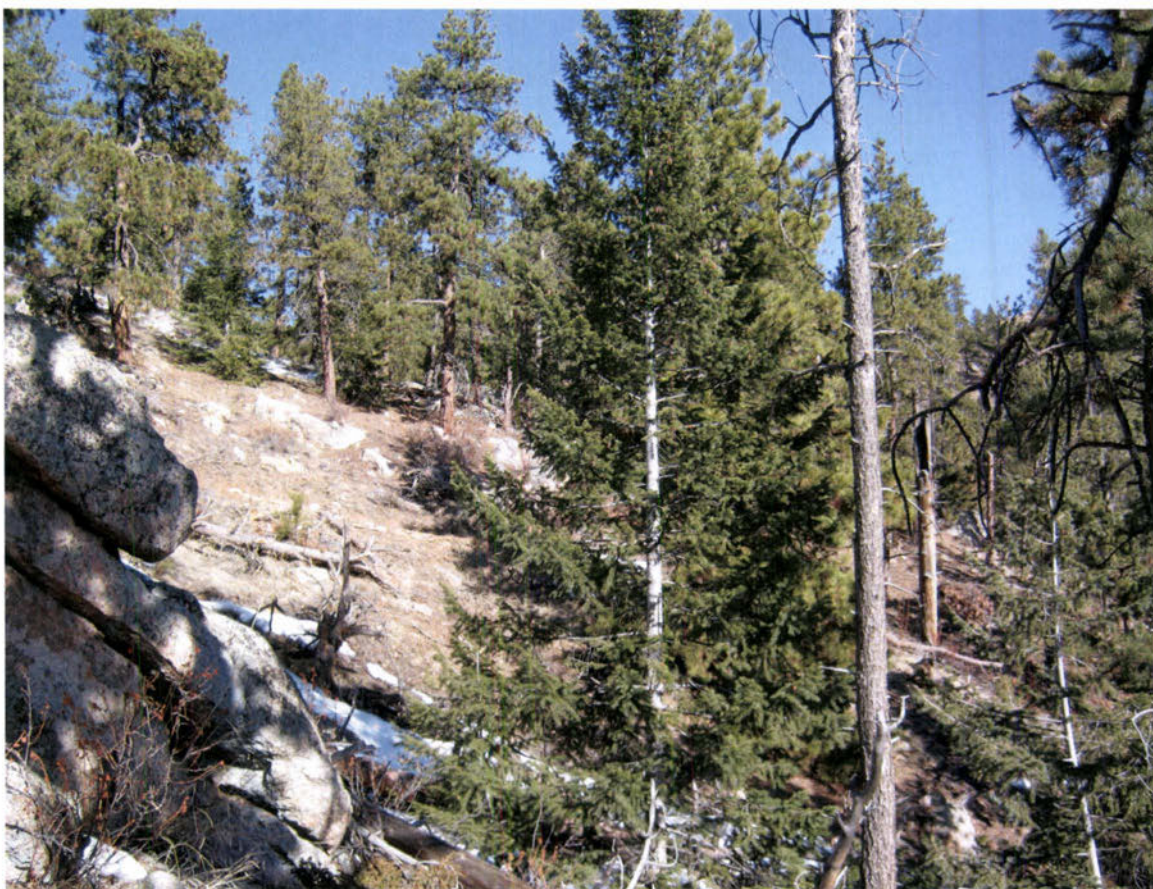
Management Unit 4

Description: Unit 4 is 90 acres of mixed ponderosa pine and Douglas-fir forest. This area received fuels mitigation thinning treatment in 2009. Most slash and logs remain on site and have yet to be piled and burned or removed. The slopes in this unit range between 15 and 60 percent and have aspects of south and east. Dwarf mistletoe is present throughout this unit in some of the residual trees.

The trees have an average DBH of 9.8 inches and an average height of 36 feet. Average basal area across Unit 4 is 68 square feet per acre. This is a desirable GSL for this forest stand. Regeneration consists of 117 ponderosa pine and 50 Douglas-fir seedlings, and 8 ponderosa pine and 8 Douglas-fir saplings per acre.

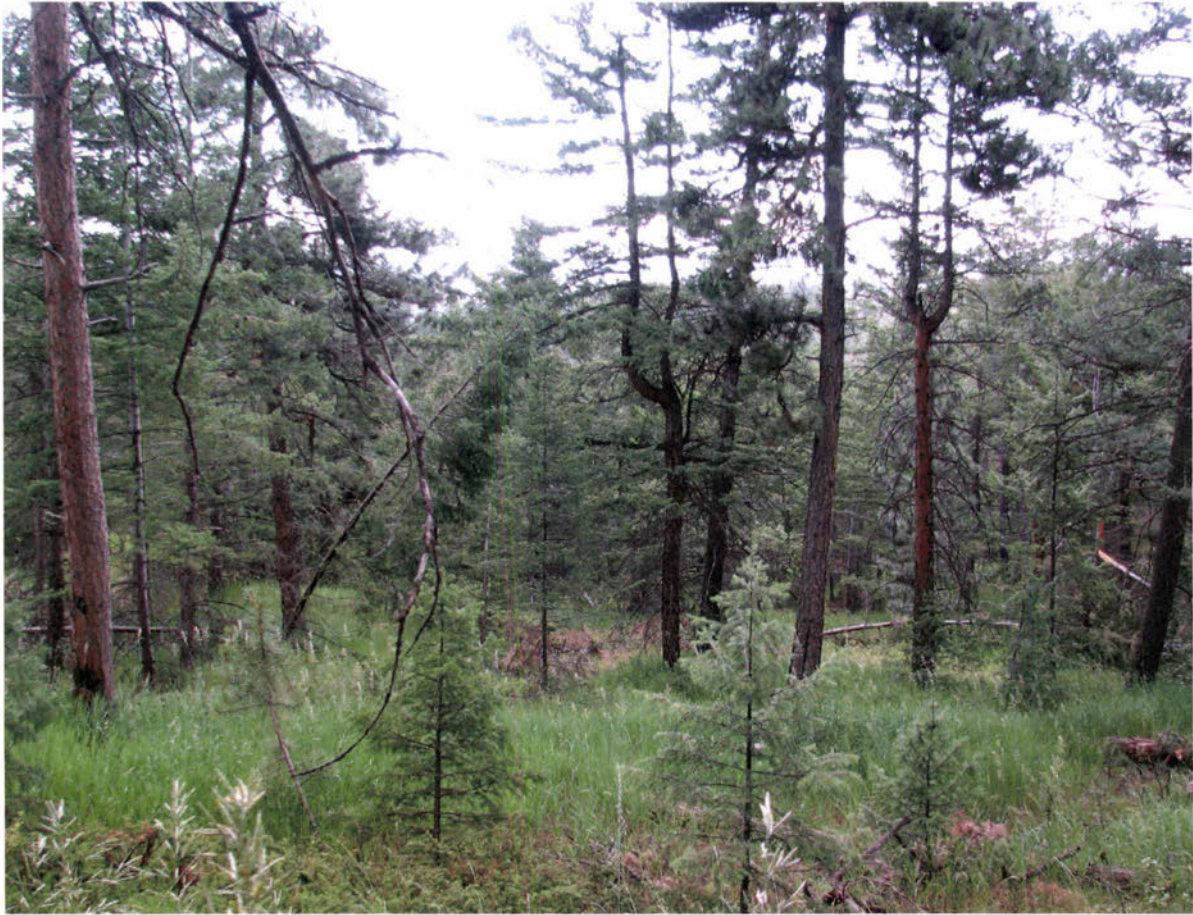
Management Unit 5

Description: Unit 5 consists of 34 acres of mixed Douglas-fir and ponderosa pine forest. The eastern portion of this unit was part of the thinning that occurred in 2009. Slopes range from 10 to 40 percent with aspects of north to northeast with some southern exposure on the west side of the unit.

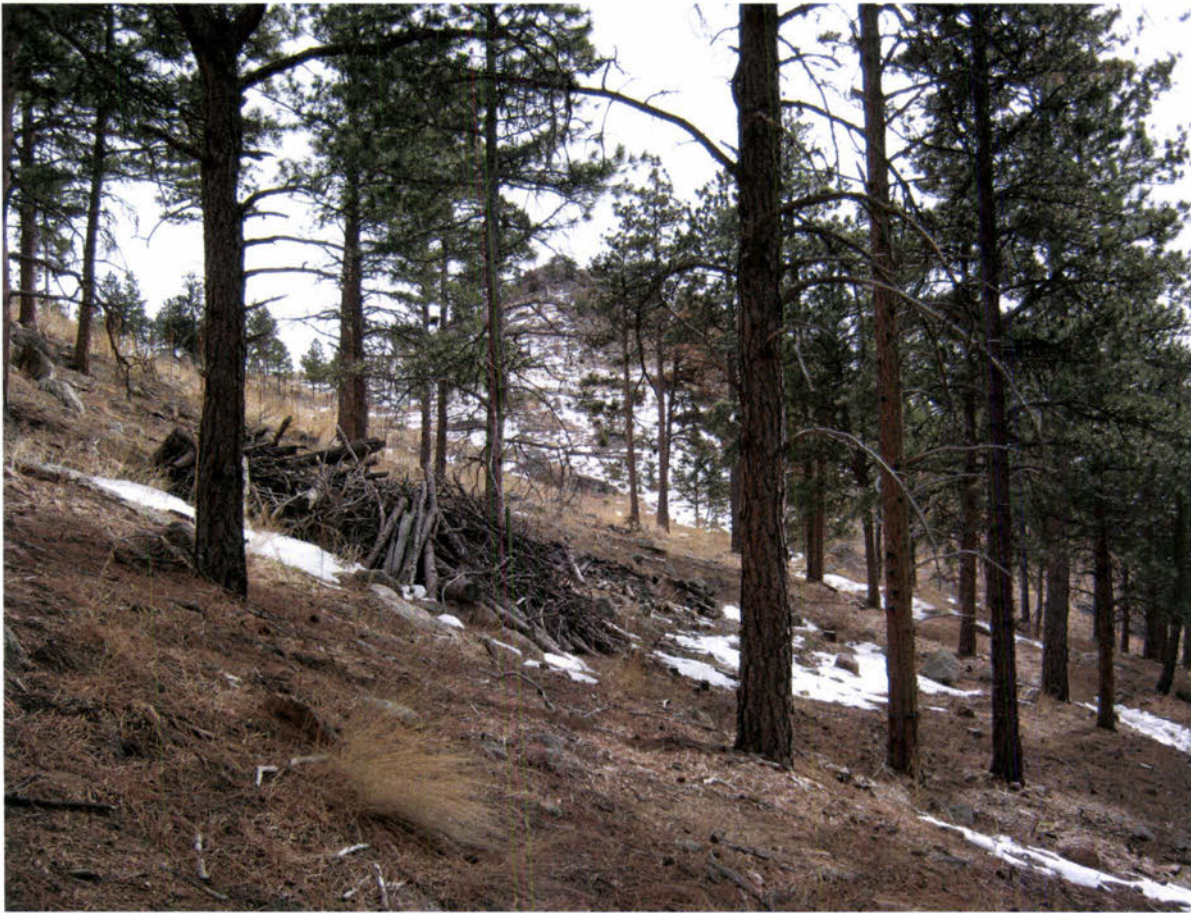
Management Unit 6

Description: Unit 6 consists of 115 acres of ponderosa pine forest. Recent thinning that occurred in 2003 and 2009 has resulted in a fairly open stand of healthy trees across this area of the property. Slopes on this generally west-facing aspect range from 20-40 percent. Some dwarf mistletoe infested trees are present, but overall this is a healthy stand of trees.

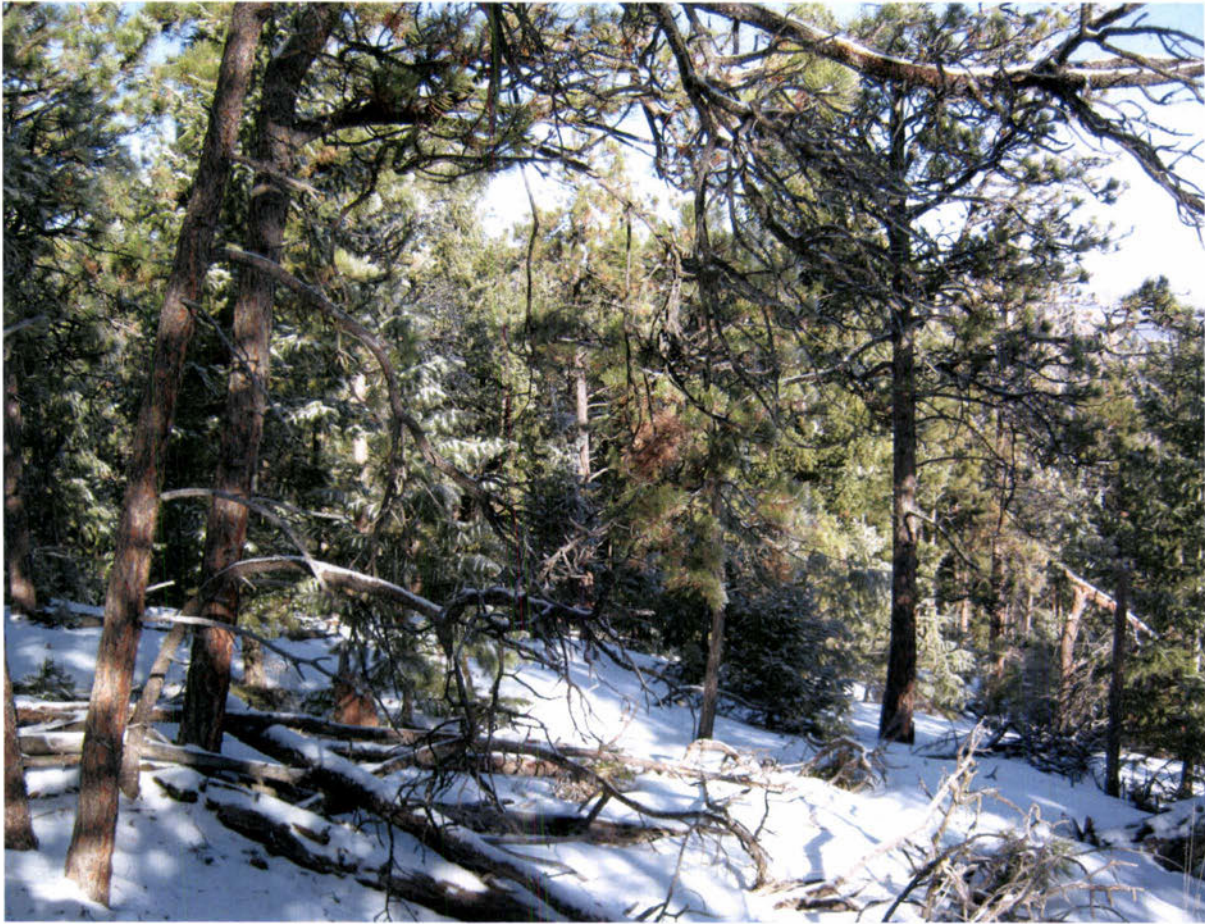
Management Unit 7

Description: Unit 7 consists of 200 acres of mixed ponderosa pine and Douglas-fir. Slopes are steep and range from 20 to 65 percent on a generally east facing aspect. There has been no recent forest management within this portion of the park. Some areas in this unit contain heavy dwarf mistletoe and down woody fuels.

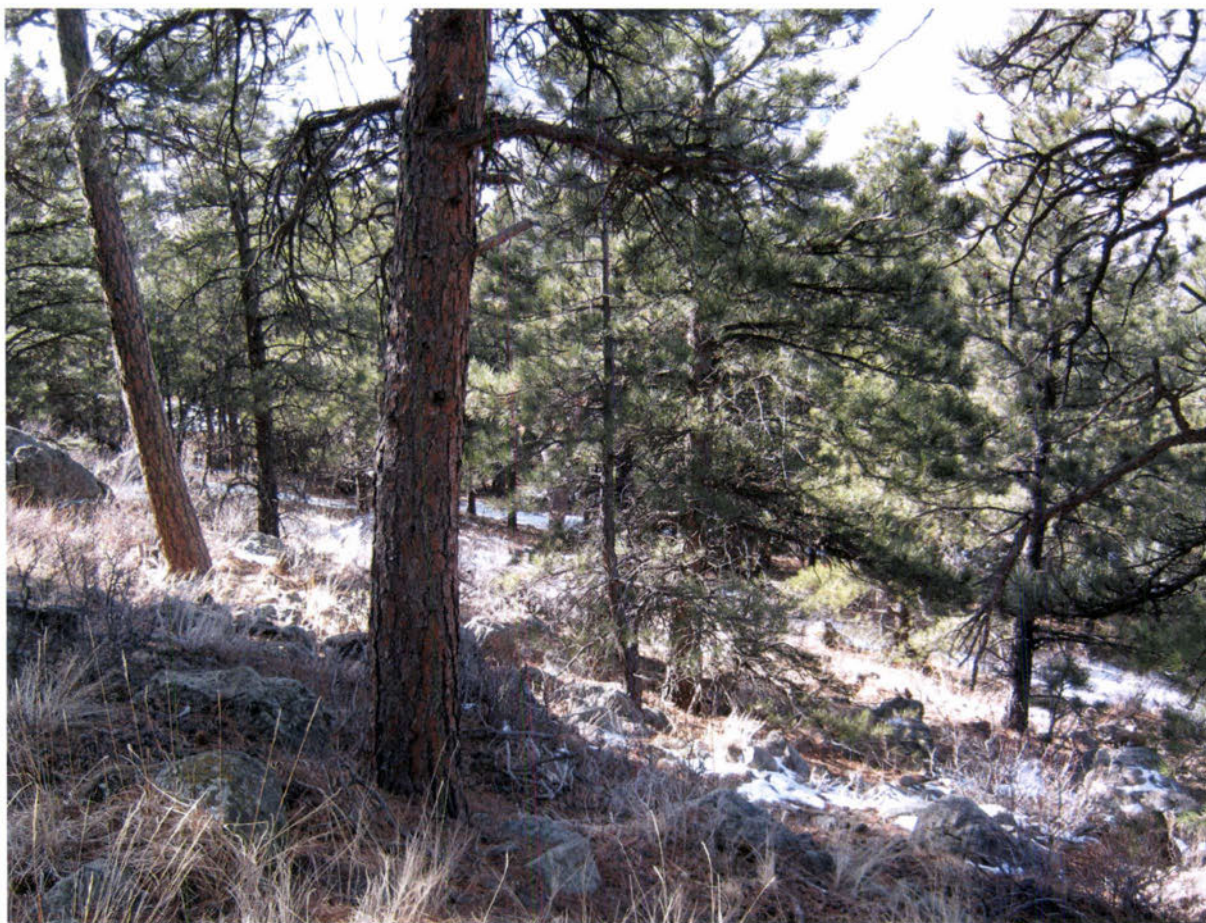
Management Unit 8

Description: Unit 8 consists of 146 acres of ponderosa pine and open meadows. Slopes range from 5 to 60 percent on generally west, southwest aspects. Most of the eastern portion of this unit was thinned in 2005 and 2006. The western portion and the area surrounding Horsetooth Rock is fairly inaccessible and rocky.

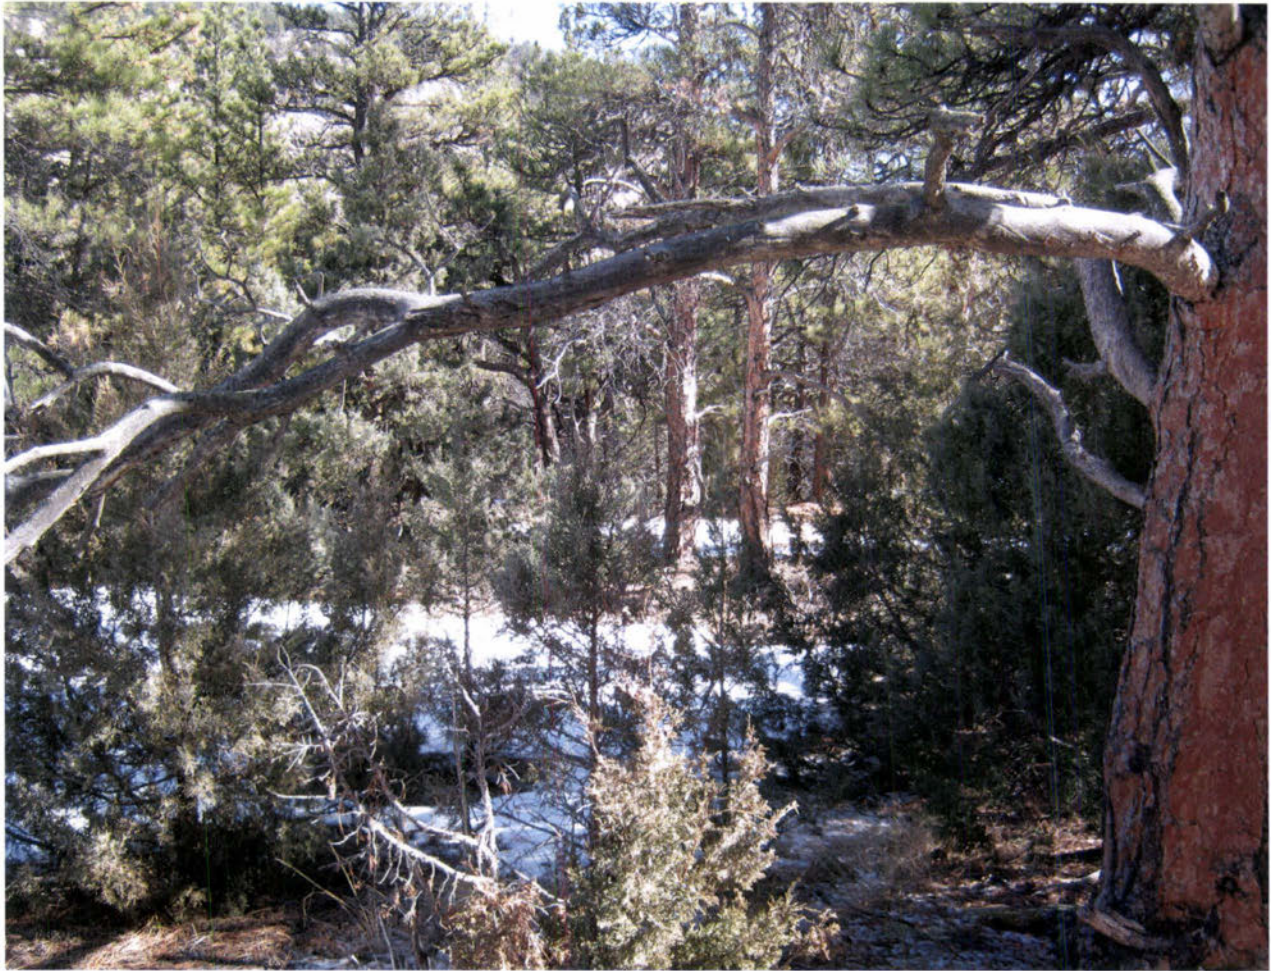
Management Unit 10

Description: Unit 10 consists of 25 acres of ponderosa pine and Douglas-fir forest on the lower flats of Hughey Open Space. The majority of this unit is relatively flat except for the portion sloping toward the drainage on the northeast side. The general aspect is east to northeast with slopes of 0 to 40 percent. Rocky Mountain juniper is a large component of the understory and mid-story vegetation. Remnants of old stone walls and some rock piles can be found in this area, which indicate some historical significance. These cultural remnants should be considered when making management decisions for this portion of the property.

Average tree diameter is 9.7 inches and average height is 41 feet. Stand basal area is 107 square feet per acre, which is somewhat overstocked for a recommended GSL of 60 to 80.

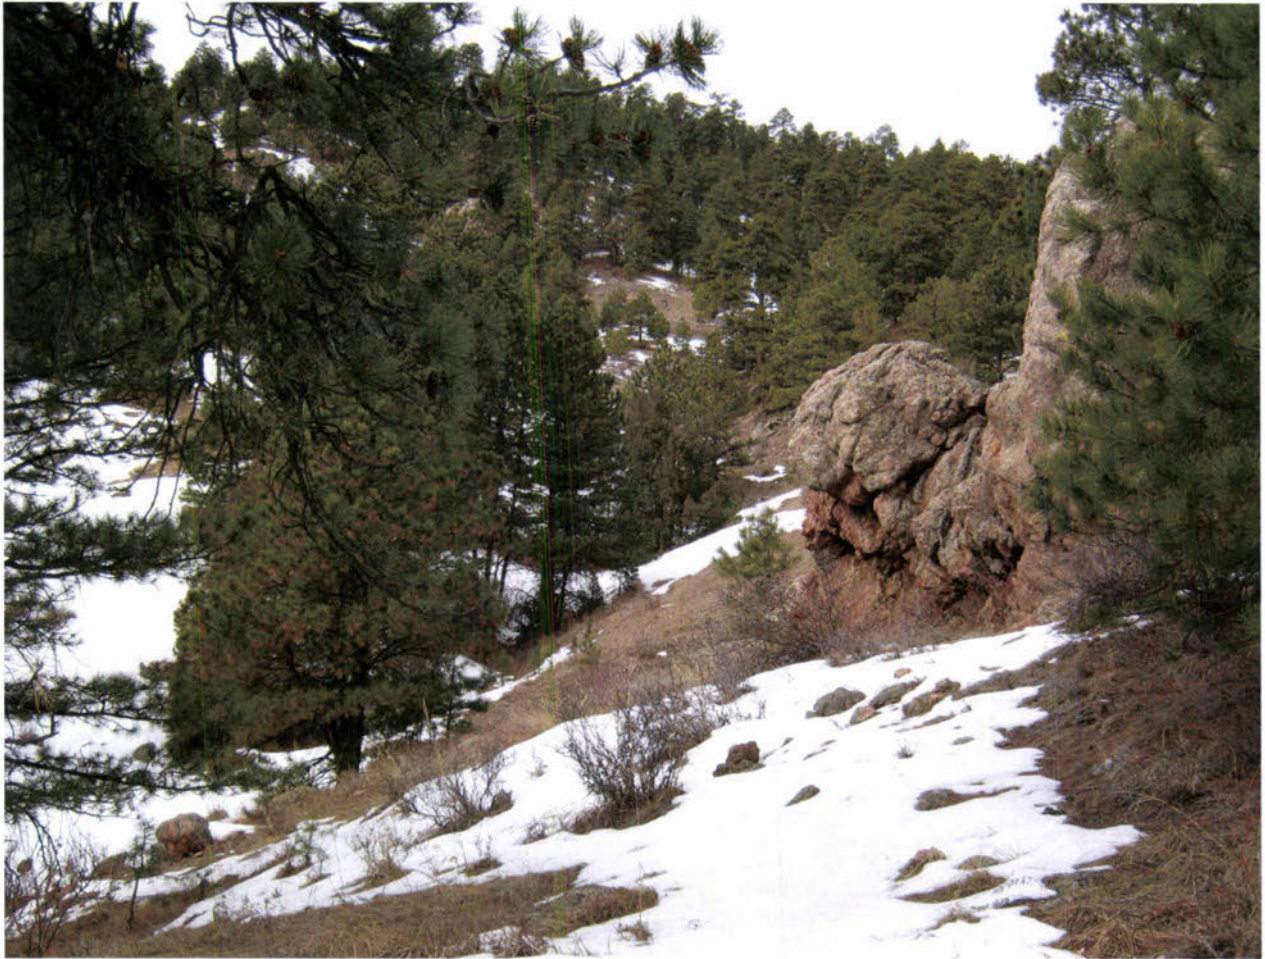
Management Unit 12

Description: Unit 12 consists of 323 acres of open ponderosa pine forest and meadows on sloping rocky terrain. Slopes range from 20 to 60 percent on generally west, southwest aspects. There are few pine seedlings and saplings present, but none were recorded on the inventory plots.

Average tree diameter is 12.1 inches and average height is 29 feet. Stand basal area is 53 square feet per acre in the forested portions of this unit. This is a healthy stocking level considering the dry growing conditions in this part of Horsetooth Park. Shrubs present across Unit 12 include; yucca, mountain mahogany, prickly pear, sage brush, and common juniper. Wildfire hazard is rated as moderate to very high.

Recommendations: No management necessary.
