FOREST STEWARDSHIP PLAN

**Horsetooth Tract
Colorado State University Research Foundation
PO Box 483
Fort Collins, CO 80522
970-482-2916**

**Prepared by:
Jamie M. Dahl
Fort Collins District
Colorado State Forest Service
Foothills Campus, Building 1052, CSU
Fort Collins, Colorado 80523-5075
(970) 491-8660**

September 2010

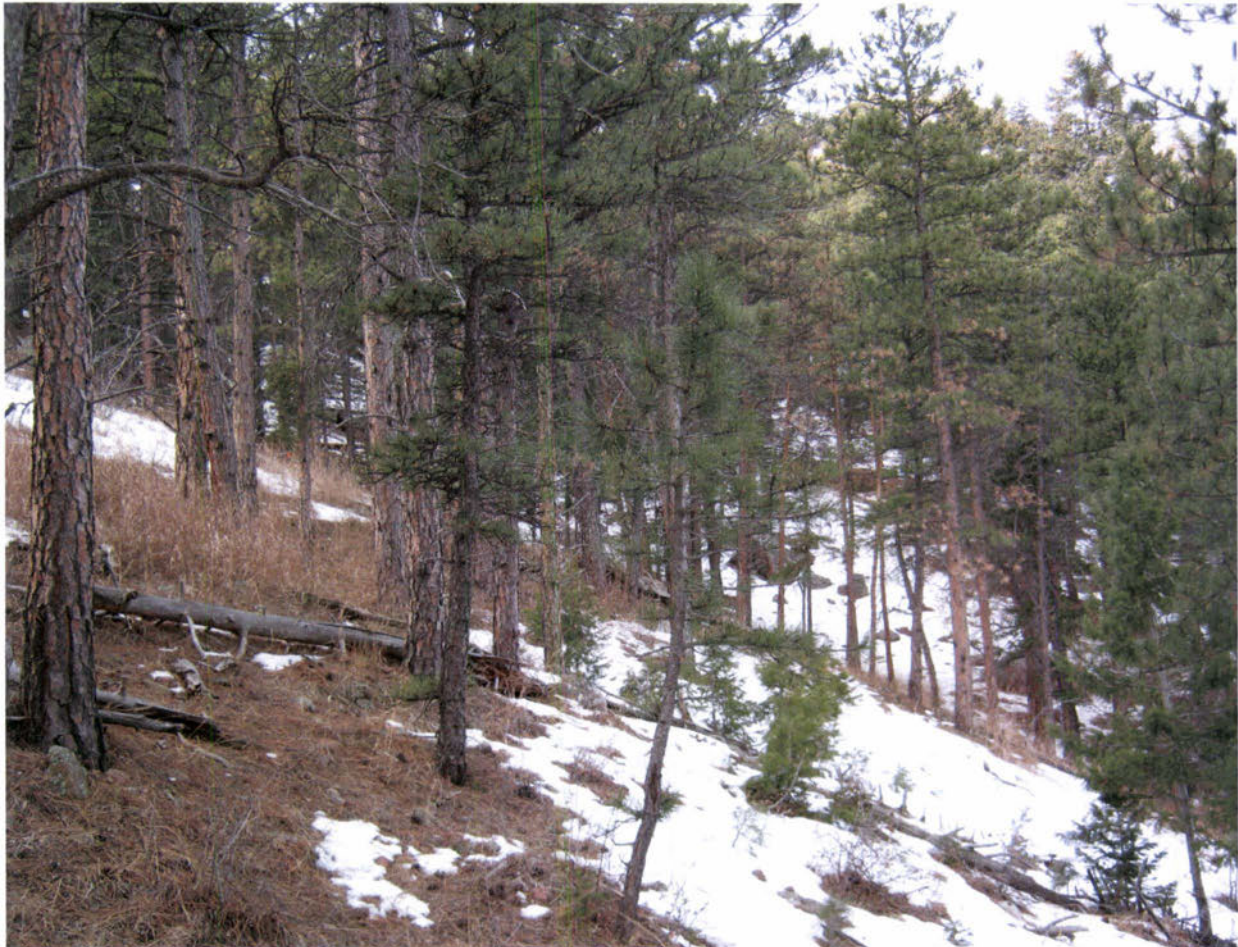
Management Unit 13

Description: Unit 13 is 42 acres of mixed ponderosa pine and Douglas-fir forest. Parts of this stand were thinned in 2006. Slopes are steep at 25 to 60 percent and generally north, northeast facing. There are some pockets of bark beetle throughout this stand and also some heavy dwarf mistletoe.
