Survey of Seeps and Springs on Bureau of Land Management lands in northern Hinsdale County 2006-2007

Prepared for: Bureau of Land Management, Gunnison Field Office 216 N. Colorado Gunnison, Colorado 81230

Prepared by: Stephanie Neid, Delia Malone, and Jennifer Jones

> > March 1, 2008

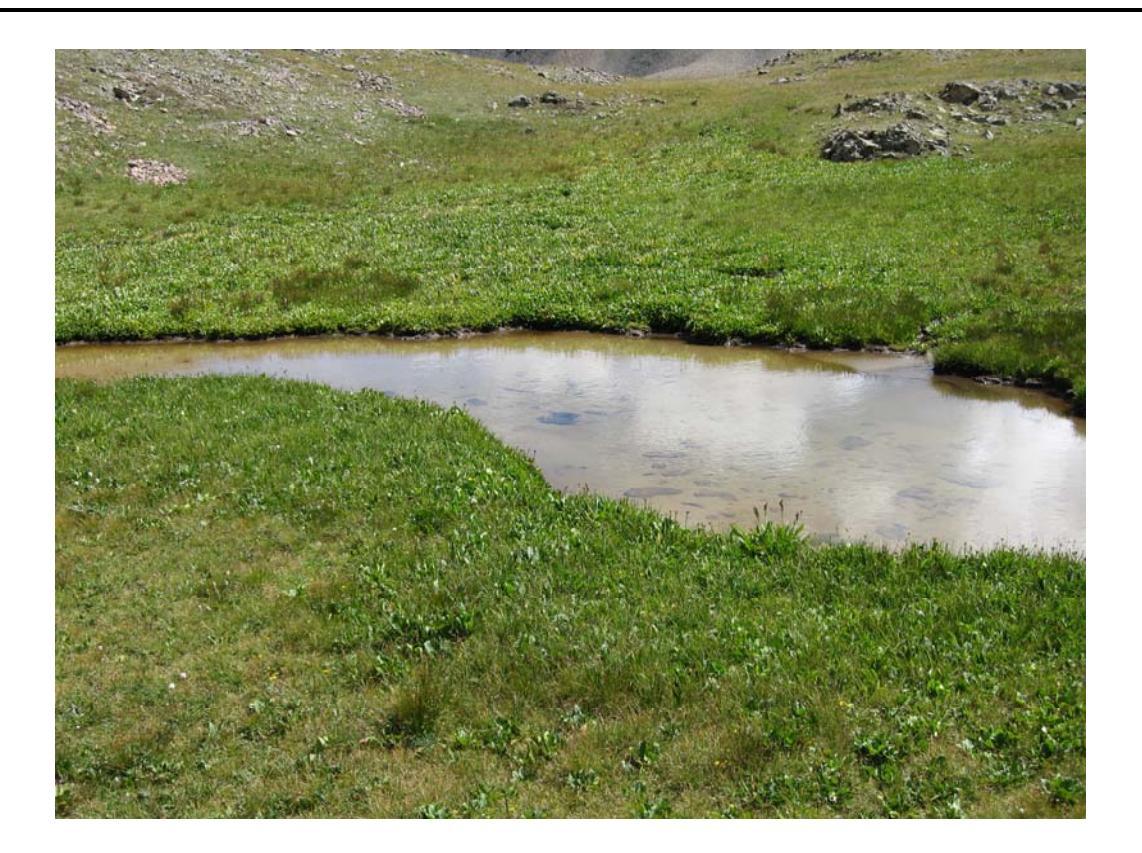
Upper Snare Creek Standard Checklist Proper Functioning Condition

Potential (ecological status that can be attained without above limiting factors or without limiting factors what is the ultimate goal for assessment area) Wetland is functioning at its potential natural community with no disturbances contributing to unacceptable conditions in the area. Hydrology is stable and wetland vegetation is vigorous.

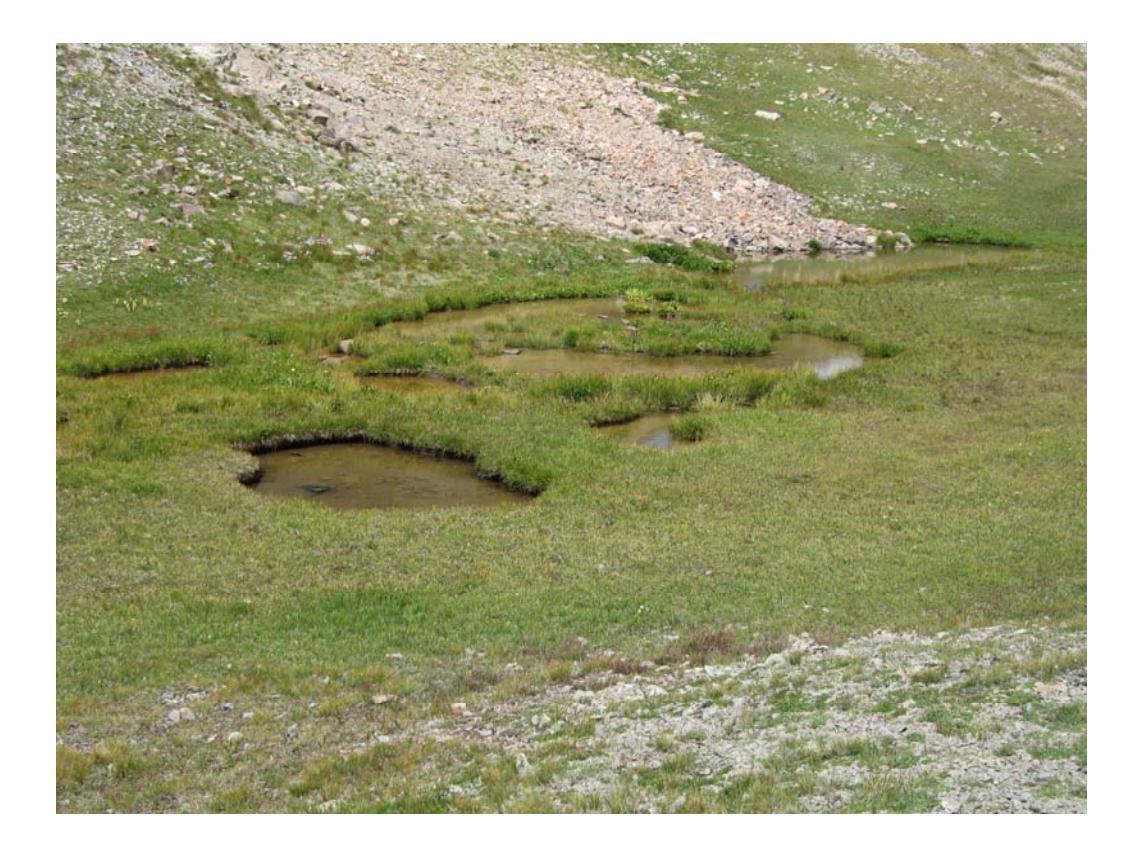
Powderhorn Lakes Standard Checklist Proper Functioning Condition

Potential (ecological status that can be attained without above limiting factors or without limiting factors what is the ultimate goal for assessment area) Wetland is functioning at its potential natural community with no disturbances contributing to unacceptable conditions in the area. Hydrology is stable and wetland vegetation is vigorous.

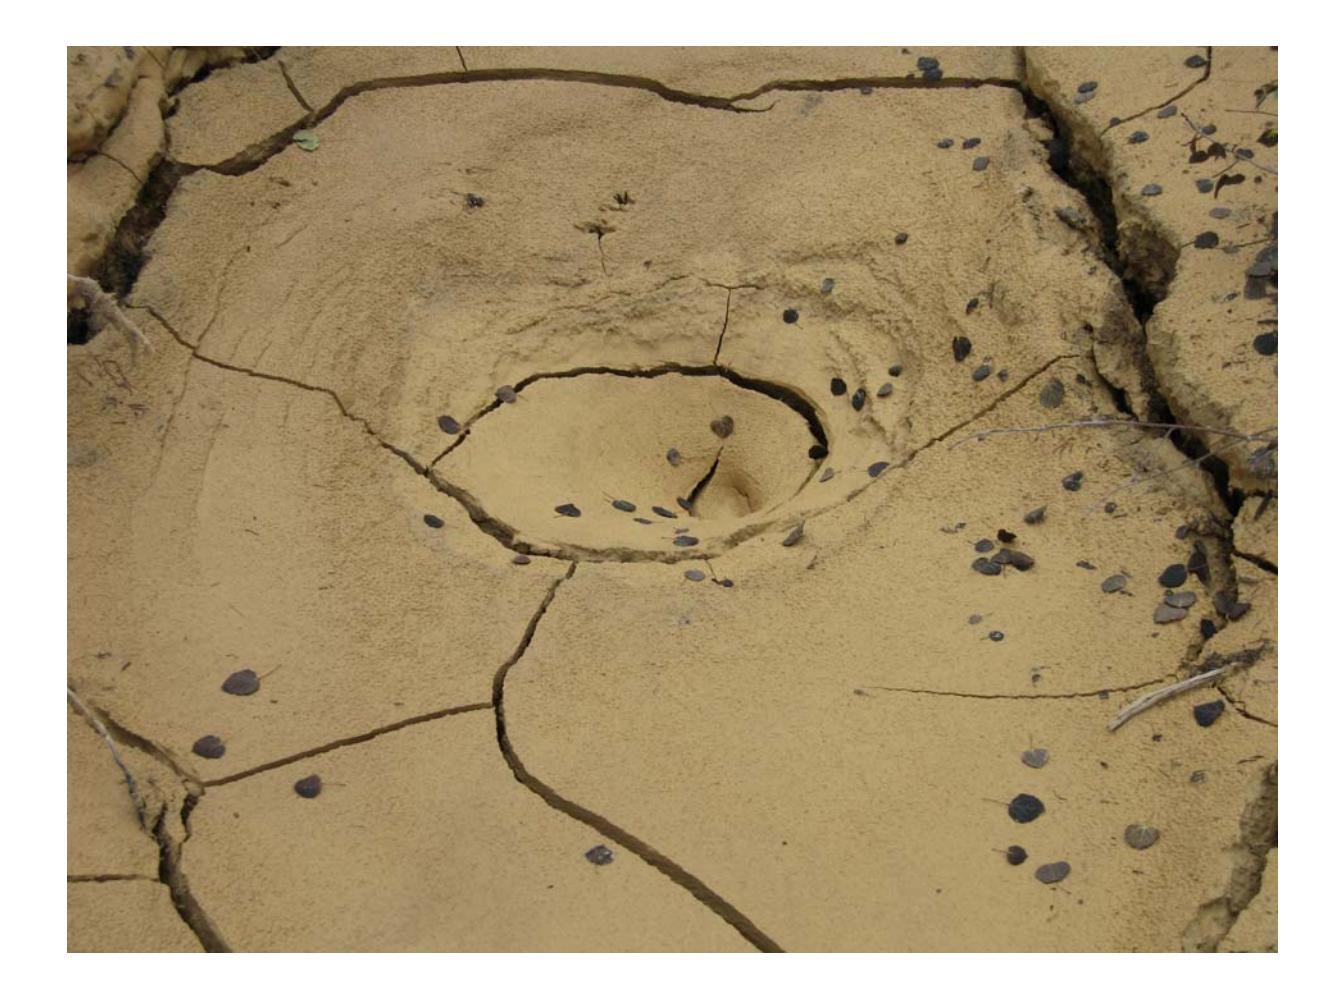
Red Mountain Seeps Standard Checklist Proper Functioning Condition

Potential (ecological status that can be attained without above limiting factors or without limiting factors what is the ultimate goal for assessment area) Seep indicated by BLM not a functioning wetland. There is no consistent hydrologic regime present and no stable vegetation. Soils are highly erodible with little structure to support wetland vegetation.

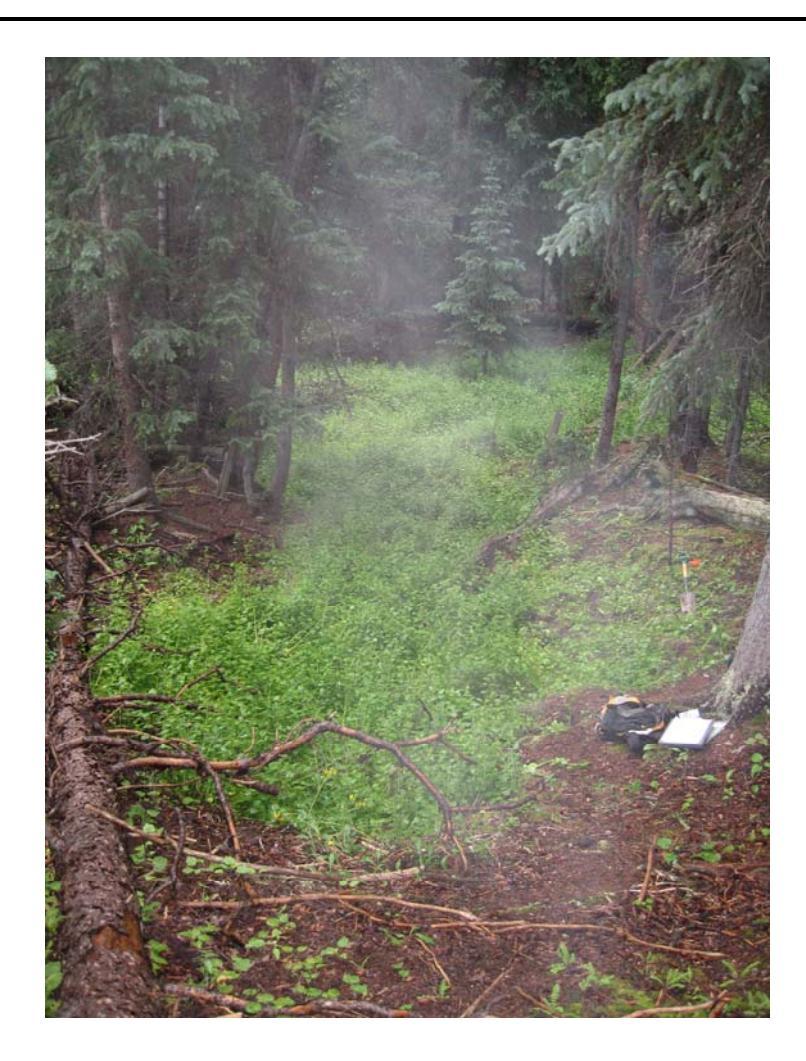
Red Mountain Seeps Standard Checklist Functional – At Risk

Potential (ecological status that can be attained without above limiting factors or without limiting factors what is the ultimate goal for assessment area) Site is functioning at its potential natural community with little disturbance in the immediate area. There are no factors currently limiting the area's potential or causing unacceptable conditions. Off highway vehicle use, old trail/road, and past mining activity in the area may alter site hydrology or alter species composition, but do not appear to be impacting the site at present.

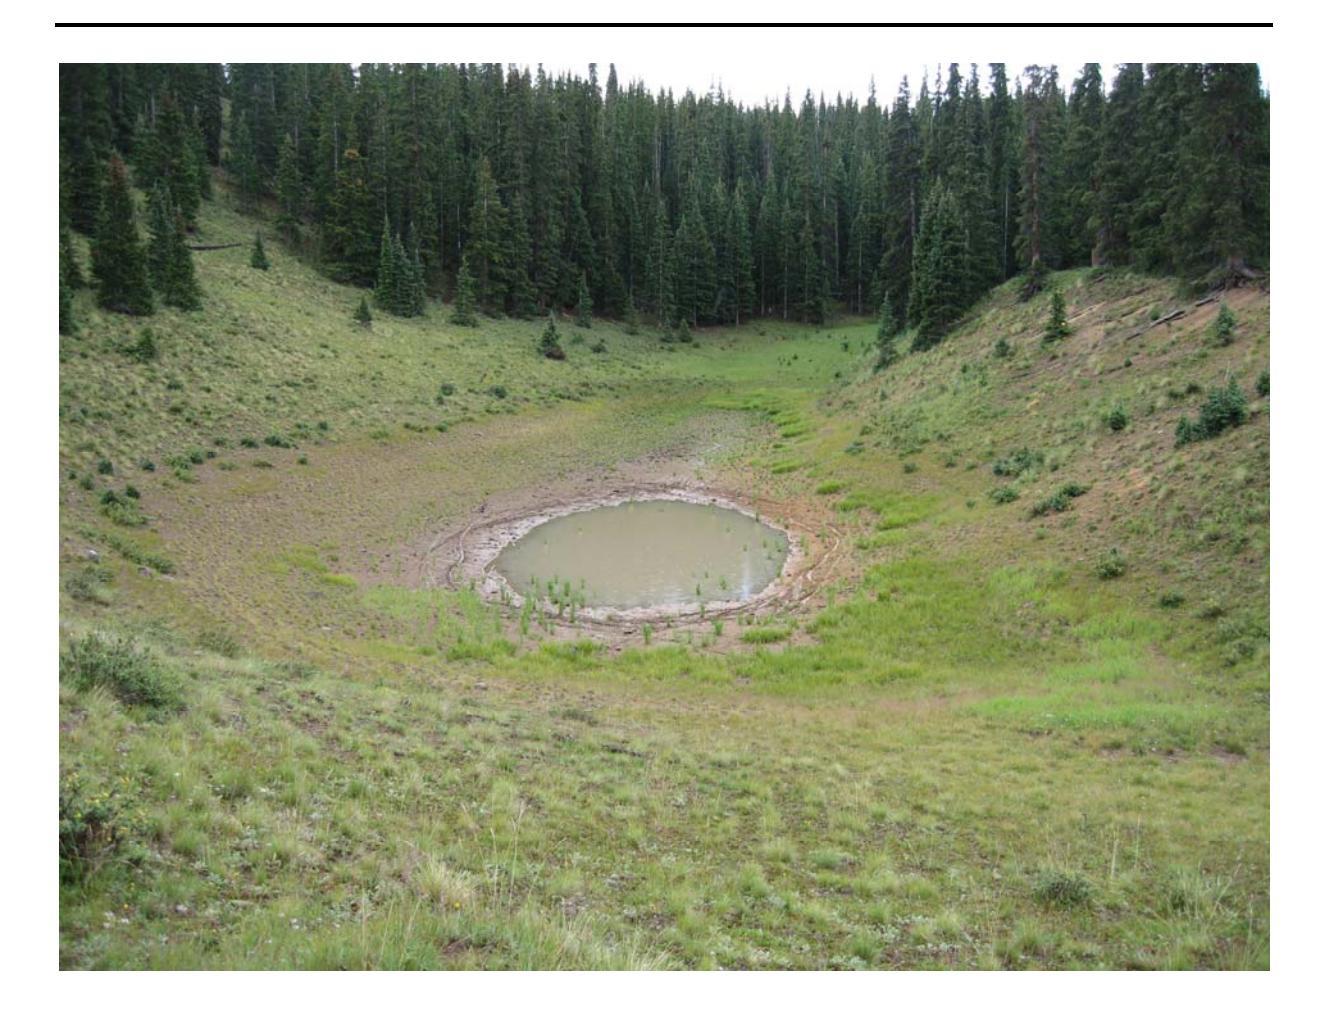
Red Mountain Seeps Standard Checklist Proper Functioning Condition

Potential (ecological status that can be attained without above limiting factors or without limiting factors what is the ultimate goal for assessment area) Wetland is not functioning at its potential natural community due to impacts from recreational use and drying. Drying does not appear to be from anthropogenic disturbances. Restriction of OHV use in the area may help wetland species become more vigorous and revegitate shores around the pond.

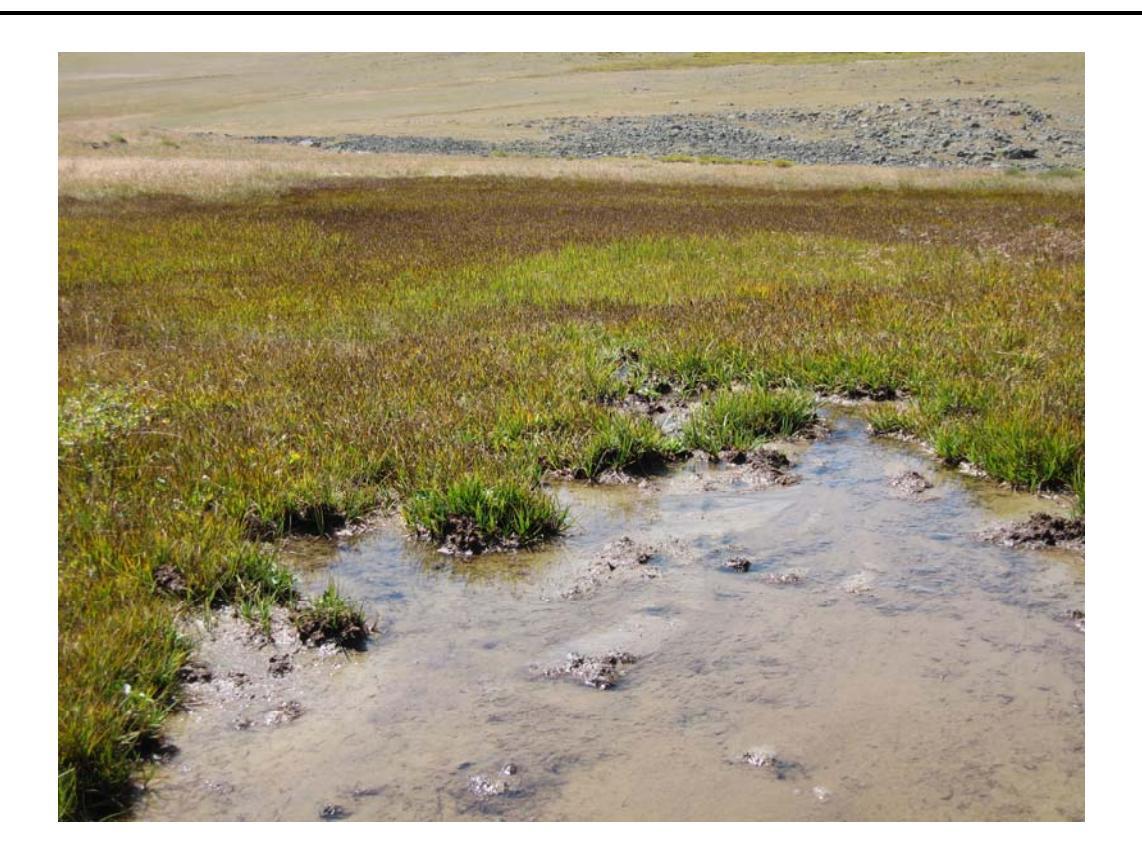
Devils Lake Seeps Standard Checklist **Proper Functioning Condition**

Potential (ecological status that can be attained without above limiting factors or without limiting factors what is the ultimate goal for assessment area) Wetland is functioning at its potential natural community with little anthropogenic disturbances in the area and no disturbances leading to unacceptable conditions.

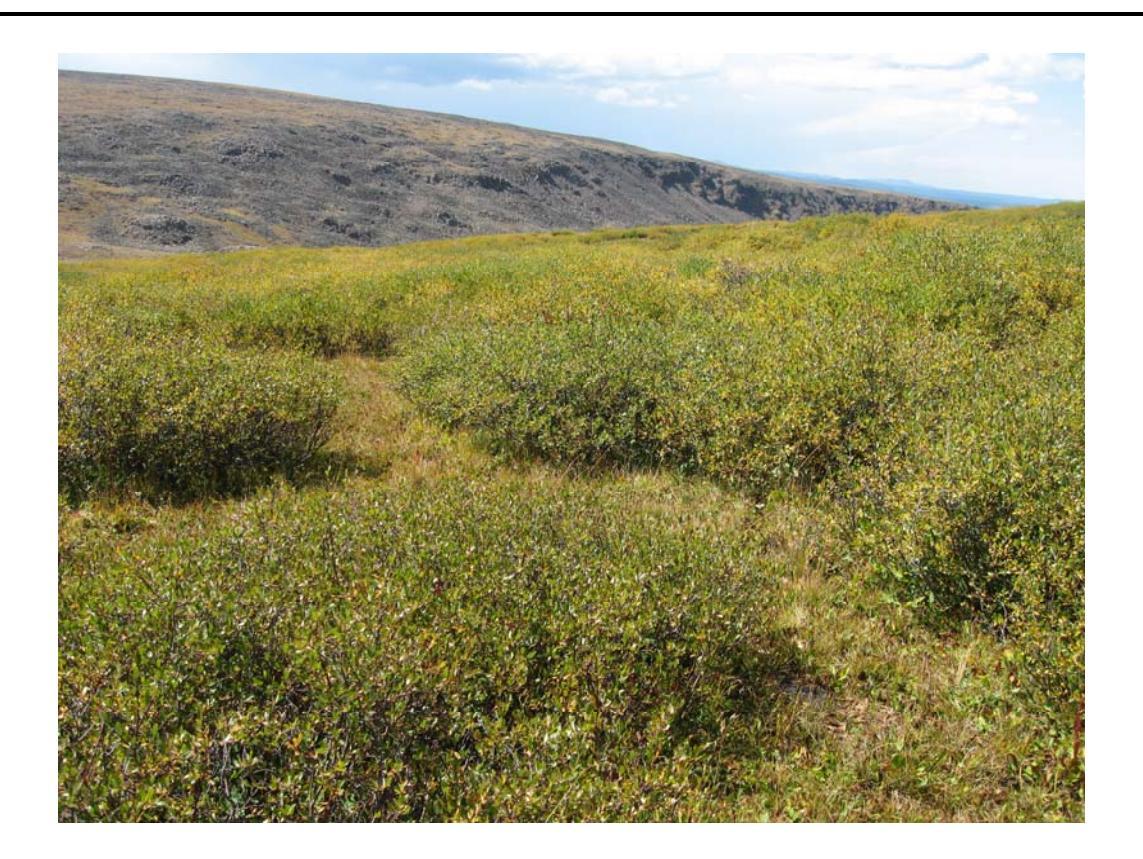
Devils Lake Seeps Standard Checklist Proper Functioning Condition

Potential (ecological status that can be attained without above limiting factors or without limiting factors what is the ultimate goal for assessment area) Wetland is functioning at its potential natural community with little disturbance in the area and no disturbances leading to unacceptable conditions.

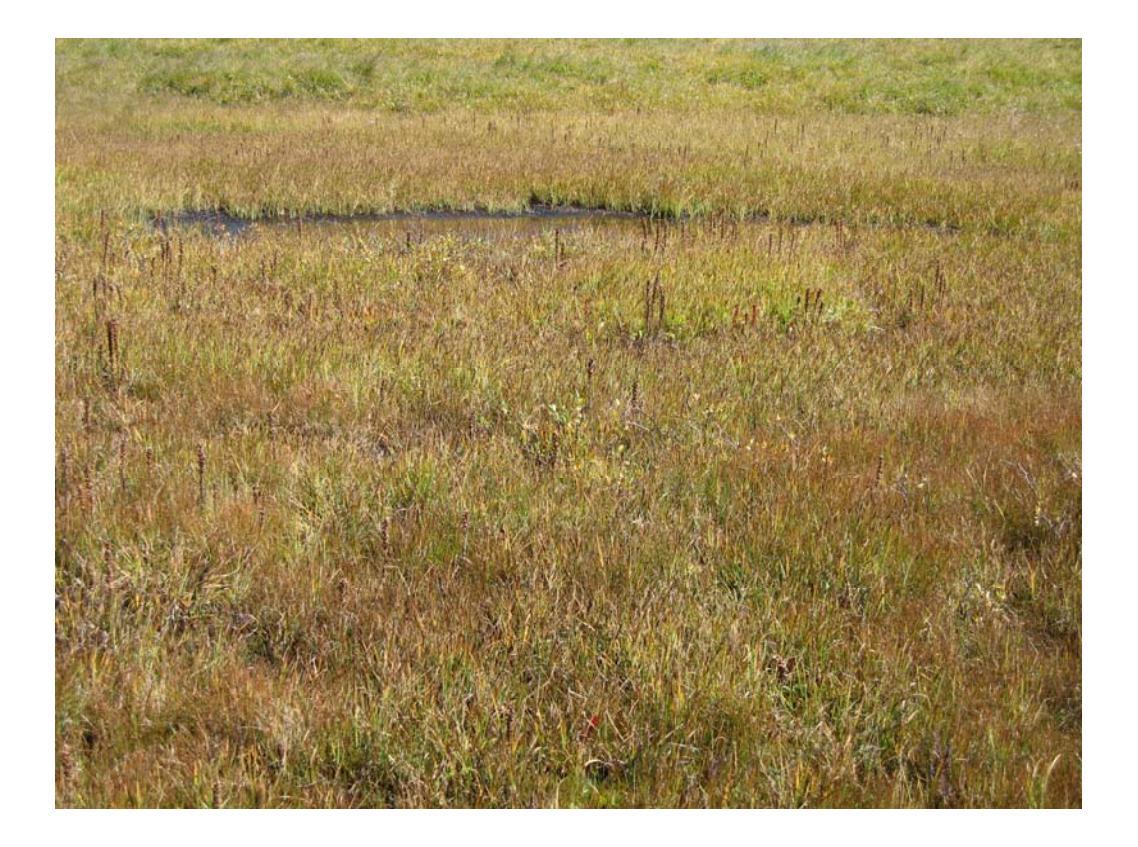
Devils Lake Seeps Standard Checklist Nonfunctional

Potential (ecological status that can be attained without above limiting factors or without limiting factors what is the ultimate goal for assessment area) Wetland is functioning at its potential natural community with little anthropogenic disturbance in the area an no disturbances leading to unacceptable conditions.

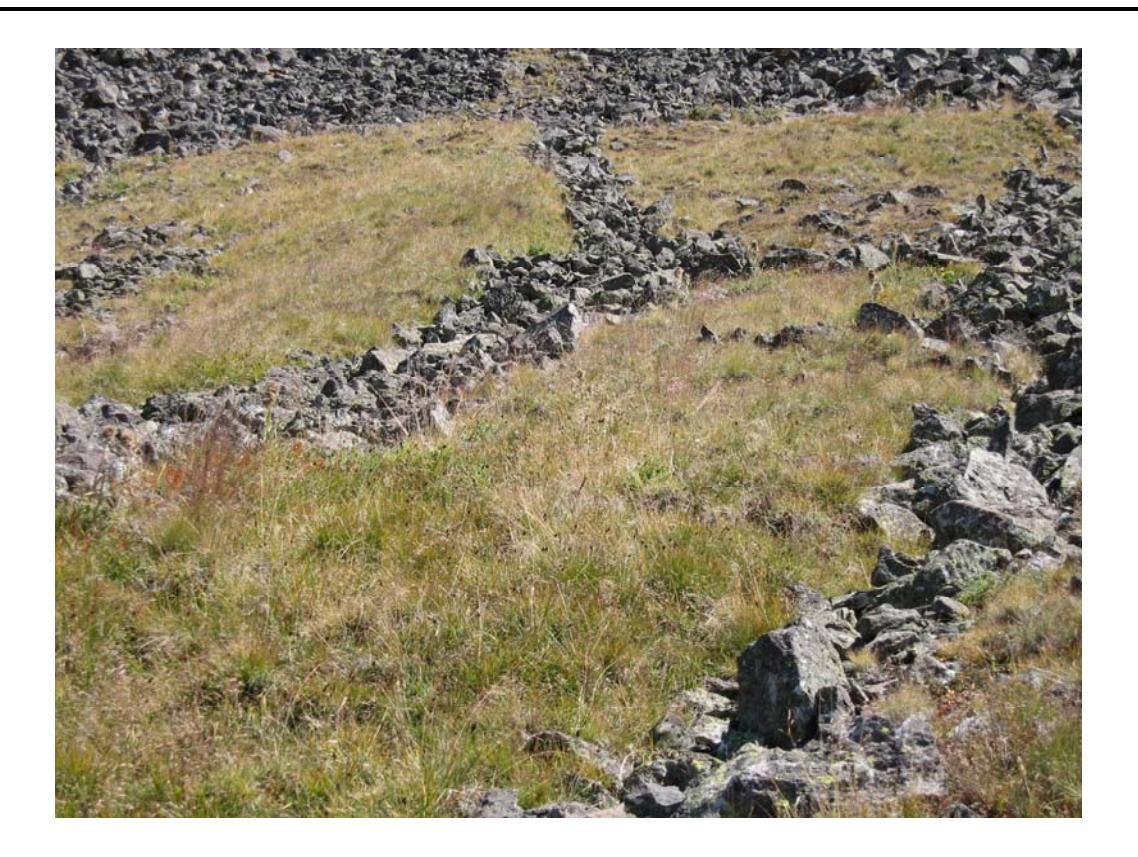
Devils Lake Seeps Lentic Standard Checklist Proper Functioning Condition

Potential (ecological status that can be attained without above limiting factors or without limiting factors what is the ultimate goal for assessment area) Site indicated by BLM seeps and springs map is not a functioning wetland. The area has few distinctive wetland species, no wetland soils, and likely only short, seasonally wet conditions.

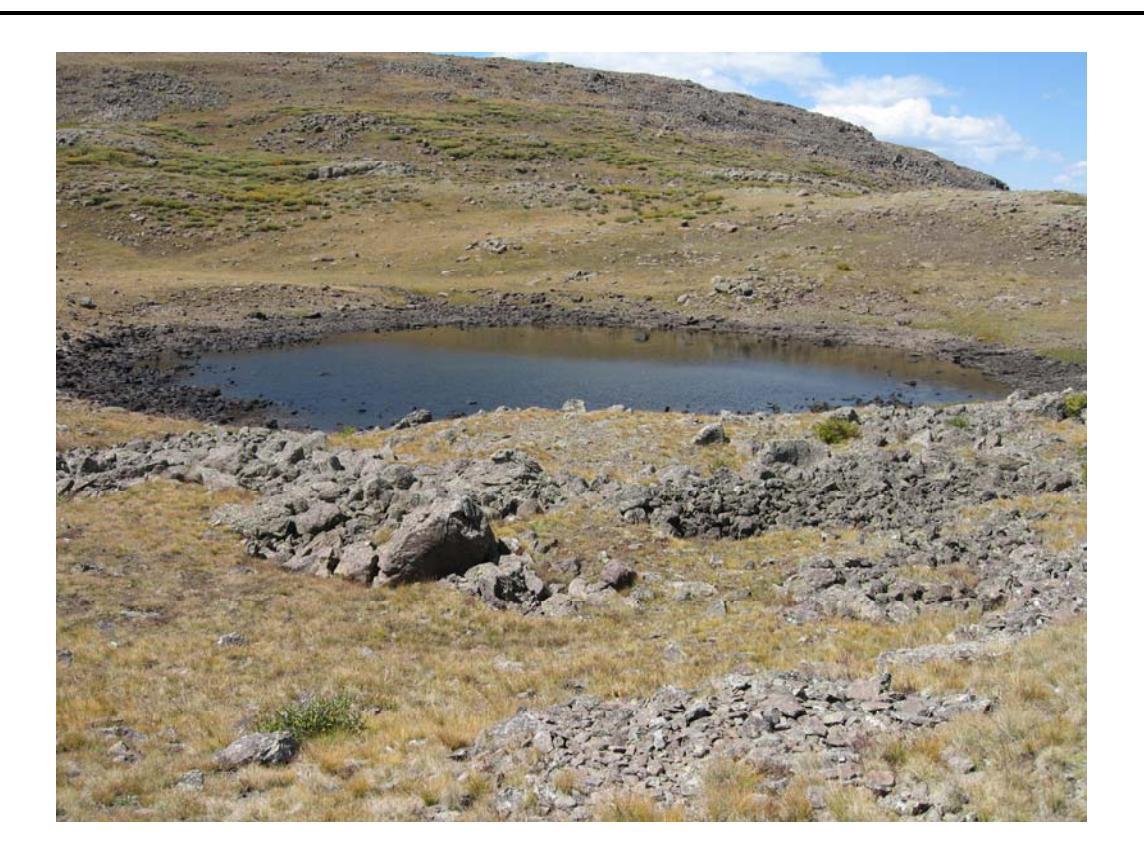
North Fork of Henson Creek Standard Checklist Proper Functioning Condition

Potential (ecological status that can be attained without above limiting factors or without limiting factors what is the ultimate goal for assessment area) Wetland is functioning near its potential natural community. There are few anthropogenic disturbances and little use in the area. Fluctuations in water level and drying appear to be natural.

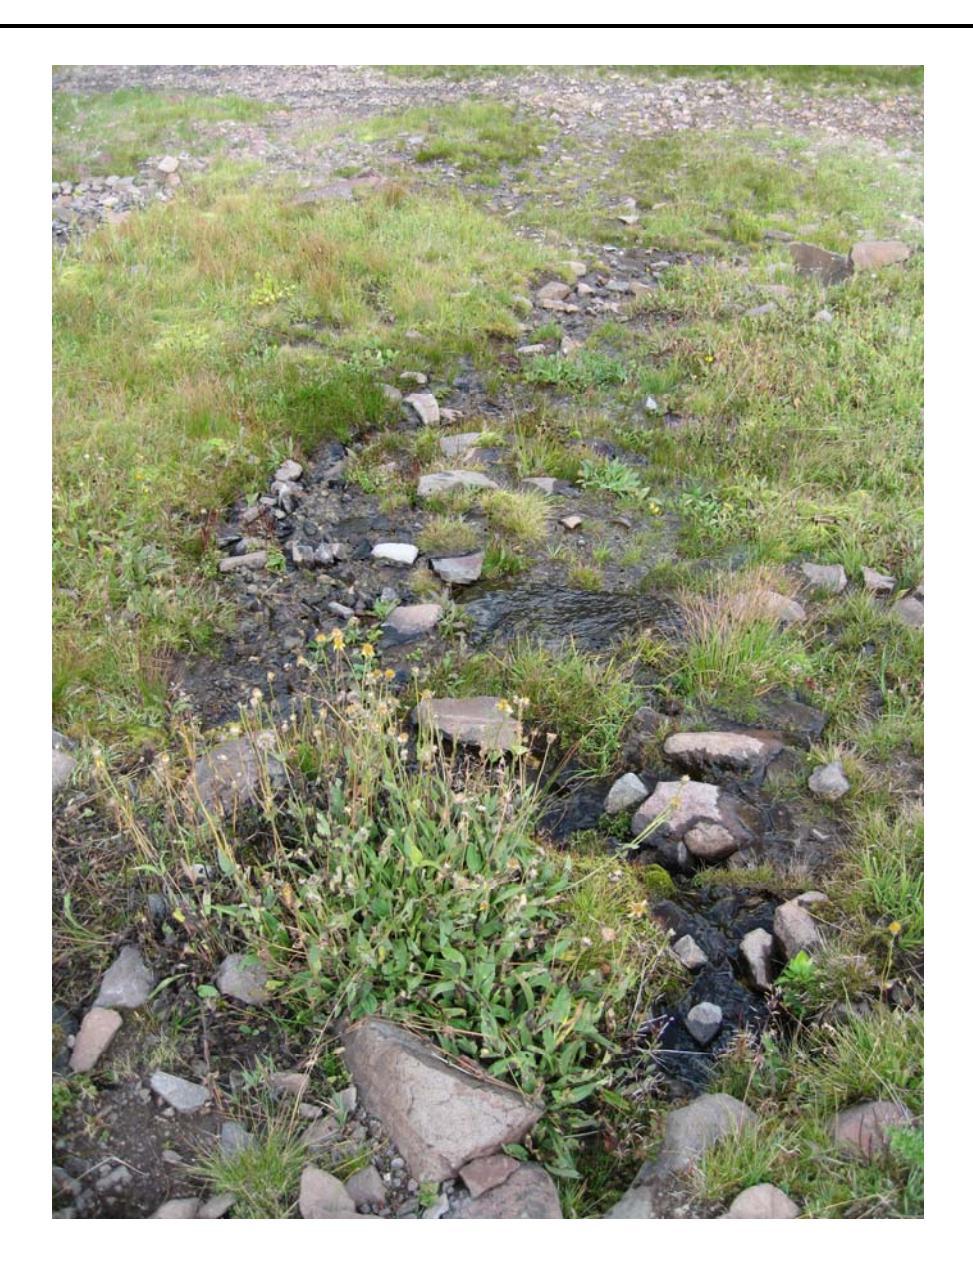
North Fork of Henson Creek Standard Checklist Non-Functional

Potential (ecological status that can be attained without above limiting factors or without limiting factors what is the ultimate goal for assessment area) Wetland is functioning at its potential natural community with no disturbances causing unacceptable conditions and few disturbances in the area.

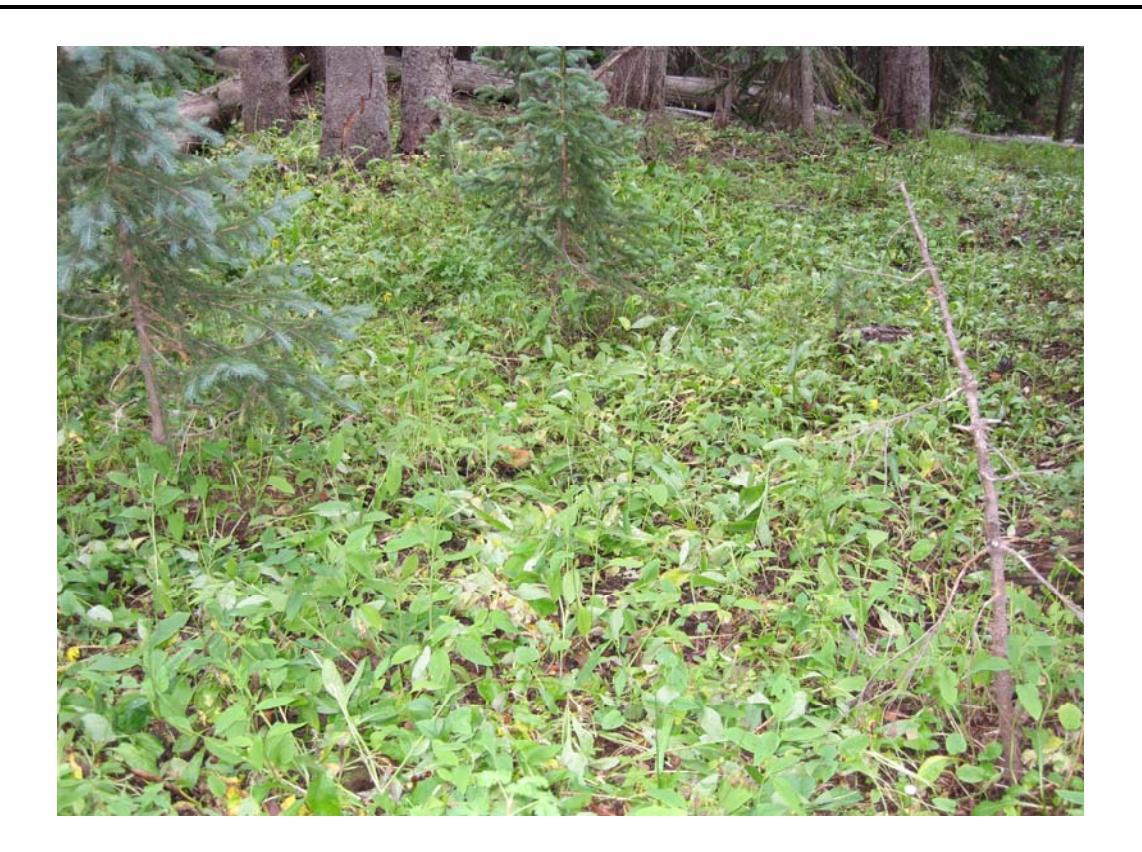
North Fork of Henson Creek Standard Checklist Proper Functioning Condition

Potential (ecological status that can be attained without above limiting factors or without limiting factors what is the ultimate goal for assessment area) Site is not a functioning wetland with few wetland obligate species, no consistent hydrologic source, and no evidence of recent or recurring inundation.

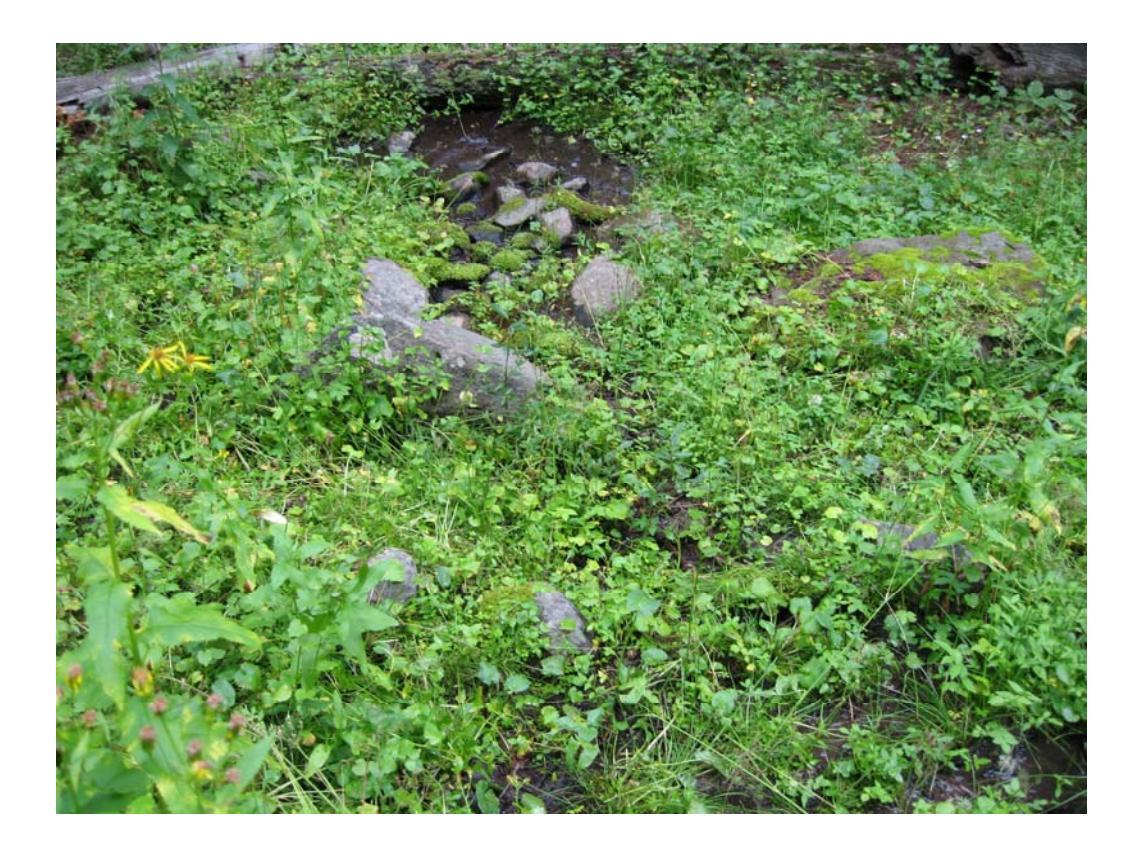
North Fork of Henson Creek Standard Checklist Proper Functioning Condition

Potential (ecological status that can be attained without above limiting factors or without limiting factors what is the ultimate goal for assessment area) Wetland is functioning at its potential natural community with no disturbances causing unacceptable conditions and few disturbances in the area.

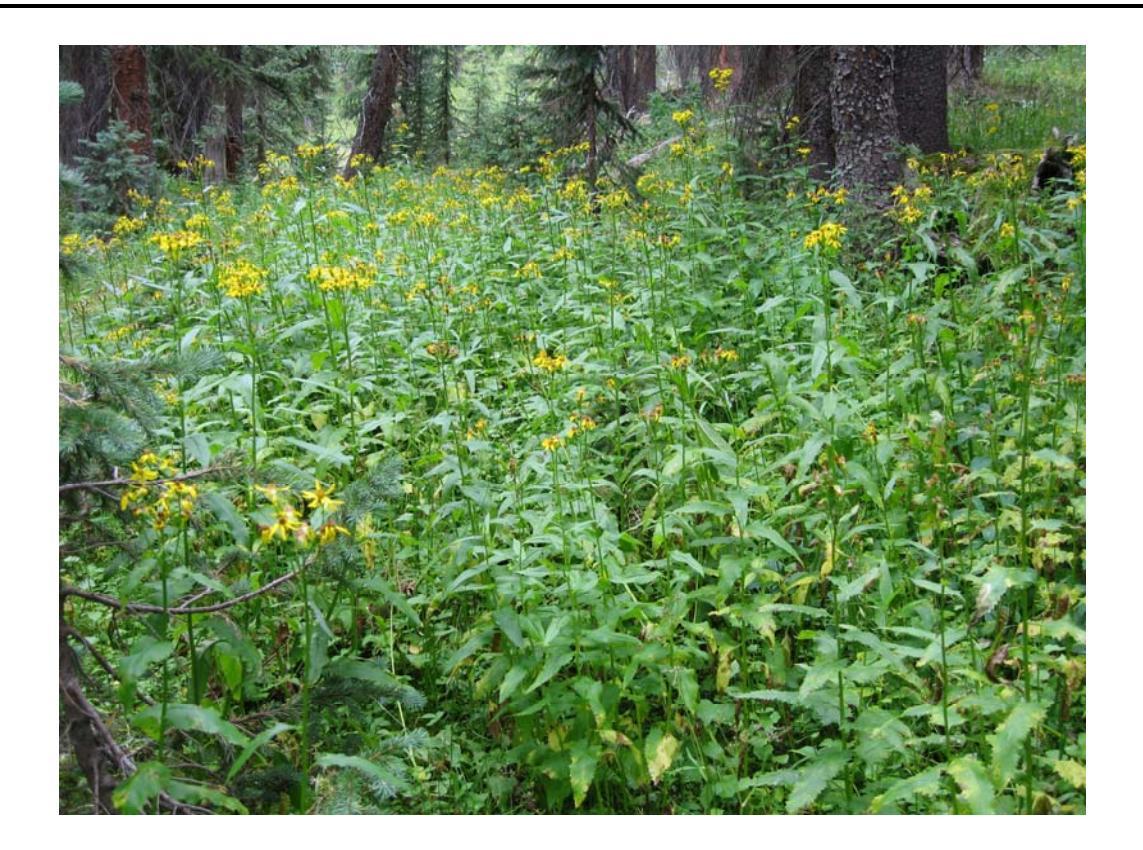
Cooper Lake Standard Checklist Proper Functioning Condition

Potential (ecological status that can be attained without above limiting factors or without limiting factors what is the ultimate goal for assessment area) Wetland is functioning at its potential natural community with no disturbances causing unacceptable conditions and few disturbances in the area.

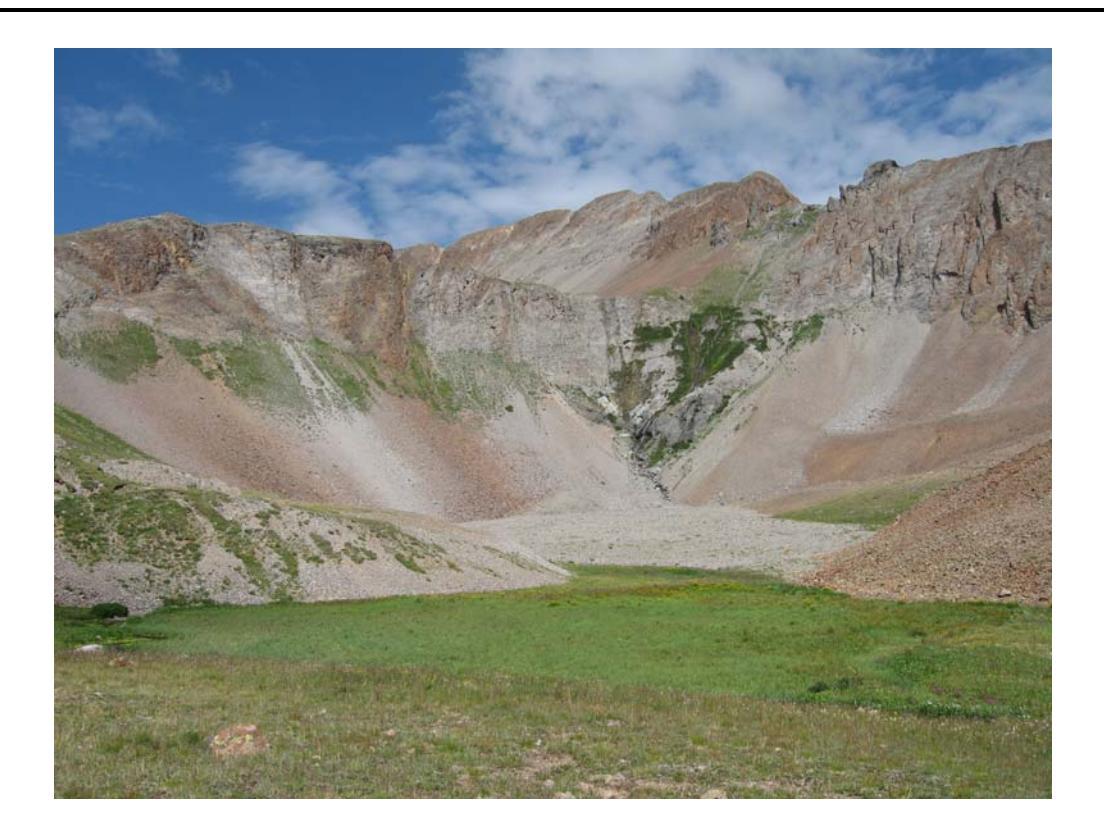
Cooper Creek Standard Checklist Proper Functioning Condition

Potential (ecological status that can be attained without above limiting factors or without limiting factors what is the ultimate goal for assessment area) Wetland is functioning at its potential natural community with very little anthropogenic disturbance in the area. Small trail leading up to site does not appear heavily used. Natural disturbances may include spring flooding and avalanche activity.

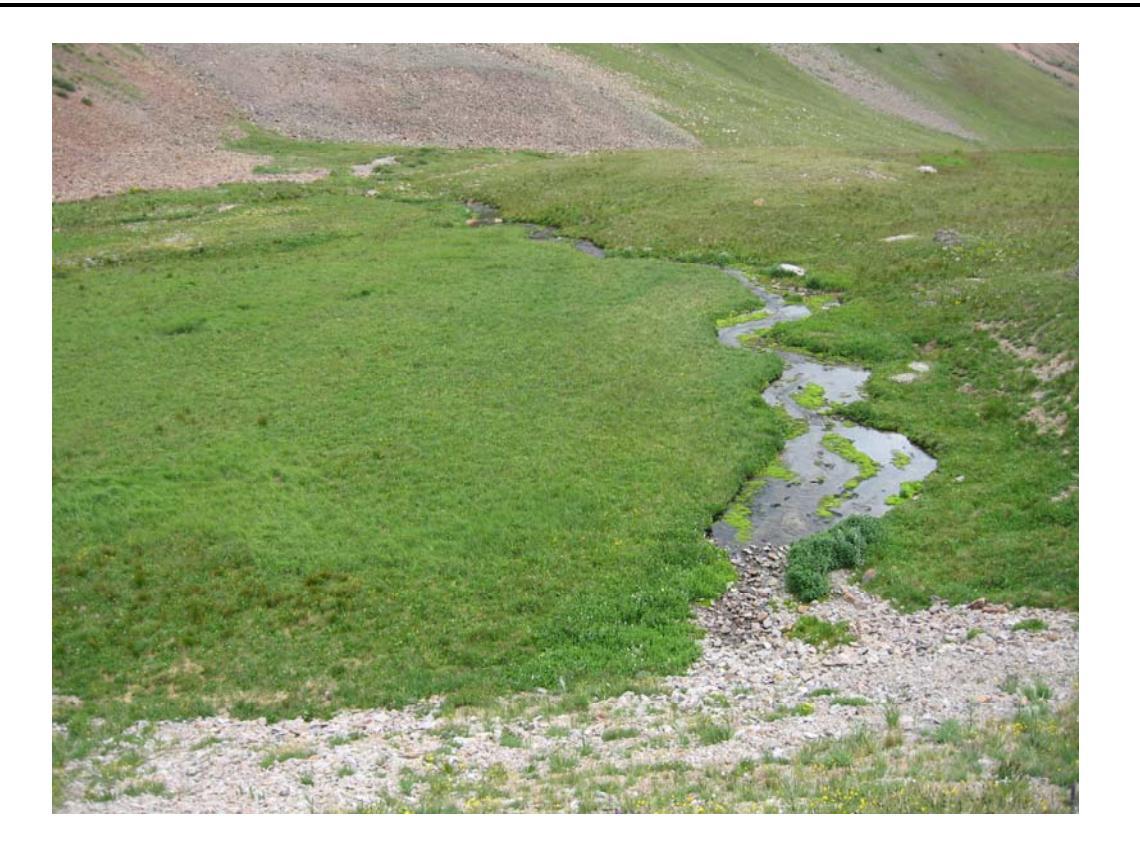
Cooper Creek Standard Checklist Proper Functioning Condition

Potential (ecological status that can be attained without above limiting factors or without limiting factors what is the ultimate goal for assessment area) Wetland is functioning at its potential natural community with very little anthropogenic disturbance in the area. Small trail leading up to site does not appear heavily used. Natural disturbances may include spring flooding and avalanche activity.

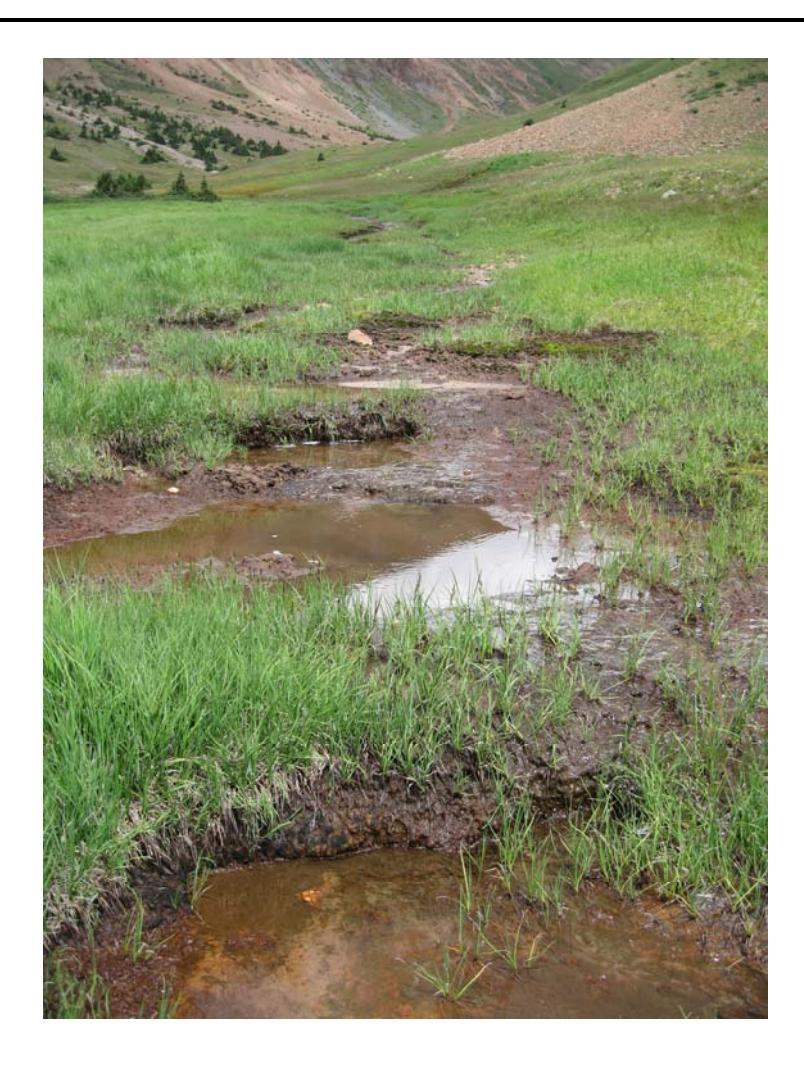
Upper Snare Creek Standard Checklist Proper Functioning Condition

Potential (ecological status that can be attained without above limiting factors or without limiting factors what is the ultimate goal for assessment area) Site is functioning just below its potential natural community due to bare patches and extensive sloughing of peat in some areas. The causes of sloughing are not evident and may be caused by natural actions such as surface flows, wildlife use, or hydrologic heave. There are few anthropogenic disturbances in the area. Past mining in the watershed may impact site hydrology and water quality, but does not appear to be impacting the site at present.

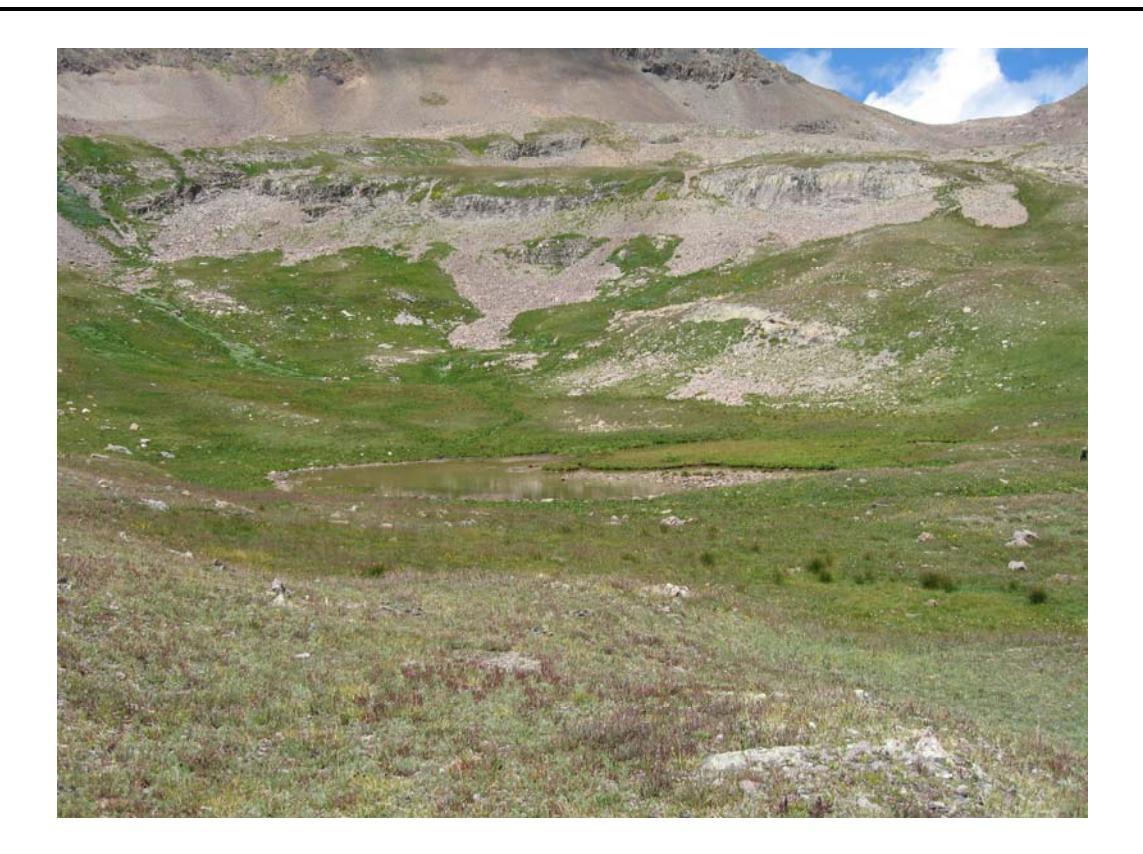
Upper Snare Creek Standard Checklist Proper Functioning Condition

Potential (ecological status that can be attained without above limiting factors or without limiting factors what is the ultimate goal for assessment area) Wetland is functioning at its potential natural community with no disturbances contributing to unacceptable conditions in the area. Hydrology is stable and wetland vegetation is vigorous.

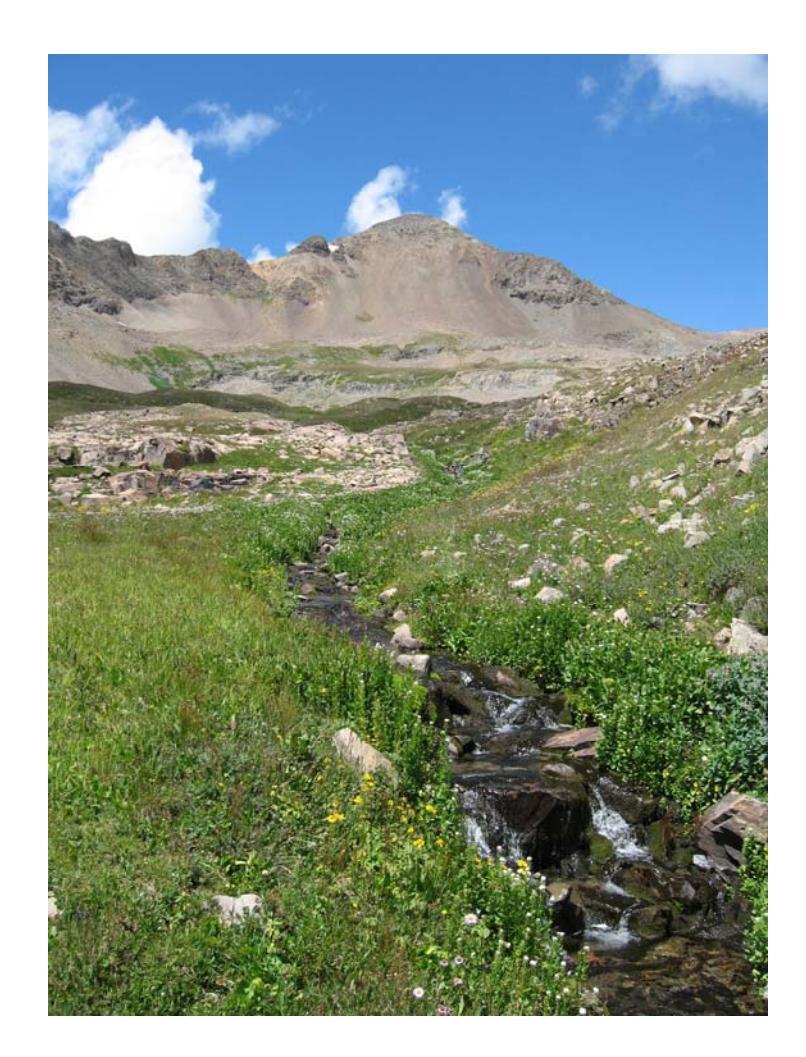
Upper Snare Creek Standard Checklist Proper Functioning Condition

Potential (ecological status that can be attained without above limiting factors or without limiting factors what is the ultimate goal for assessment area) Wetland is functioning at its potential natural community with no disturbances contributing to unacceptable conditions in the area. Hydrology is stable and wetland vegetation is vigorous.

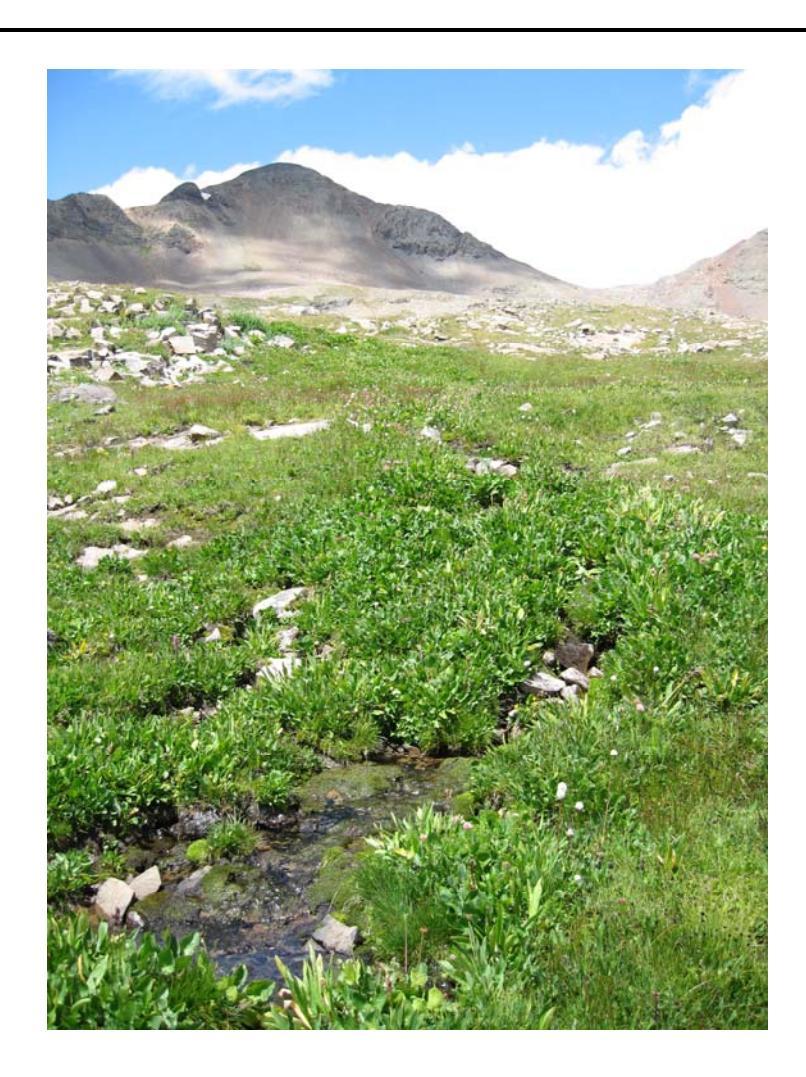
Devil's Hole Spring Lentic Standard Checklist Functional – At Risk

Potential (ecological status that can be attained without above limiting factors or without limiting factors what is the ultimate goal for assessment area) Wetland is functioning at its potential natural community with no disturbances contributing to unacceptable conditions in the area. Hydrology is stable and wetland vegetation is vigorous.
