Survey of Seeps and Springs on Bureau of Land Management lands in northern Hinsdale County 2006-2007

Prepared for: Bureau of Land Management, Gunnison Field Office 216 N. Colorado Gunnison, Colorado 81230

Prepared by: Stephanie Neid, Delia Malone, and Jennifer Jones

> > March 1, 2008

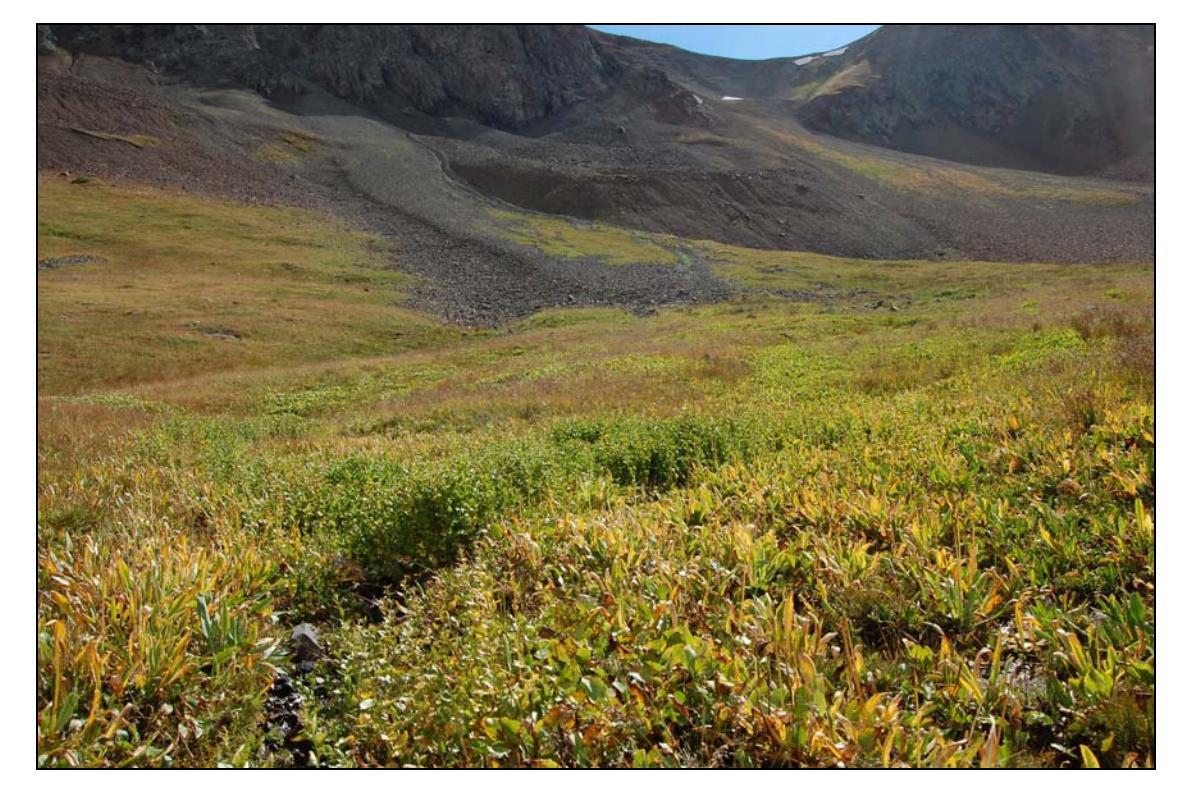
Name of Riparian-Wetland Area:		Boulder Gulch			
Date:	ate: 9/5/2007 S		Segment/Reach ID:	Add8	
ID Team Observers:			Malone		
Potenti	Potential:				
Site is a seep in an alpine meadow and is at potential.

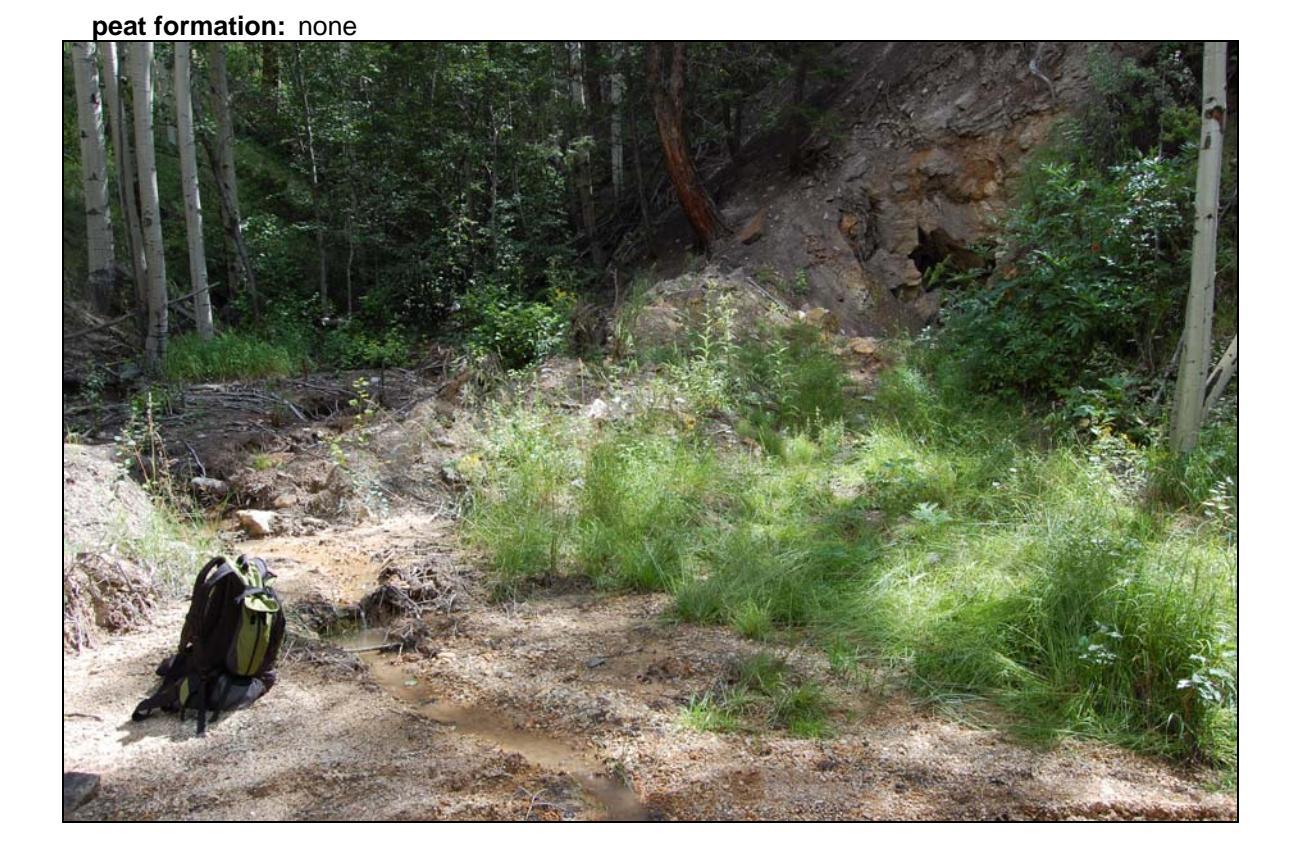
Name of Riparian-Wetland Area:		Henson Creek		
Date:	8/24/20	07	Segment/Reach ID:	AM-2316
ID Team Observers:		Malone		
Potential:				
Site is a mine dump. Site is not at potential.

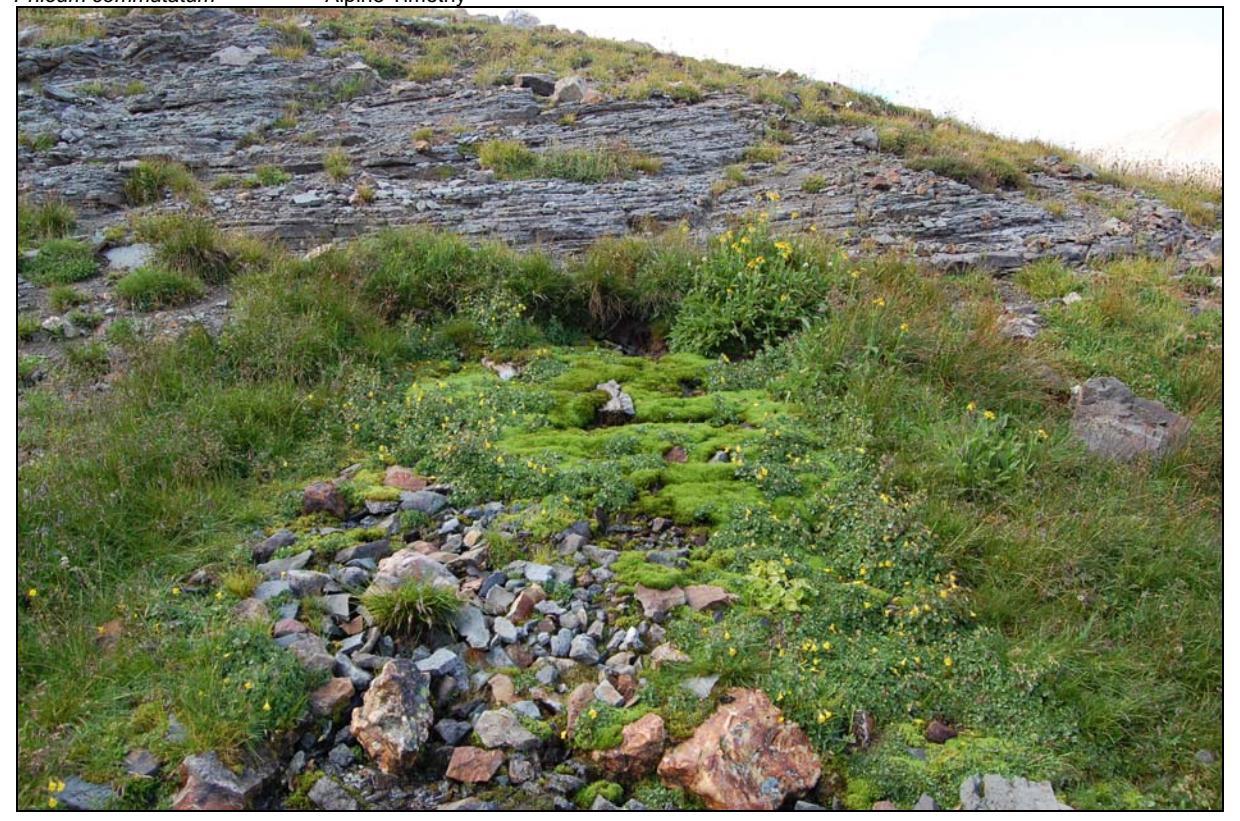
Name of Riparian-Wetland Area:				Cinnamon Pass
Date:	Date: 9/3/2007 S		Segment/Reach ID:	D-333
ID Team Observers:			Malone	
Potenti	Potential:			
Site is a seep in the alpine tundra and is at potential.
