THESIS

MULTI-AXIAL FATIGUE STRENGTH OF STRUCTURAL BOLTS IN
SLIP-CRITICAL CONNECTIONS UNDER COMBINED CYCLIC AXIAL AND SHEAR
DEMANDS

Colorado State University

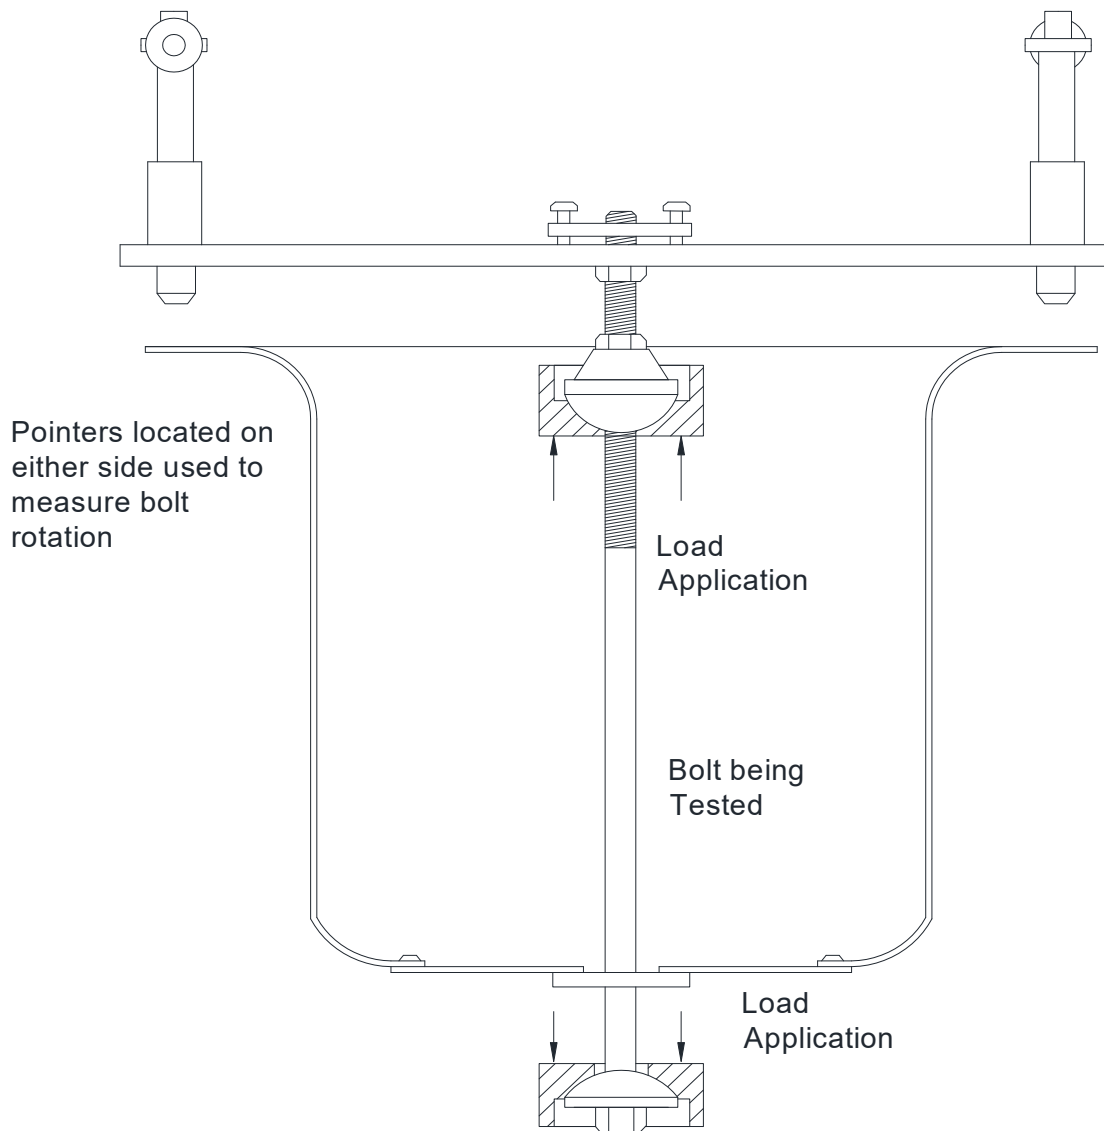
Figure 2-1 Axial Oscillation Set-up from (Goodier and Sweeney 1945).

The first theories about rotational loosening were based on the assumption that an oscillatory axial load on the bolt would have the effect of rotating the nut loose. The first researchers to propose a theory of axially loaded loosening were Goodier and Sweeney (1945). In their study, 19 mm (3/4 in.) bolts were loaded from 2.22 kN to 26.69 kN (500 lb to 6000 lb) in tension while monitoring the rotation of the nut. The maximum rotation detected was 2 degrees, and the minimum was 0.7 degrees in 500 cycles. Figure 2-1 illustrates the arrangement used to conduct axial loading tests.

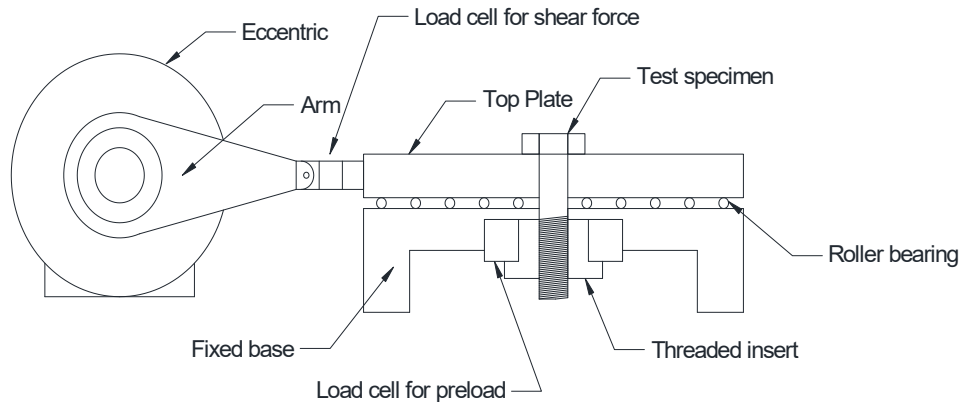
Figure 2-2 Schematic of a typical transverse vibration loosening experiment: after Pai and Hess (2002)

Figure 2-2 shows the basic test setup for a loosening experiment.

Pai and Hess (2002) conducted an “experimental study of loosening of threaded fasteners due to dynamic shear loads.” Their study tested 63.5 mm (2.5 in.) and 76.2 mm (3 in.) long grade 5 and grade 8, 0.5 UNC 13 (0.5 in. diameter and 13 threads per inch) screws with varying types of lubrication to induce different friction coefficients for the threads and the head. The results showed that loosening occurs at significantly lower shear forces than those required to initiate slip of the head (*critical slip*). This occurs via *localized slip* in the threads, which is stored through friction on the back cycle and expands throughout the rest of the threads. In fact, the data showed that shear loads of 59%–66% of those required to cause complete slip of the head (*critical slip*) were sufficient to generate sustained loosening. The study highlighted the different factors contributing to loosening, and the source of loosening was eventually isolated through alternating types of lubricant on threads and head. Figure 2-3 shows the mechanism for the progressive loosening of a

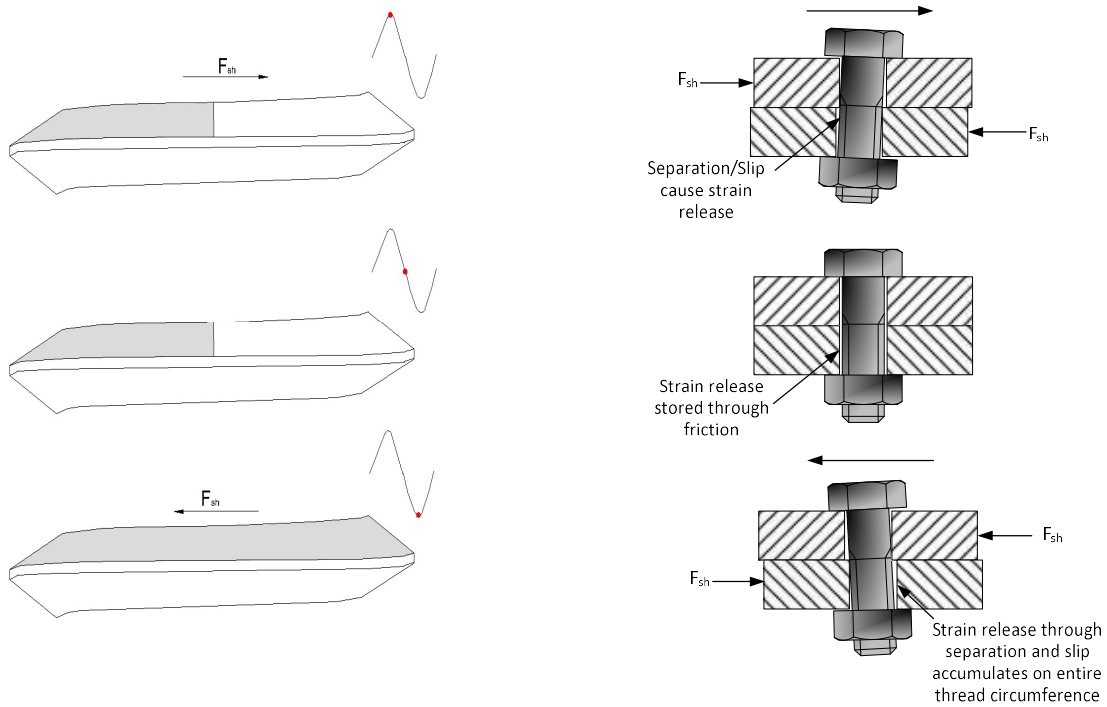
Figure 2-3 Thread slip accumulation with points of stick, slip and strain for each point during the shear reversal

bolt via the accumulation of slip in the threads with varying direction of the shear force (F_s) throughout each cycle.

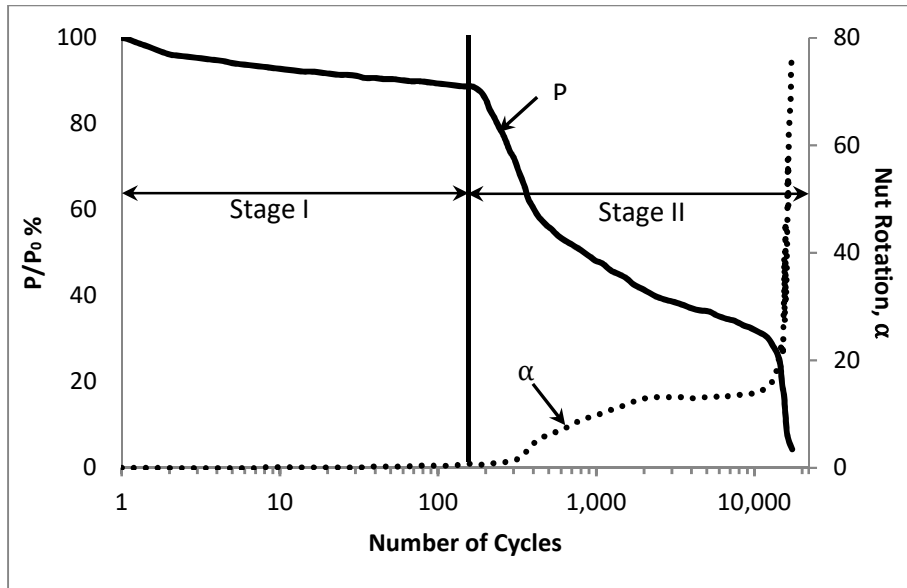
Figure 2-4 Two stages of loosening and nut rotation (adapted from Jiang et al., 2003)

Jiang et al. (2003) carried out an investigation of the early stage self-loosening of bolts under shear load. They designed their own experiment with an ability to run displacement and load control tests. Results showed that early stage self-loosening is caused by local cyclic plastic deformation in the threads. Jiang et al. (2003) Figure 2-4 shows the difference between early stage loosening and the faster rate of the second stage. Also, comparing displacement vs. load control tests they were able to deduce that displacement between the plates is a more telling factor in loosening compared to the shear force.

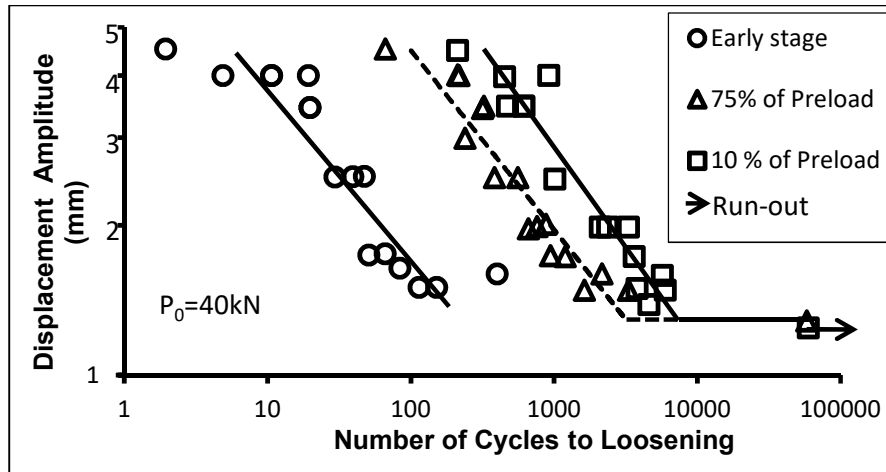
Figure 2-5 Typical plot of displacement amplitude vs. number of cycles (Jiang et al. 2004)

After their initial investigations, Jiang et al. (2004) conducted another study using M12X1.75 (0.5 in.) bolts preloaded up to 75% of the yield stress subjected to transverse cyclic displacement and found that the dividing line between early stage loosening and continued self-loosening was at 0.5 degrees of nut rotation. In the early stage, the loss of preload occurs because of non-rotational causes such as stress relaxation. This loss then initiates the second stage of self-loosening in which the rotation of the nut dominates the loss of preload. Additionally, the plots of the amplitude of the displacement vs. the number of cycles to failure resemble fatigue S-N plots. Figure 2-5 shows a typical plot of the displacement amplitude against the number of cycles to loosening. For this study, total loosening was considered to have happened when the preload reached 10% of its initial value.

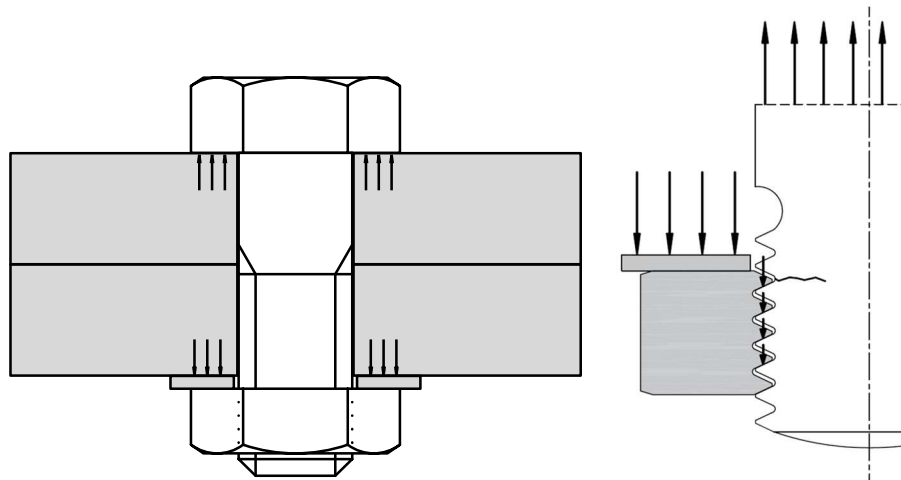
Figure 2-6 Bolt subjected to cyclic tension and crack nucleation at the first engaged thread: after Schijve (2001)

Experiments have been conducted on bolts loaded in cyclic tension, including prying action (Astaneh et al. 1989). Astaneh et al. (1989) evaluated double-angle, beam-column connections and subjected them to rotation. They were fastened using $\frac{3}{4}$ in. ribbed bolts that had been removed from an existing structure along with new $\frac{3}{4}$ in. diameter A 325 bolts. The resulting load configuration on the bolts was cyclic tension with some prying action. They determined that these idealized pinned ended connections would fail because of bolt failure due to thread stripping at a rotation greater than 0.025 radians (1.43 degrees) on the ribbed bolts, which contained shallow threads. Conversely, A 325 bolts that had been properly pre-tensioned to 70% of proof strength developed ductile behavior, and the failure occurred in the angles. Figure 2-6 shows a preloaded bolt subjected to cyclic tension and a crack nucleating at the first engaged thread.

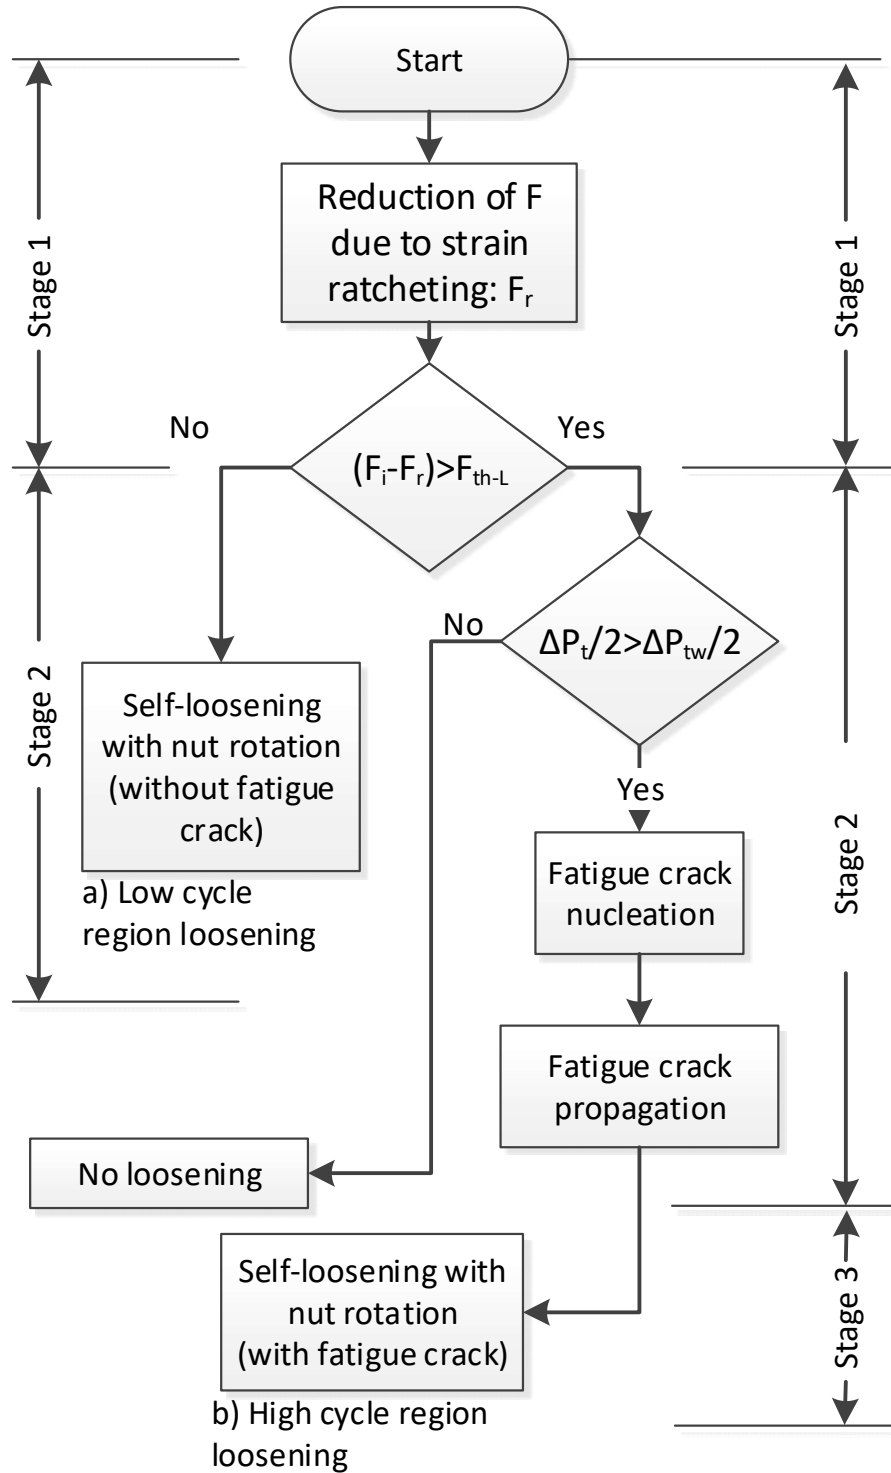
Figure 2-7 Loosening fatigue mechanism (Hashimura and Socie 2006)

Following the lead of the similarity of the loosening curves to the S–N fatigue curves developed for bolted and welded connection, Hashimura and Socie (2006) studied the coupled phenomenon of loosening and fatigue of bolted joints subjected to transverse vibration. The study included testing M10 bolts without washers and with threads in the shear plane. The experiment was run under displacement control with the use of rollers in between the plates to reduce friction. Preloads were applied only up to a maximum of 50% of the yield strength of the bolts. The study showed that if a bolt loosens in the low cycle region of 10^3 to 10^4 cycles, crack nucleation is not present and that the loss of pre-tension is attributable to rotational loosening. Alternatively, if the bolt loosened in the high-cycle region of 10^5 to 10^6 cycles, a crack was observed at the root of the first engaged thread in every bolt tested (Hashimura and Socie, 2006). Figure 2-7 illustrates the different mechanisms by which a bolt may loosen or fatigue as presented by Hashimura and Socie (2006).

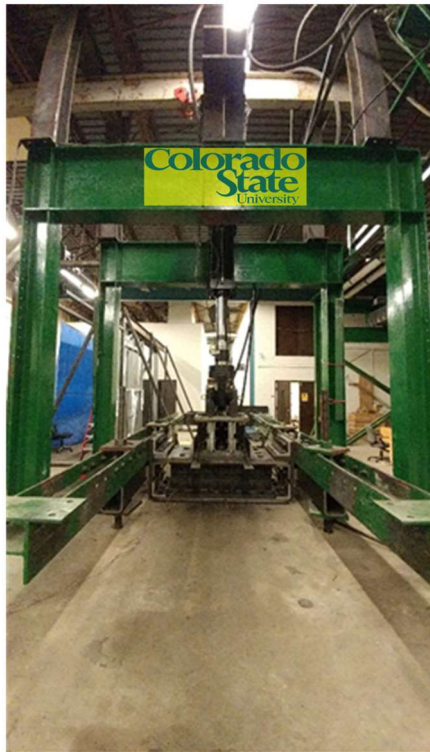
Figure 3-1. Frame Front Elevation

The experiments were carried out on top of a 0.61 m (2 ft.) thick reinforced concrete block which itself lay over a 0.61 m (2 ft.) thick reinforced concrete strong-floor. This setting allowed for anchoring the frame down via four 2 inch diameter threaded rods each six foot long to the concrete strong floor. The setting is shown below in Figure 3-1 and Figure 3-2.

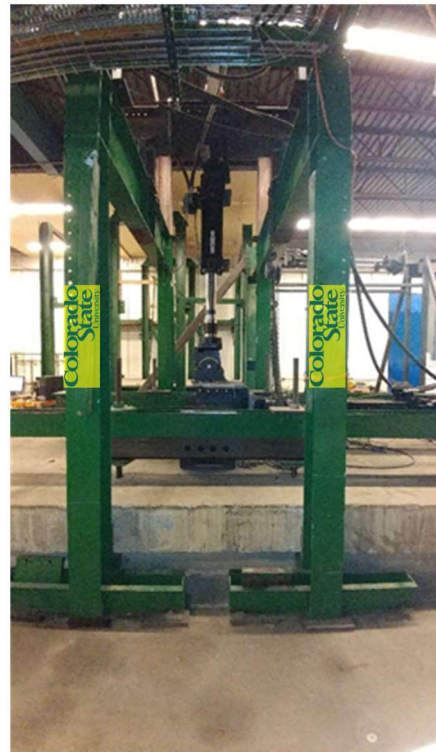
Figure 3-2. Frame Side Elevation

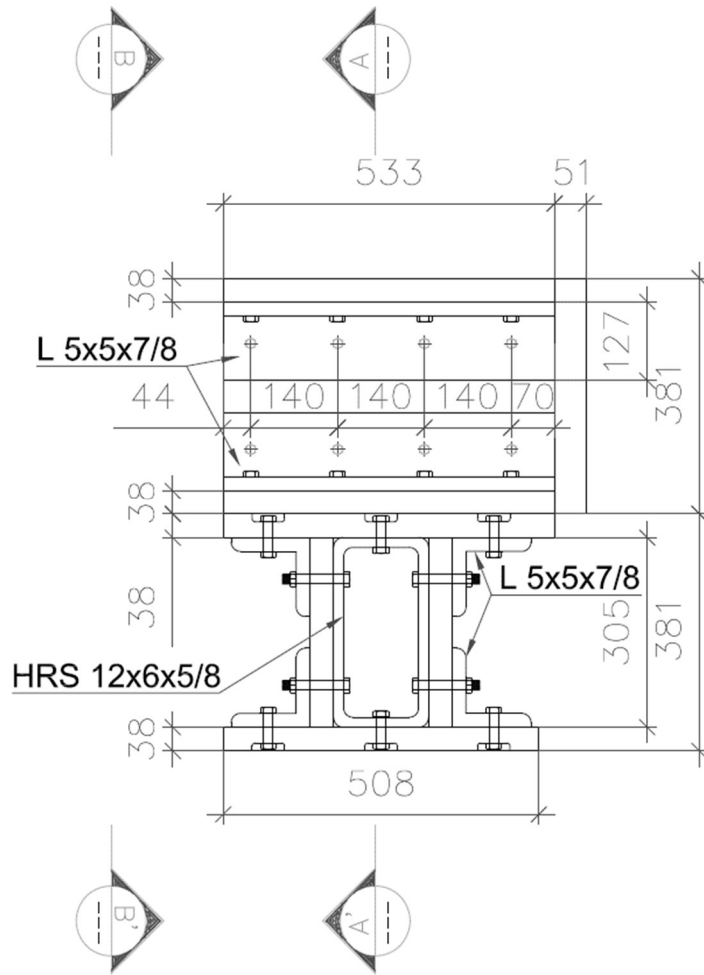
Figure 3-3 Load Transfer Elevation Cut [dim in mm]

To arrive at the final configuration, design calculations for different alternatives were carried out on MathCAD and following the design principles and standards set forth by the AISC manual of steel construction. Furthermore, finite element models were developed using ABAQUS to evaluate stresses at certain critical locations of the experimental apparatus. These stresses were the main constraint since they needed to be maintained below the Constant Amplitude Fatigue Limit (CAFL) to avoid fatigue cracks on the load transfer mechanism through the duration of the experiment at maximum loads. The CAFL for high-strength bolts that are snug-tight with cracks originating at the root of the first engaged thread is 48.26 MPa (7 ksi) and for bolt holes with cracks originating at the side of the holes is also 48.26 MPa (7 ksi). Given these inputs and several iterations with different plate thicknesses and bolt locations and sizes, the final design was established. Drawings of this configuration can be seen in Figure 3-3, Figure 3-4 and Figure 3-5.

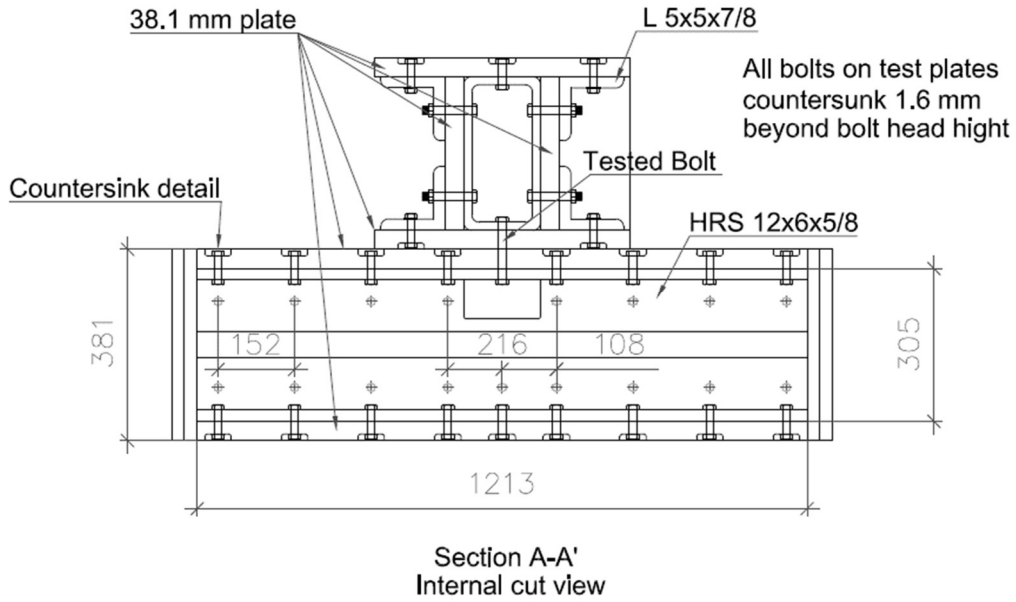
Figure 3-4 Load Transfer Internal Cut Front View [dim in mm]

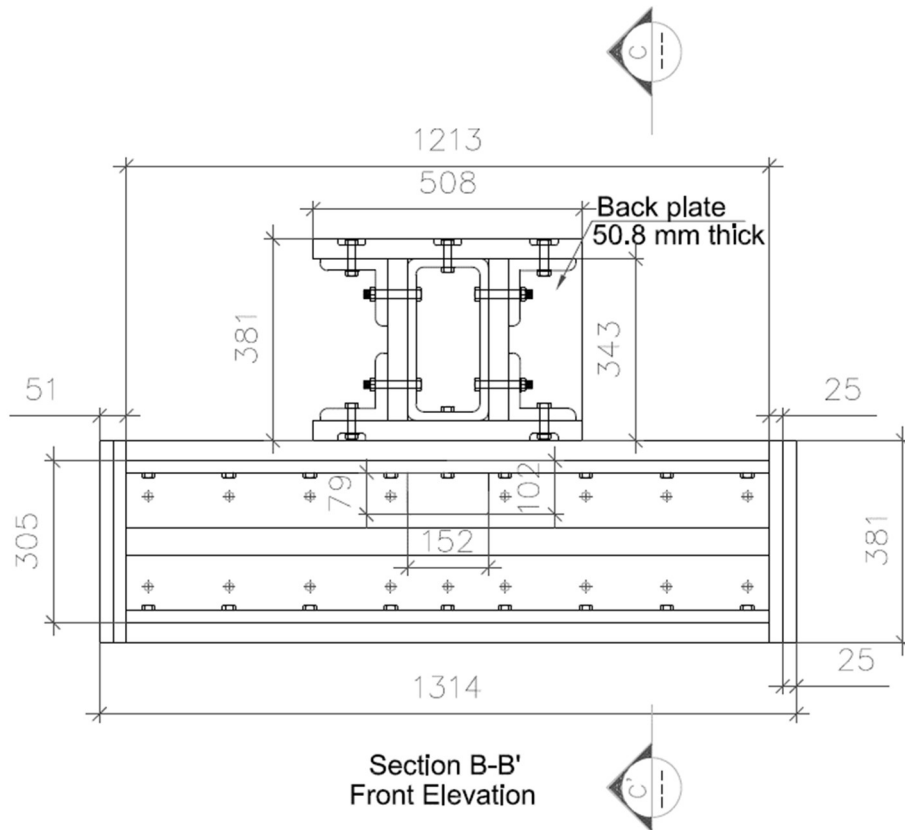
Figure 3-5 Load Transfer Front Elevation [dim in mm]

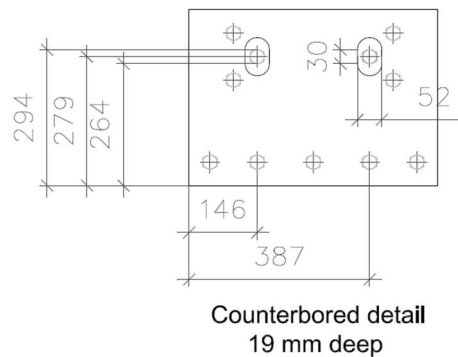
Figure 3-6 Top box, back plate [dim. in mm]

The above design was broken down into individual part drawings for shop fabrication. Each part was accurately drawn for perfect fit. Pieces were marked and cut to size using a band saw. Next, each part was marked using a height gage with 100th in. precision to localize the hole positions.

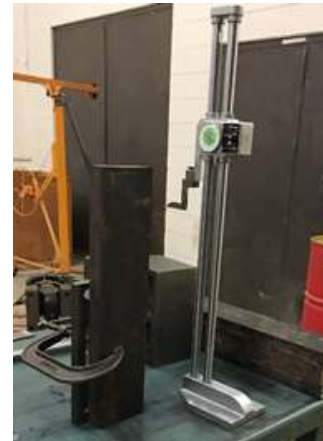
Figure 3-6 shows the detail of the counterbore holes to be milled using a titanium coated carbide endmill on the CNC machine. Figure 3-7 shows the height gage used to mark directly on the plates the crosslines for each hole location. Each piece was squared against the table and marked accordingly.

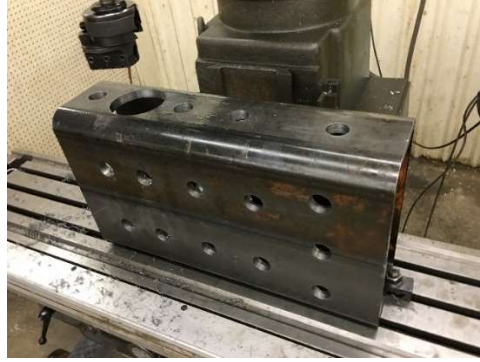
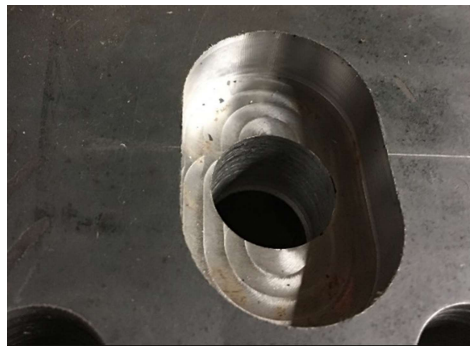
Figure 3-8 a) Magnetic Drill b) Drill station for top 3 inch hole c) CNC machine with carbide endmill d) counterbore hole milled using CNC machine.

The holes and counterbores were then drilled using various drilling and milling methods. Figure 3-8 shows the methods used and a sample counterbored hole.

Counterbores as shown in Figure 3-8-d) were used to capture the heads of bolts so that the straight edges prevented the bolt from rotating and it could be tightened using a single wrench from the opposite side. The depth of the counterbore would allow the outermost surface of the bolt head to be depressed about a millimeter below flush with the plate. This was done to create a flat and unfettered surface for the interface between the plates comprising the slip-critical connection to be tested.

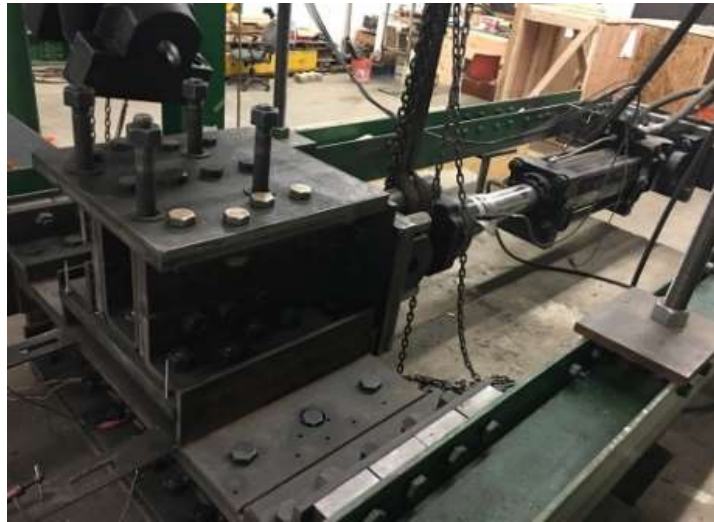
Figure 3-9 Setup For Loosening Test

The bolt being tested connected and clamped the bottom plate of the top box to the top plate of a lower orthogonally placed built up section that closed the loop and returned the load back to the frame. As such, the bolt was the only connecting element between the two shear plates. Each of these shear plates has a thickness of 1.5 inches. These were built up bolted sections with counterbored holes where necessary to provide a flat surface for the horizontal shear interface plane. For this experiment the vertical actuator was not used to isolate the effects of cyclic shear on the loosening phenomenon as explored in the literature. Lateral bracing was provided by placing angles on the sides of the top box bolted to the bottom section and greased on the sides to avoid creating additional friction. A chain hoist was used as a vertical brace for the actuator knuckle to reduce torsional loading thus eliminating any prying action. Figure 3-9 shows the physical setup while. Figure 3-10 and Figure 3-11 show drawings of the front view of the test and a side sketch of the arrangement respectively.

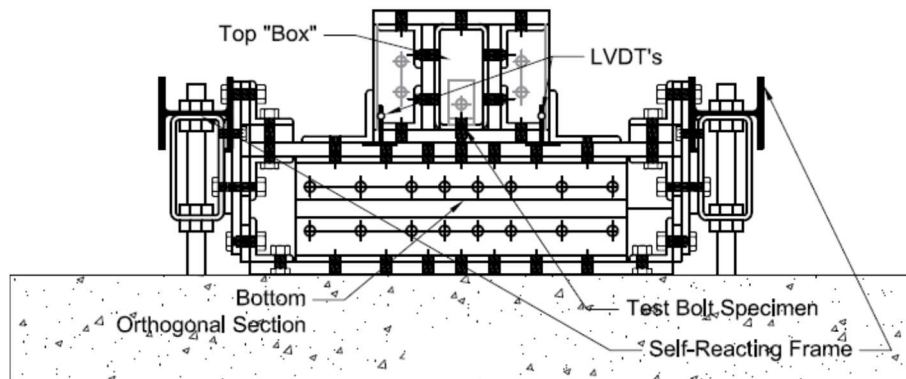
Figure 3-10 Front Elevation

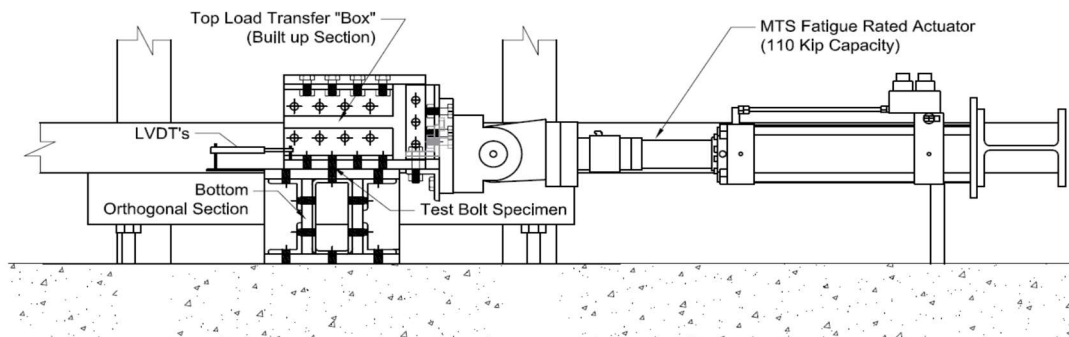
Figure 3-11 Side Elevation

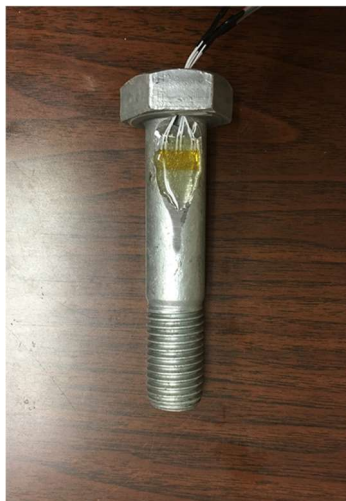
Figure 3-12 Bolt Instrumentation

Strain gages were used to determine the preload during tightening and throughout the test. Strain gage selection was done considering the size and necessary strain readings. The strain gages used for this experiment were rosette strain gages from Omega (reference number KFH-3-350-D17-11L3M3S). These had a 350 ohm resistance on a 3 mm grid for each direction including one vertical along the length of the bolt and two at 45 degrees on either side. One rosette strain gage was attached to each bolt on the side as shown in Figure 3-12.

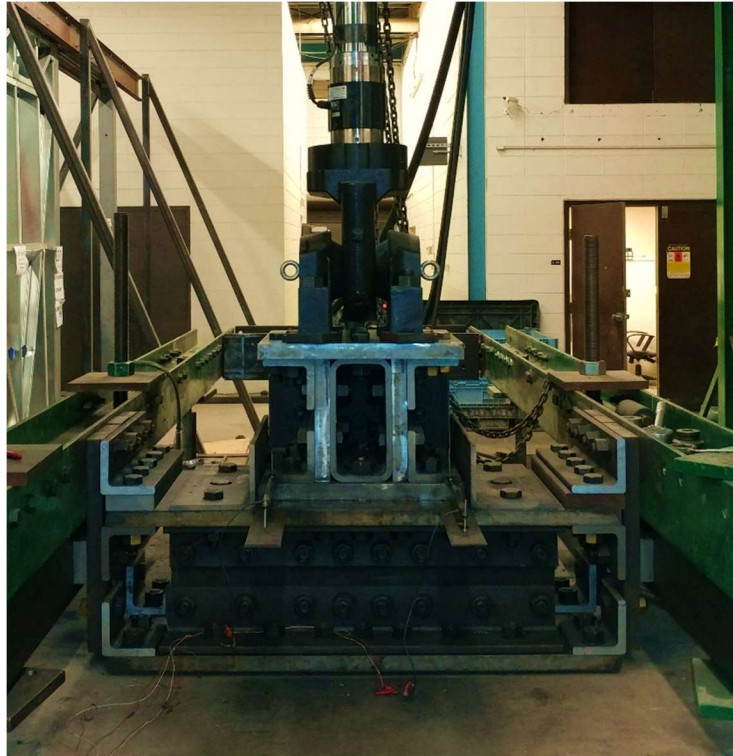
Figure 3-13 Front View of the Multiaxial Setup

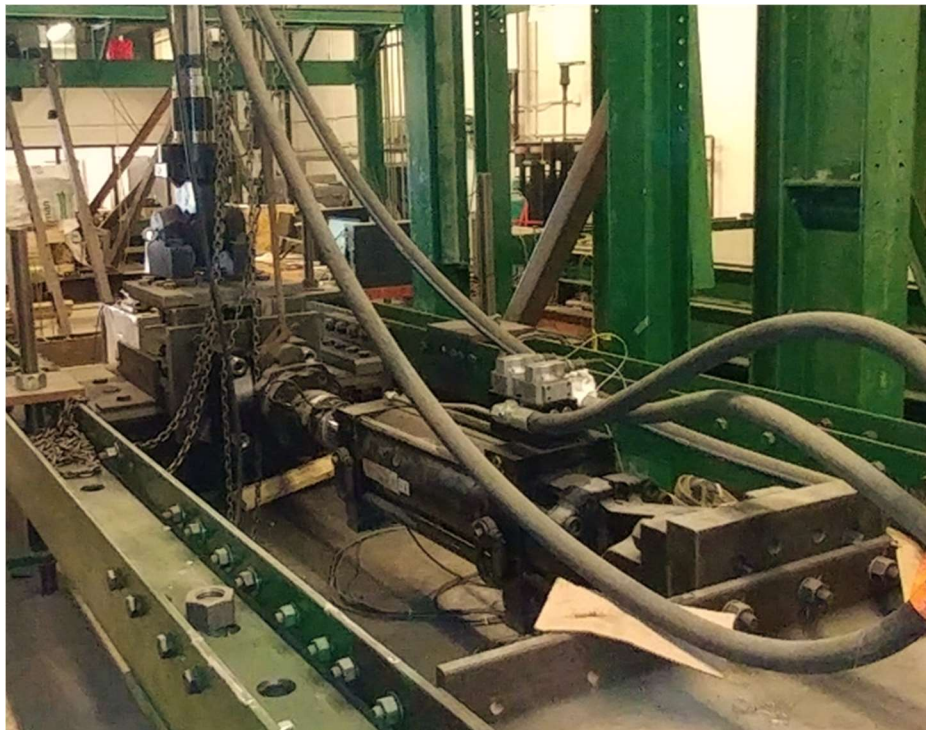
Figure 3-14 Horizontal Actuator Attached to Back Plate

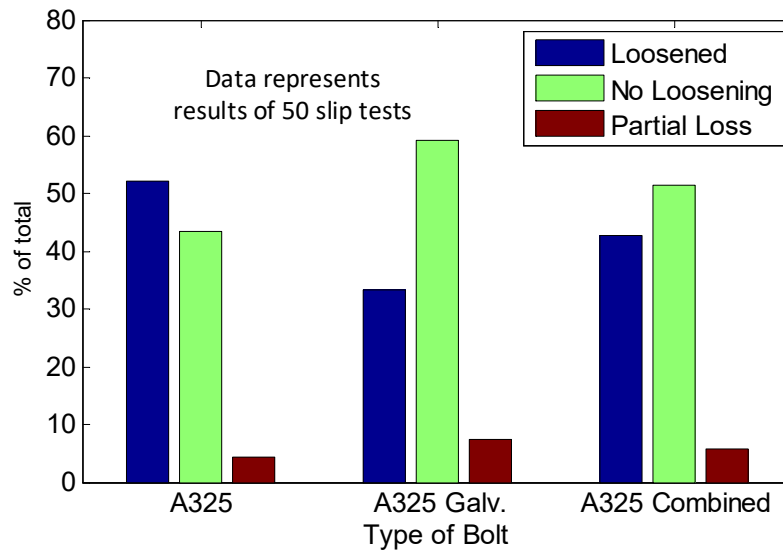
Figure 4-1 Overview of Loosening of High Strength Bolts

Figure 4-1 shows a graphic representation of all the results and a general bar graph showing the percentage of bolts that loosened, did not loosen, and partially loosened for each type of bolt tested.

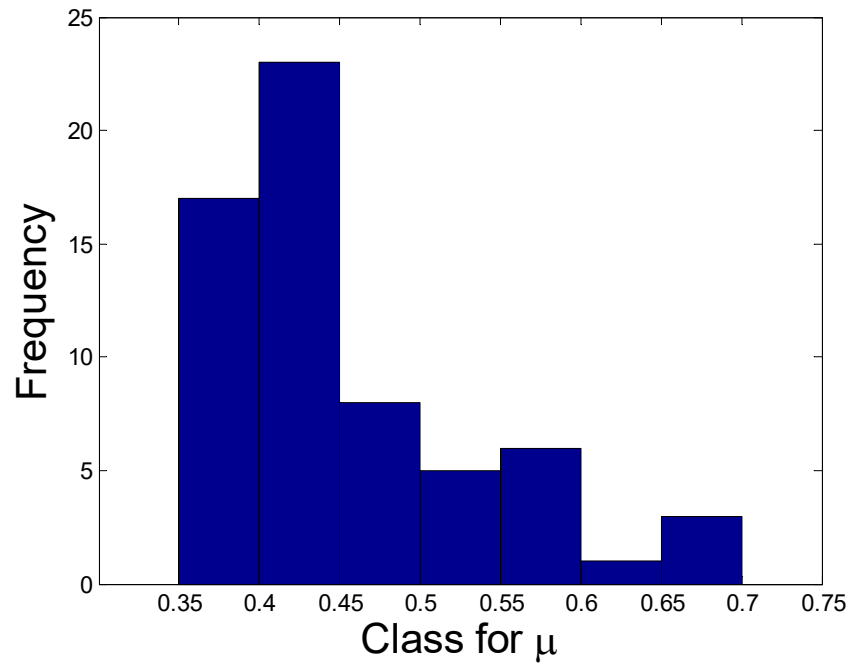
Figure 4-2 Histogram of μ

The friction coefficients were experimentally derived. The variations in the friction coefficient were accounted for by testing and updating it each time the bolt was changed. The initial measurement showed a value of 0.35 and this was taken to initiate the first tests. Nevertheless, there was variation throughout the tests and a general increase of the coefficient as the tests progressed. The coefficients of friction determined experimentally ranged from 0.35 to 0.68 with a mean of 0.46 and a standard deviation of 0.1. Some factors that contribute to these variations are changes in ambient temperature and the accumulation of steel powder due to wear throughout the tests. These were controlled to some extent by running at a similar time of day each day and by cleaning the plates between bolt installations. Figure 4-2 shows a histogram of the values obtained for μ .

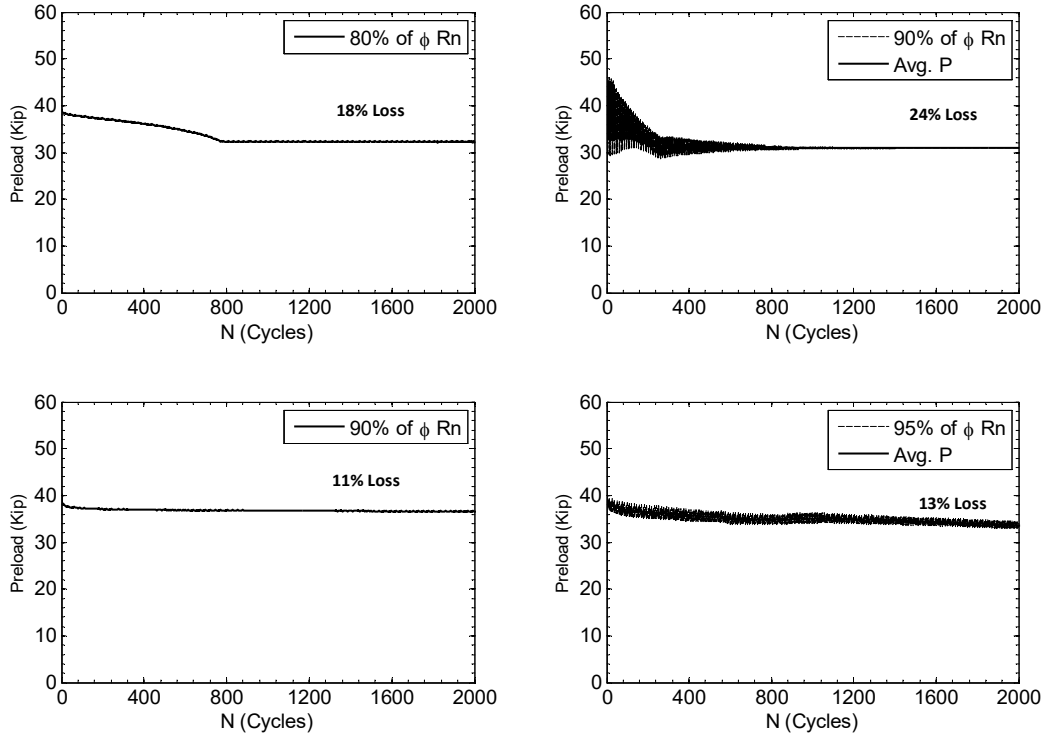
Figure 4-5 Plots of Partial Loss in Galvanized A-325 bolts

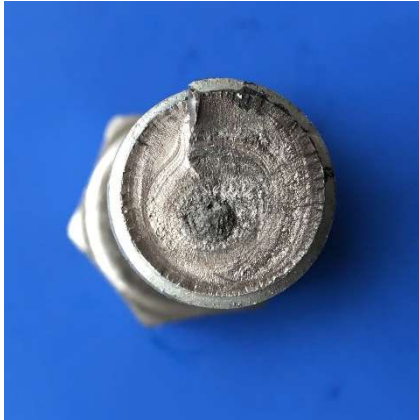
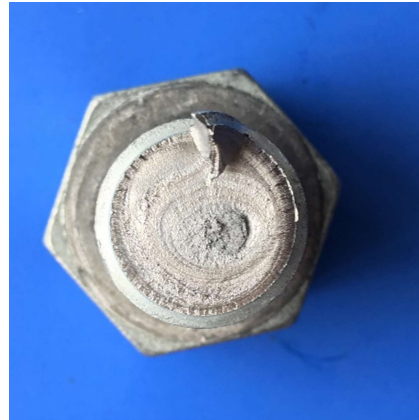
As shown in Figure 5-1, the crack grows progressively inward from the root of the first engaged thread. In the first specimen below the crack follows the helical shape of the threads and striations are seen in a concentric pattern.

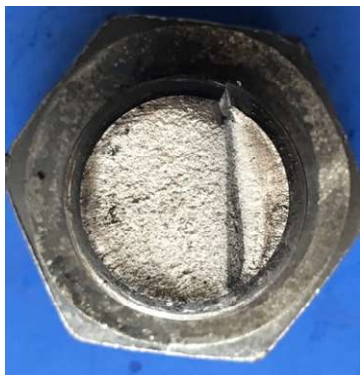
The regular A325 bolt shown in Figure 5-2 has a parallel yet unbalanced crack growth from both ends of the shear plane. Fracture occurred when the cross section had been significantly reduced.

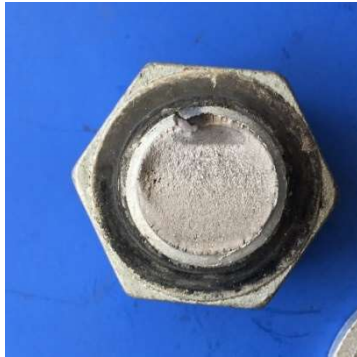
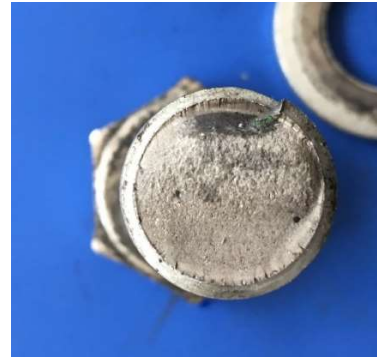
Figure 5-3 Fractographic Profile of Specimen #6 (Galv. 16S_16T N=32,964)

Figure 5-3 shows specimen number six a galvanized A 325 tested at a stress combination of 110 MPa (16 ksi) of shear and 110 MPa (16 ksi) of tension. Multiple initiation points are seen on one edge of the bolt as shown at the bottom of the images below showing that the stresses were well distributed. This is because the bolts were not subjected to any significant bending which would

produce localized maximum tension at a specific point. Finally, fracture occurred at the other end of the bolt as seen in the upper part of the images below.

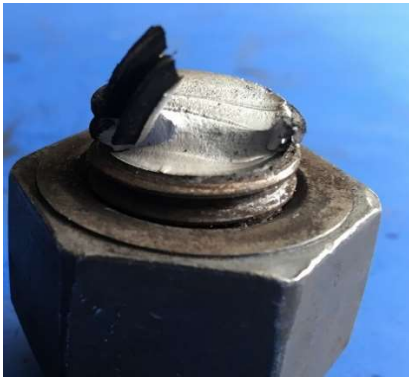
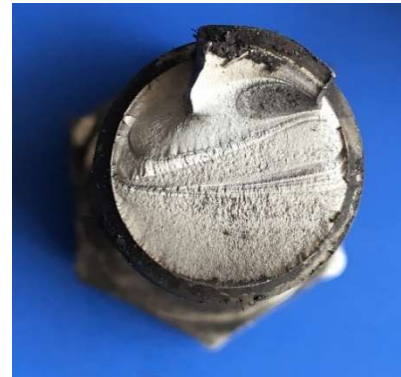
Figure 5-4 Fractographic Profile of Specimen #20 (Reg. 16S_16T N=53,484)

Specimen number twenty shown in Figure 5-4 shows tearing of the threads. The fatigue striations suggest a small rotational effect with thumb.

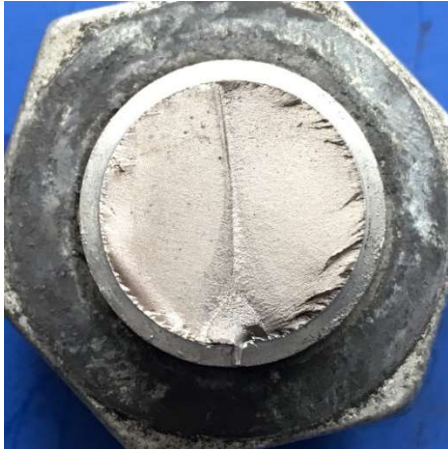
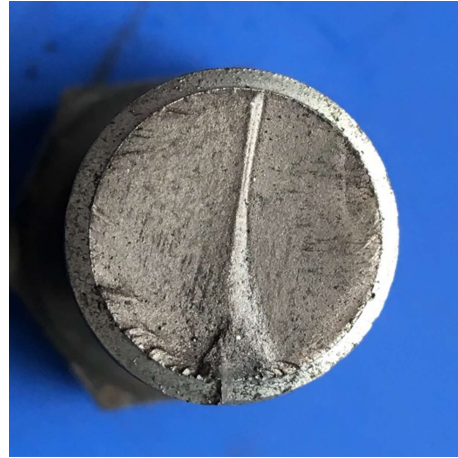
The images in Figure 5-5 are of specimen number ten subjected to 55 MPa (8 ksi) shear and 55 MPa (8 ksi) tension. This galvanized bolt has a fracture region that extends in a thin line (vertical in the images) across the bolt perpendicular to the crack growth direction.

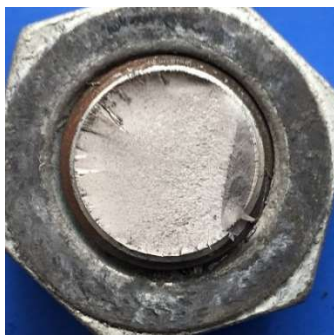
Fractographic profiles of specimen number four shown in Figure 5-6 below begin a series of figures showing a two to one relationship in tension to shear stress. Specimen 4 shows the finer grain in the fatigue region to the left in the pictures. This stable crack dominated by tension and less rotationally affected by shear grew from the left and culminated in the fracture zone on the right.

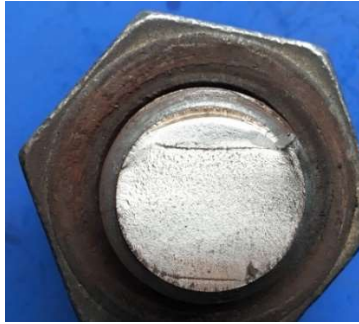
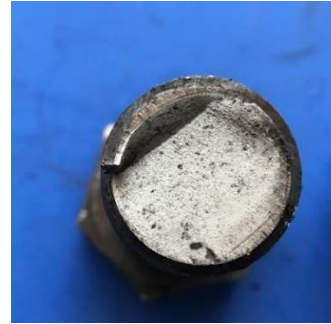
Figure 5-7 Fractographic Profile of Specimen #15 (Reg. 10S_20T N=228,736)

A similar pattern as above is seen in Figure 5-7 which shows a Regular bolt for the same stress combination. As in the previous section there is evidence of no bending because of multiple initiation points.

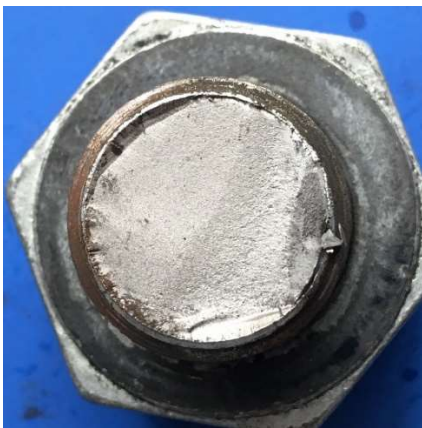
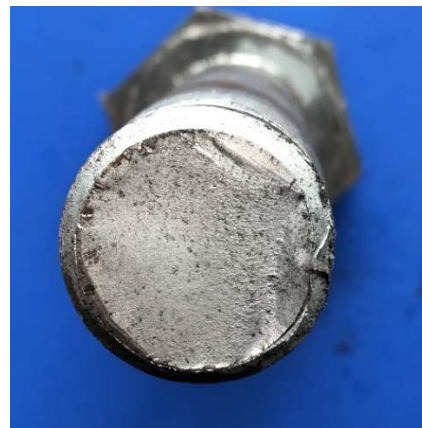
At a reduced stress combination of 55 MPa (8 ksi) in shear and 110 MPa (16 ksi) in tension a larger fatigue region and a smaller fracture region can be seen. Figure 5-8 and Figure 5-9 show the failure profile for specimen number nine (galvanized) and twenty-two (regular) with a typical horizontal crack growth plane and a fracture plane with a characteristic change in angle.

Figure 5-8 Fractographic Profile of Specimen #9 (Galv. 8S_16T N=180,070)

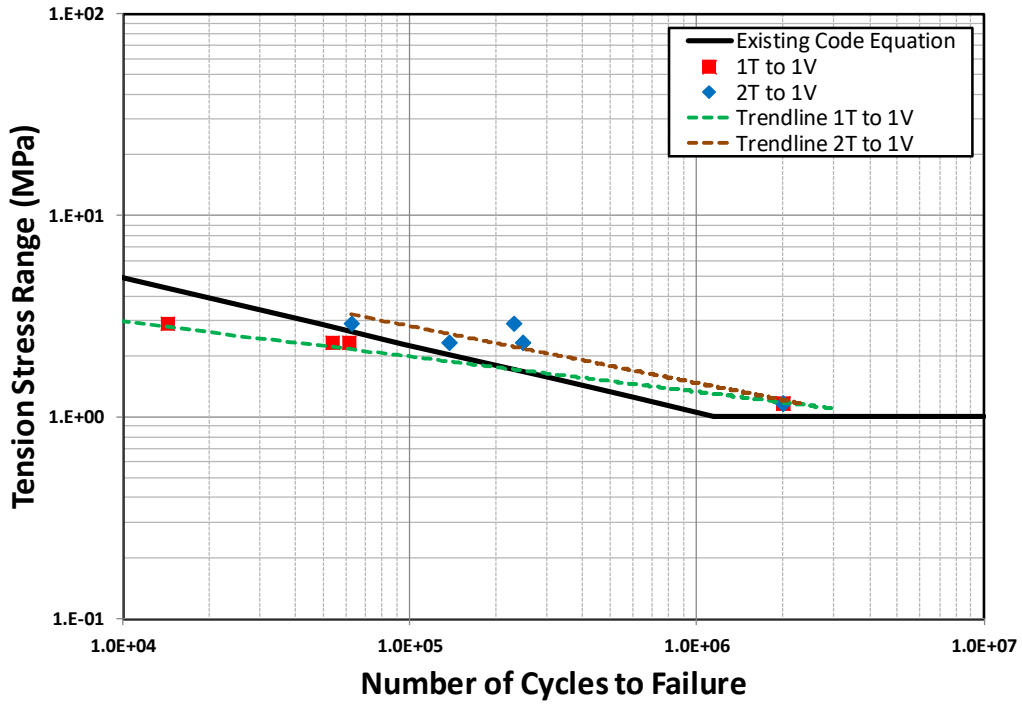
Figure 5-10 Galvanized A325 Tension S-N Curve

Figure 5-10, Figure 5-11, Figure 5-12, and Figure 5-13 show the S-N curves for Galvanized A325 tension, A325 tension, Galvanized A325 shear, and A325 shear, respectively. For the tension S-N curves in Figure 5-10, Figure 5-11, the data set shows a close resemblance to the equation provided for fatigue for bolts subjected to tension only. As expected the red dot and green trend line for a one-to-one relationship of tension to shear have lower fatigue life compared to the same value of tension but with half the shear. The fatigue lives are increased when the shear is only half of the tension compared to the one-to-one relationship. For the shear S-N curve in Figure 5-12, and Figure 5-13, the figures clearly show that adding tension to the shear reversals causes obvious reduction to the fatigue strength in comparison to shear only loading.

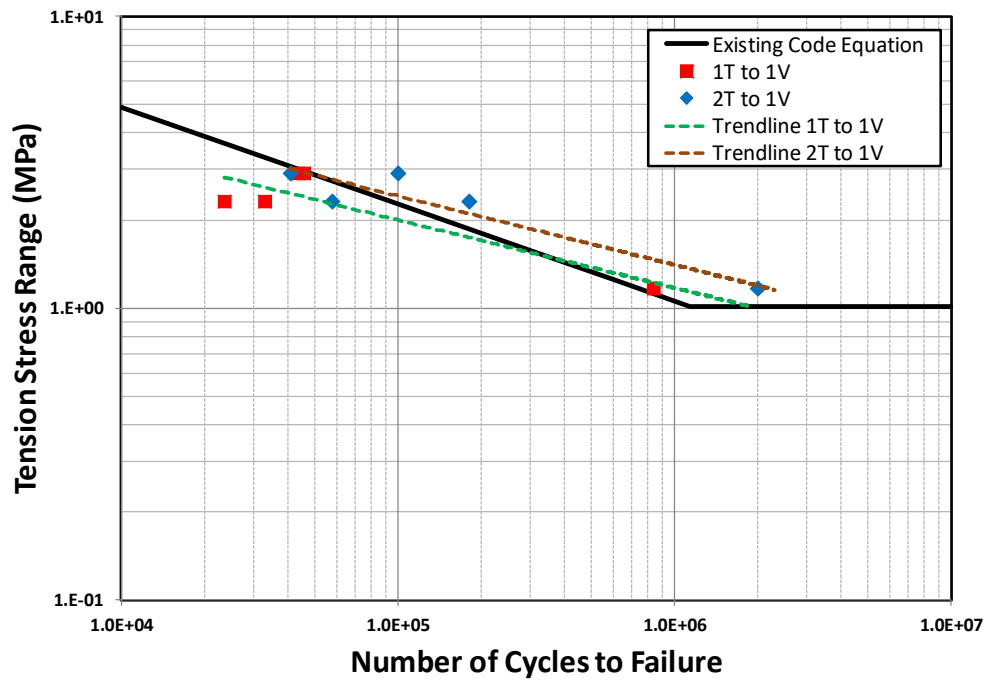
Figure 5-11 Regular A325 Tension S-N Curve

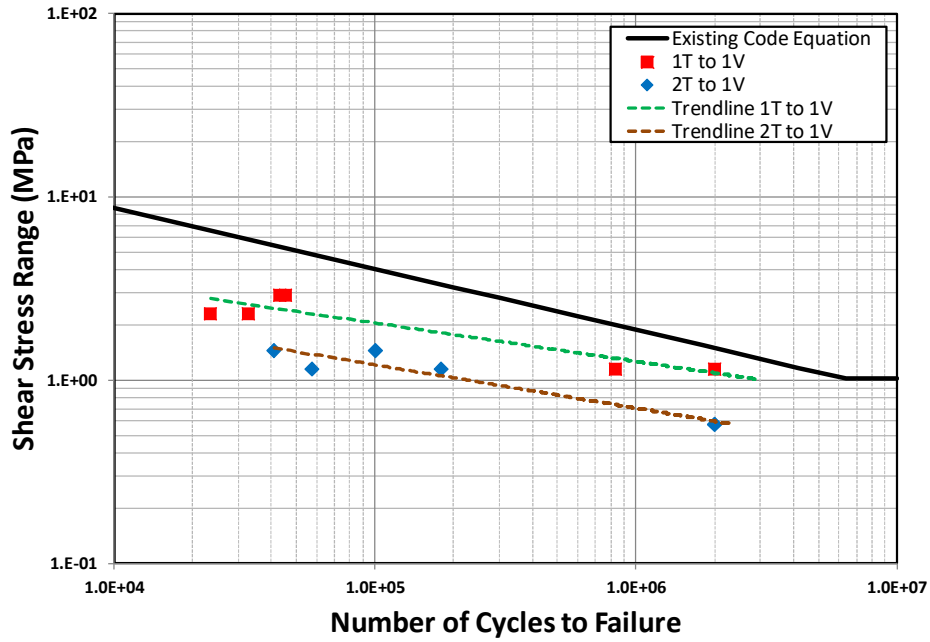
Figure 5-12 Galvanized A325 Shear S-N Curve

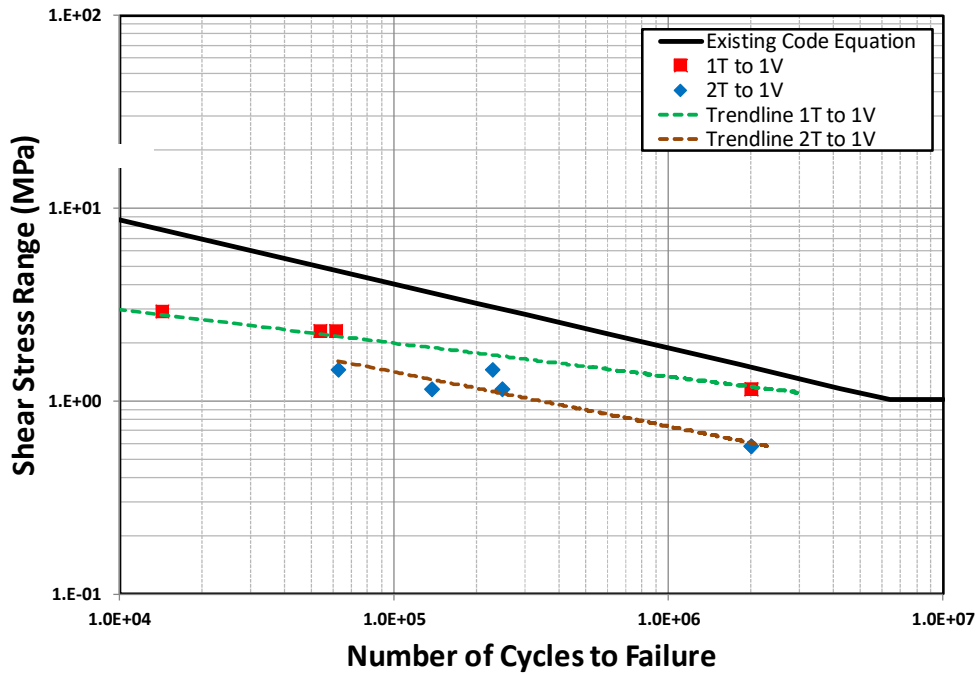
Figure 5-13 Regular A325 Shear S-N Curve

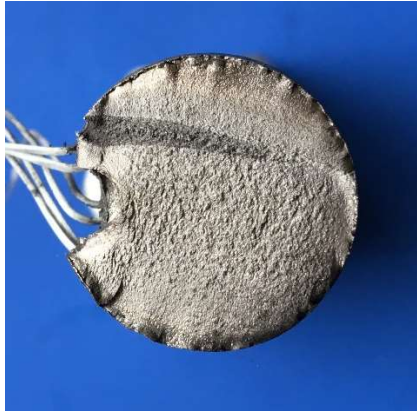
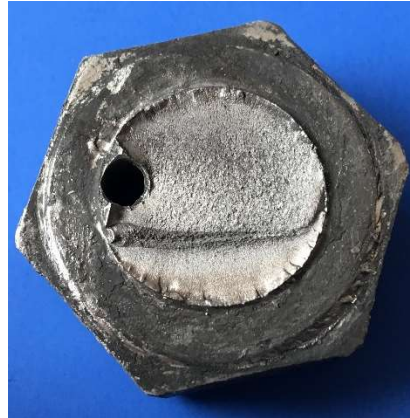
Figure A - 1 Fractographic Profile of Specimen #1 fractured at head due to instrumentation hole
