THESIS

MULTI-AXIAL FATIGUE STRENGTH OF STRUCTURAL BOLTS IN
SLIP-CRITICAL CONNECTIONS UNDER COMBINED CYCLIC AXIAL AND SHEAR
DEMANDS

Colorado State University

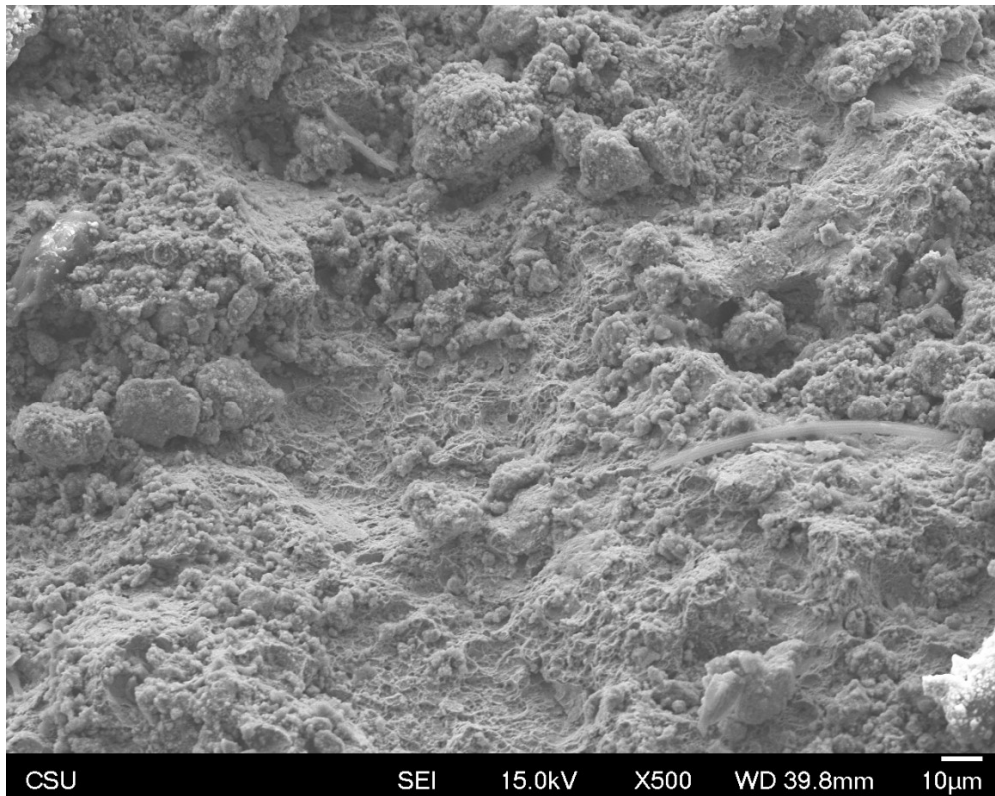
Figure B-1 X500 Fracture zone surface near threads specimen #10 (Galv. 8S_8T N=838,878)

Where fracture occurred, the surface appears rough. On the other hand, there is a smooth patterned surface where fatigue took precedence.

Failure surfaces for specimen #10 (Galv. 8S_8T N=838,878), were magnified using SEM at varying levels of magnification. These are shown in Figure B-1, Figure B-2 and Figure B-3.

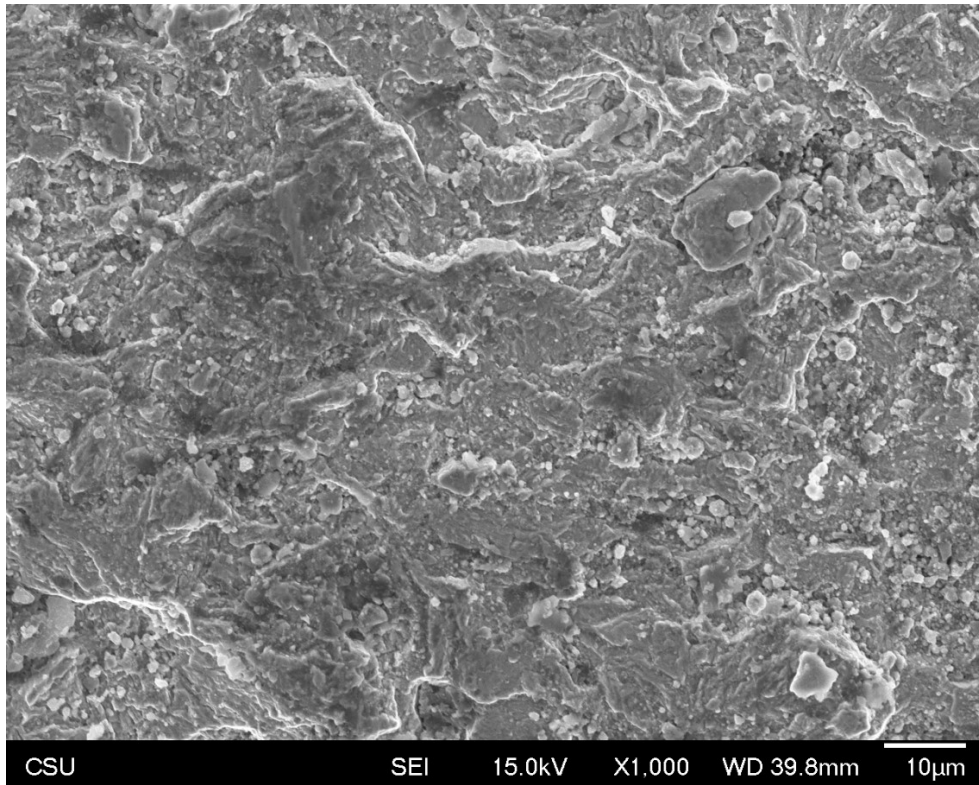
Figure B-2 X1000 Fatigue zone specimen #10 (Galv. 8S_8T N=838,878)

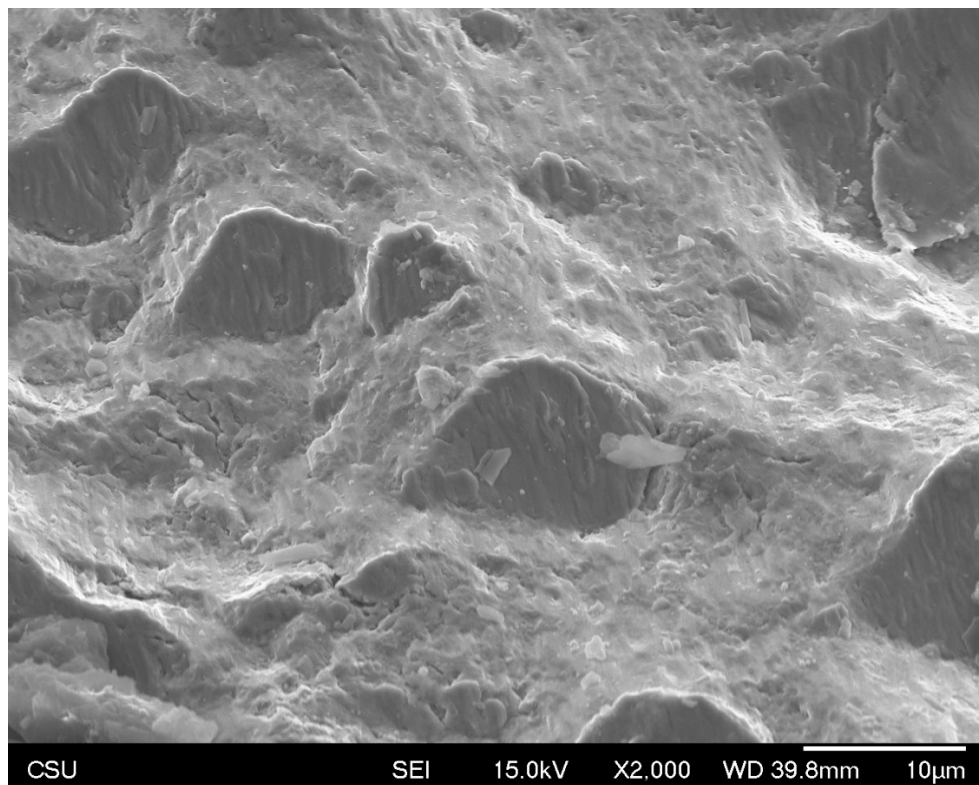
Figure B-3 X2000 Fatigue zone crack growth surfaces specimen #10 (Galv. 8S_8T N=838,878)

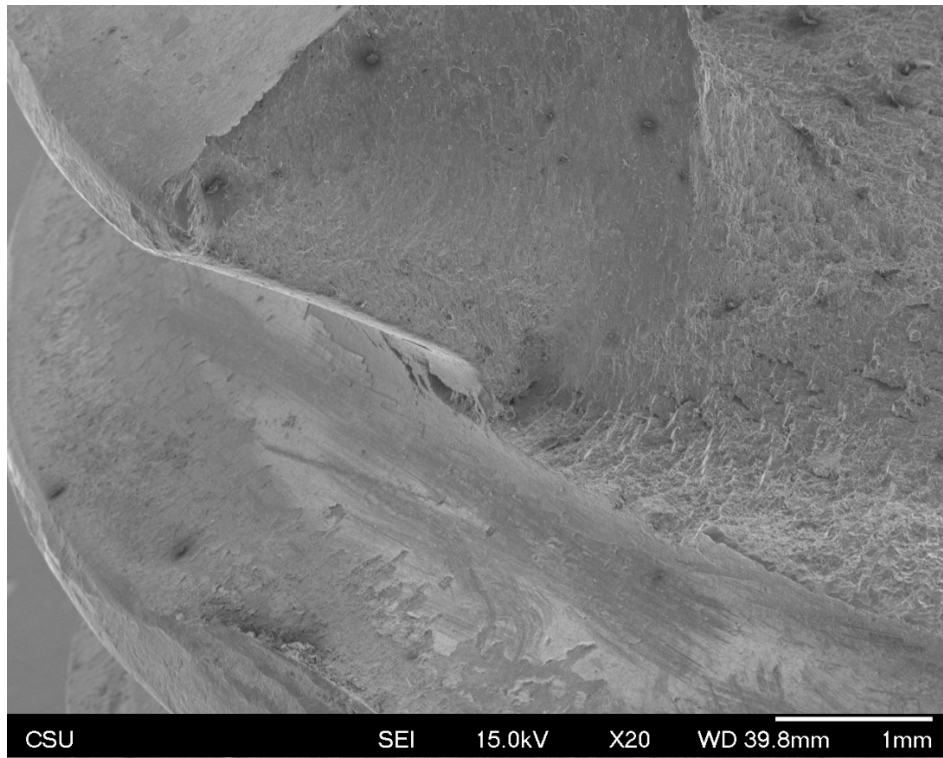
Figure B-4 X20 Threads at fracture zone specimen #13 (Reg. 20S_20T N=6876)

Specimen #13 (Reg. 20S_20T N=6876) is shown below in Figure B-4 and B-5, with similar characteristics.

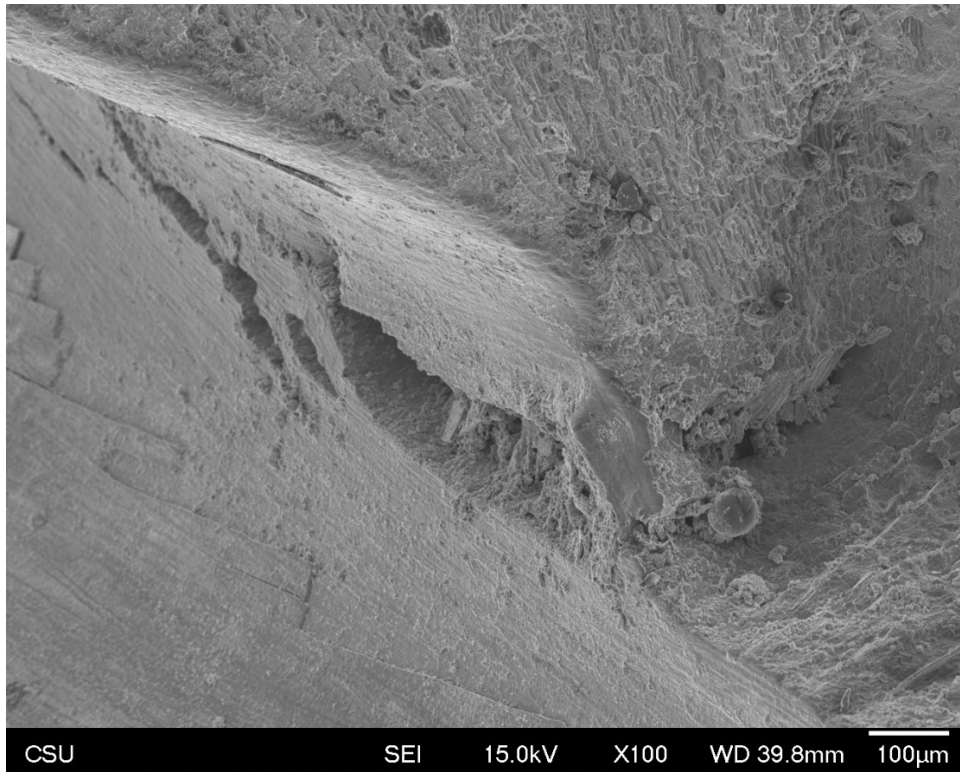
Figure B-5 X100 Threads at fracture zone specimen #13 (Reg. 20S_20T N=6876)

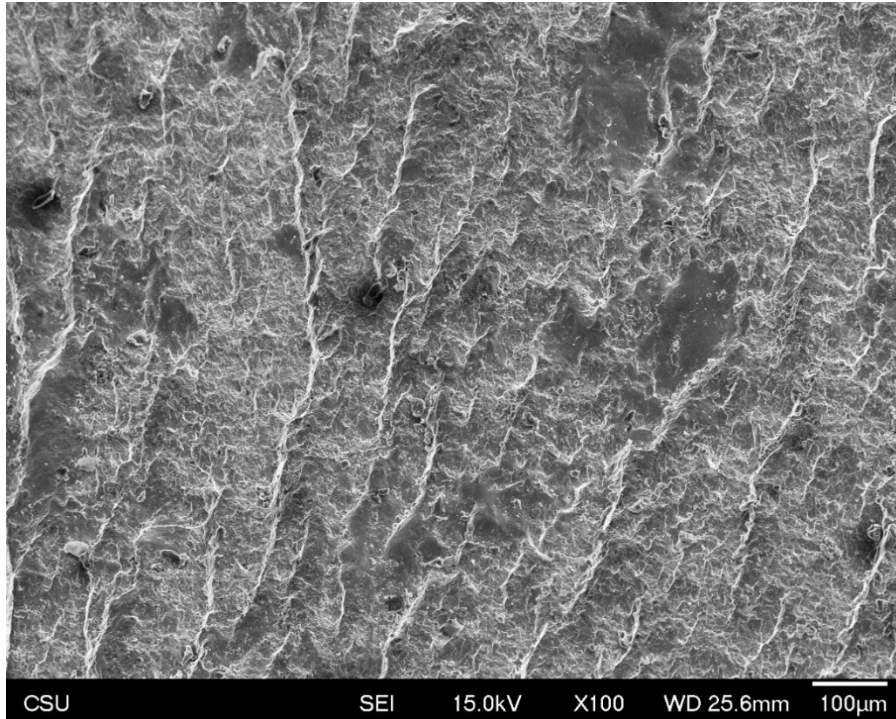
Figure B-6 X100 Fatigue zone specimen #8 (Galv. 8S_16T N=57,455)

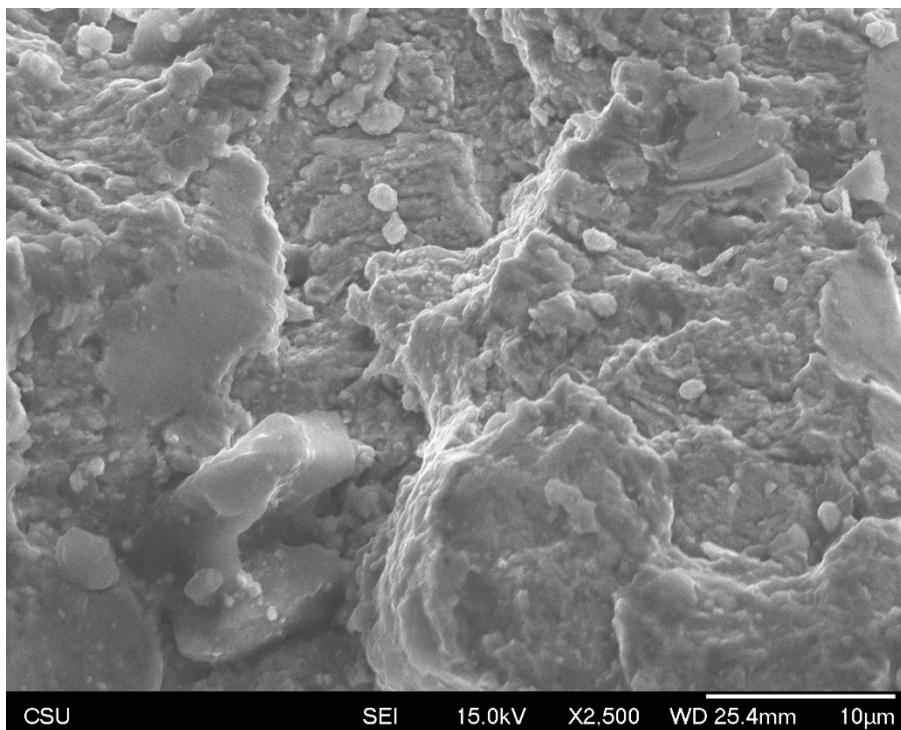
Figure B-7 Fatigue Zone X2500 Specimen # 8 (Galv. 8S_16T N=57,455)

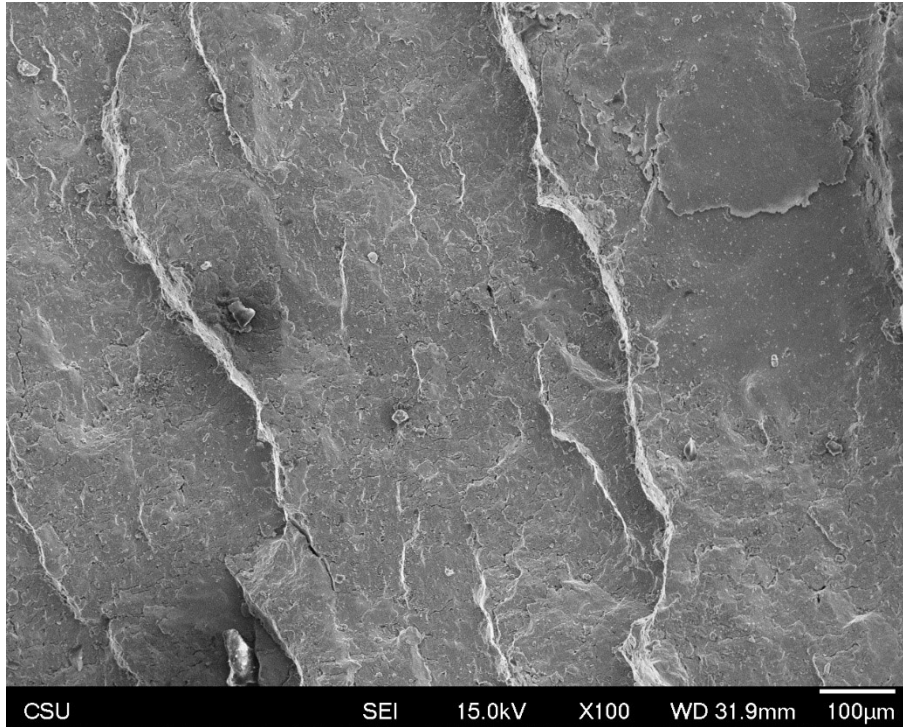
Figure B-8 SEM of Fatigue Zone X100 Specimen # 14 (Regular B 20s_20t N=14,248)

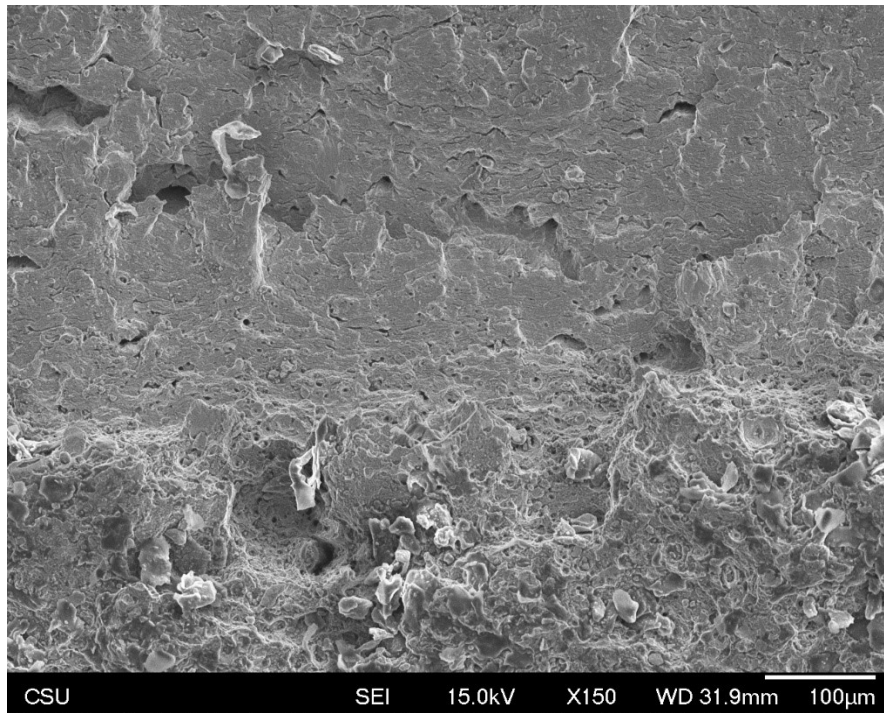
Figure B- 9 SEM Transition from Fatigue to Fracture Zone X150 Specimen #14 (Regular B 20s_20t N=14,248)

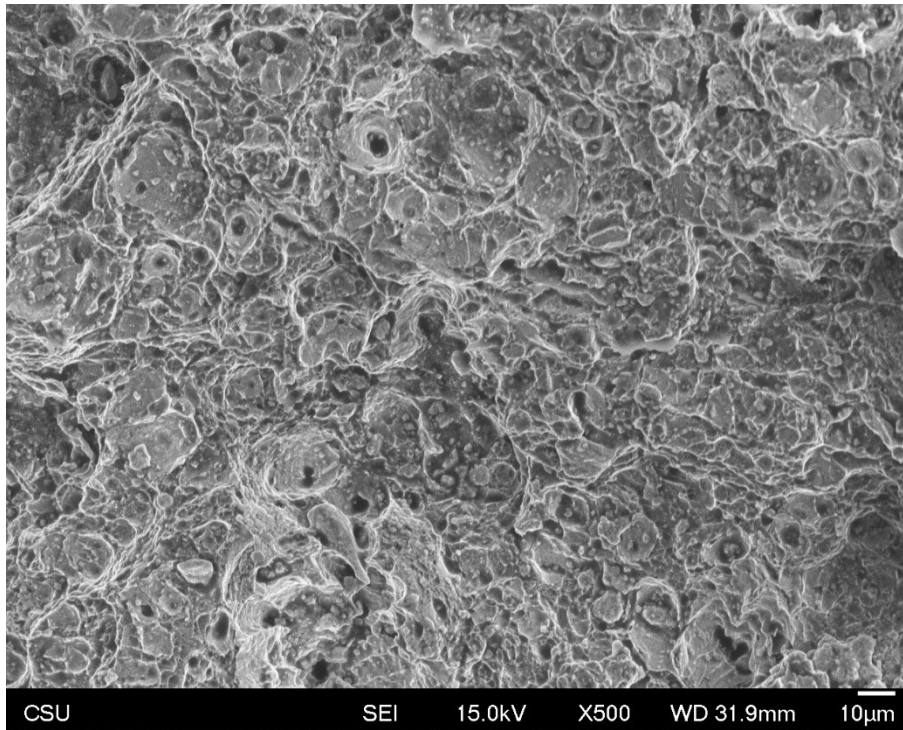
Figure B- 10 SEM Fracture Zone X500 Specimen #14 (Regular B 20s_20t N=14,248)
