EVALUATION OF SURFACE AND SPRINKLER
IRRIGATION SYSTEMS ON THE
SEEDSKADEE DEVELOPMENT FARM

E. Gordon Kruse
and
Howard R. Haise

SWC Research Report # 414

Northern Plains Branch
Soil and Water Conservation Research Division
Agricultural Research Service
United States Department of Agriculture

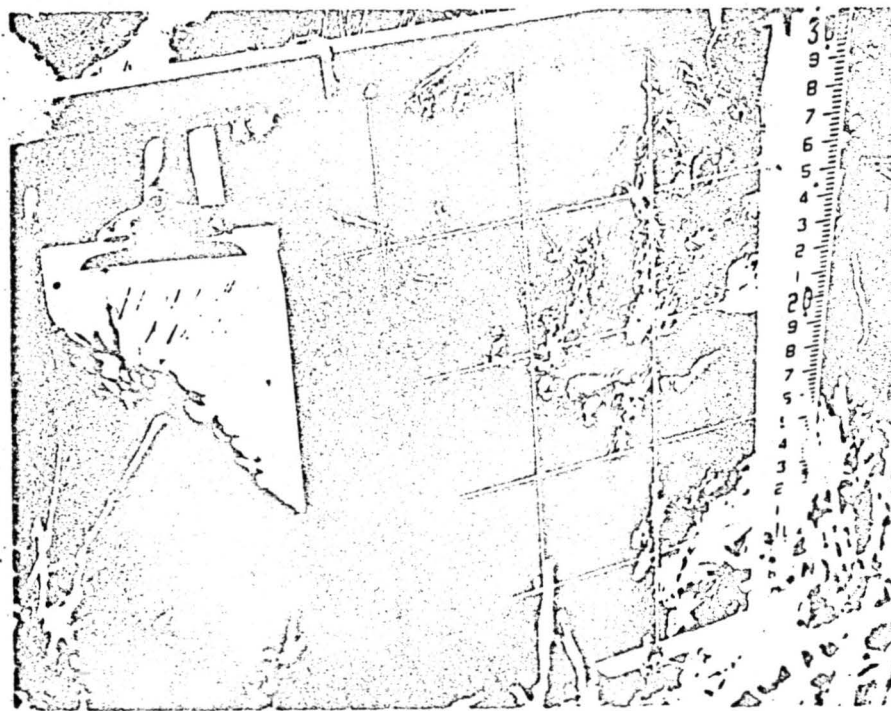
Figs. 11-12.--Root and soil profiles on Field 12, lower bench, Seedskaadee Development Farm.

Hole #7	Hole #8
Depth of top soil	8"	9" (cemented layer
Alfalfa root depth	30"	18" at 12-24")
Grass root depth	24"	12"

the north end of the field, roots only penetrated about 12 inches. Restricted root growth, apparently due to a calcium layer, was noted in hole #8. Field 12 was seeded to grass and alfalfa in 1965. The roots shown in the photographs therefore represent approximately two and one-half seasons of growth under sprinkler irrigated conditions.

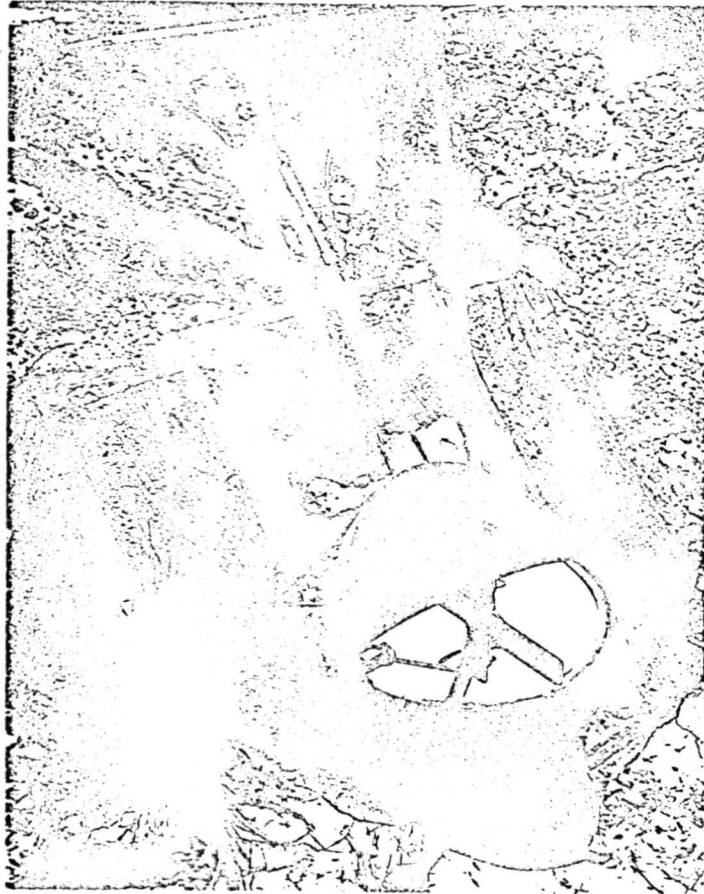
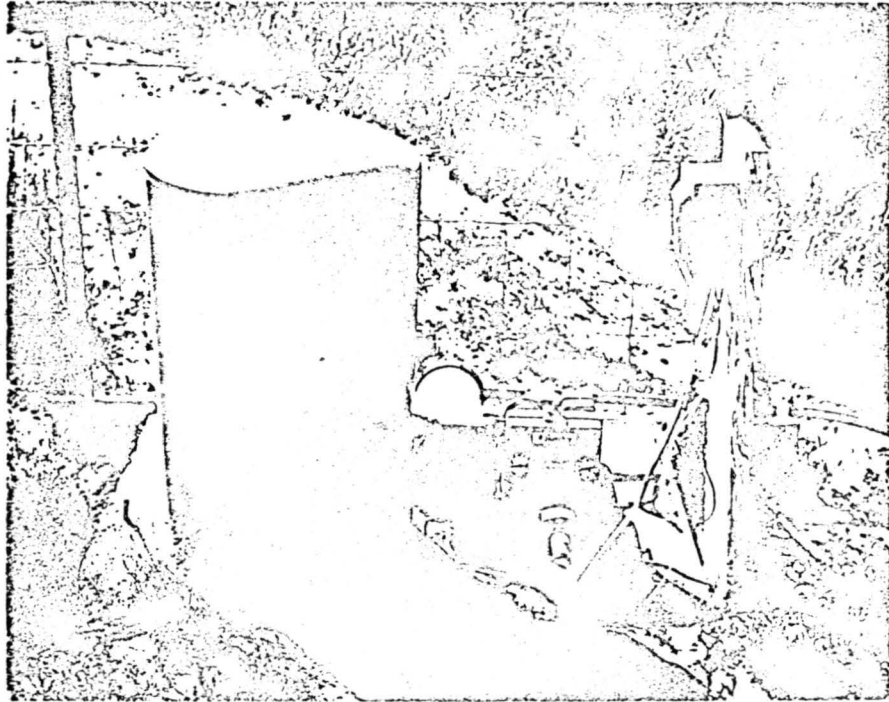
Fig. 20.--Equipment for providing water pressure for hydraulic automation system. Pump takes its supply from open irrigation ditch. All water passes through filter (behind pressure tank) before entering field supply line.

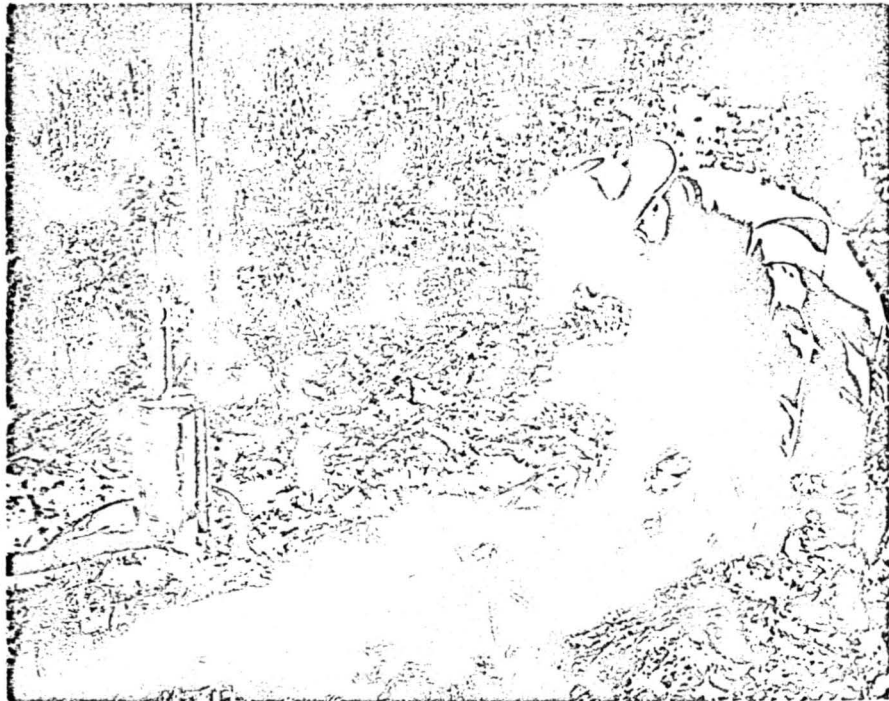
Fig. 23.--Calibration of neutron depth moisture gage in area of deep soil near research area. Large (2000 cc) samples were taken in this area to gravimetrically measure water content and bulk density.

A Troxler neutron depth moisture gage was used in an attempt to determine changes in soil moisture before and after irrigations. The gage was calibrated in three different ways (all comparisons with gravimetrically obtained samples), Fig. 23. All calibrations differed and, furthermore, none agreed with the standard calibration furnished by the manufacturer. Therefore, results of all soil-water determinations are questionable and are not used extensively in this report.
