THESIS

THE EFFECTS OF LONG TERM DRAINAGE AND RESTORATION ON SOIL
PROPERTIES OF SOUTHERN ROCKY MOUNTAIN SEDGE FENS

David W. Schimelpfenig

Colorado State University

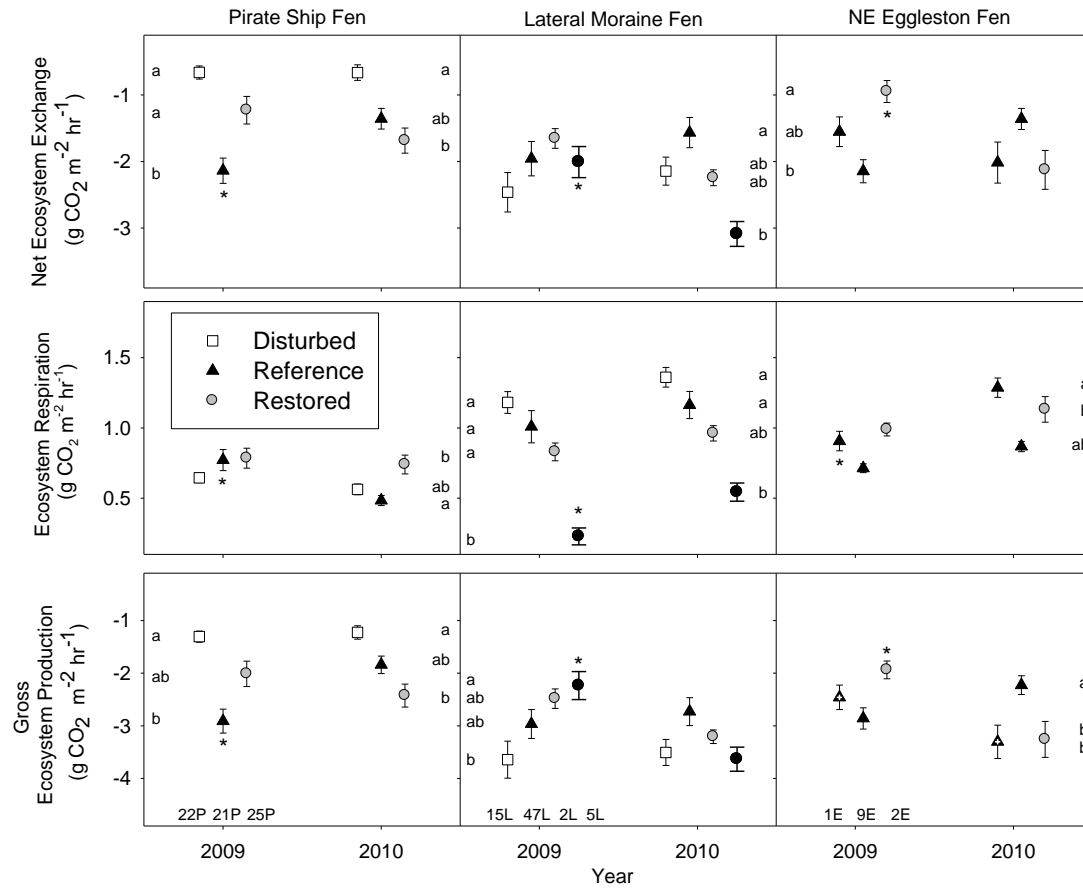
Figure 3. Mean CO₂ flux by well and year at each study fen. Error bars show 1 standard error from the mean. Negative values indicate CO₂ uptake into fen soil, positive values indicate loss to atmosphere. (*) indicates 2009 mean significantly different from 2010 mean within each treatment (p < 0.05). Letters indicated statistical significance of fluxes compared across treatments within each fen and year. Flux means within each year with same letter are not significantly different (p > 0.05). Well numbers are included along x-axis for reference.

(Figure 3). The minimal change in ER with increasing depth of water table below the surface has been observed in fens in the Rocky Mountains (Chimner & Cooper 2003b) and southern Finland (Ruita et al. 2007). This is likely due to the high water holding capacity, low K_s , and abundance of smaller pores that maintain high soil water content as the water table fluctuates below the surface (Deppe et al. 2010).

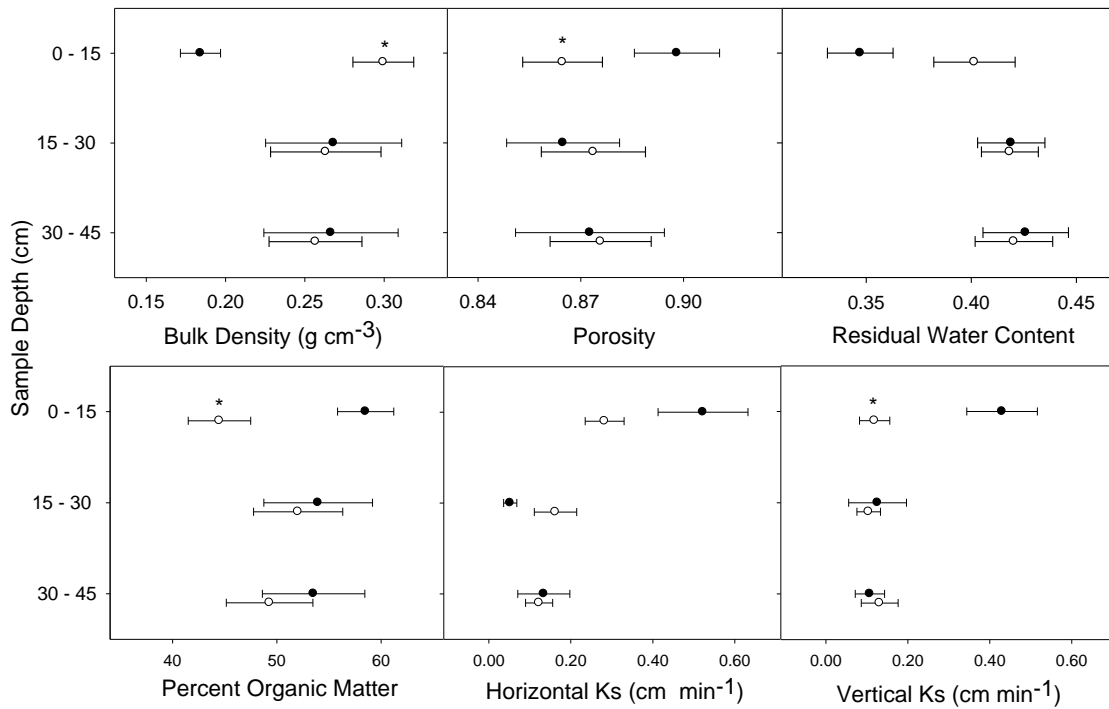
Figure 6. Soil property means (standard error) with samples from all fens pooled by treatment (open = disturbed/restored, closed = reference). Differences in means were analyzed at each sample depth using the Wilcoxon rank sum test. (*) indicates means are significantly different ($p < 0.05$).

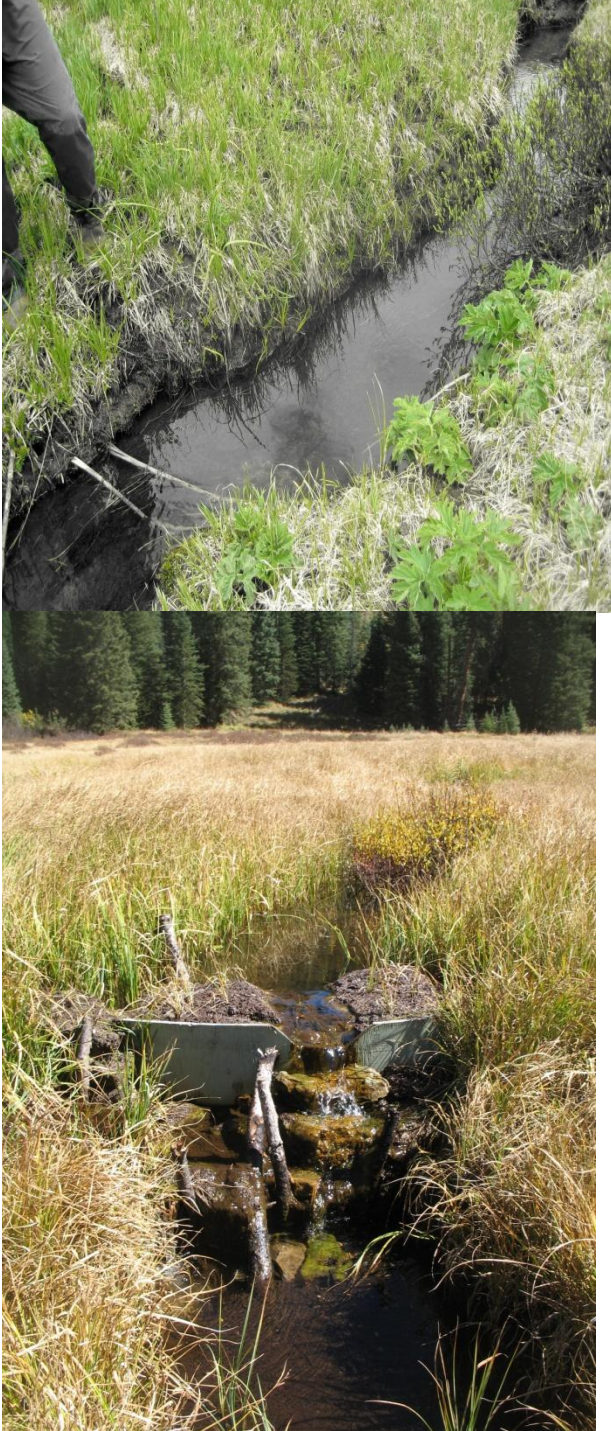
Figure 8. Pre restoration (left) and post restoration (right) view of plywood dam in Lateral Moraine Fen. Dam has v-notched weir, rock armoring on spillway, and has been filled with peat blocks planted with sedge plugs.

(<1 m), shallow (< 0.75 m), low gradient (~1%), and had relatively low flow rates. These factors limited the erosion potential and allowed small, simple structures to block flow in the ditches. Dams must be securely anchored to the ditch walls and channel bottom (> 15 cm deep) to avoid failure by scour under the bottom or sides. The locations where excess water is directed as it flows out of the ditch is important to consider. At low flows it may be possible to redirect water across the fen as sheet flow, an effective method to create stable hydrologic conditions. However, during spring runoff or periods of high intensity precipitation, there is a potential for erosion and the creation of additional channels in poorly vegetated wetlands. Installing v-notch weirs to direct excess water during high flow events through the pre existing ditch is one way to address this concern (Figure 8).

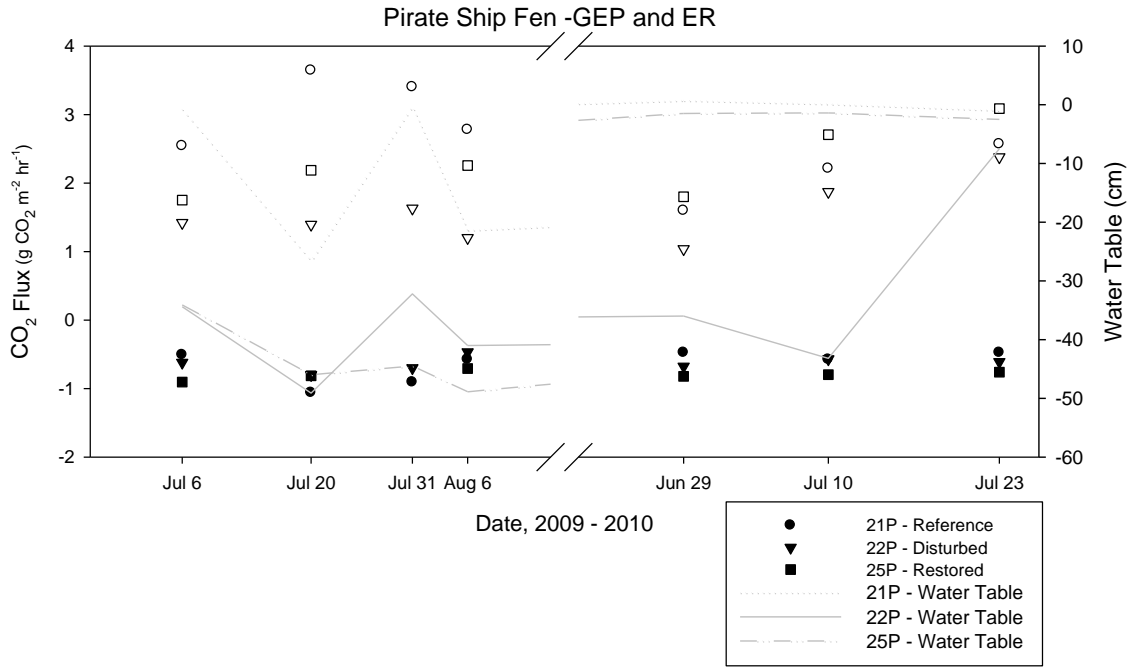
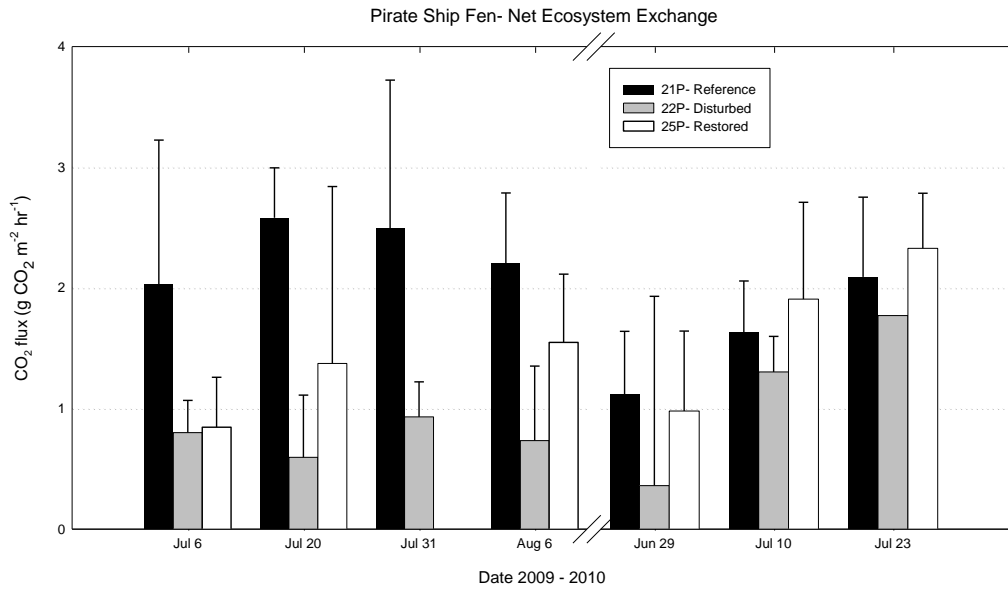
Figure PS-3: Mid day CO₂ flux averaged by well from Pirate Ship fen, *Open symbols* are Gross Ecosystem Production (GEP), *Closed symbols* are ecosystem respiration (ER). Net ecosystem exchange (NEE) error bars represent 1 standard deviation from the mean.

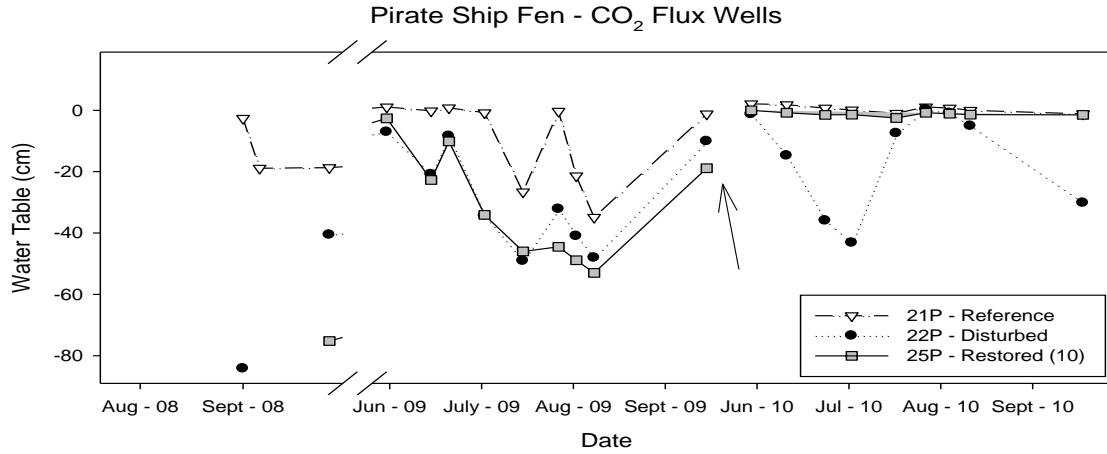
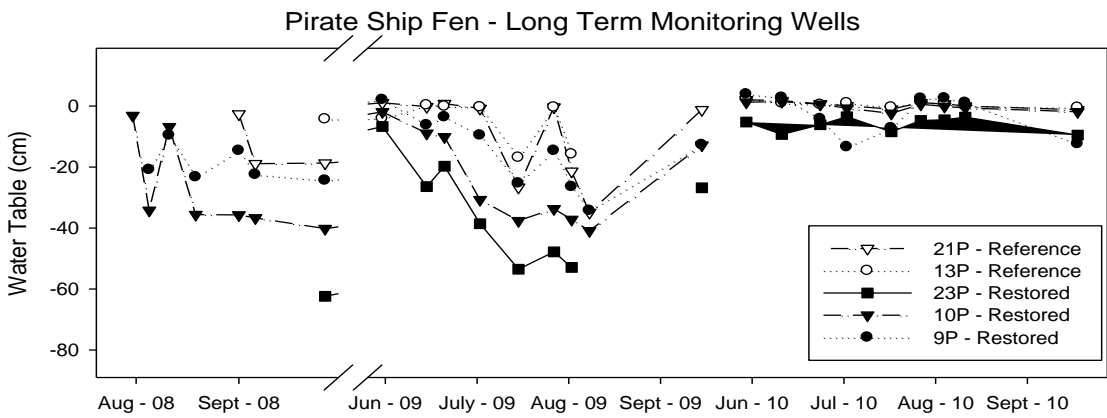
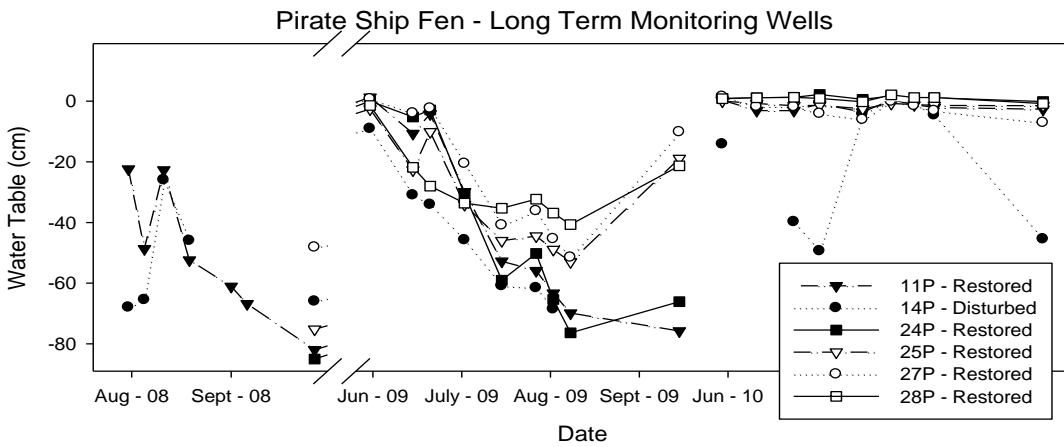
Figure PS-5: Water Table position for Pirate Ship wells with a) CO₂ flux sites. b, c) Long term monitoring wells remaining in the fen. Arrow indicates approximate date of restoration for restored wells.

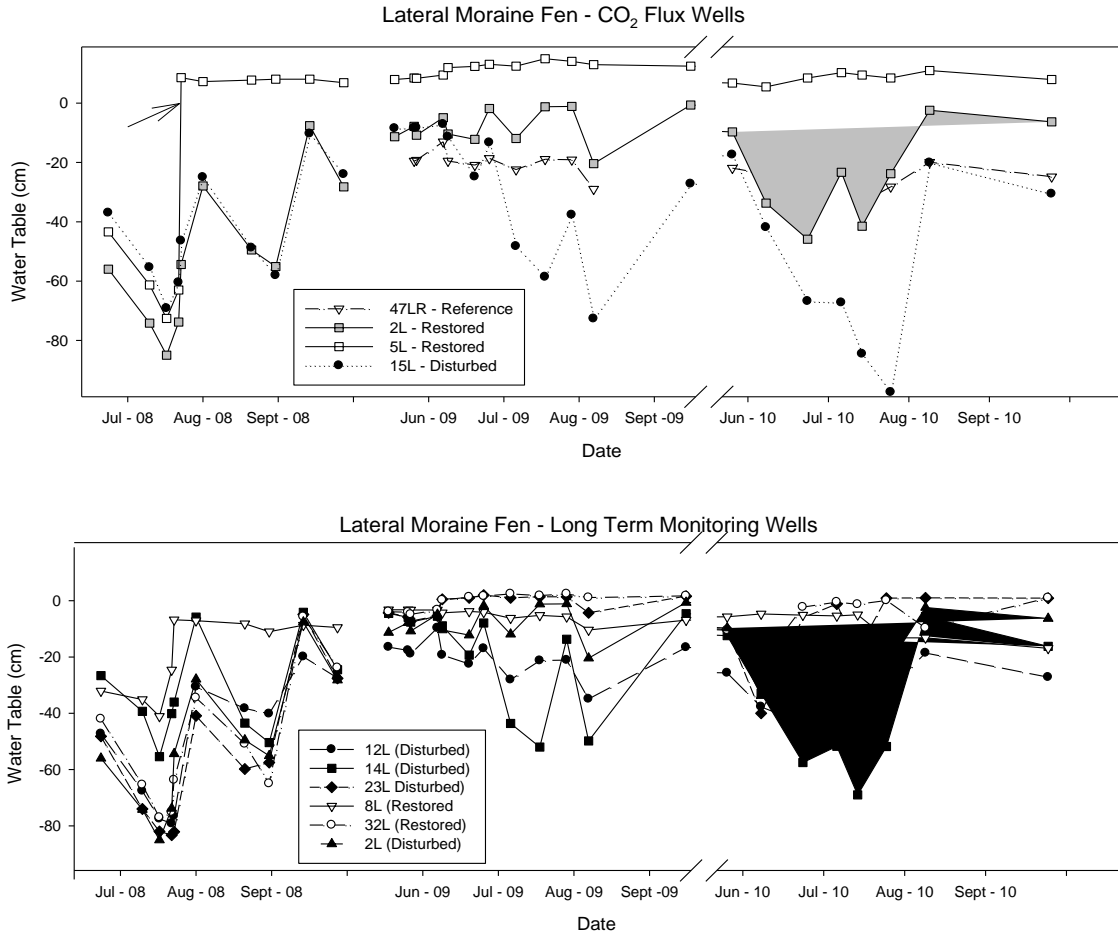
Figure LM-5: Water Table position for Lateral Moraine Fen wells with CO₂ flux sites and long term monitoring wells. Arrow indicates approximate date of restoration for restored wells.

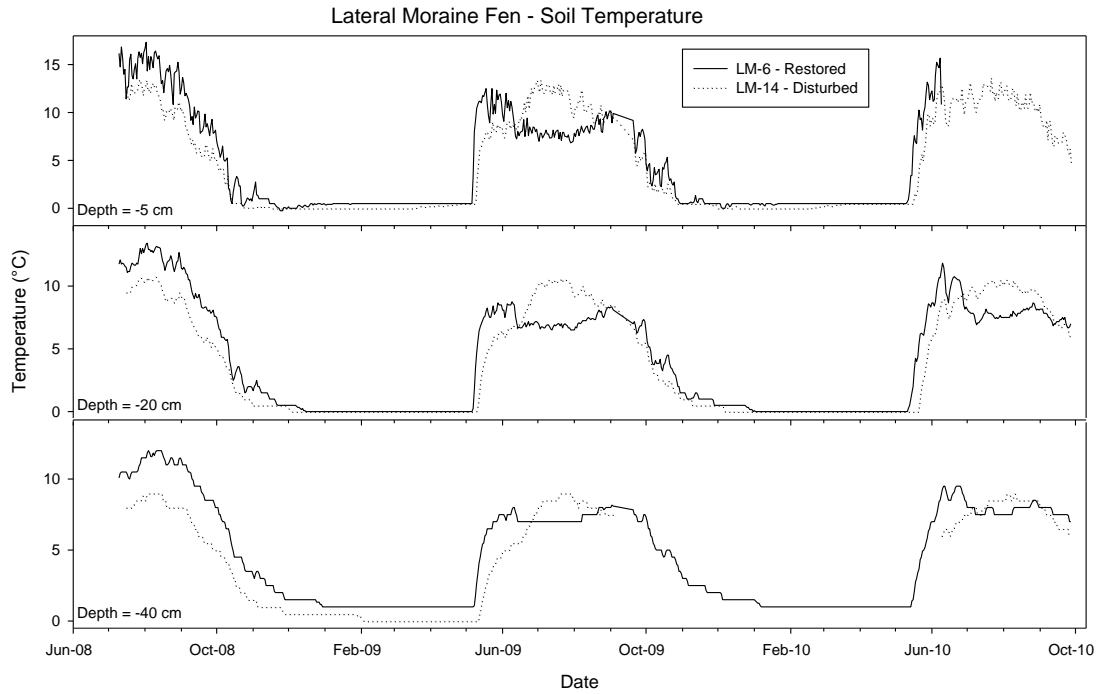
Figure LM-6: Soil temperature for Lateral Moraine fen disturbed well 14 (dashed line) and restored well 6 (solid line) at three depths. Temperatures were logged at 6 hour intervals from June 2008 to September 2010 using Thermocron® I- buttons. Note -40 cm depth disturbed I button was not functioning from September 2009 to June 2010.

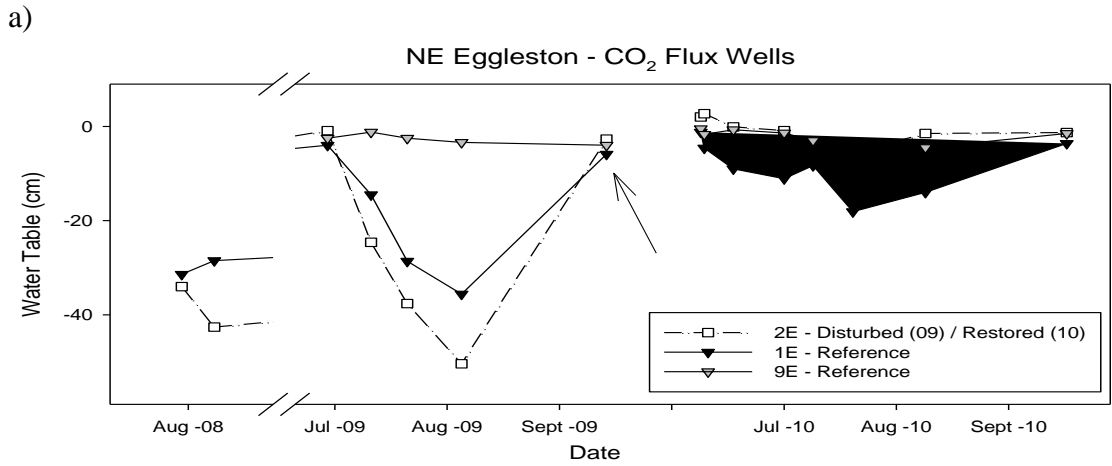
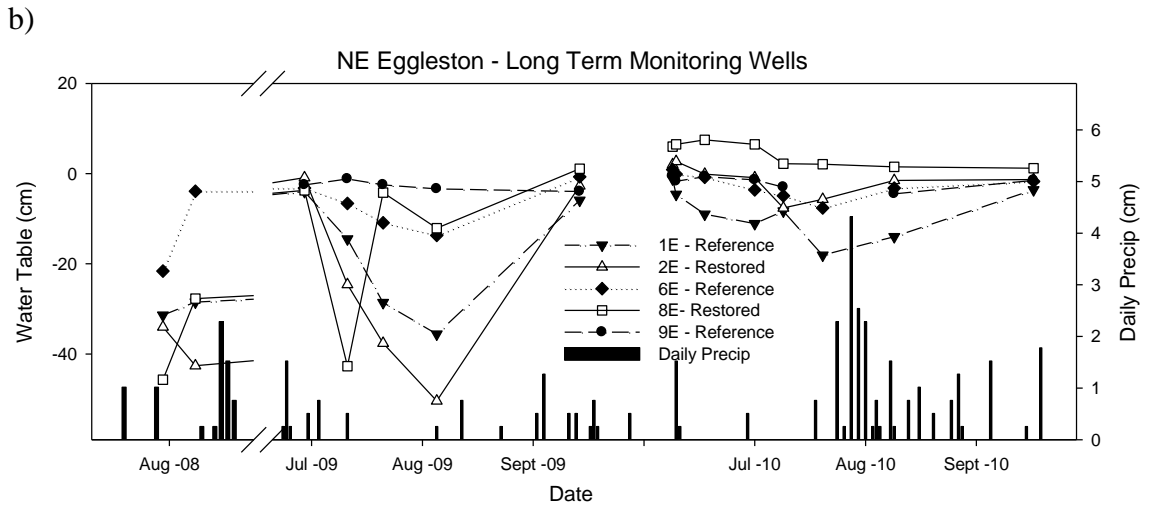
Figure NE-5: Water Table position for NE Eggleston wells with a) CO₂ flux sites and b) long term monitoring wells. Arrow indicates approximate date of restoration for restored wells.
