Survey and Assessment of Critical Urban Wetlands:

City and County of Denver

June 2015

Colorado Natural Heritage Program

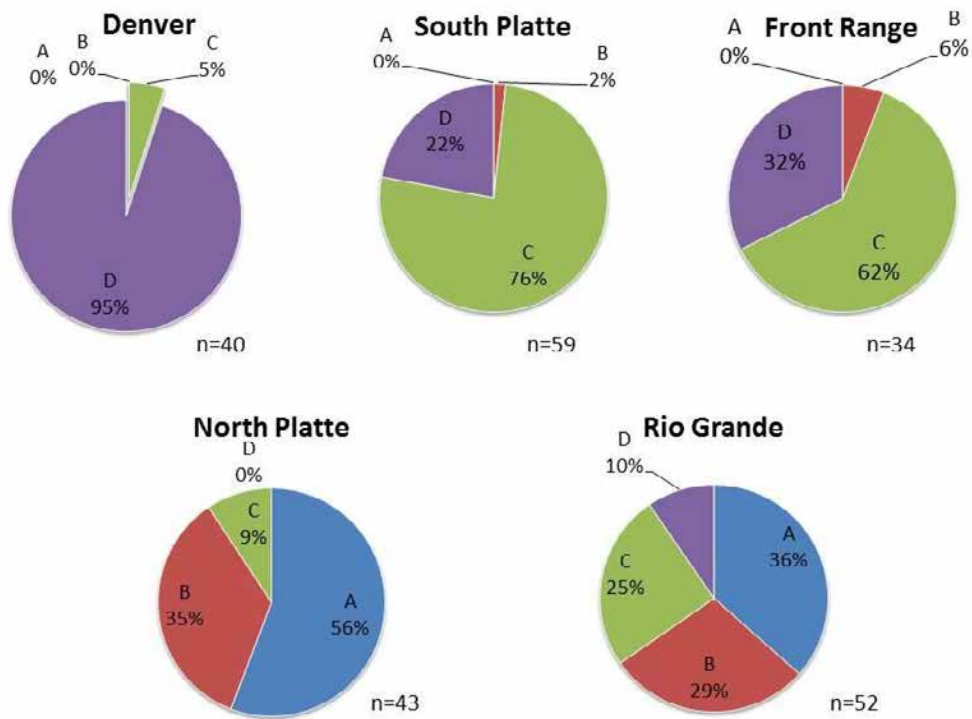
Figure 14. Comparison of Denver County Wetland Condition Ranks using Ecological Integrity Assessment methods. Wetlands condition ranks are as follows: A = Excellent; B = Good; C = Fair; D = Poor.

For a statewide comparison, wetland condition ranks have been documented for the South Platte River Basin (Lemly et al. 2014), northern Front Range (Lemly et al. 2013), North Platte River Basin (Lemly and Gilligan 2012), and Rio Grande Headwaters River Basin (Lemly et al. 2011). The North Platte and Rio Grand Basins are large and include much less developed landscapes and mountainous topography. These basins had numerous A ranked wetlands. The South Platte River Basin, of which Denver County is a small portion, had no A ranked wetlands and only 2% B ranked, reflecting much of the agricultural lands on the northeastern plains of Colorado. The northern Front Range study was similar to the South Platte, with no A ranked sites, few B ranked sites, and largely C ranks (Figures 14 & 15). Denver County scores are expected as it is the most intensely developed section of the South Platte River Basin.

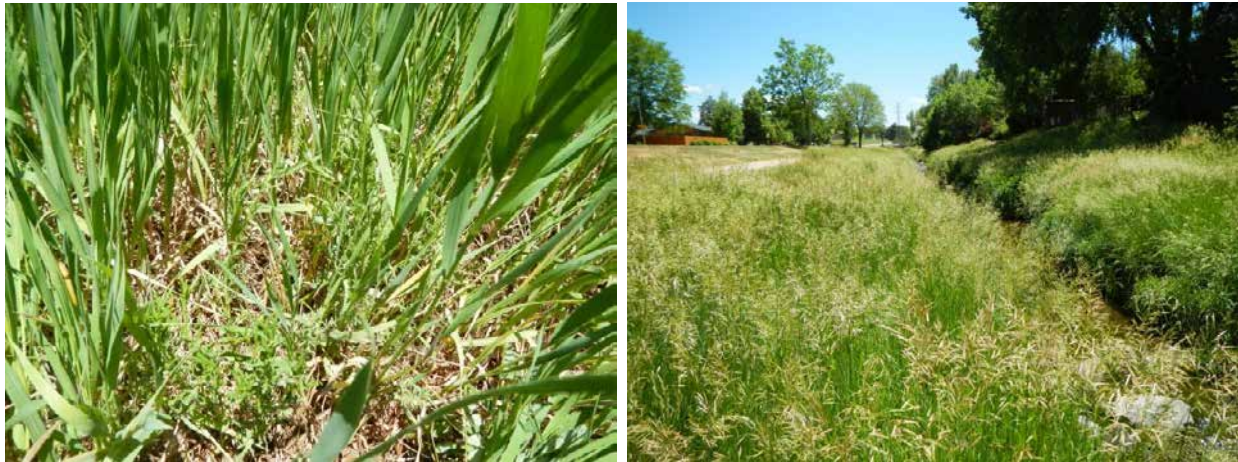
Figure 17. Prairie ragweed (left), a rare prairie plant is tucked into a dense smooth brome dominated shore of Goldsmith Gulch. Photo: P. Smith June 17, 2014.

Prairie ragweed (*Ambrosia linearis*), a rare plant tracked by CNHP, was documented at Goldsmith Gulch (Figure 17). It was reported originally in 2004 by biologist Rick Brune from that location and verified by CNHP in 2014. Prairie ragweed, a globally and state vulnerable (G3/S3) species is an endemic known only from the plains of eastern Colorado. This species occurs in intermittent streams and around playa margins. This population might represent a relictual population that was protected in the gulch buffer (which was not mowed at the time of the survey) that has managed to survive in this urban environment. This is particularly interesting because this site received the lowest overall EIA score of all of the AAs surveyed.

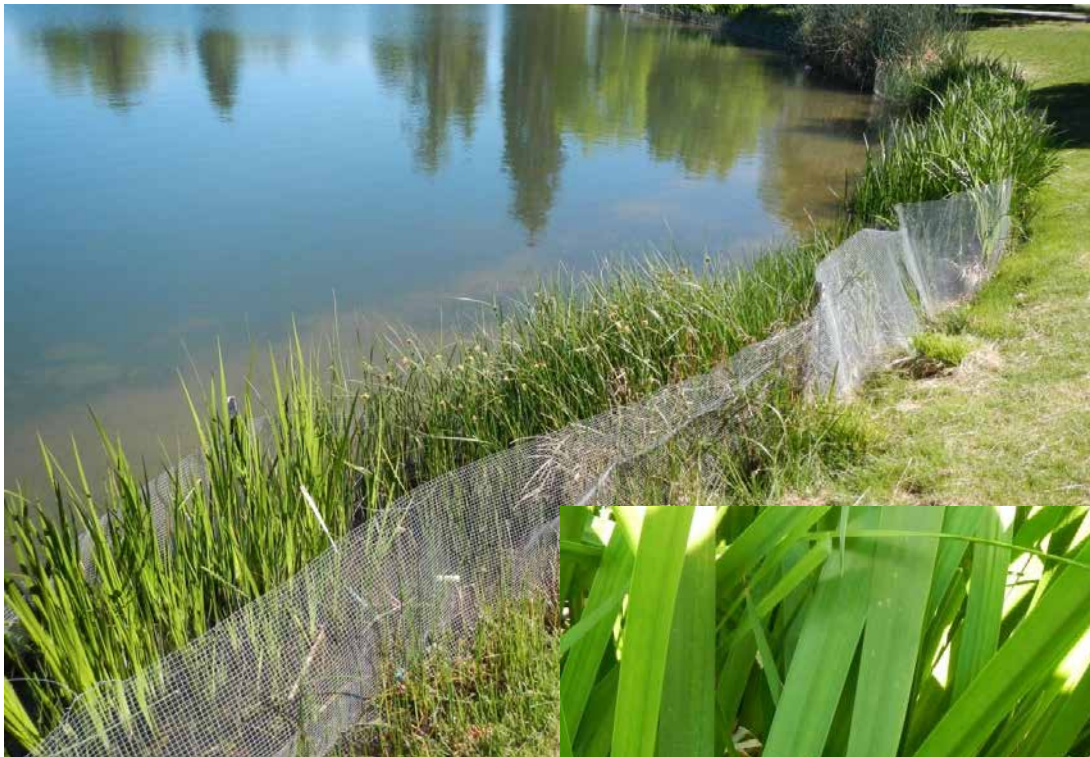
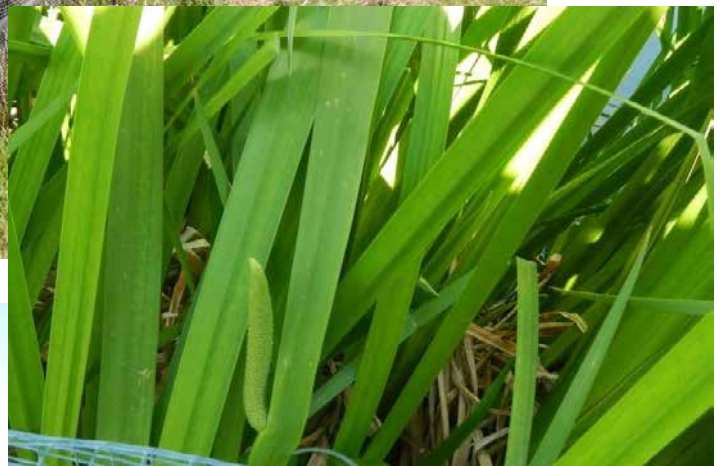
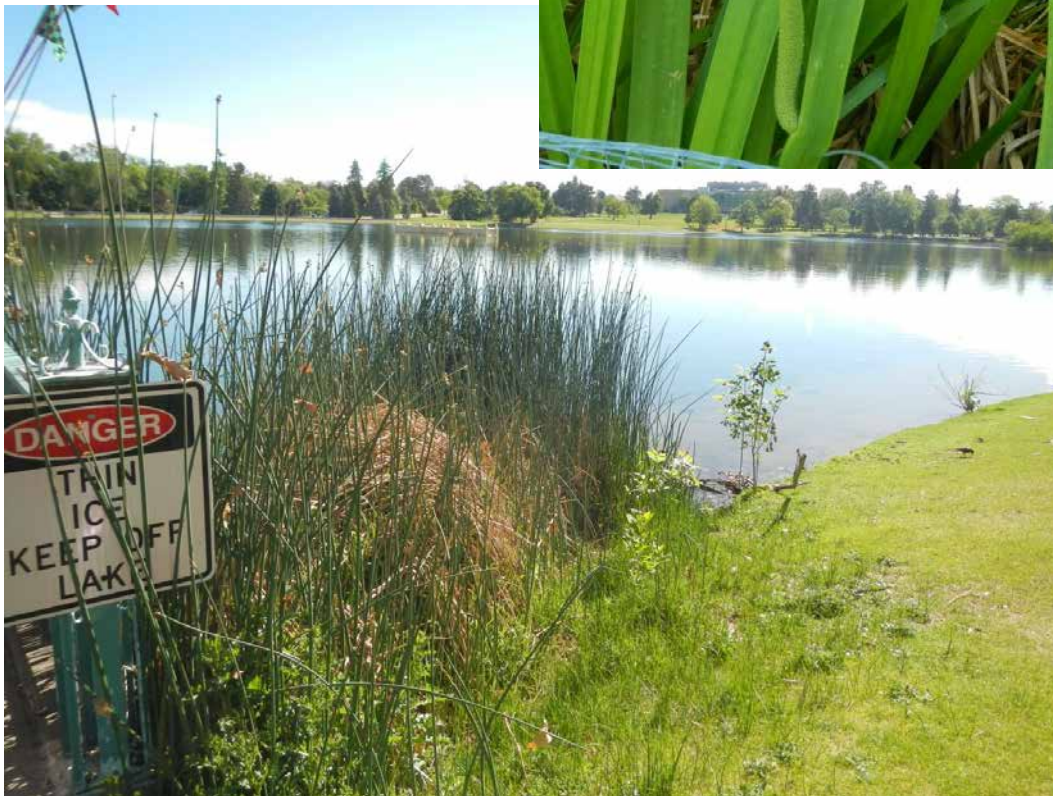
Figure 18. Ferril Lake at City Park with very small wetland fringes along shoreline that include sweet flag. Native wetland plants are visible trying to grow in the mowed zone. This is a great example where reducing mowing alone would improve the plant zone on the lakeshore and would protect the lake's water quality while reducing maintenance costs.

including City Park (Figure 18). Two excavated lakes at City Park include Ferril and Duck Lakes. They are totally surrounded by manicured areas and paved trails, and even paved shoreline in some areas in a very densely developed metro park area. In the small areas where the wetland plants are allowed to flourish along the lakeshore, there is a high quality very narrow vegetated buffer of tall native herbaceous plants that has developed around the shoreline that contains a population of the rare CNHP tracked plant, sweet flag (*Acorus calamus*). Many of the man-made features in Denver have been lakes or ponds for over 100 years (Dudley 2004) and have developed wetland vegetation around them or maintain wetland plantings well, with Berkeley and Rocky Mountain Lakes being two examples. Both of these lakes had some native plant occurrences including some rare and uncommon plants: duck meat (*Spirodela polyrhiza*), sweet flag (*Acorus calamus*), and broadfruit bur-reed (*Sparganium eurycarpum*).

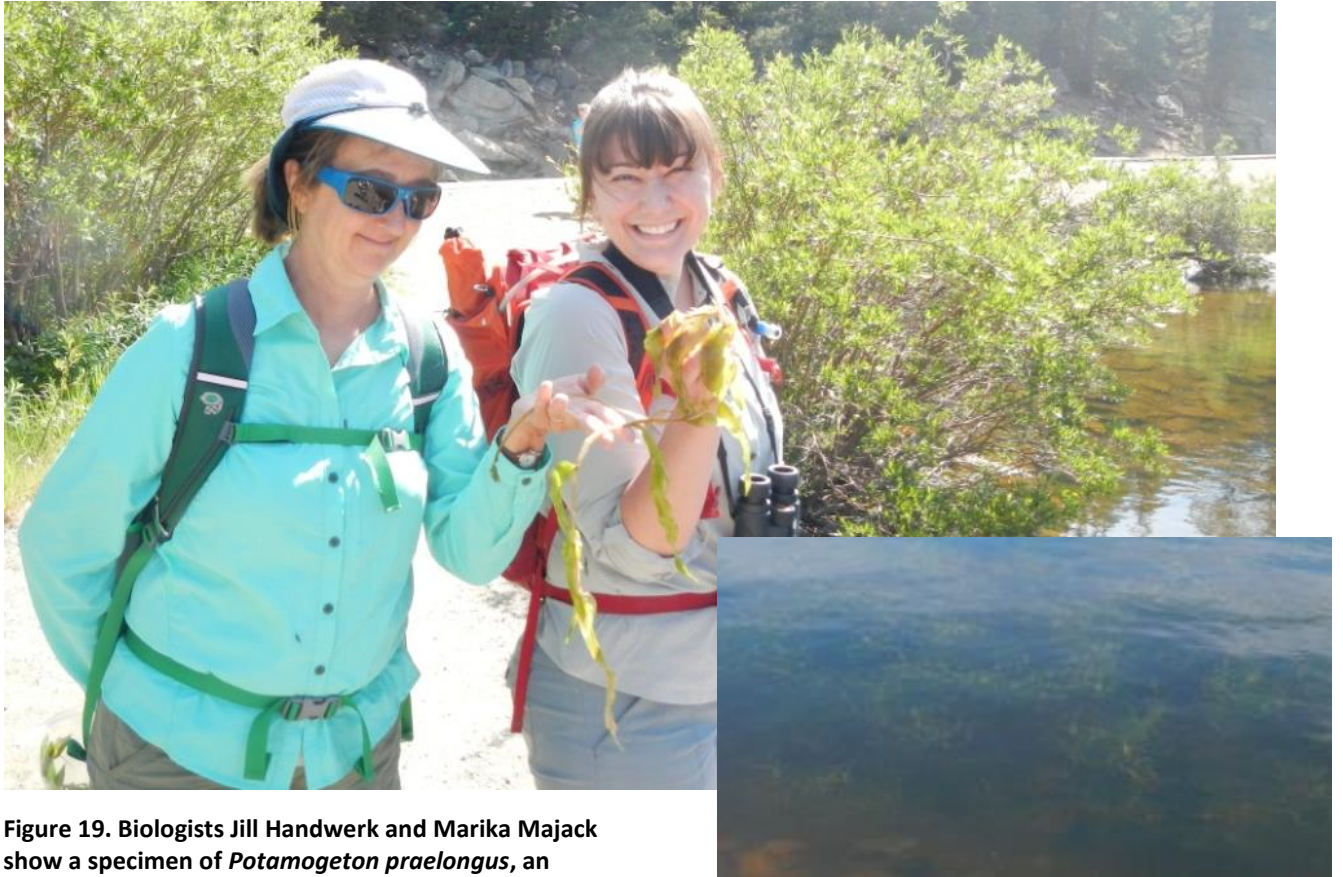
Figure 19. Biologists Jill Handwerk and Marika Majack show a specimen of *Potamogeton praelongus*, an uncommon native pondweed, at Echo Lake Mountain Park. Inset shows submerged plants. Photo: P.Smith July 09, 2014).

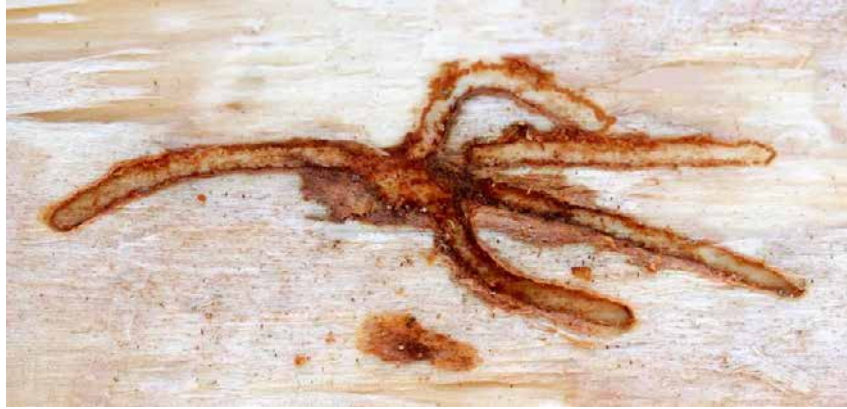
Egg galleries of the Four-eyed Spruce Beetle from just under the bark of a fallen Engelmann Spruce, Echo Lake

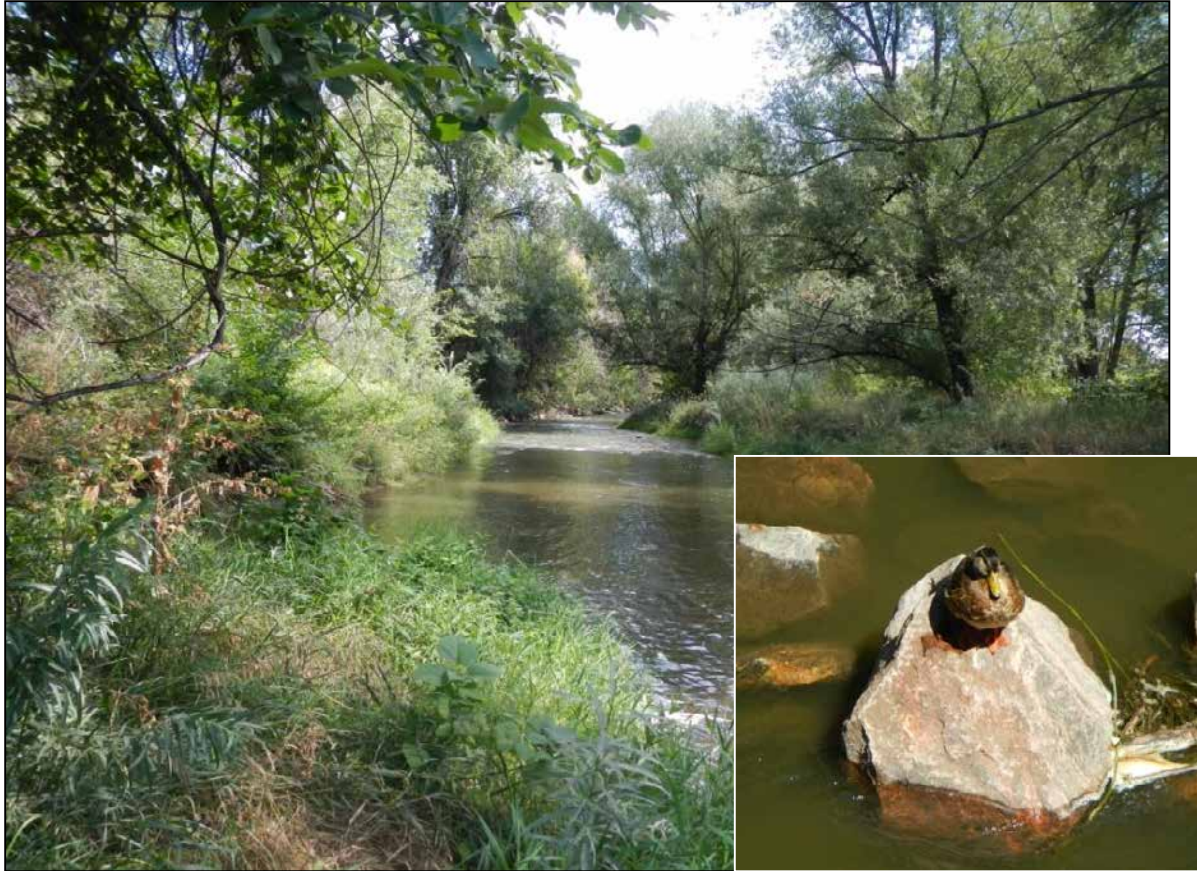
General Description: The Bear Creek East AA includes a one mile stretch of Bear Creek that flows between the east side of Bear Creek Park to South Lowell Boulevard. The northern section of the river is bounded by Highway 285 (S. Hampden Boulevard). Dense urban development surrounds the assessment area and includes residences, paved roads, highways, schools, ball fields and a cemetery. This section of the river has a very thick forested overstory with shrub and herbaceous layers. The forested wetlands supported along this riverine wetland are uncommon in Denver County. Plains cottonwood (*Populus deltoides* ssp. *monilifera*) and lanceleaf cottonwood (*Populus x acuminata*) are two important native overstory species while crack willow (*Salix fragilis*), green ash (*Fraxinus pennsylvanica*), and Siberian elm (*Ulmus pumila*) are common non-native overstory species. A number of cultivated woody plants were also observed in the understory. These are garden escapes that are growing on the riverbanks: catalpa (*Catalpa speciosa*), tree of heaven (*Ailanthus altissima*), silver maple (*Acer saccharinum*), honey locust (*Gleditsia tricanthos*), linden (*Tilia* sp.), and common buckthorn (*Rhamnus cathartica*).

Rank Comments: This survey area was ranked 2.1 for the overall EIA score. For Denver County, the overall EIA ranks ranged from a high of 2.8 (C) to 1.3 (D). Of the 40 sites in Denver County there was a range of 13 different numerical scores. Five other sites scored a 2.1 overall EIA, placing the Bear Creek East AA at number 6 out of the 13 possible scores (medium range). The connectivity of the river and the development of forested banks add greatly to the quality of this site and account for a higher Hydrological Condition score in the C range. Because this area is on the west side of the County, the development is not quite as extreme as it is further east. The forested overstory helps cool the water which is important for many wildlife species as is the structure provided by the trees, shrubs and herbs for feeding, nesting, and predator and prey relationships. The vegetated zone along this stretch of river is significant here and helps filter pollutants from surrounding urban runoff. This AA also has a higher buffer score because some of the surrounding land within 100 meters of the site is not paved, the average width of buffer provided by vegetation (manicured lawns are not included) averages about 34 meters which is excellent in this densely developed urban area. The plant biodiversity was moderate with 77 different species present within the AA. These factors contributed to the score and are indicative of good hydrological functioning of this area and potential for restoration and regeneration of a more highly functioning system.

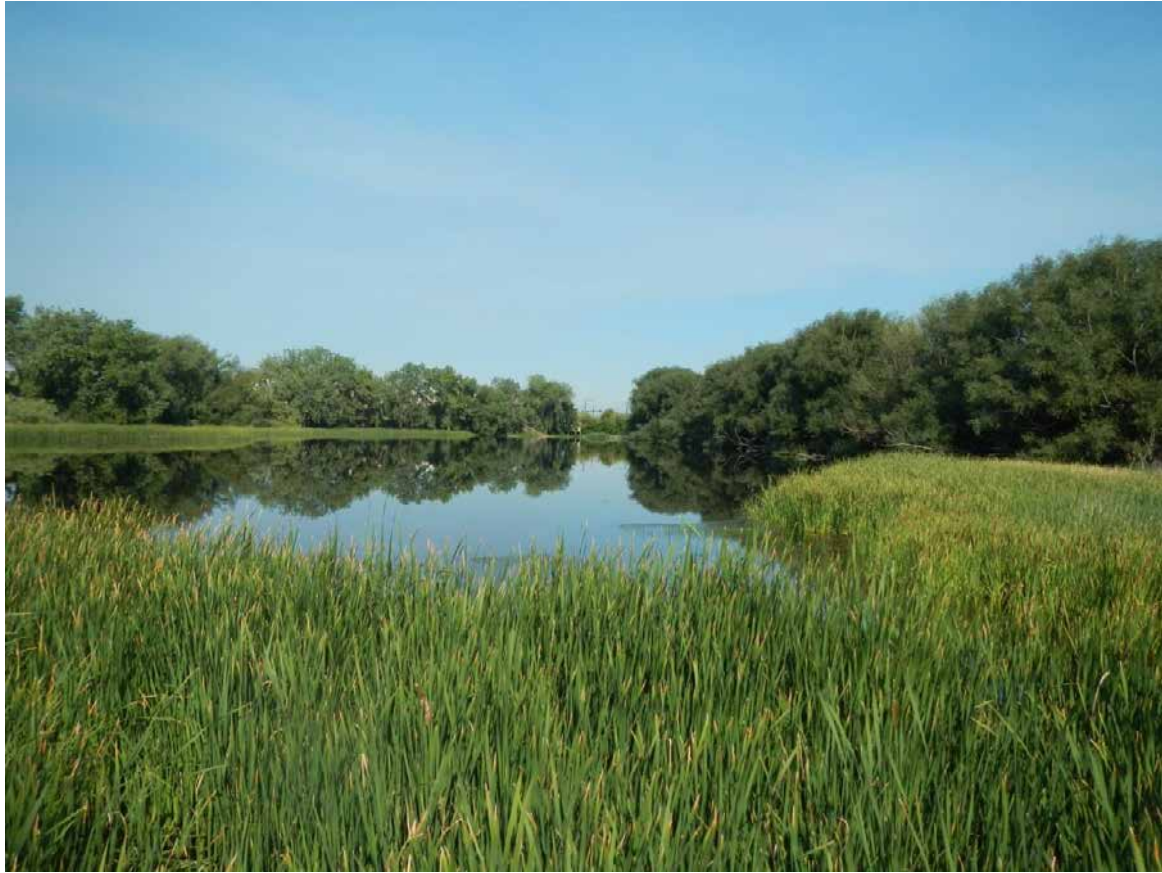
Key Environmental Factors: The low development in the surrounding upland buffer areas which were found to have a large variety of native prairie species is a very important environmental factor that likely protects and enhances this wetland site. The Landscape Context score in the C range and the Biotic Condition scores were both relatively high compared to other urban Denver sites.

Rank Comments: This survey area was ranked 2.0 for the overall EIA score. For Denver County, the overall EIA ranks ranged from a high of 2.8 (C) to 1.3 (D). Of the 40 sites in Denver County there was a range of 13 different numerical scores. Eight other sites also scored a 2.0 overall EIA, placing this AA at number 7 out of the 13 possible scores which is in the medium range. The landscape context rank was quite high for this site reflecting the low development in the surrounding buffer lands. The plant diversity and native plant cover were high and were reflected in the fairly high Biotic Condition score for this site. The Hydrologic Condition is not as high as the other scores because of the miles of storm drains that feed the wetland and the dam structure within the AA.

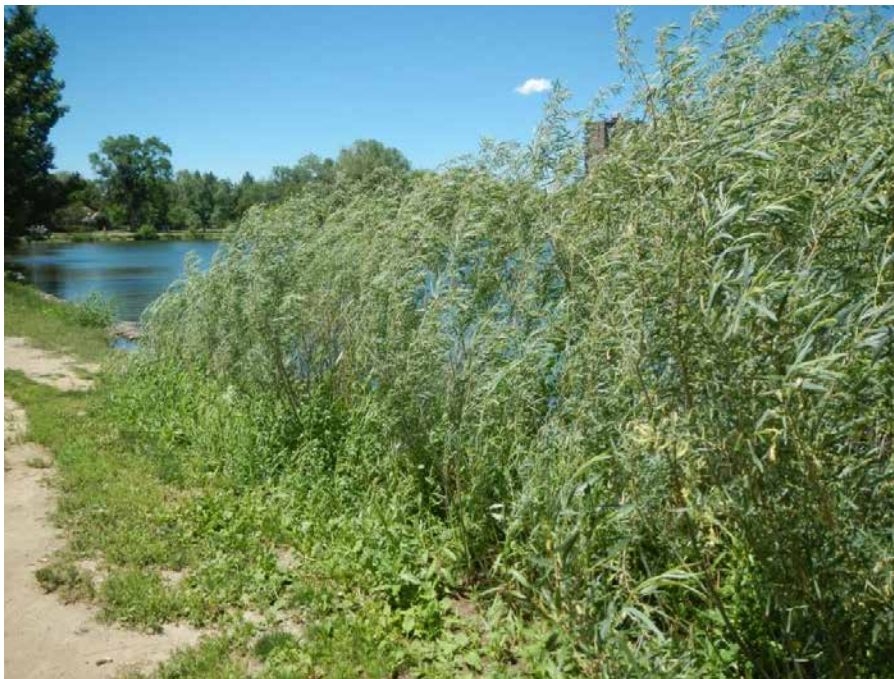
Photo 1. Native willow shrubs along Smith Lake shoreline. P. Smith 2014

Key Environmental Factors: The very small fringe of wetland plants on east-southeast shores of the lake are very important because they have the potential to expand by not mowing to the water's edge (Photo 1).
