THESIS

EVALUATION OF RAPID SCANNING TECHNIQUES FOR INSPECTING CONCRETE  
BRIDGE DECKS WITH ASPHALT OVERLAY

Colorado State University

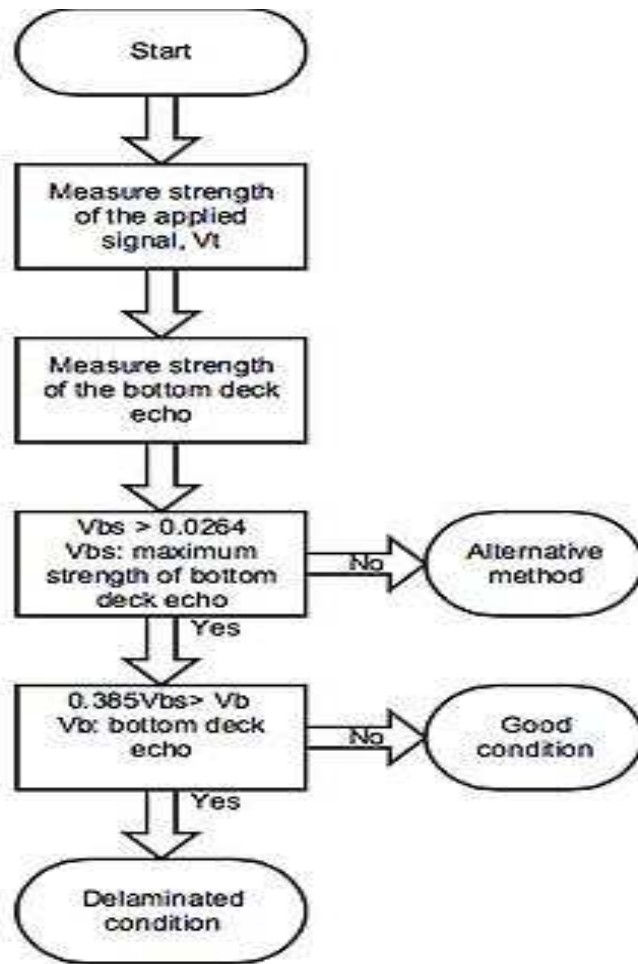
Figure 1: Finding delaminated areas using bottom deck attenuation technique (ASTM, 2008)

The procedures for obtaining the reflection amplitudes for the three procedures in this section are explained using flow charts using figure 1, figure 2 and figure 3.

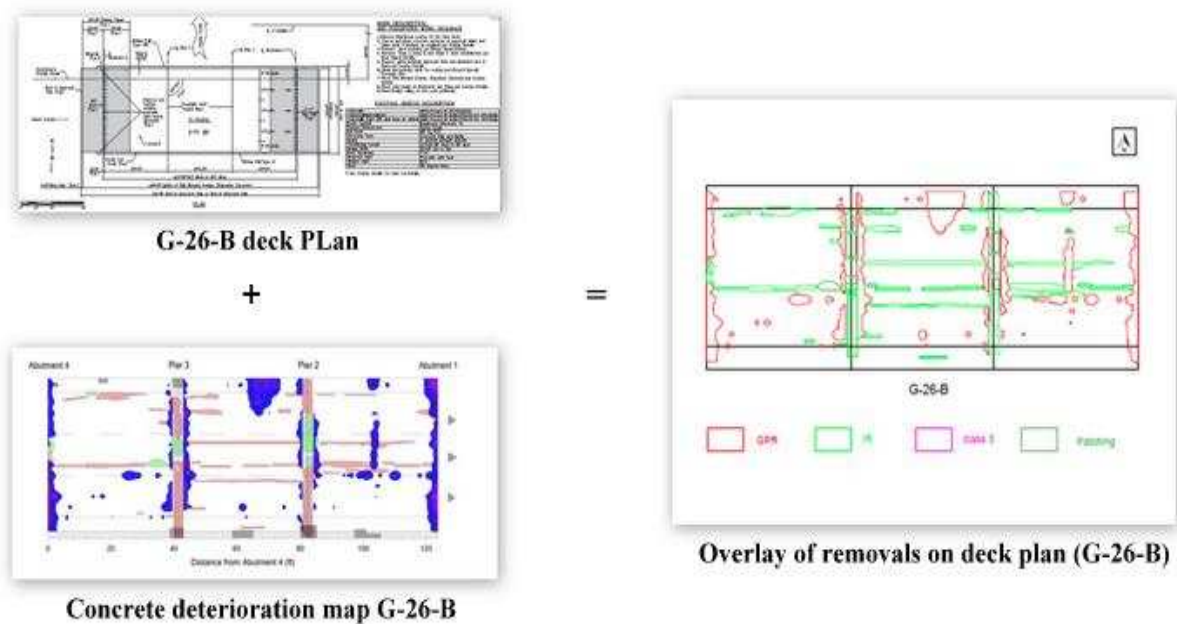
*Figure 5: Removals estimation map preparation from NDE data*

scale in AutoCAD. These areas were traced to the deck plan using mouse cursor. Such an overlay typically includes estimations for class-1, class-2, and class-3 removals along with the existing patching work. Unique colors are provided for each of the estimations and patching. Figure 5 is an example of the procedure used for preparing a map of concrete deterioration in deck G-26-B using NDE reports.

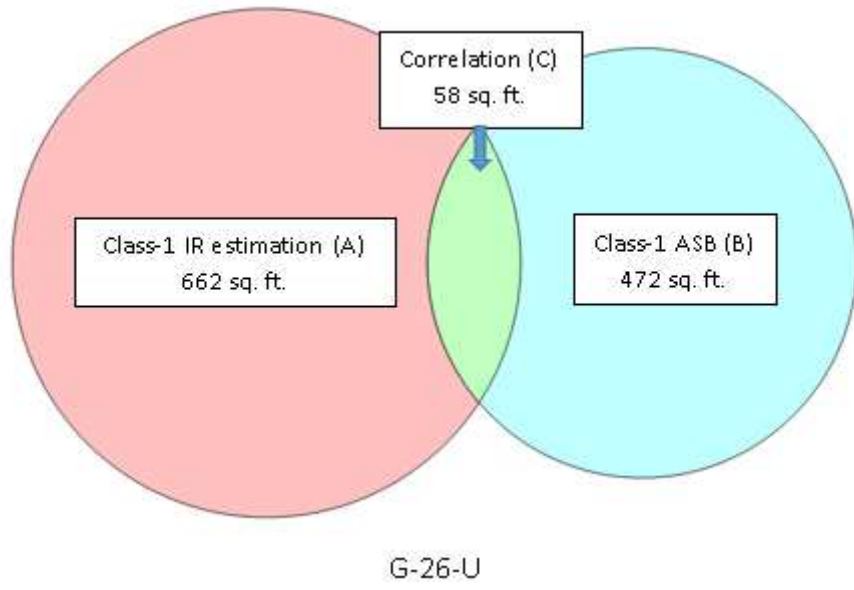
Figure 7: Comparison of G-26-U class-1 data

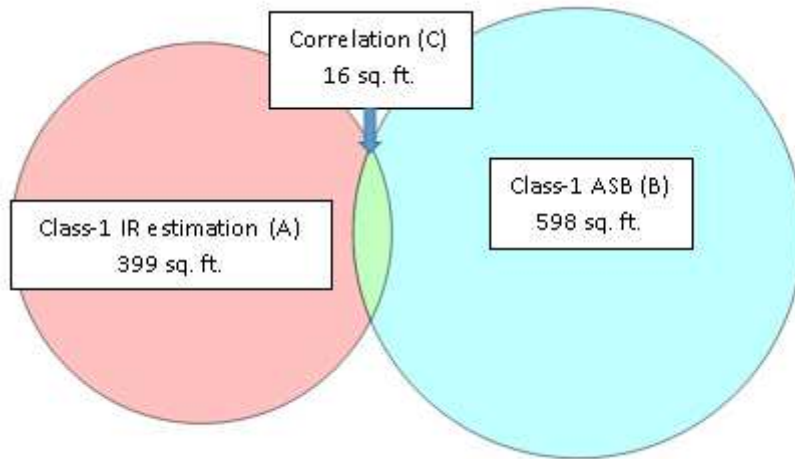
*Figure 9: Comparison of G-26-T class-1 data*

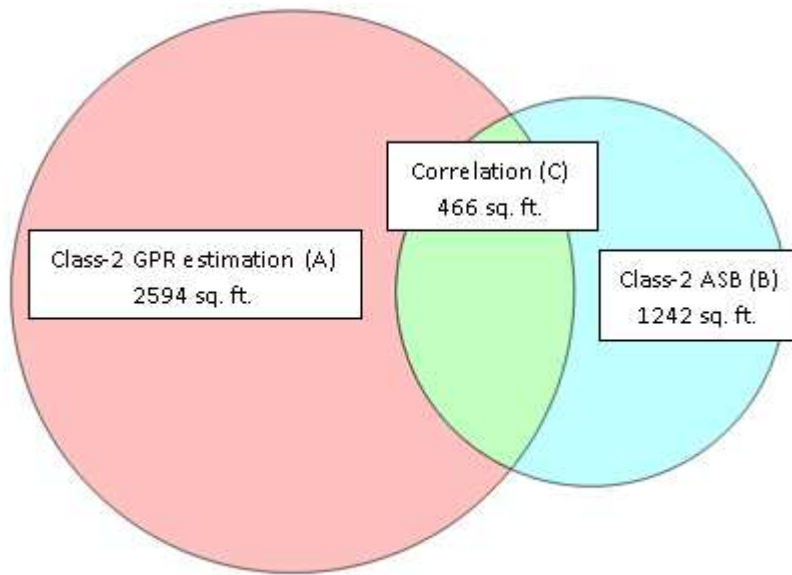
*Figure 12: Comparison of G-26-S class-2 data*

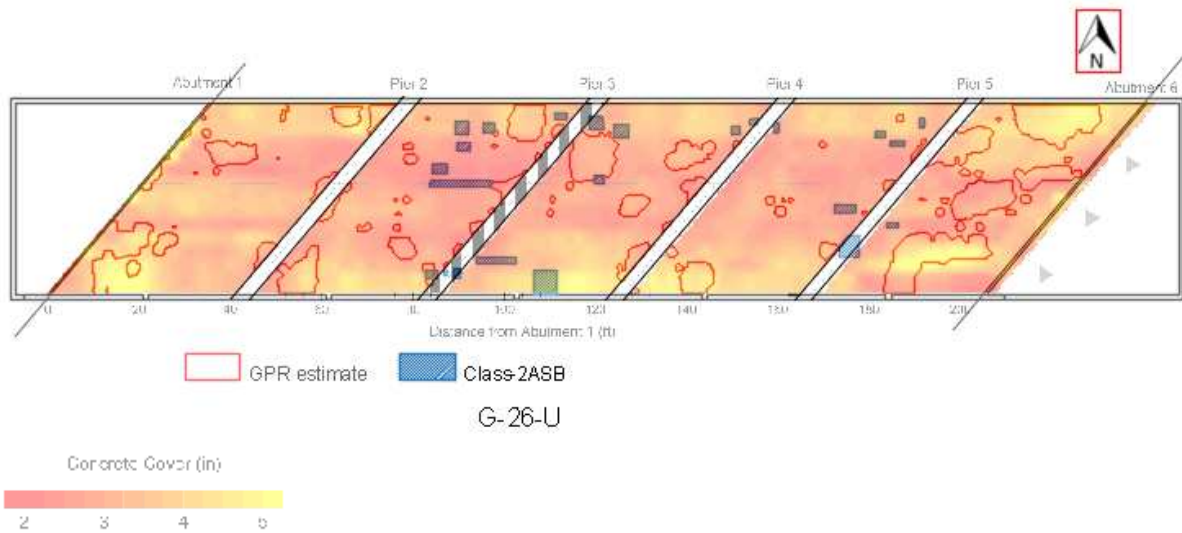
Figure 17: Contour map of concrete cover overlaid on deck plan with class-2 estimation and as-built data for G-26-U

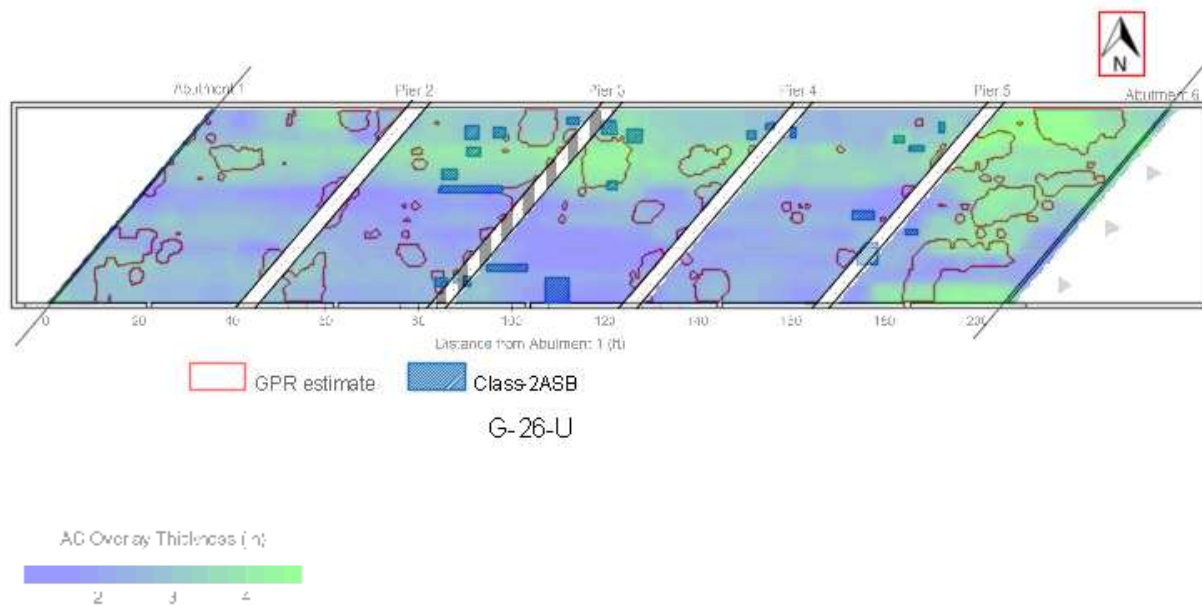
Figure 18: Contour map of asphalt cover overlaid on deck plan with class-2 estimation and as-built data for G-26-U

Figure 18 shows the overlay of GPR estimated class-2 on the contour map of asphalt thickness along with class-1 and class-2 as-built data. The asphalt thickness on the deck ranging from 0 in. to 5 in., the areas of higher thickness are represented in lighter green with increasing darkness to darker blue for minimum thickness. The areas of higher cover were calculated to be 6% of the total deck area using a similar procedure used on concrete cover maps. The deck has higher asphalt thickness on the fifth span from west and along the north extreme of the deck. It is also noted that 56.6% of estimated class-2 areas falls under areas of lighter color i.e. areas of higher asphalt thickness.

This means that about 76.6% of the area estimated using GPR is either under areas of higher concrete cover or higher thickness of asphalt or both.

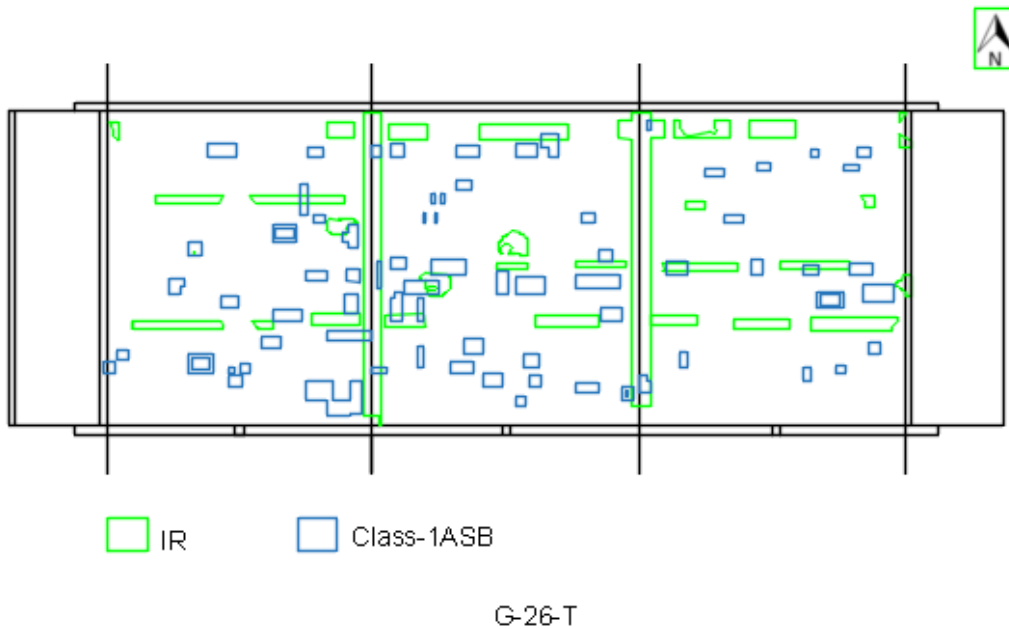
*Figure 19: Class-1 estimation and as-built data on deck plan for G-26-T*

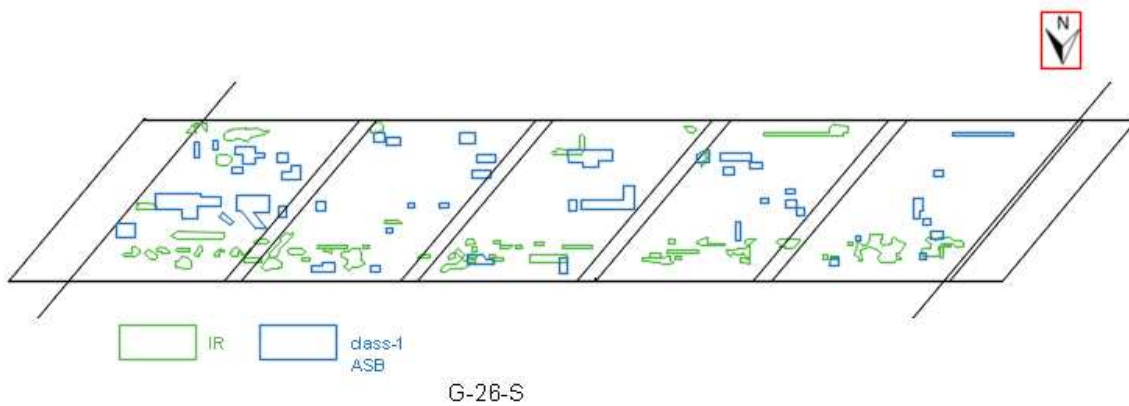
*Figure 23: Class-1 estimation and as-built data on deck plan for G-26-S*

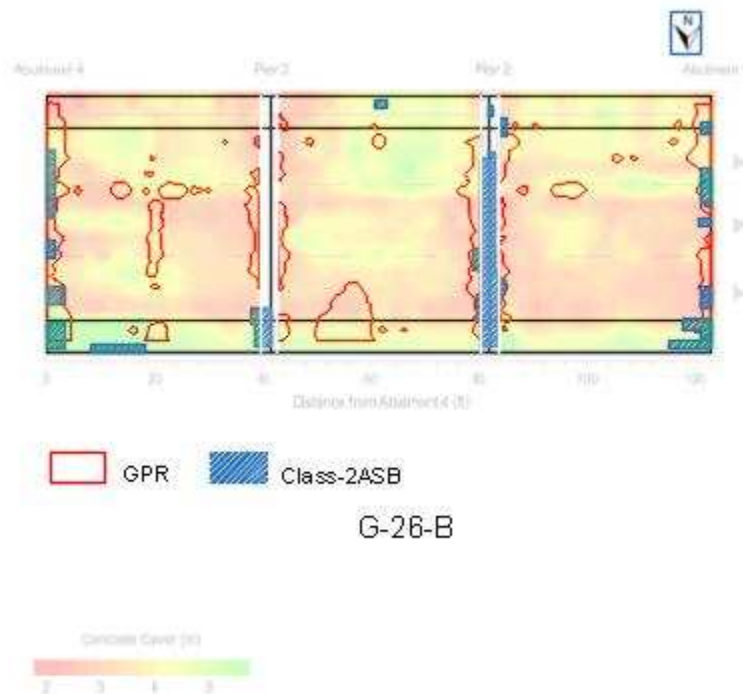
Figure 29: Contour map of concrete cover overlaid on deck plan with class-2 estimation and as-built data for G-26-B

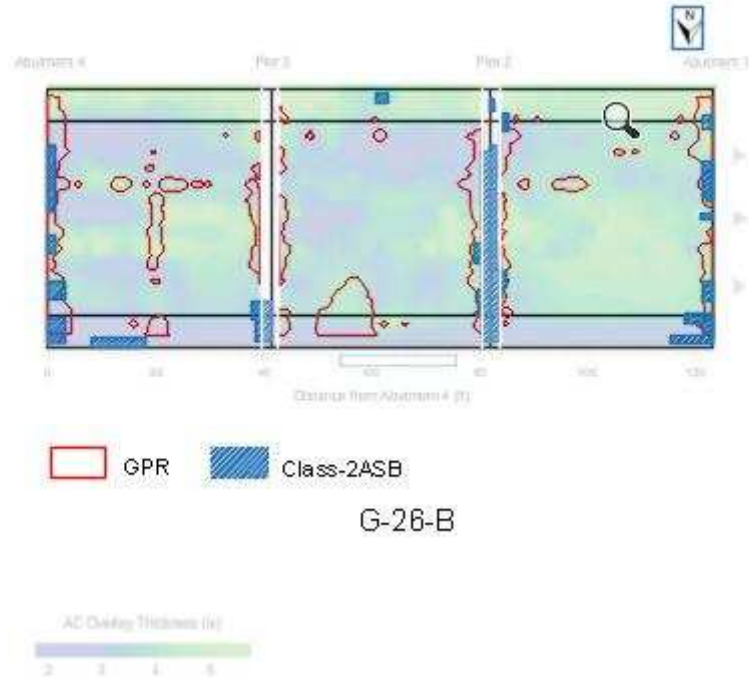
*Figure 30: Contour map of asphalt cover overlaid on deck plan with class-2 estimation and as-built data for G-26-B*

Figure 30 shows the overlay of asphalt thickness and estimated class-2 repair areas on the deck plan. The contour map shows areas of higher thickness in lighter green to areas of smaller cover in darker shades of blue.

GPR estimations show good correlations with the as-built data. The extreme north side of the deck has regions of higher thickness of both asphalt and concrete. The overlays show that there are three patches of class-2 work outside the class-2 areas estimated using GPR. Two of them on the first span from east side fall in the area of higher asphalt and concrete thickness near the extreme northern region of the deck. The third patch in the second span from the east falls in an area of higher concrete cover towards the southern edge of the deck. Of the 2593.76 sq. ft. rebuilt only 20 sq. ft. of repair work falls in regions away from deck joints.

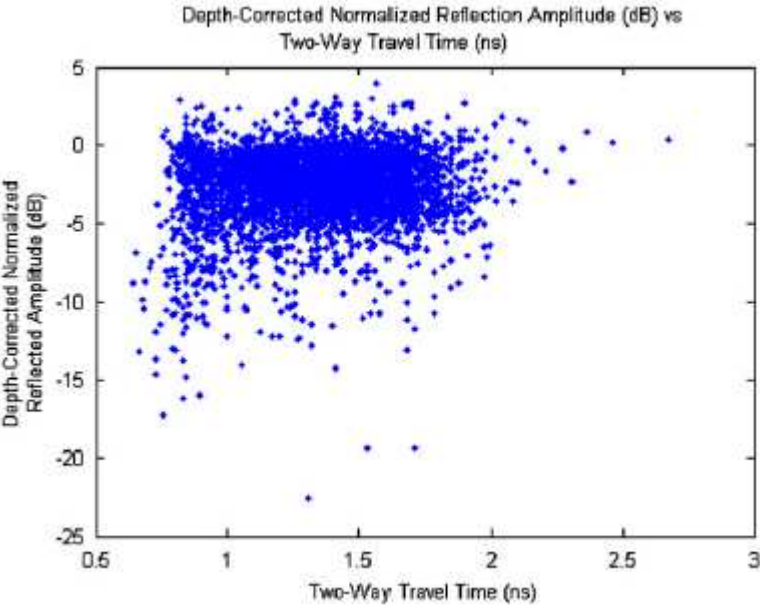
*Figure 33: Depth correction normalized reflection amplitude vs two-way travel time (Barnes & Frogeron, 2008)*

The depth correction procedure picks the 90<sup>th</sup> percentile amplitudes corresponding to each two-way travel time and assumes that the amplitudes above the 90<sup>th</sup> percentile are not influenced by deterioration. When not influenced by deterioration the amplitude variations are assumed to be caused only due to depth variations. The depth correction process applies regression analysis on the 90<sup>th</sup> percentile amplitudes to arrive at a more suitable common depth for the entire deck (Barnes & Frogeron, 2008). Using the corrected depth this procedure removes the depth dependent amplitude effects from the data and presents the data for a common corrected depth. The resulting plot between depth corrected reflection amplitude and two way travel time would be as shown in figure 33. The purpose of using depth correction procedure is to minimize the depth related errors on the deterioration estimation.

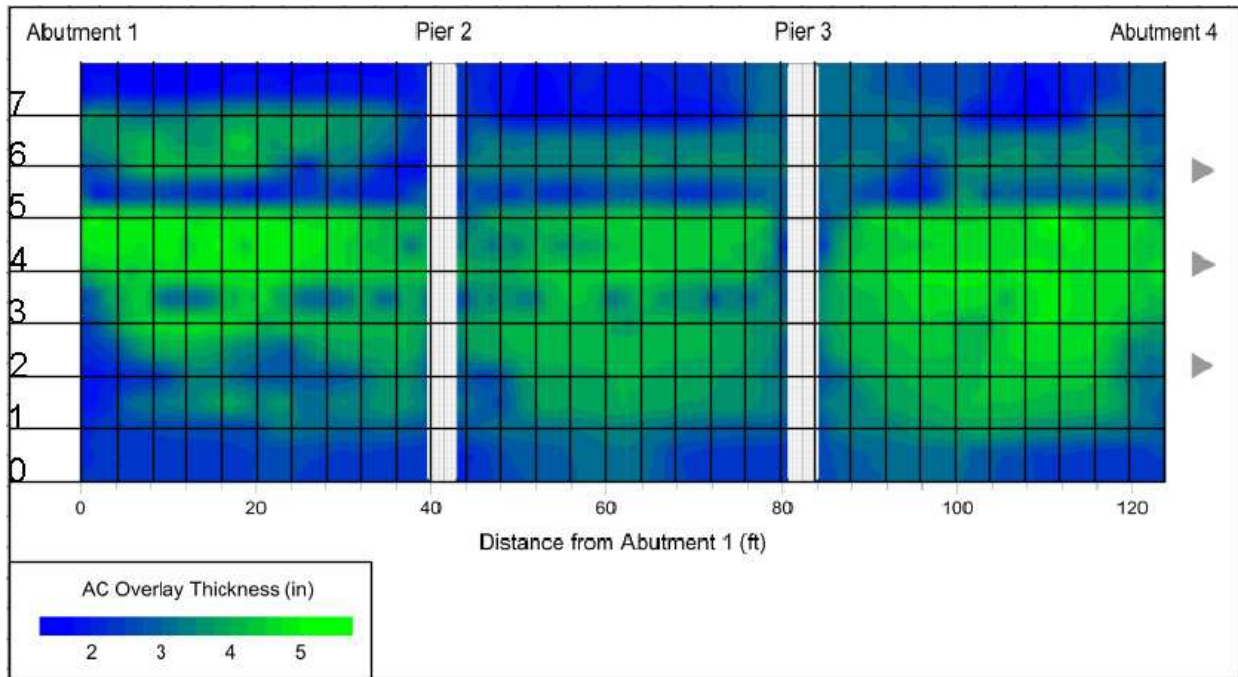
Figure 35: Segmented surface area of deck G-26-T with contour map of asphalt overlay

Figure 35 is segmented asphalt deck plan of G-26-T with the contour map of asphalt overlay. In table 12 the segments selected in step-3 are further subcategorized into respective asphalt cover categories as explained in step-4.
