Soil-Cement for High-Velocity Spillway Flow Applications

Korey J. Kadrmas¹, P.E., Project Manager, and Robert J. Huzjak², P.E., President,
¹RJH Consultants, Inc.
9800 Mt. Pyramid Court, Suite 330
Englewood, CO 80112
²RJH Consultants, Inc.
9800 Mt. Pyramid Court, Suite 330
Englewood, CO 80112
Email: kkadrmas@rjh-consultants.com

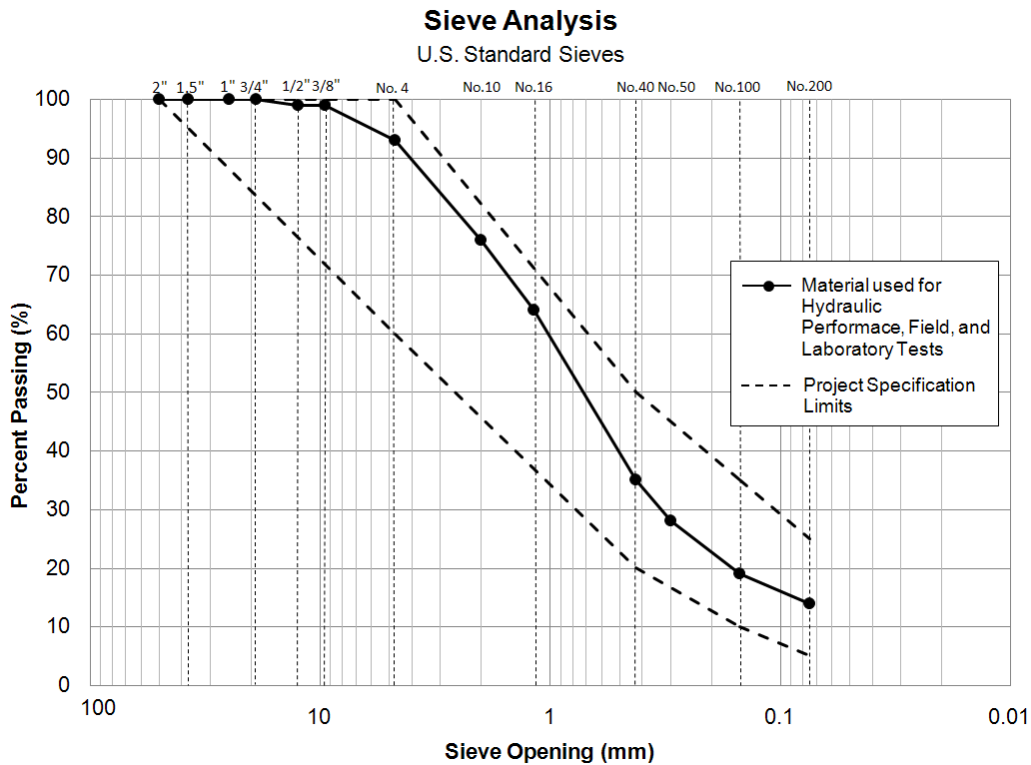
Figure 1. Base Soil Gradation Band

- Free from organic material with no lumps of clay larger than 1 inch (2.5 cm).
- Sulfate content less than 0.2 percent.
- Plasticity index of 6 or less.
- Meet the gradation band shown on Figure 1.
- Moisture density relations in accordance with ASTM D 558.
- Compressive strength in accordance with ASTM D 1633 with minimum compressive strengths of 600 pounds per square inch (psi) (42.2 kg/cm²) at 56 days.
- Freeze-Thaw durability tests in accordance with ASTM with a maximum loss of 8 percent.
- Wet-Dry durability tests in accordance with ASTM D 559 with a maximum loss of 6 percent.

Soil-cement samples were prepared in the laboratory to establish the target density for preparation of the field test specimens. The gradation of the base material used for these laboratory density tests is shown as the solid line on Figure 1.

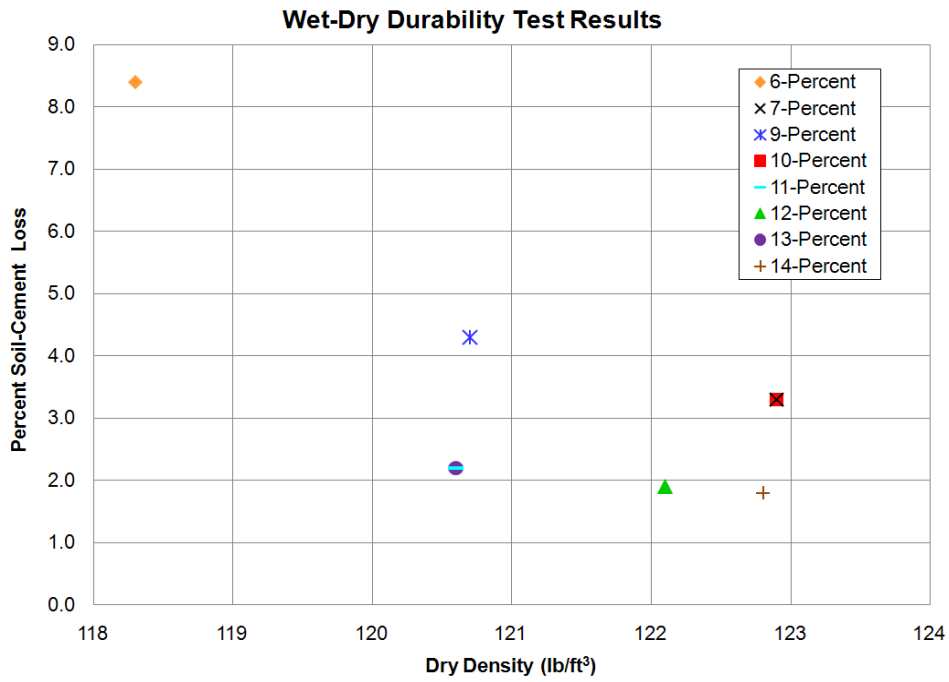
Figure 2. Wet-Dry Durability Test Results

The above test results demonstrate that all the mix designs meet the compressive strength and freeze-thaw durability requirements. However, a minimum cement content of about 7 percent was required to meet the wet-dry durability design criteria. In addition to meeting the above strength and durability requirements, the soil-cement intended for use on the spillway needed to resist significant erosion from high velocity flows. Based on these findings, the soil-cement with cement contents of 8, 10, and 12 percent was selected for the hydraulic performance test.

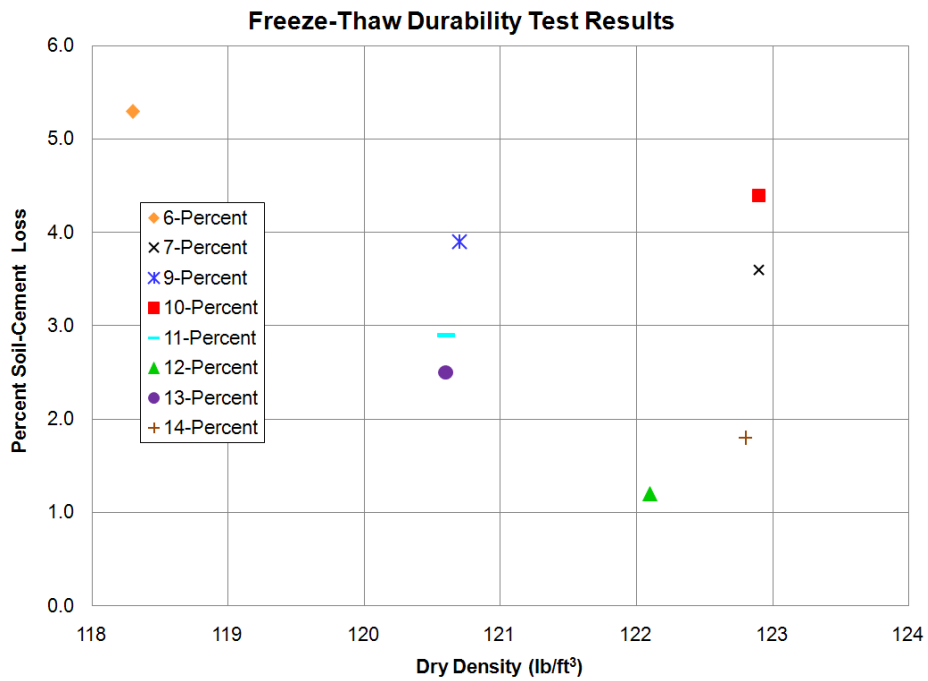
Figure 3. Freeze-Thaw Durability Test

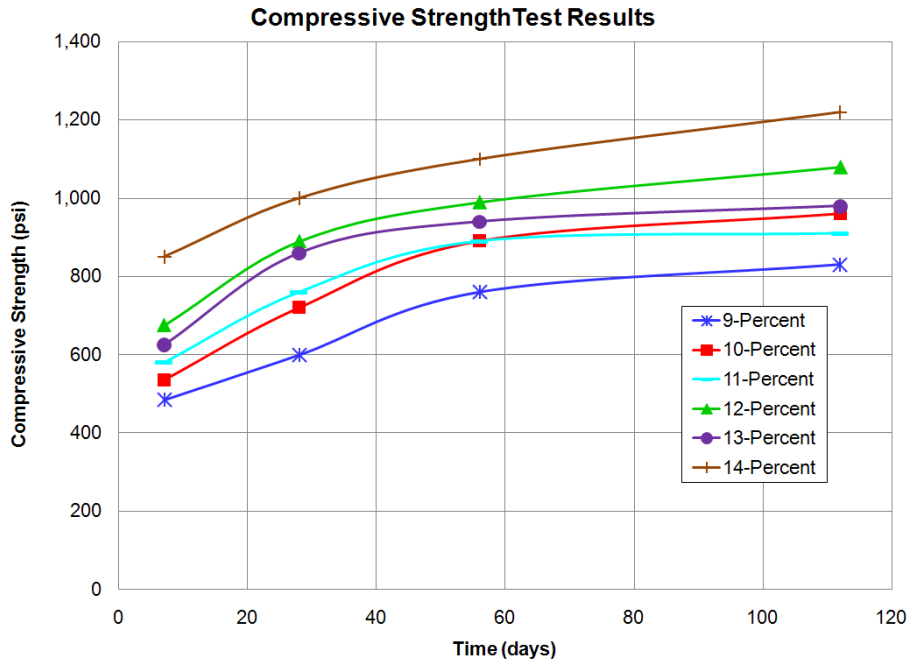
Figure 4. Compressive Strength Test

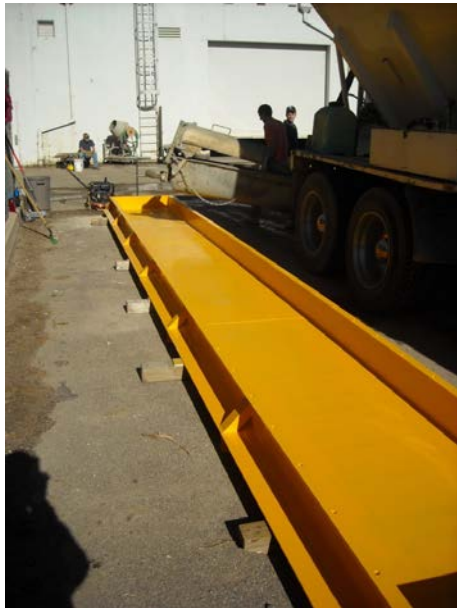
Photograph 1. Soil-Cement Test Box

Steel test boxes were constructed specifically for this evaluation. The soil-cement test boxes had nominal interior length, width, and depth dimensions of 30 feet, 3 feet, and 8 inches (9.1 m, 0.9 m and 0.2 m), respectively. A soil-cement test box is shown in Photograph 1.

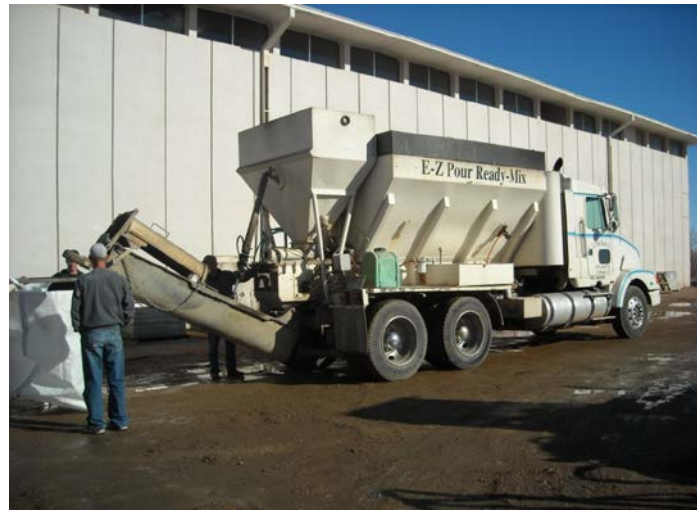
Photograph 2. Volumetric Cement Mixer (Ready-Mix Truck)

Three soil-cement test specimens were constructed with cement contents of 8, 10, and 12 percent cement content by weight. Prior to placement in the test boxes, the Portland cement, soil, and water mixture were mixed using ready-mix truck as a volumetric cement mixer. The mixer contained a system of hoppers (two), sprayers, conveyor belt, chute, and auger, as shown in Photograph 2.

Provisions followed to prepare the soil-cement mixture included: First the soil was weighed and loaded into the large hopper. The cement was then weighed and loaded into the small hopper. The soil and cement were then released from their respective hoppers onto a conveyor belt at designated rates to ensure the mix was consistent with the mix design. Water was then sprayed as shown in Photograph 3 onto the soil and cement at a designated rate to ensure the mix was consistent with the mix design.

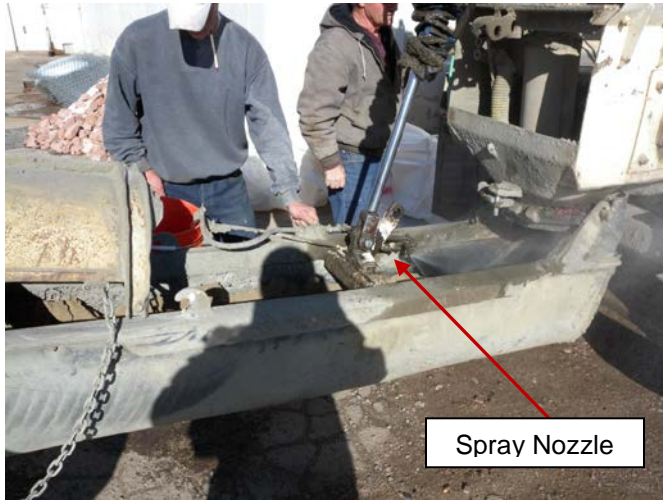
Photograph 3. Water Applicator and Chute

The combined materials were then conveyed into a half-pipe chute where a rotating auger mixed the materials. Soil-cement was placed in two lifts and compacted using a vibratory plate compactor to achieve a compacted thickness of 4 inches (10.2 cm) per lift. The first lift of the soil-cement mixture was placed uniformly into the soil-cement test boxes as shown in Photograph 4. After compaction of the first soil-cement lift, the surface was scarified with a rake prior to placement of the second lift as shown in Photograph 5.

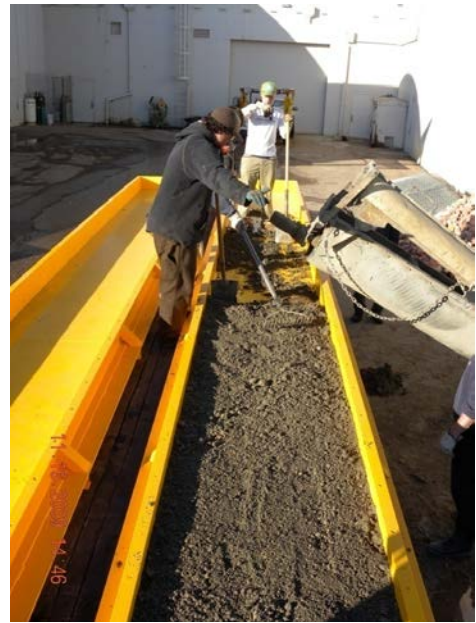
Photograph 4. First Lift Placement

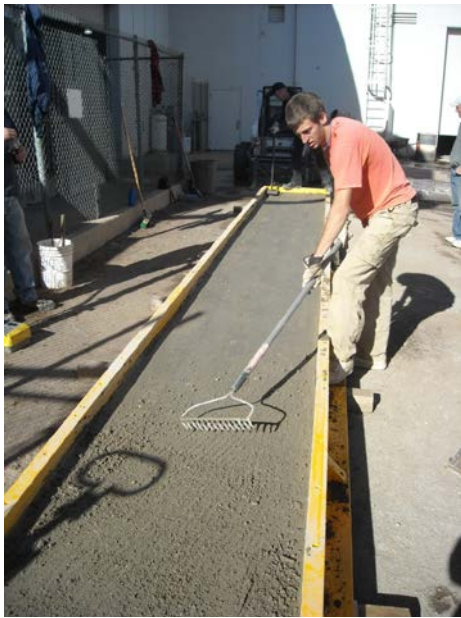
Photograph 5. Scarification between Lifts

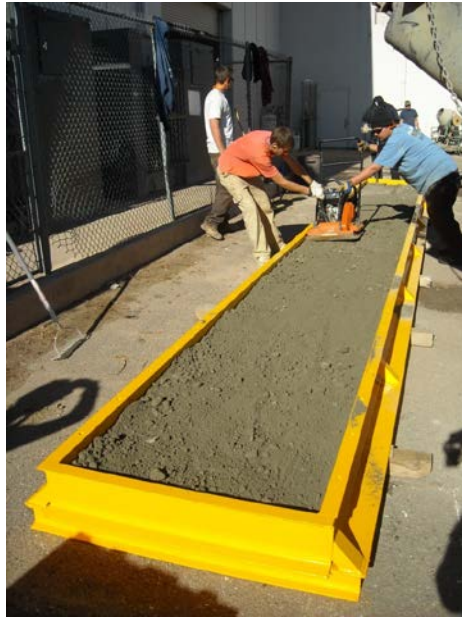
Photograph 6. Lift Compaction

Compaction of the final second lift for one of the test boxes is shown in Photograph 6. In the corners of the test boxes, the soil-cement was compacted using hand tampers to create a uniform and consistent top appearance to the soil-cement in the test boxes. Field density tests were completed at random following each 4-inch (10.2 cm) lift placement and were performed in general accordance with ASTM D 2992 to record the density of the placed materials.

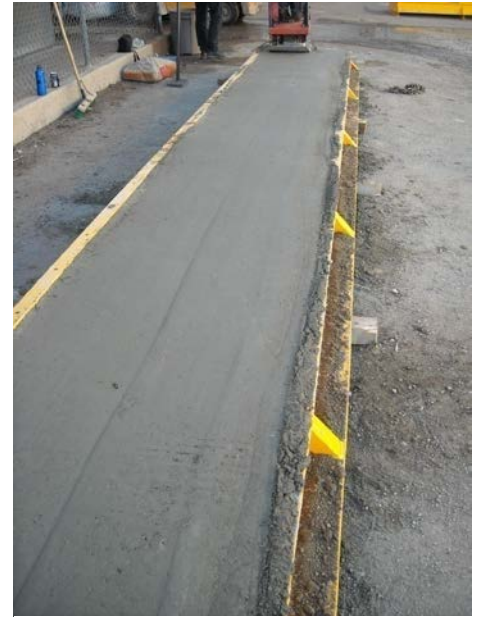
Photograph 7. Soil-cement Test Box

The finished surfaces of the soil-cement in the test boxes were touched up by hand to fill or smooth any surface defects. A completed soil-cement test box prior to curing is shown in Photograph 7.

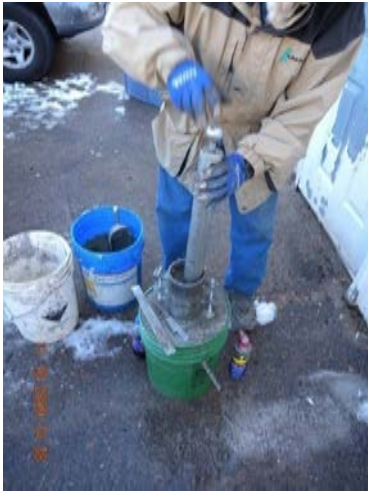
Photograph 8. Puck Preparation

Pucks (“samples”) were prepared from the materials used for each test specimen for subsequent laboratory testing. The pucks were developed according to ASTM D 558 using 4-inch-diameter (10.2-cm-diameter) steel molds about 4.6 inches (11.7 cm) deep and in three lifts. The materials were compacted using a 5.5 lb. (2.5 kg) hammer, falling 12 inches (30.5 cm), with 25 blows per each of the three lifts as shown in Photograph 8.

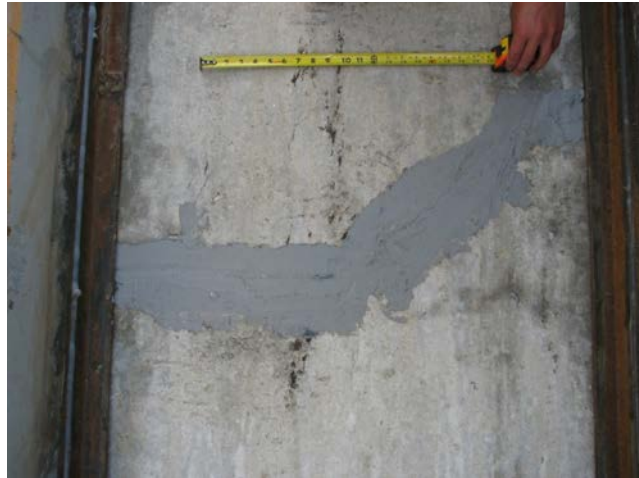
Photograph 9. Epoxy Paste Crack Repair

A few hairline cracks were observed on the surface of the test specimens following transport to the testing facility. These cracks were the result of transporting the test boxes. The objective of the testing was to evaluate the erosion performance of the soil-cement and not the effect of joints or cracks. The cracks were sealed using a high-strength, structural epoxy paste (Sikadur 31, Hi-Mod Gel) as shown in Photograph 9 so the cracks would not impact the test results. The epoxy paste was applied to seal the cracks and provide a smooth surface to reduce the potential for impacting hydraulic flow velocities and to provide a test specimen without defective locations. The evaluation of the test specimens focused on locations outside the limits of the cracks.

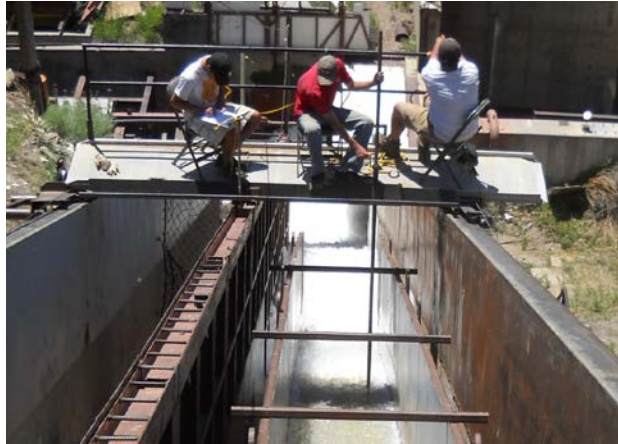
Photograph 10. Point Gage Measurement System

Elevations along the surface of the test specimens were recorded prior to and after termination of each test at the same locations as the “test in progress” water surface readings. Elevations were recorded to the nearest +/- 0.01 foot (0.3 cm) using an elevated point gage and survey level on a rail assembly over the flume. The flow rate along the test specimen was measured in the flume independently of flowmeter measurements using the point gage to record flow depths during the 6-hour test and convert the measurements to flow velocities. The point gage measurement system is shown in Photograph 10.

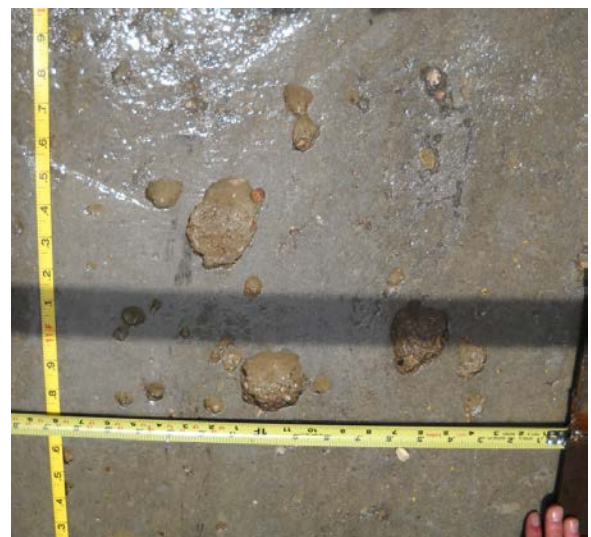
Photograph 17. Close Up – Erosion area after Test 3 – 10 Percent at 100 cfs

After Test 3, the existing pits from Test 2 did not appear to increase significantly in diameter or depth. The largest pit, about 5 inches (12.7 cm) in diameter, deepened to a total of about 1 1/4 inches (3.2 cm). The 3-inch-diameter (7.6 cm diameter) pits appeared to remain about 3 inches (7.6 cm) in diameter, and deepened to a total depth of about 1 inch (2.5 cm). The remaining pits did not appear to increase in diameter or depth. An increase in the number of small pits less than 1 inch (2.5 cm) in diameter and less than 1/4 inch (0.6 cm) in depth was observed. The minor amount of localized erosion appeared to increase slightly.
