## **ACB Armoring Potential Failure Modes At Dam Embankments and Spillways**

Paul Schweiger, P.E.<sup>1</sup>, Darin Shaffer, P.E.<sup>2</sup> and Jim Nadeau<sup>3</sup>

**Keywords:** *Potential Failure Modes, ACB, Armoring, Overtopping, Embankments, Spillways*

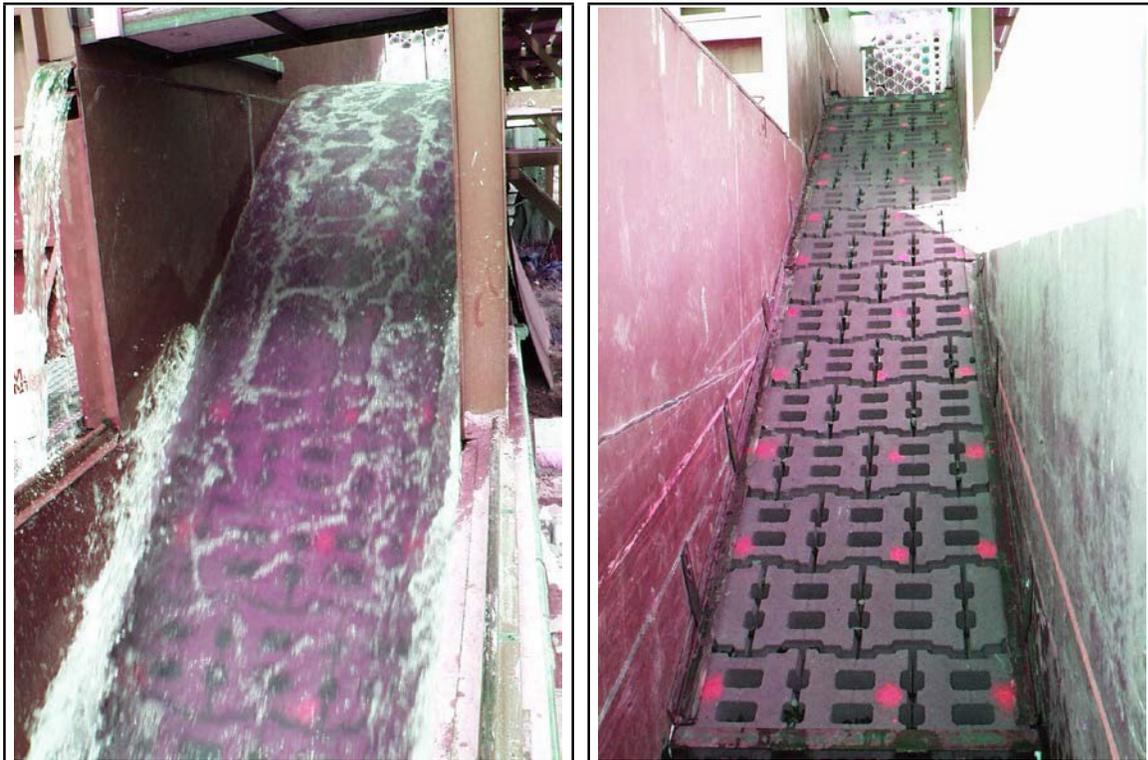
Figure 1. Full-Scale Laboratory Testing of ACB Systems at Colorado State University (Photos by Armortec)

Of the erosion protection systems evaluated, cable-tied concrete blocks, also referred to as articulating concrete blocks (ACBs), were found to provide the most effective protection against high-velocity induced erosion in full-scale tests conducted in Great Britain and the United States (Powledge et. al., 1989; USDOT, 1989). Analyses demonstrated the stability of ACB armoring systems on embankment slopes as steep as 2H:1V with overtopping depths exceeding 4 feet and terminal flow velocities exceeding 26 feet per second.

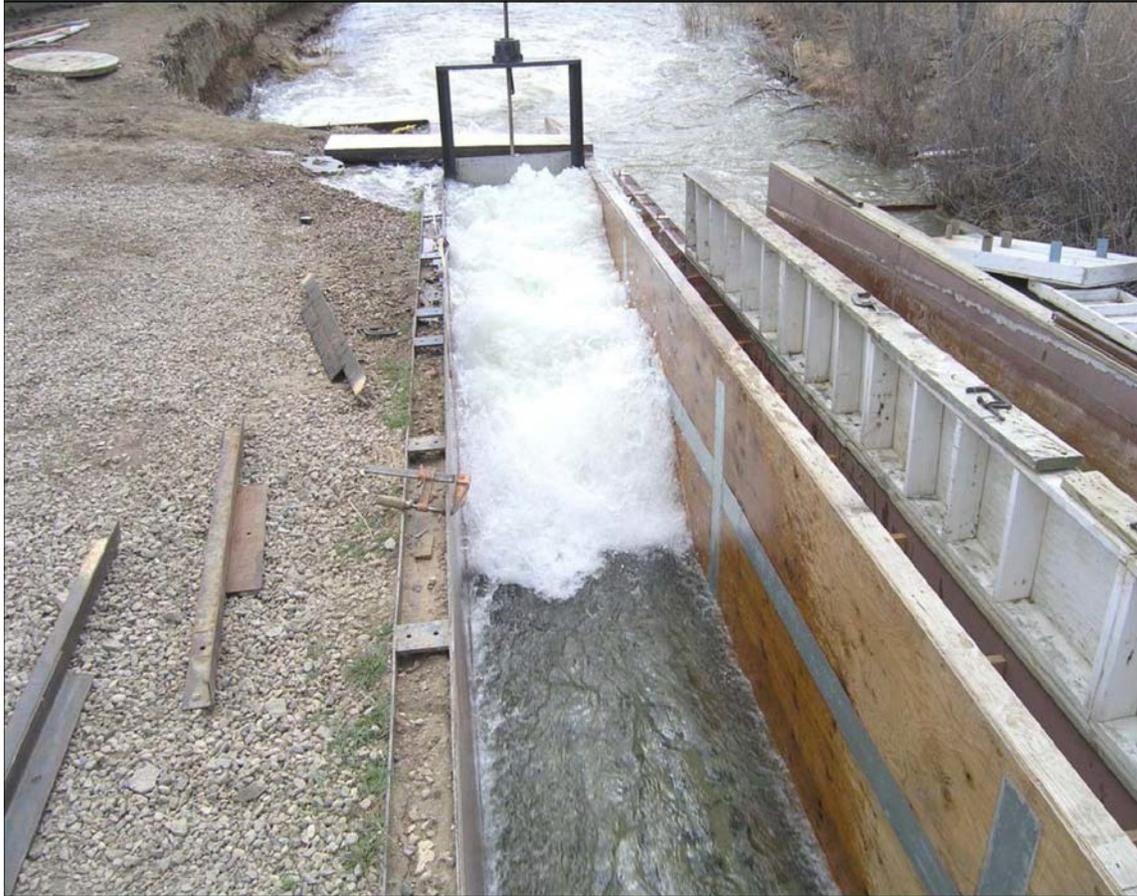
Figure 2. Full-Scale Test of Hydraulic Jump on ACBs in CSU Flume (Photo Courtesy of Chris Thornton)

An important unknown about the performance of ACB systems was how they performed under the influence of a hydraulic jump. In March 2006, CSU performed the first hydraulic jump testing of an ACB system for Armortec Erosion Control Solutions, Inc. (AECS), [Thornton et. al., 2007]. Three full-scale tests were conducted in controlled laboratory conditions for the purpose of identifying stability threshold conditions under the influence of a hydraulic jump. The tests were performed in a 4-foot-wide flume on a 65-foot-long slope with a 7.7H:1V (12.6%) grade. A picture showing the hydraulic jump testing is shown in Figure 2. The block system tested was the AECS 50T ACB system which is a tapered open-cell block with a maximum thickness of 6 inches and an average weight of 82 pounds. A 4-inch thick filter layer of gravel was installed directly on the concrete floor of the flume under the blocks with a Filterweave® 500 geotextile placed between the gravel layer and blocks. The open cells were also filled with gravel. The ACB system was tested to see if it could endure 1-hour of overtopping without any visible block lifting. The discharges used to test the ACB system were 21, 90, and 168 cfs. The 168 cfs was the highest flow possible that could be retained within the 6-foot high flume walls and corresponded to an overtopping depth of approximately 5.8 feet. No movement of the revetment system was observed for all conditions tested including for the most severe hydraulic jump that could be contained within the flume.

In February 2011, CSU conducted hydraulic jump tests on the SD-475 OCT ACB system manufactured by Premier Concrete Products, Inc. [Pluemer et. al., 2011]. The SD-475 OCT block system is a tapered open-cell block with a maximum thickness of 4.75 inches and an average weight of 65 pounds. The tests were performed in a 4-foot-wide flume on a 70-foot-long slope with a 2H:1V slope. An 8-inch soil embankment was placed on top of the concrete flume floor. Propex Geotex 1201 non-woven geotextile fabric was placed onto the compacted subgrade embankment over which 4-inches of gravel drainage material was placed and leveled. Fortrac 30G Geogrid was placed onto the gravel drainage material before placing the SD-475 OCT blocks and chinking the open cells with gravel drainage material. The ACB system was tested in 1-foot increments of overtopping for 2-hour durations. The first test with approximately 1-foot of overtopping (15 cfs) was observed to be stable. Test 2 with approximately 2 feet of overtopping (30 cfs) yielded a transition point between stable and unstable conditions, with observed localized block instability but no loss of intimate contact. The performance threshold, as identified as loss of intimate contact with the subgrade, was reached during Test 3 corresponding to approximately 3 feet of overtopping. The aforementioned tests appeared to indicate that on flat slopes, ACBs can be stable when subjected to the influence of a hydraulic jump. As the slope becomes steeper and the unit discharge is increased, ACB systems can become unstable.

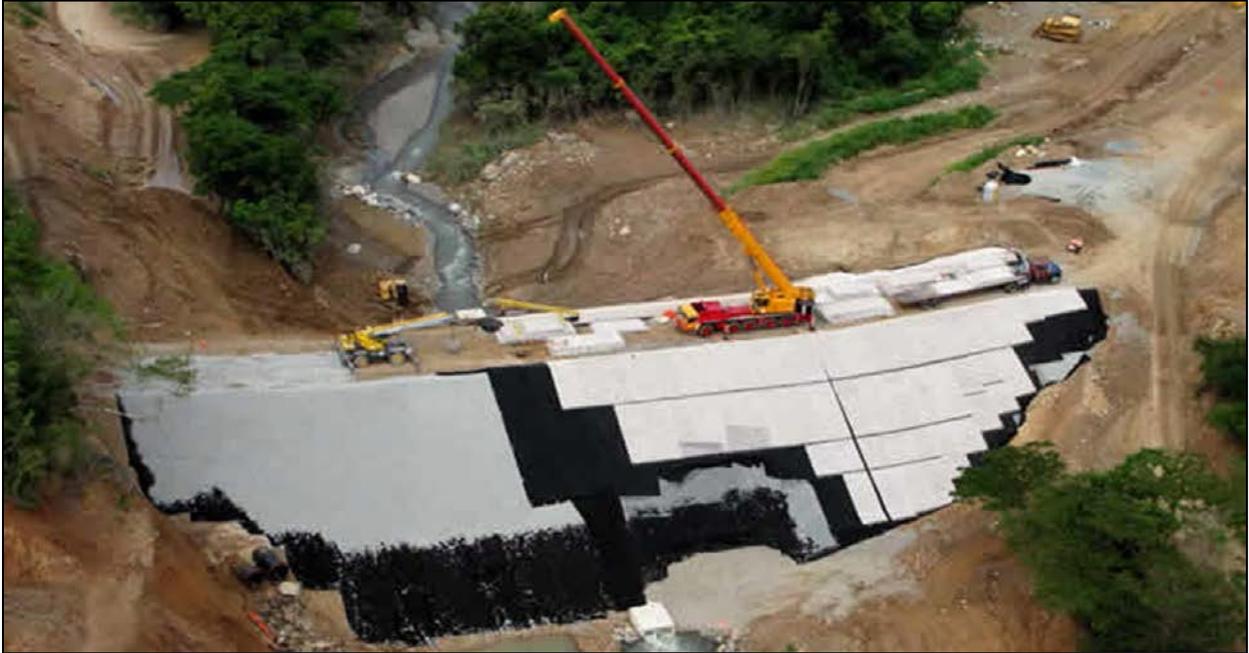
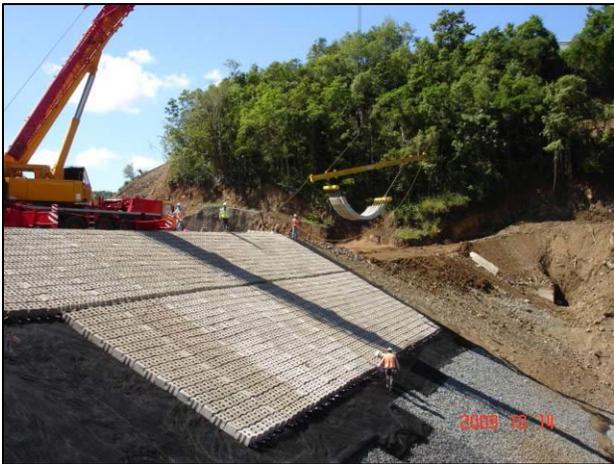
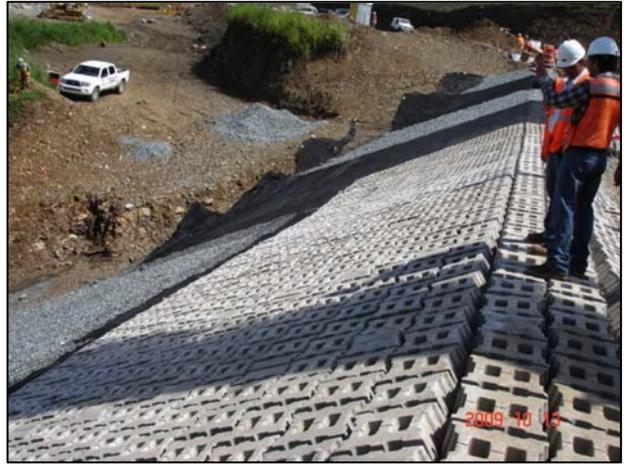
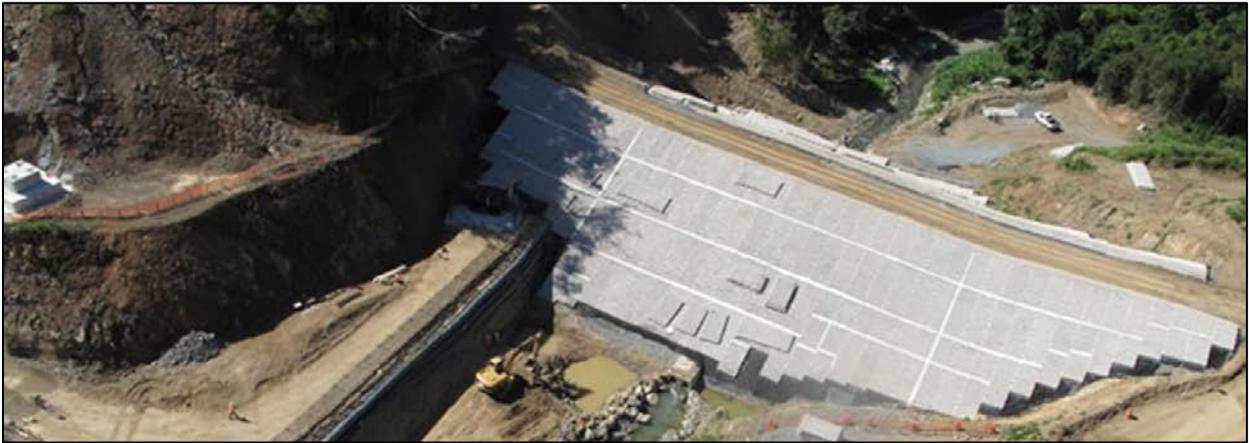
Figure 3. Photos Showing Installation of ACBs on Portugués Cofferdam, Puerto Rico (Photos Courtesy of Jacksonville District USACE)

Since the project was located in a flashy watershed, the contractor elected to construct an earthen upstream cofferdam armored with ACBs to accommodate overtopping. The cofferdam was constructed with earth fill to a height of approximately 50 feet with a 2H:1V downstream slope. The downstream slope was armored with 46,436 square feet of ARMORTEC 70T open-celled ACB mats having a maximum block thickness of 8.5 inches and an average weight of 120 pounds per block. These are the largest open-celled tapered blocks manufactured by ARMORTEC/CONTECH. The mats were cabled together with polyester rope. The foundation treatment under the ACB system consisted of placing a geotextile (CONTECH C100NW) on the earth embankment followed by 6-inches of gravel, then another layer of geotextile (CONTECH C100NW) with a geogrid (Tensar BX 1300) on top of the geotextile. The reason for placing the second layer of geotextile on top of the gravel drainage material is unknown. The sides of the ACB mats were not connected to each other and no special toe treatment appears to have been specified. A row of concrete jersey barriers lined the roadway on both the upstream and downstream sides of the top of the cofferdam. Construction photos of the cofferdam are shown in Figure 3.

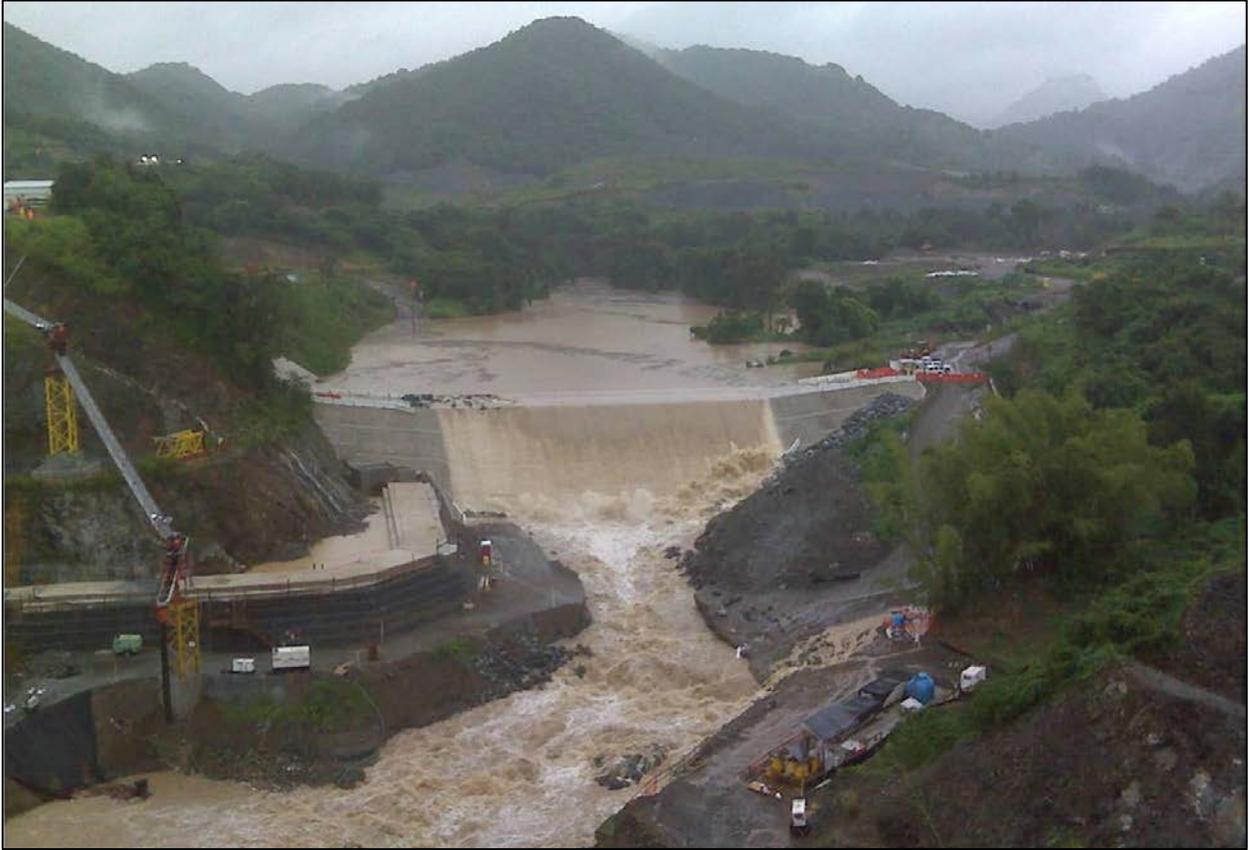
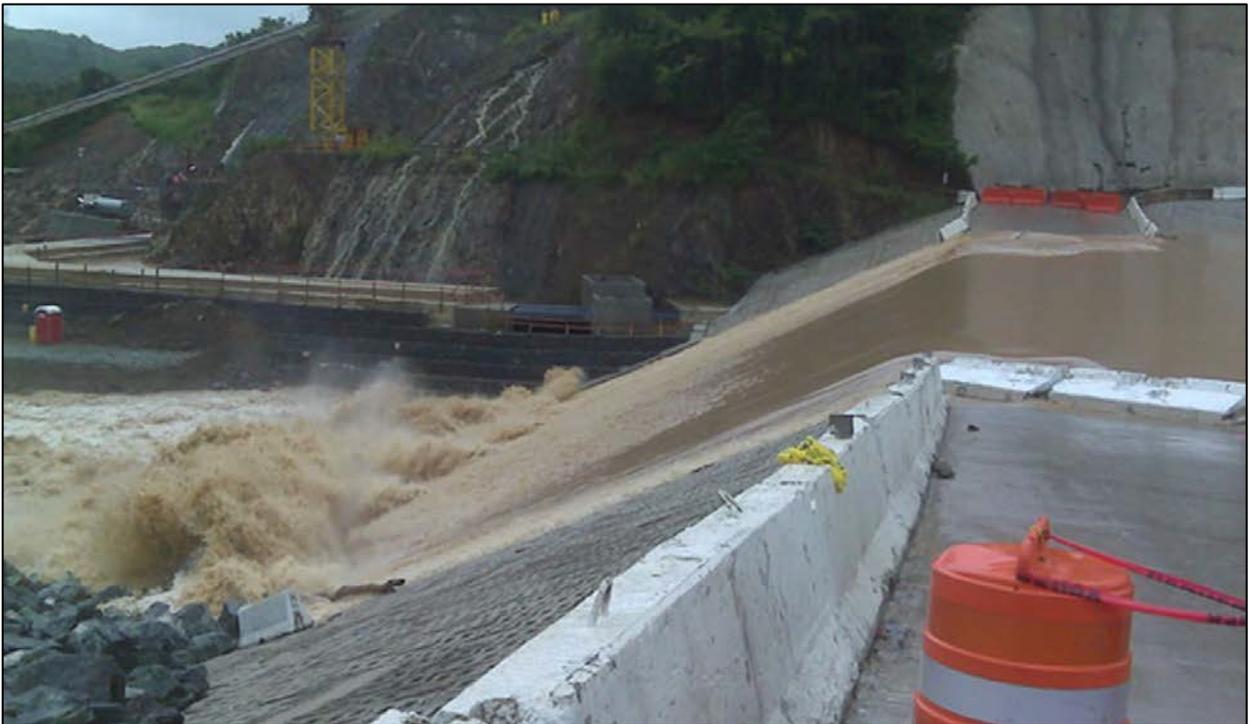
Figure 4. Photos Showing Overtopping of Portugués Cofferdam during Significant Overtopping Event (Photos Courtesy of Jacksonville District USACE)

The cofferdam was overtopped several times, with a maximum overtopping depth of approximately four feet. Photos showing the cofferdam during a significant overtopping event are provided in Figure 4. This is the most significant example of an earthen embankment armored with ACBs that was overtopped that the authors are aware of. Although the downstream toe of the ACB armoring was damaged (see Figure 5) during the most severe overtopping event, the cofferdam did not erode, and performed satisfactorily throughout construction of the RCC dam. Some of the damage to the ACBs may have occurred as a result of the concrete jersey barriers and other debris being washed off the crest of the cofferdam and tumbling down the slope.

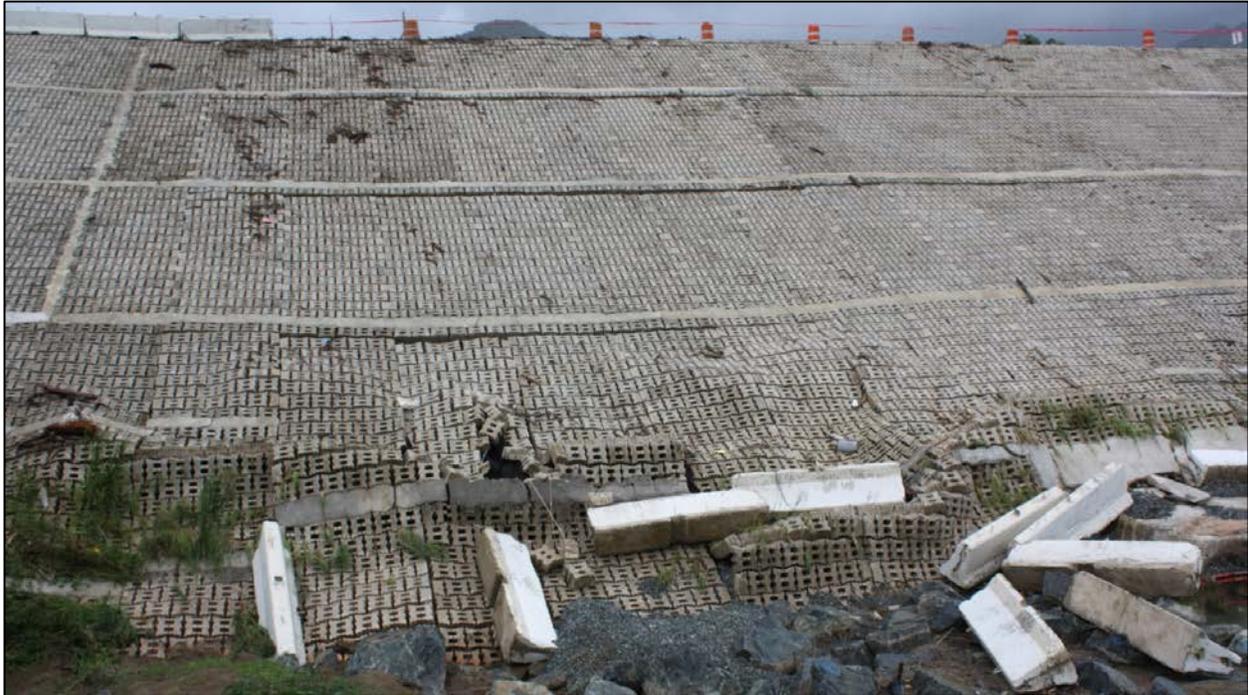
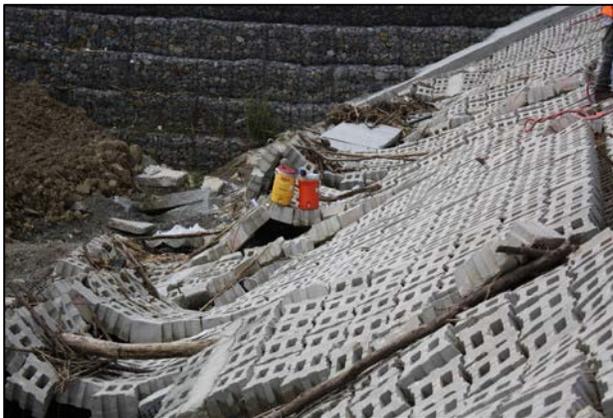
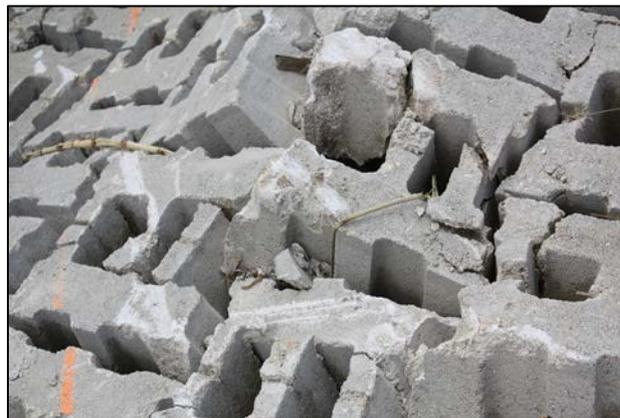
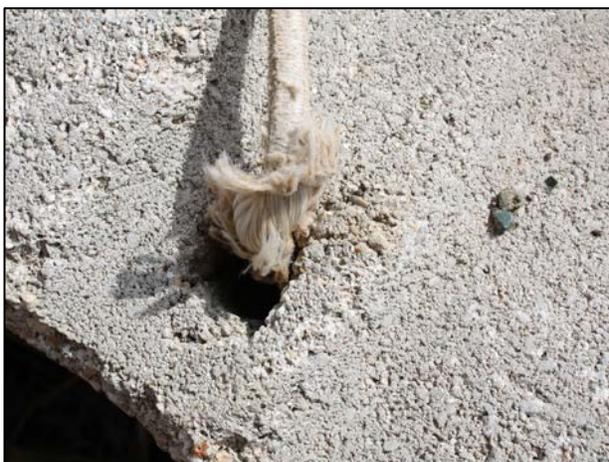
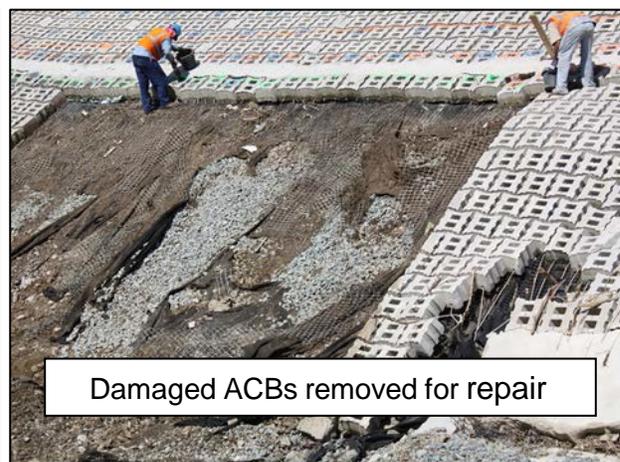
Figure 5. Photos Showing Damage to Bottom of ACB Armoring Following Overtopping of Portugués Cofferdam (Photos Courtesy of USACE)

**PFM #4 – Damage to ACBs Due to Impact from Debris.** Although concrete blocks can be manufactured to be highly erosion resistant and durable, they remain unreinforced and brittle. Under severe impact loads, it is possible for blocks to become damaged. At Shavers Creek Dam, during installation of the ACB system on the downstream slope of the dam, a dump truck traversing on the installed ACB armoring became unstable and flipped over onto its side. Surprisingly, the damage to the ACB system was minimal. At Portugués Cofferdam, however, during one of the more severe overtopping events, when the cofferdam was overtopped by approximately 4 feet, the jersey barriers lining both the upstream and downstream sides of the crest of the cofferdam became unstable and were washed down the ACB armored downstream slope. The 8-inch thick cast-in-place concrete cap on the crest of the cofferdam also became uplifted and dislodged, and also washed down the ACB armored slope. Following the flood event, the ACB system was inspected and some of the blocks were observed to be damaged (see Figures 5 and 10).

1. Eliminate the geotextile between the gravel drainage layer and the ACBs, but leave the geogrid.
2. Lace the sides of the ACB mats together to provide additional stability and prevent separation of the mats.
3. Flatten the slope of the cofferdam at the toe.
4. Eliminate the concentrated flow conditions at the groins.
5. Eliminate the concrete jersey barriers and concrete paving on the dam crest.
6. Anchor the ACB mats at the toe of the cofferdam using soil anchors.
7. Use stronger cables.
8. Use concrete armor units at the toe of the cofferdam.

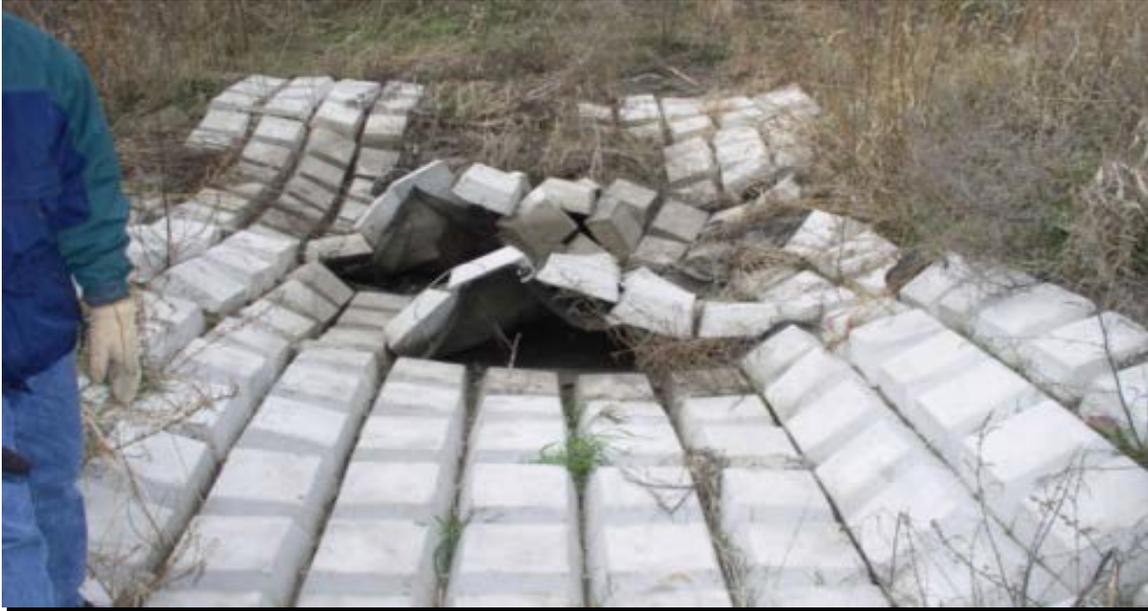
Figure 6. Photos Showing Example of PFM #1

The potential failure mode associated with placing a geotextile directly beneath the ACB mats consists of seepage flowing vertically downward through the ACB mats and geotextile both on the downstream slope of the embankment and beyond the formation of the hydraulic jump. The seepage then flows into and along the gravel drainage layer and exits upward through the geotextile and the ACB mats just upstream of the hydraulic jump where the tailwater is lowest. If the permeability of the geotextile is inadequate, or if the geotextile clogs, the geotextile will act like a geomembrane and result in uplift under the ACBs. If the uplift force exceeds the combined weight of the water and ACBs above the geotextile, the ACBs will displace upward as shown in Figure 6 and illustrated in Figure 7.

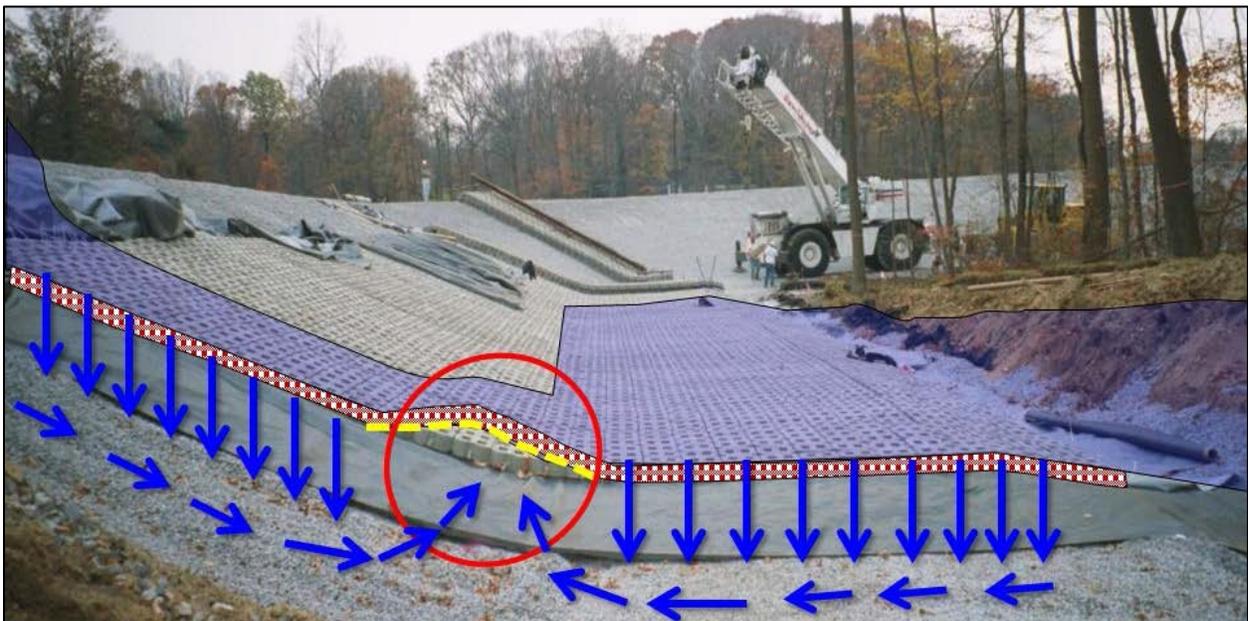
Figure 7. Schematic Illustrating Concentrated Flow from Under Geotextile to the Lowest Water Level Just Upstream of the Hydraulic Jump (PFM #1)

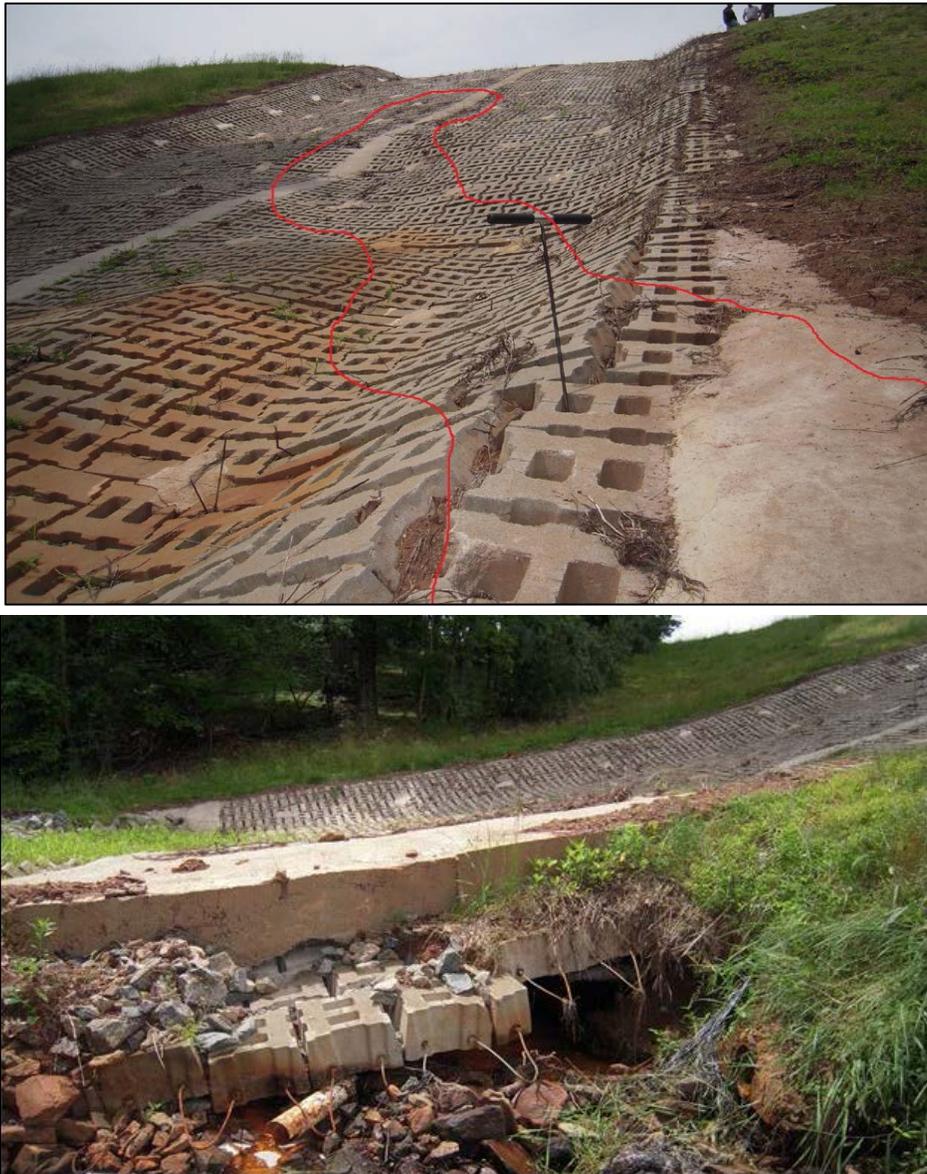
***PFM #2 - Piping Under ACB Mats.*** Classic “piping” occurs when soil erosion begins at a seepage exit point and erodes backwards, supporting a “pipe” or “roof” along the way. Four conditions are needed for development of piping: (1) a concentrated leak/ source of water (of sufficient quantity and velocity to erode material), (2) an unprotected seepage exit point, (3) erodible material in the flow path, and (4) material capable of supporting a pipe or a roof (Von Thun 1996). In the ACB embankment armoring example shown in Figure 8, the ACB-lined channel on the embankment is perched at the toe of the dam creating a hydraulic gradient from the flow in the spillway chute to a low point beyond the left side of the ACB armored chute. The hydraulic gradient must be sufficient to cause seepage and erosion at the exit point. If the seepage exit is unfiltered, the earth material along the flow path can erode. Erosion or piping is then initiated and can continue from the unfiltered outlet and progress upstream under the ACB armored layer towards the crest of the embankment. In the photo in the top of Figure 8, the piping erosion terminated near the crest of the dam because the flow over the spillway stopped. Had the flow over the ACB armoring persisted, the piping would have progressed through the crest of the dam embankment and ultimately breached the dam.

Figure 8. Photographs Showing Piping Under the ACB Armoring Over an Embankment (Top) and the Piping Outlet (Bottom).

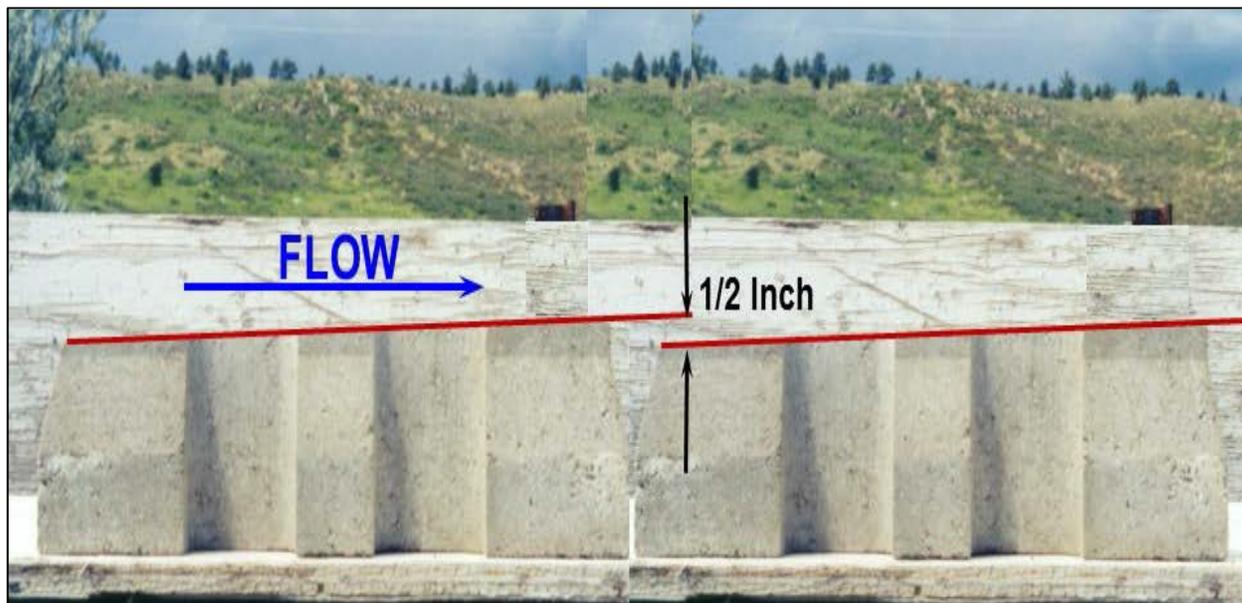
**PFM #3 – Installation Errors of ACB Armoring.** For steep-sloped, high-velocity applications, the additional destabilizing force associated with form drag, where the frontal profile of the block is subject to direct impact by the flow often controls the selection of the ACB system. A vertical projection of 0.5 inches is often assumed for typical project conditions (Armortec, 2000). The tapered ACB system consists of a downstream thickness of approximately 0.5 inch greater than the upstream. The taper is designed to eliminate/minimize the effects of the vertical projection (see Figure 9).

Figure 9. Photograph Illustrating Tapered Block System.

The authors have observed ACB mats being installed backwards with the tapered blocks facing the wrong direction. This mistake can occur if the contractor is not aware that the blocks are tapered, since the taper can be subtle and the ACB mattresses are symmetrical. If the ACB blocks are installed backwards, the blocks will have a protruding upstream face that will result in significantly increased form drag that can destabilize the system.

A recommended requirement is to have the ACB manufacturer's technical representative onsite during installation of the ACB system to ensure that the ACBs are installed correctly. Some ACB systems have arrows stamped onto the blocks, or paint on the downstream edge of the block to help contractors install the ACB mats correctly.

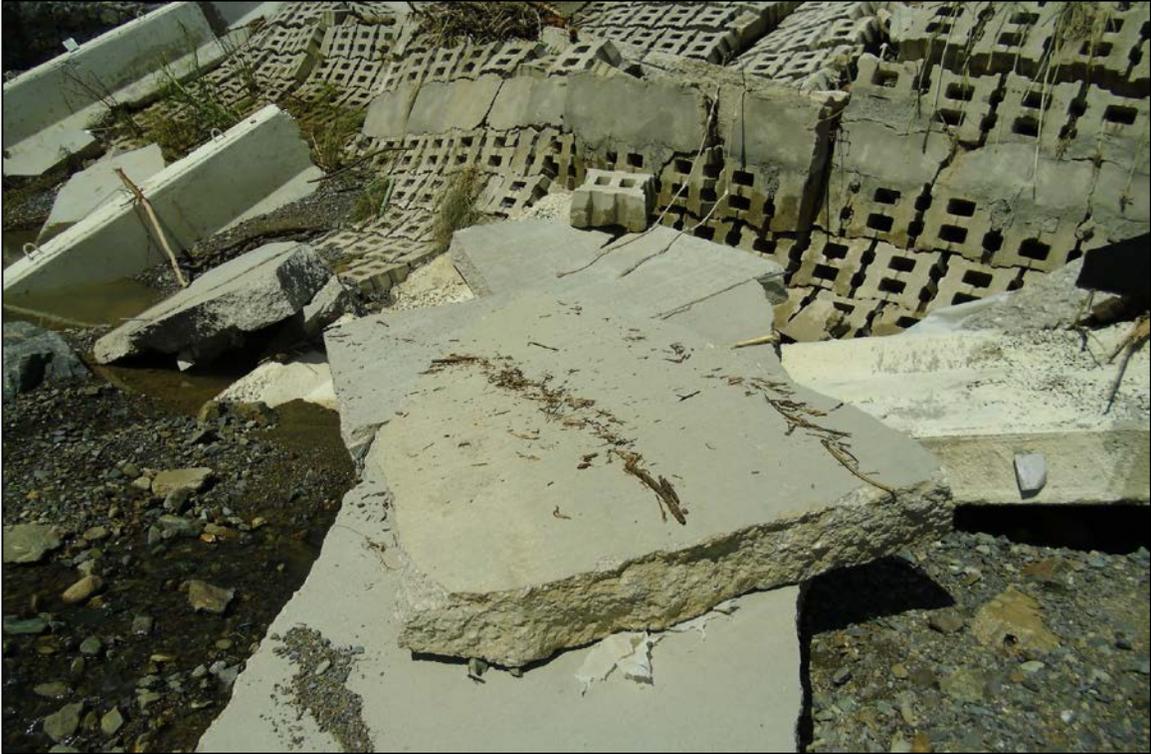
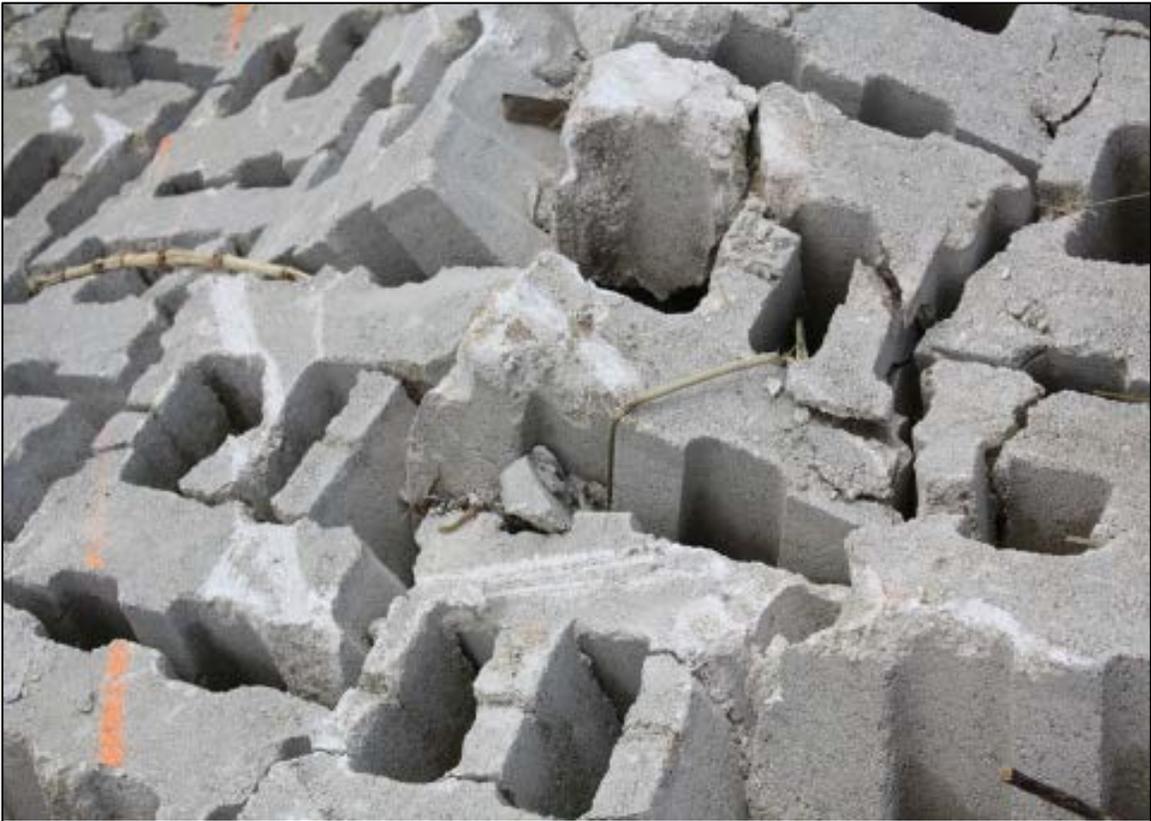
Figure 10. ACB Armoring on Portugués Cofferdam Damaged from Debris Impact (Concrete Jersey Barriers and Concrete Slabs).

Despite the damage to the ACBs, the system remained intact and continued to provide erosion protection. Following the overtopping event that caused damage to the ACB armoring, the contractor repaired the damage and replaced the concrete jersey barriers with plastic jersey barriers (see Figure 11).

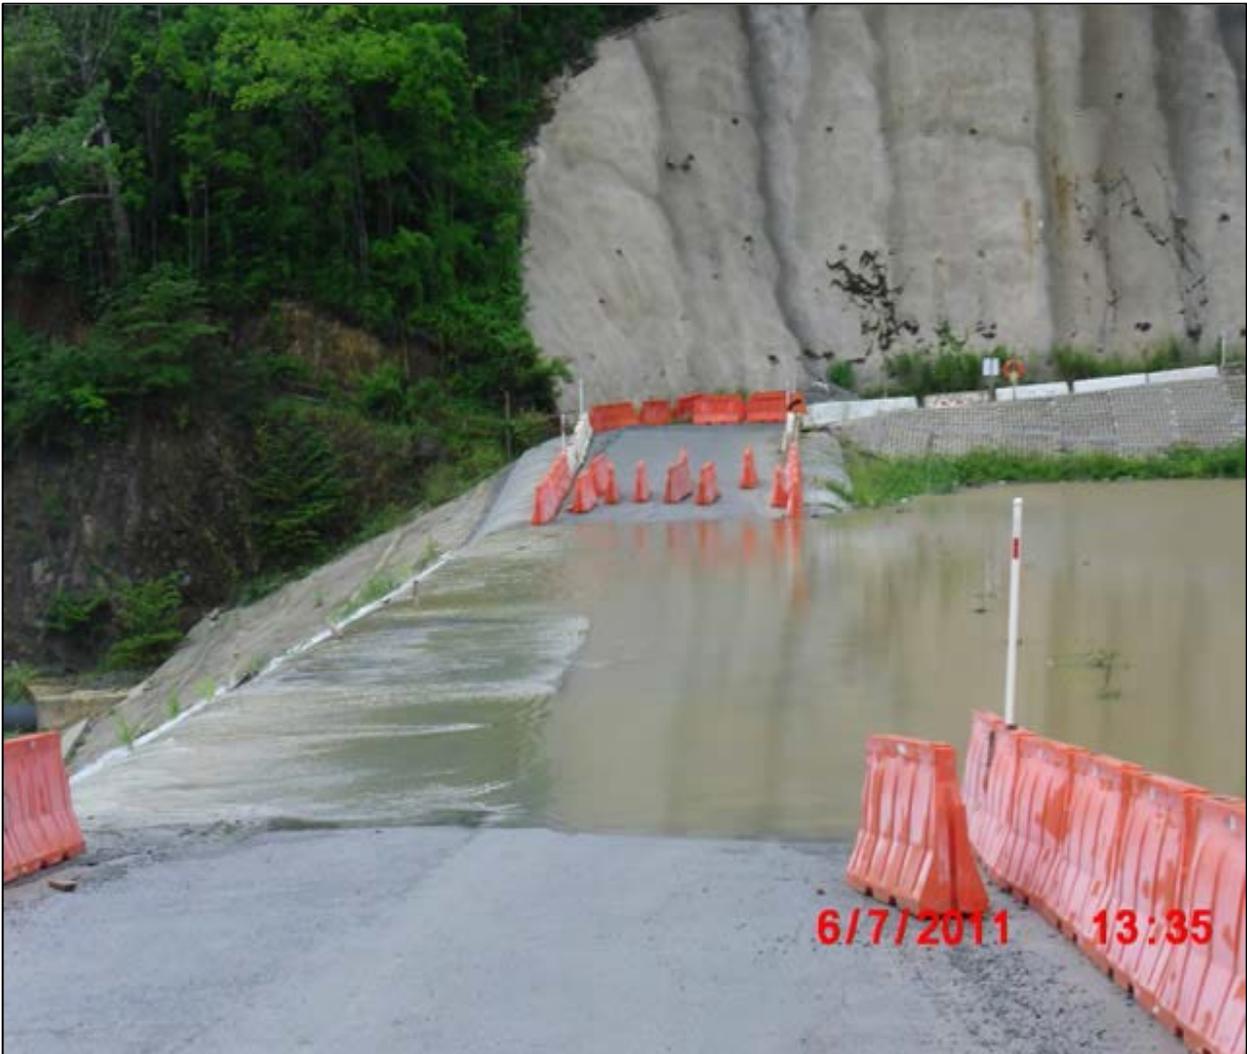
Figure 11. Photograph showing plastic jersey barriers used to replace the concrete jersey barriers at Portugués Dam to prevent impact damage to the downstream ACB armoring should the jersey barriers become unstable and wash down the downstream face of the ACB armored cofferdam.

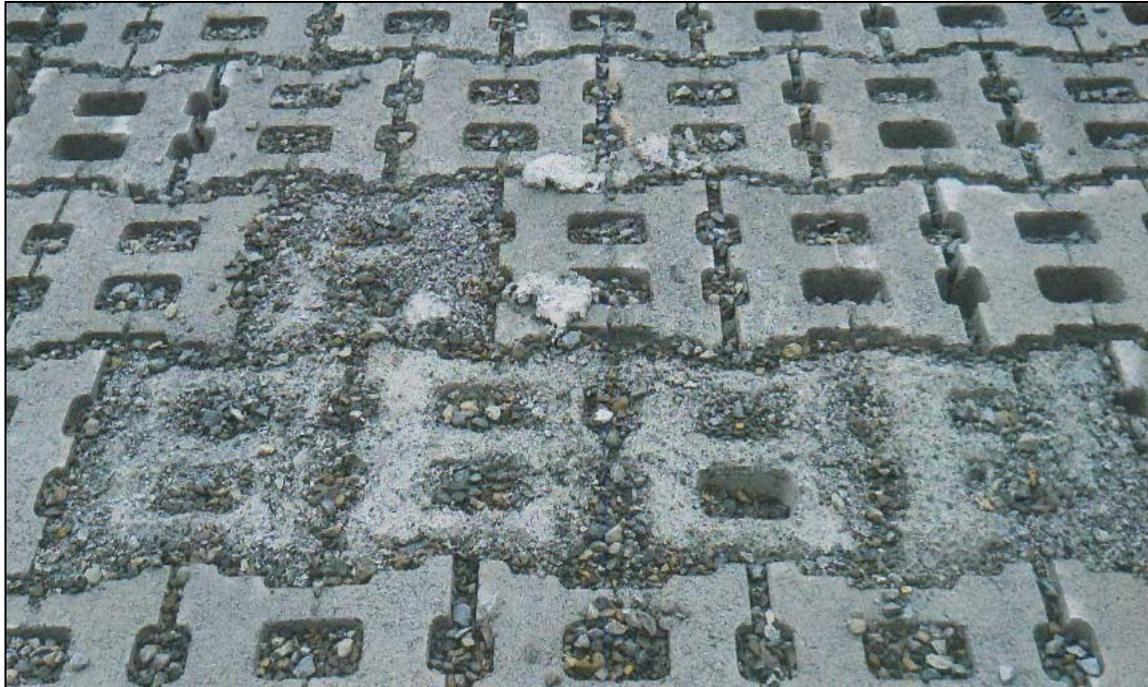
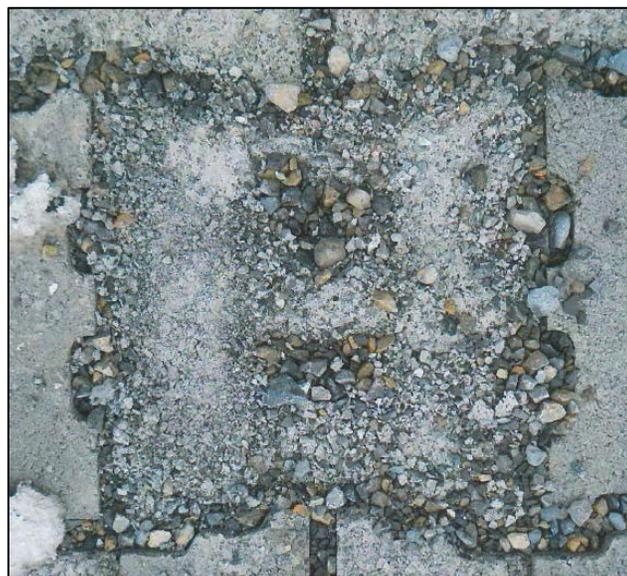
The authors are aware of one ACB installation at Lake Mokoma Dam in Sullivan County, Pennsylvania where the installed ACB system experienced premature deterioration and disintegration of some of the concrete blocks (see photos in Figure 12). Initially it was believed that the problem was related to insufficient compaction and “popcorning”, a phenomenon in the dry cast concrete process that sometimes occurs at the end of a manufacturing cycle/batch with dry cast material. These blocks are normally culled at the point before the concrete blocks are moved onto racks and into the kiln. After curing is the last opportunity to discard the blocks before the blocks are incorporated into mats. Regardless of the exact reason why the blocks were of poor quality, the problem was related to the manufacturing of the blocks and poor quality control at the plant. This appears to have been an isolated incident, however, it reinforces the importance of specifying random testing of the ACB blocks being installed along with other quality control measures.

Figure 12. Photographs of Deteriorated ACB Blocks Due to Poor Quality Control during Manufacturing

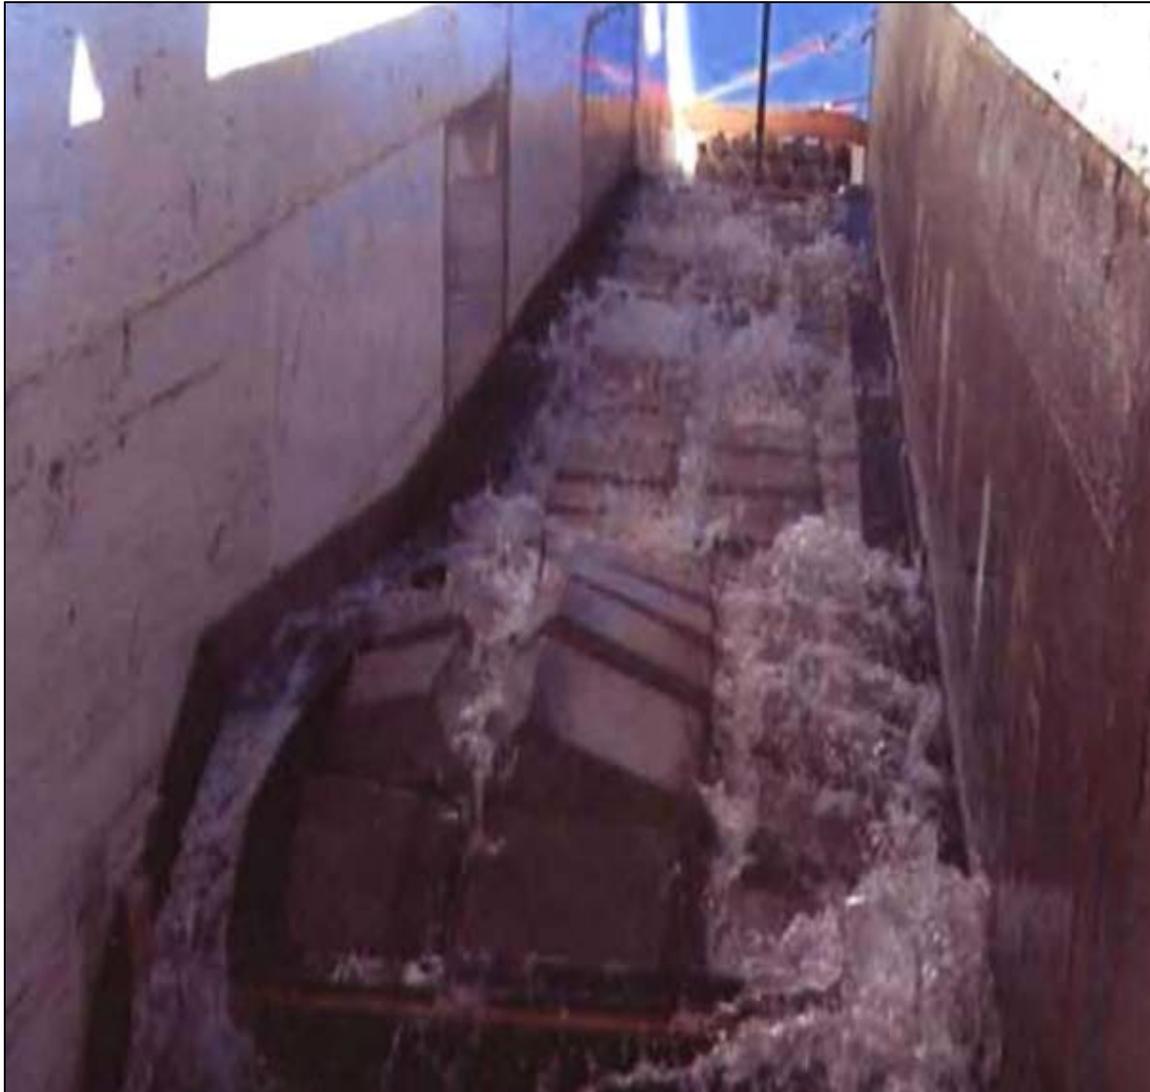
***PFM #6 – Use of Unproven ACB Systems and Installation Details.*** Full-scale flume tests on a closed-cell ACB system was performed at the CSU testing facility in 2004. It was determined that the revetment system reached performance thresholds after only 8 minutes of overtopping flow (~1-foot of overtopping) due to buckling of the blocks near the toe plate. The testing was stopped upon observing the buckling of the blocks. The highest lift of individual blocks was approximately 0.5 feet at the peak of the deformation (see Figure 13). This full-scale testing demonstrates that there are differences between ACB systems and their under treatment that can make a significant difference in their performance and stability. Therefore it is very important that only ACB systems with satisfactory laboratory or other performance data be used.

Figure 13. Photograph Showing Laboratory Testing of an ACB System that Failed after 8 Minutes of Testing Under 1-foot of Overtopping (Photo looking upstream).

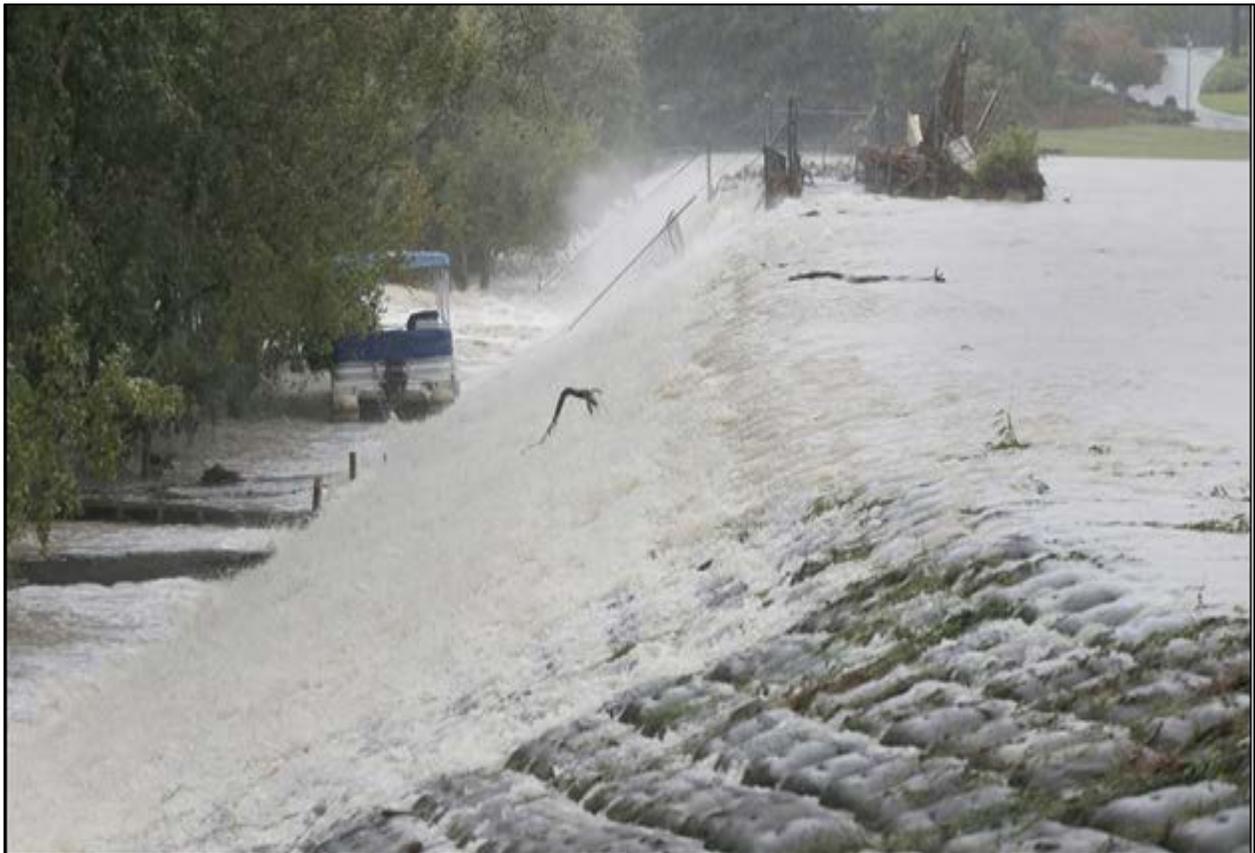
***PFM #7 – Deterioration from Exposure.*** If the ACB system is exposed, it may be subject to deterioration from normal weathering and erosion. Forest Lake Dam is an embankment dam in Columbia, South Carolina that was armored with a Fabriform ACB system in the 1980s. The Fabriform Articulated Block revetment system consists of rectangular concrete blocks cast in place within a nylon fabric or quilt, and linked together by reinforcing cables (if required) inserted between the two layers of fabric prior to fine aggregate concrete injection. Forest Lake Dam was overtopped in 2015 and successfully protected the embankment from erosion (see Figure 14). Similar embankment dams located upstream and downstream that were not armored failed or were significantly damaged as a result of overtopping.

Figure 14. Photograph of Forest Lake Dam Showing Overtopping of Embankment Dam Armored Using Fabriform ACB System during Hurricane Joaquin
