## **ACB Armoring Potential Failure Modes At Dam Embankments and Spillways**

Paul Schweiger, P.E.<sup>1</sup>, Darin Shaffer, P.E.<sup>2</sup> and Jim Nadeau<sup>3</sup>

**Keywords:** *Potential Failure Modes, ACB, Armoring, Overtopping, Embankments, Spillways*

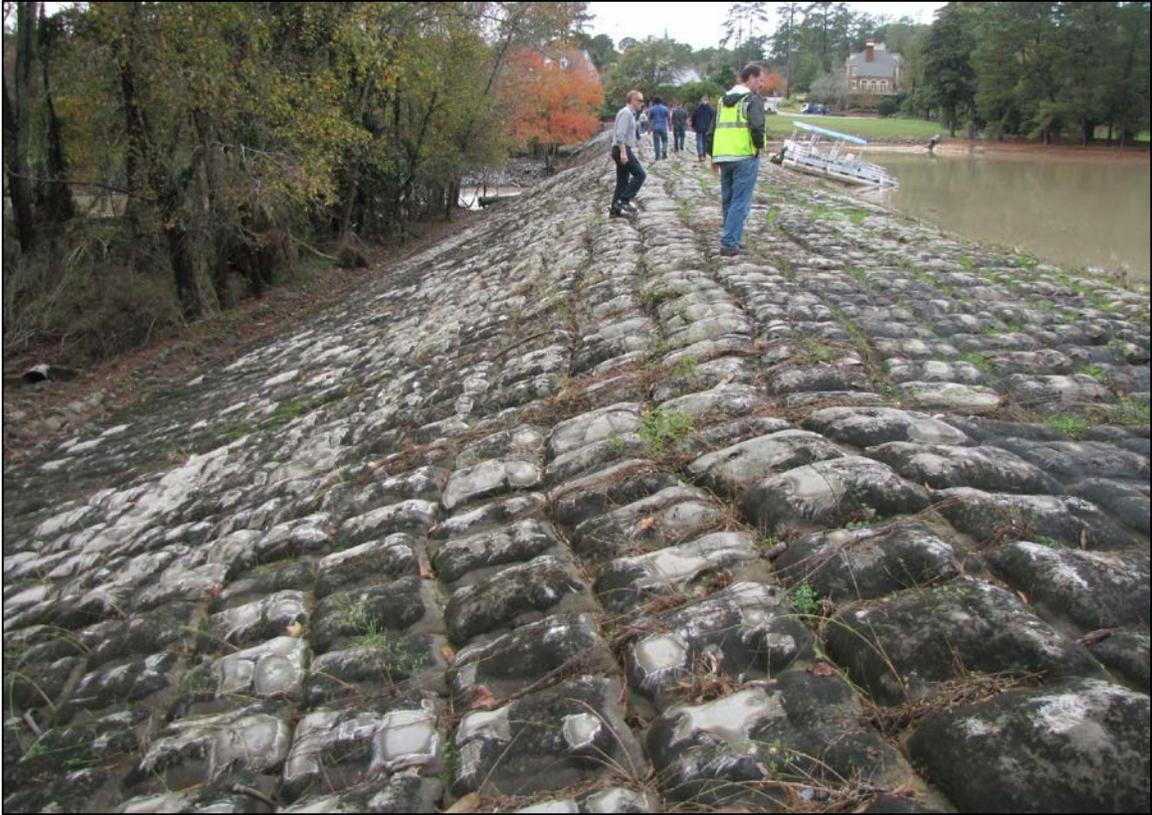
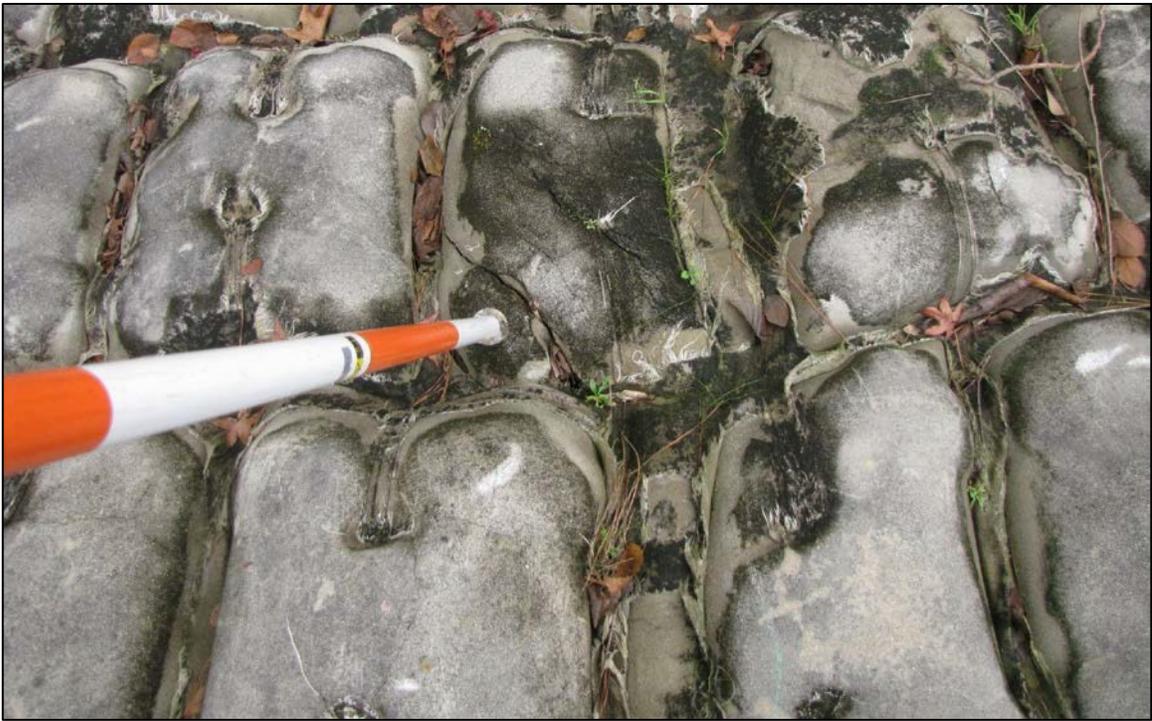
Inspection of the Fabriform ACB system at Forest Lake Dam after the 2015 overtopping event showed that the system remained intact. The nylon material that holds the concrete blocks together, however, was showing significant signs of deterioration (see photographs in Figures 14 and 15). The deterioration consists of missing nylon fabric over the tops of many of the concrete blocks. Some of the exposed remaining nylon fabric was weak and easily removed by hand. The nylon fabric that was not exposed (around the edges and underneath the concrete blocks) appeared to remain strong and durable. As the exposed nylon fabric continues to deteriorate, the concrete blocks will eventually lose the benefits of this restraint (unless the system included the optional internal cables) and lose their full capacity to protect the embankment from overtopping flows. At some point, the condition of this ACB system will need to be assessed and potentially reinforced or replaced to continue providing the needed protection for the embankment.

Figure 15. Photographs Taken in 2015 Following a Overtopping of Forest Lake Dam during Hurricane Joaquin Showing Condition of Fabriform ACB System Installed in the 1980s

For most ACB systems, deterioration of the concrete blocks can be addressed by specifying a suitable mix design that is appropriate for the exposure conditions. For example, a mix design with a higher compressive strength may be specified for exposure conditions subject to frequent freeze-thaw cycles or aggressive soil or water conditions such as salt water or acidic soils. Oversized nylon or stainless steel cables can also be specified for greater durability. Completely covering the ACB armoring with topsoil and seeding is another option to protect the ACB system from deterioration due to exposure.

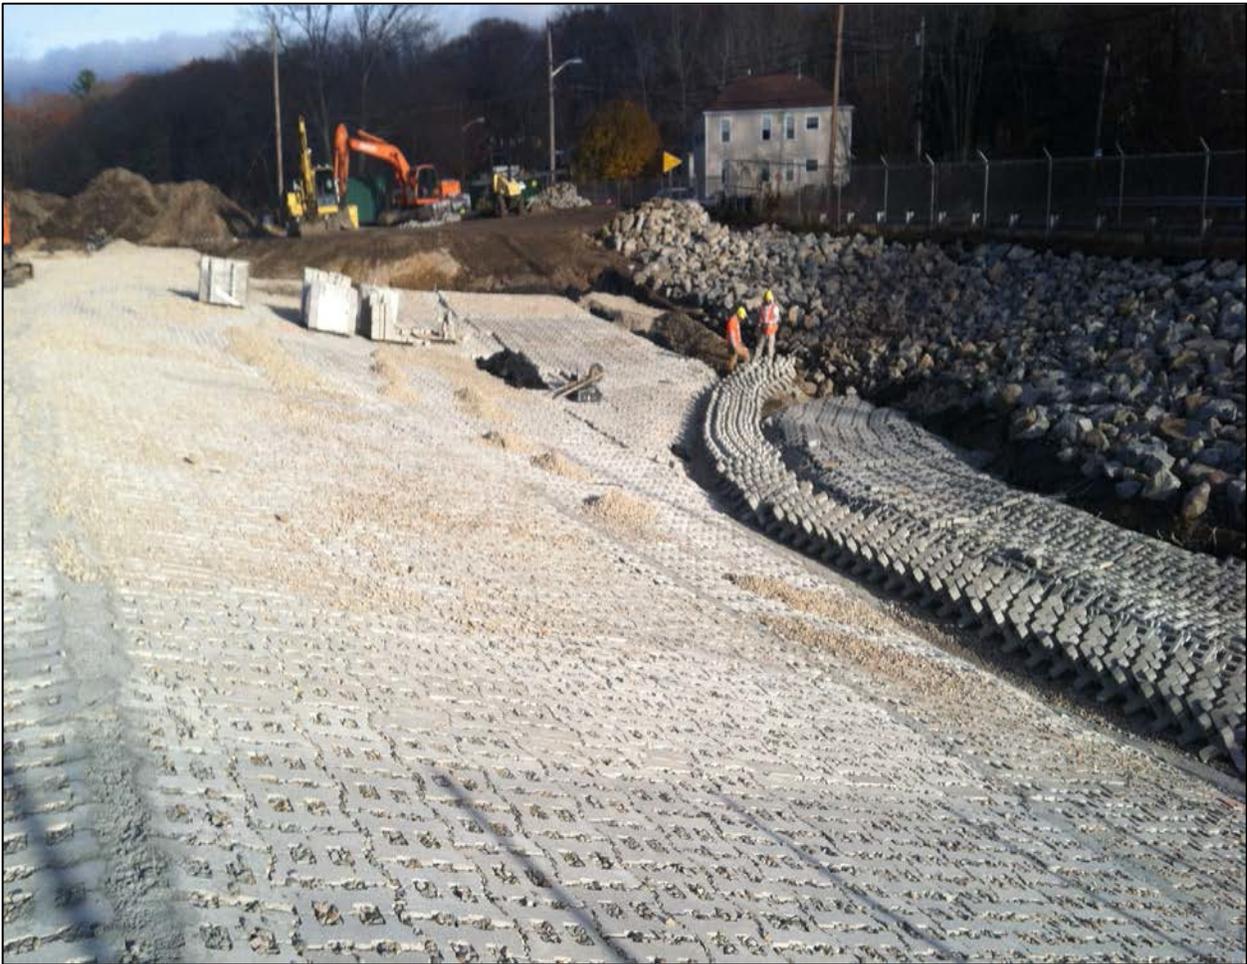
Figure 16. Photograph of ACB System with Armoring Units Installed at the Toe of the System to Provide Energy Dissipation of the Flow

***PFM #8 – Vandalism.*** If the ACB system is exposed, it may be subject to vandalism. Although less susceptible to vandalism than gabions where the wire baskets can be cut or damaged, or riprap, where individual rocks can be rearranged or taken, some features of ACB installations have been prone to vandalism. In particular the end treatment where armoring units (A-Jacks) have been used at the toe of the ACB system to provide energy dissipation (see Figure 16). Figure 17 shows photographs of armoring units that have been damaged by vandalism. It is reported that the damage to the armoring units shown in Figure 17 was the result of kids tossing large rocks against the units. A simple solution to prevent this type of vandalism is to bury the units so that they are not exposed. This may be feasible if the overtopping protection is not frequently activated. If the overtopping protection is frequently activated, covering the armor units with riprap may be sufficient.

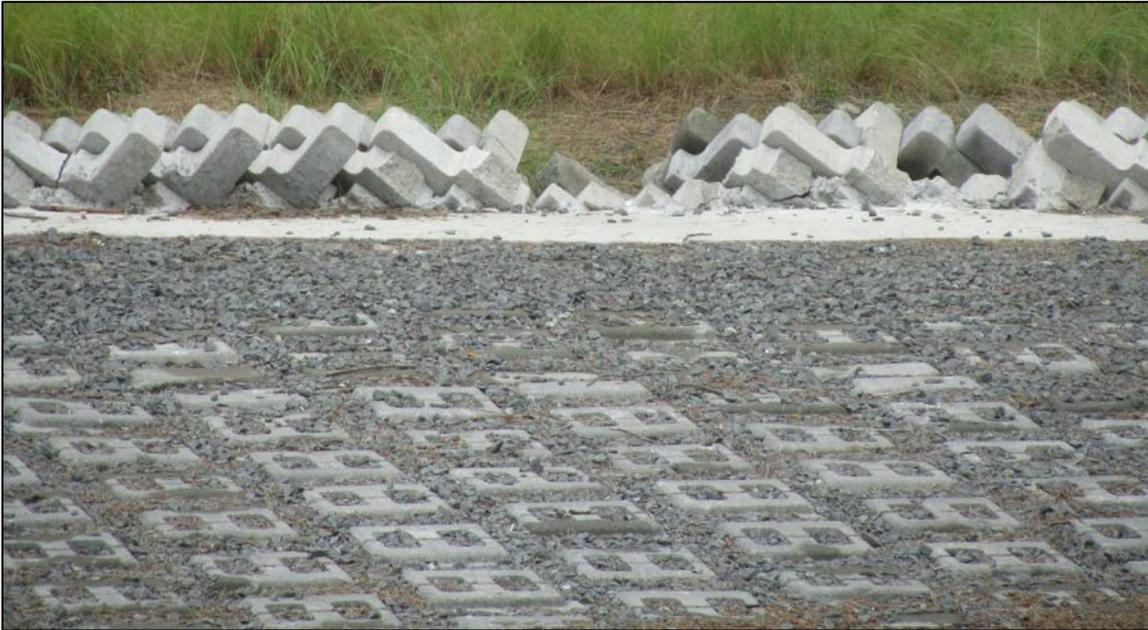
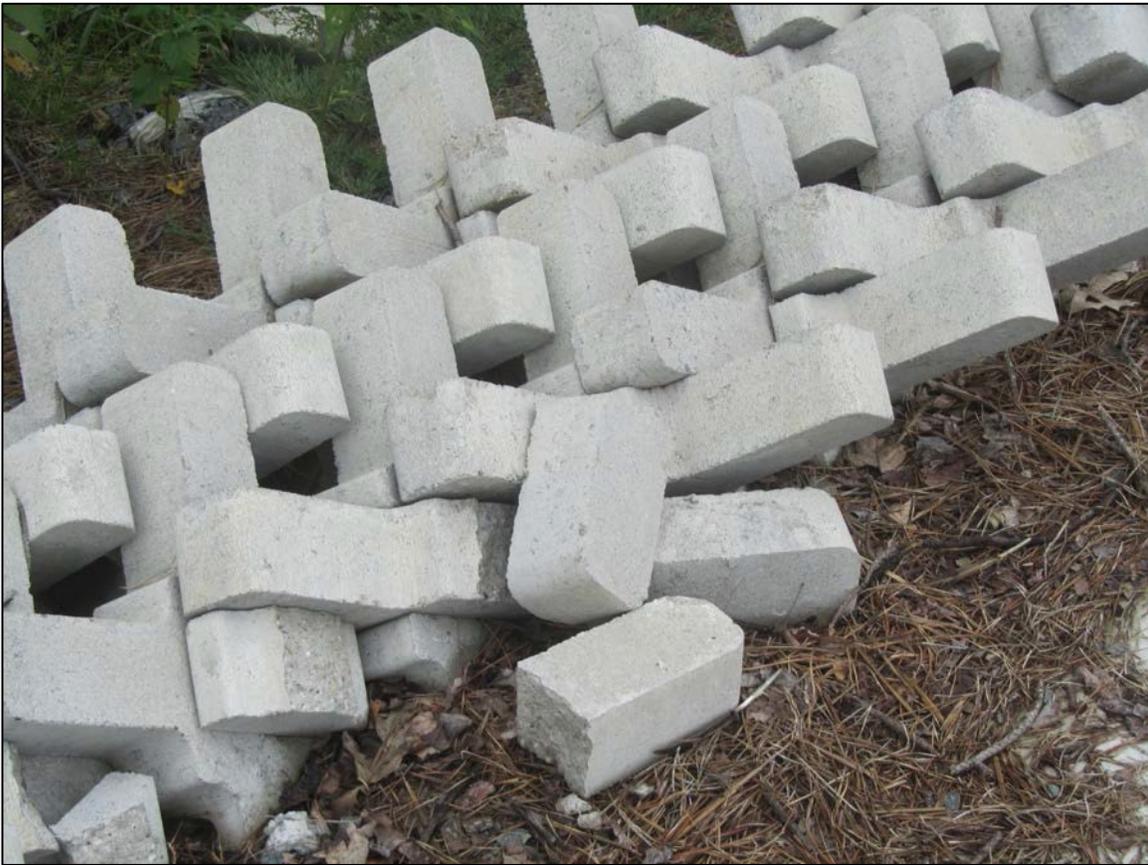
Figure 17. Photographs Showing Armoring Units Damaged from Vandalism

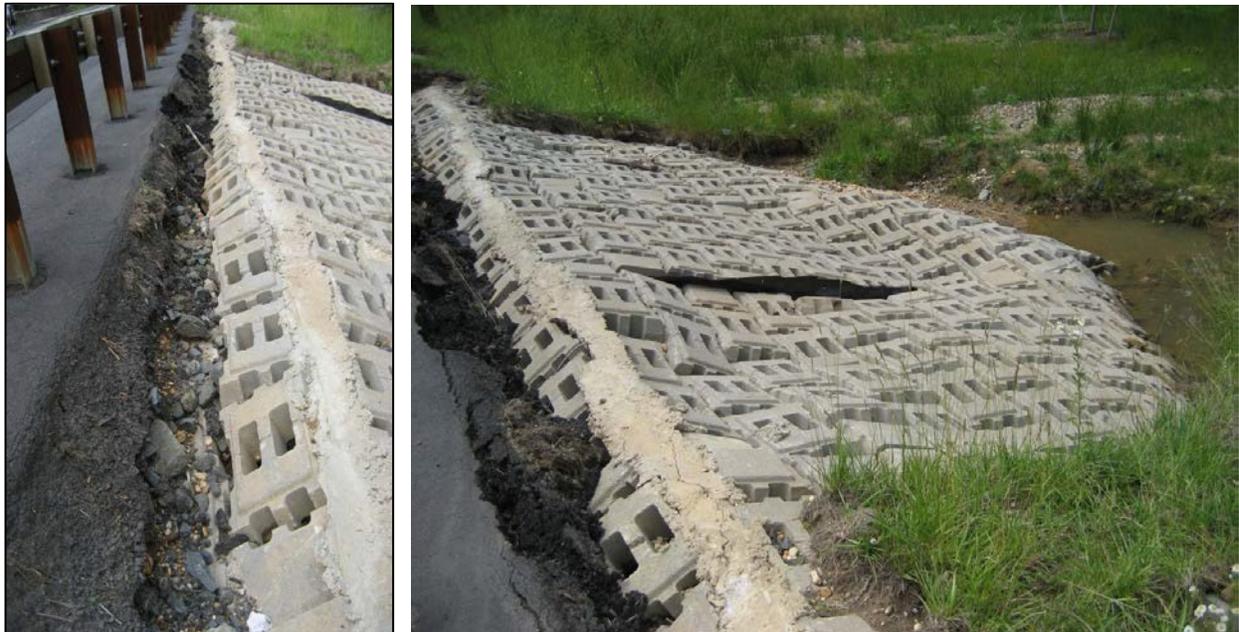
**PFM #9 – Poor Transition Details.** The upstream and downstream ends as well as the sides, and wherever the ACB system transitions or is connected to another structure, require special attention and details. These transition areas, if not adequately protected can lead to block movement, erosion of the subgrade, and head cutting of the ACB system. Figures 18 and 19 show two examples where problems with the transition details led to movement of the ACB systems, however, there was no uncontrolled release of water.

Figure 18. Photographs of ACB Installation at Grover's Mill Dam Showing Armoring Units Damaged from Inadequate Transition Details at the Top of the Installation

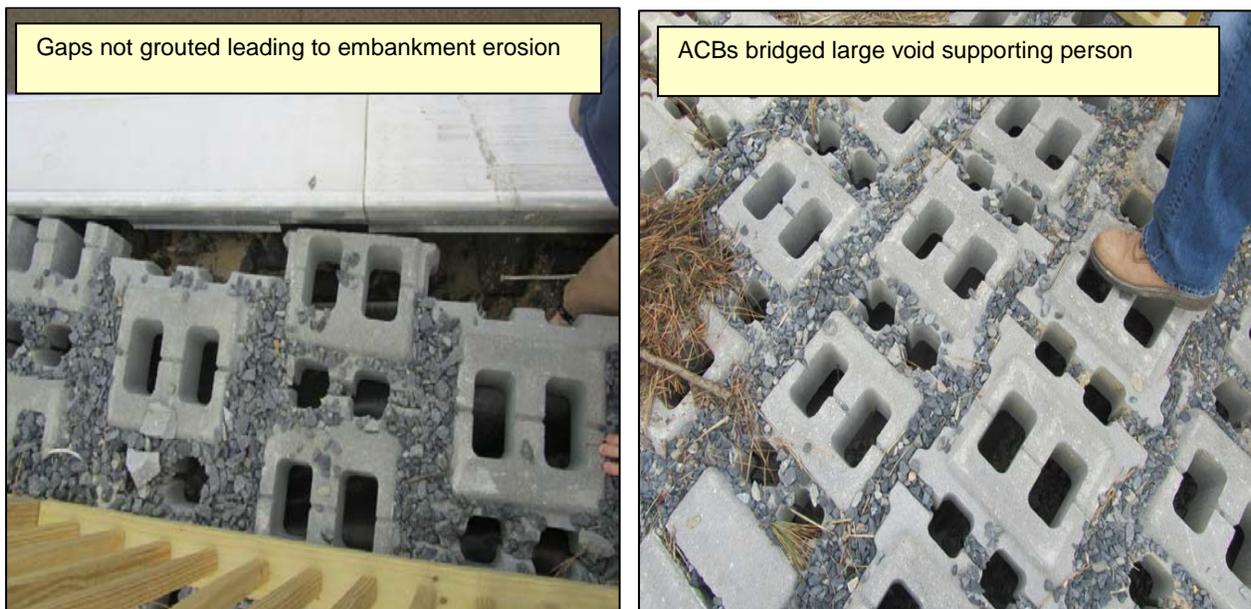
Figure 19. Photographs of ACB Installation at Lake Riviera Dam Showing Inadequate Transition Details along the Right Side of the ACB Installation
