THESIS

CORROSION TESTING OF ALLOYS FOR BIOMASS COOKSTOVE COMBUSTORS

Kelly Banta

Colorado State University

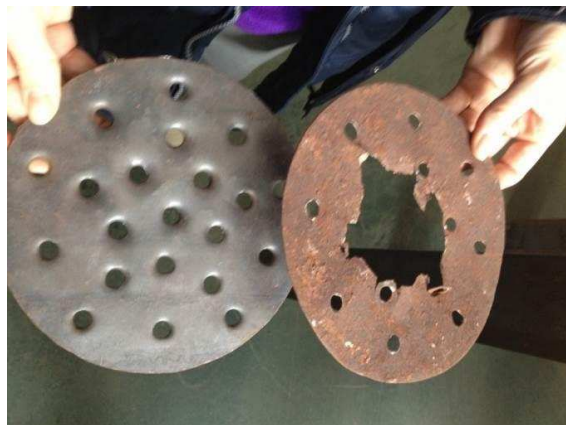
An example of how severe corrosion in a cookstove can be is shown in **Figure 1**.

**Figure 1:** *Charcoal stove fuel grates, new (left) and corroded (right).*

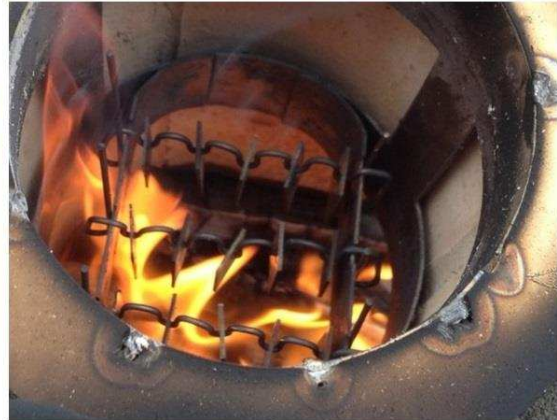
**Figure 2:** Photographs of coupons in (a) lab furnace test and (b) in-situ cookstove test.

Both tests were carried out to a total of 1000 hours of exposure, representing a year of use if a stove is used for ~2.7 hours per day. However, it should be noted that the use of salt species accelerated the corrosion in this testing.

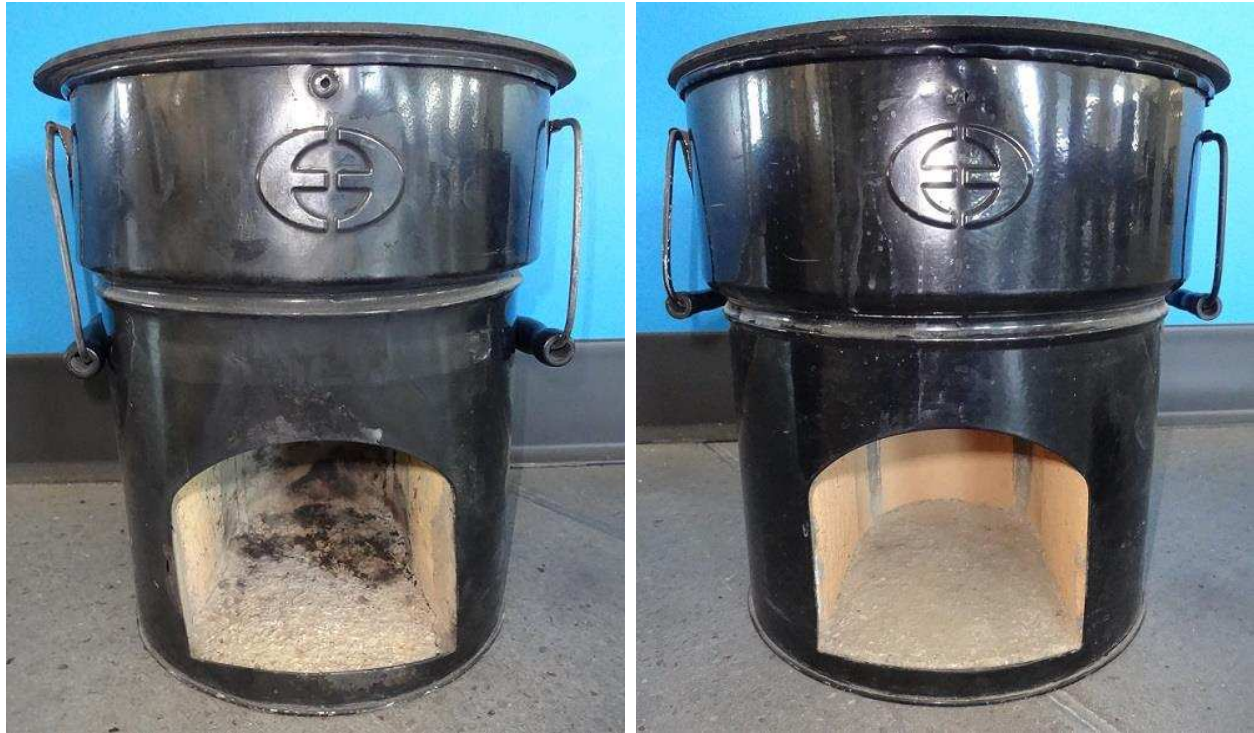
Envirofit's B1200 rocket elbow stove, now discontinued, was chosen for the in-situ testing. The B1200 was used because it has a ceramic chamber, which is less susceptible to corrosion than a metal chamber, as it would be undesirable for the stoves themselves to degrade or fail during testing due to corrosive attack. Both stoves in their conditions prior to testing are shown in

**Figure 3:** *In-situ testing stoves prior to test. Stove A: left. Stove B: right.*

However, despite the precaution of using stoves with ceramic chambers, the bottom lining of the Stove B chamber slowly wore away during operation, and had to be replaced around 550 hours. This failure is discussed further in Chapter 3.

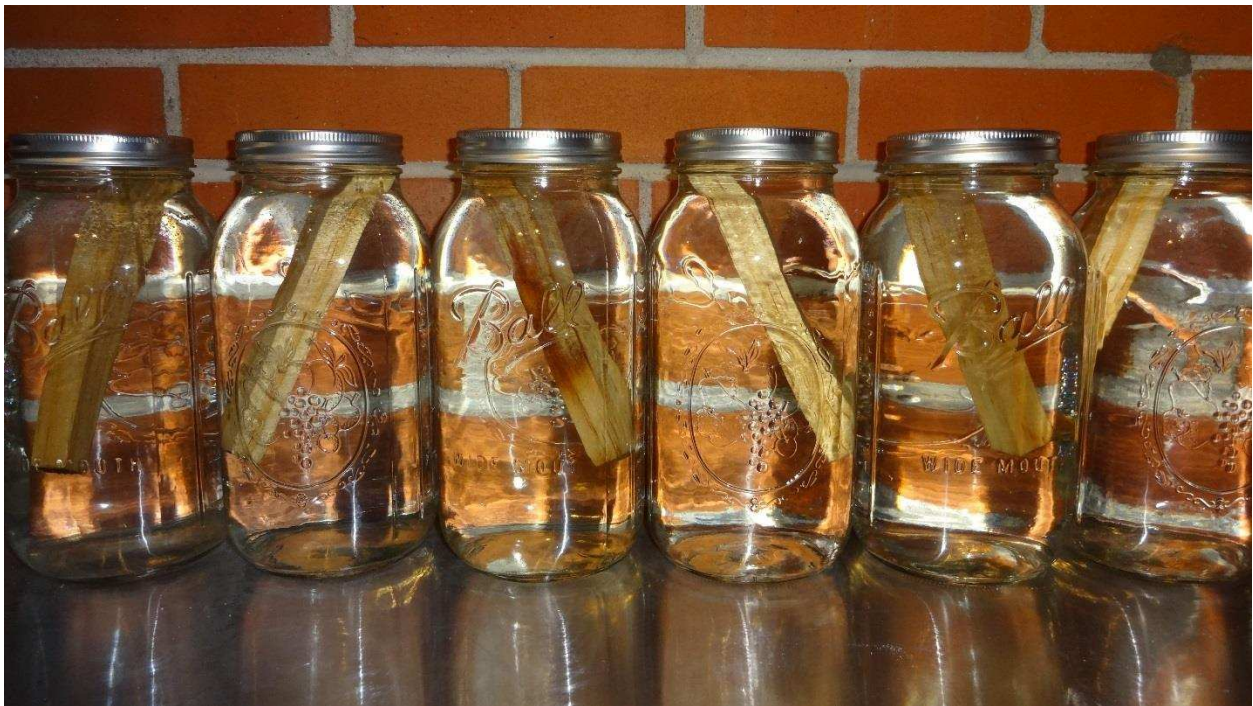
The following procedure was used to estimate a target salt concentration of the water used for soaking the wood. Solutions of six different salt concentrations were created in 2-L mason jars. Each jar was filled with 1800 g of water and different quantities of salt. Seven-inch pieces of pine wood were dried in a kiln at 100 F for 3 days, then placed and sealed in the jars and allowed to soak for 11 days. Solution conductivity was measured every 2-3 days during the salting process using a CDM 80 Conductivity Meter (Radiometer Copenhagen). Jars are shown in **Figure 4**.

*Figure 4: Initial jar soaking study.*

After soaking for 11 days, the sticks from Jar A (highest salt) and Jar F (lowest salt) were removed from the jars for halogen testing. The sticks were cut in half and the halves used for testing were dried for 24 hours at 110 F then dried at 215 F for 72 hours. Contents of all jars, and halogen results for jars A and F are summarized in **Table 2**.

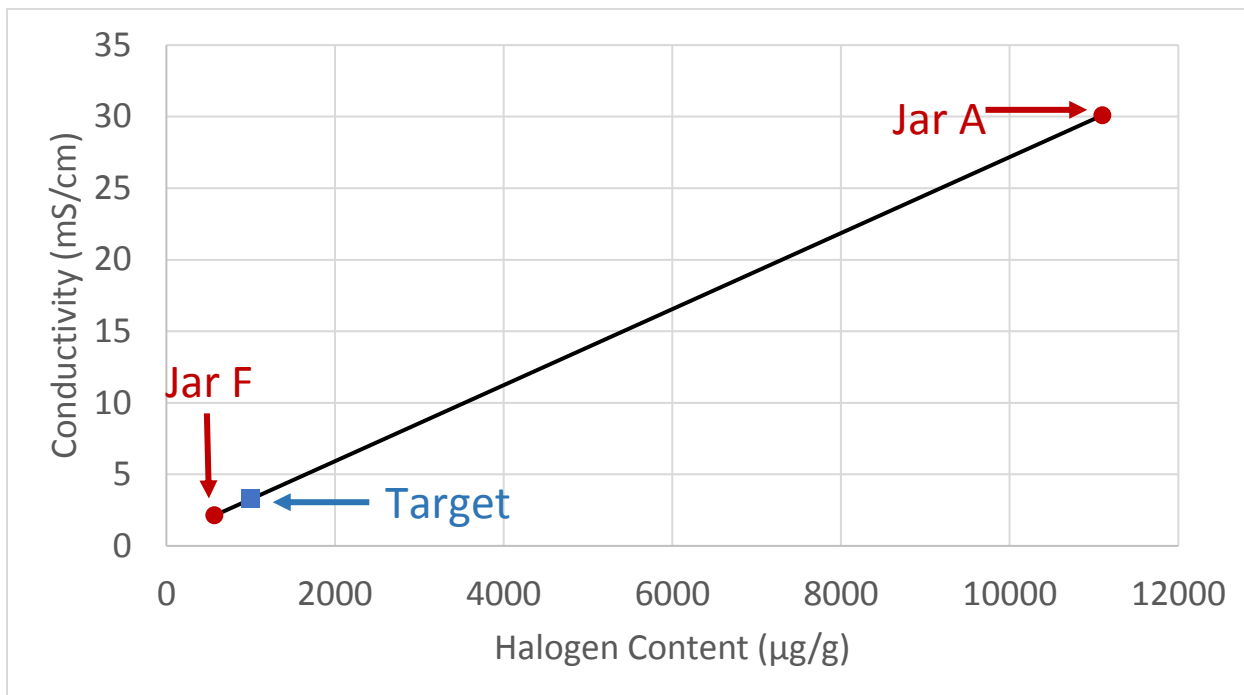
The goal behind measuring conductivity was that conductivity could be an indicator of salt concentration. A correlation between halogen content and conductivity was found so that, in theory, instead of measuring the mass or volume of water to determine the salt concentration, salt could be added to the water until the desired conductivity was achieved. It was determined by linear interpolation between Jar A and Jar F that, to achieve the target halogen content of 1000 µg/g, a conductivity of around 3.3 mS/cm was needed, as shown in **Figure 5**. More samples were not analyzed due to the cost of analysis.

**Figure 5:** Target conductivity for soaking water. Conductivity needed for target halogen content of 1000 µg/g was 3.3 mS/cm.

It was found later that a direct correlation between initial conductivity and halogen content could not be made, discussed in section 2.6.3.

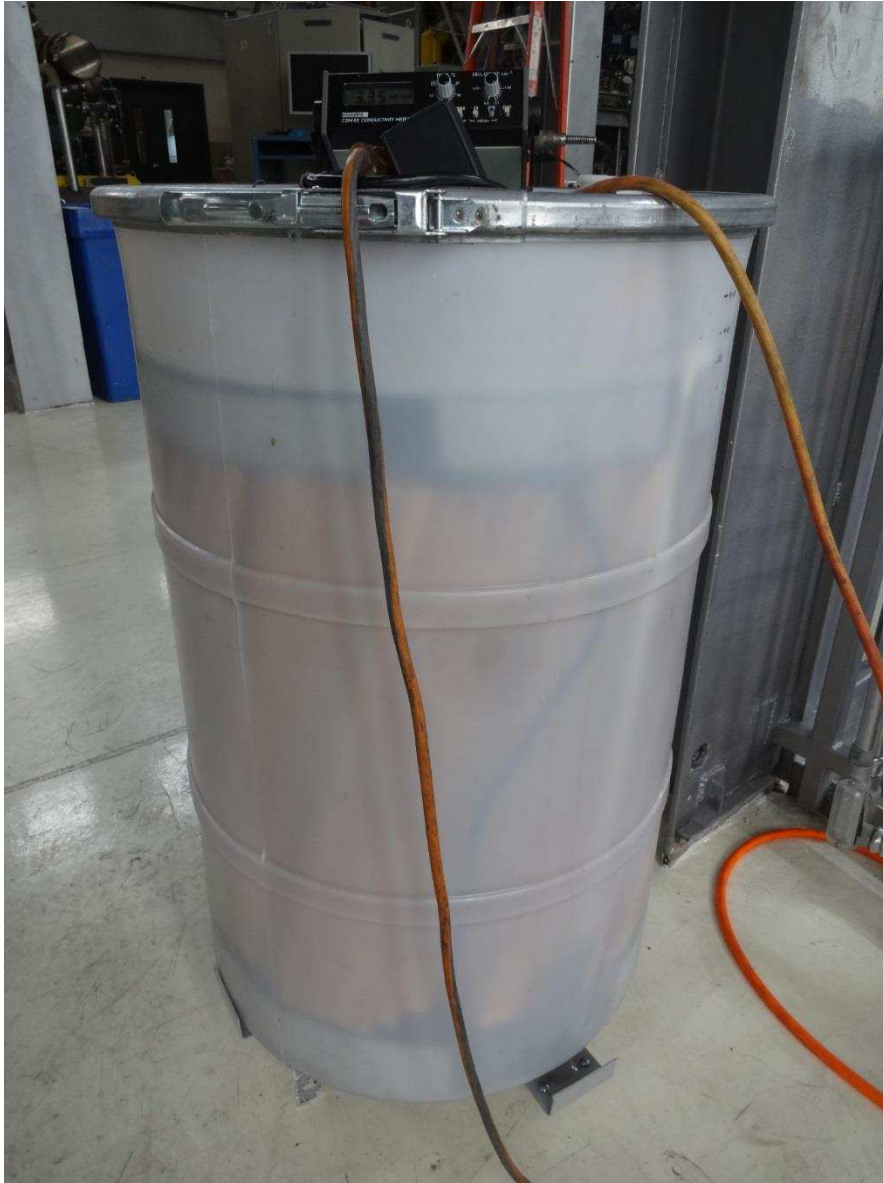
Initial small batches of ~40 kg of salted wood were soaked in a 55-gallon polyethylene barrel. Sticks were cut to 24" and placed vertically in the barrel until the barrel was full, a total of ~200-300 sticks. To keep the wood submerged, a stainless steel plate, which was cut to fit inside the

barrel and which had holes to permit passage of water, was placed on top of the ends of the sticks, then bricks were placed on top of the plate. Tap water was added to the barrel until the water level was above the stainless steel lid and 2-3" from the top, then salt was gradually added to the barrel. An 80 gal/hr pump with the inlet at the bottom of the barrel and outlet at the top of the barrel was included to help maintain uniform salt concentration throughout the barrel. The pump ran continuously. The wood soaked for a total of 12 days (Batch 1) to ensure that the tank had reached a state of equilibrium. The small-batch salting barrel with a load of wood after water was drained after soaking is shown in **Figure 6**.

**Figure 6:** *Small batch salting tank.*

In the 55-gallon barrel, the force needed was up to ~120 lb and was supplied by a stainless steel cover which was placed directly on top of the sticks. In addition, several bricks were placed on top of the stainless steel cover.

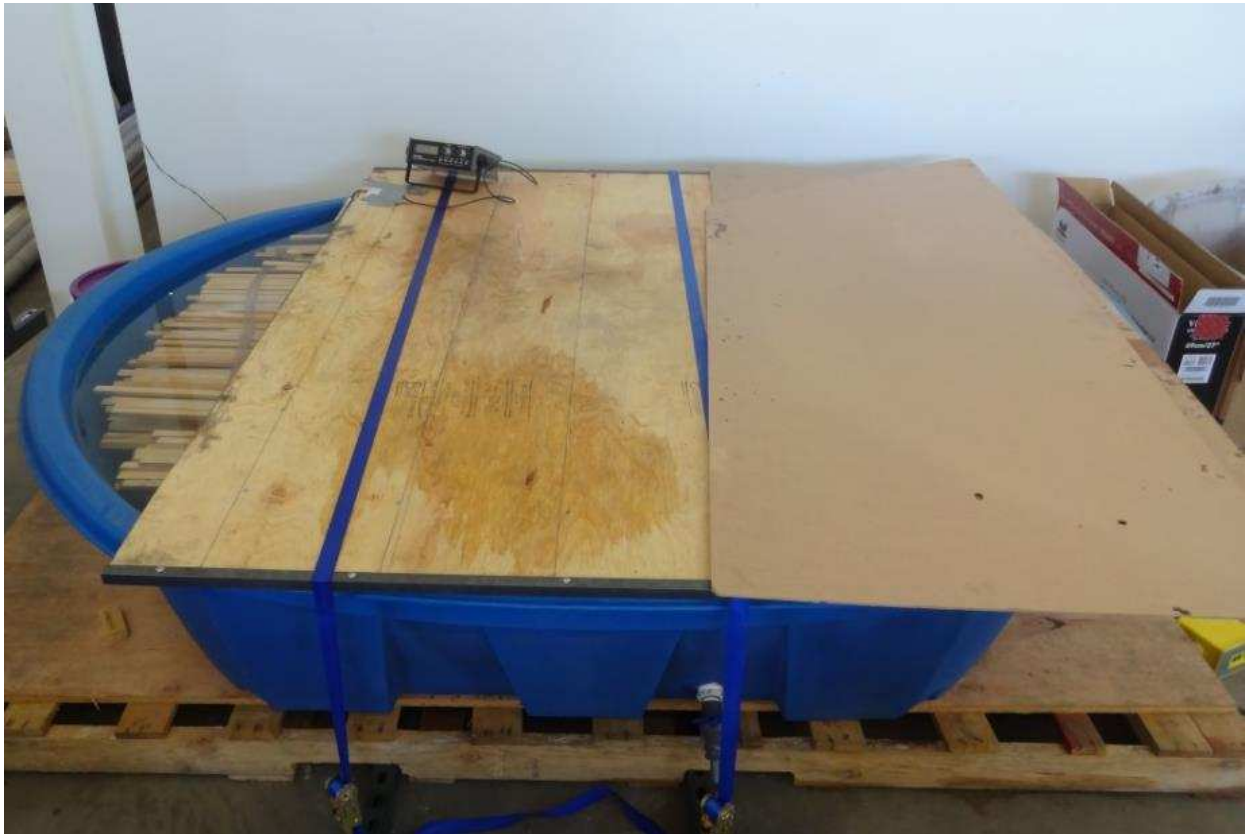
The large-batch salting tank, shown in **Figure 7**, consisted of a 300-gallon plastic stock tank and a lid that was placed on top of the tank to keep the wood submerged.

**Figure 7:** *Large batch salting tank.*

The first step in the salting process was to fill the tank with wood. Stick length varied from 4 feet to 7 feet. Four-foot lengths were placed at the bottom of the tank where the tank was smaller, and 6-ft and 7-ft lengths were placed at the top where the tank was longer. Next, the lid was secured, and then the remainder of the volume inside the tank was filled with water. The tank was filled via hose. Total water volume was estimated by measuring the time to fill a 5-gallon bucket with

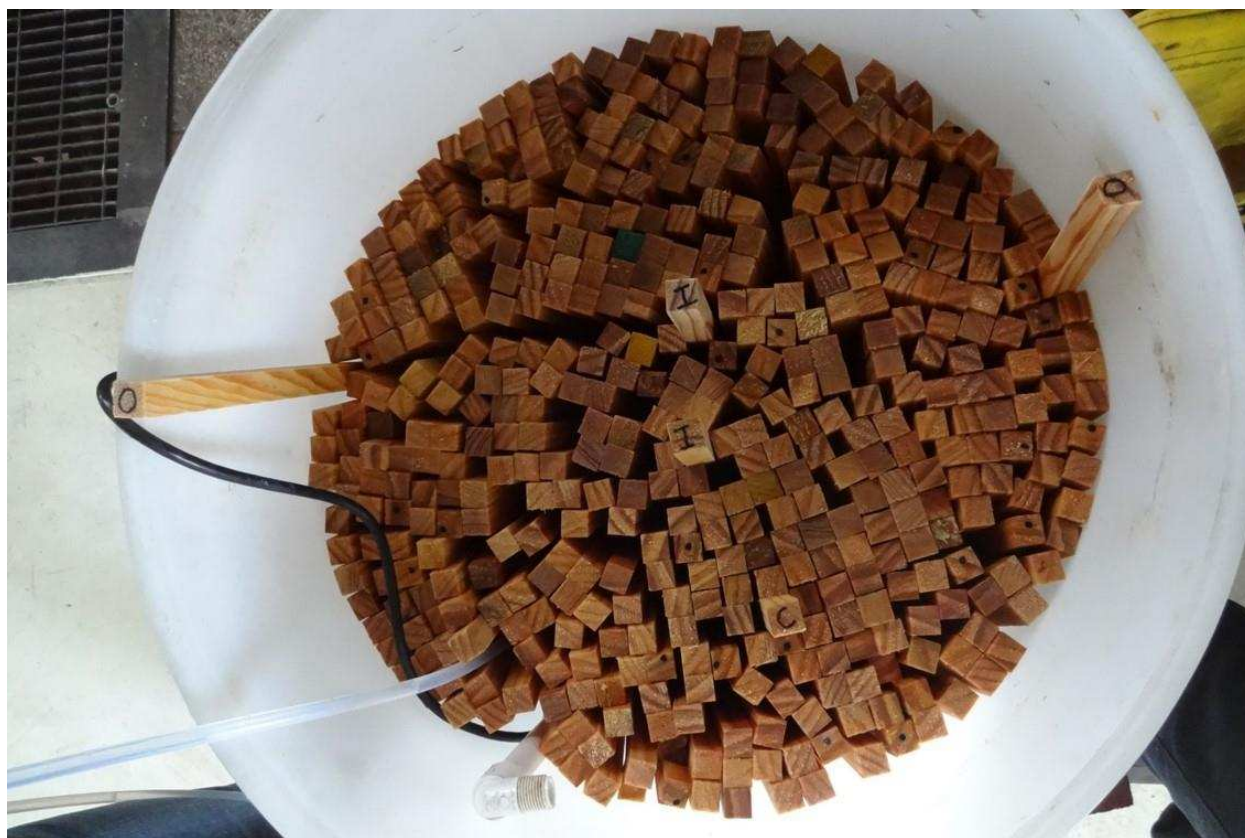
inside where sticks were closely packed. Sticks from which samples were taken are those labeled and raised above the rest in **Figure 9**.

**Figure 9:** Location of sticks from location/packing study.

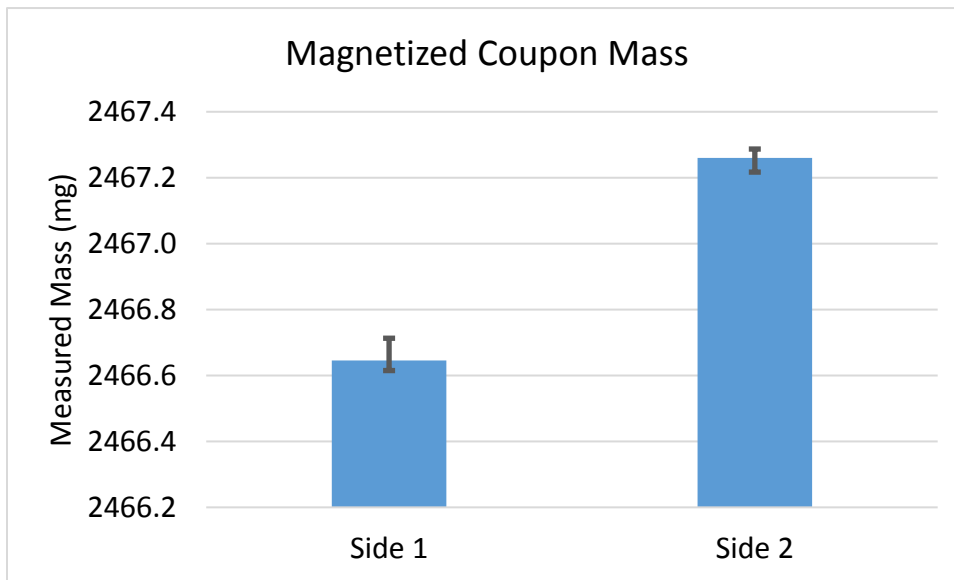
During measurement of initial coupon mass, it was found that for some coupons, mass measurements were not repeatable. During experimentation to determine the cause of this problem, it was observed that even though measurements were highly variable, when a coupon was placed on one side, its average measured weight was significantly higher than when placed on the opposite side, as shown in **Figure 13**.

**Figure 13:** Magnetization - measured mass of coupon when weighed on both sides. Error bars show range of measurements for each side. 14 measurements on each side.

Thus, it was hypothesized that the coupons might be magnetized. At this point, all coupons were demagnetized using a Magnetizer/Demagnetizer (Kendrick & Davis, Syosset, NY). After demagnetization, the mass measurements of the coupons were consistent. Demagnetization was subsequently included in the initial procedure for all new coupons added to the test matrix.

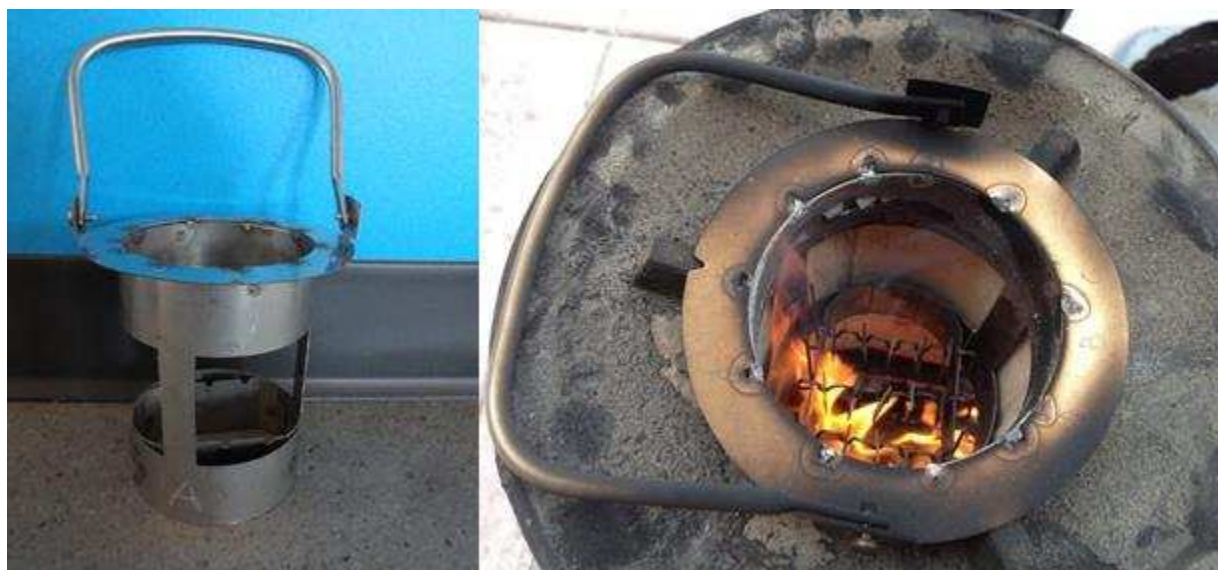
To allow direct exposure of material samples to combustion products for the in-situ portion of the test, fixtures from which coupons could be hung were fabricated and placed inside of each stove. The fixtures were designed to hang coupons inside the stoves such that they would be directly exposed to the flame and would also be located near the hottest part of the combustion chamber, in order to simulate the exposure that a combustion chamber itself would receive. Each fixture was supported by its top flange, which rested on the top of the pot supports of each stove. The body of the fixture hung inside the chimney, and held coupons at the base of the chimney, as shown in **Figure 14**.

*Figure 14: Fixture for hanging coupons inside stove.*

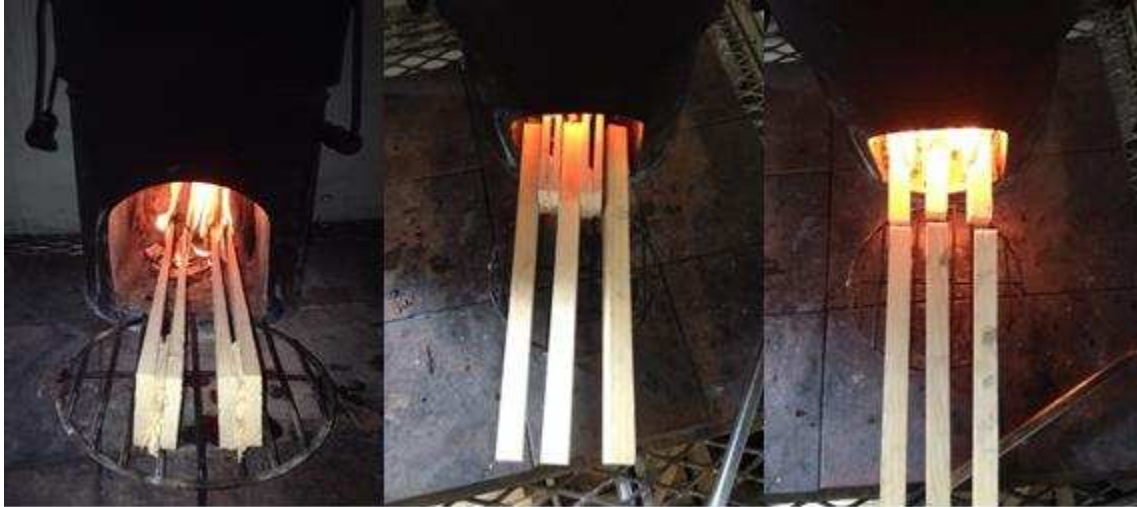
Each stove was started using two unsalted pine shim packs. When the shim packs had burned about halfway, three salted pine sticks were loaded into the stove. Sticks used in testing were 0.75" by 0.75" by 12". New sticks were fed three at a time, and each new stick was placed so that it was in line with the stick ahead of it. The stove feeding process is illustrated in **Figure 18**.

**Figure 18:** *Startup of stove using shim packs, transition from shim packs to sticks, and transition from one set of sticks to the next.*

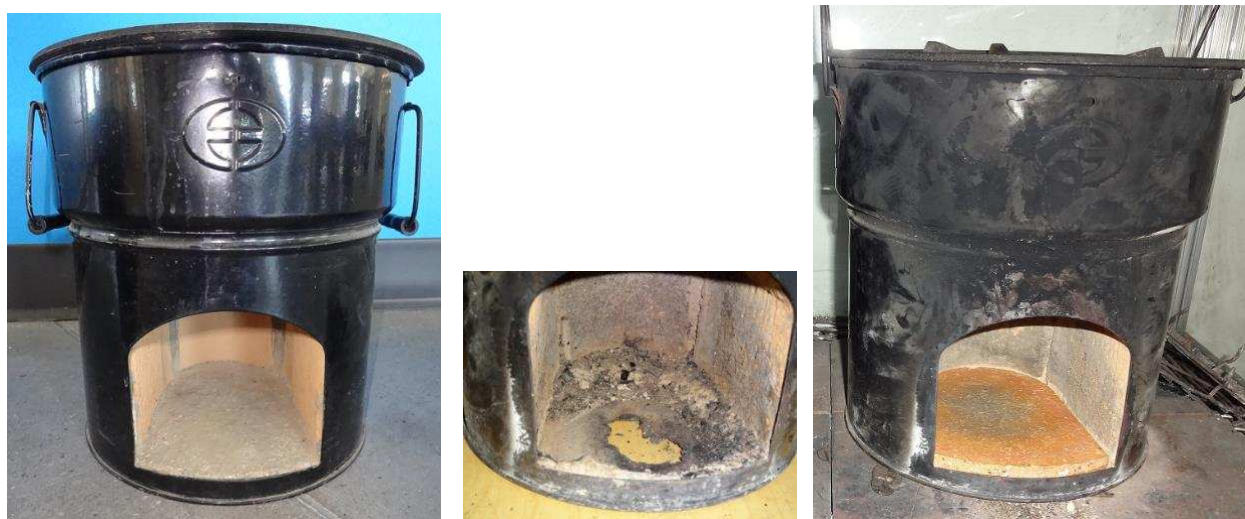
Stove B was repaired by removing the remainder of the ceramic in the degraded chamber, and replacing it with the bottom ceramic tile of a different stove. The circular ceramic bottom combustion chamber liner of an Envirofit G3300 stove was cut to the shape of the inside of the Stove B chamber using a waterjet cutter. Stove B, before and after repair, is shown in **Figure 19**.

**Figure 19:** Stove B before testing (left), at 550 hours - before repair (middle), and after repair (right).

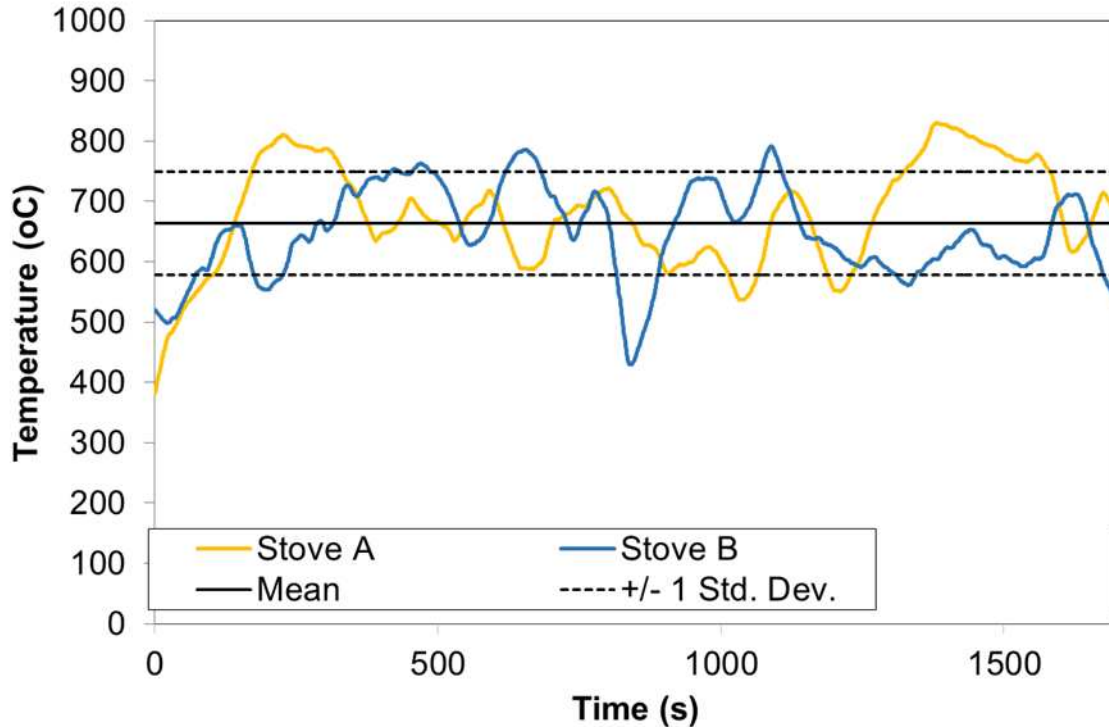
To ensure that the operation of the Stove B was not significantly affected after replacing the bottom tile, temperature profiles of Stove A and B were recorded while the stoves were operated as similarly as possible. A thermocouple was placed in each stove near the bottom back of the chimney, directly in the flame zone. It was placed at the same level as the coupons, and thus experienced the same temperatures as the coupons would experience. The comparison of temperature profiles is shown in **Figure 20**.

**Figure 20:** Temperature profiles inside stove chimneys after repair of Stove B.

It can be seen that the temperatures of the stoves were very similar to each other. During the test, Stove A had a mean temperature of 677°C with a standard deviation of 85°C, and stove B had a mean temperature of 650°C with a standard deviation of 79°C. The difference in mean temperature between stoves was only 34% of the standard deviation of stove B, and thus, it was determined that stove B produced adequately similar temperatures to stove A for the exposure of coupons to proceed.

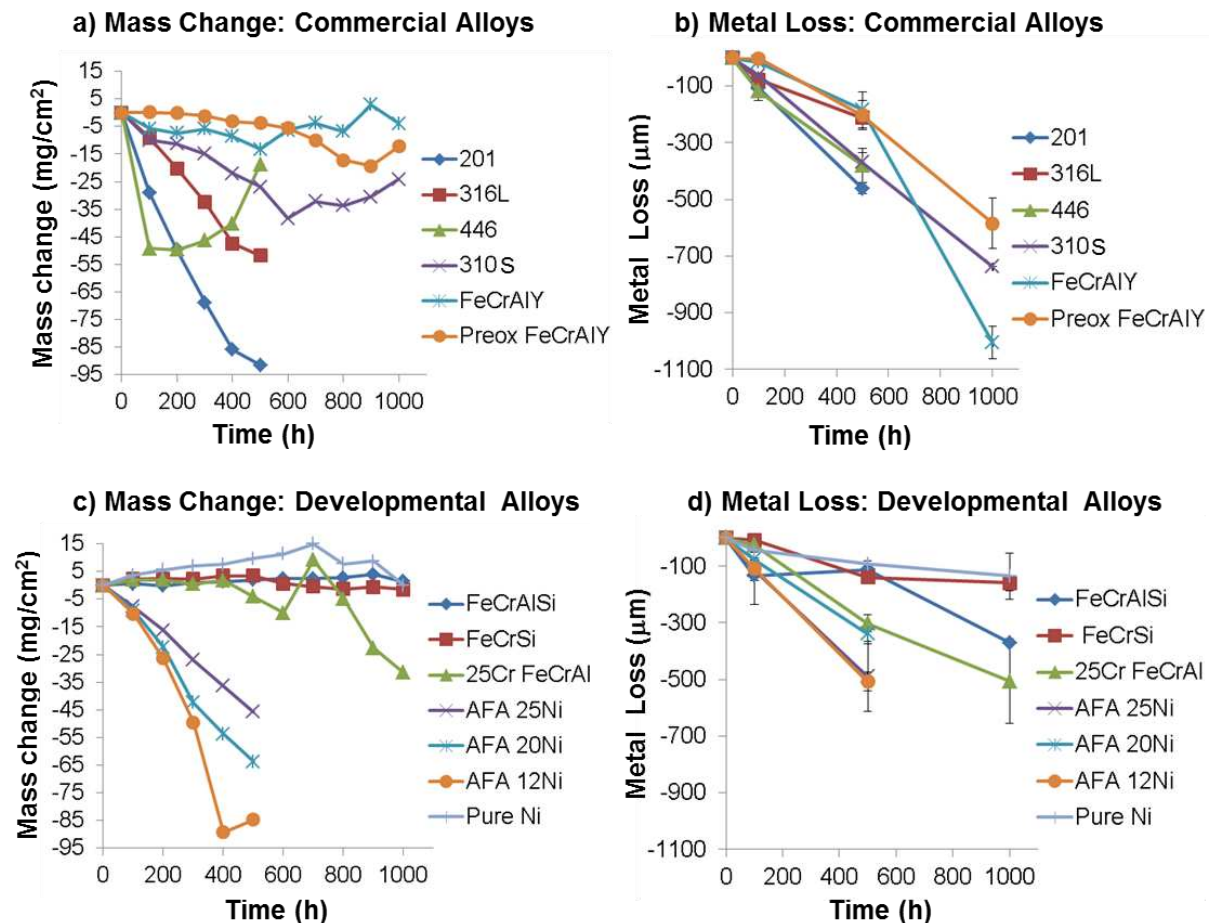
Results from the 800°C furnace test are shown in **Figure 23**.

**Figure 23:** Corrosion data from 800°C lab furnace testing. Metal loss data plotted as the average  $\pm 1$  standard deviation of the 3 locations of greatest attack. The environment was air + 10% H<sub>2</sub>O, with salt added at the start of testing and re-applied after every 100 h cycle.

While in the 600°C test, the best-performing commercial alloys and developmental alloys showed similar metal loss, there was a notable difference between the best developmental alloys and the best commercial alloys in the 800°C furnace test. In terms of metal loss, the best-performing developmental alloy, FeCrSi (metal loss = 160  $\mu\text{m}$ ), performed substantially better than the best-performing commercial alloy, Preoxidized FeCrAlY (metal loss = 580  $\mu\text{m}$ ).

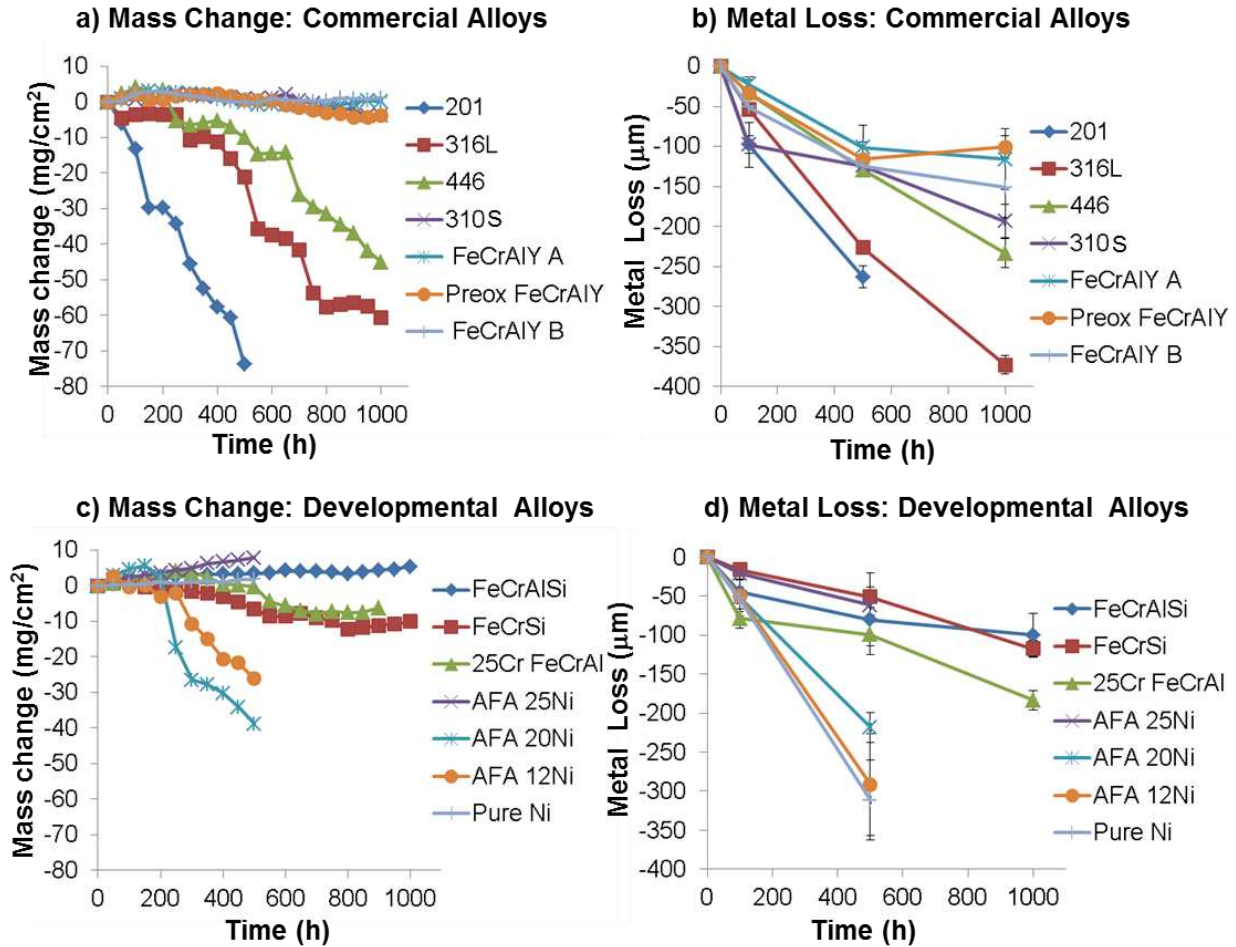
For the in-situ test, metal losses ranged from 100  $\mu\text{m}$  to 370  $\mu\text{m}$ , and mass changes ranged from -60.7  $\text{mg}/\text{cm}^2$  to 5.3  $\text{mg}/\text{cm}^2$ . Mass change plots clearly show high corrosion rates in 201, 316L, and 446, and these alloys also showed the highest metal losses from cross-section analysis. As in the 800°C furnace test, the best-performing commercial alloys were FeCrAlY and preoxidized FeCrAlY, with metal losses of 110  $\mu\text{m}$  and 100  $\mu\text{m}$ , respectively, and mass changes of 0.1  $\text{mg}/\text{cm}^2$  and -3.9  $\text{mg}/\text{cm}^2$ , respectively. The best performing developmental alloys were FeCrSi and FeCrAlSi, with metal losses of 117  $\mu\text{m}$  and 100  $\mu\text{m}$ , respectively. In-situ cookstove test results are shown in **Figure 24**.

**Figure 24:** Corrosion data from in-situ cookstove testing. Metal loss data plotted as the average  $\pm 1$  standard deviation of the 3 locations of greatest attack. FeCrAlY A and FeCrAlY B are duplicate samples run in each of the two cookstove test beds utilized. Salted pine wood was burned to induce accelerated corrosion conditions.

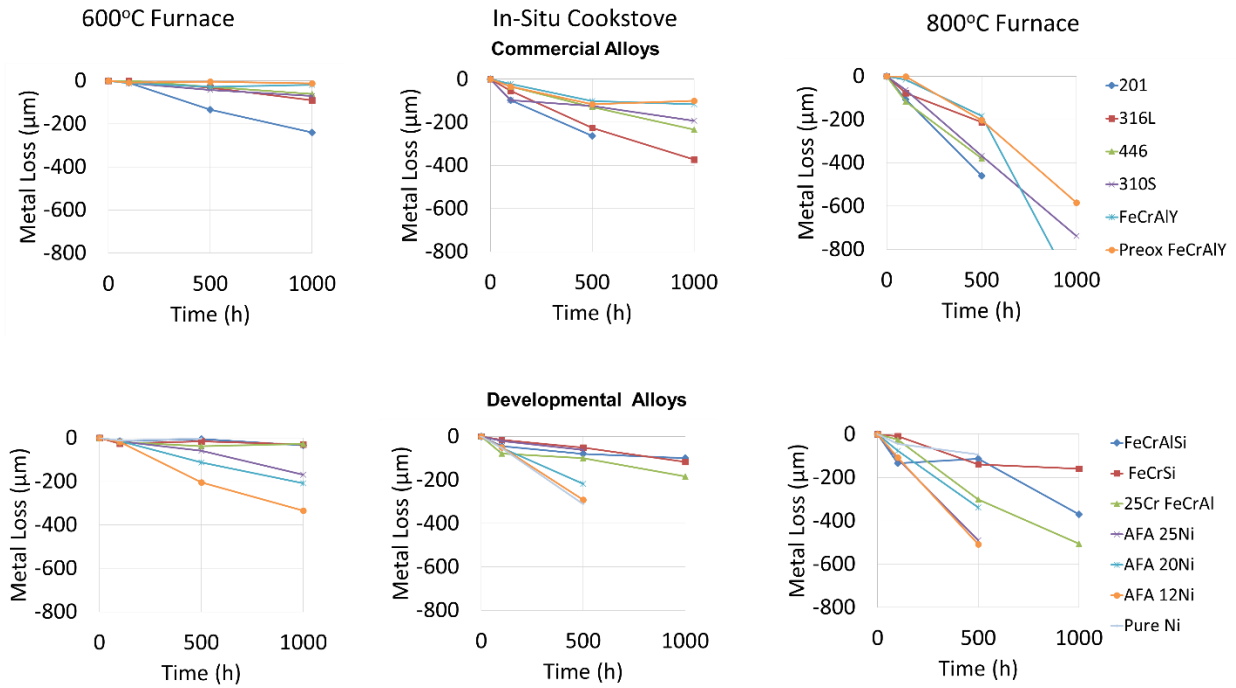
A quantitative comparison between the metal loss results is shown in **Figure 25**, below.

**Figure 25:** Metal loss results for 600 C lab furnace, in-situ cookstove, and 800 C lab furnace tests.
