SEDIMENT SEALING TRIAL WITH SS-13 IN COACHELLA CANAL  
IN SOUTHERN CALIFORNIA

A summary of Development Activities carried on by the  
Imperial Irrigation District during the Period of 1955 -1960

R. D. Dirmeyer, Jr.

R. T. Shen

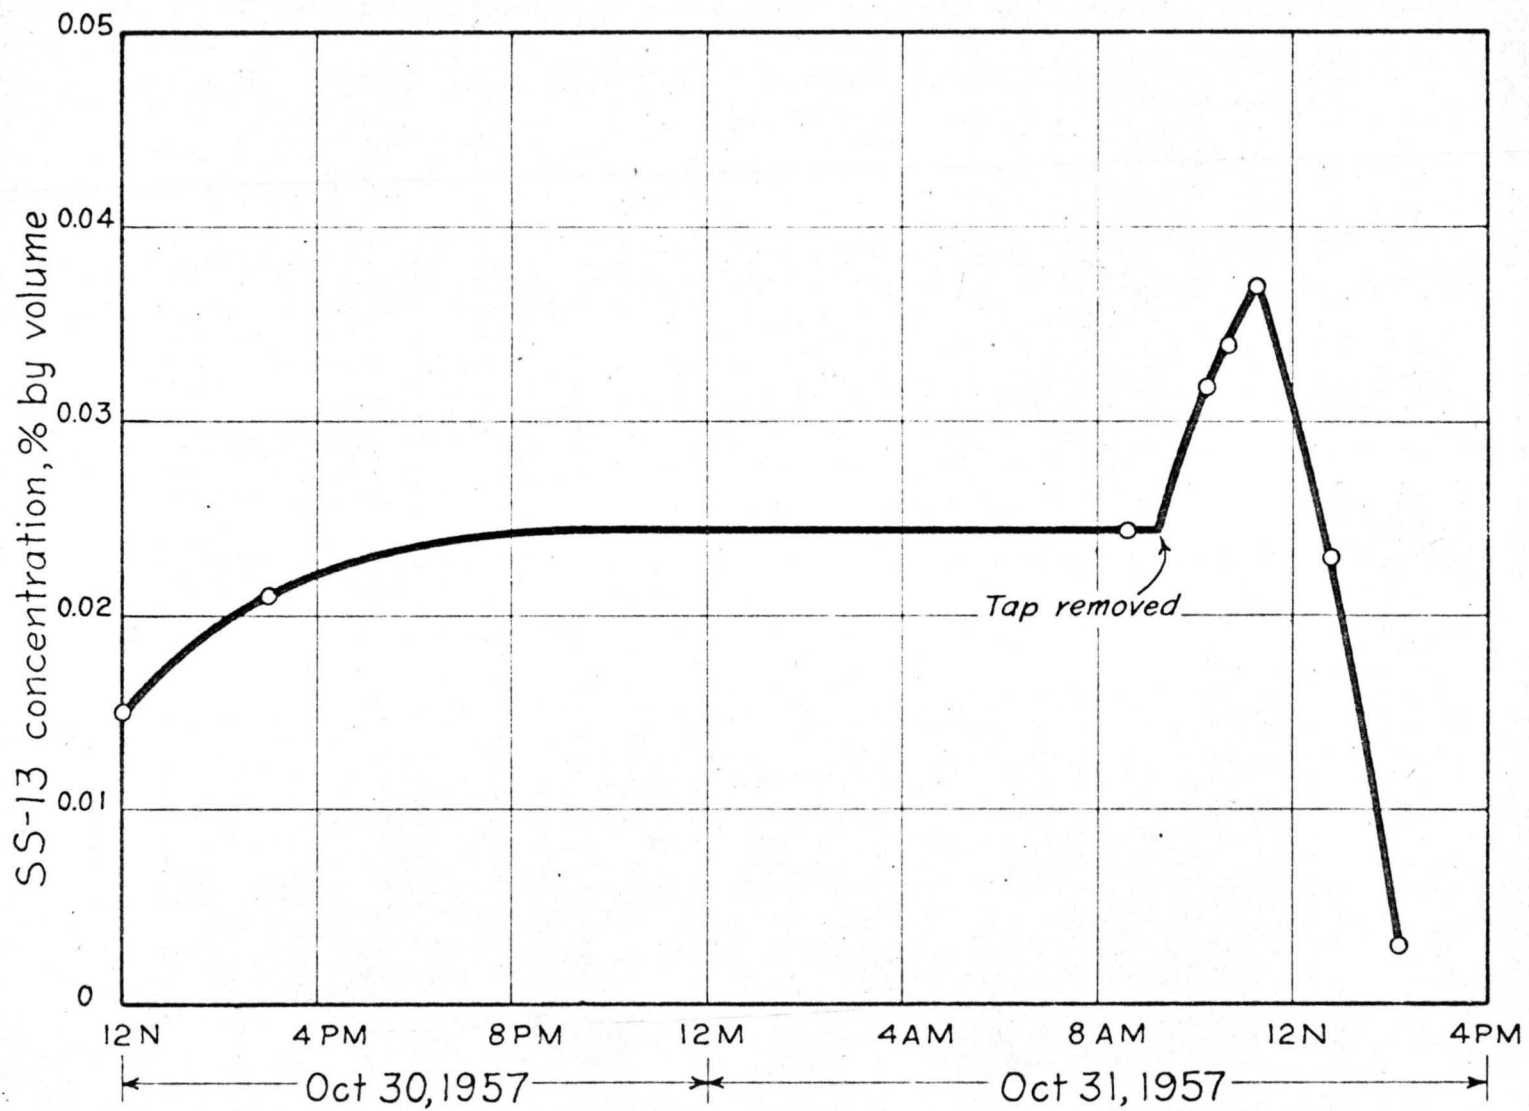
Fig. 15 Concentration history at Sta. 695 during installation of SS-13

At 7:40 am., October 31, 1957, the canal flow was resumed. The earth dam (Fig. 14) at the lower end of the reach was broken 1 hour and 45 minutes later at 9:20 am. It took 5 hours and 25 minutes for all of the treated water to flow from Reach No. 2 (Fig. 15).

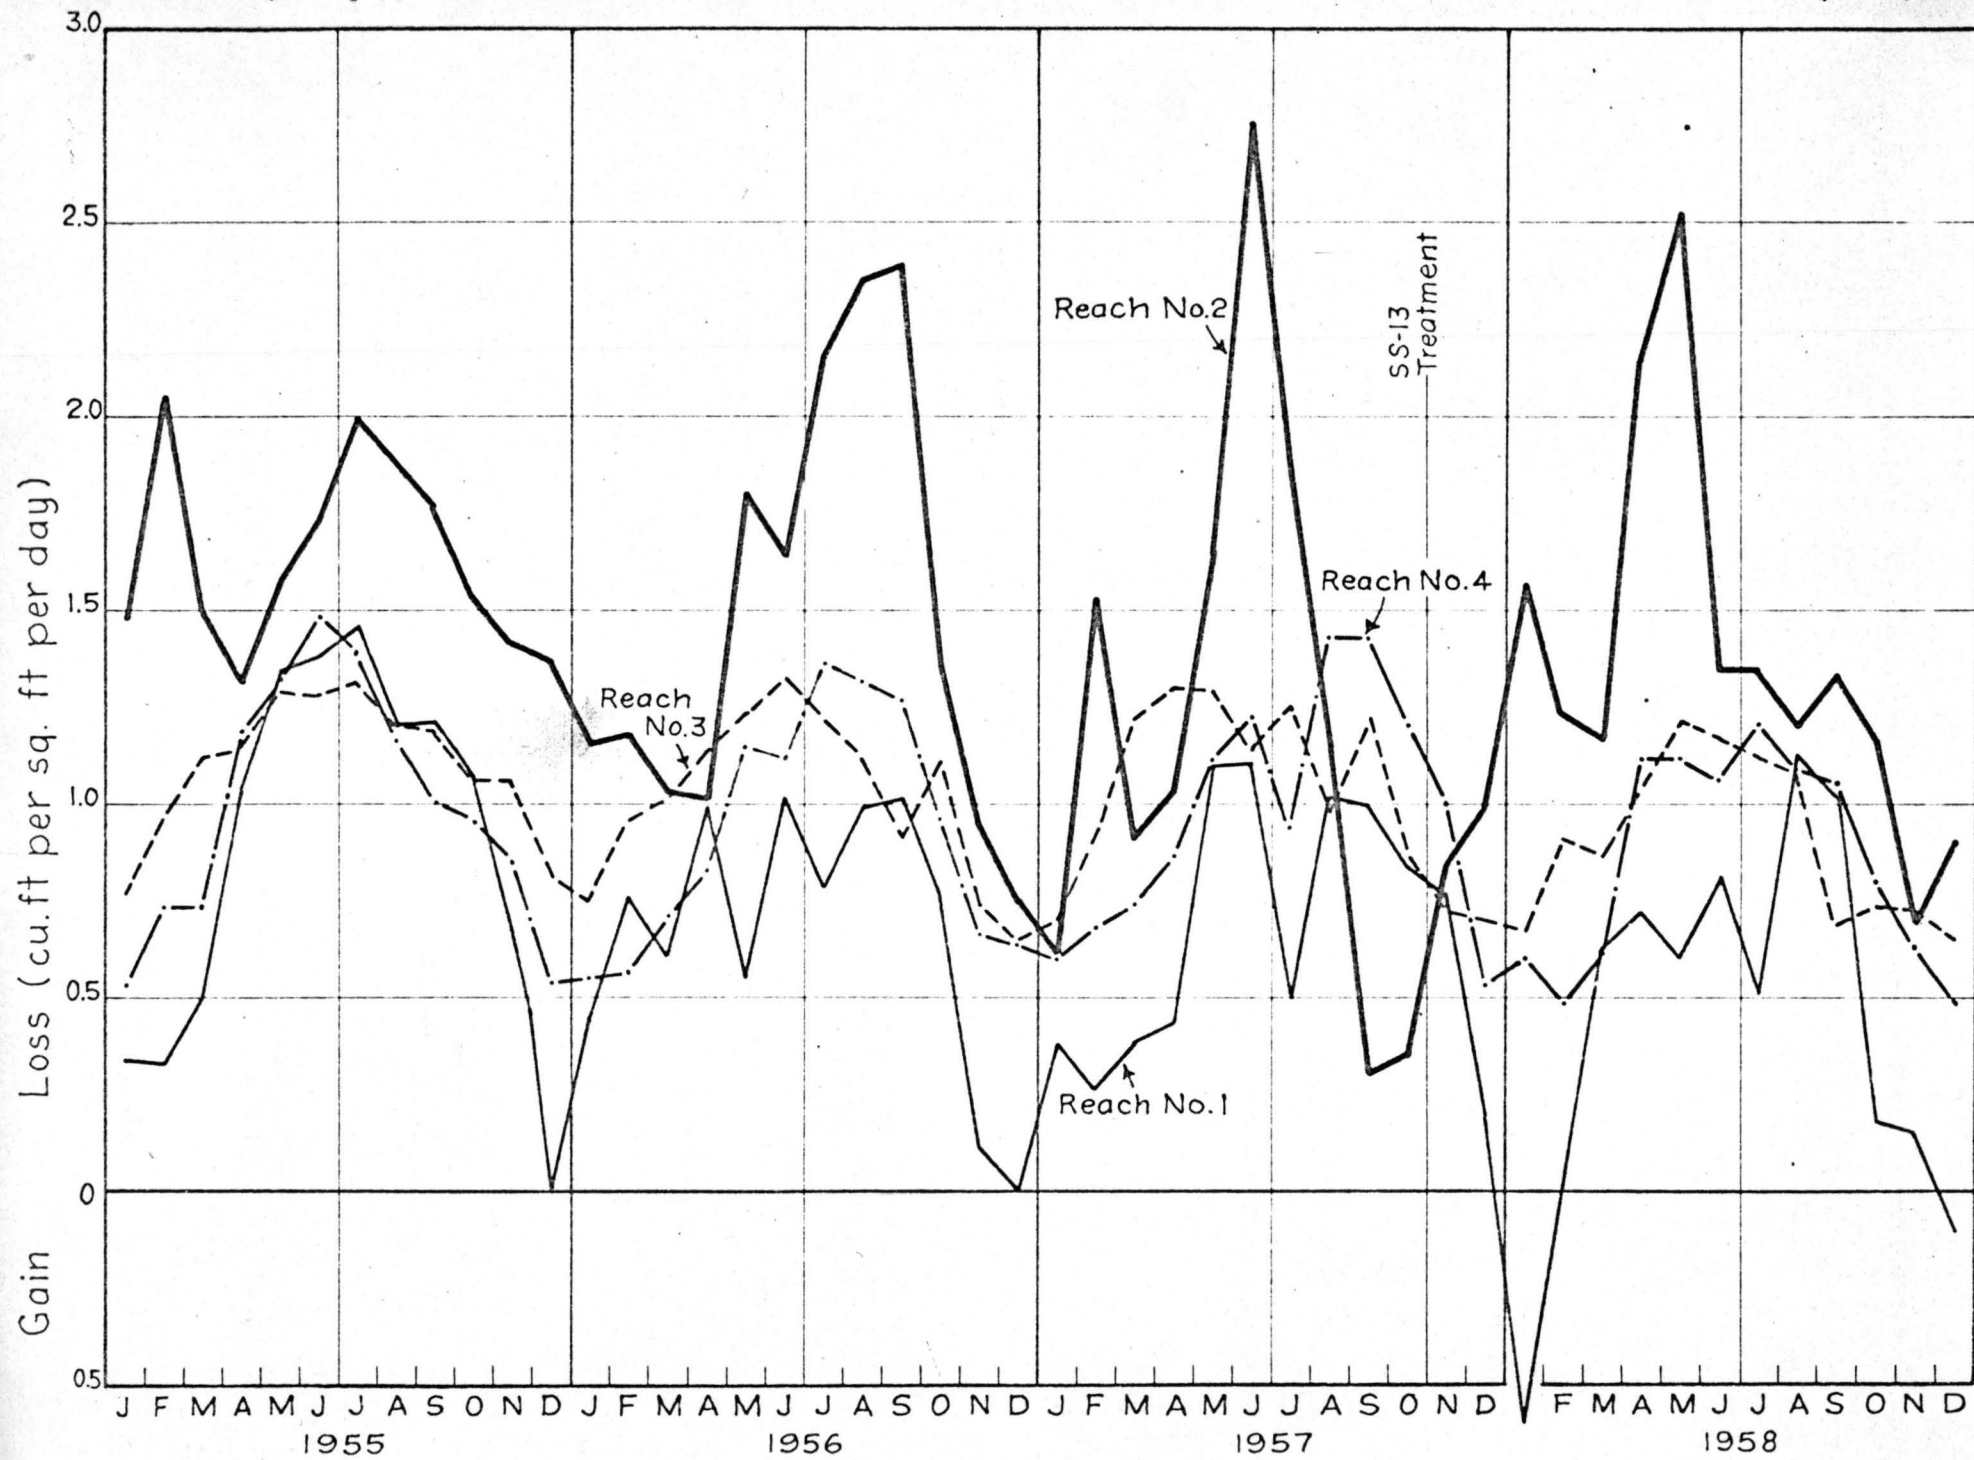
Fig. 16 Superimposed plot of losses by reaches

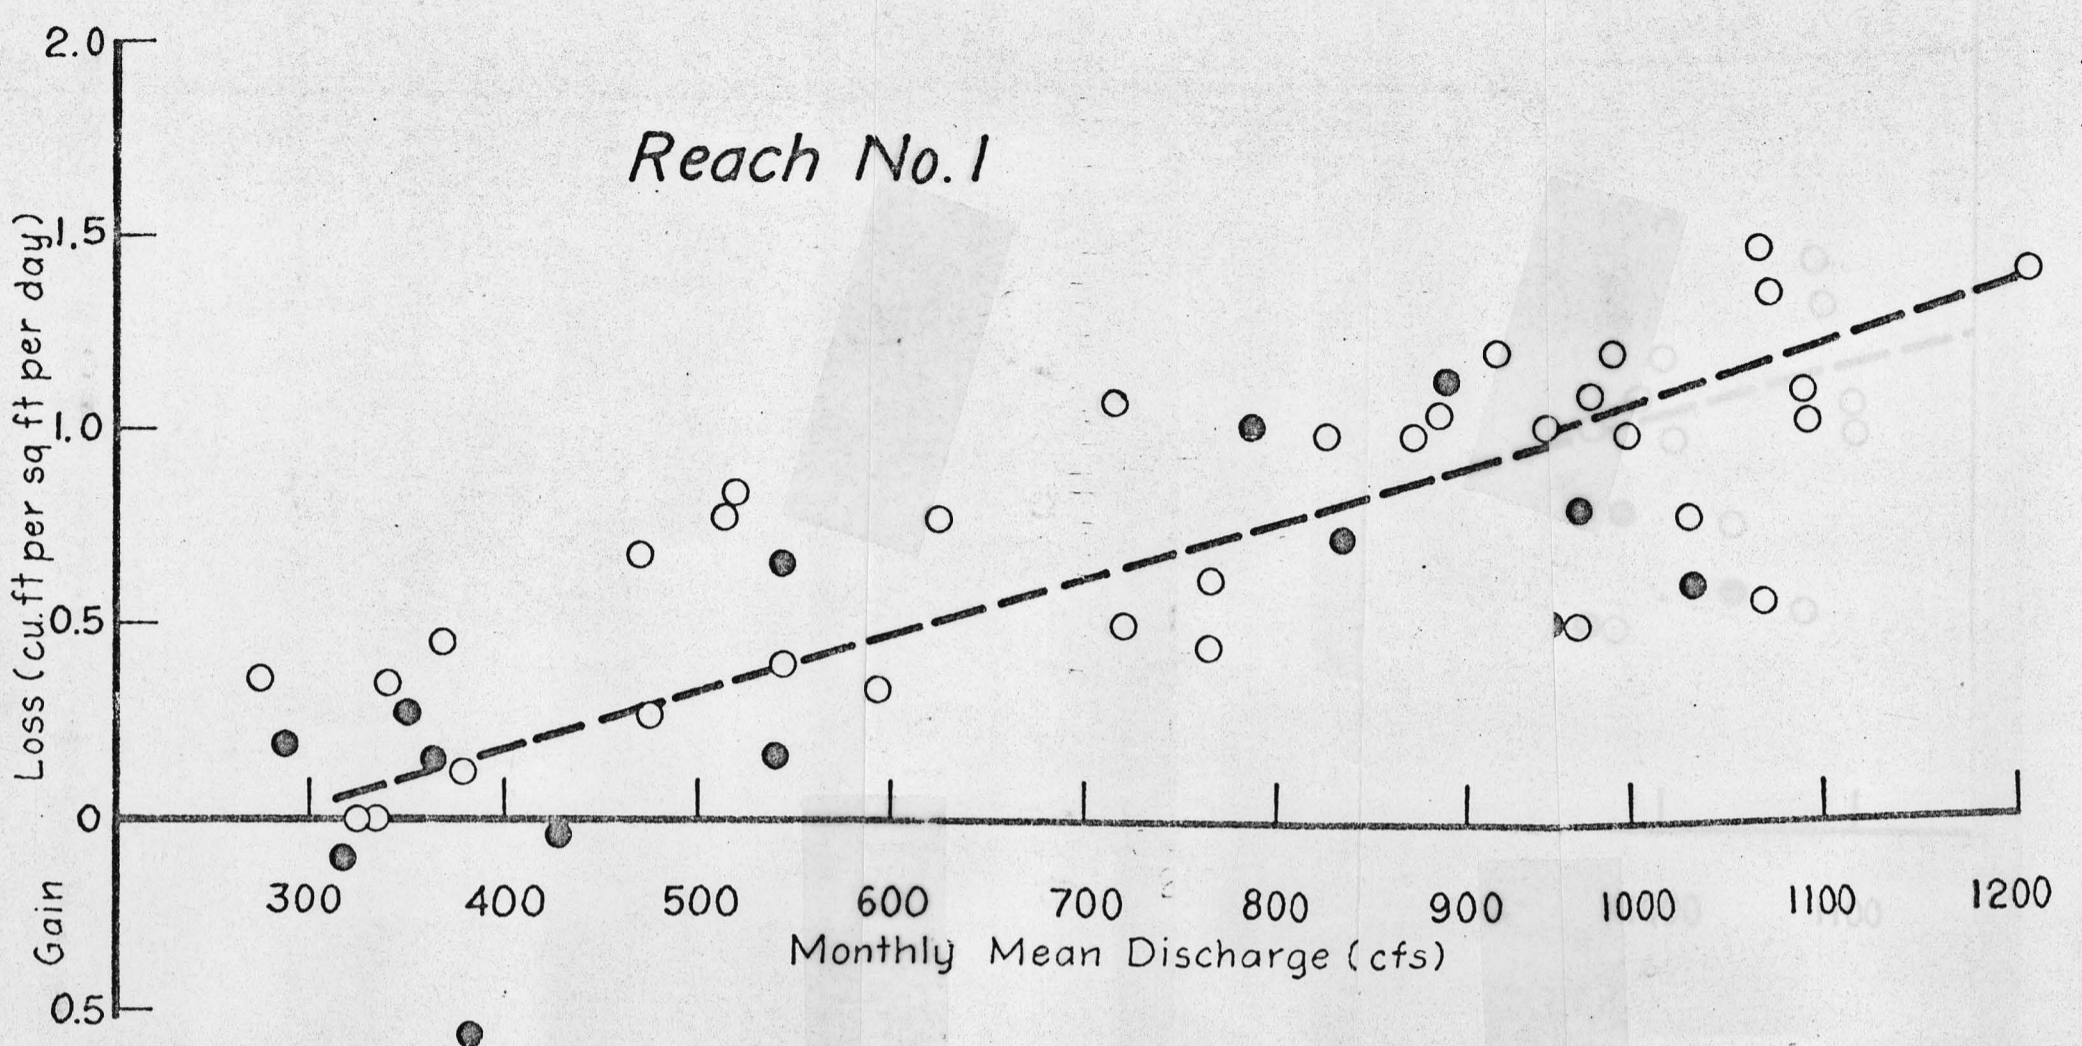
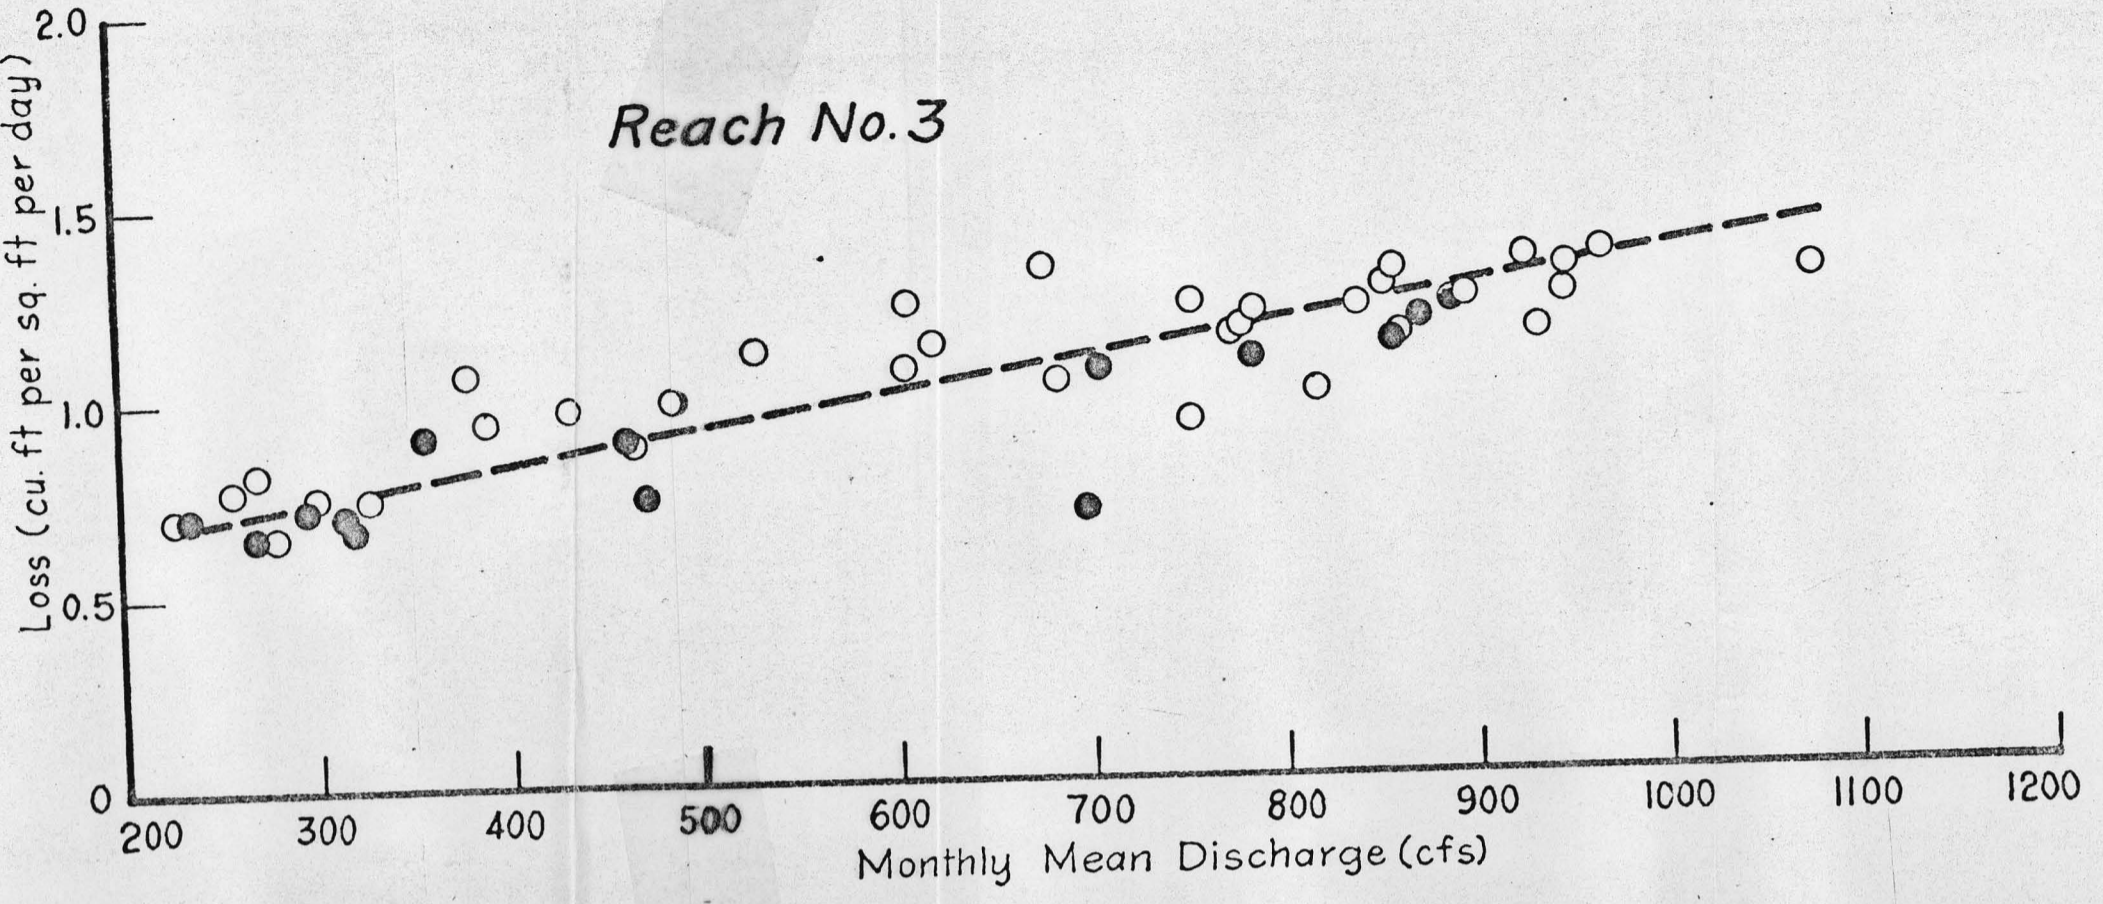
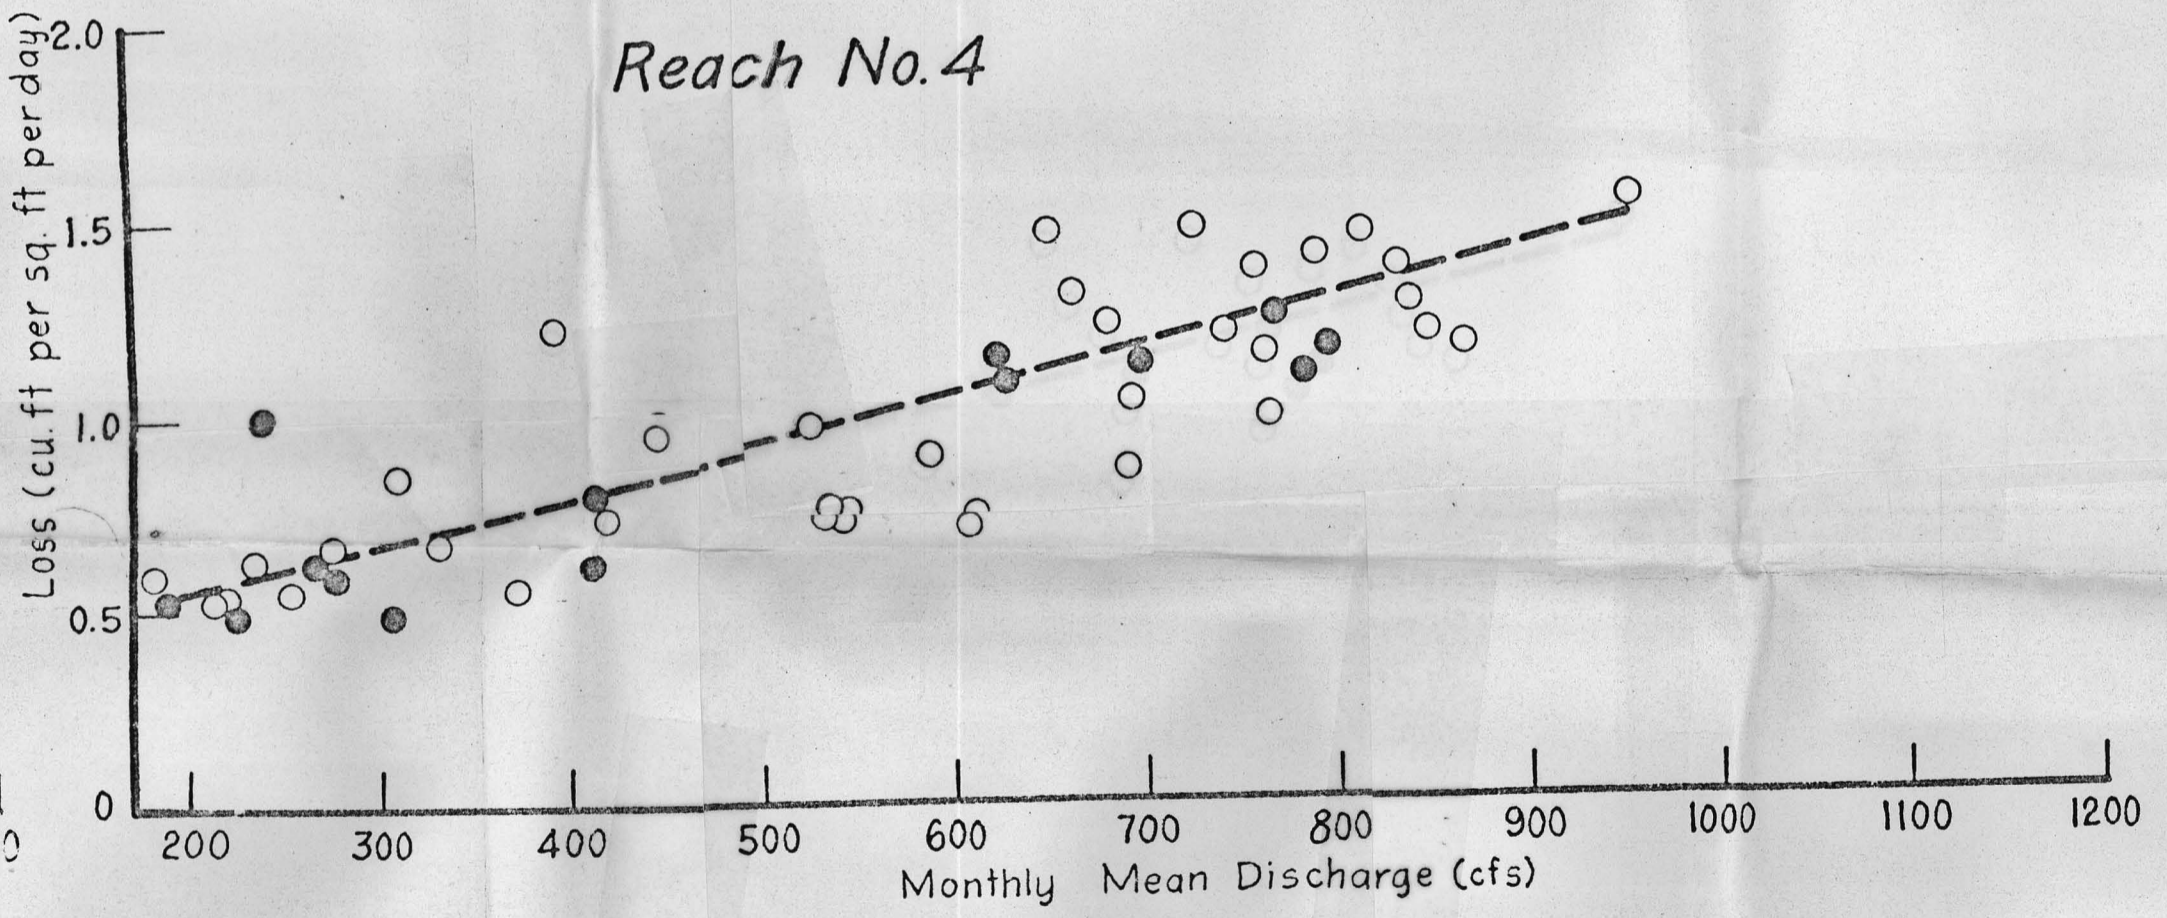
○ Data taken before treatment of Reach No. 2  
January 1955 to October 1957

● Data taken after treatment of Reach No. 2 with SS-13  
November 1957 to December 1958

*Fig. 18 Plot of monthly loss by reaches*

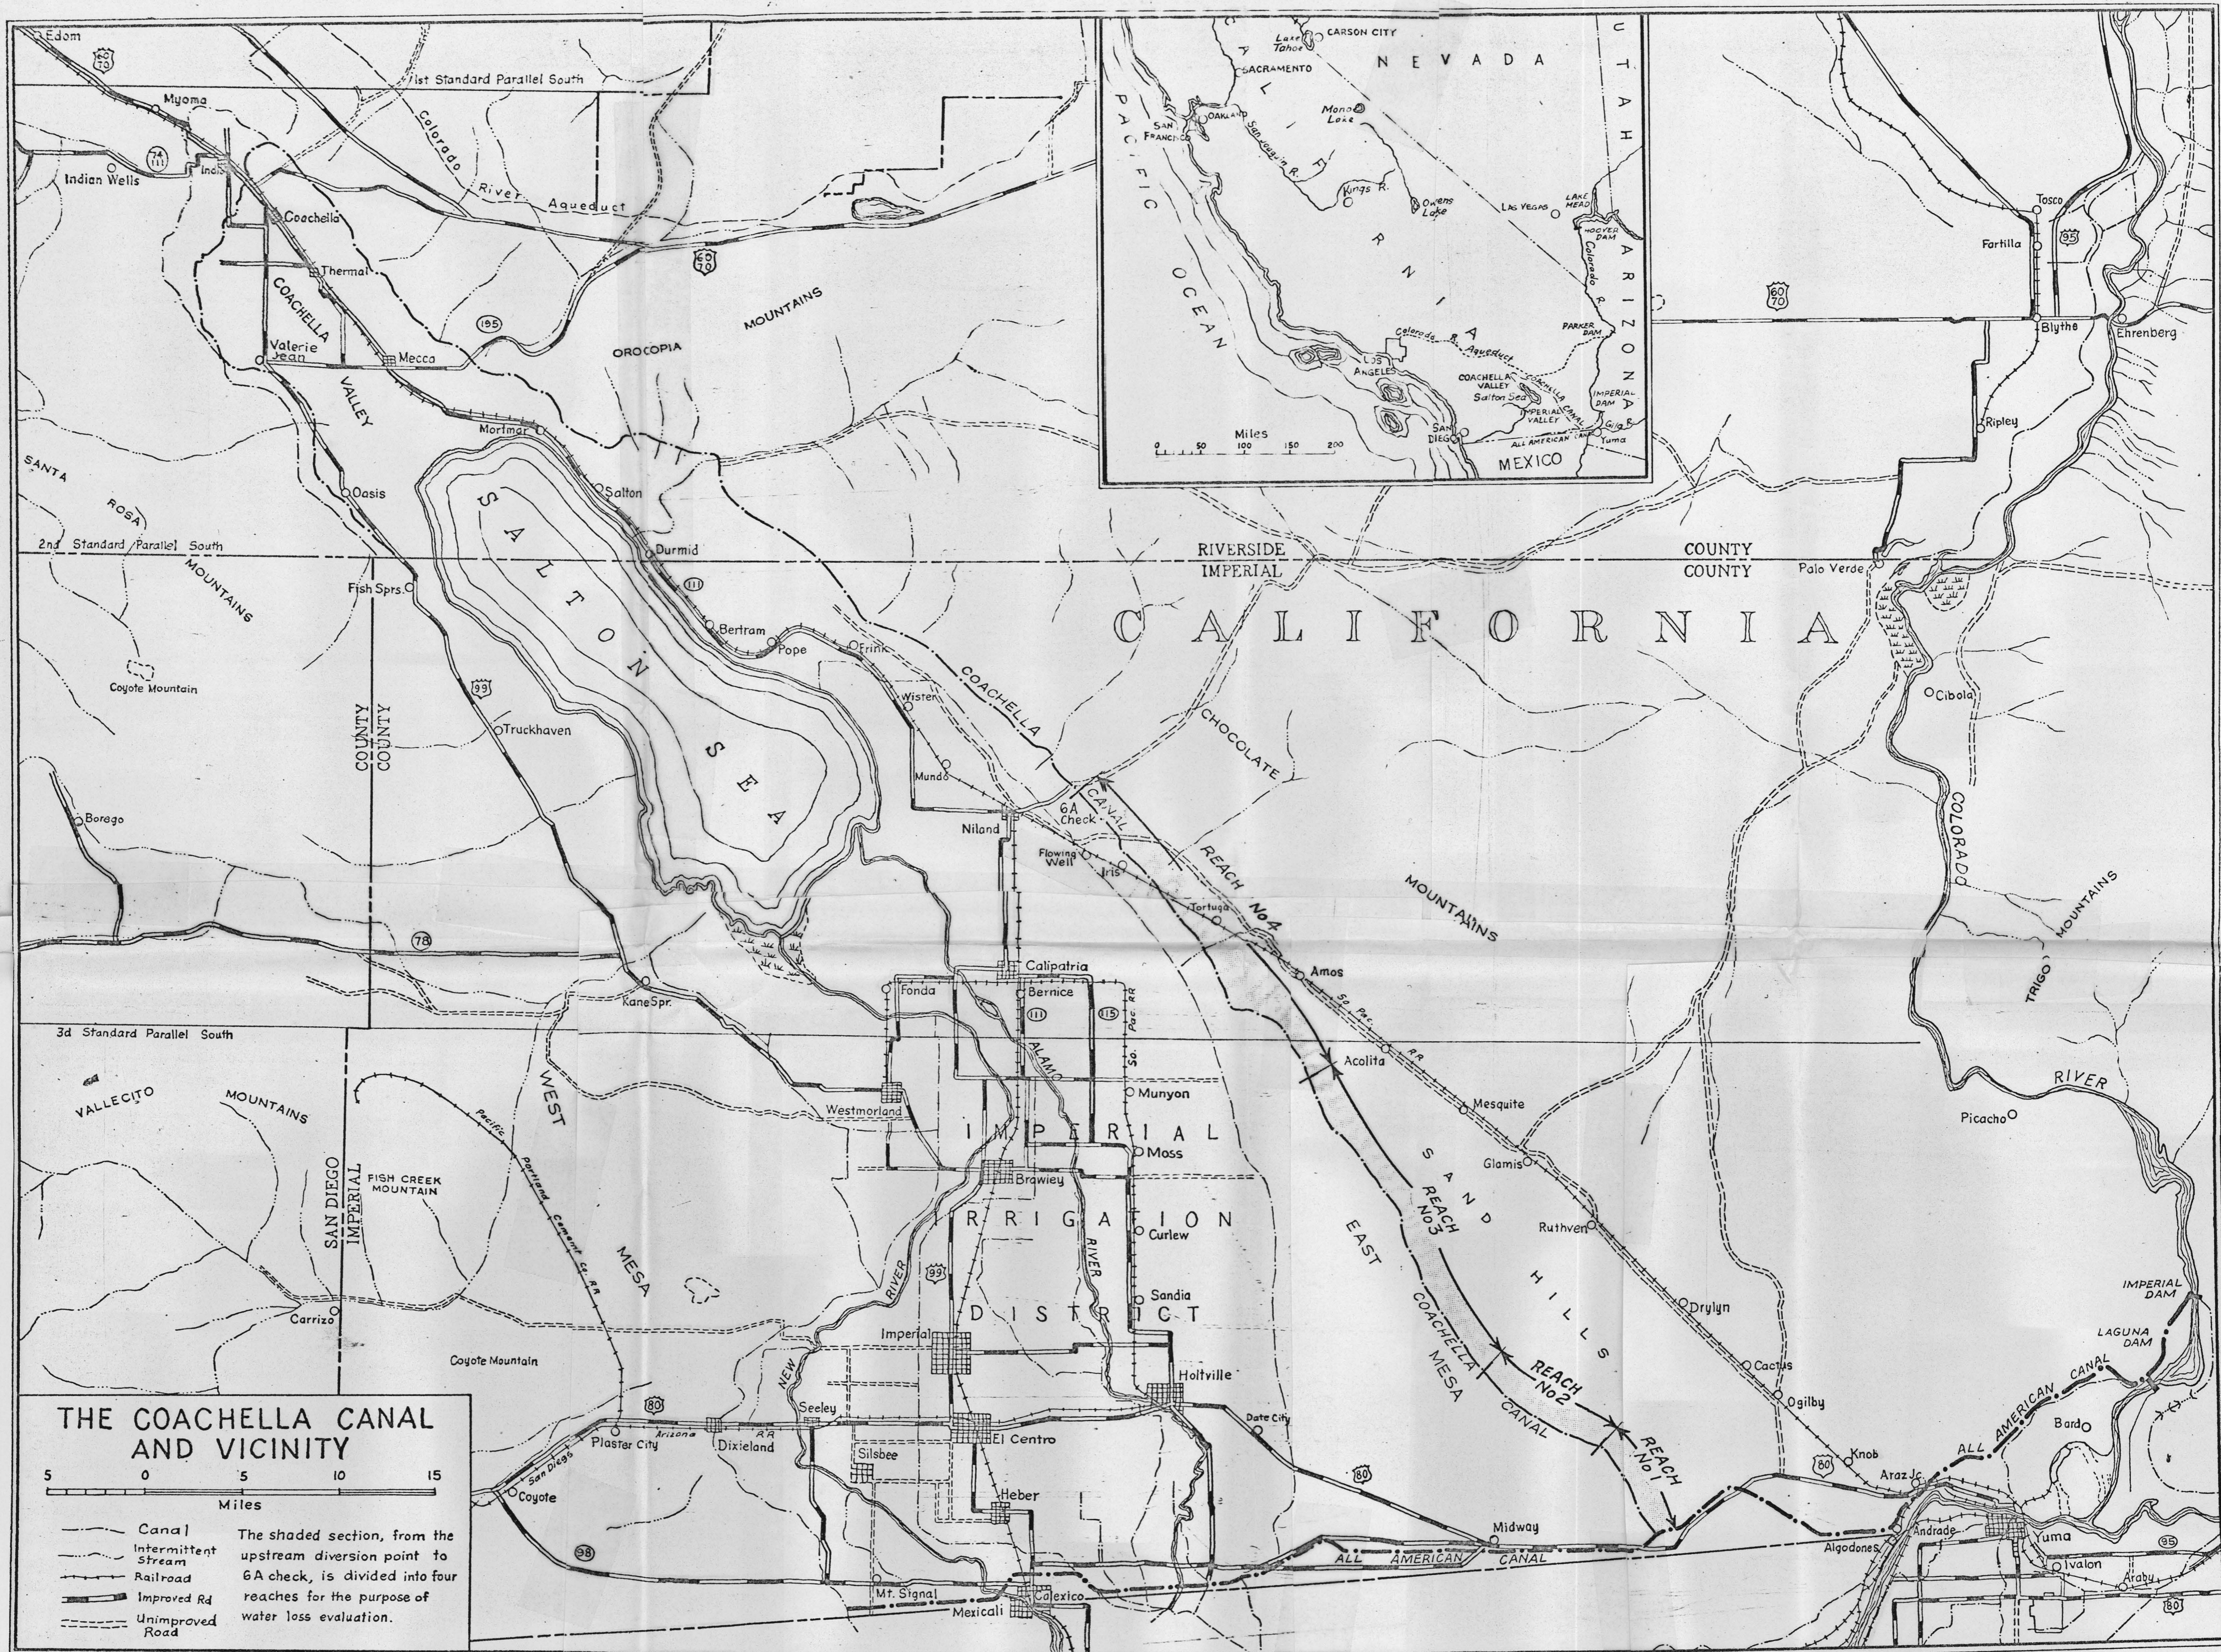
**THE COACHELLA CANAL AND VICINITY**

The Coachella Canal is one of the major supply canals delivering Colorado River water into the Imperial Valley. It delivers a limited amount of irrigation water to the East Mesa area of the Imperial Irrigation District, but its present main function is to deliver water to the Coachella Valley County Water District in the north end of the Imperial Valley, north of the Salton Sea. Operation of the canal began in 1945; on May 1, 1952, the Imperial Irrigation District assumed operation and maintenance<sup>1</sup> of a portion of the canal from the All-American Canal to the 6A check, a distance of 49 miles. See Fig. 1.
