THESIS

LOGJAM ATTENUATION OF ANNUAL SEDIMENT WAVES IN EOLIAN-FLUVIAL  
ENVIRONMENTS, NORTH PARK, COLORADO

Julia Grabowski

Colorado State University

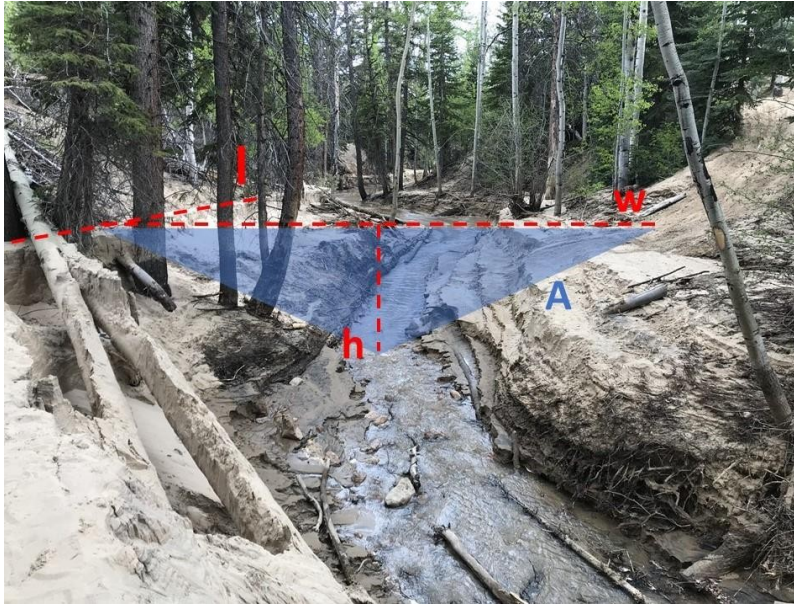
**Fig. 6.** Diagram illustrating the measurement of width ( $w$ ), height ( $h$ ), and the 10 m length ( $l$ ) of SAS ISV in North Sand Creek, demonstrating how ISV is modeled as a triangular prism. In this case, the highest SAS level is preserved on both sides of the channel.

At 10 m increments along the channel, the highest SAS on either side of the creek was identified, and a laser rangefinder was used to measure its height above the active channel to the nearest decimeter. I measured SAS width, also to the nearest decimeter, from the point at which the horizontal surface intersected the bounding slope. If the highest SAS level was extant on only one side of the channel, the full width was measured to the opposite slope at the level's approximate elevation (Fig. 6)

Incised Sand Volume (ISV) associated with an SAS was estimated by modeling the incised sand as a triangular prism at each 10 m of the SAS length, and summing these together (Fig. 6). For 10 m increments where an extant SAS was not observed, but SAS levels were evident both upstream and downstream of the gap, it was assumed to represent a section of SAS destroyed prior to observation, and the width and height were linearly extrapolated in Excel.

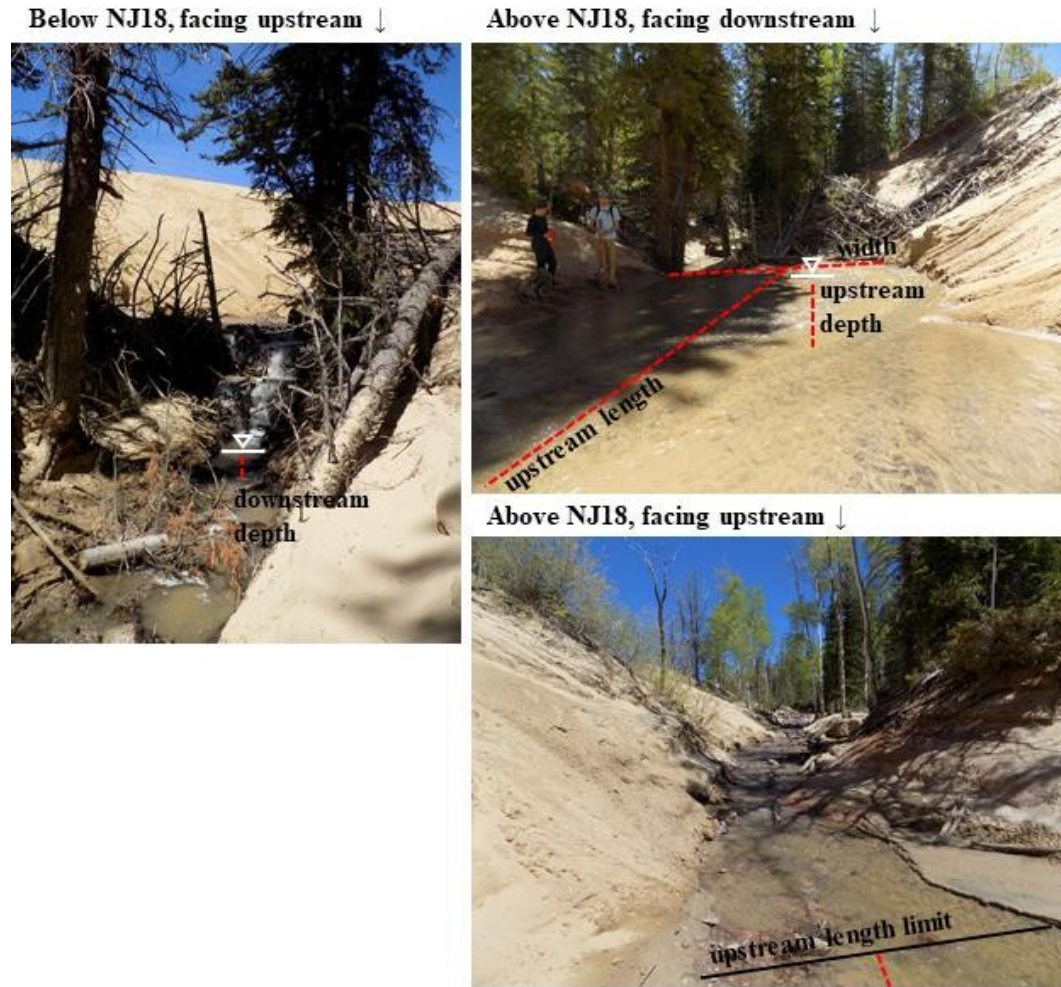
**Fig. 8.** Diagram representing the four field measurements made at logjams that were used to calculate sand wedge volume

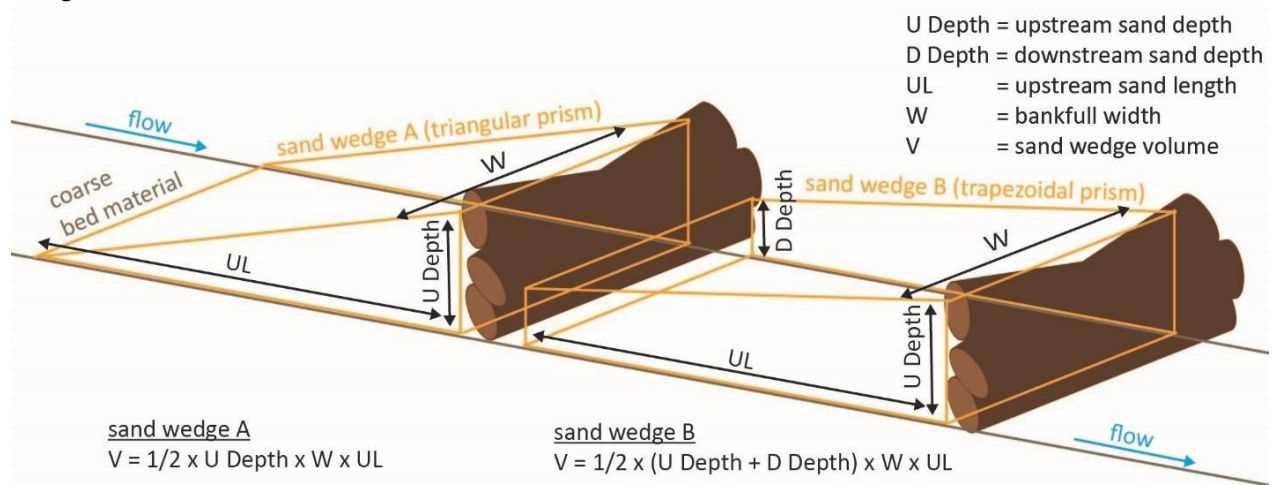
**Fig. 9.** Diagram demonstrating the calculation of sand wedge volume as either a triangular prism (sand wedge A) or a trapezoidal prism (sand wedge B)

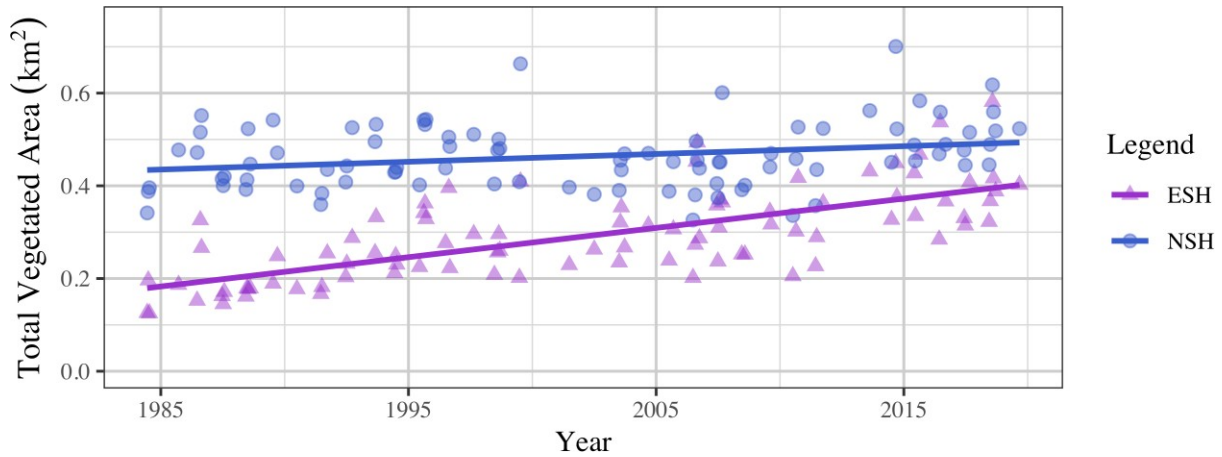
**Fig. 12.** Values and fitted regression lines for the total estimated vegetated area within East Sand Hills (ESH) and North Sand Hills (NSH)

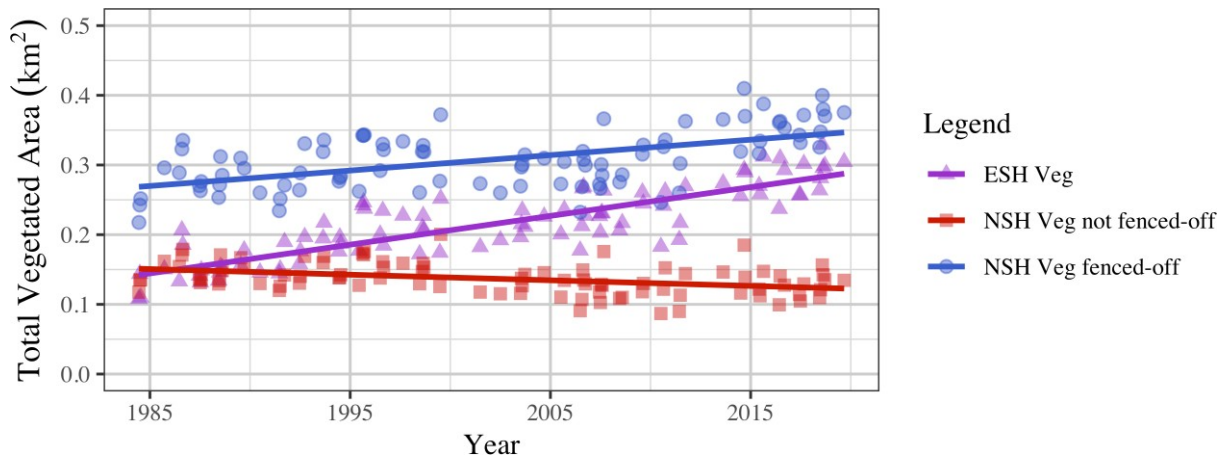
**Fig. 13.** Values and fitted regression lines for total estimated vegetated area within vegetated areas on East Sand Hills (ESH) and North Sand Hills (NSH), with areas on NSH split into areas fenced-off to OHV users, and those not fenced-off

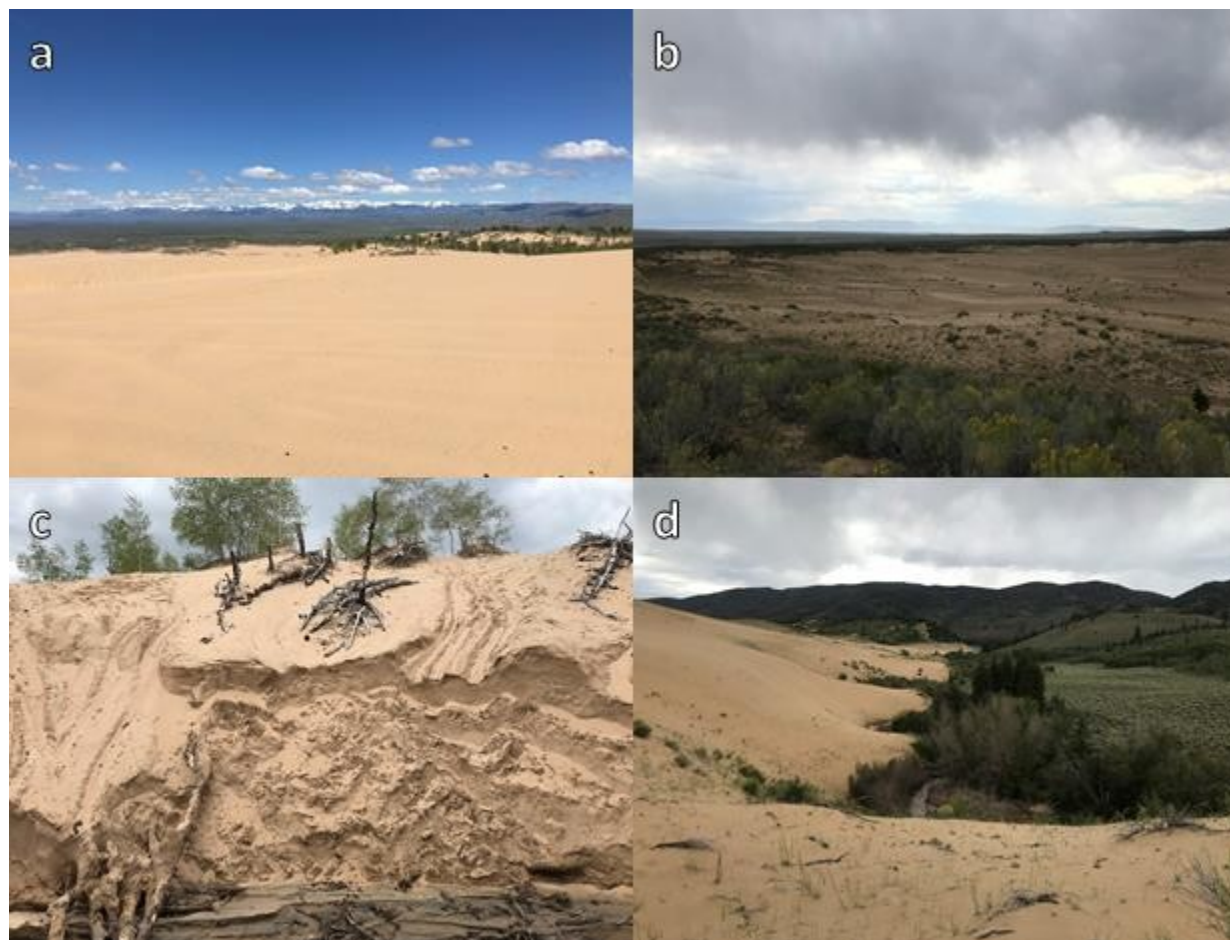
**Fig. 14.** Qualitative comparison of the sand dunes on (a) North Sand Hills and (b) East Sand Hills, and the dune-creek interface at (c) North Sand Creek and (d) East Sand Creek. All photos were taken in the summer of 2019.

Although not quantified in this study, the North Sand Hills and East Sand Hills dunes exhibited clear qualitative differences possibly related to OHV impact (Fig. 14). The East Sand Hills dune area is almost entirely covered with sparse grass and shrubs, while the North Sand Hills dune area is almost entirely bare. Additionally, along the North Sand Creek dune-creek interface, I observed widespread evidence for recent vegetation disturbance and gravitational slumping, while I observed no evidence for either along the East Sand Creek dune-creek interface.

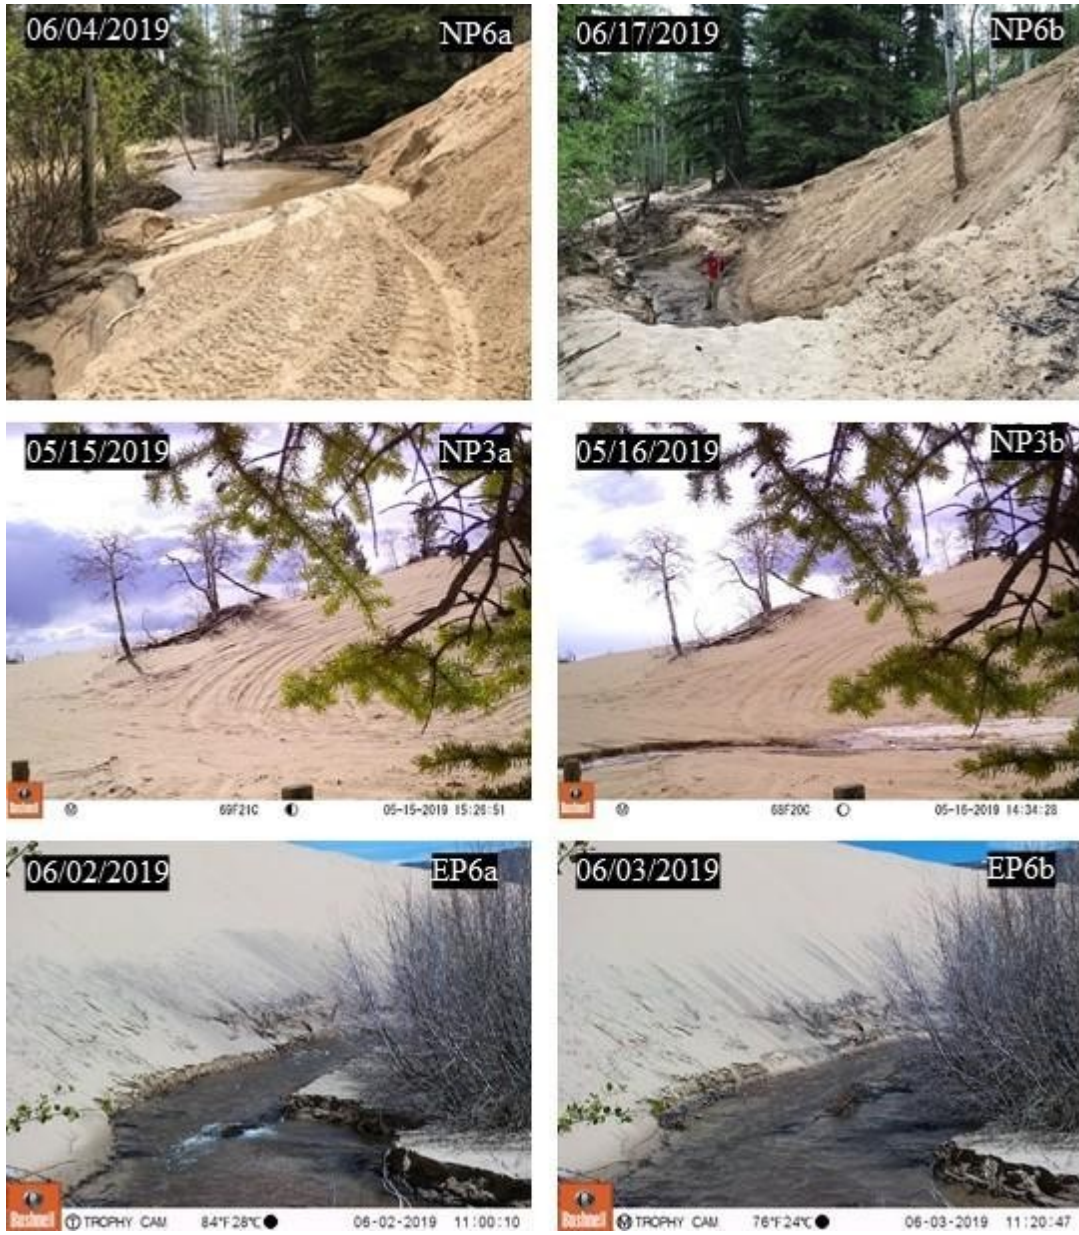
**Fig. 15.** Selected repeat photos demonstrate rapid incision and the formation of SASs during the early summer in North Sand Creek locations NP6 and NP3, and the collapse of an SAS at East Sand Creek location EP6.

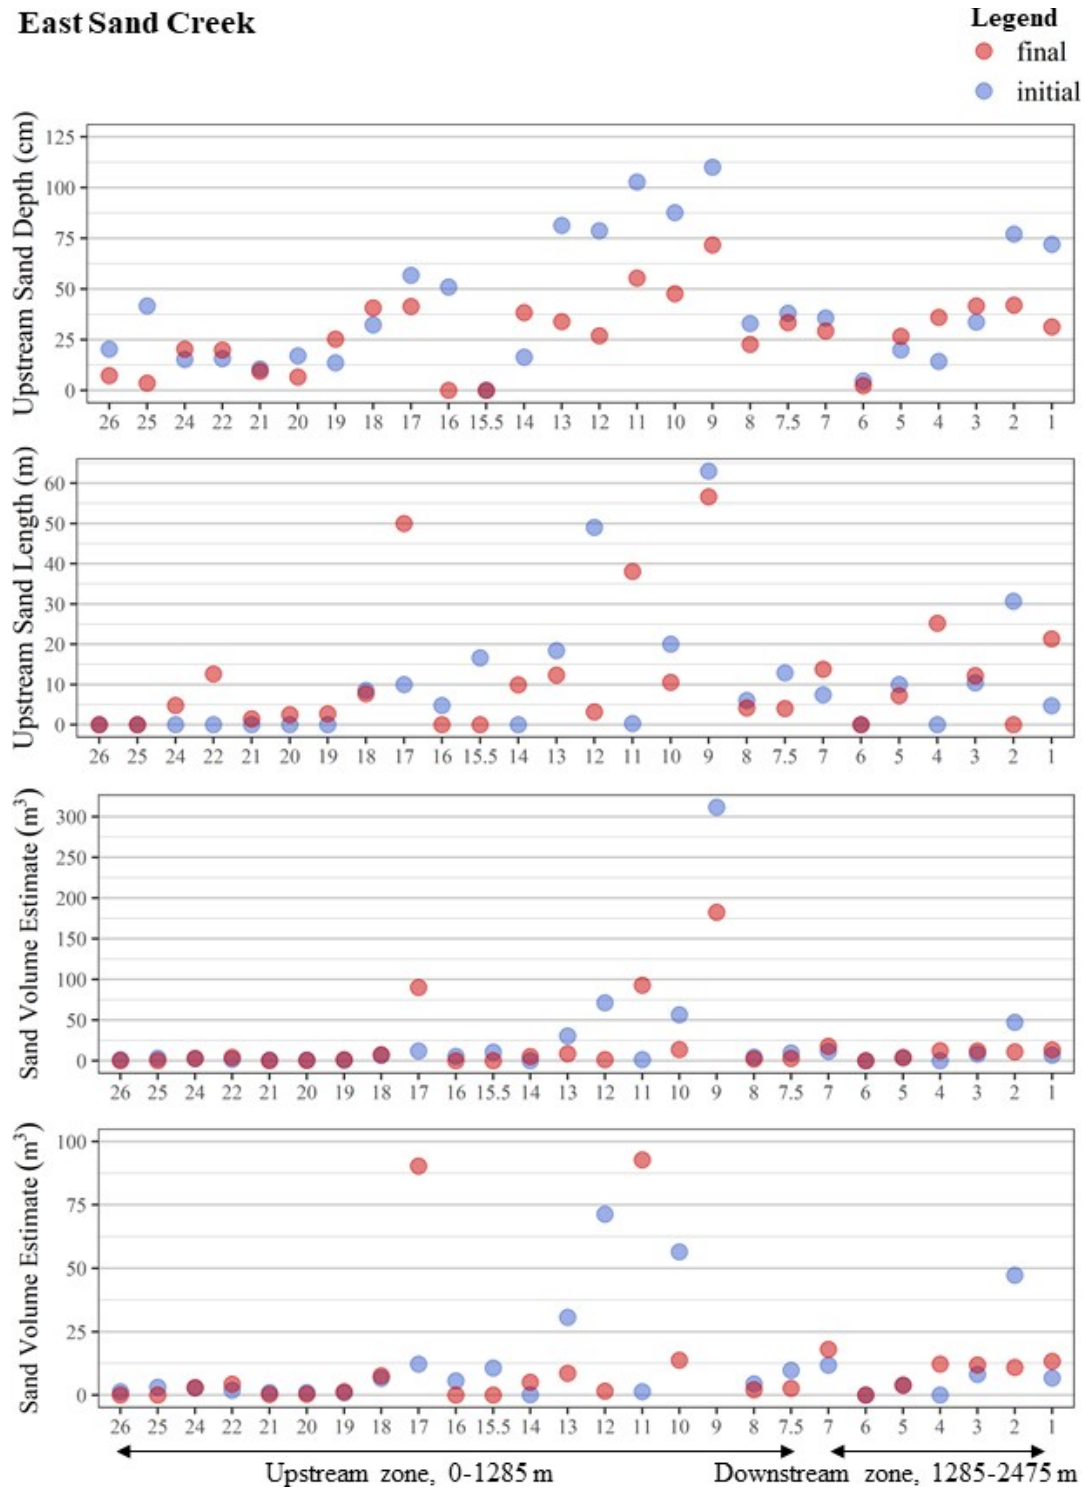
**Fig. 18.** Initial and final measurements for sand wedge upstream sand depth, upstream sand length, and estimated volume for all logjams in East Sand Creek. Logjam ID number is represented on the x axis. Volume is represented on axis representing the full range of measurements, as on a y-axis maximum of 100 m<sup>3</sup> to make data from smaller sand wedges visible.

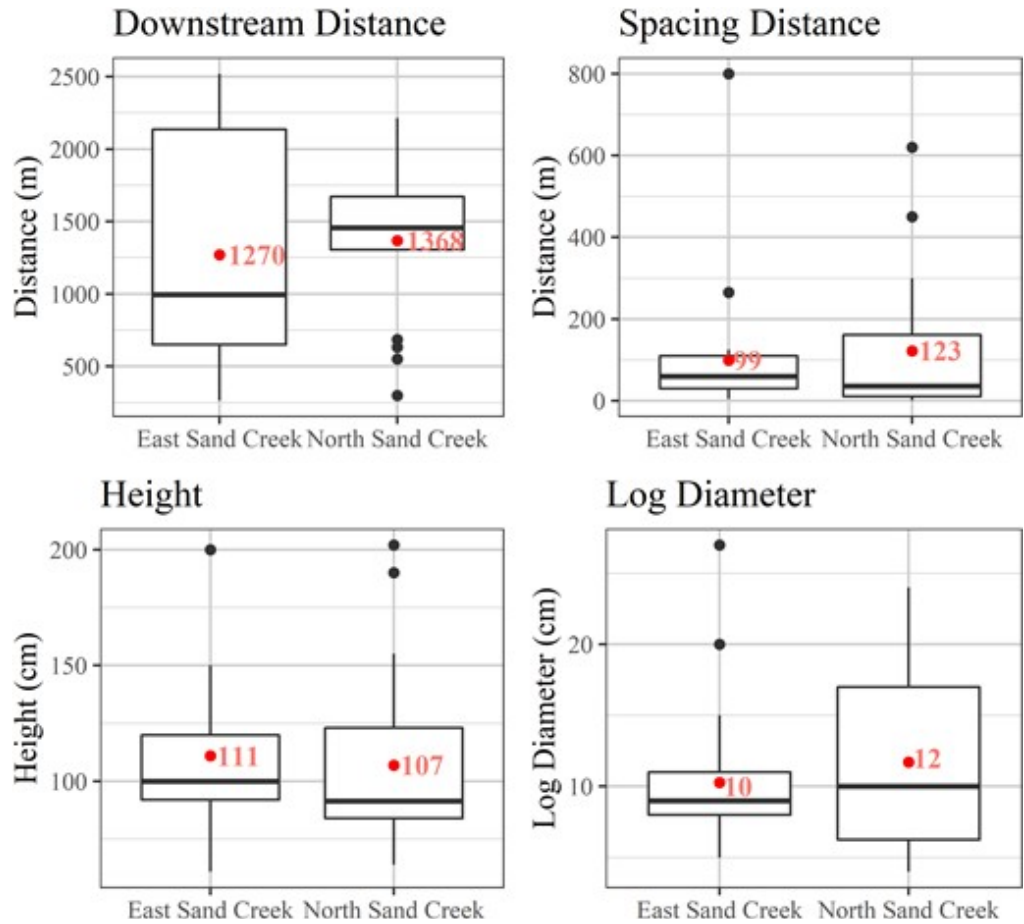
**Fig. 19.** Box-and-whisker plots of four variables potentially associated with storage volume: (a) downstream distance, (b) spacing distance, (c) logjam height, and (d) largest log diameter. Horizontal lines represent the data median; labeled red points represent the mean; boxes represent the range of the first and third quartile; whiskers represent the range of the first and fourth quartile; and points represent potential outliers.

The MANOVA test of the four measured variables potentially associated with a logjam’s sand storage capacity—distance downstream, spacing distance, height, and largest log diameter (Fig. 19)—returned a p-value of 0.828, indicating failure to reject the null hypothesis that there is a difference between the means in any of these variables between the two creeks. This suggests that differences in logjam sand storage between the creeks are driven by differences in sediment transport dynamics rather than by characteristics of the logjams.

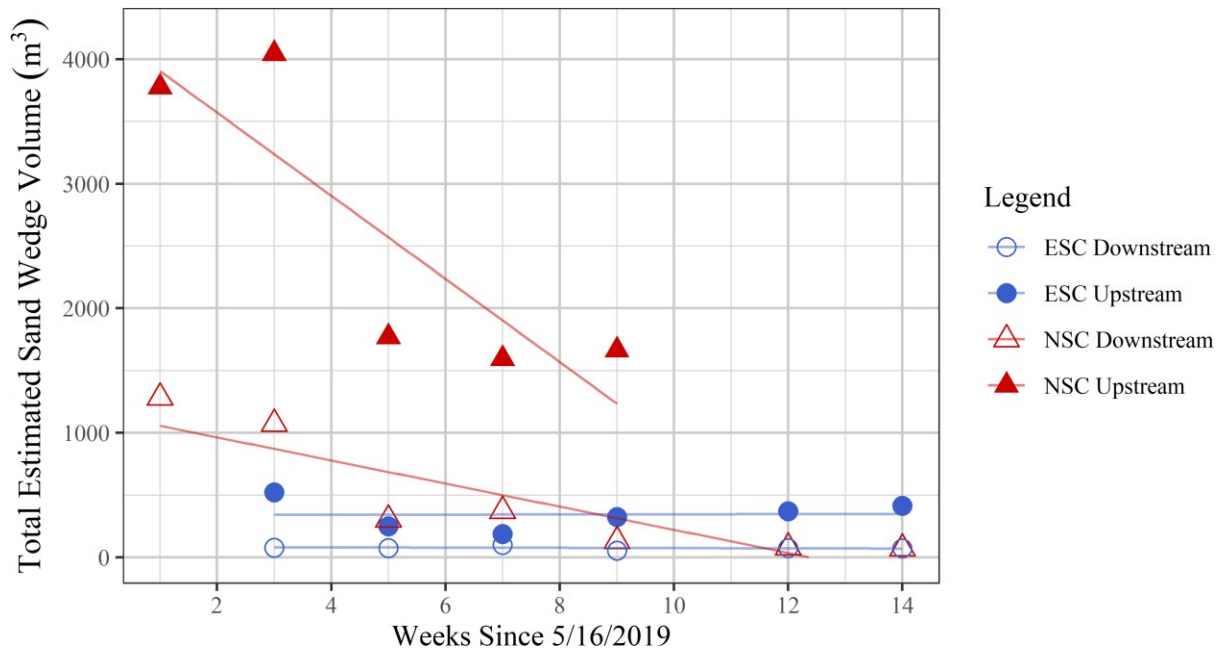
**Fig. 20.** Values (points) and fitted regression lines for the total logjam sand wedge storage over time for each zone.

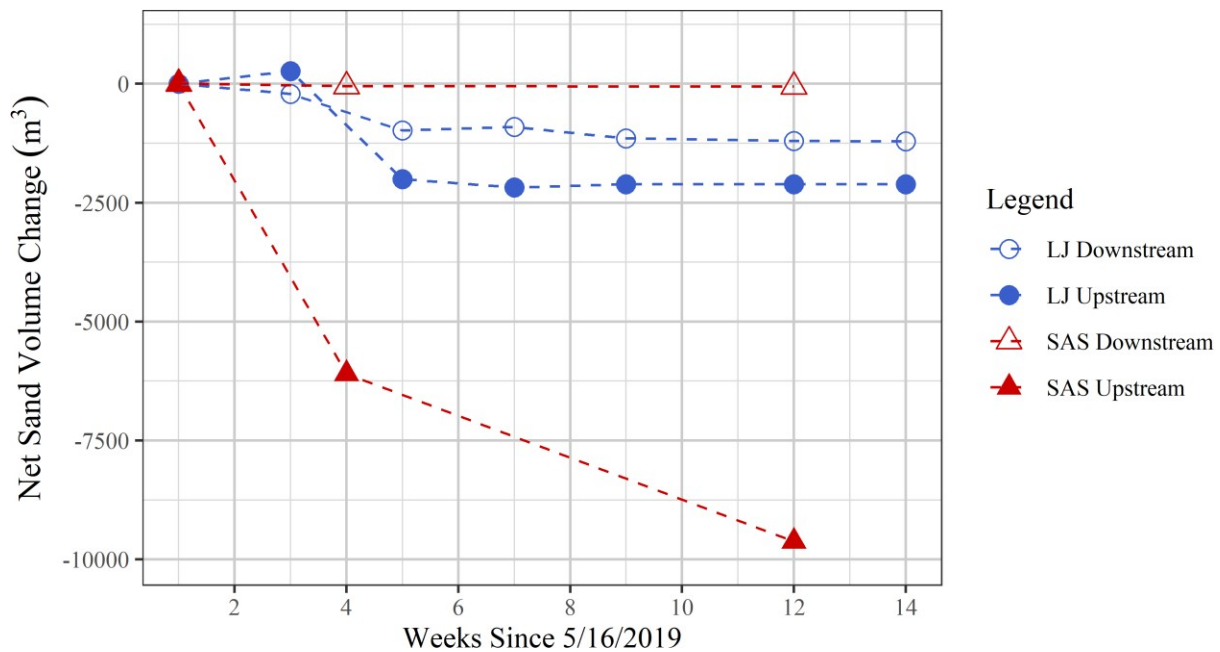
**Fig. 21.** Plot comparing net loss in sand volume over time within logjam sand wedges and within the rest of the channel, as determined from SAS measurements. ISV of SASs were inferred to be 0 on 16 May 2019 (the first week of flow in the upstream zone). Lines in the plot are not fitted regression lines and are meant only to qualitatively compare the approximate rates of sand loss before and after the possible threshold-crossing event between weeks 3 and 4.

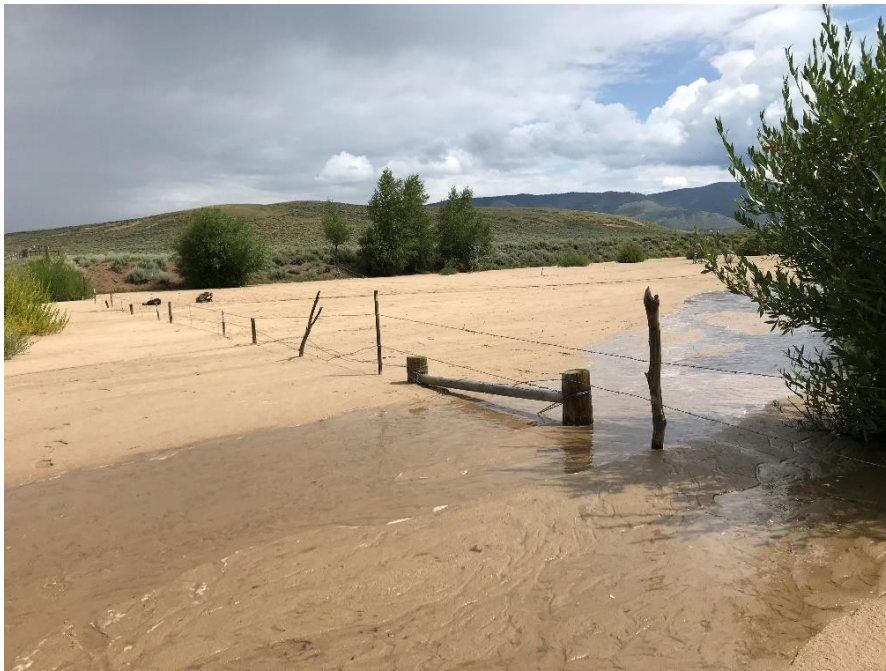
**Fig. 22.** A buried fence crossing North Sand Creek on State Line Ranch, 5.5 km downstream of the active sand dunes. This photo was taken on 8 August 2019.

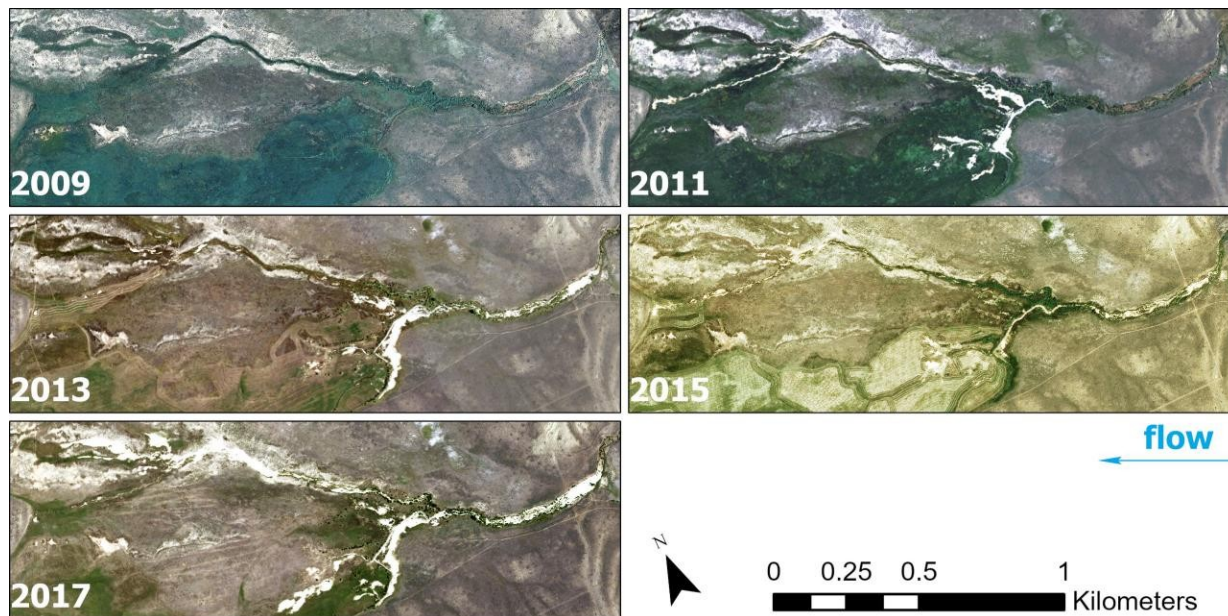
**Fig. 23.** NAIP imagery of the irrigation network diverted from North Sand Creek on State Line Ranch from 2009-2017 (USDA, 2009-2017). Channel widening and aggradation is evident beginning in 2011 and expands into other parts of the channel through 2017. The irrigation network was dredged between the 2013 and 2015 images, but the dredged area appears to have filled again with sand by 2017.

through 2017 (Fig. 23). It may be that the irrigation network is receiving most or all of the sand incised from the area near the active sand dunes. During the summer of 2019, I measured the amount of sand incised from the upstream zone to be 9600 m<sup>3</sup>—for reference, this is almost the volume of 4 Olympic-sized swimming pools.

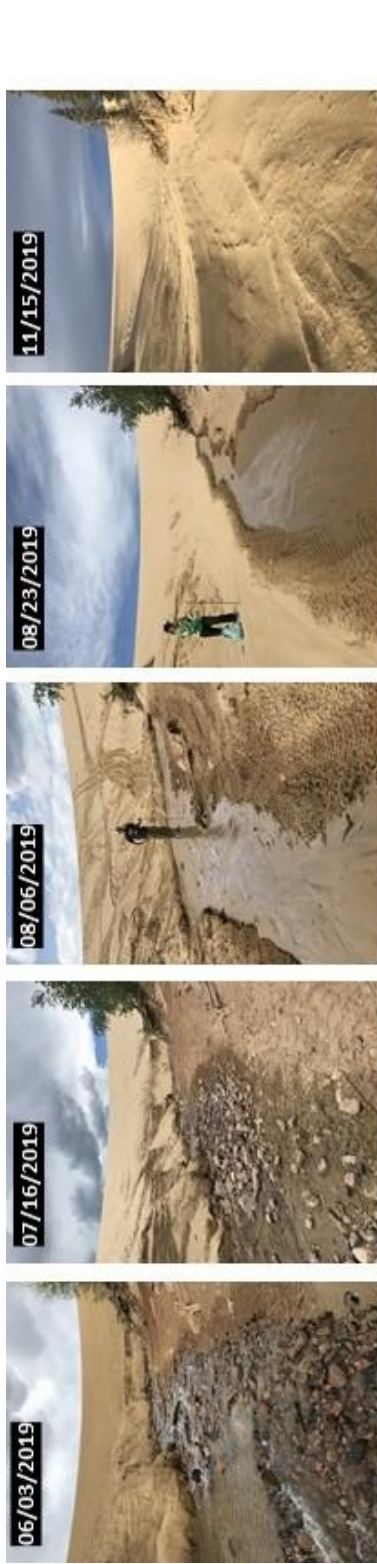
NP8 (H): Oversteepened sand bank in June indicates recent incision. Consistent bed material of mixed cobbles, gravels, and sand throughout June and July, evident aggradation by aeolian sand in August through November.

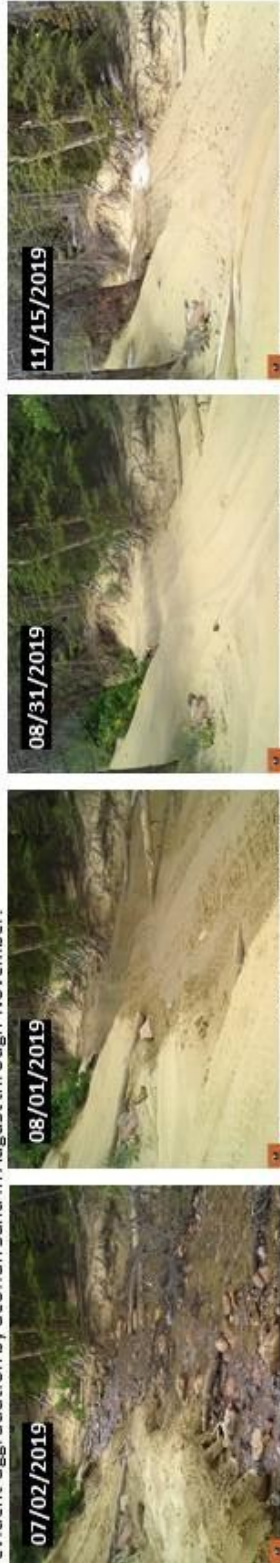
NP7 (G): Oversteepened sand bank in July indicates recent incision. Consistent bed material of mixed cobbles, gravels, and sand throughout June and July, evident aggradation by aeolian sand in August through November.

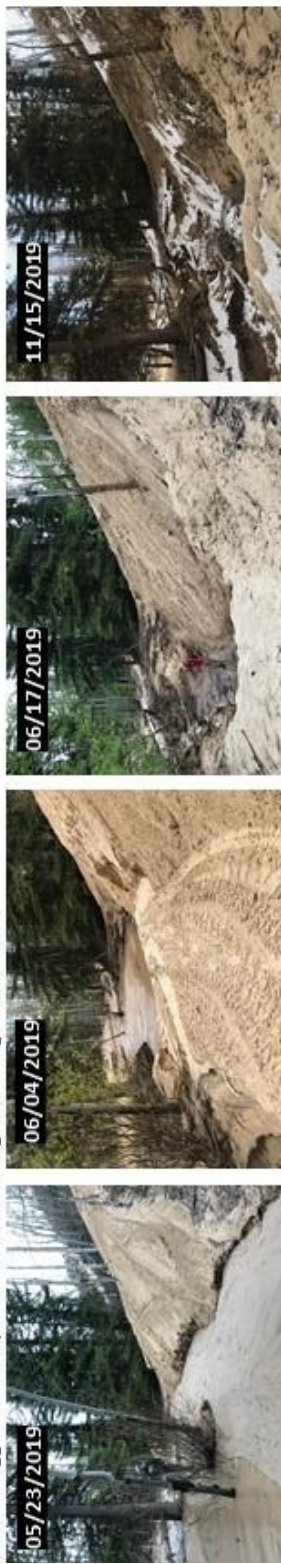
NP6 (H): A wide, sand-bedded channel in May and early June, narrowing and incising by about 2 vertical meters in mid-June, exposing scattered cobbles in the bed. Incision is evidently accompanied by gravitational slumping of the right bank. The channel does not notably change through November.

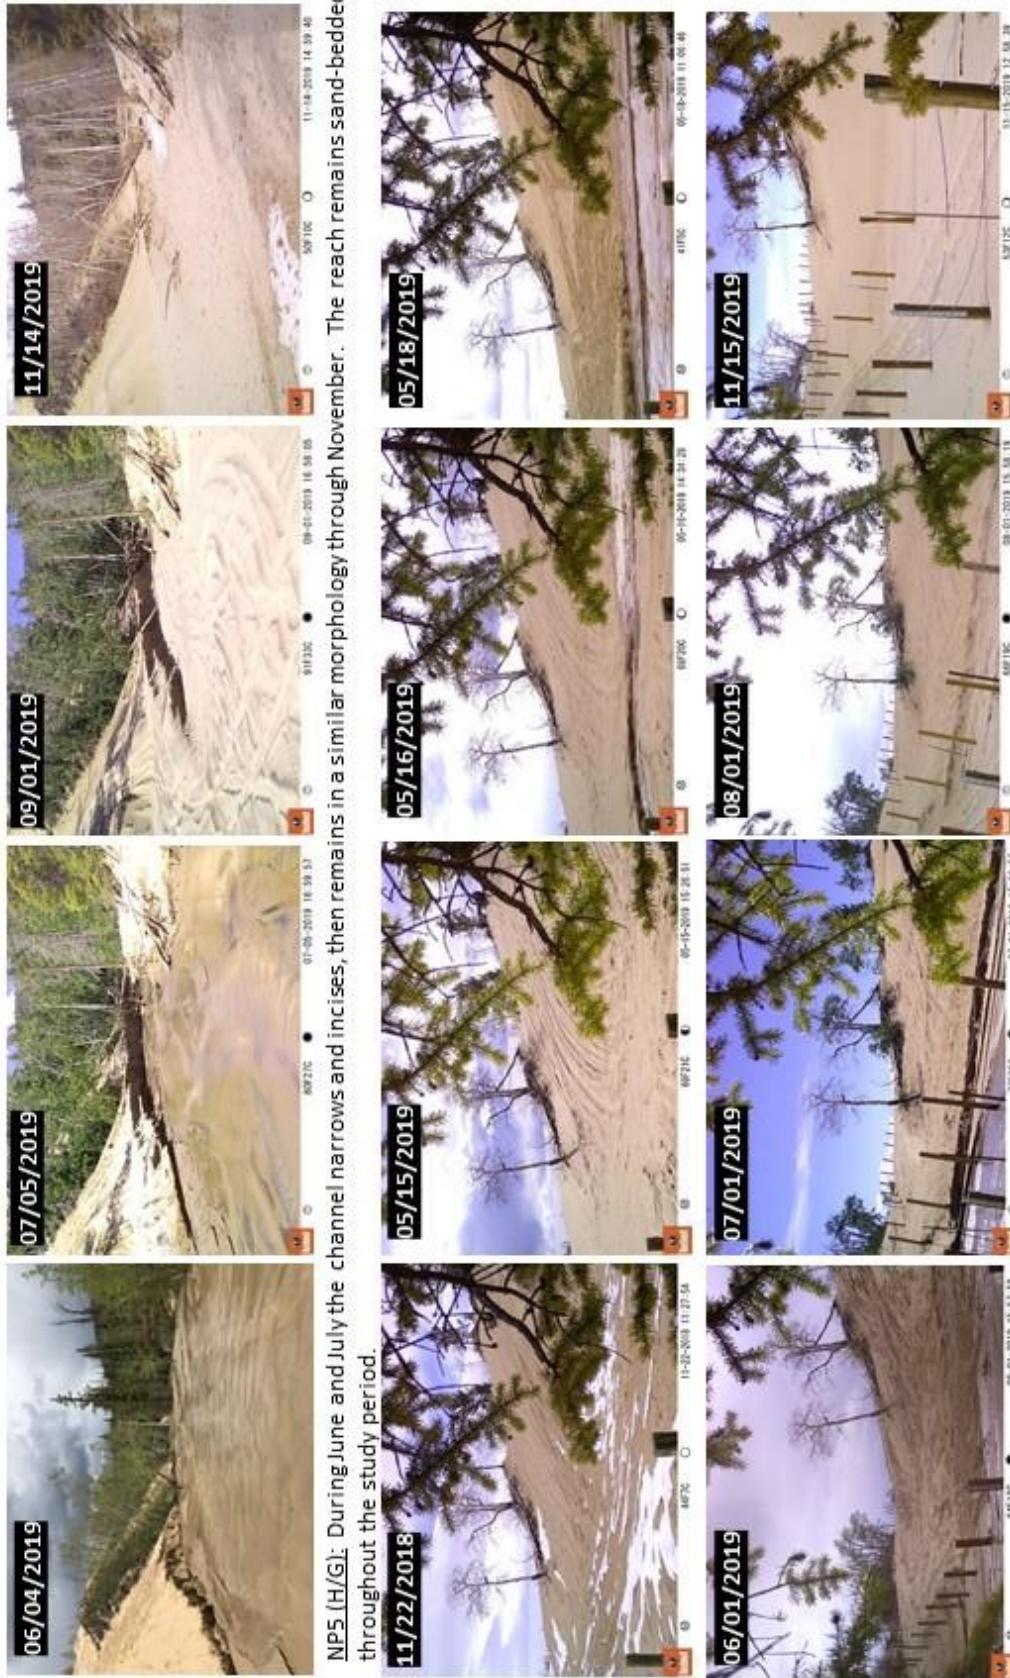
**NP5 (H/G):** During June and July the channel narrows and incises, then remains in a similar morphology through November. The reach remains sand-bedded throughout the study period.

**NP3 (G):** Rapid incision is evident between 5/16 and 5/18, following stability since November of the previous year. <1 m-tall SASS form during June and July as the channel incises and migrates. The dune slope relaxes, possibly due to aeolian transport, and the channel aggrades between August and November. The reach remains sand-bedded throughout the study period.

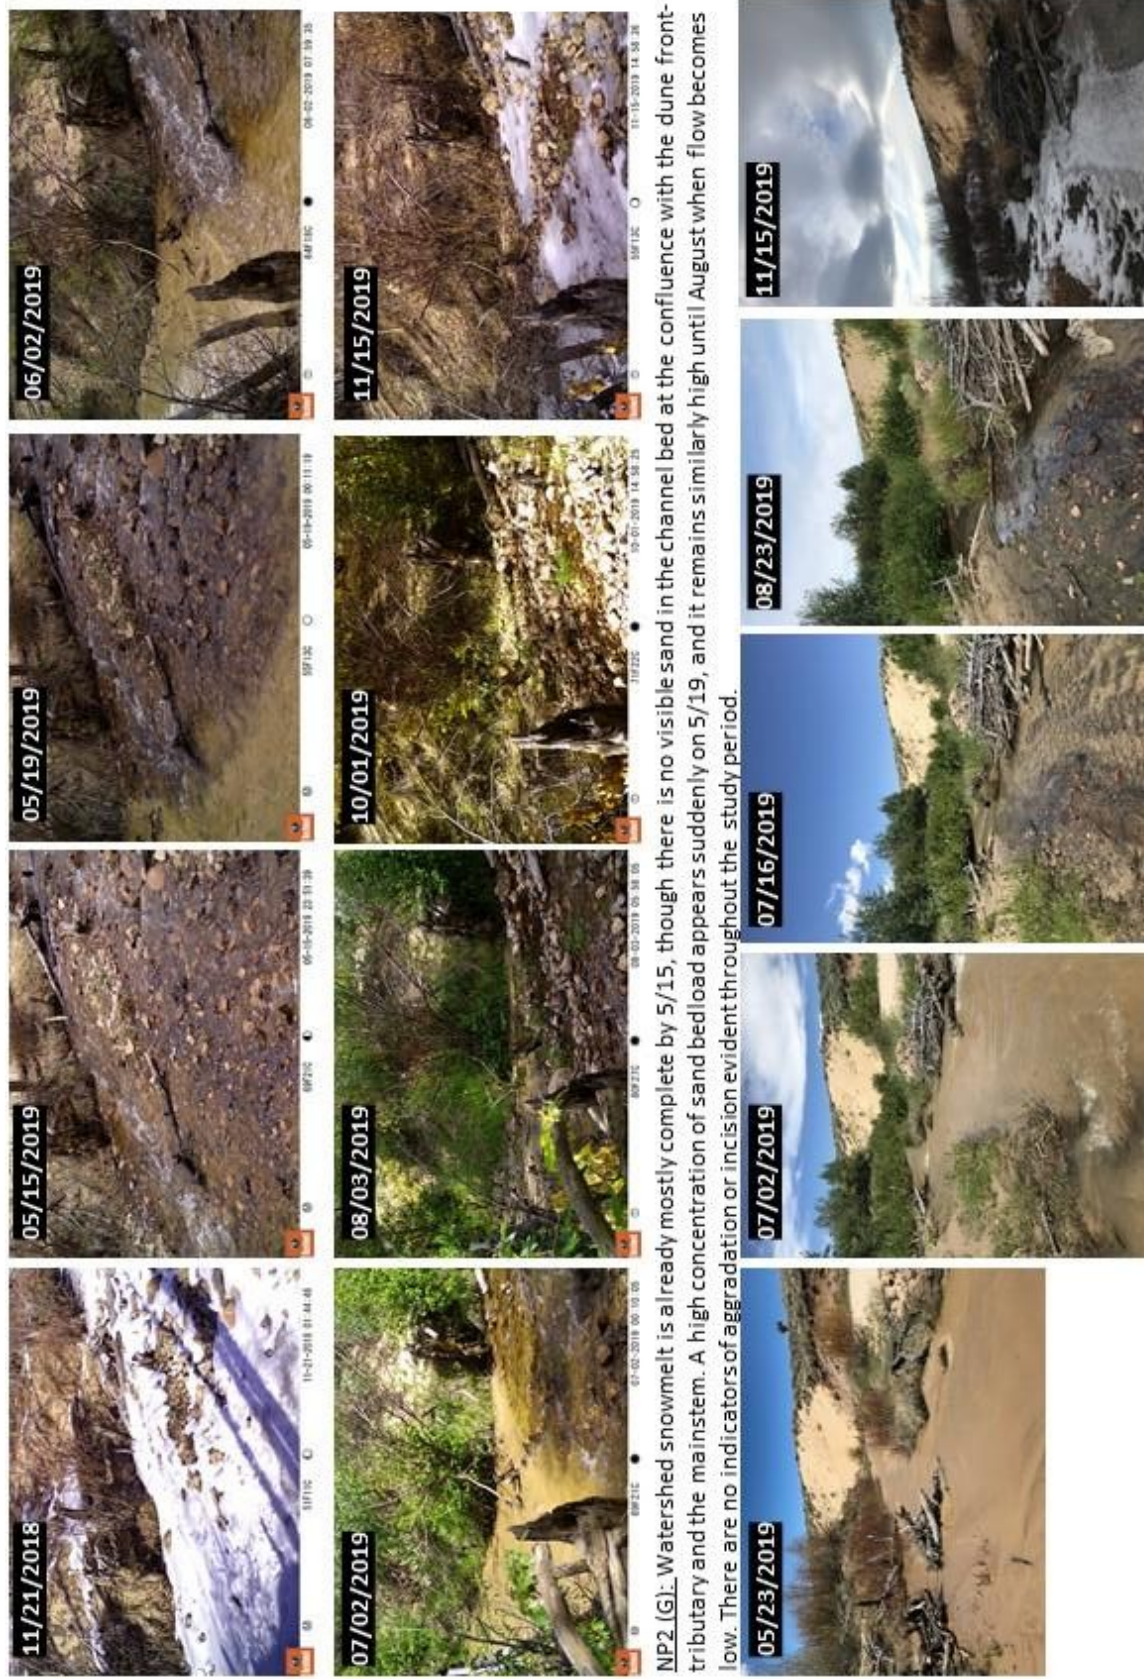
NP2 (G): Watershed snowmelt is already mostly complete by 5/15, though there is no visible sand in the channel bed at the confluence with the dune front-tributary and the mainstem. A high concentration of sand bedload appears suddenly on 5/19, and it remains similarly high until August when flow becomes low. There are no indicators of aggradation or incision evident throughout the study period.

NP1 (H): Over the course of the summer, the channel narrows and becomes visually less turbid. By mid-July scattered cobbles are visible in the bed, which indicates incision, though it is not as dramatic as the repeat photo locations of the upstream zone.

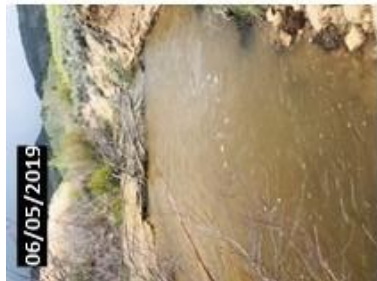
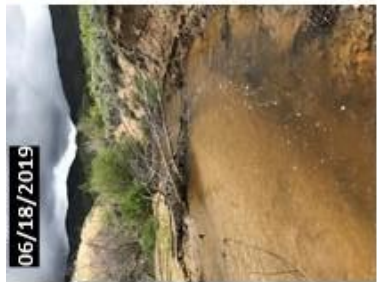
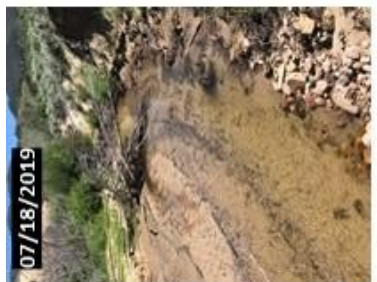
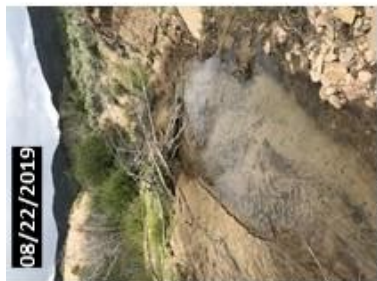
**EP7 (H):** No indicators for either incision or aggradation evident throughout the study period. The bed material remains a mix of cobbles and sand.

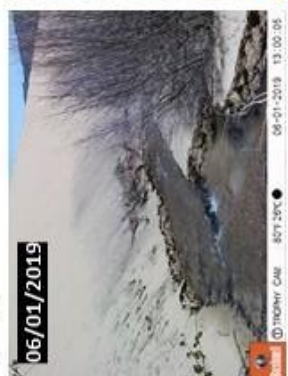
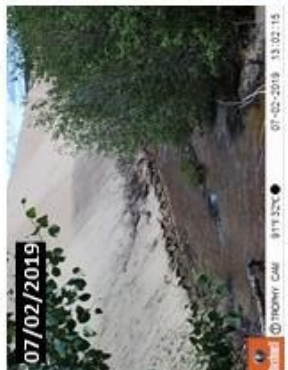
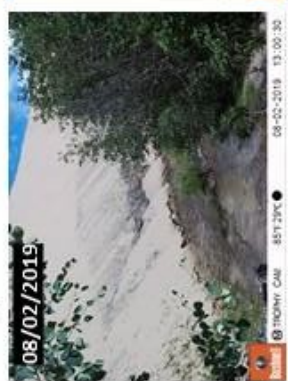
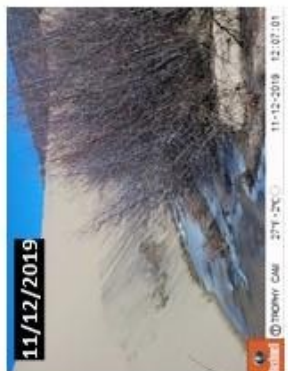
**EP6 (G):** A <1 m tall SAS on first observation in June indicates recent aggradation followed by incision. The SAS is destroyed in June. The channel bed material remains a mix of sand and gravel throughout the study period.

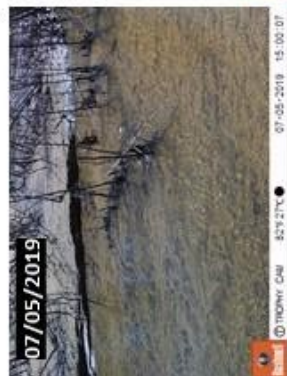
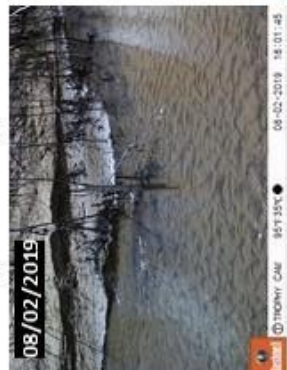
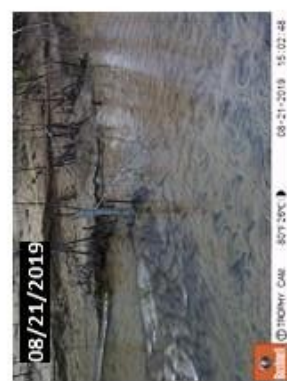
**EP5 (G):** No indicators for either incision or aggradation evident throughout the study period. The reach remains sand-bedded throughout the study period.

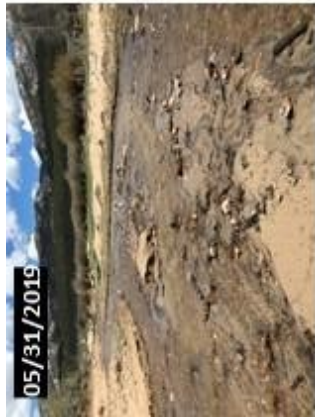
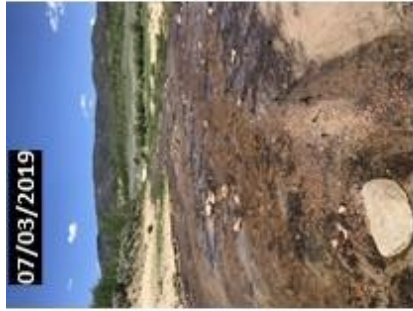
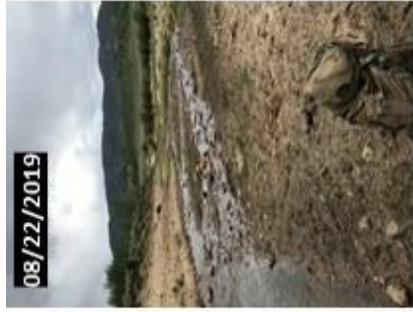
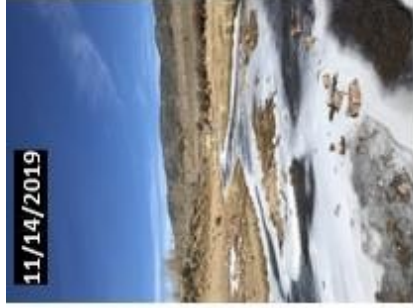
EP4 (H): No indicators for either incision or aggradation. The bed material remains a mix of sand, gravel, and cobbles throughout the study period.

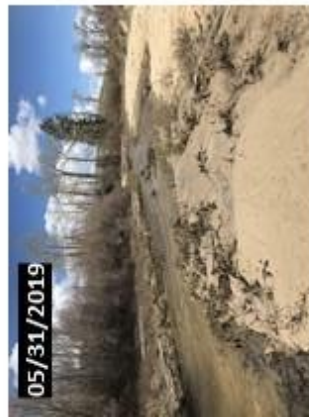
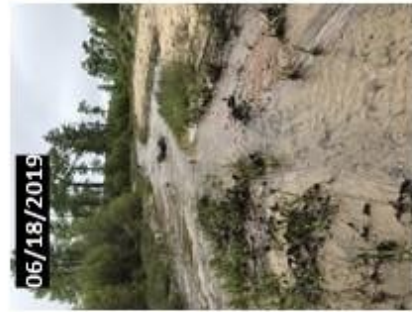
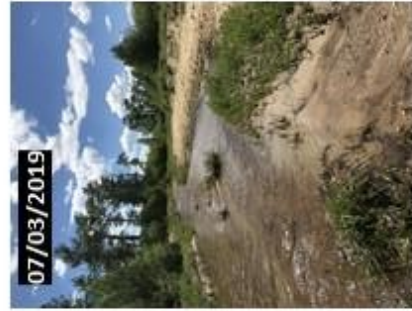
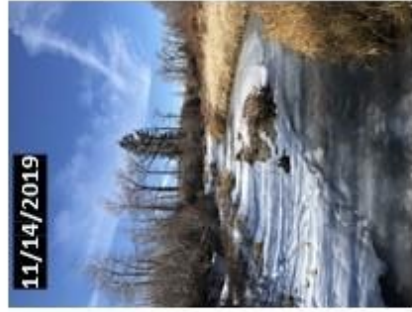
EP3 (H): No indicators for either incision or aggradation. The bed material remains a mix of sand and gravel throughout the study period.

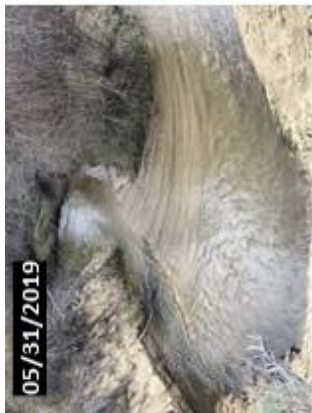
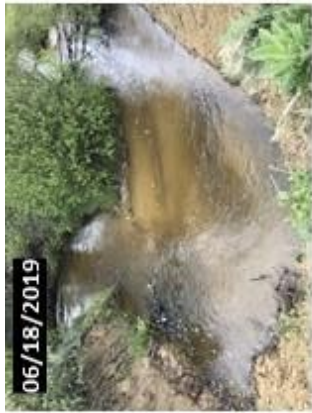
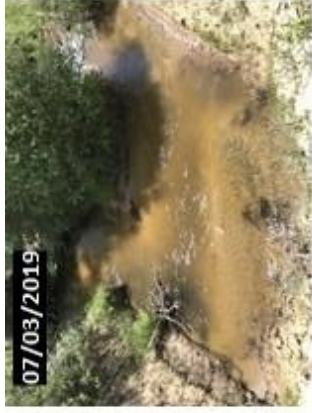
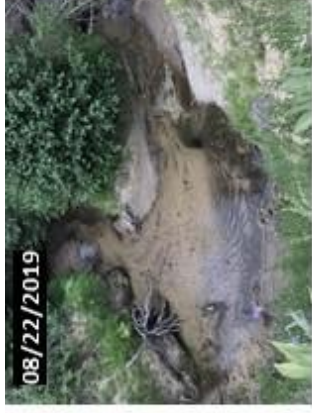
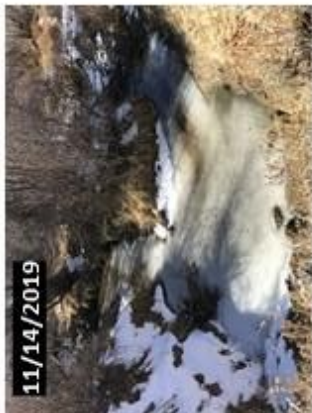
EP2 (H): The reach is sand-bedded throughout June and July. Some gravel appears in August which was not visible before, potentially indicating incision.

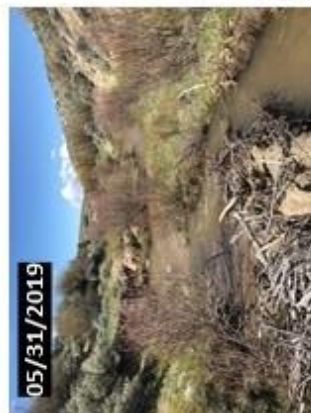
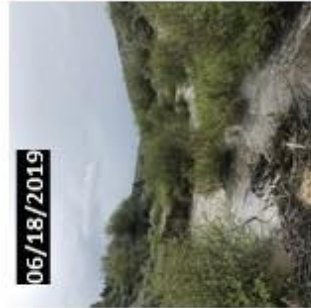
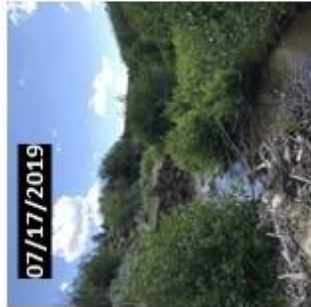
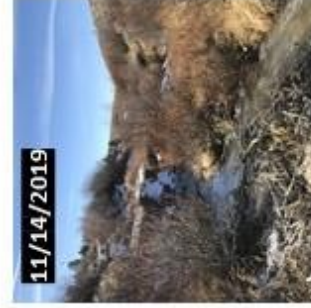
EP1 (H): No indicators of either incision or aggradation. The reach remains sand-bedded throughout the study period.
