**Riparian Assessment
Of the
North Fork Gunnison River
And
Lower Gunnison River**

Prepared by
Colorado Natural Heritage Program
Colorado State University
Fort Collins, CO 80523

Prepared for
The Delta Soil Conservation District
Delta, CO 81416

February, 2000

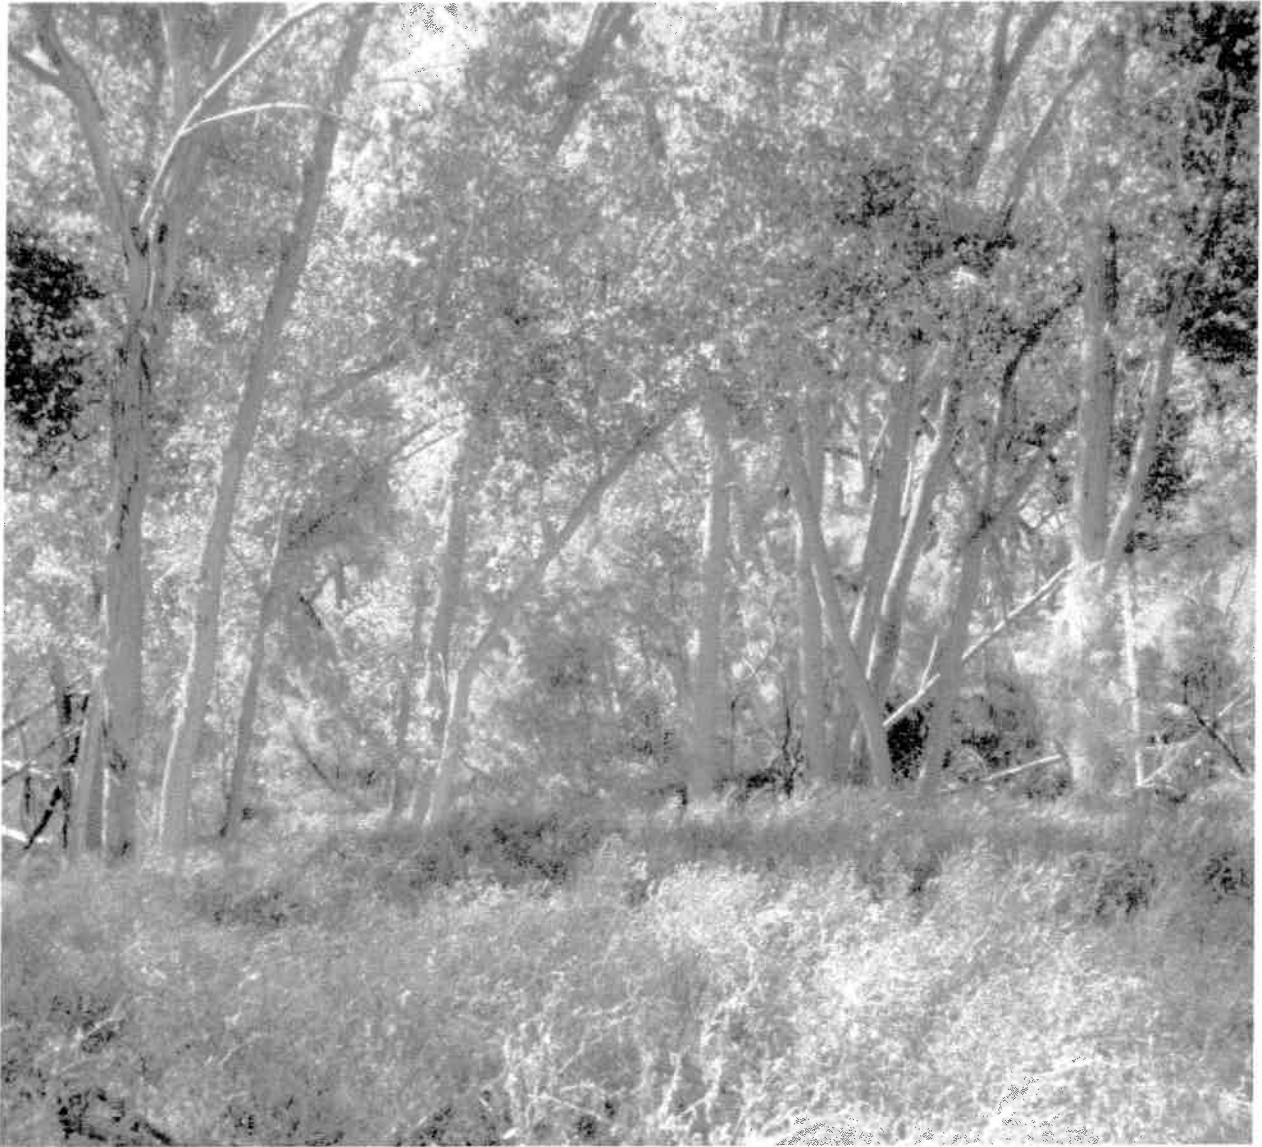
Condition: Although the location appears to have very little disturbance in the form of developed or modified land, the natural communities that were once present on the location have been largely replaced by a variety of weedy species. While the location retains its overstory of Fremont’s cottonwood (*P. deltoides* var. *wislizenii*), the shrubby species tamarisk (*T. ramosissima*) and Russian olive (*E. angustifolia*) dominate the understory. Yellow toadflax (*Linaria vulgaris*), Russian knapweed (*Acroptilon repens*), and Russian thistle (*S. iberica*) were present in the herbaceous layer. The invasion by weedy species has altered the ecological characteristics and reduced the value for conservation of biological diversity. Although the upstream banks of the site are elevated from the river by as much as 3 m (10 feet) in some areas, numerous active flood channels dissect the site. Despite the evidence of recent floods on the site, regeneration of Fremont’s cottonwood (*P. deltoides* var. *wislizenii*) was not apparent. Invasion of the site by tamarisk (*T. ramosissima*) and Russian olive (*E. angustifolia*) may also be determining factors in the lack of Fremont’s cottonwood (*P. deltoides* var. *wislizenii*) regeneration.

Photo: Interior view of location #3. Note overstory of Fremont's cottonwood (*P. deltoides* var. *wislizenii*) with understory containing tamarisk (*T. ramosissima*), Russian knapweed (*A. repens*), and yellow toadflax (*L. vulgaris*)

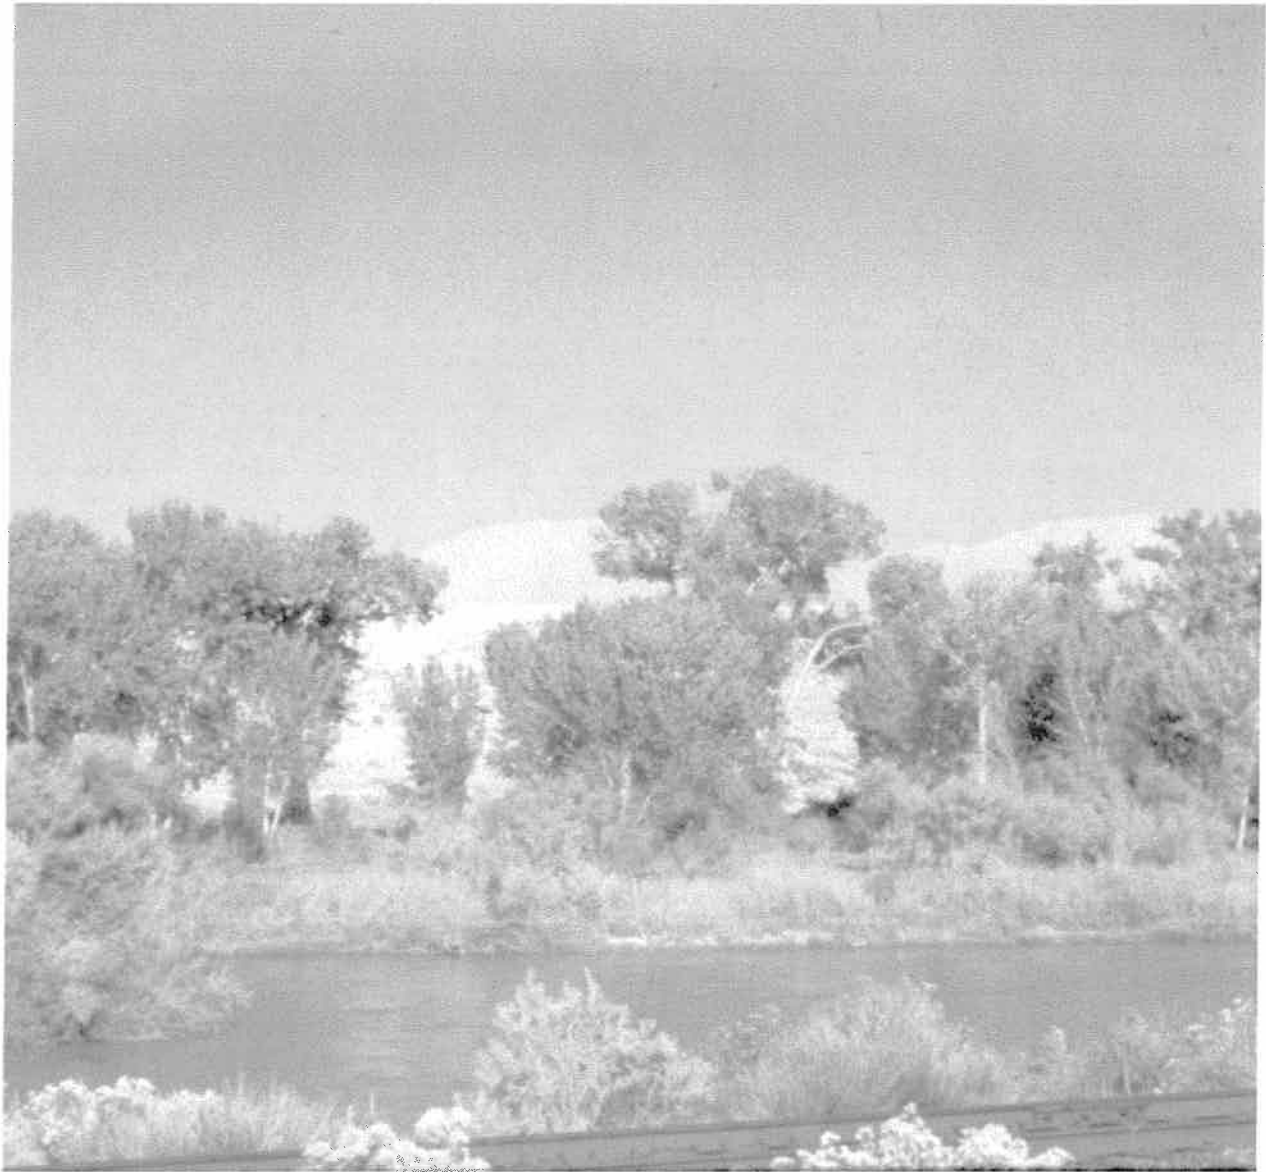
Condition: This location appears to have very little disturbance in the form of developed or modified landform. A variety of weedy species has largely replaced the natural communities that were once present here. The Fremont’s cottonwood (*P. deltoides* var. *wislizenii*) overstory is present and some coyote willow (*S. exigua*) does occur along the riverbank. The understory is dominated by tamarisk (*T. ramosissima*), Russian olive (*E. angustifolia*) and herbaceous weeds such as cocklebur (*X. stumarium*), Russian knapweed (*A. repens*), and goosefoot (*Chenopodium* spp.). There was no evidence of cottonwood (*P. deltoides* var. *wislizenii*) regeneration on this site.

Photo: View of location from parking lot at Whitewater Put-In

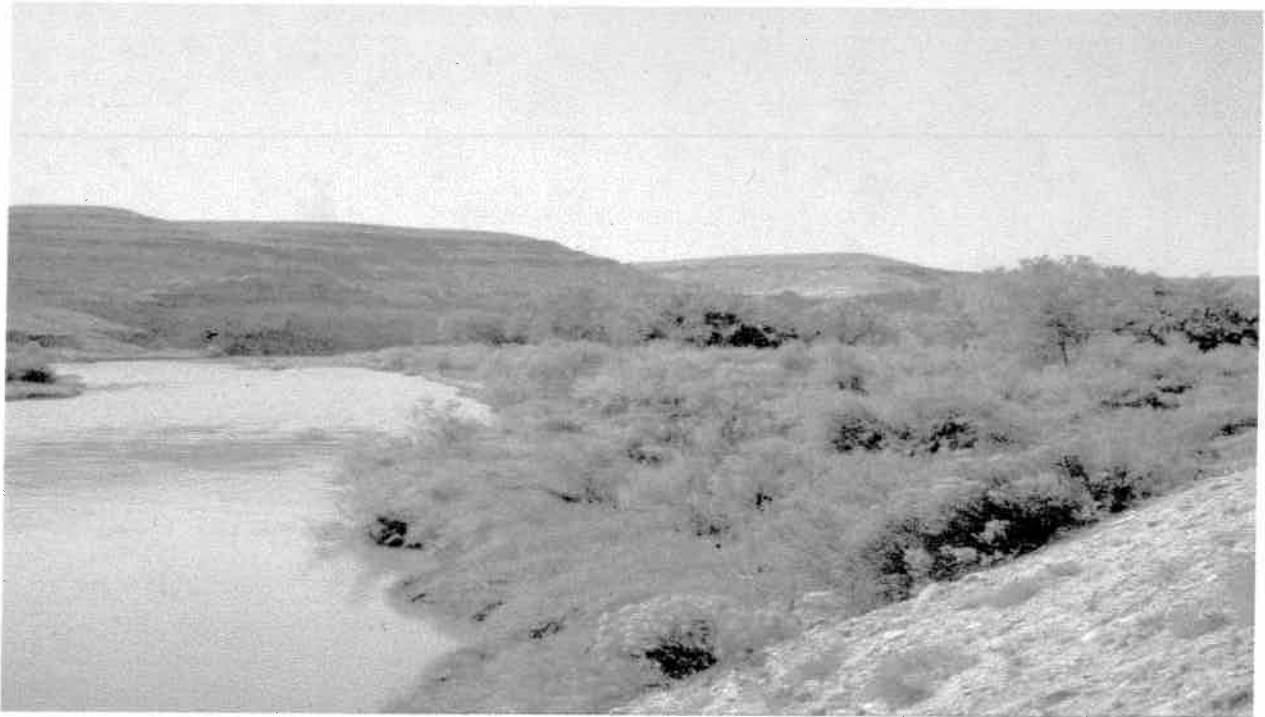
Condition: The weedy species tamarisk (*T. ramosissima*) and Russian olive (*E. angustifolia*) have invaded this location and replaced the understory vegetation that was natural there. Modifications to the landforms of the site include construction of the railroad through part of the area and some small two-track roads. The approaches to the railroad trestle are elevated above the flood level of the river and divide parts of the floodplain on either side of the river. Woody flood debris was evident over most of the areas.

Photo:View of river right downstream of railroad trestle

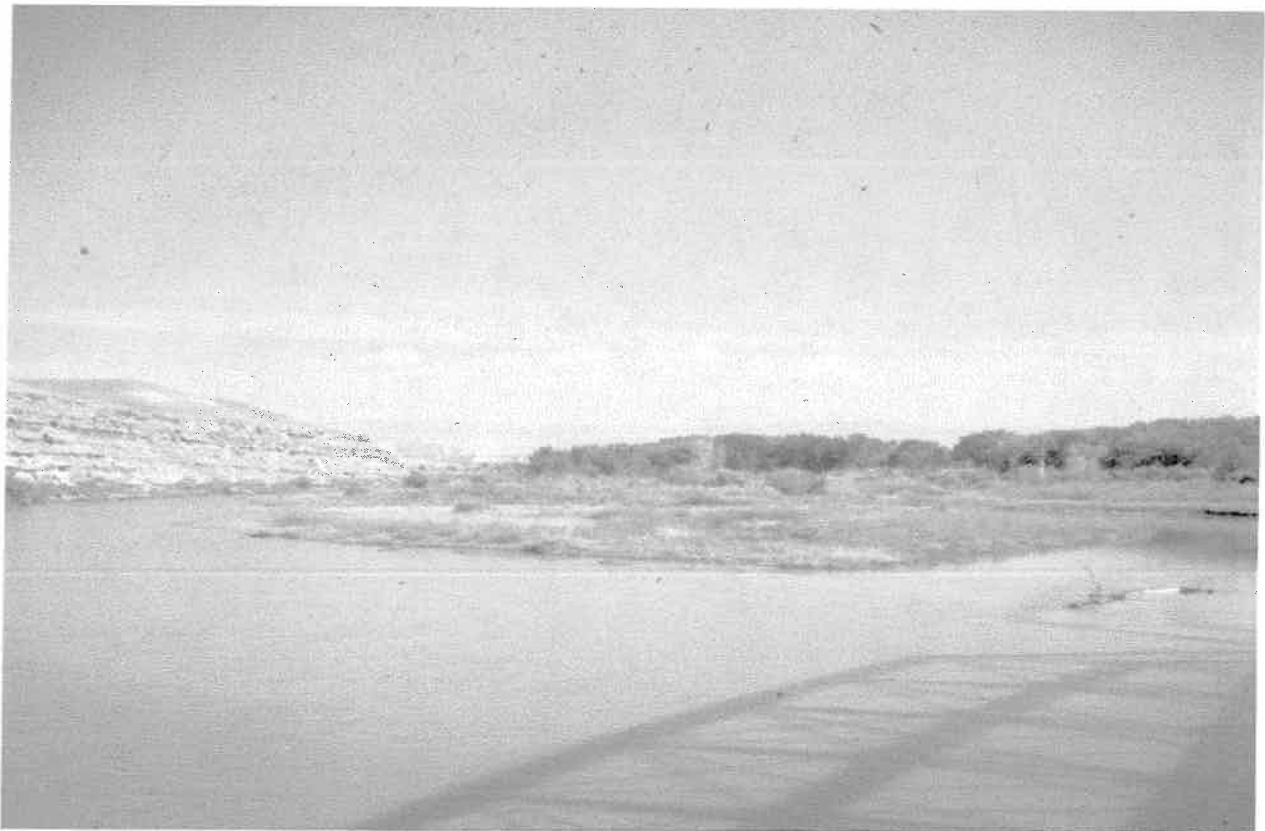
View of river left upstream of railroad trestle

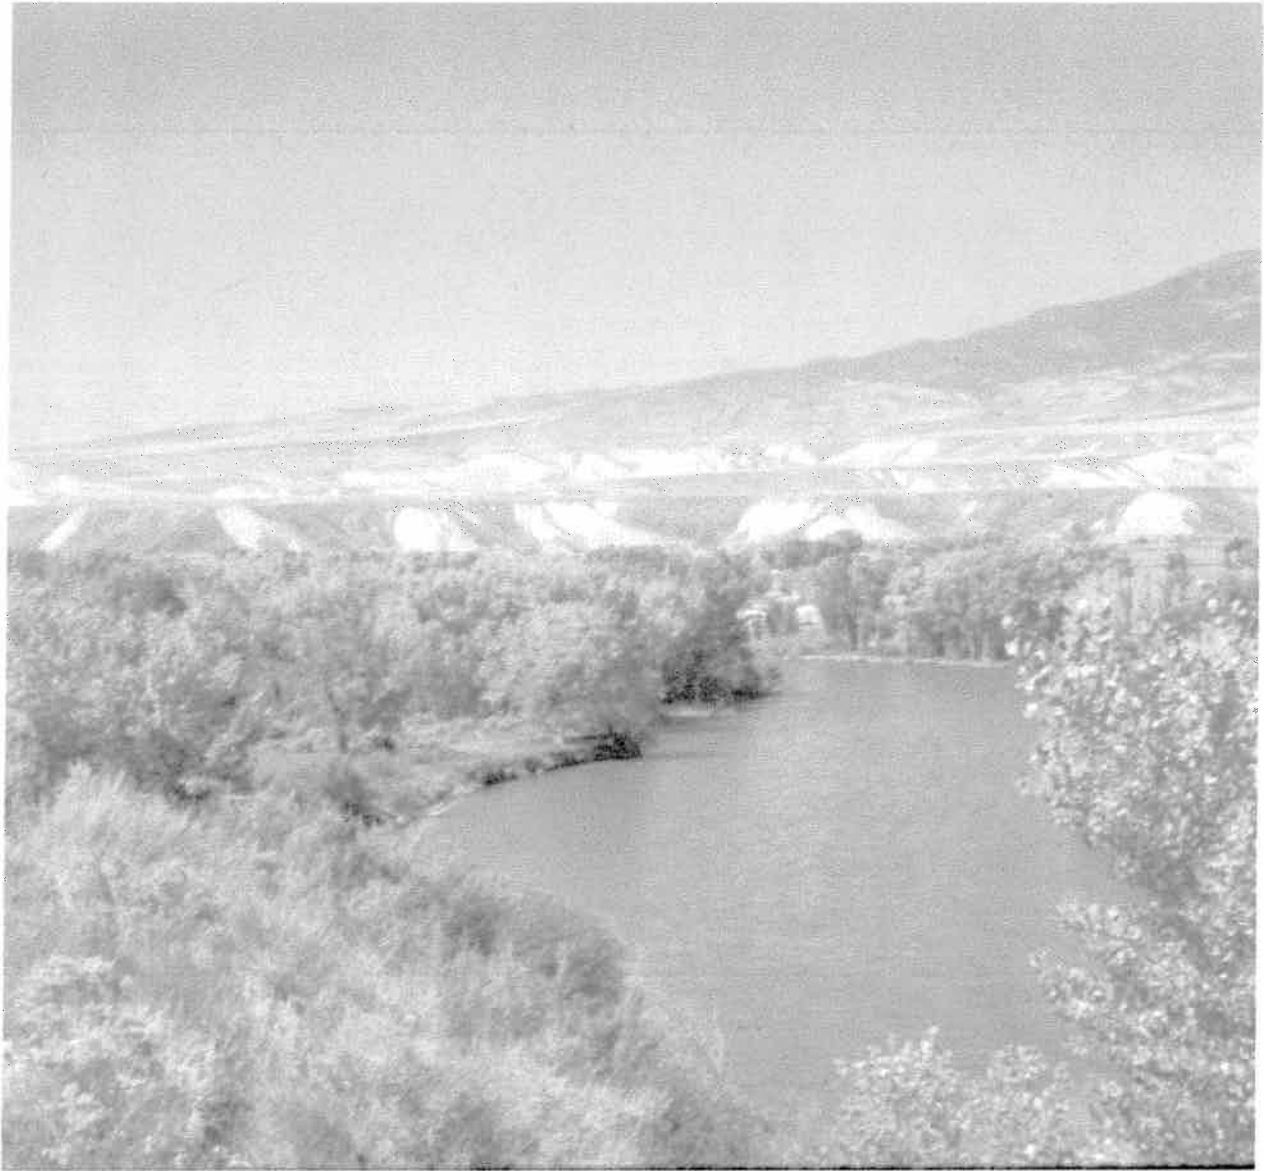
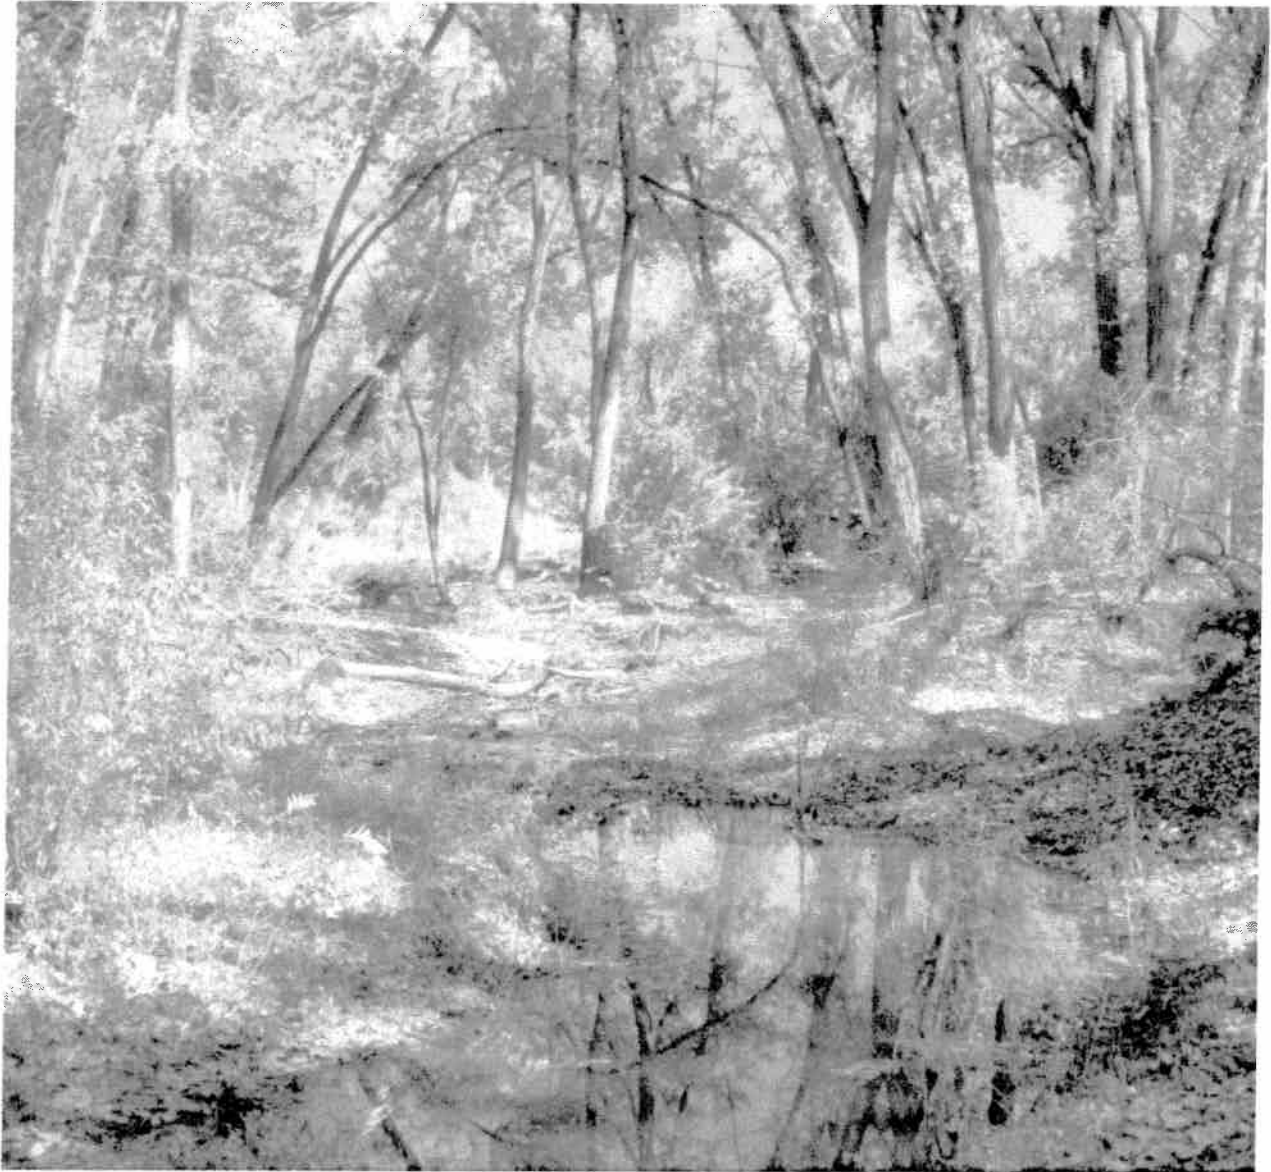
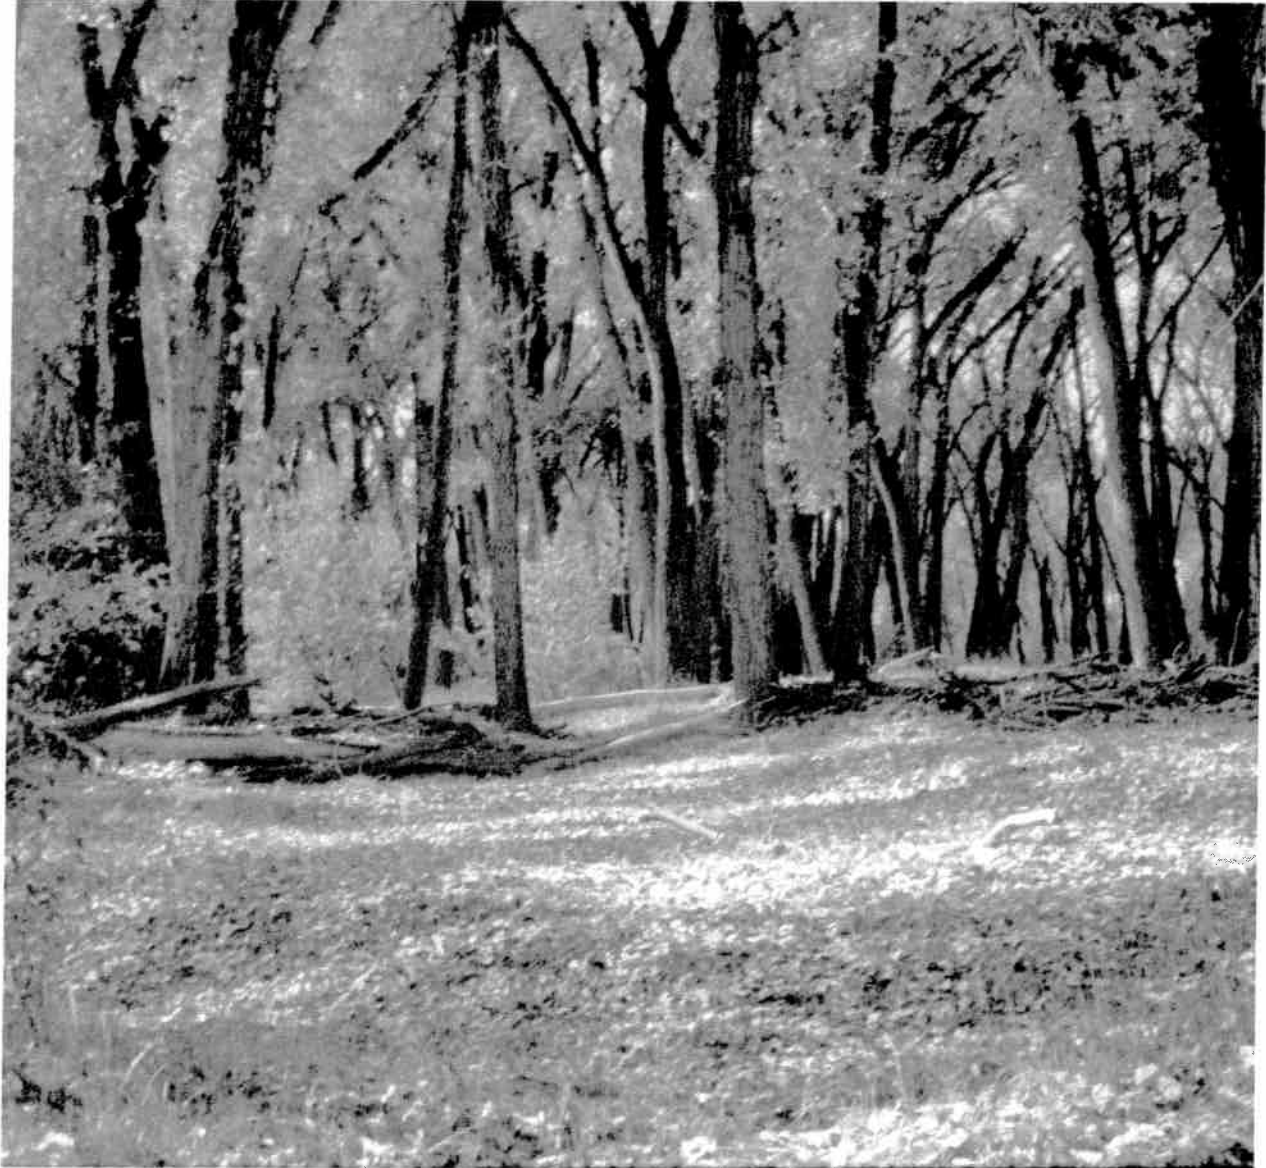
Photo:

Condition: This is a good condition location with no landform modification and limited impacts by invasive weedy species. The weedy species observed include tamarisk (*T. ramosissima*), Siberian elm (*U. pumila*), and *Kochia* (*K. scoparia*). Relatively minimal

restoration and management input would be needed to return this point bar location to its historic condition.

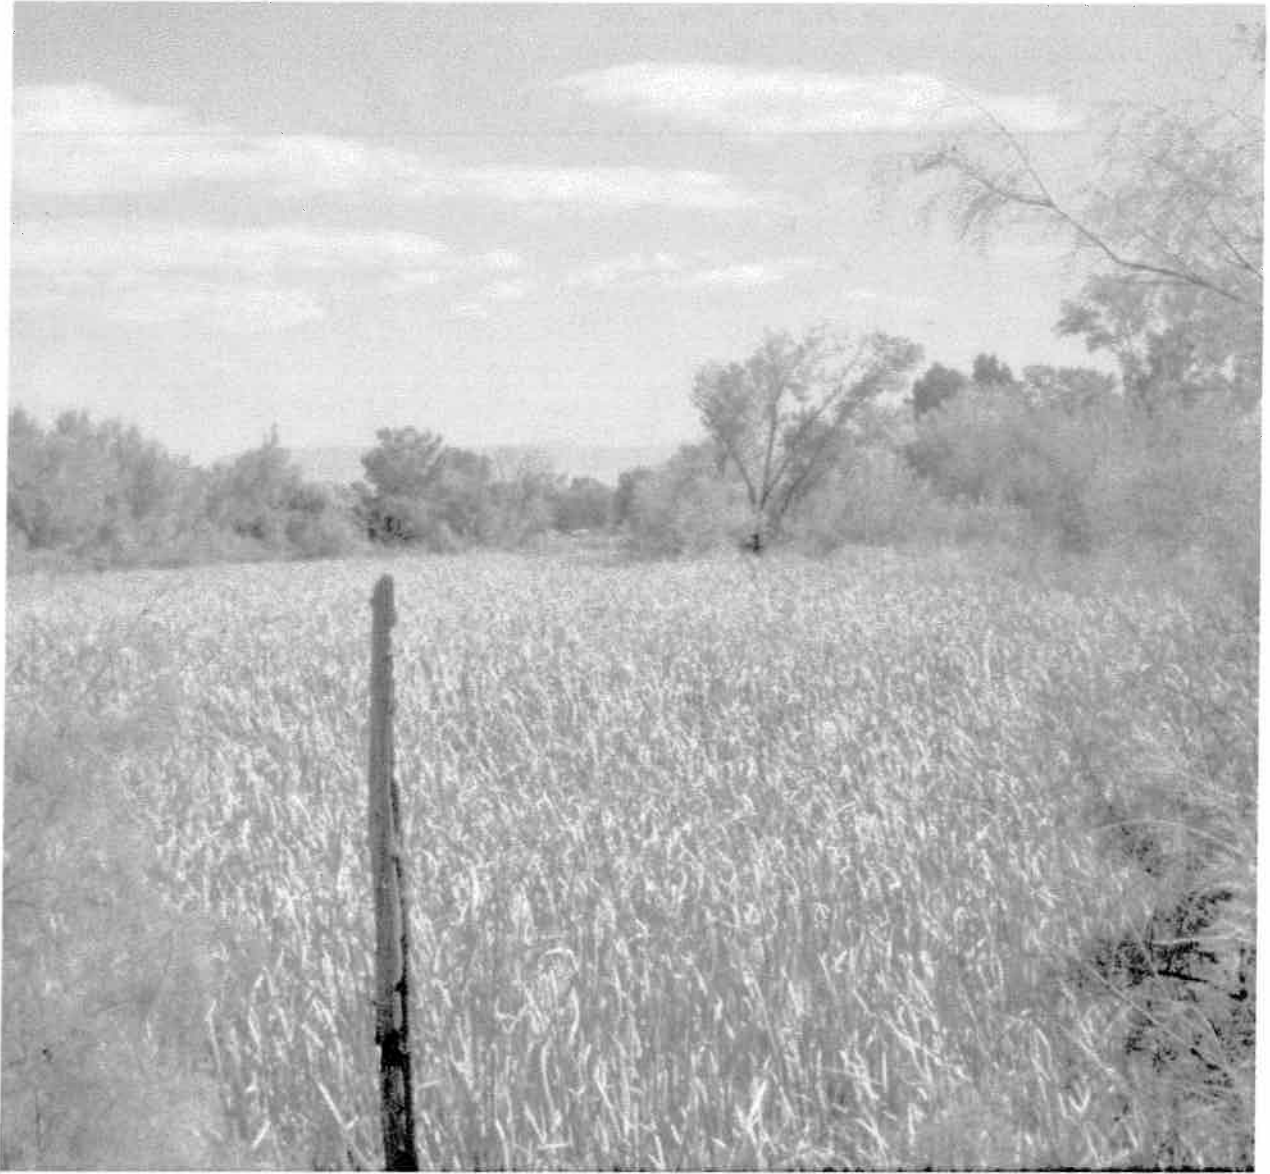
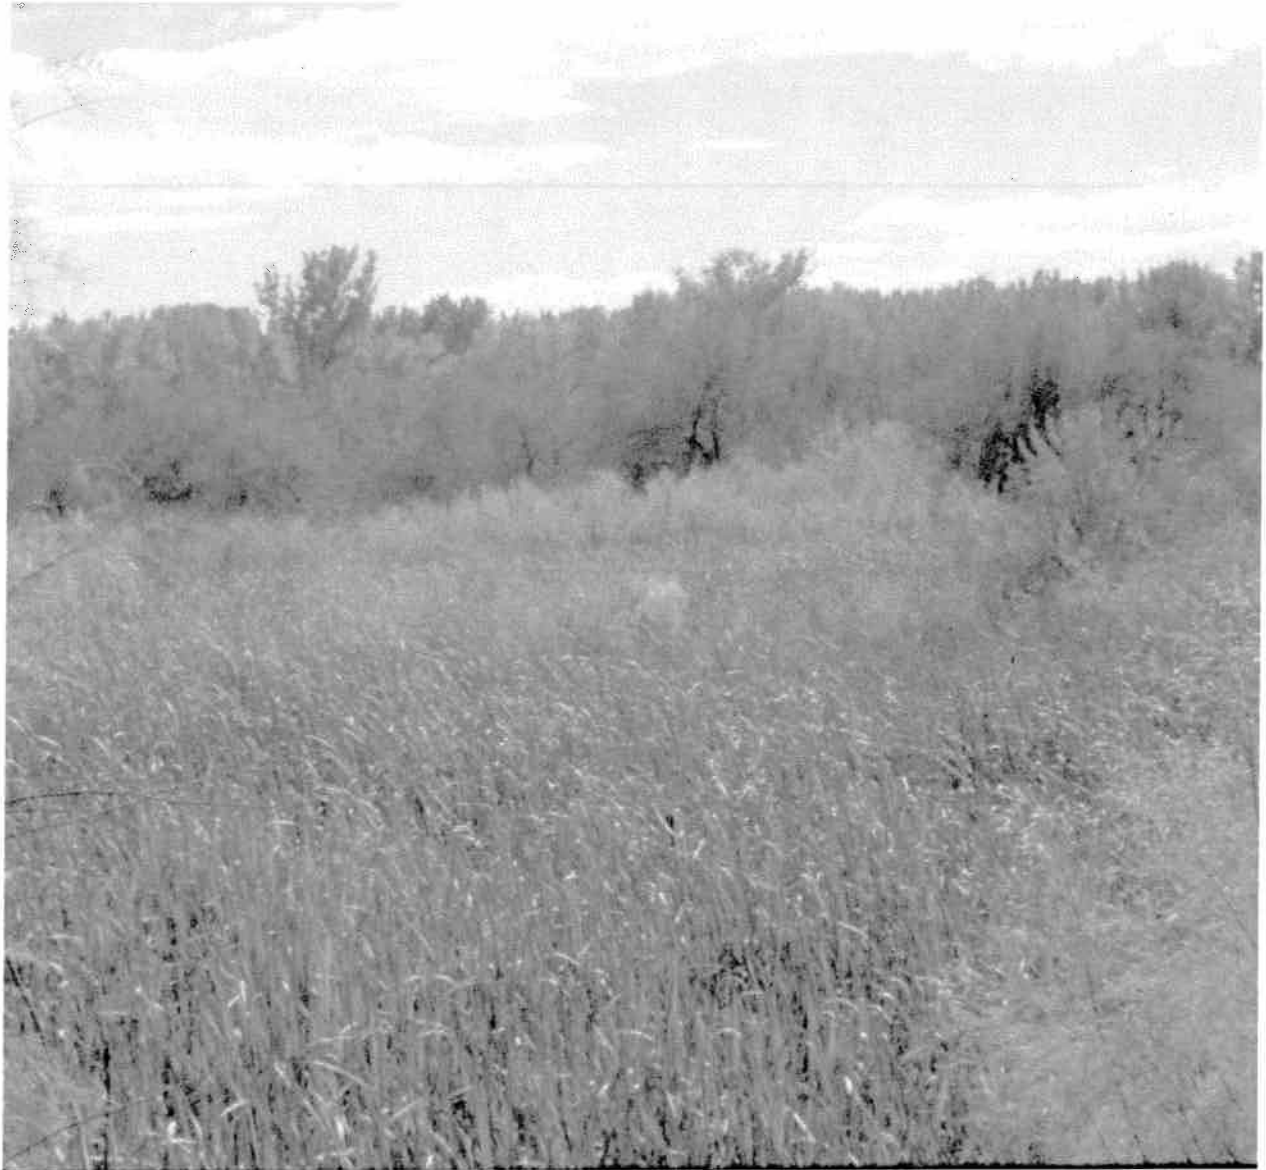
Photos:

Condition: The condition of this location appears to be good, although further investigation should be conducted to determine the degree to which weedy species have invaded the site.

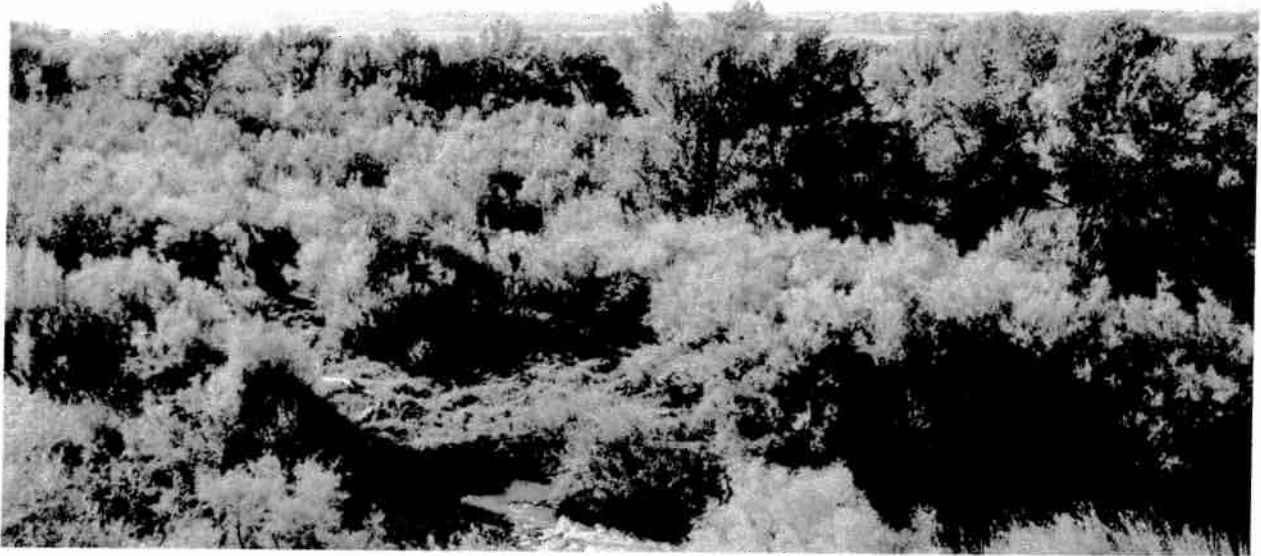
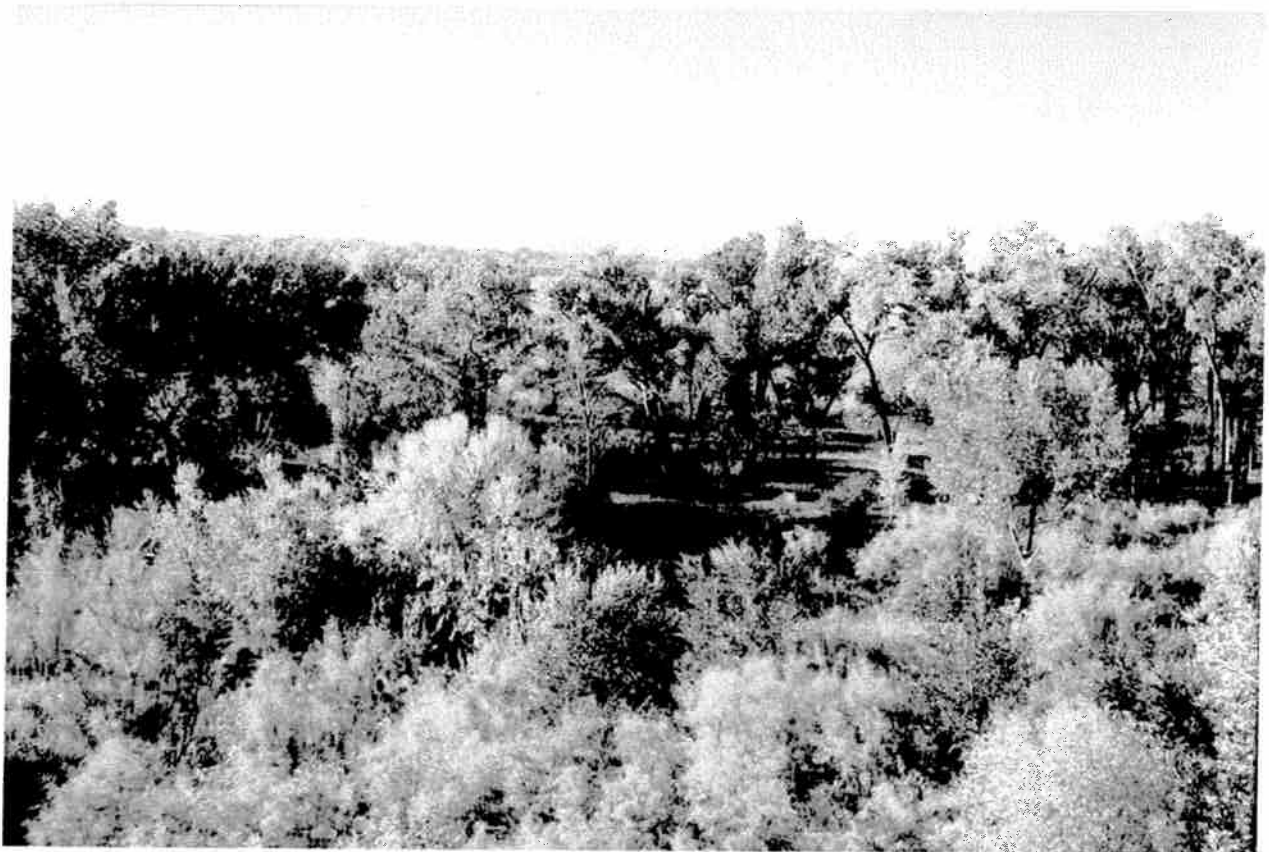
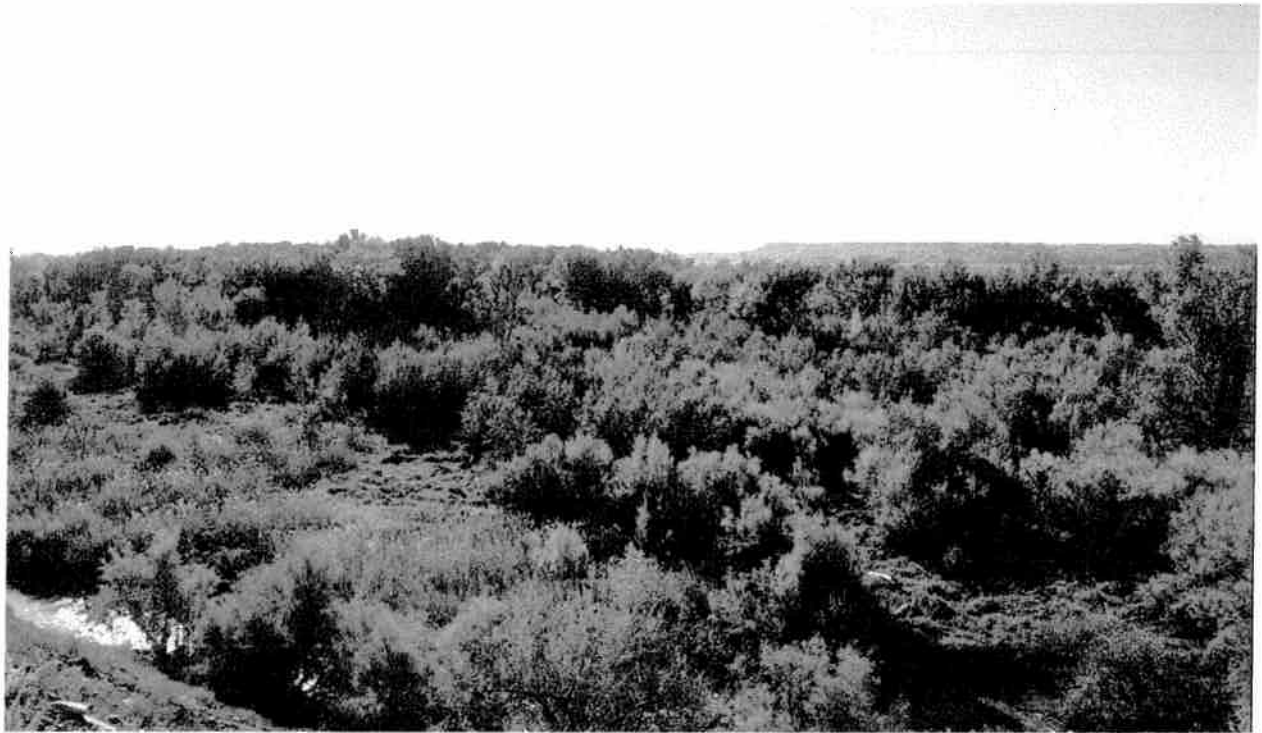
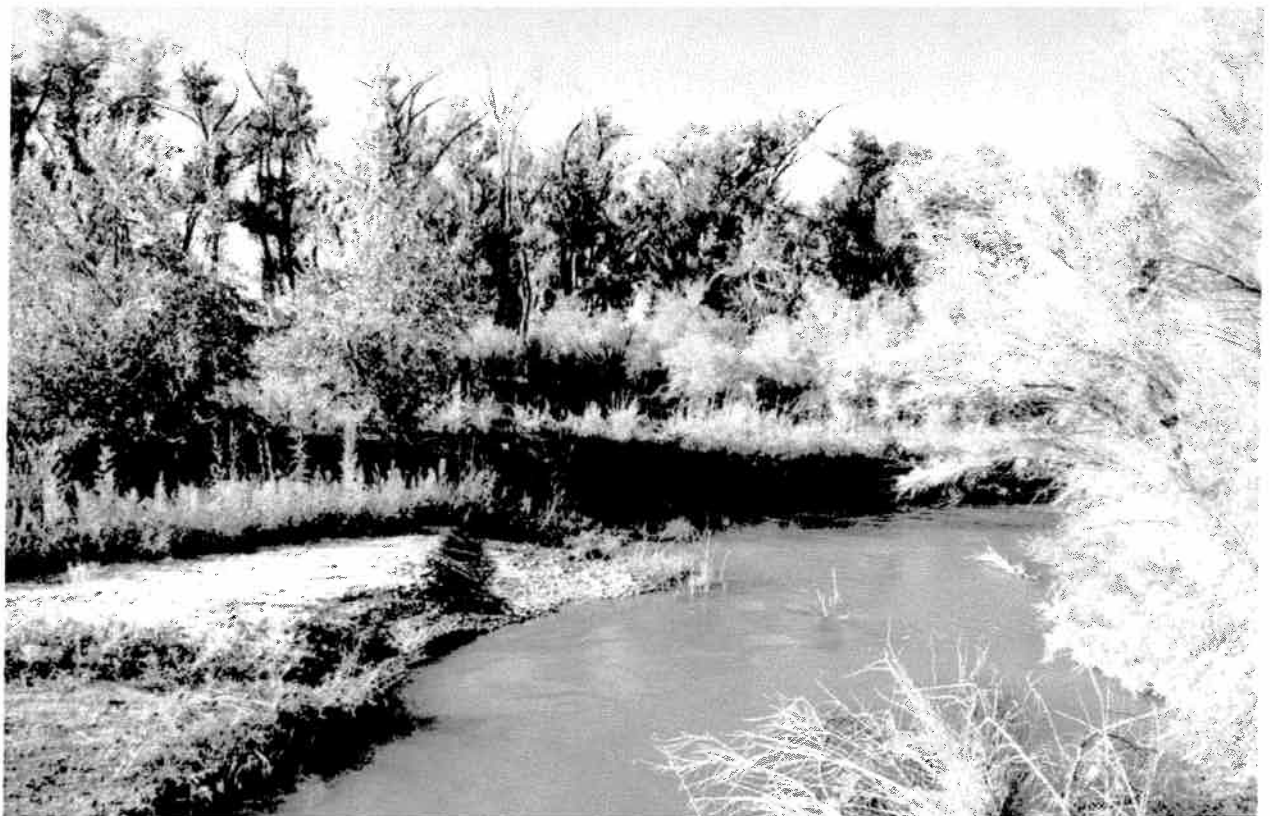
Photo:

Condition: This location appears to be in fair condition. There are no landform modifications evident, however the presence of weedy shrub and herbaceous species throughout most of the site does degrade the condition of the remaining cottonwood forest. Removal of the

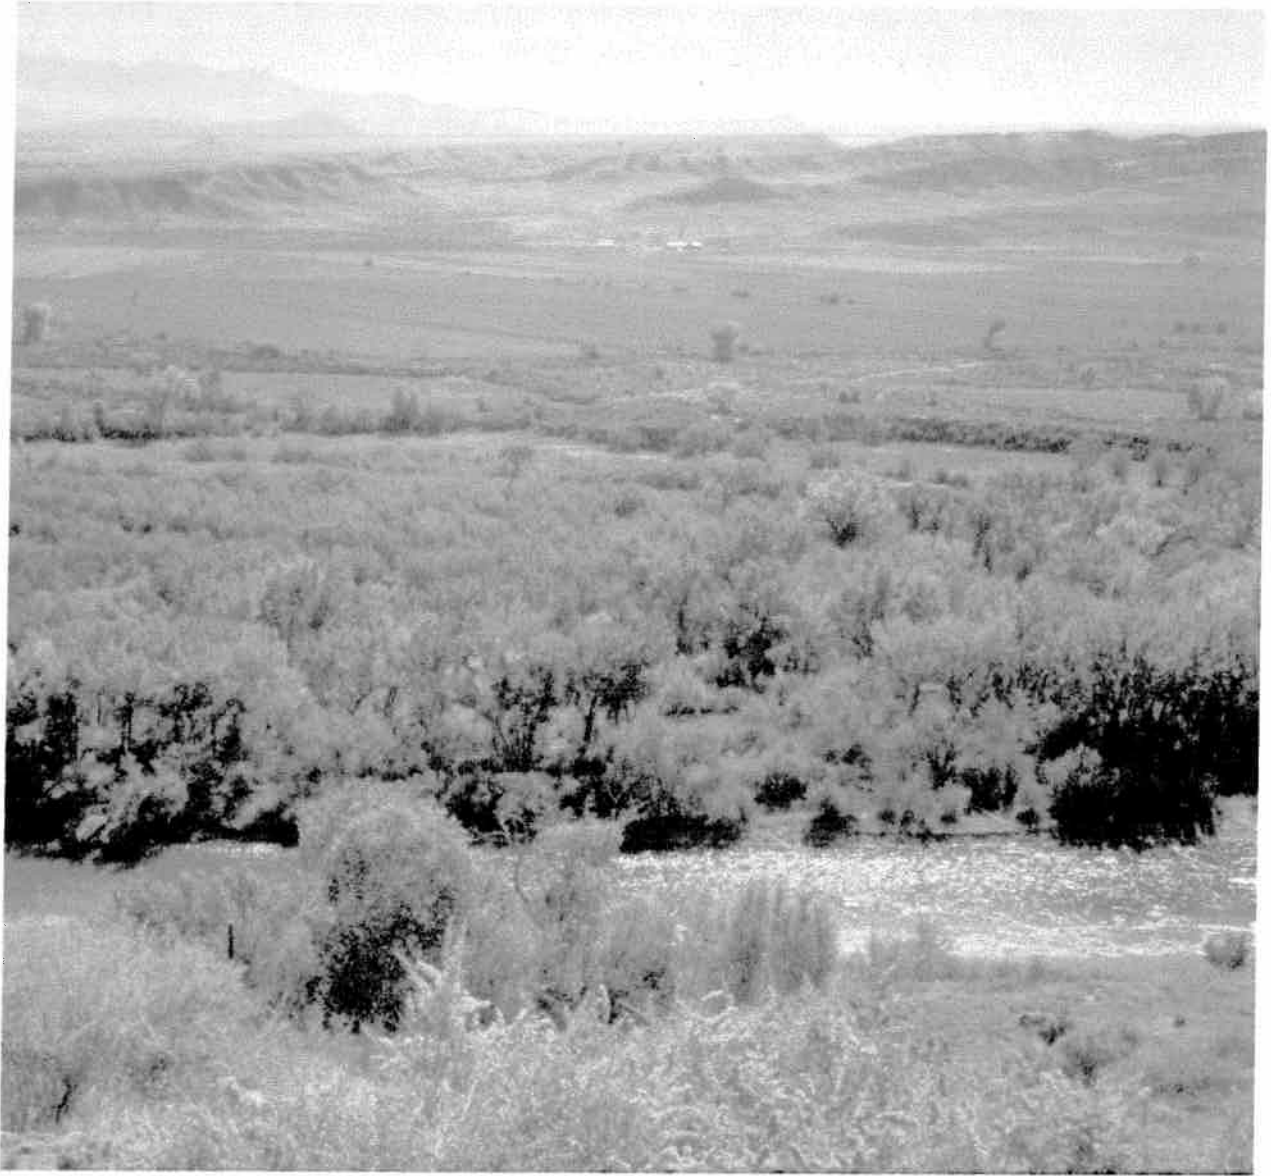
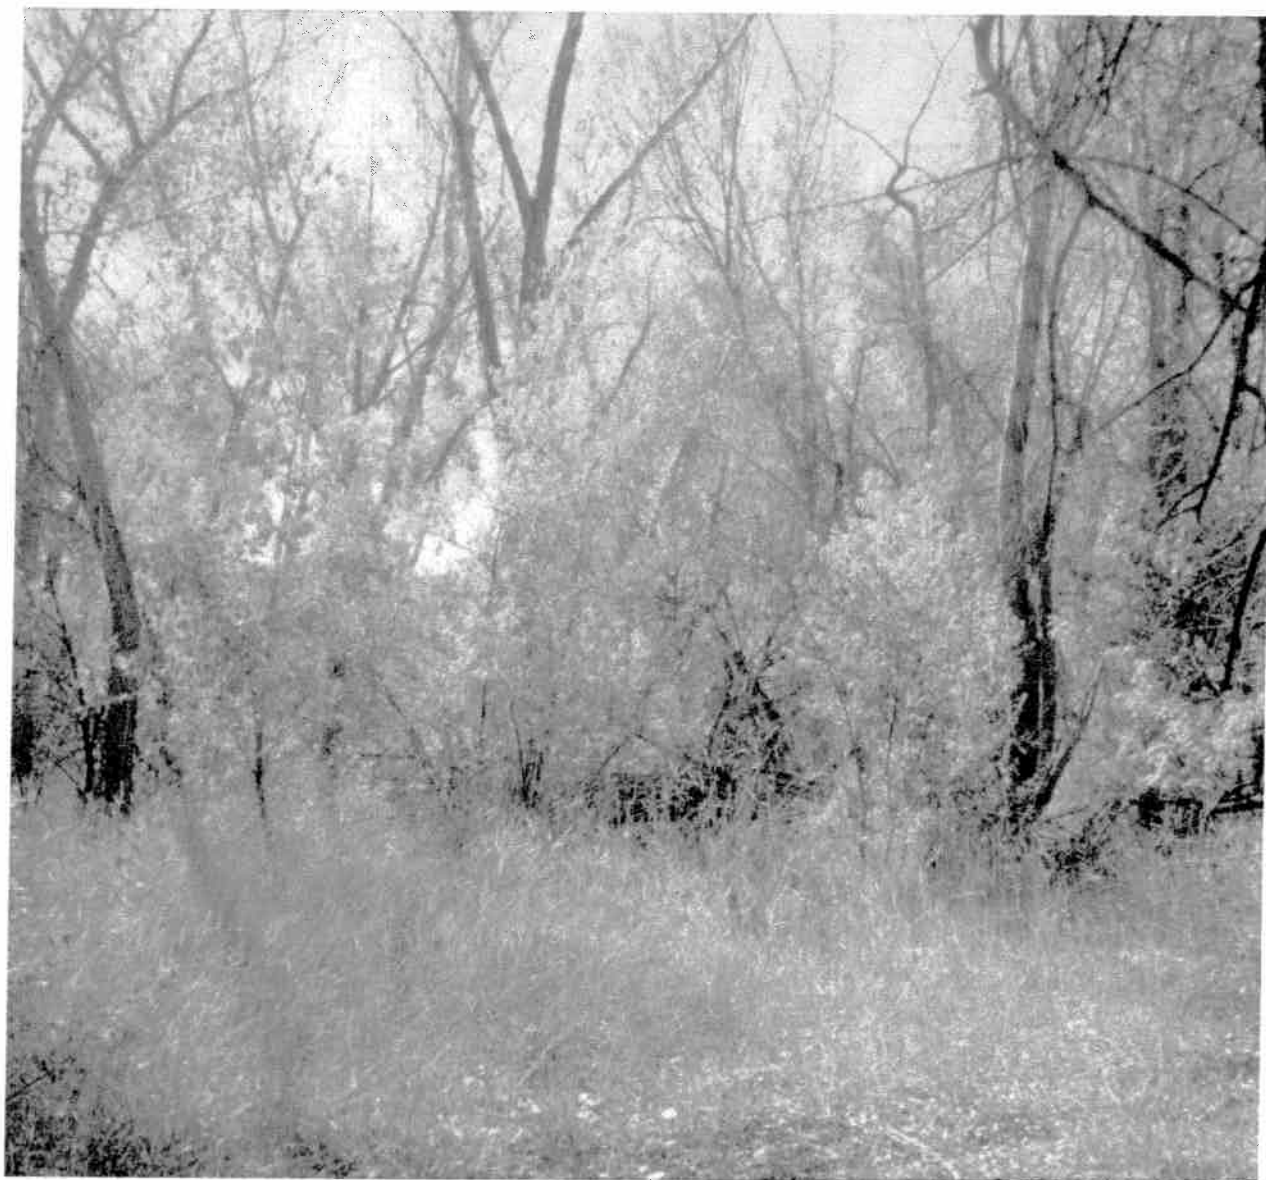
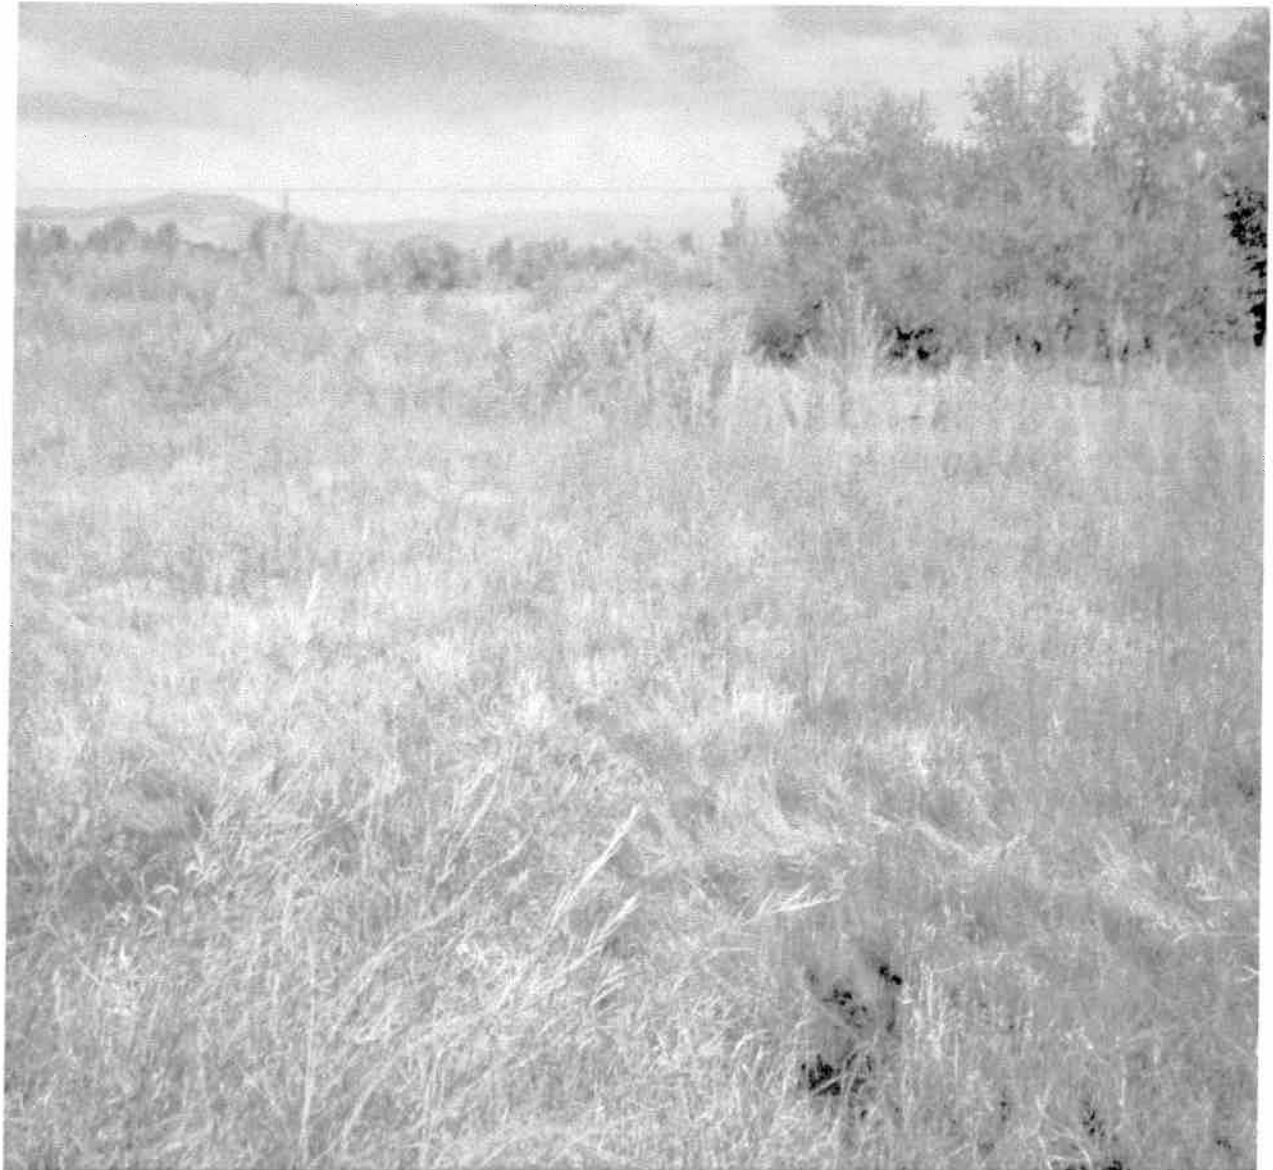
Photo:

Condition: The weedy species tamarisk (*T. ramosissima*), Russian olive (*E. angustifolia*), and Russian knapweed (*A. repens*) degrade the condition of this site. There was only a minimal amount of cottonwood (*Populus* sp.) regeneration occurring at the downstream portion of the site.
