**Riparian Assessment
Of the
North Fork Gunnison River
And
Lower Gunnison River**

Prepared by
Colorado Natural Heritage Program
Colorado State University
Fort Collins, CO 80523

Prepared for
The Delta Soil Conservation District
Delta, CO 81416

February, 2000

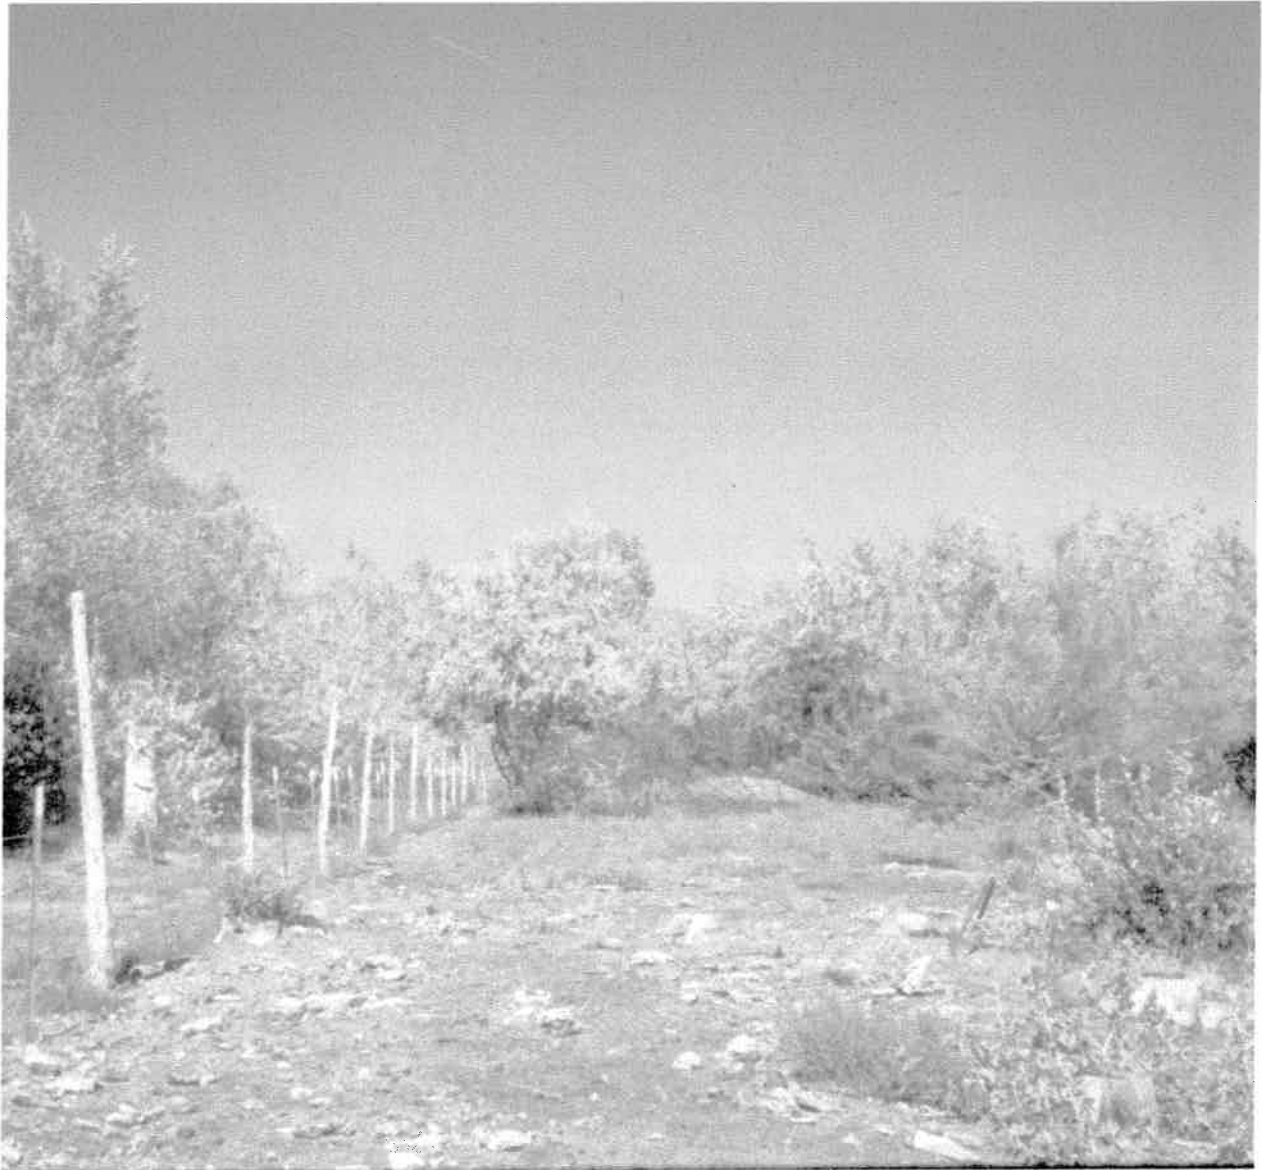
Photo:

Condition: Past landuse practices have heavily impacted this site. The site is heavily infested with weedy species and has been physically modified from its original floodplain form. A large dike and several large piles of river cobbles line the bank of the North Fork River in this reach. Livestock corrals, barns, and the property owners residence are located on the former floodplain behind the dike. A small fishpond has been excavated behind the owner’s residence. This site has the lowest conservation potential of all the sites reviewed.

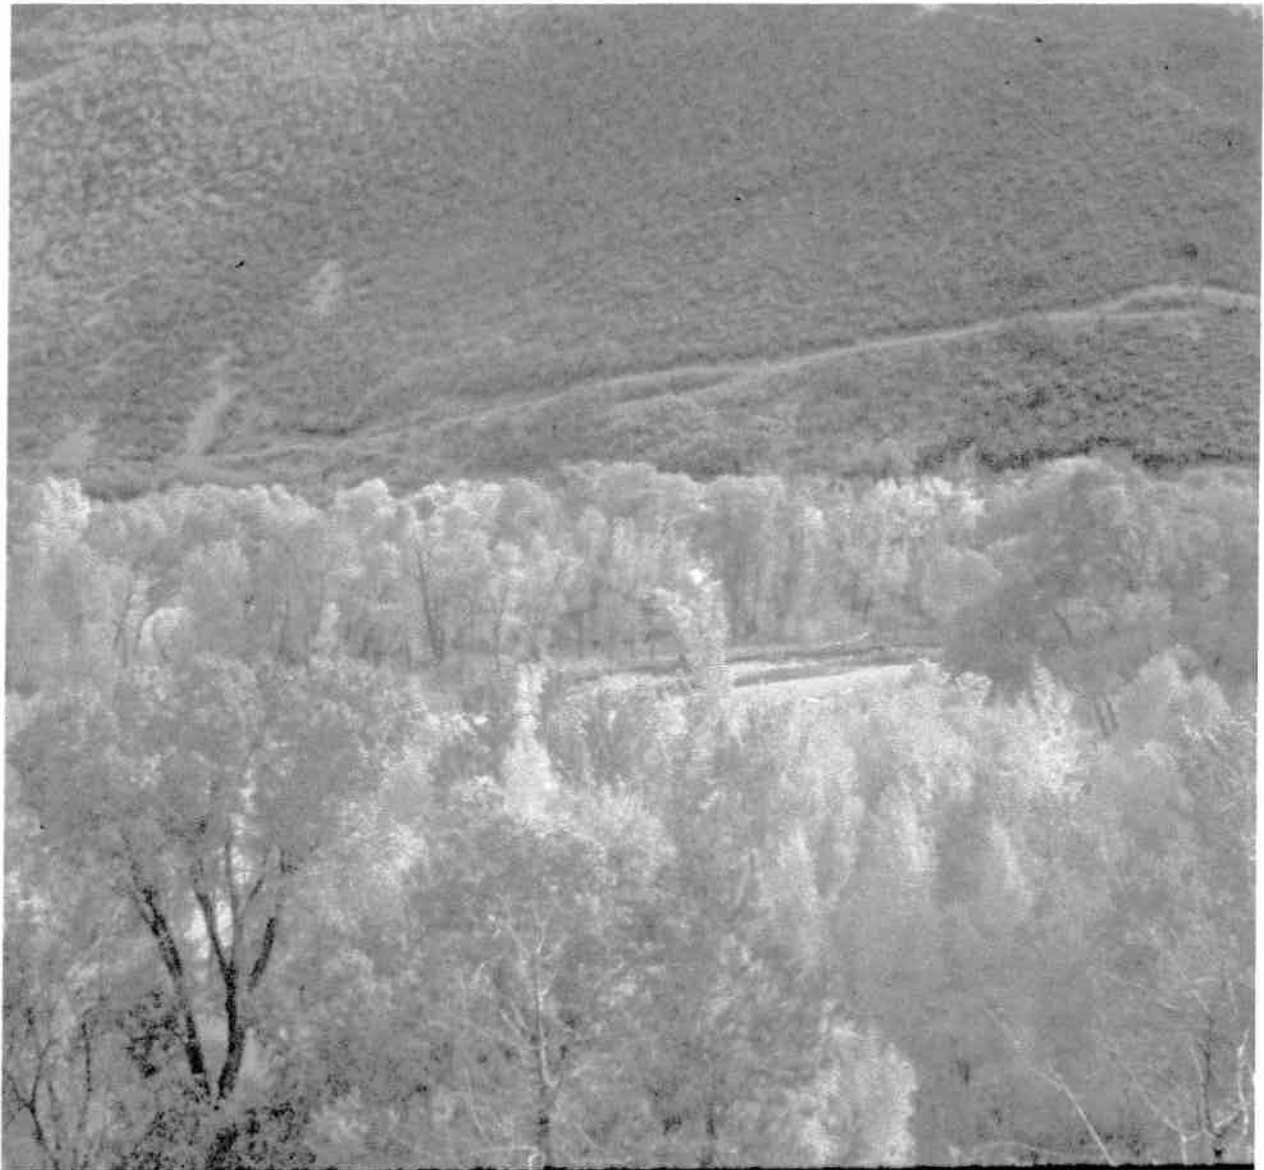
Photo:

Condition: This community is in good condition. There is no tamarisk (*T. ramosissima*), Russian olive (*E. angustifolia*), or weedy herbaceous species present in this location. The physical landform of the site is in its natural state. Parts of the site nearest to the upland margin are presently in hay meadow. An eroded gully toward the upstream end of the site may be the result of a failure in the Stewart Ditch that runs on the hillside above the site. There are a large number of young narrowleaf cottonwood (*P. angustifolia*) seedlings throughout the site.

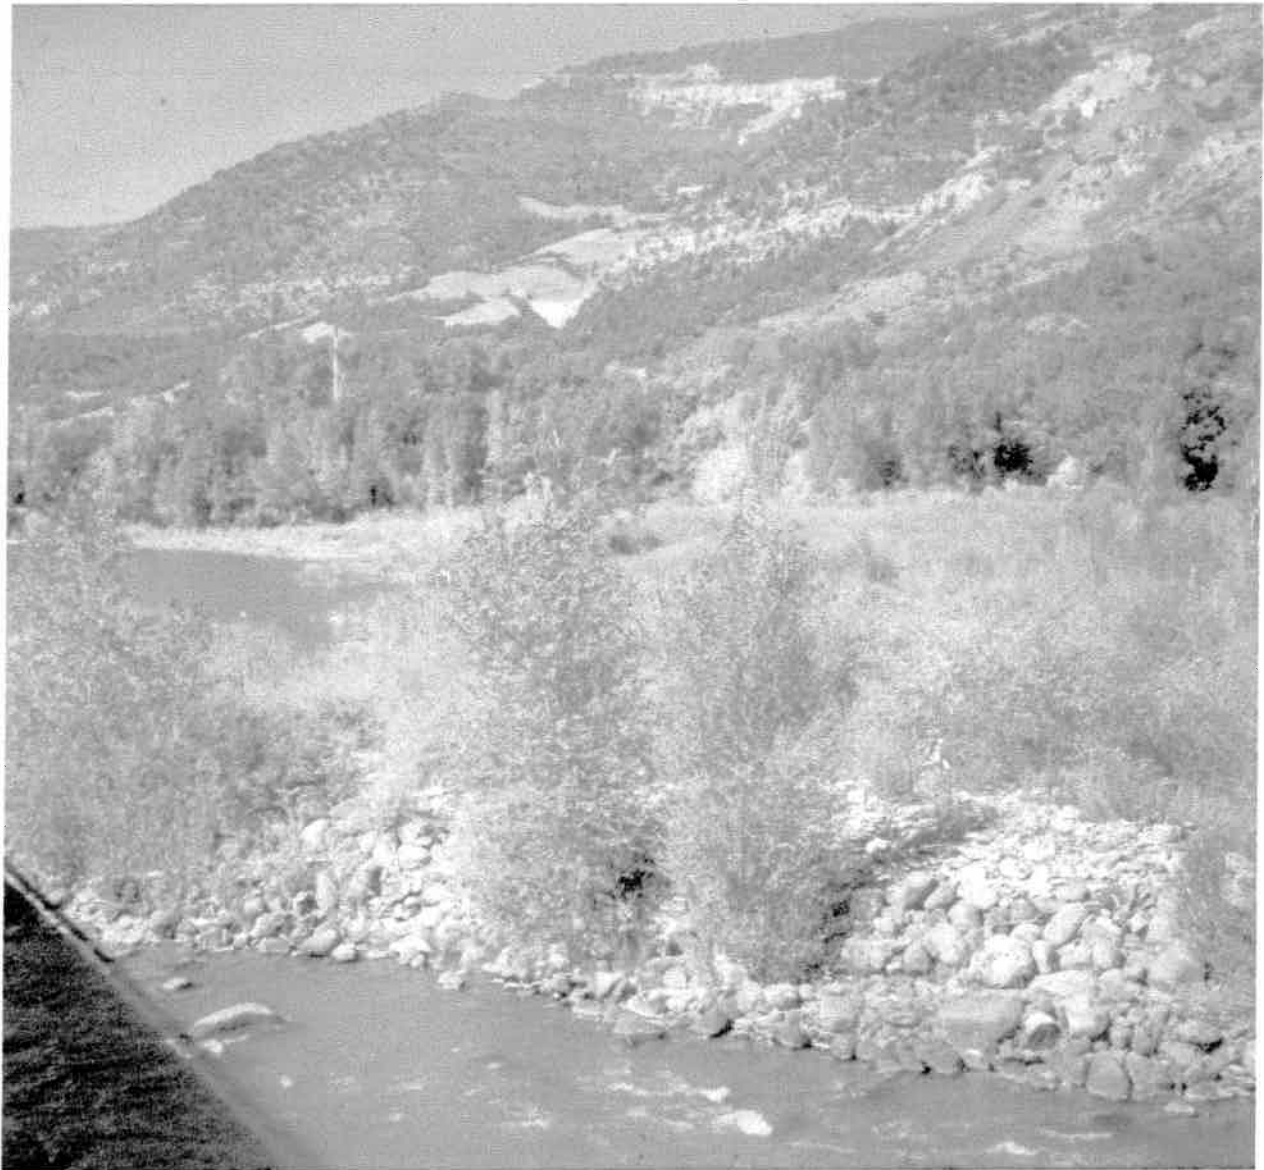
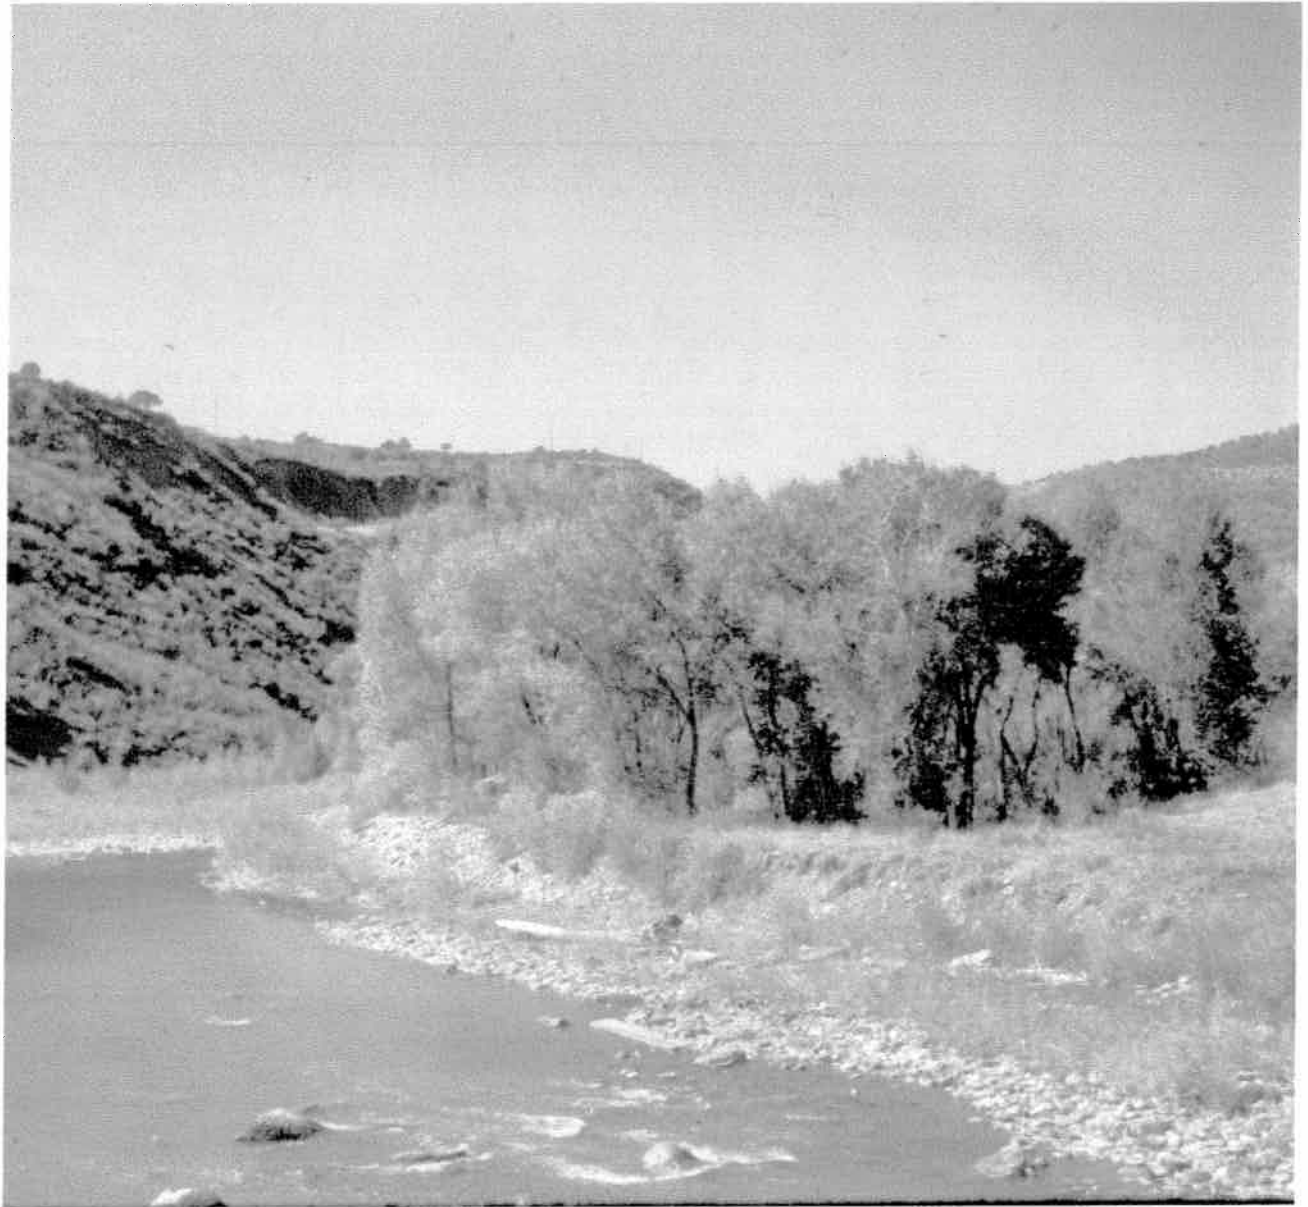
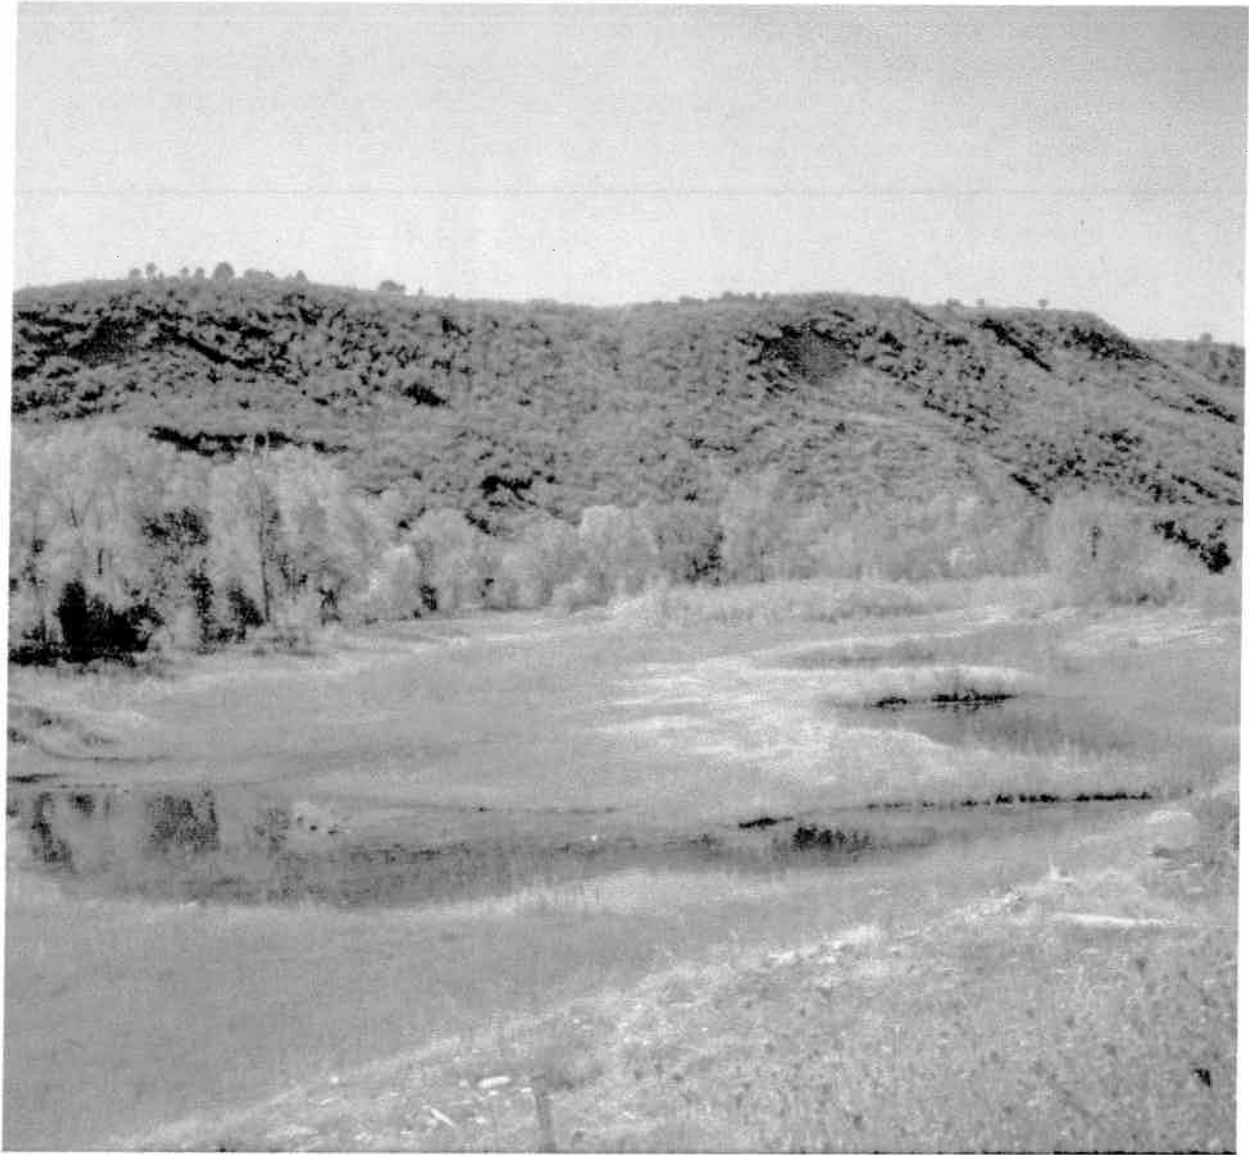
Photo:

Location Description: This site is located where the recently constructed bridge on Highway 133 crosses the North Fork Gunnison River above Bowie. The construction project disturbed and divided the natural riparian community at this location. Additionally, portions of the site appear to have been reworked for wetland mitigation purposes. The site now consists of four separate areas. The areas on the northwest and southeast sides of the road are the assumed wetland mitigation sites. The area to the northeast is a meadow, while the area to the southwest side of the bridge supports a remnant of riparian cottonwood forest (*P. deltoides* var. *wislizenii*-*P. angustifolia*). Based on its size, the condition of the vegetation present, and the landscape context, this location has low to moderate value for conservation of riparian vegetation communities. Based on the ranking criteria this location has an overall rank of “C”.
