THESIS

ASSESSING CHANNEL CHANGE AND BANK STABILITY
DOWNSTREAM OF A DAM, WYOMING

ASSESSING CHANNEL CHANGE AND BANK STABILITY DOWNSTREAM OF A DAM, WYOMING

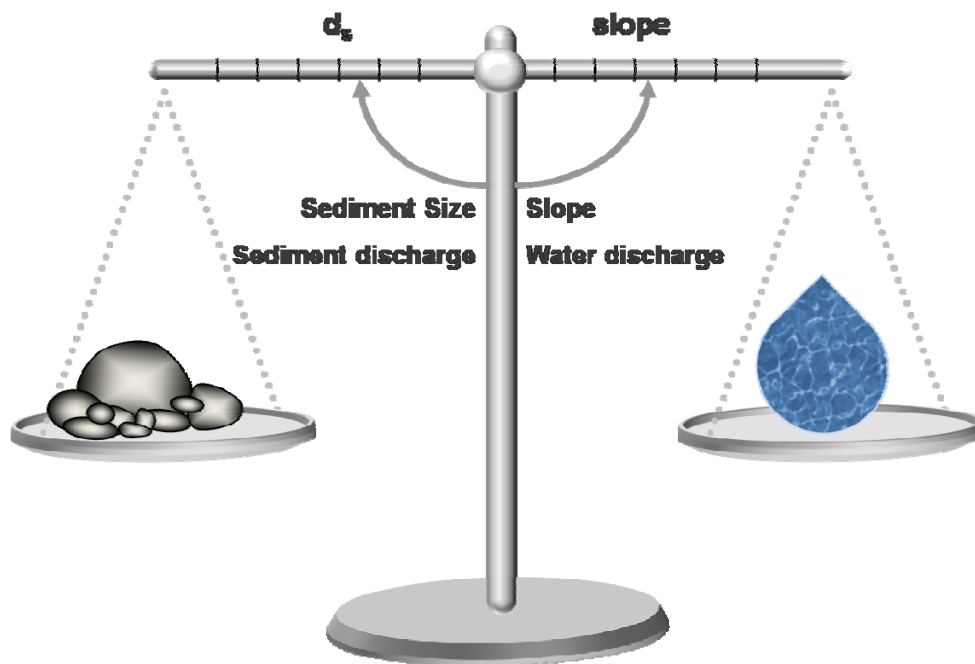
Figure 1.1: Schematic of Borland's depiction of Lane's Balance (1955).

The volume on one pan represents sediment discharge, and the droplet on the other pan represents water discharge. The balance arms represent the bed material size and the friction slope. If all are in balance, the needle points downward to an equilibrium condition. If any of the four terms are out of balance, degradation or aggradation occurs such that there is either a net gain or loss of material moving through a reach. If the transport capacity exceeds the available supply, bed and/or bank erosion can result. The river widens and/or deepens its channel as additional sediment is transported. Erosion reduces the stream gradient and typically exposes coarser material. If the transport capacity is less than the available sediment supply, aggradation or bed-finishing can result. Stream gradients lessen and bank angles decline.

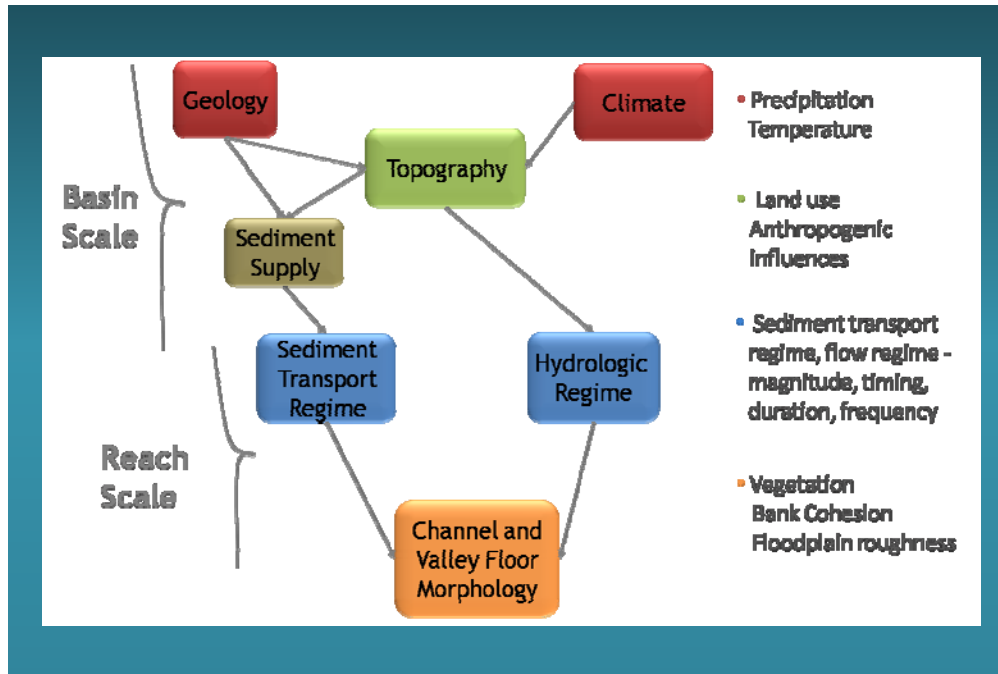
Figure 1.4: controls in a watershed as adapted from Grant et al., 2003 (Figure 1).

Feedbacks occur between geologic constraints and sediment supply, hydrologic events and topographic controls (see Figure 1.4). However, during shorter time periods of analysis, other drivers of considerable influence include riparian vegetation and bank strength. Numerous studies have shown that the impact of a dam can be directly related to the magnitude of alteration in the hydrograph and sediment flux of the river system from dam operation (Petts, 1979, 1982; Williams and Wolman, 1984; Carling, 1988; Brandt, 2000; Grant, 2003). In most river systems there are more controls than depicted with Lane's balance.

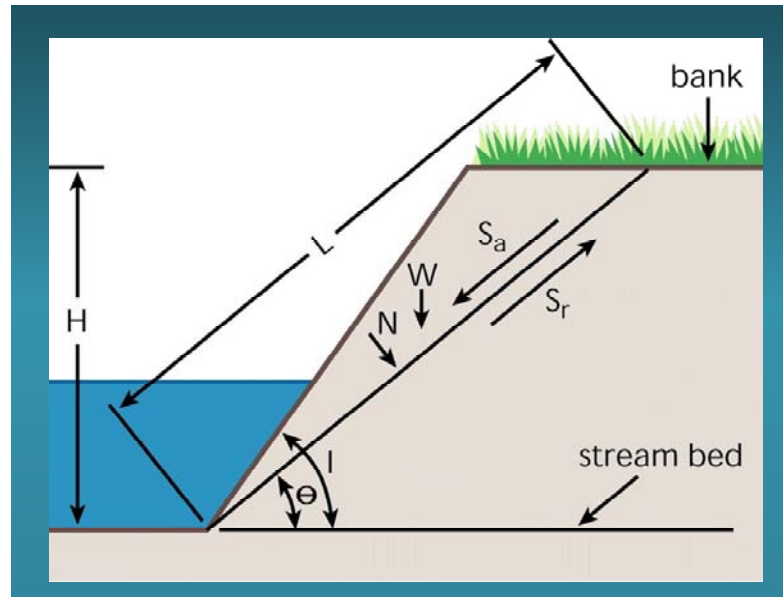
Figure 1.5: Components of bank shear strength: H represents bank height, I = bank angle, L = failure plane length, Sa = driving force, Sr = resisting force, θ = angle of the failure plane, N = normal component of weight, W, to the failure surface (FISRWG 2001, Figure 7-30).

where: $\sigma = W \cos \theta$, W = weight of the failure block, c = cohesion, L = failure plane length, ϕ = friction angle and θ = failure plane angle (see Figure 1.5).

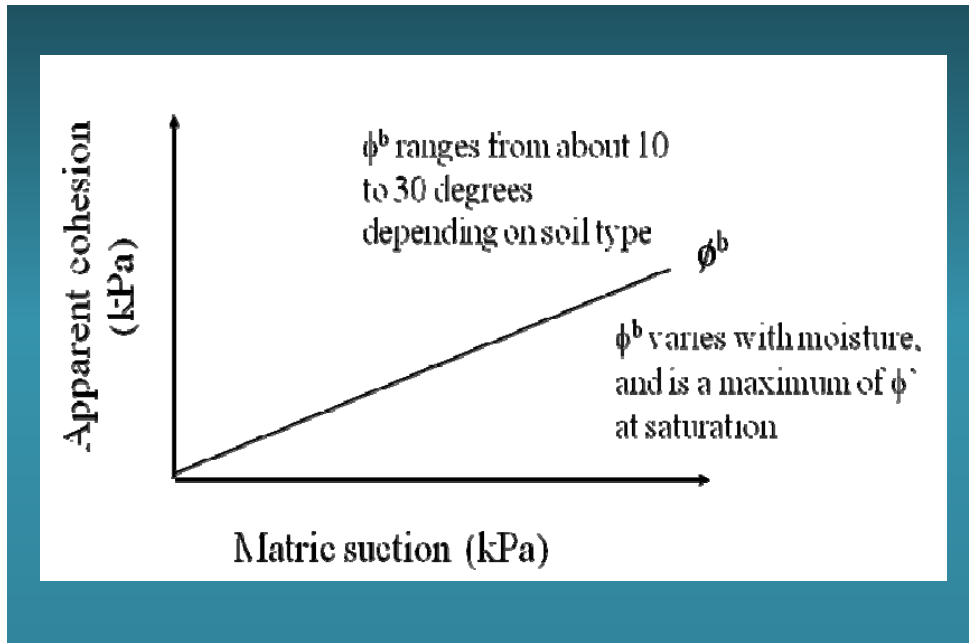
Figure 1.7: The effect of matric suction on apparent cohesion and bank strength. Note that negative pore-water pressures provide an apparent cohesion and greater shear resistance. Positive values of pore-water pressure reduce shear strength. (Derived from Andrew Simon, unpublished figure)

Where c_a = apparent (total) cohesion, c' = effective cohesion, $(\mu_a - \mu_w)$ = suction on the failure plane, and ϕ^b = angle representing the relation between the shear strength and the matric suction (Simon and Collison, 2002). The latter value varies between all soils and generally ranges between 10 and 20 degrees (as presented in Simon from Fredlund and Rahardlo, 1993). Soil shear strength increases with increasing matric suction (Figure 1.7).

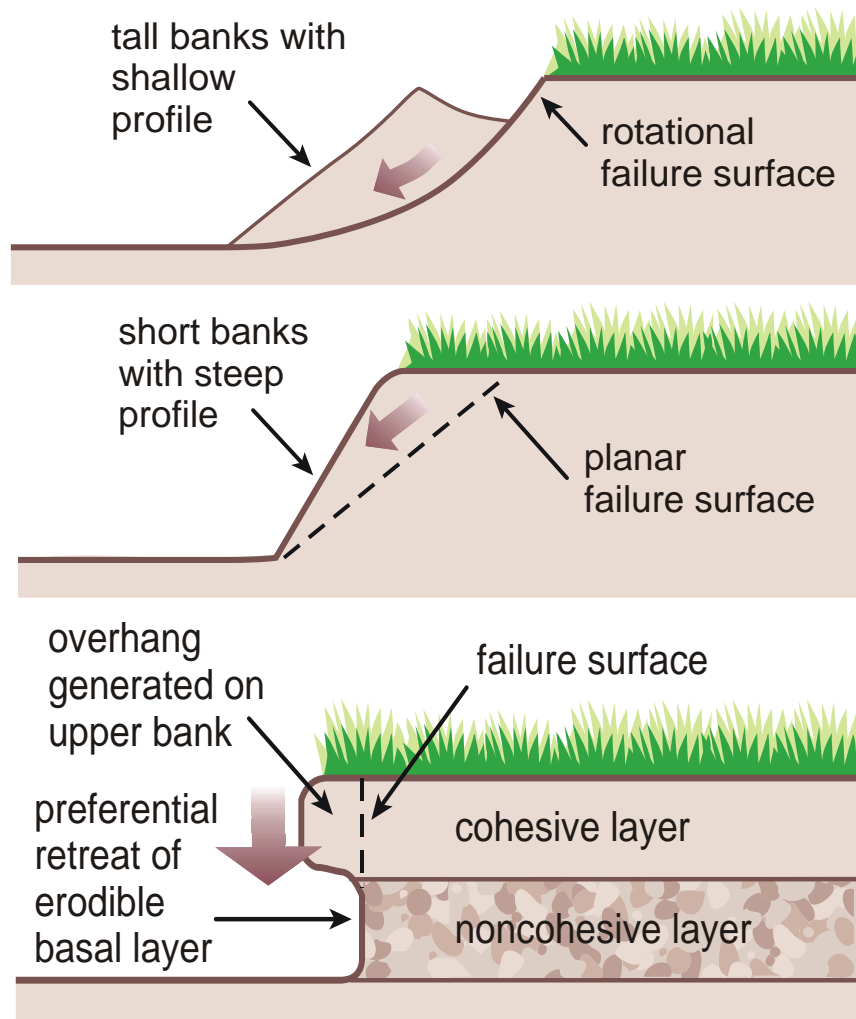
Figure 1.8: Modes of mass failure as depicted by FISRWG 2001, Figure 7-29.

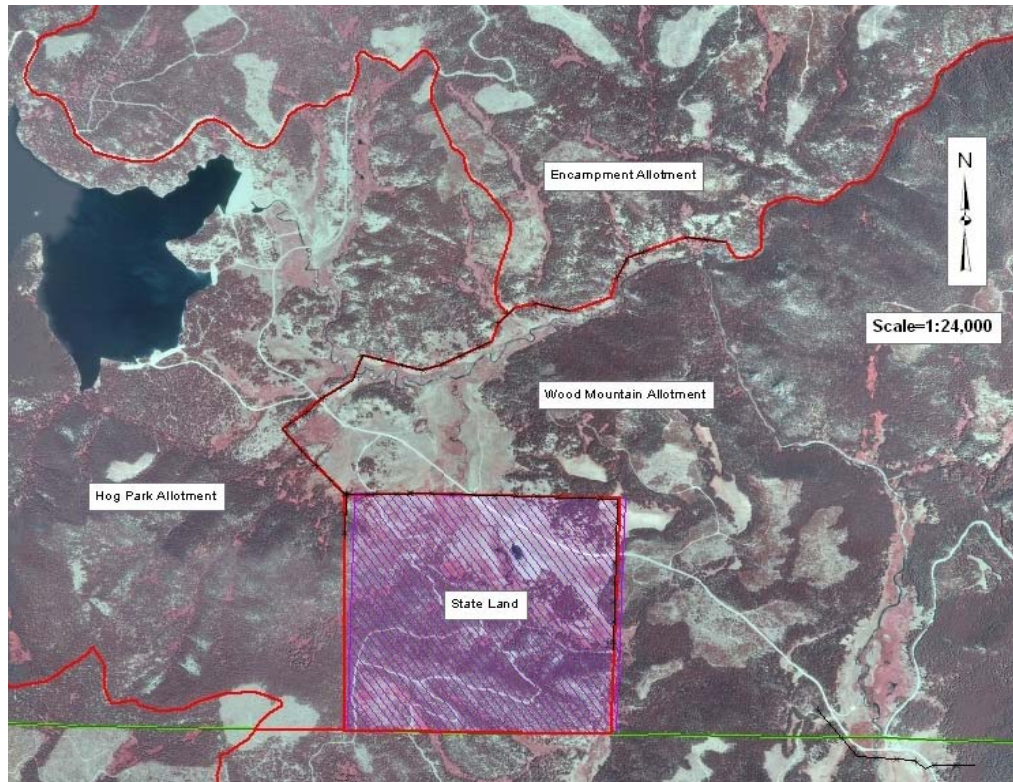
Figure 2.2: Depiction of current grazing allotments in Hog Park Creek. Note that reaches 2, 3 and 4 of this study are in a current allotment, while reach 1 is excluded. Image courtesy of W. Haas, Rangeland Management Specialist, Medicine Bow National Forest.

In 1978, measures were put in place in the South Fork Hog Park Creek and part of Hog Park Creek area to relieve overstocking by cattle. At that time the permits for Wood Mountain Allotment, which includes the study area (Figure 2.2), included a limited number of animals and a limited grazing season, between July 1 and September 15. Cattle used the portion of Hog Park Creek below the dam, in addition to reaches 2, 3, and 4 that are within the Wood Mountain Allotment. A fence completed in 1989 curtailed livestock movement into the portion of Hog Park Creek below the dam (reach 1). Forage utilization and bank trampling have mostly been light and intermittent along that reach since 1989. Along the sections of Hog Park Creek and South Fork Hog Park Creek that have continually experienced grazing (reaches 2, 3, and 4), livestock use has mostly been moderate since 1982, although there have been some years with higher use levels.

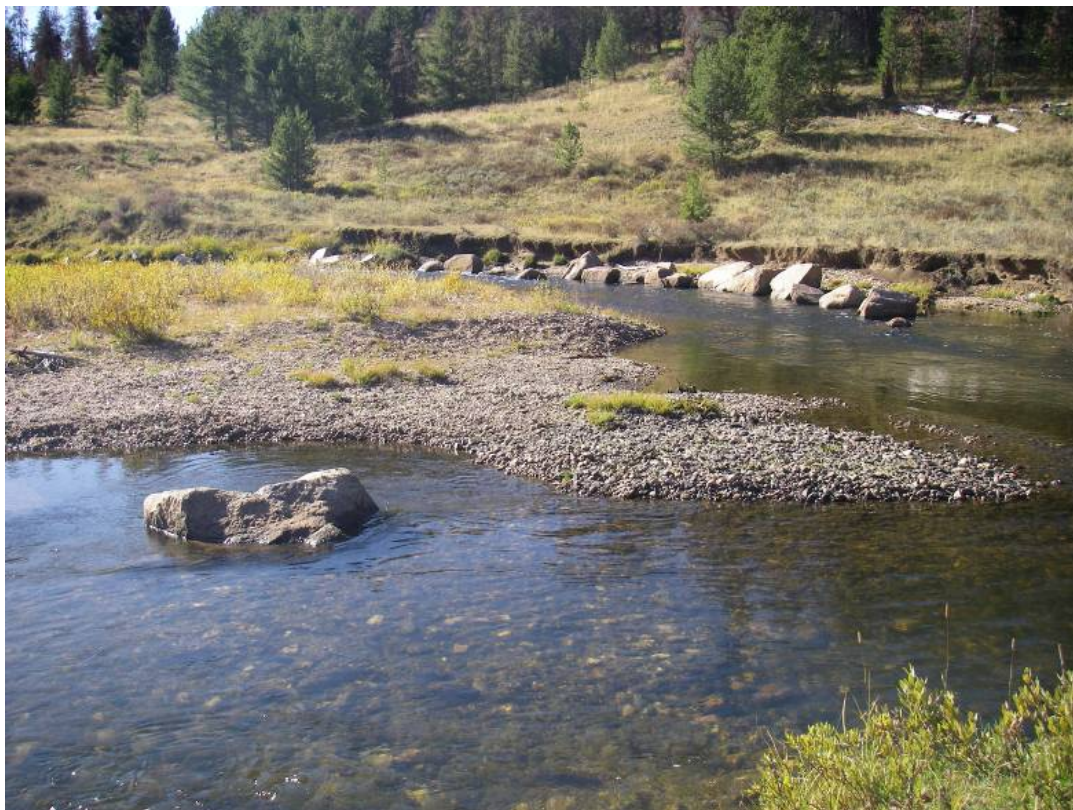
Figure 2.3: Photos taken in 2008 of instream structures placed throughout Hog Park Creek in the 1970's. The picture is taken adjacent to and just upstream of Site 3.

In an apparent response to what was perceived as increased erosion rates throughout Hog Park Creek below the dam, boulder and log structures were constructed in the early-mid 1980's at various locations along reach 1 and reach 3 to stabilize channel banks and improve aquatic habitat (Figure 2.3). The placement of many of these structures have actually increased bank erosion and widened the channel as flows are directed toward the banks. Little documentation exists, however, of channel characteristics prior to the installation of the structures and the design specifications of the structures. Although these structures have locally influenced channel morphology, these changes are not readily apparent on aerial photographs or quantified in the planform analysis of channel change.

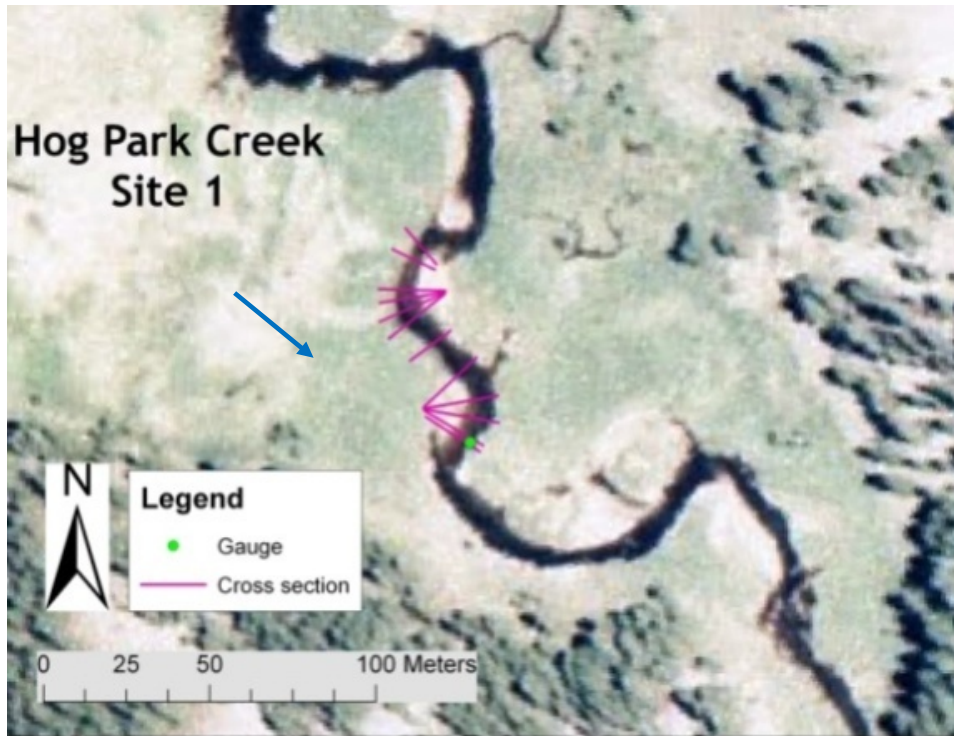
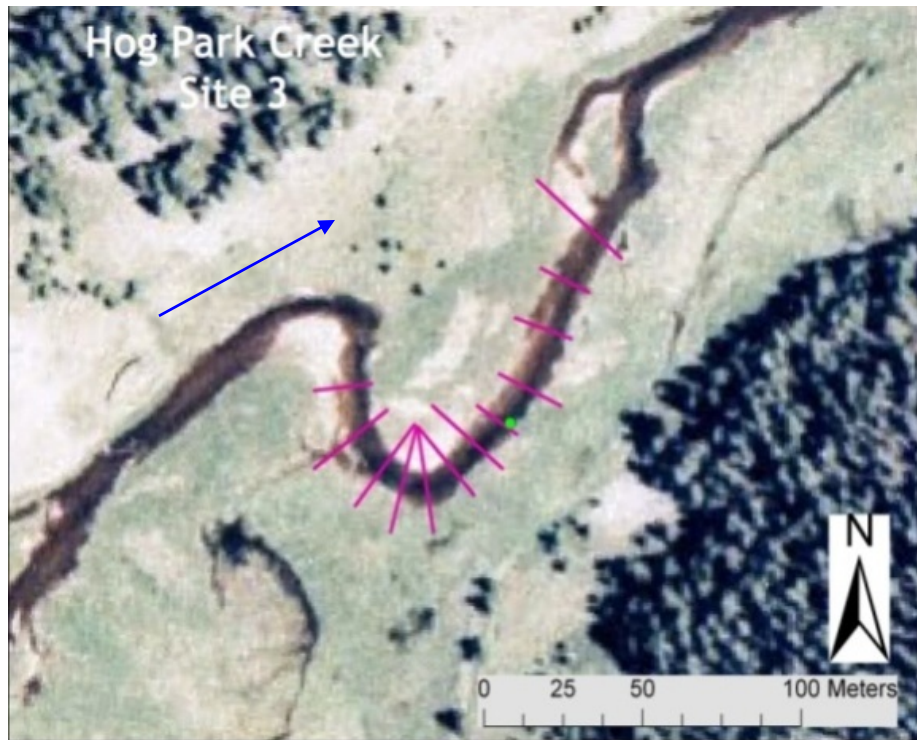
Figure 3.1: Site and cross section characteristics for sites 1-4. Direction of flow is indicated by the blue arrows. Green dots indicate the location of a pressure transducer (Site 2, 3) or crest gauge (Site 1 - 4).

The resurvey of established cross sections was done using a Topcon GTS 212 total station in 2008 and 2009 (Table 3.1). The cross sections, originally placed in 2004 and 2006, are identified by rebar pins on both the right and left margins of the floodplain or terrace (Figure 3.1). The total station location is benchmarked by a cemented rebar pin. A tape was strung from left bank to right bank, with most cross sections extending 5 meters or more onto the floodplain. A range of 20 to 40 survey points were taken at each cross section, indicating surface gradient changes, shifts in dominant substrate composition, erosion pin locations, vegetation shifts, the top and bottom of the bank and bank toe, the left bank and right bank wetted edge perimeter, thalweg, and the top and bottom of the benchmarked cross section endpoint pins. In this study, bankfull flow was identified by obvious topographic indicators adjacent to the channel; specifically, a topographic break in the bank from vertical or nearly vertical bank walls to a horizontal floodplain. Bankfull flow in this study represents the point at which flow spills over onto the floodplain.

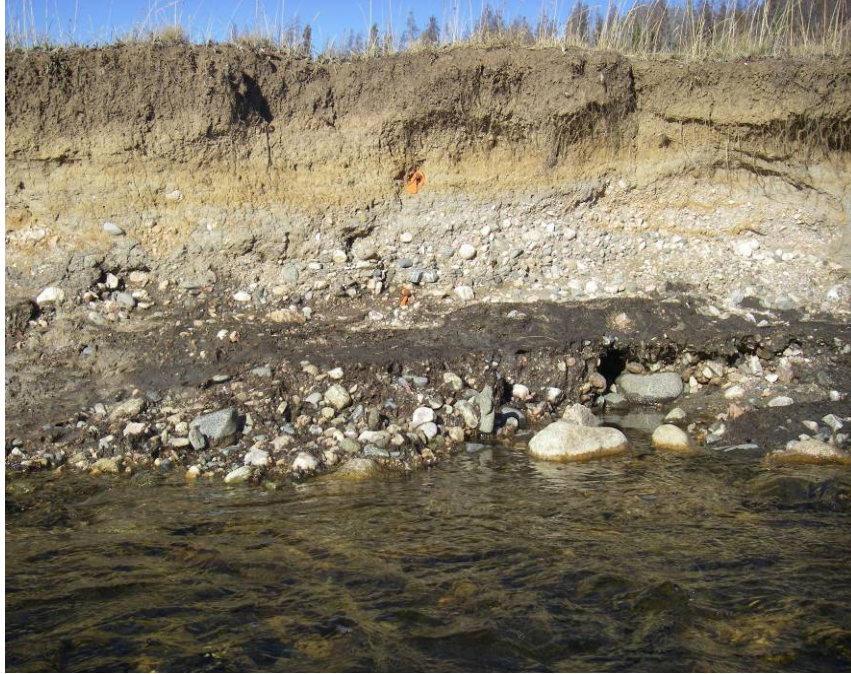
Figure 3.2: Example of the placement of two erosion pins in a vertical bank. The bank is located in a meander bend in Site 4, pins are indicated by orange flagging.

Ninety erosion pins were established in 2006 by USFS personnel in each of the four study sites. Rebar pins (0.8 m length) were placed at points one-third and two-thirds of the bank height in the cross section line of banks with slopes greater than 20 degrees (Figure 3.2). The pins were driven perpendicular into the bank until protruding approximately 1- 2 cm from the bank. Erosion pins were installed in banks experiencing active erosion and displaying no evidence of erosion in 2006. These were measured, surveyed, and reset following high flows in 2007, 2008 and 2009. Each pin was measured on the downstream side of the pin from the end of the pin to the point where it intersects the bank. Both the distance below the top of the bank and the extent of undercut were recorded. Erosion rates were derived from sequential cross section surveys, but the extent of bank erosion may not be captured at undercut banks. Erosion pins and undercut profiles are assumed to provide a more accurate measurement of the annual extent of erosion.

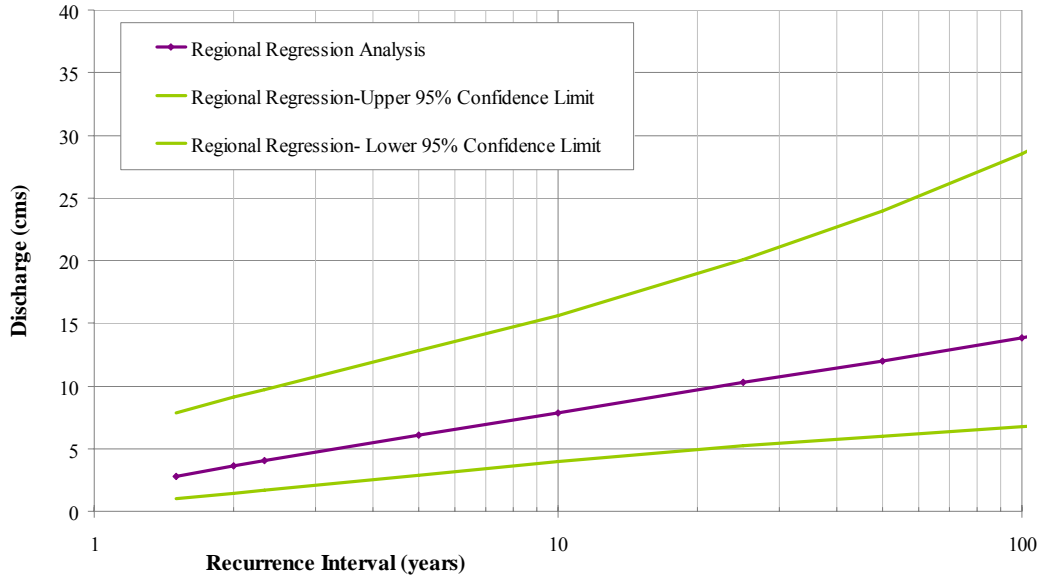
Figure 4.1: Regional regression-derived estimated discharges for various flood magnitudes representing an unregulated condition in Hog Park Creek.

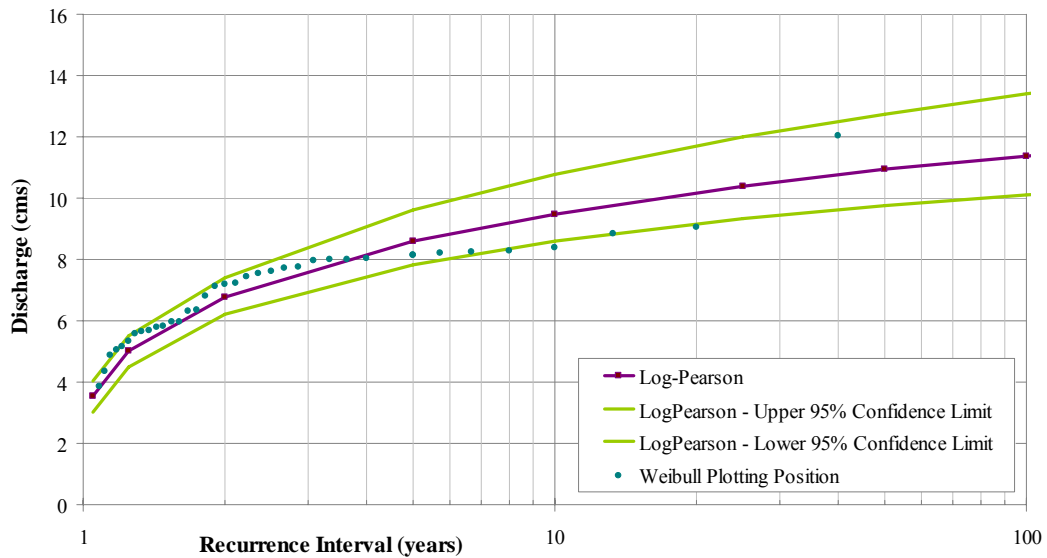
Figure 4.2: Calculated discharges for recurrence interval storm events using the Log Pearson Type III method (USGS Bulletin 17B), indicating the discharge associated with flows of given frequencies.

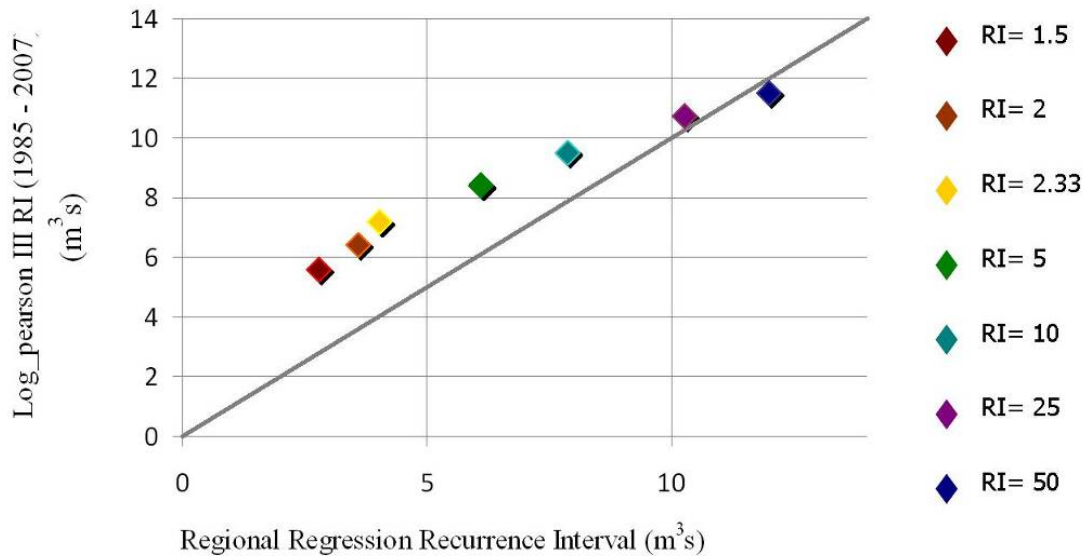
Figure 4.3: Regulated and unregulated magnitude of flows of a given recurrence interval calculated for current (y-axis) and unregulated (x-axis) conditions. Points below the mid-line display the relative decreases in discharge of a given frequency, and the converse for points above the line under current dam operations.

A comparison of recurrence interval discharges is plotted in Figure 4.3 and results are presented in Table 4.1. The discharge for recurrence intervals of 2, 5, 10, 25 and 50 years for the pre-dam time period is placed on the x-axis and the post-dam time period on the y-axis. The 45 degree centerline describes agreement between the discharges of a given recurrence interval. If the discharge for a given recurrence interval remains the same for both the current and unregulated results, then the point would lie on the line. The points above the centerline indicate that discharges are occurring more frequently under regulation than compared with unregulated conditions. Points located below the line indicate discharges that are occurring less frequently than would be predicted for unregulated conditions.

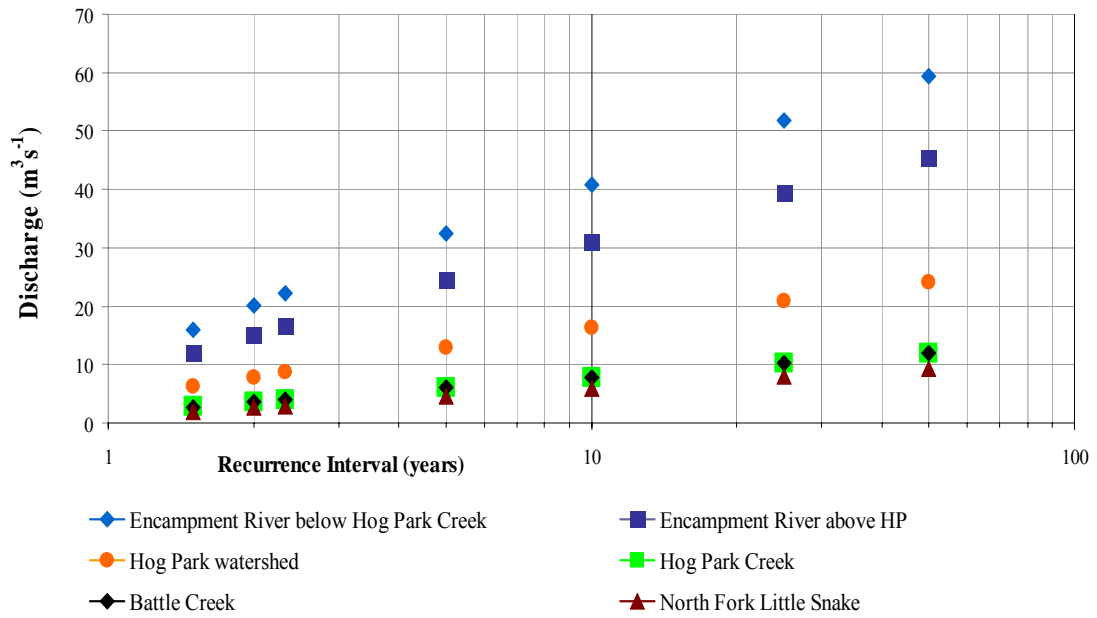
Figure 4.9: Recurrence interval calculations for various gauges. Notice the similarity of data from the Hog Park flume, North Fork Little Snake and Battle Creek gauges.

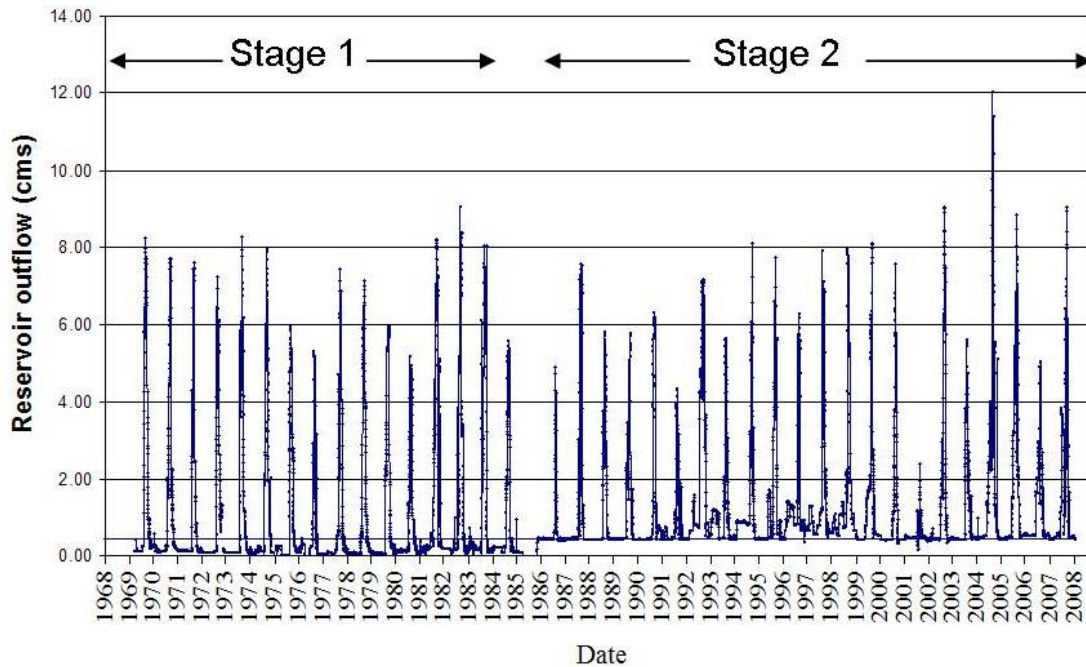
Figure 4.10: Hydrologic time series of the CBOPU data set. The x-axis is time, while the y-axis displays discharge values.

found that a suitable descriptor of the ability of a dam to impact the flow regime is a ratio of annual water discharge to storage capacity of the reservoir. He found that large dams in western states have a discharge-storage ratio ranging between 1.4 and 4.6. If the ratio is one or greater, then the dam stores more than the annual yield. The ratio between the storage capacity and the annual water yield of Hog Park Creek increases an order of magnitude from 0.14 to 1.17 between the Stage 1 and Stage 2 flow eras due to the augmentation of discharge from the North Fork Little Snake Basin. The ratio in Hog Park Creek is contrastingly low to larger rivers, although the shift from Stage 1 to Stage 2 represents a significant change in the hydrology of the basin. The historical time series for Hog Park Creek is provided in Figure 4.10 and does not include the Battle Creek dataset.

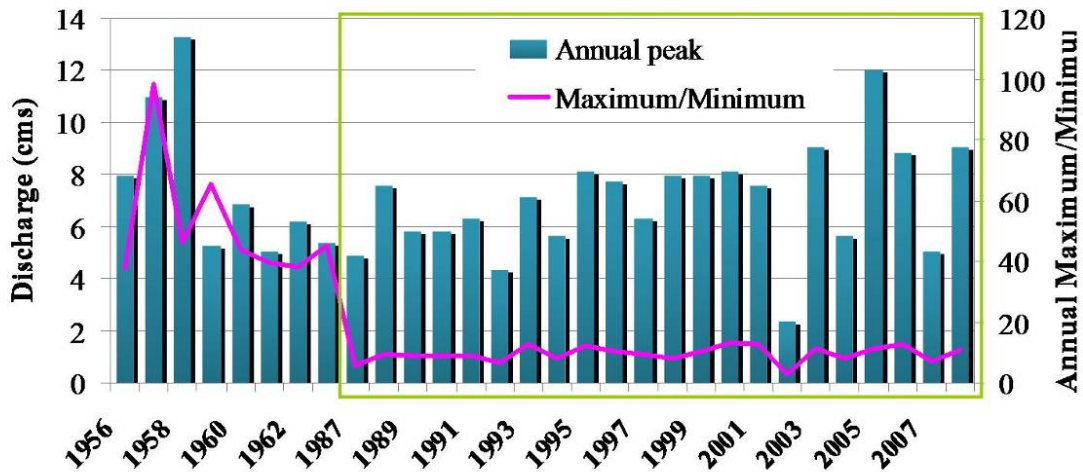
Figure 4.11: Mean daily annual maximum discharge plotted with the ratio of maximum discharge to minimum discharge for the combined data set. The highlighted section represents the time period following Stage 2 implementation.

In general, it can be observed that flow heterogeneity has been reduced. Figure 4.11 plots the maximum daily mean annual discharge for the period of record against a ratio of the maximum annual to daily mean annual discharge. Beginning with the dam enlargement in 1985, a significant shift can be observed such that the variability in the annual hydrograph is dampened as a result of higher than normal base flows and reduced peak flows, as described in the recurrence interval analyses. Table 4.4 provides reservoir and annual discharge statistics between the three time periods. The ratio of the reservoir storage capacity relative to the annual discharge increases from 7.3 to 46.1. This metric relates to the ability of a dam to influence the geomorphic properties of a river or stream system (Graf 2006). The increase in storage capacity, combined with the flow augmentation, has the potential for considerable influence on Hog Park Creek.

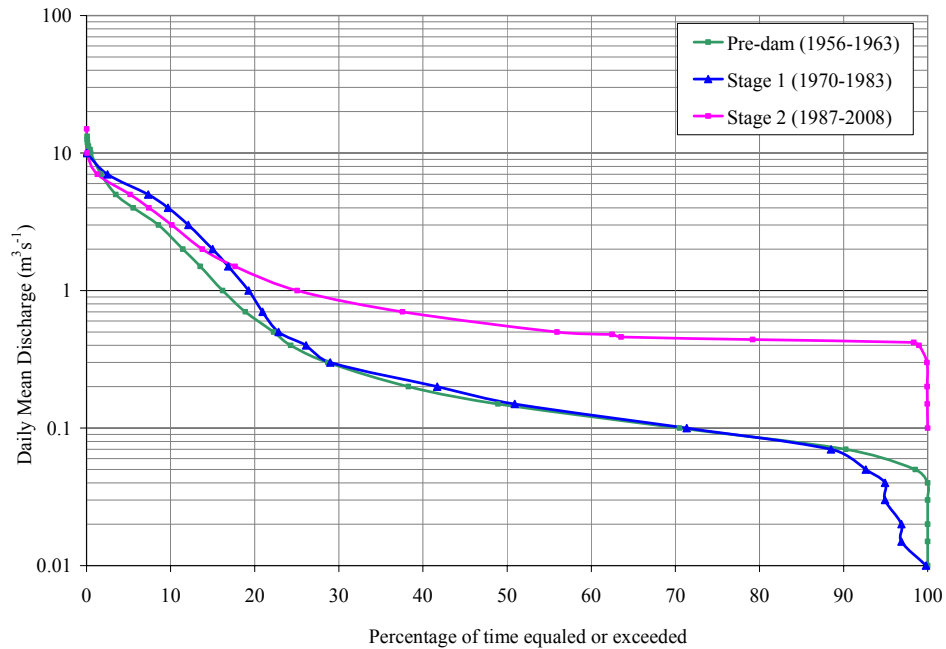
Figure 4.12: Duration curve for Pre-dam (1956-1963), Stage 1 (1970-1983), and Stage 2 (1986-2008) flow eras.

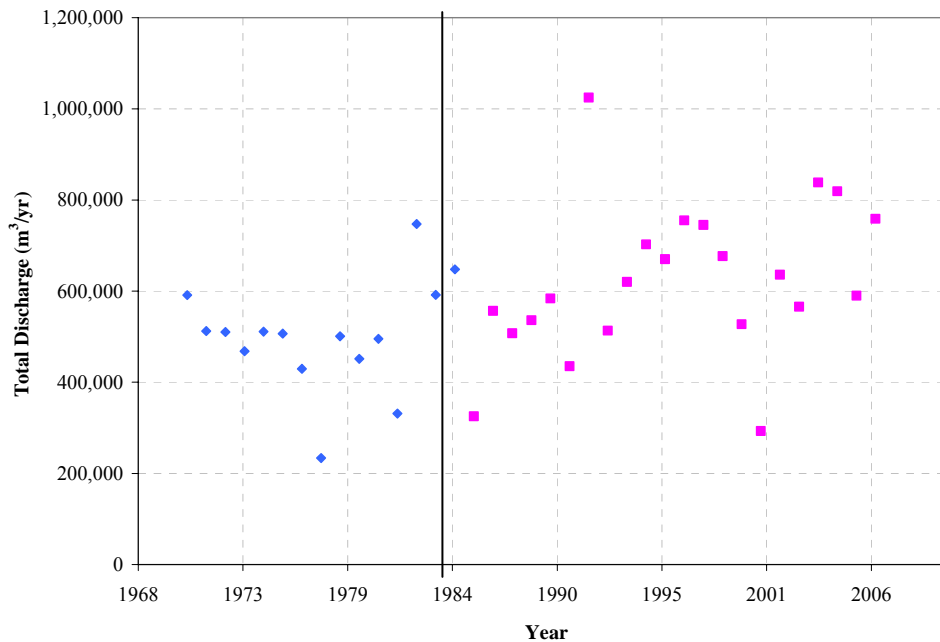
Figure 4.13: Total annual discharge from the reservoir in Hog Park Creek, Stage 1 (blue) and Stage 2 (pink). The two time periods are separated by the solid black line.

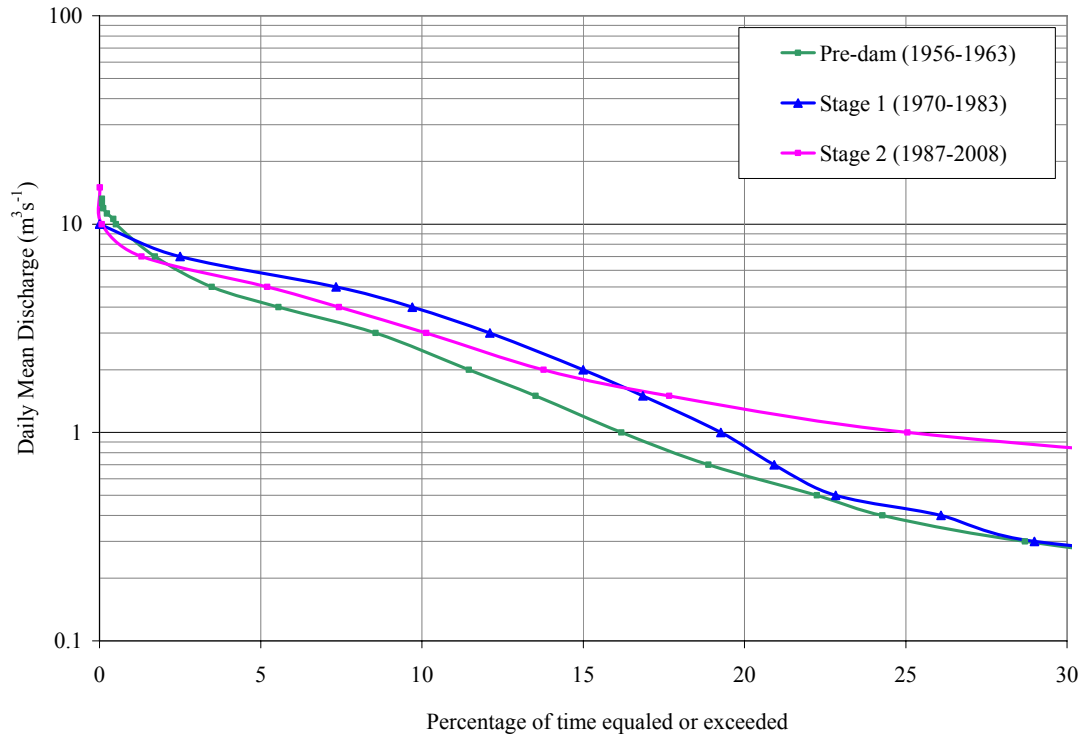
Figure 4.14: Flow duration curve for three flow eras, depicted for higher flows of less exceedance probability (0-30%).

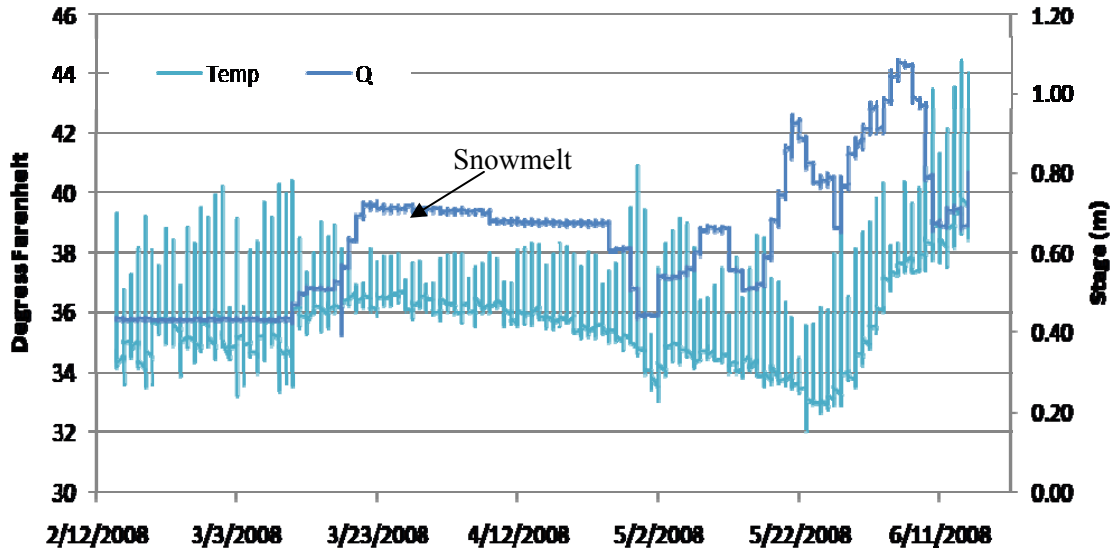
Figure 4.15: Pressure transducer data from site 2 Hog Park Creek, 2008. Note the abrupt decrease in water temperature as the river stage exceeds 0.7 meters due to melting of snow accumulated on the bank of the channel.

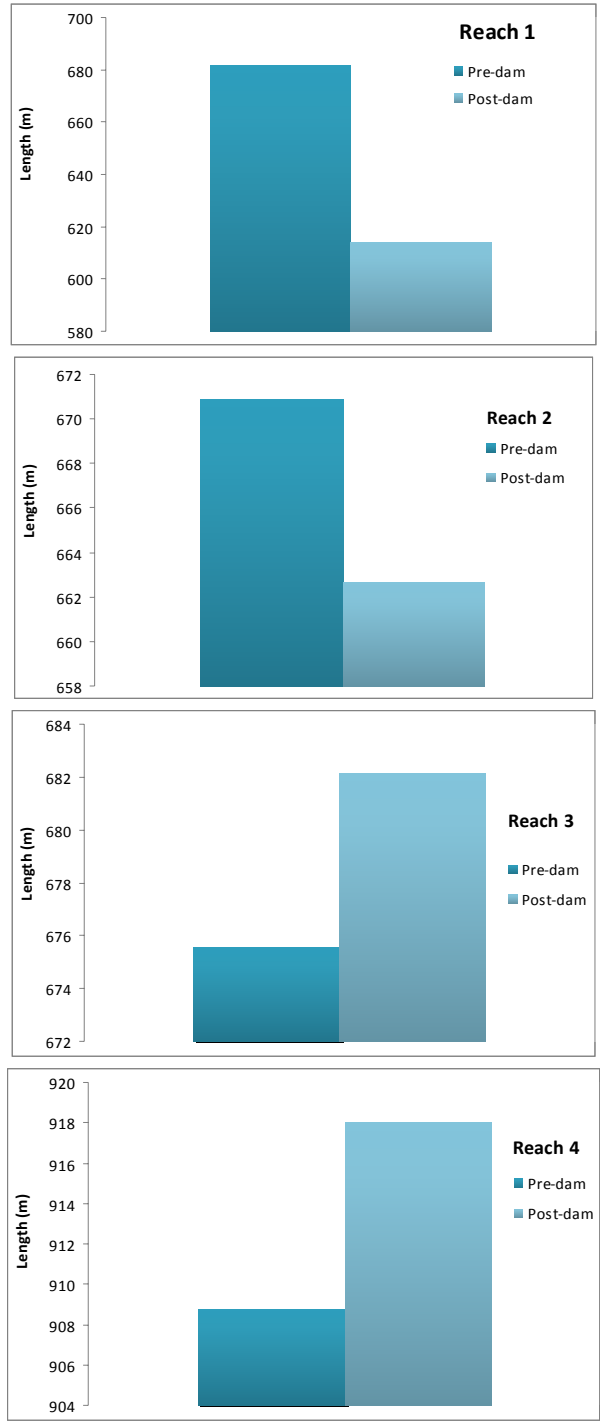
Figure 4.21: Total lateral migration distances averaged for each reach, comparing pre- and post-dam time frames. The values represent summed absolute values of migration distance length measured every 3-5 m longitudinally between each series of aerial photographs. The pre-dam data set is comprised of the changes from 1937 to 1955 and 1955 to 1966. The post-dam category includes datasets from 1966 to 1973, 1973 to 1983, 1983 to 1991 and 1991 to 2001.

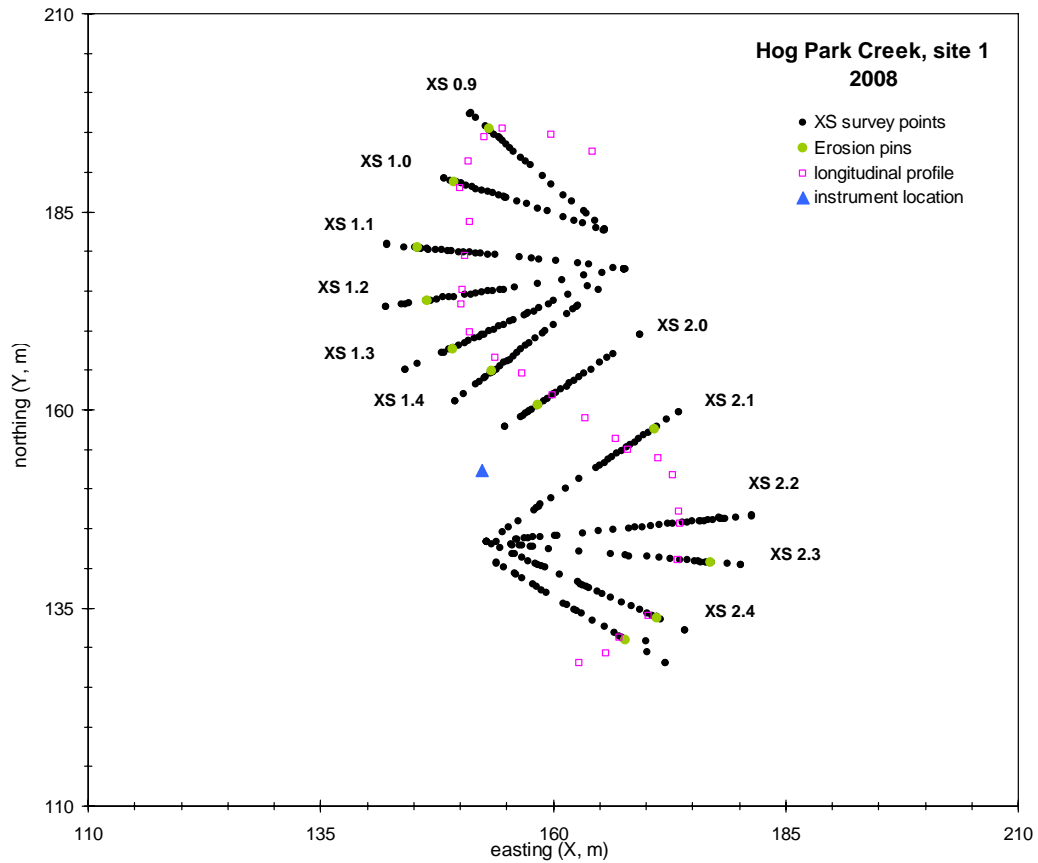
Figure 4.25: Planform schematic generated from survey data, Site 1 2008.

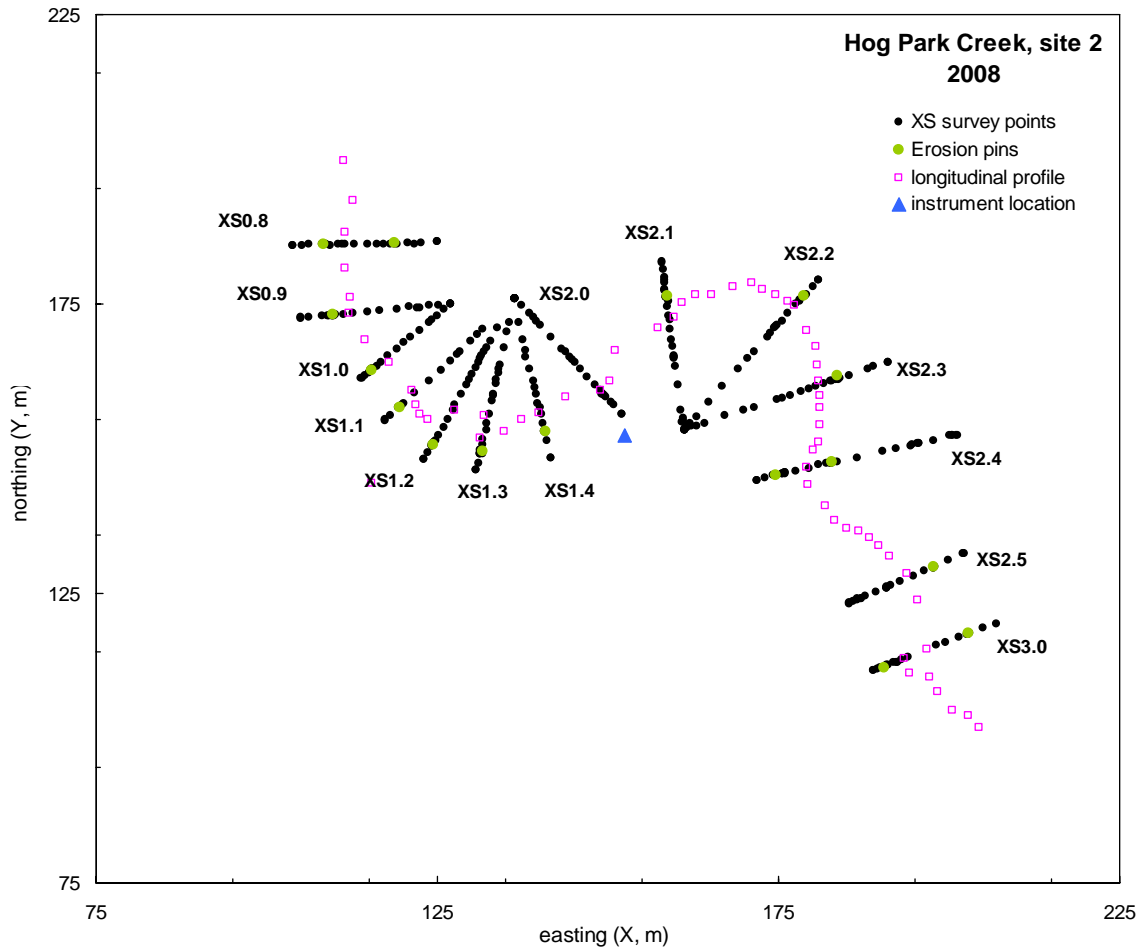
Figure 4.29: Planform schematic of Site 2, generated from survey data, 2008.

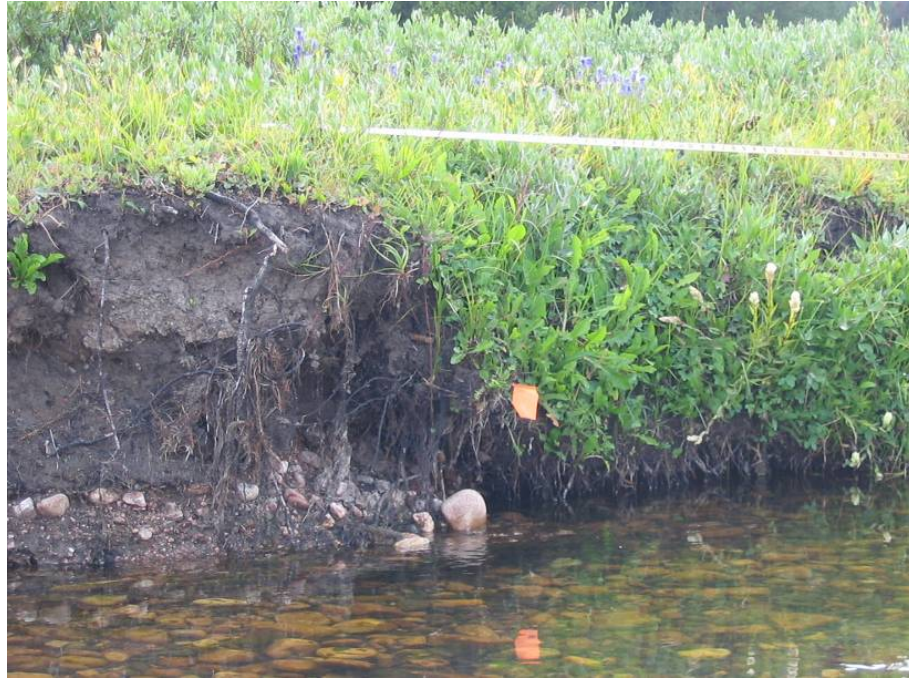
Figure 4.30: Photo of partially failed bank in site 2.

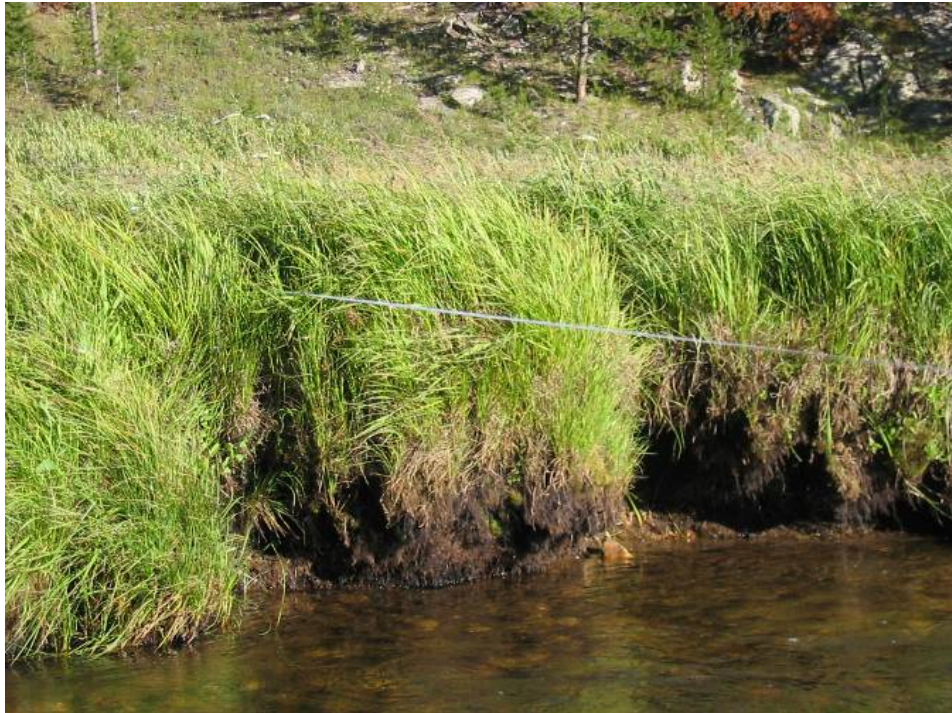
Figure 4.35: Example of bank undercutting and mesic grasses providing cohesion to the soil, site 3 cross section 2.1.

Site 3 is downstream of the confluence with South Fork Hog Park Creek. It is the longest site and has the largest channel capacity of the sites (Figure 4.34 through Figure 4.36). Previous beaver activity has encouraged side channels and main channel widening. There is minor beaver activity currently in the upper portion of site 3, but no dams or lodges exist today.

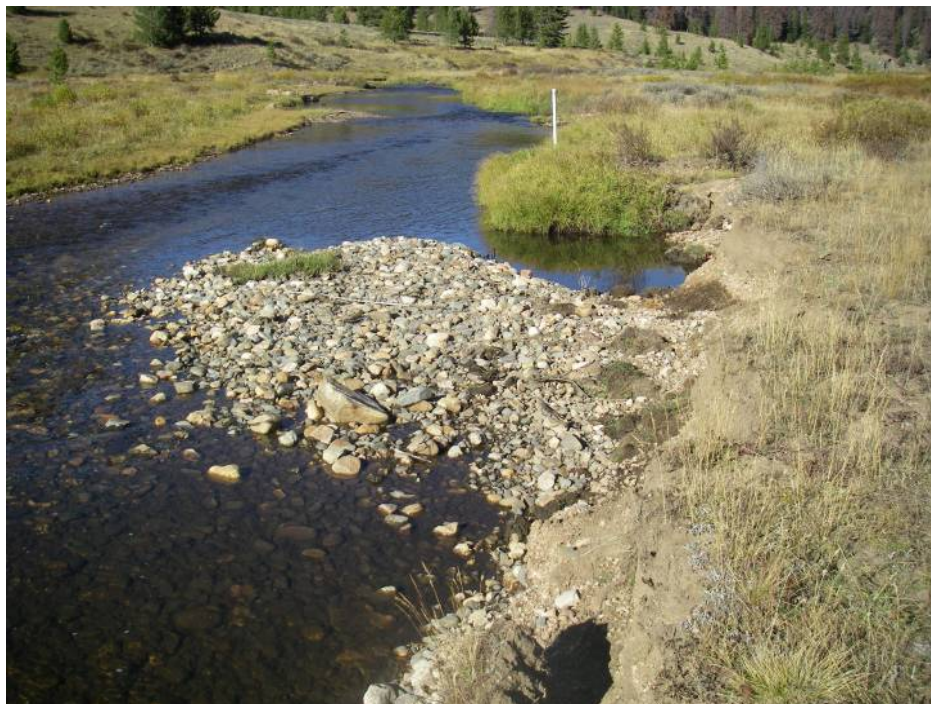
Figure 4.36: Evidence of bank erosion and alluvial sediment deposition, site 3 cross section 1.6.

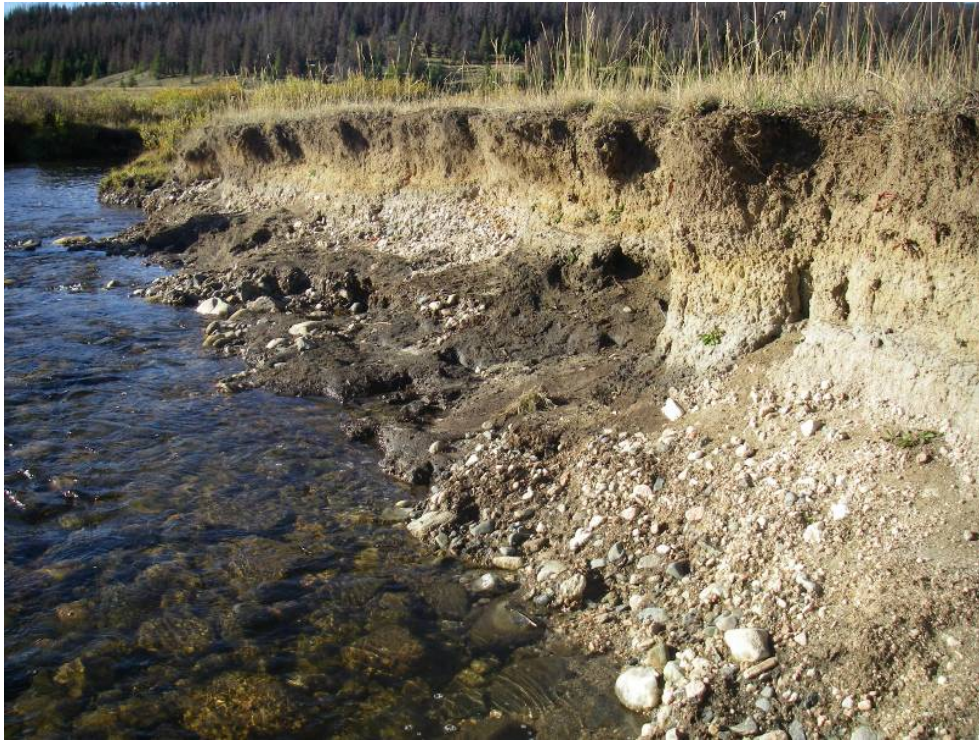
Figure 4.44: A photograph of vertical banks. Note the clay lens mid-bank, which is unique to site 4.

Erosion in the form of both hydraulic scour and mass wasting occurs along the outside of the meander bend in site 4 (Table 4.14). Cross sections 1.1, 1.2, and 1.3, 1.4 are located along an exposed high bank terrace. This location also shows sign of cattle trampling and degradation of the upper bank vegetation. Significant bank erosion also occurred at cross sections 0.9, 1.4, 2.0, and 2.1 in 2009 (Figure 4.41 through Figure 4.43). Site 4 has the lowest amount of erosion over time when compared to sites 1, 2, and 3. The terrain throughout site 4 is somewhat anomalous to the other three sites. A portion of the channel in the site runs along a high terrace and additional soil layers are exposed in this section, including a cohesive clay lens in the highest banks (Figure 4.44 and 4.45).
