THESIS

ASSESSING CHANNEL CHANGE AND BANK STABILITY
DOWNSTREAM OF A DAM, WYOMING

ASSESSING CHANNEL CHANGE AND BANK STABILITY DOWNSTREAM OF A DAM, WYOMING

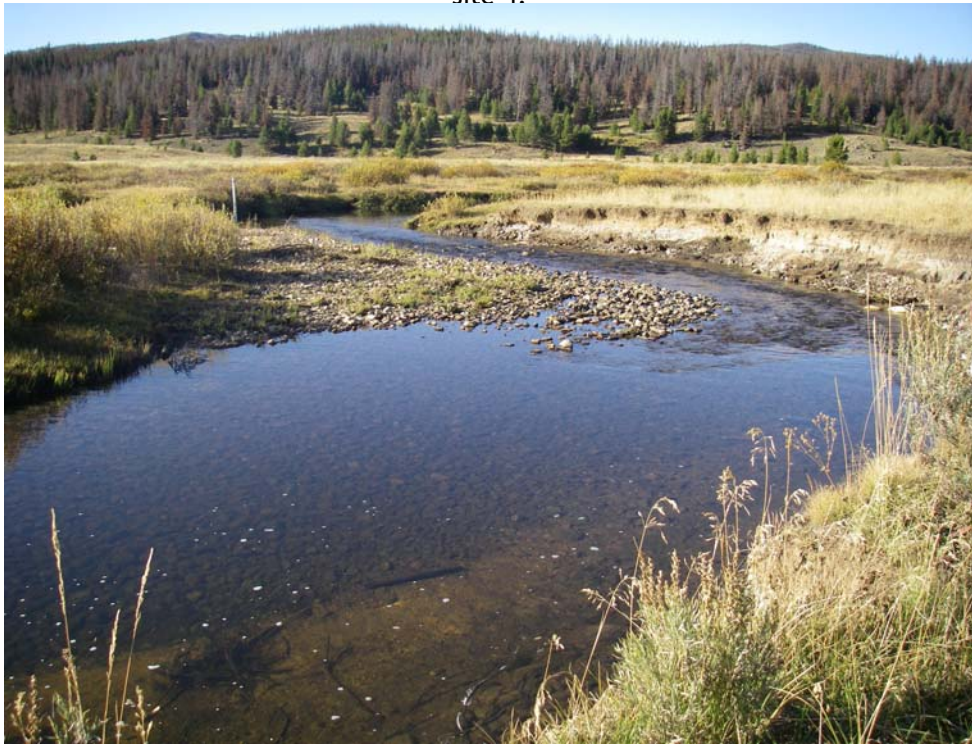
Figure 4.45: Photograph of site 4, looking downstream.

Erosion in the form of both hydraulic scour and mass wasting occurs along the outside of the meander bend in site 4 (Table 4.14). Cross sections 1.1, 1.2, and 1.3, 1.4 are located along an exposed high bank terrace. This location also shows sign of cattle trampling and degradation of the upper bank vegetation. Significant bank erosion also occurred at cross sections 0.9, 1.4, 2.0, and 2.1 in 2009 (Figure 4.41 through Figure 4.43). Site 4 has the lowest amount of erosion over time when compared to sites 1, 2, and 3. The terrain throughout site 4 is somewhat anomalous to the other three sites. A portion of the channel in the site runs along a high terrace and additional soil layers are exposed in this section, including a cohesive clay lens in the highest banks (Figure 4.44 and 4.45).

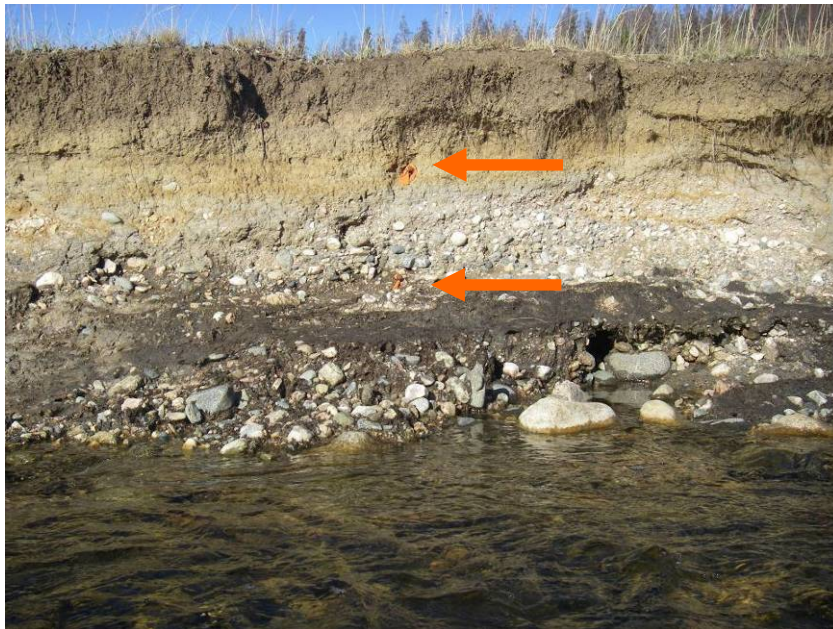
Figure 4.46: Erosion pin locations in a vertical bank, Site 4, 2009. The erosion pin locations are denoted with orange markers.

To determine the amount of correlation between bank erosion and independent variables collected during field surveys, a correlation model is applied to measured physical characteristics within each site. The methods of data collection are thoroughly described in Sections 3.1.2, 3.1.3, and 3.1.4. Lateral erosion of the bank, as measured using erosion pins during 2006-2008, is applied in a correlation model with several site- and reach-specific characteristics. Erosion pins were placed in vertical banks in many cross sections, as portrayed in Figure 4.46, and resurveyed in 2007, 2008 and 2009. The erosion pin data are provided in Appendix C.

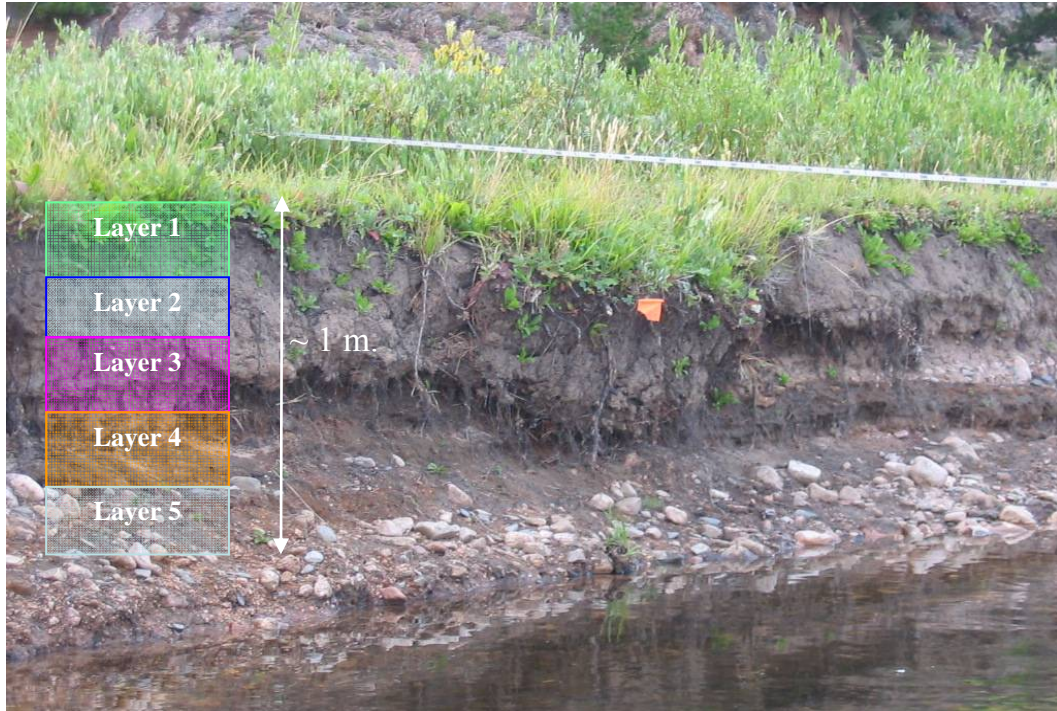
Figure 4.48: Example of soil layers in Hog Park Creek as described in bank geometry parameterization.

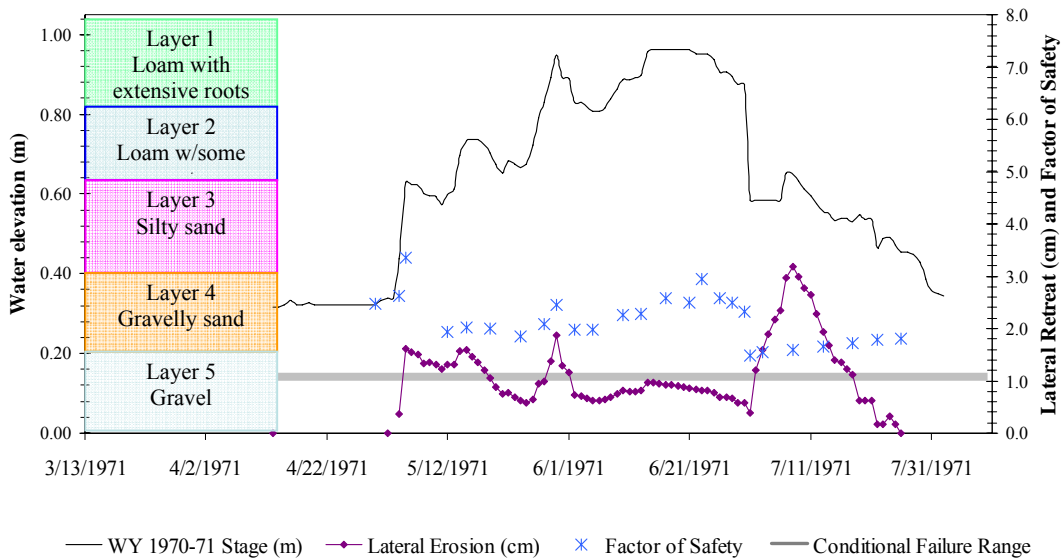
Figure 4.49: Results of BSTEM modeling for the water year 1971.

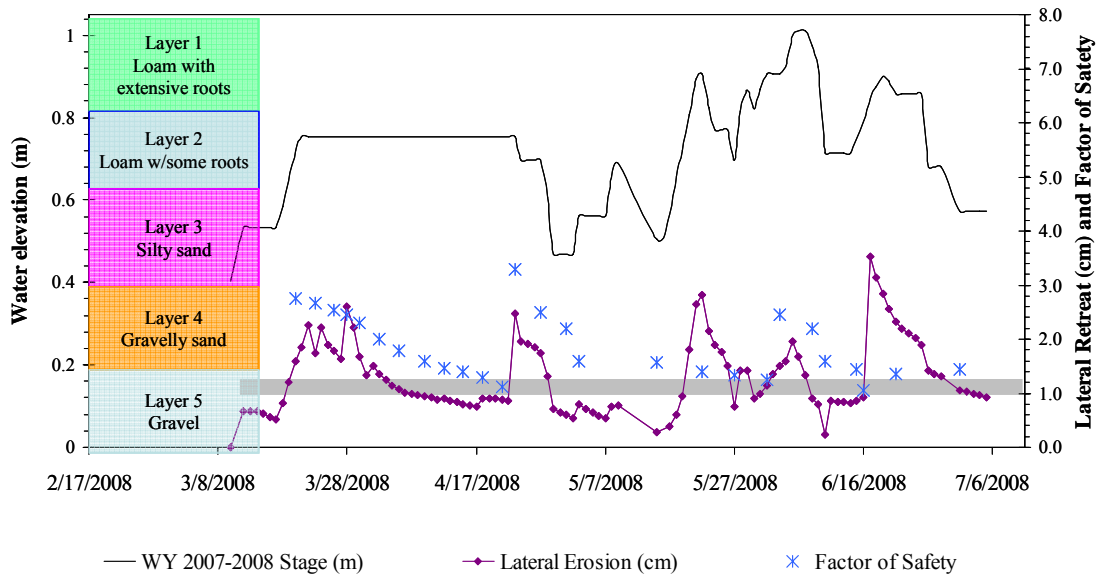
Figure 4.50: Results of BSTEM modeling for the water year 2008.

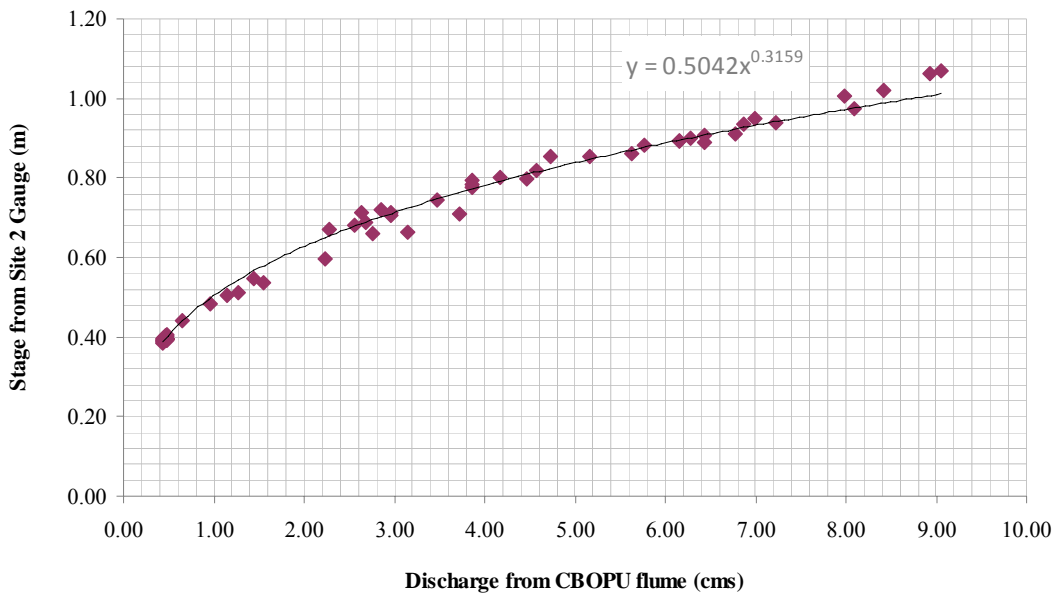
Figure 4.51: Discharge stage rating curve WY 2008.

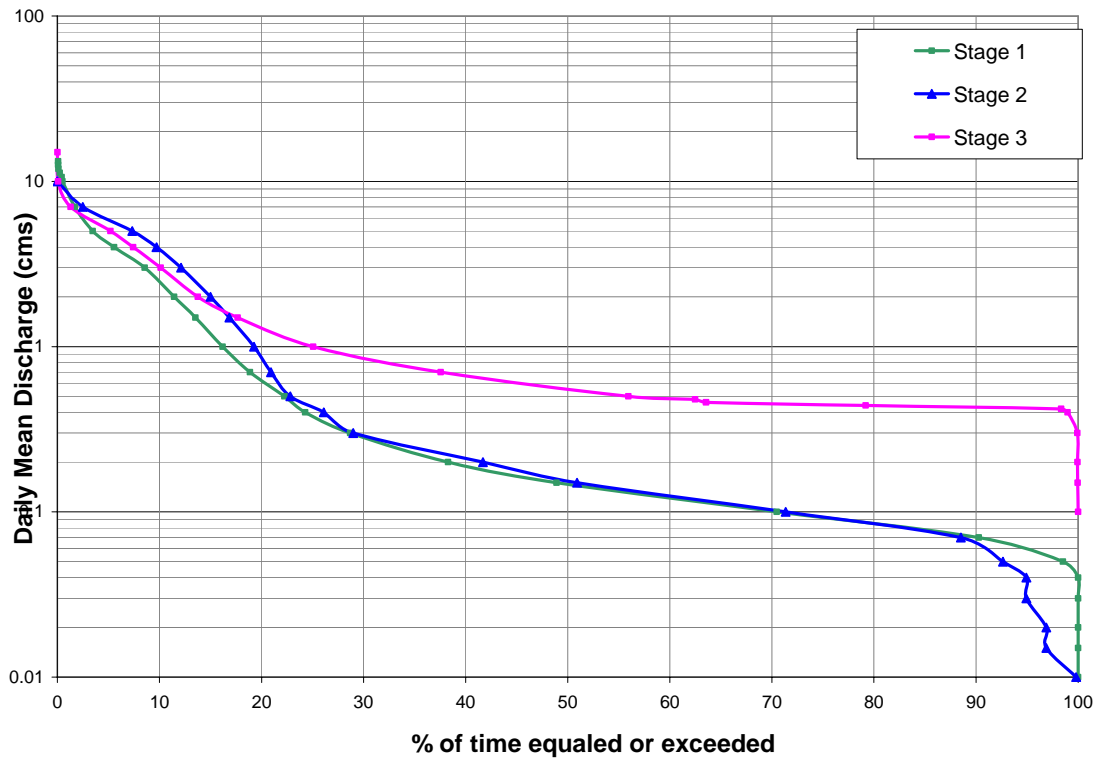
Figure 4.52: Flow duration curve for the three flow eras.

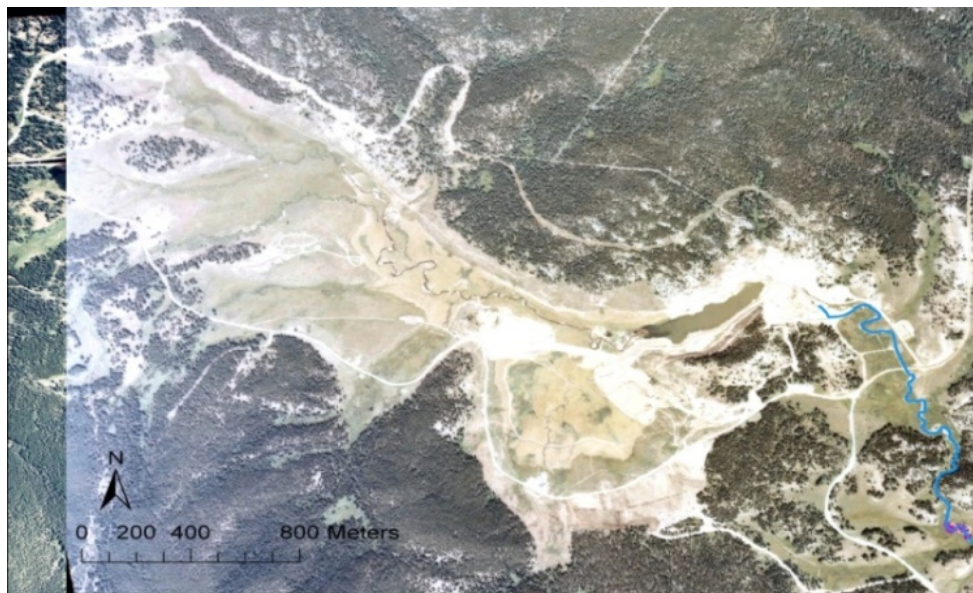
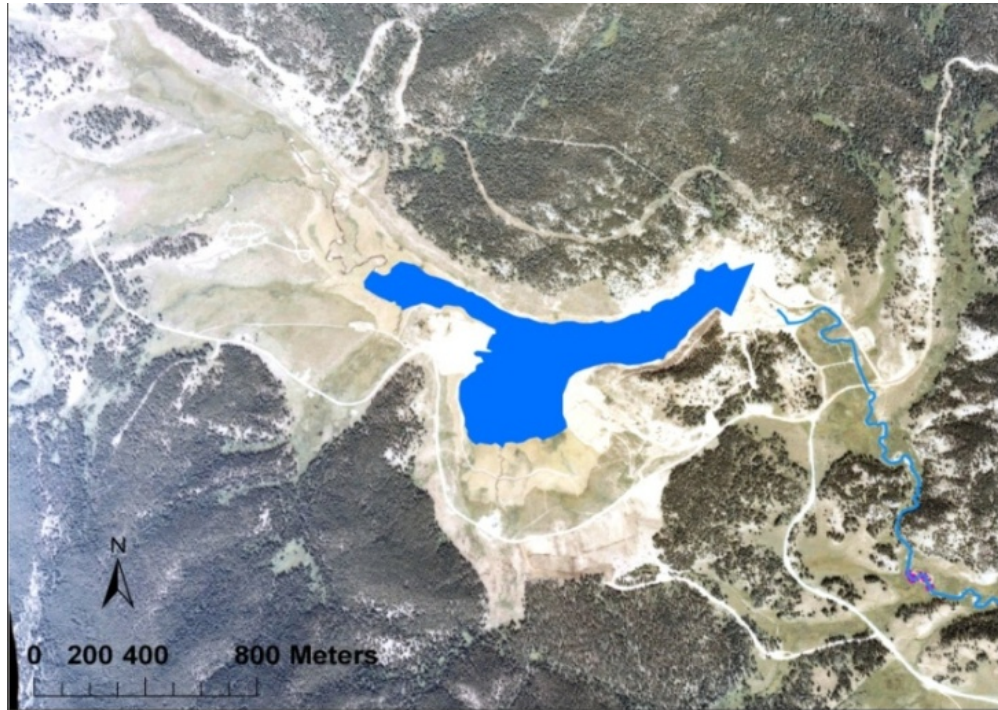
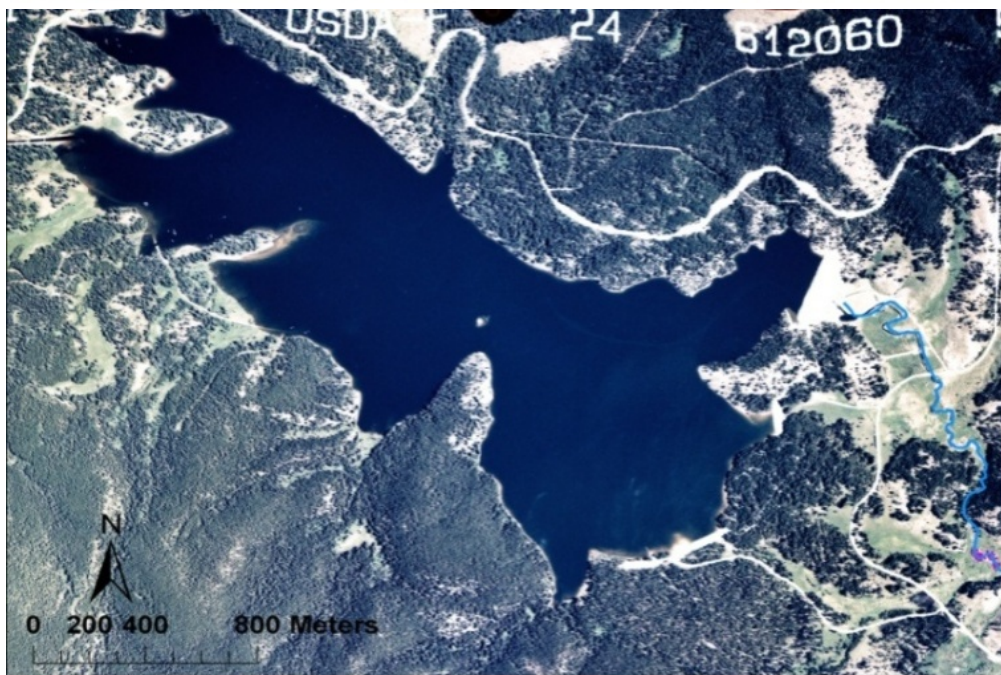
Figure 5.2: Time series depiction of changes in storage capacity with (a) the only image of the reservoir area with no impoundment in 1983 when the Stage 2 enlargement was in construction and flows bypassed the dam, (b) the same 1983 airphoto with the 1977 reservoir surface water extent superimposed, (c) an airphoto taken in 2001 with the full extent of Stage 2 storage capacity.

It is important to consider the landscape context of a dam before drawing conclusions about its downstream effects. At the site of Hog Park Dam, the contributing drainage area is 32 km² (12.2 mi²). The surface area which now comprises the reservoir is a large, low gradient valley which originally functioned as a low energy, transport-limited zone (Figure 5.1). Contributing streams to the upper watershed are short, small in size (< 14 km²) and underlain by a resistant geology. Historically, this upper watershed most likely contributed relatively little to the downstream sediment budget because ample discharge rarely persisted to transport the sediment that was available. Dams are efficient at trapping sediment, and many studies relate to the impact that the disruption in sediment continuity can have on morphologic and ecologic channel conditions. The impact of Hog Park Dam may not be as extensive since the upper watershed is atypical relative to many other dammed watersheds, serving as a sediment deposition zone. The glacially scoured upper valley trapped sediment, lacking the discharge to transport it farther through the system. Most likely, the impact on the sediment budget following Stage 1 implementation is similar to the impact today, following Stage 2 (Figure 5.2). If the sediment

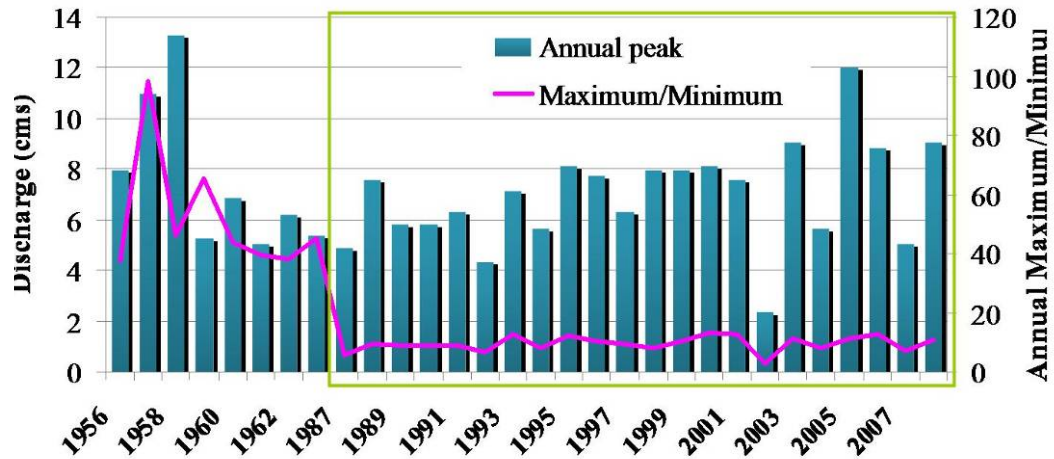
Figure 5.3: Discharge data summarizing the loss of flow heterogeneity throughout the three flow eras. The highlighted box displays the Stage 2 operations. Hydrologic changes also impact the sediment transport regime. Stream bed substrate contributes to roughness in the channel, refugia for organisms, and morphologic stream features for habitat diversity. It is not only the hydrograph which is of concern, but also its effect on the sediment transport regime and the sediment budget. With lack of sediment passage at the dam, a majority of the sediment input comes from fine sediment from the banks in the upper reaches, but this is likely to be rapidly carried out of the system in suspension. Coarse sediment supply from the upper watershed is not arguably being interrupted in significant quantities. The lack of adequate amounts of coarse sediment to replenish gravel bars, as observed in cross sectional analyses and through field observation, is most likely a result of the increased duration and frequency of higher flows. Although incipient motion analyses were not done, it is hypothesized that flow releases in the early spring and the extended high flow durations characteristic of Stage 2 operations likely increase quantities of sediment transport annually, lending to the apparent diminution of coarse sediment in Hog Park Creek. The historical 2-year event is exceeded annually during the current operational regime. The current two-year recurrence interval discharge surpasses that of the historic 5-year (6.1 m³/s) recurrence interval

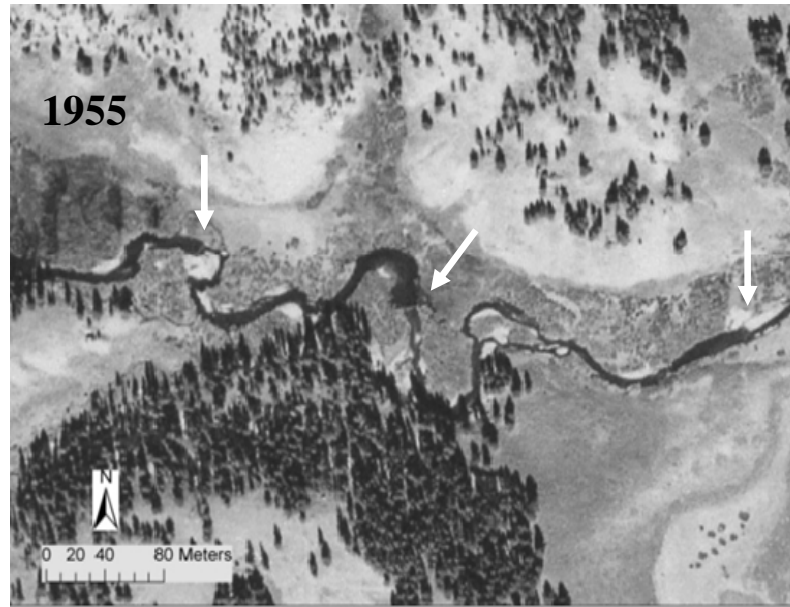
Figure 5.4: Beaver dams and ponds in reach 2, Hog Park Creek, 1955.

complexity occurs following 1955 (Figure 5.4 and Figure 5.5). Beaver ponds provide increased habitat diversity and complexity to the aquatic ecosystem (Naiman et al., 1988; Olson and Hubert, 1994). This diversity in habitats allows for diversity in bed material size distribution and dissipation of flow energy, which are all important to aquatic species. The dams and ponds trap silt and organic material, eventually filling and raising the level of the valley floor (Ives, 1942). The meadows created by filled beaver ponds provide increased habitat diversity in the terrestrial ecosystem, as well.

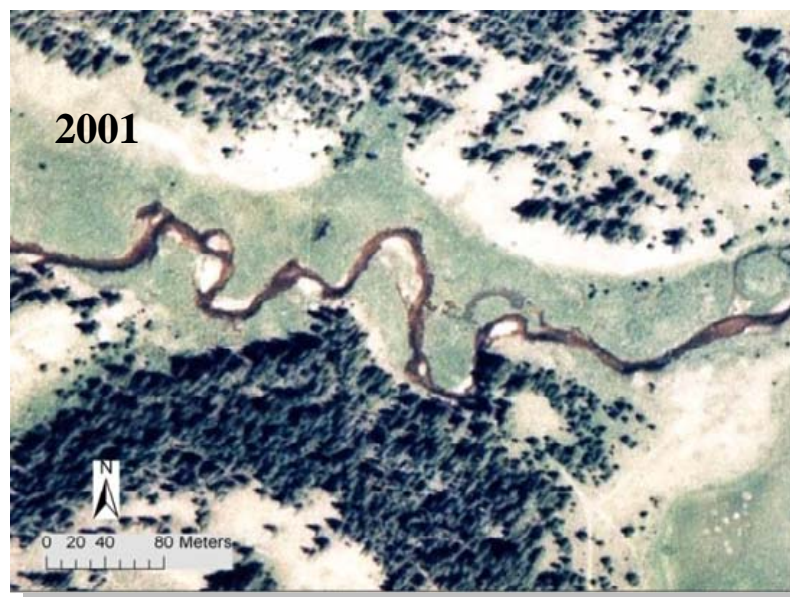
Figure 5.5: Beaver presence in reach 2 in 2001

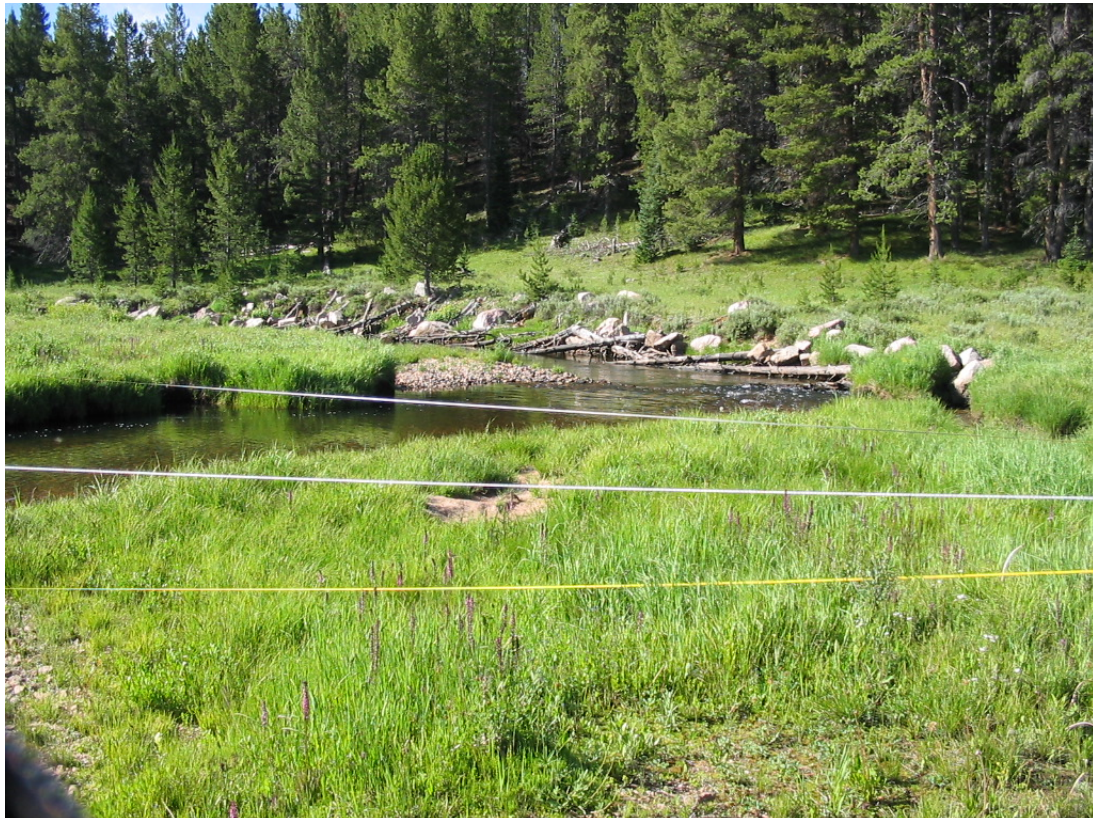
Figure A.4: Downstream end of Site 1, 2008. Note the in-stream structures placed in the 1970's. These are downstream of the study site.

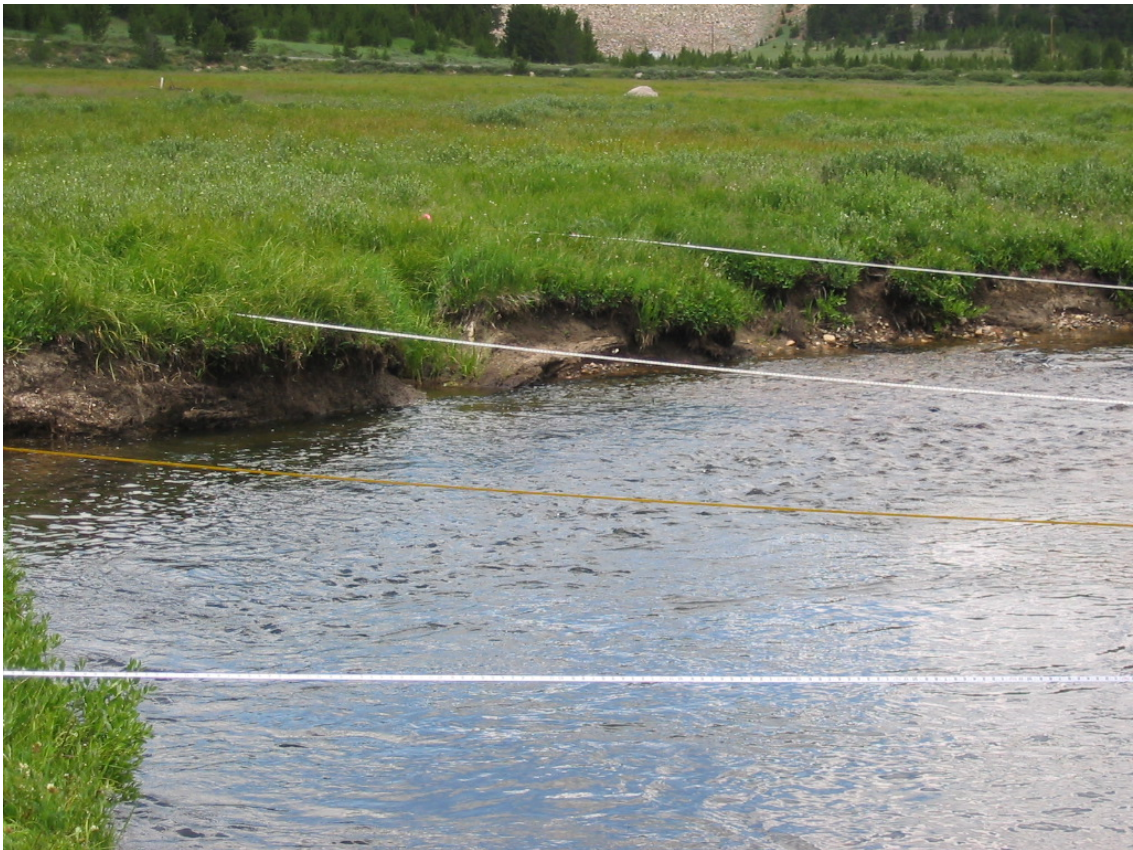
Figure A.7: typical bank erosion along right bank in Site 1, 2007. Photo by D. Cenderelli.

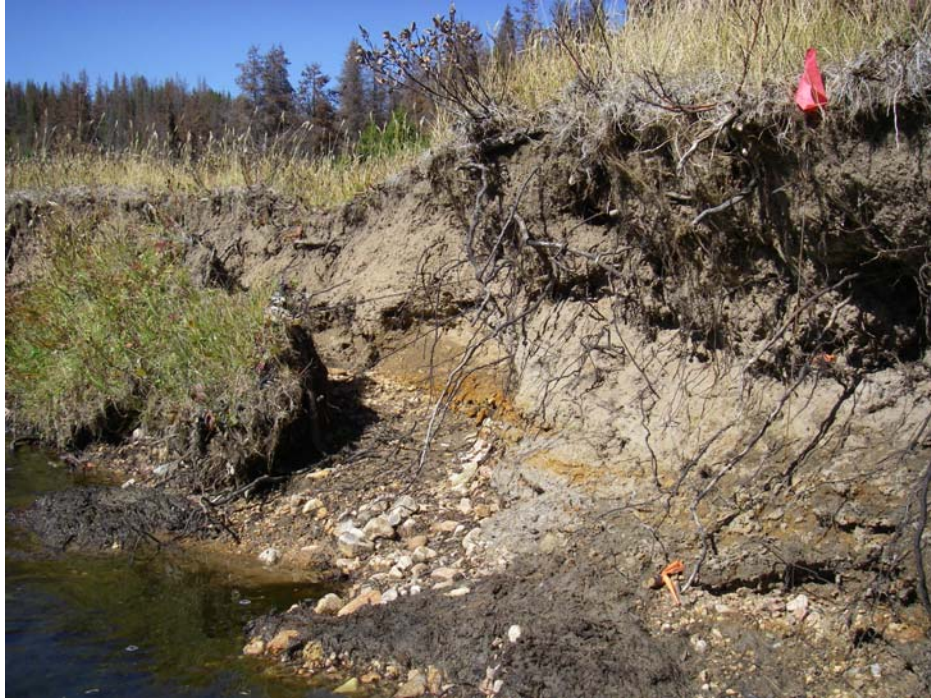
Figure A.13: Bank erosion in Site 2, 2008.

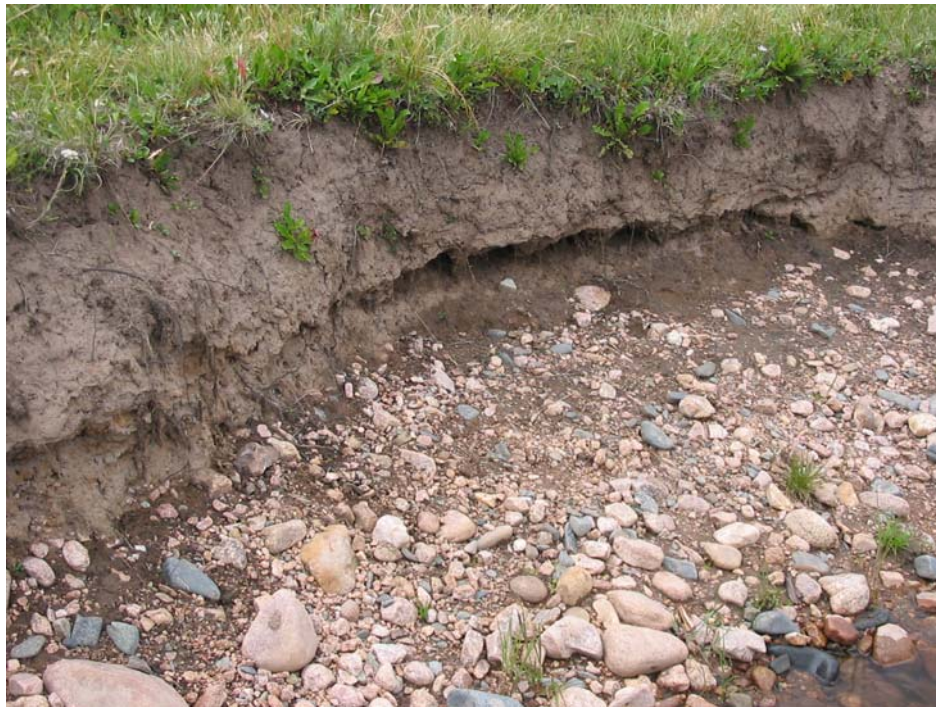
Figure A.14: Bank erosion along right bank in Site 2, 2009. Note the coarser gravel deposit at the toe, and preferential erosion occurring mid-bank.

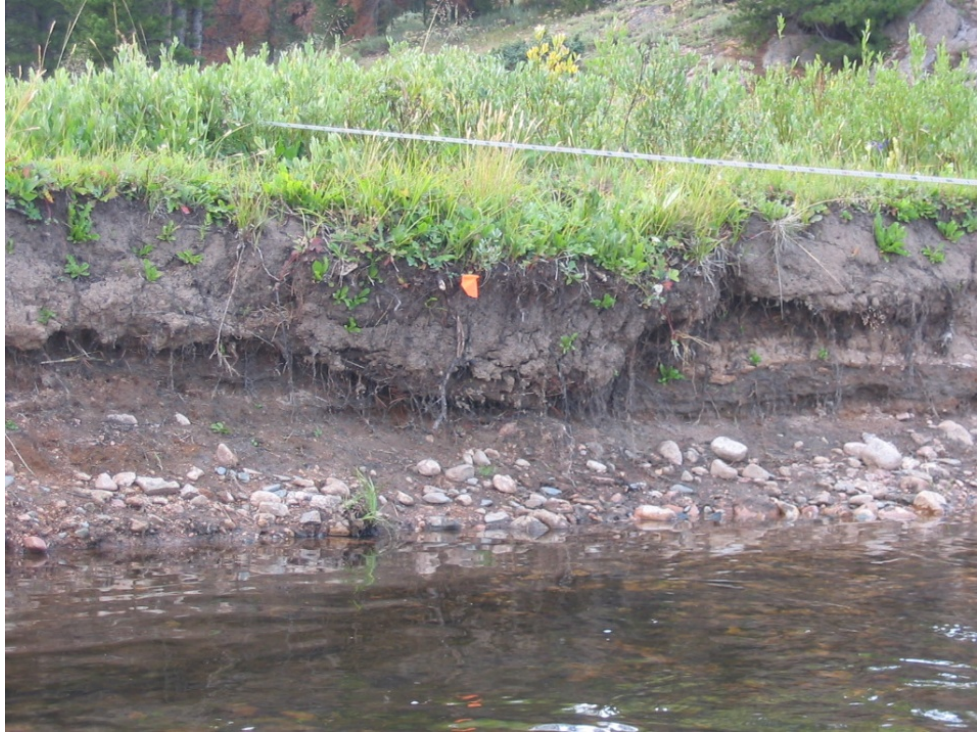
Figure A.15: An example of slumping in Site 2, 2008. A tension crack exists in the bank top. The orange flag indicates an erosion pin location, indicating a cross section, also is located here.

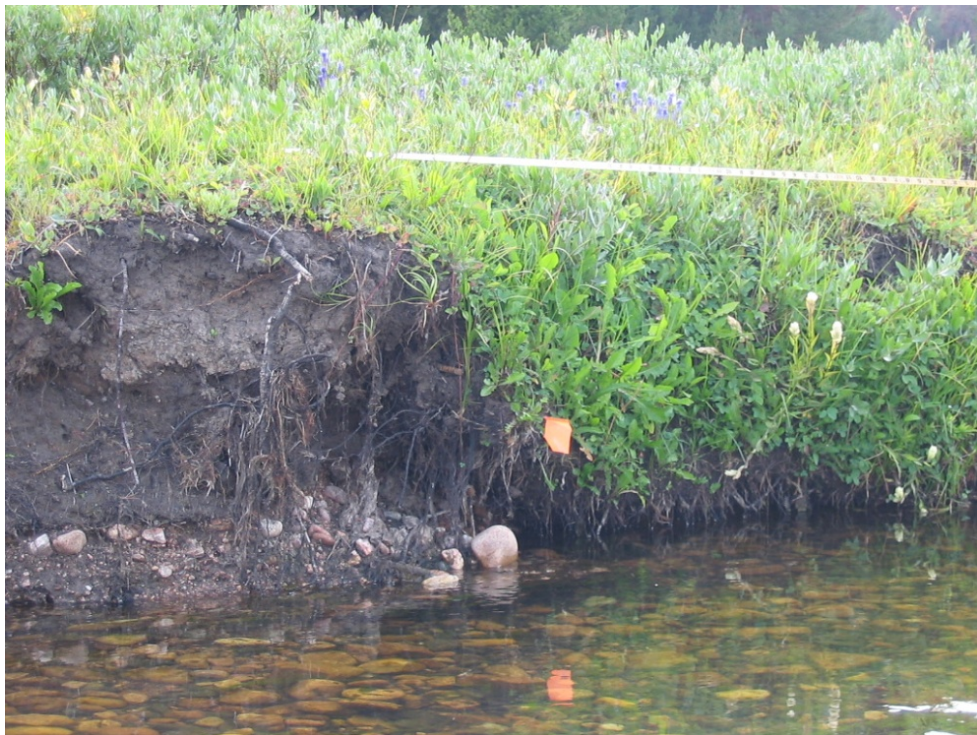
Figure A.16: Bank slump and bank failure in Site 2, 2008.

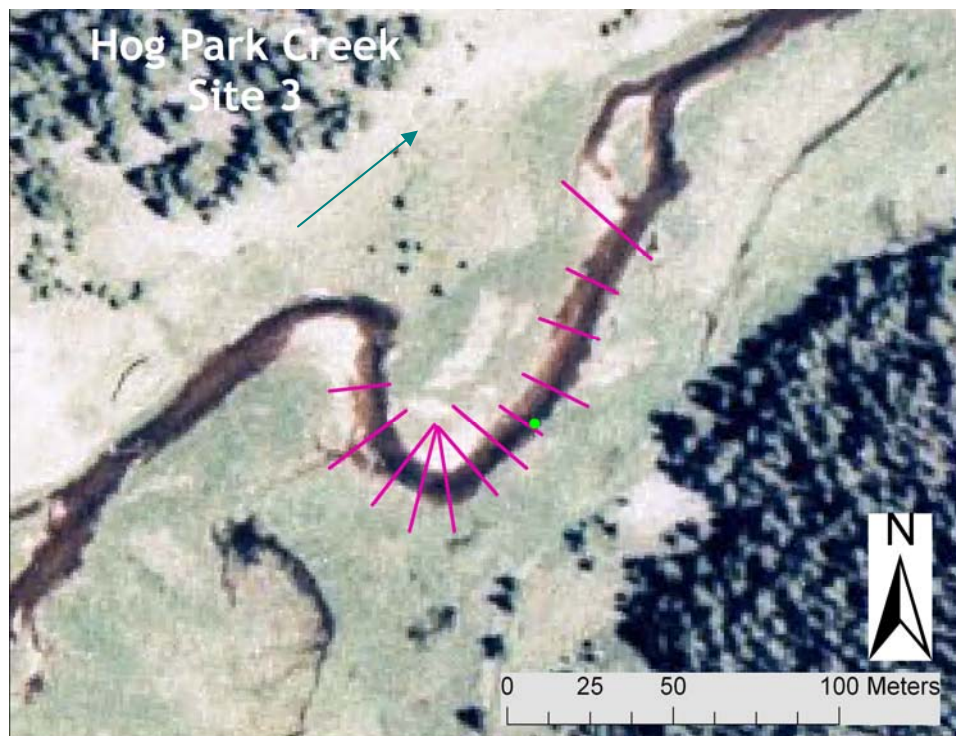
Figure A.17: Aerial photograph (2001) of Site 3, with cross sections (pink) and pressure transducer (green circle) locations indicated.

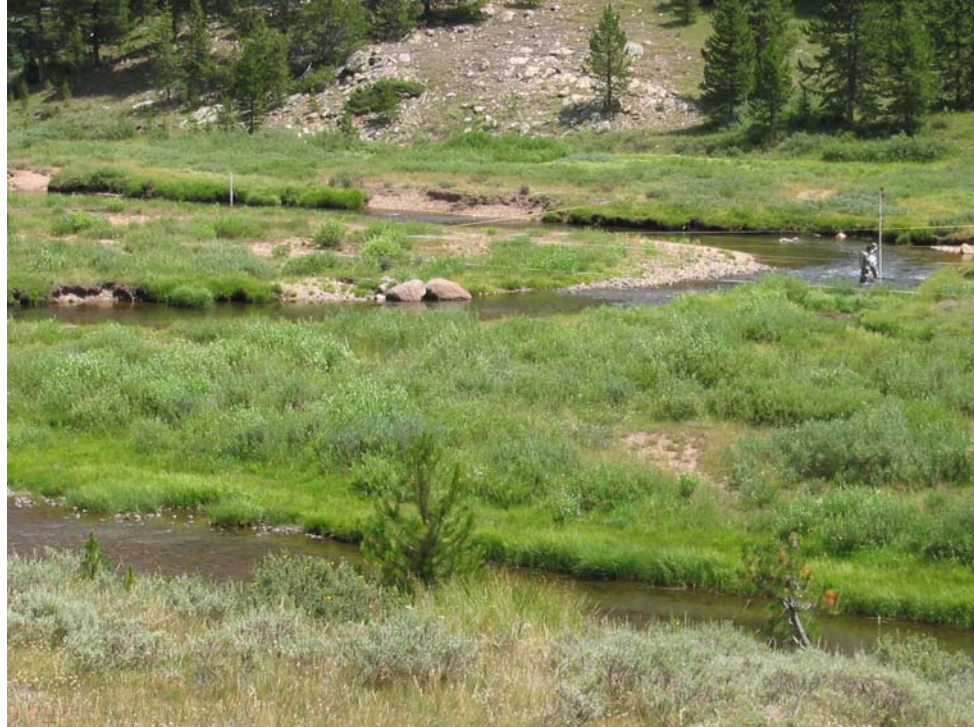
Figure A.20: Looking downstream in Site 3 from the top, 2007. Note the white PVC pipe housing the pressure transducer recording stage data. Photo by D. Cenderelli.

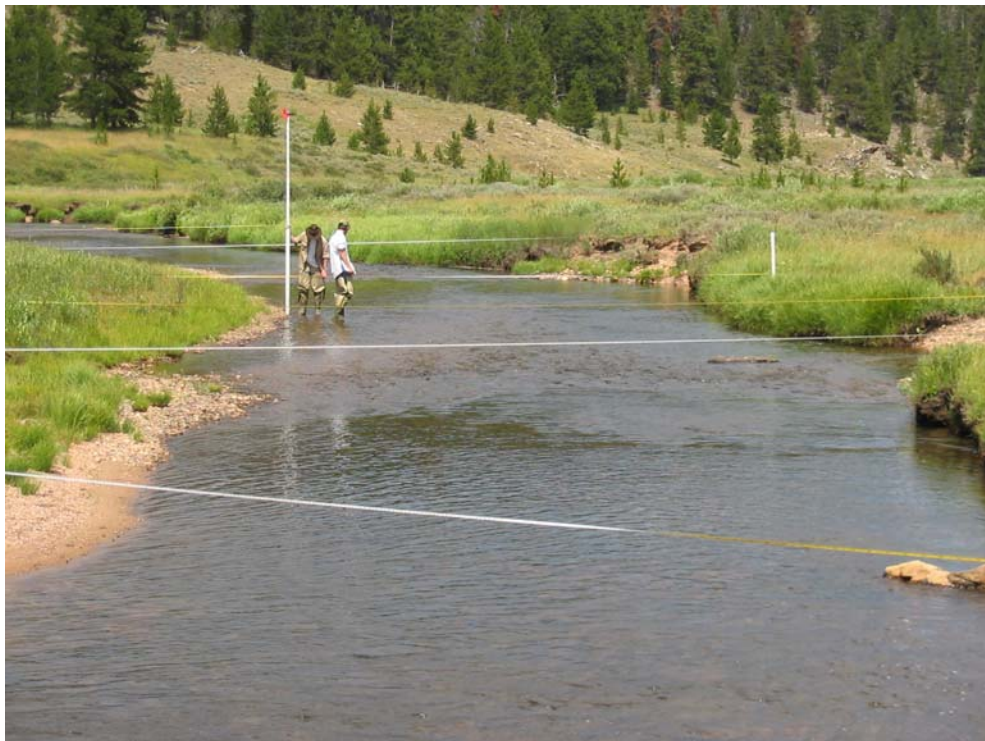
Figure A.21: Cross section locations in Site 3, 2007 (photo by D. Cenderelli).

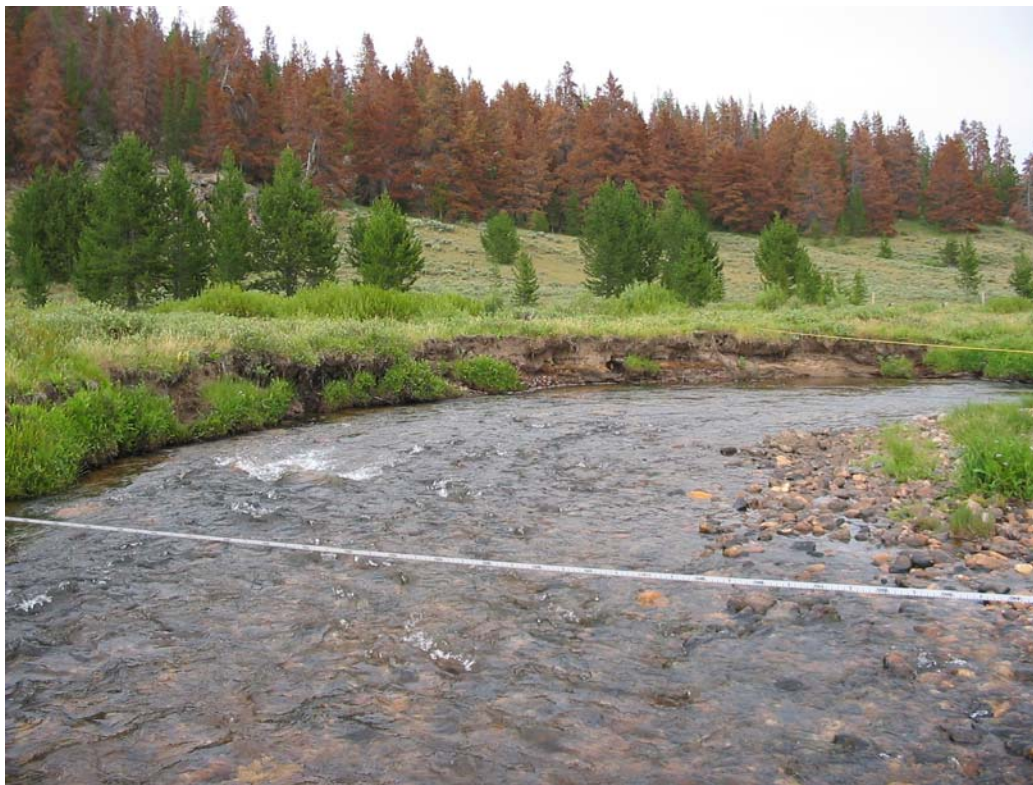
Figure A.22: Bank erosion in Site 3, along outside of meander bend, 2007 (photo by D. Cenderelli).

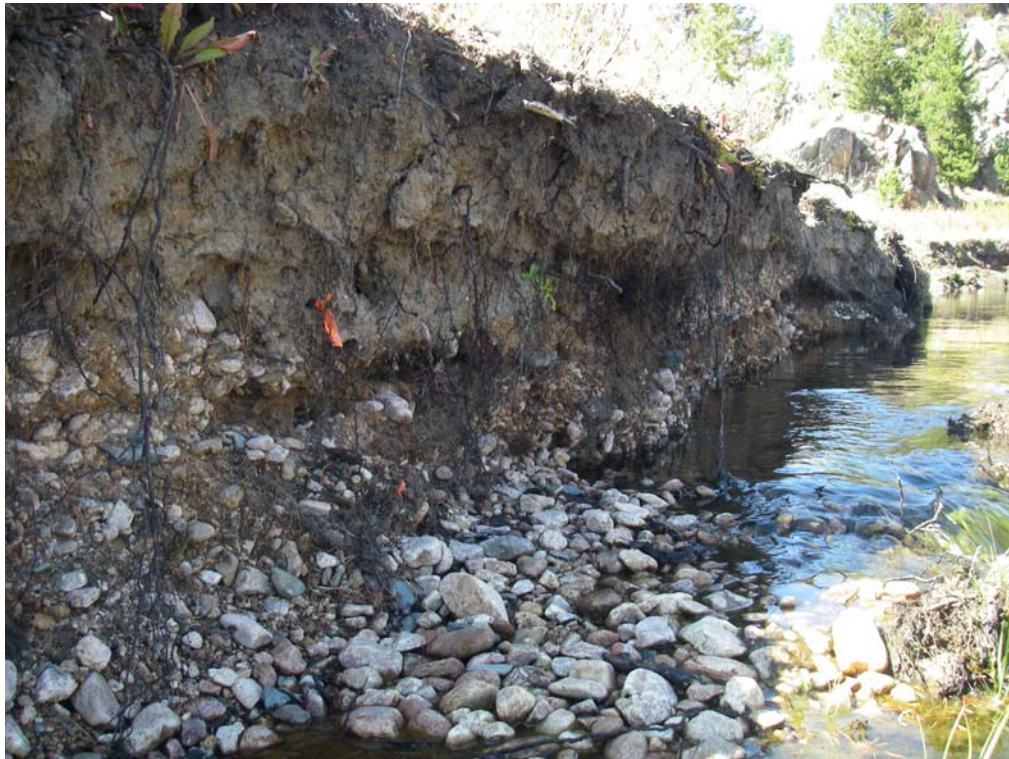
Figure A.24: Bank profile in Site 3, 2009. Note the orange flag tied to an erosion pin.

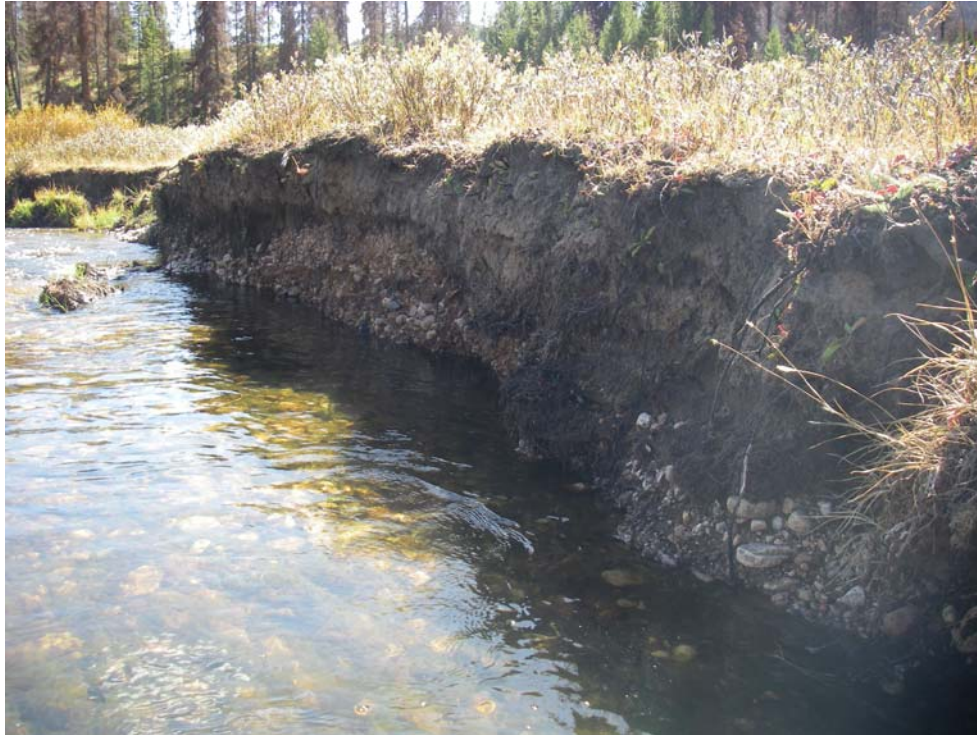
Figure A.27: Bank erosion in Site 3 at low summer base flow, 2008.

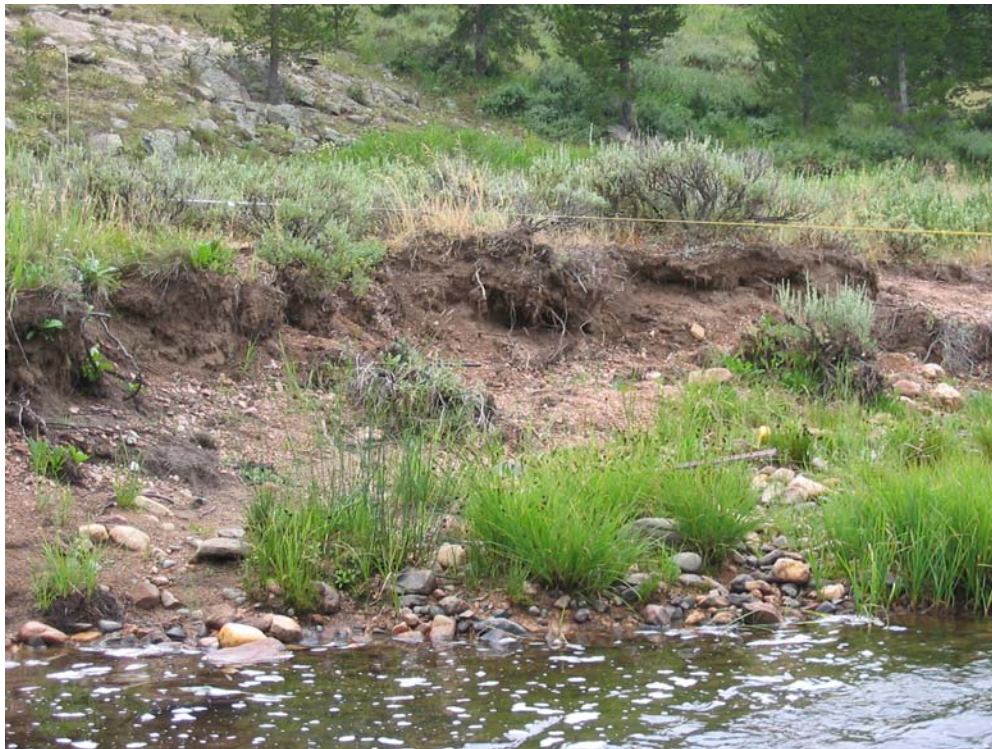
Figure A.28: Bank profile in Site 3. This section is used by cattle in the fall for access to the channel, 2008.

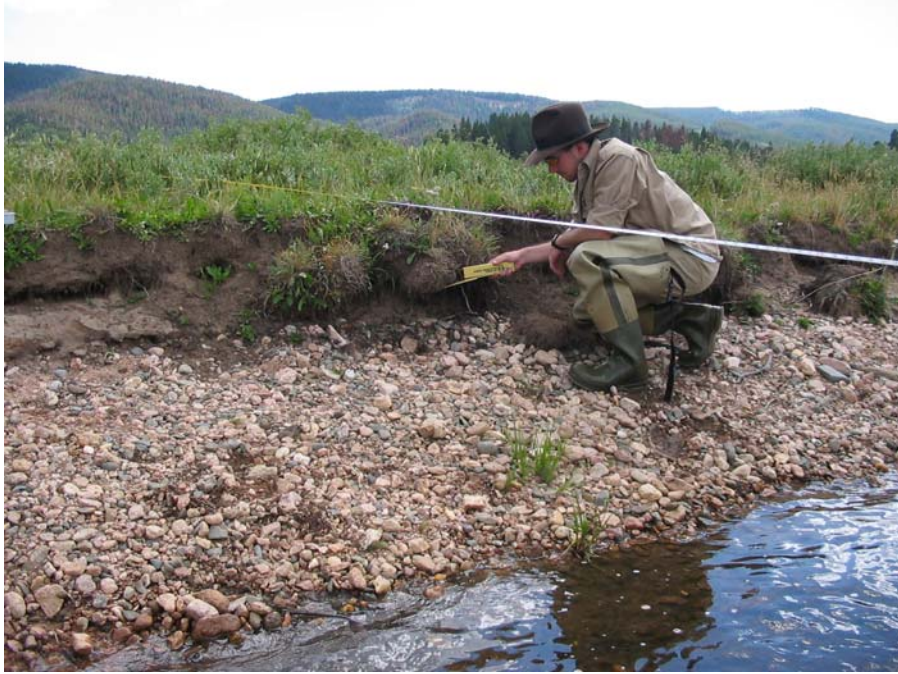
Figure A.29: Erosion pin measurement in Site 3, 2007 (photo by D. Cenderelli).

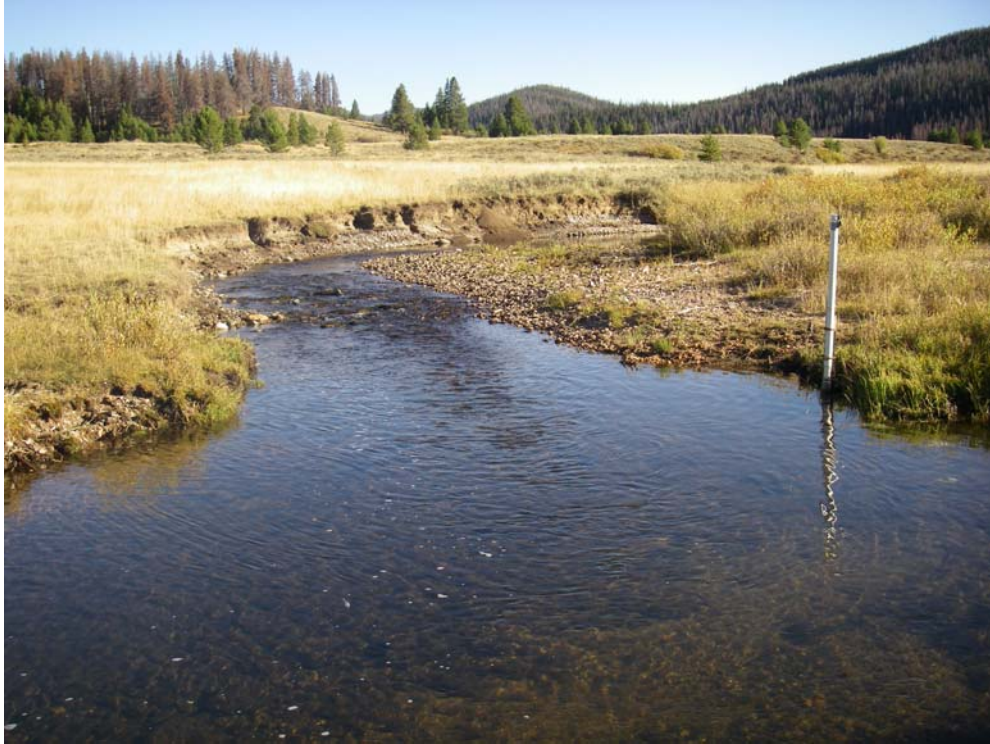
Figure A.33: Looking upstream in Site 4. Photo location approximately midway through the site. White PVC pipe house the crest gauge, 2009.

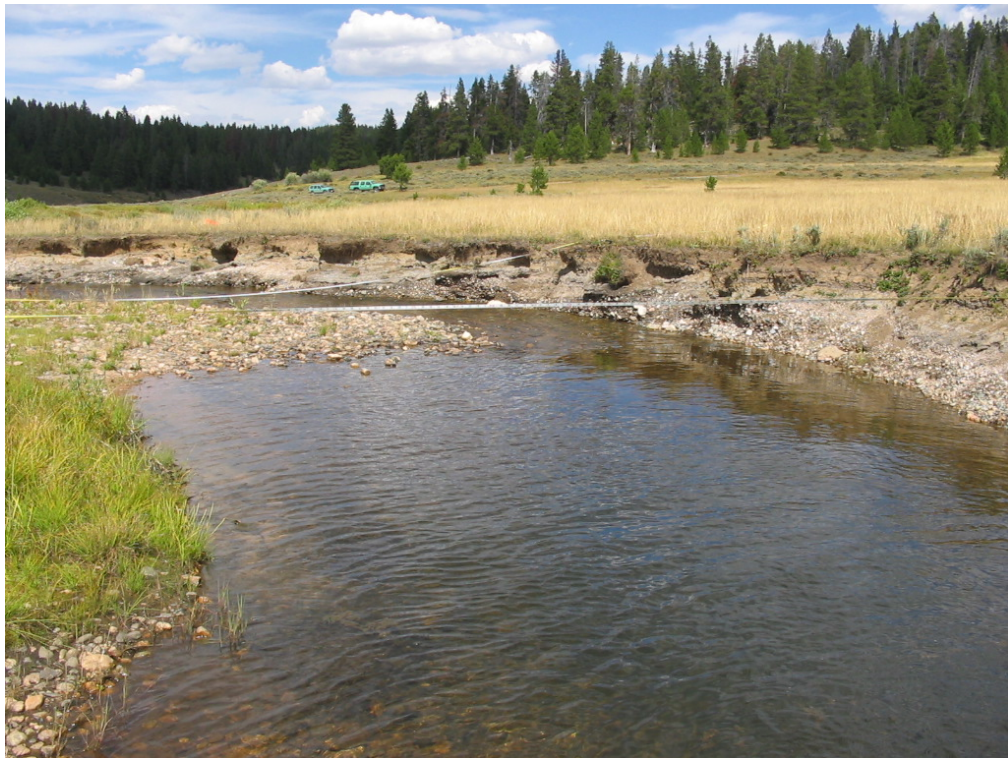
Figure A.37: Erosion along outside of meander bend in Site 4, 2007 (photo by D. Cenderelli).
