**PROCEEDINGS
HIGH ALTITUDE REVEGETATION
WORKSHOP NO. 18
MARCH 2008**

COLORADO WATER RESOURCES RESEARCH INSTITUTE
Information Series No. 107
Joe E. Brummer, Editor
March, 2008

**Colorado State University
Fort Collins, Colorado
March 4-6, 2008**

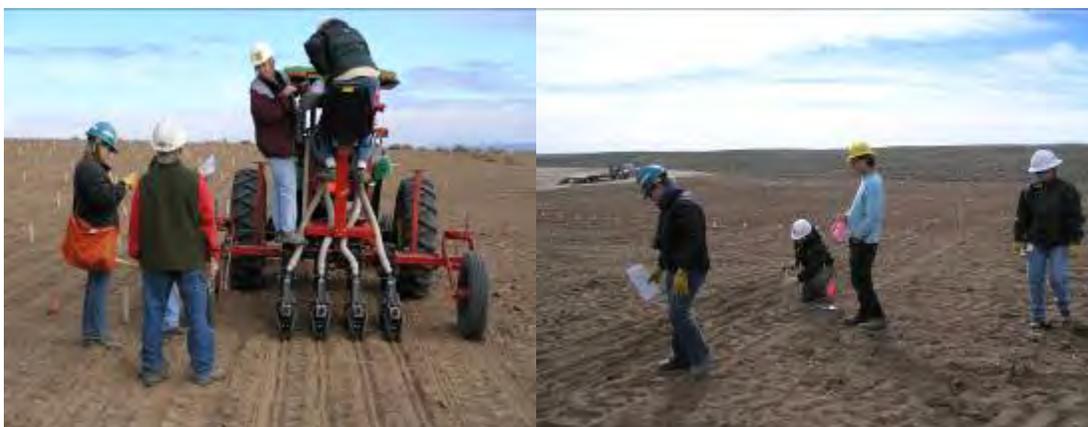
Shell replicated plots, October 2005

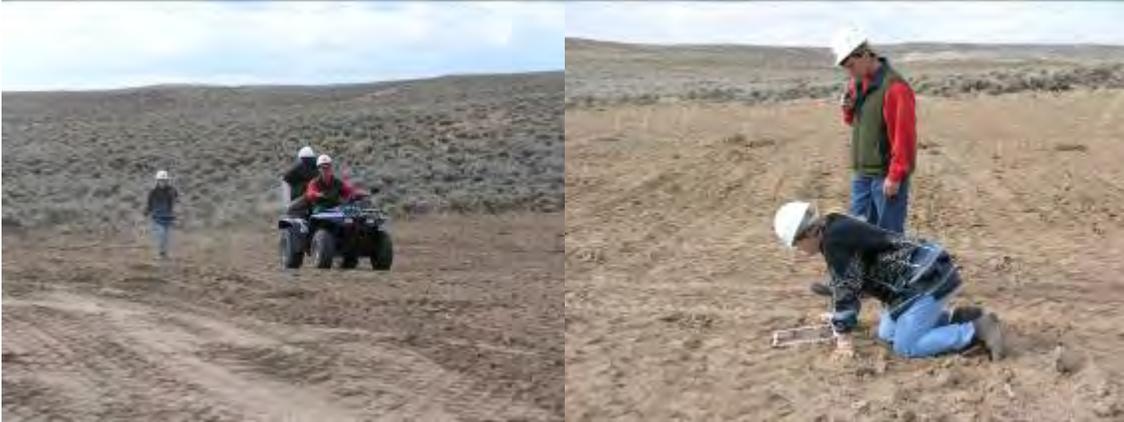
Shell broadcast-seeded plots, October 2005.

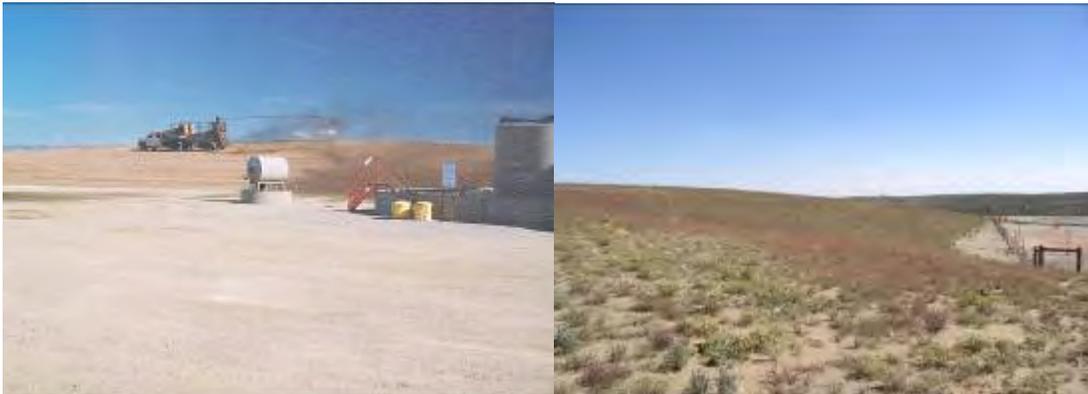
Shell hydro-seeding with Shell seed mixture: December 2005 (left) and October 2007 (right).

The hydro-seeding method was the least successful, and in fact, was twice considered a failure. Mixing seed directly into the slurry and applying as a one-step mulch application on a smooth slope surface, promotes seed movement and seedling desiccation due to drying and shrinking of the mulch. To restrict seed movement and promote seed-to-soil contact, a two-step approach is preferred where 1) the seed is separately mixed in a trace amount of mulch and applied directly to a roughened soil surface, followed by 2) a second application of mulch to reduce soil erosion and enhance micro-climate conditions necessary for germination and establishment (Holzworth, 2007).

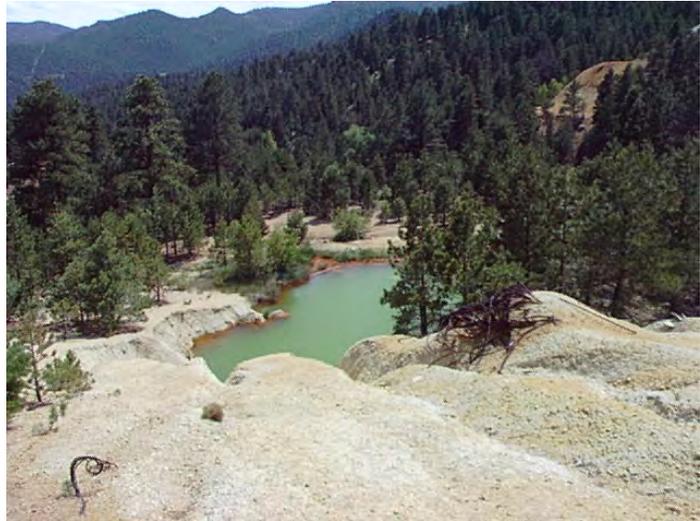
Photo 6. Mine pond at toe of waste rock pile.

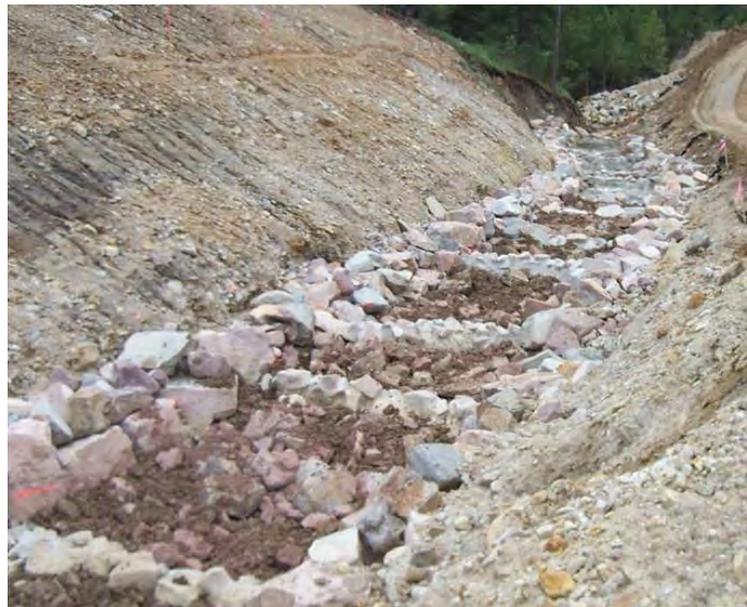
Photo 8. Balarat Gulch Diversion Channel, 2004.

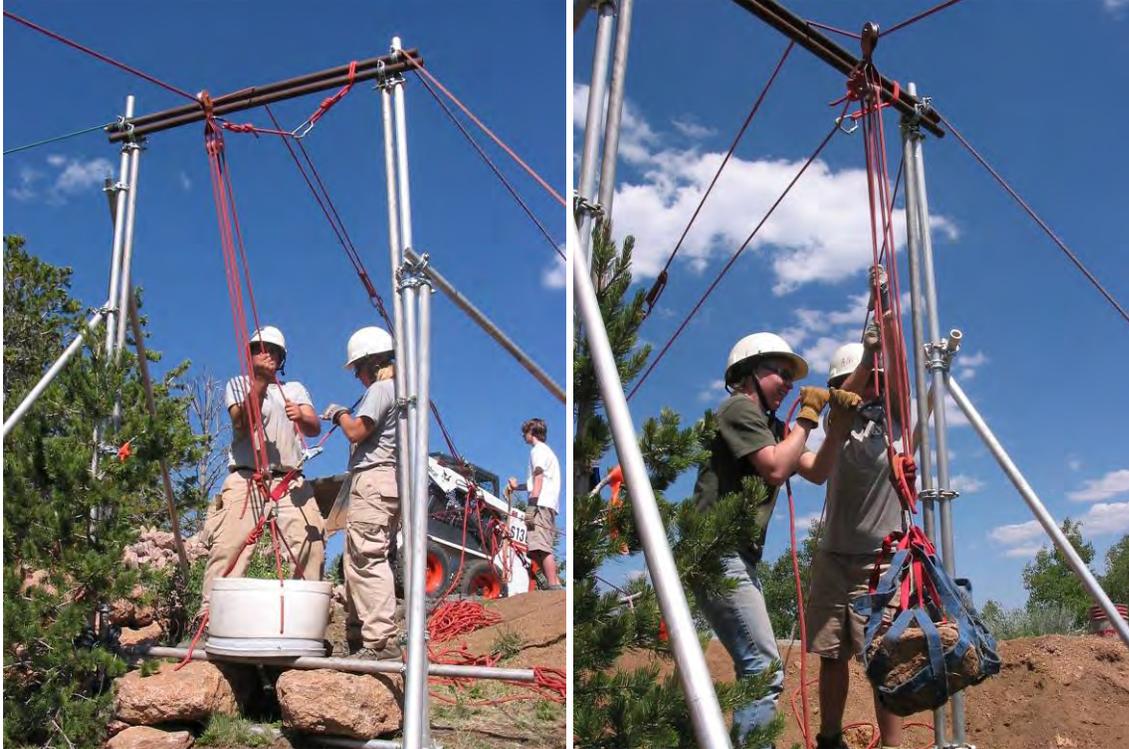
Figure 1 and 2. Example of Rock Tram with bucket and rock sling

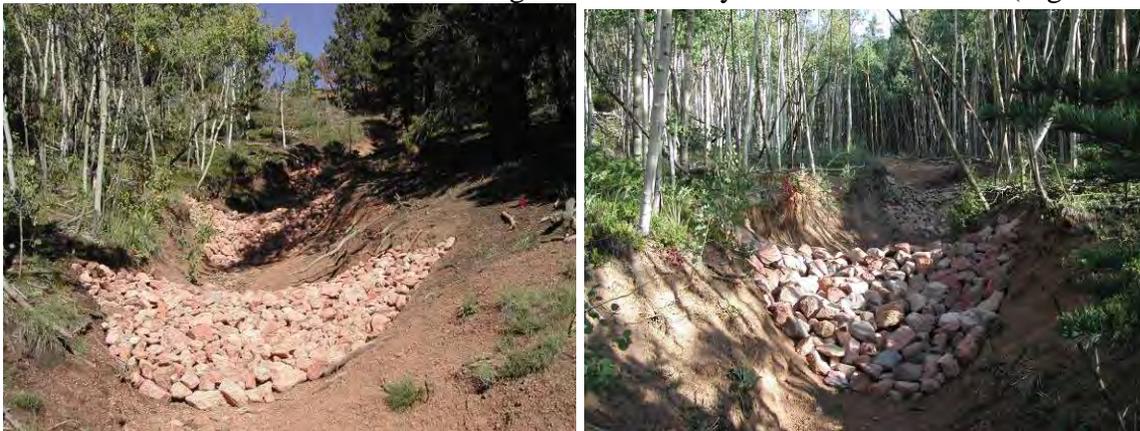
Figure 7 and 8. Examples of finished check dams.

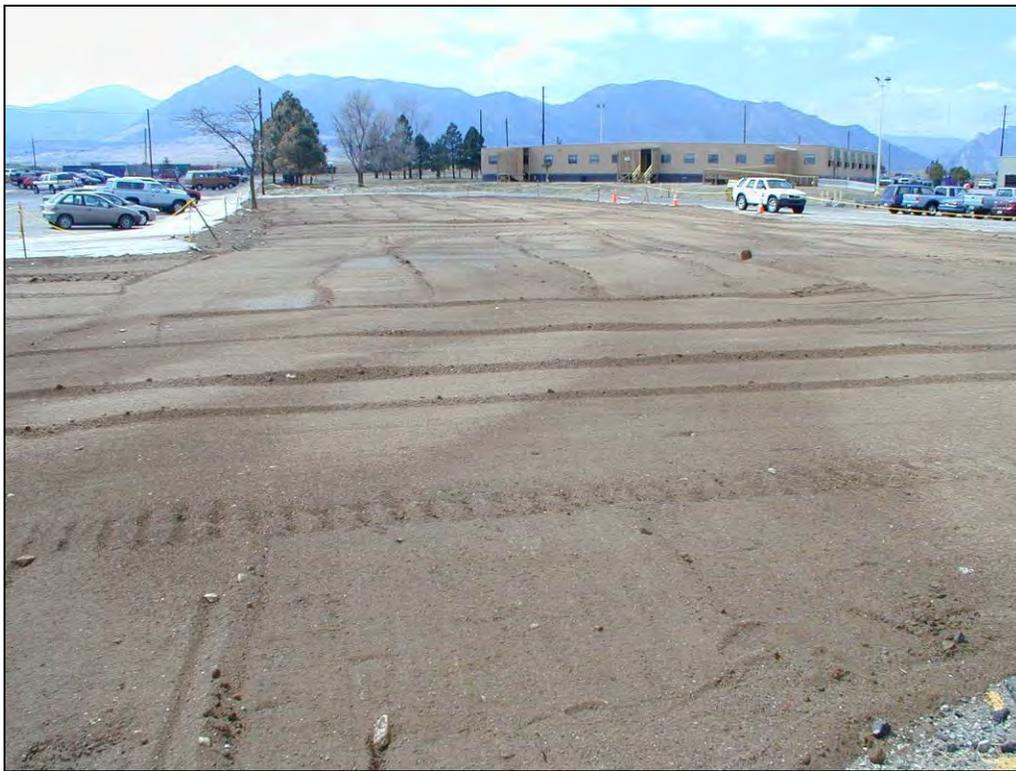
Figure 2. Topsoil trial at the former Building 111 revegetation location.

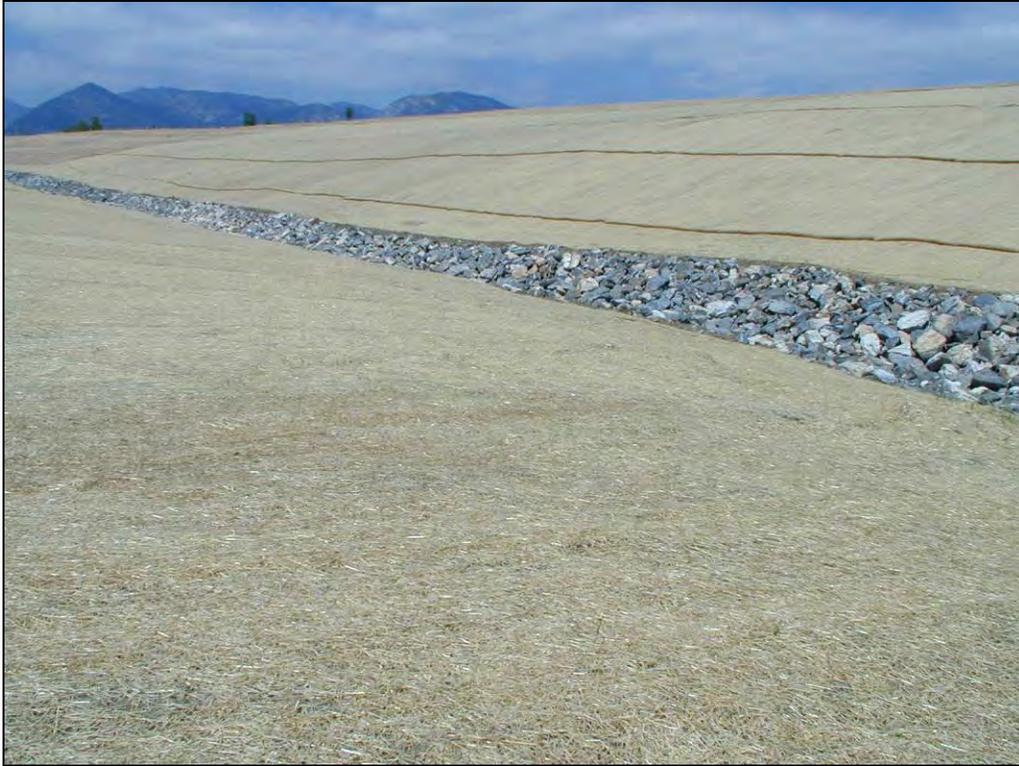
Figure 3. Temporary erosion blankets (and wattles on far hillside) used to protect soil and prevent erosion on the hillslopes at the Site.

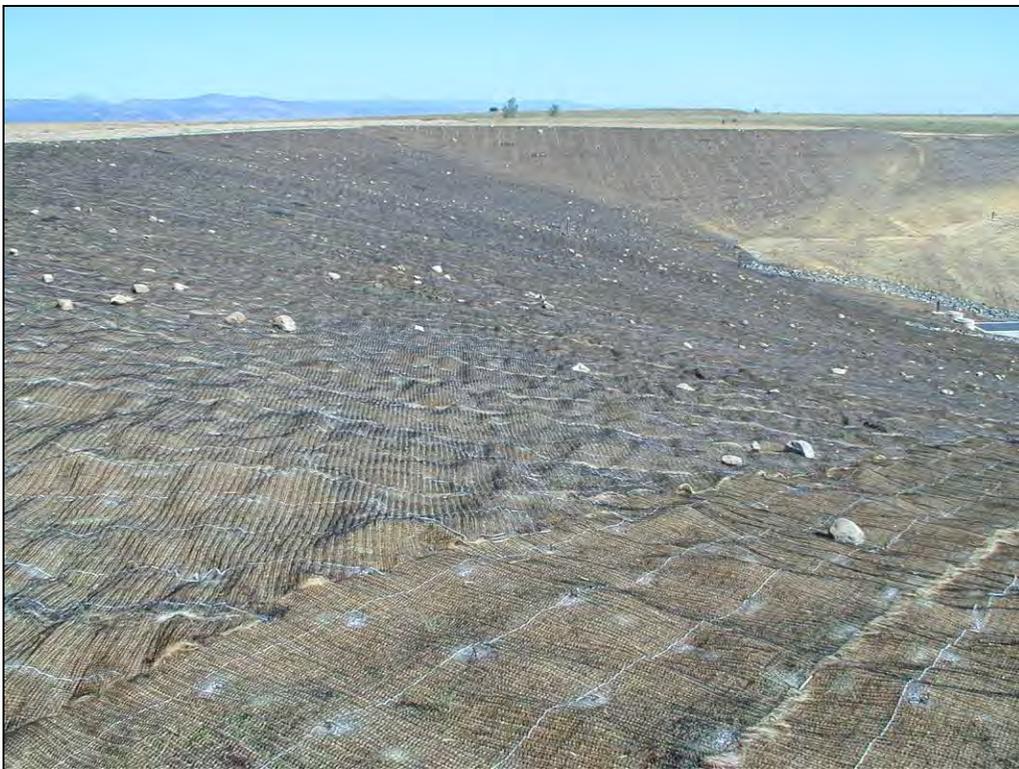
Figure 4. Permanent erosion control blankets on the steep face of the Present Landfill.

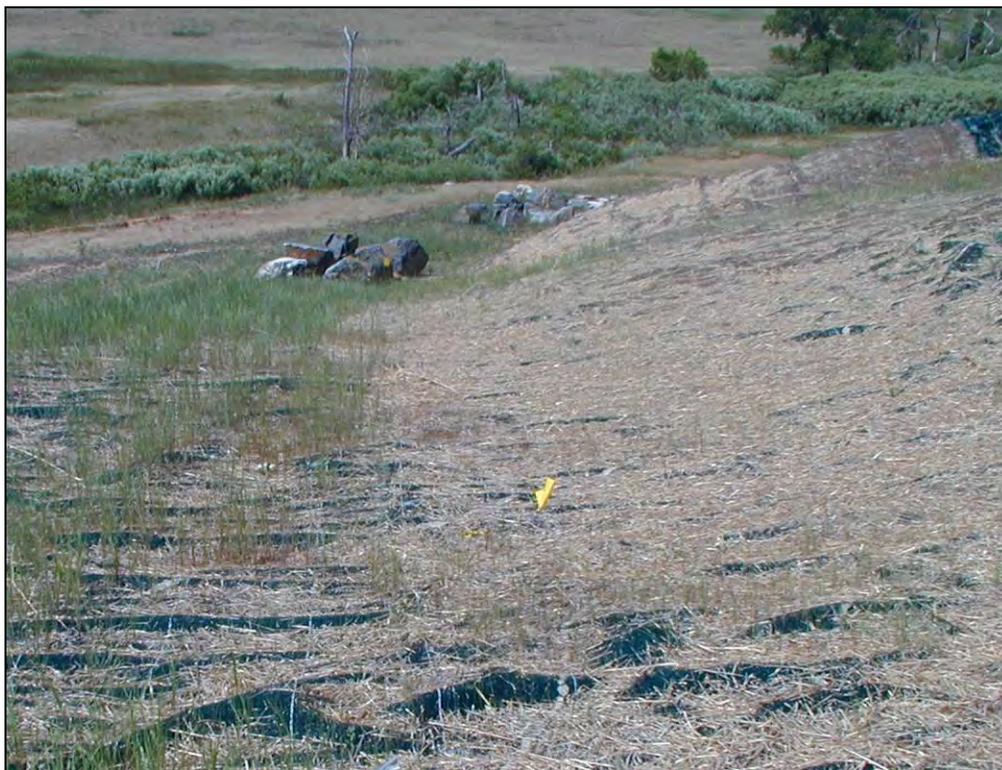
Figure 5. Windblown straw deposited in a drainage inhibiting plant germination.

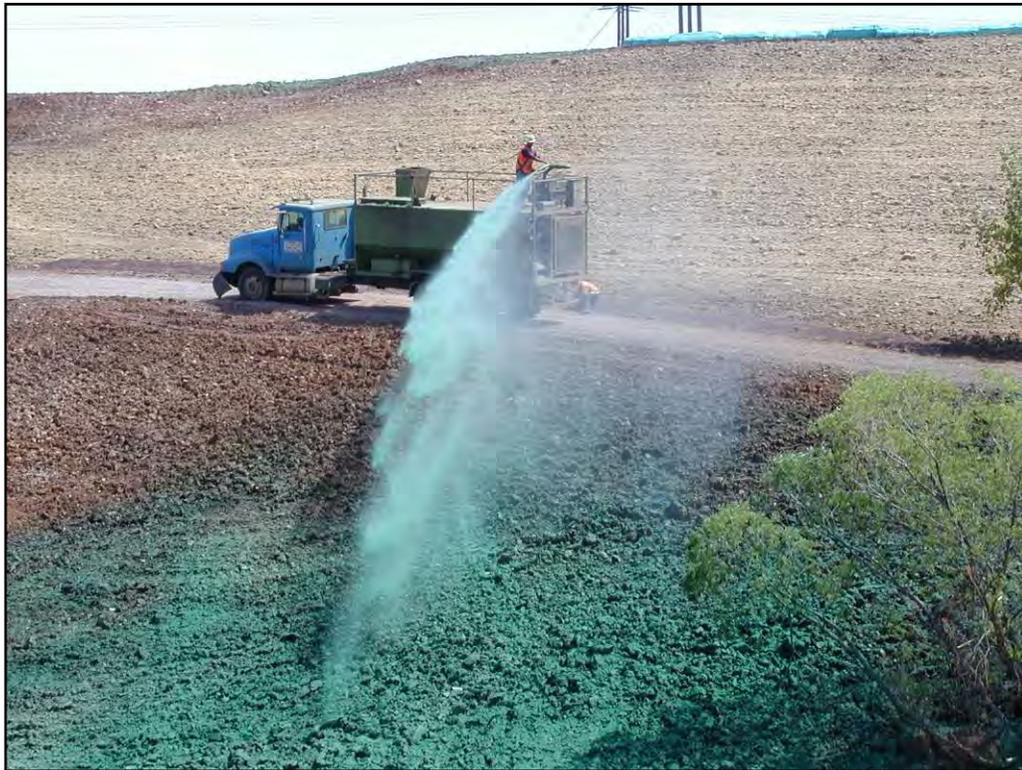
Figure 6. Flexterra application on a hillslope at the Site.

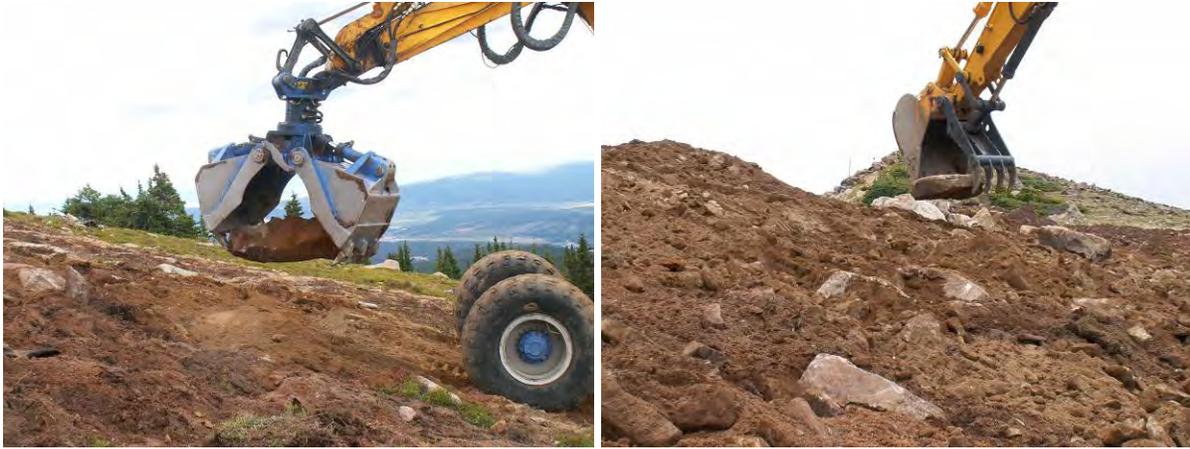
Photo: Eagle Wind rock placement with clam bucket and spider hoe. (Right) Panoramic lift rock placement with excavator with a bucket thumb

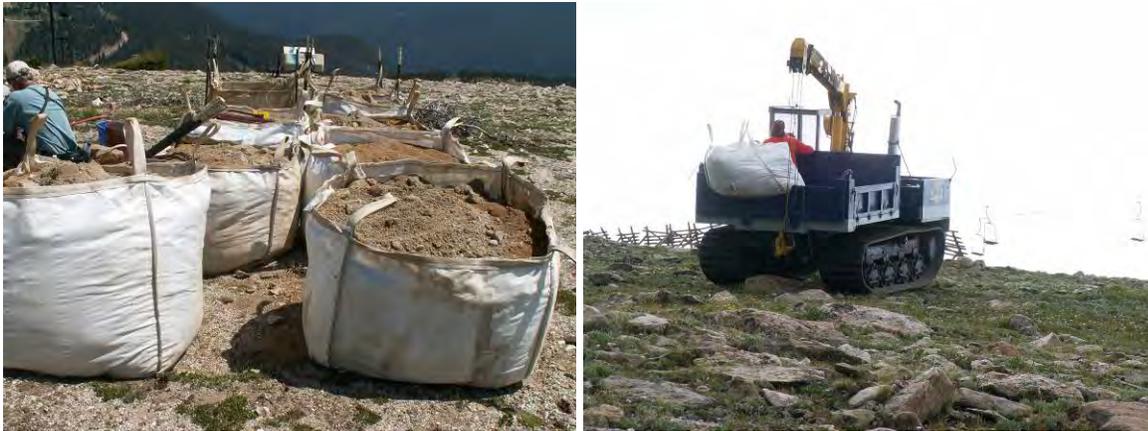
Photo: Soil bags used above treeline. Limited loose soil on undisturbed ground. (Right) One soil bag was removed by Maruka rubber tracked dump truck the others were removed by helicopter

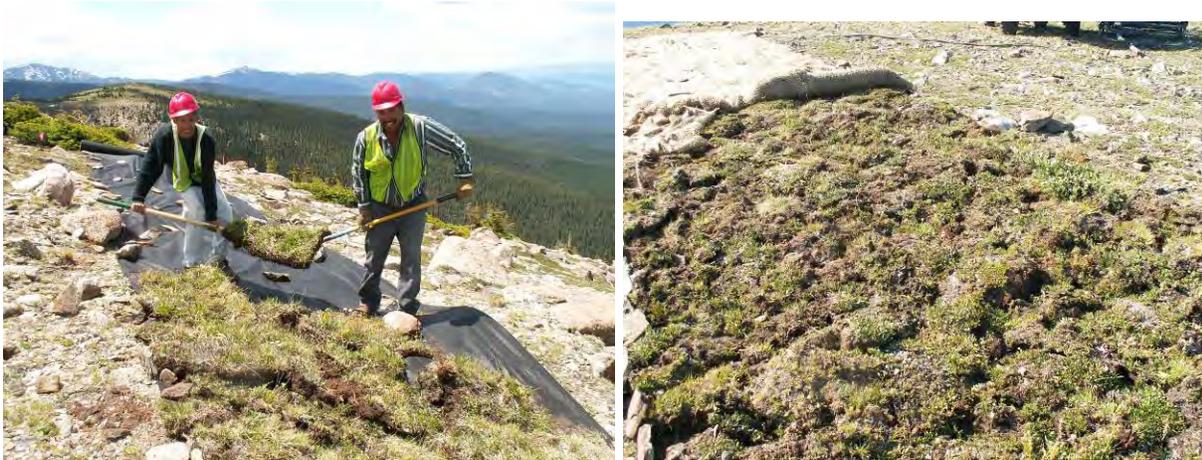
Photo: Eagle Wind (11,500') plant salvage large sections. Placed on geotextile outside disturbance

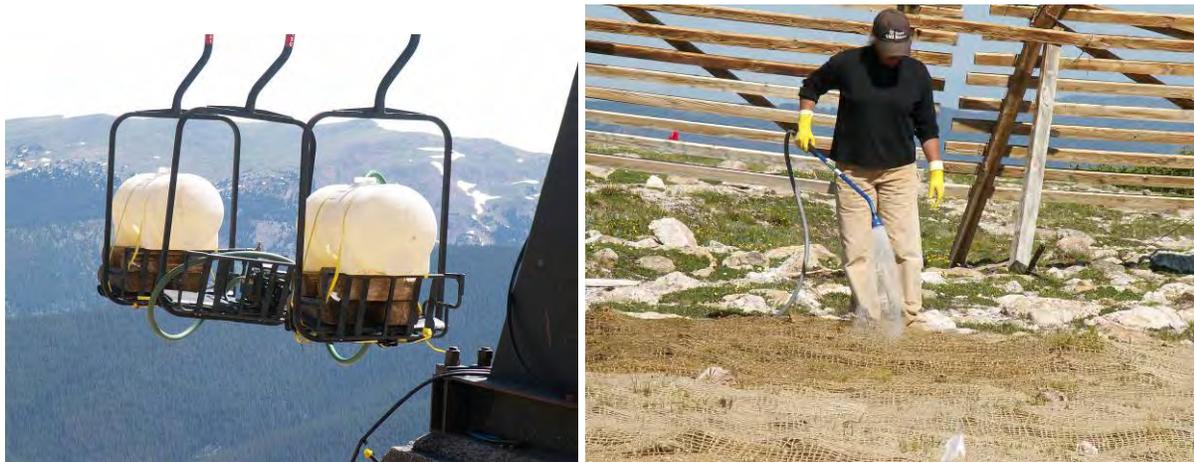
Photo: Water tanks and pump on the Panoramic lift. (Right) Soaking watering spray

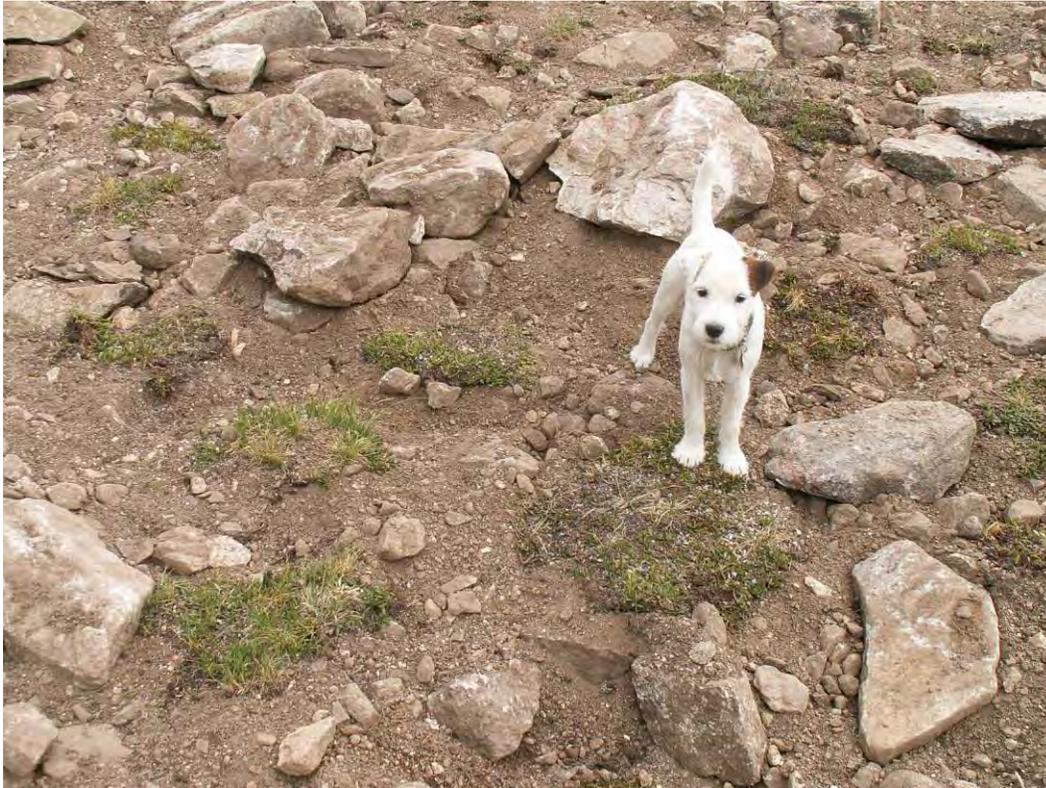
Photo: Panoramic Lift completed hand set plant material and rocks

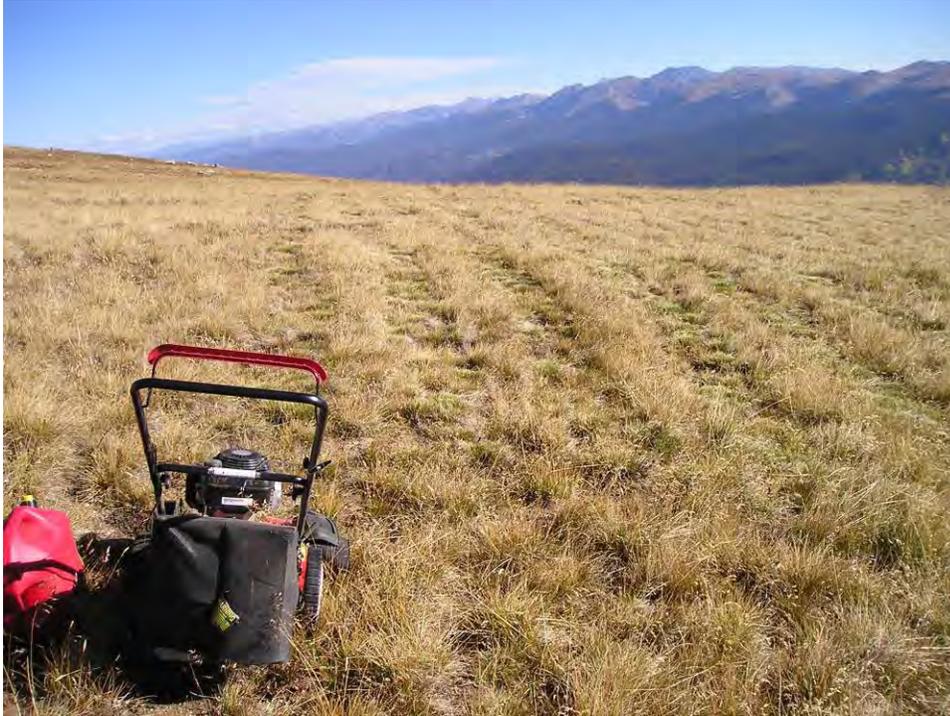
Photo: Mowing seed collection method adjacent to the Panoramic lift disturbance.

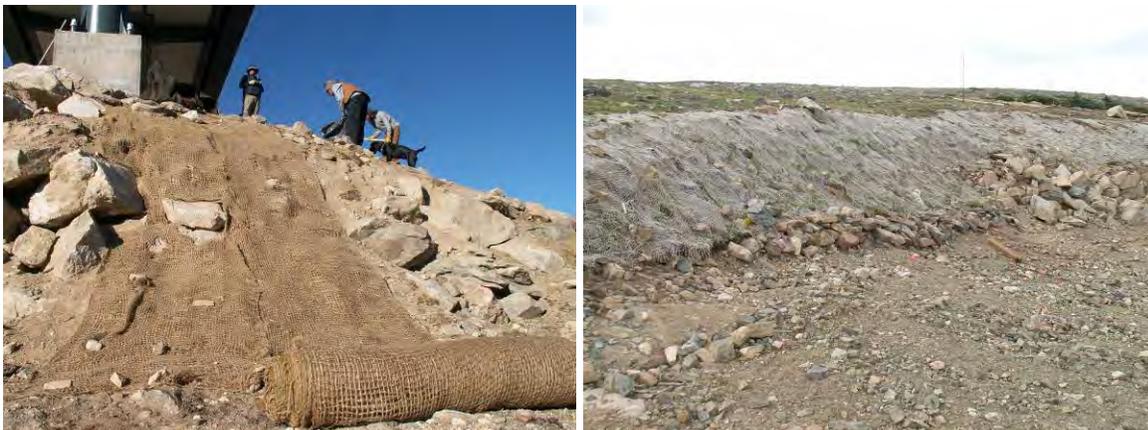
Photo: Jute mat installation Panoramic lift. (Right) Jute mat installation Eagle Wind lift

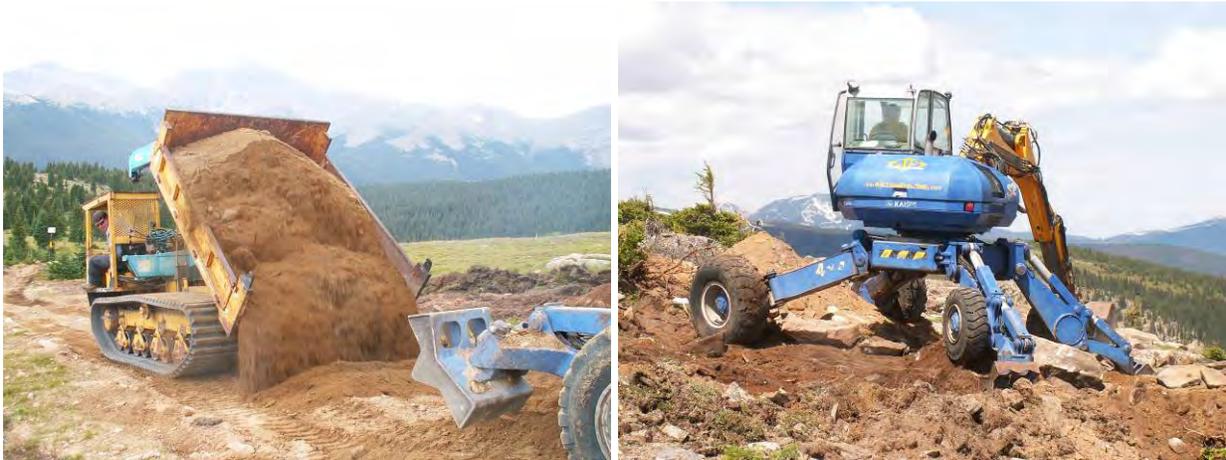
Photo: Maruka rubber tracked dump truck and spider hoe used on the Eagle Wind lift.

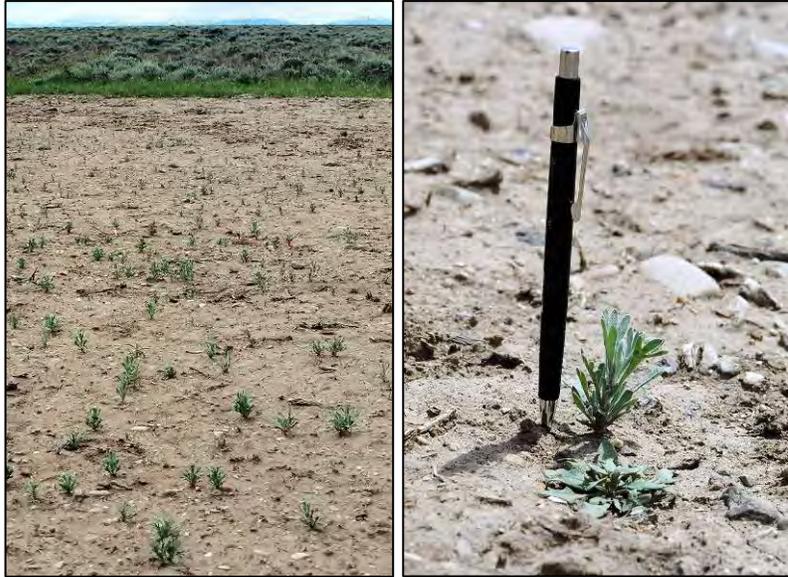
Figure 21. MESA 12-28. Wyoming Big Sage seedlings. Photos taken 6/15/05. See also Figures 20 & 21, taken near the same site on this location.

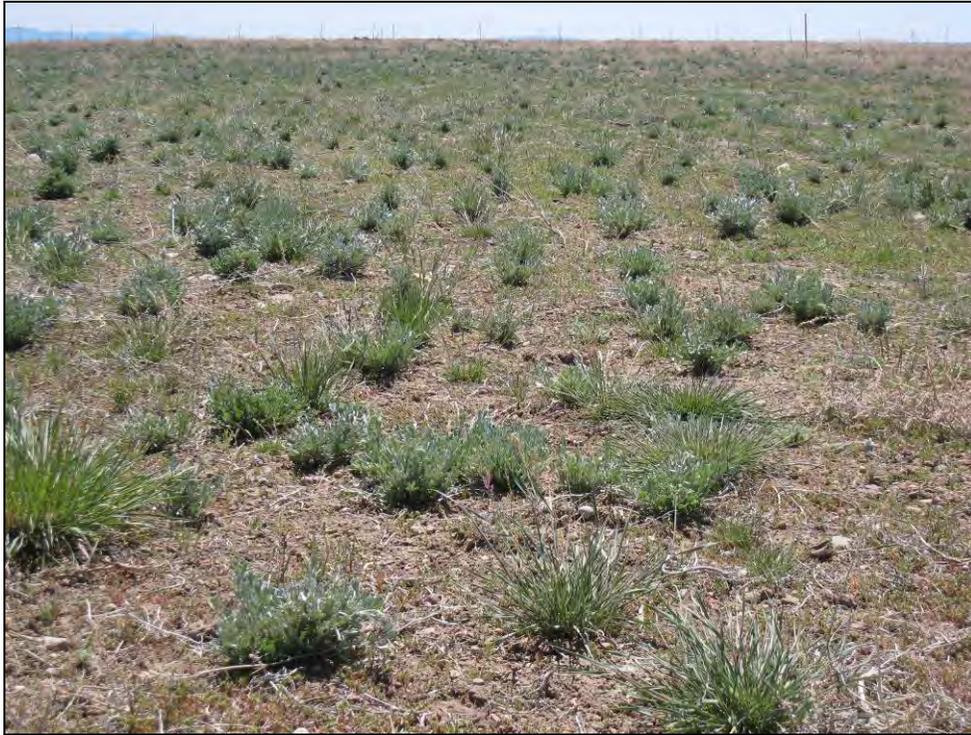
Figure 22. MESA 12-28. Wyoming Big Sage, Fourwing Saltbush and bunch grasses. 5/29/07 photo.

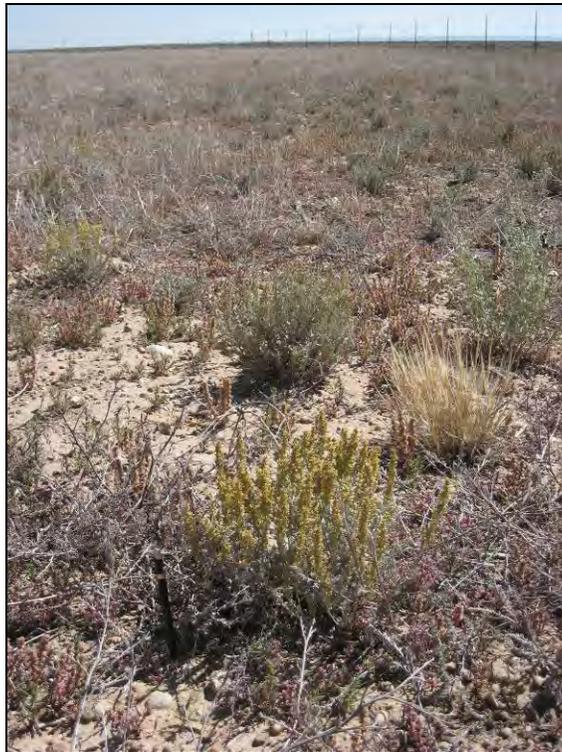
Figure 23. MESA 12-28. Wyoming Big Sage in seed - same location as Figures 20 & 21. 9/14/07 photo.

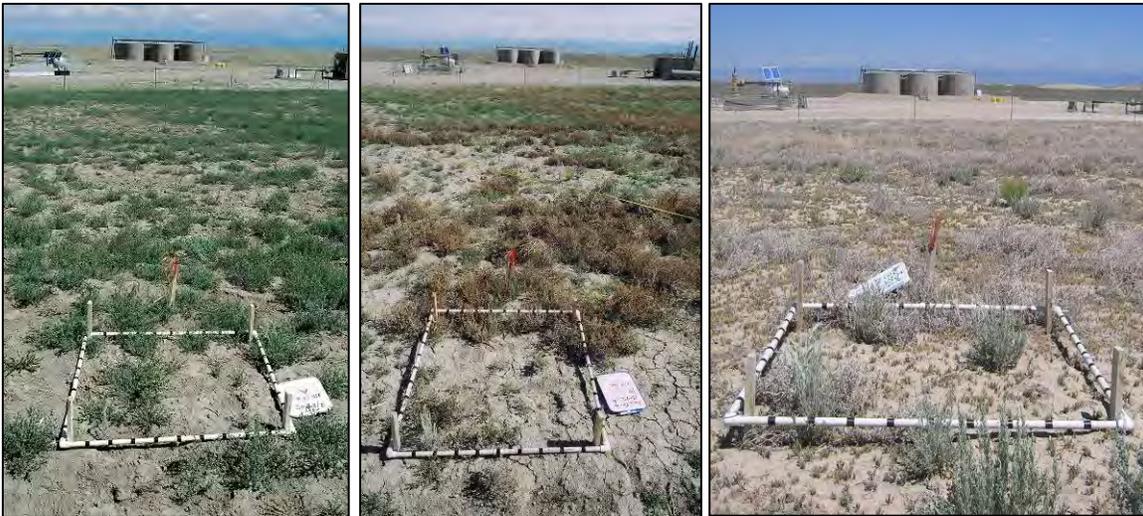
Figure 26. NEW FORK 13-32. Photoplot New Fork 13-32 A. Photos taken (left to right): 7/25/05, 7/12/06 and 7/9/07. View to north. One meter square frame. Larger green shrubs in 2007 photo are Wyoming Big Sage and Winterfat, with some Fourwing Saltbush. Increasing effects of dry years are evident in 2006 and 2007 photos.
