THESIS

A CHANNEL STABILITY ASSESSMENT AND LOGISTIC REGRESSION MODEL FOR A  
REACH OF MUDDY CREEK BELOW WOLFORD MOUNTAIN RESERVOIR, IN NORTH-  
CENTRAL COLORADO

Cory A. Williams

Colorado State University

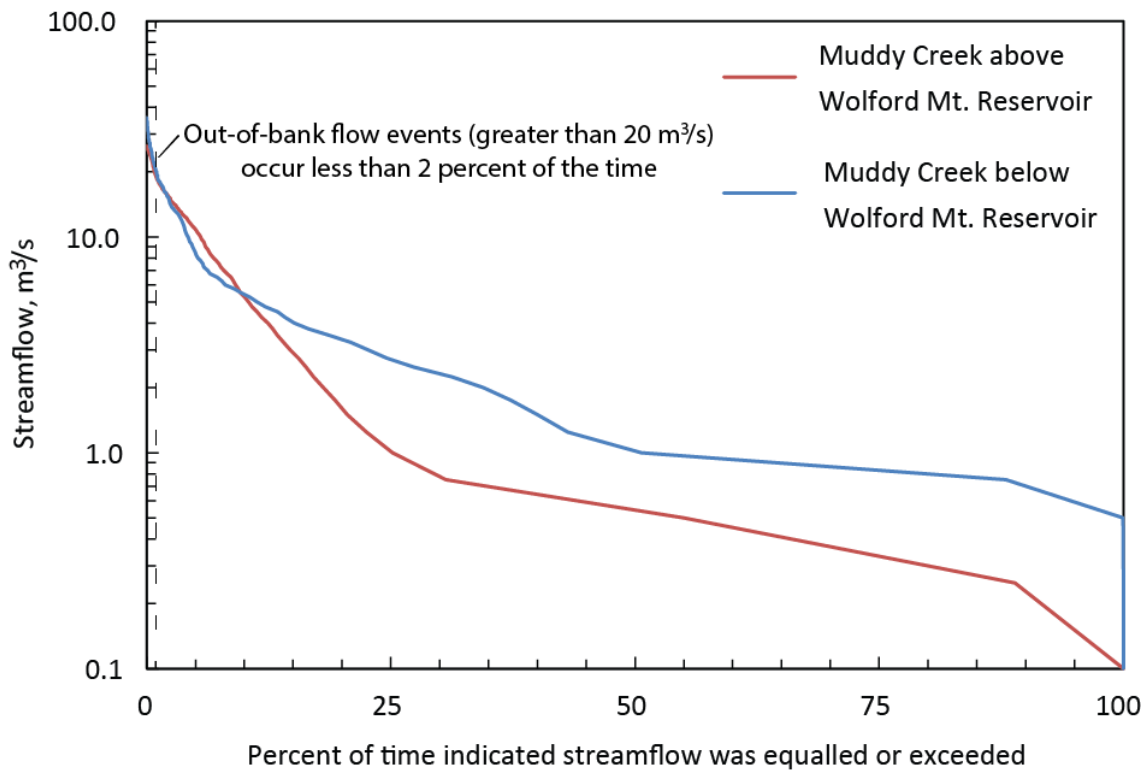
Figure 2. Streamflow duration curves above and below Wolford Mountain Reservoir. Data for Muddy Creek below Wolford Mt. Reservoir includes the post-reservoir time period only.

Ruddy (1987) estimated that at least 97 percent of the total-sediment discharge in Muddy Creek was transported in the suspended phase. A review of the particle size analysis from Elliott *et al.* (2011), in conjunction with field observation, shows that bed-load transport occurs only during extreme flow conditions, and in limited locations within the reach. A two-dimensional hydrodynamic model was used to assess median grain-size transport within two reaches of Muddy Creek (Elliott *et al.*, 2011). The results show that only isolated areas of the gravel bed are mobilized, even at flows that are out-of-bank (greater than 20 m<sup>3</sup>/s or 697 ft<sup>3</sup>/s) (Elliott *et al.*, 2011). These flow conditions occur less than 2 percent of the time based on available streamflow data at USGS streamflow gage 09041400 (Figure 2).

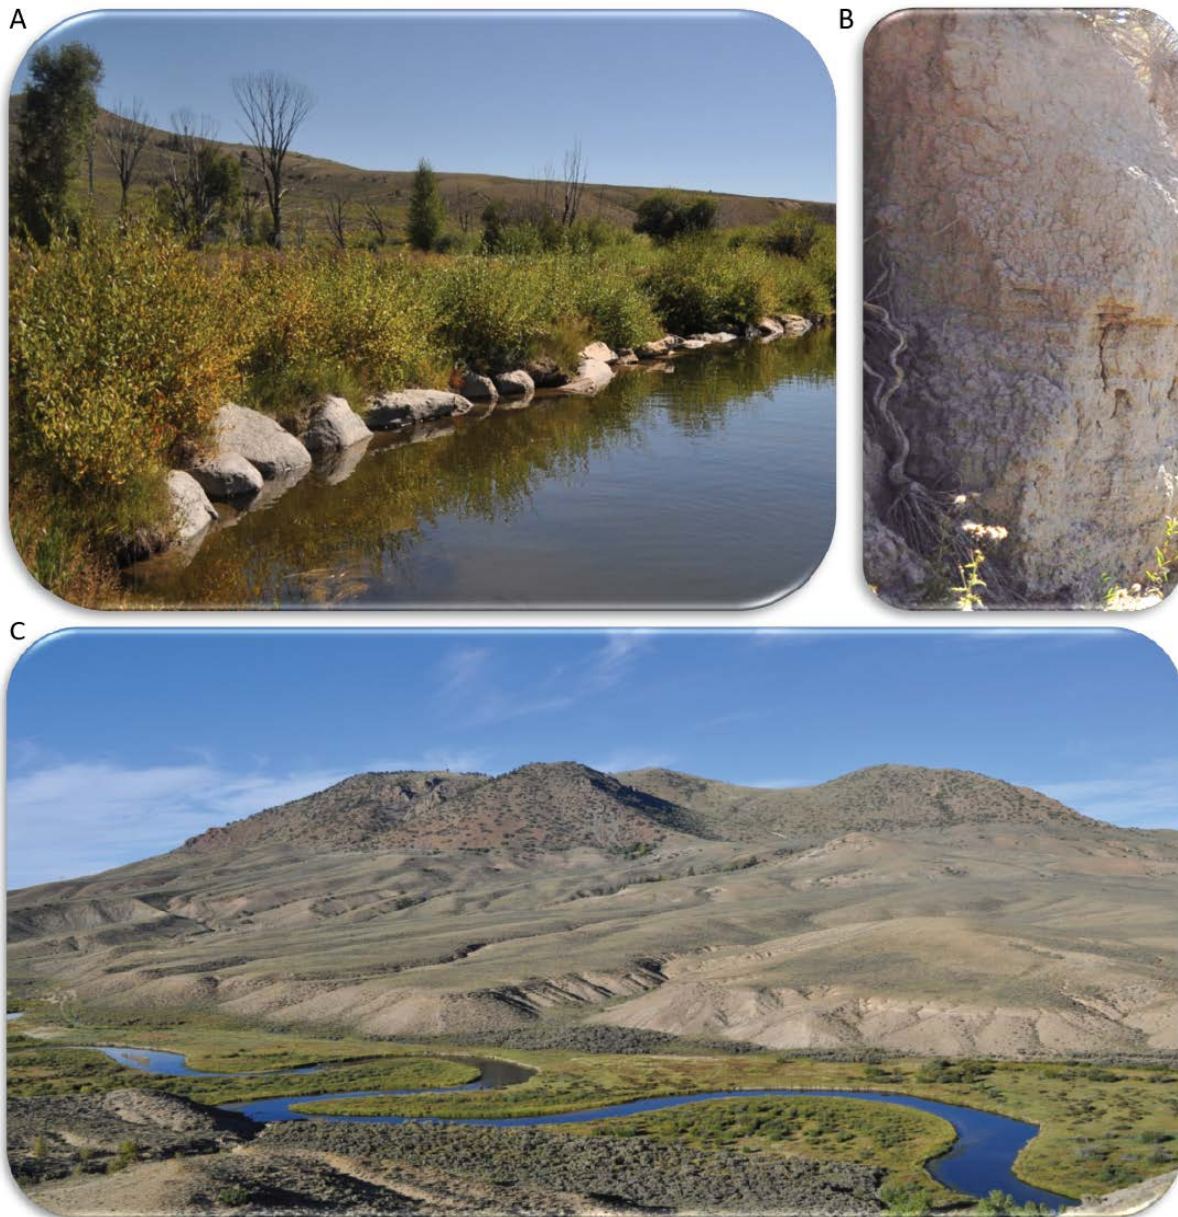
Figure 4. Photographs showing (A) willow and boulder erosion-control structures, (B) streambank sediment profile (fine-grained overbank deposits), and (C) vegetation distribution in Muddy Creek below Wolford Mountain Reservoir, September 16-27, 2013.

with inter-bedded layers consisting of particles sizes from boulders to clay). Geomorphic indications of erosion were used to identify the spatial occurrence and extent of recent streambank erosion within the reach. Some examples of streambank and riparian characteristics and streambank erosion are shown in Figures 4 and 5.

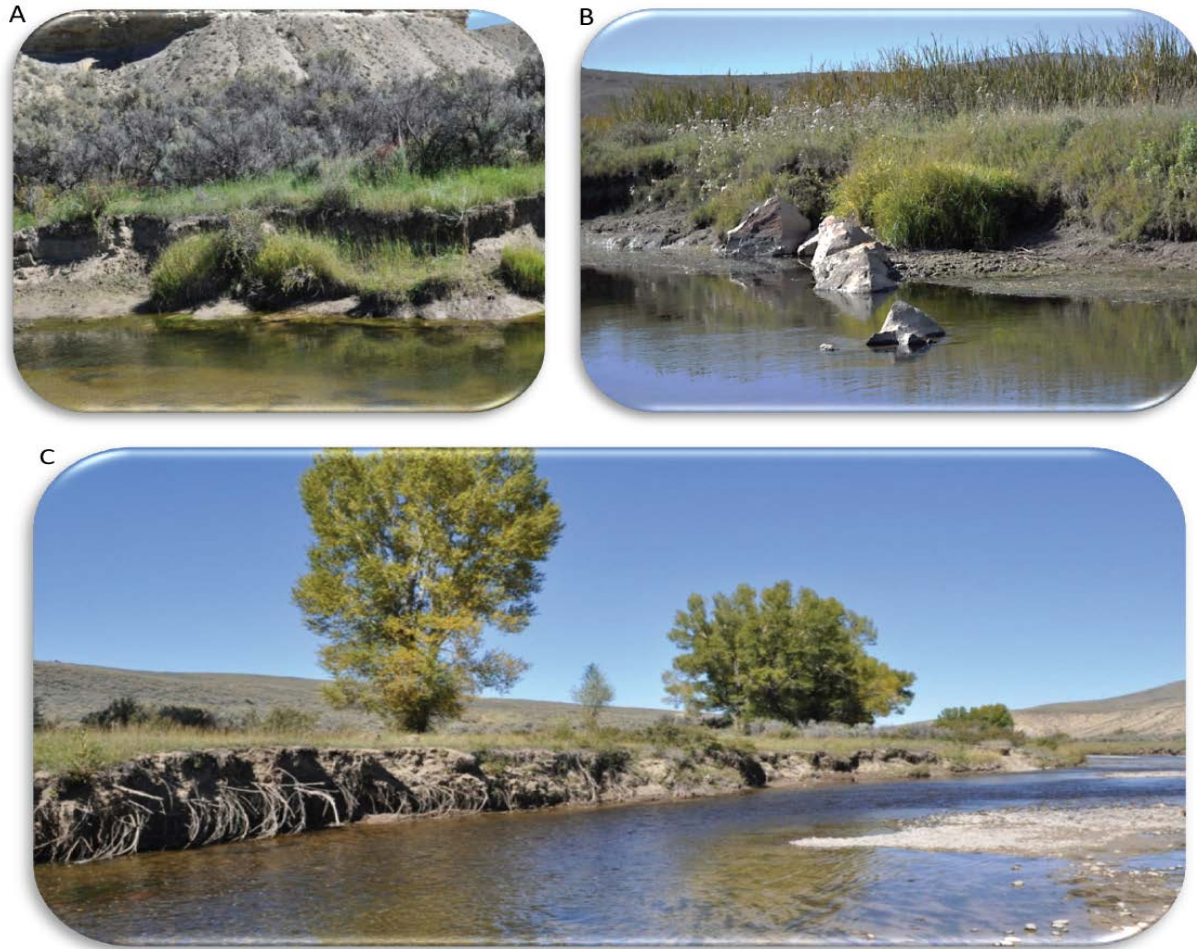
Figure 5. Photographs showing (A) mass wasting or block failure, (B) flanked j-hook, and (C) exposed roots indicative of recent streambank erosion in Muddy Creek below Wolford Mountain Reservoir, September 16-27, 2013.

Undercutting of these streambanks produced cantilevered blocks of intact alluvium, often heavily vegetated, with numerous observed blocks of vegetation and soil that have mass wasted into the channel and remained intact. Orientation of these blocks and the relative depth of flow within the channel determine how long these blocks remain in place on the streambed. In some locations these blocks have retained their original orientation and appear to have reestablished along the streambank toe, reducing the observed streambank height and further armoring the streambank slope.

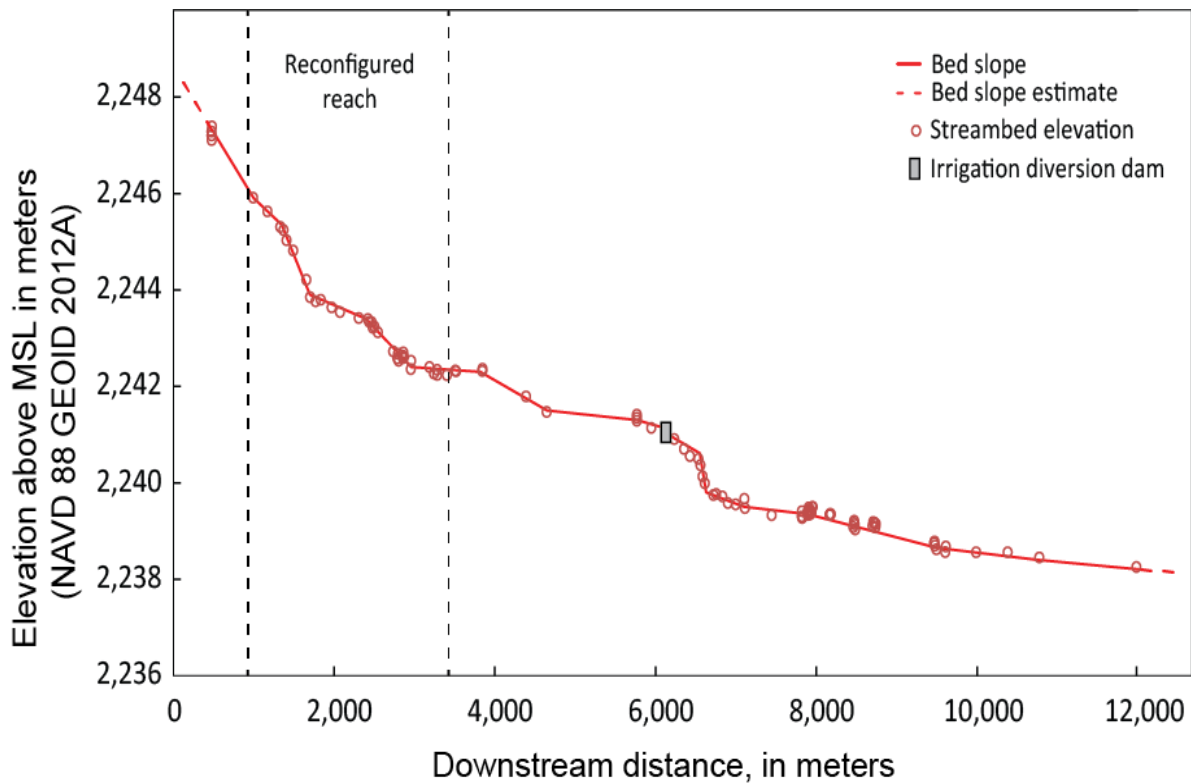
Figure 7. Graph showing bed slope determined from surveyed points and best-fit line.

Bed slope throughout the reach is shown as the best-fit line in Figure 7. Bed slope is steepest in the first 1.7 km of the reach and also for the first 0.5 km downstream of the irrigation

diversion dam. The reconfigured reach contains both steep and flatter reaches that alternate in pattern and were often controlled by manmade boulder structures, bedrock outcrop, and coarser riffle deposits. The downstream-most 5 km of the reach show a more consistent and less steep bed slope profile.

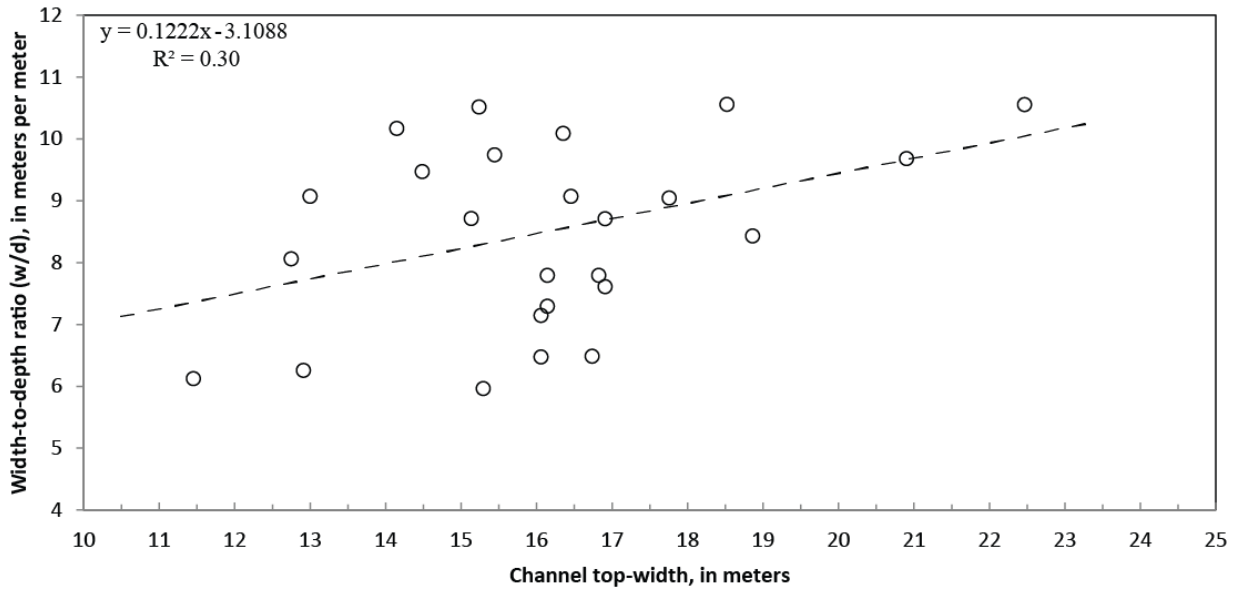
Figure 8. Scatter plot showing the relation between width-to-depth ratio (w/d) and channel top-width based on cross-section surveys of Muddy Creek below Wolford Mountain Reservoir.

Cross-section surveys along Muddy Creek were used to evaluate channel geometry. A positive correlation between channel top-width and width-to-depth ratio was found (Figure 8). Width-to-depth ratios ranged between 6 and 11 for the surveyed cross sections along Muddy Creek, with top-widths ranging between 11 and 23 m. Additional analysis showed an association between channel top-width and vegetation occurrence in riparian areas. The mean channel top-widths in areas dominated by grasses are wider than those in areas dominated by willows (p-value less than 0.001) (Figure 9).

Within the study reach, as channel top-widths increase so does the width-to-depth ratio ( $w/d$ ) (Figure 8). The  $w/d$  ratio is a commonly used metric to describe cross-sectional channel geometry (Knighton, 1998). There can also be an association between larger  $w/d$  ratio and enhanced streambank erosion or channel instability (Rosgen, 2006). Vegetative influences are correlated to observed differences in mean channel top-width with wider channel-top-widths associated with areas dominated by grasses (Figure 9). In combination, flow angle-of-attack, outside of meander bend, and channel top-width can describe areas that are more susceptible to streambank erosion, especially in areas where fluvial energy is directed at the streambank, such as the outside of tight meander bends (Knighton, 1998). Areas of wider top-width may also occur in areas that are at a different stage of the CEM where changes in dominant geomorphic process are occurring and aggradation of the streambed may occur in conjunction with future increased streambank stability (Schumm *et al.*, 1984). Further monitoring would be needed for confirmation.

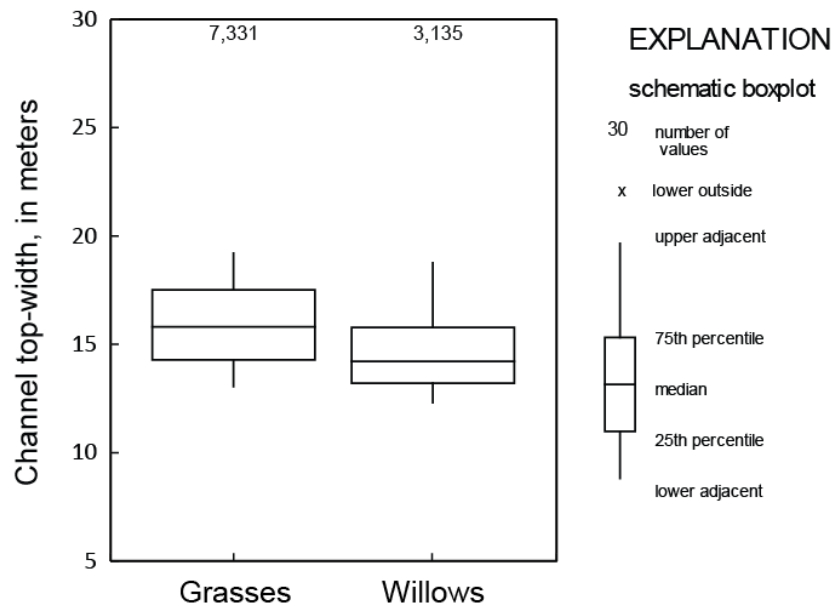
Figure 9. Comparison of channel top-width based on riparian vegetation in Muddy Creek below Wolford Mountain Reservoir.

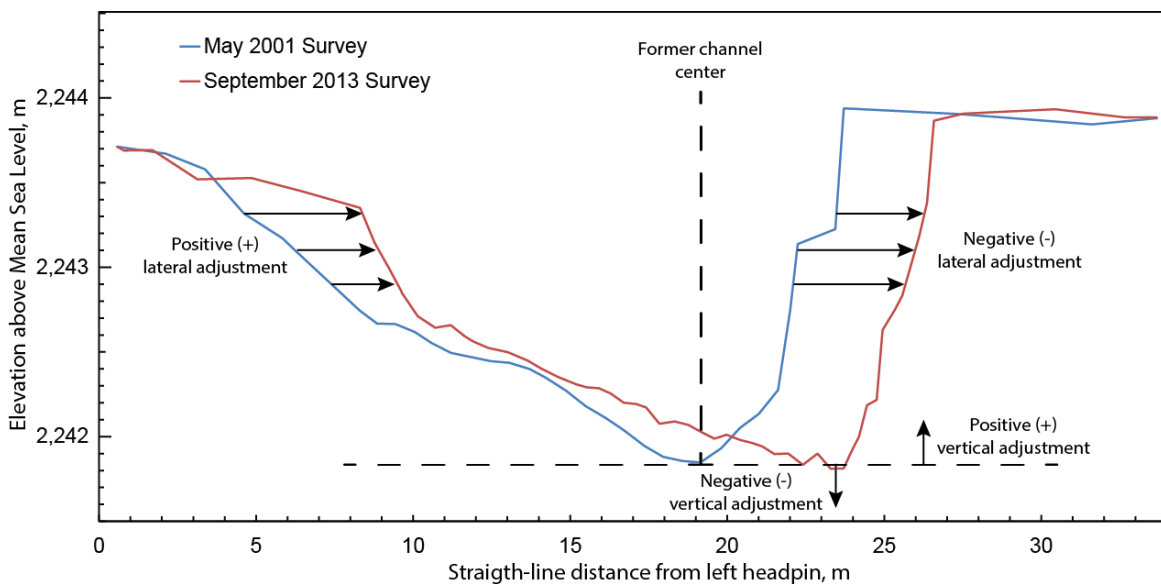
Figure 11. Explanation of vertical and lateral adjustment definitions in cross sections.

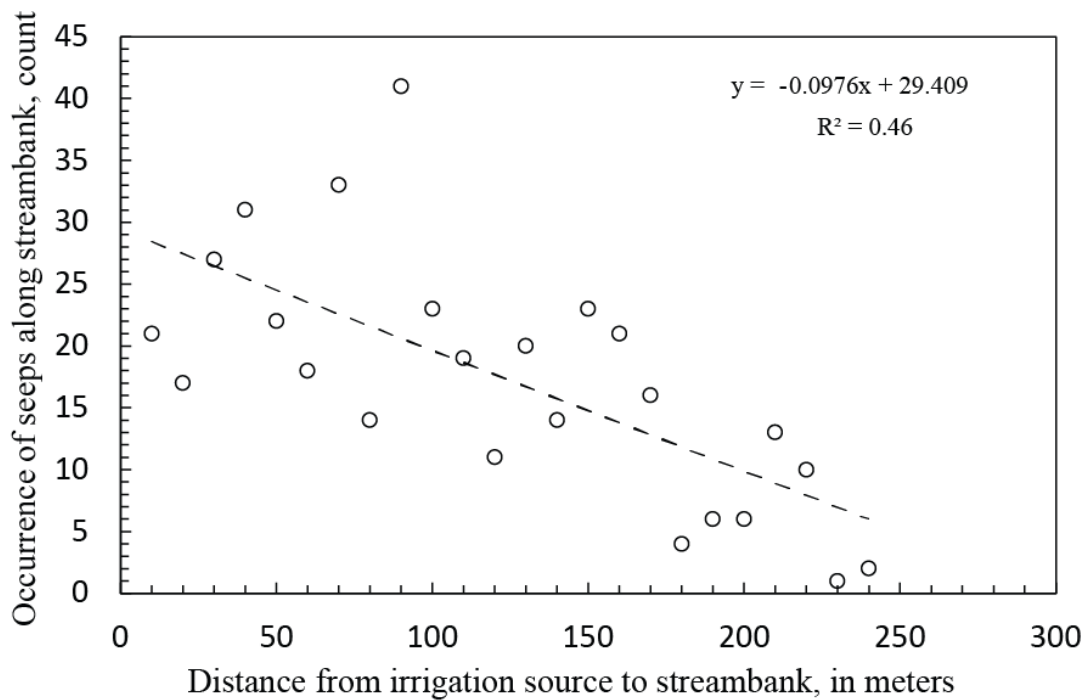
Figure 14. The relation between irrigation ditch/irrigation turnout and streambank seeps.

Comparisons of the locations of observed seepage along streambanks and irrigation infrastructure show the effects of water augmentation within the valley bottom. An assessment of seepage proximity to irrigation infrastructure and mitigation wetlands shows that the distance from streambank seeps to unlined irrigation ditches and irrigation turn-outs was highly significant (p-value less than 0.0002) within the study reach (Figure 14). Interpretation of Figure

14 shows that the distance from which irrigation source appears to affect streambank seep occurrence extends outwards to a distance of 250 m.

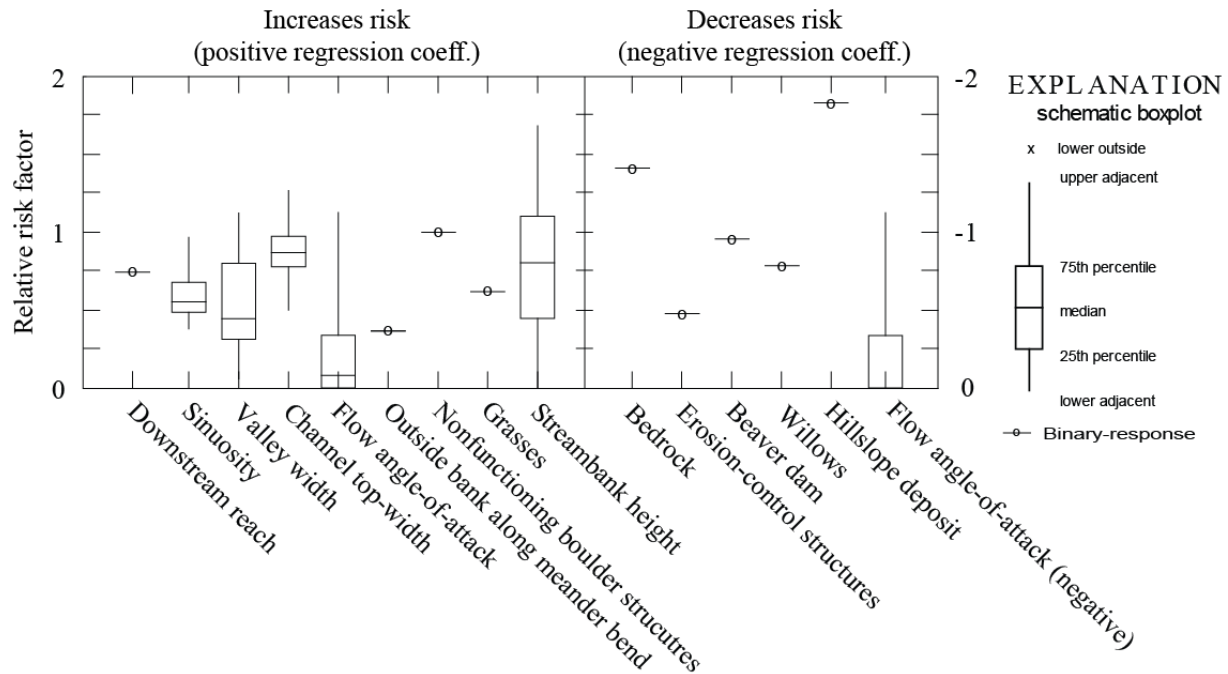
Figure 15. The relative risk factor magnitude for each logistic regression parameter.

Further support arises from the logistic regression, where backwater areas upstream of two beaver dams were found to decrease the risk of streambank erosion (Figure 15). Both beaver dams were located within Group 2, and were built on top of boulder weirs within the reconfigured reach. These structures, in conjunction with the beaver dams, produced areas

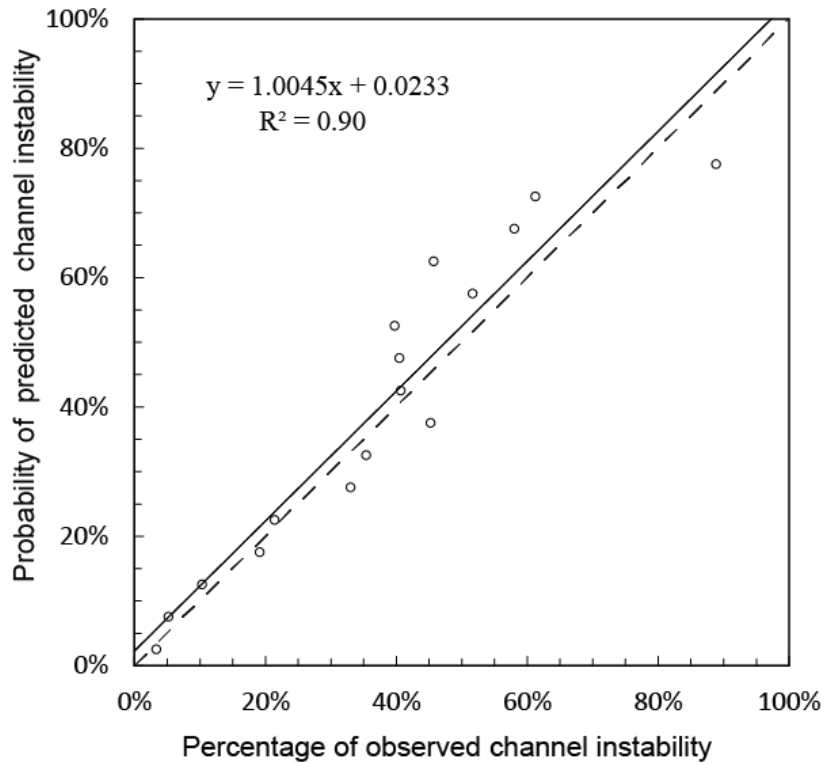
Figure 16. Goodness-of-fit of logistic regression predictions and streambank erosion.

A validation of the logistic regression model is presented through the assessment of the error related to the predictions of streambank erosion risk (ranging from 0 to 100 percent). The mean standard error of prediction for the logistic regression model is 1.2 percent, with a maximum error of 7.3 percent within the validation data set. A second assessment of error is shown in Figure 16 where a random, independent subset of observation (~12,000 observations) was used to validate the logistic-regression model predictions. Simple linear regression (SLR) analysis was used to quantify the goodness-of-fit of the observed streambank erosion and predicted values. A perfect SLR model (1:1-line) would have an  $R^2$  value of 1.0, a slope of 1.0, and a y-axis intercept of zero. Points plotting above the 1:1-line indicate that the logistic regression is over-predicting streambank erosion (a margin of safety); points plotting below the 1:1-line indicate under-predictions of streambank erosion. In general, the logistic regression

validation approximates the 1:1-line for predicted and observed streambank erosion, and the y-axis intercept is approximately zero, indicating a good linear fit. The coefficient of determination ( $R^2$ ) of the SLR is 0.90, indicating 90 percent of the variability is explained. This verification indicates that the risk for streambank erosion in the validation data set is well characterized for the independent validation data set.
