# THE USE OF ACOUSTIC DOPPLER SENSORS TO IMPROVE FLOW MEASUREMENTS DURING DROUGHT CONDITIONS IN SPAIN

M.J. Cook<sup>1</sup>, PhD  
Neus Tarafa<sup>2</sup>  
Felix Bueno<sup>3</sup>  
Andrés Alonso-Martirena<sup>4</sup>  
Juan José Villegas<sup>5</sup>

## ABSTRACT

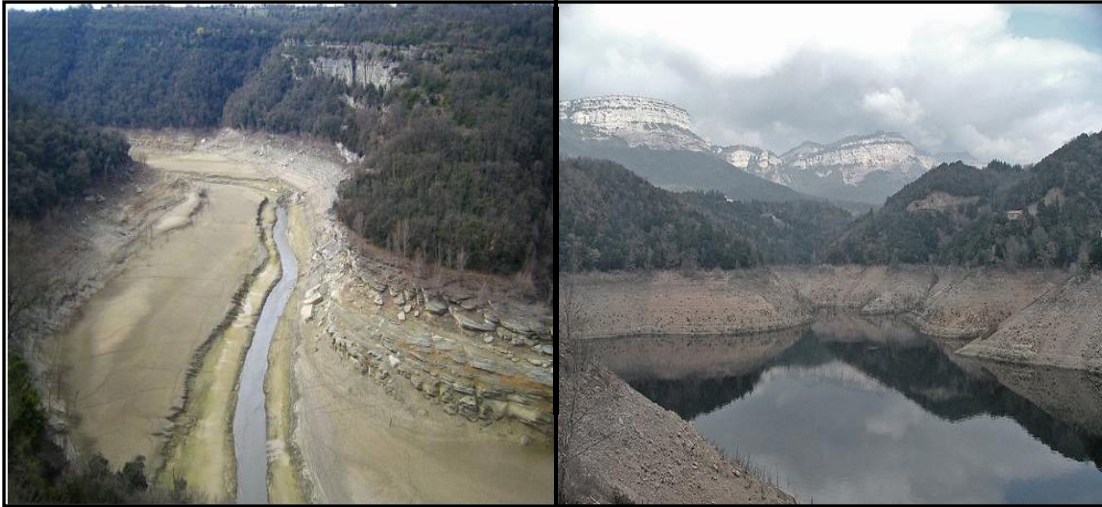
Figure 2. Images from the extreme drought in Catalunya

During 2004 to 2008 Catalunya (Figure 1), the autonomous region of Northeast Spain experienced the worse drought in nearly 100 years. In 2008 the drought conditions left many reservoirs at less than 20% capacity (Figure 2). Various options were studied to rectify the situation; among these were to transport water to the region by diverting and pumping water from another watershed as well as transporting water from southern France by train or boat. Additional drinking water resources will be provided from a desalination plant due to be completed in mid 2009. However considering the continuous stress on streams to provide source water to public works systems, irrigation water to growers, diversions for hydroelectric plants all while trying to maintain an ecosystem along the stream corridor this project was seen as a potential key for future water resources management.

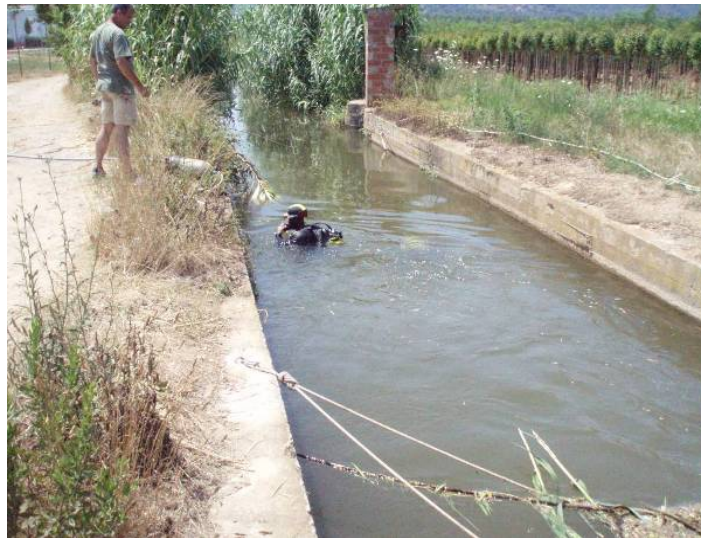
Canal Vinyals This channel, as shown in Figure 4, is a rectangular cement irrigation canal with a regular distribution of water velocities and a low sedimentation rate. An Argonaut SW (3.0 MHz) was installed at the bottom of a straight section of the canal approximately 100 ft from the gage house. Typical flow depths range from 1 to 5 ft of water.

Figure 4. Photo of Canal Vinyals

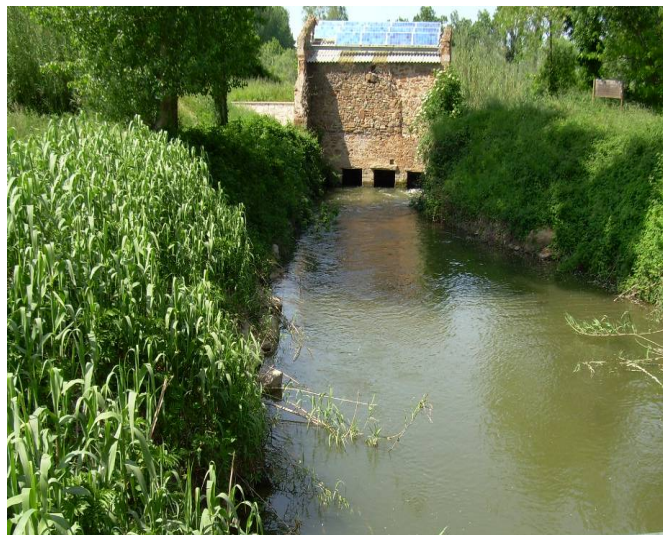
Resclosa de Canet This irrigation canal (Figure 5, looking downstream) has an unpaved irregular bottom as well as an irregular distribution of water velocities across the channel. An Argonaut SL (1.5 MHz) was installed on the right bank of the canal at 1.70 ft from the bottom. The installation depth was determined to be optimal based on the review of historical data at the site. The SL was installed approximately 40 ft from the gage house.

Figure 5. Photo of Resclosa de Canet

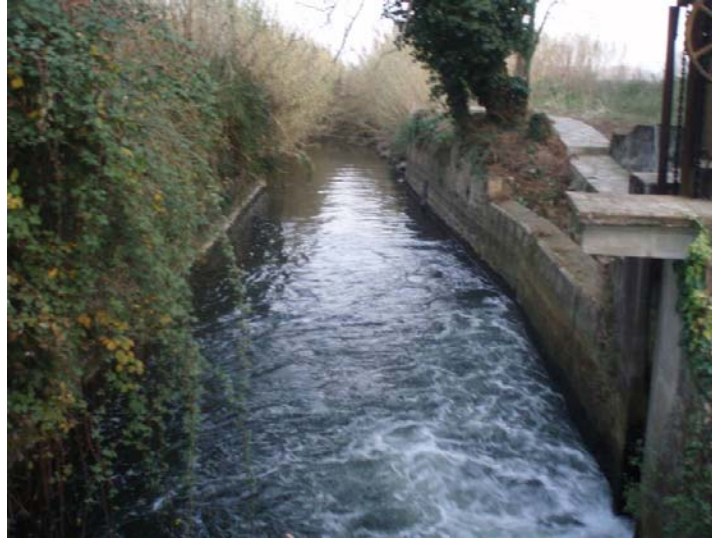
Canal Sentmenat This irrigation canal (Figure 6) is a rectangular channel with an irregular bottom. Due to the curvature of the canal and the irregular bottom, irregular velocities are often observed. An Argonaut SL (1.5 MHz) was installed 2.62 ft above the deepest point of the canal and 2,600 ft from the gage house.

Figure 6. Photo of Canal Sentmenat

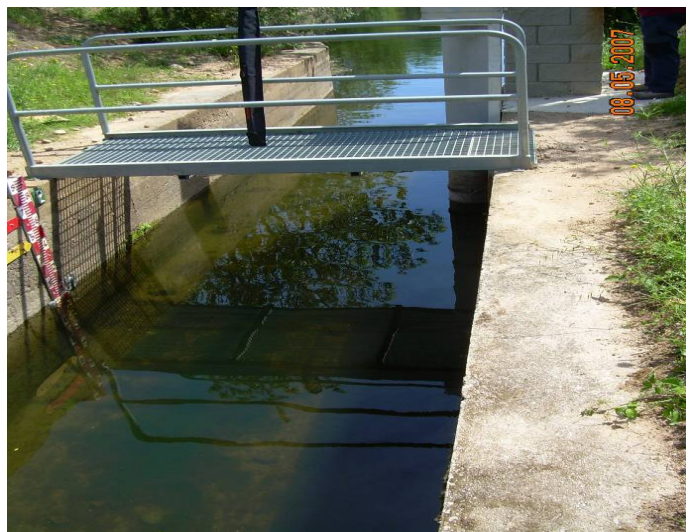
Canal Marge Esquerra de la Muga (Pont de Molins) This rectangular irrigation canal is concrete lined with a low sediment load. Since the canal has a regular distribution of velocities, the SW (3.0 MHz) was installed on the bottom of the canal just below the foot bridge and next to gage (Figure 7). The distance between the gaging station and the sensor is approximately 20 ft.

Figure 7. Photo of Canal Marge Esquerra de la Muga

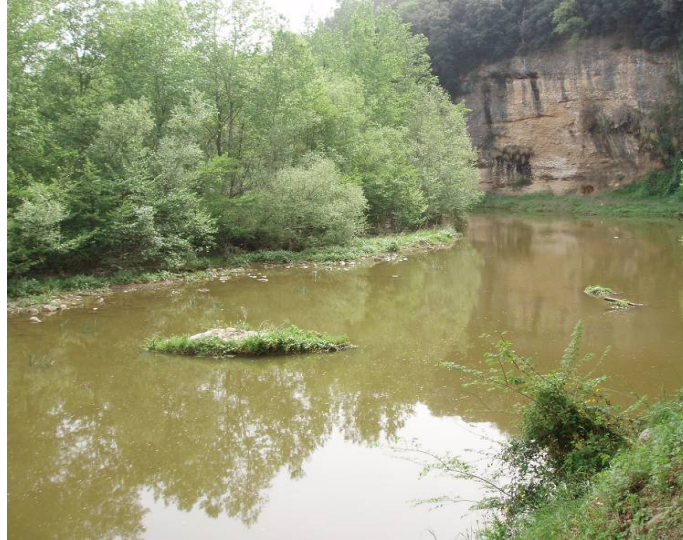
Rio Fluvia - Esonella The Argonaut SL (1.5 MHz) was installed on the right bank of the Fluvia River near Eponella at 1.5 m from the deepest portion of the stream at a level

that should always be submerged based on historical data. The stream has an uneven rocky channel bottom and irregular flow velocities. The SL is installed some 230 ft from the gage house. Figure 8 presents a photo of the downstream section of the Rio Fluvia, just upstream from where the SL is installed.

Figure 8. Photo of the Fluvia River near Esponella
