THESIS

THE ROLE OF DYNAMIC ICE-BREAKUP ON BANK EROSION AND LATERAL
MIGRATION OF THE MIDDLE SUSITNA RIVER, ALASKA

Renee A. Vandermause

Colorado State University

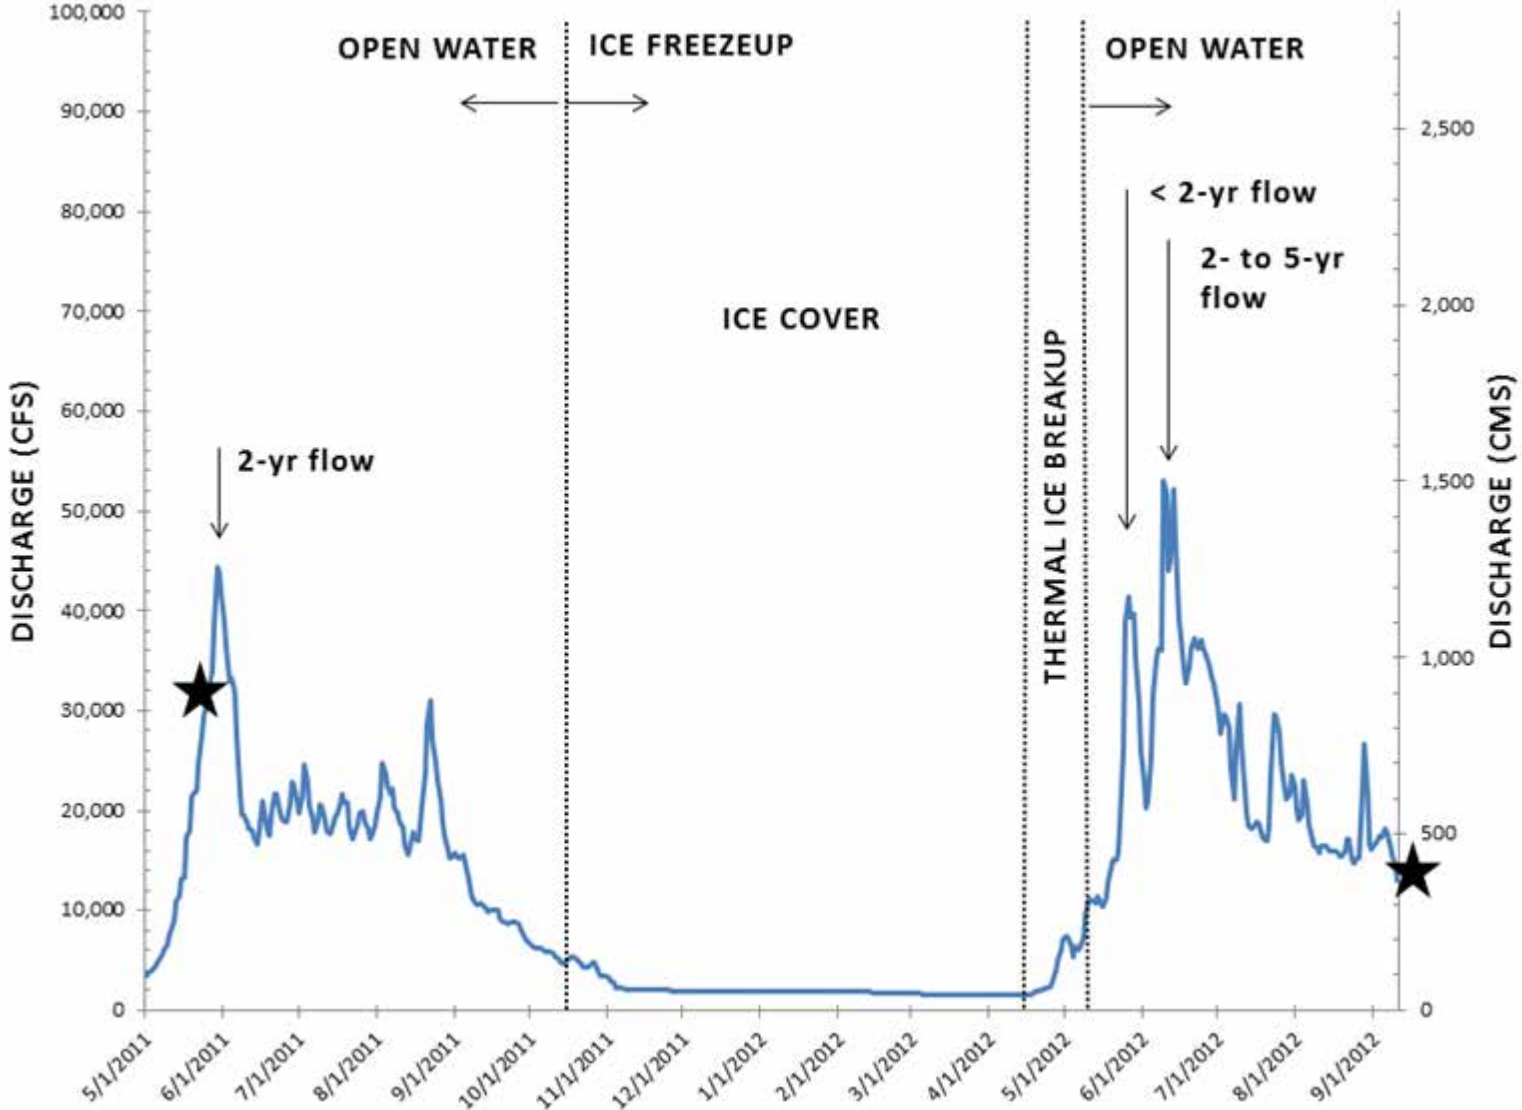
Figure 4-1. Mean daily discharge between 2011 and 2012 aerial imagery flights at Gold Creek gage. The black stars represent date of aerial flight.

Both one-year time periods experienced multiple flows higher than the 2-yr recurrence interval (i.e., flows whose stage exceeded the gravel-sand contact in the bank profile) while overall, open-water flows during 2012 to 2013 were greater. The main distinction between the two time periods however, is the nature of the ice-breakup; whereas the winter 2011 to 2012 had a thermal breakup of the ice cover, the winter 2012 to 2013 had a dynamic breakup of the ice cover that preceded a peak flow event whose magnitude was between the 20- to 50-yr recurrence interval. Figure 4-3 shows the flow record during the spring ice breakups.

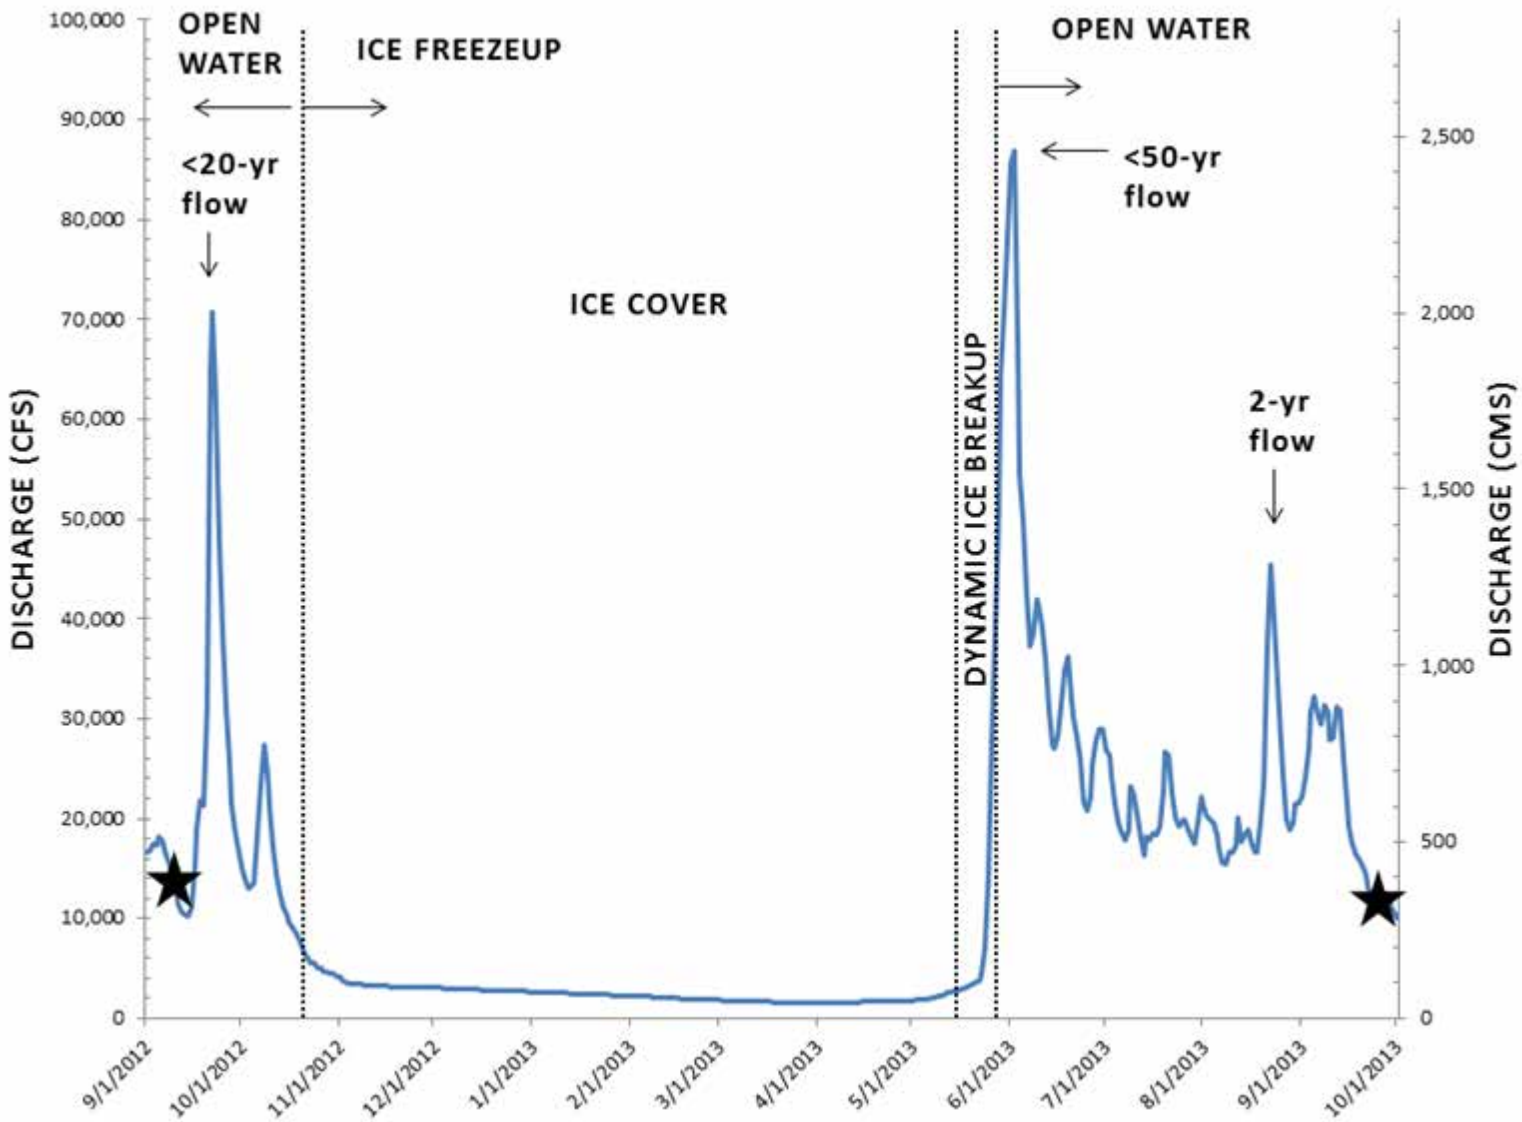
Figure 4-2. Mean daily discharge between 2012 and 2013 aerial imagery flights at Gold Creek gage. The black stars represent date of aerial flight.

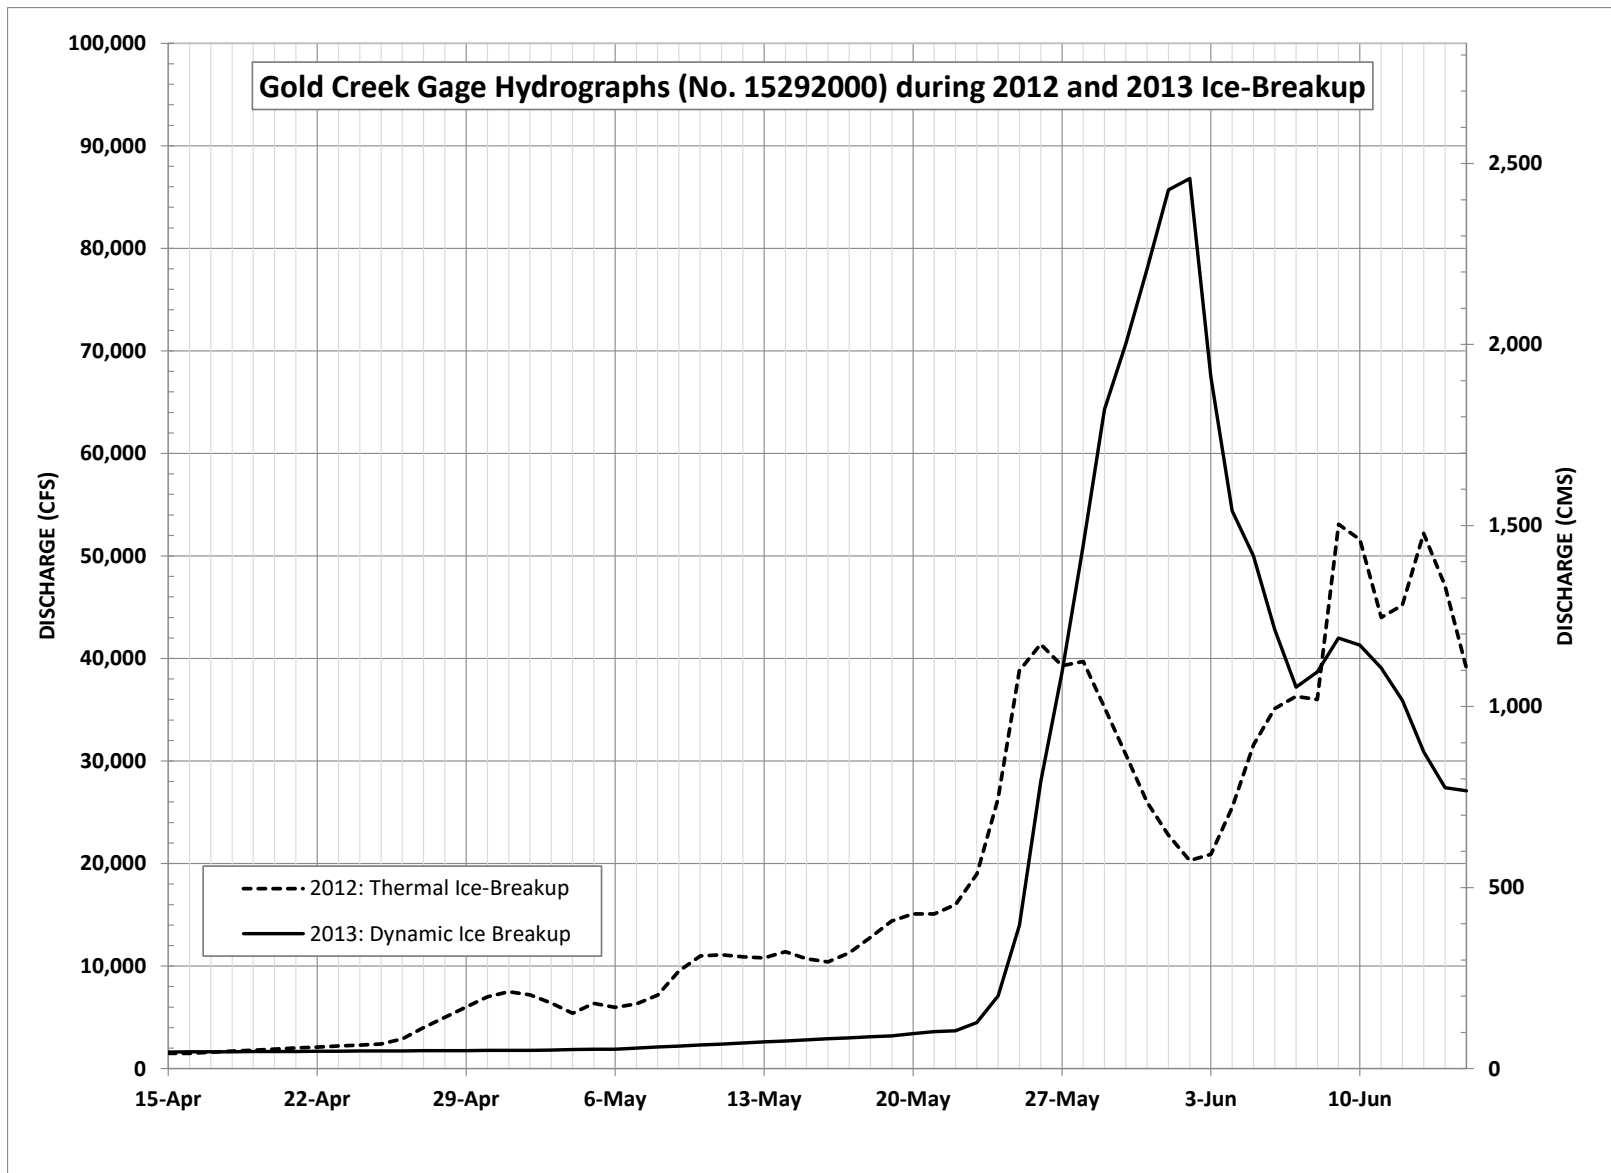
Figure 4-3. Mean daily discharge at Gold Creek gage during 2012 and 2013 ice-breakup.

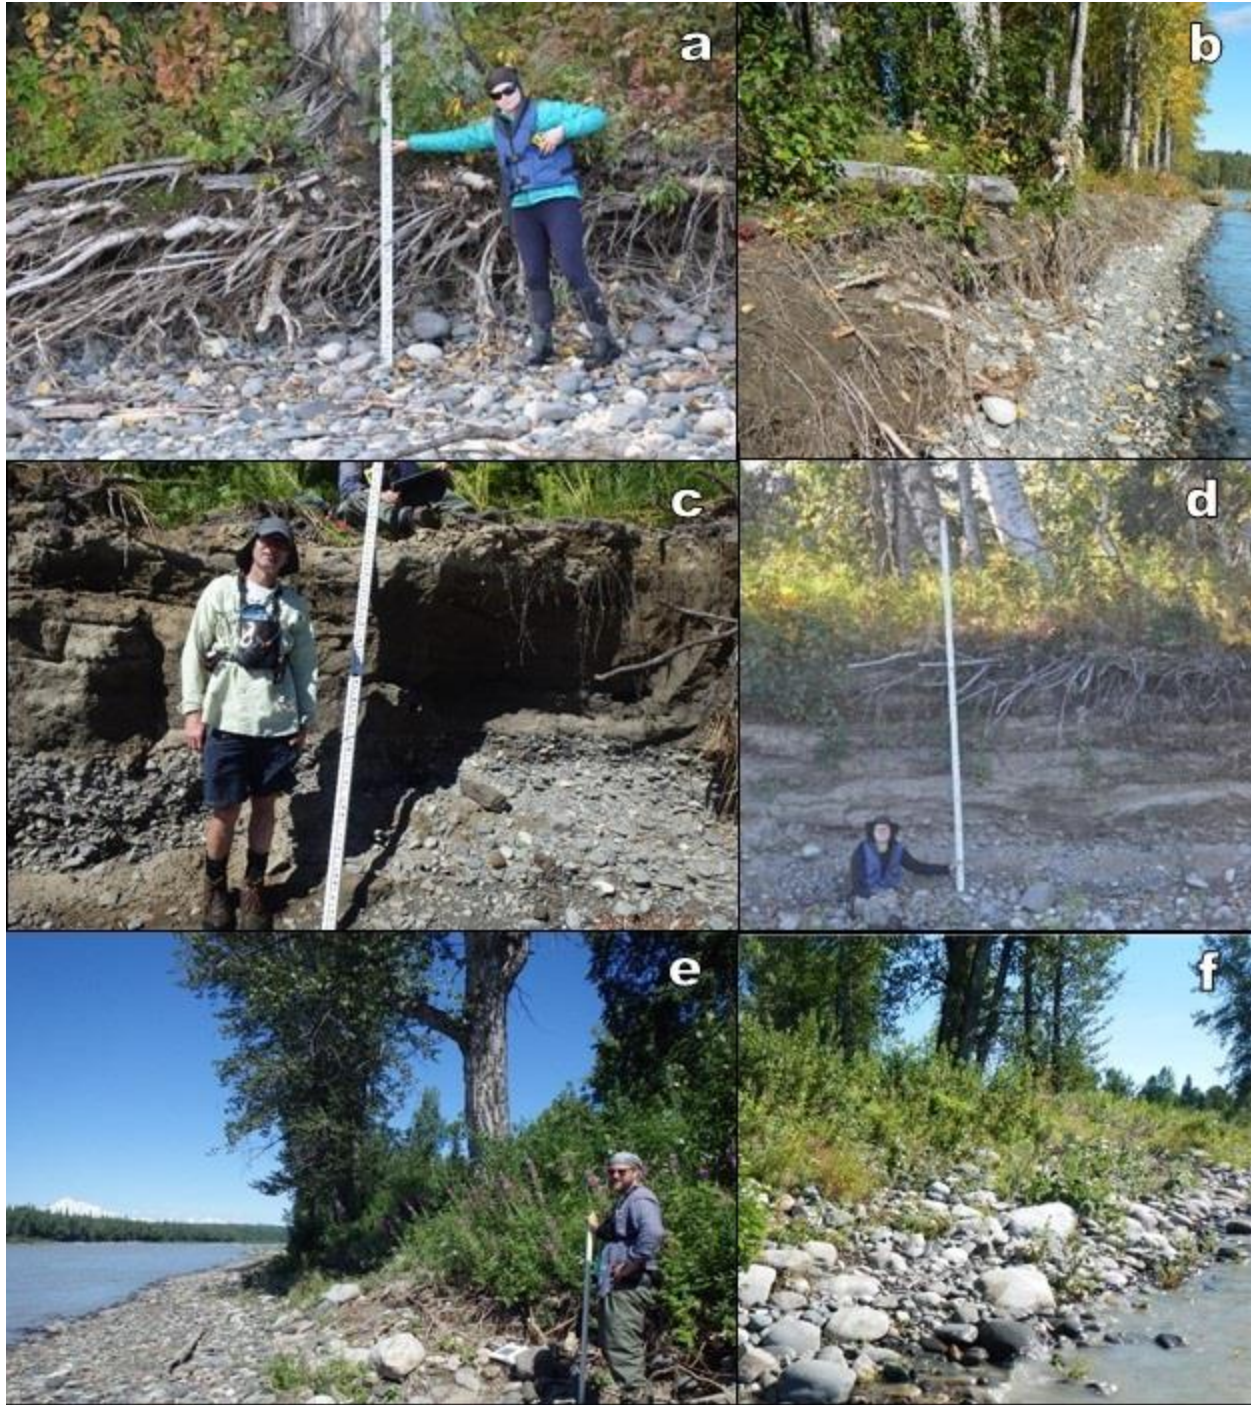
Figure 5-1. Common features of bank conditions along Reaches 6 and 7 of the Susitna River: (a) broken and sheared roots with a downstream slant and a gravel-cobble pavement at the bank toe; (b) cantilevered bank with draped rootmats; (c) destabilized older surface and collapsing bank; (d) high, vertical bank with downstream slant to roots; (e) a gravel-cobbled paved bank toe below high terrace surface; (f) a gravel-cobbled paved and vegetated gradual sloping angled bank below active floodplain unit.

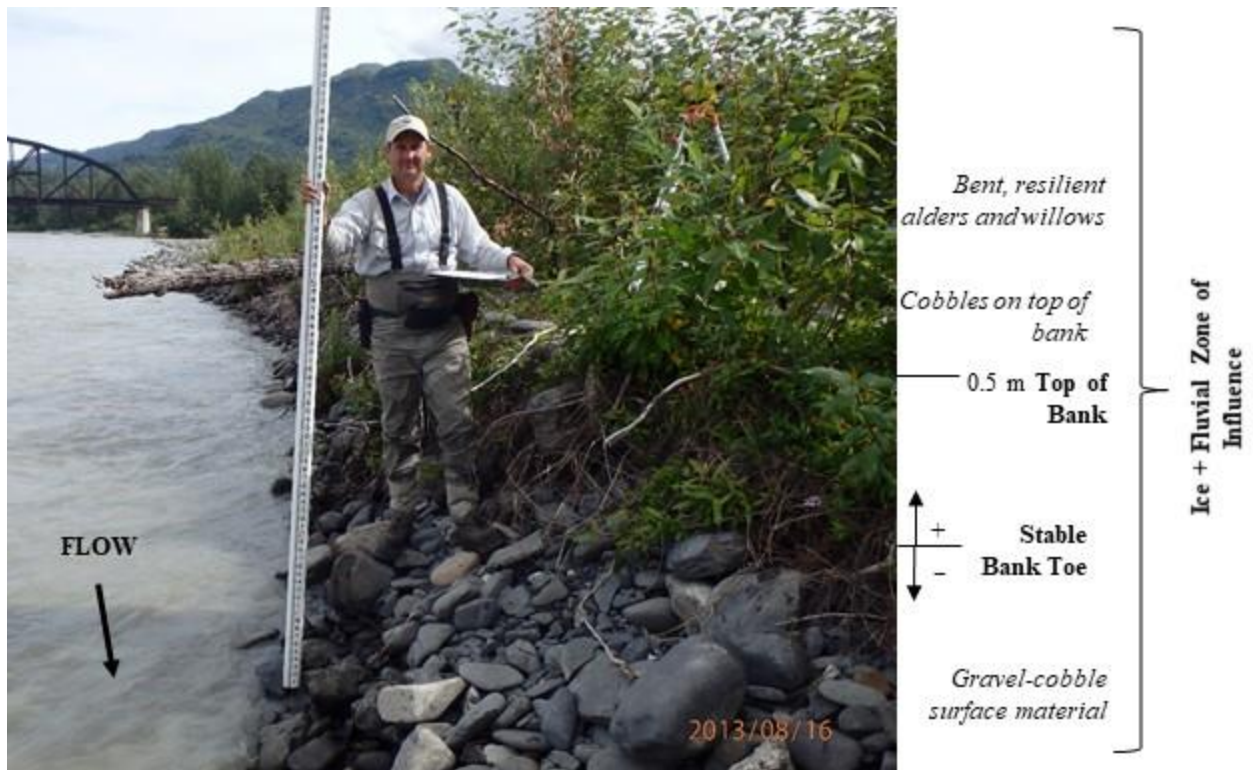
Figure 5-2. Schematic of low-gradual sloping bank on vegetated bar observed on the Middle Susitna River. Flow moving from top of photo to bottom of photo.

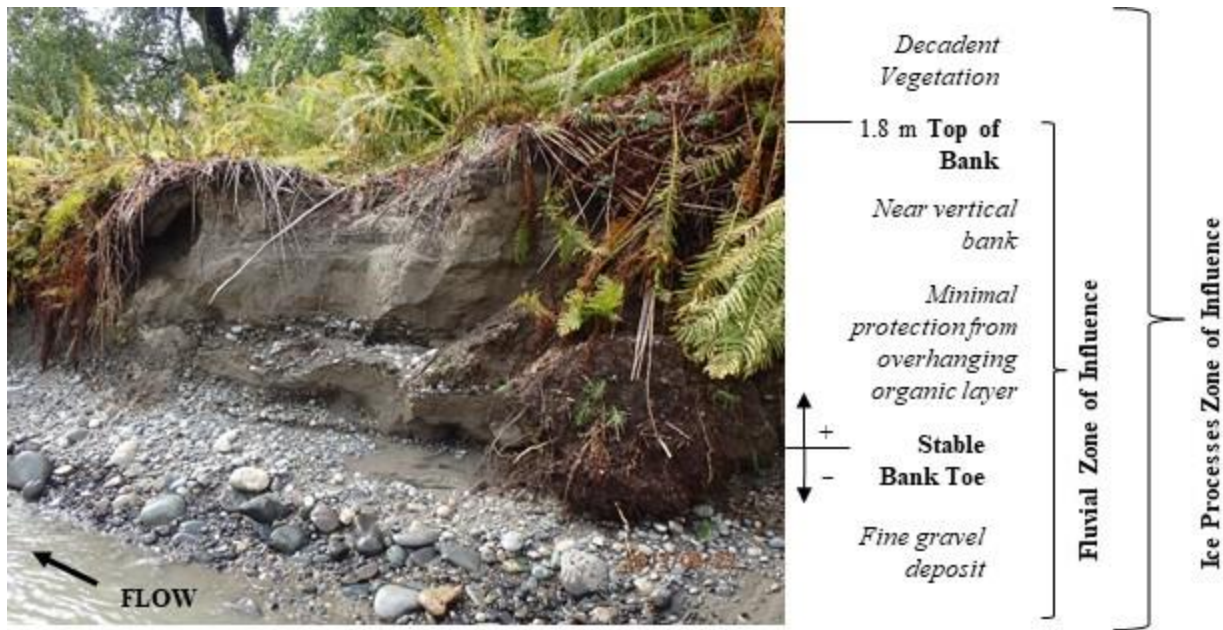
Figure 5-4. Schematic of vertical bank on old floodplain/terrace surface observed on the Middle Susitna River.

Figure 5-4 illustrates a vertical bank form; a common bank form on older geomorphic surfaces and terrace surfaces where there is little root-reinforcement to the upper bank layer. The bank is particularly susceptible to flowing ice-rubble or entrainment by water flow. In Figure 5-4, note the dry layer of bed material at the bank toe is absent of cobble; this condition could indicate removal of sediment particles by ice, or the coarser surface material could have been buried by a finer grained sediment deposit (possibly sourced from the basal gravel core in the adjacent bank).

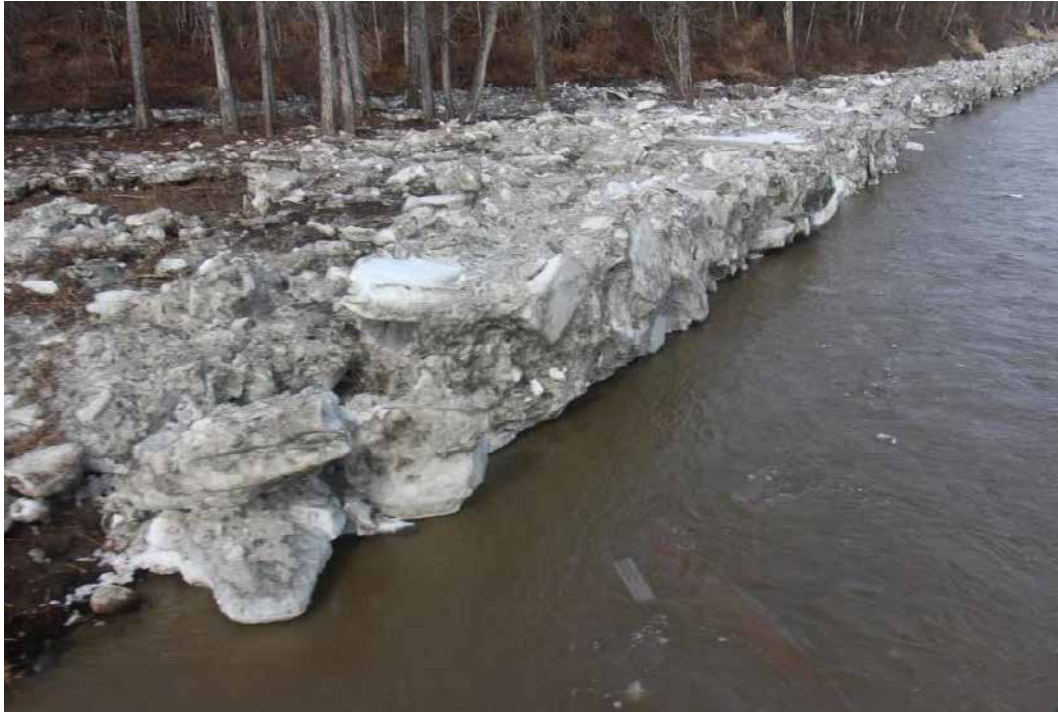
Figure 5-7. View upstream of shear wall of ice rubble along the Middle Susitna River near RK 174. Photo was taken by HDR Alaska, Inc., on May 5, 2014.

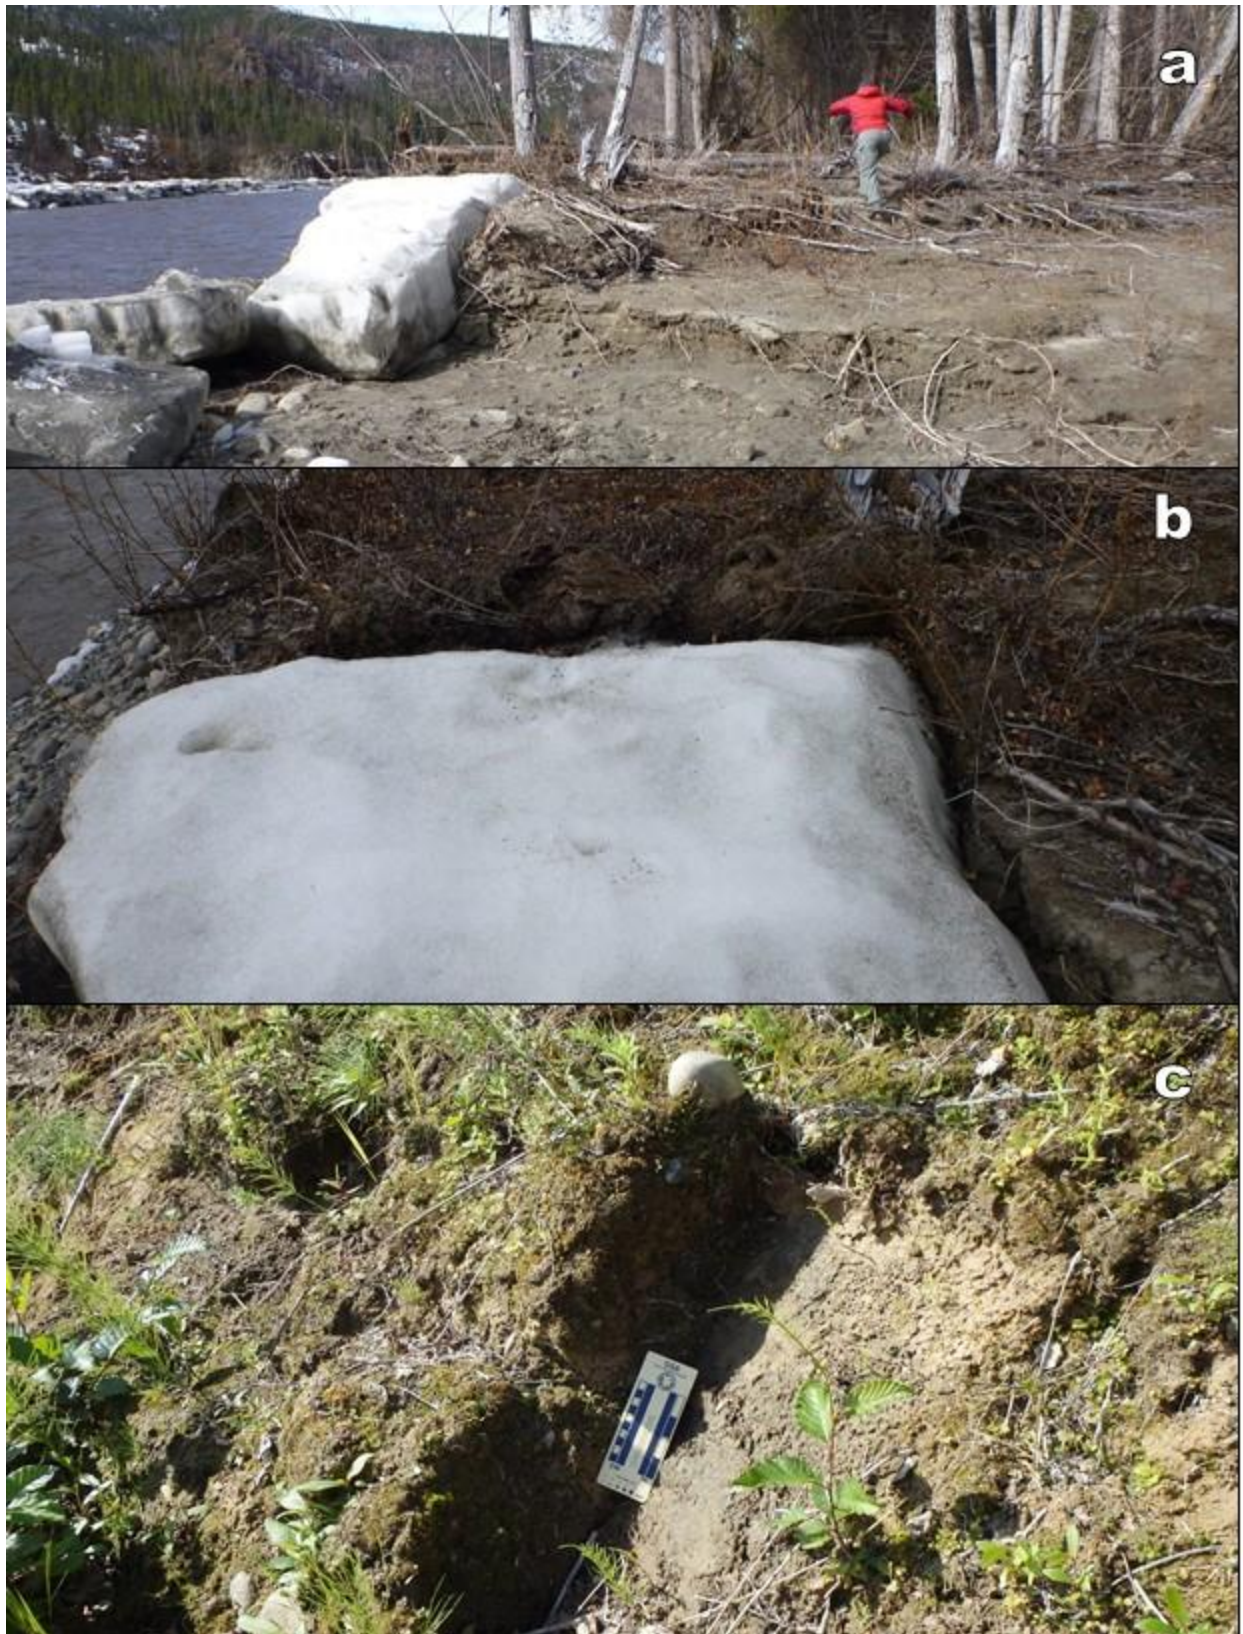
Figure 5-11. Illustrations of ice-block gouging: (a) and (b) are photos taken on May 5, 2012 of head of island at RK 299; and, (c) photo taken on July 23, 2013 of bank at RK 175.

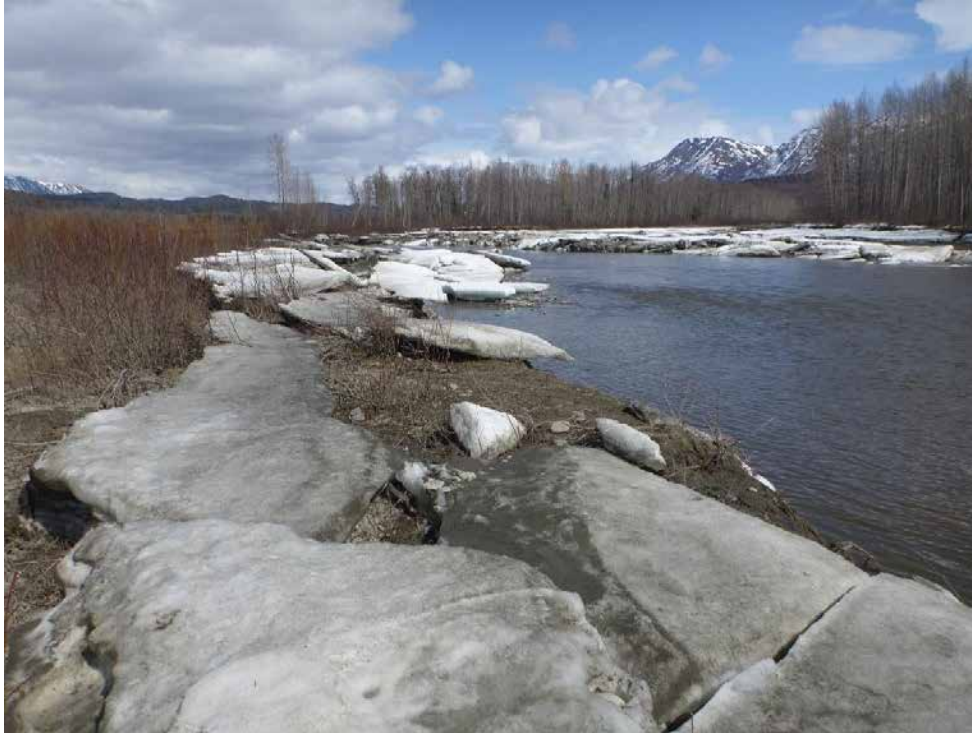
Figure 5-14. Ice floe ride-up on bank in May 9, 2012 causing minimal damage to overbank vegetation. This photo was taken by HDR Alaska, Inc.

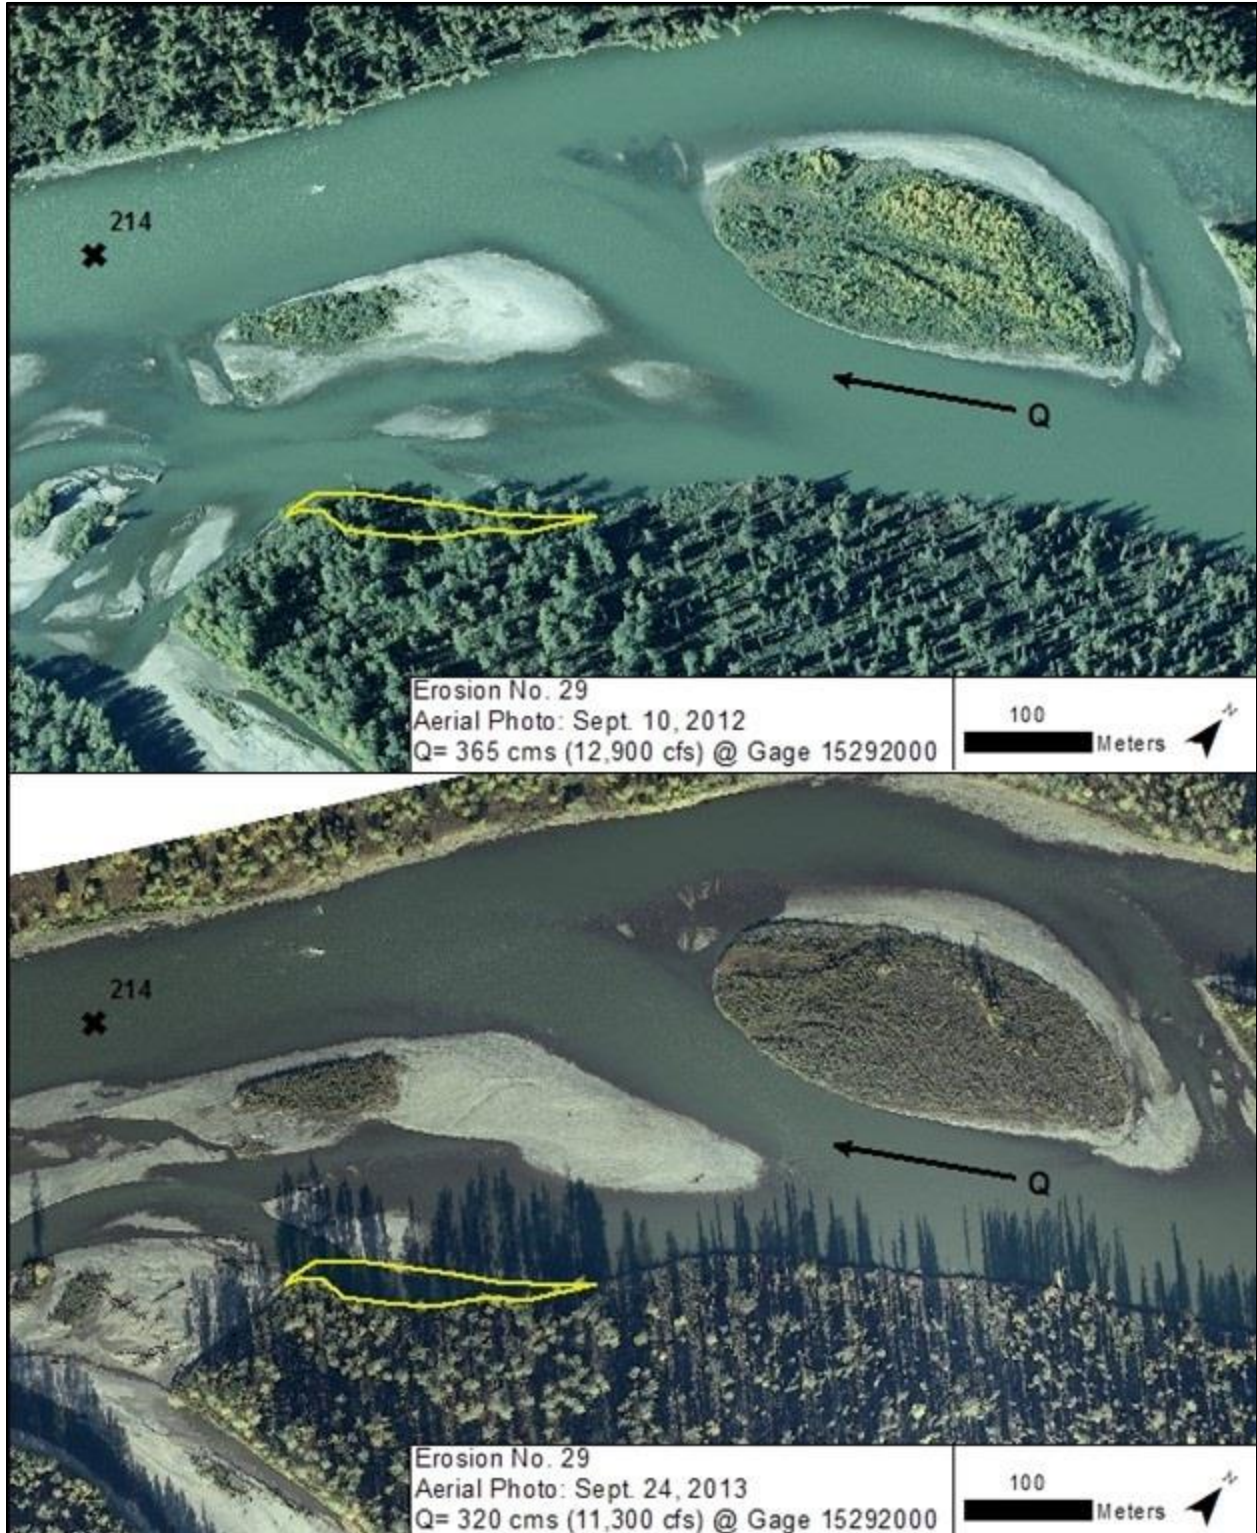
Figure 5-23. Erosion Location No. 29 in 2012 and 2013 aerial photographs. Note the shape of the bankline change from a convex to a concave shape.

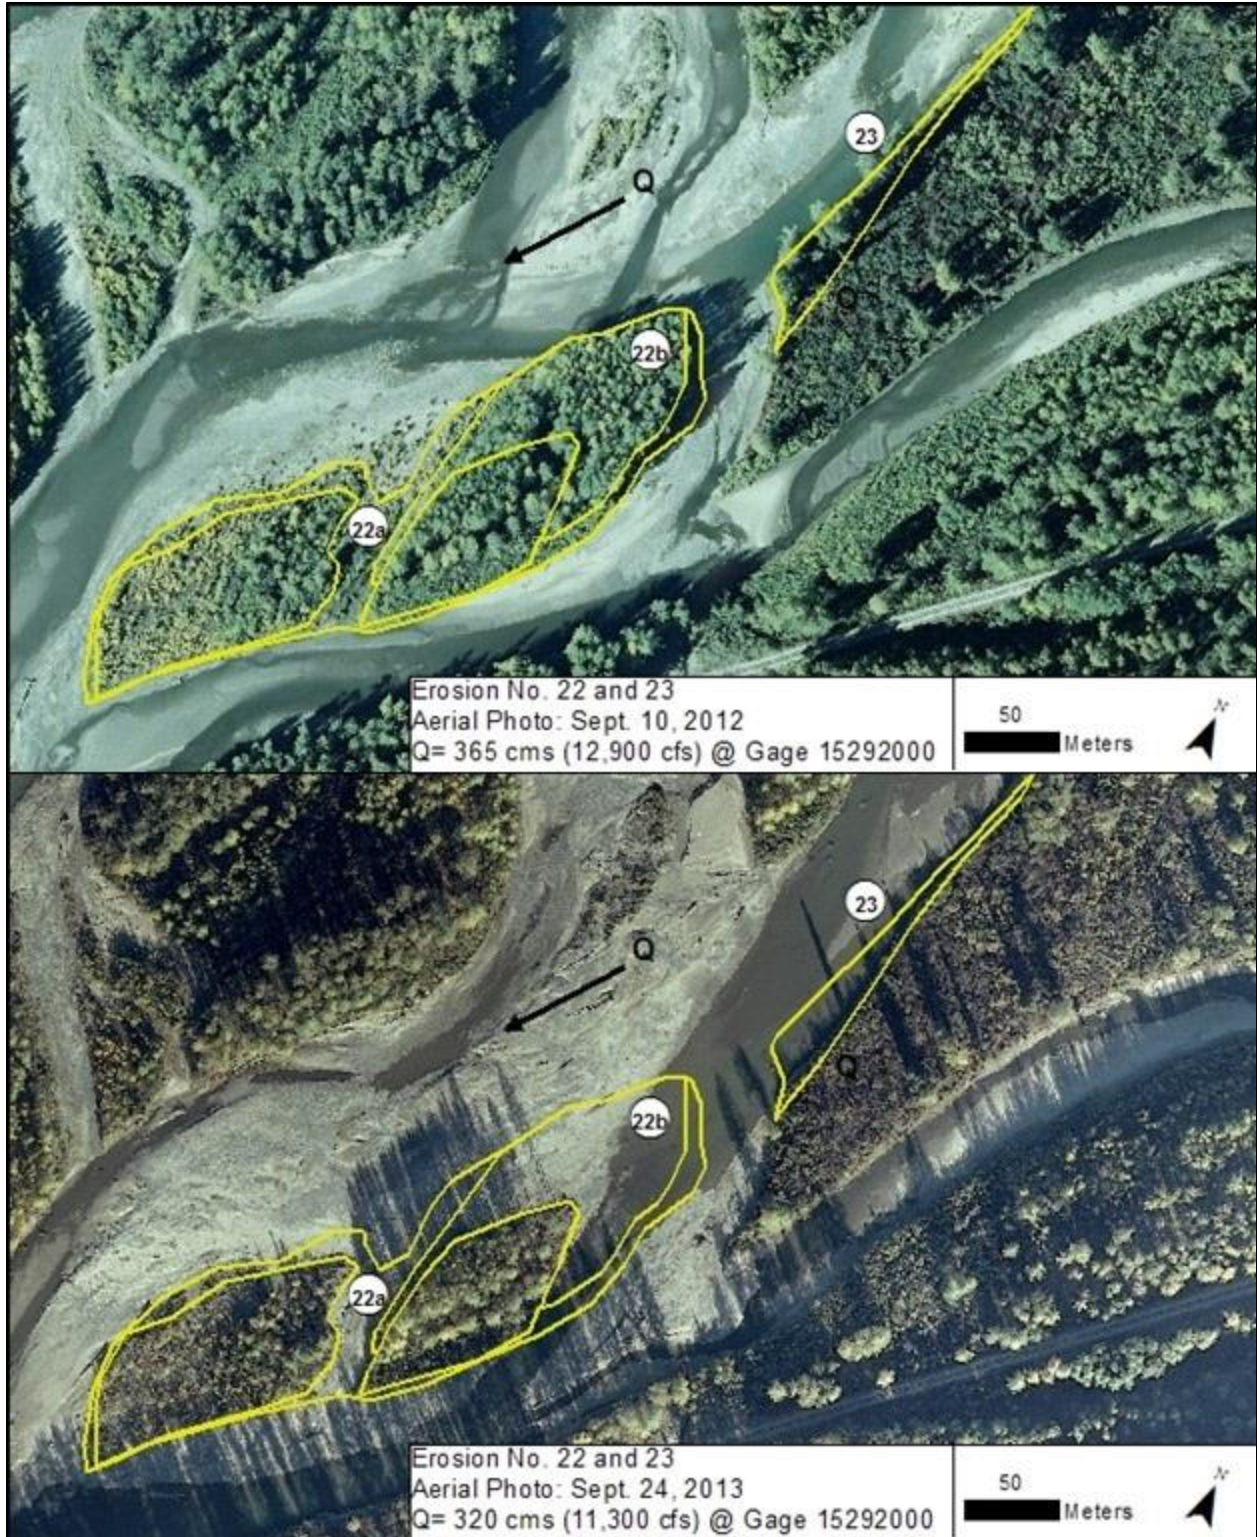
Figure 5-25. Erosion Location No. 22a (low-lying vegetation), No. 22b (mature vegetation), and No. 23 in 2012 and 2013 aerial photography.

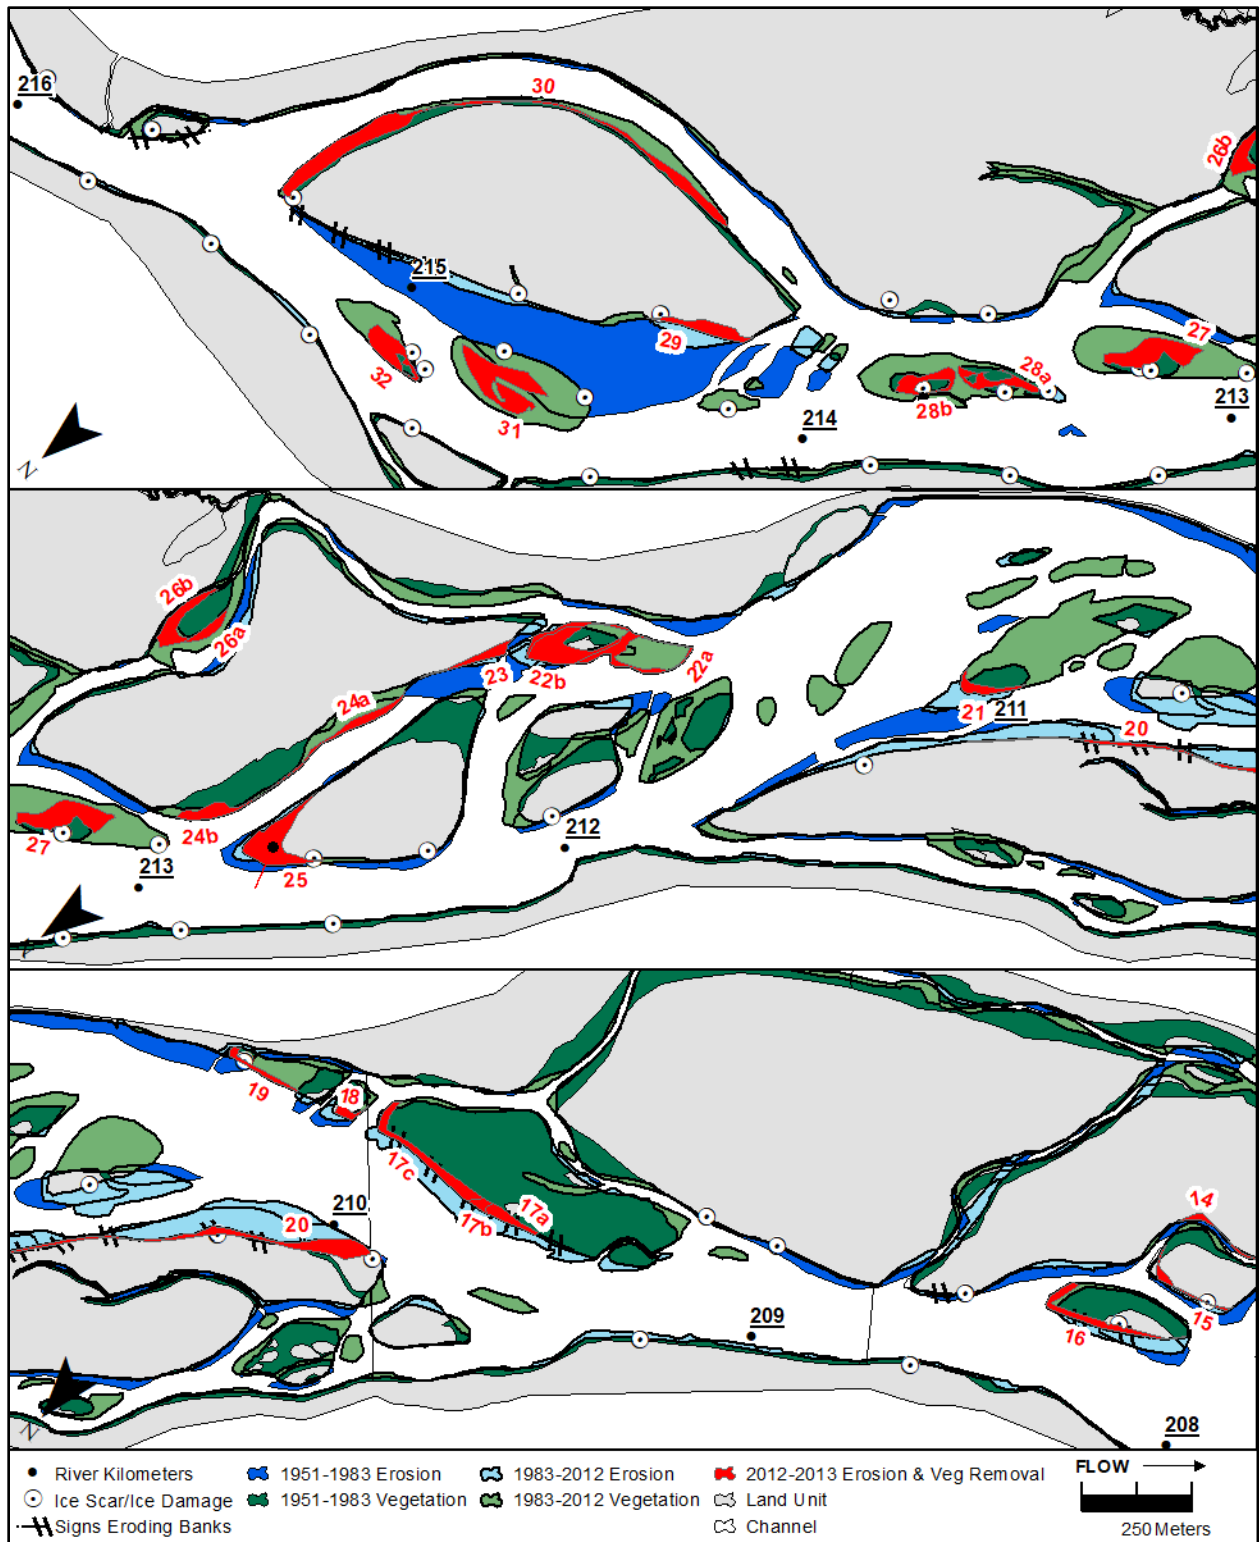
Figure 5-38. Long-term and short-term turnover mapping for Reach 6 RK 216 - RK 208. The red numbers indicate erosion locations between 2012 and 2013 (Section 5.2.2).

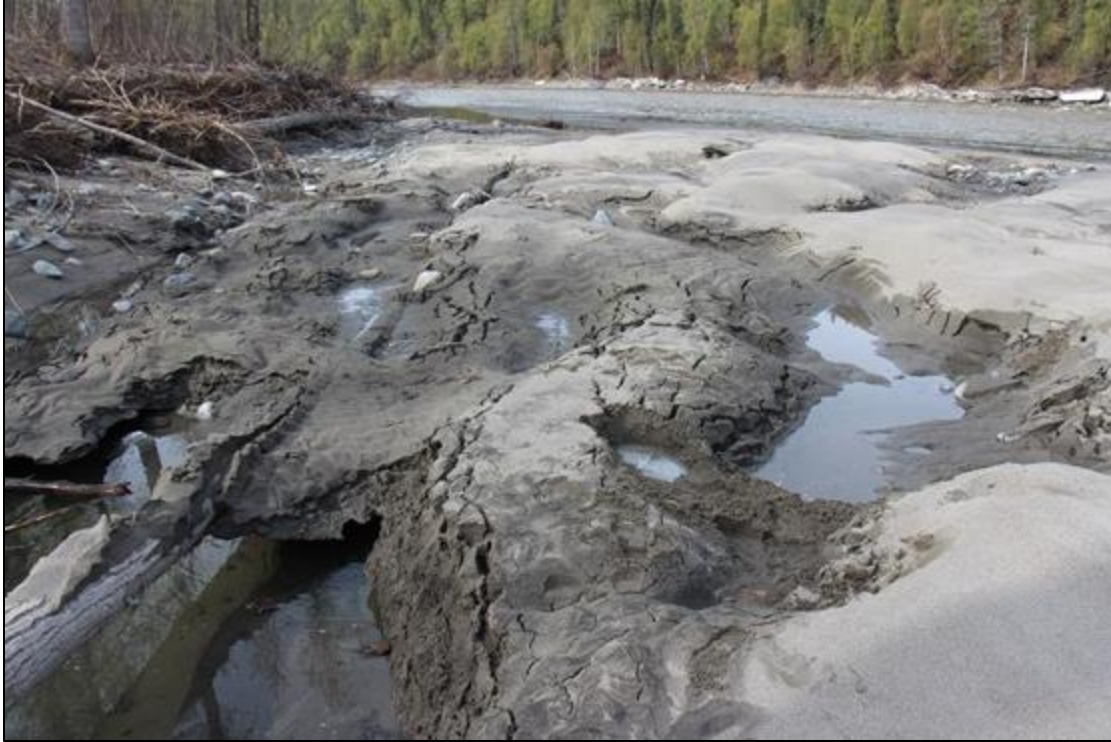
Figure 6-4. Sand aggradation from ice-induced flooding in Focus Area 128 during 2014 ice-breakup. Sand deposited on ice-cover which subsequently melted. (Photo courtesy of Jon Zufelt, HDR Alaska, Inc.).

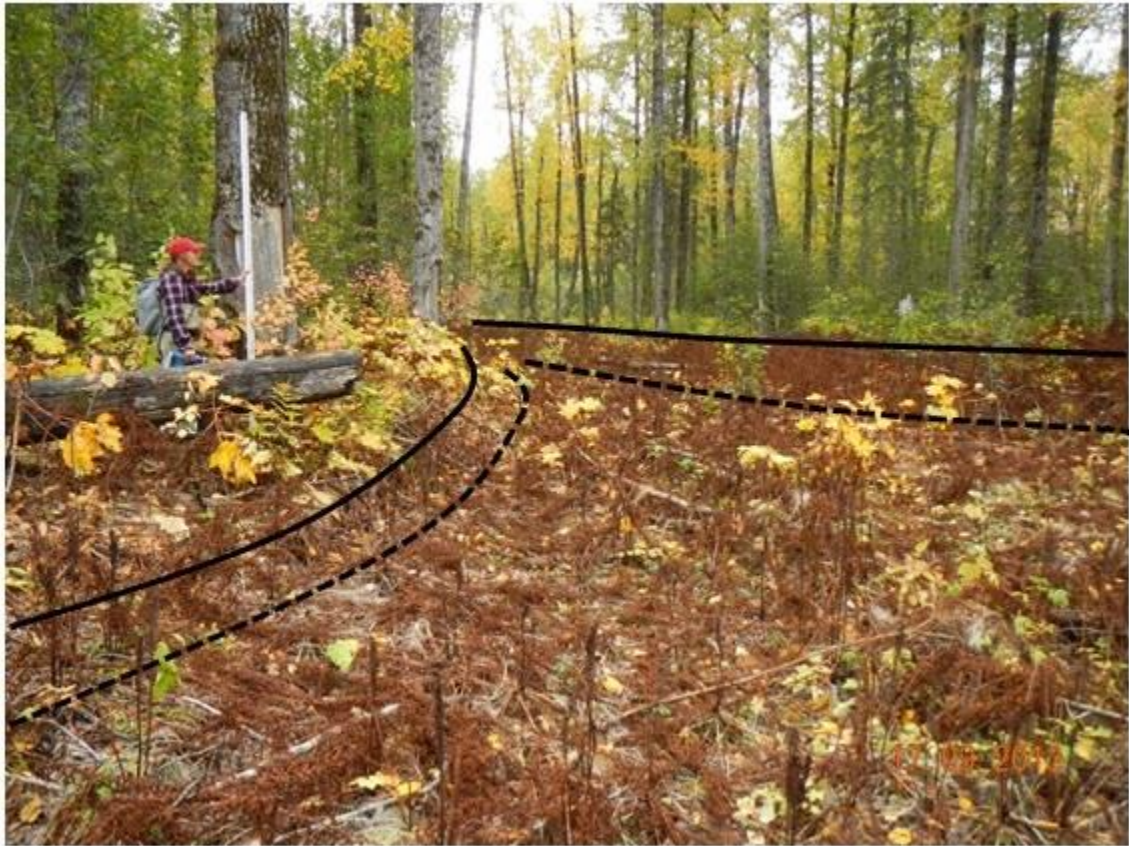
Figure 6-7. View down chute channel at RK 187 (shown by black arrows in Figure 6-6) with broken down vegetation and ice scars on trees up to 2m above ground level.

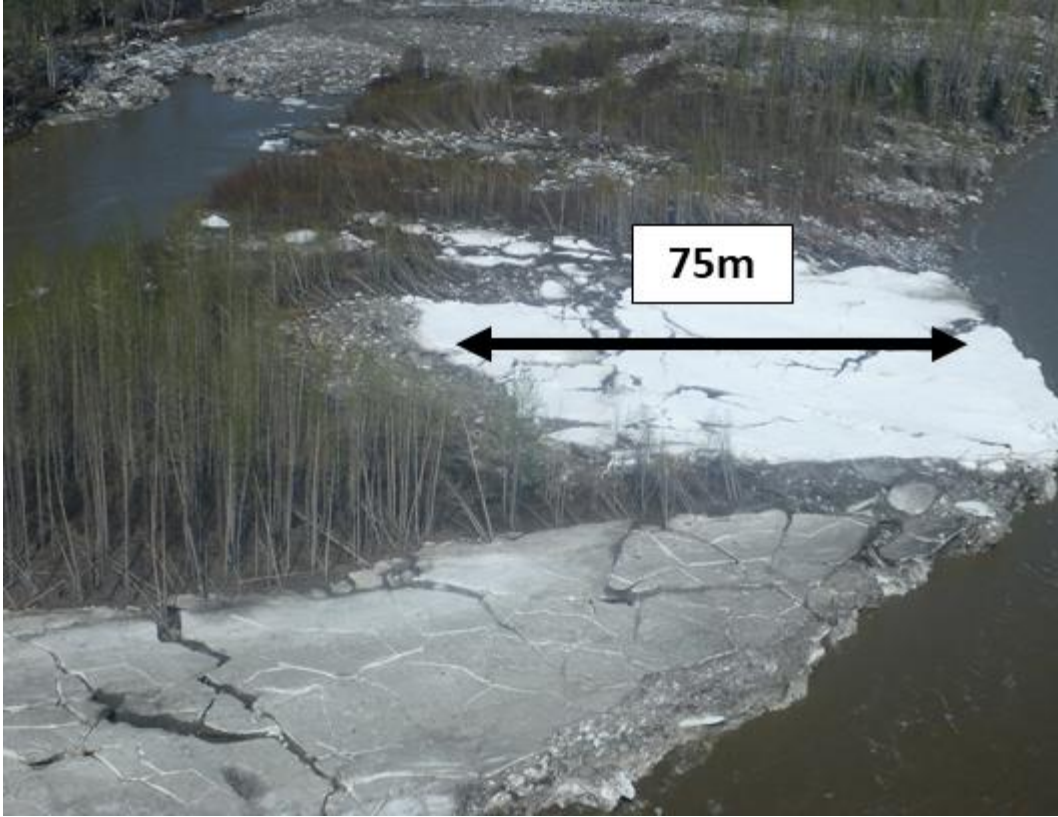
Figure C-2. Ice floes alided with and shoved over a vegetated bar in the Middle Susitna River. The ice floes failed in flexure, as the sheet-cracking indicates. This photo was taken May 29, 2013 by HDR, Inc.

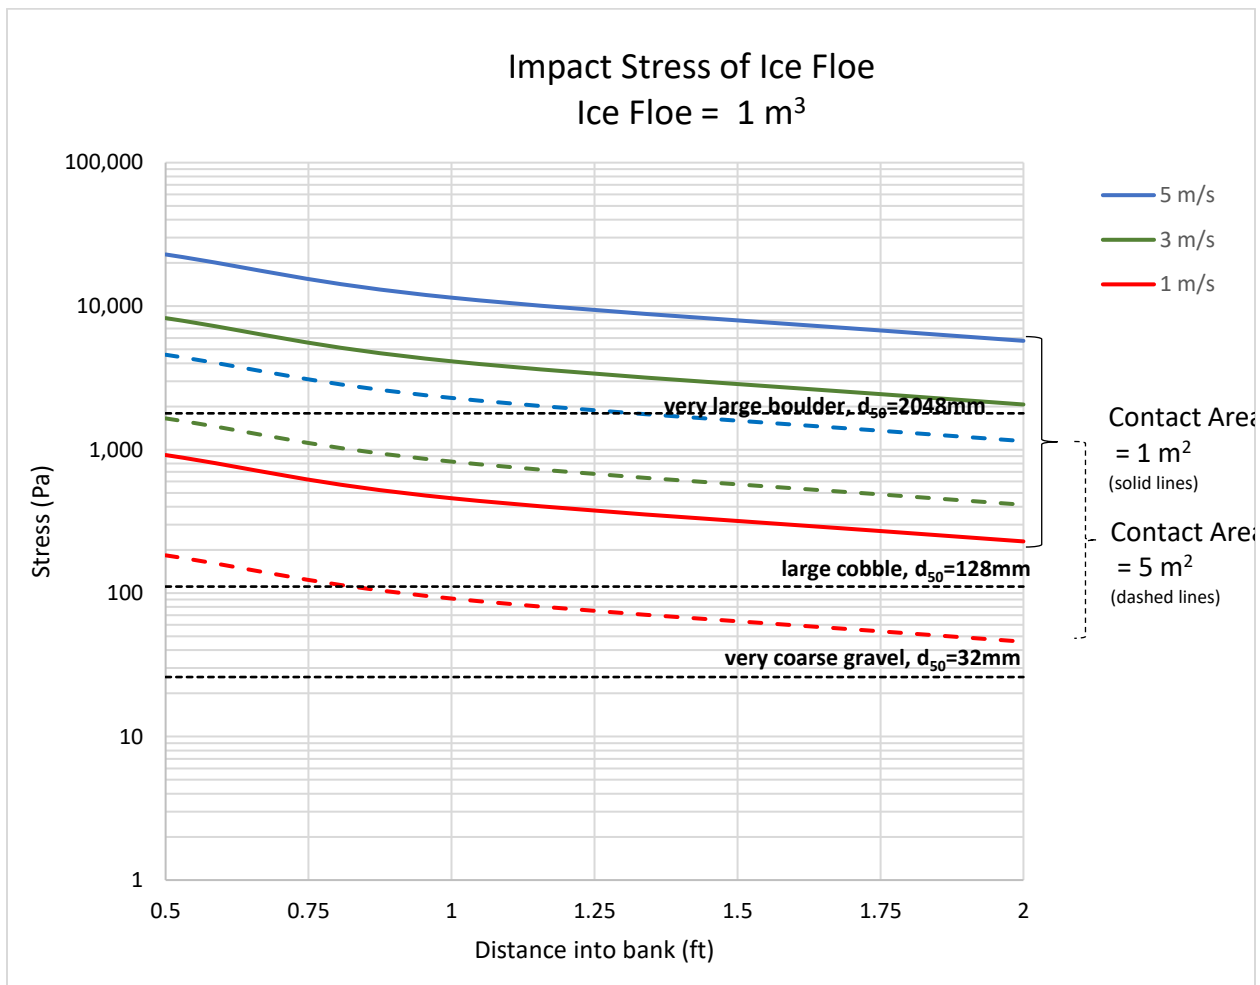
Figure C-4. Stress impact of a 1 cu. meter ice floe at varying velocities and contact areas.
