THESIS

THE ROLE OF DYNAMIC ICE-BREAKUP ON BANK EROSION AND LATERAL
MIGRATION OF THE MIDDLE SUSITNA RIVER, ALASKA

Renee A. Vandermause

Colorado State University

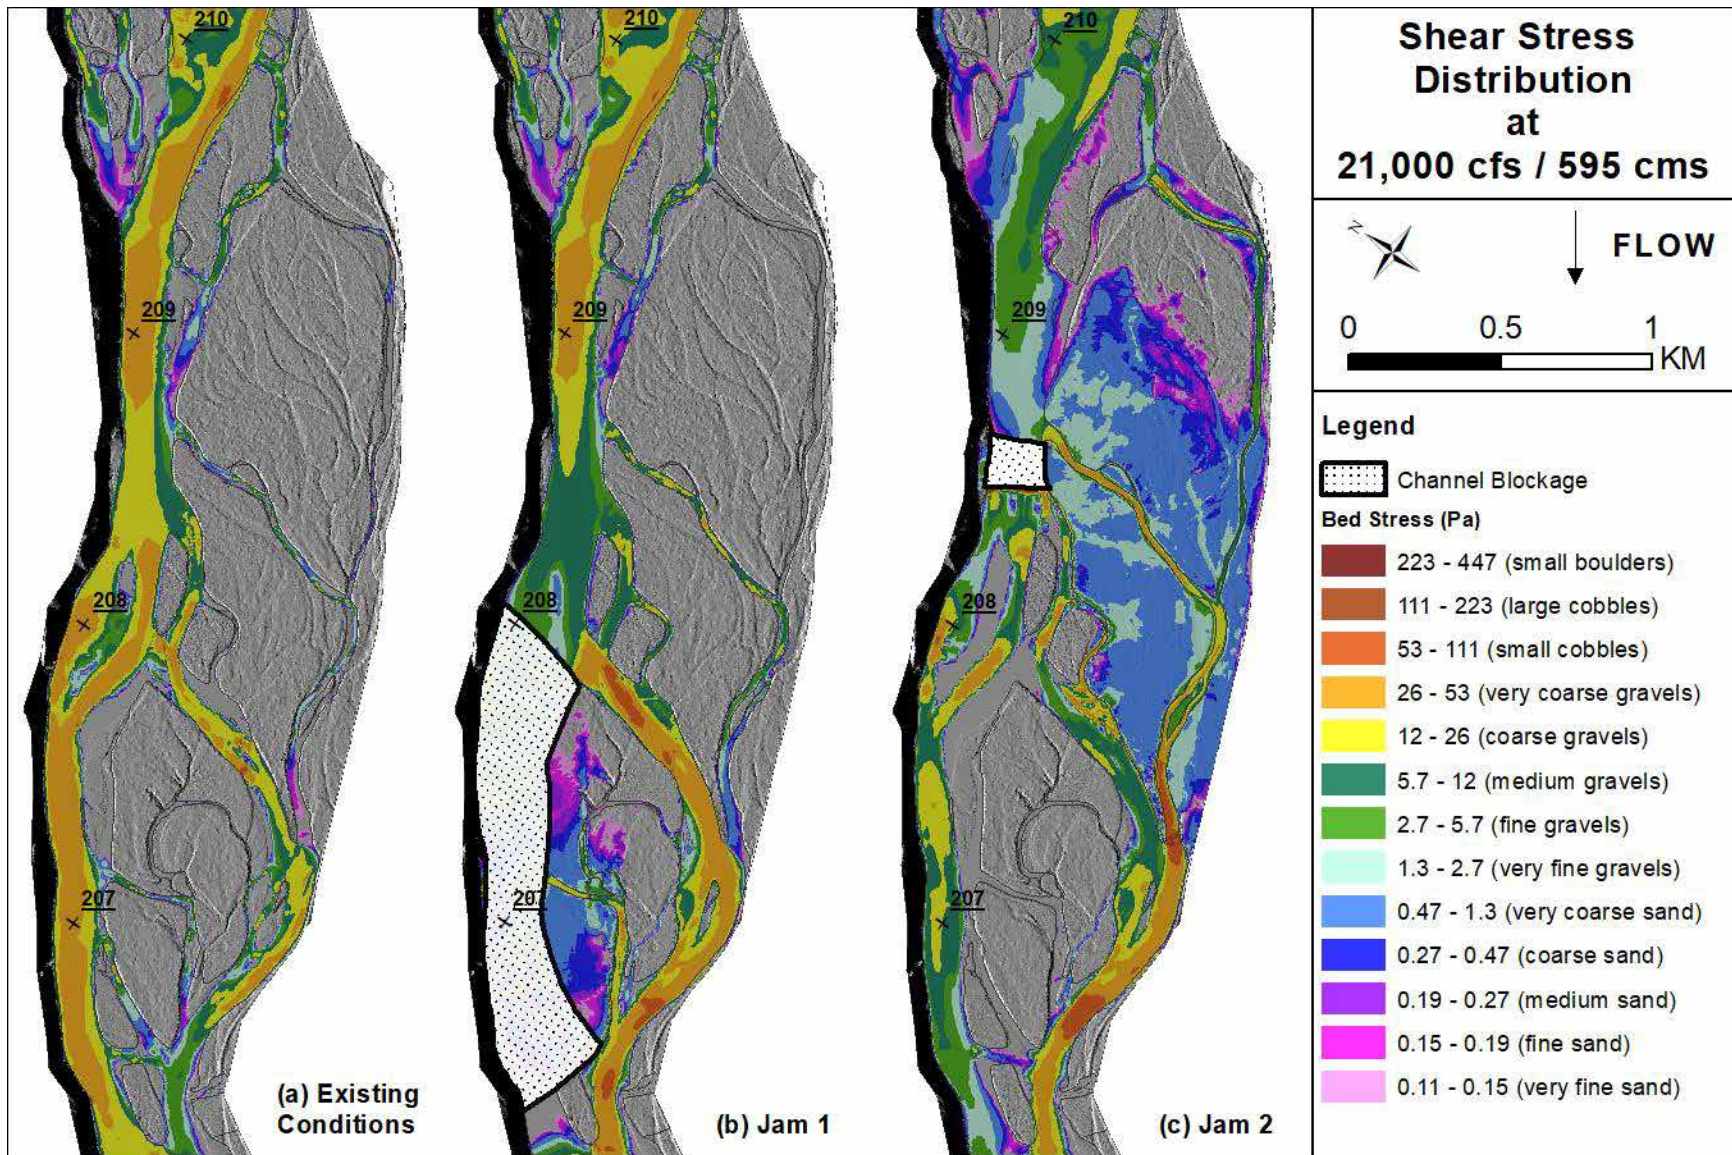
Figure D-7. Shear stress for two scenarios of flow diversion into secondary channels compared to existing condition at 595 cms.
