**REMOTE SENSING FOR INTERPRETING  
SOME ASPECTS OF THE ENVIRONMENT  
RELATED TO THE MT. ELBERT  
PUMPED-STORAGE POWER PLANT**

Morris M. Skinner  
and  
Dennis E. Dorratcague  
Colorado State University  
Fort Collins, Colorado 80521

September 1973

Prepared for  
BUREAU OF RECLAMATION  
Department of the Interior  
Denver, Colorado 80225

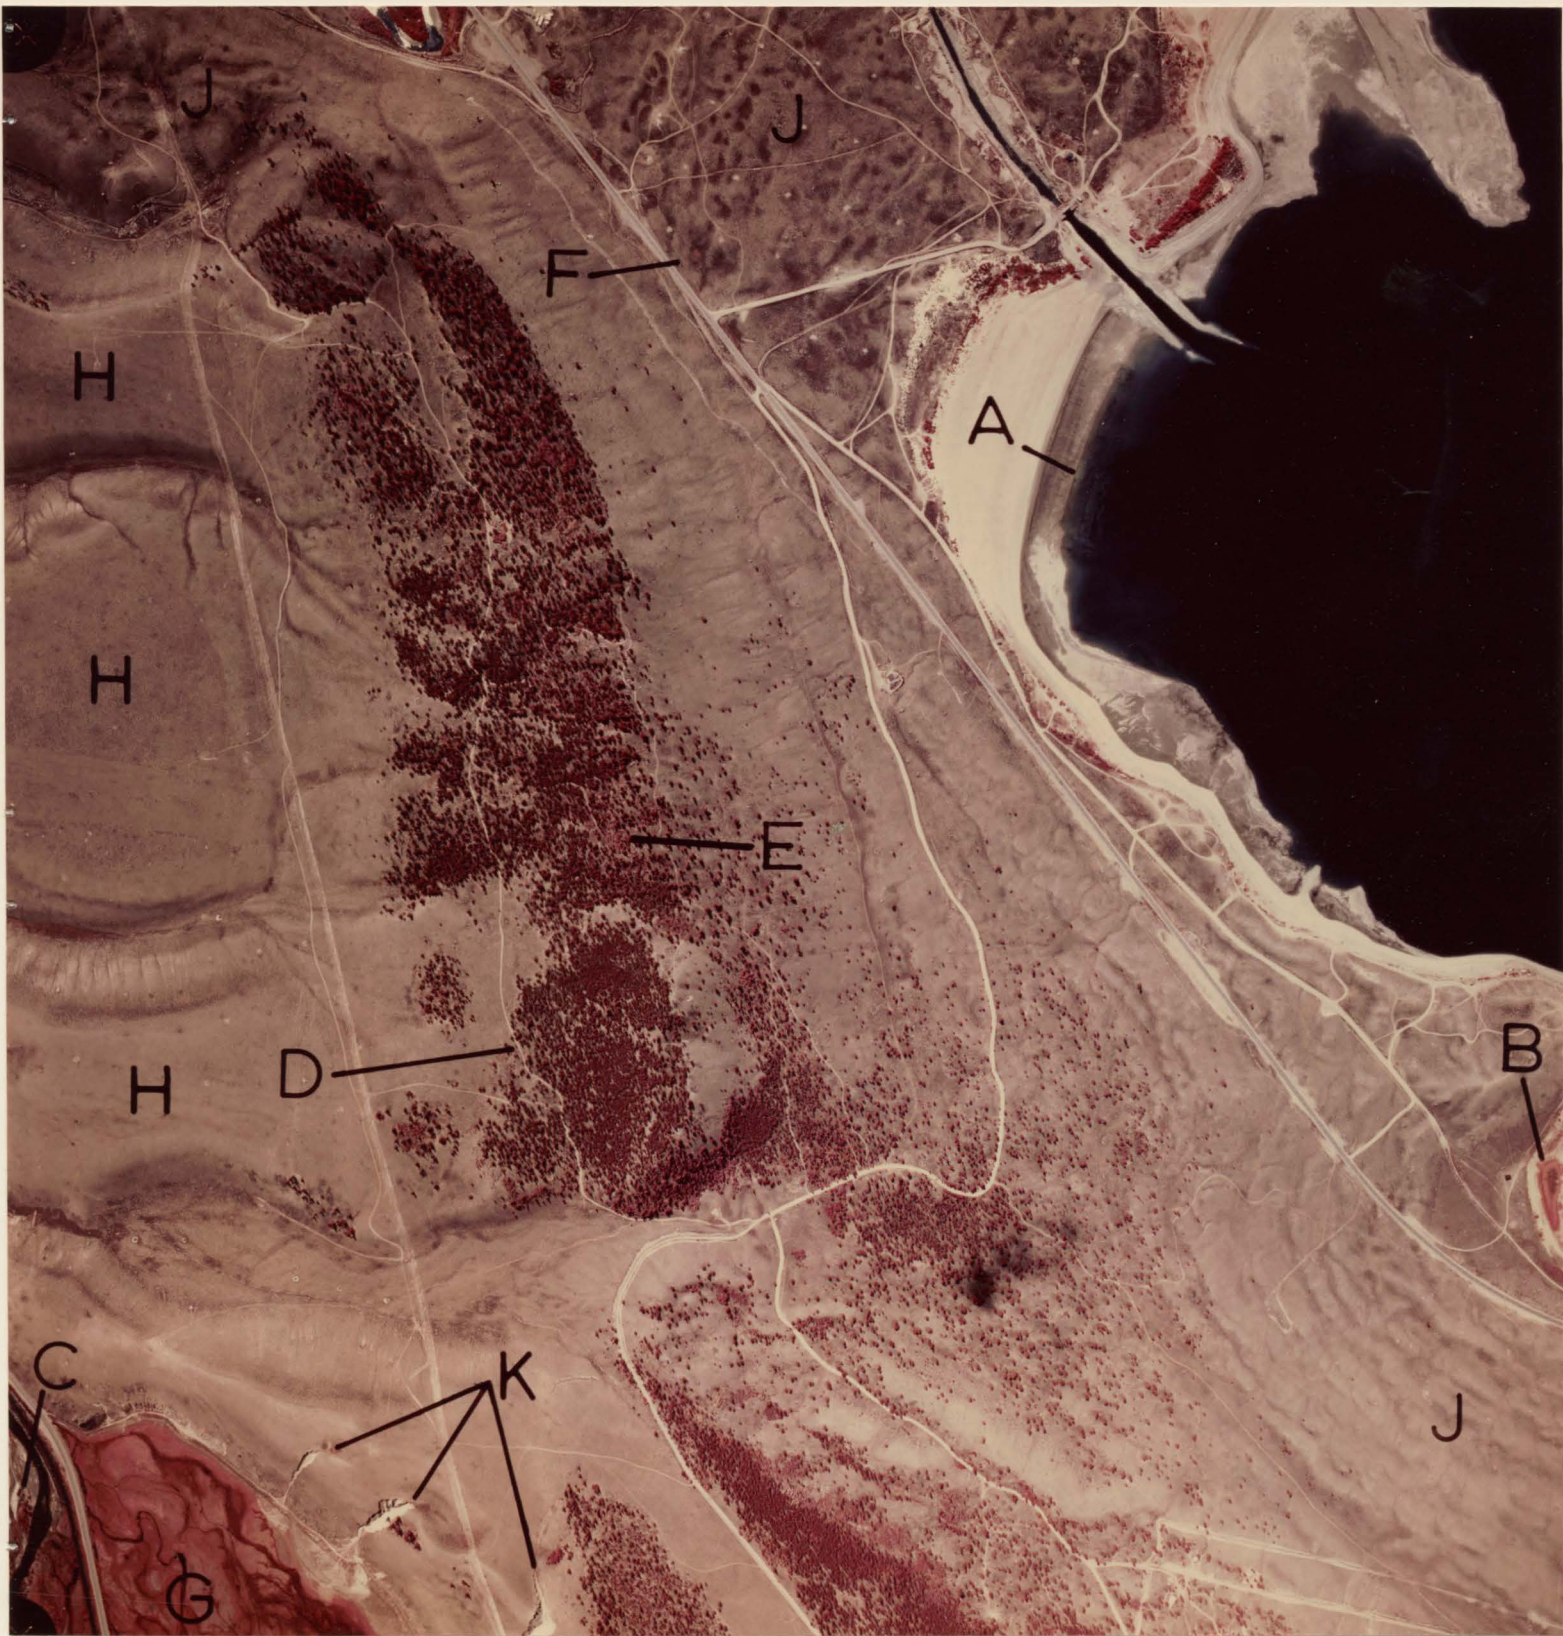
Fig. 2 - Color Infrared Photograph #7841

Fig. 2 displays a variety of vegetative species including aquatic vegetation, both submersed and bank type, willows, pines, aspens, sagebrush, grass, and hay meadow.

Aquatic vegetation was identified as chara (stonewort) mixed with a small representation of one species of pondweed. These plants were found in the shallow region adjacent to the bank line near the outlet of lower Twin Lakes, and are identified as position A on the photograph. Position B indicates the location of aquatic vegetation identified as smartweed (Polygonum spp.), an emergent aquatic weed.

Willows, identified at location C, have a characteristic color and shape and are generally found along stream banks or areas of high moisture availability. The conifers at location D have a characteristic pointed top and dark red color. Conifers also are identified as single units whereas willows grow in clusters. Aspen growth, identified at location E, is characterized by color and is often found within stands of conifers or in isolated patches or in bands corresponding to available moisture and soil conditions at certain elevations. Color changes are particularly noticeable in the fall. During the winter season and in the early spring the aspen is free of leaves and can be identified by that characteristic. The aspen also has a characteristic shape and texture.

Typical sagebrush areas are identified at F. Sagebrush in this area is identified by color, texture, and pattern. At certain times of the year the sagebrush can take on a red color, but on this photograph the plant is generally green to dark green.

The marshy meadow area, shown at location G, has a brilliant red color corresponding to lush, green vegetation. The darker colors within the meadow are very wet areas or areas where some of the vegetation is dead. Open water areas, that are relatively clear, appear dark on the color infrared photography.

Terrace and moraine areas are indicated at locations H and J, respectively. These two areas can be distinctly identified by shape and pattern. Three terrace locations are identified, and three areas of moraines are identified.

Three examples of erosion and extensive head cutting are shown at location K. This erosion process seems to stem from the topographic depressions located at the uphill end of the erosion channel. Snow-melt water from these depressions coupled with both the saturated condition of the slope during the thaw and the fine soil material produced a very dramatic erosion area. These

### Vegetation: Fig. 2; Reference color infrared photograph #7841

Grass cover exists in the areas of the sagebrush cover, but, at this time of the year, is relatively dormant and consequently appears green to very light green. In areas where moisture is available the grass can take on a red color which indicates green vegetation.

The meadow area at G describes an area where there is high moisture availability; this feature can often be used to identify the flood plain limits of river valleys, especially during the growing season.

types of indicators point out the instability of the soil, particularly under saturated conditions and sparse vegetative cover. Excavations involving steep side-slopes, particularly where the moisture content might be high or where moisture content might increase periodically, should be avoided in areas exhibiting such instability characteristics. The fine textured material of this area has a characteristic light tone on color infrared photography when it is dry.

Twin Lakes is relatively clear and free from suspended material. This condition is characterized on the photography by the dark color wherever the depth is greater than a few feet. Experience has shown that color infrared film can be used to identify bottom features in shallow, clear water, however.

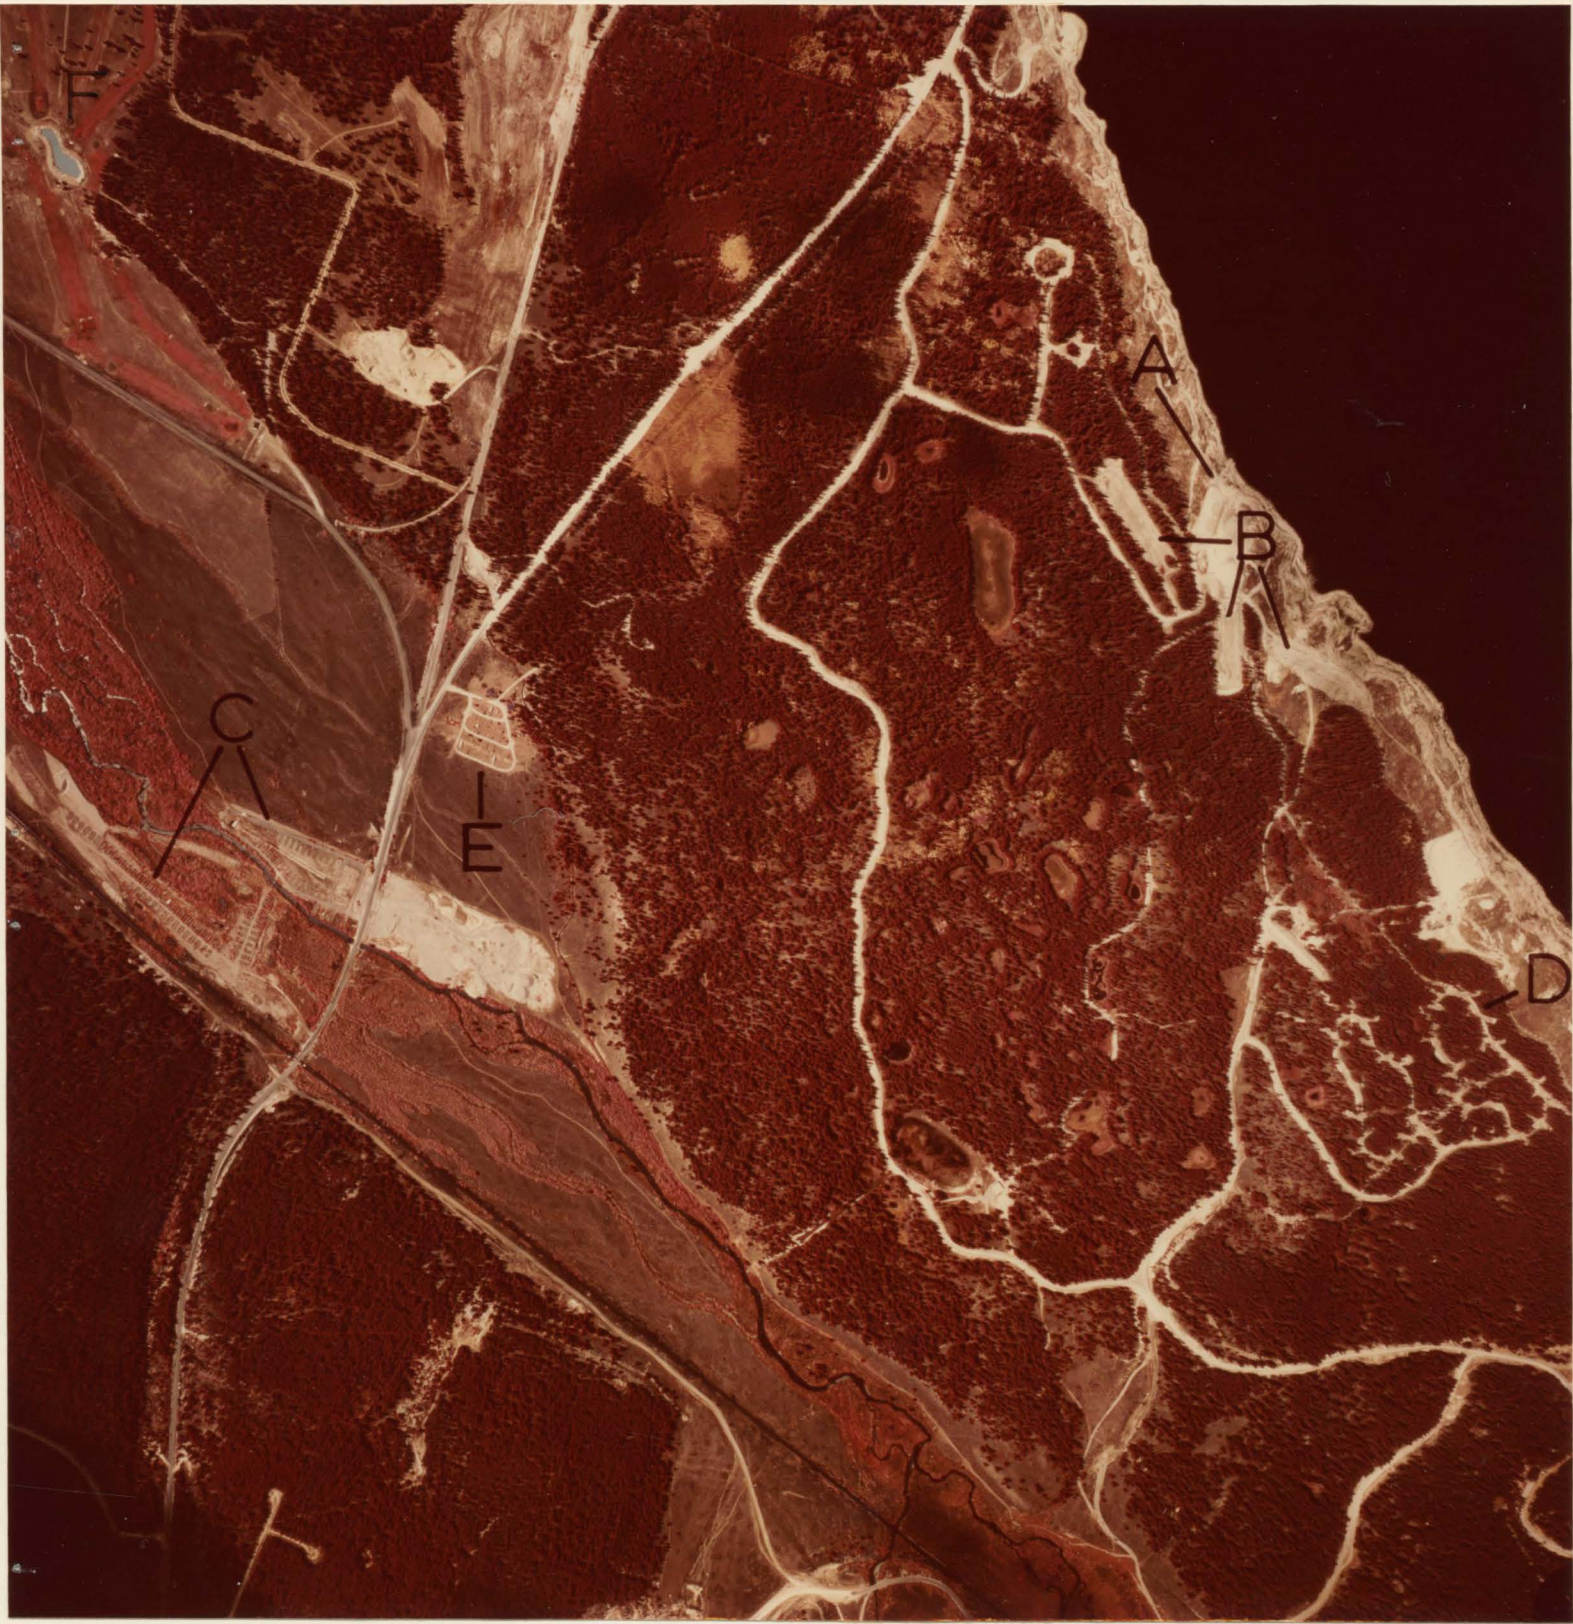
Fig. 3 - Color Infrared Photograph #8687

The following interpretation relates to certain specific aspects of recreational use. Location A shows the construction site for a boat ramp, and the accompanying parking lot is at B. Suitable water depths for launching boats can be identified with color infrared photography; and, conversely, the shallow areas along a bank line can be identified by the light-blue color near the shoreline, see Fig. 1. The topographic relief along the banks can be identified by stereo observation of adjacent, overlapping photographs.

Trailer park patterns are of a variety of different types. One example is shown at location C. This particular area has been used by transient labor forces and very few of the trailer houses remain, but the foundations and trailer pads are still in evidence. Trailers and camper counts can be accomplished with relatively small-scale color infrared photography.

The forest service campground shown at location D identifies the road network, the camp locations, and the general environmental conditions of the campground. Stereoscopic observation of such locations can facilitate the design of the drainage system, identify possible hazards due to flash flooding, and locate other potential hazards to campground users. The color

Location E identifies an area where an individual operator has set up a parking area for campers. This is characterized by unusually high camper density, very little consideration for aesthetics, and a lack of trees. A few campers are in the parking area at this time and it is possible to identify individual campers and trailer houses.

Location F identifies a golf course, and the location of the fairways are enhanced by the red tone due to the green vegetation. An example of impaired water quality is located in this area. The pond located just to the left of the letter F has a characteristic light blue color which generally indicates relatively high turbidity.

Recreation: Fig. 3; Reference color infrared photograph #8687

Tree species in this photograph include pine, aspen and willow. The willows are located adjacent to the stream bed. The pines are the predominate tree species and are characterized by their darker red color and conical shape. A few aspen are intermingled among the conifers, and, at this time of the year, are experiencing some color change.

Roadway surfaces are identified by their color. The asphalt roads are characterized by dark color, and the roads with aggregate surfacing have a very light tone.

The color infrared photography affords the opportunity to view relatively heavy willow cover areas and judge where the bank line would be accessible for fisherman. In addition, the characteristics of the stream can be evaluated more effectively since pools and crossings and width characteristics are in evidence. Generally, under magnification the depth distribution in a channel can be interpreted. Recent sediment deposits such as point bars or alternate bars can be identified by the light color, which generally indicates an unstable stretch of river; whereas the bars that are vegetated indicate areas of greater stability.

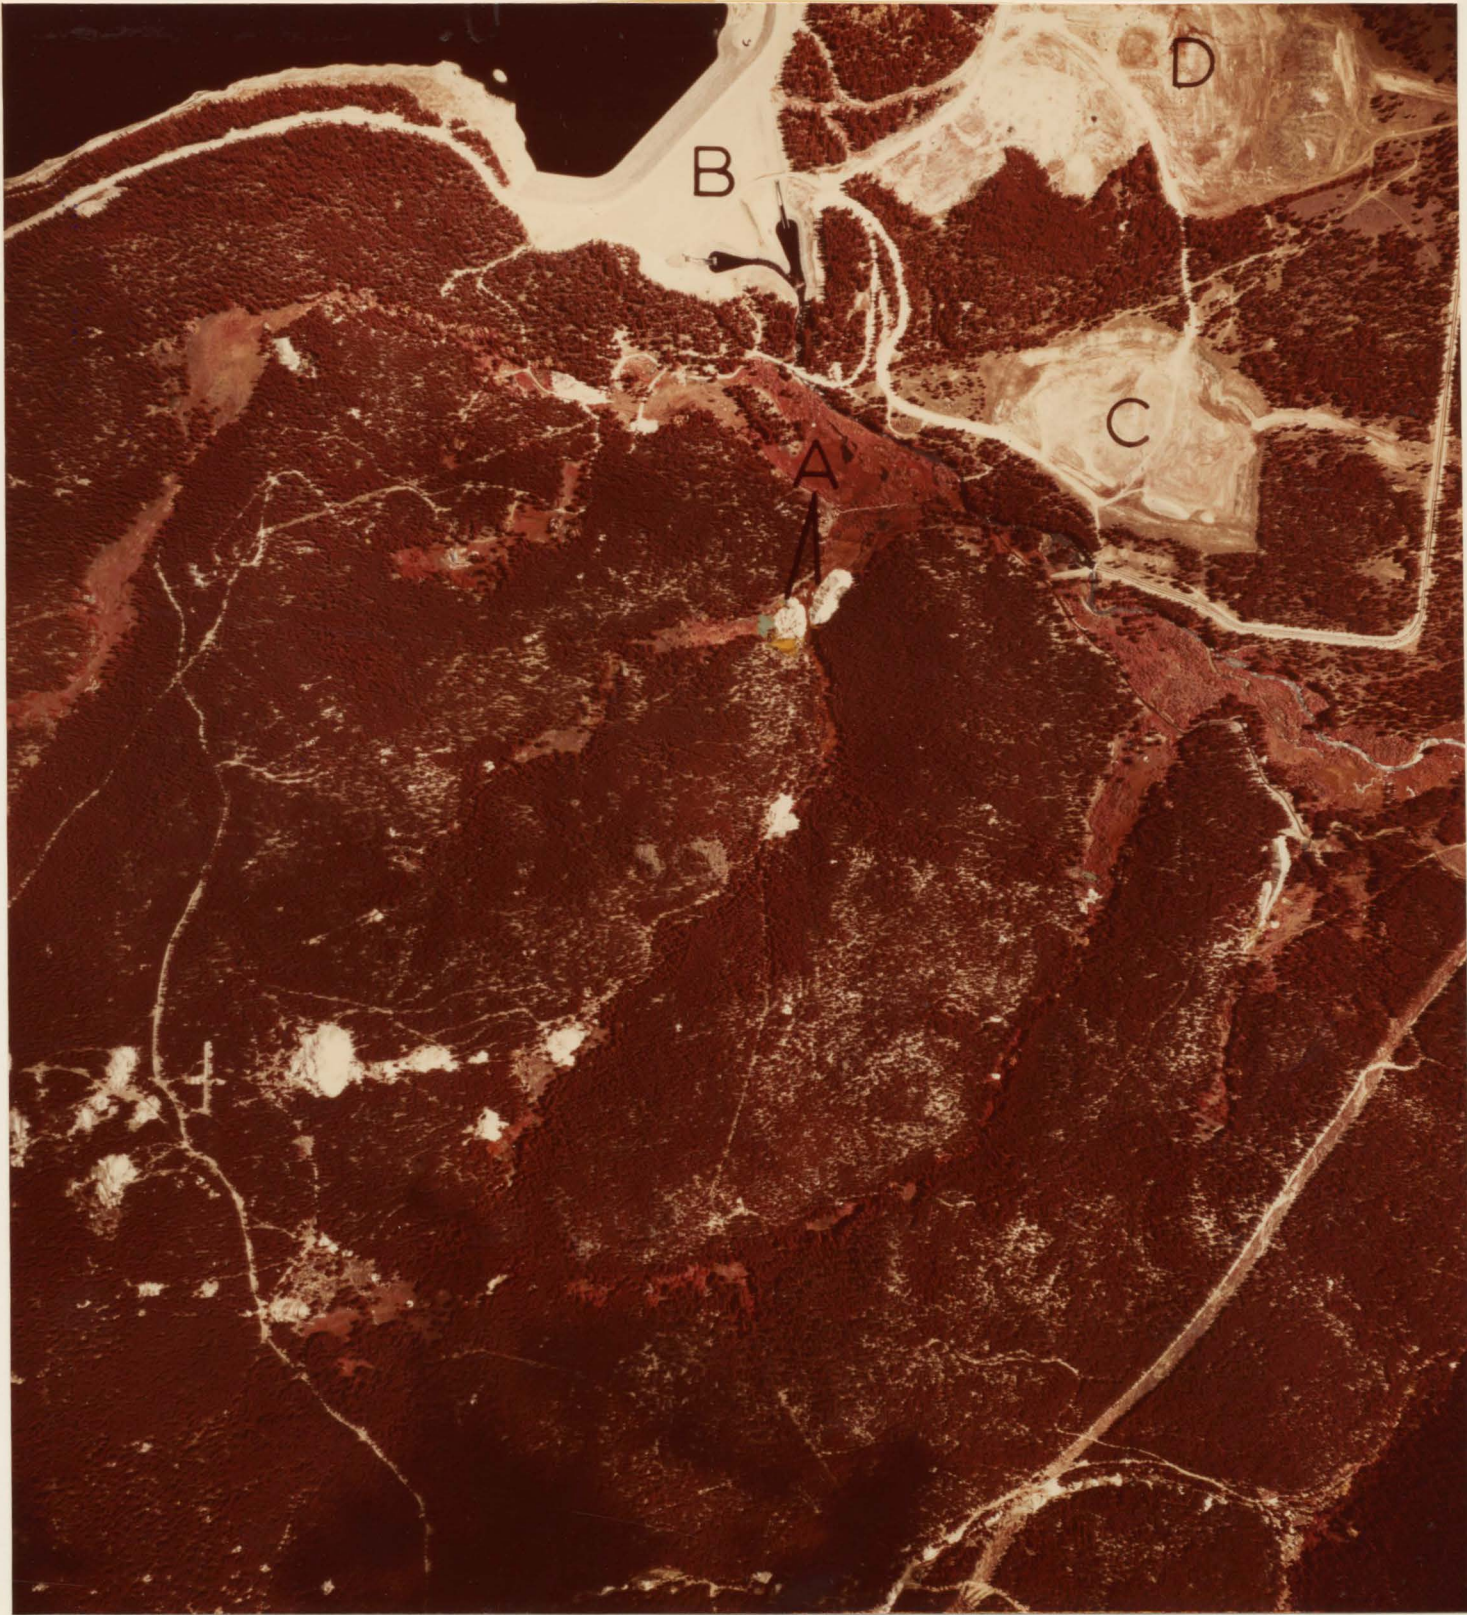
Fig. 4 - Color Infrared Photograph #8698

In the vicinity of Leadville, Colorado there is a history of extensive mining operations and exploration. The color infrared photography can be used to identify some mining operations and exploration pits. For example, mine tailings are indicated at point A. The two tailing piles are evidenced by the light colored material, and the main drainage ponds are indicated by their dark turquoise color. Upon closer examination of this area, there is another small holding pond on top of the tailings, and one can observe the leakage out of this pond through a portion of the tailings and into the tributary streams. Mine waste water and water leaching through mine tailings can often introduce serious water quality problems and alter the surrounding environment.

Location B identifies the dam on Turquoise Lake. A large excavation pit at point C and an area at D where the cover has been removed is shown on the photograph. Such excavation areas and stripped areas often devalue the environmental quality of such areas and efforts are being made to restore such areas to their natural state in new construction by the Bureau. Color infrared photography can be used very effectively to evaluate such damage and to monitor the repair operations.

#### Mining Operations: Fig. 4; Reference color infrared photograph #8698

Open shafts and pits provide a tremendous hazard to users of recreation sites. The color infrared photography can be used very effectively to locate such potential hazards. Many light colored areas, that indicate mining operations, can be noted in this photograph. Access roads to these various mining operations and test pits are in evidence and considerable amount of damage appears to have been done to the landscape, including the grass cover and the various tree species.

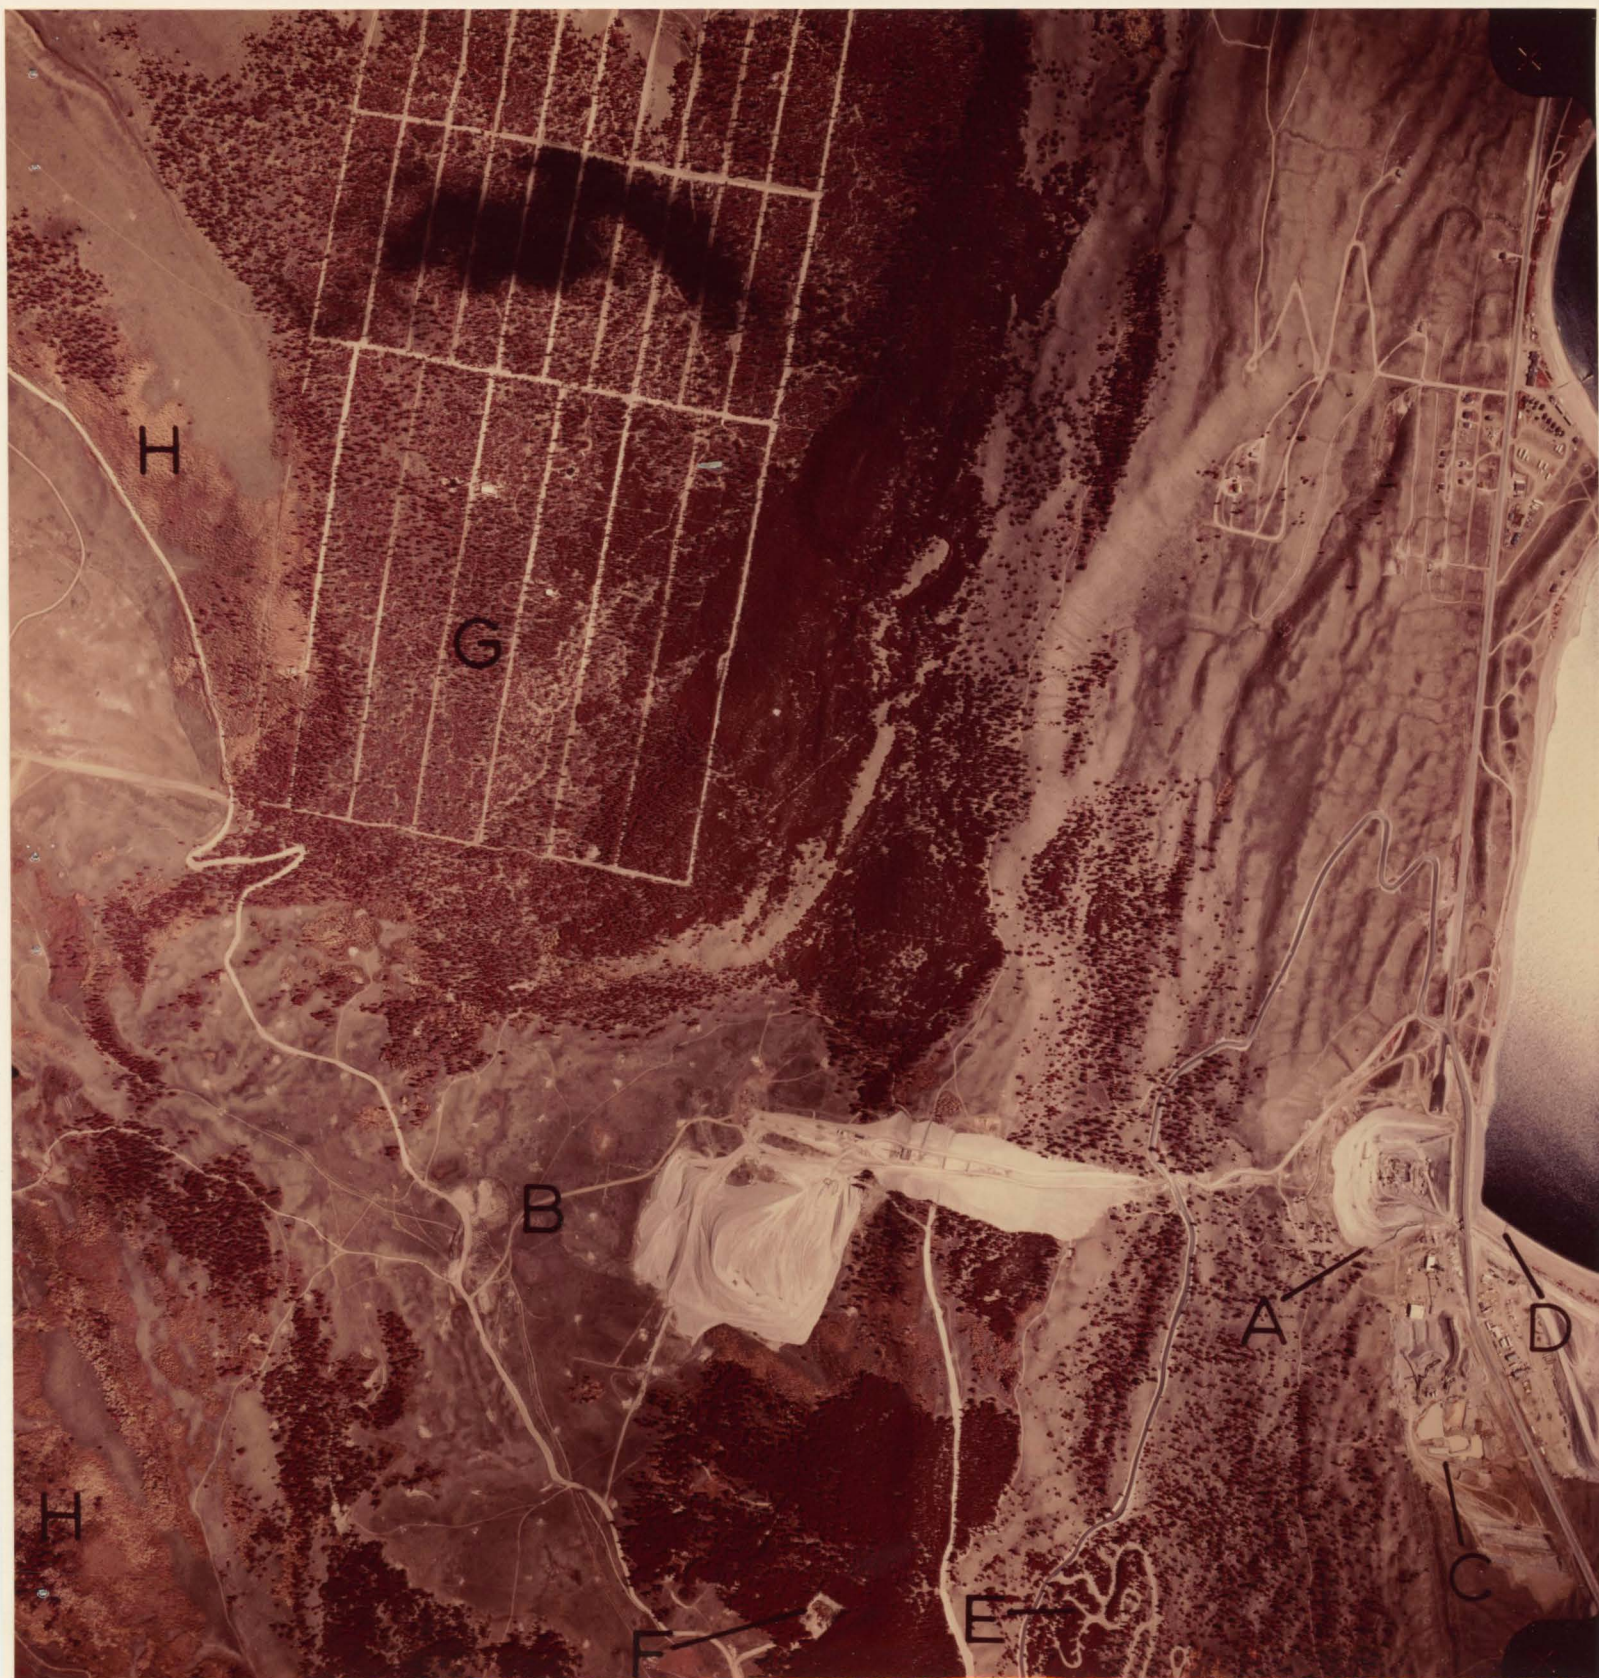
Fig. 5 - Color Infrared Photograph #8720

Location A on Fig. 5 identifies a large slip area on the west side of the excavation of the pumping plant. The entire north shore of the Twin Lakes area is composed of moraines and slip failures on steep slopes can be expected. Areas of increased moisture content are identified within the excavation by the tone change (darkened). The very light color in the excavations is characteristic of the exposed soils and rocks of the area. Point B represents the location of Mt. Elbert forebay. This area also lies in the moraines and would be expected to have very high infiltration rates. A network of test holes are in evidence in the area of the Mt. Elbert forebay site which were drilled in order to evaluate the extent of the infiltration capacity.

At location C the aggregate plant and the washing ponds are identified. No evidence exists to show that any of the washwater is returning to the Twin Lakes. There is a very small drainage identified at Point D; this drainage was not running at the time the photograph was taken or was discharging only a small amount of water of low turbidity.

Other interesting features on this photograph includes the Lake View Campground at point E, garbage dump at point F, a land development operation at G, and the dense growth of aspens at H.

Geology: Fig. 5; Color infrared photograph #8720, also, see Fig. 6:  
Thermal infrared imagery #3269
