MONITORING WILDLIFE-VEHICLE COLLISIONS: ANALYSIS AND COST- BENEFIT OF ESCAPE RAMPS FOR DEER AND ELK ON U.S. HIGHWAY 550

Report No. CDOT-2015-5

May 2015

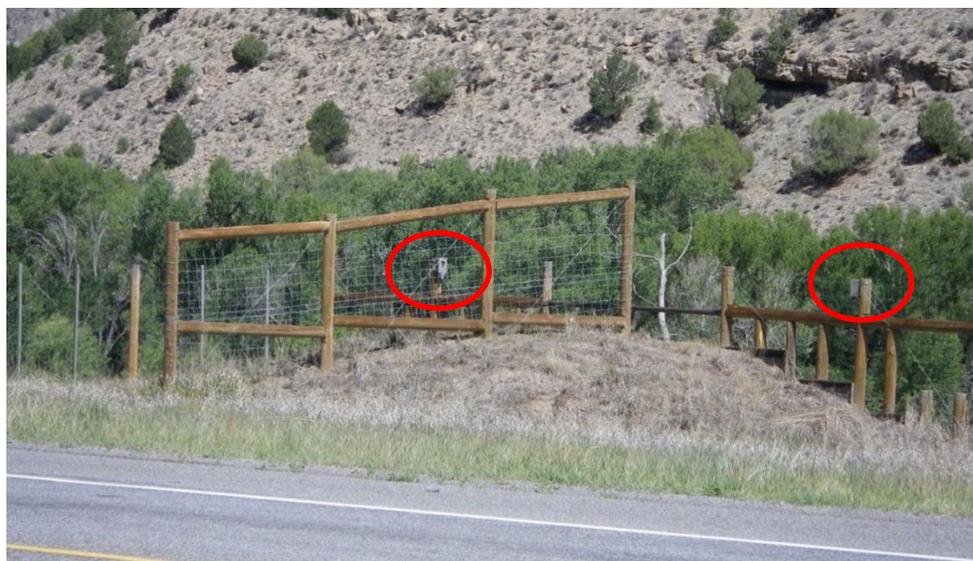
Figure 2. A representative earthen escape ramp along Highway 550 depicting camera placement (cameras circled in red).

We monitored 11 ER along Highway 550 using motion-sensitive infra-red cameras (Attack IR™, Cuddeback, De Pere, WI). We monitored ramps continuously for a period of two years (August 2012 – July 2014) and deployed two cameras at each ramp by bolting them within protective cases (CuddeSafe™, Cuddeback, De Pere, WI) to posts of the wildlife fence (Figure 2).

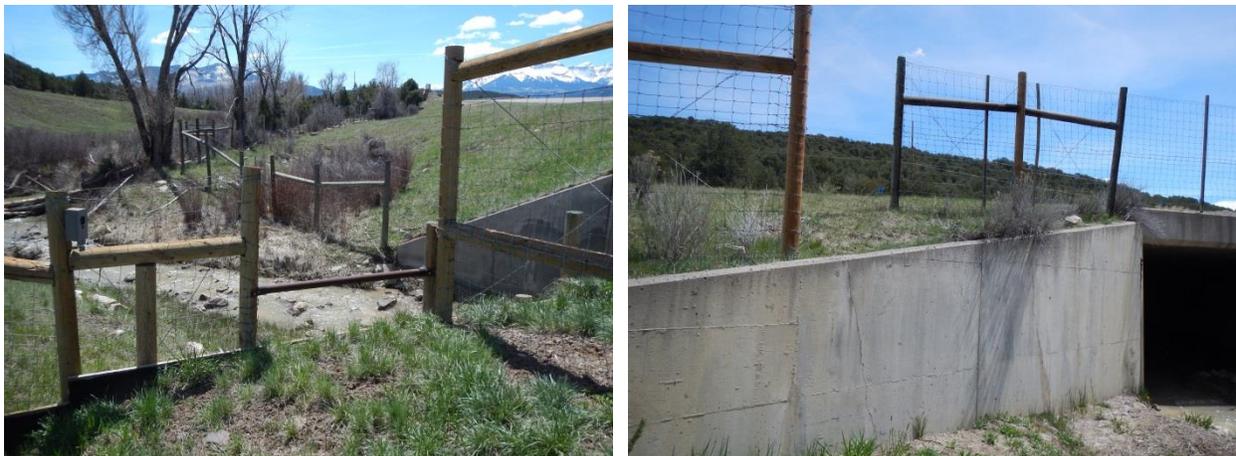
Figure 3. Escape jumps along Dry Creek from the right-of-way above the creek (left) and Alkali Creek from the creek bed (right).

In addition to the camera monitoring of the 11 ER, we also placed one camera at each of two escape jumps at Alkali and Dry creeks, which both pass under Highway 550 through box culverts. Escape jumps have been created by intentional gaps in the fencing above the box culvert headwall at both of these creeks. The Dry Creek escape jump is located on the east side of the highway near milepost (MP) 106. The Alkali Creek escape jump we monitored is on the west side at MP 109-. The fencing gaps are above areas along the vertical headwall that are at heights low enough to provide animals a location where they can jump to safety, but high enough to discourage animals from jumping up into the ROW. A horizontal bar is present on one half of the jump at Dry Creek (Figure 3).

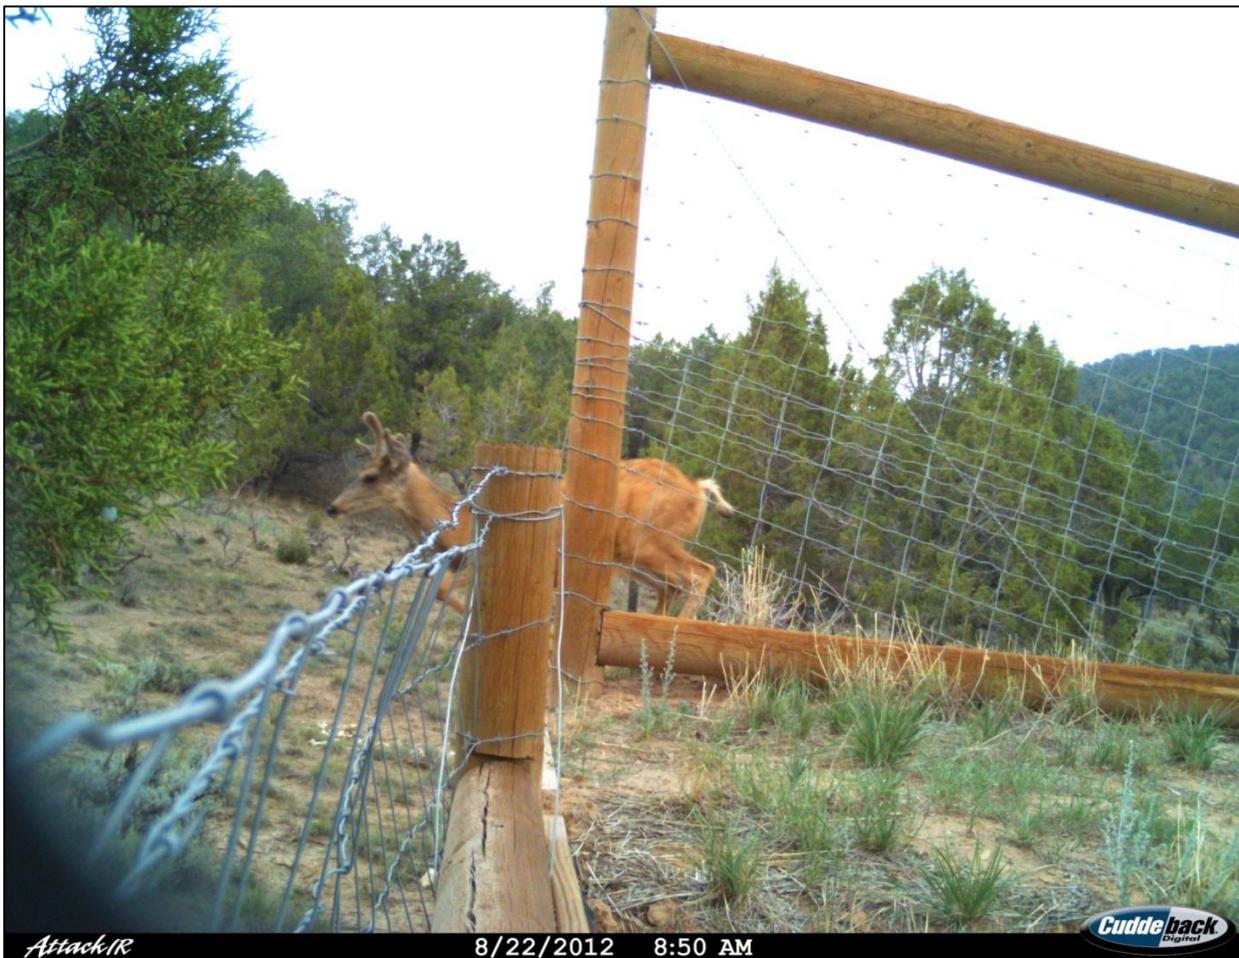
Figure 4. A deer making a successful escape at Ramp 20.

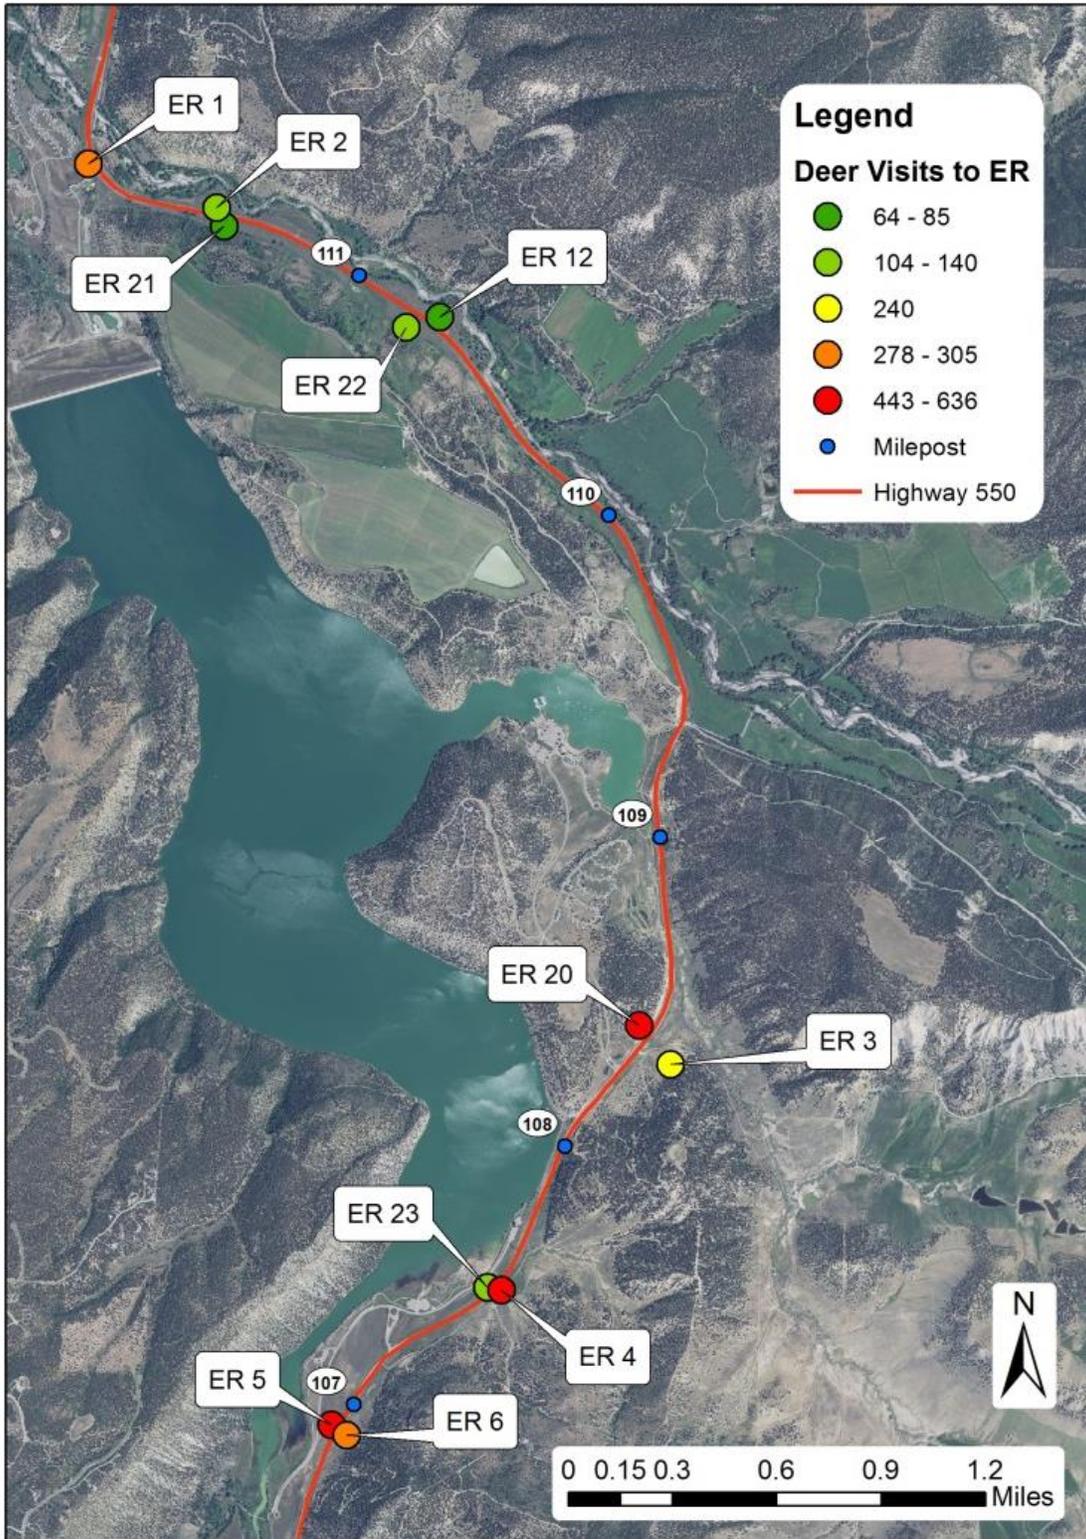
Figure 5. Spatial distribution of mule deer visits recorded at 11 escape ramps along Highway 550 from August 1, 2012 to July 31, 2014.

Most deer visits occurred at the six ER toward the southern half of the study area (Figure 4). The northern five ER had a total of 650 deer visits and the southern six ER had 2,315 deer visits.

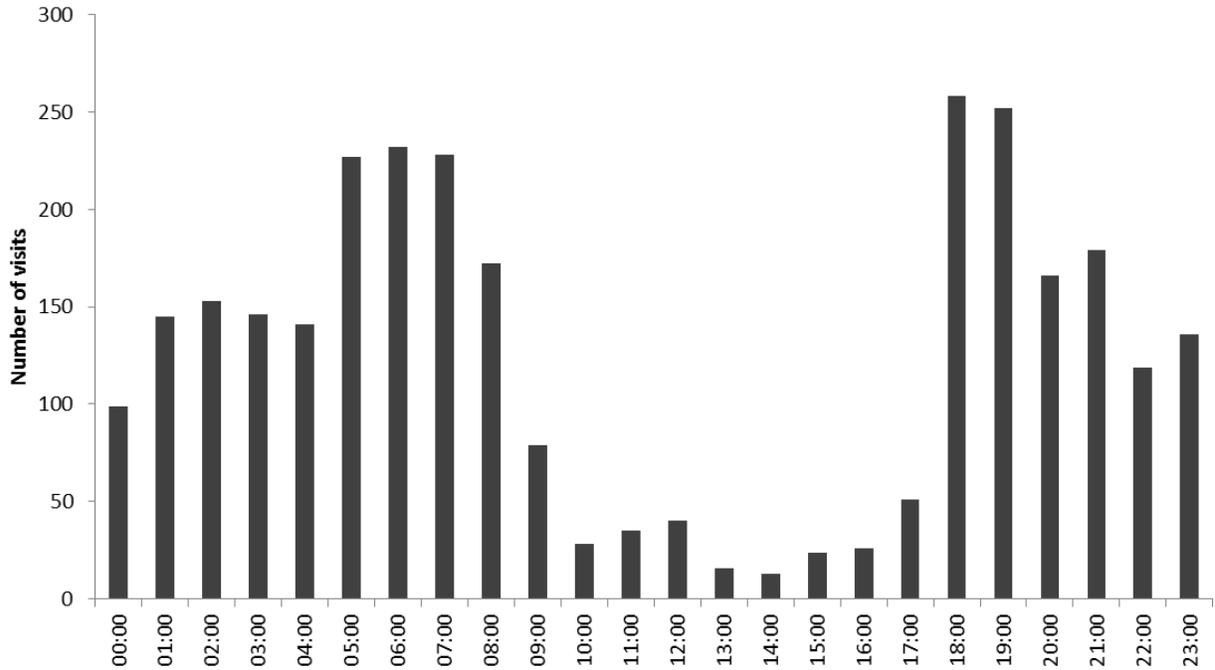
Figure 6. Hourly distribution of visits of mule deer to 11 escape ramps along Highway 550, Ouray County, Colorado USA, from August 2012 – July 2014.

Mule deer visits to ER were also quite variable temporally on both hourly (Figure 5) and monthly (Figure 6) scales. Most visits occurred during the early morning and late evening, and seasonally during the fall, peaking in November, and the spring, peaking in May. Visits decreased during the summer and increased again each October.

Most deer activity we observed at ER was nocturnal with peaks during the crepuscular time periods (Figures 5 & 6). This pattern is consistent with other studies observing crepuscular and nocturnal ungulate activity (Ager et al. 2003) and indicates that usage levels at ER may be generally reflective of overall activity patterns of deer in the area. We observed a seasonal peak of visits during the fall and spring with decreased activity during the winter and summer months. Based on this activity pattern, warning signs (indicating potential presence of wildlife on the highway), that are triggered by nightfall (reduced light) may help reduce WVC.

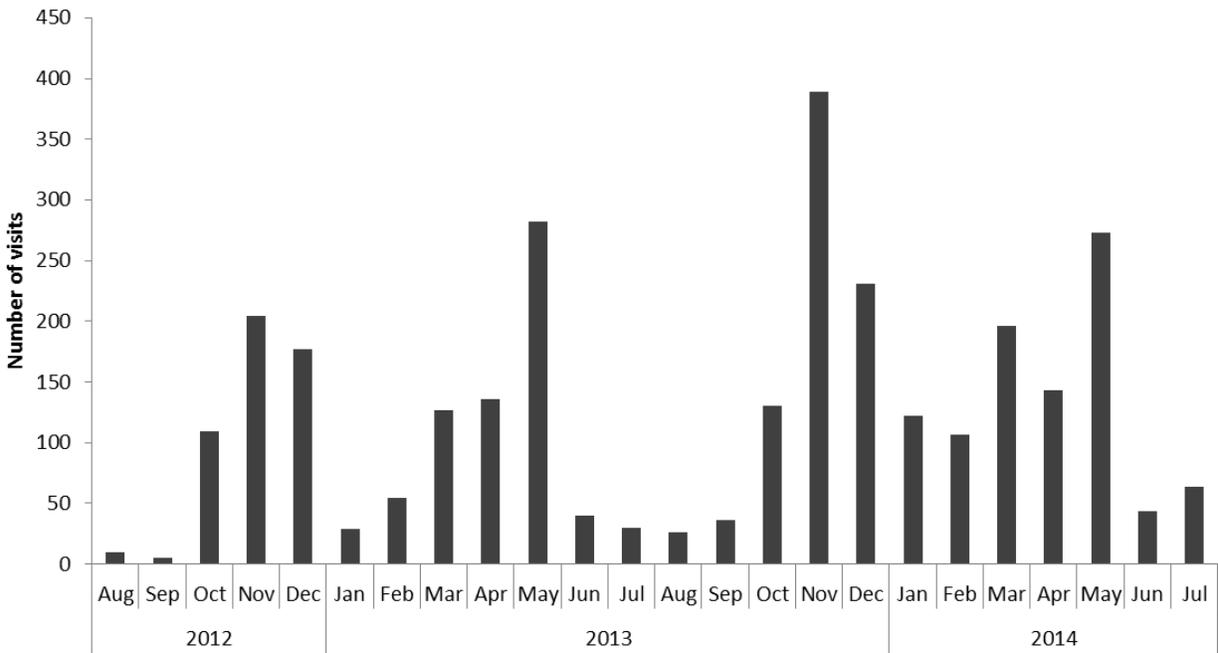
Figure 7. Monthly distribution of mule deer visits to 11 escape ramps along Highway 550 from August 2012 – July 2014.

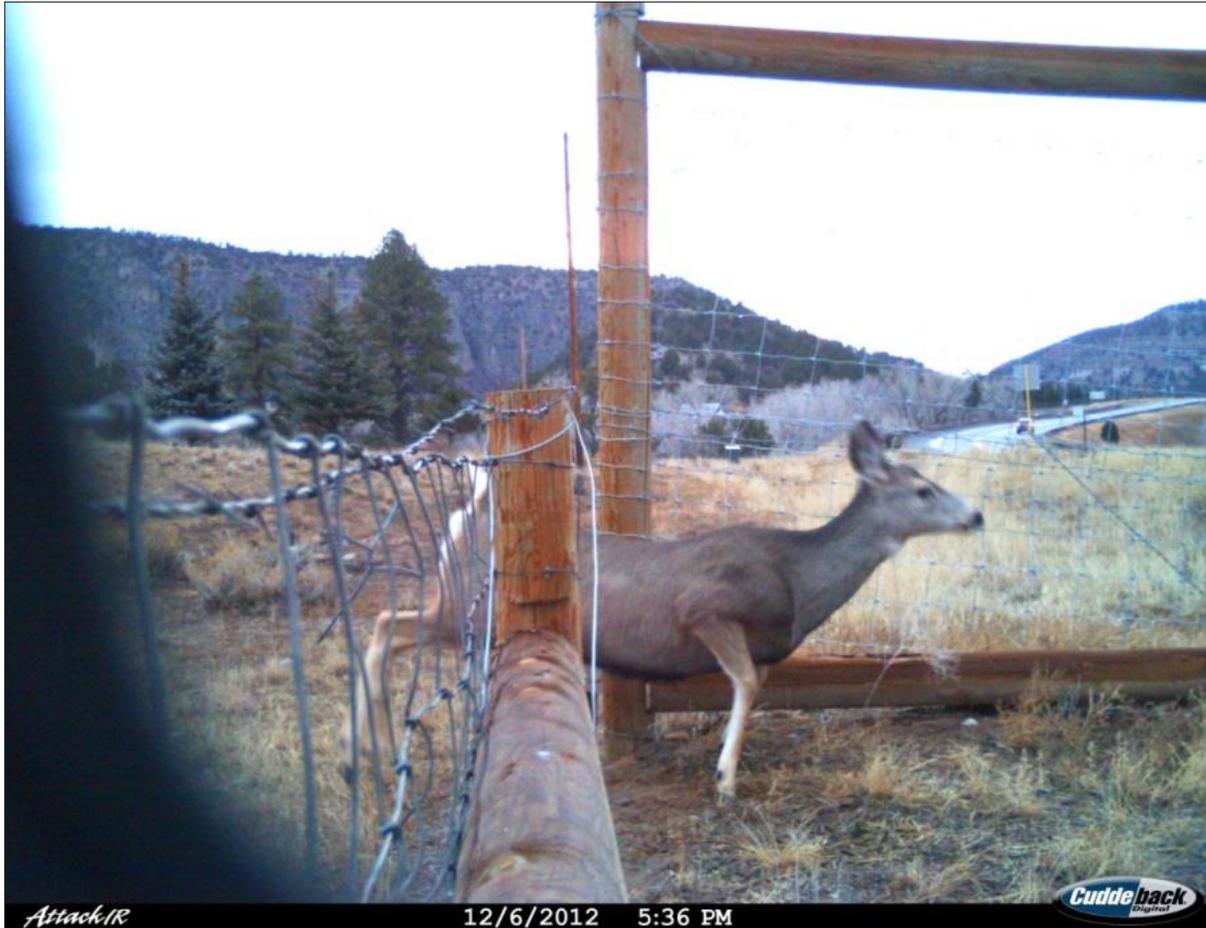
Figure 8. A deer making an unsuccessful reversal attempt at Ramp 1. Subsequent video data show the deer falling back to the safe side of the wildlife fence and walking away.

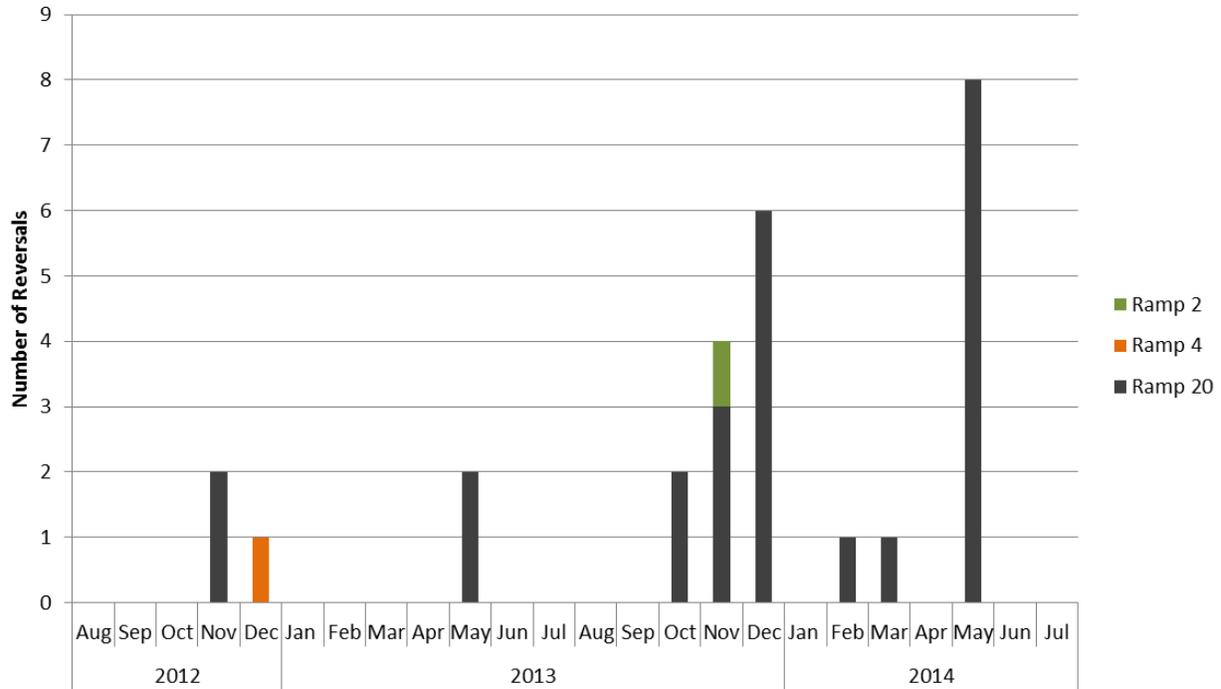
Figure 9. Monthly distribution of mule deer reversals at three escape ramps along Highway 550 from August 2012 – July 2014.

All but two successful deer reversals occurred at Ramp 20, which is located approximately 675 feet from the Dutch Charlie Entrance to Ridgway State Park. This ER also had the greatest number of deer visits as well as the highest percentage of successful escapes of any ER in the study area. Reversals at Ramp 20 occurred throughout the study period (Figure 8), with most occurring during the spring and winter and none in the summer (June, July and August).

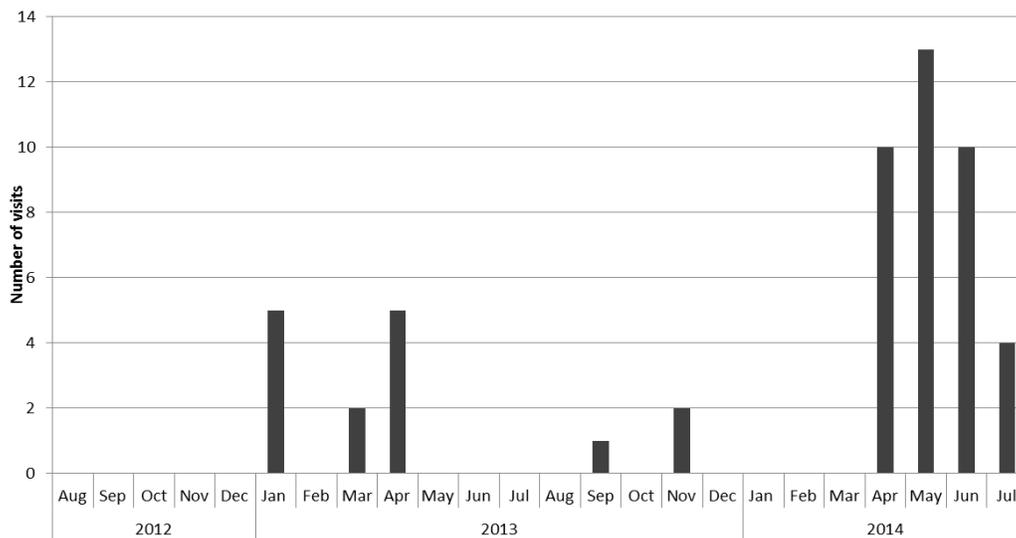
Figure 10. Monthly distribution of elk visits to 11 escape ramps along Highway 550 from August 2012–July 2014.

There were no reports of elk-vehicle collisions during the study period, but elk were observed at ER in the ROW side of the wildlife fence during this time. The study area falls within the overall range for elk in Colorado and within the winter concentration range and severe winter range (CPW 2013). While elk were observed during the fall and winter, most visits to ER occurred during the spring and summer (April – July) (Figure 9).

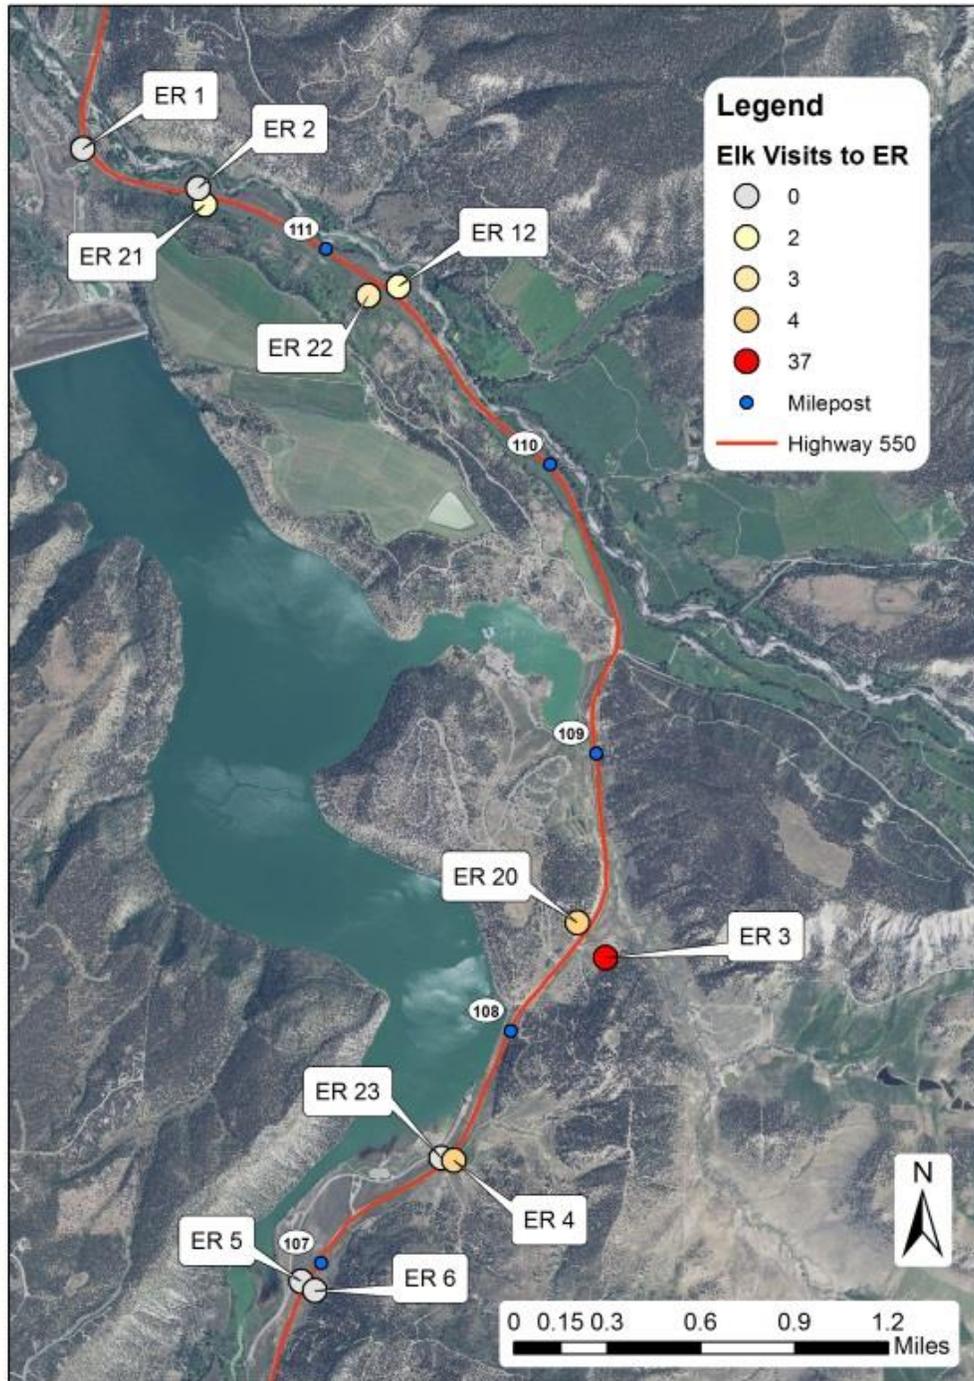
Figure 11. Spatial distribution and frequency of elk visits recorded at 11 escape ramps along Highway 550 from August 1, 2012 to July 31, 2014.

The majority of elk visits occurred at Ramp 3, which is the ER located furthest from the highway of any ER in this study (over 500 feet). Elk visits were distributed widely across the study area and were centrally located, with no visits occurring at the northernmost or southernmost ramps (Figure 10).

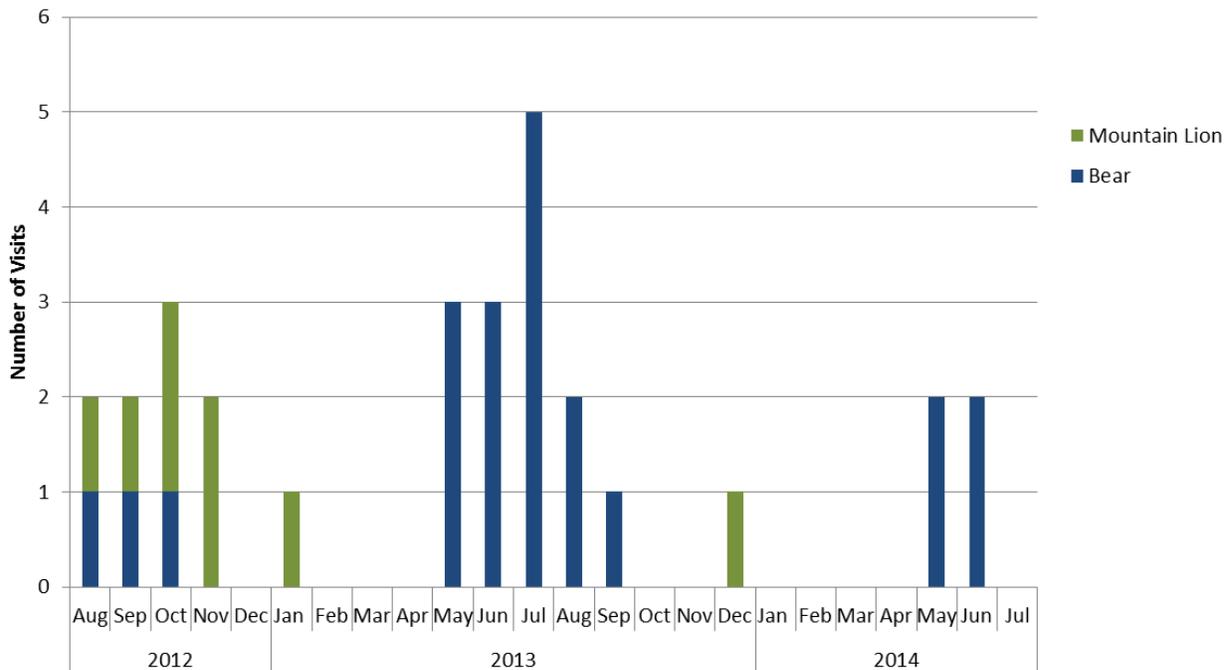
Figure 12. Monthly distribution of mountain lion and black bear visits to 11 escape ramps along Highway 550 from August 2012 – July 2014.

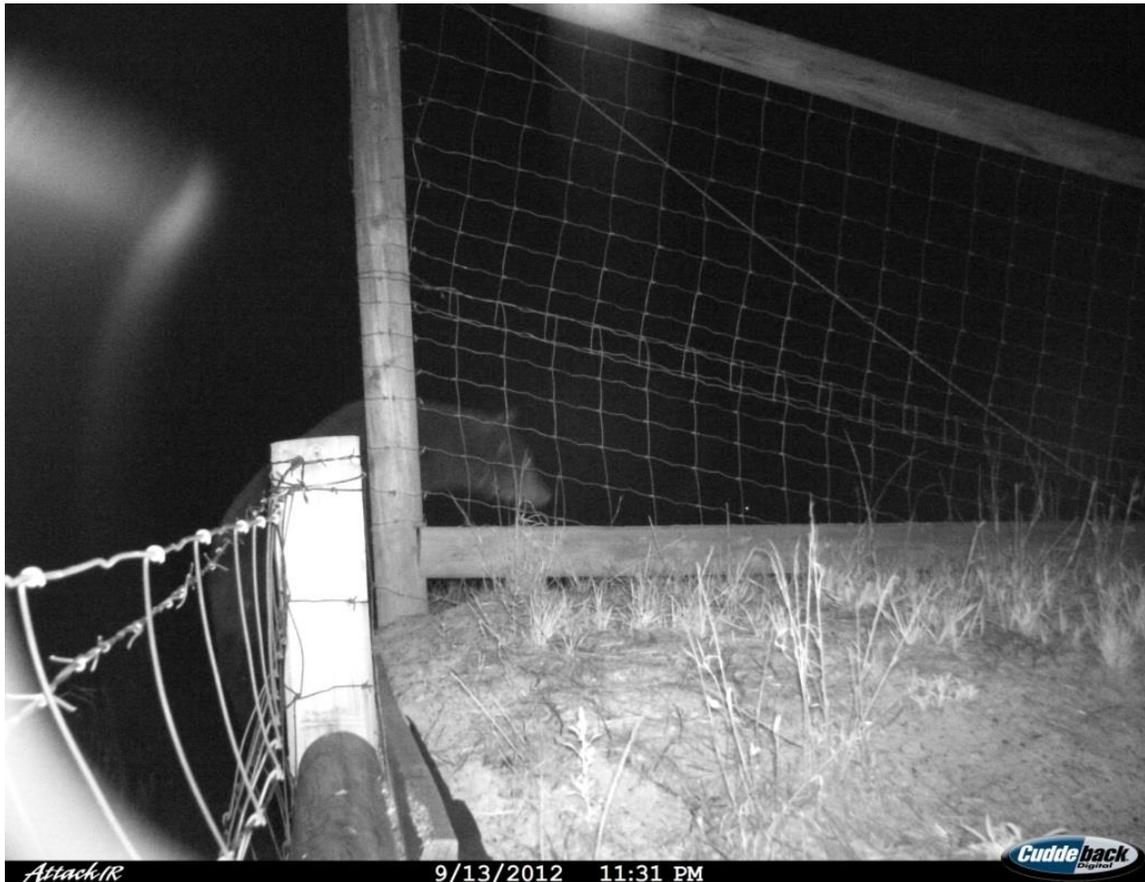
Figure 13. A black bear making a successful reversal by climbing up the vertical wall on the safe side of the fence.

Escapes made by bears were often made by the bear climbing down the vertical wall of the ramp to the safe side of the wildlife fence. In a similar fashion, reversals were made by bears climbing up the vertical wall and into the ROW (Figure 12).

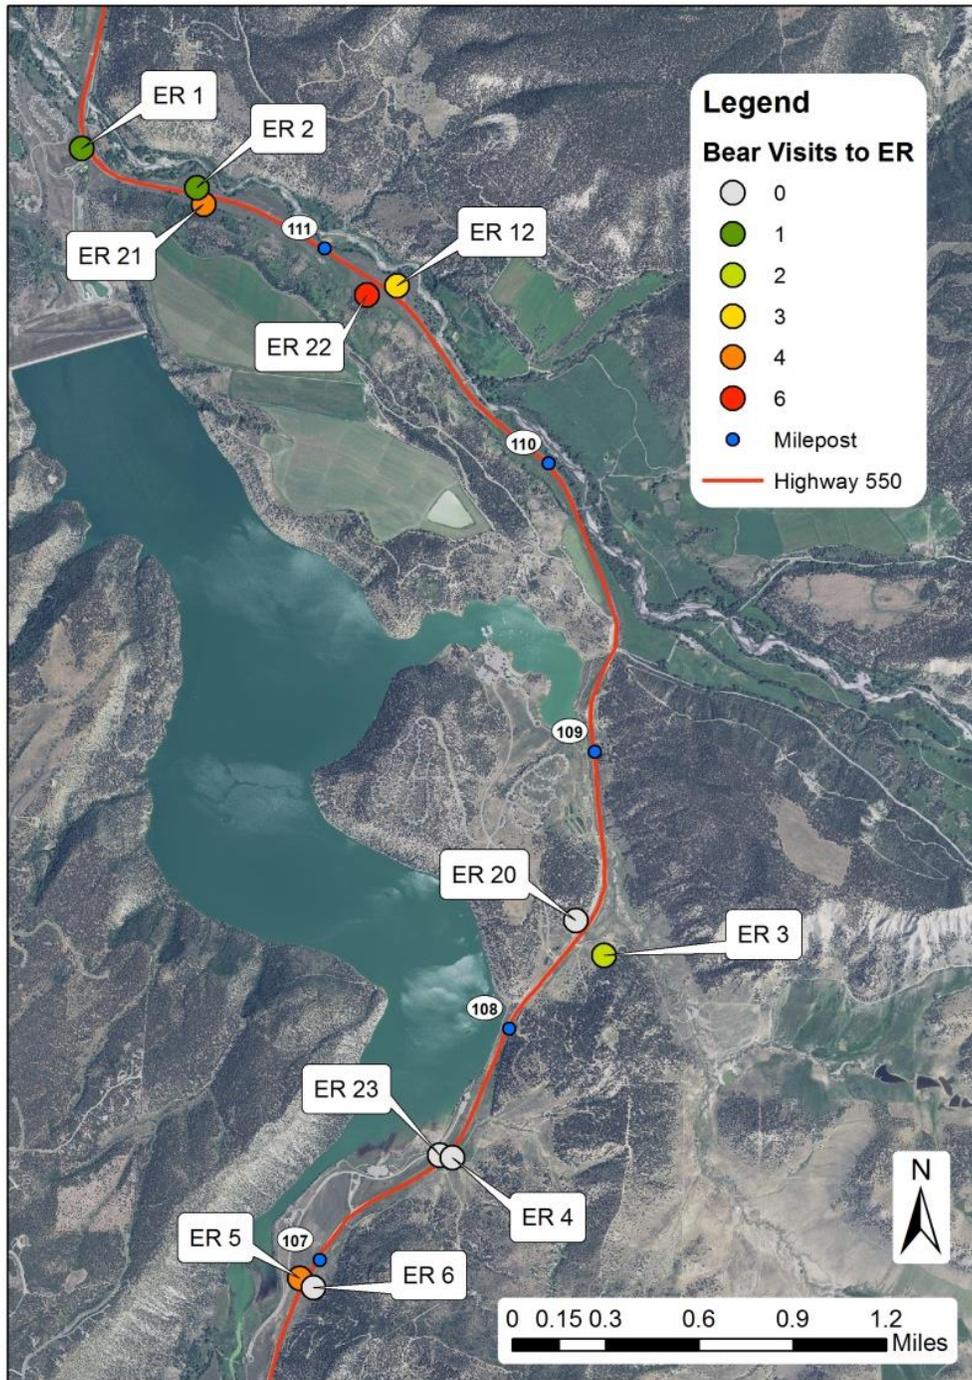
Figure 14. Spatial distribution and frequency of black bear visits recorded at 11 escape ramps along Highway 550 from August 1, 2012 to July 31, 2014.

Most visits by black bear occurred at the north end of the study area, especially at ramps 21 and 22, however four visits were observed at Ramp 5 at the southern end (Table 8; Figure 13).

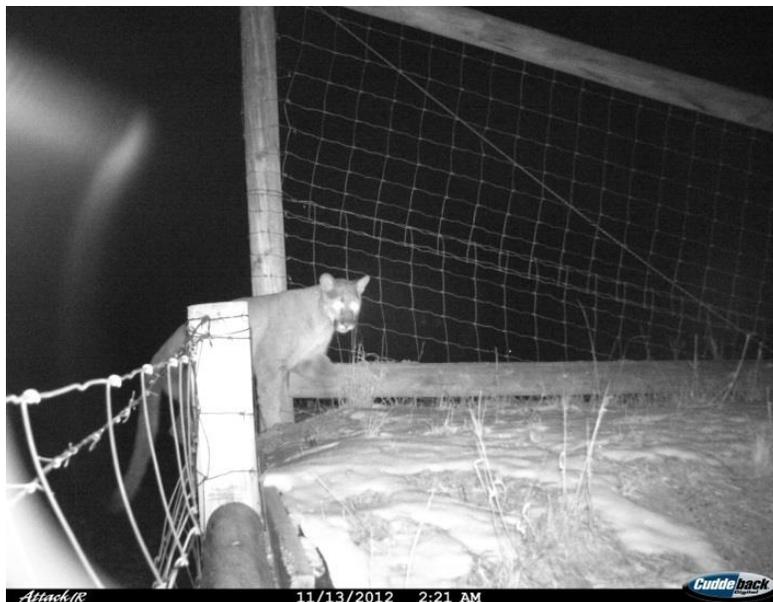
Figure 15. A mountain lion making a successful reversal by jumping up the vertical wall on the safe side of the fence.

Photo and video evidence indicates mountain lions were able to jump up to the ramp from the safe side of the fence to make reversals into the ROW (Figure 14).

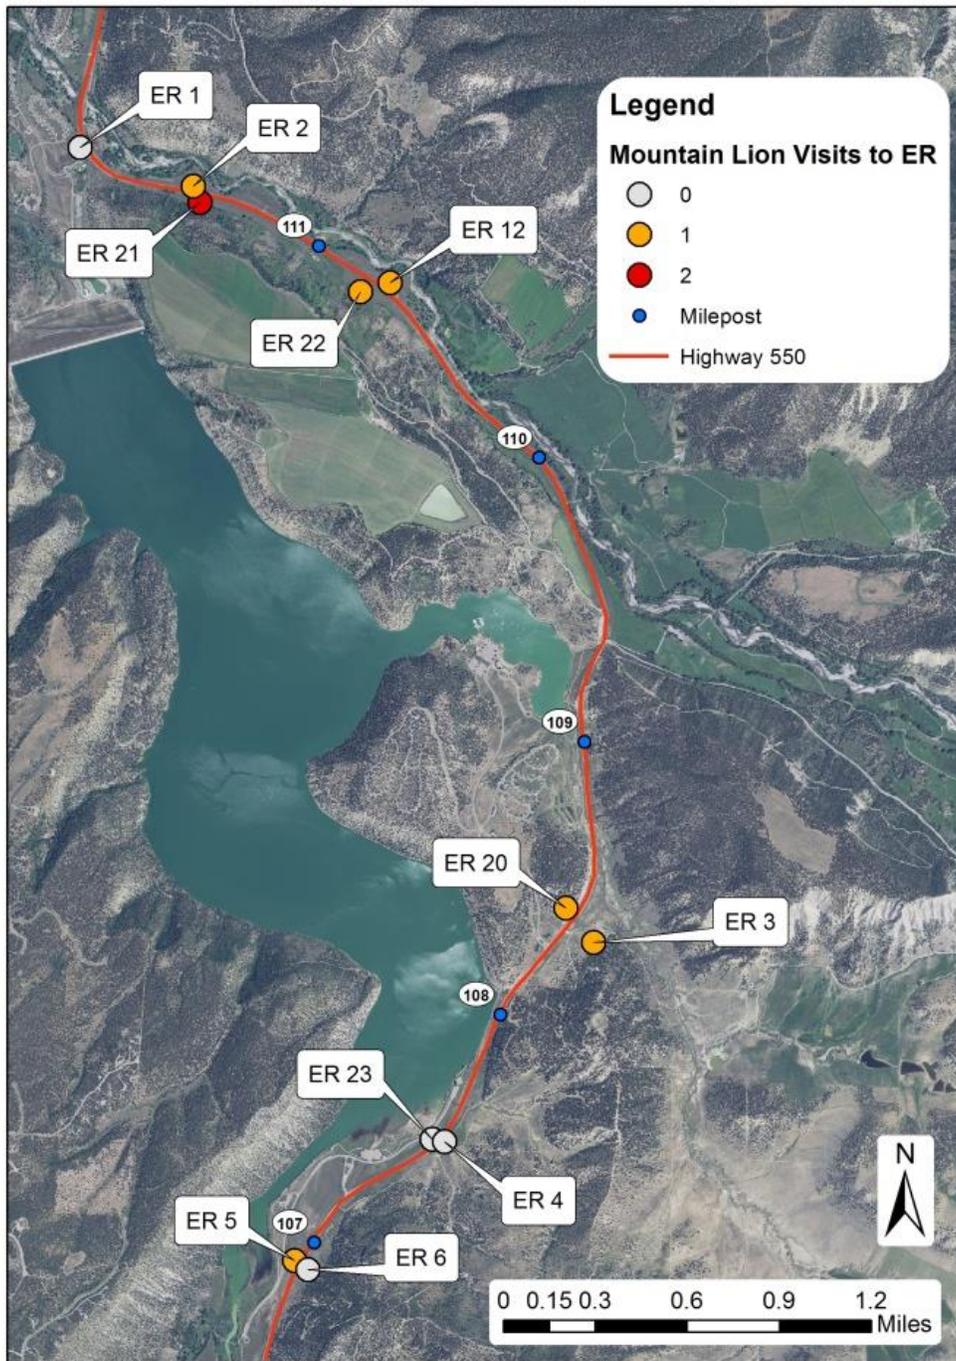
Figure 16. Spatial distribution and frequency of mountain lion visits recorded at 11 escape ramps along Highway 550 from August 1, 2012 to July 31, 2014.

We observed mountain lion at seven of the 11 ER (Table 9 and Figure 14) and these visits were distributed widely across the study area (Figure 15). The study area falls within the overall range for mountain lion in Colorado, and the areas surrounding the highway north of MP 112 and west of Ridgway Reservoir are designated as mountain lion-human conflict areas (CPW 2013). Mountain lions were observed at ER from late summer (August) to mid-winter (January) (Figure 11).

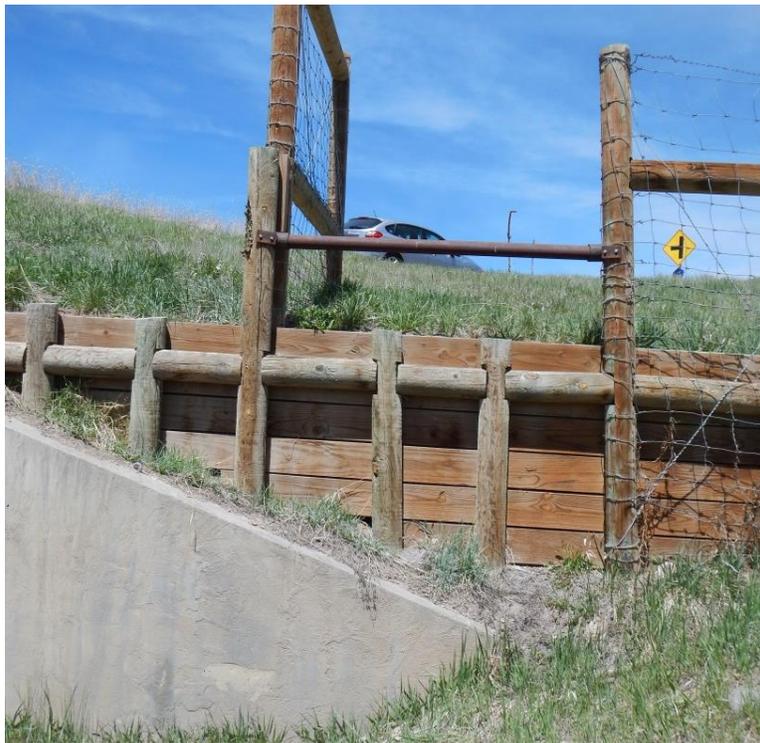
Figure 17. Dry Creek escape jump along Highway 550 from the creek bed.

The escape jump at the culvert along Dry Creek was visited to a much greater extent than the jump at Alkali Creek. A total of 147 deer visits were recorded at the Dry Creek escape jump. Of these 147 observations, we documented 42 successful escapes, 90 non-escapes, 11 undetermined observations, and four reversals from the creek bed into the ROW. The deer making the reversals into the ROW used the side of the perpendicular fencing without the horizontal bar and were able to jump up relatively easily, likely using the ramp created by the slanted headwall on the creek side of the jump (Figure 16). Thirty-one of the 42 (73.8%) successful escapes occurred on the side of the escape jump without the horizontal bar. Fox, coyote, American badger (*Taxidea taxus*), raccoon, and skunk were observed in addition to deer at this escape jump. Coyote and fox were observed making successful escapes as well as gaining access to the ROW using this escape jump.

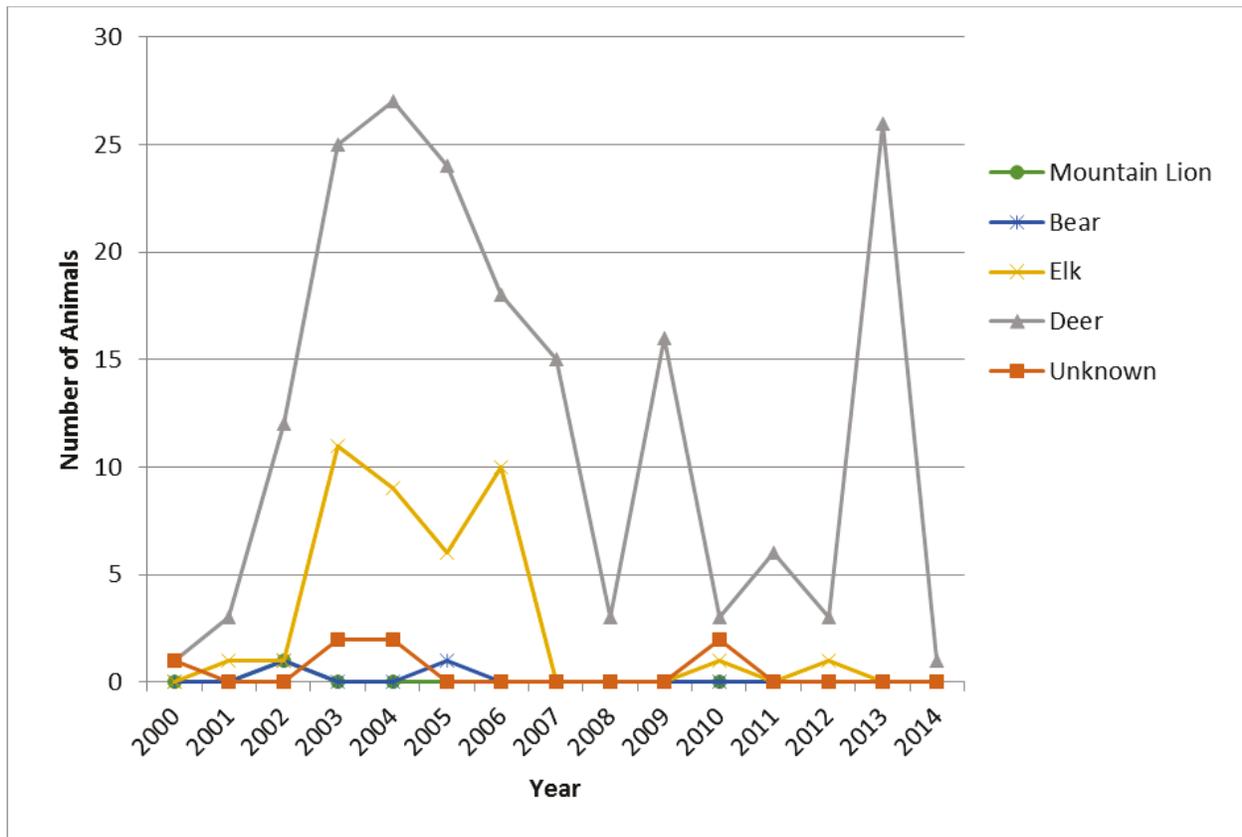
Figure 18. Wildlife-vehicle collision data for May 2000 through July 2014 for Milepost 105 through 113 along Highway 550.

WVC data for Milepost 105 through MP 113 from May 2000 through July 2014 were analyzed to investigate potential declines in WVC following ER construction (Figure 17). WVC data collection by CDOT maintenance crews began in October 2005 and we assessed data through July 2014. Data collected by the Colorado State Patrol (CSP), which are used by CDOT for official WVC numbers, are complete through June 2012. The data collected by CDOT maintenance crews are useful as a supplement to the CSP data to provide information on unreported wildlife mortality. Animals recorded as “unknown” are large enough to cause a traffic accident and are often deer or elk.

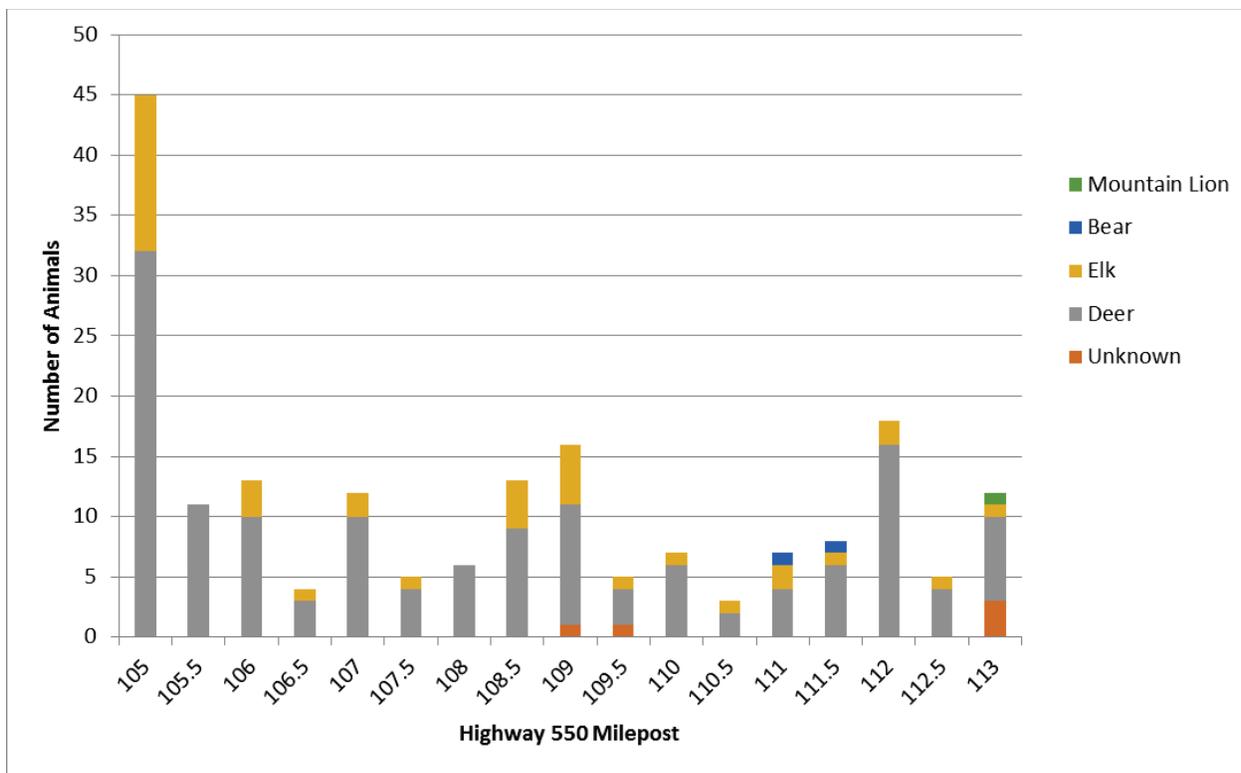
Figure 19. Pre-construction wildlife-vehicle collision data for May 2000 through April 2010 for Milepost 105 through 113 along Highway 550.

Some of the WVC data collected by CDOT maintenance did not have specific mileposts attributed to each animal, but were reported as number of individuals collected between two mileposts on a particular day. For the most part, the locations provided for these records were completely contained within the study area. When this was not the case and the milepost endpoints partially fell outside of the study area, the percentage of overlap with the study area was multiplied by the total number of animals reported to give an approximation of the number of animals collected within the study area on that date. Three of these records occurred in 2013 and accounted for 25 deer collected in that year within the study area. One additional record occurred in 2007 and accounted for two deer. These records were used in the compilation of data within the study area over a yearly basis (Figure 17) and in the cost-benefit analysis, but were not used in the analysis of animals by milepost (Figures 18 and 19).

Using April 30, 2010 as our date of delineation between pre-construction (Figure 18) and post-construction (Figure 19) for the eight ER, we evaluated data from 10 years prior to construction to the end of the study period (July 31, 2014). We determined rates of WVC for deer and elk by calculating the number of WVC per mile per year for both pre-construction and post-construction time periods.

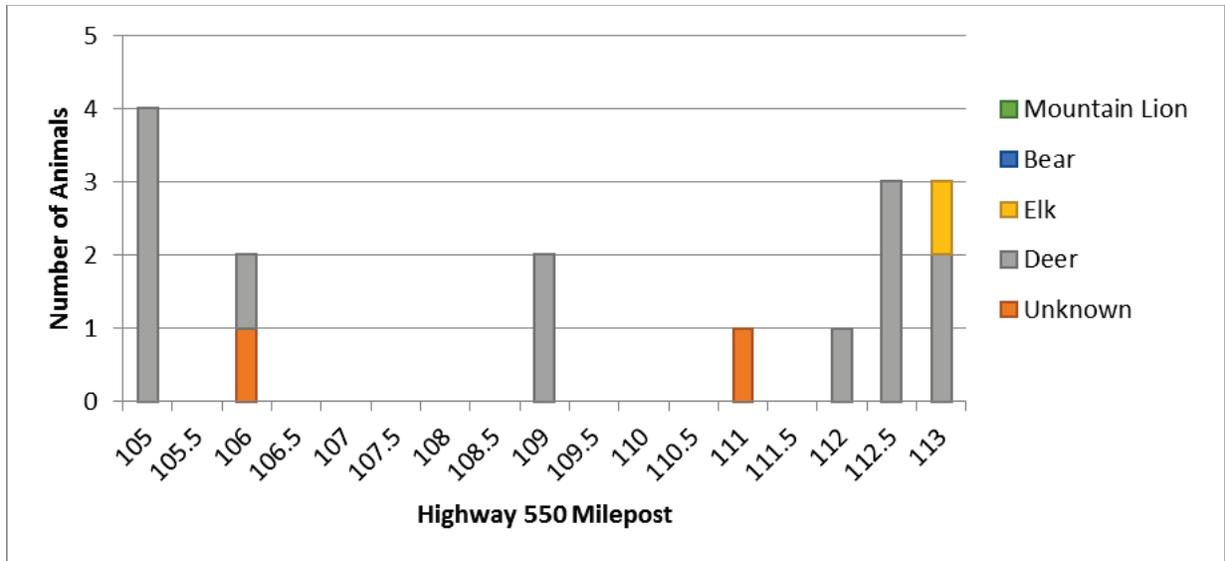
Figure 20. Post-construction wildlife-vehicle collision data for May 2010 through July 2014 for Milepost 105 through 113 along Highway 550.

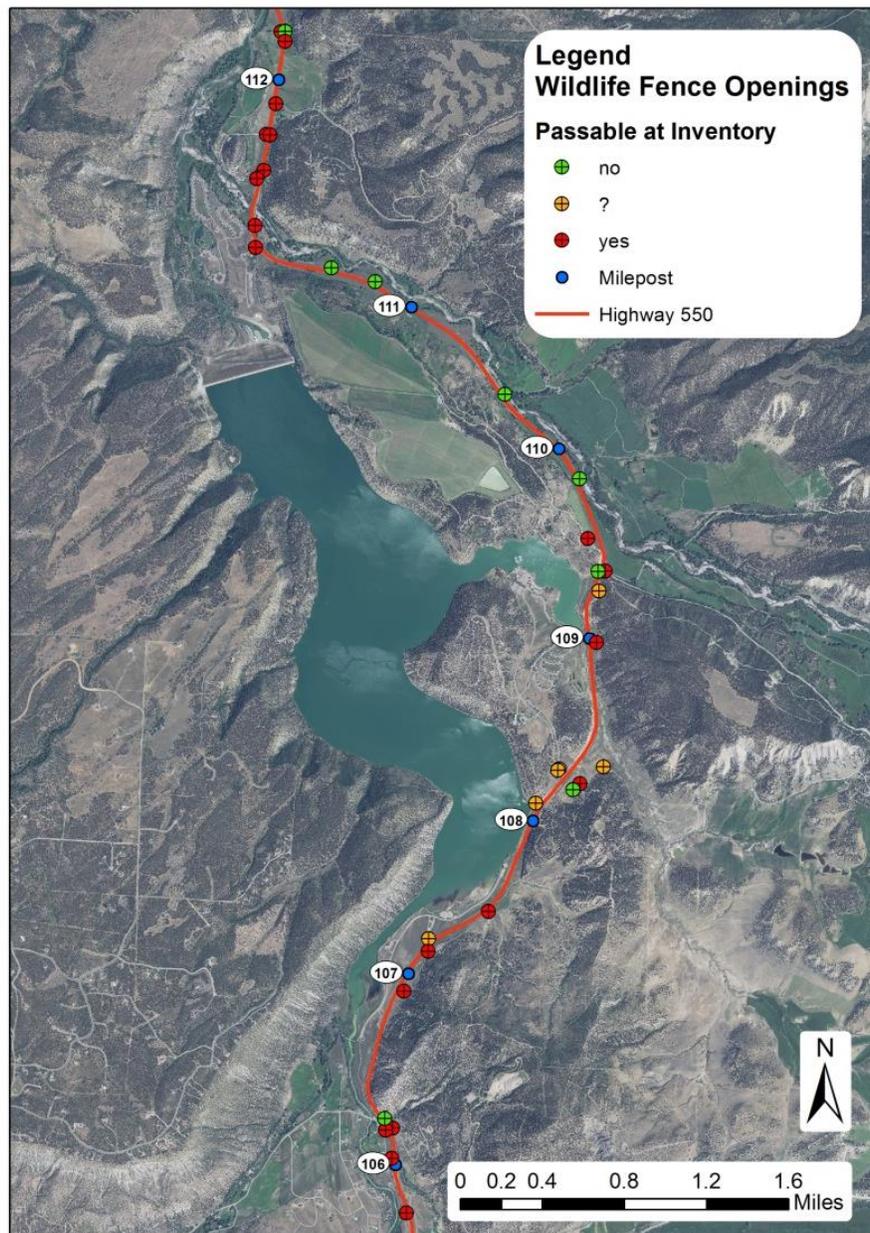
Figure 21. Openings in the wildlife fence along Highway 550. Legend indicates openings deemed passable by deer at the time of inventory.

Close openings in the wildlife fencing. The greatest factor leading to potential WVC is the sheer number of wildlife, especially deer, observed within the ROW at ER. We observed 2,965 visits of mule deer to ER over the two-year study period. Averaged over the study period, this equates to over four visits to ER within the study area per day. There were undoubtedly many additional wildlife intrusions into the ROW during this time period that did not result in visits to an ER. It is recognized that wildlife fencing is often not an absolute barrier to wildlife (Bissonette and Hammer

2000; Putman 1997), however fence maintenance and repair of holes are necessary (Feldhamer et al. 1986) as well as functional complementary structures at access roads such as wildlife guards (Allen et al. 2013) or double cattle guards (Cramer et al. 2014). Clevenger et al. (2001) found that WVC were not associated with gaps (access points), however in their study area they noted only 10 access points along 44 km (27.3 mi.) of highway. We recorded 34 openings in the wildlife fence from MP 106 to MP 112+ that had the potential to allow deer or other wildlife access to the ROW (Figure 20; Appendix B). Twenty of these openings were easily passable by deer at the time of the inventory. Many of these openings were noted by SREP (2006) in their inventory of gaps along this stretch of Highway 550.
