MONITORING WILDLIFE-VEHICLE COLLISIONS: ANALYSIS AND COST- BENEFIT OF ESCAPE RAMPS FOR DEER AND ELK ON U.S. HIGHWAY 550

Report No. CDOT-2015-5

May 2015

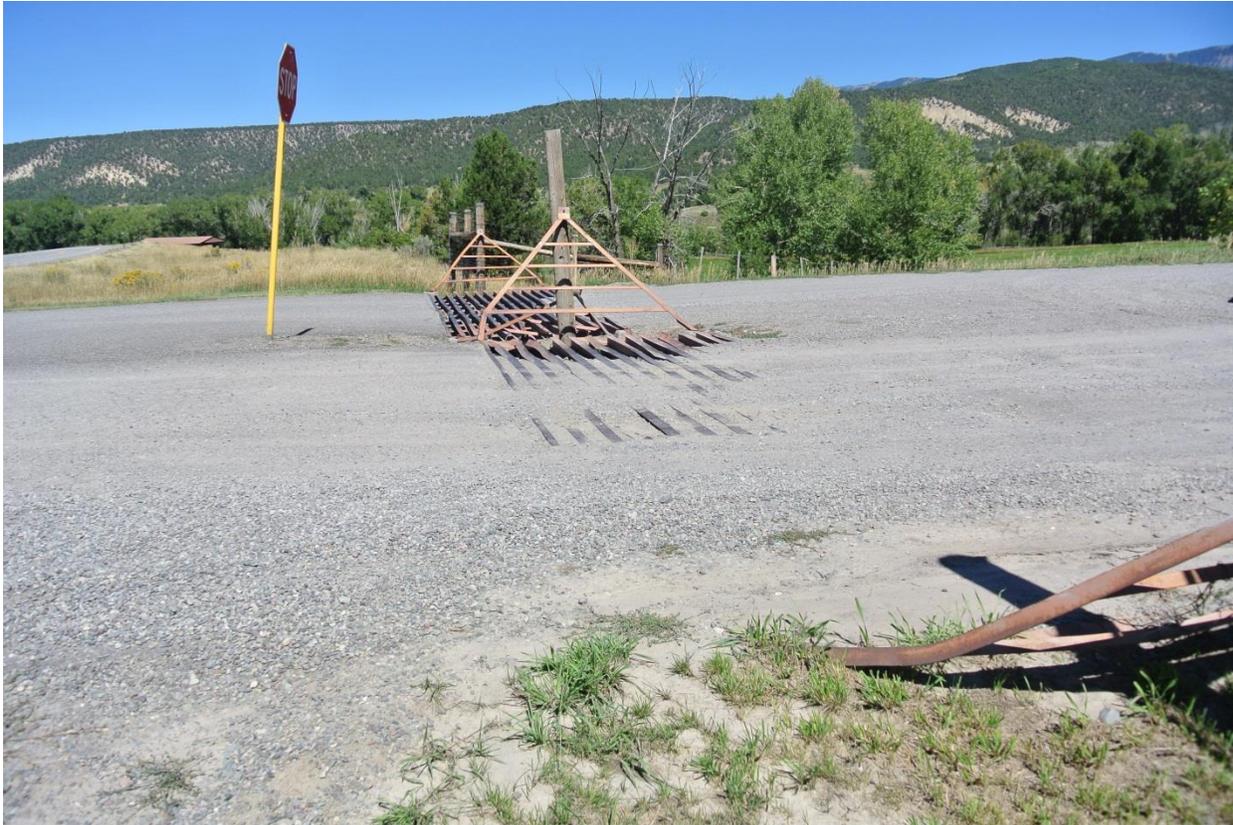
Figure 22. Cattle guard at the intersection of County Road 8, County Road 8A and Highway 550.

Improve guards. To reduce the number of wildlife entering the ROW, double cattle guards, wildlife guards or electric mats should be considered at all access roads. Guards should have rounded surfaces on the top to deter animals from walking across the bars (Cramer et al. 2014) and should be maintained to remove debris from vaults. Single cattle guards and painted lines simulating cattle guards are ineffective for diverting mule deer and elk compared to double cattle guards and wildlife guards (Cramer 2012; Cramer et al. 2014). Allen et al. (2013) found that wildlife guards (6.6 m X 6.8 m steel grates) were 93.8% effective at deterring mule deer movement at access roads in Montana. Reed et al. (1974) evaluated the effectiveness of deer guards (flat mill steel ½-inch wide at the top and spaced 4 inches apart) and found that 16 of 18 mule deer crossed the deer guard after being released from cages. Concern for safety of pedestrians and bicyclists using traditional guards led to the development of a wildlife grate pattern that was 99.5% effective in excluding Key deer (Peterson et al. 2003), but this design would likely need to be modified for use with mule deer and elk as these are larger species. Regardless of the mitigation method chosen, structures must be maintained to be effective. During this study, the vaults of some guards were filled in with gravel, rendering them ineffective. One example of this is at the intersection of County Road 8 where guard vault was completely filled in with gravel (Figure 21). In their inventory of gaps in the deer fencing along this same stretch of highway, SREP (2006) also noted that this guard was filled with stone.

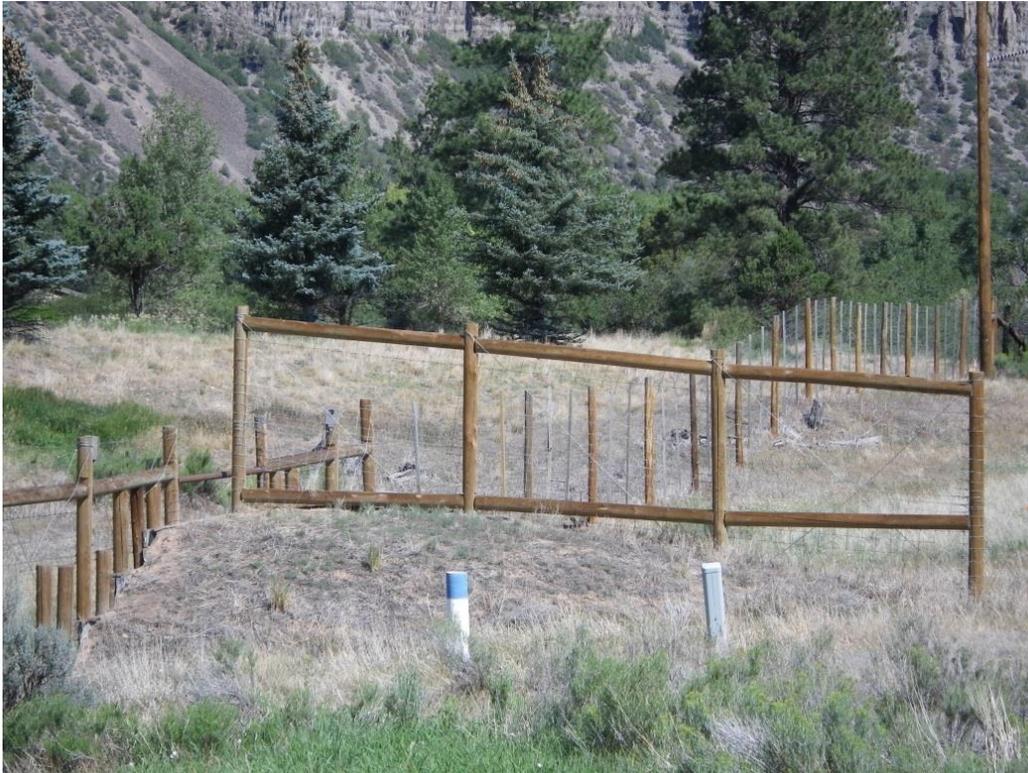
Ramp 1. MP 111.5 on the west side of the highway near the Pa-co-chu-puk Entrance to Ridgway State Park.

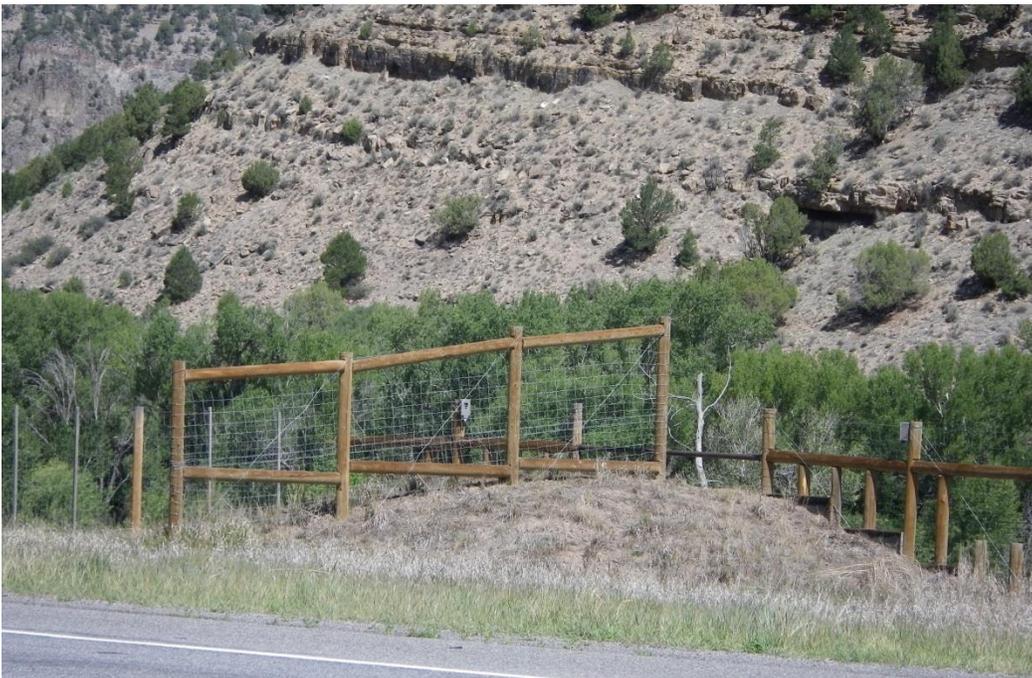
Ramp 2. MP 111+ on the east side of the highway.

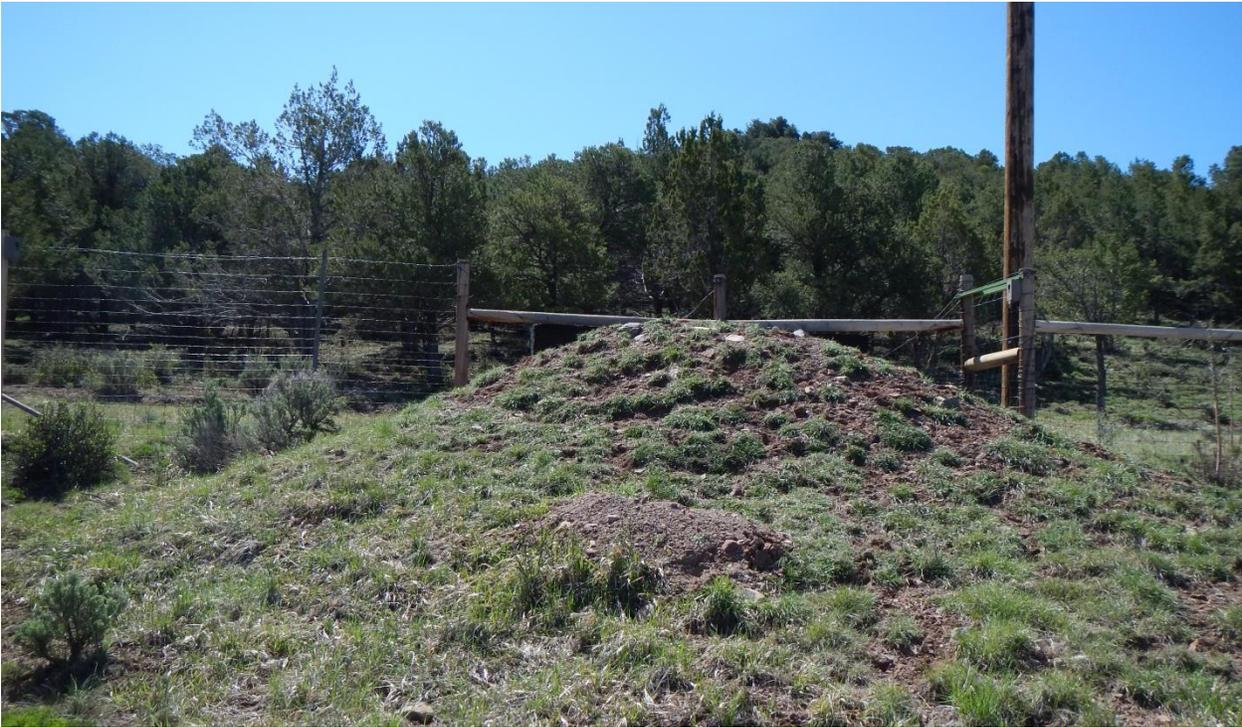
Ramp 3. MP 108+ on the east side of the highway.

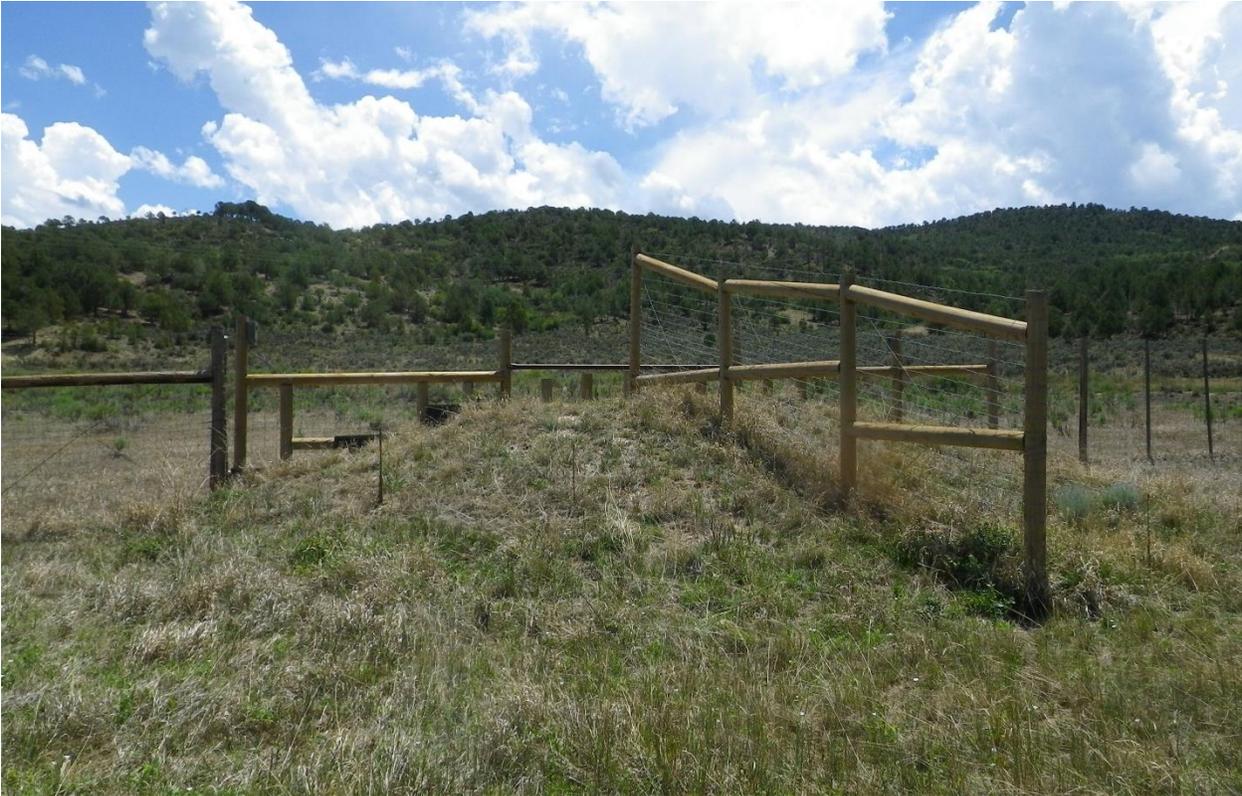
Ramp 4. MP 107.5 on the east side of the highway.

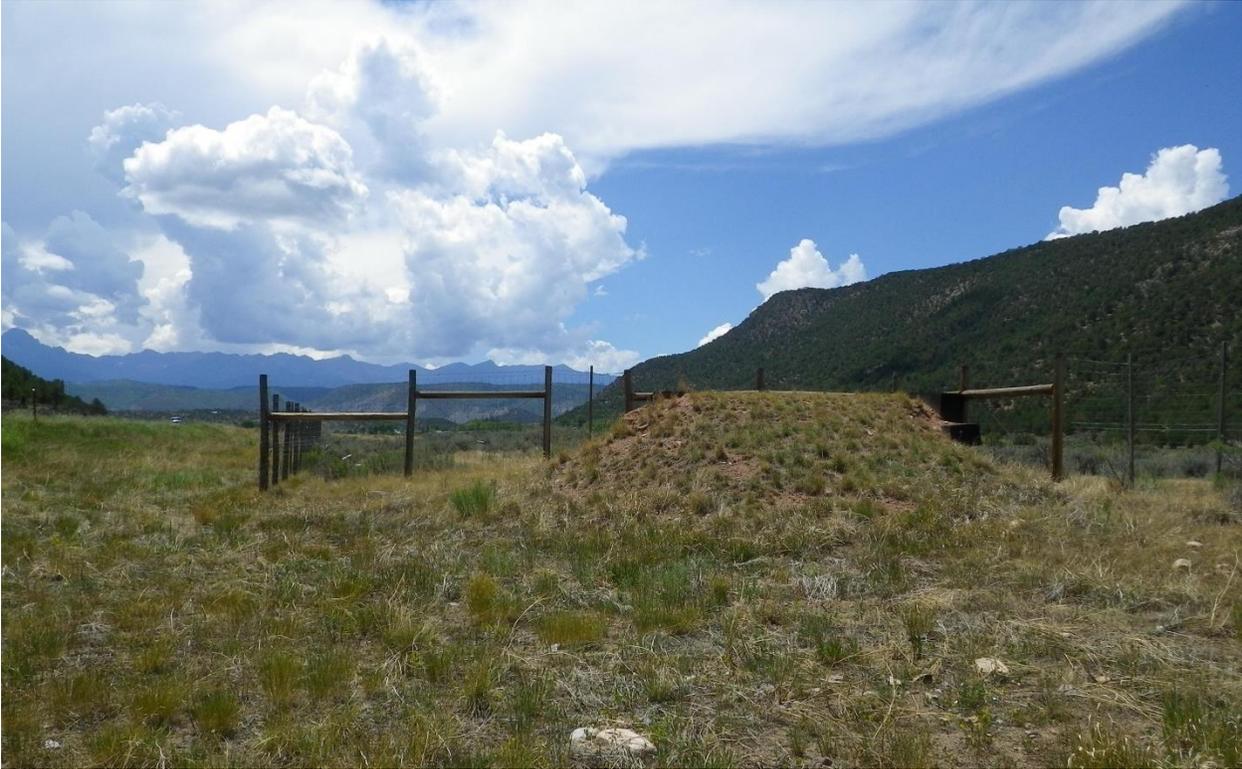
Ramp 5. MP 107- on the west side of the highway.

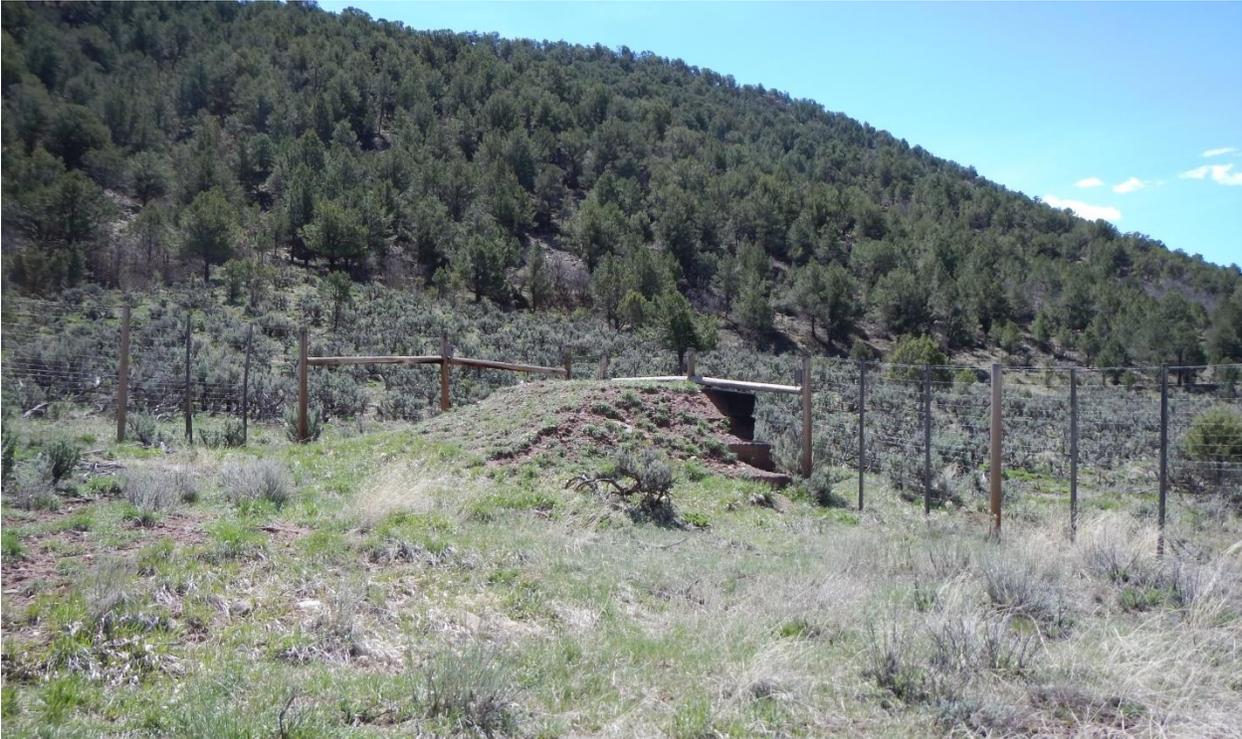
Ramp 6. MP 107- on the east side of the highway.

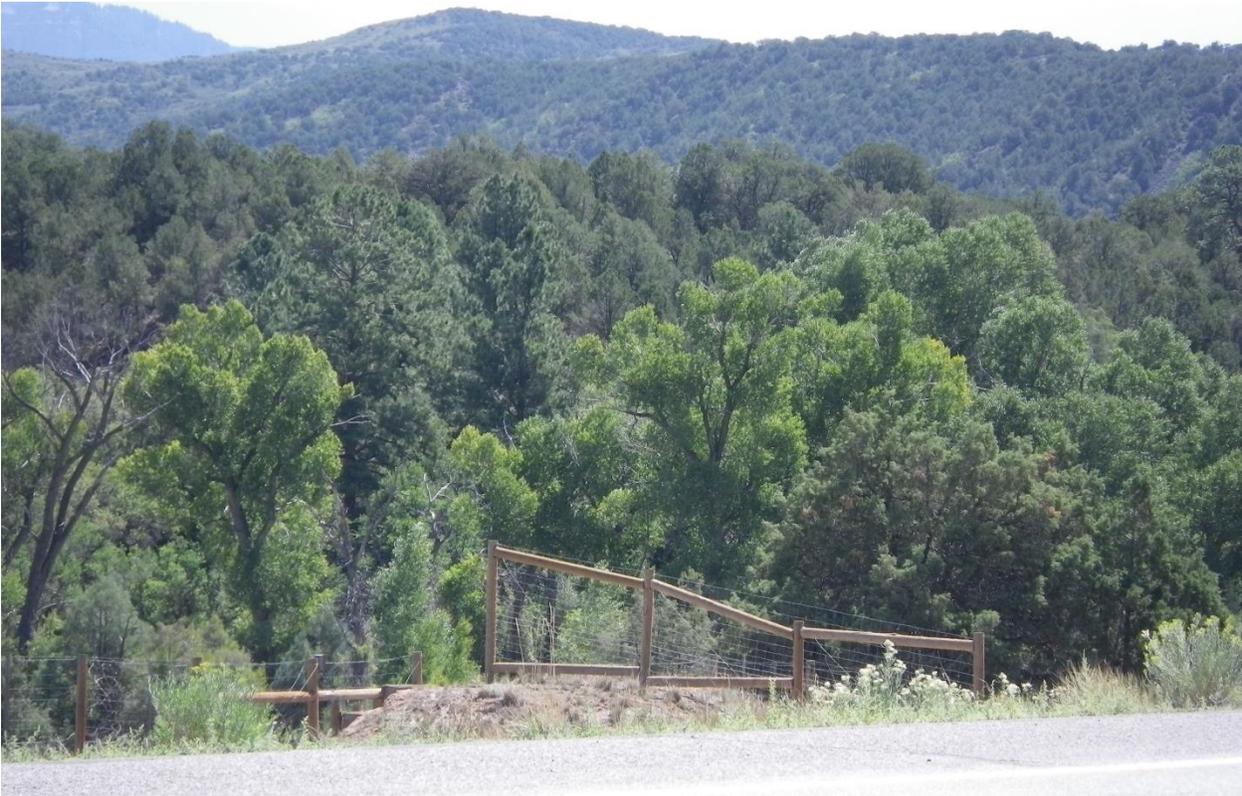
Ramp 12. MP 111- on the east side of the highway.

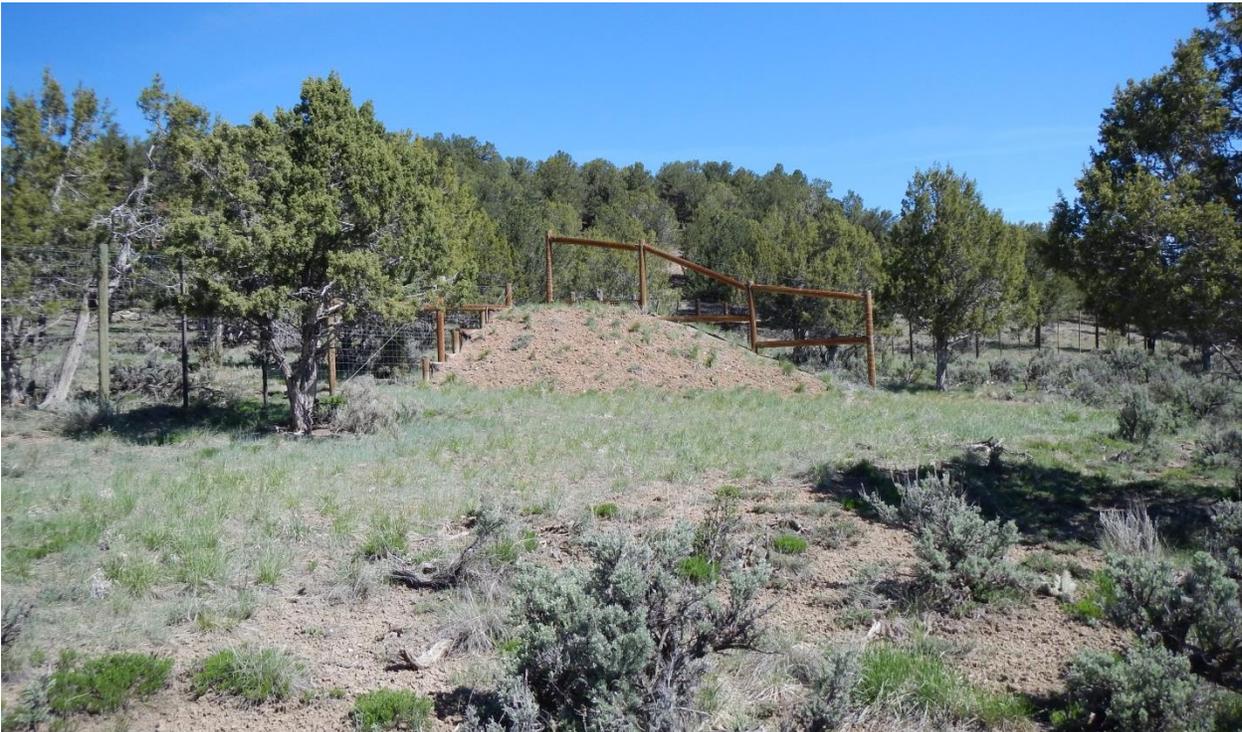
Ramp 20. MP 108+ on the west side of the highway near the Dutch Charlie Entrance to Ridgway State Park.

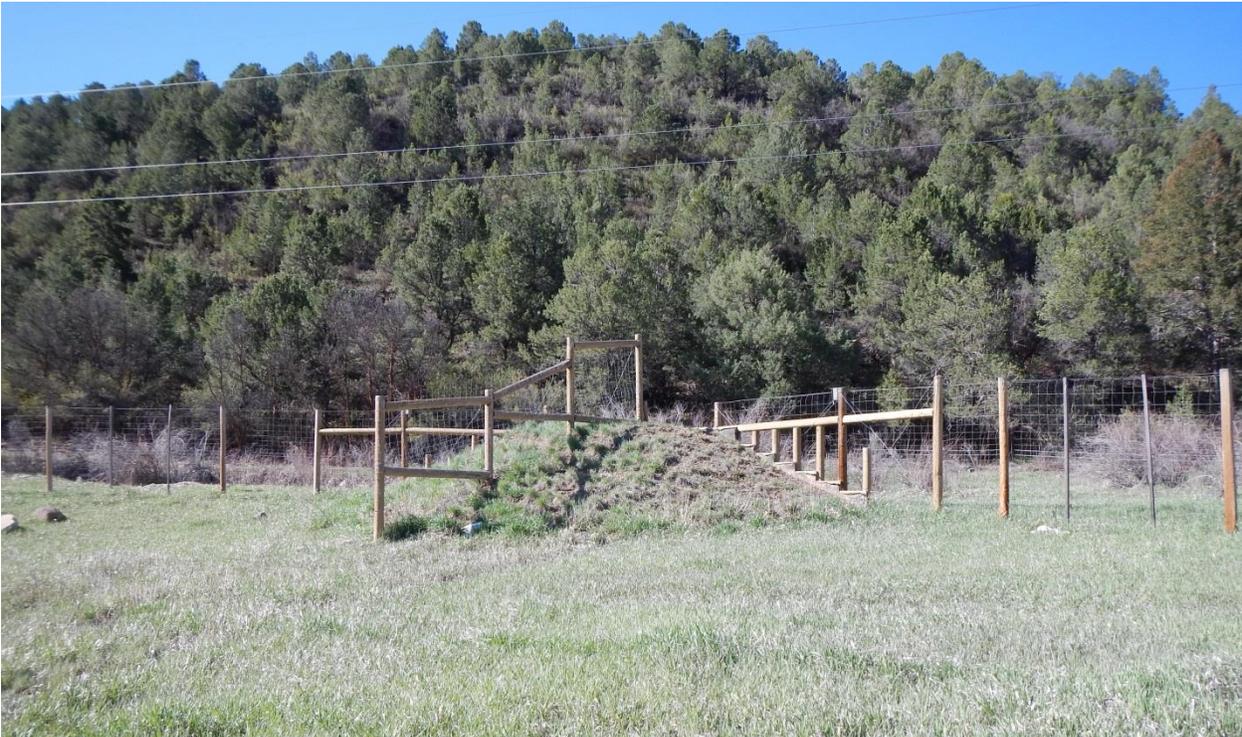
Ramp 21. MP 111+ on the west side of the highway.

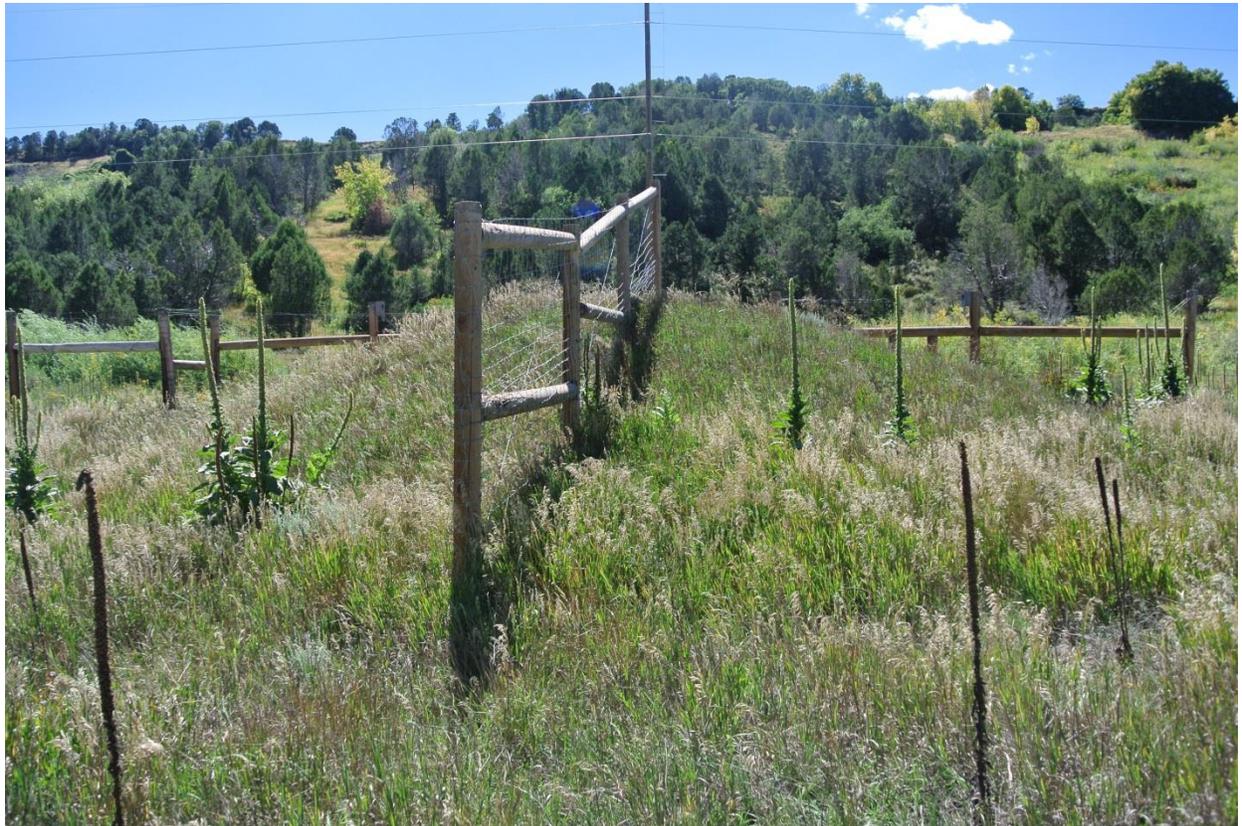
Ramp 22. MP 111- on the west side of the highway.

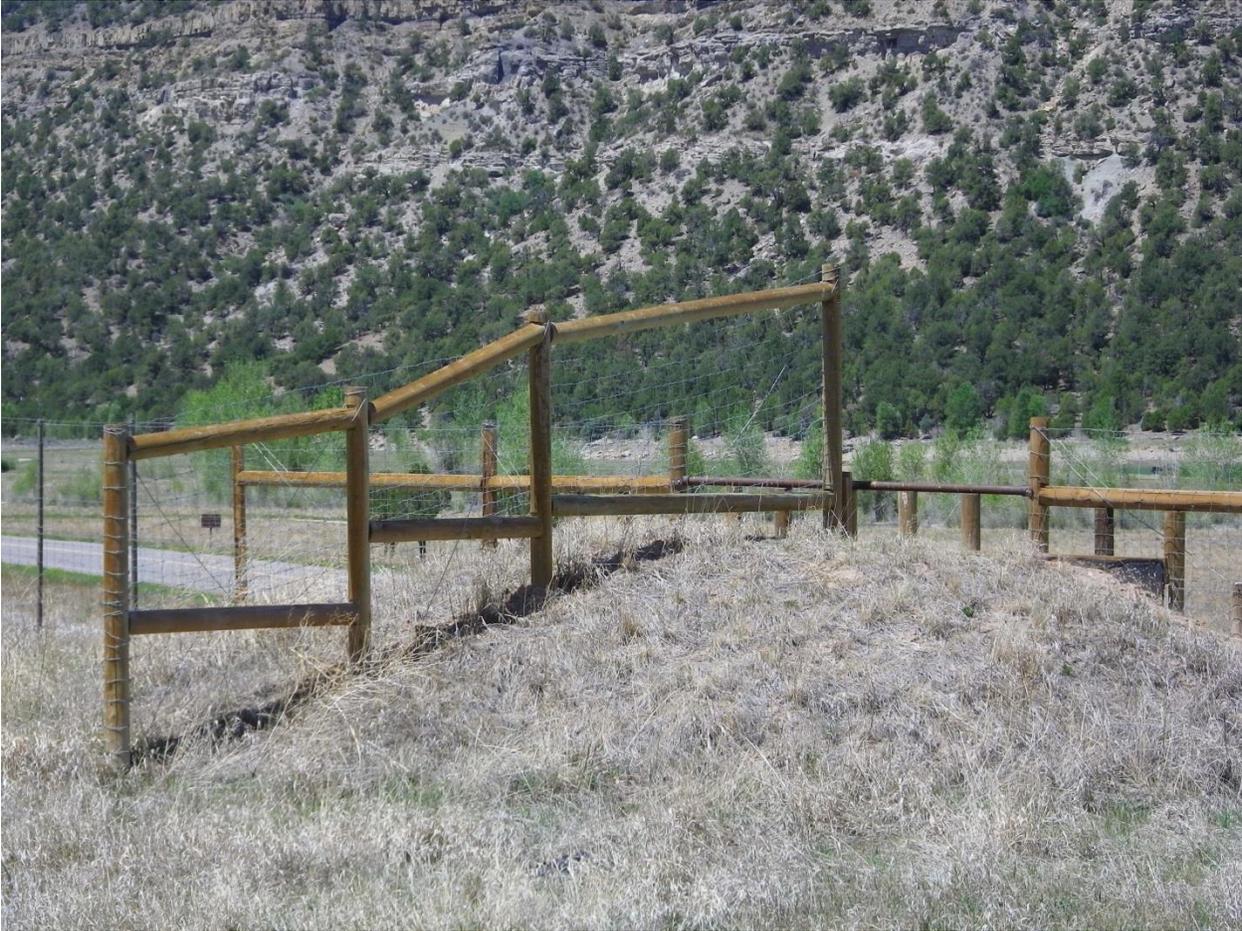
Ramp 23. MP 107.5 on the west side of the highway.
