THESIS

EXPERIMENTAL ASSESSMENT OF CRACKED STEEL BEAMS UNDER MECHANICAL
LOADING AND ELEVATED TEMPERATURES

Bashir Ahmadi

Colorado State University

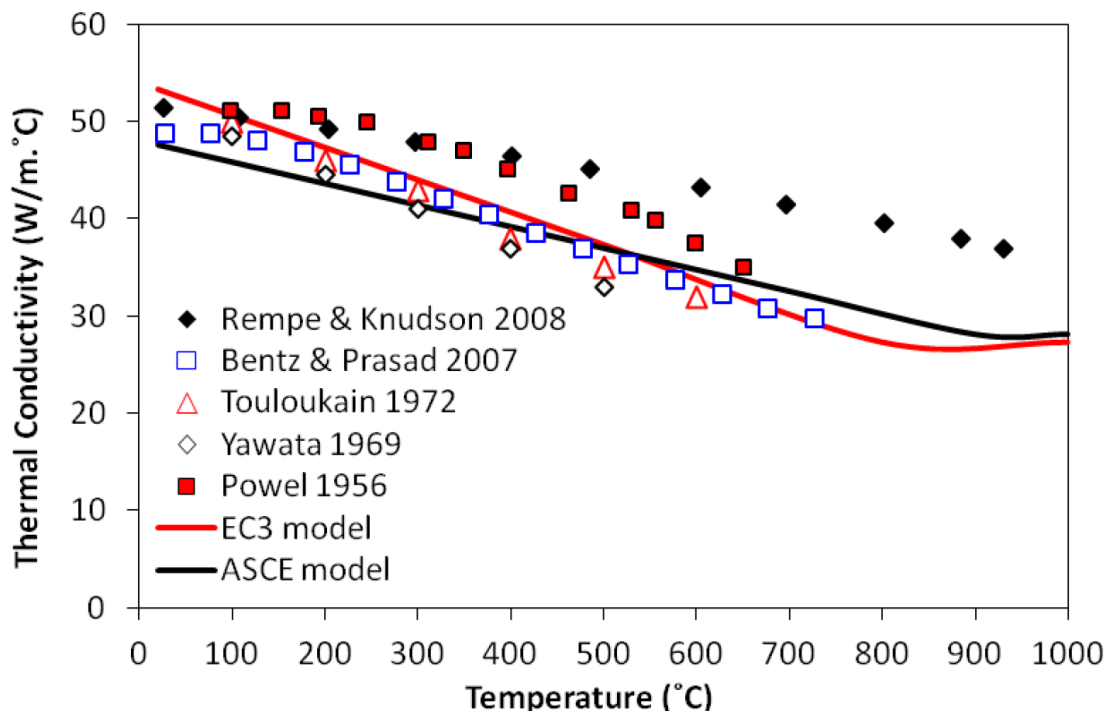
Figure 2-9: Thermal conductivity of steel as a function of temperature (Aziz, 2015)

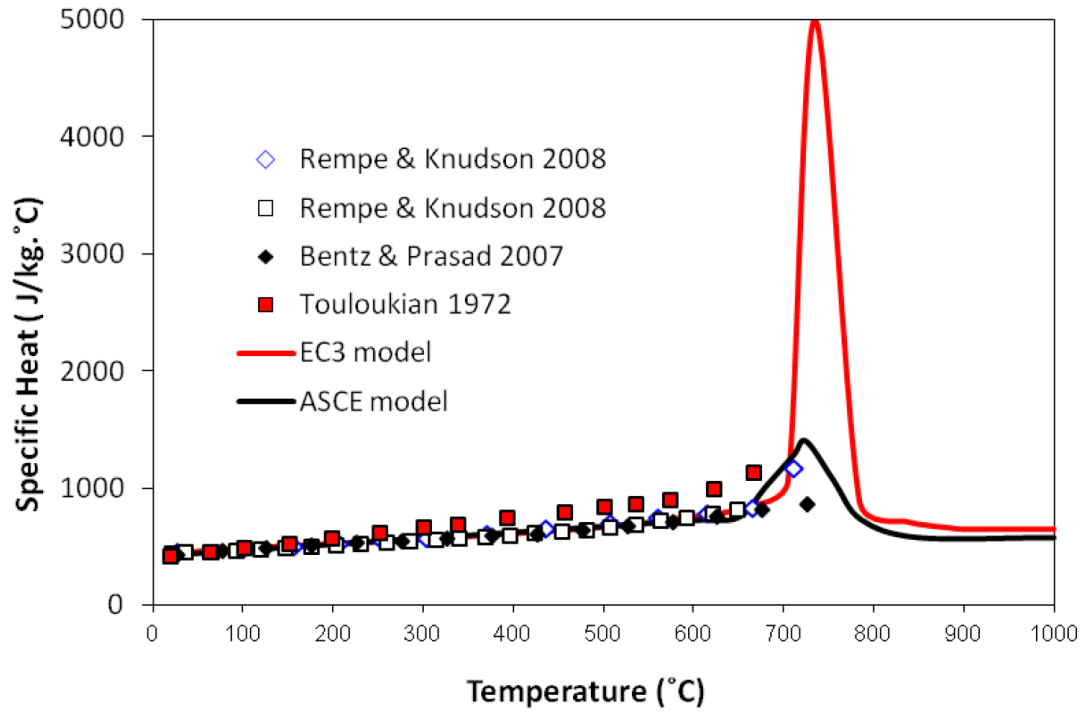
Figure 2-10: Specific heat of steel as a function of temperature (Aziz, 2015)

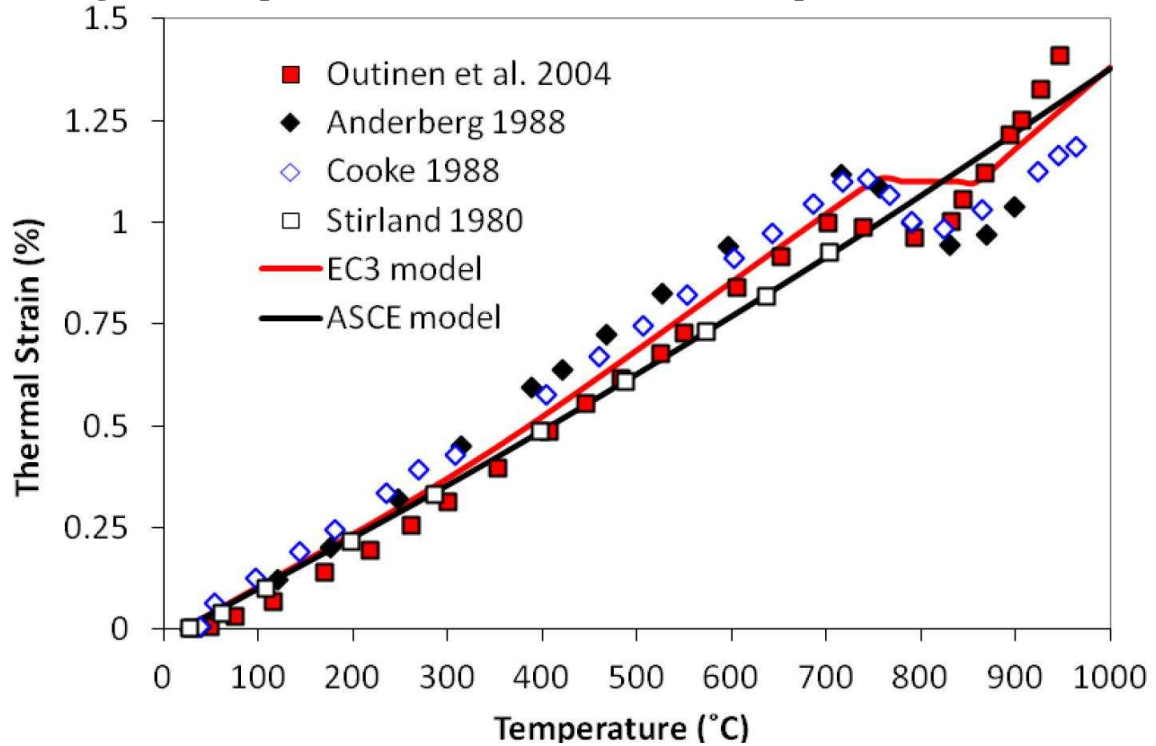
Figure 2-11: Thermal strain of steel as function of temperature (Aziz, 2015)

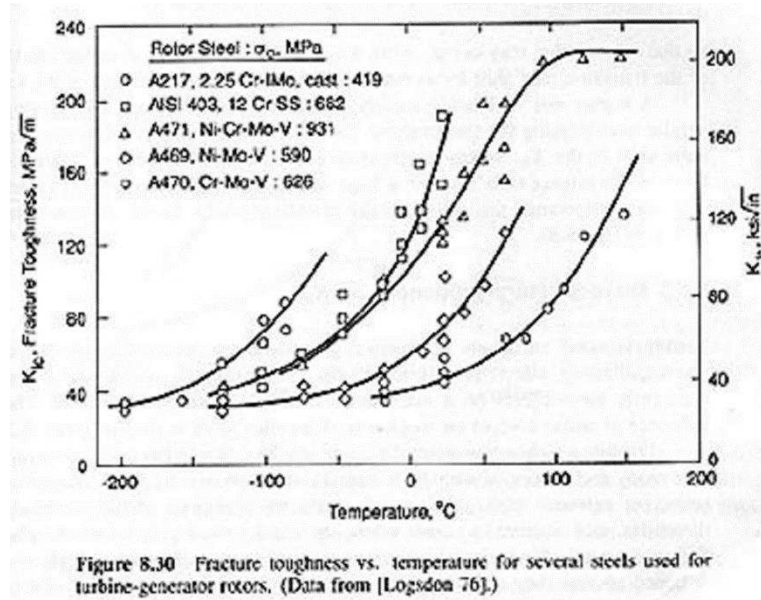
Figure 2-16: Fracture toughness of steel as function of temperature (Dowling, 1993)

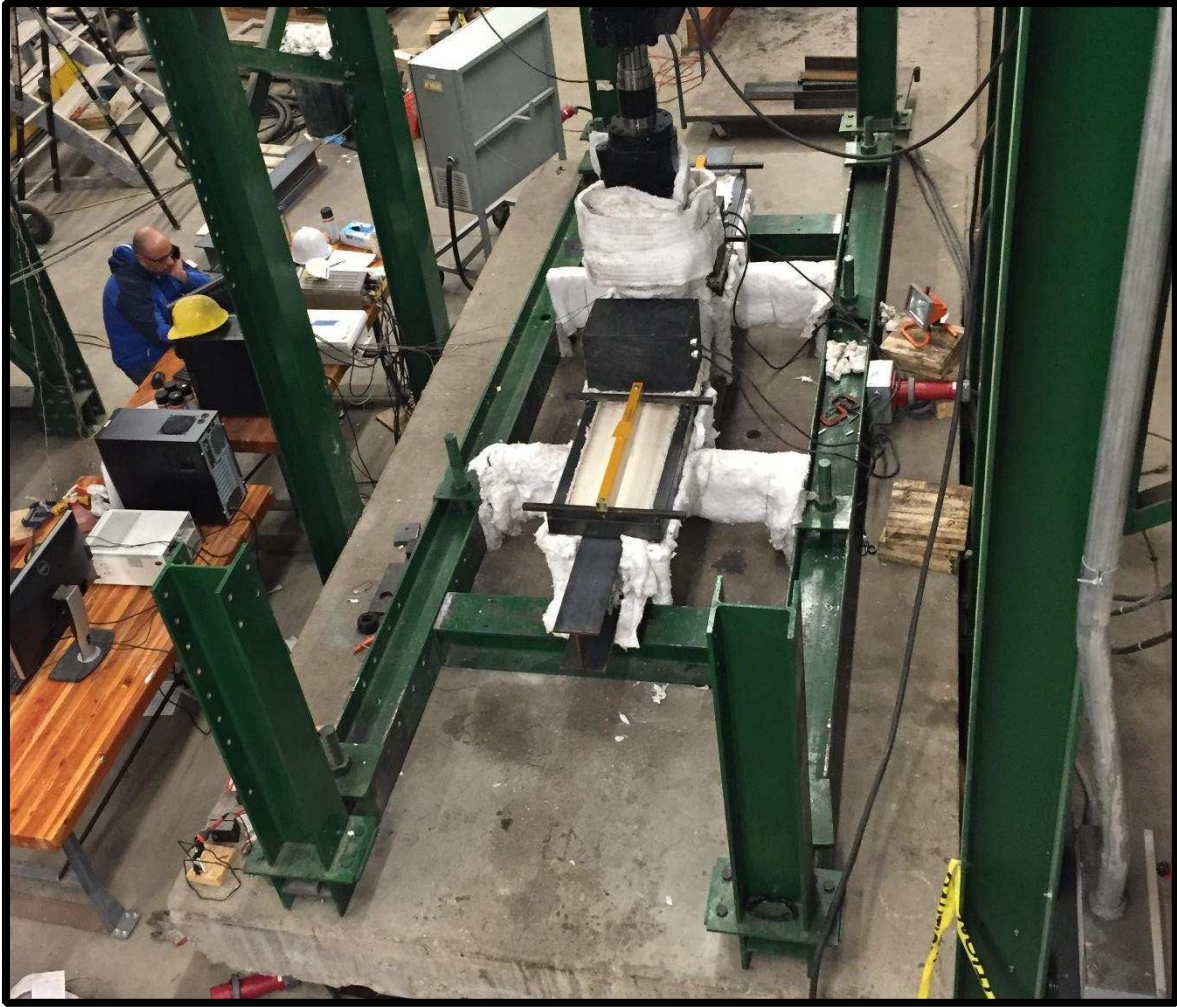
Figure 3-9: Top view of finished test setup

The second component of the test setup is temperature distribution application which includes a pair of ceramic radiative heaters, heaters' frames and ceramic fiber glass insulation chamber. The ceramic radiative heaters were placed on top of the beam for temperature distribution from the top flange across and along the beam and an insulation chamber made from ceramic fiber glass is provided around the beam in order to confine the avoid the heat loss. Photos of the test setup with and without insulation are included in Figure 3-6 and Figures 3-7, respectively. The ceramic radiative heaters were supported vertically through placing their edges on two small heaters' frames, which are shown in Figure 3-7. Figure 3- 8 shows the ceramic heaters front view, which was placed facing the top flange of the beam specimens to provide heat transfer through conduction. Figure 3-9 includes top view of a finished test setup.

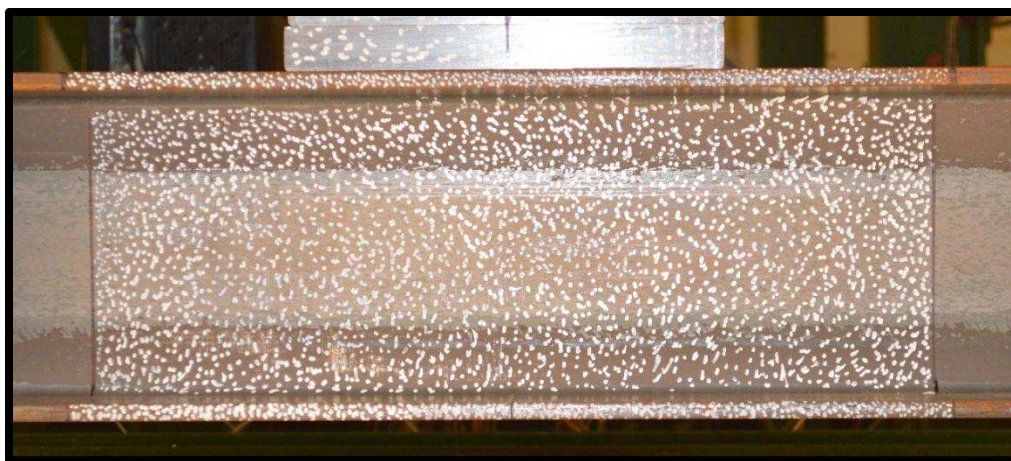
Figure 3-14: Front View of the specimen mid span used for capturing pictures for DIC analysis

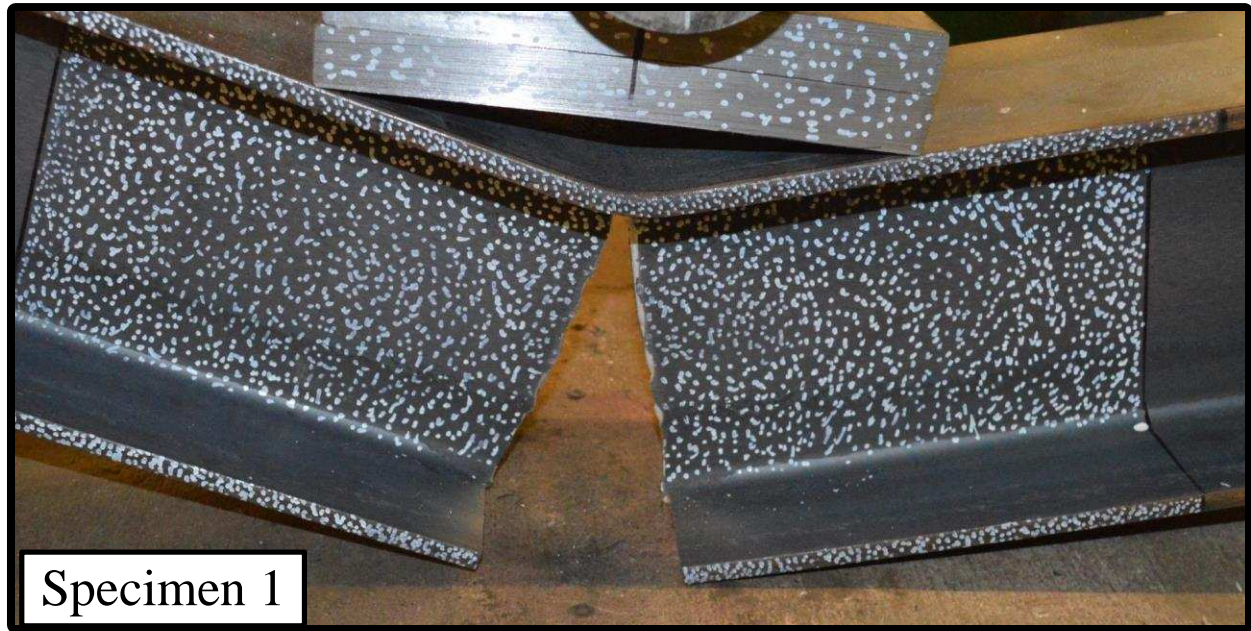
Figure 4-19: Specimen 1 global failure behavior

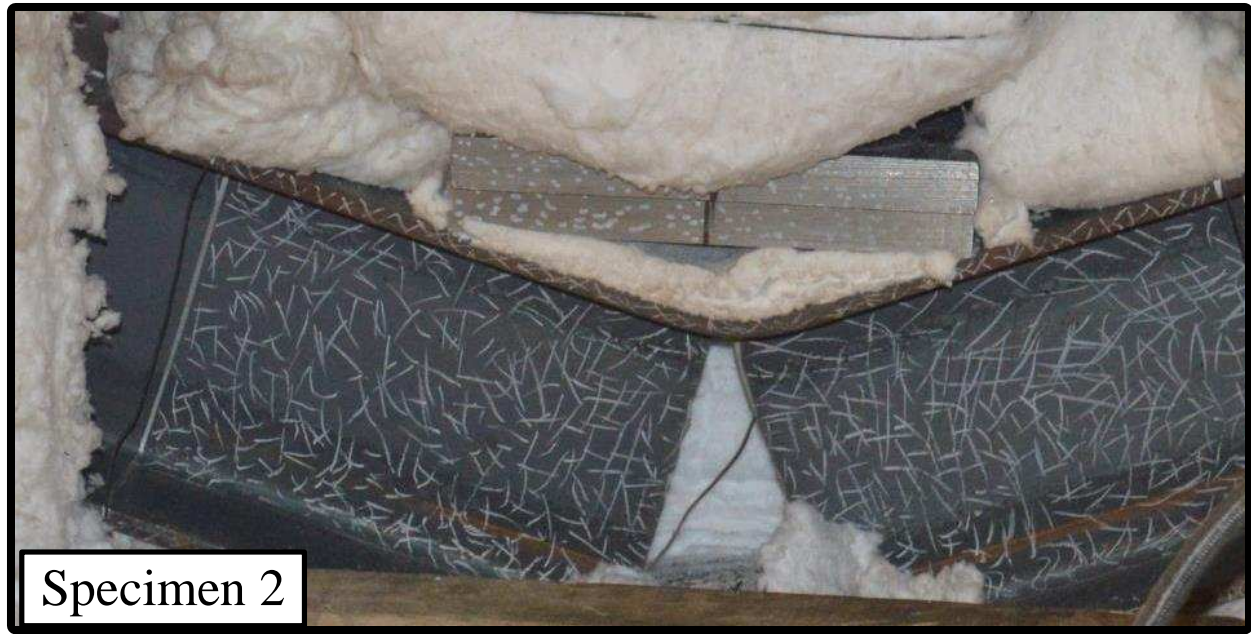
Figure 4-21: Specimen 2 global failure behavior

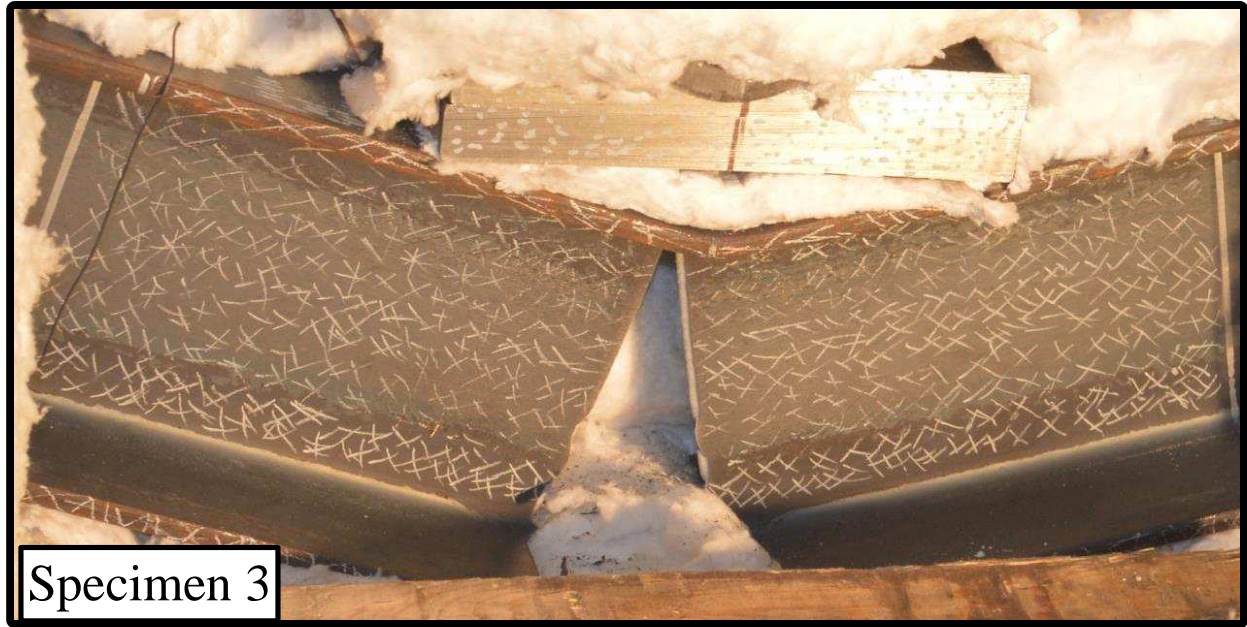
Figure 4-23: Specimen 3 global failure behavior
