DISSERTATION

VEGETATION AND LITHOLOGIC INFLUENCES ON CHANNEL MORPHOLOGY

IN THE SOUTHWESTERN U.S.

Celeste Wieting

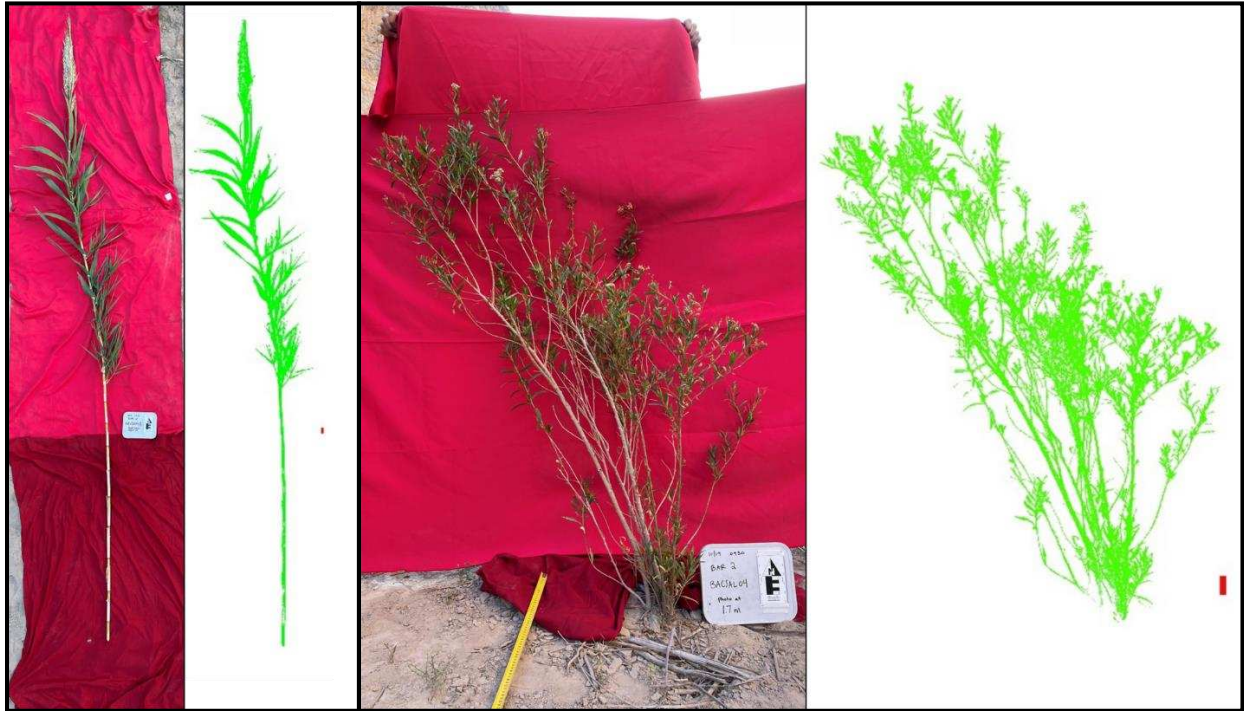
Figure 2.3. Examples of edited photos to use within ELA for quantifying upright plant frontal area. Images are of giant cane (left) and baccharis (right).

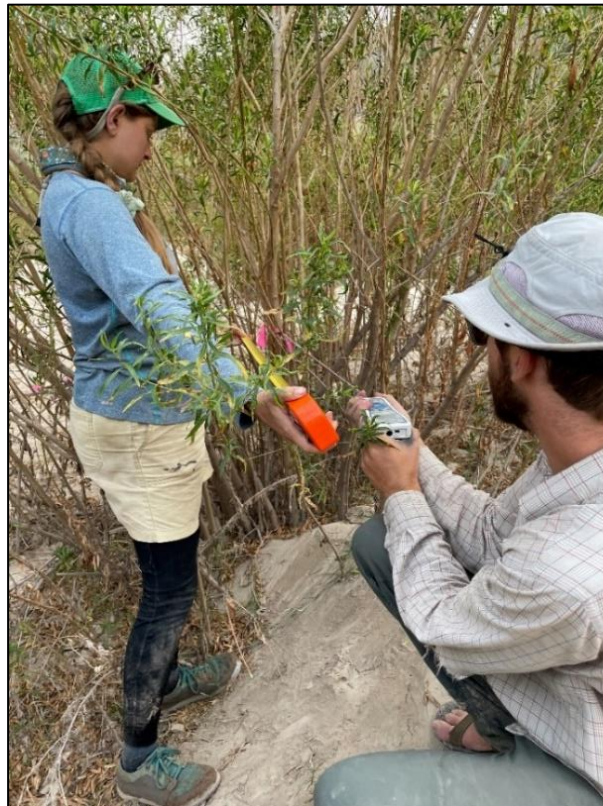
Figure 2.4. Measuring the force-displacement relationship for a baccharis plant to calculate flexural rigidity.

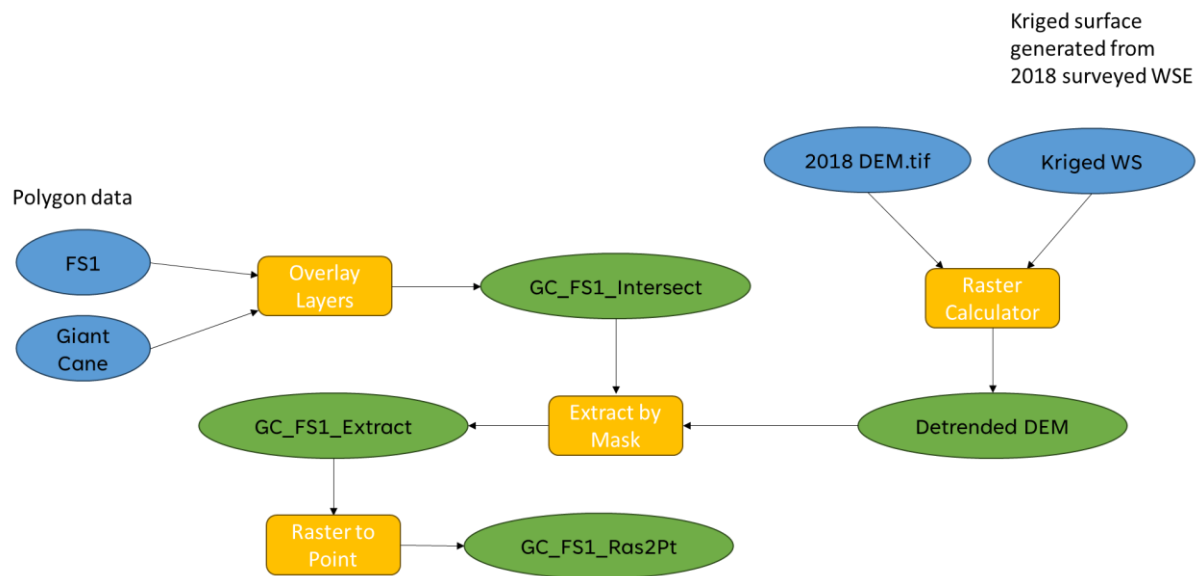
Figure 2.5. ArcGIS PRO model builder workflow to create overlapping geomorphic and vegetation point data.

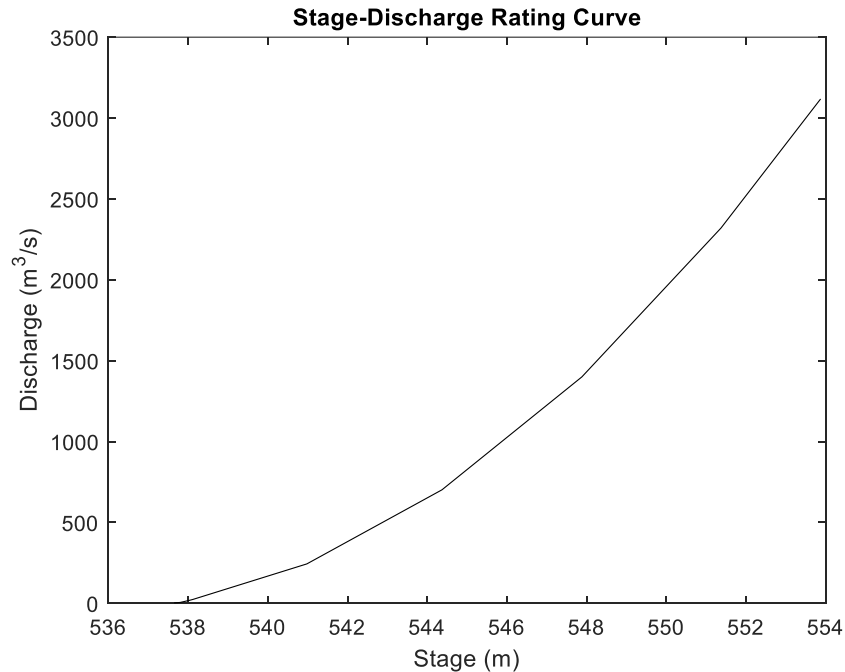
Figure 2.8. Downstream boundary condition stage-discharge rating curve for Reach 1 including bars 6 and 7. The original rating curve was created by Blythe (2018) and was adjusted for this study for topographic agreement between all topographic-related datasets in the hydraulic model analysis.

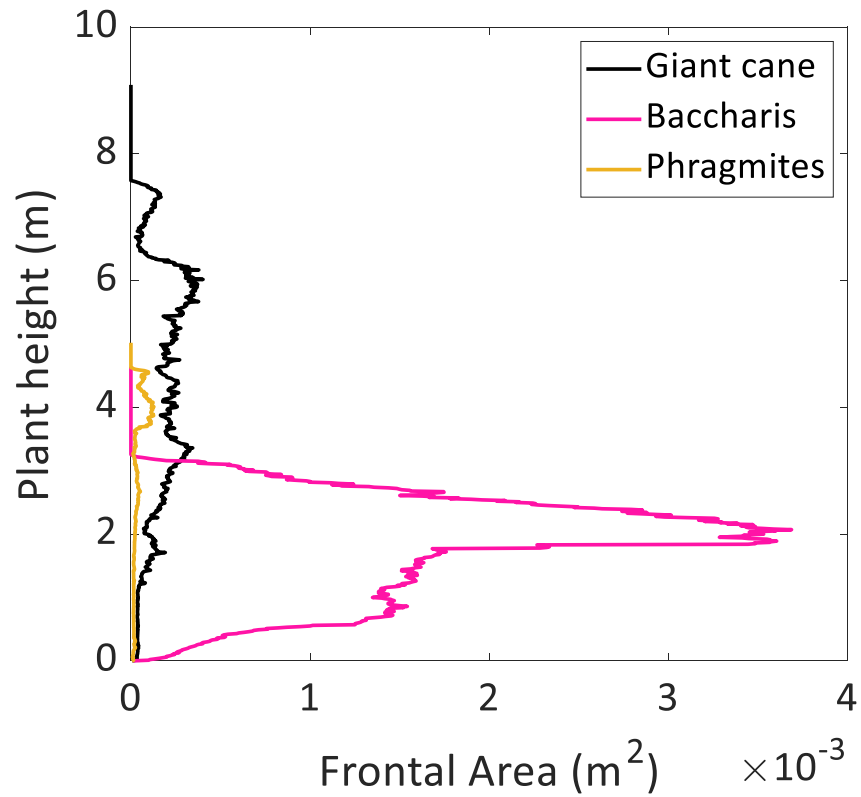
Figure 2.11. Average non-normalized upright frontal area curves for individual plants. These curves are essentially the raw data from the photographs of plants taken with a red background.

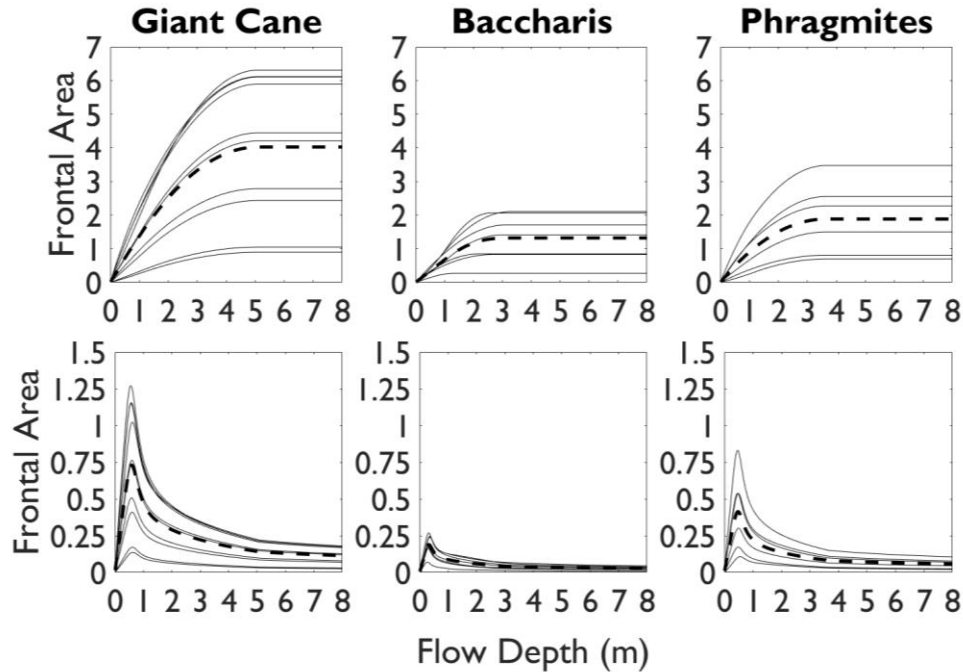
Figure 2.14. Frontal area curves for upright (top) and flexible (bottom) plots. Curves are normalized by plot area. Solid lines represent individual plants and the dashed line represents the mean.

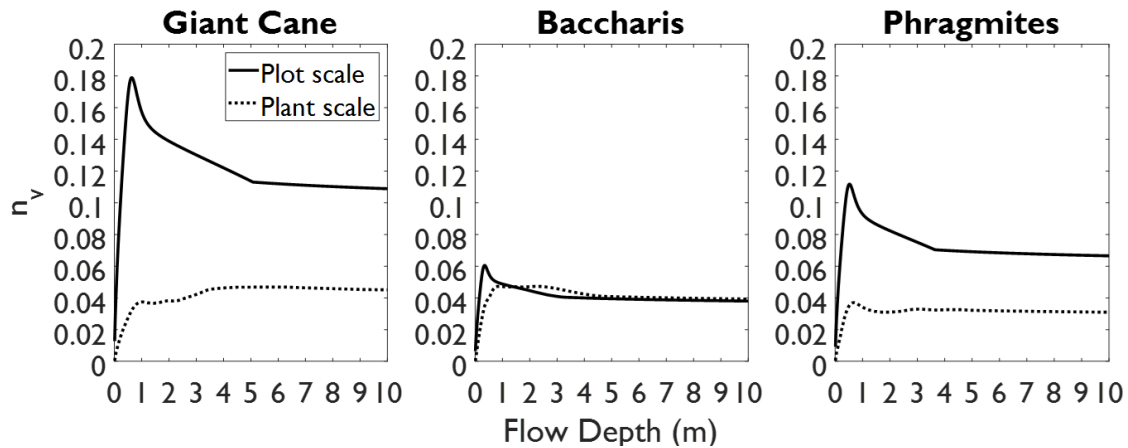
Figure 2.15. Depth-varied vegetation roughness for specific plant species calculated at the individual plant and plot scales.

Vegetation roughness from native baccharis was less than giant cane or phragmites (Figure 2.15), but baccharis was commonly found growing in the active channel (Figure 2.17). The low flexural rigidity of baccharis suggests that it is flexible enough to bend over instead of break during floods, which limits its resistance, results in lower hydraulic roughness, and improves its chances for survival in high velocity environments. But, if decreasing channel narrowing is a goal of natural resource managers and baccharis is prolific in the active channel, should the management attention be shifted to baccharis? Vegetation-elevation histogram findings suggest

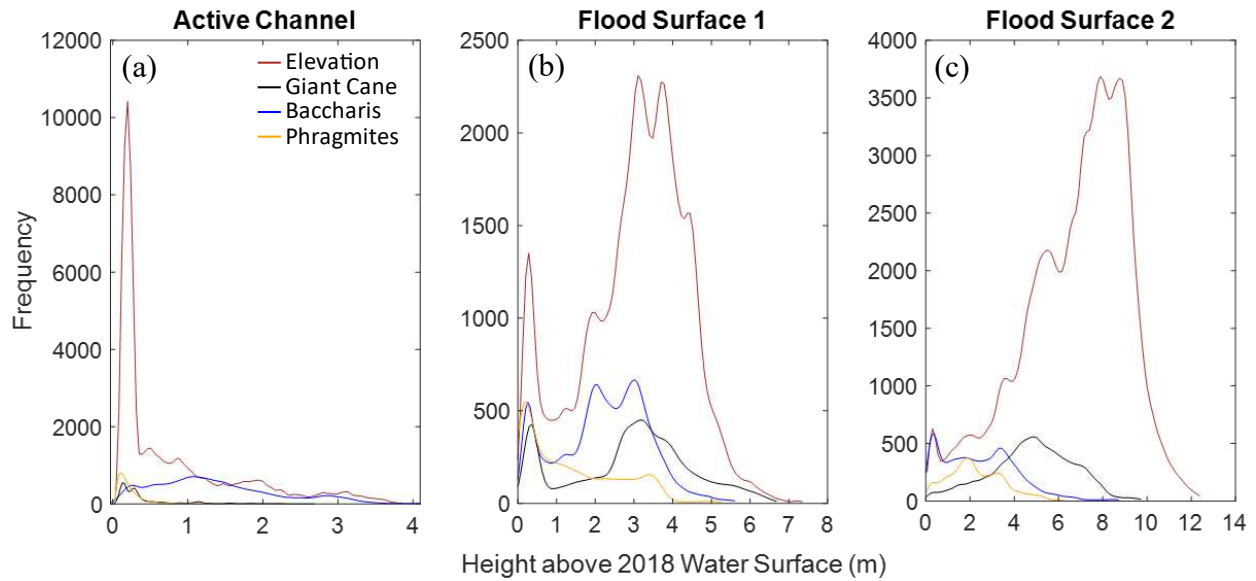
Figure 2.17. Cumulative histograms of detrended elevation for Giant Cane, Baccharis, Phragmites and all surface cover types on the (a) active channel, (b) flood surface 1, and (c) flood surface 2.

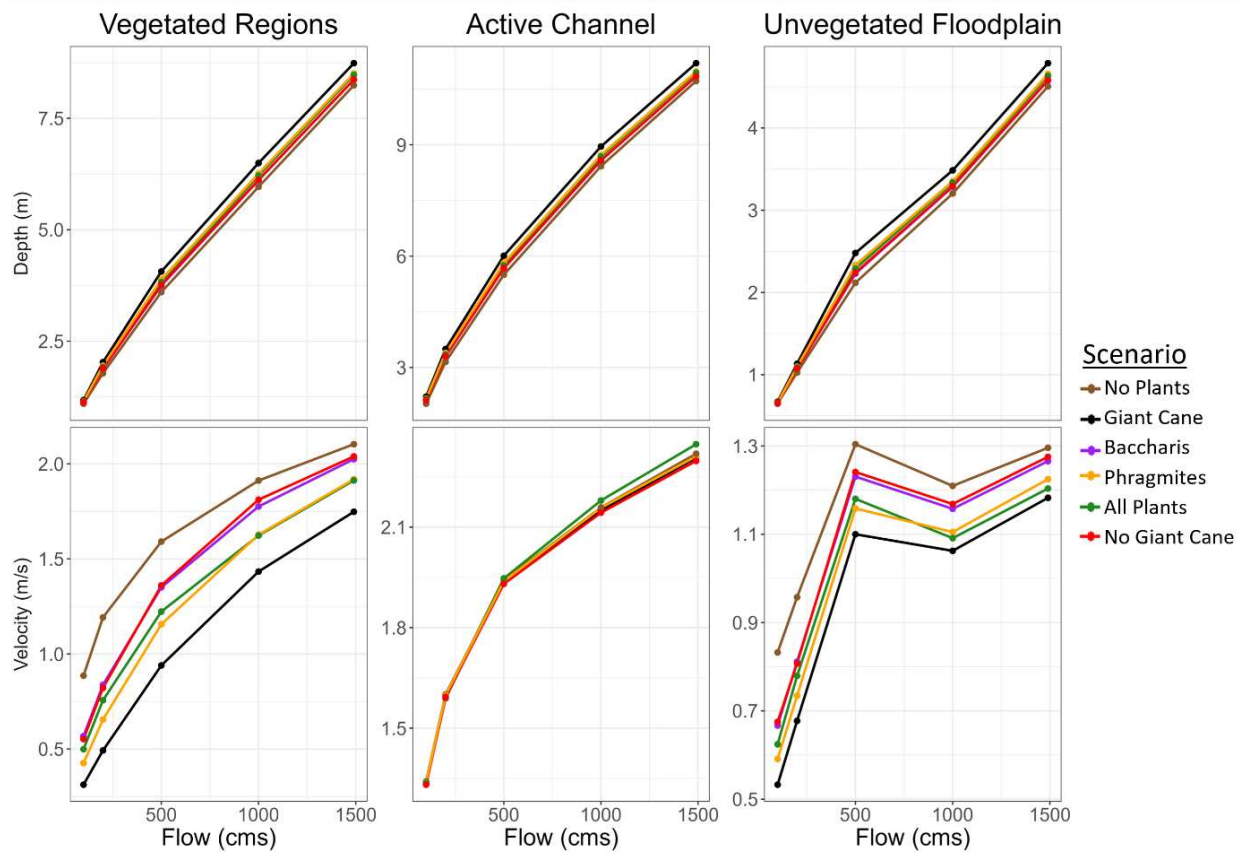
Figure 2.18. Mean values for flow depth and velocity within (left) vegetated regions, (middle) the active channel, and (right) the unvegetated floodplain. These data along with median, standard deviation, minimum, and maximum are included in Appendix A, Tables A5-A7.

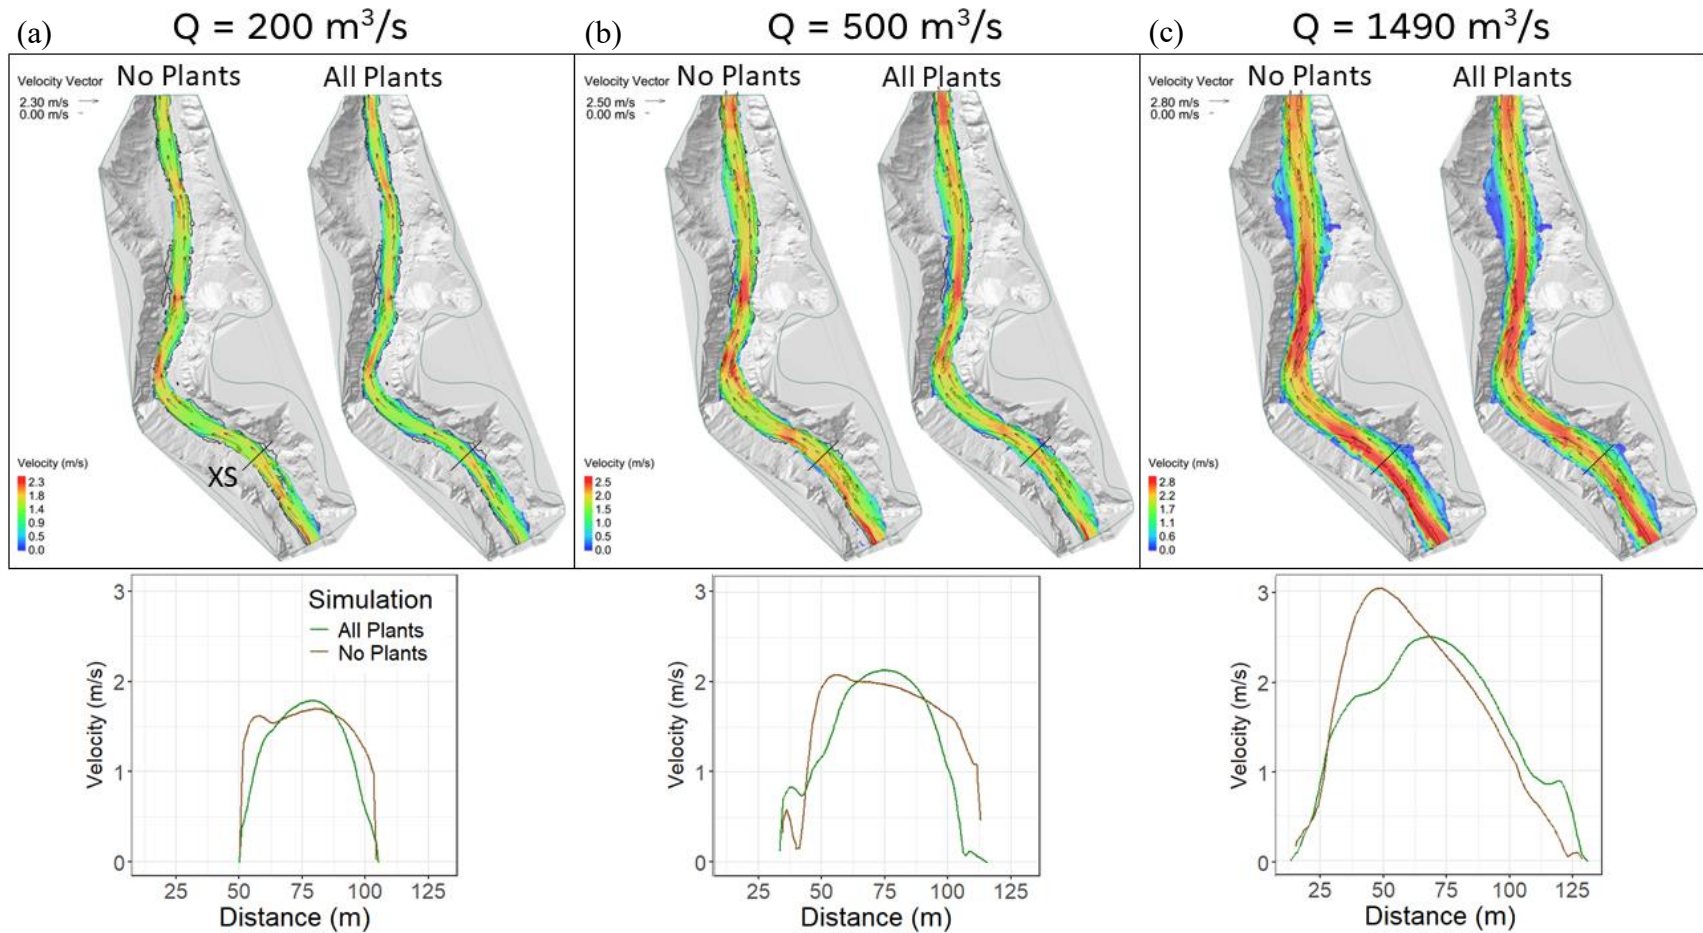
Figure 2.19. A comparison of the influence of vegetation (Scenario 5) to the no-vegetation scenario (Scenario 1) at the reach scale and at a cross section at Bar 6 for (a) $200 \text{ m}^3/\text{s}$, (b) $500 \text{ m}^3/\text{s}$, and (c) $1490 \text{ m}^3/\text{s}$.

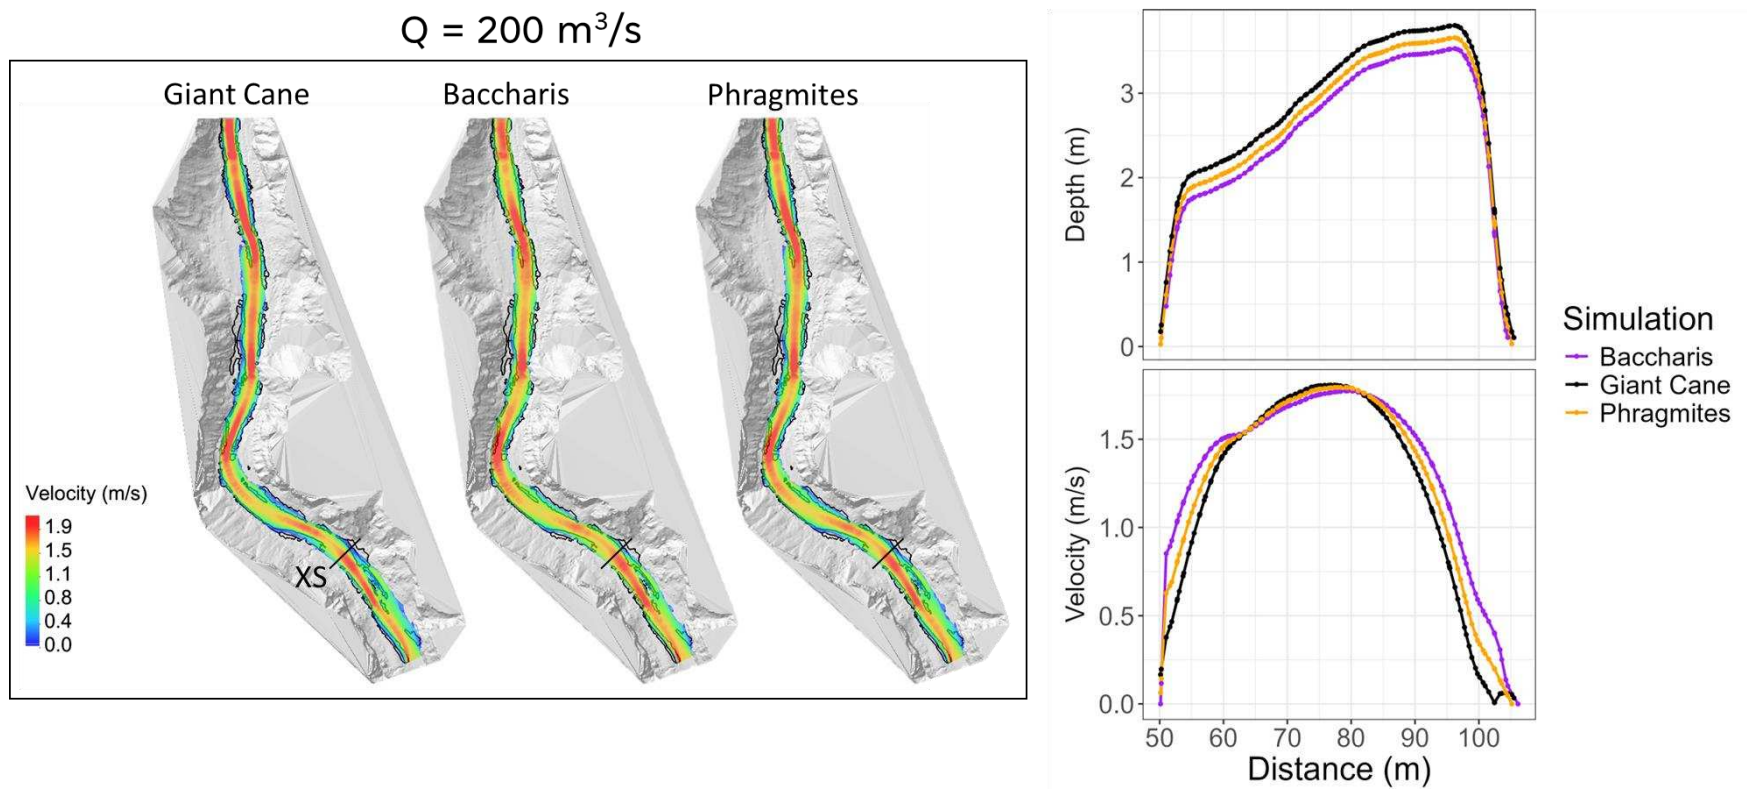
Figure 2.20. Reach-scale velocity results for scenarios 2-4 at a simulated discharge of $200 \text{ m}^3/\text{s}$. Cross-section results include both depth and velocity for each scenario.

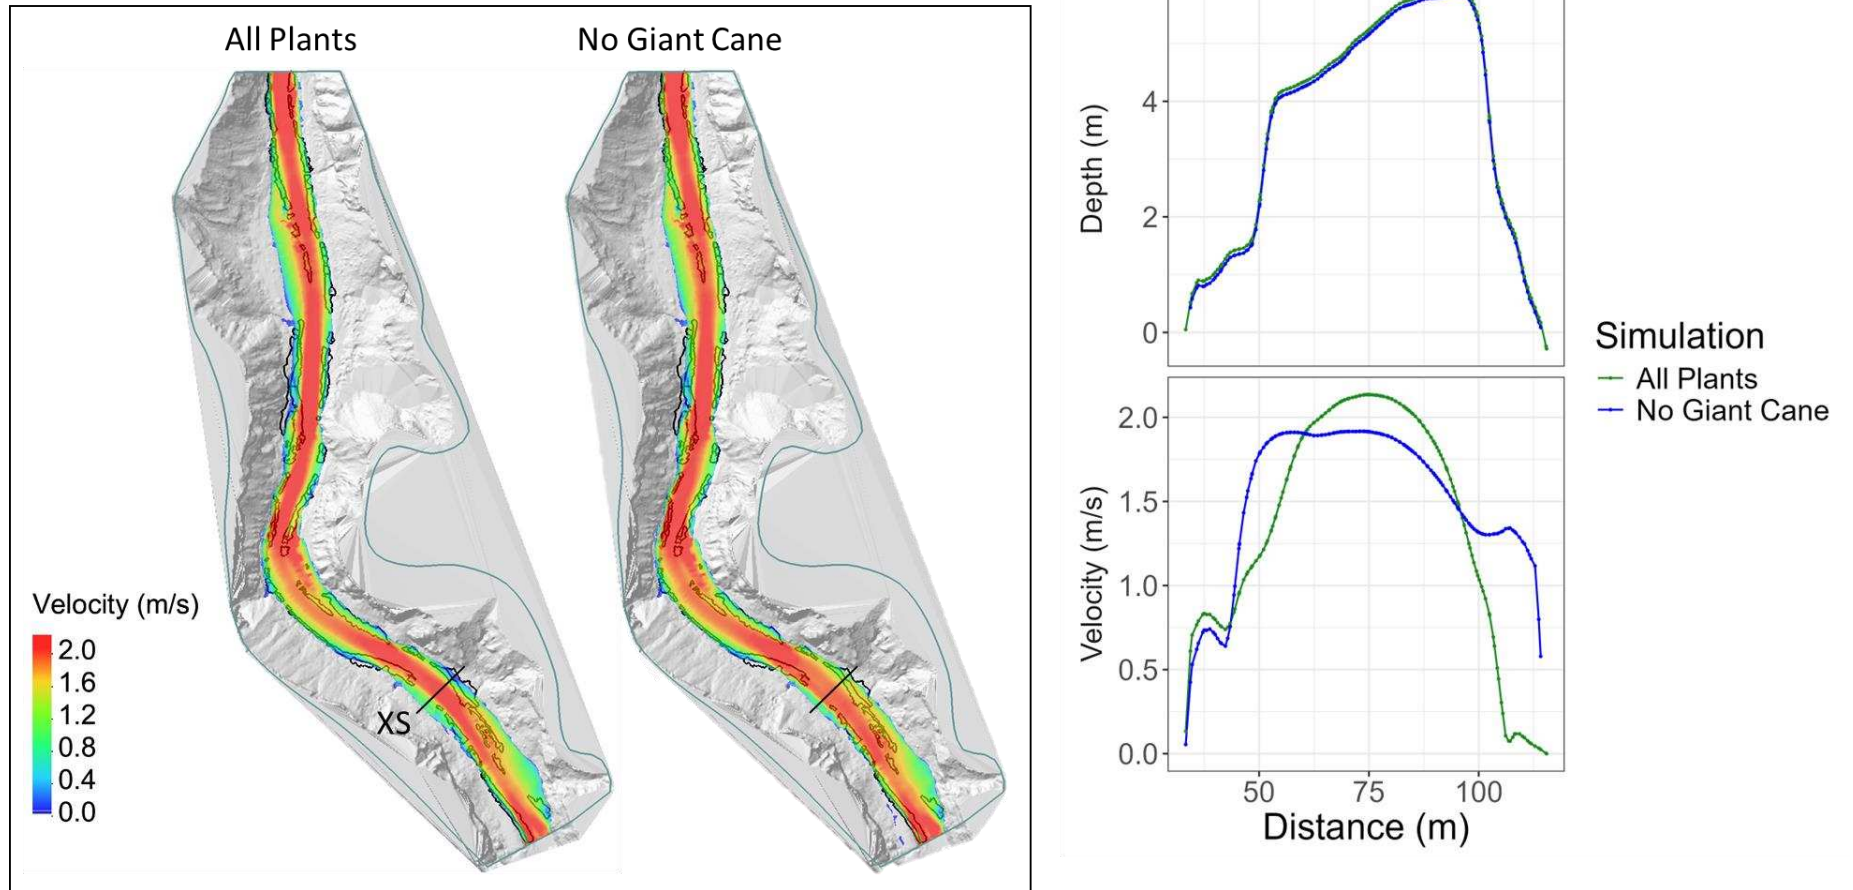
Figure 2.21. Reach-scale effects of giant cane removal on velocity. Cross-section results include both depth and velocity for each scenario.

Replacing all existing vegetation with giant cane (Scenario 2) led to approximately 30 cm of WSE increase within the modeled reach (Figure 2.21). In contrast, when giant cane polygons were removed from the model without replacement (Scenario 6), the WSE decreased by around 10 cm (Figure 2.21).

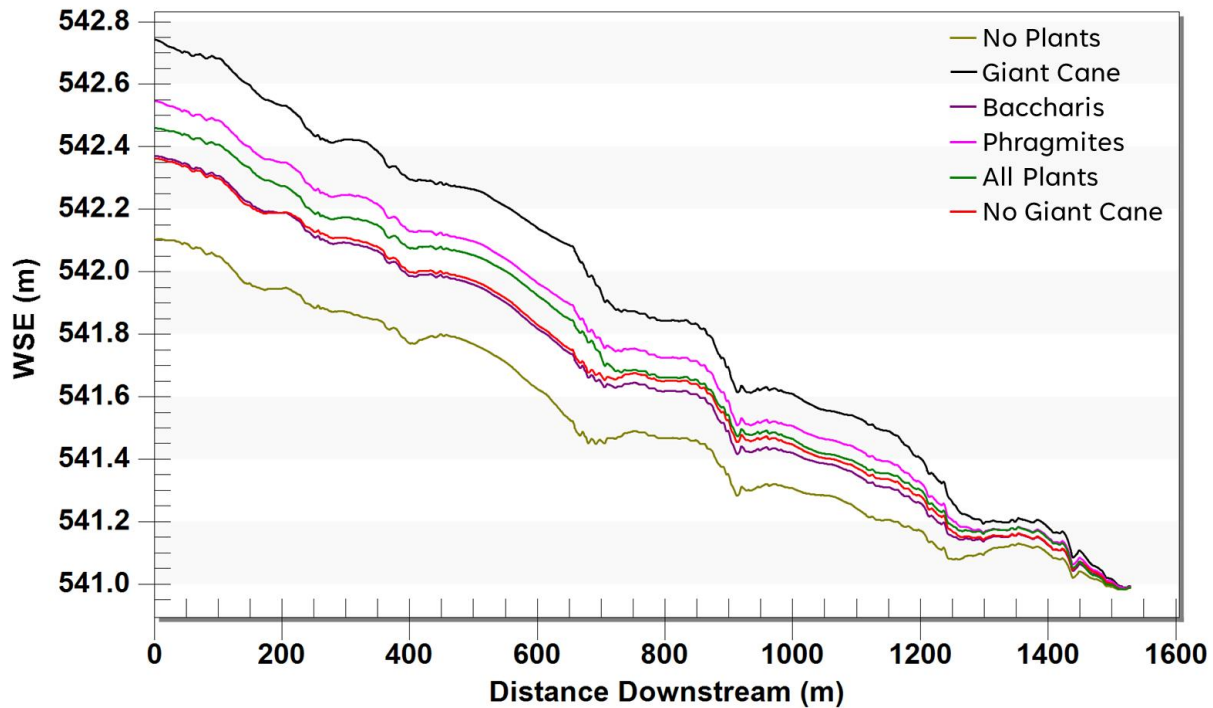
Figure 2.22. Centerline WSEs for different modeling scenarios. WSE converges at the downstream boundary of the modeled reach due to the stage-discharge rating curve boundary condition.

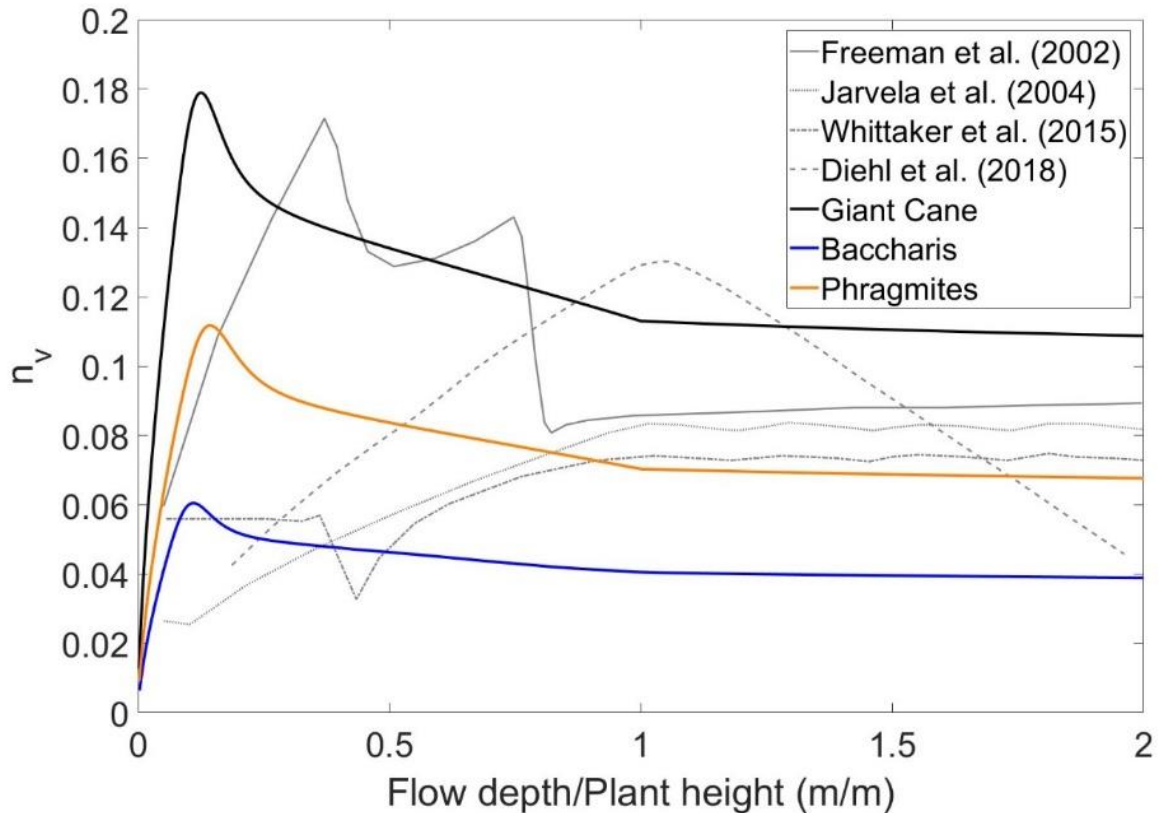
Figure 2.23. A comparison of the vegetation roughness curves calculated for flexible plants in this study and others.

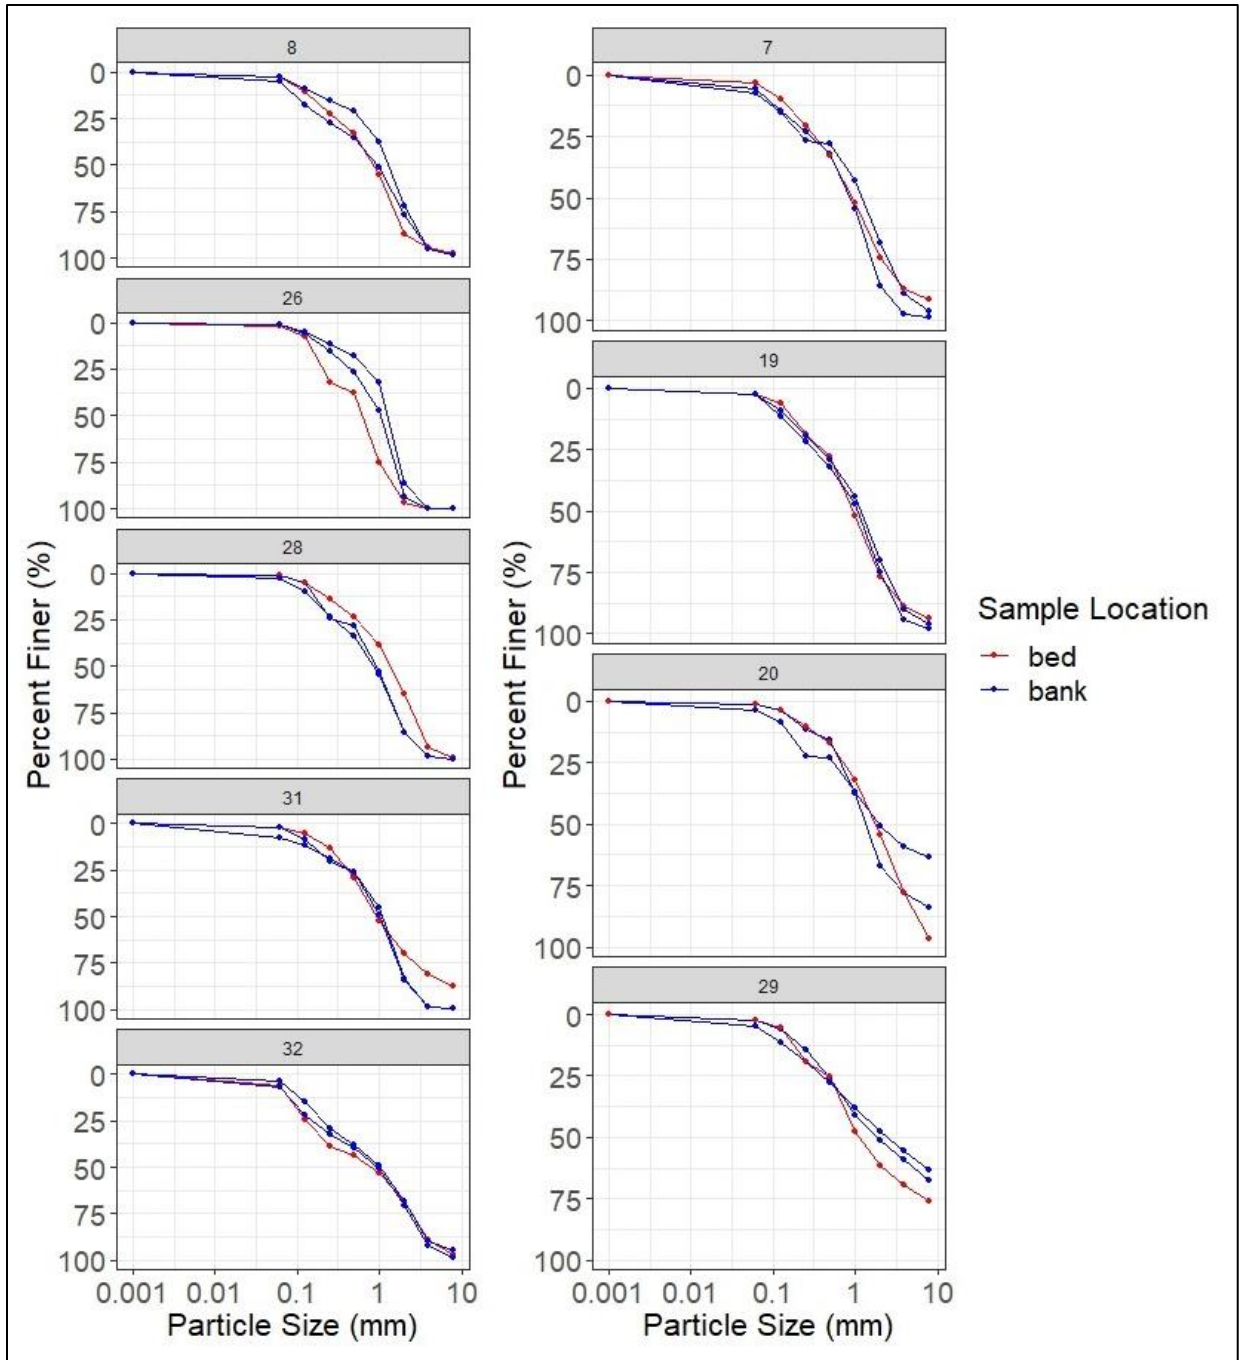
Figure 4.13. Grain size distribution plots for gullies with bed and banks made of cinders (left) and Moenkopi-sediments (right).

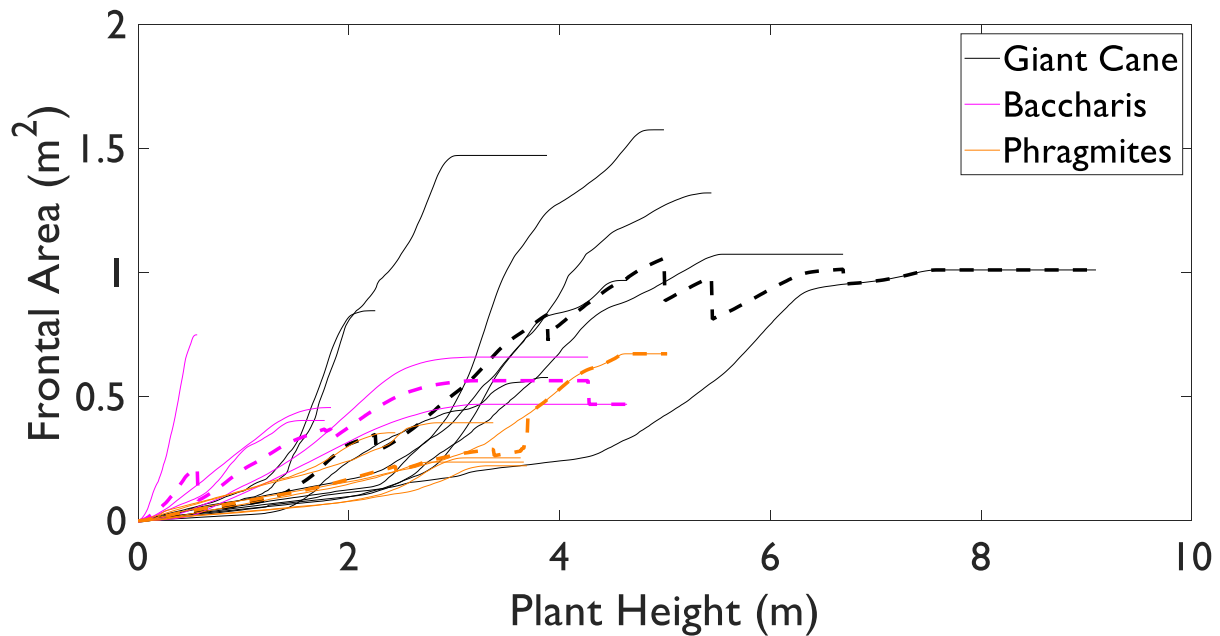
Figure A2. Non-normalized cumulative frontal area curves for individual upright plants. These curves are essentially the raw data from the photographs of plants taken with a red background.
