# THE EFFECT OF LOSS OF BEAVERS AND THEIR PONDS ON FINE SEDIMENT TRANSPORT ALONG THE COLORADO RIVER, ROCKY MOUNTAIN NATIONAL PARK

## PROJECT INTRODUCTION

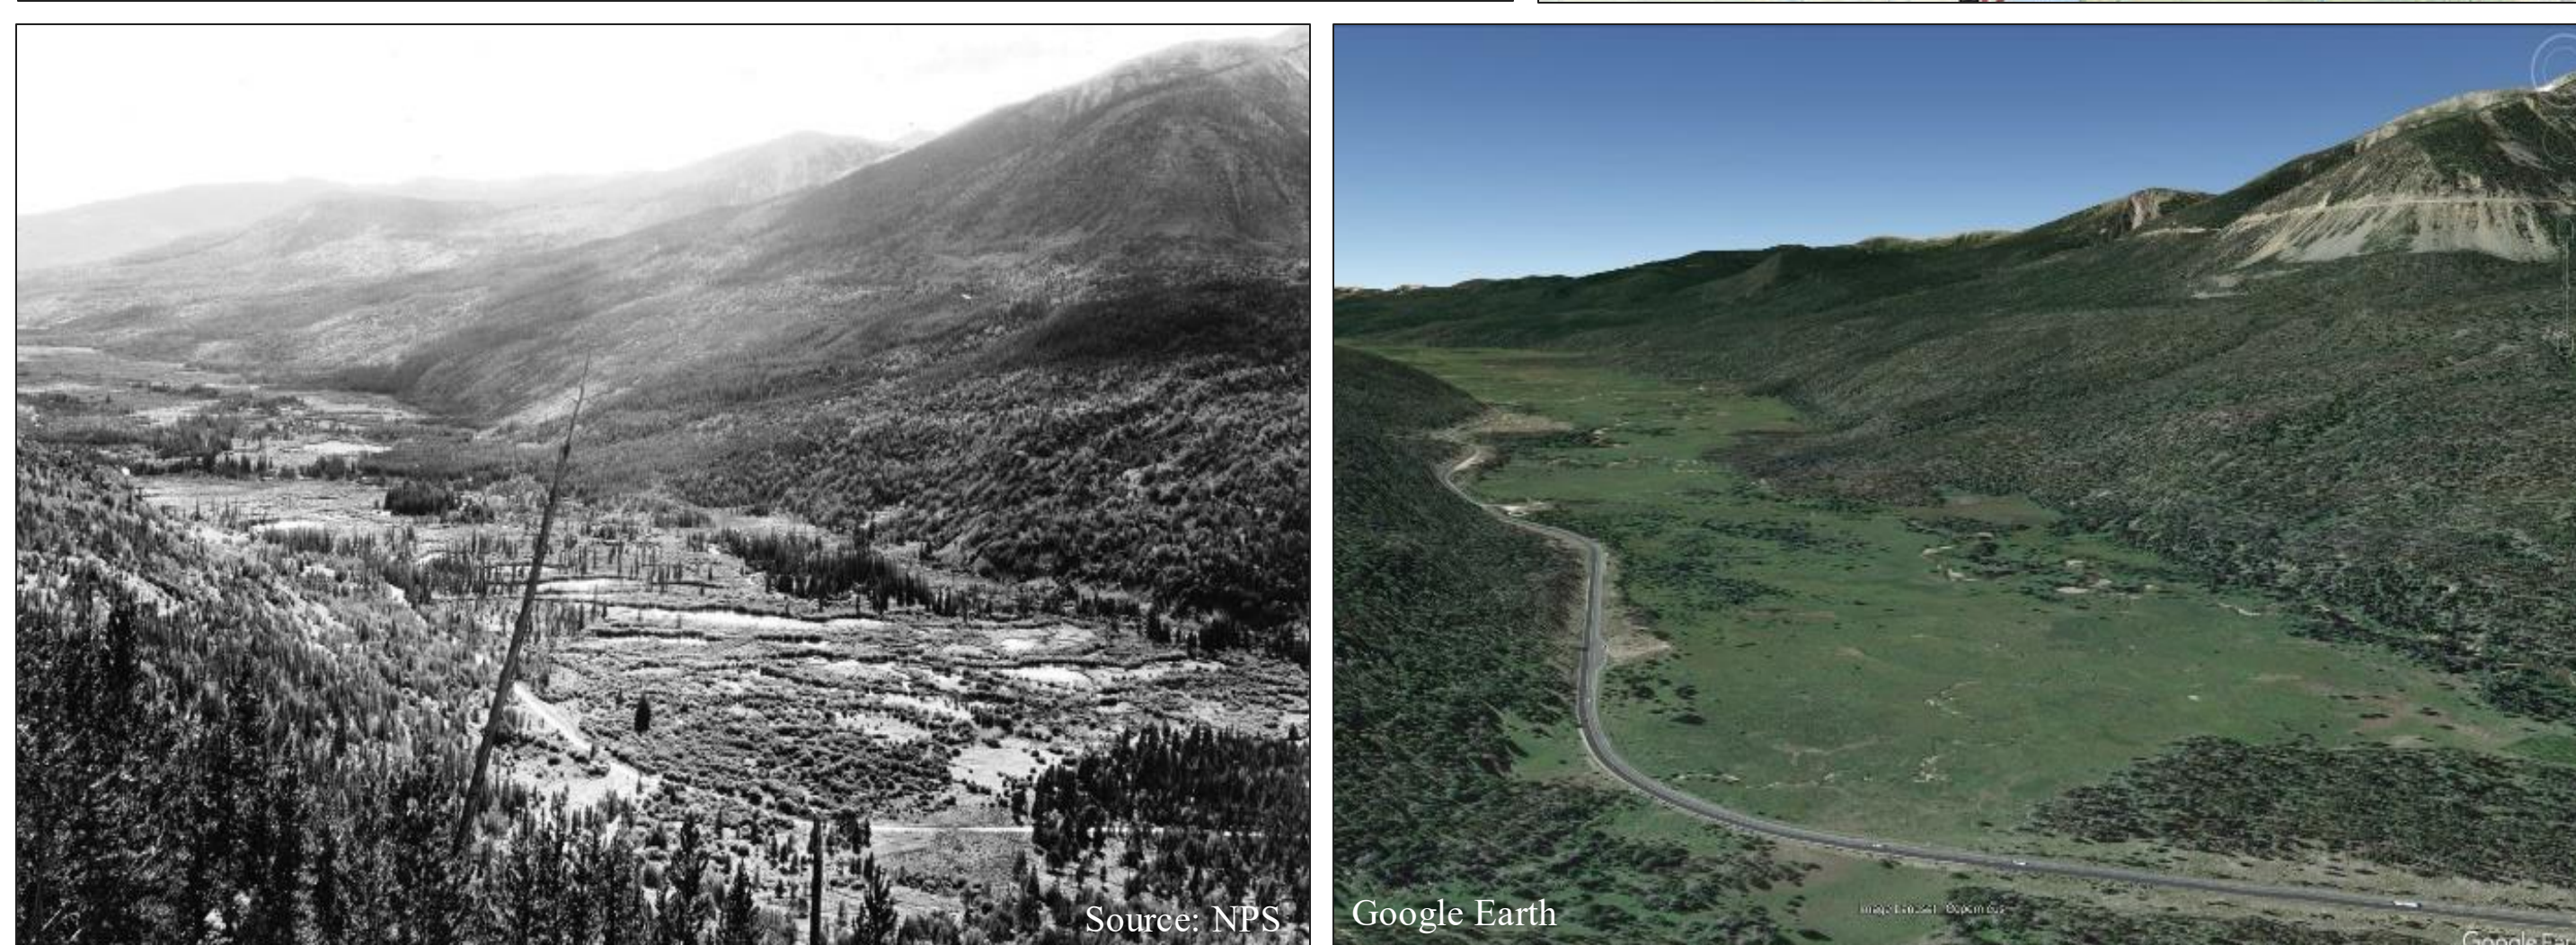
Upper Colorado River in the Kawuneeche Valley, Left: 1920, Right: 2019

High concentrations of nutrients and fine sediment are entering reservoirs in Grand County, CO. It is hypothesized that the fine sediment derives from bank erosion and channel incision upstream on the Colorado River in Rocky Mountain National Park associated with groundwater table declines due to the loss of beaver dams and the ponds they impound.

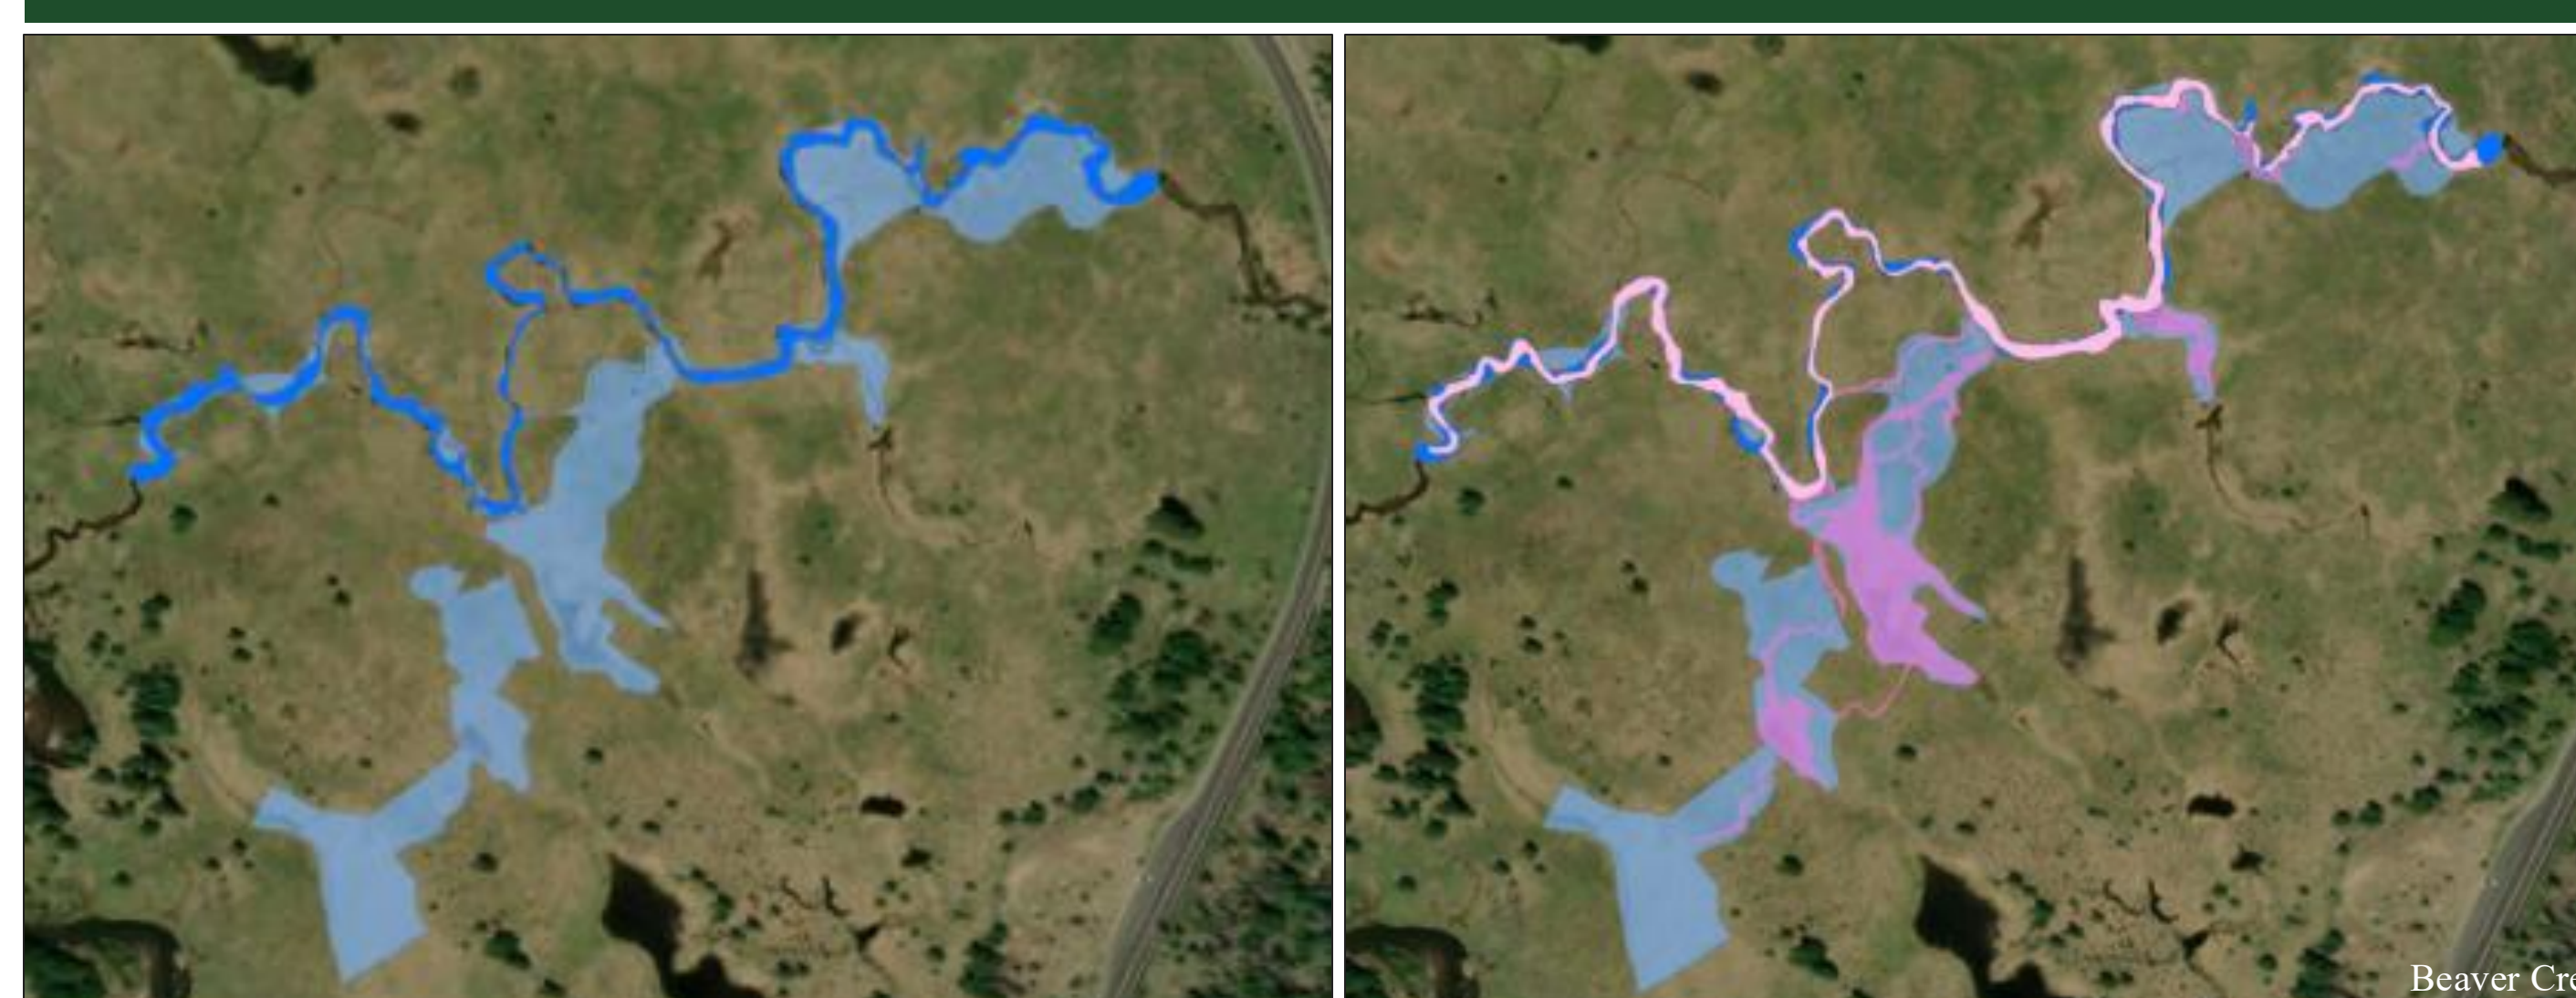
## INUNDATION SURVEY RESULTS

High Flow  $Q = 28.75$  cfs  
Inundated Area: 12875 meters<sup>2</sup>

Low Flow  $Q = 2.05$  cfs  
Inundated Area: 3348 meters<sup>2</sup>

- Structures were successful at pushing water onto the floodplain.
- Post-construction elevations were consistently higher than pre-construction, indicating deposition of sediment upstream from structures on Beaver Creek.
- ~5.00 cm/m of sediment aggradation along the thalweg.
