THESIS

SHAKE TABLE TESTING OF HYBRID WOOD SHEAR WALL SYSTEM

Colorado State University

Fall 2019

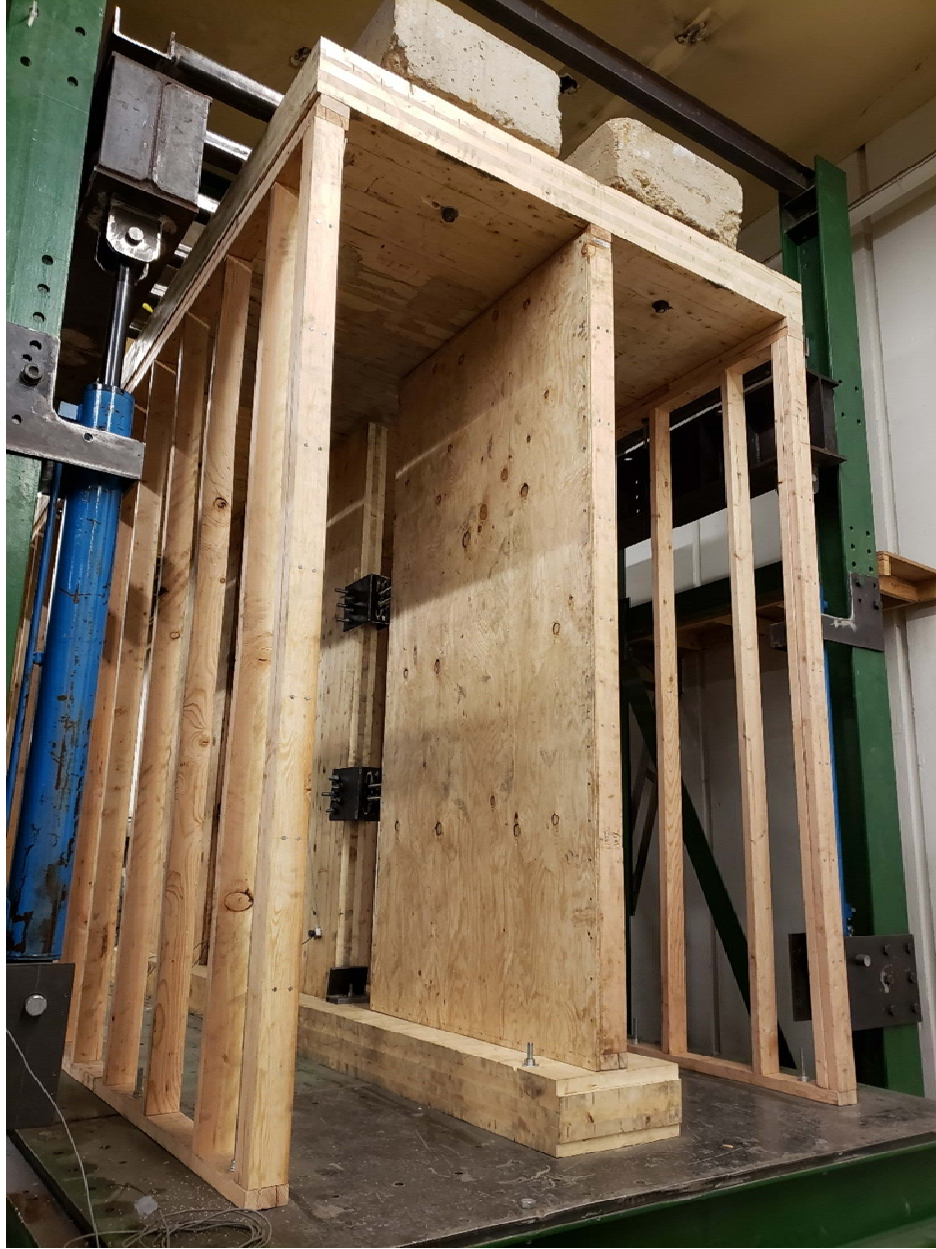
Figure 2.1(b): Test setup for the first test with connection between the LiFS walls and the rocking CLT wall panel

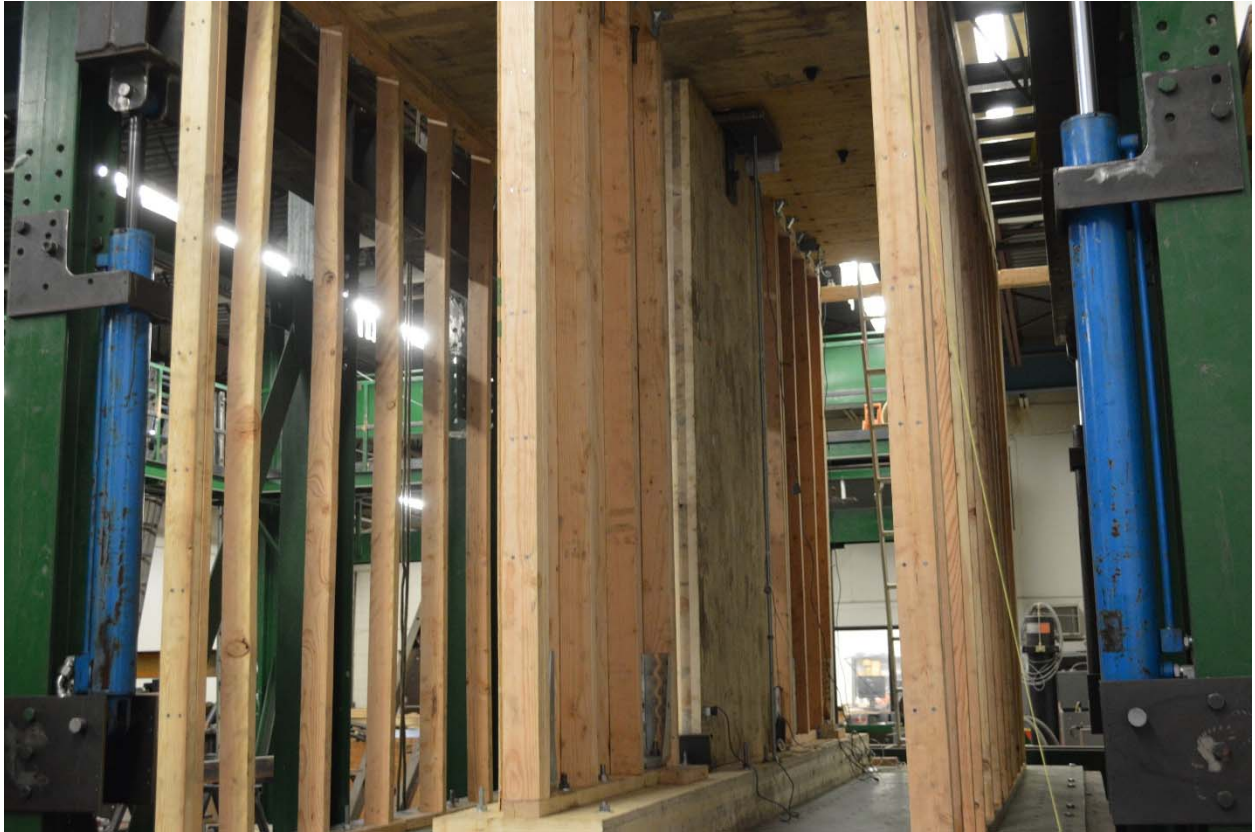
Figure 2.1(c): Test setup with connection between the rocking CLT wall panel and the Mass diaphragm

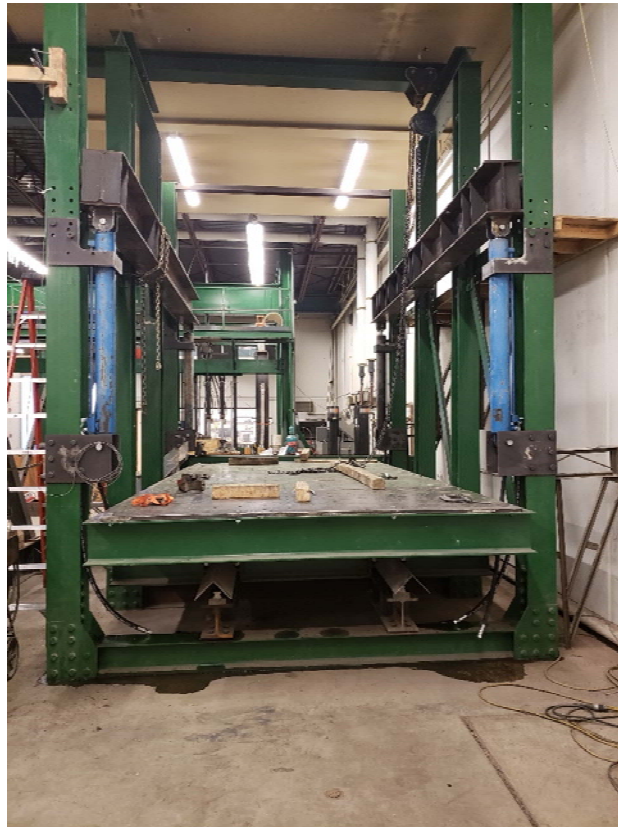
Figure 2.9 (a): Installation of hydraulic system

A separate hydraulic system comprising of 4 hydraulic cylinders were installed around the shake table on the four columns located around the shake table. Two ½” thick steel plates were used to attach the hydraulic cylinders to the flange of the columns. The steel plates were bolted to the flange using six A307 bolts and a 1 ½” diameter pin material was used to pin the cylinders to the steel plates. Two W14x61 beams spanned in the North-South direction over the hydraulic columns to support the seismic mass. The hydraulic cylinders with the beams were first erected in place. The hydraulic cylinders were operated using a small hydraulic pump unit with controllers to operate the hydraulic cylinders. The controller allows operation of one hydraulic cylinder at a time. The seismic mass was raised and pinned to the column while repair work was carried out. During the testing the hydraulic cylinders and the beams were detached from the seismic mass and pinned 6 inches below the seismic mass for additional safety.

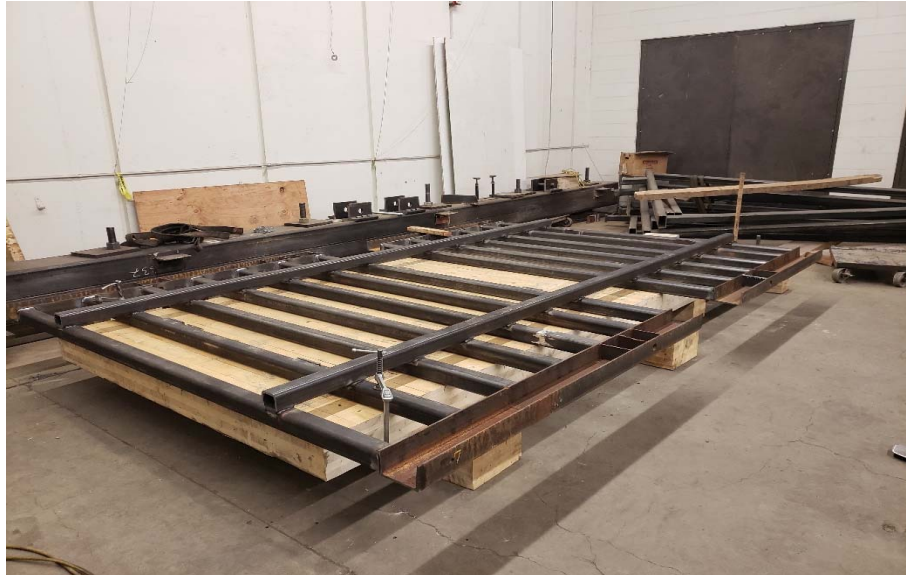
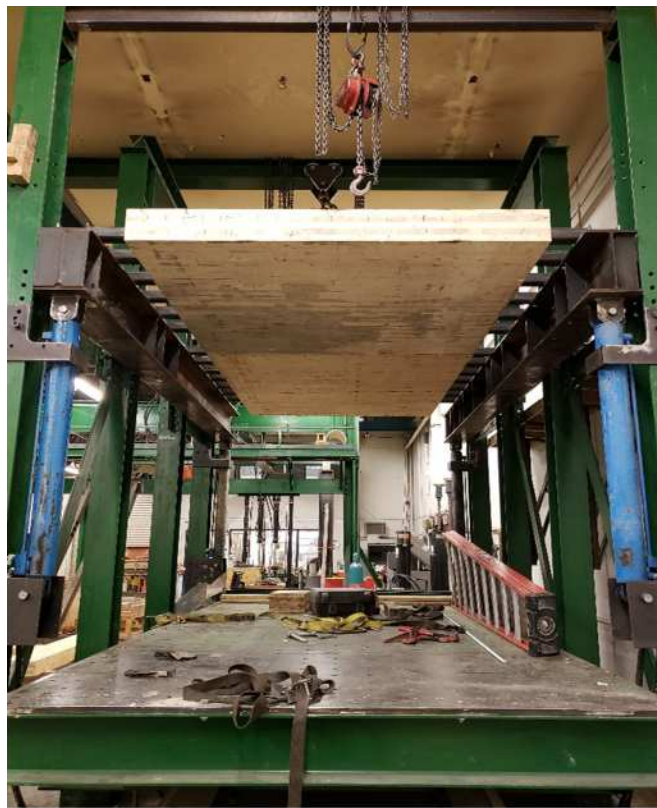
Figure 2.9 (b): Steel frame and CLT diaphragm before and after erection

frame using eight angle brackets. The frame and the CLT diaphragm was placed over the beams using a chain hoist and fork lift and then the frame was attached to the beams using four small bolts to hold it in place on the beams.

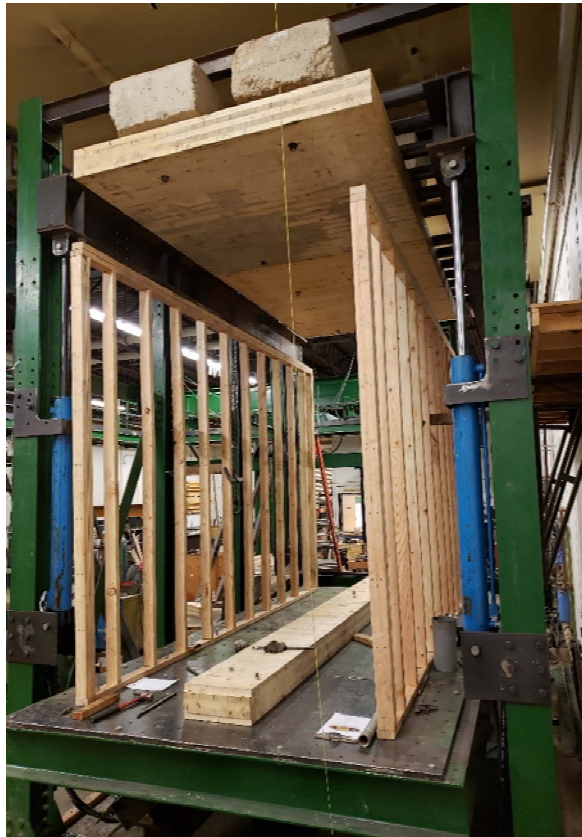
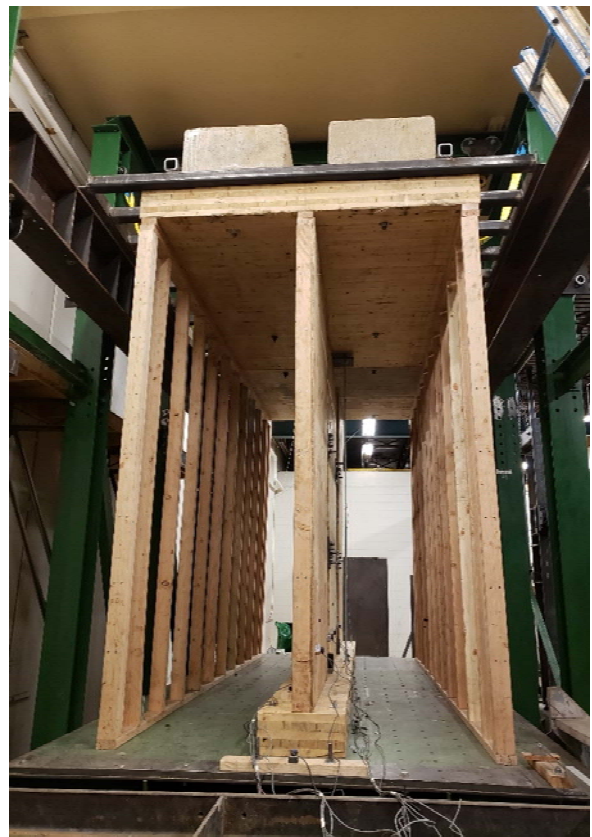
Figure 2.9 (d): Installation of walls and complete test setup

Once the seismic mass was placed in position over the frame, the seismic mass was lifted up approximately 2 ft. over the height of the walls and pinned to the columns. The LiFS walls and gravity frames were constructed first before installation. The gravity wall frames were then placed in position and then the base CLT for the hybrid shear wall system was installed in place. The rocking CLT wall was then placed over the base CLT followed by the installation of the LiFS walls on either side of the CLT wall panel. Once the walls were installed in place the seismic mass was lowered over the walls. The seismic mass was attached to the double top plates of stud walls using 5/8" threaded rods. The rods were attached to the CLT diaphragm to which the seismic mass was attached. The hydraulic system was detached and lowered from the seismic mass once the mass was set over the walls.

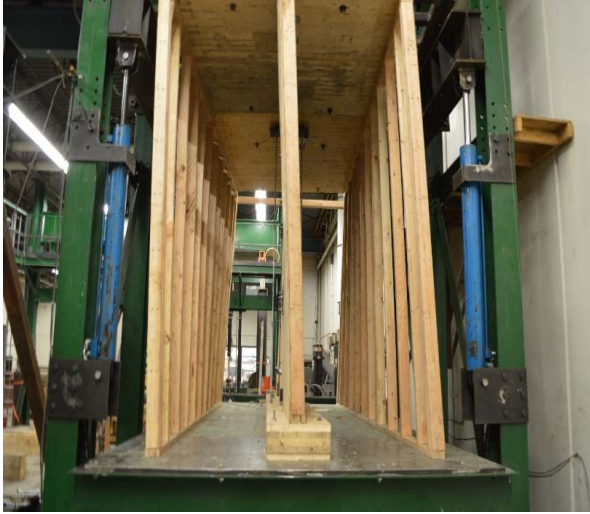
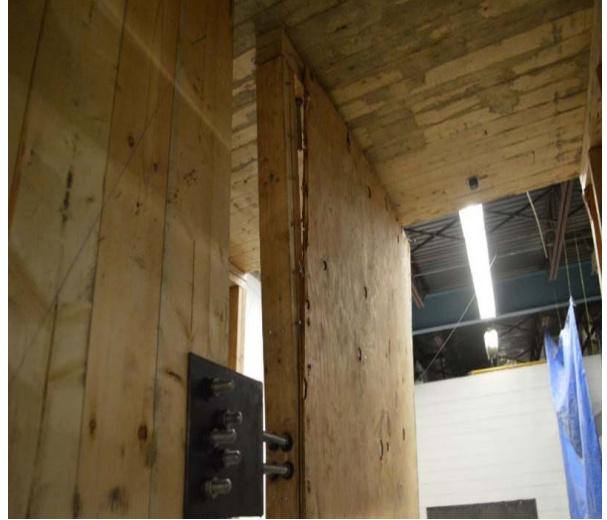
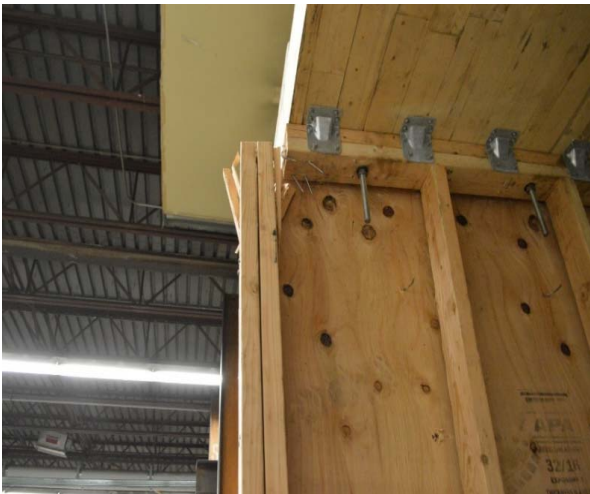
Figure 3.1: (a) Overall structure after the MCE event; (b), (c): Damage to the studs of the LiFS wall; (d): The failure of studs on LiFS walls; (e), (f): Damage to the connection between studs and top plate

The post-tensioned rods were tensioned again to the initial post-tension force before the test. The same rods were used since the rods had not yielded in the previous tests. The structure was subjected to Loma Prieta ground motion scaled to MCE hazard levels. During the test, bending failure was inflicted to the studs to which the shear transfer brackets were attached. Also the structure experienced torsion which was not expected. Since the failure of the LiFS wall studs was not desired, the brackets connecting the LiFS walls and rocking wall CLT panel were redesigned for use in the subsequent tests.

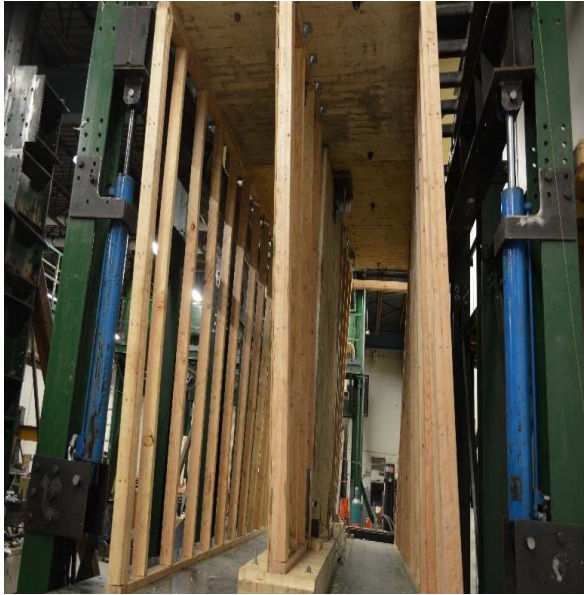
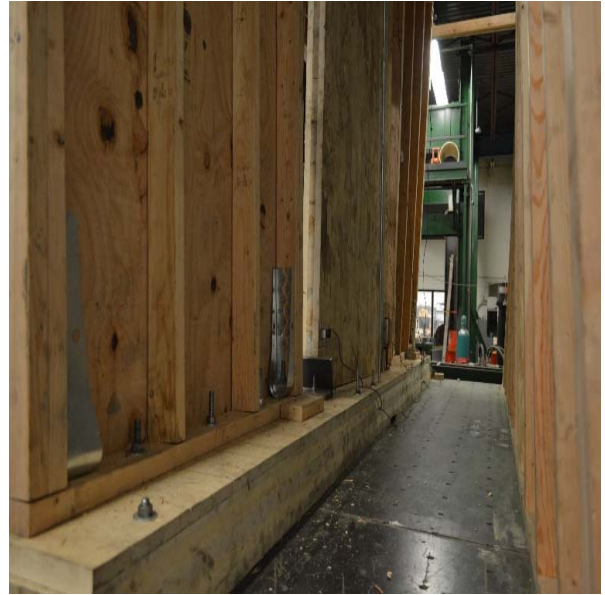
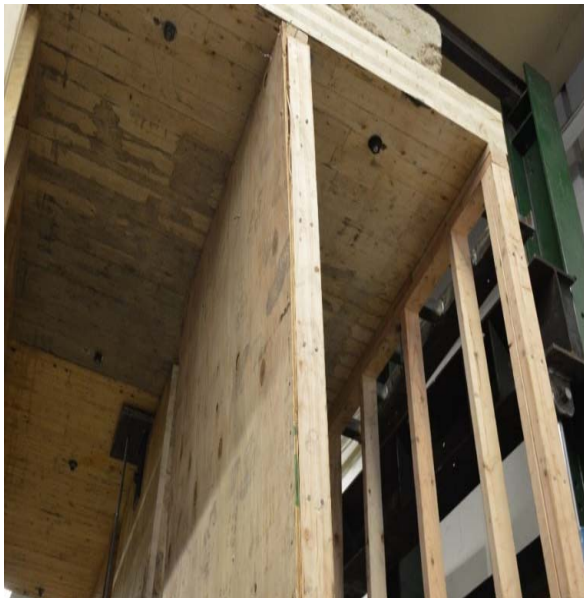
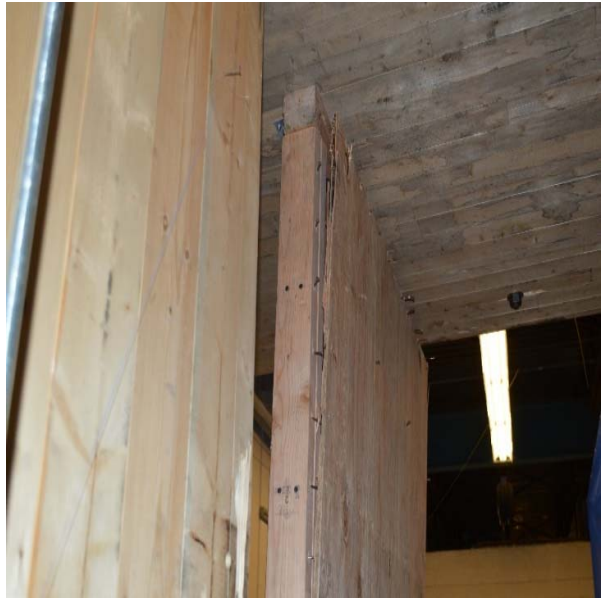
Figure 3.2: (a): Overall structure after the MCE event; (b): The shift of the CLT wall panel due to torsion; (c), (d): Damage to the sheathing and withdrawal of nails in the LiFS walls

It was observed that the connection modification for the shear transfer system between the top mass and the rocking CLT wall panel performed well under the MCE intensity shake until the point of the test stoppage. The rocking CLT wall panel was rotated out of plane due to torsion caused by the test setup since the rocking CLT wall panel was attached to the top mass and there was no resistance to the out of plane rotation. The torsion was induced even though there was even distribution of weight on the structure eventually resulting in the installation of roller support to prevent torsion in subsequent tests.

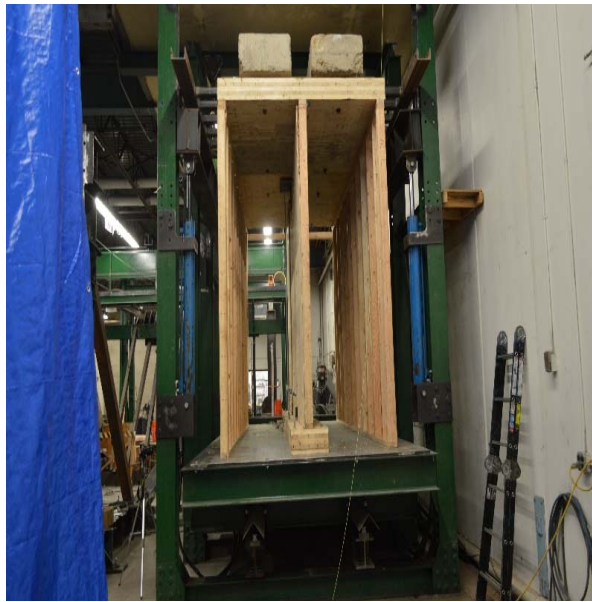
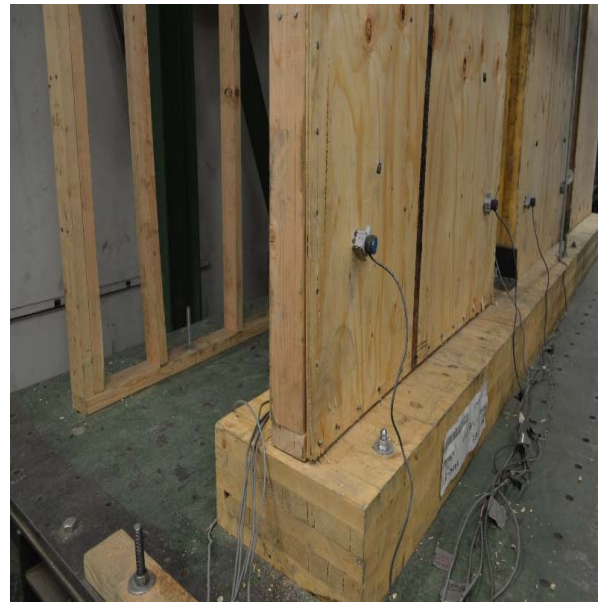
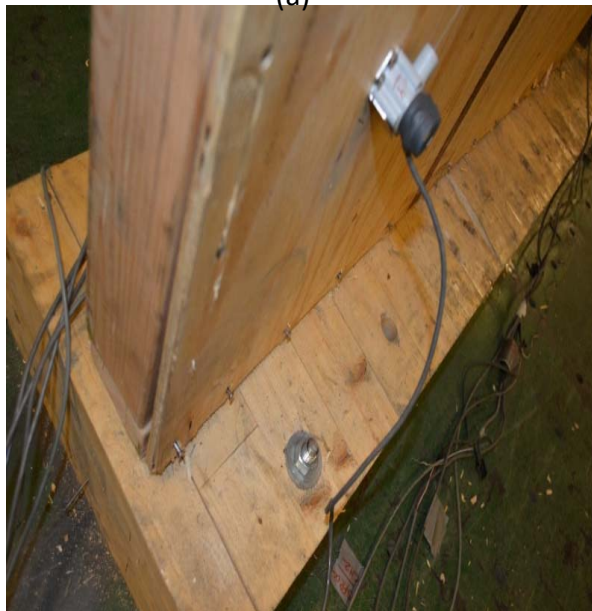
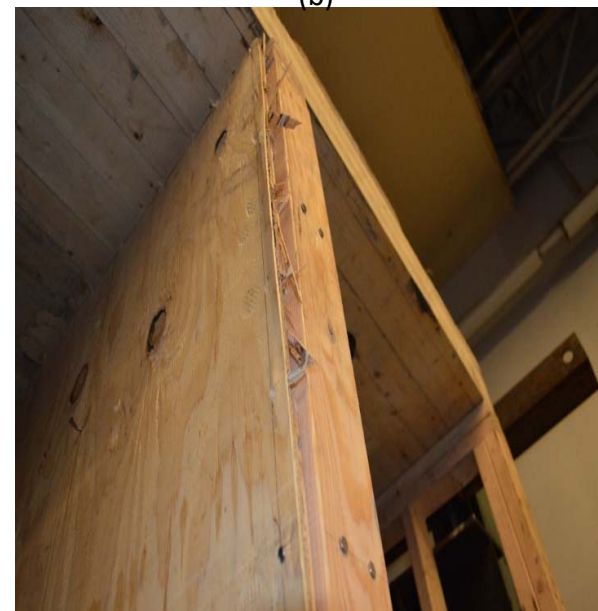
Figure 3.3: (a): Overall structure after the MCE event; (b): Damage to the sheathing of the LiFS wall; (c): Edge nail withdrawal on the sheathing of the LiFS wall; (d): Damage to the sheathing of the LiFS wall

performance of the test structure was as expected with no accidental torsion from the test setup. The structure was able to completely re-center after the MCE intensity shake. The LiFS wall sheathing was damaged along the edges with edge nails partially withdrawing. There was no damage to the studs of the LiFS walls and the gravity frames of the structure.

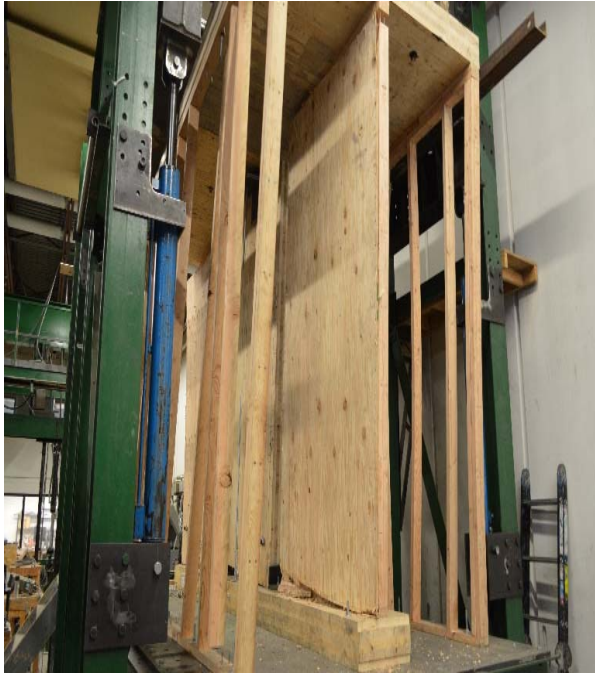
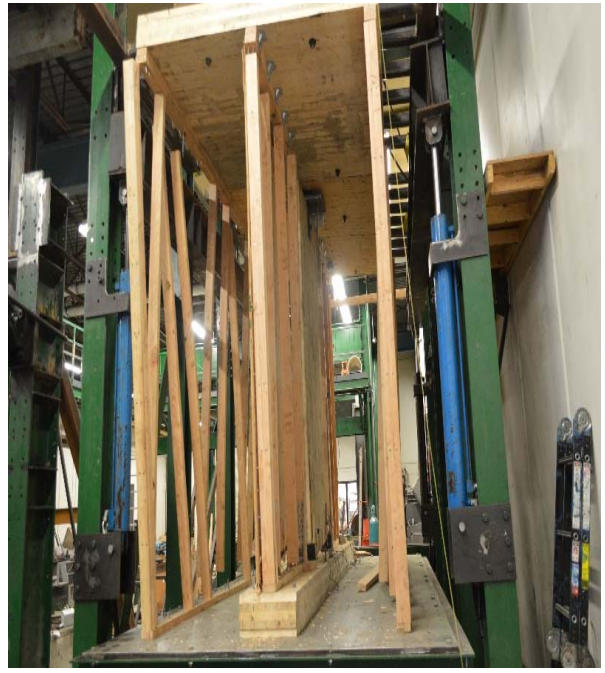
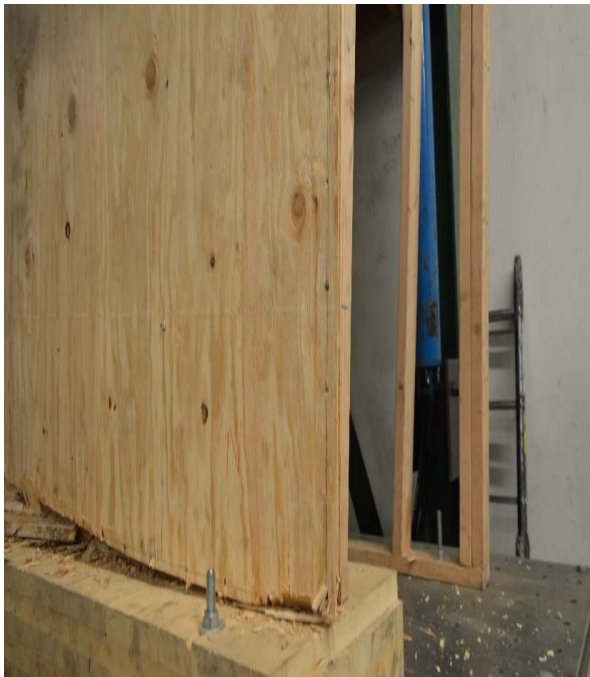
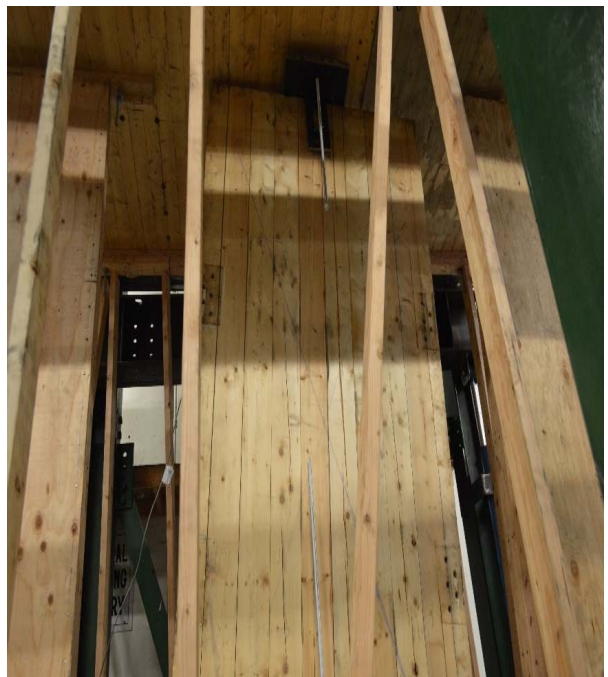
Figure 3.4: (a), (b): Damage to the overall structure; (c): Damage to the sheathing of the LiFS wall; (d): PT bar fracture and damage to the studs of the gravity wall

The Northridge ground motion record from the Rinaldi station was used for the final test. The structure was subjected to three ground motions one after the other with no repair works carried out between the tests. The structure was able to completely re-center after the first ground motion and there was some withdrawal of nails on the LiFS walls sheathing. The structure was checked for safety before the second ground motion. There was some significant damage to the LiFS structure after the structure was subjected to the second ground motion. Most of the sheathing nails on the LiFS walls were either withdrawn or the sheathing was damaged itself. The holdown on the South end of the South LiFS was damaged indicating some amount of damage was sustained by studs in the LiFS. The structure was once again checked for safety before running the third ground motion. The structure was completely damaged at the end of the third ground motion with the top plates of the LiFS walls completely sheared off the studs. The rocking CLT wall panel was not able to re-center the system due to fracture of the PT bars. The gravity frames on the east and west side of the hybrid shear wall system was completely damaged at the end of the third ground motion. The seismic mass was secured by the safety straps which engaged during the ground motion. The string pot measuring the displacement at the top of the system failed during the second ground motion and therefore the lateral displacement data was not recorded for the second and third ground motions. However, this test was useful to understand the collapse mechanism of a rocking CLT wall panels from a qualitative perspective.

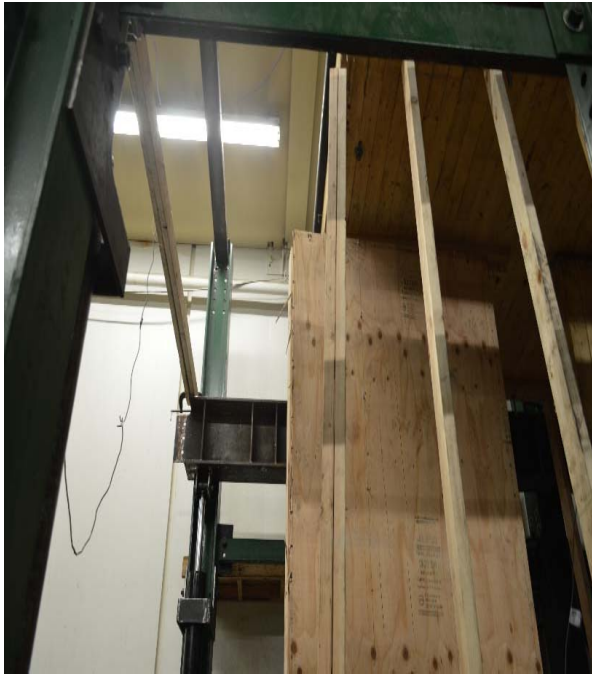
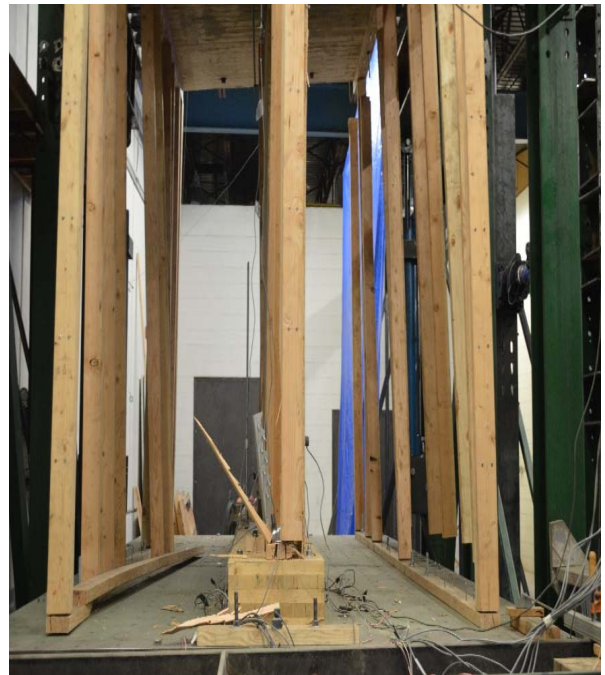
Figure 3.4: (e), (f): Rocking CLT wall panel after the test; (g), (h): Damage to the studs of the LiFS wall and holdown of the LiFS wall
