A REMOTE SENSING STUDY OF SEDIMENT
IN THE CLARKS FORK YELLOWSTONE RIVER

Bureau of Reclamation
Department of the Interior
Denver, Colorado

Civil Engineering Department
Colorado State University
Fort Collins, Colorado
November, 1972

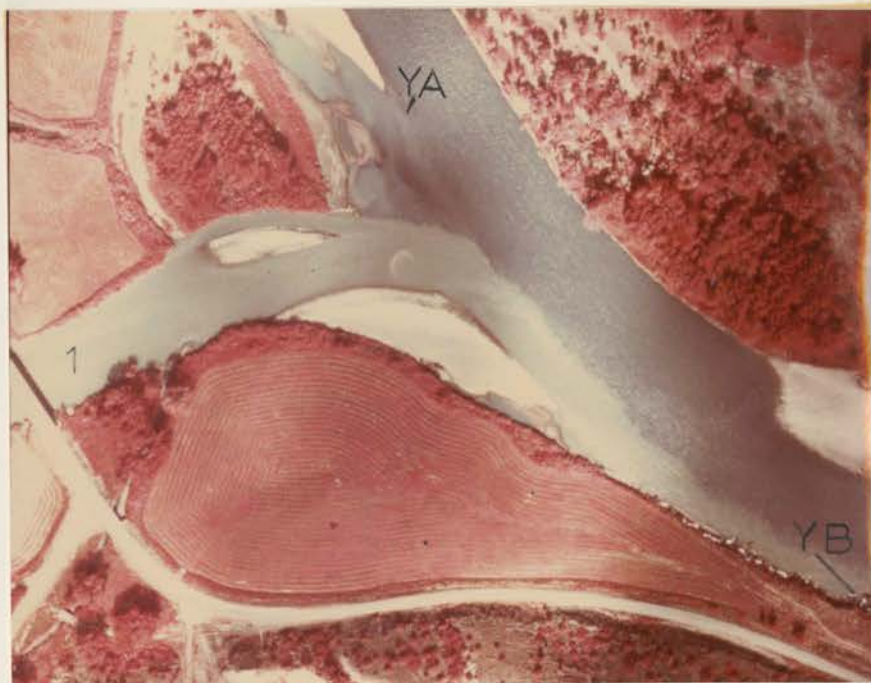
Figure 4. Confluence of the Clarks Fork Yellowstone River and the Yellowstone River.

Figure 4 - is the confluence of the Clarks Fork Yellowstone River and the Yellowstone River. Samples of suspended sediment indicated 35 ppm at Point YA upstream from the confluence on the Yellowstone; 85 ppm at Point YB downstream from the confluence, and 145 ppm at Point 1 on the Clarks Fork Yellowstone River upstream from the confluence. The higher sediment concentration is clearly delineated by the lighter,

Sampling Site	Suspended Sediment Concentration (PPM)	Turbidity (JTU)
YA	35	21
YB	85	39
1	145	75

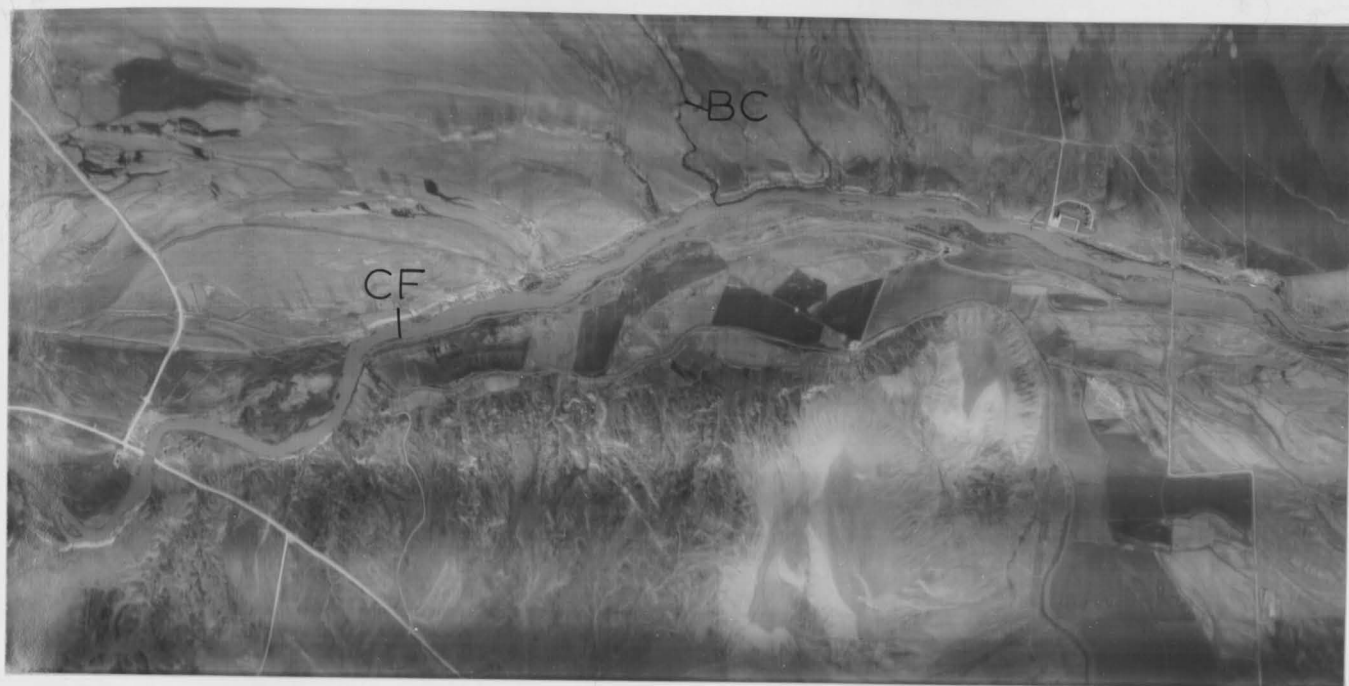
Figure 8. Thermal Infrared Imagery of confluence of Bennett Creek and Clarks Fork Yellowstone River.

Figure 8 - is the thermal infrared imagery of the area that corresponds to the confluence shown on Figure 7. Bennett Creek is designated "BC", and the Clarks Fork Yellowstone River "CF" in Figure 8. The colder water of Bennett Creek, the plume and mixing zone, are clearly identified by the darker tone on the imagery. The plume can be observed on the imagery for approximately 1,500 feet downstream from the confluence. The temperature of the water in Bennett Creek was not measured, but the temperature of the Clarks Fork Yellowstone River approximately one third mile upstream from the confluence was 57°F and at a point approximately one half mile downstream was 55°F. The downstream measurement was obtained at a point 20 feet from the left bank and was probably in the cold water plume.

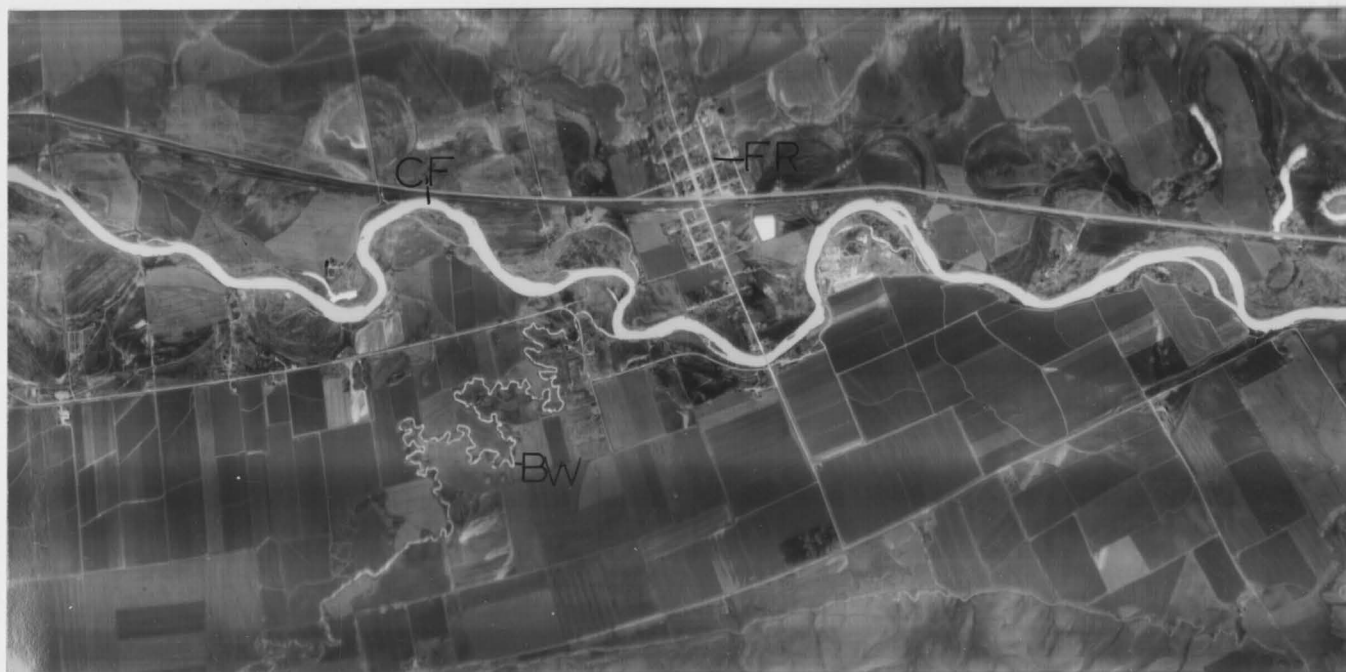
Figure 9. Thermal Infrared Imagery of the vicinity of Fromberg, Montana (showing Blue Water Creek and Clarks Fork Yellowstone River).

Figure 9 - shows the thermal infrared imagery obtained in the vicinity of Fromberg, Montana (FR). Bluewater Creek (BW) enters the Clarks Fork Yellowstone River (CF) near this town and shows up as the white line meandering through the irrigated fields on the right bank. The temperatures of the two streams are approximately equal (64°F) at their confluence and this is indicated by the same level of grey on the imagery. The imagery was obtained at approximately 6:50 am Mountain Daylight Time.
