THESIS

ENVIRONMENTAL EFFECTS OF THE 1978 SUNNYSIDE MINE FLOOD

Colorado State University

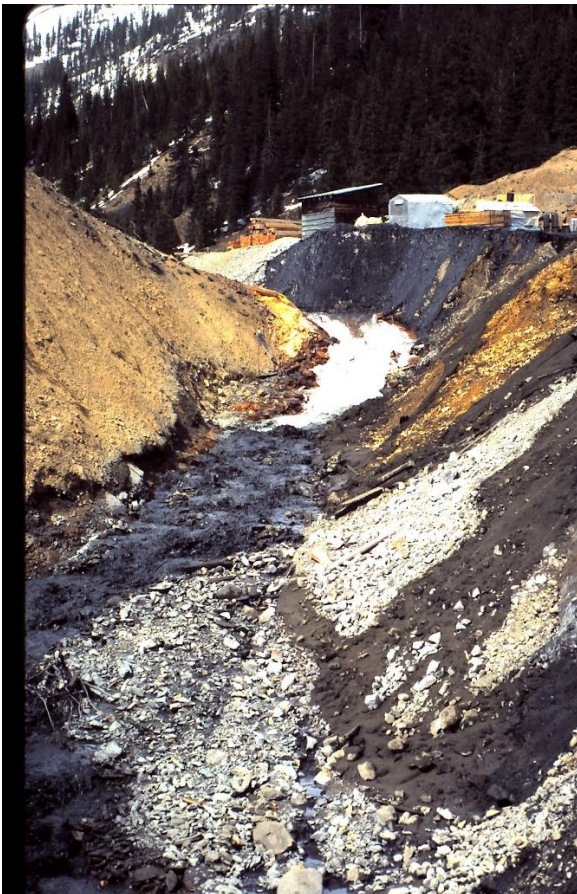
Figure 4: Photos taken at Gladstone and the American Tunnel the day after the flood. A) mine structures were damaged and a large amount of black mud was deposited. Photo is taken from immediately west of the American Tunnel entrance facing upstream. B) Gravel and black mud were deposited and a channel was sharply incised just downstream of the mine. Photo is taken looking downstream toward the entrance of the American Tunnel. Photographs courtesy of Bill Jones.

Bill Jones, former Standard Metals assayer and author of Chapter C of USGS Professional Paper 1651 (2007), was in town when the flood occurred. He reports watching the sheriff (Virgil Mason) go “screaming out of town” at approximately 6:15 pm. Jones was waiting for a SJCHS meeting to start at 7 pm, and another member of the historical society reported that there was a flood warning in Bertramville, a neighborhood approximately 0.5 km north of the SJCHS building (which is on the northeast end of Silverton, closest to where Cement Creek enters the town) (Vandeberg, 1978). Jones recalled watching the flood come into town from the courthouse and said that the water was only a foot below the bridge that crossed Main Street, which typically had several feet of clearance. The water was carrying 8’ by 8’ mine shaft timbers, was filled with black mud, and smelled like diesel fuel and sulfur. Between 8:30 and 9 pm, Sheriff Virgil Mason returned to town. According to Jones, Sheriff Mason was typically very calm, but the magnitude and severity of the flood made him a “shaking nervous wreck.” Jones also shared his experience of going up to Gladstone and Lake Emma in the week after the flood. He said that the bridge 1.5 miles (2.5 km) downstream of Gladstone had been washed out by the flood waters. He also took photographs of Gladstone, Cement Creek, and the site where Lake Emma used to be (Figure 4, Appendix A). Photographs taken in the days after the flood show a significant amount of damage, including the deposition of mud and some erosion of channel banks at Gladstone just below the entrance to the American Tunnel (figure 4).

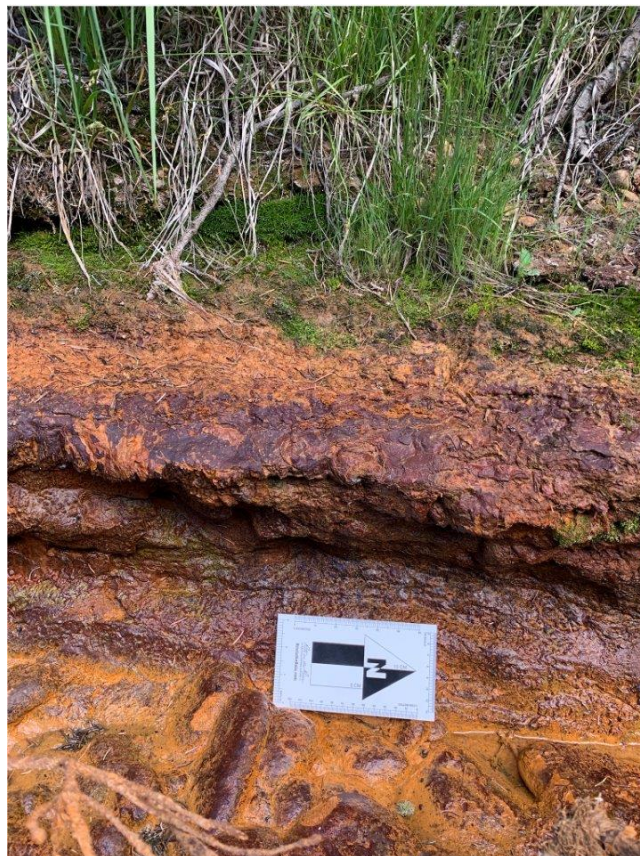
Figure 5: Lake Emma flood horizon preserved in Grassy Gulch at sampling site GG2. A layer of dark, organic rich, fine grained sediment is overlain by a bright orange clay layer. The sediment above these layers is sandy and similar in character to sediment throughout the Cement Creek watershed.

Likely flood deposits were identified between approximately ten to twenty centimeters above the typical spring flood level at a number of sites along Cement Creek. Where preserved, the flood horizon is marked by layers of dark brown silt and bright orange silt to clay. Both layers are not visible at all sampling sites throughout the flood horizon, and the dark brown to black layer is present and identifiable more often than the orange clay layer. The thickness of flood deposit remaining is variable but was observed up to 8 cm thick (figure 5).

Figure 8: Site GG2, in Grassy Gulch, has three distinct types of sediment evident with depth. Figure 5 in section 4.2 shows these layers. The top layer (0-1”) is identified as laumontite, a calcium zeolite, while the black, organic rich layer identified as the top of the 1978 flood horizon is identified as chabazite (a zeolite), gypsum, and diopside, and the orange layer below, interpreted as the bottom of the flood horizon, is interpreted as thomsonite-Ca, vermiculite, and iron smectite.

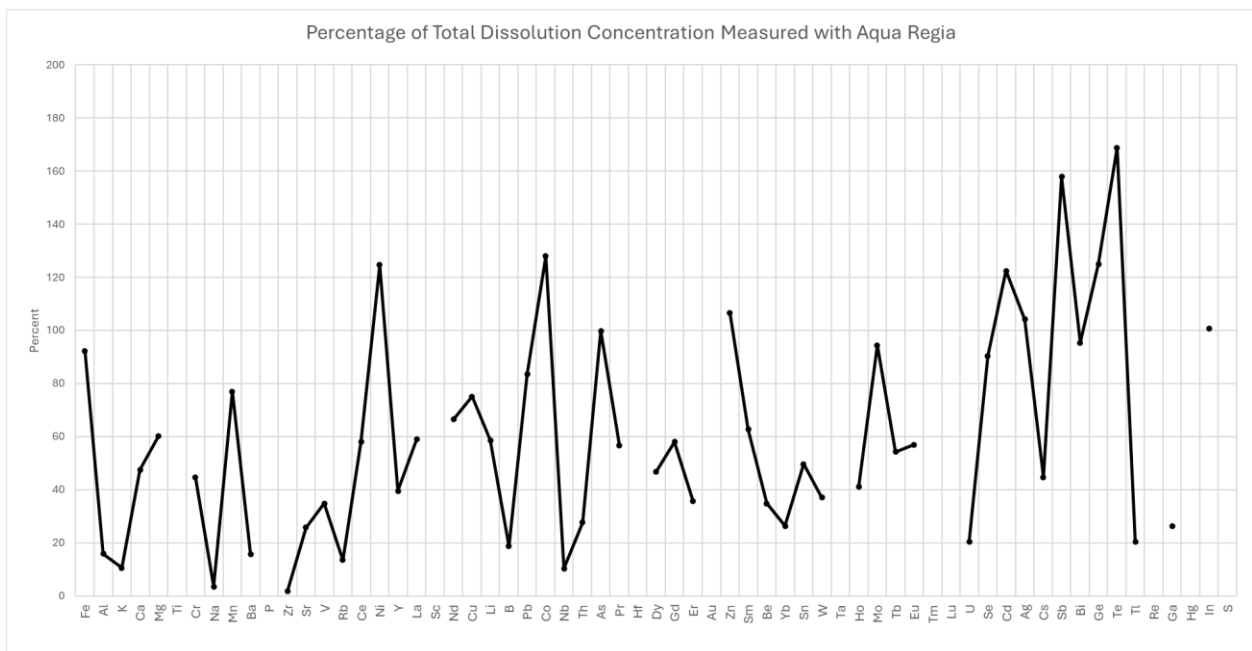
Figure 10: Plot showing the percentage of the average concentration measured by 4-acid total dissolution analysis that is measured on average by aqua regia analysis ( $(AR/TD) \cdot 100$ ) for the tested elements. Gaps in the line show elements that four acid dissolution does not test for or elements where values were consistently below the detection method of aqua regia, so no differences could be calculated.

germanium, and tellurium. However, most elements that are not associated with ore formation have lower reported concentrations in aqua regia than in 4-acid total dissolution, indicating that aqua regia was not fully dissolving and analyzing the minerals hosting those elements. However, the ore-related elements that are most important to this study were not as affected as other elements (figure 10). Additionally, four acid total dissolution analysis does not report values of gold, mercury, phosphorus, sulfur, or titanium. Based on these limitations as well as the cost of analysis, aqua regia was determined to be the best method for this study.

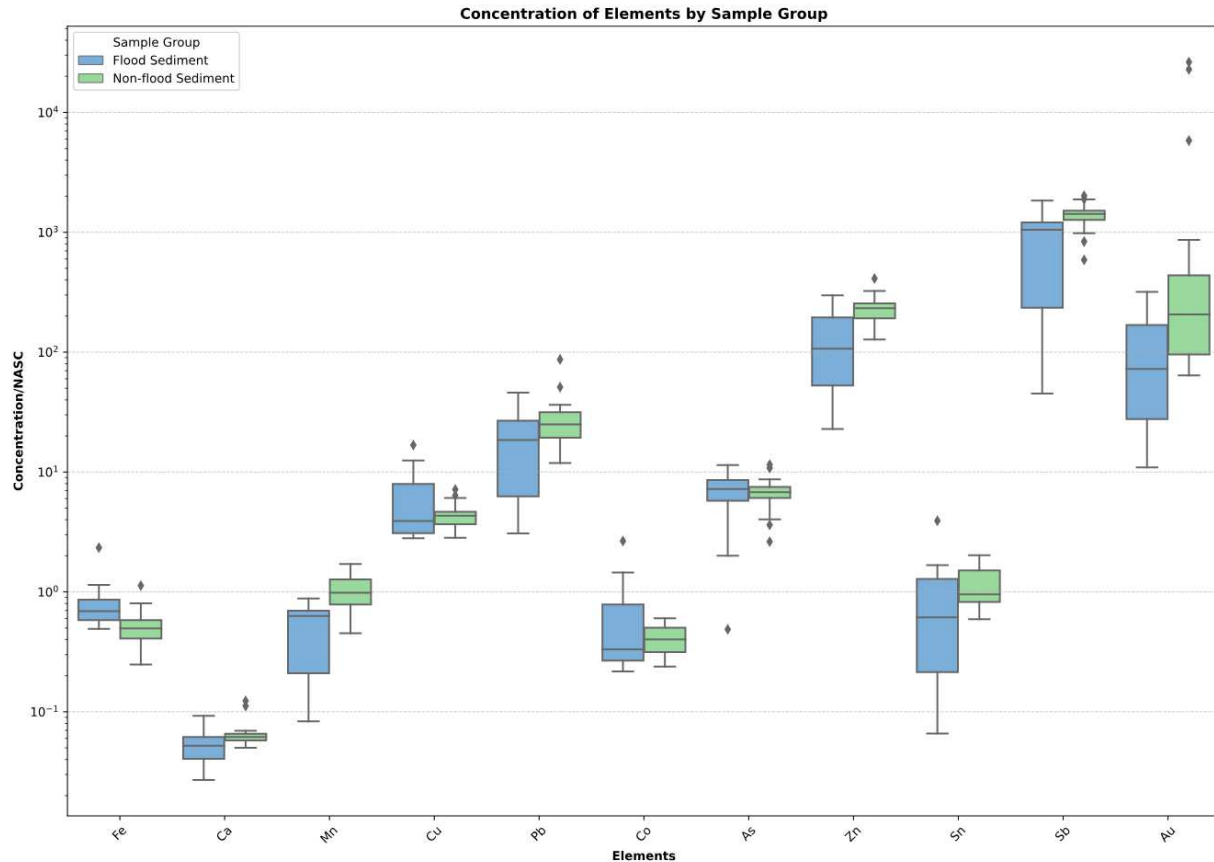
Figure 13: Ranges of notable elements in flood and non-flood sediments. Concentrations are normalized in order to better visualize trends across elements with very different concentrations. The elemental makeup in flood deposits has greater variability than other deposits.

While the difference in elemental concentrations is minor, the Lake Emma flood sediment typically has slightly lower average concentrations of most elevated elements than the normal stream sediment. However, that is not the case for iron. Although most samples are depleted in iron compared to the NASC normalization, the Lake Emma sediment has 59% more iron than the non-flood sediment on average (figure 13).

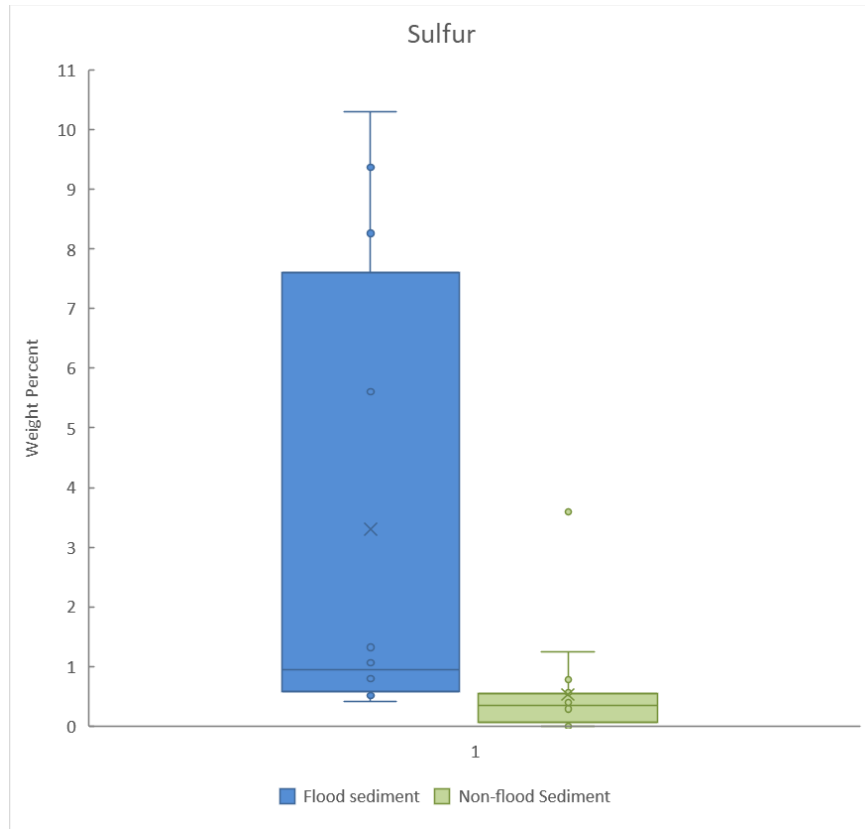
Figure 14: Comparison of weight percent sulfur in Lake Emma flood sediments (blue) and other Cement Creek sediments (green). There is a wider range of concentrations in the Lake Emma sediment, but overall, the Lake Emma sediment has higher concentrations of sulfur.

Since sulfur could not be normalized using the NASC, it is not included in the above diagrams. However, sulfur concentrations can be compared between the two suites of samples without normalization. As with many other elements, the Lake Emma flood sediment had a much wider range of sulfur concentrations than the other sediment did. The weight percent sulfur was also much higher on average in the Lake Emma flood sediment (figure 14).

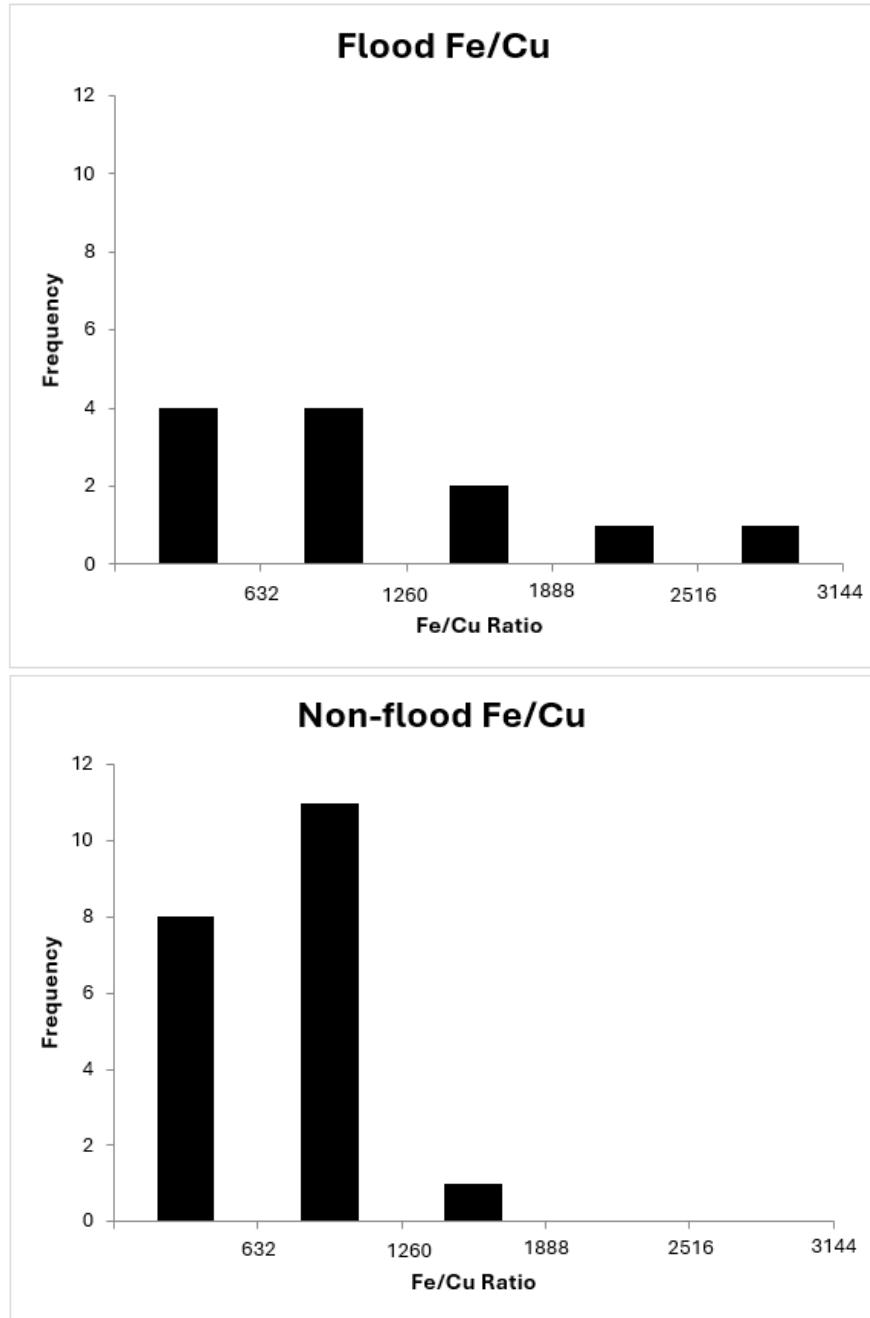
Figure 18: Frequency distributions of Fe/Cu ratios in the Lake Emma flood sediment and other stream sediment. The flood samples have a wider spread of ratios, but overall have higher Fe/Cu ratios than the other sediments.

Although pH does not correlate well with Fe/Cu ratios of unfiltered water samples from previous studies in Cement Creek, analysis of the Fe/Cu of the sediments in this study can still provide insight. The Lake Emma flood sediment collected in this study has significantly higher average Fe/Cu ratios than the non-flood sediment, as well as a wider range of values (figure 18).

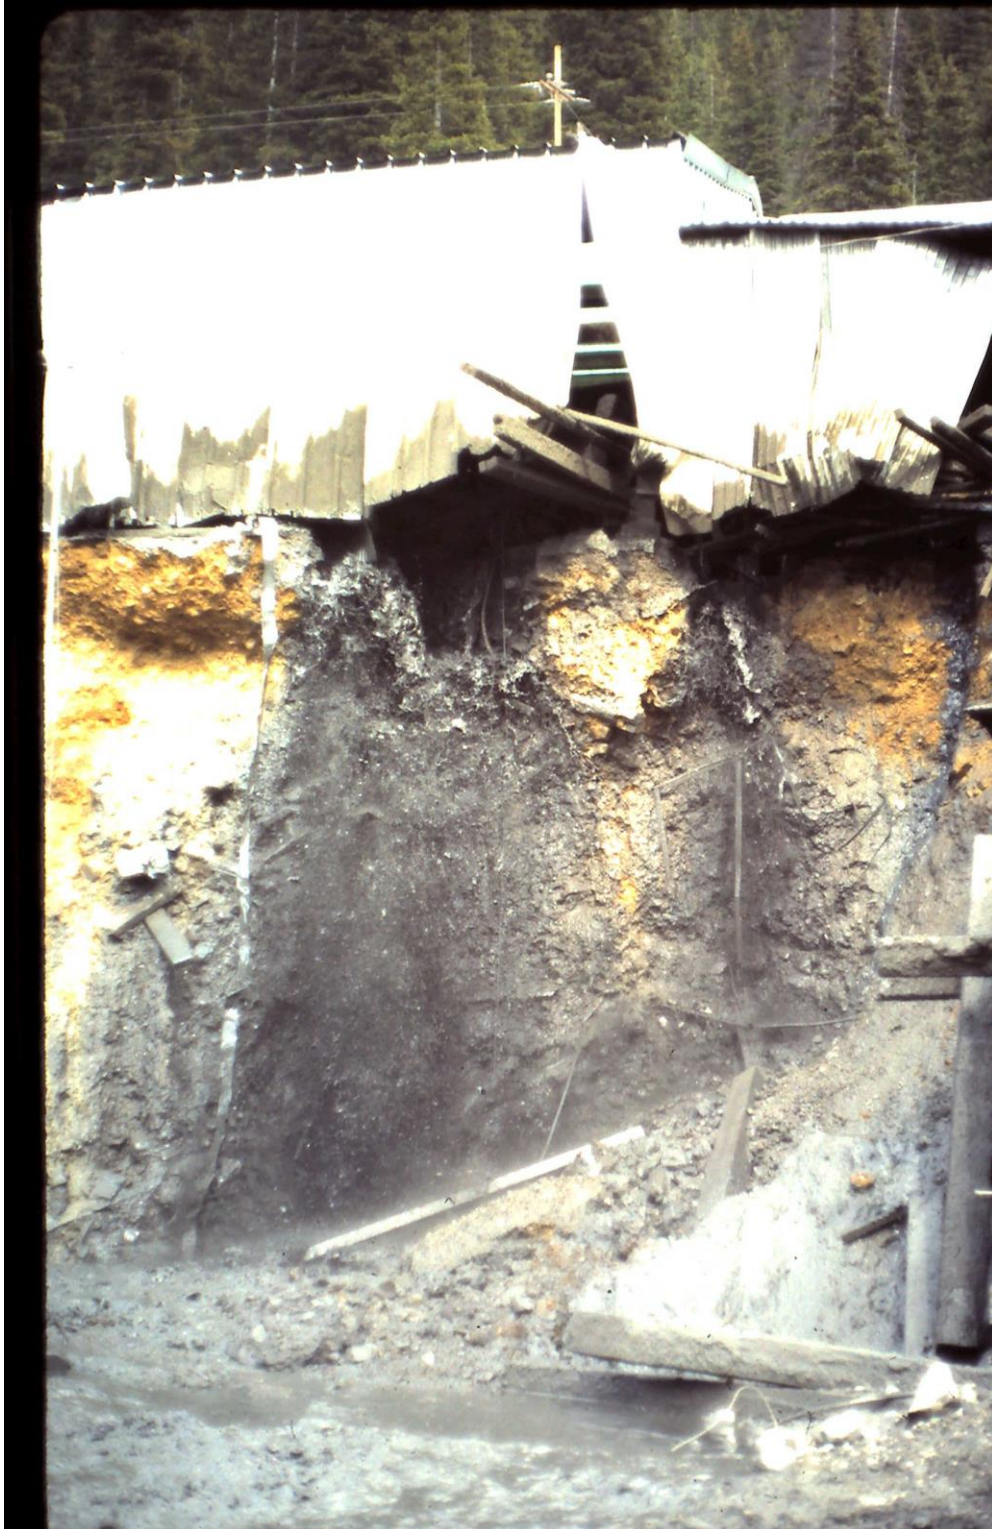
American Tunnel discharge point. William R. Jones, June 5, 1978.

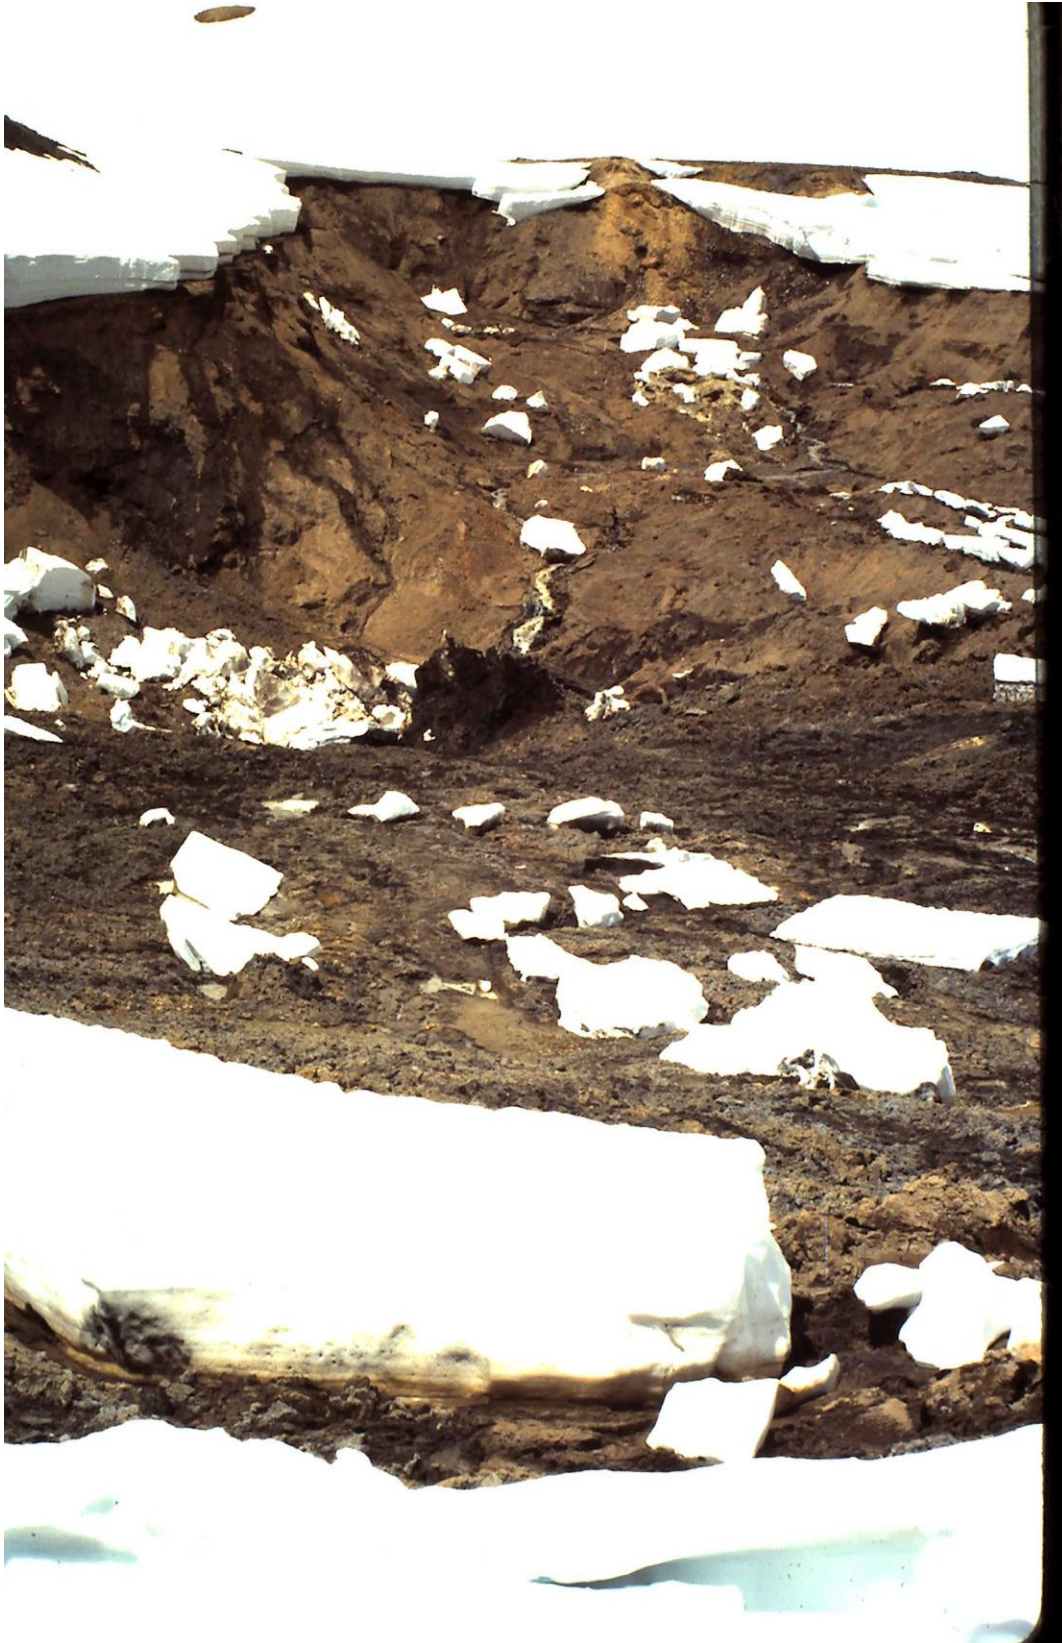
Lake Emma center at stope. William R. Jones, June 11, 1978.
