**Proceedings
High Altitude Revegetation
Workshop No. 14**

Information Series No. 91

HIGH ALTITUDE REVEGETATION WORKSHOP

**Colorado State University
Fort Collins, Colorado
March 8-10, 2000**

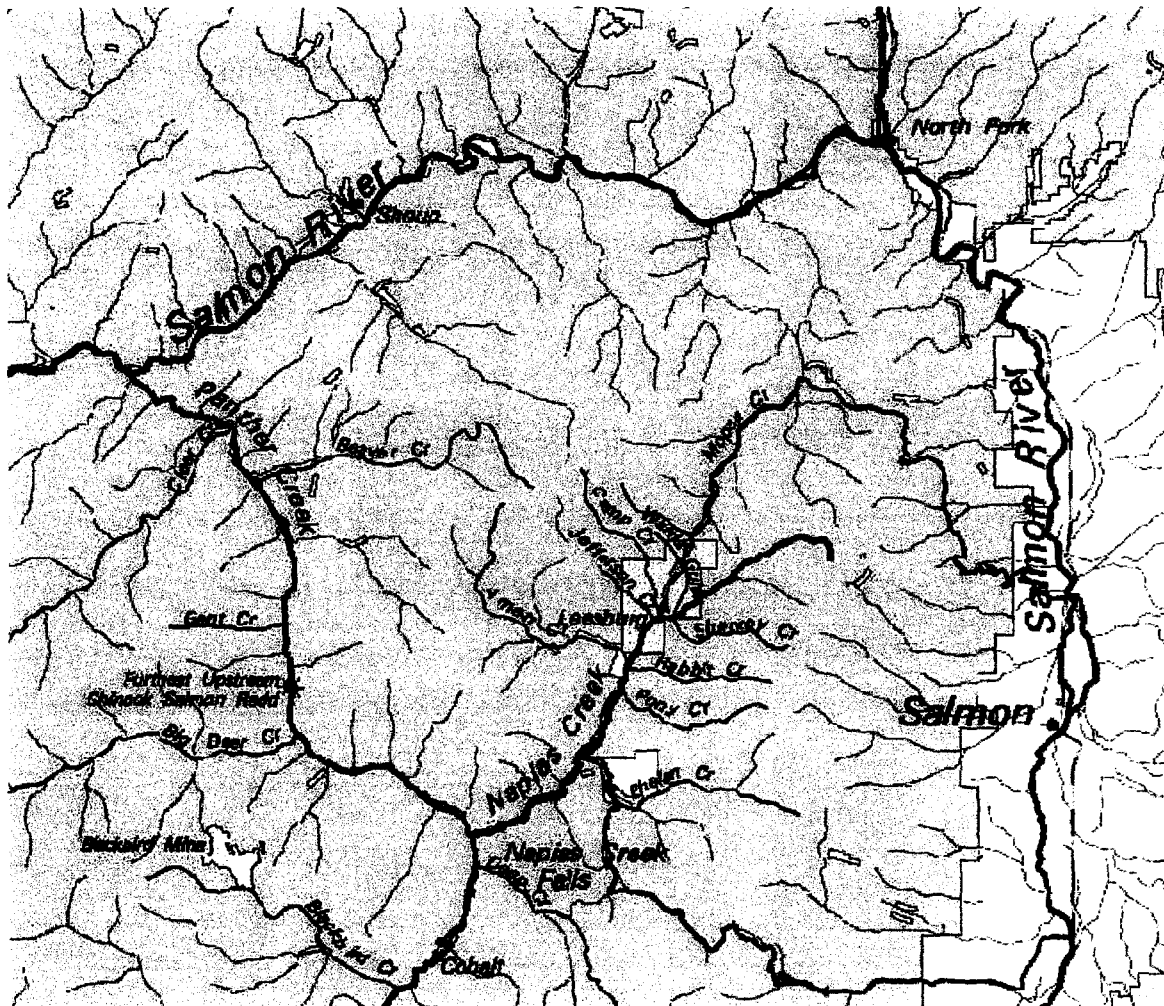
Figure 2 - Detailed Map of Napias Creek Drainage

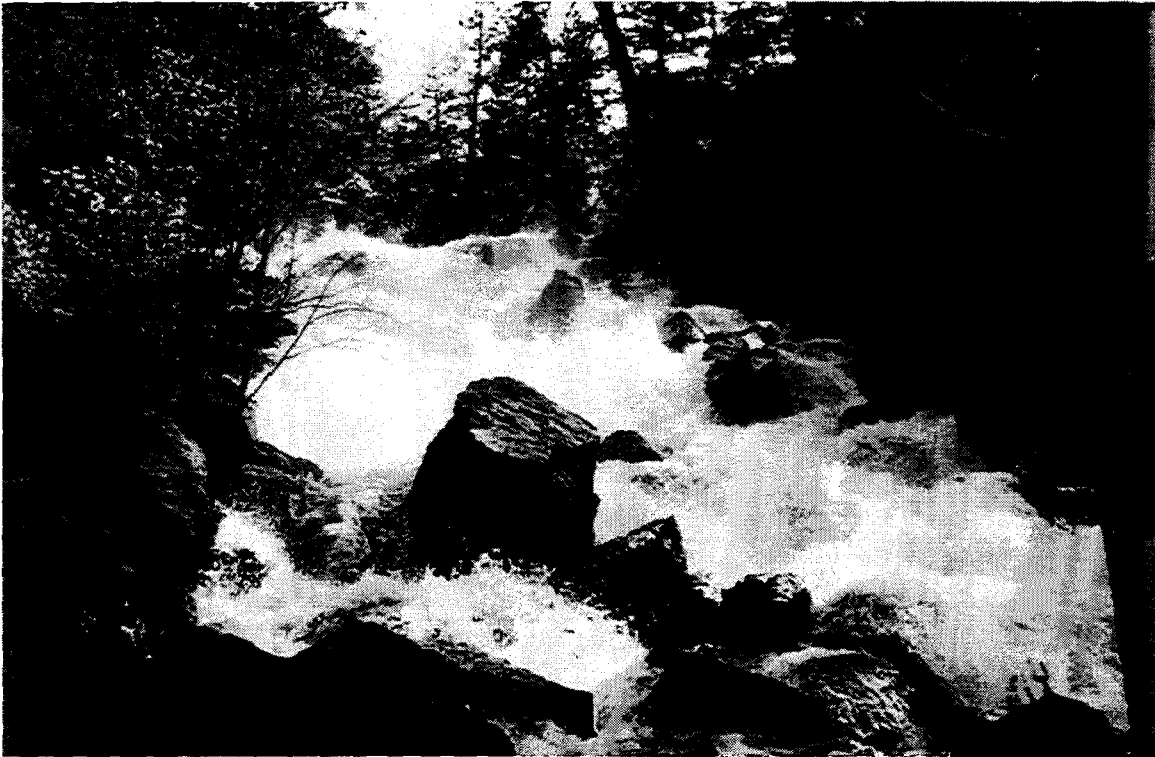
Figure 3 - Upper Napias Creek Falls

is also where a series of steep cascades naturally occur (Chapman 1997). The cascades and falls are located in the last 2 miles of the Napias Creek drainage. The area critical to the passage evaluation (the cascades or falls) is especially steep and carries a gradient of 21% for about 575 feet. At numerous points in this steep section of Napias Creek there are falls in excess of 10 feet (Figure 3).

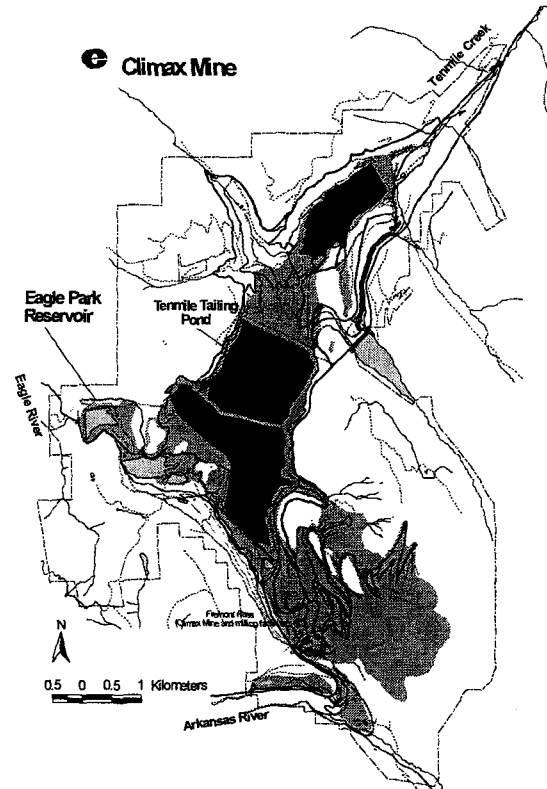
Figure 1. Diagram of the Climax Mine showing locations of the three drainages and the location of Eagle Park Reservoir

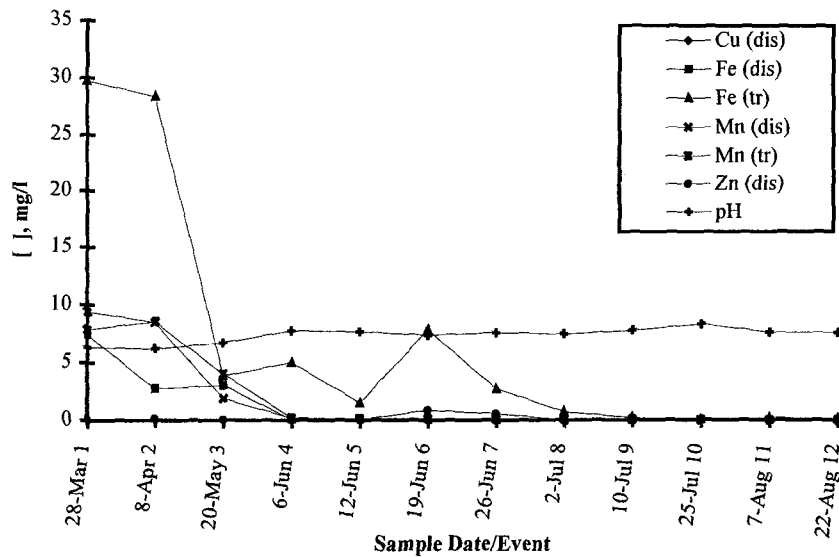
Figure 2. Eagle Park Reservoir Water Quality Trend 1997

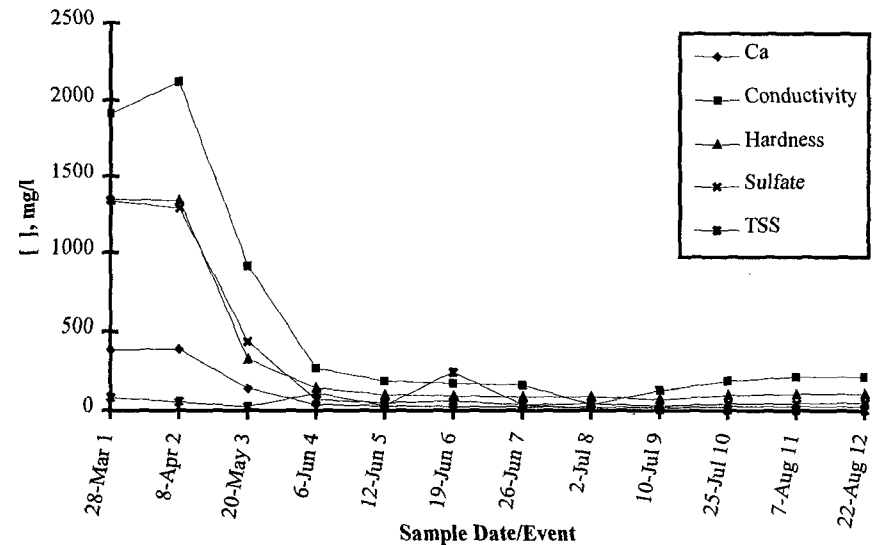
Figure 3. Eagle Park Reservoir Water Quality Trend 1997

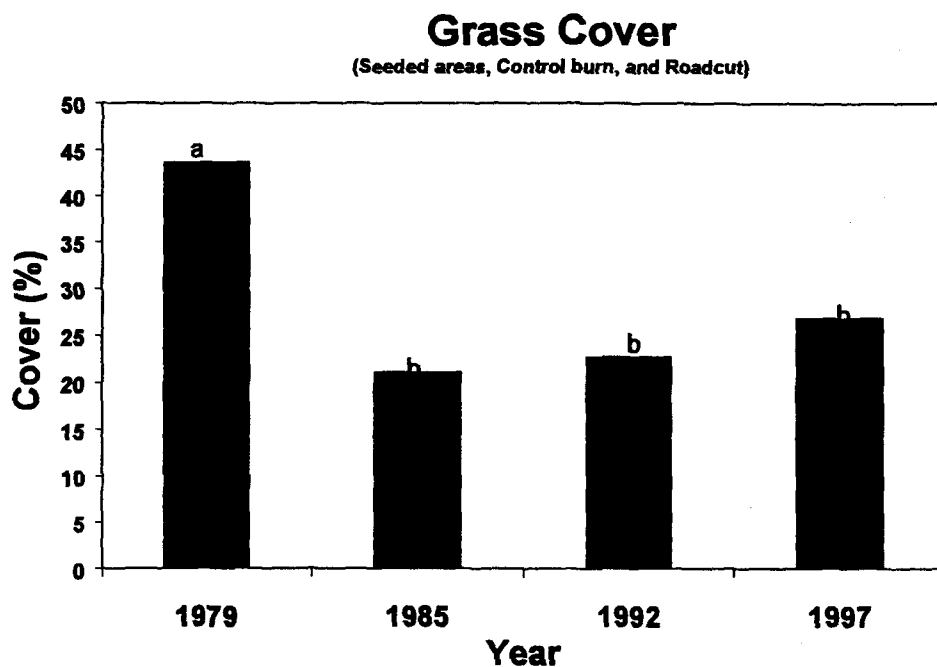
Figure 1. Average grass cover for all treatments at the Urad-Henderson reclamation area from 1979 through 1997. Different letters above a bar indicate significant differences ($P < 0.05$).

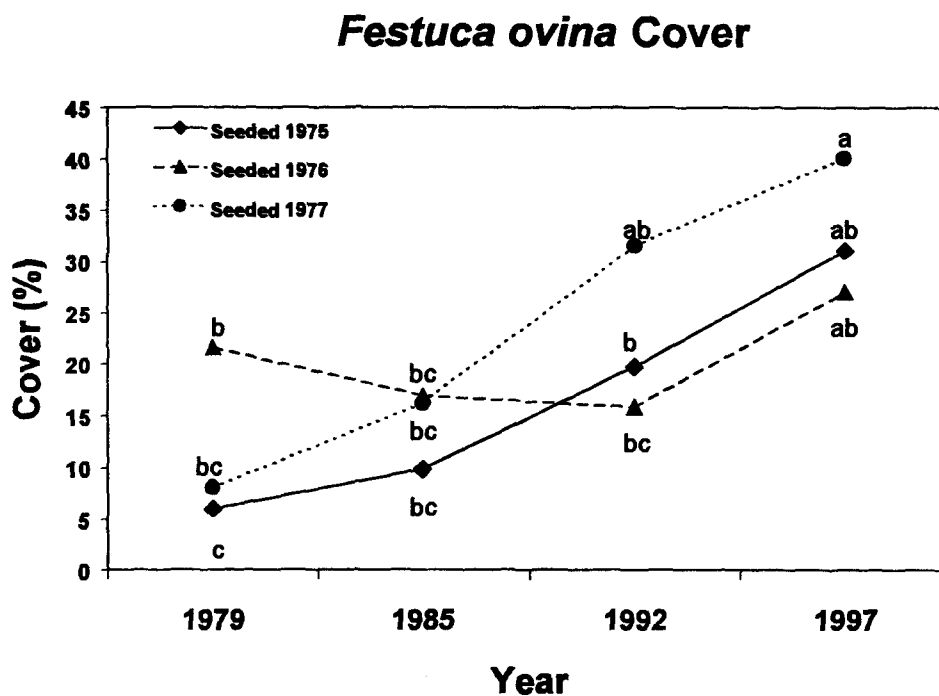
Figure 2. Aerial cover of hard fescue (*Festuca ovina*) from 1979 through 1997 on Urad tailing reclamation areas seeded in 1975, 1976, and 1977. Means with different letters are significantly different ($P < 0.05$).

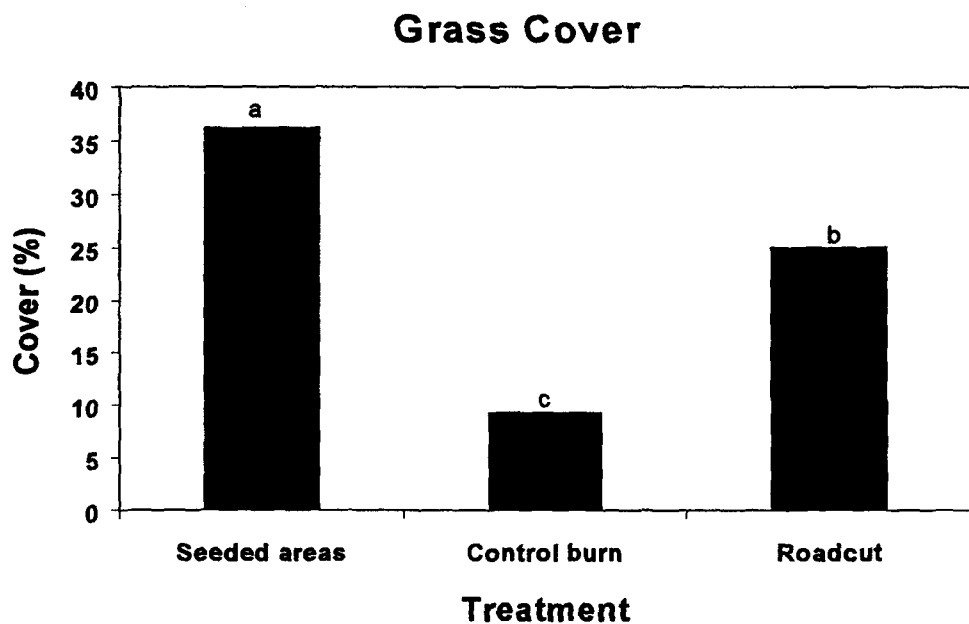
Figure 3. Average grass cover from 1979 through 1997 on seeded areas of the Urad reclaimed tailing, control burned area, and a road cut near the Henderson Mine. Different letters above a bar indicate significant differences ($P < 0.05$)

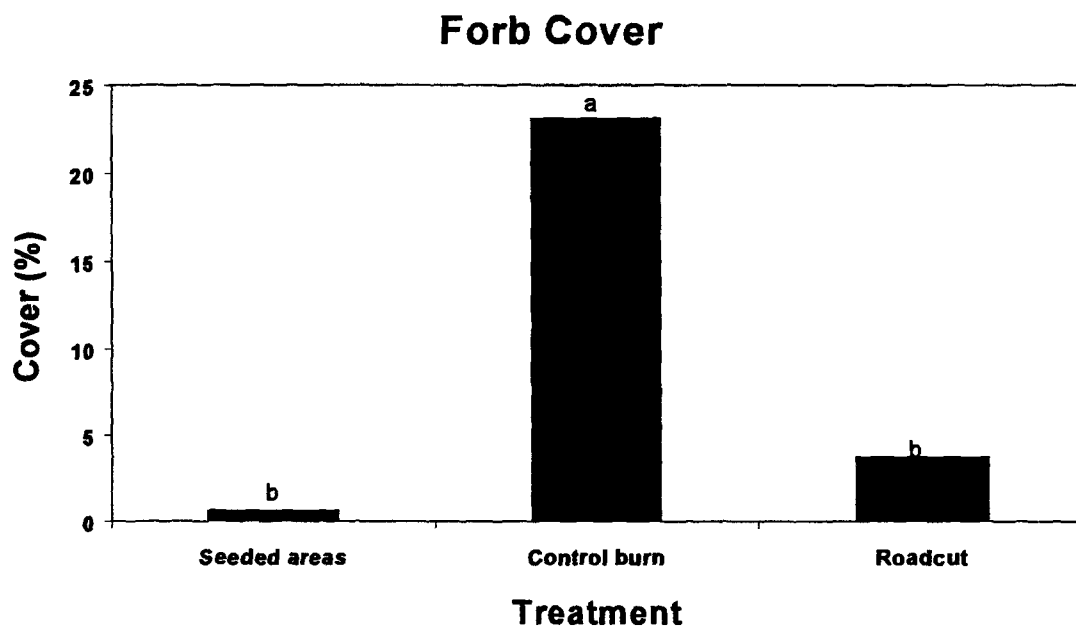
Figure 4. Average forb cover from 1979 through 1997 on seeded areas of the Urad reclaimed tailing, control burned area, and a road cut near the Henderson Mine. Different letters above a bar indicate significant differences ($P < 0.05$).

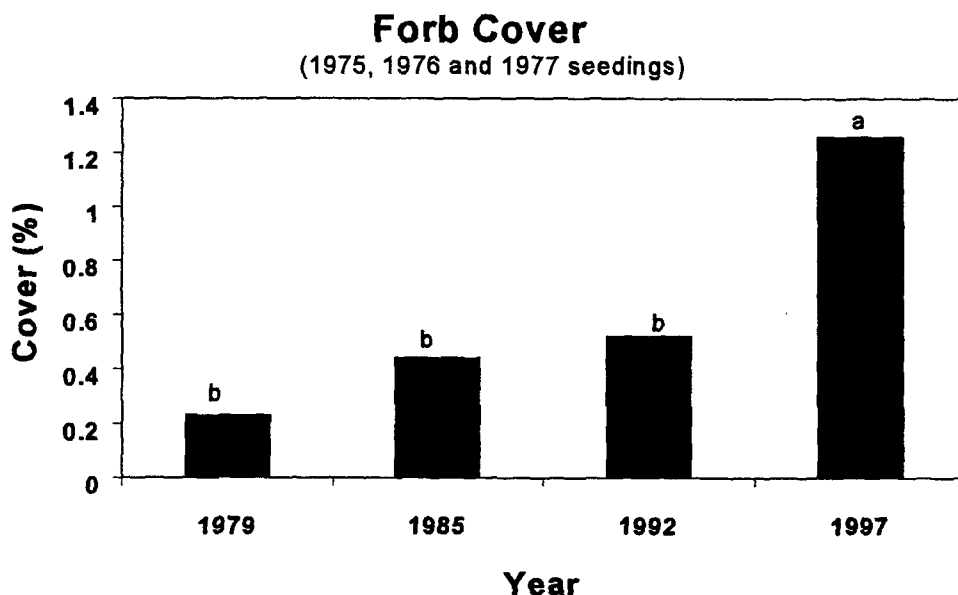
Figure 5. Average forb cover from 1979 through 1997 for areas seeded from 1975 through 1977 on the Urad tailing reclamation area. Different letters above a bar indicate significant differences ($P < 0.05$).

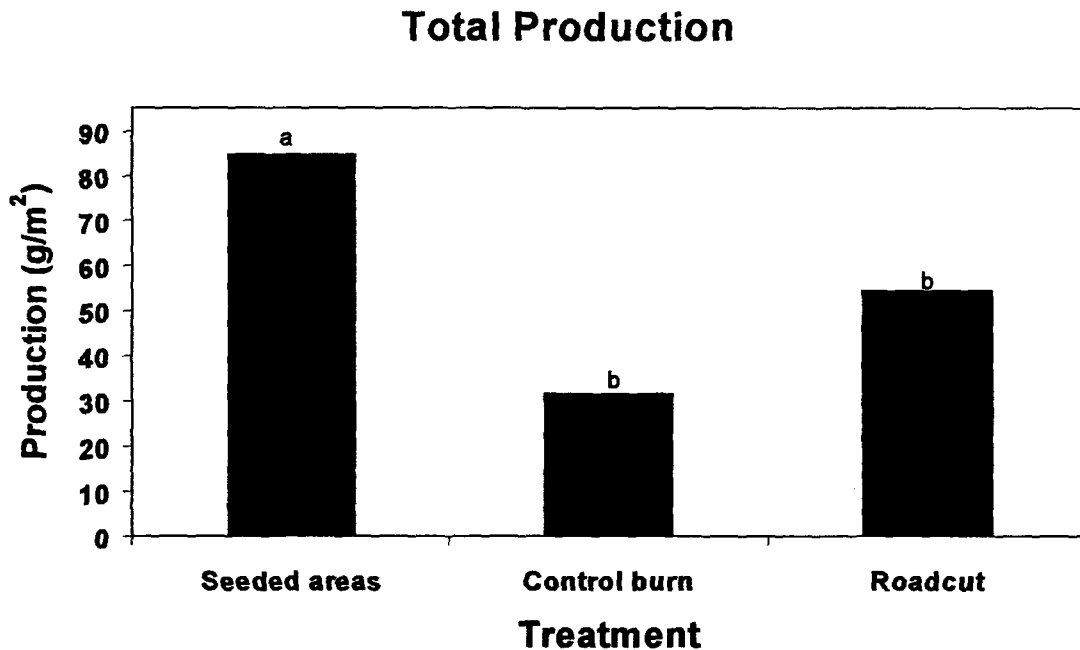
Figure 6. Total aboveground biomass production for seeded areas on the Urad reclaimed tailing, control burned area, and a roadcut near the Henderson Mine. Production values are averages for the years 1979, 1985, 1992, and 1997. Different letters above a bar indicate significant differences among areas ($P < 0.05$).

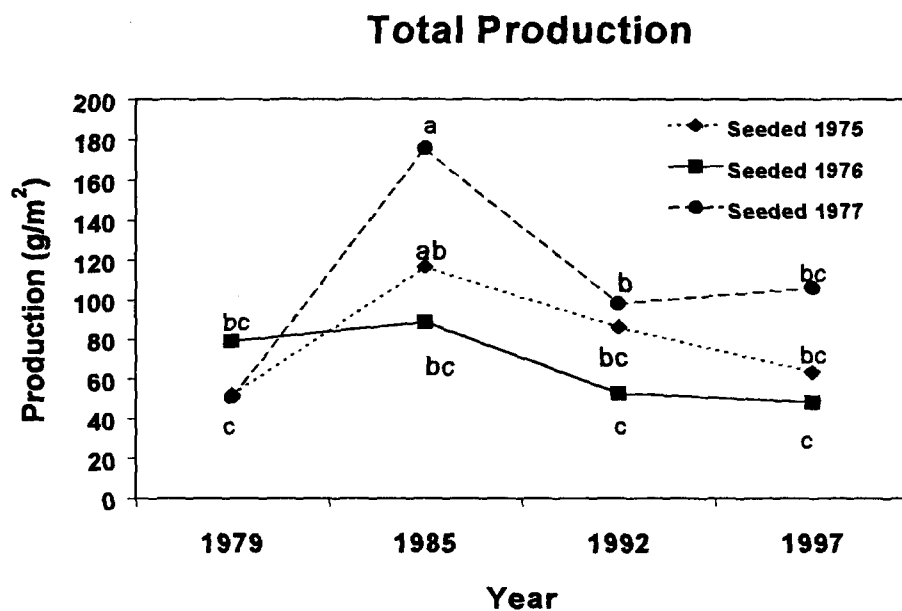
Figure 7. Total aboveground biomass production from 1979 through 1997 on Urad tailing reclamation areas seeded in 1975, 1976, and 1977. Means with different letters are significantly different ($P < 0.05$).

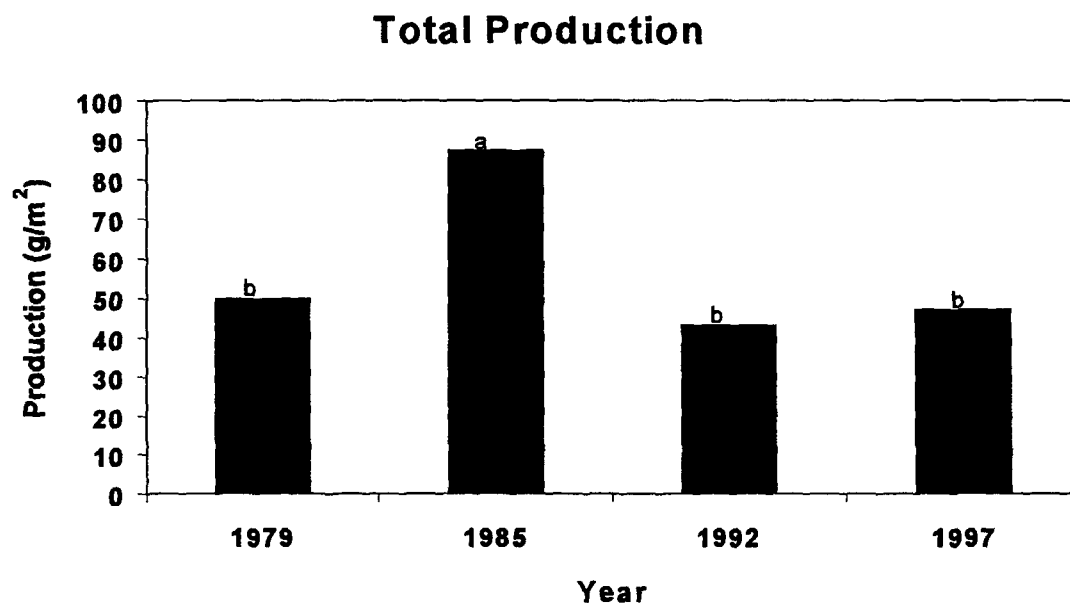
Figure 8. Total aboveground biomass production on Urad tailing reclamation from 1979 through 1997. Different letters above a bar indicate significant difference ($P < 0.05$).

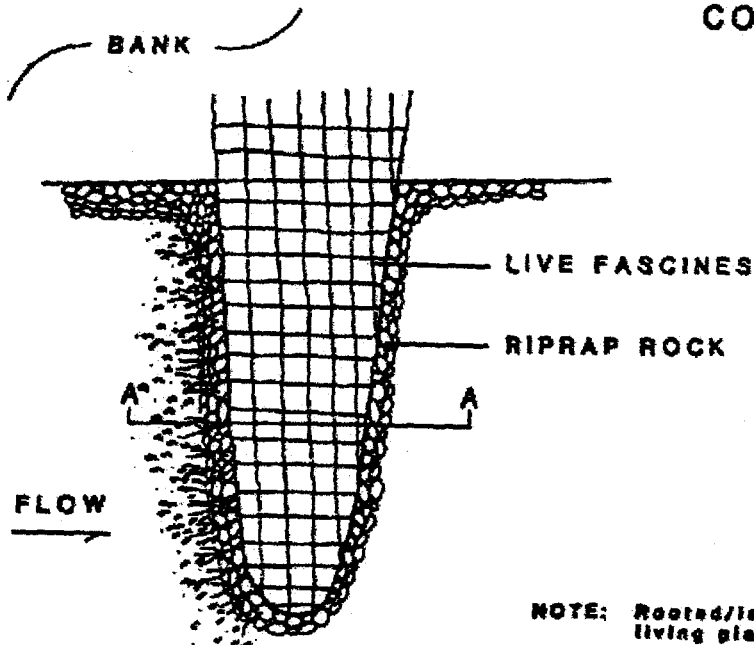
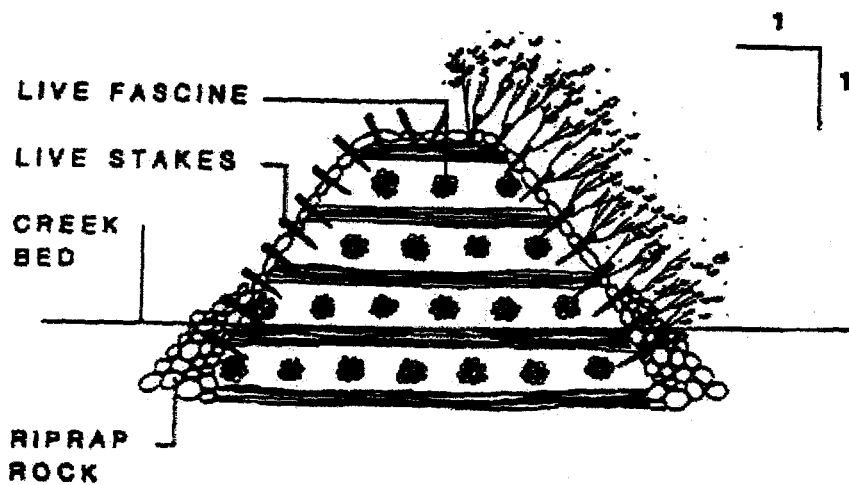
LIVE BOOM CONSTRUCTION

NOTE: Rooted/leafed condition of the living plant material is not representative at the time of installation.

PLAN VIEW

SECTION A - A

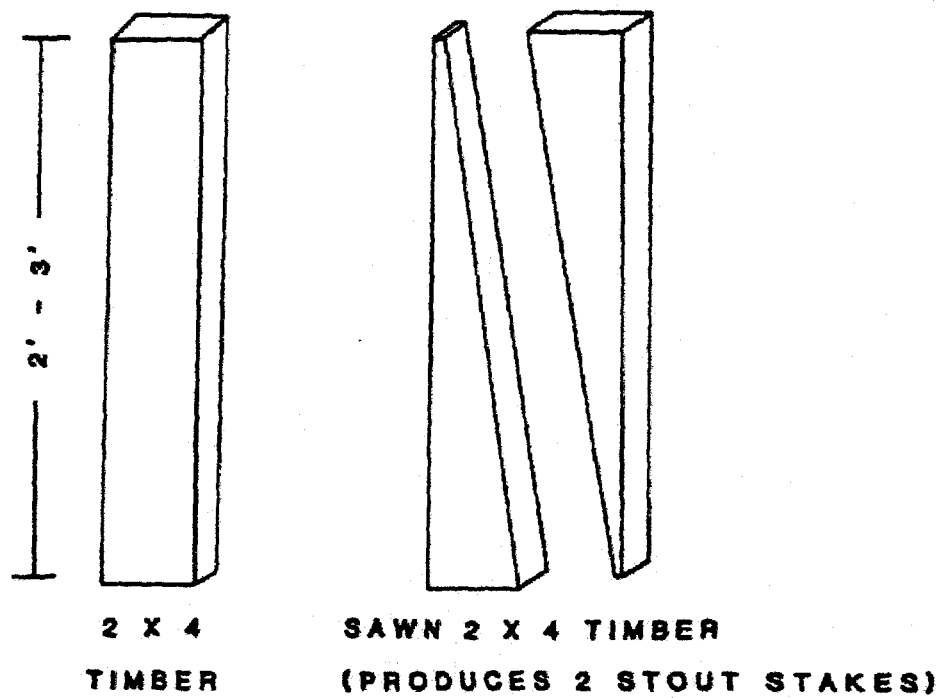
DEAD STOUT STAKE

Figure 2. Dimensions for Stout Stakes.

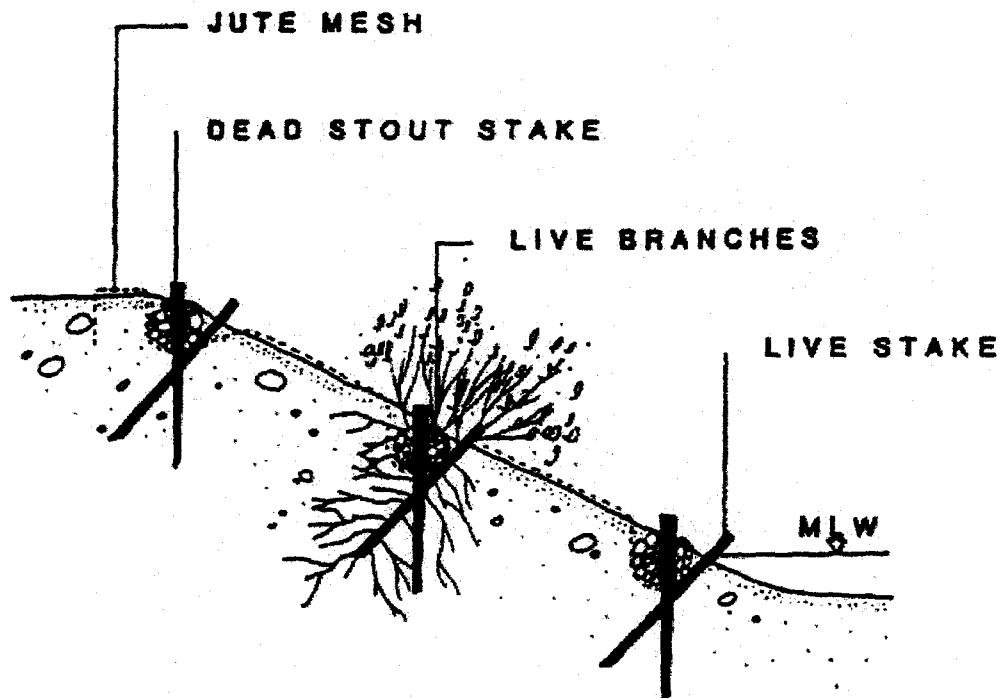
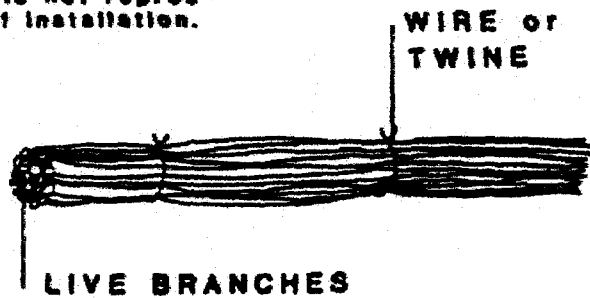
Figure 4. Design details for Live Fascine/Jute Mesh Installation.

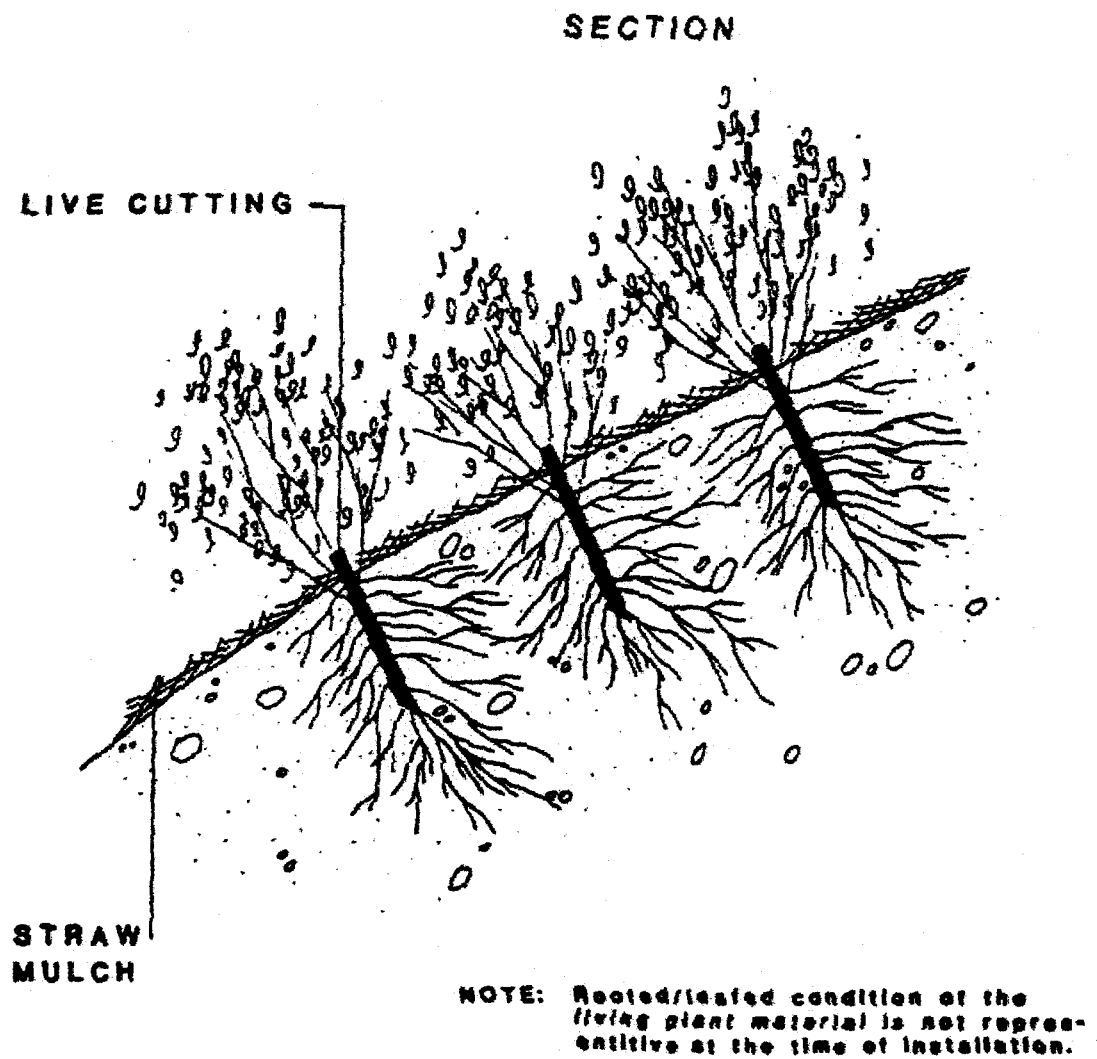
**LIVE STAKE
(With Straw Mulch)**

Figure 6. Design Details for Live Stake with Straw Mulch.

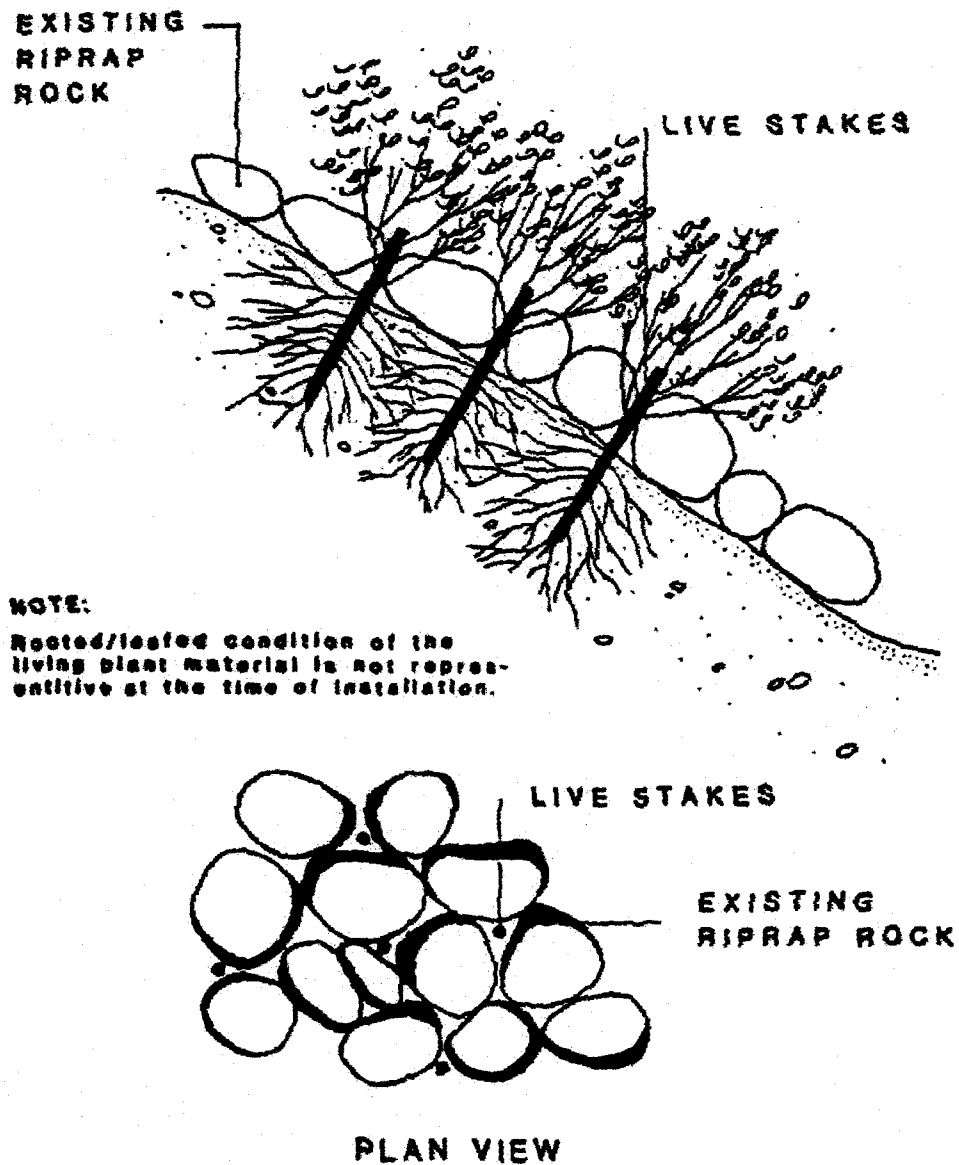
JOINT PLANTING

Figure 7. Design Details for Joint Planting.

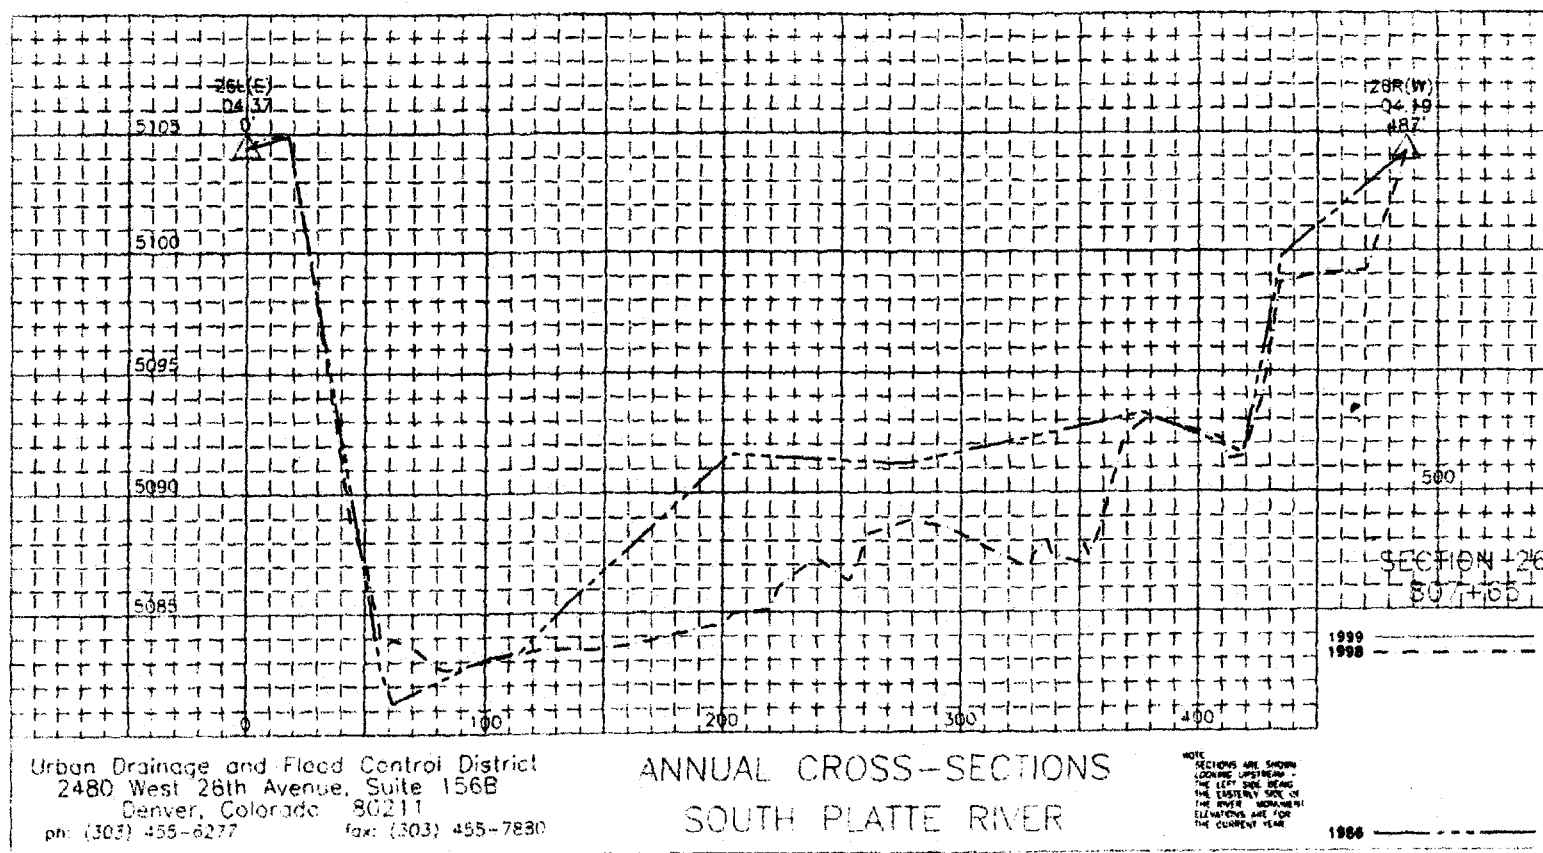
CROSS-SECTION UPSTREAM OF CLEAR CREEK

Figure 8. South Platte River Cross Section Upstream of Clear Creek.

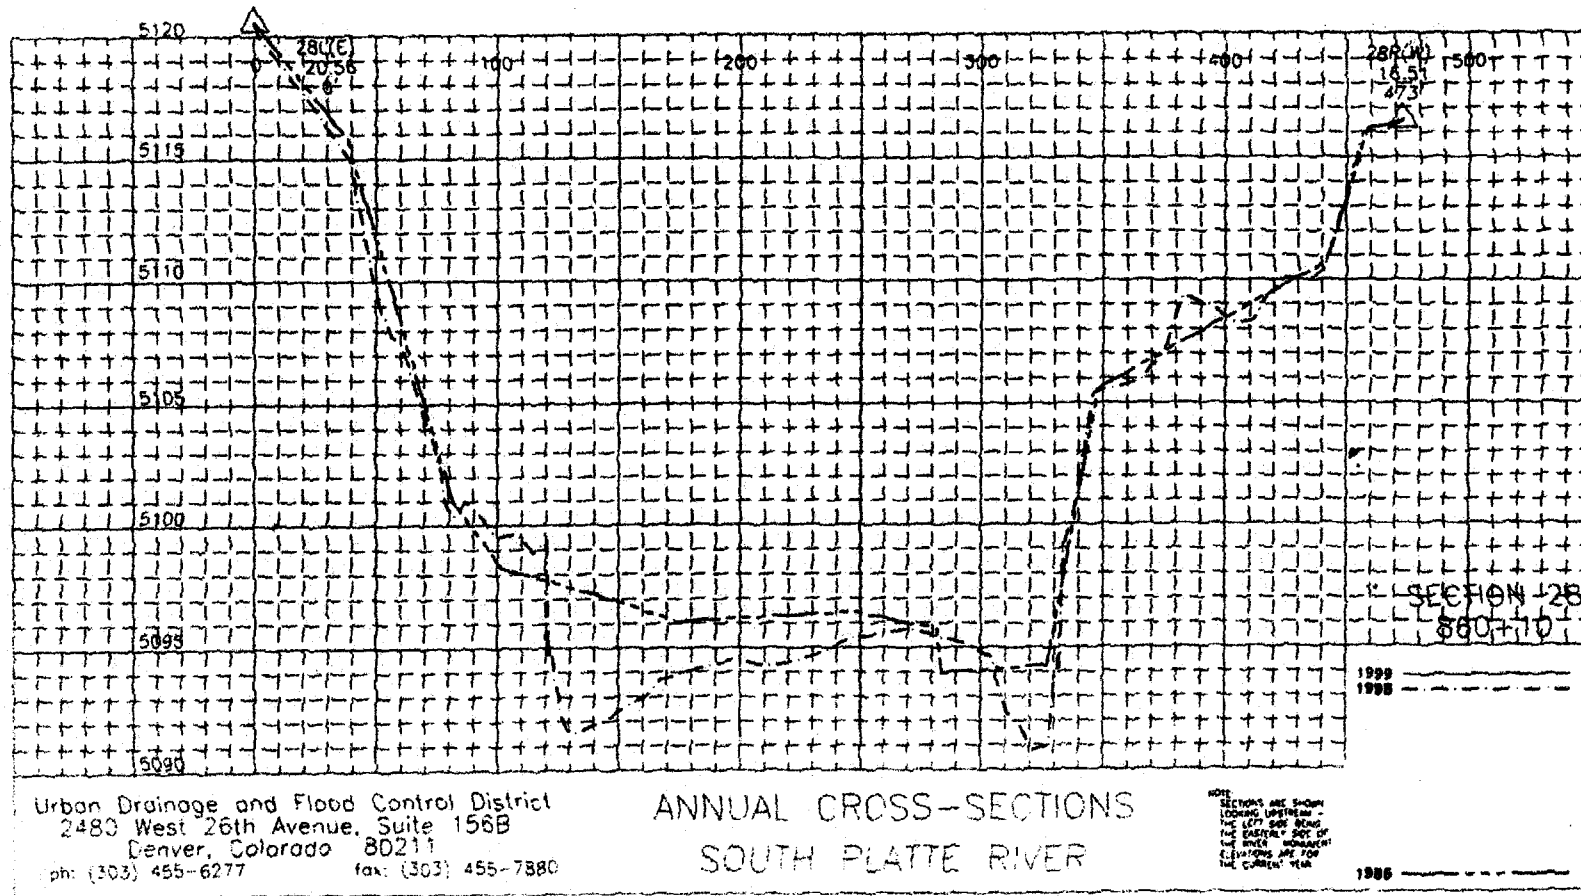
CROSS-SECTION DOWNSTREAM OF CLEAR CREEK

Figure 9. South Platte River Cross Section Downstream of Clear Creek.

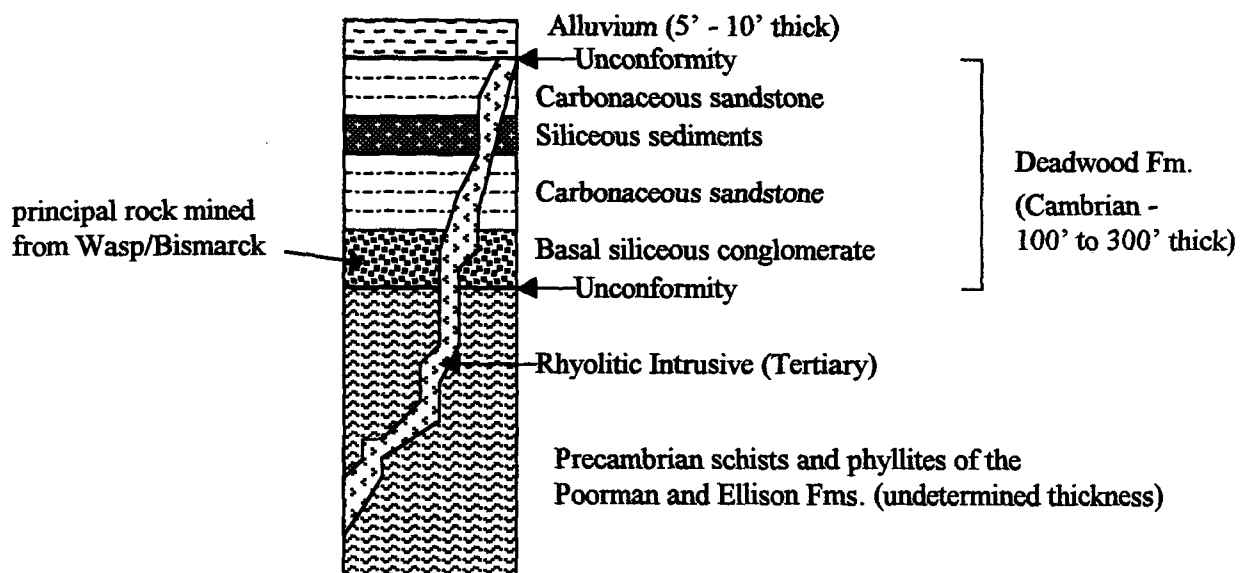
Figure 2
Simplified Geologic Section for the Wasp/Bismarck Site

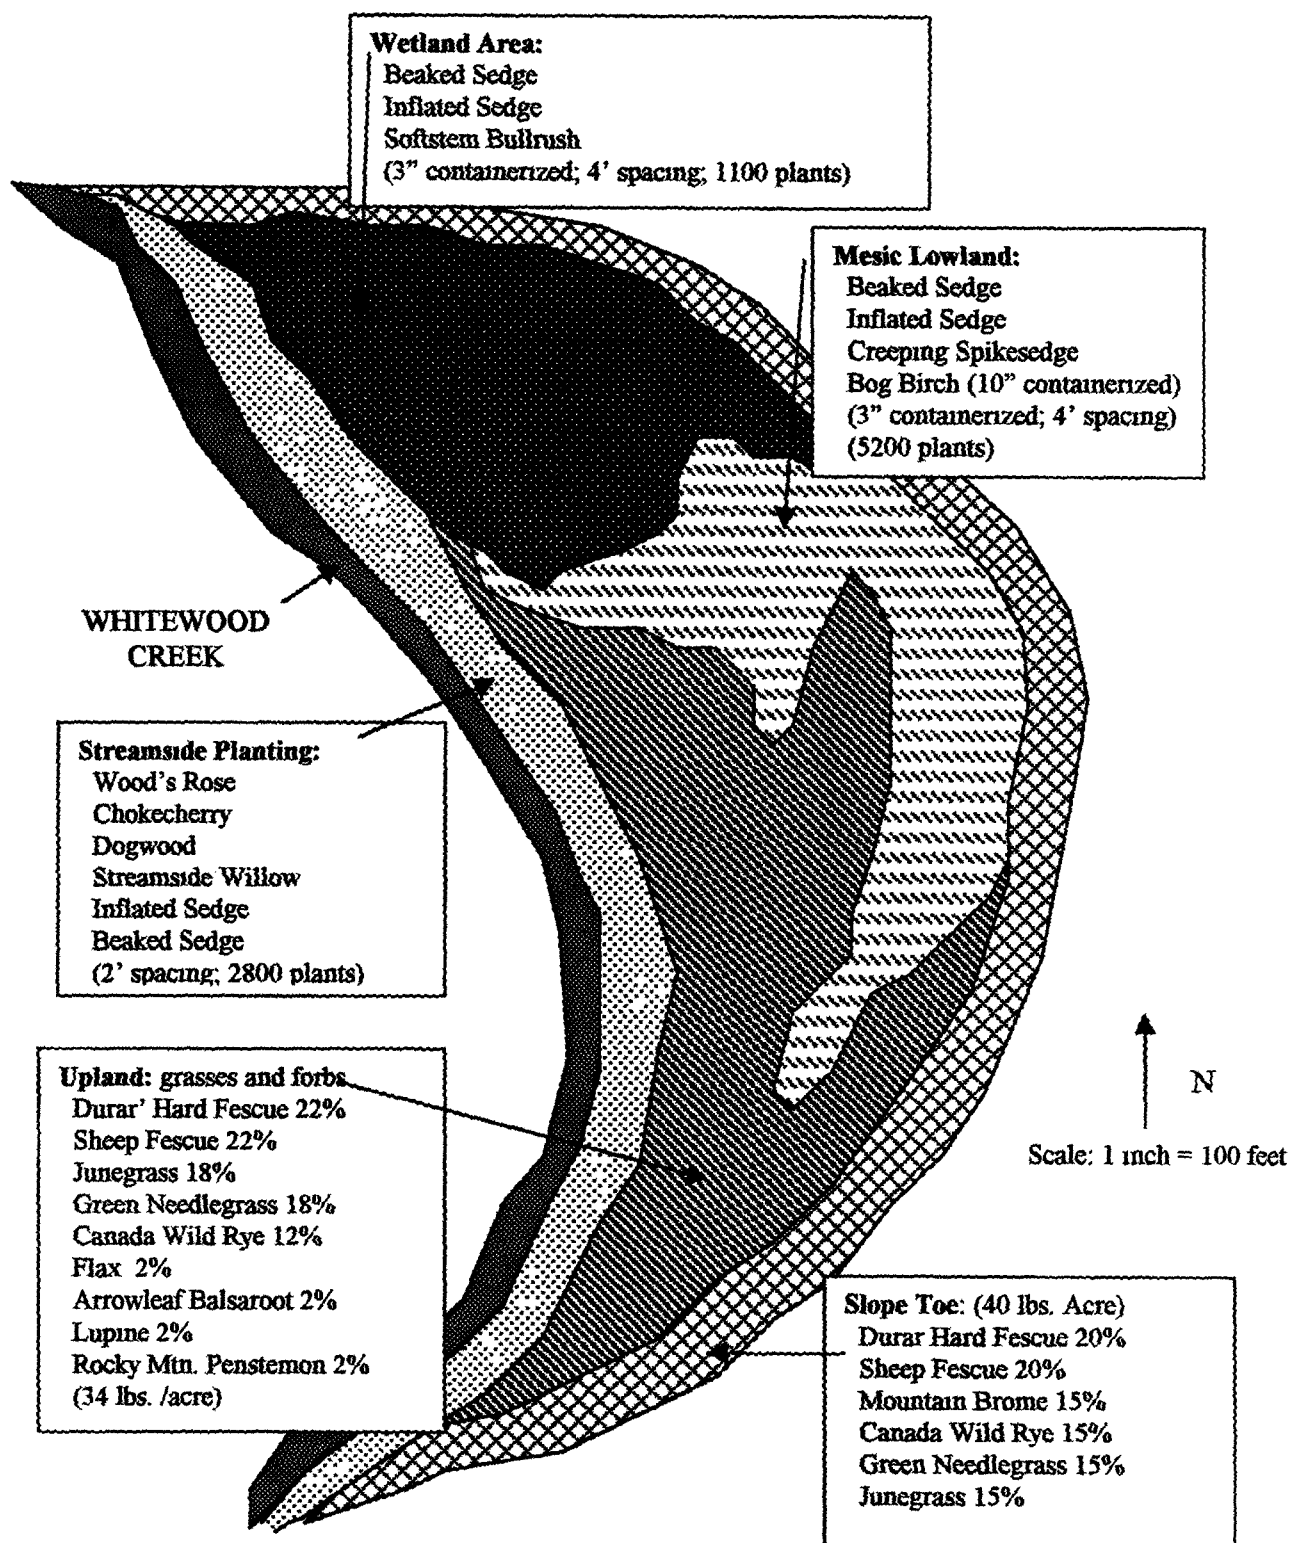
Figure 4
 The Wasp/Bismarck Wetland Planting Design

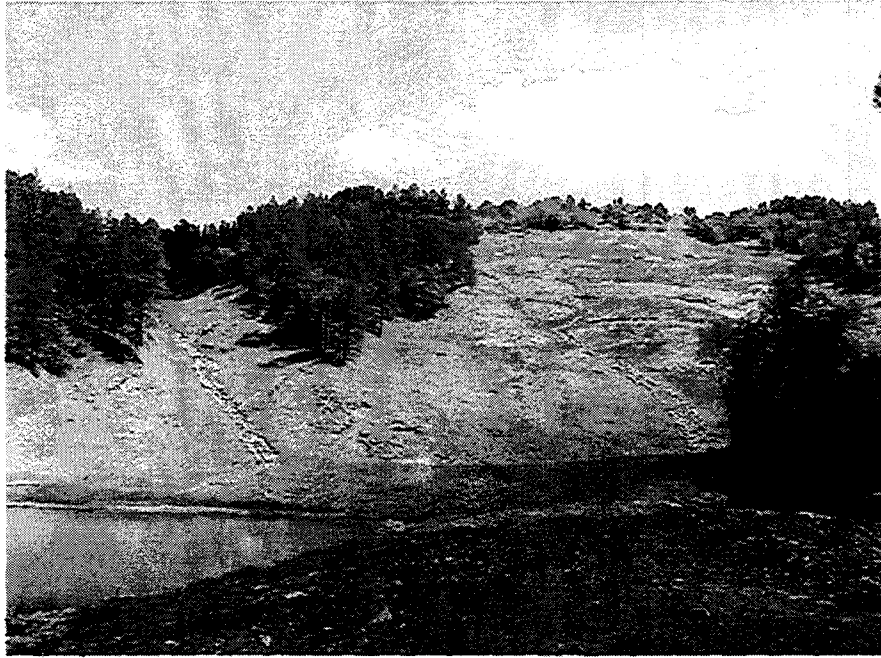
Plate 1. A post reclamation photograph of the Wasp/Bismarck mine sites. The Wasp mill site foundation is situated top of the hillside on the upper right side of the photograph. The Bismarck mill foundation is not pictured but exists on the left side of the photograph just behind trees in the Alder Creek drainage. Note the pond in the foreground.

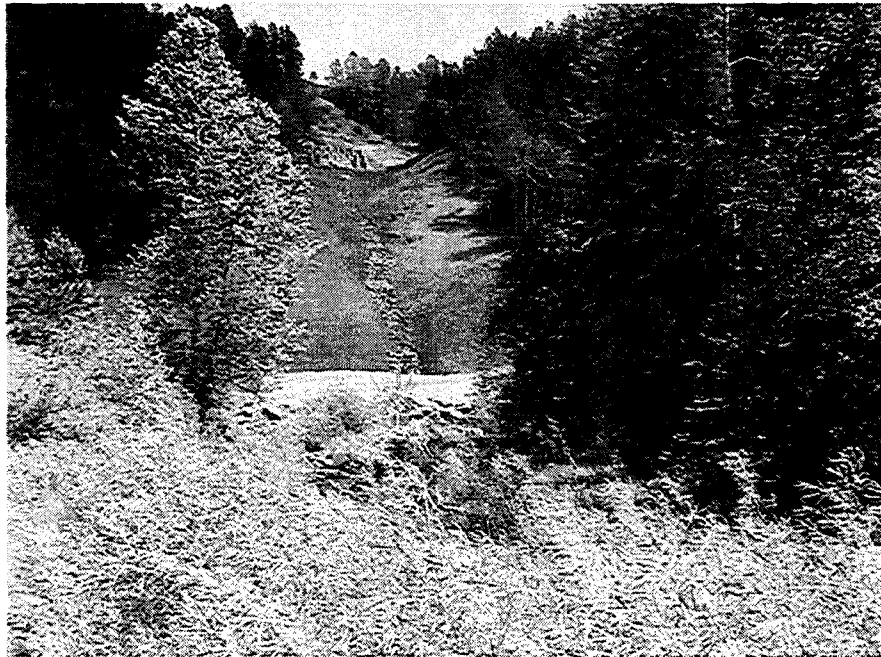
Plate 2. A post reclamation photograph of Whitewood Creek in the foreground and the Bismarck mill site in the background. The Alder Creek drainage follows the rip-rap channel to the Whitewood Creek floodplain.

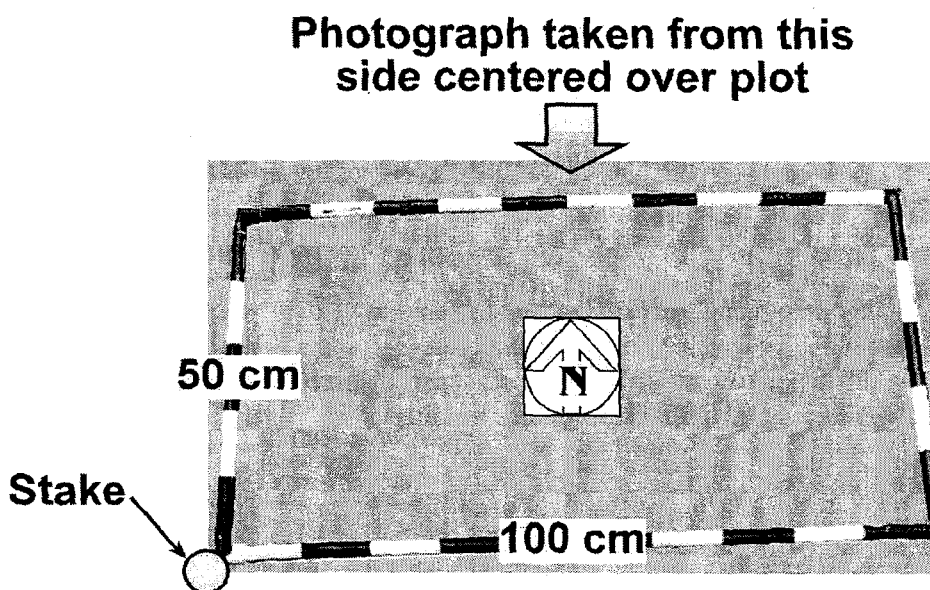
Figure 2. Photo quadrat set against the stake and aligned north-south for repeatability.
