THESIS

EVALUATING THE BOND DURABILITY OF FRP-CONCRETE SYSTEMS SUBJECTED
TO ENVIRONMENTAL EXPOSURES

Oscar Rafael Mata Carrillo

Colorado State University

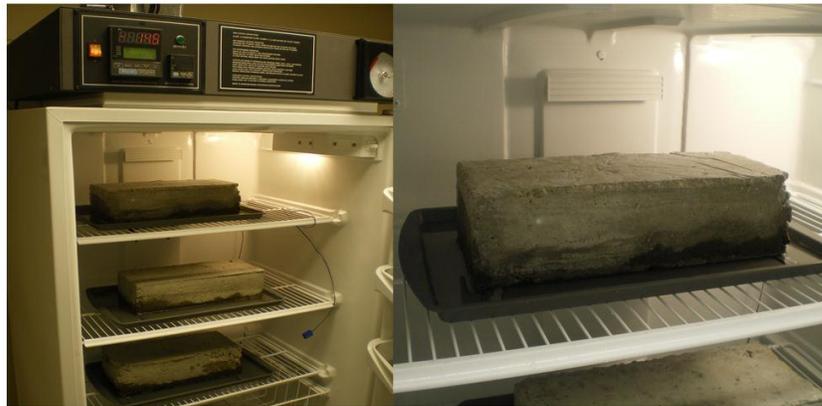
Figure 3.1. FRP Reinforced Concrete specimens undergoing free-thaw exposure

Freeze-thaw exposure was applied to some of the specimens. Since there is no specific standard for testing FRP-concrete bond under freeze thaw conditions, the exposure used by Yun and Wu (2011) was followed in this study. Two ASTM standards for concrete were used as guidance to develop this exposure: ASTM C666 (2003) and ASTM C672/C672M (2003). A total of four blocks underwent freeze-thaw exposure: two for Stage 1 and two for Stage 2, resulting in a total of 6 pull-off tests per stage. No small beams for bending tests were considered for freeze-thaw exposure due to limited freezer space. Specimens were placed in the Magnesium Chloride solution with the FRP side down at a depth no smaller than 0.25 in (6 mm) (ASTM C672/C672M, 2003), as illustrated in Figure 3.1.

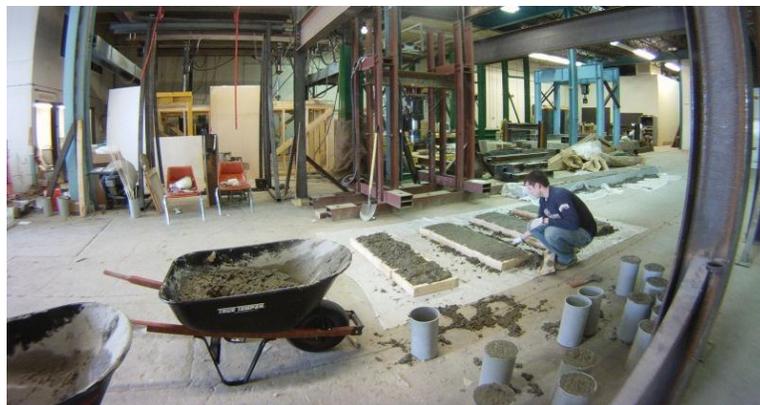
Figure 3.2. Casting of concrete specimens

Wooden molds were fabricated prior to casting the concrete. Once the forms were finished, the mixing truck arrived at the Colorado State University Engineering Research Center to proceed with the pouring of concrete. A total of 45 blocks for pull-off tests, 42 beams for bending tests, and 17 cylinders for compressive strength tests were cast, as shown in Figure 3.2. The details on these specimens (including dimensions) are specified in the following sections. The concrete specimens were allowed to cure for 5 days before removal from the forms. During this 5-day period, curing was aided by sprinkling water on the surface and covering them with sheets of transparent polyethylene plastic to help prevent water from evaporating.

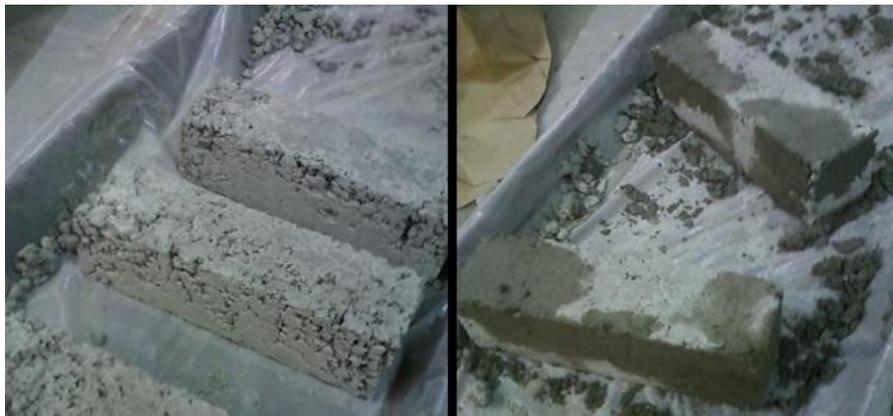
Figure 3.3. Concrete beams before (left) and shortly after (right) patching

Following the removal of the blocks and beams from the forms, it was observed that some of the small beams showed a considerable amount of voids/ air pockets on the sides. Since Class D concrete has a significant amount of large aggregate, the workability of the mix was low which made it difficult to achieve proper compaction in small molds. Such behavior was not anticipated as previous related studies did not specify the maximum aggregate size used in their concrete samples. As a result, a total of 9 beams were repaired and patched using Class S mortar mix, and allowed to harden for 30 minutes before they were placed in water containers with the other specimens for curing. Figure 3.3 shows the characteristics of the specimens before and after mortar patching. All specimens were fully submerged in water for the remaining 23 days of the curing stage to provide them with as much moisture as possible and prevent cracking during this period.

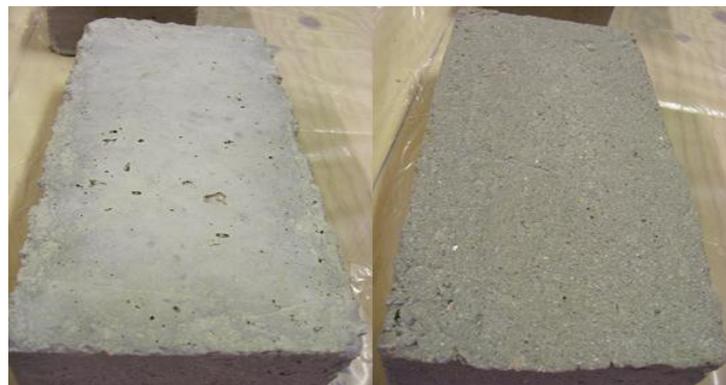
Figure 3.4. Concrete surface before (left) and after (right) sandblasting

All of the specimens were first sandblasted to the level of aggregate using 30 Grit silica based sand. The purpose of sandblasting was to eliminate any loose particles, debris, and uneven surfaces. Specimens were then air blasted to remove any dust and dirt accumulation from the surface. A surface that is sandblasted and air blasted ensures improved bonding of the carbon fabrics to the concrete. Figure 3.4 illustrates the concrete surface before and after sandblasting.

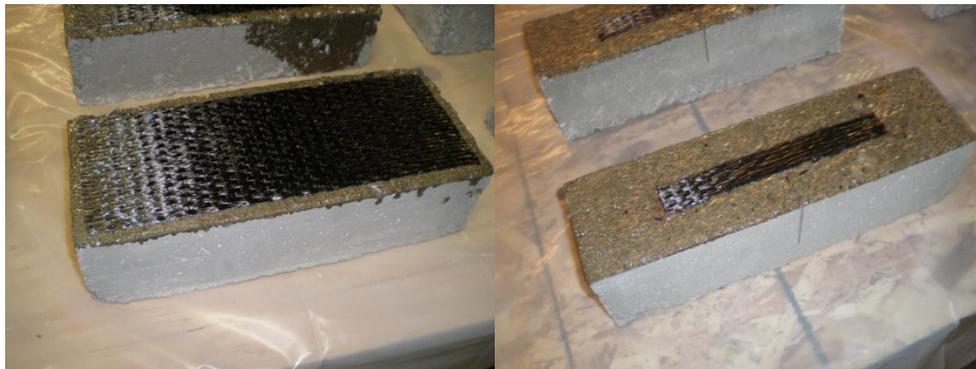
Figure 3.5. Concrete specimens reinforced with CFRP for pull-off (left) and flexural (right) tests

epoxy used in the application of the CFRP. This two-part epoxy contained a resin and a hardener that were thoroughly mixed at a 2:1 ratio by volume. Rollers were used to ensure uniform pressure during CFRP application and to remove significant air pockets. Finally, any minor air pockets were removed by smoothly but firmly applying pressure on the specimens, starting from the center and moving towards the edges. The wet-layup procedure was repeated on the appropriate specimens to complete the double-layer and triple-layer CFRP reinforcement. Figure 3.5 shows the concrete blocks and beams reinforced with CFRP.

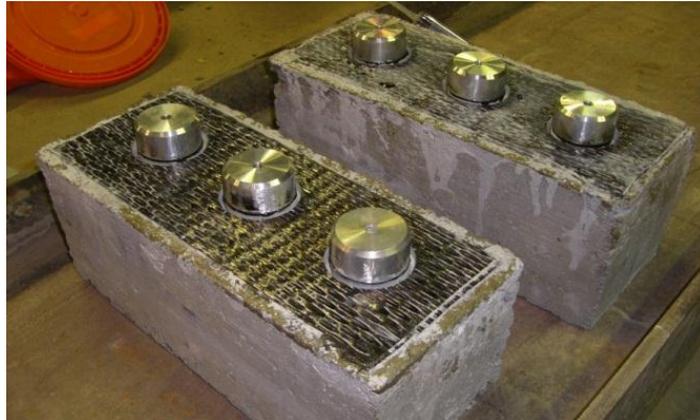
Figure 3.7. Concrete specimens following adhesion of dollies

minimum of 24 hours before performing pull-off tests. Figure 3.7 shows the dollies adhered to the concrete specimens.

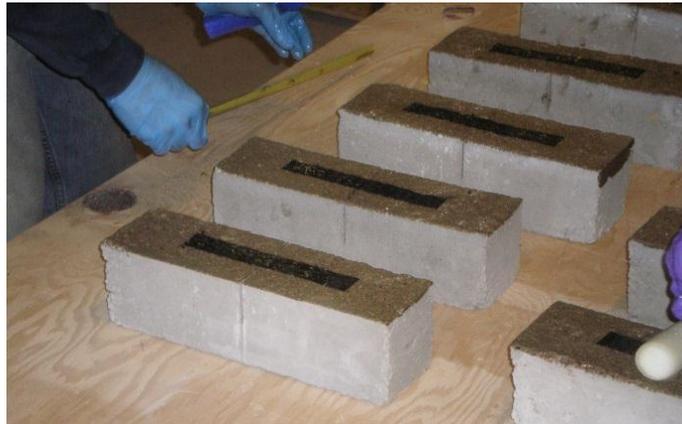
Figure 3.9. Concrete beams reinforced with CFRP

For the beam bending tests a total of 42 small beams were cast, with dimensions of 14 in x 4 in x 4 in (356 mm x 102 mm x 102 mm), as illustrated in Figure 3.9. Following the 28-day cure, the beams were saw cut at mid-span on the tension face to a depth of 2 in (50 mm), equivalent to half of the beam height. Prior to beam reinforcement, the fabrics were cut into strips of 8 in x 1 in (203 mm x 25 mm). Two layers of CFRP sheets were applied on all 42 specimens to evaluate the possibility of failure not only between the concrete and the fibers, but also in between the sheets. Prior to CFRP reinforcement, the surface was prepared using sandblasting and air blasting procedures, as described in Section 3.4.2.

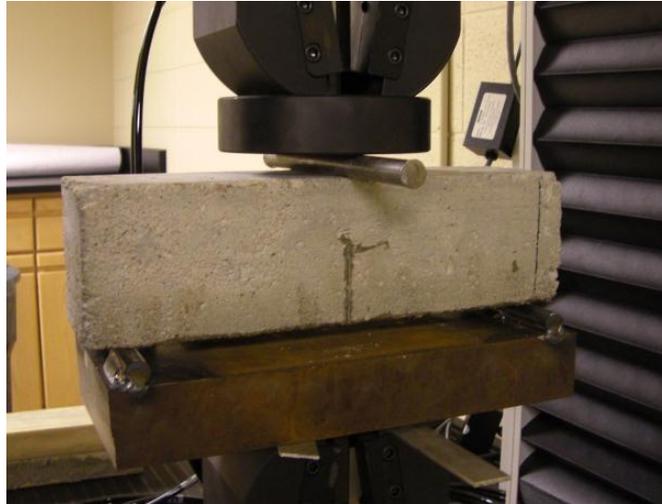
Figure 3.10. Beam fixture and specimen

A United Testing Machine Model SFM – 300 kN was used to conduct the flexural tests. The main parameters recorded by the testing machine were time, force, and crosshead position. In order to be able to place the beams on the machine properly for testing, a loading fixture was built. This fixture consisted of a 13.5 in x 6 in x 2 in (343 mm x 152 mm x 50 mm) steel plate with a 3 in x 2 in x 0.5 in (76 mm x 50 mm x 13 mm) steel plate welded at the bottom in the shape of a “T” to allow proper gripping in the machine. Two smooth bars were welded along the 6 in length which served as simple supports of the beam. These bars were separated by 12 in, equivalent to the span under analysis. Figure 3.10 shows the fixture in the machine, and the beam setup for testing.

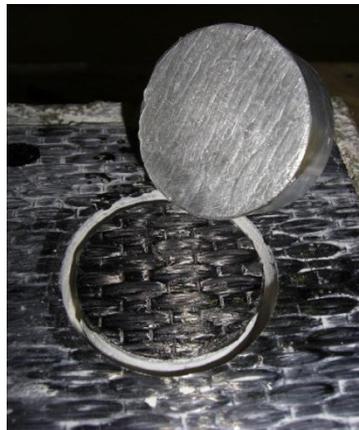
Figure 3.12. Pull-off Mode A failure

A total of six pull-off tests were conducted for stage zero. Block #1, equivalent to test labels 1, 2, and 3 showed results of 374 psi (2.58 MPa), 442 psi (3.05 MPa), and 391 psi (2.70 MPa), respectively. Out of the three pull-off tests planned on Block #1, test 1 showed an adhesive failure between the dolly and the CFRP, labeled as failure Mode A by ASTM D7522/D7522M (2009). As stated in Table 2.1, this was not considered an acceptable failure mode, mainly because the CFRP-concrete bond did not show failure. Figure 3.12 below illustrates the adhesive failure mode from test 1.

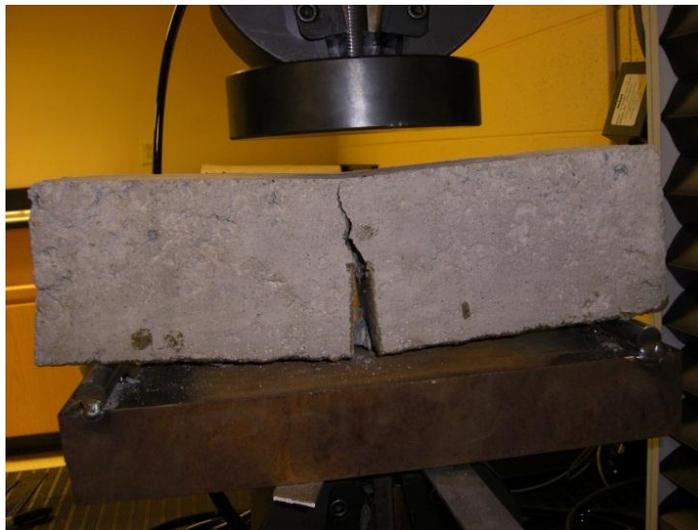
Figure 3.16. Beam following crack failure

Stage 0 contained three small beams to be tested under three-point flexure. Due to an error with the testing machine, one specimen was prematurely damaged so the remaining two were used as the control specimens. As previously mentioned, a United Testing Machine Model SFM- 300 kN was used and the parameters recorded were time, force, and deflection as measured by the crosshead position. Figure 3.16 shows failure of one of the beams and how a single flexural crack was developed at the top of the saw cut, as desired.

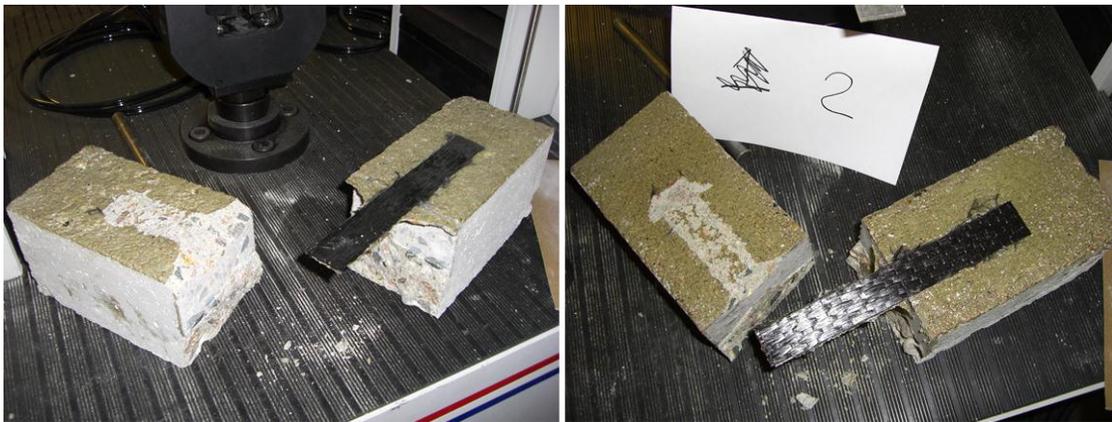
Figure 3.17. Beam 1 (left) and Beam 2 (right) following testing

Both beams from this stage showed a fairly similar failure behavior, in which one side of the beam de-bonded before the other. However, the peak force witnessed on Beam 1 was considerably higher, 0.563 kips (2.50 kN) greater than for Beam 2. The larger force resisted by Beam 1 also resulted in a displacement of 0.029 in (0.74 mm) greater than for Beam 2. One possible reason for Beam 2 having a lower peak force is a weaker CFRP-concrete bond coming from the CFRP application. The darker spots on the failure surface for Beam 2 show that the CFRP did not completely adhere to the concrete substrate during application. Beam 1 contained little to no adhesive layer on top of the concrete surface after failure, which indicates that the CFRP was fully bonded to the concrete. Figure 3.17 shows the failure surfaces for both specimens and it is noticeable how Beam 2 contained a significantly higher amount of adhesive on the concrete.

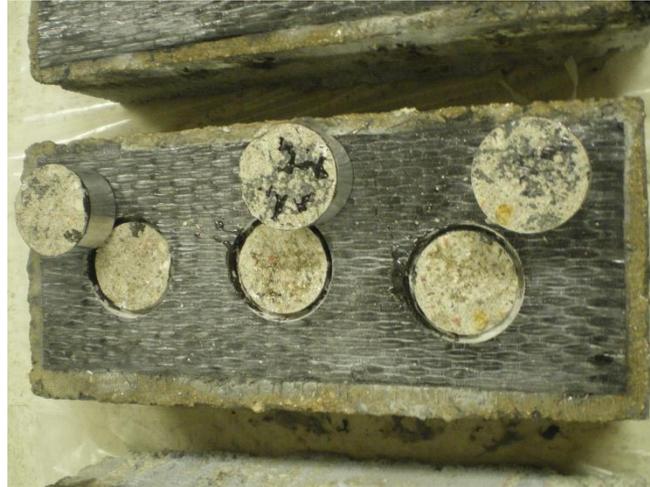
Figure 3.19. Mode F failures (ASTM D7522) during Stage 1 testing

the FRP-concrete interface, combined with a partial concrete failure is seen. Figure 3.19 below shows a typical failure Mode F encountered during testing. The figure illustrates how the CFRP did not fully adhere to the concrete, and it is noticeable by the black spots of CFRP that are still visible, especially on the middle dolly.

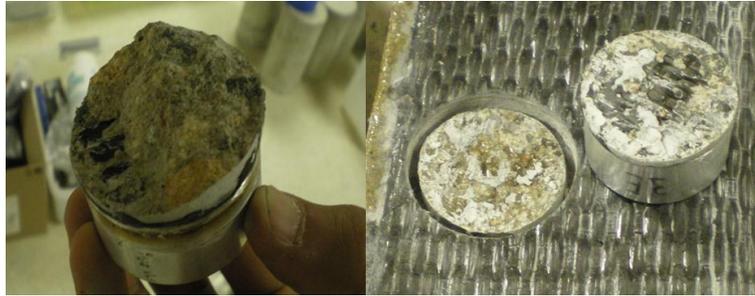
Figure 3.20. Test #35 (left) vs. Test #38 (right)

Finally, throughout testing the forty five pull-offs, three special cases were encountered. A special note worth discussing in the chloride based deicer group with triple layer reinforcement is the large discrepancy encountered within the six pull-offs. Test #38 resulted in the absolute lowest value for the entire stage, with a strength of 80 psi (0.55 MPa). On the other hand, test #35 resulted in the absolute highest value among the 45 pull-off tests performed in this stage, with a strength of 627 psi (4.32 MPa). This particular pull-off was characterized as an ideal concrete failure, Mode G in ASTM D7522. It is believed that the reasons for the extremely large discrepancies among the specimens that underwent the exact same conditioning is due to the large aggregate present on test #35, as well as the presence of moisture within the concrete-FRP interface on test #38. This moisture was noticed because of the lighter color of the concrete, as well as a softer and more clayey feel to the touch. Notice in Figure 3.20 the large aggregate on Test #35, as well as the lighter color and thinner layer of concrete on test #38.

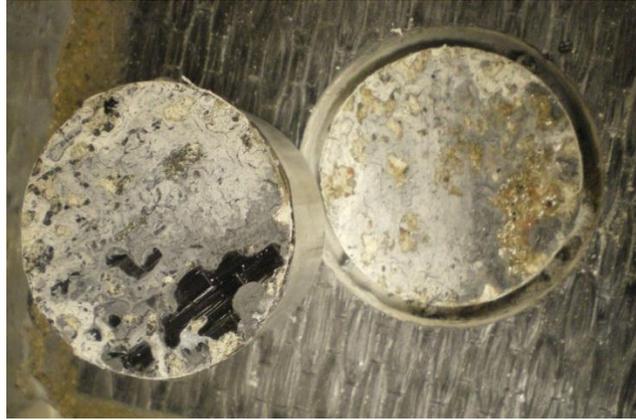
Figure 3.21. Presence of moisture at CFRP-concrete interface

The same moisture level – strength relationship was witnessed in dollies #25, #26, and #27 (Block 9) within the non-chloride based deicer group, as well as dollies #33 from Block 11, and dollies #37 and #38 from Block 13. With these patterns identified, one can draw the conclusion that the presence of moisture does in fact reduce the pull-strength. However, reasons why some dollies within the same group may or may not have exhibited moisture are unknown. A characteristic example of a dolly showing sign of moisture is illustrated in Figure 3.21.

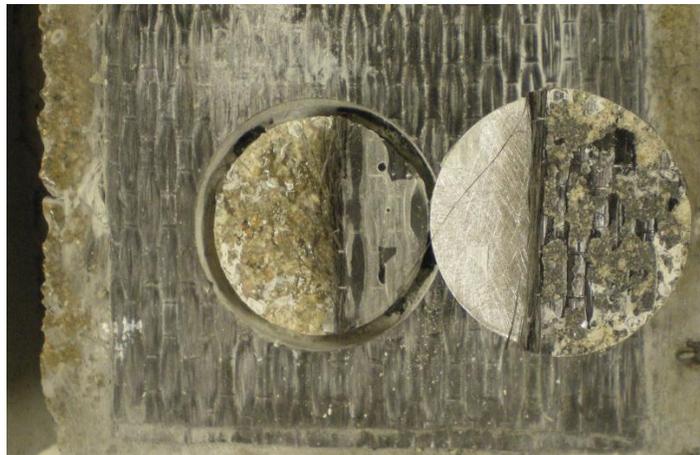
Figure 3.22. Combined Mode A and Mode F failure

The last special case consisted of having a mixed failure mode between Mode A and Mode F. In this special case, the CFRP fibers may not have been fully saturated during application, causing separation of the bundles. Figure 3.22 shows how half of the dolly completely detached from the concrete at an adhesive level on the dolly-FRP interface, whereas the second half was seen as an adhesive failure on the concrete-FRP interface.

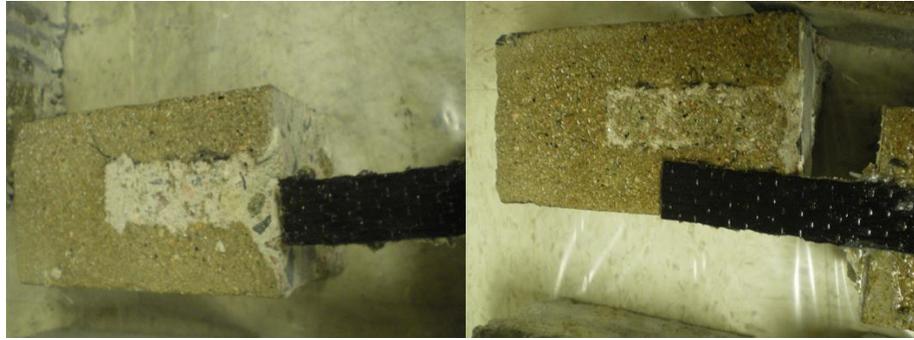
Figure 3.23. Beam #1 (left) vs. Beam #8 (right) failure

Two control specimens were kept at dry conditions and room temperature. From the thirteen beams tested, these two possessed the highest peak load values at 4.242 kip (18.87 kN) and 3.843 kips (17.09 kN). The absolute lowest load experienced on the beams was identified on Beam #8, corresponding to immersion in non-chloride based deicer. Figure 3.23 below clearly demonstrates the major differences in the bond between one of the control specimens (Beam #1) and Beam #8. The larger area of darker spots on the concrete surface where the CFRP failed was found noticeable. The dark spots correspond to the cured epoxy adhesive that did not fully bond with the CFRP strip. Although it is possible that the non-chloride deicer may have contributed to degradation of the bond, the other potential cause for this behavior is improper adhesion of the CFRP onto the concrete during preparation.

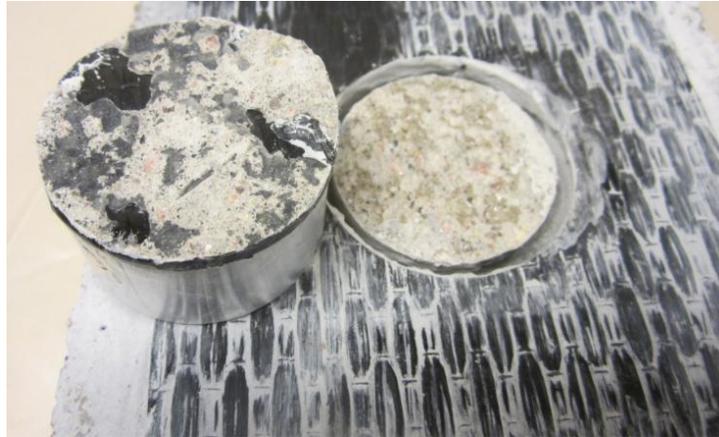
Figure 3.24. Representative Mode F failure for Stage 2

Once again, the most common failure type corresponds to Mode F. Thirty two of the forty five pull-off tests resulted in this failure mode, equivalent to 71% of the total. Figure 3.24 below shows a representative failure for these thirty two dollies. The black spots on the dolly correspond to sections where the CFRP did not fully adhere to the concrete, followed by partial concrete detachment within the same dolly.

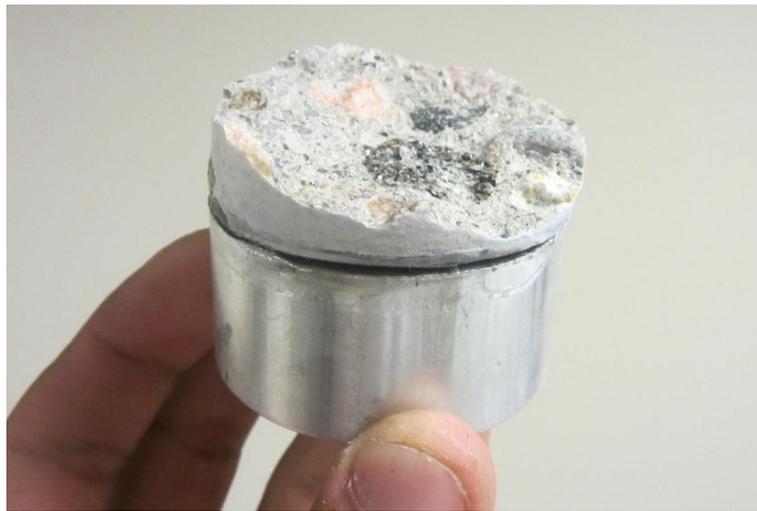
Figure 3.25. Mode G Failure in Dolly #20

Four blocks were exposed to a non-chloride based deicer, equivalent to a total of twelve pull-off tests. Two of these blocks were reinforced with two layers of CFRP, and the remaining two blocks with three layers of CFRP. Failure modes varied from Mode A in three pull-offs, Mode F in eight dollies, and the last one corresponded to an ideal Mode G failure. Figure 3.25 shows the Mode G failure that was witnessed on dolly #20 from this stage, corresponding to one of the blocks reinforced with two layers of CFRP.

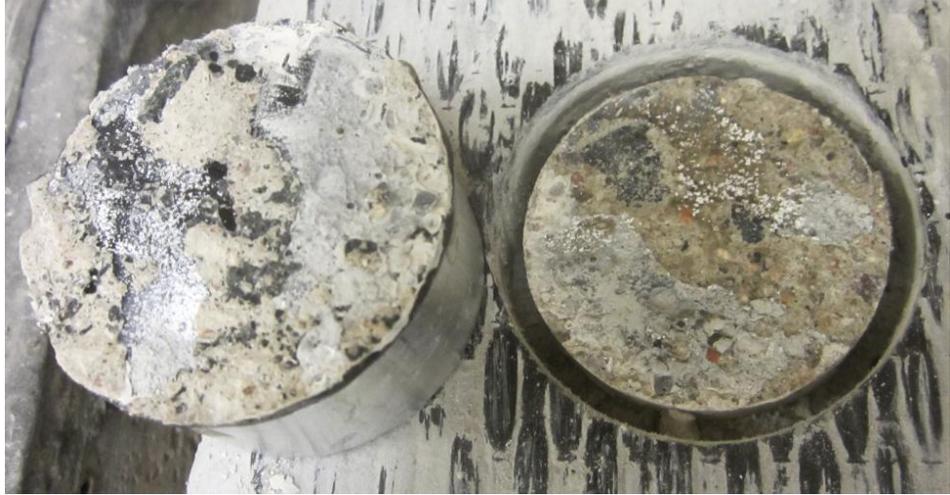
Figure 3.26. Presence of moisture on Dollies

In this stage, the presence of moisture in some of the dollies was also witnessed. Two of the dollies within the water exposure group, three within the wet-dry cycle group, three within the non-chloride based deicer group, and nine within the chloride-based deicer group, were the specimens that showed moisture between the concrete and FRP. Once again, the different tonalities of gray as well as a softer more clayey feel to the touch helped identify which dollies showed levels of moisture. The amount of moisture ranged from very small spots around the edges, to larger areas within the dolly. Figure 3.26 shows a characteristic image of the presence of moisture in the specimens. As far as moisture – strength relationship in the water group, no logical pattern was found. In fact, dollies #8 and #9 resulted in the highest bond strength in the group, even though these were the ones that showed some moisture within the group. However, dollies #25, #26, and #27 did turn out to be weakest ones within the non – chloride based deicer group. For the chloride based deicer group, the moisture-strength relationship makes sense in the double-layer reinforcement ones, where dollies #28, #29, #32, and #33 showed the lowest strengths as oppose to the drier ones. These patterns, however, are difficult to interpret, as the moisture was not present within individual blocks, but rather within individual dollies.

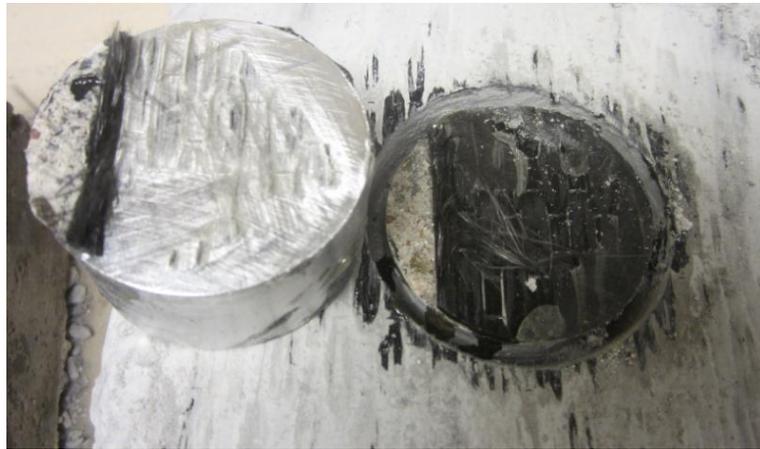
Figure 3.27. Combined Mode A and Mode F failure in Dolly #42

Finally, the special case in which a combined Mode A and Mode G failure was witnessed in dolly # 31 from Stage 1, was also seen in Stage 2 in dolly #42. Figure 3.27 shows dolly #42 with this particular failure. The cause may have been once again due to improper adhesion of the fabric, causing separation of the bundles, or due to a weak pattern of concrete on one side.
