# D.A.F. DARRIEUS VERTICAL AXIS WIND TURBINE AT THE C.S.U. DAIRY FARM

FINAL REPORT

JULY 1980

Department of Civil Engineering Colorado State University Fort Collins, Colorado 80523

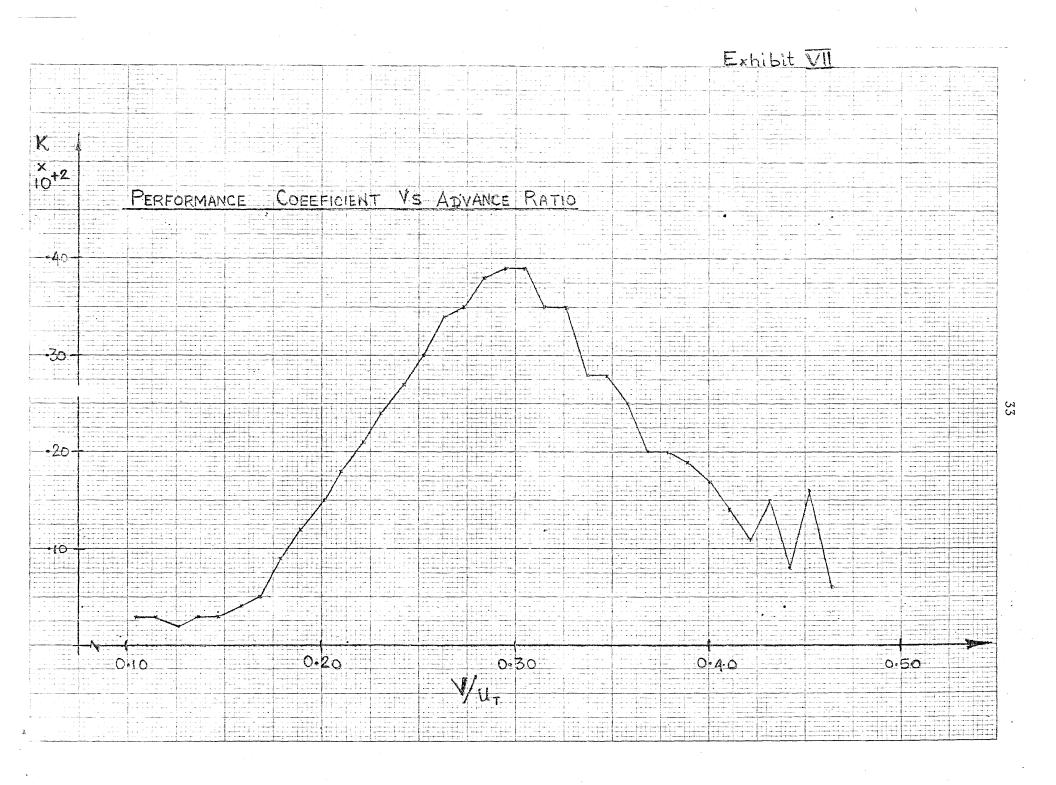
${
m V_R}$  \* Reference velocity in miles per hour The curve of the performance coefficient developed is plotted in Exhibit VII. Table 1 gives the data points for the averages of the combination of all the data, a total of 6,894, ten second interval points were used, equivalent to 19.15 hours total data acquisition time.
