## MCCLUSKY CANAL IMPROVEMENTS

### ABSTRACT

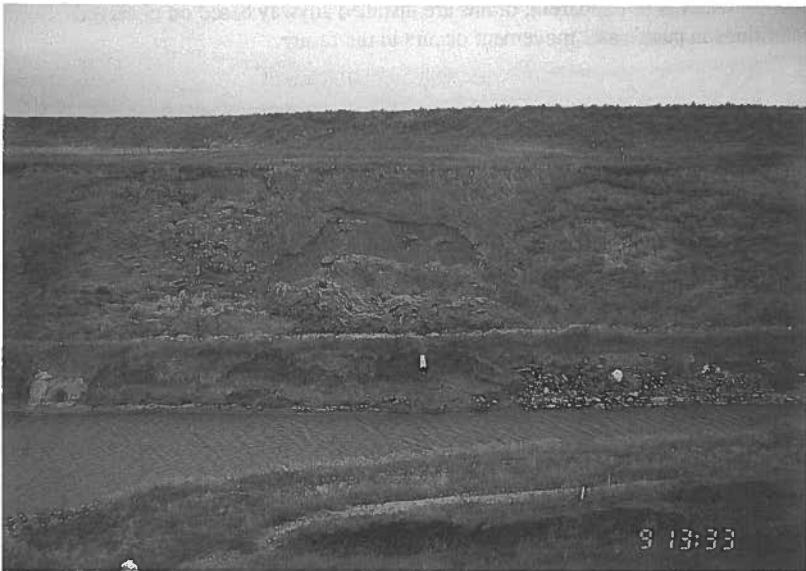
Fig. 2. The two slides in the center and right side of the picture are examples of shallow slides which have occurred on the McClusky Canal.

**Slide prevention methods during the past four years on the McClusky Canal have been intensified and quite successful.** The primary methods implemented during this time are the removal of the slide material to unload the slope, along with installing a gravel "french" drain or conventional plastic pipe drain with a gravel envelope. These methods have been generally successful. In cases where

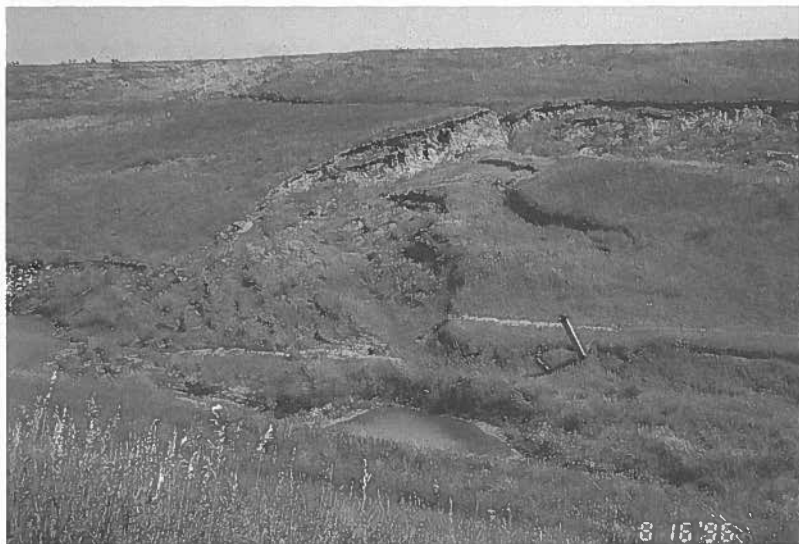
Fig. 3. This is an example of some of the severe deep slides which have occurred on the McClusky Canal (note movement of pipe at mid right of picture)

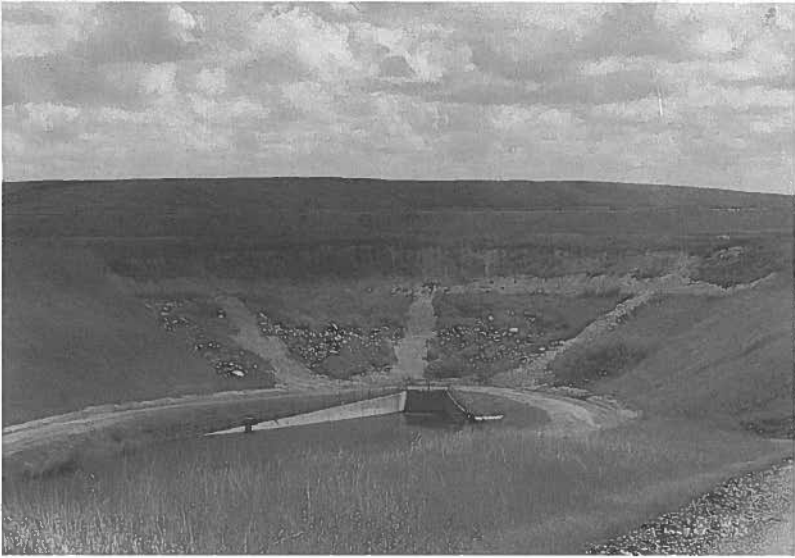
Figure 4 shows the area where a slide occurred at a tunnel outlet and threatened a railroad track and state highway above. This was the first slide improvement completed by the District, and it proved to be successful, as the sliding has completely stopped. The procedure used was to remove some of the slide material and dig three trenches up the slope as shown in Fig. 4 to be used primarily as outlet drains to the perimeter interceptor drain also shown in Fig. 4. A corrugated plastic pipe was installed in the perimeter and outlet drains and they were filled to the surface with a gravel envelope material. As mentioned above, this method has proven to be quite successful, especially when the flowing water is evident, which makes it easier to locate the drains to achieve maximum effectiveness.

Fig. 4. Completed french drain work on a slide which jeopardized a state highway and railroad track above the slide.

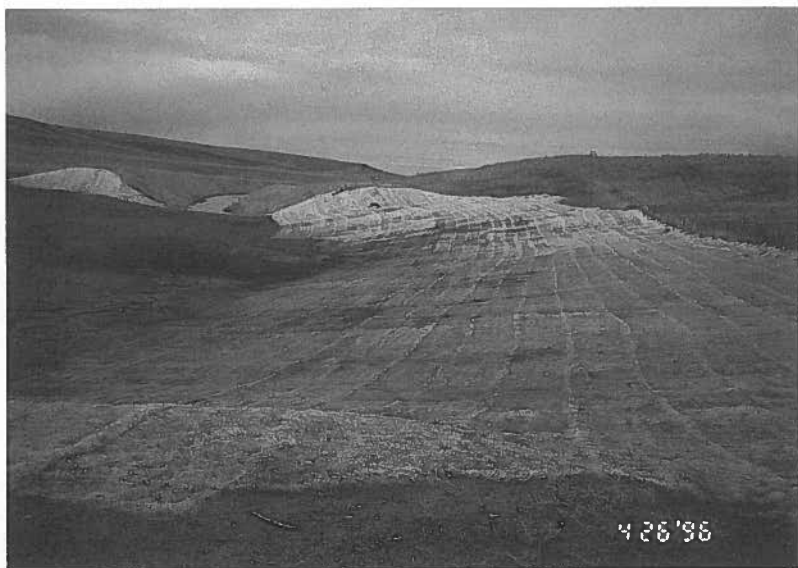
Fig. 6. An overall view of the completed work shown in Fig. 5. The area has been seeded and a mat installed to prevent erosion.

Another successful method used has been the placement of a conduit in the channel where sliding has occurred. An illustration of this work is shown in Fig. 5 displaying installation and Fig. 6 showing preparation for seeding with grass. The channel, in this case, was a 40 cfs outlet channel where sliding became apparent in 1994. The first method tried was to unload the canal banks of the slide material and change the slope to about 4:1 without installation of drains; the slide reoccurred in about two weeks. Since the slide was encroaching on the channel right-of-way, it was decided to install a 3' by 5' (0.97 meter by 1.61 meter) box culvert to eliminate the slide problem over a length of about 450 feet (145.2 meters). This work was quite costly (U.S. \$250,000); however, it has been successful and will not likely cause future problems. This method may be cost prohibitive in a large, long channel; however, it should be considered for shorter, smaller channels.

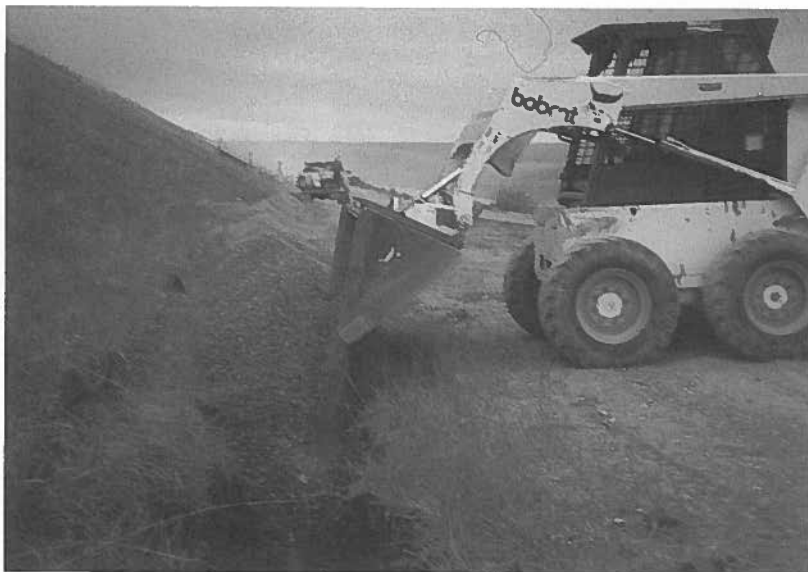
This deficiency is being corrected by the installation of a six-inch (15 cm) diameter slotted corrugated pipe tubing into the open drain, which is excavated to the desired grade at an average depth of about four feet (1.29 meters). A graded gravel envelope material, ranging in size from 0.75 inches (1.9 centimeters) to a 200 screen size, is placed in the trench so that the drain tubing is enveloped in at least four inches (10.2 centimeters) of the material. The graded envelope material is brought to about 1.5 feet (0.48 meters) above normal ground surface. The purpose of extending the gravel envelope above ground surface is to provide a catch basin for sediment accumulation and removal. Figure 7 illustrates the installation of these drains on the McClusky Canal.

Fig. 7. V drain installation at the outside of the O&M road. Note the drain tubing at the bottom center of the picture.

This improvement program has been very effective in providing drainage for the O&M roads and intercepting and draining surface and groundwater from the berm area. Many of the O&M roads are now passable in a timely manner throughout much of the year, and the general condition of the roads and berm areas have improved dramatically, resulting in a significant savings of time and money. Prior to the installation of these drains, sloughing and sometimes total collapse of the O&M roads were experienced; this problem is now minimal.

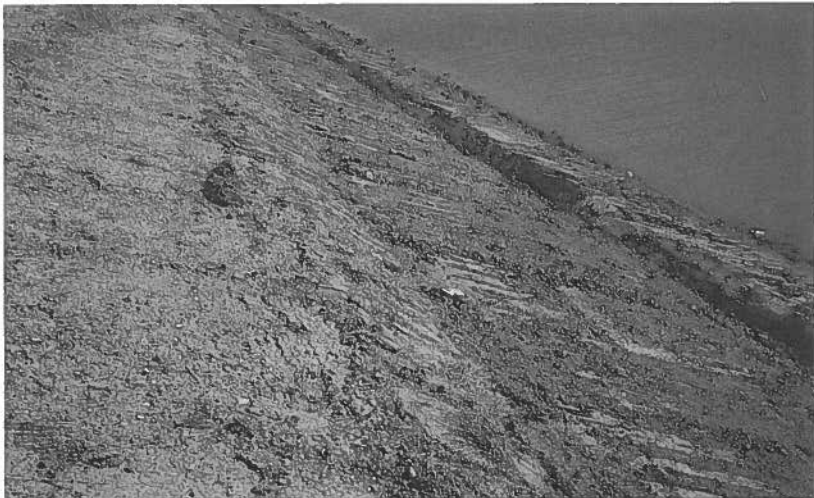
**Fig. 10.** Organic and other foreign material is removed followed by placement of material on the bank. The bank is then smoothed, compacted and a keyway (upper right) installed to prevent slippage of material.

The installation of the graded crushed material has been primarily done under contract, and the cost has varied from US \$17-20 per linear foot (0.32 meters) of canal. A procedure for the installation of the beach belting material, which is quite effective and efficient has been developed. It consists of clearing the bank of vegetation and other material about ten feet between stipulated elevations and hauling in and placing selected material to obtain a smooth side slope. The bank is then watered and compacted with a roller attached to a backhoe. About a 12-inch (30.5 cm) keyway is cut into the bank at the bottom elevation and sloped upward to prevent slippage of the beachbelting material. A permeable geotextile material is then placed on the canal side slope to hold the soil in place. A front-end loader or conveyor attached to the rear end of a dump truck distributes the beachbelting material evenly on the geotextile and canal bank.

Figures 10 and 11 illustrate the installation of the beachbelting material on the canal side slopes and Fig. 12 shows the completed work.

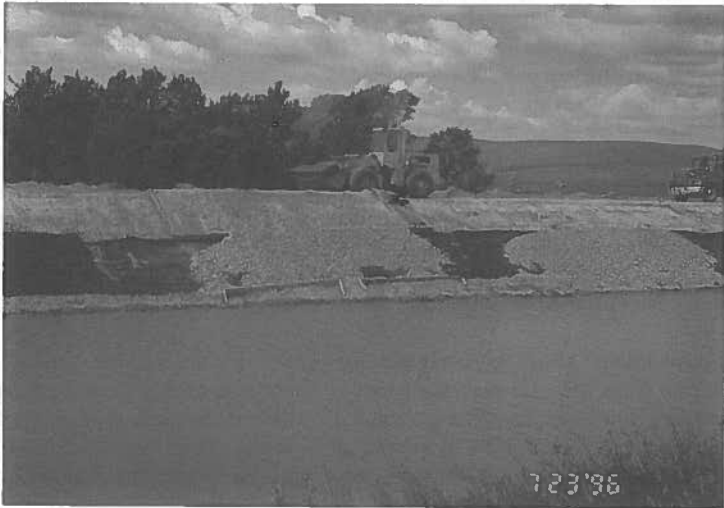
**Fig. 11. The beach belting material being placed on the geotextile on the canal bank.**

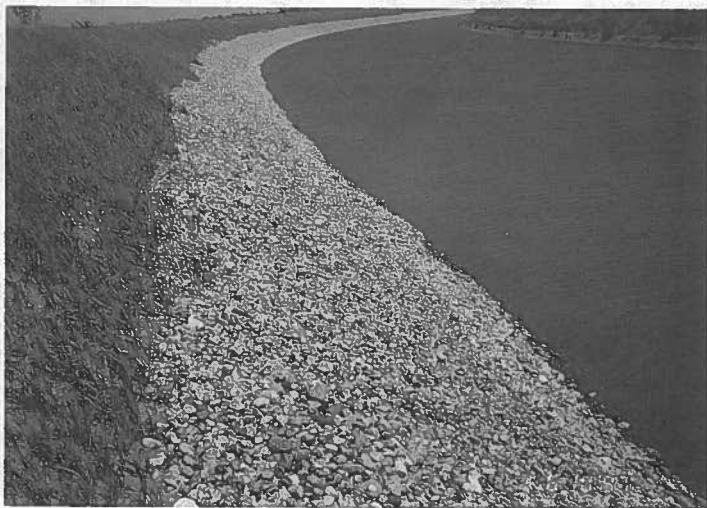
**Fig. 12. The beach belting placement is complete.**
