**Survey of Selected Wetlands within the
Bureau of Land Management
White River Resource Area
(Rio Blanco, Garfield, and Moffat Counties, CO)
2008**

Prepared for:
White River Field Office
220 East Market St.
Meeker, Colorado 81641

Prepared by:
Denise Culver, Ecologist
April 2008

Colorado Natural Heritage Program
Warner College of Natural Resources
8002 Campus Delivery
Colorado State University
Fort Collins, Colorado 80523-8002
Email: heritage@cnhp.colostate.edu
<http://www.cnhp.colostate.edu>

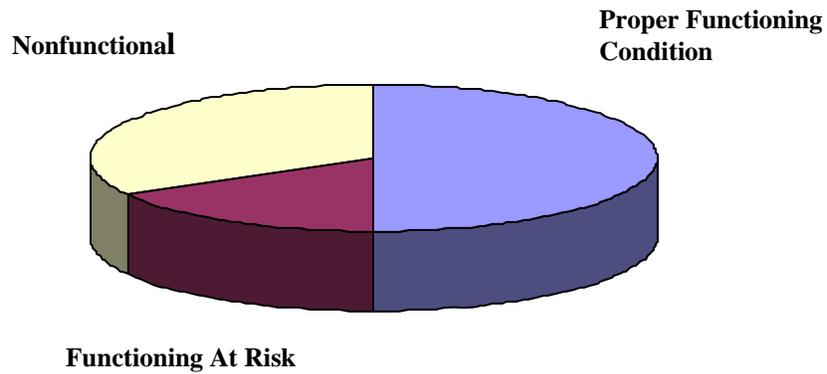
Figure 2. Summary of Proper Functioning Condition analysis.

Twelve wetlands were surveyed from June 2007 through September 2007 (Appendix A). Six were determined to be Proper Functioning Condition, 2 were Functioning At Risk, and 4 were determined as Nonfunctional (Table 4, Figure 2).

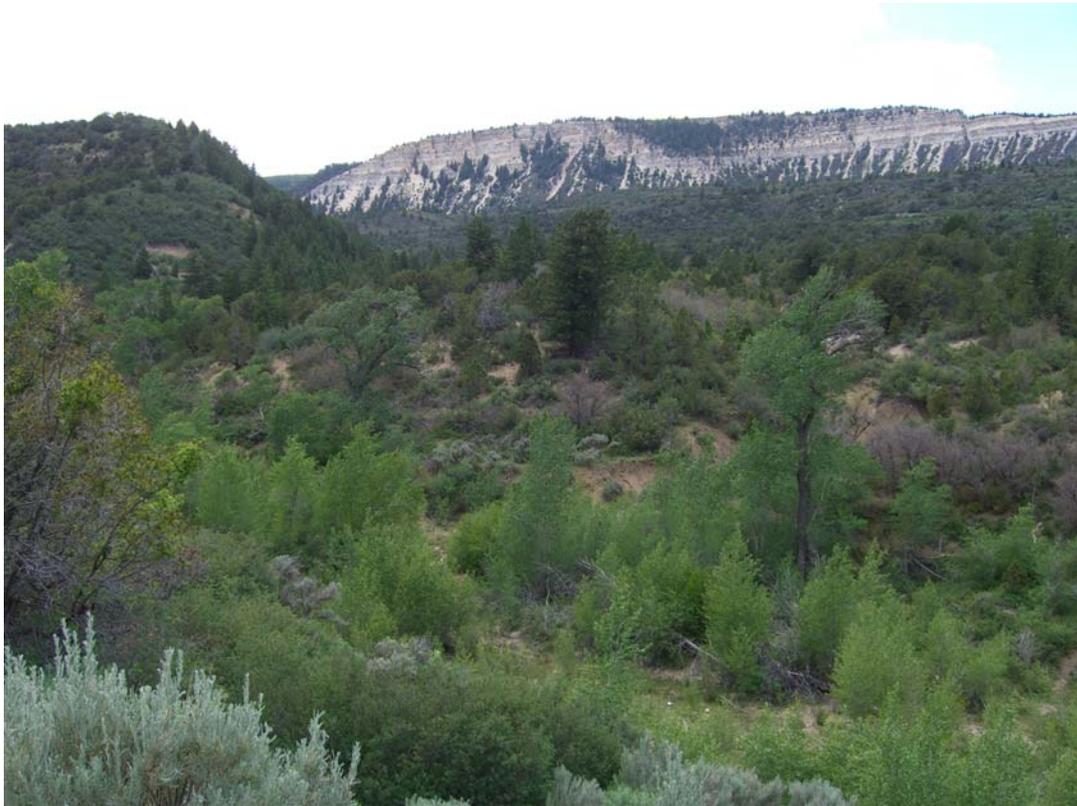
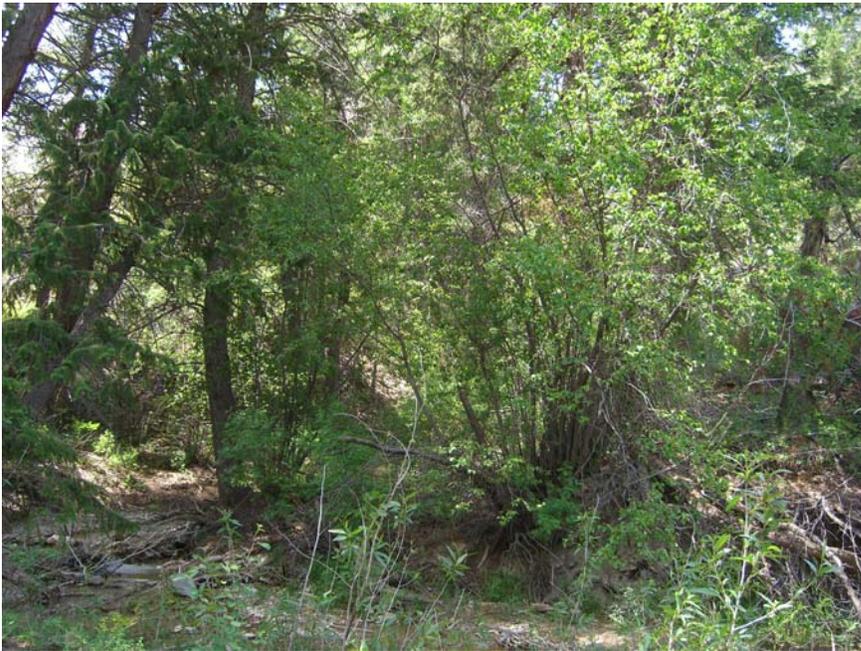
Lake Creek Spring.

Did not locate the spring discharge area, likely either hidden by vegetation or further upstream. The wetland is dominated by birch with forb understory. No hydrological alterations present, very little domestic livestock grazing. Bear sign observed

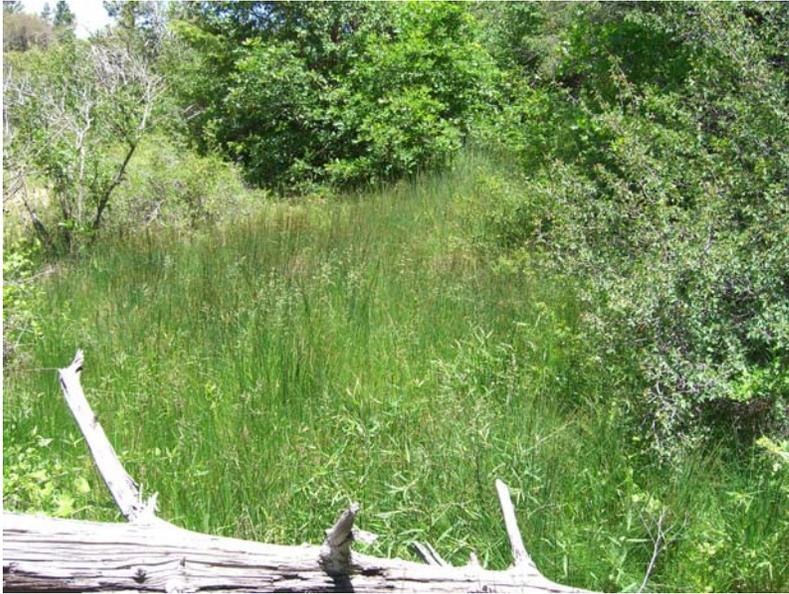
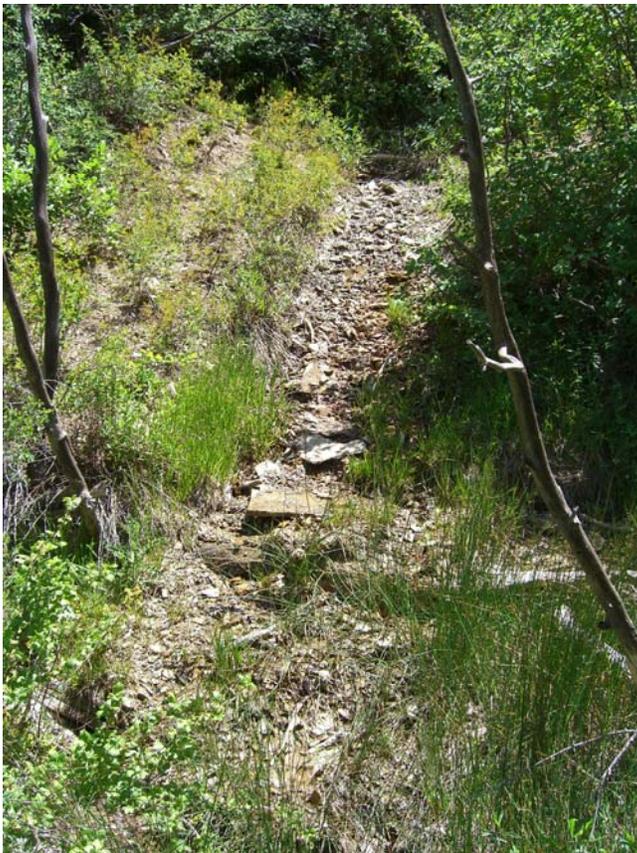
Soldier Creek Spring.

Spring is located above Soldier Creek on east slope. It is dominated by graminoids. Ground is saturated, but no open water observed. No hydrological alterations present, very little domestic livestock grazing. Bear sign observed

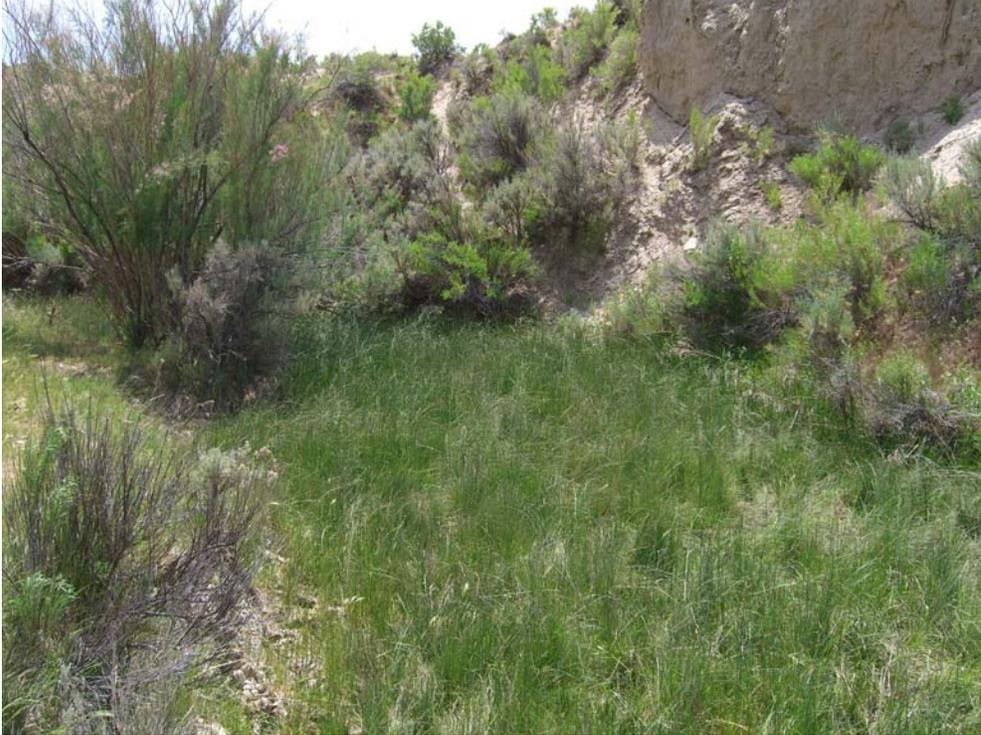
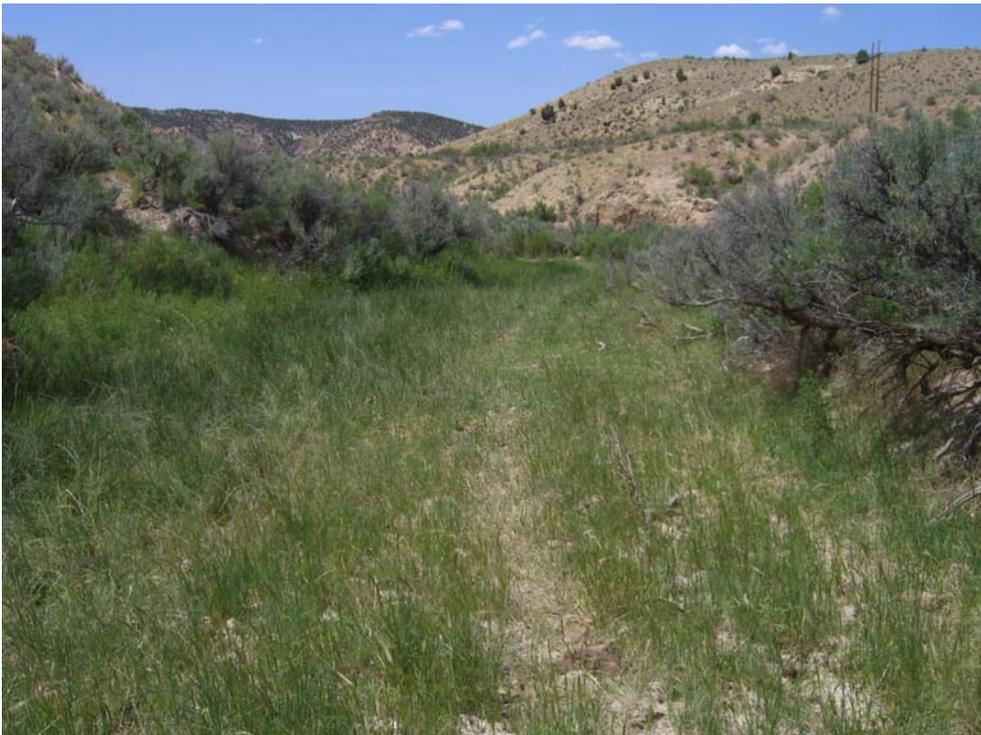
Monument Wash.

Spring is located just north of Hwy 64. No open water noted, but soils indicated permanent saturation. Dominated by bulrush and spikerush. No hydrological alteration observed, light grazing evidence.

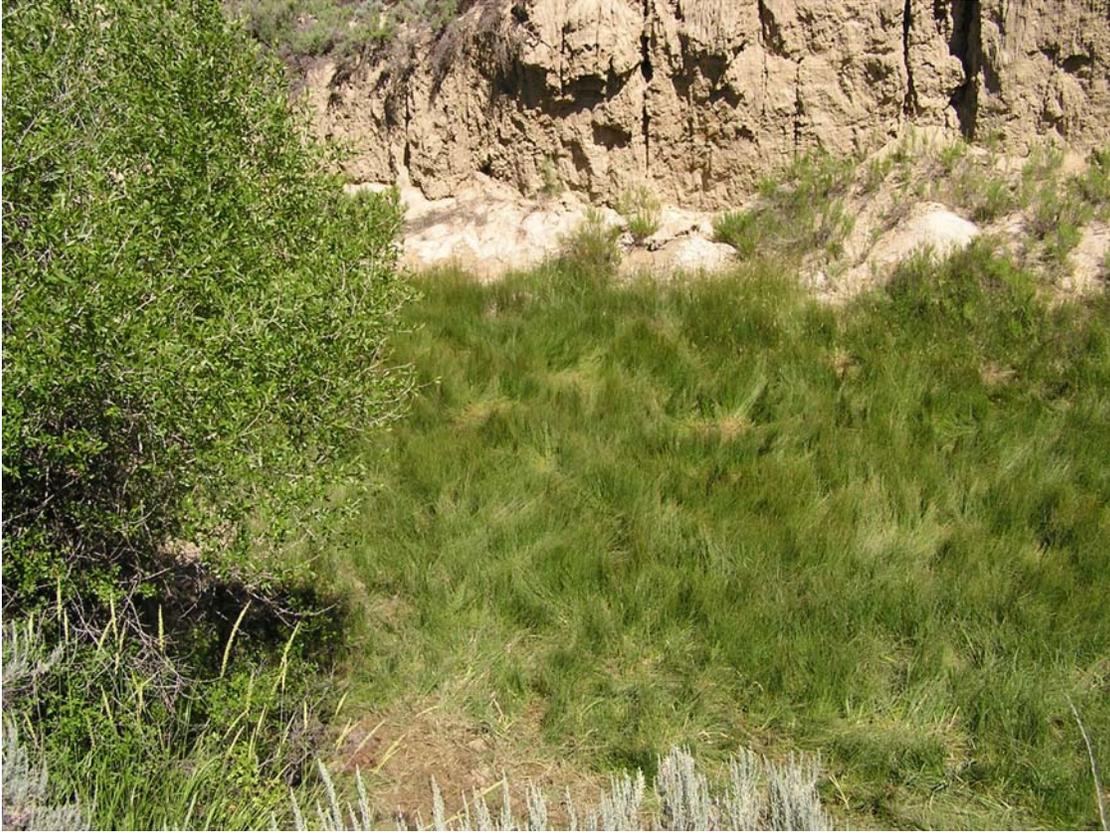
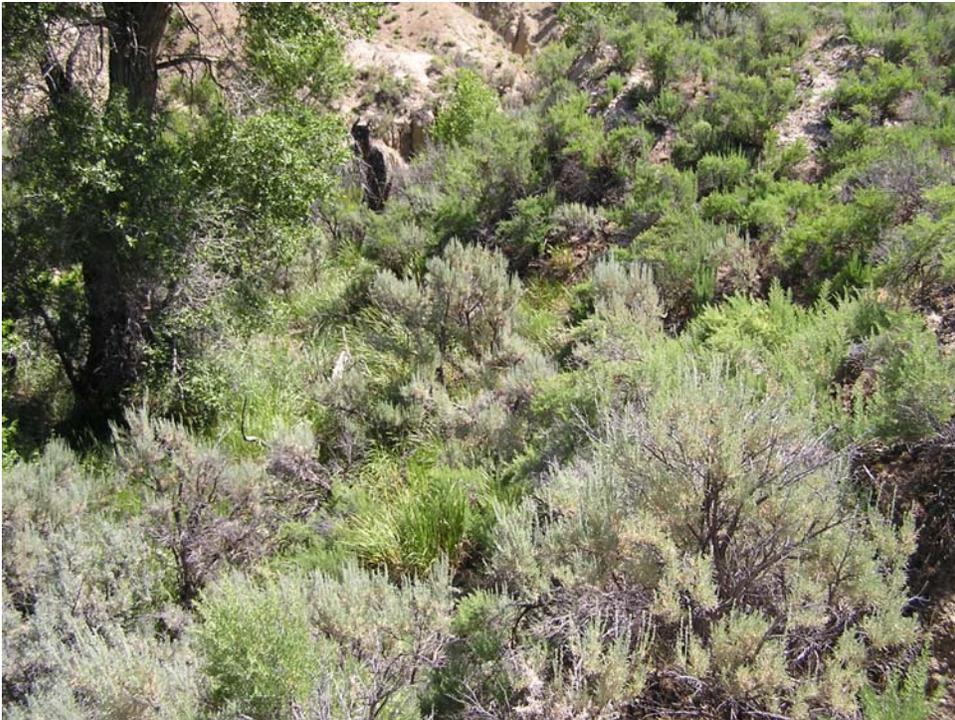
Crooked Wash.

There is evidence of grazing, but majority of activity is in Crooked Creek Wash, not directly impacting the spring.

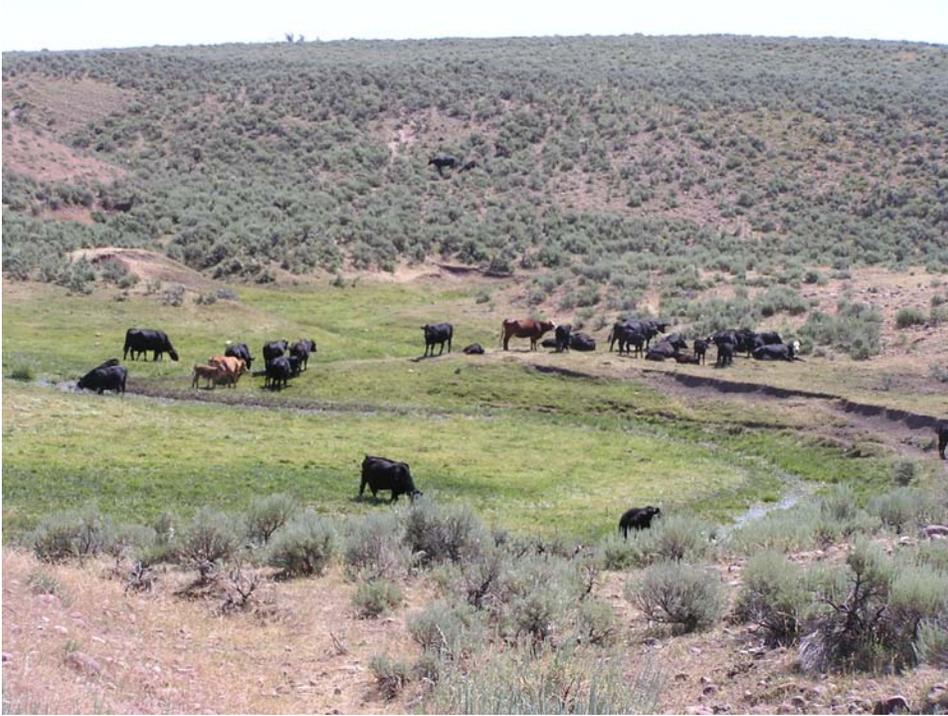
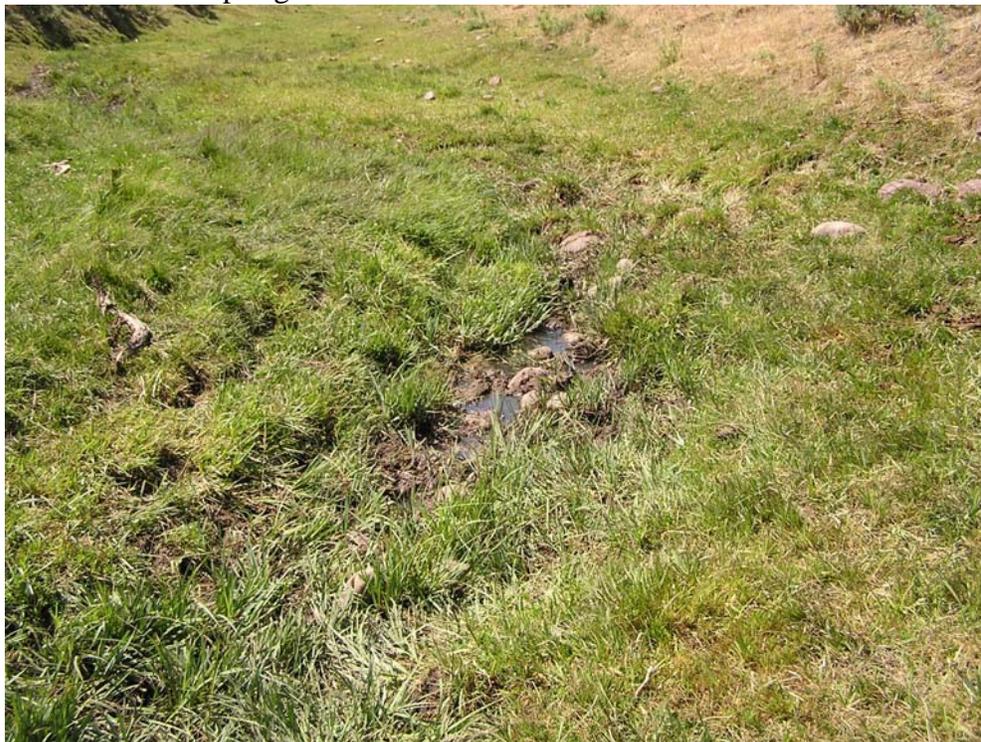
Meadow Creek Spring

Wetland is not functioning at its potential due to cattle grazing and spread of non native plants

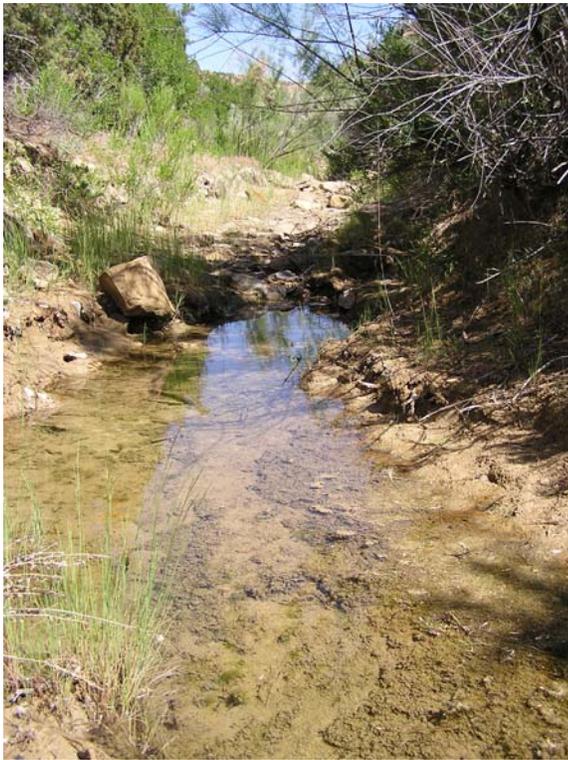
Chase Draw, only open water next to county road.
